UK AIRPROX BOARD

**Analysis of
Airprox in UK Airspace**
Report Number 5
July 2000 to December 2000

Report by the UK Airprox Board,
'Analysis of Airprox in UK Airspace'

(July 2000 to December 2000)

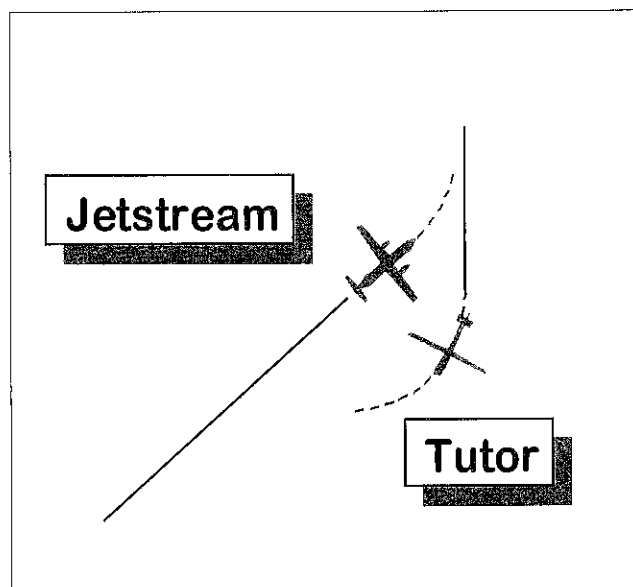
THE JETSTREAM PILOT reports heading 020° at 190 kt having levelled off at FL 70 with cloud 4000 ft above and 500 ft below. He was receiving a RIS from Cranwell on 250·05 and was advised of traffic in his 1 o'clock 5 NM at 6500 ft. He and his student searched for it without success and ATC gave an update: 1 o'clock 3 NM, 6500 ft manoeuvring. It was still not visible and when ATC advised that it was at 1 NM he broke left and saw the ac, a Grob Tutor, during the manoeuvre. It was white and very hard to see against the white/grey background despite a careful search in the right area.

Members were briefed on the HQ EFT findings from their study, which concluded that the problem of the Tutor's lack of conspicuity in certain conditions appeared to be insurmountable. The SSR trial, however, had been successful and the procedure implemented whereby the ac type could now be passed in traffic information so that other pilots could be warned of the presence of an ac they might not be able to see easily. In this Airprox, while members understood that the Jetstream pilot filed the Airprox to draw attention to the Tutor's lack of conspicuity, they concluded that it had occurred

Cause: The Jetstream pilot flew into conflict with traffic of which he had been warned.

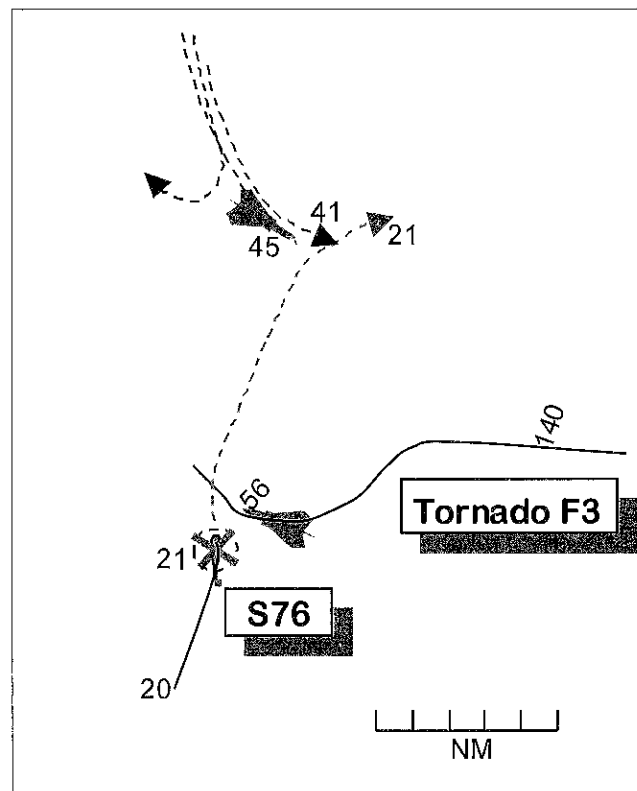
THE S76 PILOT reports heading 010° at 145 kt en route to an offshore platform at 2000 ft RPS and receiving a RAS from Anglia Radar on 125-275. He followed various avoiding action turns given with a sense of urgency by the controller to avoid several military ac in the area, despite which no ac was

seen. Traffic had been reported 11 NM away at FL 85 descending and then less than 500 ft above and 1 NM away; he considered the risk of collision was high.

Cause: The Tornado's flightpath caused concern to the Anglia Radar controller and to the S76 pilot, compounded by incomplete information from the Neatishead WC to the Anglia Radar controller, each of whom was providing a different radar service.

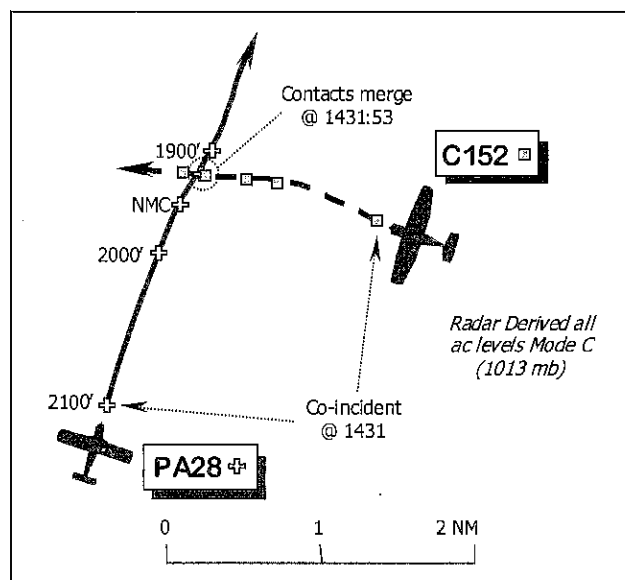
THE C152 PILOT reports conducting the navigation section of a PPL skills test, flying from Blackbushe to Chippenham, at 2500 ft QNH (1024mb). The candidate was flying the ac from the LHD seat. They were receiving a FIS from Farnborough LARS and squawking A 0441, but Mode C is not fitted.

It was apparent that both pilots were operating under VFR in good weather conditions and the relative geometry of their respective courses should have enabled each to sight the other's ac. Under the 'Rules of the Air' the PA28 pilot was required to give way in this situation. However, that presupposed he had seen the Cessna early enough to do so, which he had not. Instead he had closed to a range of 500 m, quite close, before spotting the C152. This left sufficient time to look to Port, clear his L turn and look down, before he committed himself to this avoiding action. This late sighting members concluded was part of the cause. Though the instructor in the RHD seat of the C152 would have had to look cross-cockpit to see the PA28, it should have been visible to him as they converged, but it was not spotted until after it had passed below. This made it effectively a non-sighting and was agreed by the Board to be the second part of the cause. A further point on 'right of way' was not to assume anything. Pilots must be alert to other ac and be prepared to take action to avoid a collision if the other pilot does not appear to be 'giving way' as might be required by the geometry of the situation. A GA pilot member was concerned at the division of lookout within the C152. Here was a salutary lesson - although the student in the LHS should have had a good searching look around for other traffic before going 'heads-in' to update the flight log, whilst the student was doing this, the onus on 'searching' passed to the instructor.

Cause: A late sighting by the PA28 pilot and a non-sighting by the C152 pilot.

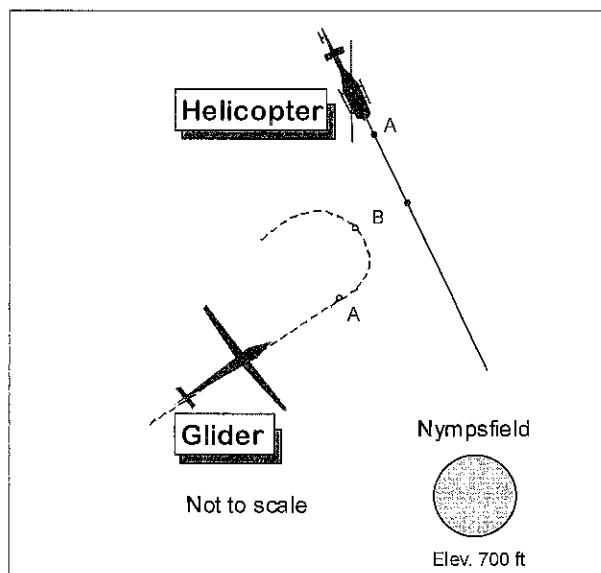
THE DG 505 GLIDER PILOT reports joining the Nympsfield circuit on a dual local training flight in a slow descent passing 1000 ft QFE (1700 QNH) at 50-60 kt. The visibility was 18 km, 2000 ft below cloud, in VMC. His glider was white and he was listening out on frequency 129.9. When 1 NM NW of the gliding site on a NE heading, with his student flying the ac, he saw a helicopter, possibly a Jet Ranger, 'gaudy' in colour, 250 m ahead (see diag. point A). He took control and turned L as rapidly as possible; the helicopter did not alter course and passed 150 m away on a steady SSE track at the same level (diag. point B). As the student pilot had not seen the conflicting ac the instructor thought that they would probably have collided if he had not taken control. He also stated that the conflicting helicopter had been seen flying through the area

AIS MILITARY reports that despite exhaustive enquiries the identity of the reported helicopter remains unknown. Replays of the Clee Hill, Burrington and Heathrow radars do not show either the glider or helicopter. A radar data analysis and comprehensive procedural trace including ATS units, airfield and airstrip operators as well as 16 helicopter operating/leasing companies failed to identify the reported ac. Exceptionally, therefore, the helicopter remains untraced.

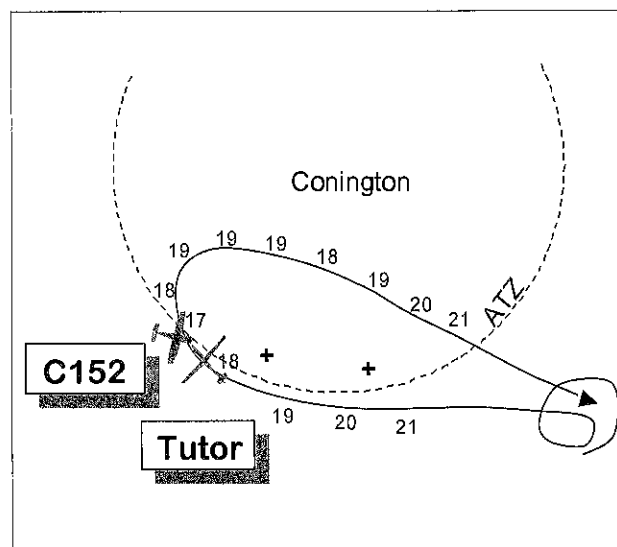
THE CESSNA 152 PILOT reports heading 100° at 90 kt having just rolled out downwind for RW 28 LH at Peterborough (Conington), at 1000 ft QFE. His ac was white with a blue stripe. He saw a G115 in RAF colours 200 m in his 1 o'clock crossing right to left ahead; he took control from his student, descended and turned right 20-30° to avoid it. It passed 200 ft above and 100 m away in a right turn which took it back across his track and out of the ATZ again. He considered the risk of collision was medium; the ac was light coloured against a light background and gave poor contrast and he was closely monitoring his student on his final dual before first solo. He added that over the last 5 months Wyton-based G115s have frequently infringed the Conington ATZ despite numerous conversations with them; this was the closest he had been to an incident in 20 years of flying. He was in communication with Conington Radio and his transponder was at standby.

Members were advised that the student pilot of the Tutor had been debriefed about avoiding the Conington ATZ and agreed that while his choice of field for a PFL was clear of the ATZ, it did not allow for his apparent disorientation when climbing away and his subsequent proximity to the ATZ. The Board was also advised that the training unit had taken on board the need to avoid Conington and hopefully these 2 aviation neighbours would be able to co-exist safely in future. As to the incident itself the Board considered that the ATZ infringement was not the cause of the Airprox but more the result of it in that the Tutor only actually entered the ATZ during his avoiding action. Members considered that the primary cause was late sightings of the other ac by both pilots. At the same time it was not surprising that the Cessna pilot had not seen the Tutor earlier as its lack of conspicuity had already become a matter of concern to the RAF.

Cause: Late sighting by both pilots on the boundary of the Conington ATZ.

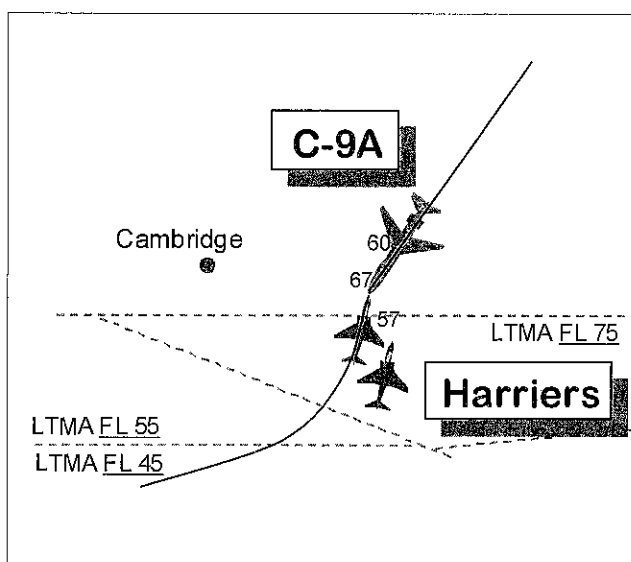
AIRPROX REPORT No 143/00

THE C-9A PILOT reports heading SW between MLD and BKY, cleared by London Radar to descend to 3500 ft and fly at 310 kt, destination Northolt. Although receiving a RAS he was not warned of traffic which closed from ahead in a climb, triggering a TCAS 'Climb' RA. He saw the other ac, a pair of Harriers, pass about 1000 ft below after he had pulled up.

Cause: Conflict of flightpaths in Class G airspace resolved by both parties.

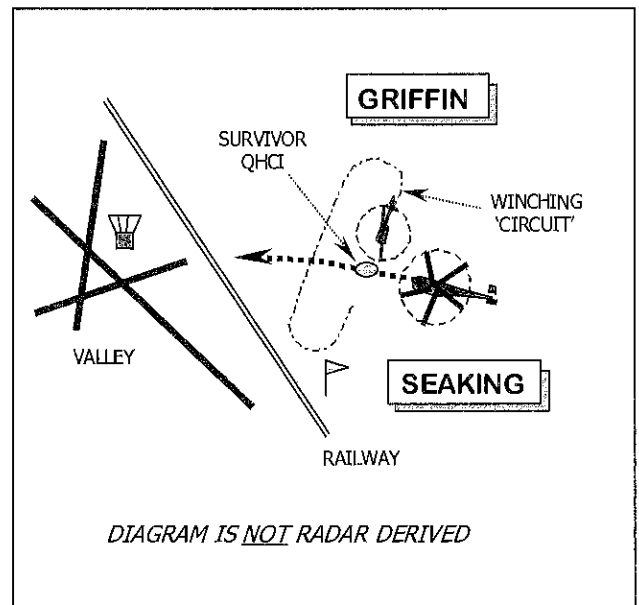
AIRPROX REPORT No 144/00

THE GRIFFIN HT1 HELICOPTER PILOT, a QHI, provided a comprehensive report stating that he was conducting a pilot winching training sortie in an area of scrub land on the golf course just to the E of Valley aerodrome. He was occupying the LHS with the student 'handling' pilot in the RHS. The helicopter has a black & yellow colour scheme, position lights, upper red anti-collision beacon and HISLs were all on, and he was squawking 3/A 3764 with Mode C, whilst in receipt of a "listening watch" from Valley TOWER on a 'quiet' frequency for the instructional sortie.

pilot and the Board endorsed the concerns expressed by PTC regarding the Griffin's colour scheme. The low speed and height of the Griffin, with little relative movement to the Sea King, would have all impeded visual acquisition without the 'heads up' that traffic information should have provided. Moreover, controller members noted the apparent absence of any circuit information to the Sea King pilot from the ADC. From the Griffin pilot's perspective there was little he could have done to preclude this close encounter. Denied the benefit of an RT 'cue' on the quiet frequency and concentrating on the winching in progress he was placed in a difficult position with little room to manoeuvre when the Sea King was first spotted as it unexpectedly flew past. Thus the Sea King PF was probably the only one who could effect the outcome, when he eventually saw the Griffin and effected an avoiding action "*gentle*" L turn. With all this in mind members agreed that this Airprox was caused by a late sighting by the Sea King pilot of the inconspicuous Griffin, resulting from a lack of traffic information from the ADC.

Cause: A late sighting by the Sea King pilot of the inconspicuous Griffin, resulting from a lack of traffic information from the ADC

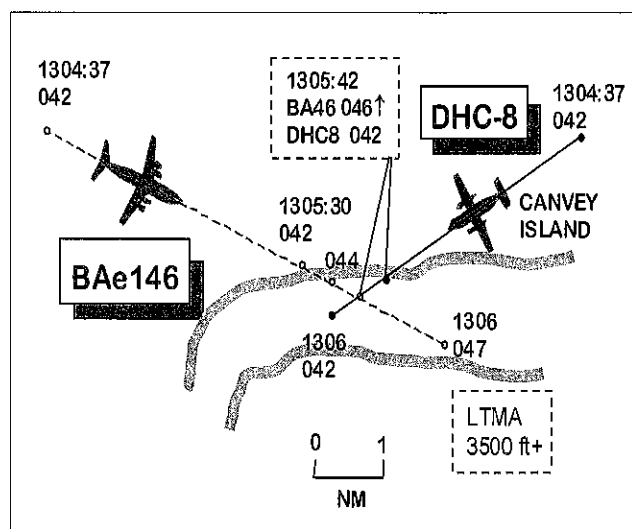
THE BAe146 PILOT reports flying en route to Zurich to the NE of London City level at 4000 ft heading 070° in IMC; TCAS indicated traffic at 11 o'clock coming towards his ac, range 12 NM at the same level. As this traffic closed to 6 NM, he attempted to contact ATC but was unable due to RT congestion. Shortly thereafter a TCAS TA then an RA climb was received; the weather was broken cloud and the traffic could be seen on his left handside and slightly below. A climb was commenced immediately and after passing the other ac by about 200 - 300 ft vertically he informed Thames Radar of his TCAS action and descended back down to 4000 ft.

Cause: The Thames Radar controller did not maintain standard separation between the BA46 and DHC8.

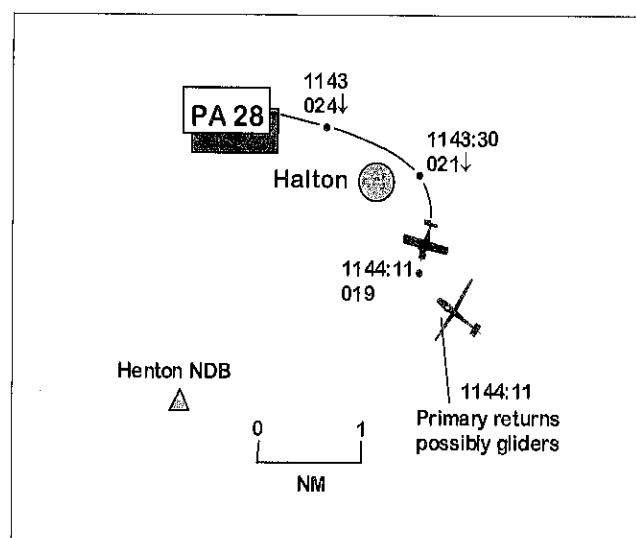
THE LS6C GLIDER PILOT reports operating in the Halton Aerodrome ATZ at 45 kt, 1500 ft QFE 997 (QNH 1011) on a solo flight. He was receiving a listening watch from Halton Radio on 130.42. The visibility was >10 km, 700 ft below cloud in VMC. The glider was white with blue marks. Whilst ridge soaring just SE of the aerodrome, he commenced a lookout scan over and behind his left wing for any traffic owing to an anticipated L turn away from the ridge towards the airfield. Nearing completion of the scan L to R, another pilot reported an ac in conflict which he saw 200 m away heading straight towards him at the same level. The ac appeared to commence a L turn so the glider pilot turned L and commenced a dive, passing 100 m clear horizontally at the same level. The other ac was a low wing single engine type with fixed uc

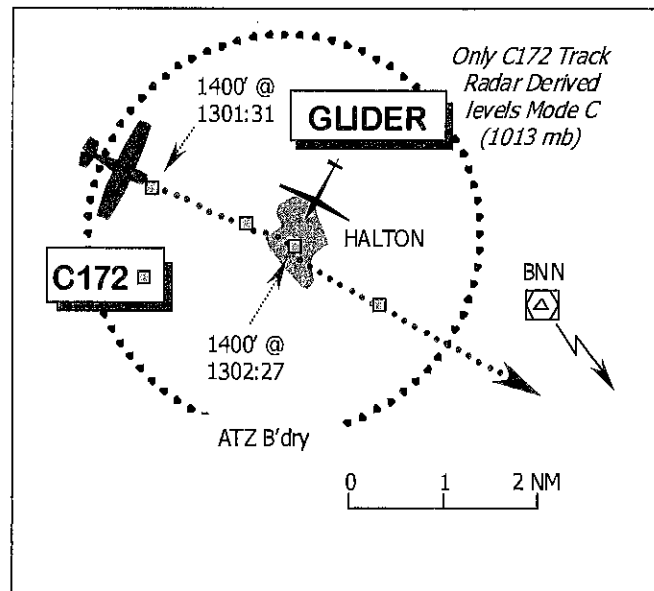
THE KA13 GLIDER PILOT reports that he was being winch launched at Halton Aerodrome heading 200 (M)° at 60 kt for an instructional sortie with a student. He climbed to 700 ft Halton QFE (998 mb) on the winch, about 800 ft below cloud, when the winch driver spotted a single engine high wing light ac overflying the launch area heading about 125° (T) and aborted the launch. He saw the other ac at about the same time as the winch operator. The light ac passed about 200 m astern and about 300 ft above his glider at the closest point with a high risk of a collision. His workload was high after the launch was aborted, but the student was not aware of the other ac at all.

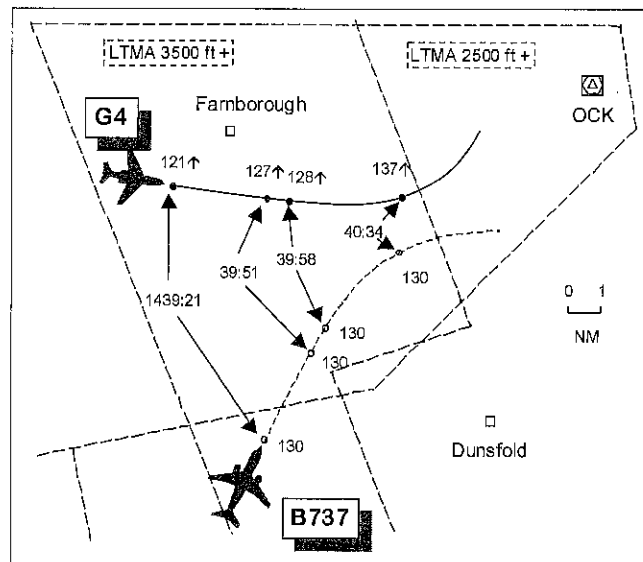
THE B737 PILOT reports flying inbound to Luton from Barcelona heading 035° level at FL 130 at 280 kt. The visibility was 50 km in VMC. The LATCC TC controller issued an avoiding action R turn onto heading 090° with the conflicting ac reporting a TCAS RA; the other ac was not seen.

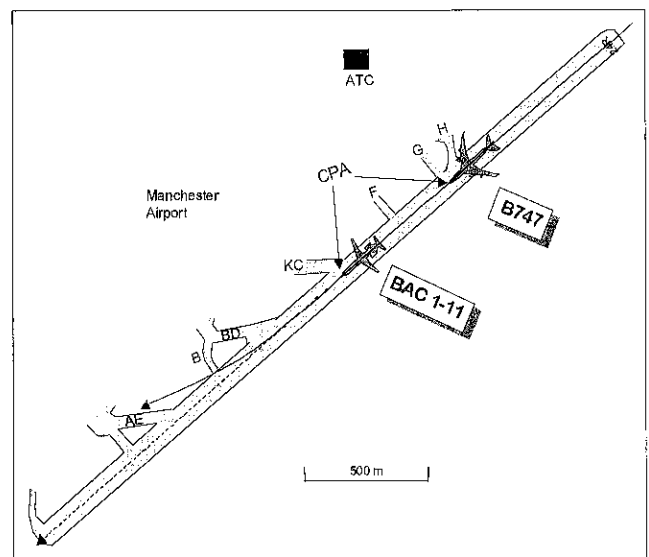
Date/Time: 16 Sep 0716 (Saturday)
Position: 5321 N 0216 W (Manchester Airport)
Airspace: CTZ (Class: D)
Reporter: Manchester ATC

<u>First Aircraft</u>	<u>Second Aircraft</u>
<u>Type:</u>	BAC 1-11	B747-41
<u>Operator:</u>	CAT	CAT
<u>Alt/FL:</u>	Take-off	Go around
<u>Weather:</u>	VMC CLBC	VMC CLBC
<u>Visibility:</u>	22 km	NK
<u>Reported Separation:</u>		NK
<u>Recorded Separation:</u>		480 m

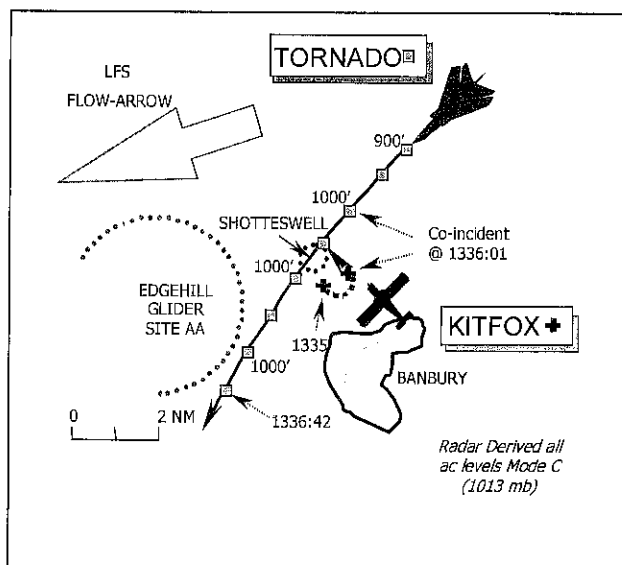
THE DENNEY KITFOX Mk II PILOT reports that his ac colour scheme is black with a yellow sunburst on the upper mainplane and the HISL was on. He was flying downwind in the circuit for RW15 at Shotteswell aerodrome, N of Banbury. Whilst heading 330° (M) at 60 kt, level at 600 ft QFE (982 mb), he was looking at the RW threshold and planning the turn onto base leg, when he first spotted the camouflaged fast jet. It emerged from under his port side having flown 300 ft below his ac with minimal horizontal separation and with a "fairly high" risk of collision. He adds that no avoiding action was taken as the jet was already clearing to the SW when first seen.

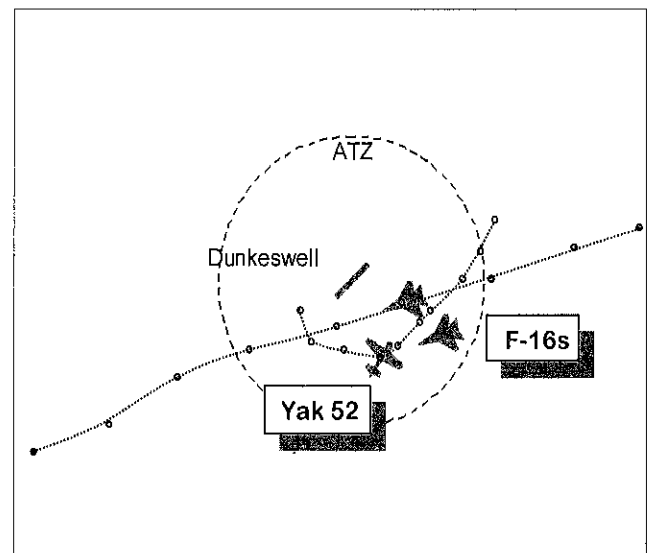
AIRPROX REPORT No 151/00

THE YAK 52 PILOT reports heading 050° at 110 kt downwind LH for RW 23 at Dunkeswell when he saw a grey F16 pass along the runway at about 1000-1200 ft agl. Almost immediately a second F16 passed directly above him by about 200 ft, on a

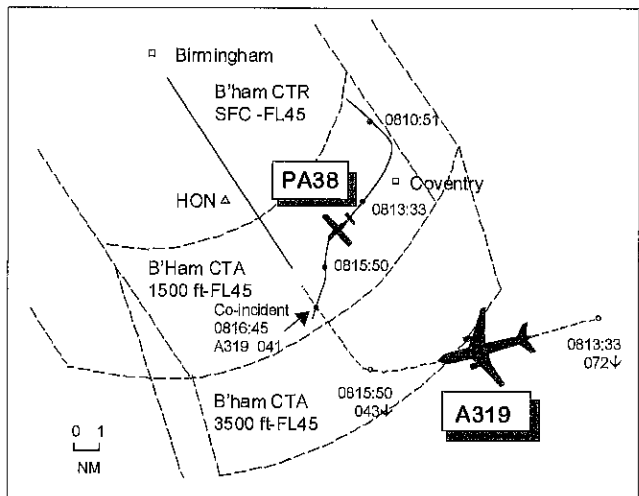
THE A319 PILOT reports heading 330° at 180 kt established on the ILS RW33 at Birmingham. He was receiving an APR service from Birmingham ATC on 118.05 MHz; the weather was CAVOK. On commencing descent on the glidepath, he received a TCAS TA, "traffic", on crossing traffic which was squawking but with no Mode C. The ac was seen to be a PA38, which passed directly underneath by 600-700 ft. He took no avoiding action but assessed the risk of collision as medium as he was commencing descent on the ILS.

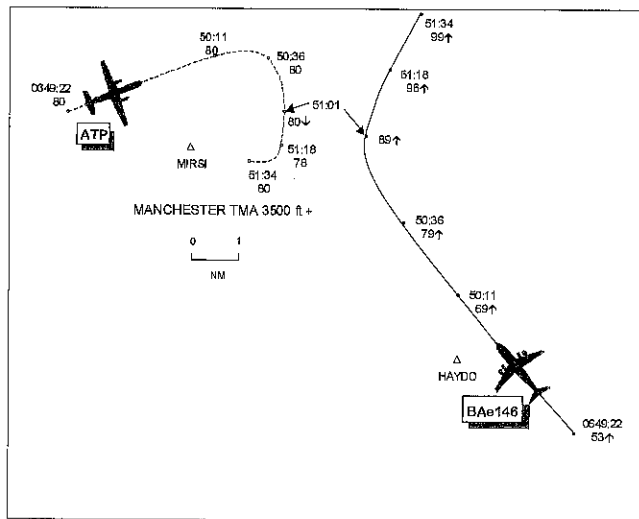
THE ATP PILOT reports flying in the MIRSI hold at 160 kt level at FL 80 in VMC. Whilst turning outbound at MIRSI he received a TCAS RA, "monitor vertical speed", which was followed by an ATC avoiding action R turn onto heading 270°. The other ac was seen on TCAS to pass 1.5 NM away at the same level and he assessed the risk of collision as medium.

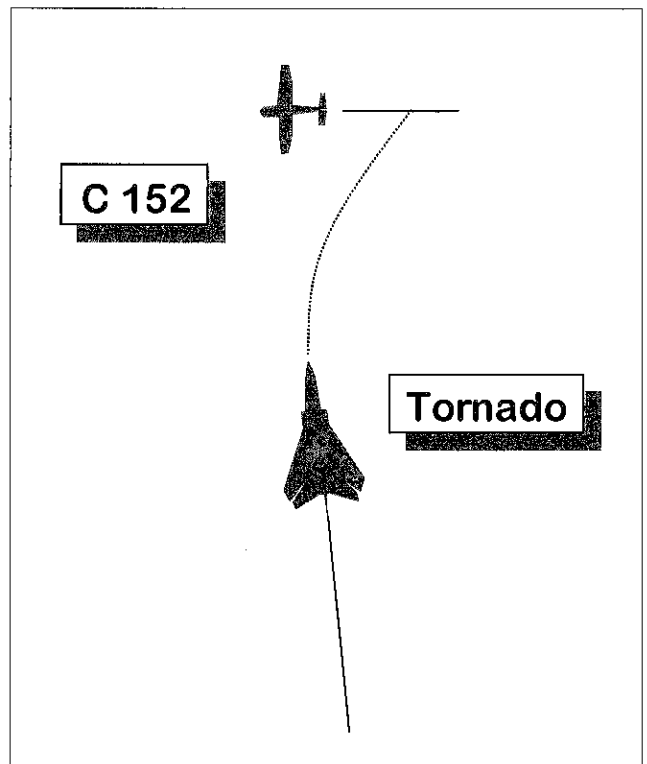
THE CESSNA 152 PILOT reports heading 270° at 90 kt during a photographic sortie with a photographer on board. He was receiving a FIS from Inverness on 122-6. While heading W by Beaully Firth at 600 ft he saw 2 Tornados cross L to R ahead of him by 400 m. Minutes later he could see one in the distance and then the other one came over a ridge towards him. He commented that he was in no position to get out of its way and it passed some 2-300 m astern of him. There was no time for avoiding action and the risk of collision was high.

a collision avoidance system, why the Tornados could not use the restricted airspace 20 NM to the N, and why Lossiemouth had not picked him up on radar and warned the Tornados.

HQ STC comments that although the Tornado crew had complied with the local requirement for all Lossiemouth-based ac to be in radio contact with Lossiemouth Departures or VHF Approach when operating in the vicinity of Inverness, the Cessna had not requested a service from the unit and, more importantly, was not visible on radar. The Cessna, therefore, was not called to the Tornado crew. Consequently, the onus was on both crews to see and avoid. The increased cockpit workload on approaching Tain Range may go some way to explain the late sighting by the Tornado crew; nevertheless, there was still sufficient time for them to take avoiding action.

Cause: Conflict of flightpaths resolved by the Tornado pilot.

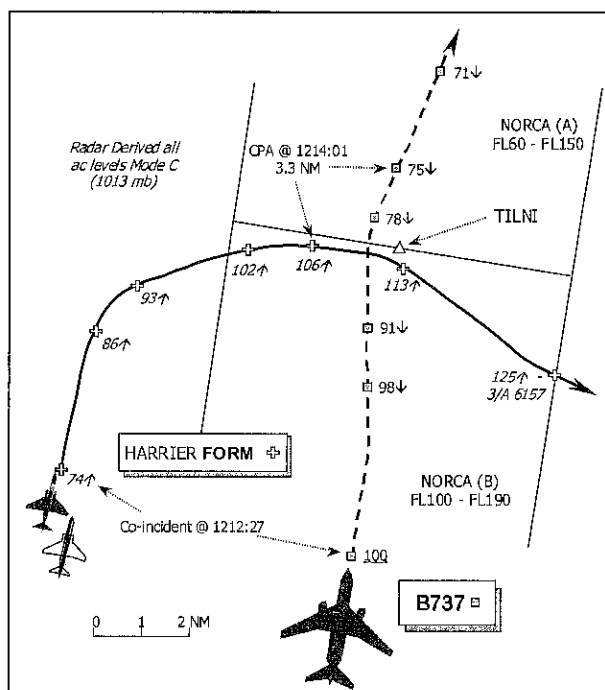
THE NEWCASTLE APPROACH RADAR CONTROLLER (APR) reports that the B737 had recently been identified 32 NM S of Newcastle, descending to FL 100 within the Northern Off-route Co-ordination Area (NORCA), inbound to Newcastle and placed under a RAS. The B737 was tracking along the NORCA centreline approaching TILNI and the crew had been instructed to descend to FL 60 on a heading of 005° to remain within the NORCA. An ac squawking A7001 was observed about 8 NM to the W of the B737 on a parallel track climbing through FL 88; the B737 crew was advised, but shortly afterwards the unknown ac turned towards the B737. An avoiding action R turn to head 040° was given to try to maintain separation, but the A7001, climbing through FL 109, then crossed about 1.5 NM, he thought, behind the B737, before crossing overhead TILNI, climbing through FL 116. The squawk then changed to A6157, a London Radar code, who was contacted by landline to obtain the details of the other ac. LATCC (Mil) and the B737 crew were advised an Airprox would be filed.

ATSI reports that the B737 was inbound to Newcastle from London Heathrow. The ac had been identified and was descending to FL 100 on the centreline of the NORCA in receipt of a RAS from the Newcastle APR. The controller observed other traffic 8 miles W of the B737 on a parallel track, squawking 7001 climbing through FL 88 Mode C. Further descent was given to the B737 and shortly afterwards the 7001 traffic turned towards the B737. Avoiding action was passed and the 7001

It was clear from the APR's report and the radar recording that the B737 was initially level at FL 100 - the base level of NORCA (B). Controller members did not think this was sound practice as requiring GAT to fly at the base level appeared to provide no benefit against any unknown traffic operating near to the base of NORCA (B). Moreover, members noted the APR's intention of descending the B737 to FL 60 to keep it within the 'NORCA', but the radar recording revealed that it had been descended out of NORCA (B) before the Harrier started to turn towards the airliner. If the descent was for avoiding

Cause: Controller perceived confliction.

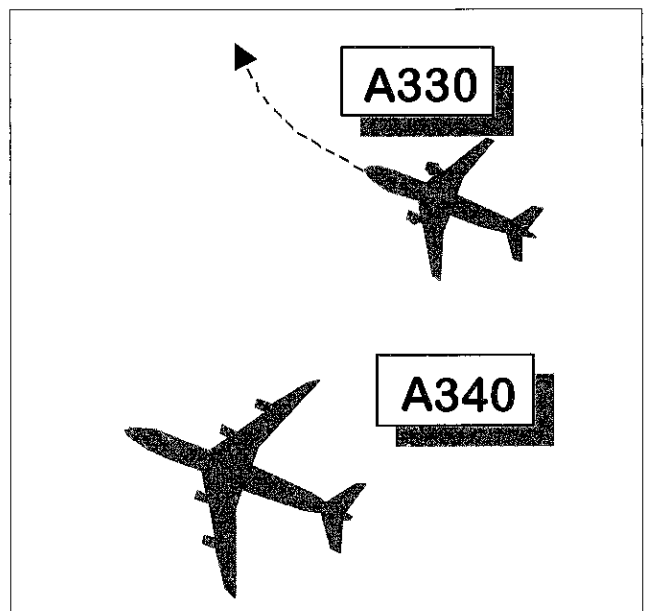
THE A330 PILOT reports heading 290° at M 0.82 and level at FL 370 in clear air. He was aware of the A340 1000 ft below and slightly left which he was slowly overhauling on the same track. He was

heard a TCAS “climb climb” warning and noted that the A340 TCAS symbol had changed colour to red on his navigation display. He looked out and down at the A340 which was some 200 to 300 ft to his left in a nose-up attitude and climbing steeply. The A340 passed through his level before he had time to react to the TCAS warning and the TCAS was still issuing a climb instruction for a short while after the A340 had climbed above him. He continued to monitor the A340 visually and on TCAS. It appeared to reach an apogee above FL 380 although by this time it had fallen behind the A330. Nevertheless, it was still laterally quite close to his track so he altered course to the right to make space for it to descend back to FL 360. After a short discussion with the A340 crew on VHF radio, he broadcast a warning of severe turbulence on the common VHF frequency and then reported both the turbulence and the Airprox to Shanwick on HF Radio. There were no injuries on board the A330 although there were spillages in the cabin.

A340 Data The A340 crew received a TCAS TA at 1409 (ac clock time) alerting them to the proximity of the A330. From 1420:40 the ac suffered increasing variation in windspeed (41 kt) and air temperature (10° C) which in turn caused fluctuations in pitch angle, normal g, altitude, calibrated airspeed, engine RPM and Mach No. One minute later in a particularly vigorous fluctuation, the ac's Mach No briefly increased to 0.87 and within 2 seconds fluctuated between 0.855 and 0.882. This excursion above the Mach 0.86 limit triggered a Master Warning at 1421:40 and automatically disengaged the autopilot. One second later the TCAS issued an RA with a "Descend" audio warning.

For 18 seconds after the autopilot disengaged the ac remained within 200 ft of FL 360 but once AoA law was invoked the ac began to pitch nose-up. The pitch-up continued for 17 seconds reaching a peak of 15° nose-up shortly before the first nose-down sidestick command was applied. Throughout this phase the ac climbed rapidly (reaching a peak rate of about 6,000 ft/min) due to the increase in lift created by the flight control system's capture of a *prot*. (The ac passed FL 370 about 10 seconds after starting its climb.) The ac reached its apogee at FL 384 at 1422:28 where the airspeed had decayed to 205 KIAS and 0.67 Mach even though full thrust had been applied. Throughout the turbulence encounter, the normal g fluctuations were between 0.5g and 1.5g. There were 7 cycles of temperature change, the second cycle being the most severe. The crew subsequently descended back to FL 360 and successfully re-engaged the autopilot and autothrust systems.

Members commended the AAIB on their lucid and detailed report which made it clear to the Board that the cause of the Airprox was that the A340's climb, generated by the capture of 'a prot', was not contained by the crew in time to prevent the ac climbing through the level occupied by the A330. Board members who fly Airbus ac believed that there must have been a breakdown in the clear allocation of responsibilities on the flight deck. In Airbus ac it is essential that only one pilot flies the ac while the other deals with associated duties, and that both pilots fully understand who is handling the ac. There appeared to be an over-riding desire in the A340 flight deck to get the autopilot to re-engage instead of flying the ac. In a conventionally controlled ac, the ac may not be exactly in trim when the autopilot trips out and the natural tendency on autopilot disconnect will be to take hold of the flying controls. However, in a fly-by-wire ac, an autopilot disconnect will leave the ac in trim and it will maintain the last selected attitude so the normal natural tendency of a pilot to reach for the controls in the event of a disconnect may be abated. With the handling pilot's hand on the sidestick, an unwanted climb could have been stopped straight away, cancelling a prot law at the same time. It appeared that for many seconds after the autopilot disconnect, no-one was flying the A340.

Cause: The A340's climb, generated by the capture of ' α prot', was not contained by the crew in time to prevent the ac climbing through the level occupied by the A330.

- 2000-67** The CAA forward a recommendation to the appropriate international bodies to review overtaking procedures in RVSM airspace.
- 2000-68** The CAA forward a recommendation to the appropriate international bodies that they reconsider the need for commanders to inform ATC of all lateral offset manoeuvres of less than 2 NM in Oceanic airspace, irrespective of the reason for the manoeuvre
- 2000-69** The CAA bring this incident to the attention of the Eurocontrol RVSM Safety Assurance Section as soon as practicable so that its impact on the safety case may be properly considered.
- 2000-70** The CAA forward a recommendation to the appropriate international bodies to consider standardising lateral track offset procedures which are independent of wind direction.

In addition, the Board made a recommendation of its own; that the 'turbulence induced' capture of α prot law (in circumstances such as those encountered in this Airprox) should be introduced in Airbus flight simulator training, firstly to establish some sort of norm for the size of level deviations across the Airbus pilot population, and secondly to train pilots to cope promptly with the situation.

Recommendations: (1) The Board strongly supported AAIB recommendations 2000-67 to 70 provided that account was taken with 2000-67 of the different lateral separations used in the radar and non-radar ATC environments.

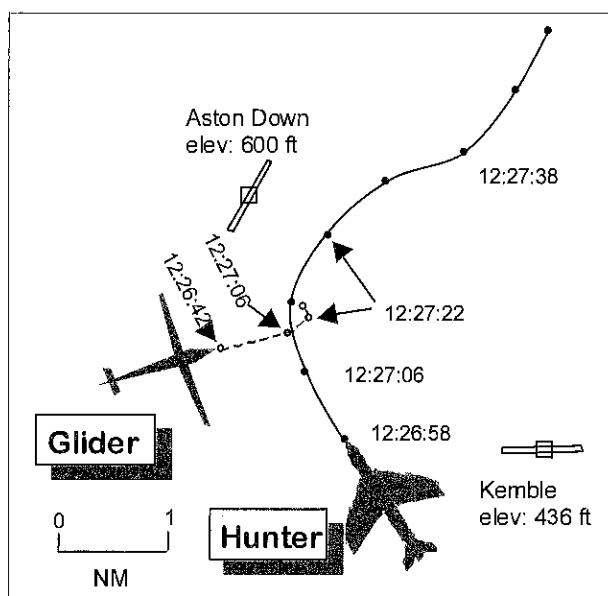
THE CIRRUS 703 GLIDER PILOT reports flying solo downwind LH for runway 21 at Aston Down heading 360° at 55 kt and level at 900 ft QFE 1000

Cause: The Hunter flew close enough to cause the glider pilot concern for the safety of his ac.

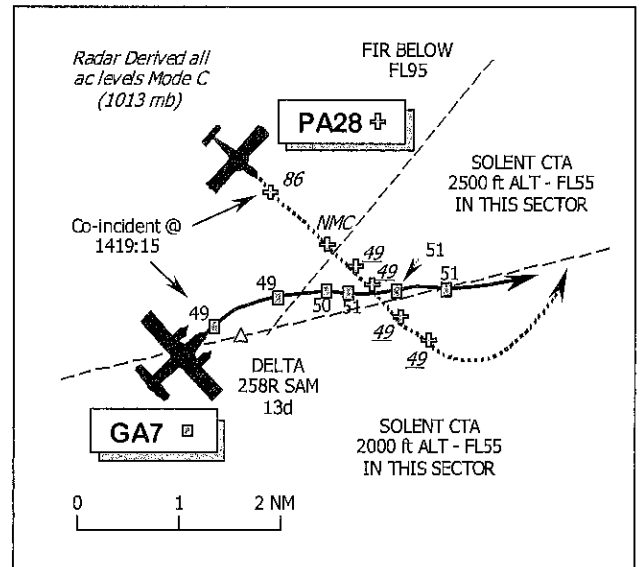
THE GULFSTREAM GA7 PILOT reports he was instructing an IFR training flight under simulated IF with a student; IF screens were in place for the LHS. They were flying in VMC – 5 NM clear of cloud horizontally with an in-flight visibility of 20 km and out of the sun. The ac has a blue/white livery, anti-collision beacon and HISLs were on. They were in receipt of a RCS, from SOLENT RADAR and squawking A1740 with Mode C.

While cruising at 135 kt, level at FL 50, about 258° SAM 9 NM heading 075°(M), a blue and white low wing single engine light ac – possibly a Cherokee type - was spotted at the 10-30 position, about 250 yd away crossing ahead from L – R. A slight pull-up was made to avoid the other ac, but the late sighting prevented earlier action; he banked L then R as the other ac passed about 100 ft below and 200 ft ahead with a “high” risk of a collision. The ac disappeared from view into the blind spot under the nose with no apparent change of level or track. It reappeared at the 3-30 position, still about 100 ft below his ac, before turning L and flying back toward him. SOLENT kept him informed and there was no further danger. He added that the IF training screen fitted on the LHS adversely affected vision from the cockpit and contributed to the late spot. He reported the Airprox to SOLENT RADAR on RT.

THE PA28 PILOT submitted his report over 3 months after the event stating he was conducting an IMC training sortie with a student. The ac has a blue and white livery, HISLs were on and a squawk of A7000 was selected with Mode C on, whilst listening out on the BOURNEMOUTH APPROACH frequency of 119.62 MHz.

He was flying in and out of cloud, between layers at 5000 ft, Portland RPS (1013 mb), with an in-flight visibility of 10 km. Toward the end of the flight, about 11 NM W of SAM, in the vicinity of the Stoney Cross VRP they were turning through 090°, he thought, to intercept the 270°R at 95 kt, when APPROACH broadcast a request to an ac N of the Bournemouth CTR to identify itself. He responded and was subsequently asked to switch off Mode C, as it was apparently mis-reading. (UKAB Note (1): Such a transmission is not evident within the RT transcript before 1434). Upon landing he telephoned Bournemouth ATC and was advised of the Airprox report. Neither he, nor his student, saw any other ac at the time of the Airprox.

The PA28 Mode C indication is slightly erratic about 45 sec before the Airprox. However, the vertical separation reported by the GA7 pilot is exactly in accord with the indicated Mode C separation observed at the time of the Airprox.

GA instructor pilot members were concerned that the IF screens fitted in the GA7 might have adversely affected the instructor pilot's vision from the cockpit more than normal. Although not a frequent occurrence, impaired 'lookout' caused by IF screens has been a recurrent theme in several Airprox involving IF training flights. This Airprox took place on the boundary of the SOLENT CTA and clearly illustrates the need for a careful lookout when operating close to or crossing the boundary of CAS. IF screens are used to simulate IF conditions and preclude the use of external references by the PF. However, CAP 682 (Part 5) Appendix 5 - *Requirements for ac used on IR modular courses of flying training* stipulates that IF screens must “*be angled to ensure minimum interference to the all-round lookout from the normal seating position of the instructor*”. The presence of IF screens does not absolve the instructor from his requirement to lookout whilst acting as the 'safety pilot'. Members were in no doubt that there was a lesson here for all instructors.

Cause: The PA28 pilot entered CAS without a clearance and flew into conflict with the GA7, which he did not see.

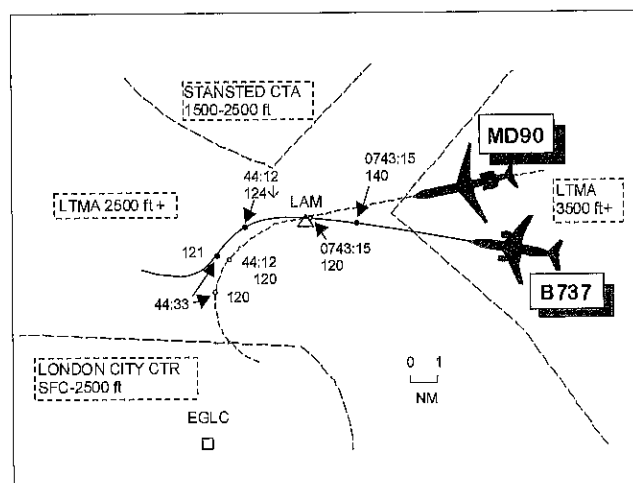
THE MD90 PILOT reports entering the LAM hold at FL 120 at 220 kt inbound to Heathrow. The visibility was unlimited in VMC. He was given avoiding action by ATC owing to another ac descending in the hold to FL 120. The ac was not sighted visually but was tracked on TCAS; no TCAS alert was received. The reported traffic passed 2 NM horizontally and 100 ft vertically clear.

Pilot members commented on the lack of a TCAS alert when the subject ac were flying adjacent in the hold. However, it was apparent that the ac were effectively line astern with no closure rate which would put them outside the TCAS alert parameters. The Board also noted that the MD90 crew missed the descent instruction RT call, possibly owing to a simultaneous transmission, but also the avoiding action call shortly after transferring to the Heathrow frequency. Concern was also expressed over the B737's crew using a high rate of descent (ROD). Although it was acknowledged that there was a need to use a minimum ROD of 500 ft/minute, the use of high RODs could lead to the generation of TCAS alerts within busy airspace and particularly within holding patterns.

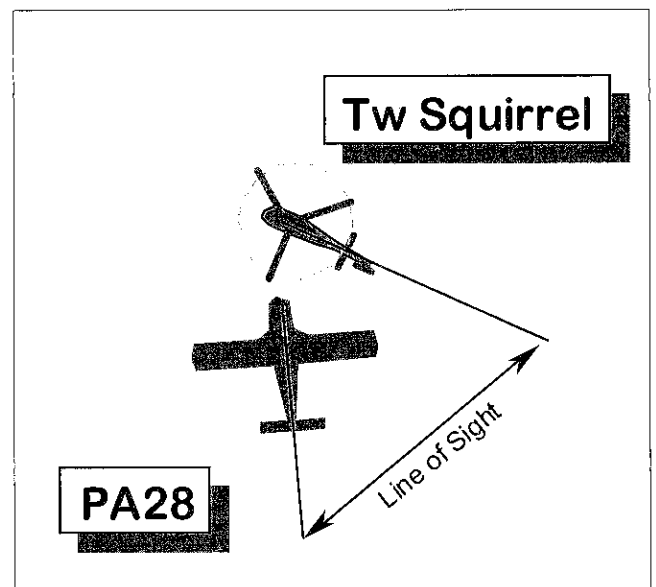
THE TWIN SQUIRREL PILOT reports heading 338° at 120 kt cruising at 1500 ft with autopilot engaged and returning to base having completed a

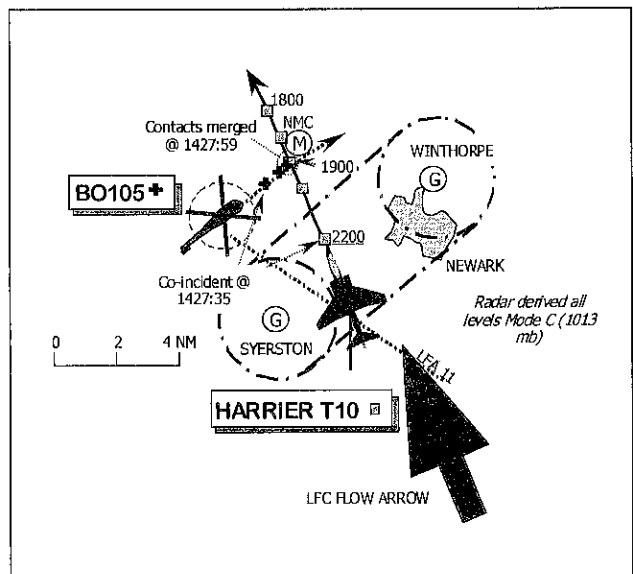
THE Bo105 HELICOPTER PILOT reports that he was returning from Nottingham Tollerton to Waddington, VMC at 110 kt, 150 ft below cloud; visibility to E/N/S was good. The helicopter colour scheme is blue and white, HISLs, navigation lights and the landing lamp were all on and he was squawking A0020, but neither Mode C nor TCAS was fitted; he was receiving a FIS from Waddington ZONE.

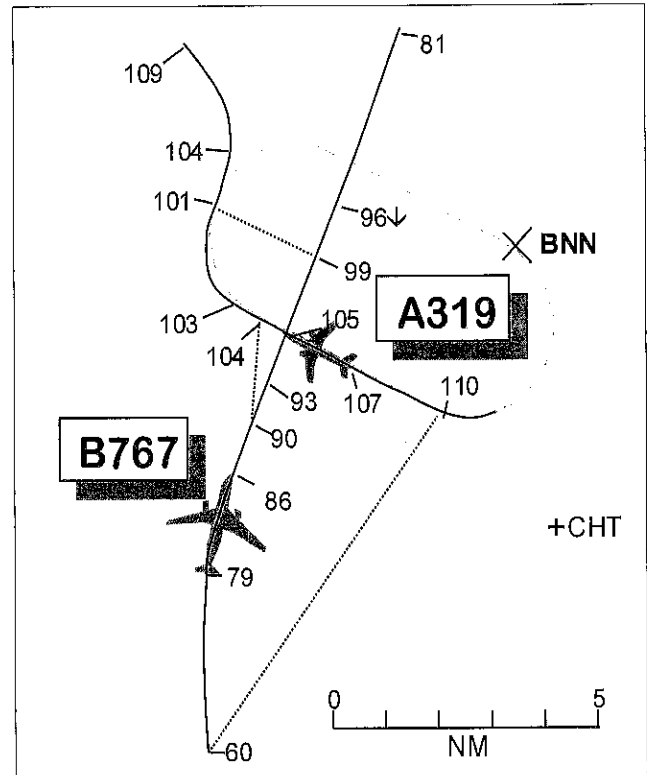
THE B767 PILOT reports heading N at 250 kt; he had been cleared to climb to 6000 ft (QNH 974 mb, 28.76 in) and then to FL 90. The crew intended to set their altimeter to 29.92 in when above the TA; however, they mistakenly set it to 28.92. They did not see the A319 and could not remember any TCAS indications when asked afterwards but they were following avoiding action instructions in that period.

Their fleet manager advised that setting 28.92 in would cause the altimeter to under-read by nearly 1000 ft and a climb to an indicated FL 90 would result in the ac being close to FL 100. All company

ac have altimeters with 2 subscale windows; one for each unit of pressure. Company policy, in areas that use mb (Hpa) pressure settings, is to set 1013.2 mb above the TA; the pilots involved are thoroughly familiar with this policy but somehow reverted back to inches as they transitioned to QNE. Cross checking of altimeter settings between the pilots is mandated in company SOPs.

The crew's recollection that there were no TCAS indications in the B767, despite the TA in the A319, was puzzling. The fleet manager confirmed that the ac had TCAS ver 6.4A and there was no reason why there should have been no TCAS indications to the crew; TCAS alerts are not recorded on the FDR. He has thoroughly debriefed the crew concerned and issued a bulletin to all pilots reminding them of the lessons learned.

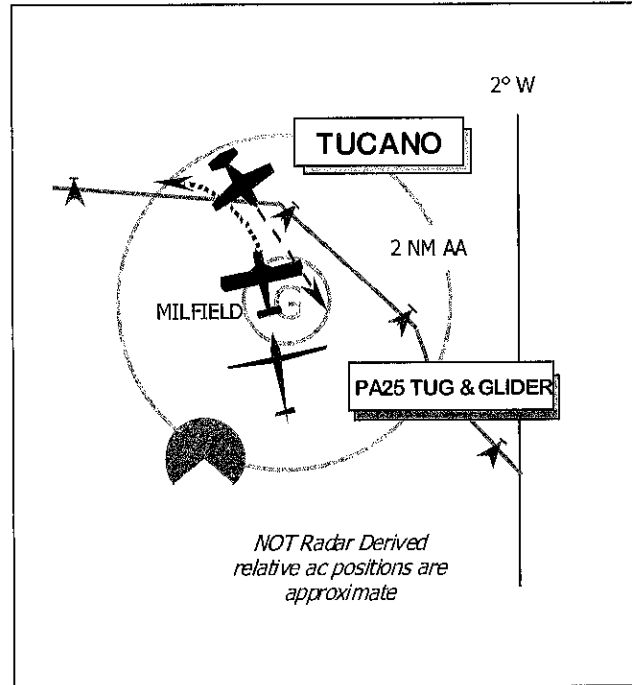
THE PIPER PA25 PAWNEE PILOT reports that he was executing an aerotow glider launch from Milfield aerodrome and in contact with Milfield RADIO on 130.1 MHz. The ac livery is yellow, but no lights were displayed. Just after take-off about 0.5 NM NNW of the site, passing 300 ft agl in the climb, heading 340° at 70 kt, a black Tucano with wing lights 'on' was spotted "head-on", about 0.5 – 0.75 NM away descending towards him. He turned hard L with 40° of bank, to avoid the Tucano, which also turned L and passed down the starboard side at the same height about 200 yd away with a "High" risk of a collision.

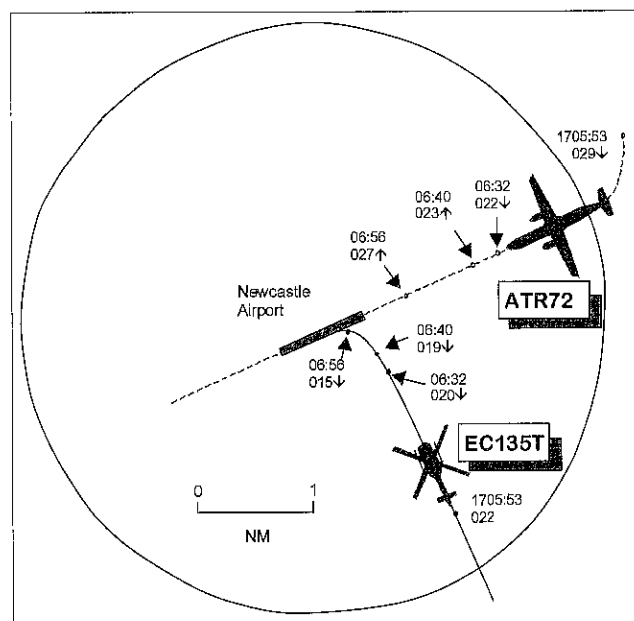
AIRPROX REPORT No 168/00

THE NEWCASTLE ADC reports that the EC135T was operating to the S of Newcastle and called on frequency for a rejoin; the pilot was instructed to report at the mid point of RW 25. When the helicopter was approx. 4 NM S of the aerodrome, he instructed the pilot to orbit R owing to an inbound ATR72 at 4 NM final on a visual approach for RW25. No response to this was received so he

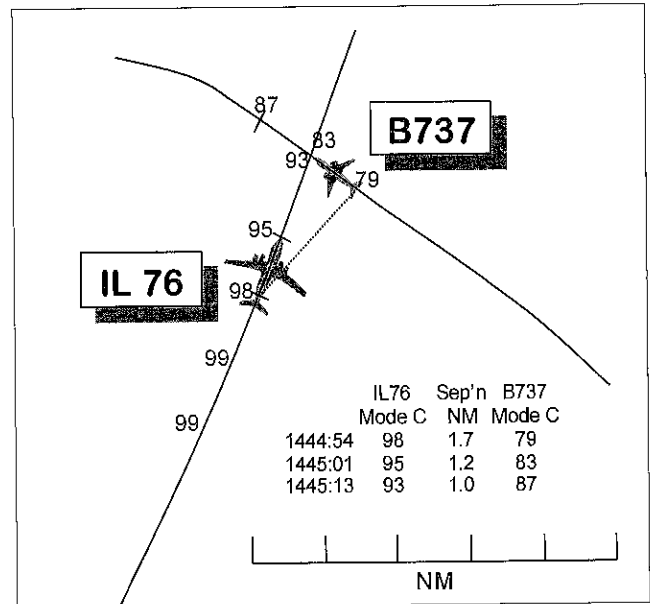
AIRPROX REPORT No 169/00

THE B737-300 PILOT reports heading 330° at 290 kt, passing FL 85 for FL 90 on departure from Stansted RW 23 on a BUZAD 6R SID when he

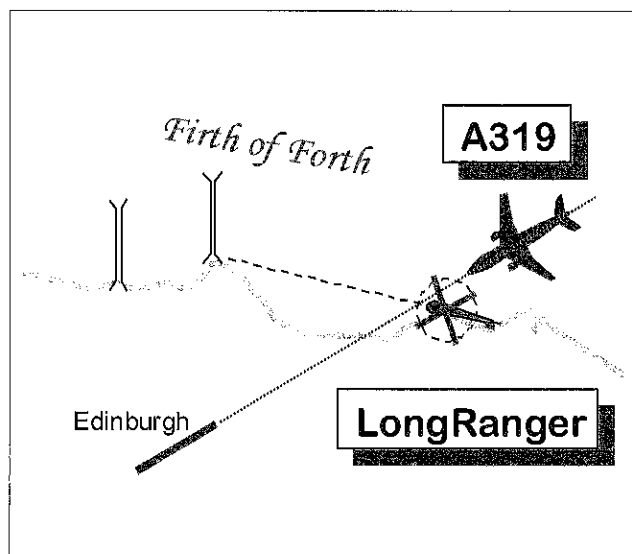
AIRPROX REPORT No 170/00

THE A319 PILOT reports flying at 130 kt on a visual approach to RW 24 at Edinburgh. ATC informed him that a helicopter was lifting from Granton for 'the bridges' and he received a TCAS TA when passing 1300 ft on final. He saw the helicopter about 500 m away at 11 o'clock and below; ATC stated it was at 1000 ft. The risk of collision was low but he was flying the approach one dot high on the ILS; had he been on the glidepath it would have been exceedingly close.

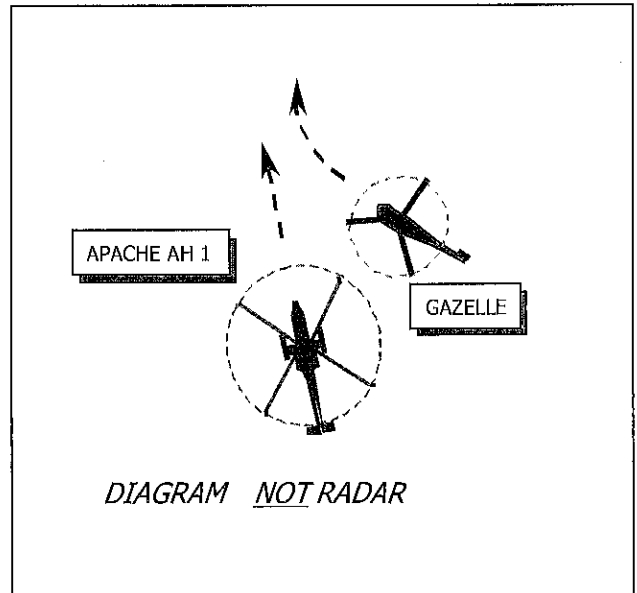
THE GAZELLE PILOT, a QHI and the PF, in a very full and frank account reports he was flying a 'Competence to Instruct' (C to I) sortie for a QHI student, and completing of a series of Engine Off Landing (EOL) exercises of different profiles in the Engine-Off Practice Area (EoPA) circuit at Middle Wallop. After flying 4 EOLs, as the PF, he was demonstrating a maximum range EOL. Clearance was obtained from ATC to climb to 2000' QFE (1000 mb) for this exercise. A 'finals' RT call was made just prior to entering autorotation and at a height of 1500 ft the throttle was retarded. He reduced the rotor speed (NR) down to 330 RPM to demonstrate the maximum range configuration and at 500 ft QFE, heading 310° with the throttle fully retarded he converted to a 60 kt autorotation for the EOL. An Apache helicopter was suddenly spotted by the student QHI through the port side cockpit bubble, hover taxiing in the same direction as the Gazelle's heading, directly underneath and moving into his committed landing area, for which they were short finals. Assessing the risk of collision as very high, he initiated a turn to the R as the student PNF advanced the throttle fully. By 150 ft AGL, with the throttle fully forward to the gate, an overshoot was successfully initiated into powered flight. The vertical separation was assessed as about 150 ft directly below his helicopter.

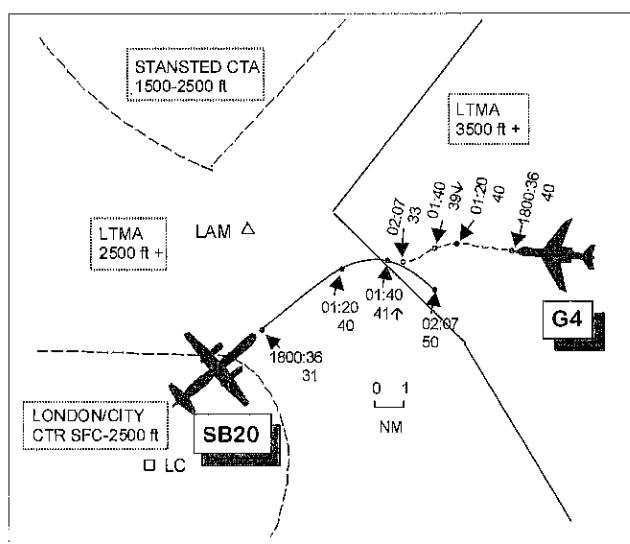
AIRPROX REPORT No 172/00

THE G4 PILOT reports flying inbound to Northolt heading 260° at 250 kt maintaining 4000 ft QNH 976 mb. He was in IMC, in cloud, at night, with anti collision and strobe lights on whilst receiving a radar control service from Heathrow Director. Avoiding action instructions were given to turn L heading 180° and to descend to 3500 ft with which he complied. Immediately thereafter, a TCAS TA then RA "climb" was received whilst following ATC instructions and the conflicting ac was seen as he descended out of cloud at 3500 ft in his 2 o'clock whilst still in the turn. It passed 2.5 NM clear and 200 ft above and he assessed the risk of collision as medium.

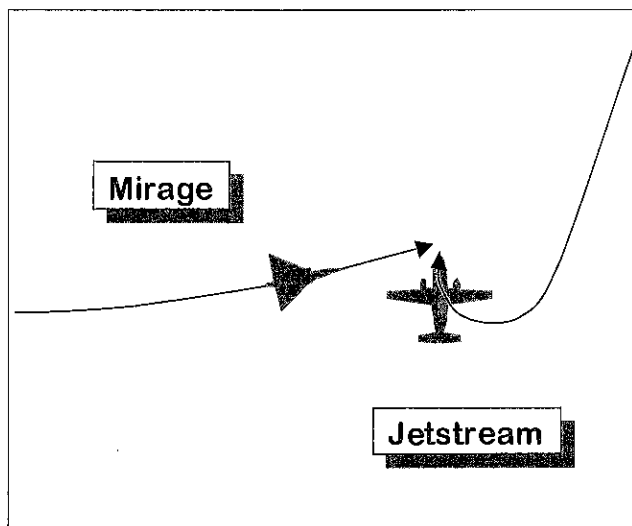
THE JETSTREAM PILOT reports heading N at 160 kt having seen 2 Mirages pass on an easterly heading, 0.5 NM away and 500 ft above. A few seconds later a 3rd ac passed across his nose at the same level about 200 yd ahead. It was too late to take avoiding action and the risk of collision was high. A call to Waddington confirmed that 4 Mirages had just departed; he did not see the 4th at all. He was not receiving an ATS at the time of the incident.

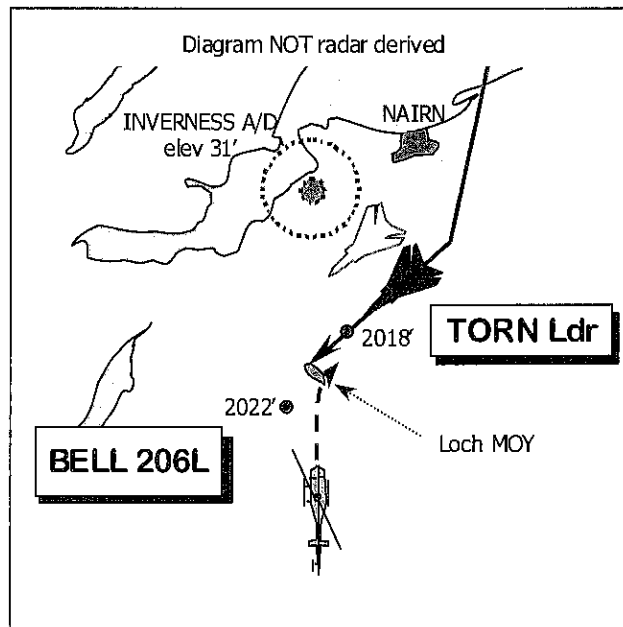
THE TORNADO GR1 PILOT reports leading a pair on a low-level cross-country sortie in loose battle formation at 430 kt; the No 2 was positioned 4 km to starboard. Both ac were camouflage grey but

HISLs were on and 3/A 7001 selected with Mode C, whilst under a FIS from Lossiemouth; workload at the time was relatively low.
