UK AIRPROX BOARD

**Analysis of
Airprox in UK Airspace**
Report Number 5
July 2000 to December 2000

Report by the UK Airprox Board,
'Analysis of Airprox in UK Airspace'

(July 2000 to December 2000)

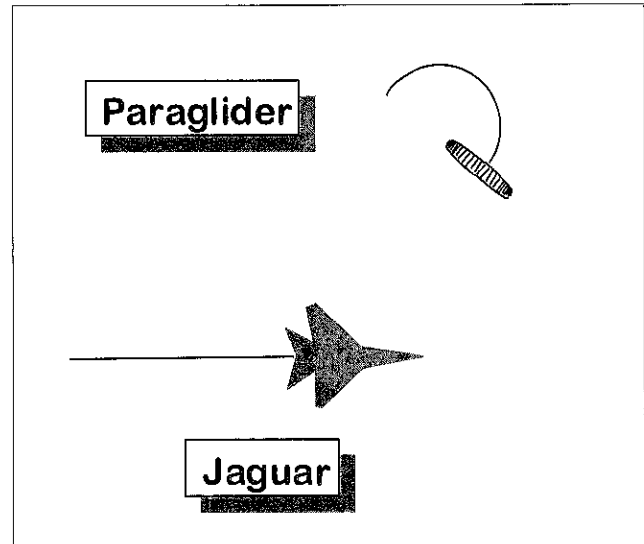
THE JAGUAR PILOT reports flying at 450 kt as No 3 of a 4-ac formation at low level. The No 2 spotted and called a paraglider as a threat to his (No 3's) track. He delayed his turn at a waypoint to avoid the reported traffic's position (at that stage he could not see it) but pulled up to 4-500 ft Rad Alt to cross a slight ridge and continued to look out for it. He spotted it as he rolled out of the turn; it was 200 m ahead and 100 ft below, too close for avoiding action, and it passed 100 ft to his left and 100 ft below. Had he not climbed, the risk would have been far greater.

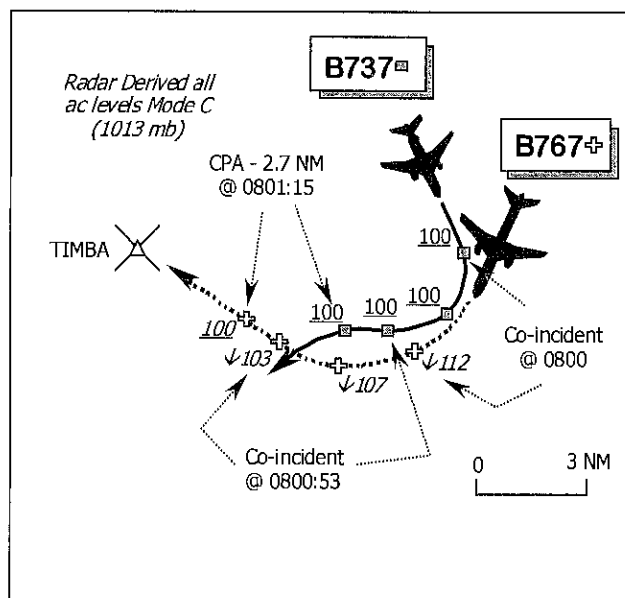
THE B737-400 PILOT reports that he was flying the TIMBA hold at 220 kt, level at FL 100 prior to landing at Gatwick. He was technically IMC as the cloud tops were about 200 ft below him, but good VMC above, when the B767 was observed visually

and on TCAS as it descended down toward his level. The B767 turned into the hold at the same level – FL 100, levelling about 2-3 NM ahead of his ac. He reported this apparent erosion of separation to ATC who passed avoiding action and he turned in 'heading select' onto 210° to avoid the B767. Afterwards he turned back toward TIMBA,

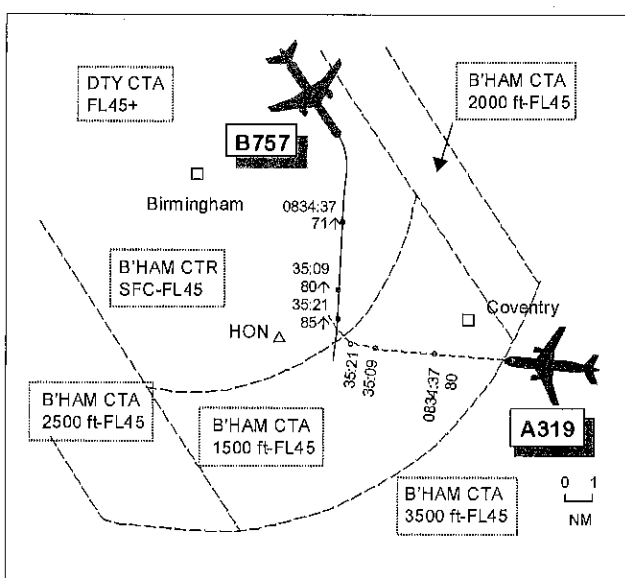
THE B757 PILOT reports flying outbound from Birmingham climbing to FL 160 heading 140° at 250 kt. The visibility was >20 km, 3000 ft above cloud and between layers in VMC, and he was receiving a Radar Control service from LATCC. On receiving an initial TCAS TA alert, the conflicting ac was at first hidden by the windshield pillar (between Capt's No 1 & DV windows). The F/O, PF, heard the TCAS RA "*climb*" and partially heard ATC issue "Emergency turn heading 190°, stop climb FL 90"; he complied with both simultaneously. The Capt, PNF, concentrated on the ATC avoiding action instructions and missed hearing the TCAS RA but saw it on his HSI. The subject ac, first acquired visually by the F/O, passed 700 ft below and he assessed the risk of collision as high. A TCAS 'monitor vertical speed' was received passing FL 91, and the maximum level attained was FL 94 before returning to FL 90. He believed TCAS "saved the day" as the ATC emergency turn may have been issued too late.

The Birmingham Director observed the B757 climbing above FL 60 and turning towards the A319. At 0834:50, he issued an avoiding action instruction to turn R, to the A319 pilot, onto heading 030° and passed traffic information. The A319 pilot reported the other ac in sight and assessed that it appeared to be climbing above him. No reference was made to TCAS but, in the subsequent written report, it was stated that the flight received a TCAS RA "Do not climb".

Turning to the risk, members noted that the B757 pilots had received a TCAS TA then an RA "climb" in addition to ATC avoiding action instructions, which were followed. The A319 pilots also received ATC avoiding action instructions and TI which

Cause: The COWLY SC did not take the A319 into account when he issued instructions to the B757 pilots to climb through the A319's level.

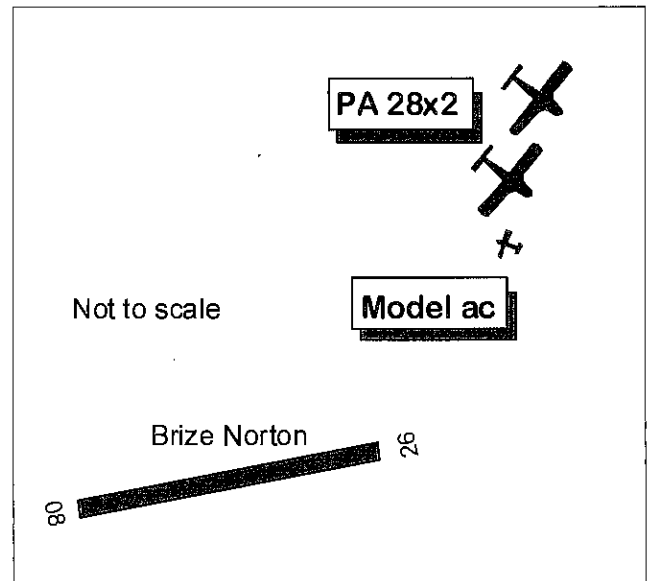
AIRPROX REPORT No 179/00

Date/Time: 4 Nov 1636 (Saturday) Twilight
Position: 5147 N 0132 W (2.5 NM NE Brize Norton)
Airspace: ATZ/CTR (Class: D)
Reporting Aircraft Reported Aircraft
Type: PA28 x2 Model ac
Operator: Civ Club untraced
Alt/FL: 1000 ft NK
 (QFE 998 mb)
Weather VMC CAVOK NK
Visibility: 50 km NK
Reported Separation: 0 V 50 ft H/NK
Recorded Separation: not recorded

THE PA28 PILOT reports leading a two ac formation in echelon port from Burford VRP returning to Brize Norton to intercept the RW 26 centreline, range 1 NM, at 1000 ft QFE. The weather was CAVOK with visibility 50 km and he was receiving an aerodrome control service from Brize Norton Tower on 123.72. His intention was to break R at 1000 ft overhead the RW 26 threshold, at 3 second intervals for a RH circuit stream landing. He had just completed his landing checks and whilst maintaining a lookout his passenger (non-pilot) pointed to a conflicting ac, that turned out to

Cause: Conflict near the edge of the Brize Norton ATZ, within the Control Zone, with an untraced model ac.

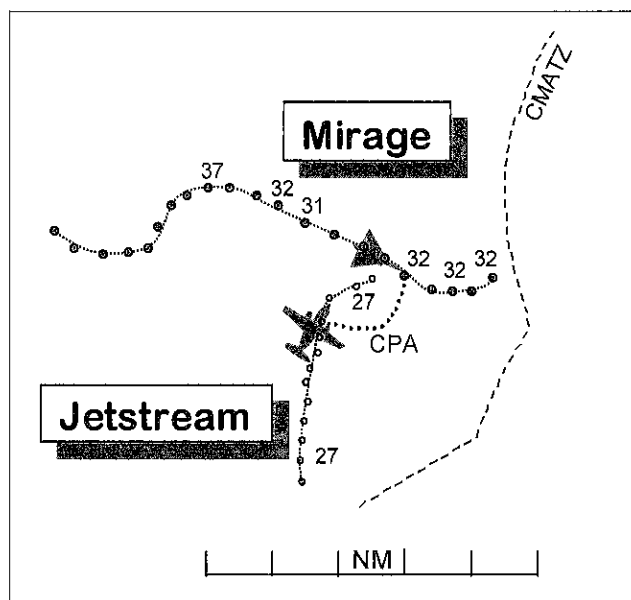
THE JETSTREAM PILOT reports heading 060° at 130 kt on a closing heading for a PAR to RW 09 at Cranwell, at 1500 ft, IMC in and out of Cu clouds. Director informed him of Waddington traffic, 2 ac, 500 ft above. On handover to talkdown he exited cloud and saw a Mirage, gear down, slightly above and 0.5 NM away heading about 130°. It was turning left away from him and descending to his level, apparently to avoid cloud, and then climbed. He did not see the second of the 2 contacts called.

ac had looked normal on the PARs. Members agreed that within the tolerance of SSR accuracy and an 8 sec interval between radar sweeps there was a possibility of a small, short deviation by the Mirage but nothing that would constitute a significant departure from its assigned height. It was suggested that the cloud structure may have disguised the Jetstream pilot's horizon, leaving him with the impression that vertical separation was inadequate, and the Board agreed that this was probably the cause of the Airprox report. The Jetstream pilot may also have been concerned that he could not see the 'second' ac he had been warned about. In fact the one he saw was the second; the first being well ahead down the Waddington PAR glidepath at the time of the sighting. The Board agreed that there had been no risk of collision in the encounter.

Degree of Risk: The Jetstream pilot perceived that vertical separation was inadequate.

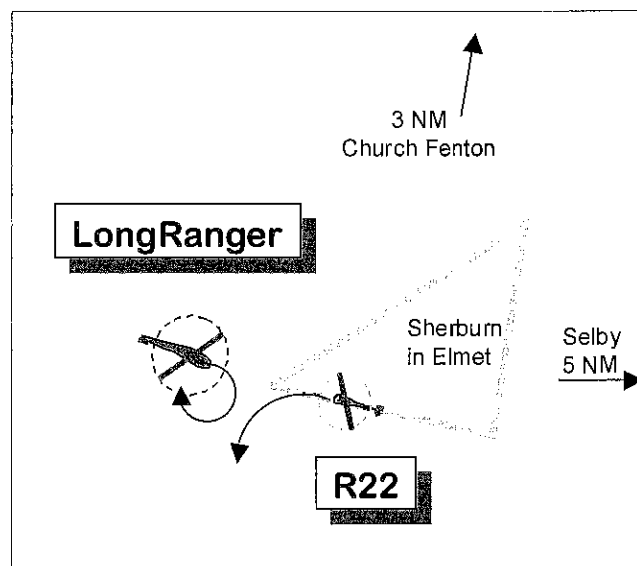
<u>Airspace:</u>	ATZ	(<u>Class:</u> G)
	<u>Reporting Aircraft</u>	<u>Reported Aircraft</u>
<u>Type:</u>	R22	LongRanger
<u>Operator:</u>	Civ Trg	Civ Comm
<u>Alt/FL:</u>	50 ft ↑ (agl)	50-100 ft (QNH)
<u>Weather</u>	VMC CLOC	VMC CLNC
<u>Visibility:</u>	7 km	10 km
<u>Reported Separation:</u>	0.25 NM/500 ft	
<u>Recorded Separation:</u>	NK

THE R22 PILOT reports conducting a PPL (H) licence test and had returned to Sherburn, making his initial call to Sherburn Radio on 122.6. There were no ac in the circuit so he set up for an autorotation to the into-wind runway, RW 29. He heard the LongRanger pilot call to say he was on a powerline patrol 3 NM S of Church Fenton and was routeing to Selby at low level. Sherburn Radio replied that there was little activity and that fixed wing ac were using RW 01/19, which was the only useable runway due to floodwater. The position given by the LongRanger pilot indicated that he was inside the ATZ (he had not heard the pilot ask for or receive permission to enter the ATZ) but meant that the LongRanger was 1 NM E of him and going away. He called his intentions for the PFL and aimed half way down the runway. On completion he called lifting for a 29 LH circuit and as he transitioned, heading 290° at 60 kt, he saw the LongRanger in his take-off path about 0.25 NM ahead. It was following the powerlines that run close to the RW 06 and 11 thresholds and was at about 75 ft, twice the height of the powerline poles. He turned hard left, calling visual with it, and put his landing light on. Turning right and stopping were not options. The LongRanger performed a tight right orbit, returning to the hover facing the airfield. He considered there had been a moderate risk of collision.

The Board considered that, in the circumstances of the emergencies associated with the flooding, the filing of an Airprox by the R22 pilot showed a lack of understanding, but he may not have been fully aware of the difficult conditions the LongRanger pilot was operating under. At the same time it appeared that the LongRanger pilot was not where he thought he was; if the R22 pilot's recollection of the LongRanger's position report to

GA members considered that, despite the flooding, the LongRanger pilot should have been able to recognise earlier (from hangars, etc) that he was coming upon the airfield at Sherburn and wondered if he had become somewhat over task-oriented, or was perhaps relying too much on Church Fenton to advise him of his location. While sympathising with the LongRanger pilot's predicament, the Board concluded that his unfortunately inaccurate position report followed by his effectively unannounced entry into the Sherburn ATZ were the causes of the conflict with the R22.

Cause: Following an inaccurate position report, the LongRanger entered the Sherburn ATZ unannounced.

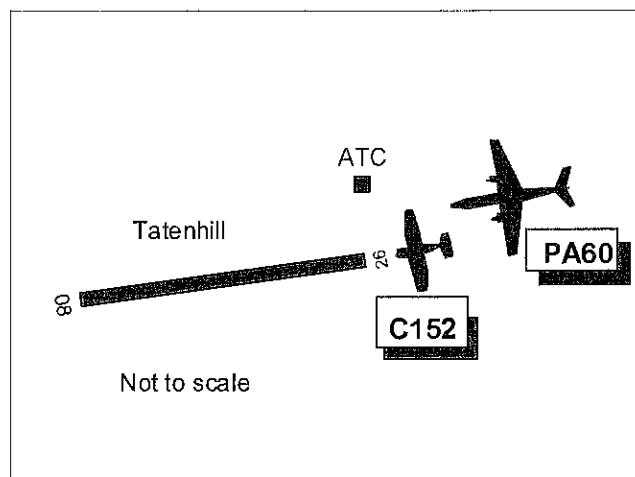
AIRPROX REPORT No 182/00

Date/Time: 4 Nov 1120 (Saturday)
Position: 5249 N 0145 W (RW26 threshold Tatenhill A/D - elev. 450 ft)
Airspace: ATZ (Class: G)
Reporting Aircraft Reported Aircraft
Type: C152 PA60
Operator: Civ Trg Civ Pte
Alt/FL: 100 ft ↓ 500 ft ↓
(QFE) (QFE)
Weather VMC CLBC VMC CLBC
Visibility: 20 km >10 km
Reported Separation: 50 ft H&V/ 500 m H
Recorded Separation: not recorded

THE C152 PILOT reports flying a local dual training circuit detail with his student at Tatenhill LH RW 26. The visibility was 20 km with no significant cloud and he was receiving an A/G service from Tatenhill radio on 124.07. The ac was white and green with a red anti-collision beacon switched on and was squawking 7000 with Mode C. Whilst downwind, he heard a pilot call (later found to be the PA60 pilot), reporting he was joining the circuit on a L base position. He was unable to see the joining ac so he positioned onto L base then onto final approach at 1.5 miles. The student reported "final to roll" which was acknowledged by the A/G operator. He did not remember hearing the PA60 report L base but heard him reporting on final approach. He looked out the rear window but was unable to see the PA60 whilst continuing approach. As he crossed the RW 26 threshold numbers at 100 ft, the PA60 overtook him on his RH side, just below the R wing, whilst carrying out a go around; the other ac was close enough to hear its engines as he passed. No avoiding action was taken and he continued talking the student through the landing procedure as he was just about to roundout. He estimated a separation distance of 50 ft both horizontally and vertically and believed the safety of his ac had been compromised.

The PA60 pilot had a responsibility to conform to the "pattern of traffic" formed by the C152 intending to land. Members agreed that the former, in positioning his ac onto L base then final approach without having seen or establishing the position of the C152, had not integrated safely into the circuit pattern. There seemed to be no good reason for this, given the reported weather conditions and the availability of the A/G radio facility. When the C152 was eventually seen, about half a mile ahead and above, it was too late to do anything other than commence a go-around. This should have involved the application of power and a simultaneous pitch change to a nose-up climbing attitude, followed by a climbing turn onto the dead-side whilst maintaining visual contact with the other ac throughout.

incident remembered the situation and recalled that the PA60 had been observed to pass between the Cessna and the ATC building when carrying out the go-around. Moreover, the go-around had not followed the normal profile expected. Taking this into account together with the C152 pilot's report, the Board concluded that the PA60 pilot had flown close enough to cause the C152 pilot concern.

- a. The PA60 did not integrate safely into the circuit pattern.
- b. Late sighting by the PA60 pilot.
- c. On the go-around, the PA60 flew close enough to cause the C152 pilot concern.

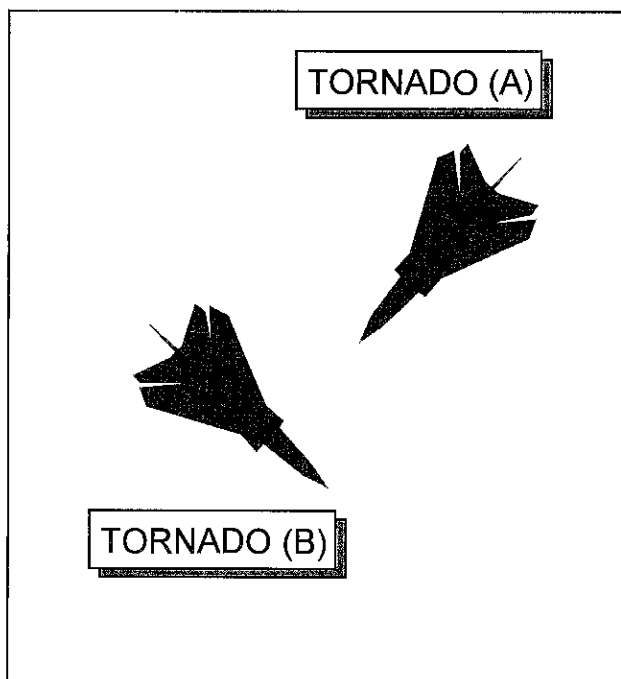
THE REPORTING TORNADO GR 1 PILOT (A) reports that he was leading a pair of Tornados on a bounced low-level evasion sortie at 444 kt. The ac was camouflage grey/green, HISLs were on and

3/A 7001 was selected with Mode C. Whilst heading 221° about 10 NM N of Barrow-in-Furness descending through 680 ft Rad Alt, another unknown Tornado GR1 was suddenly spotted at R 2 o'clock, at a range of 350 ft, very close. The other Tornado passed directly in front of his ac from R – L at the same height, whereupon he flew

through the other ac's slipstream. It was seen too late to take avoiding action, but he added that their formation lookout was "very high" during a low workload phase of the flight. He assessed the risk of a collision to be "very high".

HQ STC comments that this Airprox occurred at low level, by day and in VMC and it is therefore of considerable concern that not one of the crew members saw the confliction in sufficient time to take avoiding action. The lack of relative movement, ac conspicuity and cockpit/canopy obstructions were probably all factors and, in the absence of any effective collision warning system, such an incident remains an operating hazard.

Cause: Effectively, a non-sighting by both formations.

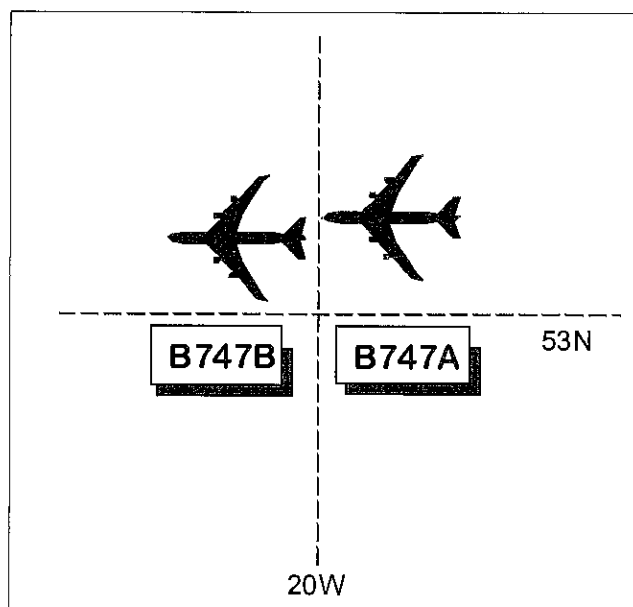
AIRPROX REPORT No 184/00

Date/Time: 07 Nov 1516
Position: 5300 N 2000 W
Airspace: CTA (Class: A)
Reporter: SOACC
First Aircraft Second Aircraft
Type: B747 (A) B747 (B)
Operator: CAT CAT
Alt/FL: ↑ FL 360 FL 360
Weather VMC CAVOK VMC CLOC
Visibility: 50 km >10 km
Reported NK 800 ft V
Separation:
Recorded Separation: not recorded

THE SHANWICK OACC EN ROUTE controller reports receiving a pilot's report, relayed from Ballygirreen, that B747 (A) was leaving FL 350 for FL 360; B747 (A) was displayed in the Flight Data Processing System (FDPS) as cleared at FL 350 showing no climb profile. However, the ATC/ line showed ATC/LLVLP 350 53N 20W BLVLP 360 52N 30W from the copy plan (ATC/LEAVE LEVEL 350 AT 53N 20W BE LEVEL AT 360 AT 52N 30W); the climb profile predicted that B747 (A) would be 3 minutes behind B747 (B) at FL 360. He telephoned Ballygirreen to relay to B747 (A) pilot to stop his climb; co-incidentally, Ballygirreen were about to phone him as they had no details of the B747 (A)'s automatic climb. He then sent a message to B747 (B) to climb to FL 370 as B747 (A) had reported at FL 352. B747 (A) then reported at FL 350 so he cancelled the climb clearance to B747 (B) and sent confirmation to the B747 (A) pilot to maintain FL 350.

It was not evident that a potential conflict existed, between the subject ac, until B747 (A) reported passing 020W and leaving FL 350 for FL 360. On prediction by the ER Controller, (not the one in position when B747 (A)'s new flight statement was received), it was noted that a conflict existed with B747 (B) which was maintaining FL 360, three minutes ahead. The ER Controller acted swiftly and ensured that a message was sent, via Ballygirreen, to stop the climb of B747 (A). Additionally, a message was prepared to instruct B747 (B) to climb to FL 370. As reports were received that B747 (A) had levelled at FL 350, the instruction to B747 (B) was not transmitted. The minimum separation was estimated as three minutes and 700 ft, whereas the requirement was either ten minutes or 1000 ft.

The ATSI adviser appraised members that the ORCA system, as used in the ScOACC, had worked as intended during this incident and that it had been the PLANNER controller's lack of awareness on part of the ORCA system that led to the Airprox; the controller had not realised that the ATC/ remarks added onto the IUD scribble line would attach itself to the prime plan when he used the ACCCL button. The generation of copy plans for conflict probing mirrored the FDPS system but the 'automatic climb' facility was not used very often. Members noted that the software did not automatically check data inputs or generate a positive acceptance challenge (ie do you wish to accept YES/NO) to the operator before accepting and transmitting the data. However, the PLANNER should have been aware of this error after his ACCCL action from the difference in the clearance levels on his display between the main text and the ATC/ line text. Also, the ScOACC MATS Pt 2 required the EN ROUTE controller, who was on duty at the time when the new flight statement was generated, to have correlated the ATC/ line to the flight profile; this second check should have highlighted the unwanted instruction to climb and have been brought to the PLANNER's attention for correction. Members were clear that this omission by the EN ROUTE controller had contributed to the Airprox. As a side issue, members could not understand why the person involved remained a mystery and were critical. An ATCO member commented that in using the ORCA system, there did not appear to be any sort of read-

Looking at the risk element, members noted that the B747A crew had received and complied with the ORCA 'automatic climb' clearance. It had been the pilot's report (PIREP) at 20W that had alerted the EN ROUTE controller and the Ballygirreen HF operator to the situation which, fortunately, was resolved expeditiously and safely. The B747B crew had received a TCAS TA which alerted them to B747A's presence which they acquired visually below them. This visual sighting surprised the Board, since the PIREPs at 20W indicated the subject ac were 3 minutes apart with B747A flying behind B747B. However, the B747B crew were sure they had seen a B747 which was the subject

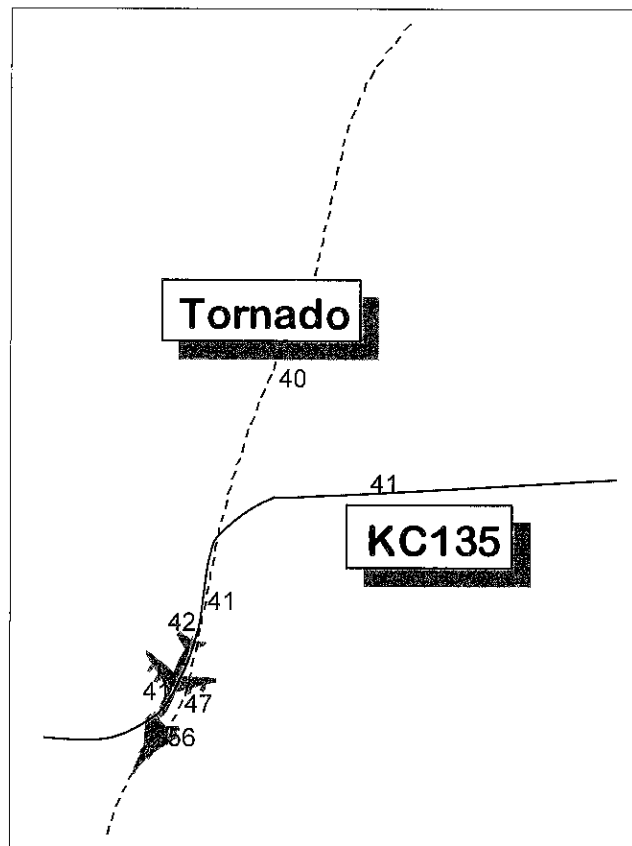
THE KC-135 PILOT reports heading 270° at 210 kt downwind in the radar pattern for RW 11 at Mildenhall, at 3000 ft QNH in cloud and receiving a RAS from Lakenheath Approach. ATC called pop-up traffic 8 NM N of him, fast moving; if not in

sight to turn left onto 170°. He informed ATC he was IMC and started to turn. ATC advised that the traffic continued to close and passed several avoidance vectors with the other ac still closing in his 6 o'clock. When it was less than 1 NM, ATC issued a traffic alert. At this point he initiated a descent to 2000 ft and saw the other ac diverging from overhead into his 10 o'clock. ATC advised it was 600 ft above and appeared to be manoeuvring to follow him. The other ac was not in contact with ATC and he considered the risk of collision was high.

THE TORNADO PILOT reports transiting at 2500 ft agl, VMC below cloud and on NVG, as a singleton, his leader having RTB u/s. He was not receiving an ATS. While on a southerly heading at 420 kt he saw on NVG the lights of another ac in his 12 o'clock. His radar showed it was 3 NM ahead and it appeared to be about at his level but he was unable to determine its direction of travel. He climbed, maintaining VMC to pass directly over the other ac, he estimated by 1000 ft. He thought the risk of collision was low.

Board concluded that the cause of the Airprox was the Tornado pilot flying close enough to the KC135 to cause its pilot concern for the safety of his ac, but that his action removed any risk of the ac actually colliding.

Cause: The Tornado pilot flew close enough to the KC135 to cause its pilot concern for the safety of his ac.

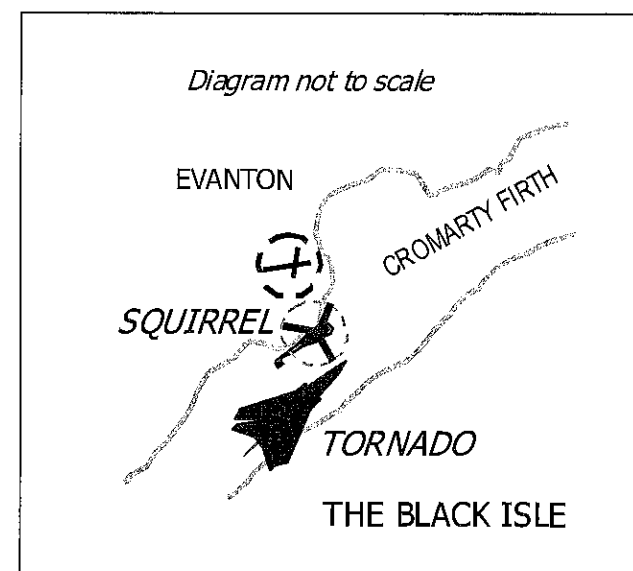
THE TORNADO GR 1 PILOT reports his ac was standard camouflage grey/green and HISLs were on whilst inbound to Tain Air Weapons Range at 500 kt, under a FIS from Tain RANGE. The Black Isle was overflown at 7-800 ft agl and he descended into the Cromarty Firth in a 1° descent through 625 ft Rad Alt. Tracking 040° at 500 kt, he became aware of a Squirrel helicopter at 11 o'clock - slightly high - about 1000 m away, heading he thought, about 120° and at an altitude of about 650 ft. Estimating that the helicopter was maintaining a constant relative bearing, he broke R and pulled up above and away to avoid it by about 20 ft vertically and 1-200 ft horizontally, but by the time this had been accomplished he had flown past it.

He added that the helicopter was in front of gently rising ground and from his perspective in the Tornado cockpit, its dark colour scheme made it very difficult to spot against the wooded background; no lights were seen. He assessed the risk of a collision as medium to high.

Cause: Late sighting by the Tornado crew.

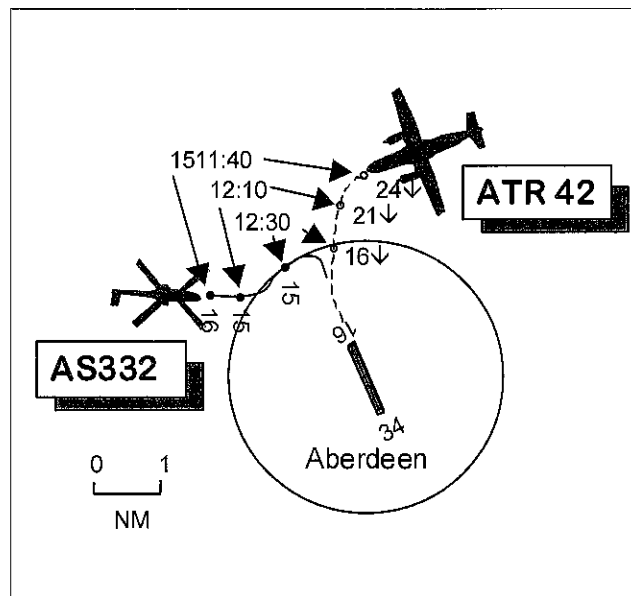
THE ATR42 PILOT reports inbound to Aberdeen joining on a L base for RW16 passing 1200 ft QNH 998 mb whilst receiving an ADC service from Aberdeen Tower on 118.1 MHz. The visibility was 30 km in VMC and the ac was displaying an anti collision beacon and white strobe lights. After reporting on L base, he heard another pilot announce "ATR visual, will slot in behind". Both he and his co-pilot were unaware of the other ac's position until they saw it, albeit late, a helicopter in his 1.30 position range 300 m, maintaining a constant heading and closing. He made an RT call to warn the other pilot of his proximity whilst the First Officer, pilot flying, turned further L to avoid. He assessed the risk of collision as high with the other ac passing 250 m horizontally and 50 ft vertically clear on his R hand side. His cockpit workload was high whilst positioning visually and carrying out final landing checks.

Cause: Perceived proximity of the AS332 caused concern to the ATR42 crew.

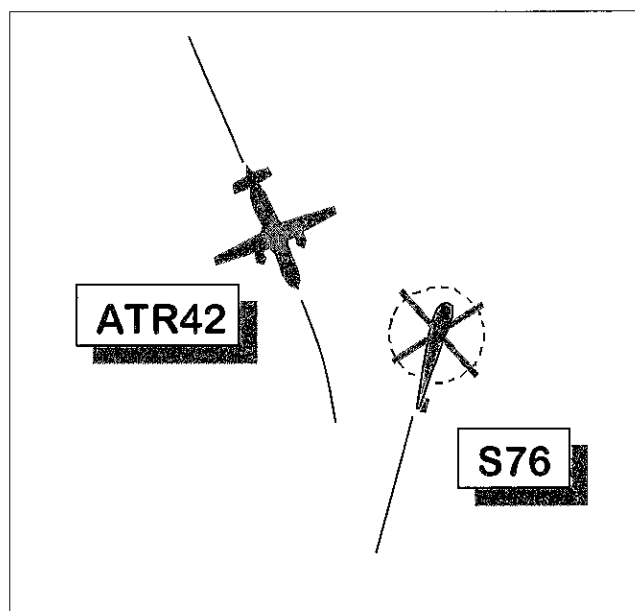
THE S76 PILOT reports heading 017° at 142 kt and climbing out of Norwich VFR while receiving a RIS from Coltishall on 125.9. He saw the ATR42 closing in his 10:30 from 5 NM away and reduced his rate of climb to pass about 800 ft beneath it as it appeared to turn away to pass to his left. He considered the situation potentially dangerous because he was flying on the Yarmouth RPS (994 mb) and the ATR, working Norwich Approach (119.35), was on the Norwich QNH (1001 mb). Coltishall had advised him of the ATR which was asking for a descent 'against him' as he was visual. He refused this request as he could not hear the ATR pilot's intentions and it seemed too close to him for a descent through his level. When the ATR passed him he queried the vertical separation, which was given as 800 ft. He considered that all ac should be on the same pressure setting when in the same airspace even if working different frequencies.

The S76 pilot specifically requested, and was provided with, a RIS, during which he was provided with TI, which referred to the ATR42, at a range of 6 NM. There is however, no requirement within the conditions of RIS to separate ac, as separation advice can only be expected when in receipt of a RAS. The ATR42 pilot, who was in receipt of a RAS, had become visual with the S76 by the time the ac had closed to 5 NM horizontal separation (the pilot reports being visual at 10 NM, APP reported that he was "visual from 5 NM away") and shortly afterwards, requested a descent. Once visual however, the controller's responsibilities for providing separation advice to resolve that particular confliction had, in effect, been achieved and the ATR42 pilot was free to descend of his own volition. The APP and ZONE controllers did not have to request the S76 pilot's approval prior to releasing the ATR42 for further descent.

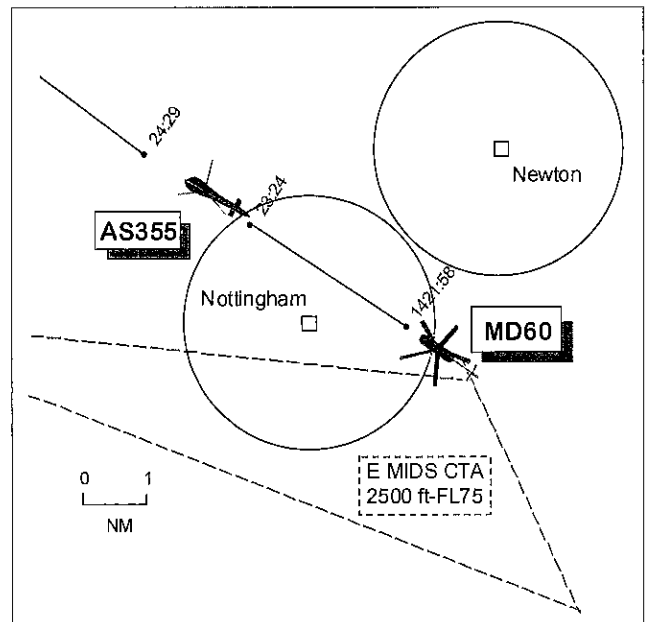
THE AS355 PILOT reports in a hover 2.25 NM NW of Nottingham Airport on a heading of 300° at 1200 ft QNH 996. He was receiving an A/G service from Nottingham Radio on 122.8, squawking a discreet code Mode A and C with strobe and anti-collision lights on. The visibility was >20 km, 2500 ft below cloud, in VMC. Whilst "on task", he heard a pilot call on frequency "half a mile N of the RW at 1400 ft" who was informed by ATC of his presence at 1800 ft, which was his previously stated max. altitude. Before he could transmit a correct altitude report, he heard the other pilot state that he "had the helicopter in sight and was departing to the N". He briefed his passengers about the presence of a conflicting ac and commenced a scan to his R to look for it as he believed it would pass about a mile to his R rear side. A few seconds later, a white helicopter with blue markings flew directly overhead and only just above them on a NW heading; the

Cause : In adequate avoiding action by the MD60 pilot.

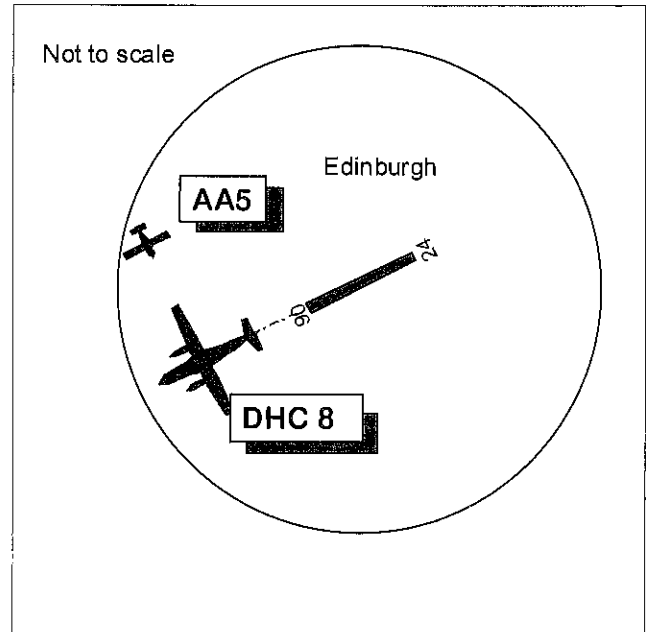
THE DHC8 PILOT reports departing Edinburgh RW24 on initial climb out to Manchester on a TLA5C SID. The visibility was 30 km in VMC and he was receiving an ADC service from Edinburgh TWR on 118.7 MHz. Shortly after passing through 1000 ft (QNH 990 mb) climbing straight ahead, he received a TCAS TA on traffic in his 2 o'clock, range 1 NM, 200 ft below. He took no avoiding action except for continuing the climb until passing clear of the conflict which he did not see; he estimated he had zero visibility ahead due to the sun being aligned with the RW QDM. He stated that this would have been a TCAS RA with "increase climb" had this function not been inhibited below 1450 RAD ALT. He also said that he had not been warned of any conflicting traffic by ATC before departure.

Cause: Perceived confliction which might have been avoided if traffic information had been passed to the DHC8 pilot.

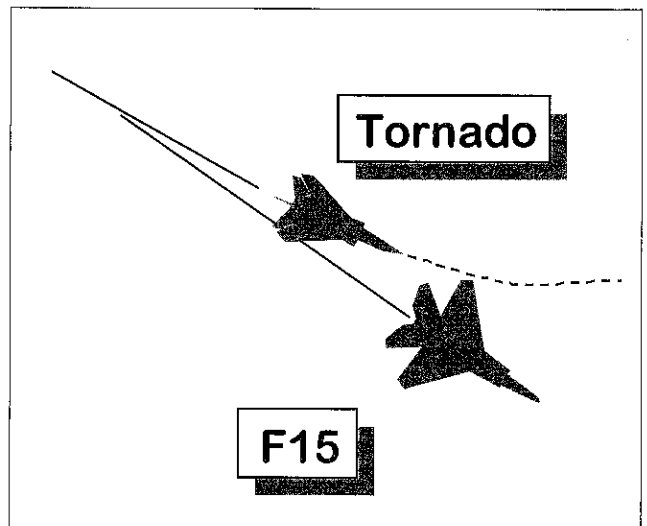
AIRPROX REPORT No 191/00

Date/Time: 16 Nov 1208
Position: 5550 N 0220 W (N of Duns)
Airspace: FIR (Class: G)
Reporting Aircraft Reported Aircraft
Type: Tornado F3 F15
Operator: HQ STC Foreign Mil
Alt/FL: 6000 ft 1000 ft
(RPS) (agl)
Weather VMC CLNC ∇ VMC
Visibility: 40 km
Reported Separation: 300 yd/1 NM
Recorded Separation: NK

THE TORNADO F3 PILOT reports heading 120° at 550 kt and 6000 ft having committed to a target from a CAP. He was in OTA C and conforming to OTA procedures (which are explained in the HQ STC comment). His navigator was looking for the target on radar and had seen a co-speed, co-heading stranger at 10 NM; he was describing the air picture to the pilot when he saw an F15 cross the nose 300 yd ahead, having climbed from beneath. He directed the pilot to jink left 10° to increase separation; the F15 gave no sign of having seen them. On contacting London Mil radar he was advised of a formation of 3 F15s which

appeared to have been conducting PIs in the same airspace. Non 1 Gp ac are permitted to do PIs in the same OTA without communicating with the 'OTA Commander' which he considered to be a major flight safety hazard. Had he come off the CAP 2 seconds earlier, he was in no doubt there would have been a collision.

Cause: Confliction of flightpaths.

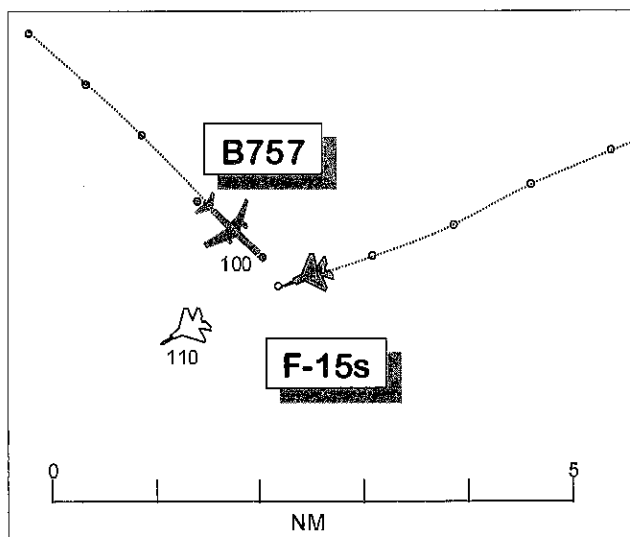
THE B757 PILOT reports climbing out of Birmingham and flying a radar heading of 175° at 300 kt. He had levelled at FL 100, IMC in cloud, and had been advised by LATCC on 130.925 of crossing military traffic at FL 110 which he could see on TCAS but not visually; it crossed 1 NM ahead and 1000 ft above. With no other TCAS traffic showing, both pilots saw visually a military fighter, possibly twin finned, cross very quickly ahead from left to right at the same level. It passed from 10:30 to 2 o'clock at very close range; both pilots heard its engines and they encountered slight turbulence from its wake. He estimated it passed 100 ft away, closer than he would have taxied past it on the ground. (UKAB Note: RT recordings show that the B757 was on an acknowledged radar heading of 140°, tracking 126°. The pilot initially passed a miss distance of 100 ft at the same level and 20 seconds later gave "about a hundred yards directly in front of us.")

However, had the second F15 been squawking (with Mode C), the confliction would have been recognised earlier, either visually by the controllers concerned, through the activation of STCA or, at a later stage, by TCAS. The AAIB's Safety Recommendation that all ac should be transponding can only be implemented in the long term. In the short term however, due to equipment limitations at both LATCC and ScATCC, the resultant SSR label clutter and STCA issues have safety implications in their own right. As an interim solution therefore, military formations within CAS are now required to maintain position within 1 NM laterally and longitudinally of each other at the same level or altitude. In addition, the controller will be required to obtain confirmation that all elements are at the assigned level prior to entering, and following any level change within, CAS. Formations unable to comply with these regulations will be split into elements, separated by the prescribed ATC separation minima, and individual squawks allocated. The interim measures, effective from

AAIB investigated the Airprox and concluded that it was caused when the second F15 crew missed the radio call instructing the formation to climb to FL 110 and as a result separation on the B757 at FL 100 was lost. The LJAO controller was operating in accordance with JSP 318A procedures by not allocating the No 2 F15 a squawk. However, as a result of the ac not squawking, the automatic alerting and collision avoidance systems provided by STCA and TCAS were rendered ineffective and neither the LJAO controller nor MID were able to detect that the No 2 ac had not climbed. If the No 2 ac had been squawking it is unlikely that the Airprox would have occurred.

Cause: The No 2 F15 crew did not climb to their cleared level.

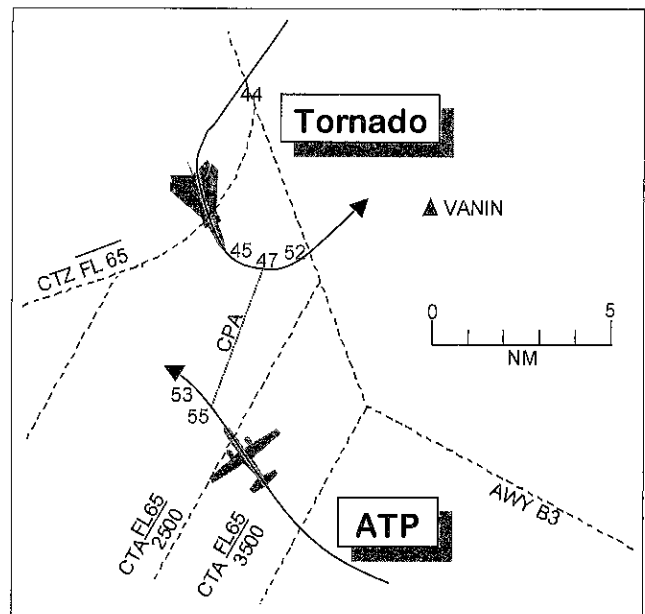
THE ATP PILOT reports heading 325° at 215 kt in descent for Ronaldsway when ATC advised of unknown traffic out to the right. A return was seen on TCAS which became a TA at about the same level. PF turned left about 5°, being visual with the airfield and PNF saw the ac which looked like a Hawk at 3 o'clock about 4 NM away on TCAS. ATC advised that the unknown ac had infringed the IOM CTA and was not on an IOM frequency.

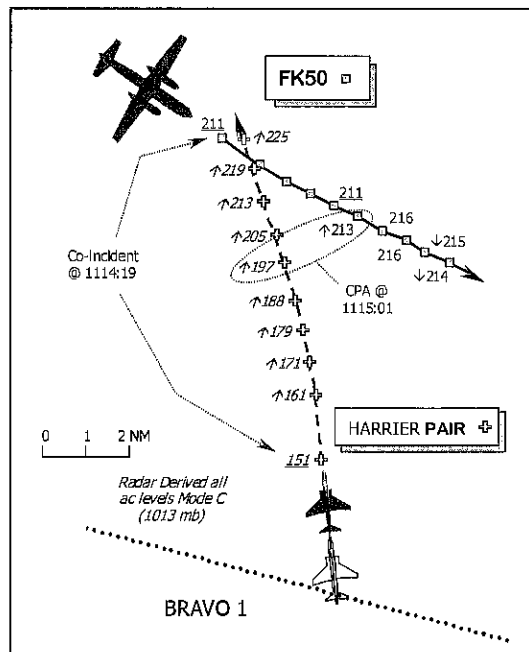
Flying at 195 kt, at a position 132° NCL 118 NM DME heading 130°, a TCAS TA was enunciated, which was followed immediately by a "Climb" RA that was complied with by the First Officer, the PF. Another ac (possibly two) was shown on TCAS 3000 ft below them and less than 5 NM ahead of his ac. Simultaneously, ATC reported the traffic but by this time they were following the RA and advised the controller accordingly. During this period the workload was high and the ATC RT messages became "blocked" by the TCAS audio.

He estimated from the TCAS display that the other ac closed within 1 NM, 3-400 ft below his ac, before clearing astern. They climbed about 500 ft above their assigned level to FL 215 before TCAS enunciated "clear of conflict", whereupon he advised ATC they were returning to FL 210. The whole event happened in less than 15 sec from the first TA to "clear of conflict" and the speed of the encounter made him think that they were probably high-speed military ac, but they were not seen.

THE HARRIER PILOT reports he was leading a pair of camouflage grey Harriers 300 yd apart, flying in-line astern after departure from Holbeach Range climbing to FL 290. HISLs are not fitted. At the time of the Airprox report they were heading 340° at 300 kt under a RIS from London RADAR, flying out of sun in VMC, with an in-flight visibility of 30 km and clear of cloud. The FK50 was not seen by either of the Harrier pilots who were unaware of any collision risk and, he thought, that they had not been informed about the ac flown by the reporting pilot.

ATSI reports with RT transcript, that the Pennine RADAR Controller was providing a RAS to the FK50 on track to join CAS at DOGGA at FL 210. The frequency was very quiet. He observed military traffic, crossing Airway B1 northbound, at FL 150. The radar recording shows the Harrier pair crossing the northern edge of the airway at FL 150 at 1113:43, 13 NM SSE of the FK50. They start to climb at 1114:23. By the time the controller noticed the conflict, some 20 seconds later, the Harrier pair was passing FL 180.

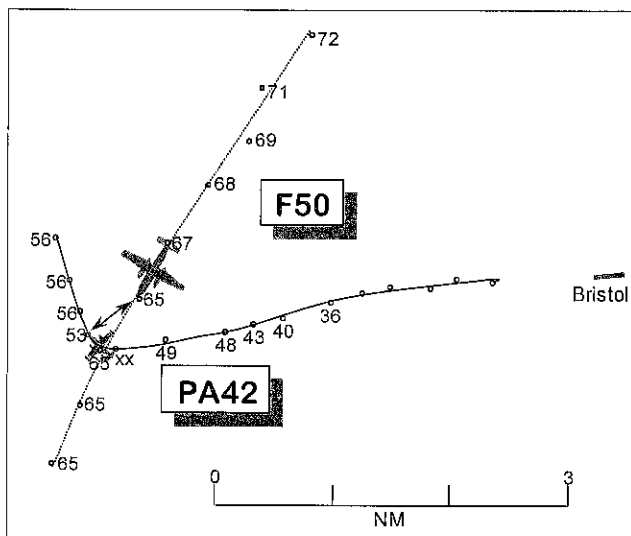
Reported Separation: 800 ft NK

Recorded Separation: 900 ft 1 NM

THE F50 PILOT reports heading 220° and cleared by Bristol ATC to descend to FL 60 during a descent into Cardiff. He was given traffic information on an ac departing RW 27 at Bristol and cleared to climb to FL 50; because he was IMC he did not expect to see it but anticipated its appearance on TCAS. Shortly afterwards it appeared, produced a TA and soon afterwards an RA - Monitor VS, less than 700 ft/min. He levelled at FL 65 and the other ac passed

Cause: The PA42 pilot climbed above his cleared level.

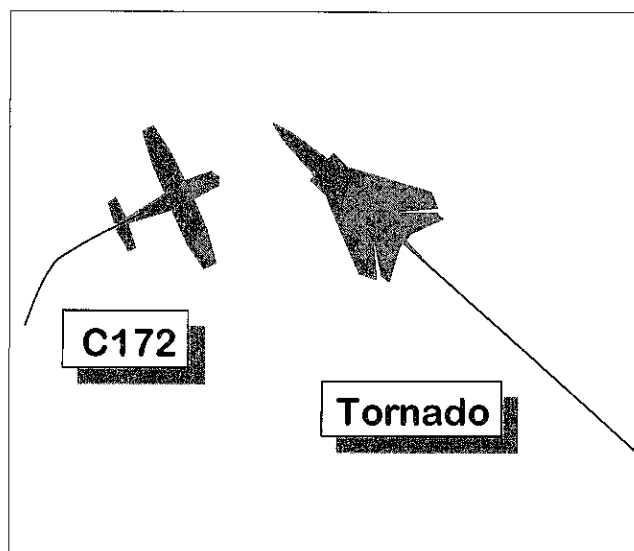
Reported Separation: 100 ft V
200 ft H/200 m

Recorded Separation: NK

THE TORNADO PILOT reports heading 310° at 450 kt having rolled out of a navigation turn when his navigator shouted "Push down". He did so and a Cessna, white with red stripes, passed about 100 ft away and above, without deviating. He had not seen it approaching from behind the canopy arch, and the risk of collision was high.

Cause: Late sightings by the crews of both ac.

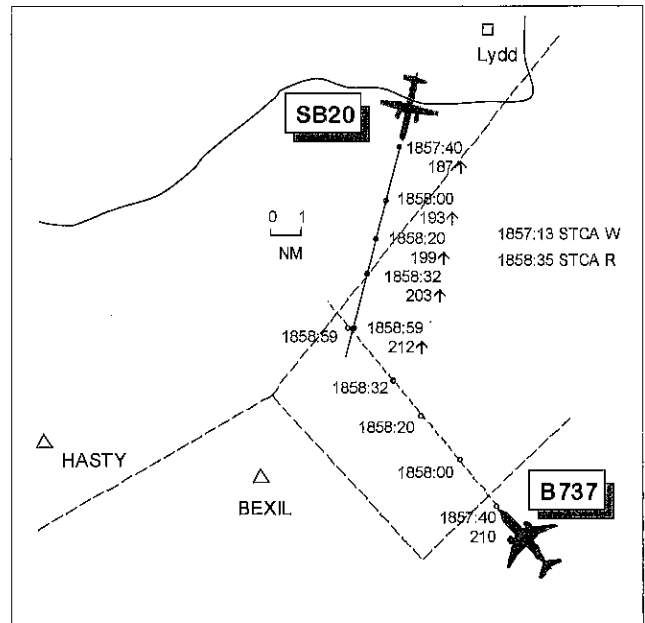
THE SAAB 2000 PILOT reports flying outbound from London City climbing at 240 kt. The visibility was >10 km in VMC at night and he was receiving an Area Control Service from London on frequency 128.42 MHz. After initially following a LYD 3T SID to DET VOR, he was issued a radar heading of 205° and was cleared to climb to FL 220, he thought. On passing FL 213, with a rate of climb 800 ft/min, he noticed the headlights of another ac on his LHS which then passed 300 m ahead, L to R, and 300 ft below. It was the B737. He assessed the risk of collision as high and was able to identify the ac's airline from its colour scheme. No avoiding action was taken as he had seen the other ac very late. He also stated that he had kept his landing lights on because the LTMA was busy with traffic; he had only seen the B737 when its crew switched their headlights on just before crossing ahead. He thought there had been an error by London Control who had not passed any avoiding action heading or traffic information and he also believed that if TCAS had been fitted it would have assisted in preventing this incident.

UKAB Note (1): Rate of climb for the SB20 until the time of the Airprox was measured at 2000 ft/min.

Cause: The SB20 crew climbed above their cleared level and flew into conflict with the B737.

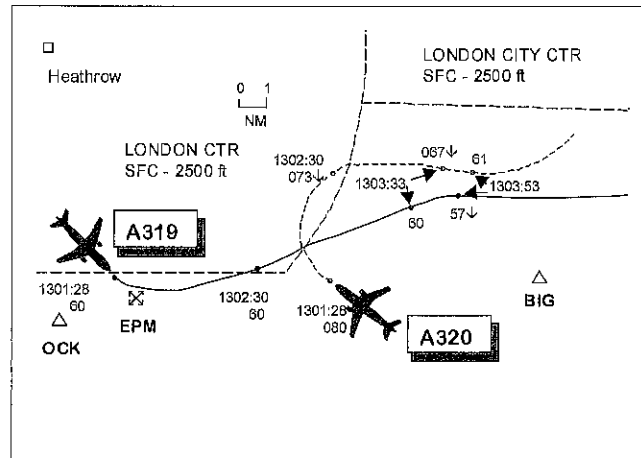
THE A320 PILOT reports flying inbound to Heathrow on a radar heading of 110° in descent from 6000 ft to 4000 ft; he was receiving an approach radar control service from Heathrow Director. On passing 5500 ft (he thought) he received a TCAS RA "climb" with which he complied, finally levelling at 6300 ft. Simultaneously, he received an avoiding action L turn from Heathrow; he saw the conflicting ac on his R hand side and below.

Cause: During a period of weather avoiding instructions, the BIG SC allowed the A319 to conflict with the A320, while unable to achieve co-ordination.

Recommendation: That the MOD and the CAA considers a review of mandatory checks to be carried out by controllers, on communications continuity, whenever Sectors/Control positions are bandboxed or split.

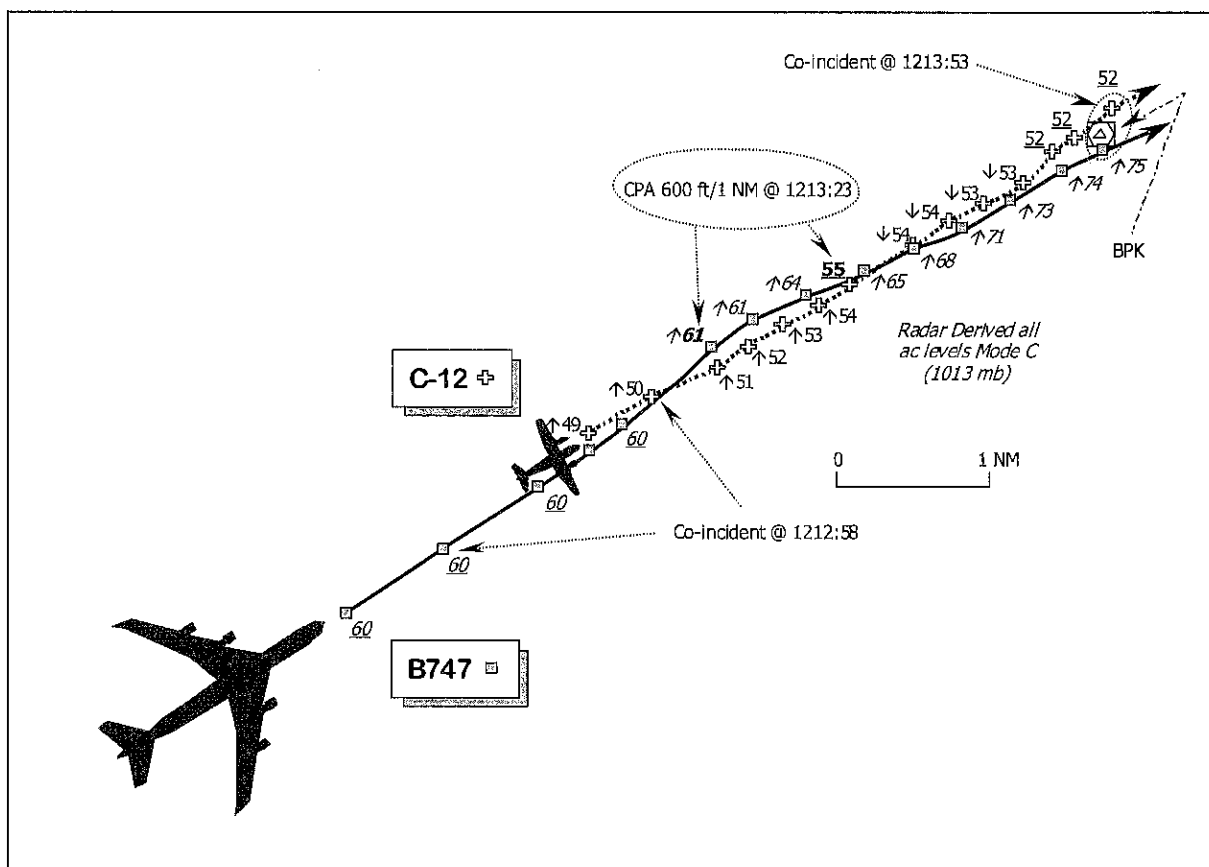
AIRPROX REPORT No 202/00

Date/Time: 11 Dec 1213
Position: 5146 N 0008 W (2 NM SW of BROOKMANS PARK)
Airspace: LONDON TMA (Class: A)
Reporting Aircraft: B747-200
Reported Aircraft: C12M (Beech 200)
Type: B747-200

Operator: CAT Foreign Mil
Alt/FL: 6000 ft (QNH 1012 mb) 5000 ft (QNH 1012 mb)
Weather: IMC IN CLOUD IMC HAZE
Visibility: Nil NR
Reported Separation: 500 ft V, 1 NM H/NR
Recorded Separation: 600 ft V, 1 NM H

Cause: The C12 crew climbed above their assigned altitude.

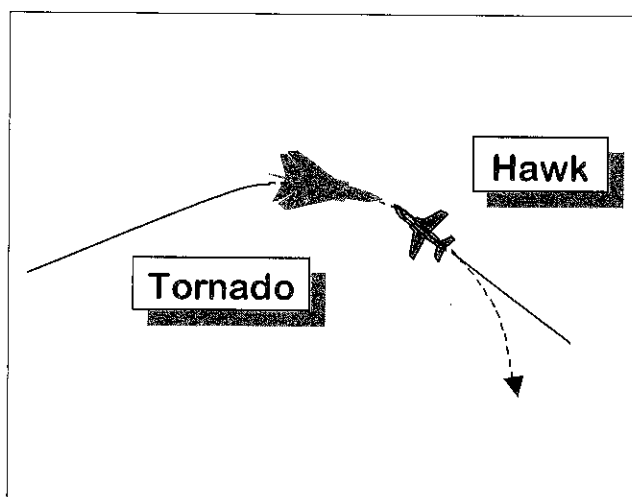
Reported Separation: 300 ft/2-300 ft V

Recorded Separation: NK

THE HAWK PILOT, part of a mixed formation that had split up, reports heading 300° at 300 kt and receiving a RIS from Neatishead as he climbed to FL 150 to cross airway B1. Neatishead was very busy and he was on a minimum deviation, fuel critical RTB. Neatishead advised of a stranger 10 NM to the NW and again at 5 NM at FL 115; he replied that he was passing FL 135. As he began to level from a 5° climb, IMC in cloud, he saw a Tornado closing from 500 m away in his 12 o'clock; it was also climbing on a reciprocal track. He bunted to level flight and the Tornado passed 300 ft above; he assessed the risk of collision as high. He had not asked for a RAS because of the high level of communication on the frequency.

Cause: Late sighting by both crews while flying without an appropriate radar service in marginal weather conditions.

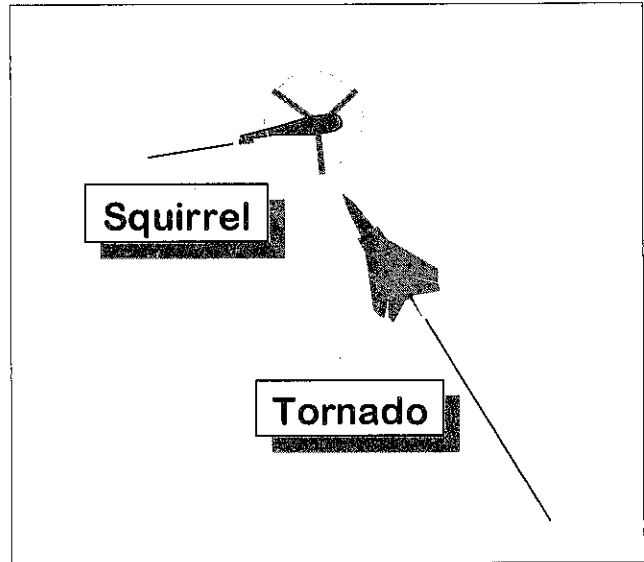
THE SQUIRREL PILOT reports heading 080° at 60 kt in a hold between inspecting sections of 11 kv power lines, while his observer familiarised himself with the line diagram. His helicopter is burgundy coloured and his HISL, strobes and nav lights were on. He was receiving Flight Information from Linton on Ouse and had been scanning to left and right for other ac but had seen none. On his next scan to the right he saw the Tornado behind his shoulder at the same height on a constant bearing, and closing very, very fast. He instinctively lowered the lever and pushed forward violently on the cyclic, losing sight of the Tornado as it passed 50-100 ft above (about 2 seconds after he first saw

it) and hearing jet noise very close. The Tornado continued without deviation and he encountered no wake from it. He then landed in a field so that he and his observers could calm down and regain composure. After resuming his task he asked Linton whether they saw the confliction on radar; they had not. He considered a collision would have been certain without his avoiding action. His workload had been minimal at the time but vision from the helicopter is impaired by door and window frames.

It was clear to members that the cause of the Airprox was a late sighting of the other ac by both crews; this was a simple fact, not a criticism. The Board agreed that sightings in these circumstances (high closure rate on small objects against a terrain background) are often late, leaving very little time for avoiding action, and a BHAB representative forcefully expressed his concern for the danger posed by military fast jets to helicopters on essential power- and pipe-line patrols. This led to a wide but inconclusive discussion; it was apparent that neither PINS nor the CANP applied to the helicopter pilot's sortie. While the most part of the inspection (as stated in Part A) was flown below military operating heights, the danger arose when the pilot was required, by the constraints in his exemption from Rule 5e, to climb and descend between sections.

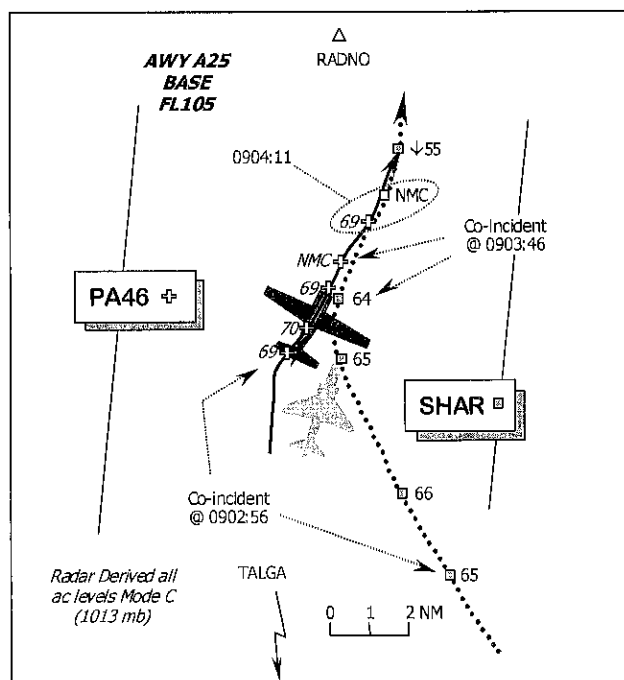
About 10 NM N of TALGA, as he was intermittent IMC – about 800-1000 ft above cloud, though the visibility ahead was unlimited he was only 0.5 NM clear of cloud horizontally in between layers - he elected to free-call Shawbury for a RIS. Whilst

heading 020° at 175 kt, checking his chart for a VOR and the Shawbury frequency, he became aware of another ac, which he thought was a Harrier, coming out of the sun. He first saw it about 1000 m away at 4-5 o'clock as it moved down his starboard side at about the same level, and "strangely" not excessively fast. The 'Harrier' passed 3-400 m away to starboard before it overtook him and made a very rapid descent to low-level between layers. He immediately free-called Shawbury for a RIS and descended to 3000 ft RPS to establish VMC as he felt quite

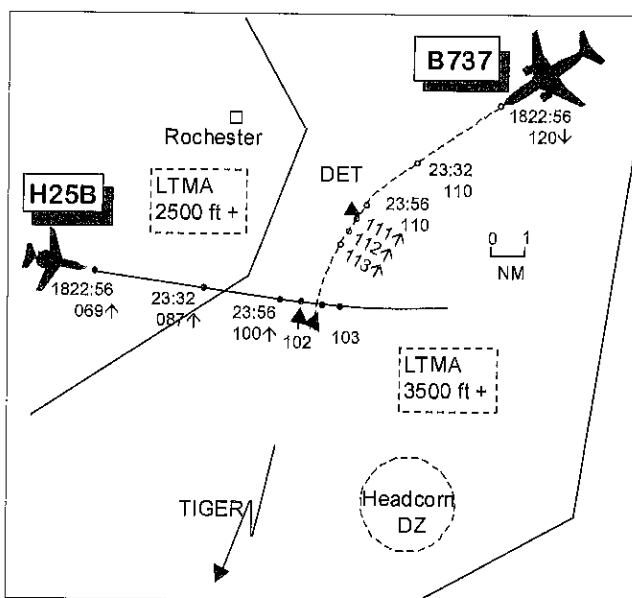
AIRPROX REPORT No 207/00

<u>Date/Time:</u>	6 Dec 1824	NIGHT
<u>Position:</u>	5218 N 0036 E (2 NM S DET VOR)	
<u>Airspace:</u>	TMA	(Class: A)
	<u>Reporting Aircraft</u>	<u>Reported Aircraft</u>
<u>Type:</u>	B737	H25B
<u>Operator:</u>	CAT	Civ Pte
<u>Alt/FL:</u>	↓FL110	↑FL100
<u>Weather</u>	VMC SHWR	IMC
<u>Visibility:</u>	>10 km	
<u>Reported Separation:</u>	300 ft V 1 NM H/NK	
<u>Recorded Separation:</u>	1000 ft V 1.6 NM H

THE B737 PILOT reports inbound to London Gatwick on a Timba 2E STAR in descent to FL 100 (he thought) at 280 kt. The visibility was >10 km in VMC and rain. On passing FL 110, he received a TCAS RA "climb" and acquired the crossing traffic visually whilst disconnecting the A/P and initiating a climb; he finally levelled at FL 113. The conflicting traffic passed 1 NM ahead R to L and 300 ft below which he had in sight at all times during the incident.
