UK AIRPROX BOARD

Analysis of Airprox in UK Airspace

**Report Number 25
July 2010 – December 2010**

Twenty-Fifth Report by the UK Airprox Board:

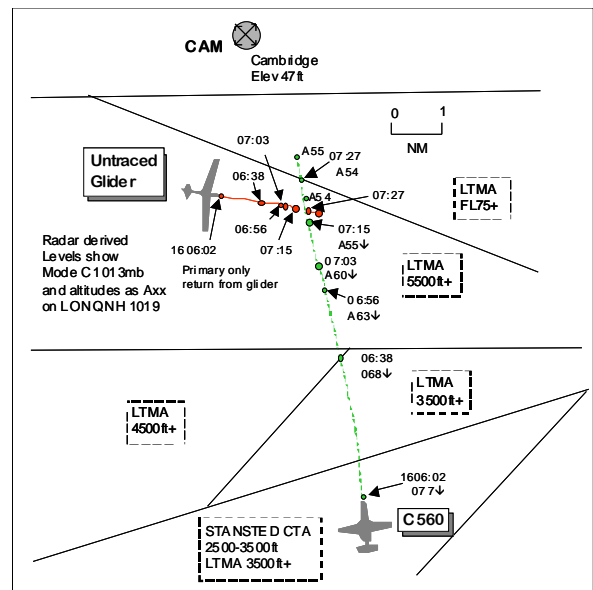
AIRPROX REPORT NO 2010084

Date/Time: 3 Jul 2010 1607Z (Saturday)
Position: 5209N 00012E
(4nm SSE Cambridge - elev 47ft)
Airspace: LFIR (Class: G)
Reporting Ac Reported Ac
Type: C560XLS Untraced glider
Operator: Civ Comm N/K
Alt/FL: 5500ft ↓
(QNH) (N/K)
Weather: VMC CLBC NK NR
Visibility: >10km NR
Reported Separation:
10ft V/20m H NR
Recorded Separation:
0.1nm H

THE C560XLS PILOT reports heading inbound to Cambridge IFR at 250kt and in communication with London squawking an assigned code with Modes S and C; TCAS was fitted. London instructed them to leave CAS in the descent to Cambridge although he was not sure if this was the cleared point or if a heading was given. They broke a layer of cloud at about 6000ft and, while receiving a call from London stating that they were leaving CAS and that Cambridge was closed, something reflected the sun on his LHS. He looked out of the L window and spotted a glider flying towards his ac very close, 15ft below and 25m away. Touch Control Steering (TCS) was initiated and he rolled to the R and pointed the ac's nose up to break the descent and move away from the glider, estimating separation was 10ft vertically and 20m horizontally at the CPA. After the avoiding action ATC repeated the transmission and he replied. After switching to Cambridge he reported the Airprox but no radar echo was spotted. The flight was continued with no further events.

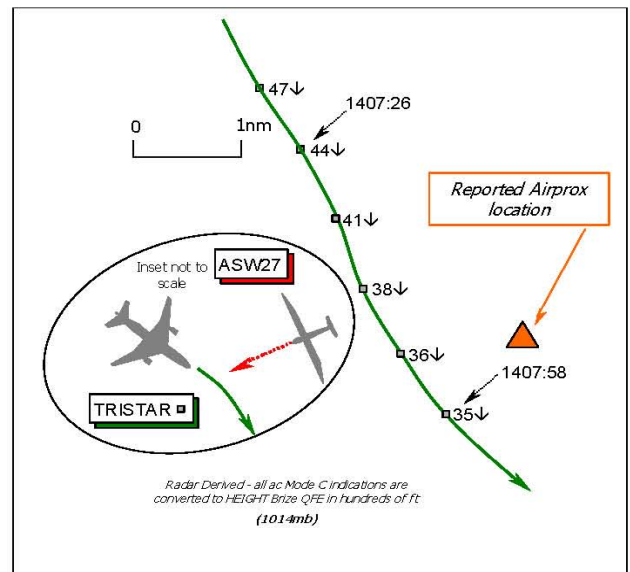
AIRPROX REPORT NO 2010086

Date/Time: 6 Jul 2010 1407Z
Position: 5150N 00158W (15nm NW of Brize Norton - elev 287ft)
Airspace: London FIR (Class: G)
Reporting Ac Reported Ac
Type: Lockheed L1011 ASW 27 Glider
Operator: HQ Air (Ops) Civ Pte
Alt/FL: ↓3500ft 3500ft
 QFE (1014mb) QFE
Weather: VMC CBCL NR
Visibility: 30km 10nm
Reported Separation:
 200-300ft slant range 25-50m H
Recorded Separation:
 Not recorded

THE LOCKHEED L1011 TRI-STAR PILOT reports he was inbound to Brize Norton under IFR in VMC and was in receipt of a TS from Brize DIRECTOR (DIR) on 133.750MHz. The assigned squawk of A3743 was selected with Mode C; TCAS and Mode S are fitted. The ac has a grey colour-scheme but the HISLs and anti-collision lights were all on.

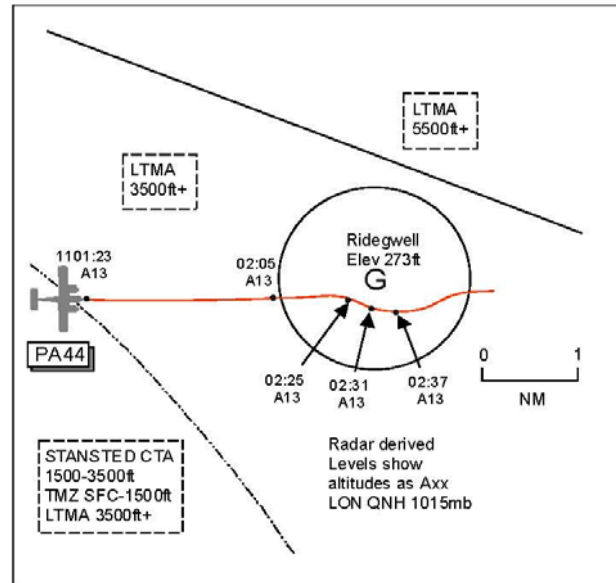
AIRPROX REPORT NO 2010087

Date/Time: 11 Jul 2010 1102Z (Sunday)
Position: 5203N 00033E
(0-25nm SW Ridgewell G/S - elev 273ft)
Airspace: LFIR (Class: G)
Reporting Ac Reported Ac
Type: ASK21 PA44
Operator: Civ Club Civ Pte
Alt/FL: 1000ft ↑ 1400ft
(QFE) (QNH)
Weather: VMC CLBC VMC CLBC
Visibility: NR >10km
Reported Separation:
Nil V/100ft H 100ft V/900m H
Recorded Separation:
NR

THE ASK21 PILOT reports flying a dual 'trial lesson' sortie from Ridgewell seated in the rear seat. The Wx was VMC with about a 5000ft cloud base and his ac was coloured white; no radio, lighting or transponder was fitted. When close to the top of the winch launch on RW23, as the glider was levelled-off prior to release at 1000ft QFE a maroon/black coloured twin-engine ac was first seen by the front seat pilot before it passed very close in front of his ac, about 100ft away at the same level, from R to L. The passenger in the front seat commented that the other ac had had to deviate to avoid a collision before it was seen to turn onto an E'ly heading to their L once passed.

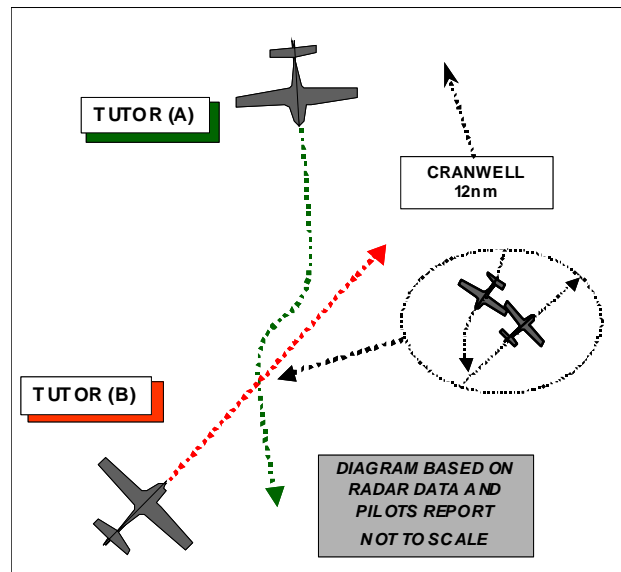
Reported Separation:
100ft V/ 100m H NR

Recorded Separation:
100ft V/0.1nm H

TUTOR (A) PILOT reports flying an instructional flight from Cranwell in a white ac, not in contact with any unit but squawking a Cranwell conspicuity code. During the climb, heading 180° at 80kt and passing 6000ft, the student pilot flew a gentle pitch up and right turn to avoid another Tutor ac, and subsequently reported the sighting to the instructor. The opposing Tutor was first seen in the 2 o'clock low position, at a distance of 100M and about 100ft below. The instructor only saw the ac as it passed below departing towards their 8 o'clock. In retrospect, having not seen the other ac until after it passed, the instructor considered the risk of collision as medium.

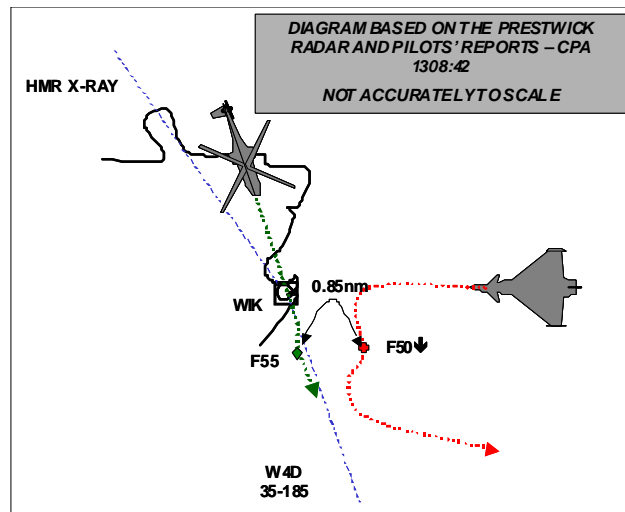
AIRPROX REPORT NO 2010089

Date/Time: 13 Jul 2010 1309Z
Position: 5822N 00302W (5nm S Wick)
Airspace: W4D (Class: F)
Reporting Ac Reported Ac
Type: EC225 Typhoon
Operator: CAT (H) HQ Air (OPps)
Alt/FL: FL55 NR
Weather: VMC CLBL NR
Visibility: >10km NR
Reported Separation:
0 V/1.0nm H 0 V/1.0nm H
Recorded Separation:
500ft V/0.85nm H

THE EC225 PILOT reports flying a scheduled passenger flight inbound Aberdeen on ADR W4D from an oil rig, in receipt of a TS from ScACC, squawking 3610 with Modes C and S. When they had just passed WIK ScACC reported a military ac to the W, he thought, of their position and shortly after TCAS gave a TA. They then saw a Typhoon ac 2-3nm away in their 9 o'clock, belly-up in a left hand turn so they turned right for 2-3sec but the Typhoon then manoeuvred around their position for about 30sec before departing to the N.

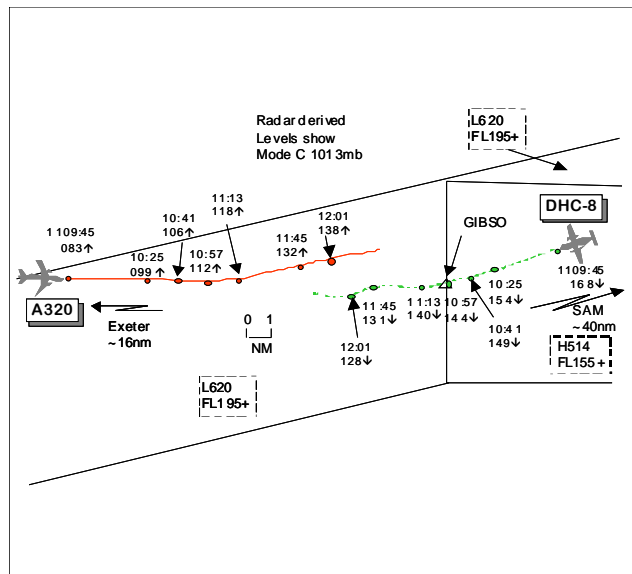
AIRPROX REPORT NO 2010090

Date/Time: 8 Jul 2010 1612Z
Position: 5045N 00238W (5nm W GIBSO)
Airspace: LFIR (Class: G)
Reporting Ac Reported Ac
Type: DHC-8 A320
Operator: CAT CAT
Alt/FL: FL145↓ FL145↑
Weather: VMC CAVOK VMC CLOC
Visibility: 10km
Reported Separation:
1000ft V/2.5nm H NR
Recorded Separation:
1000ft V/1.9nm H

THE DHC-8 PILOT reports inbound to Exeter IFR and in communication with London squawking 6260 with Modes S and C. Descending from FL180 to FL100 outside CAS in the area of GIBSO heading 270° at 340kt they were not under Western Radar cover. They saw proximate traffic on TCAS before seeing the A320 flying level, he thought, on their R in the opposite direction. As they descended through its level, a TCAS TA was generated; they turned L due S away from the A320 to avoid, estimating 1000ft vertical and 2.5nm horizontal separation at the CPA. They heard the A320 flight report a TCAS RA. He assessed the risk as low.

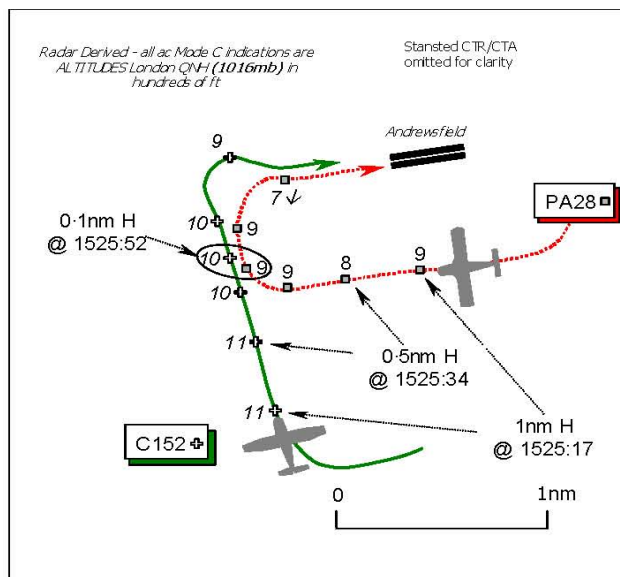
AIRPROX REPORT NO 2010091

Date/Time: 10 Jul 2010 (Saturday) 1525Z
Position: 5153N 00026E (Andrewsfield A/D - base leg RW09RHC - elev: 286ft.)
Airspace: Andrewsfield ATZ (Class: G)
Reporting Ac Reported Ac
Type: Cessna 152 PA28B
Operator: Civ Trg Civ Pte
Alt/FL: 600ft 600ft
QFE (1006mb) QFE (1005mb)
Weather: VMC VMC Sky Clear
Visibility: >20nm >20km
Reported Separation:
Nil V/150m H Not seen
Recorded Separation:
100ft V/0.1nm H

THE CESSNA 152 PILOT reports that he was instructing a student flying in the cct at Andrewsfield and in communication with Andrewsfield RADIO A/G Station. He occupied the RH seat as the instructor, with his student the PF in the LH seat. The visibility was excellent, but there was significant thermal and mechanical turbulence from a strong southerly wind and, especially on base leg, there were noticeable updrafts.

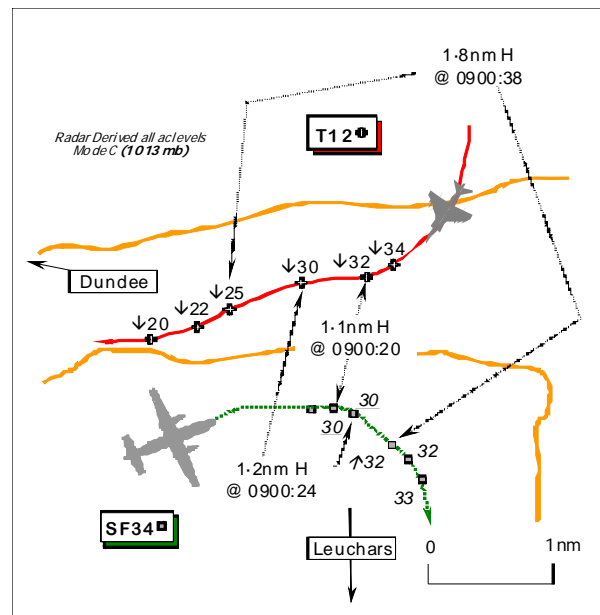
AIRPROX REPORT NO 2010092

Date/Time: 20 Jul 2010 0900Z
Position: 5626N 00252W
(3.7nm N of Leuchars - elev 38ft)
Airspace: Leuchars MATZ/FIR (Class: G)
Reporting Ac Reported Ac
Type: SAAB 340B Harrier T12
Operator: CAT HQ Air (Ops)
Alt/FL: 3000ft 3000ft
QNH (1009mb) QFE (1008mb)
Weather: VMC CLAC VMC CLBC
Visibility: 40km 20km
Reported Separation:
100ft V/2nm H 1500ft V/3nm H
Recorded Separation:
200ft V @ 1.1nm Min H
Nil V @ 1.2nm H

THE SAAB 340B (SF34) PILOT reports he was inbound to Dundee from the S at 7000ft under VFR and in receipt of a TS from Leuchars APP. He was instructed by Leuchars APP to descend to 3000ft Dundee QNH (1009mb) and asked to report visual with Dundee Airport. At a range of 6nm DME, in good VMC, they reported visual with the Airport and requested to transfer to Dundee APPROACH if Leuchars had nothing further [to affect their flight]. They were handed over, he thought, [free-called following a pre-note] to Dundee whilst maintaining level flight at 3000ft and began to position L base for RW27 with the A/P engaged, when a TCAS contact appeared on the screen to the NE rapidly approaching their position, displayed at +900ft and at a range of 8nm. The TCAS contact continued to converge on a constant 'heading' whilst descending and both he and his 1st Officer looked for the other ac but could not see it. TCAS then enunciated a 'TRAFFIC' alert. At this point, heading 070° at 180kt, with the TCAS contact about 2nm away, the Captain (PF) disconnected the A/P and turned R into a climbing turn avoidance manoeuvre. TCAS then enunciated an RA - MONITOR VERTICAL SPEED. The other ac was now showing red on the TCAS display at +100ft. Within a few seconds TCAS enunciated CLEAR OF CONFLICT. Despite good visual conditions and a good lookout from both pilots the other ac was never visually identified.

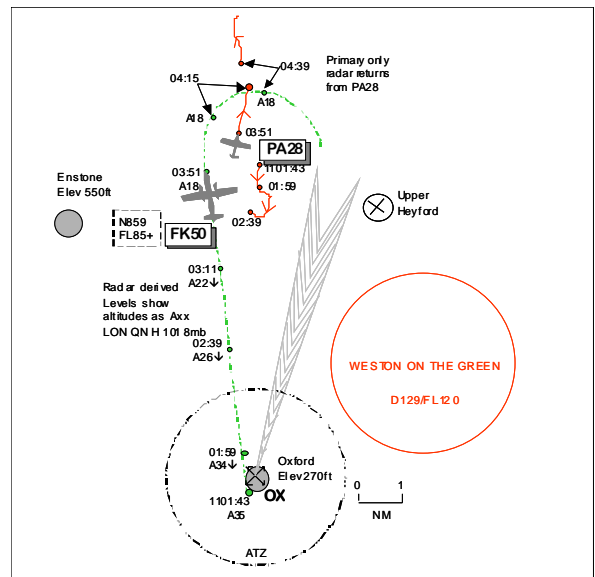
AIRPROX REPORT NO 2010094

Date/Time: 10 Jul 2010 1105Z (Saturday)
Position: 5159N 00120W
 (9nm N Oxford - elev 270ft)
Airspace: Oxford AIAA (Class: G)
Reporting Ac Reported Ac
Type: FK50 PA28
Operator: CAT Civ Trg
Alt/FL: 1800ft 2000ft
 (QNH 1018mb) (QNH 1018mb)
Weather: VMC CLBC VMC CLBC
Visibility: 10km 10km
Reported Separation:
 Nil V/<0.5nm H 500ft V/0.5nm H
Recorded Separation:
 <0.5nm

THE FK50 PILOT reports inbound to Oxford, IFR and in communication with Oxford Approach squawking an assigned code with Modes S and C. They were positioning for RW19, level at 1800ft QNH 1018mb at 150kt. Although they had been informed of several ac in the proximity of Oxford, they did not expect to see a PA28 a couple of hundred metres away (<0.5nm) on a conflicting course during their inbound turn towards the LLZ at the same altitude. They increased their AoB to tighten the turn towards the LLZ, later informing ATC of the incident after landing.

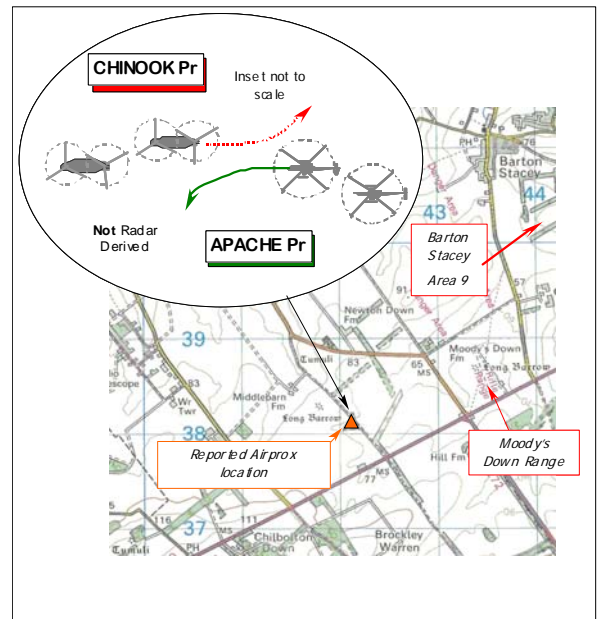
AIRPROX REPORT NO 2010096

Date/Time: 21 Jul 2010 2216Z NIGHT
Position: 5108N 00122W
 (6½nm E of Middle Wallop)
Airspace: NLFS NRR1 (Class: G)
Reporting Ac Reported Ac
Type: Apache AH1 x2 Chinook HC1 x2
Operator: HQ JHC HQ JHC
Alt/FL: 115ft 250ft
 agl agl
Weather: VMC CLBC VMC CLBC
Visibility: 15km 20km
Reported Separation:
 100ft V/nil H 100ft V/50ft H
Recorded Separation:
 Not recorded

THE APACHE AH1 HELICOPTER PILOT, a QHI, reports he was leading a pair of Apache ac, flying dual with a student as the PF, on a pairs final handling test for conversion to type. He was flying approximately 4-5 rotor spans in front of the No2 Apache. In accordance with SOPs, his lead helicopter was showing IR lighting and the No2 was fully lit; both ac were displaying glimmers [non-NVG compatible tactical lights not visible all round] and conventional navigation lights on steady bright; in addition his No 2 also had red HISLs on. He was not in receipt of an ATS but monitoring UHF LFS Common - 278.00MHz. A squawk of A2676 was selected [unverified Middle Wallop conspicuity] with Modes C & S on; TCAS is not fitted.

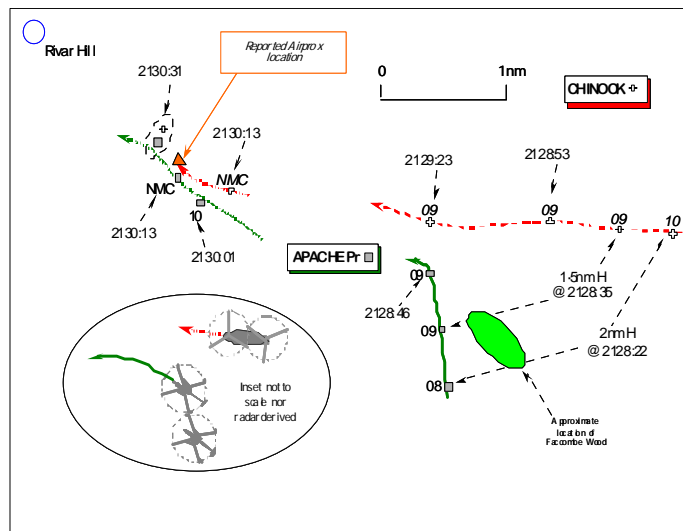
THE APACHE AH 1 PILOT reports he was leading a pairs night low-level conversion training sortie departing from Middle Wallop and routeing N from Andover at 300ft agl, VFR and not in receipt of an ATS. A squawk of A2676 was selected [unverified Middle Wallop conspicuity] with Mode C on; TCAS is not fitted. Both ac were displaying glimmers [non-NVG compatible tactical lights not visible all round] and conventional navigation lights on steady bright; in addition his No 2 also had red HISLs on.

Cause: Whilst overtaking, the Chinook pilot flew sufficiently close to cause the Apache formation concern.

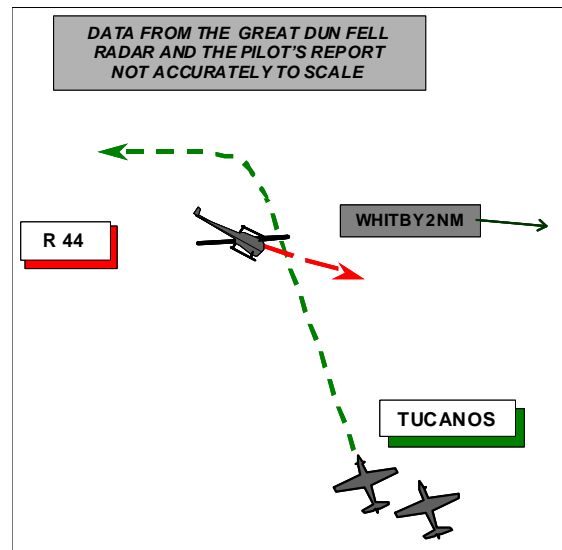
AIRPROX REPORT NO 2010098

THE TUCANO PILOT reports he was flying as No2 of a pair of black ac, with an instructor in the rear seat, with all lights switched on, Squawking 7001 with Mode C on a basic training LL navigation exercise in LFA 11; TCAS 1 was fitted but they were not in receipt of an ATC service. At a turning point just to the W of Whitby their attention was drawn to a large flock of birds that were resting on the ground. While heading 350° at 240kt, just after seeing the birds he saw a helicopter ½nm away, tracking from left to right, at about 250ft agl but bunting aggressively to avoid their formation - the helicopter was dark blue with white lettering, the top of the rotor blades could be seen as the ac pitched nose down and the flight path of the helicopter was such that it disturbed the birds on the ground and passed directly underneath both the leader and the No2. At the time both formation members had climbed from a nominal 250ft agl to around 400ft agl since they were near a town and in a busy phase of flight approaching a turning point. The crew considered that this combined with the helicopter's bunt had prevented a collision with one or other of the ac.

Cause: A late sighting by the Tucano crews and a probable late sighting by the R44 pilot.

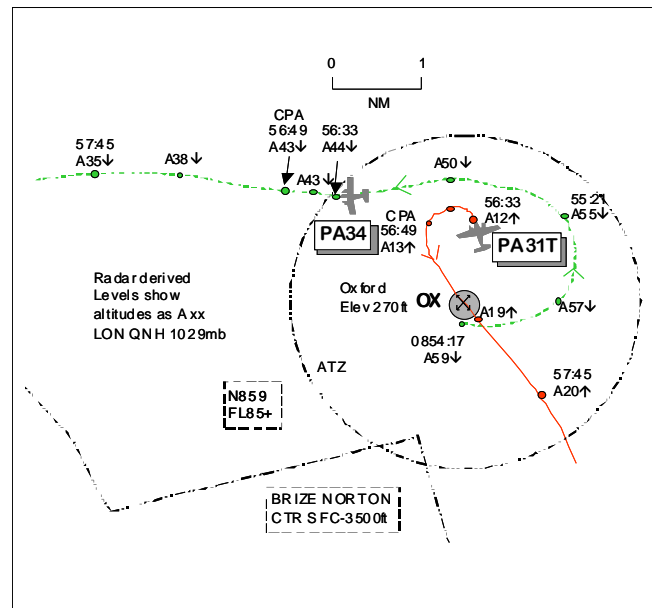
THE OXFORD ADC reports that there was a quiet traffic situation with IMC above altitude 1500ft, 1 ac departing VFR and the subject PA31T taxiing to the hold for an IFR CPT airways departure. APP was working 2 IFR inbound ac and made comment that one of the inbounds, the subject PA34 flight, was requesting an Expected Approach Time (EAT). ADC was not sure of the significance of this until later discovering that the flight had been 'held-off' in the WCO NDB area at FL60 for some time. The PA31T pilot requested departure clearance and was passed the instructions given by APP, "PA31T c/s cleared standard CPT departure hold at Botly climb FL50 remain outside CAS squawk 2234 onward frequency London Control 120.475". The flight was released subject to APP so the ac was kept on the ground awaiting release. APP then advised that the PA34 was "Beacon outbound NDB100 procedure" which placed the IFR ac to the NW of the OX descending. APP then told the ADC to change the outbound clearance on the PA31T to climb to 2500ft QNH 1020mb, making comment to suggest that a form of non-standard separation was being used. APP then released the flight which the ADC queried owing to the IFR NDB100 traffic (the PA34) but APP confirmed again that the PA31T was released. ADC was unaware of APP's traffic situation i.e. had any descent restrictions been applied to the PA34, so ADC carried out the APP's instruction and cleared the PA31T for take-off before transferring the flight to APP once airborne. As the PA31T flight contacted APP the relieving ATCO for that position was told by APP "not to take over until it was sorted out".

APP did not have access to surveillance equipment and was not sure of the exact position of the PA34. No TI or details of the plan were conveyed to the pilots. APP recognised that the procedure adopted was non-standard and resulted in the technical loss of the 1000ft deconfliction minima. This caused the pilot of the PA34 to be concerned that the safety of his ac might have been compromised. MATS Pt1, Section 1, Chapter 2, page 11, paragraph 1.3, states:

Cause: Loss of procedural separation.

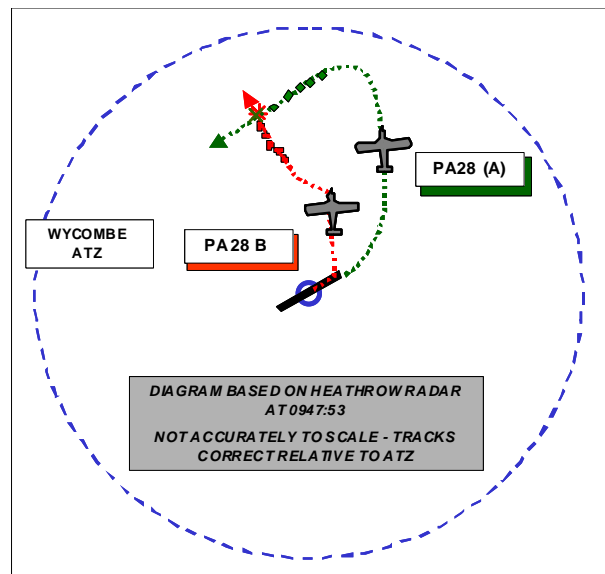
AIRPROX REPORT NO 2010100

THE PA28 PILOT (A) reports that she was conducting a CPL Skills test (partial) in the cct in a white ac with orange stripes and was squawking 7000 with Mode C, while in receipt of an Aerodrome Control Service from Wycombe TWR. The cct traffic was light and only a few transmissions were heard on the RT. While at the mid-point downwind for RW06 (LH) heading 240° at 120kt, and discussing what type of approach to do next, her candidate saw another PA28 (with wheel spats) 150m away in their 10 o'clock, crossing their flightpath from left to right, at a similar height. As he exclaimed the ac passed 100m ahead of them heading in a northerly direction.

The Board noted that the respective pilots, one a locally based examiner and the other a visitor, had seemingly interpreted the published (mandatory) noise abatement procedures differently; PA28 (A) pilot apparently continuing to the airfield boundary before turning onto 020°, while PA28 (B) turned just after getting airborne and possibly about half way down the RW. [It was not possible from the information available to determine what precise track either ac flew on getting airborne as it was not mentioned in any of the reports and the ac were below the base of recorded radar coverage]. Having been briefed on the procedures in force at the time of the incident, the Board agreed that both interpretations were understandable. There was however, an expectation from both the controller and PA28 (A) crew that the correct procedure [for RW06] was to fly the ground track as depicted in both the locally produced handout and in Pooley's Flight Guide, which continues straight ahead to the airfield boundary, rather than turning onto 020° 'as soon as safely possible', which in many cases can involve a significantly different ground track.

Cause: PA28 (B) turned into conflict with PA28 (A) in the Wycombe ATZ.

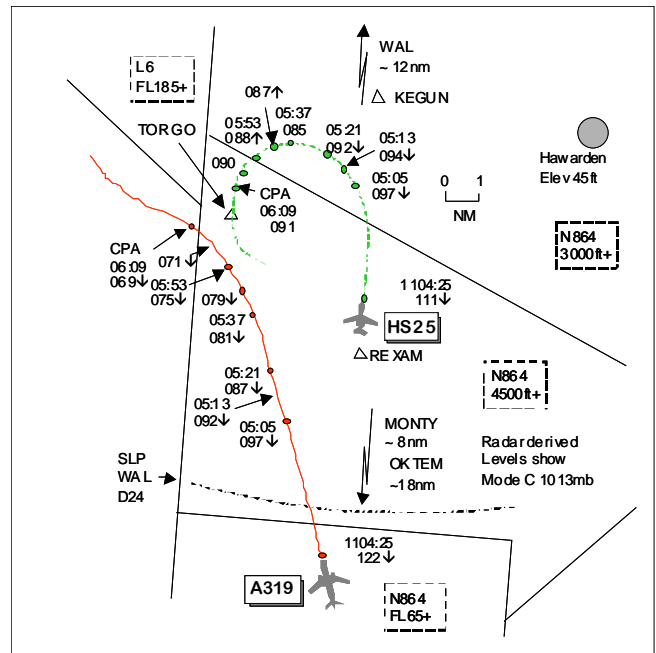
AIRPROX REPORT NO 2010101

THE HAWARDEN APR reports he was the relief radar controller and took over the position at 1042. At approximately 1055 the Liverpool Radar Controller (RC) telephoned with a release on the HS25 descending to FL70 released passing FL80 straight from ScACC. Also, Liverpool RC told him about traffic 10nm behind the HS25 which was inbound to Liverpool squawking 7455 that would be descended on top of the HS25; both ac were much higher than normal. He was about to ring ScACC to confirm that he could turn the HS25 early when Liverpool RC telephoned to say that ScACC had apologised for the level of the 2 ac and asked what he was doing with the HS25. Believing that Liverpool were working the second ac he proposed to turn the HS25 L heading 090° and descend it to 3500ft. The Liverpool RC asked if it could turn R but soon realised that this course of action would not achieve the descent profile; he agreed to the L turn and confirmed that the ac had clearance into Liverpool airspace. Now believing that the HS25 was now no longer restricted to a FL80 release he turned the HS25 L onto 090°. The second ac then began to descend very rapidly and it became clear that this ac was not going to remain above the HS25 as previously agreed with Liverpool. He warned the HS25 crew, stopped the flight's descent and then tried to speak to the Liverpool RC to ask what was happening. The Liverpool Radar Assistant answered the telephone and stated that the RC was busy so Hawarden APR told the Assistant that he had stopped the HS25 at FL90 and to inform the RC. ScACC then telephoned stating that they were continuing N with the 7455 traffic having seen that the HS25 had stopped at FL90. It was only at this point that he realised that the second ac had been working ScACC throughout.

Cause: The Liverpool APR inappropriately agreed coordination with Hawarden APR, who turned the HS25 into conflict with the A319.

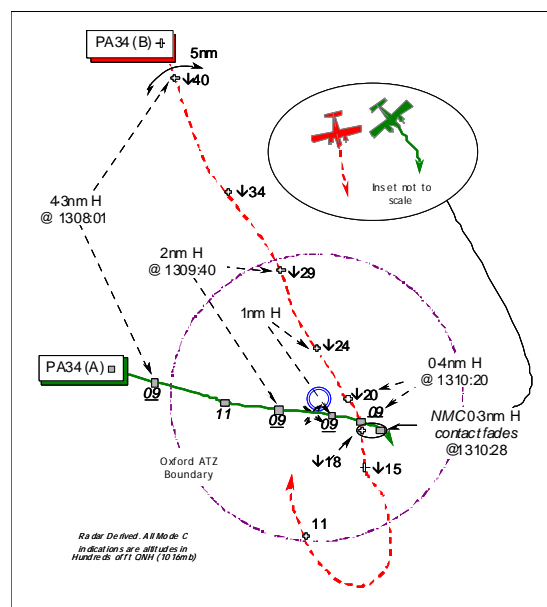
AIRPROX REPORT NO 2010102

THE PILOT OF PA34-200T (A) reports that he was instructing a local instrument training flight at Oxford under VFR in VMC finishing with an NDB approach. The runway in use was RW01 and he was flying the published OXFORD/KIDLINGTON NDB (L)/DME 100° procedure with visual manoeuvring to the active RW. On completion of the approach, as instructed by Oxford TOWER, they were joining visually to RW01RHC - low level - at 800ft QNH (1016mb) [a height of about 530ft]. The controller had instructed them to position No2 to a Zlin on final approach but at the end of the downwind leg heading 190° at 120kt, TOWER alerted them to another ac joining the cct – another PA34 that was inside of them - and therefore to position as No3 in the pattern. Looking to their R nothing was seen until his student indicated the ac was above them, where it was seen 200ft above them, gear down and descending. No avoiding action was taken as they were visual with it and he assessed the Risk as 'low'.

Cause: The pilot of PA34 (B) did not comply with the APPROACH controller's instructions.

Degree of Risk: C.

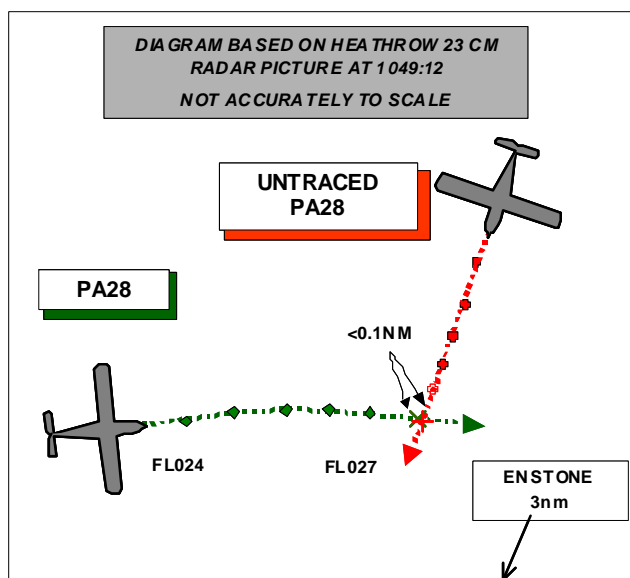
THE PA28 (A) PILOT reports that he planned to fly private VFR flight, with a student pilot in the RHS, from Kemble to Duxford in a blue and white ac with all lights on, squawking with Mode C. The route was initially via Northleach Roundabout VRP and then direct to Duxford. The route passed close to Little Rissington, Enstone and overhead Upper Heyford in order to keep them clear of the hazards at Croughton and Weston on the Green, then north of Henlow and to overhead Royston where the circuit joining instructions for Duxford were expected. They were in receipt of a TS from Brize Radar and had already sighted a number of contacts called to them. They also had a warning from the controller that there was a risk of late or no warning of traffic due his workload and the traffic density.

Cause: Effectively a non-sighting by the pilot of PA28 (A); it is not known whether or when the pilot of the untraced PA28 saw PA28 (A).

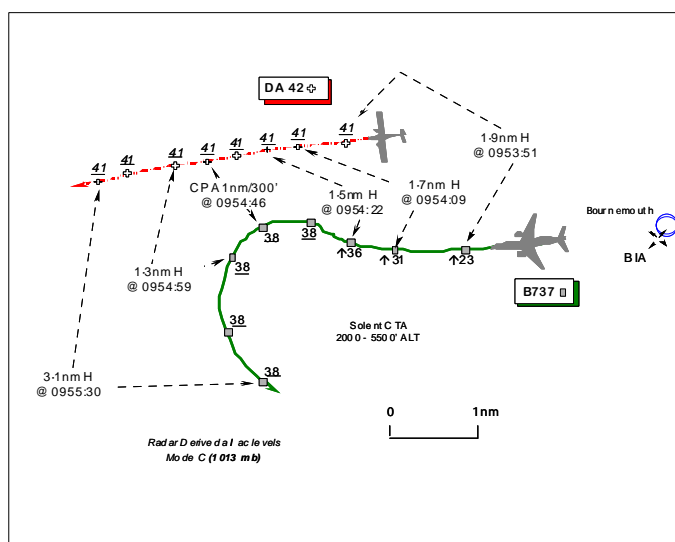
AIRPROX REPORT NO 2010104

THE BOURNEMOUTH APPROACH RADAR CONTROLLER (RADAR) reports that the B737 was departing IFR under a RCS and released to stop climb at 3000ft Bournemouth QNH. The restriction was because of a DA42, operating IFR, holding on the BIA at 4000ft QNH to the WNW of the Airport. The DA42 had been 'locked' onto a heading of 260° and the B737 crew was instructed to fly a heading of 080°, which was queried by the B737 crew but the transmissions crossed. The B737 was then observed climbing through 3000ft, so the crew was instructed to 'stop climb now' by which time their ac was at an altitude of 3700ft. TI was passed to the B737 crew about the DA42 and the airliner was turned L onto a heading of 080°. Minimum separation was estimated to be 200-300ft/1nm; once horizontal separation was achieved the B737 was climbed to FL70.

TOWER did not ensure that the 'standard clearance' was amended to include the climb-out restriction of 3000ft and did not check the fps to ensure that the amendment had been passed. The TOWER controller did pass TI about the DA42 in the hold, which aided the B737 crew's SA and alerted them to the position of the DA42 on TCAS. It was evident that the delay to the B737's departure caused by the fox, together with discussion amongst the VCR staff caused a distraction. This delay and distraction broke the natural sequence of events and interrupted TOWER's normal thought process. When the Airfield Ops vehicle reported clear of the runway, the controller resumed operations, wrongly considering that the climb restriction had already been passed and without the appropriate check of the ac's fps. Consequently, TOWER allowed the B737 to climb unrestricted to 4000ft, the level occupied by the DA42, resulting in a loss of separation.

Once the B737 was airborne and transferred to RADAR, the pilot's first transmission, correctly included the 'level reporting', with passing level and cleared level should have alerted the RADAR controller to the TOWER controller's error; however, the 'level reporting' was not heard. It was not possible to establish what caused the controller to miss the level reports, but the controller considered that it was due to workload and this is supported by the fact that RADAR had not marked the fps to signify that verification of Mode C had been achieved. The opportunity to detect and correct the error was therefore missed and this was considered by ATSI to have been a contributory factor.

Cause: TOWER did not pass the altitude restriction to the B737 crew resulting in a conflict with the DA42.

- b. The Unit include, as part of their Training in Unusual Circumstances and Emergencies (TRUCE) programme, unusual events or circumstances that cause a period of delay or break in operations, with a view to ensuring that controllers pause to complete a situational check, before resuming normal operations.

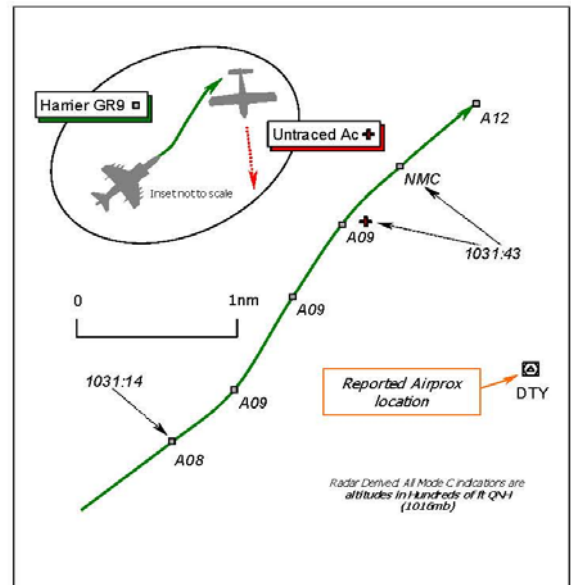
AIRPROX REPORT NO 2010105

THE BAe HARRIER GR9 PILOT reports he was on the final leg of a low-level training flight from Wittering. He was not in receipt of an ATS; a squawk of A7001 was selected with Mode C. Neither TCAS nor Mode S is fitted.

Cause: Conflict in Class G airspace resolved by the Harrier pilot.

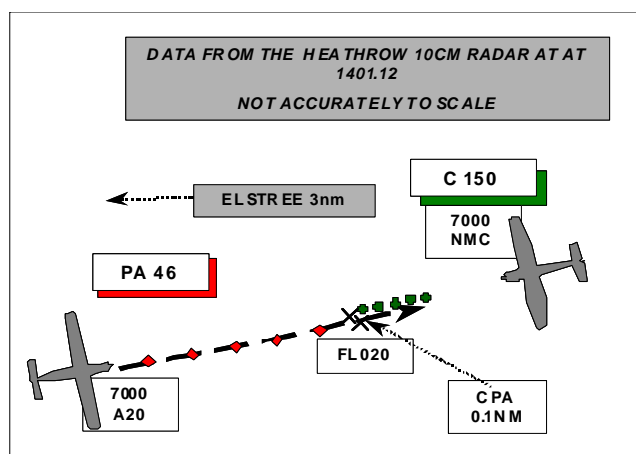
THE C150 PILOT reports flying a red white and blue ac with the tail HISL switched on, on a local private flight in communication with Elstree Information and squawking 7000, but Modes C and S were not fitted. He was heading 260° at 75kt, passing 4nm descending on the approach to RW26, having called at the Golf Course VRP, with patches of rain not affecting forward visibility to the N. He was concentrating on maintaining a stable approach when he became aware of a Piper Malibu, or similar type, flying straight and level on a reciprocal track slightly above and to the left of his track. Its landing light and white wingtip lights considerably aided his visual acquisition against the dark grey sky. He was perhaps too surprised to take avoiding action, though it was obvious that the ac would pass clear above and to the left, though as both ac maintained their respective courses, it would be very close.

The incident took place in an area of slightly reduced VMC conditions in Class G airspace where 'see and avoid' pertains. Despite the conditions the C150 pilot had first seen the PA46's lighting 600m away. Notwithstanding that he was surprised by its presence, he opted not to take any avoidance, indicating to Members that despite having time to react he considered that no risk of collision existed. The Board thought that the PA46 (solo) pilot had not seen the C150 possibly because it was obscured slightly below the nose of his ac.

Cause: Non-sighting by the PA46 pilot and a late sighting by the C150 pilot.

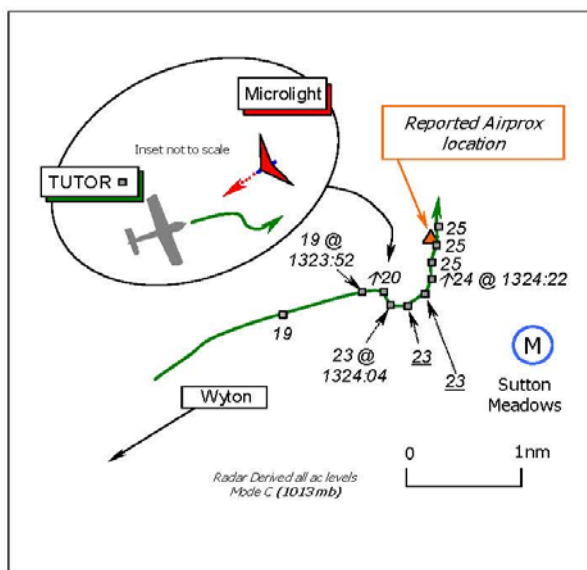
AIRPROX REPORT NO 2010108

THE GROB TUTOR II PILOT reports he was conducting a local VFR instructional sortie from Wyton and was in receipt of a BS from Wyton APP on 134.05MHz. A squawk of A7000 was selected with Mode C on; elementary Mode S is fitted but the aeroplane is not equipped with TCAS.

Cause: Conflict in Class G airspace resolved by the Grob Tutor pilot.

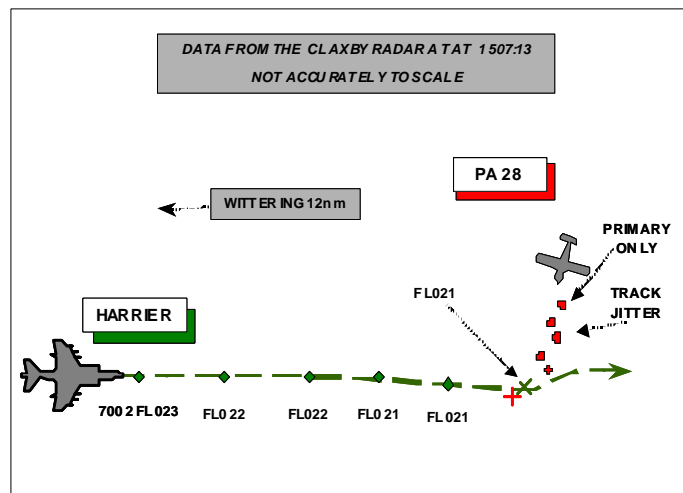
THE HARRIER PILOT reports flying a standard transit from RAF Wittering to Holbeach Air Weapons Range with an instructor in the rear seat. On exiting the MATZ heading 091° at 2000ft and 360kt he called "en-route", Cottesmore Departures acknowledged but did not call any conflicting traffic so they switched to the Range frequency but did not check in at that stage. They then accelerated to 420kt, selected a Squawk of 7002 and shortly after had a very close encounter with low-wing civil light ac passing from their left to right at the same alt. The ac was white with a dark lower half, the registration was painted in white and it was first seen 300ft away. He took avoiding action by performing a break manoeuvre up and to the left [behind it] into the clear airspace. The civil ac continued on its previous course throughout, the pilot having apparently not seen them. He assessed the risk as being Medium.

Cause: Non-sighting by the PA28 pilot and a late sighting by the Harrier crew.

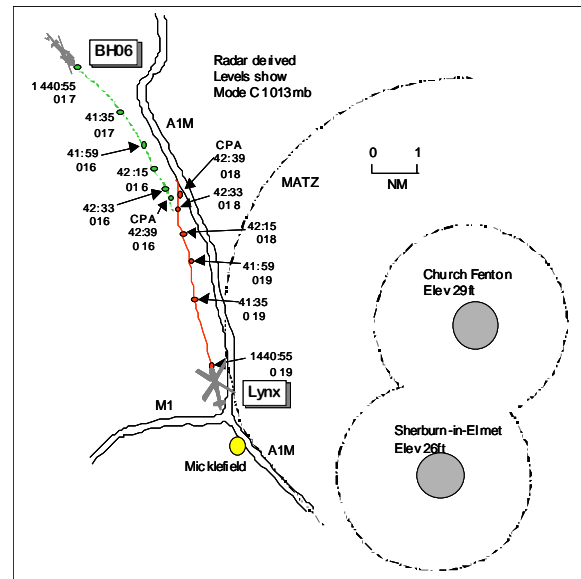
THE BH06 JETRANGER PILOT reports en-route from a private site in N Yorks to Sherburn-in-Elmet (SIE) VFR and in receipt of a BS from Church Fenton on 126.5MHZ, squawking an assigned code with Mode C. The visibility was 30km flying 4000ft below cloud in VMC and the ac was coloured blue with anti-collision and nav lights switched on. Heading 160° at 110kt and 1500ft QNH he had been handed over from Leeming to Linton-on-Ouse then Church Fenton involving 3 frequencies and 3 squawk changes. He received a call from Church Fenton on opposing traffic, 0.5nm, slightly lower to which he responded, "He's just gone past my window". He saw the Army helicopter late and turned R to avoid it, assessing the risk as high. He spoke to Linton ATC after the Airprox who informed him that under a BS there was no requirement for ATC to report conflicting traffic. He asked ATC why did he receive a very late call and was told that ATC need not have done that either. Later he asked what would have happened if there had been a mid-air collision and was told that there would be an inquiry.

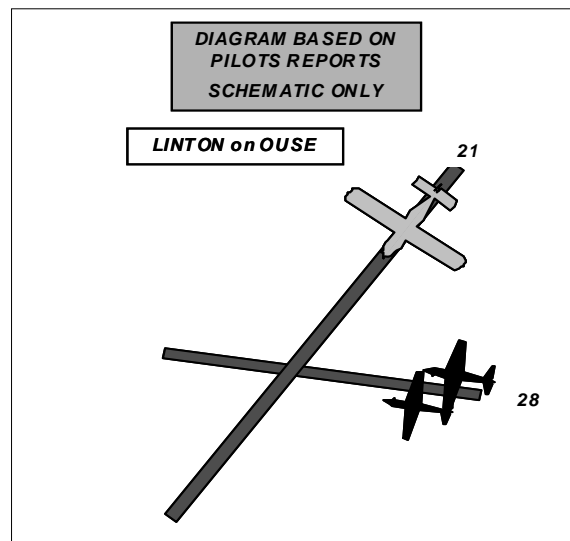
THE TUCANO PILOT reports that he was leading a pair of Tucanos on [a pairs] take-off from RW28 at Linton on Ouse, in receipt of an aerodrome control service from them. During the take off roll at about 20kt, a civilian registered GA-8 ac landed on RW21, the intersecting RW. He assessed the risk as being low. The incident was subject to a Unit Inquiry (UI) and a video from a hand-held camera was provided.

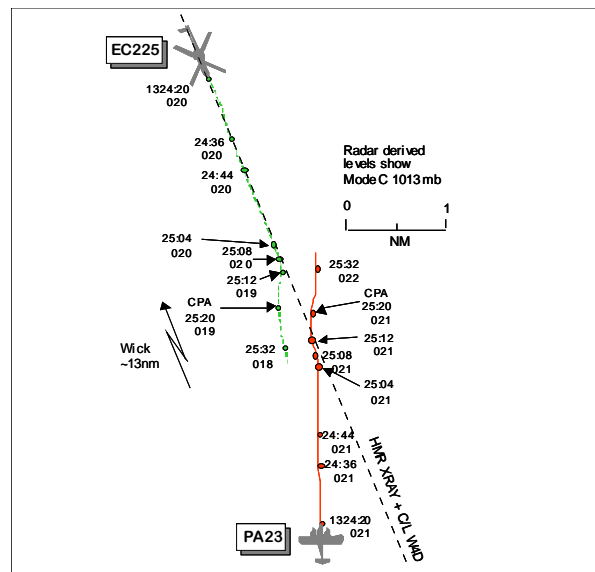
AIRPROX REPORT NO 2010114

THE EC225 PILOT reports en-route to Aberdeen VFR and in receipt of a BS from Wick on 119.7MHz, squawking 3730 with Modes S and C; TCAS 1 was fitted. The visibility was >10km in CAVOK VMC and the ac was coloured red with nav, strobe and floodlights all switched on. In the cruise S of Wick, approaching the Wick 10nm handover point at 2000ft QNH 1012mb, heading 165° at 145kt they noticed and were monitoring an ACAS contact at a similar level. They were aware of a survey ac operating low level, not above 600ft, [not the subject PA23] in the vicinity of Beatrice Platform however, there was no ACAS indication for this ac in that area. At 10nm P1 contacted the survey ac on Comm Box 1 (122.8MHz) to pass information on position and intention whilst P2 reported '10nm S of Wick' on Comm Box 2 to Wick and was told to contact Lossie Departures on 119.35MHz. On contacting Lossie, ACAS generated a TA target and aural 'traffic' alert, simultaneously as both crewmembers became visual with an ac in their 12 o'clock range <1nm at a similar level flying in the opposite direction. P1 took avoiding action by turning R and descending whilst P2 asked Lossie to standby. As the other ac passed down their LHS about 0.5nm away they identified it as a white/blue coloured twin-engine Piper type. On subsequent communication with Lossie this was identified to them by c/s and Lossie were informed of their intention to file an Airprox. He assessed the risk as high.

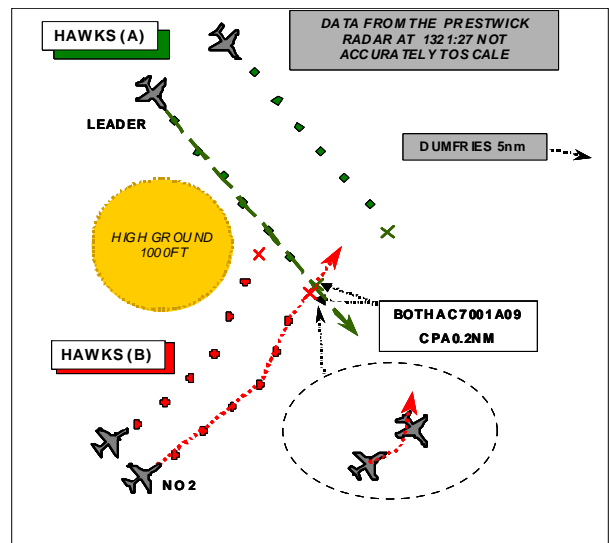
AIRPROX REPORT NO 2010115

THE HAWK T Mk1 (A Leader) PILOT reports that he was leading a pair of black Hawk ac with HISL switched on, squawking 7001 with Mode C, on a low-level training flight in LFA16 operating on a tactical frequency. While heading 150° at 420kt and at a nominal 250ft agl, he initially saw the northerly ac of a pair of Hawks about 1.5nm away. He immediately searched for a second ac and saw another Hawk at a range of about 1nm away at a similar height in his 2 o'clock position and coming directly towards him. He immediately banked to the left before rolling out and commencing a climb and he saw the southerly Hawk passing below and behind him.

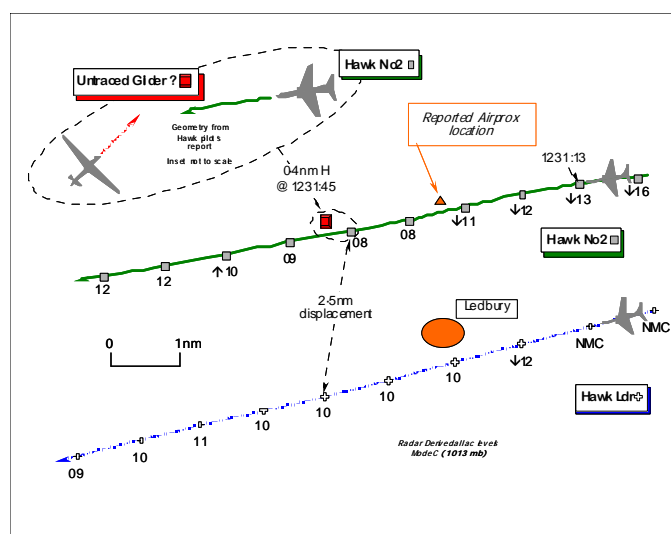
AIRPROX REPORT NO 2010116

THE BAe HAWK T1 PILOT, a QFI, reports he was the wingman of a pair of Hawks carrying out a dual instructional evasion sortie in LFA 4. They were not in receipt of an ATS but monitoring a discreet frequency. A squawk of A7001 was selected with Mode C on; neither TCAS nor Mode S is fitted. His ac has a black colour-scheme and the white HISLs were on.

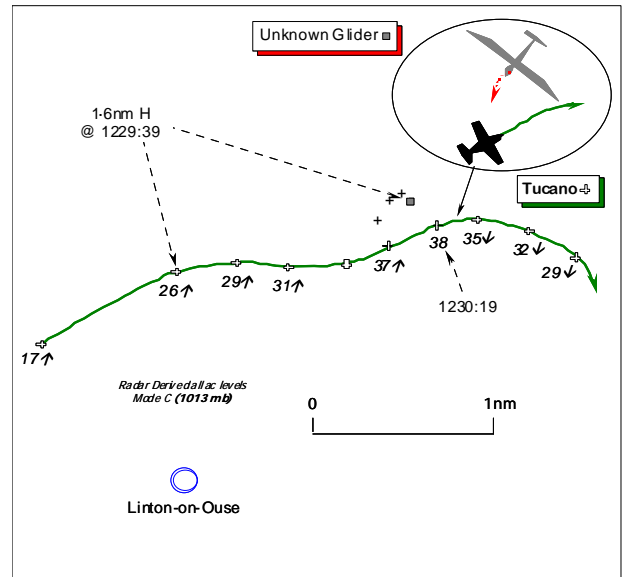
AIRPROX REPORT NO 2010117

THE TUCANO PILOT, a QFI, reports he was conducting an instructional sortie in the vicinity of Linton-on-Ouse. As the PF he was configuring his ac for a simulated stuck throttle exercise at a high power setting whilst in communication with Linton TOWER on 240.825MHz; he was not in receipt of an ATS. Wide downwind, climbing wings level through 3000ft QFE, heading E 3nm NE of the aerodrome, he became aware of a white glider orbiting near the cloudbase about 400ft above him. The glider was approaching from his 11 o'clock in a shallow L turn and to avoid it he bunted his ac to 'negate their closure' as the glider passed about 400ft above with a 'medium' Risk of collision. No discernible avoiding action was taken by the glider pilot. He stressed that he was working under a reasonably high workload at this point of the sortie as care was needed not to overspeed the landing gear and flaps, which were set to full.

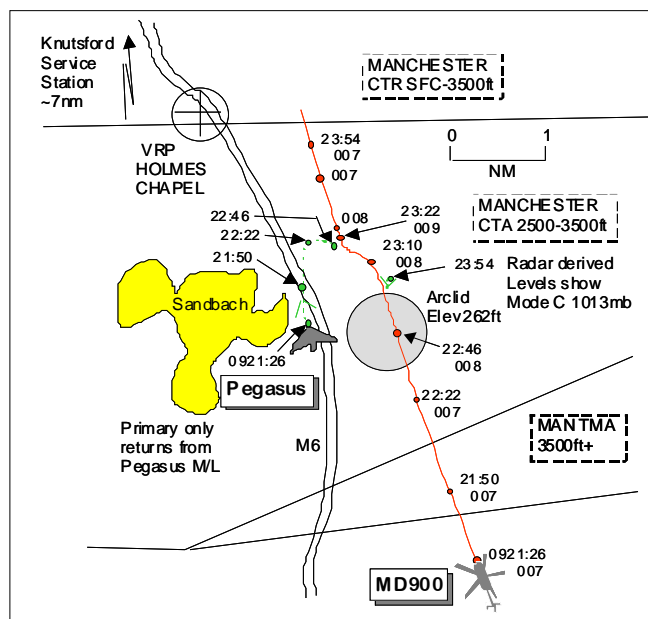
THE PEGASUS QUIK GT450 FLEXWING PILOT reports flying a dual training cct sortie from Arclid, VFR and monitoring the M/Light frequency 129.825MHz. The visibility was >10km in VMC and the ac's flexwing was coloured yellow/white. Whilst on R base leg RW20 at 700ft QFE heading 090° at 52kt, he was describing the next stage of flight to the student when he noticed movement in his R peripheral vision. On taking a closer look he saw a black or blue coloured medium sized helicopter, possibly a Eurocopter type, on a collision course heading 300° at the same height a few hundred metres away (0.25nm). He took control and descended to the L noting the helicopter also took avoiding action, he thought, by turning to its L; the helicopter then passed down his RHS by 200m. After landing he contacted Manchester Airport to report the Airprox. He believed there was a high risk of collision as the helicopter flew through the centre of an area of intense M/Light activity - the airfield is shown on charts - at cct height, with the ac involved being close enough such that the pilots felt the need to take avoiding action.

Members agreed that this Airprox would not have occurred had the MD900 pilot taken due regard of the airspace in which he was flying. Arclid is marked on 1:250000 and 1:500000 charts and as such M/Lights should be expected in the cct area during daylight hours. All that was required was a small course deviation early on to route clear of the O/H and/or a cruising altitude that was well above the cct. In this case the MD900 pilot flew through the Arclid O/H at cct height and came into conflict with the Pegasus M/Light, which he did not see, and this had caused the Airprox.

Cause: The MD900 pilot flew through a promulgated and active M/Light site and into conflict with the Pegasus M/Light, which he did not see.

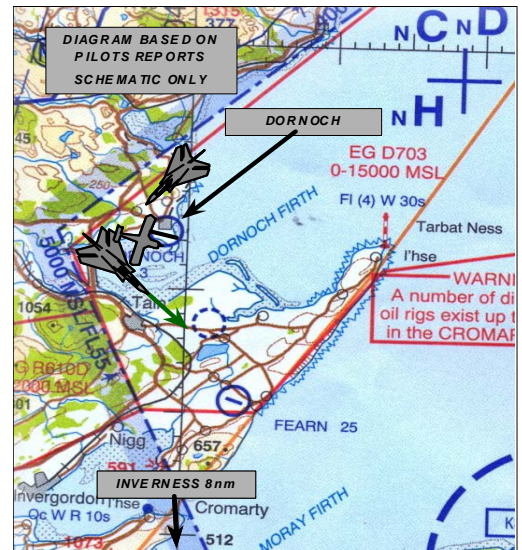
AIRPROX REPORT NO 2010121

THE TORNADO GR4 PILOT reports leading a pair of ac conducting practice weaponry in Tain Air Weaponry Range (AWR) (EGD 703 See UKAB Note (1)) squawking 7002 with Mode C. Leader was heading 130° at 500kt, 3nm W of the Range Control Tower and about to commence a high energy 'pop' manoeuvre in order to attack a target from the West, when a light ac was seen 1000ft away in the Range Danger Area, at a height of about 1000ft agl just to the left of his nose but flying away from him. He immediately passed the 'stranger's' position to his No2 who was in 30sec trail behind him and then informed the Range Safety Officer (RSO) of the light ac and requested its heading and intentions. The RSO then identified the 'stranger' and informed them that the ac was seen to be exiting the Range to the NW.

Tain is a busy Air Weapons Range with ac performing high-energy weaponry delivery profiles that sometimes preclude normal lookout since crewmembers need to concentrate on flying the weaponry pattern accurately, performing safety checks and acquiring the target. That being the case, such ranges are classified as danger areas for good reason and published procedures for landing at civil airfields such as Dornoch should be strictly adhered to. Further, Members noted that the PA28 pilot had incorrectly assumed that the Range was not active, despite that it was during the published activity hours, and he further incorrectly assumed that he could therefore enter the range without needing to get permission. Members agreed that these were key incorrect assumptions that had led to the confliction. The GA Member counselled that pilots should treat ranges with great respect, as they can be very dangerous places.

Cause: The PA28 pilot entered an active Danger Area without permission and flew into conflict with the Tornado GR4s.

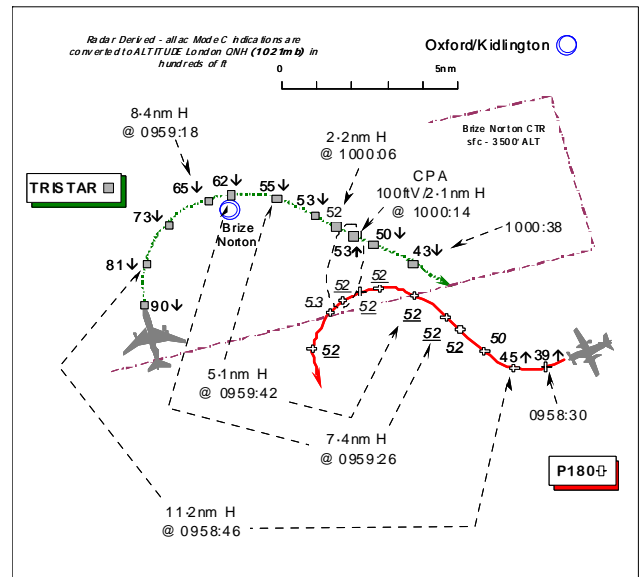
AIRPROX REPORT NO 2010122

THE LOCKHEED TRISTAR KC1 PILOT reports he was inbound to RW26 at Brize Norton from Akrotiri under IFR and in receipt of a TS from Brize DIRECTOR (DIR) on 133.75MHz. The assigned squawk was selected; Mode S and TCAS are fitted.

[UKAB Note (3): The P180 pilot reports the Tristar was not seen. When the avoiding action turn was transmitted the Tristar was actually 5.1nm NW of the P180, not NE as stated by LARS, indicating 5300ft (1013mb) and some 340ft above the P180 that was at 5200ft London QNH (1021mb) – (at the western edge of the displayed London QNH (1021mb) area). The CPA occurred at 1000:12 as the ac passed abeam, 2.1nm apart, with the Tristar indicating 100ft above the P180 on Mode C. A change of controller is noted on the transcript for the next transmission to the P180 crew at 1000:30, suggesting the mentor stepped-in at this point; "[C/S] *avoiding action turn right immediately heading 2-7-0 degrees traffic [not the Tristar] was south east 4 mile manoeuvring indicating 2 thousand 2 hundred feet below*". This was read back by the crew, "*..right heading 2-7-0 again*", before LARS [the mentor] added, "[C/S] *I am going to struggle to get you close to COMPTON under a De-confliction Service as there is a lot of conflicting traffic in that area [are you] happy to accept a downgrade to Traffic Service for your controlled airspace join?*" This was declined by the P180 crew, "*..roger we prefer a Deconfliction Service*". DIR then responded by modifying the previously transmitted avoiding action turn by 10° at 1000:56. A further avoiding action R turn was given onto E before the P180 crew was released own navigation for CPT, the CAS joining clearance issued and the flight switched to LACC.]

From an ATC perspective, once LARS had given the P180 crew the avoiding action turn onto W against another ac at 0957:39, the trainee controller was faced with a challenging situation, given the airspace constrictions and his experience level. However, at no stage did LARS attempt to coordinate with the military ATSU that was working the traffic that caused them to take avoiding action. Nor did they reduce the ATS for the high traffic density, which may have afforded them greater flexibility to route towards CPT. Although the mentor took over from the trainee immediately after the avoiding action turn away from the Tristar, this Command contends that earlier intervention by the mentor could have prevented this Airprox. Notwithstanding DIR's actions after being advised of the TCAS RA, DIR had attempted to provide the best level of ATS to the Tristar by requesting the expedite descent and turning them away from the P180.

Cause:LARS vectored the P180 into conflict with the Tristar.

The Board noted the first two internal Recommendations made within the HQ Air BM SM report and awaited further advice about the use of A/P initiated avoiding action turns, versus manual flying, when operating in un-controlled airspace.
