UK AIRPROX BOARD

Analysis of Airprox in UK Airspace

**Report Number 25
July 2010 – December 2010**

Twenty-Fifth Report by the UK Airprox Board:

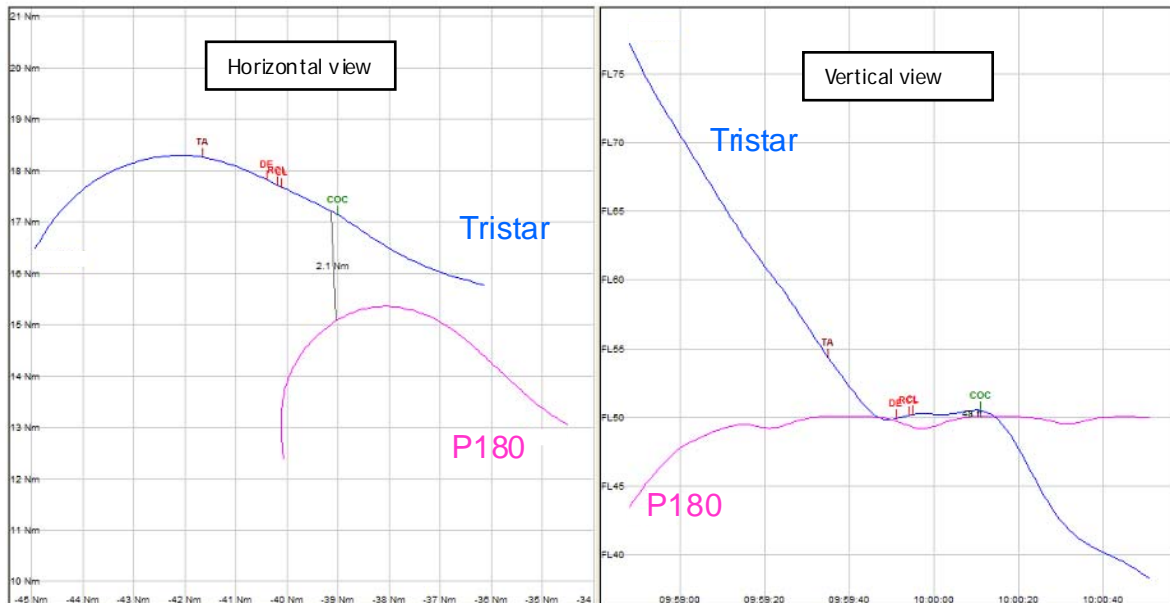
InCAS Simulation

The simulation indicates that the Clear Of Conflict message would have been generated at 1000:11.

Encounter Diagram Based on Heathrow 10 Single Source Radar Data

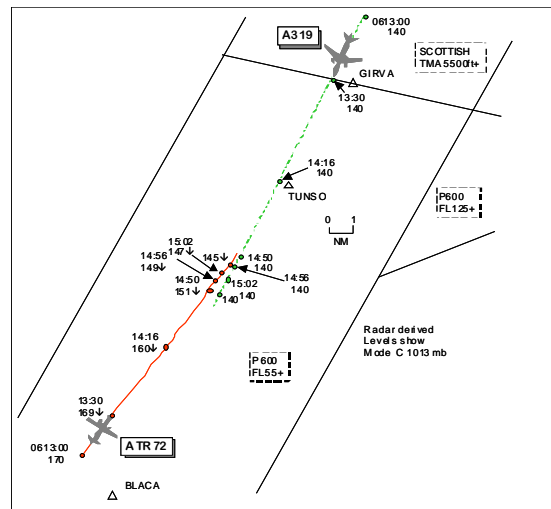
THE A319 PILOT reports cruising at FL140 en-route to Belfast IFR and in receipt of a RCS from ScACC on 123.775MHz, squawking with Modes S and C. ATC advised them of opposite direction traffic that had been cleared to descend to FL150; visual contact was made with an ATR 15nm ahead. A TCAS TA occurred as the ATR passed O/H as it had descended to +800ft of their level, before a TCAS RA 'monitor v/s' was received before 'clear of conflict' soon followed with no level deviation. Their TCAS showed the ATR to be behind them when it stopped its descent +400ft above their level. ATC checked with the ATR crew for their cleared level and told them of their 'level bust'. ATC was informed of their TCAS RA and they replied that a report had been filed. Visual contact was maintained continuously until the ATR passed O/H and he assessed the risk as high.

When the descent clearance was issued to the ATR72, the Mode S SFL did not change from the displayed FL170. The initial investigation revealed that where an ac is being flown manually it is unlikely that the SFL will change to reflect the cleared level. The SC did not notice the discrepancy between Mode S and the flight’s cleared level. His perception is that Mode S on certain ac types is unreliable and in some others it is missing completely. He thought that, in hindsight, the lack of Mode S information may have triggered something but in all likelihood he would have just considered the SFL readout to be unserviceable; the controller was aware of the phraseology relating to SFL. The SC had correctly issued the level change and monitored the read back, which was all that was required. The MATS Part 2 MOPS Section 4.3.1.6 Policy for the use of SFL states:

Members noted that the Antrim SC had not noticed the SFL/cleared level discrepancy but were surprised by his perception regarding the reliability and/or missing of SFL. A CAT Member informed the Board that whilst there is a known SFL transmission problem within a certain ac type in the UK leading to the SFL being missing, the problem is being addressed and there is no fundamental issue with the accuracy or reliability of Mode S equipment. Controller Members, familiar with LTC operations, informed the Board that checking of SFLs was 'modus operandi' since its introduction and querying of the SFL with crews, if it did not change when a flight was instructed to change level, was second nature.

Cause: The ATR72 crew descended below their cleared level and into conflict with the A319.

The unit report also recommends the review of airspace 'hot spots', where similar occurrences might be likely. This has been accepted by unit management and the ATSD En-Route Inspectorate will monitor the progress of the recommendation as required.

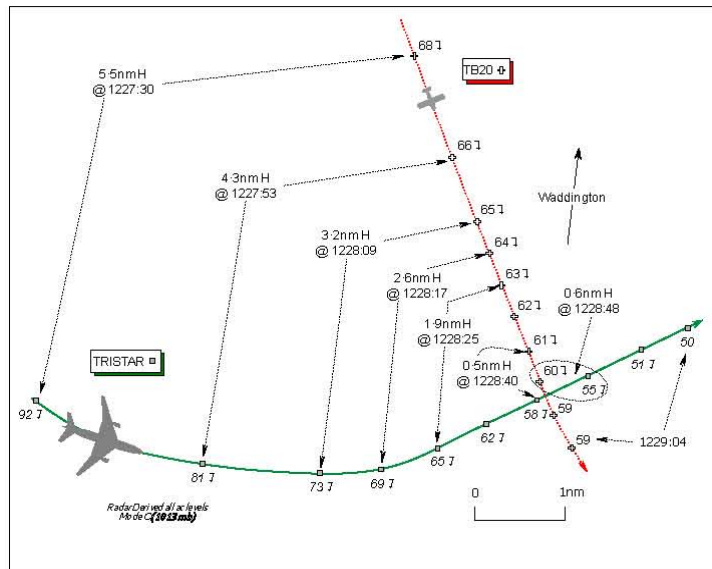
THE TRISTAR PILOT, a QFI, reports he was instructing an IFR training flight inbound to Waddington, descending to FL50 under a TS, as 'cleared' by LATCC (Mil) following a handover to Waddington APPROACH (APP) on VHF 123.3MHz. A squawk of A3612 was selected; Mode S and TCAS are fitted.

Approaching FL70 some 10nm SSW of Waddington and turning L onto 090° at 250kt, they received a broken transmission from APP and heard FL75 mentioned. Clarifying the call whilst descending at 2500ft/min passing FL67, APP instructed them to level at FL70 and a level off was immediately initiated. At the same time TCAS annunciated an RA demanding a descent that was complied with. Initially they could not make visual contact with the conflicting ac, then TCAS demanded an increased RoD that was followed accordingly. They subsequently made visual contact with, he thought, a Tutor in their 10 o'clock ¼nm away about 200ft above their ac and also descending.

APP would have been aware of the regulation regarding taking into account traffic in the immediate vicinity prior to issuing a vector to ac under their control. The ATSU has stated that the taskload on APP should not have been a problem for the controller, considering her ability and experience. However, it is clear that the taskload and complexity were significant factors in this occurrence. Specifically that APP was operating in the band-boxed APP-DIR position. The taskload and complexity faced by APP caused attentional tunnelling, which in turn meant that APP was unable to perceive the presence of the TB20, hence the Tristar was unknowingly turned into confliction with the TB20.

In concluding their determination of the Cause, some Members suggested that supervisory aspects had played a significant part here coupled with an apparent lack of timely co-ordination between APP and ZONE. Other Members considered that whilst these all had some impact and there were lessons to be learned from this Airprox for the benefit of all concerned, fundamentally, the Tristar crew were following the vectors issued and complying with ATC instructions. Whilst acknowledging the view of HQ 1Gp BM SM and weighing all these factors for relevance, the Board concluded that the Cause of this Airprox was that the Tristar was vectored into conflict with the TB20.

Cause: The Tristar was vectored into conflict with the TB20.

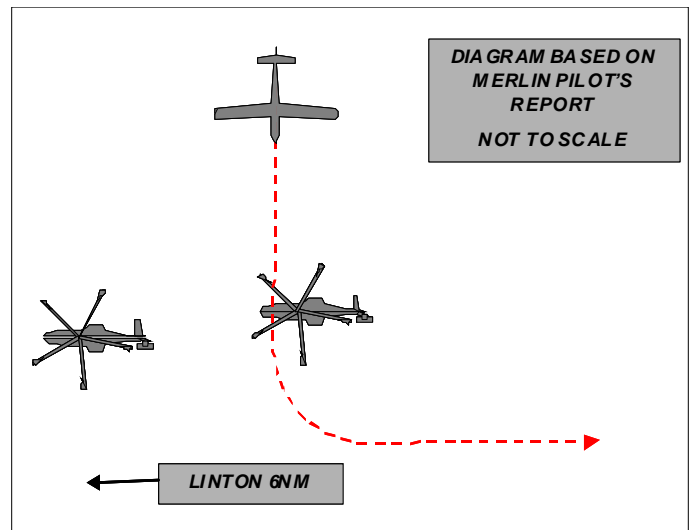
AIRPROX REPORT NO 2010125

THE MERLIN HC3 PILOT reports that he was flying as No2 in a pair of green helicopters on recovery to Linton on Ouse, squawking 7000 with Mode C but, although the ac was fully lit, TCAS was not fitted. They were listening out on Linton APP, heading 270° at 2000ft agl and flying at 120kt, when the crewman observed a glider 100m away, pass approximately 100 ft above their ac and 150m to their right. The glider was tracking from N to S and turned onto E just after the ac crossed. They were unable to take any avoiding action as the ac had crossed before there was time to react but reported the incident immediately to Linton APP and their ac was recovered with no further incident.

Members noted that both ac had been operating legitimately in Class G airspace where see and avoid is the principal method of collision avoidance; they agreed however, that gliders can be very hard to detect visually, especially when head-on, at a similar altitude and not manoeuvring.

Cause: Effectively a non-sighting by the Merlin crew and a possible non-sighting by the glider pilot.

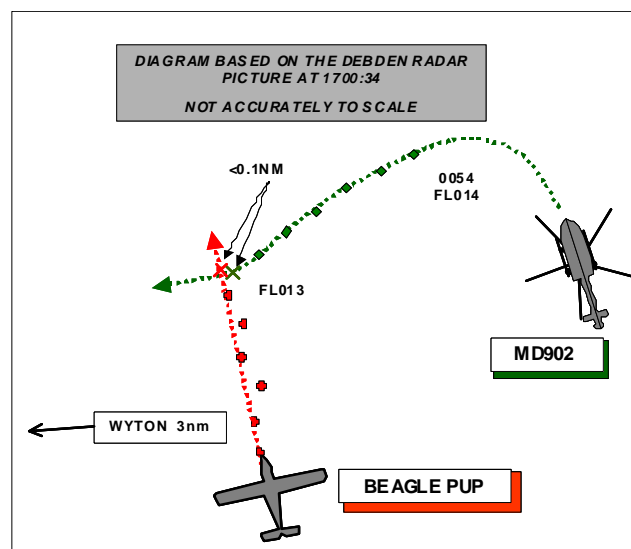
AIRPROX REPORT NO 2010126

THE MD902 PILOT reports flying a blue and yellow helicopter with all lights switched on, on a training flight with the PF in the right seat conducting IF training and the captain in the left seat responsible for the lookout. They were squawking 0054 [county police] with Mode C, in receipt of a BS from Wyton APP and he had been head-in briefly to change frequency. They were heading 260° at 100kt, at about 1300ft QFE passing 3nm on the final descent of a GPS letdown into RAF Wyton when he saw a low-wing, dark-coloured, single-engine ac ½nm away and 300ft above crossing from left to right. He advised the PF who descended the helicopter rapidly to increase separation but they could not assess the separation or risk. TCAS was fitted but no alert was displayed.

Cause: Pilot perceived conflict.

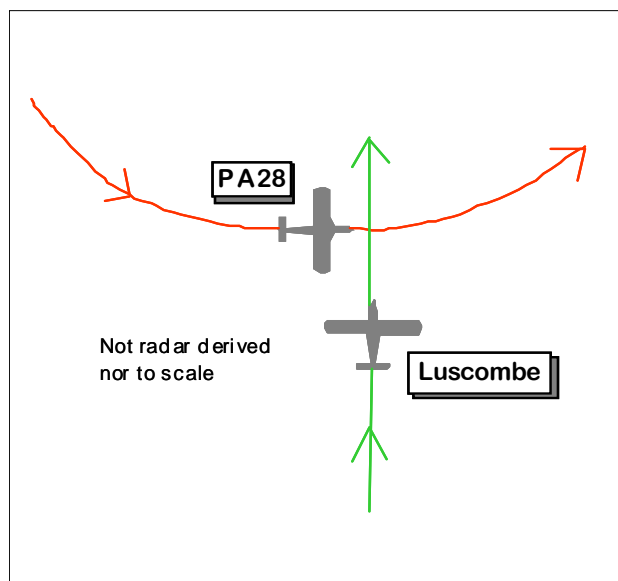
AIRPROX REPORT NO 2010127

THE LUSCOMBE PILOT reports flying a local sortie from a private site to the SW of Blandford Forum VFR and listening out with Bournemouth Approach on 119.475MHz, squawking 7000 with Mode C. The visibility was 30km flying 1500ft below cloud in VMC and the ac was coloured white/red with strobe and nav lights switched on. As he was approaching the 'Great Dorset Steam Fair' site, heading N at 2000ft QNH and 100kt, a yellow/ochre coloured PA28 appeared <100ft directly in front and 20ft above, its registration could be clearly seen, heading 070-080° flying straight and level. It was not seen earlier owing to the angle and point of approach, it being obscured by his ac's high wing. He assessed the risk as high. Later he spoke to the PA28 pilot who was apparently unaware an Airprox had occurred.

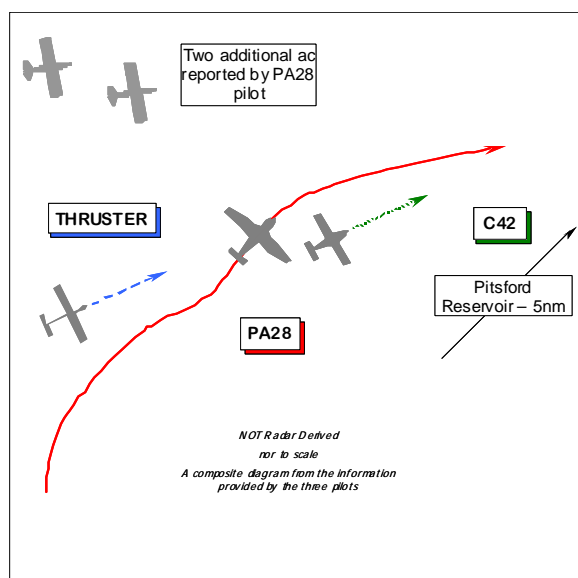
AIRPROX REPORT NO 2010128

THE C42 MICROLIGHT (ML) PILOT reports he was inbound VFR to Sywell for a light ac rally and listening out with Sywell INFORMATION on 122.700MHz [a modified BS was provided]. Following his white and dark blue C42 was a Thruster Sprint in his 7 o'clock position flown by a colleague.

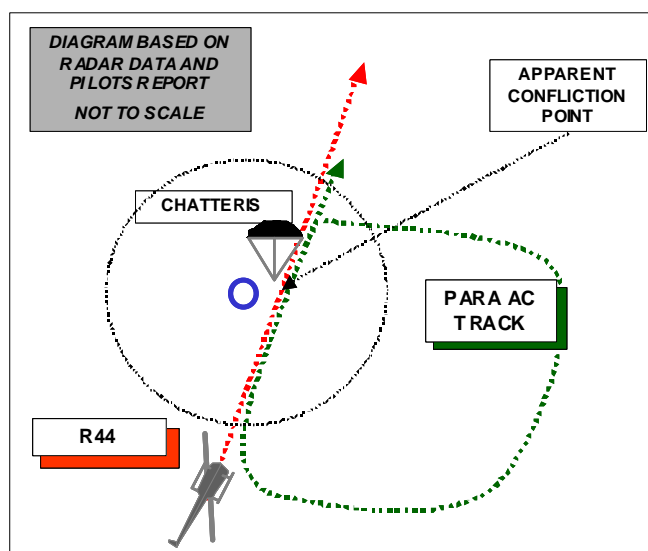
AIRPROX REPORT NO 2010129

THE SKYDIVER reports that he is the CFI of North London Skydiving Centre and jumped from their Twin Otter ac at 5000ft agl following an AFF (Accelerated Free-Fall) student who deployed his main canopy 7sec after exit. He then deployed his multi coloured canopy which opened at 3000ft and had a fully operational parachute at 2500ft when he 'released his brakes' and looked to his right, immediately seeing a helicopter coming straight towards him. His immediate reaction was to pull down on both brakes, which had the effect of slowing his descent rate and the black helicopter, which looked like an R44, passed directly below him. It was difficult to tell the helicopter's exact height but the parachutist could clearly see the single helicopter occupant wearing a pink shirt, with blue trousers and he had brown hair. As the helicopter went away from him he tried to see the registration, but due to the angle he was unable to see the markings. He landed as soon as possible and immediately spoke to the DZ controller who was in RT contact with their ac and was talking to RAF Lakenheath Radar who reported that they had tracked the helicopter.

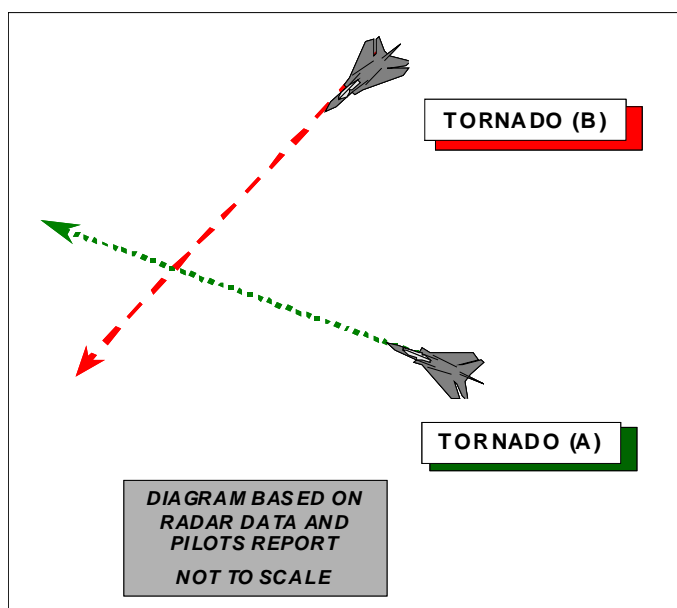
THE TORNADO GR4 (A) PILOT reports flying a singleton night training flight with red strobes, obstruction lights and nav lights switched on. Initially they were conducting GH, from surface to 12000ft (QNH 1011mb), under a TS from ScACC (Mil) but were also booked traffic for Night Sector 2A between 1930 and 2045 as per the Lossiemouth Wing Night Deconfliction Plan.

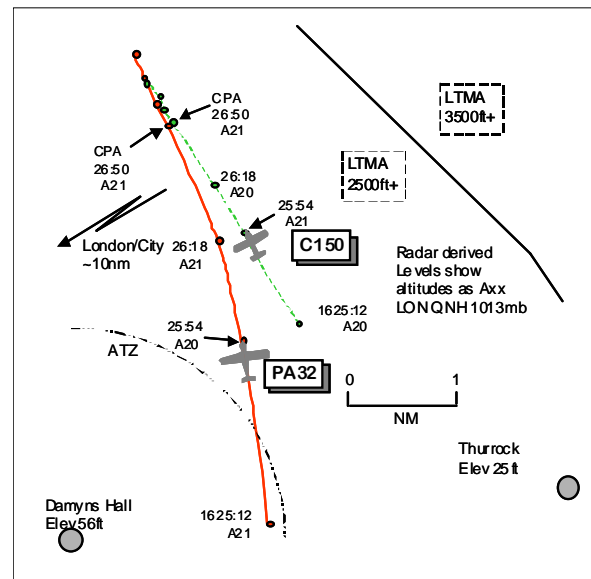
THE C150 PILOT reports flying an instructional sortie inbound to Elstree VFR and in receipt of a BS from Farnborough N, squawking an assigned code with Mode C. The visibility was >10km in VMC and the ac was coloured red/white/blue with anti-collision light switched on. After hearing TI passed to another flight he realised that they were conflicting traffic to it and that it was catching them up. Owing to their high-wing configuration, he couldn't see the other ac, which was behind them and to their L (7 o'clock) and reported to be 100ft above. Heading 330° at 85kt and 2000ft QNH they wanted to climb to overfly the Stapleford ATZ so he asked Farnborough if it was clear for them to do so, thinking the other ac may not be a factor any longer. They were told that there was no reason why they couldn't climb and just as the student advanced the throttle the other ac, a PA32, was seen to pass about 40ft above and 20-30m clear to their L.

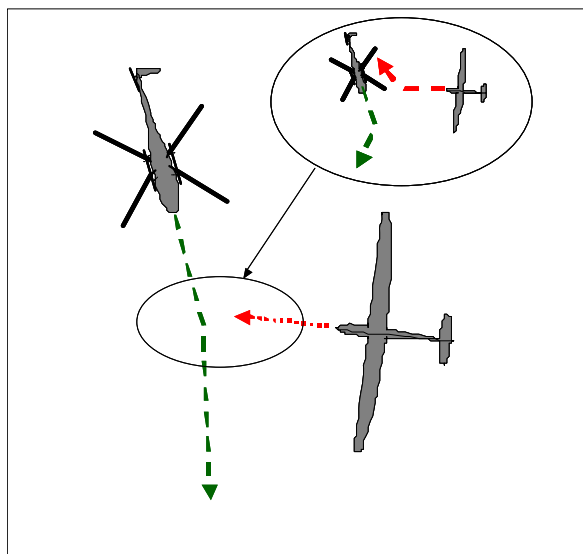
AIRPROX REPORT NO 2010132

THE LYNX PILOT reports that he was flying an Instrument Flying exercise between RAF Benson and Middle Wallop with a PAR to 'Low Approach' at Odiham en-route. He was ac commander and handling pilot in the left seat with his No 2 pilot as safety pilot in the right seat; they were in receipt of a TS from Benson and were squawking as directed with Modes C and S. The Airprox occurred shortly after they departed from Benson while they were level at 3000ft (Benson QNH) and heading 170°. There were many TI reports from ATC of other [he thought] ac in the area and he was aware that a gliding competition was taking place at Bicester, so both his 2nd pilot and himself were exercising extra vigilance and he was carrying out a regular lookout even though he was under a helmet mounted IF hood. While beginning one such lookout scan he caught a glimpse of an object in his 10 o'clock, looked up and identified it as a modern, white, fiberglass glider 200m away, at the same level and heading directly towards them. He immediately banked the ac hard right and the glider simultaneously initiated a roll to the right for avoidance. He estimated the glider was within 100m of his ac when he lost sight of it behind his door frame. They continued on track towards Odiham, and did not see the glider again. An initial report of the event was made to Benson APP, followed by a full Airprox Report 3-5min later.

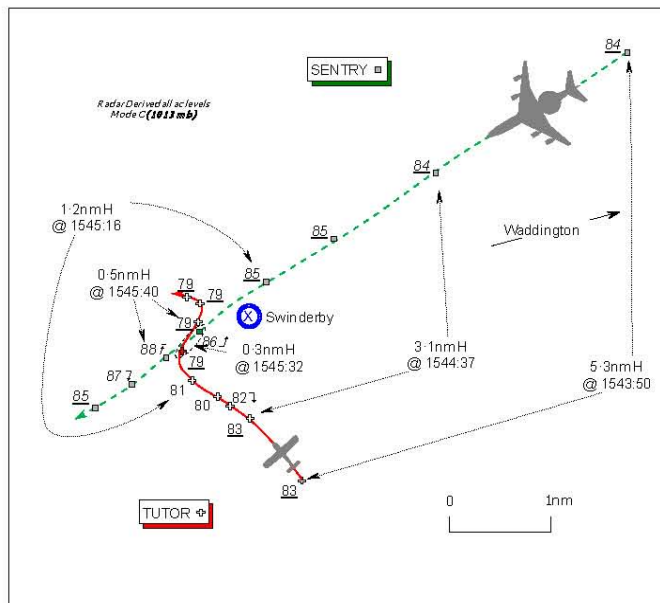
AIRPROX REPORT NO 2010133

THE BOEING SENTRY PILOT reports he was on an IFR recovery to base at Waddington and in receipt of a TS from Waddington APPROACH (APP) whilst holding in the Waddington COLBY hold - approximately 210° WAD 7nm - heading 245° at 220kt. A squawk of A3612 was selected; Mode S and TCAS are fitted. The ac has a grey colour-scheme; the HISLS were on.

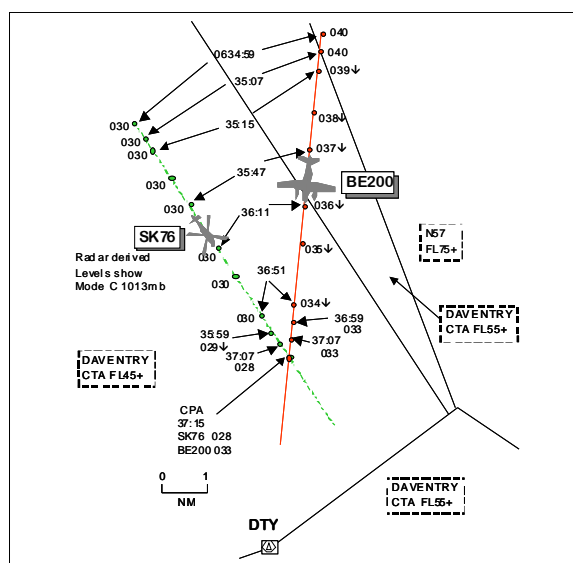
AIRPROX REPORT NO 2010134

THE SK76 PILOT reports en-route to Battersea, IFR and in receipt of a TS from Birmingham Approach on 118.05MHz, squawking 0403 with Modes S and C; TCAS 1 was fitted. The flight conditions at 3000ft QNH were IMC in and out of cloud with visibility <1000m. About 3nm NW of DTY VOR, heading 160° at 145kt, they noticed TCAS traffic >5nm away indicating 700ft above and descending on a converging course from the port side. Shortly after this Birmingham advised that there was a contact in their "10 o'clock at a similar altitude", he thought. After monitoring events for a short while they elected to take avoiding action and commenced a descent whilst trying to locate the threat ac. They also requested a "radar steer to avoid" from ATC who responded with an instruction to steer "radar heading 210°". They then observed a white coloured King Air fly O/H, wings level at a TCAS height of +300ft. Throughout their manoeuvre the conflicting ac appeared on TCAS to be maintaining a shallow descent. They declared an Airprox and asked Birmingham ATC to log the time and event. ATC advised that the conflicting ac was squawking 7000 and not working their frequency. He assessed the risk as high without avoiding action.

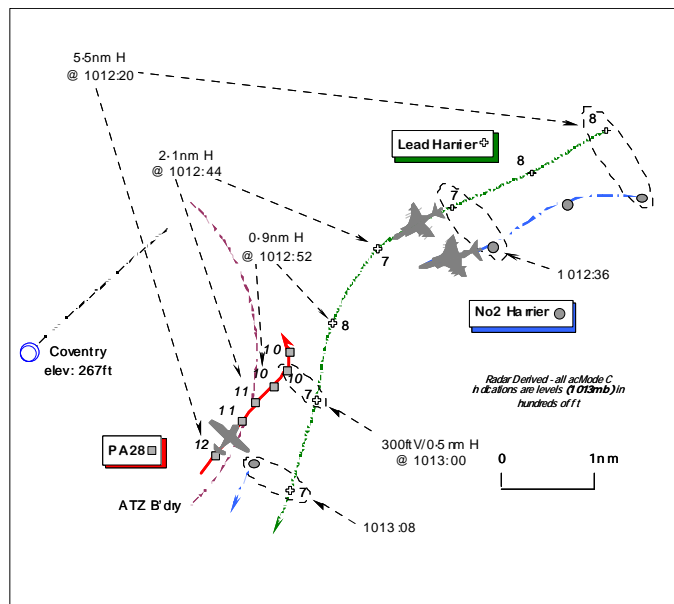
AIRPROX REPORT NO 2010135

THE HARRIER PILOT reports that he was leading a VFR low-level pairs sortie from Wittering, but because of two Royal Flights passing close to Wittering a different route to the normal VFR low-level routing was planned. This route passed 3nm from Coventry Airport and remained outside their ATZ.

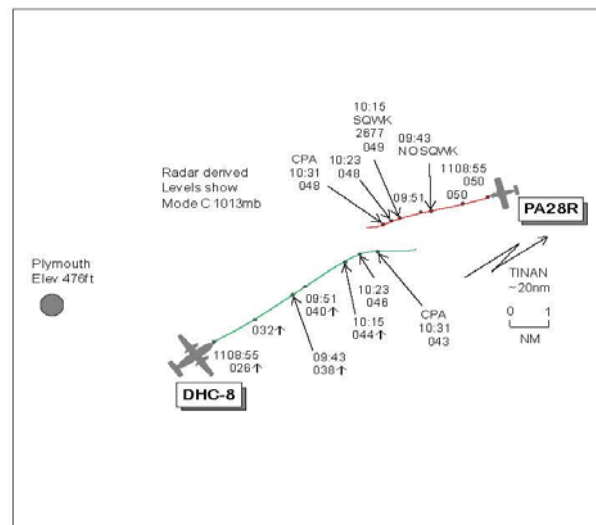
AIRPROX REPORT NO 2010136

THE DHC-8 PILOT reports departing Plymouth under IFR and in receipt of a PS from Plymouth Approach on 133.55MHz, squawking 1407 with Modes S and C. The Wx was layered cloud, SCT to BKN but improving towards the S Coast. Both RWs were in use and they elected to use RW13 for departure. On taxiing out they received the initial clearance to make a R turn out (through 300°), rather than a L turn that was expected before setting track to TINAN, owing to traffic passing through the climb out from W to E. However, the taxi phase took longer than expected resulting in the transit ac having passed well to the E, thus the R turn out was cancelled. They took off from RW13 and made a L turn towards TINAN onto heading 065° at 150kt. Approach asked for them to call passing 3000ft but as they did the frequency was busy with another flight transmitting. Passing FL45 heading 065° and 150kt an open cyan diamond (not depicted as proximate traffic) suddenly appeared on the TCAS screen in their 12 o'clock range 2-25nm and 1100ft above. It appeared so suddenly it was as if the ac's transponder had just been switched on. This coincided with another flight checking in on the frequency for the first time and being assigned a squawk of 2677. He pointed this out to the FO, PF, and within seconds it had changed to a 'descend' RA with a green arc demanding a ROD of 1000-1500fpm. The RA was followed with a R turn being initiated as it seemed as though the traffic was opposite direction. The other ac passed 200ft above and clear to their L. Normal flight was resumed following satisfactory resolution. He assessed the risk as high. He commented that the TCAS display went from clear of ac to 'other traffic' to full blown RA with exceptional speed, certainly not appearing to represent a closing speed of circa 300kt. After speaking to the ATCO, it appears that London Military saw the potential conflict either by PSR or SSR and had luckily taken the initiative to contact Plymouth Approach, asking if they were aware of the traffic. Plymouth ATC was not aware of this traffic and about this time the flight made its initial call. Plymouth immediately asked the flight to squawk conspicuity before informing the crew of the traffic to the E. It appeared to him that the ac's transponder was selected on at this stage but this was only his perception of events, and it was at this stage the RA occurred.

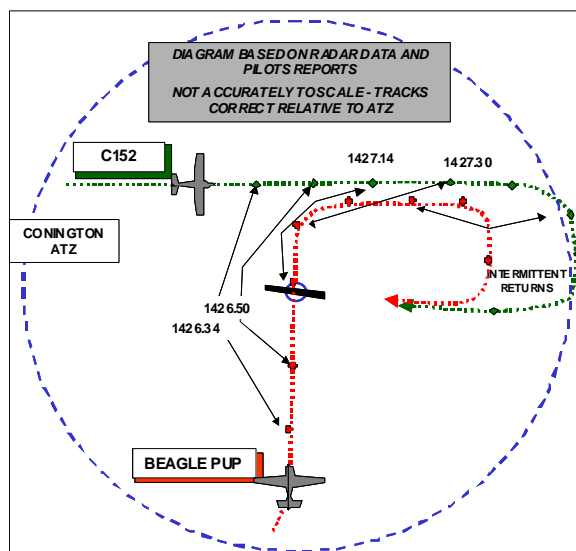
AIRPROX REPORT NO 2010137

THE C152 PILOT reports that he was instructing a student pilot on cct procedures and was in a RH pattern for RW28 at Conington with the surface wind varying between W and NW averaging 10kt. His ac was blue and white but his SSR was unserviceable and he was in receipt of an A/G service from Conington Radio; TCAS was not fitted.

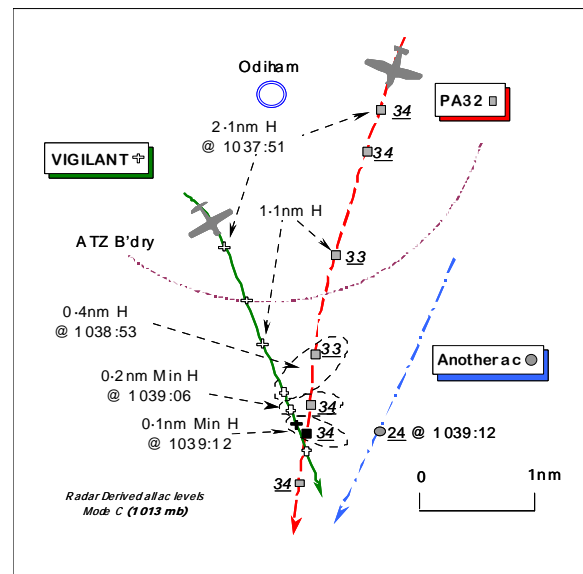
AIRPROX REPORT NO 2010138

Cause: An apparent non-sighting by the PA32 pilot and effectively a non-sighting by the Vigilant pilot.

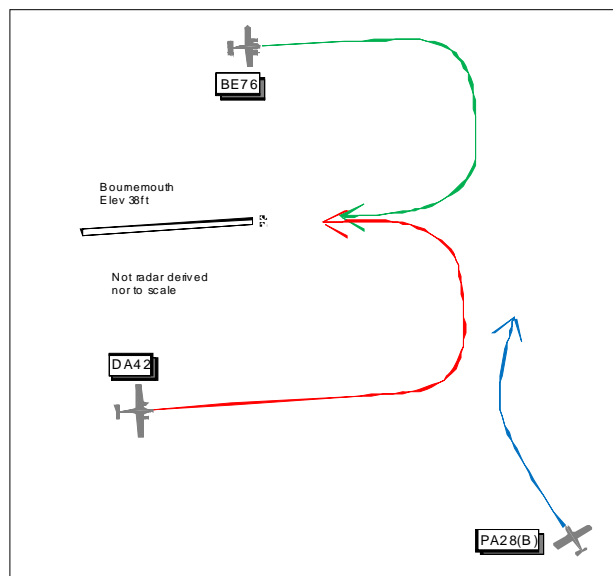
AIRPROX REPORT NO 2010139

Cause: 1. Lack of positive control by ATC.

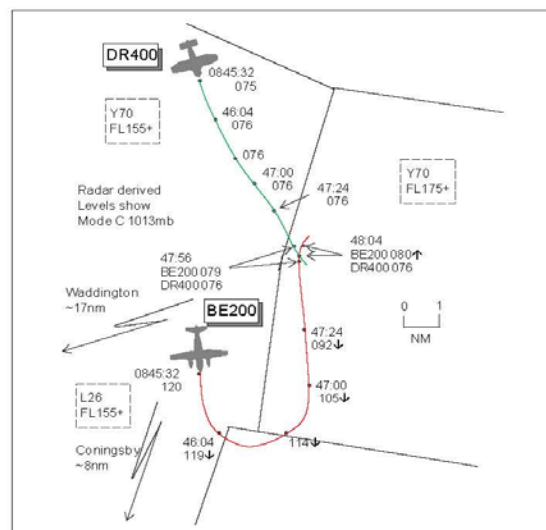
Cause: Late sightings by the pilots of both ac.

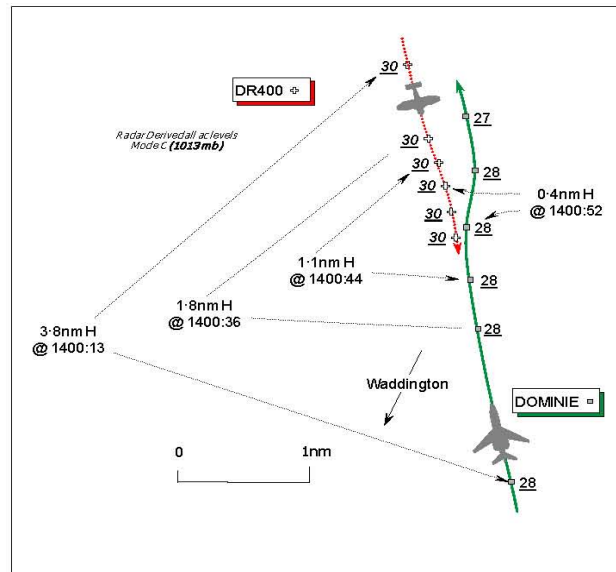
Cause: The Dominie was vectored into conflict with the DR400.

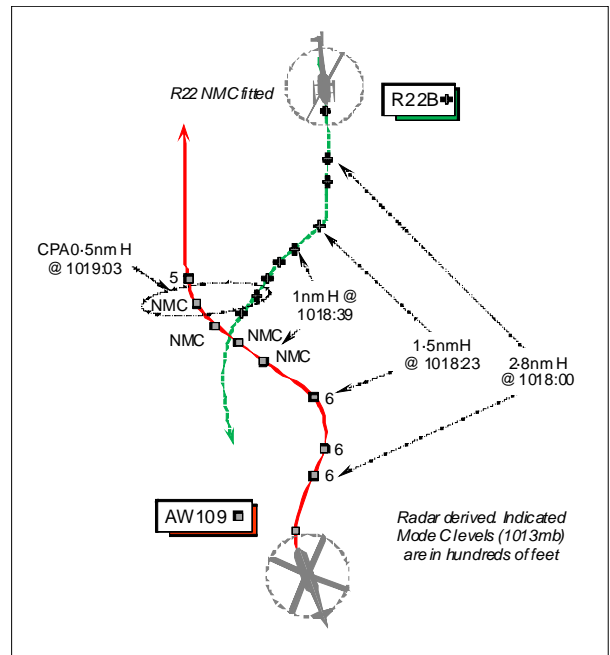
AIRPROX REPORT NO 2010144

Cause: A conflict in Class G airspace.

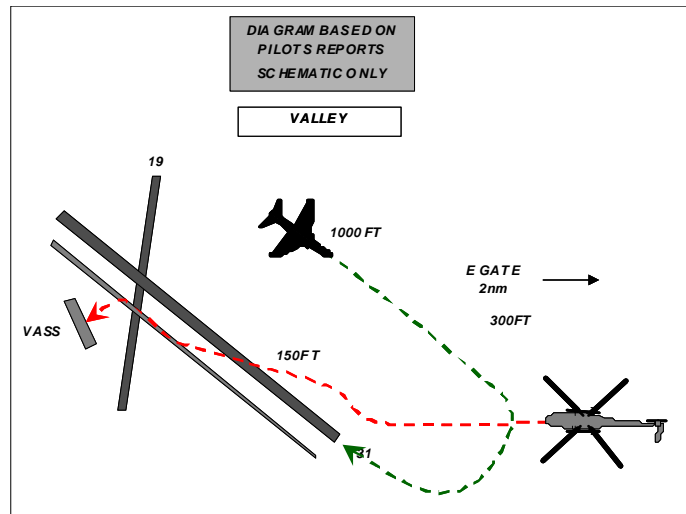
AIRPROX REPORT NO 2010145

Cause: The Lack of TI led the Hawk pilot to believe there was a conflict with the Lynx

Recommendation: 1. It is recommended that RAF Valley reviews its procedures for
co-ordinating helicopter movements under fixed-wing circuit traffic.

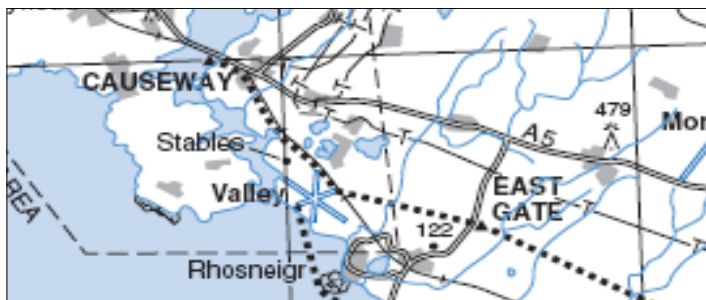
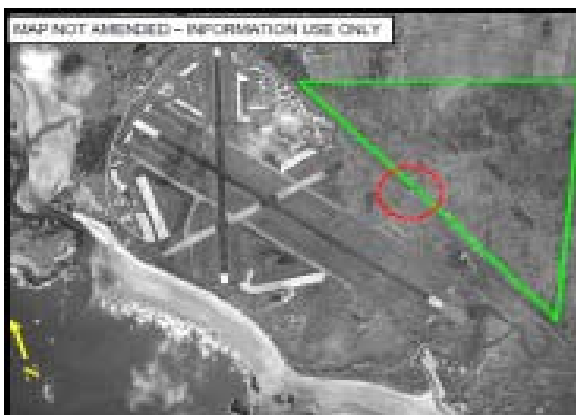
As stated at UKAB Note (1), the Mil AIP states that for ac inbound 'Flight between East Gate and Rwy 19 or 31 THR max 250ft QFE. [Pilots are to] report over East Gate inbound and outbound.' The following diagrams show East Gate and the railway line in relation to the airfield, and the area known as the 'Golf Course' which is bounded by the NE fence of the railway line, then the two fence lines running E-W and N-S forming the other 2 sides of the green triangle marked on the photograph.

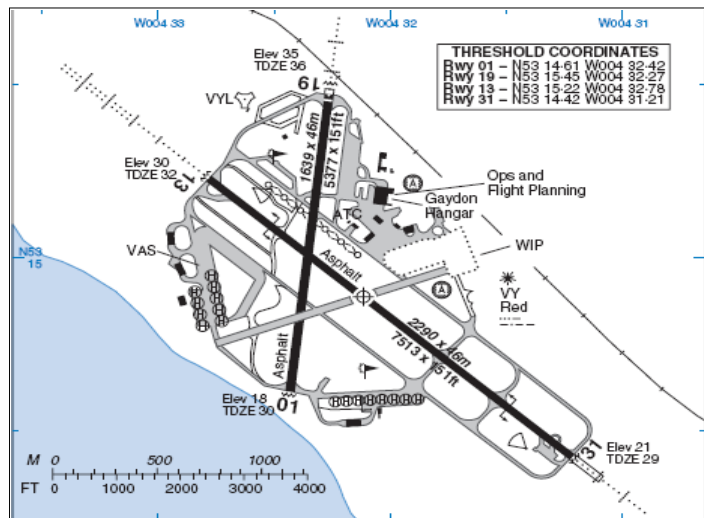
The ADC reported that he did not inform the Hawk pilot about the helicopter as it was below 250ft QFE (in accordance with the FOB), however, the unit FOB actually states that “when Rwy 31/13 is in use, Tower is to inform any ac flying a low level circuit of any rotary traffic on the golf course; all such rotary traffic is to remain below 250ft QFE.” Given that frequency separation existed between the Hawk and the Lynx, the provision of TI to the Hawk on the Lynx would have improved the pilot’s situational awareness. That said, from an ATM perspective, the ADC fulfilled his obligations to sequence the visual circuit traffic correctly and he was at all times aware of the location of both ac.

It appears that the height of the Lynx and its proximity to the RW31 threshold caused concern to the Hawk pilot and moreover, if the heights reported by the respective pilots are accurate, then only about 200ft vertical separation might have existed, supporting the Hawk pilot’s assessment of the separation. However, the Lynx crew was visual with the Hawk from early in their recovery, they remained so throughout and were content that adequate separation existed at all times.

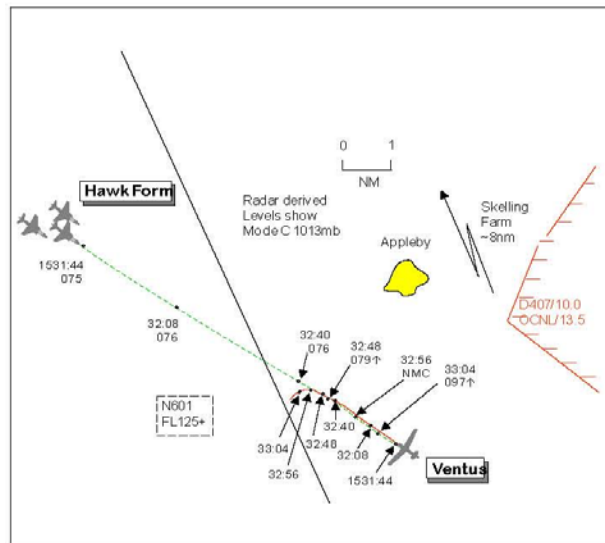
AIRPROX REPORT NO 2010146

Cause: A conflict in Class G airspace resolved by the Hawk formation leader.

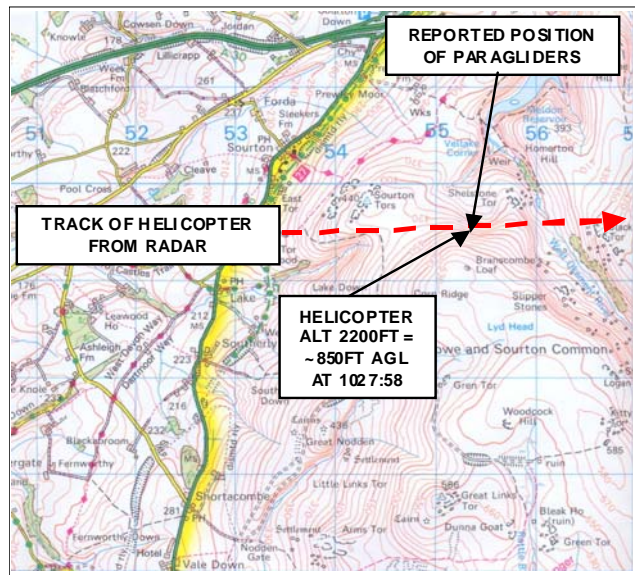
AIRPROX REPORT NO 2010147

Cause: The EC145 pilot flew close enough to cause concern to a group of paragliders, some of which he may not have seen.

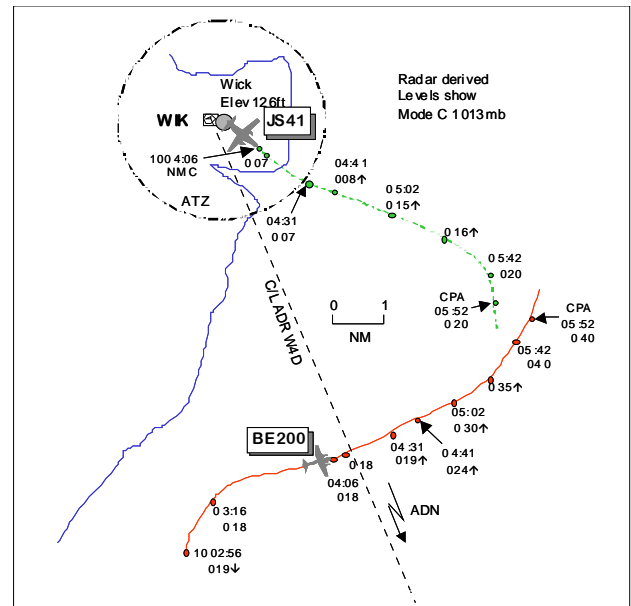
AIRPROX REPORT NO 2010148

Cause: APP cleared the BE200 into conflict with the JS41.

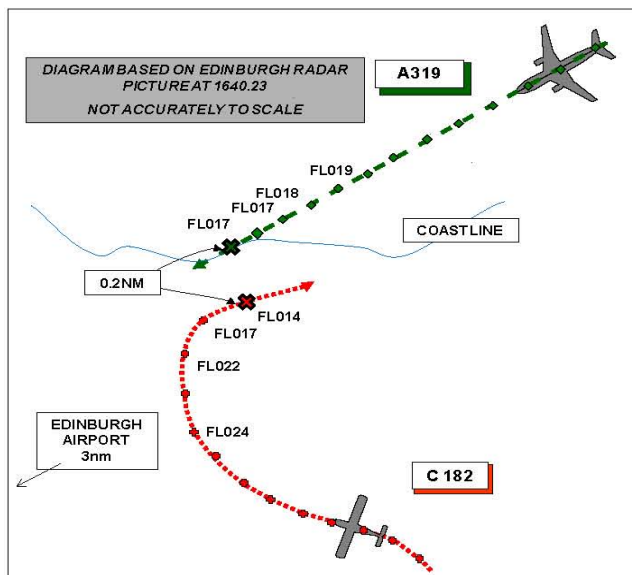
AIRPROX REPORT NO 2010149

THE A319 PILOT reports flying a CAT flight into Edinburgh under IFR and in receipt of an Approach Control Service (ACS) from them. While descending on an ILS approach to RW24, passing about 1200ft, with the ac fully configured and stable on a heading of 235° at 140kt, ATC informed him that they might see traffic ahead on TCAS, to the S of the approach path. The other ac was identified on TCAS as proximate traffic, 100ft above at a range of about 3nm, and the captain identified it visually as a C182 that was apparently orbiting in a holding pattern waiting for them to pass. However, without notice the C182 suddenly performed an extremely rapid descending RH turn and started heading straight towards them. TCAS then enunciated the C182 as 'traffic', followed straight away by an RA 'monitor vertical speed'. The FO [handling pilot] disconnected the autopilot in accordance with company SOPs and followed the TCAS RA command.

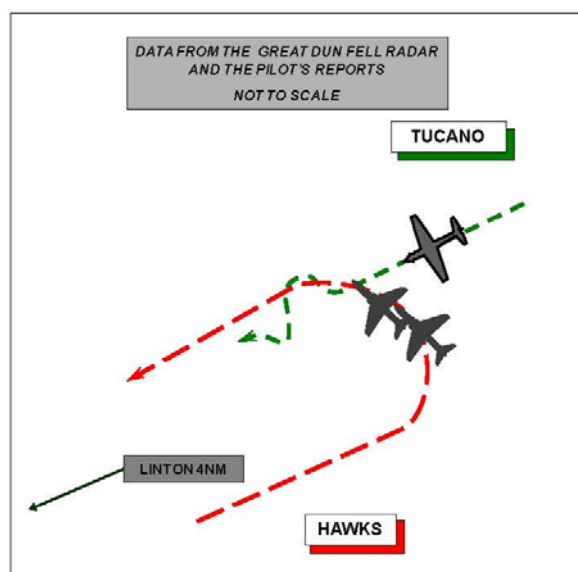
AIRPROX REPORT NO 2010153

THE TUCANO STUDENT PILOT reports he was solo and flying a visual recovery to RAF Linton-on-Ouse, squawking 7001 with Mode C, having just exited from low level and he was in receipt of a BS from Linton APP [See UKAB Note: (1)]. He was heading 230° at 160kt and 2000ft QFE, in poor visibility, and he had transmitted his recovery call to APP at about 9nm from the airfield but the reply was interrupted by a 'Practice PAN' call by another Tucano. He then became visual with the airfield and switched from APP to TWR. He later learned that 2 Hawks were also recovering [to RW 21] on a radar-to-visual recovery from the W but they were not displayed on his TCAS [1]. He was also informed later by ATC that APP had become aware of the possible confliction but was unable to warn them due to the 'Practice PAN' call in progress. The Airprox occurred as the 'Practice Pan' call was being completed and the pair of Hawks in echelon left, passed about 70m away in his 10 o'clock at the same height, in a 60° bank left turn, belly up to him. He did not take any avoiding action as he first saw the other ac at the CPA and he assessed the risk as being high. The visibility into sun (the direction of the Hawk's approach) was poor.

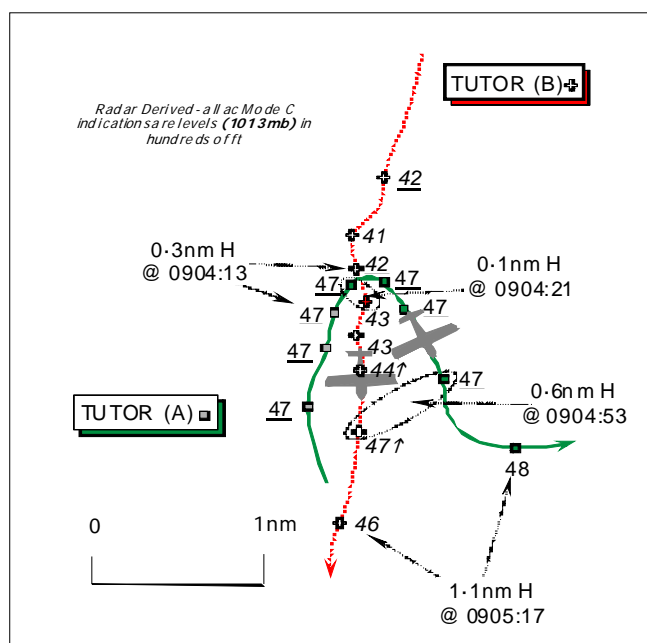
AIRPROX REPORT NO 2010158

Date/Time: 12 Oct 2010 0904Z
Position: 5252N 00024W
 (8nm SE of Barkston Heath - elev 367ft)
Airspace: Lincolnshire AIAA (Class: G)
Reporting Ac Reported Ac
Type: Grob Tutor T Mk1 Grob Tutor T Mk1
Operator: HQ Air (Trg) HQ Air (Trg)
Alt/FL: 5000ft 5000ft
 RPS RPS
Weather: VMC CLBL VMC CLAC
Visibility: 10km 40km
Reported Separation:
 200ft V/nil H 300ft V
Recorded Separation:
 Nil V @ 0.6nm H
 400ft V @ 0.1nm Min H

Cause: Effectively a non-sighting by the pilots of Tutor (A) and a late sighting by the pilots of Tutor (B).

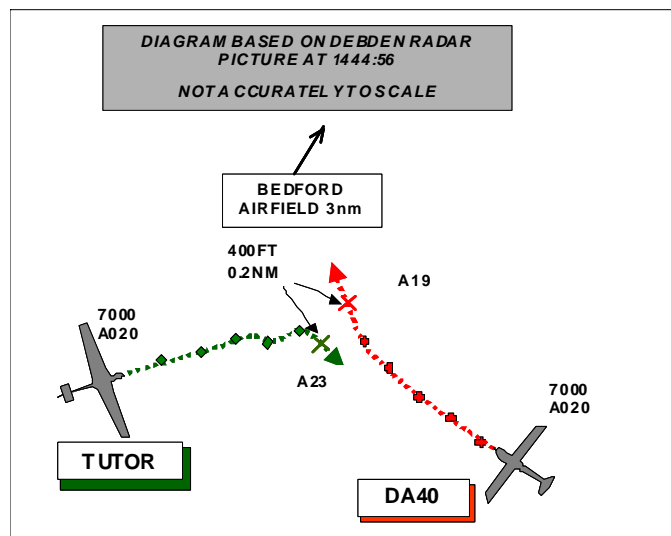
AIRPROX REPORT NO 2010159

Date/Time: 12 Oct 2010 1445Z
Position: 5205N 00026W
 (3nm SSW Bedford Airfield)
Airspace: Lon FIR (Class: G)
Reporting Ac Reported Ac
Type: Grob Tutor DA40
Operator: HQ Air (Trg) Civ Pte
Alt/FL: 1800ft 2500ft
 (RPS 1014mb) (NK)
Weather: VMC HZBC VMC CAVOK
Visibility: 20km >10km
Reported Separation:
 50ft V / 200m H 0 V/400m H
Recorded Separation:
 400ft V / 0.2nm (370m) H (See UKAB Note (1))

Cause: A conflict in Class G Airspace resolved by both pilots.

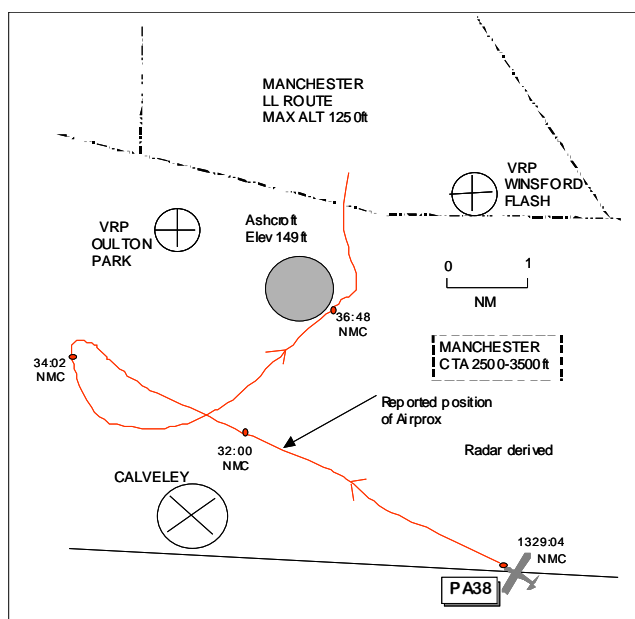
AIRPROX REPORT NO 2010160

Date/Time: 20 Oct 2010 1332Z
Position: 5308N 00235W
 (2nm S Ashcroft - elev 149ft)
Airspace: LFIR (Class: G)
Reporting Ac Reported Ac
Type: Mainair Blade PA38
 Flexwing M/L
Operator: Civ Pte Civ Trg
Alt/FL: 1200ft ↓1500ft
 (QNH 1021mb) (QNH 1021mb)
Weather: VMC CLNC VMC CLBC
Visibility: 30km >10km
Reported Separation:
 Nil V/200m H Not seen
Recorded Separation:
 NR

Cause: A non-sighting by the PA38 pilot and a late sighting by the Mainair Flexwing pilot.

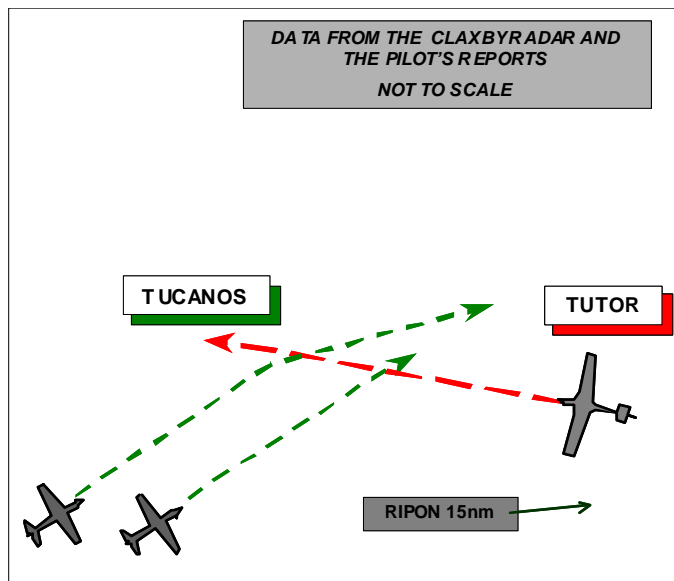
AIRPROX REPORT NO 2010161

Date/Time: 20 Oct 2010 1333Z
Position: 5406N 00157W
 (near Grimwith Reservoir)
Airspace: LFA 17 (Class: G)
Reporting Ac Reported Ac
Type: Tucano x 2 Grob Tutor
Operator: HQ Alir(Trg) HQ Air (Trg)
Alt/FL: 250 agl 500ft
 (RPS 1014mb) (RPS)
Weather: VMC CAVOK VMC NK
Visibility: 40km 5km
Reported Separation:
 100ft V/100ft H 250ft V/200m H
Recorded Separation:
 NR

The Board discussed the apparently conflicting and incomplete reports of the geometry of the incident and agreed that it had most likely been as displayed on the diagram above with the No2 Tucano moving from the left to the right side of his leader. An HQ Air Member observed that he was aware of the difficulty of assessing incidents when reports are brief; HQ Air was taking action to encourage pilots to submit comprehensive and accurate reports thus allowing thorough investigation.

Cause: A conflict in the UKDLFS resolved by the Tucano pilots, with the assistance of TCAS.

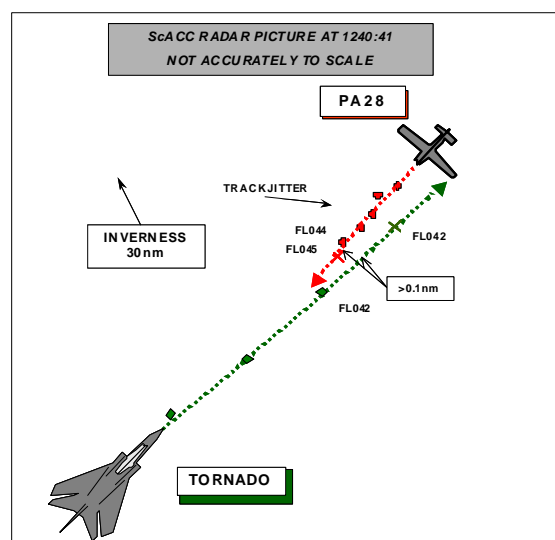
AIRPROX REPORT NO 2010162

Date/Time: 25 Oct 2010 1241Z
Position: 5706N 00340W (Cairngorm Mountains)
Airspace: LFA14/Scot FIR (Class: G)
Reporting Ac Reported Ac
Type: Tornado GR4 PA28
Operator: HQ Air (Ops) Civ Pte
Alt/FL: 500ft agl 5500ft amsl
(RPS 1014mb) (QNH)
Weather: VMC CAVOK VMC CAVOK
Visibility: 40km >10km
Reported Separation:
100ft V/500ft H 0ft V/600m H
Recorded Separation:
200 V/ >0.1nm H (See UKAB Note (1))

Cause: Late sightings by the Tornado crew and the PA28 pilot.

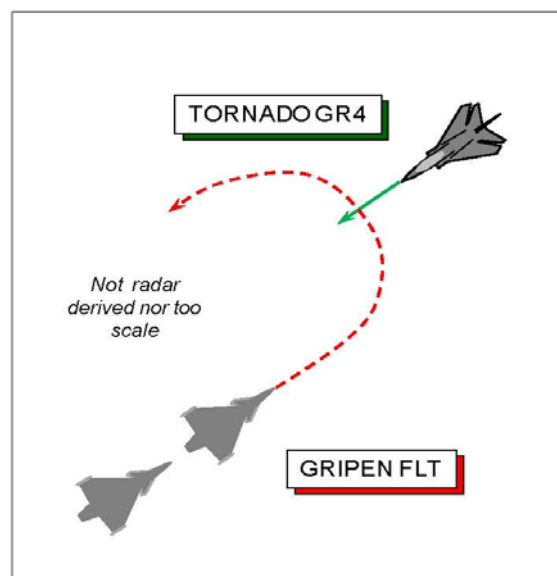
AIRPROX REPORT NO 2010163

Date/Time: 13 Oct 2010 1036Z
Position: 5750N 00313W (3nm Final Approach RW23 at Lossiemouth - elev 41ft)
Airspace: MATZ (Class: G)
Reporting Ac Reported Ac
Type: Tornado GR4 SAAB Gripen x2
Operator: HQ Air (Ops) Foreign Mil
Alt/FL: 900ft 800ft
 QFE (1022mb) QFE (1022mb)
Weather: IMC IBCL VMC In rain
Visibility: 8km >10km
Reported Separation:
 Nil V/200m H Not seen
Recorded Separation:
 Not recorded

This Airprox is the epitome of a Swiss cheese barrier erosion. Supervision of the situation by both the SUP and the DAO was not robust enough to take into account the decreasing weather conditions. This meant that ac in the visual cct were unable to gain visual contact with the GR4 on instrument approach. Furthermore, the unsuitable weather conditions made it impossible for the ADC to manage the cct by visual scan alone and provide relevant information in order for the cct traffic to take appropriate action to sequence themselves against IFR traffic. That said, whilst there is evidence that information was derived from the Highbrite ATM display, its full potential was not exploited to aid integration calling into question whether the Gripens ‘painted’ on the Highbrite. Finally, the Gripen pilots although aware of the inbound radar traffic, appear to have turned across the approach lane without first ensuring that they were visual with the radar traffic, thereby removing the final barrier to the occurrence.

Cause: Visual circuits were permitted in unsuitable weather conditions.

Degree of Risk: A.

HQ 1Gp BM SM Spt recommends that the Unit review:

The safety implications of vis cct conditions and procedures for dispersing the visual cct if weather conditions are not deemed suitable.

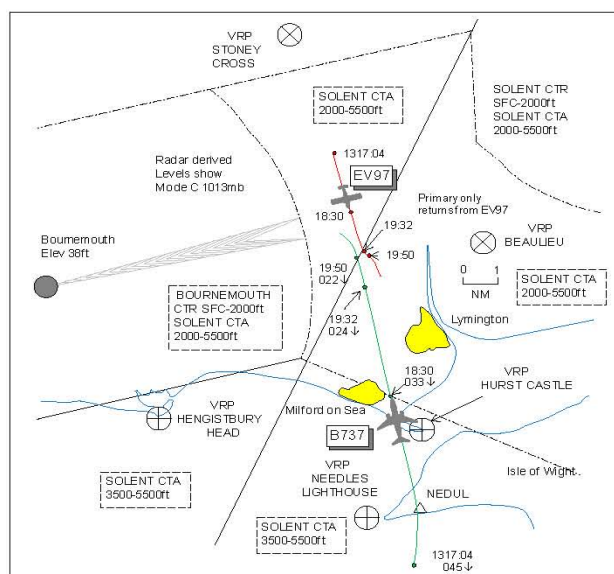
AIRPROX REPORT NO 2010164Date/Time: 21 Oct 2010 1320ZPosition: 5048N 00136W
(9nm E Bournemouth - elev 38ft)Airspace: Solent CTA/LFIR (Class: D/G)Reporting Ac Reported AcType: B737-500 EV97 EurostarOperator: CAT Civ ClubAlt/FL: 2500ft ↓ 1500ft
(QNH) (QNH)Weather: VMC CLOC VMC CAVOKVisibility: 5nm 20nmReported Separation:
Nil V/3nm H 500ft V/1-2nm HRecorded Separation:
0.4nm

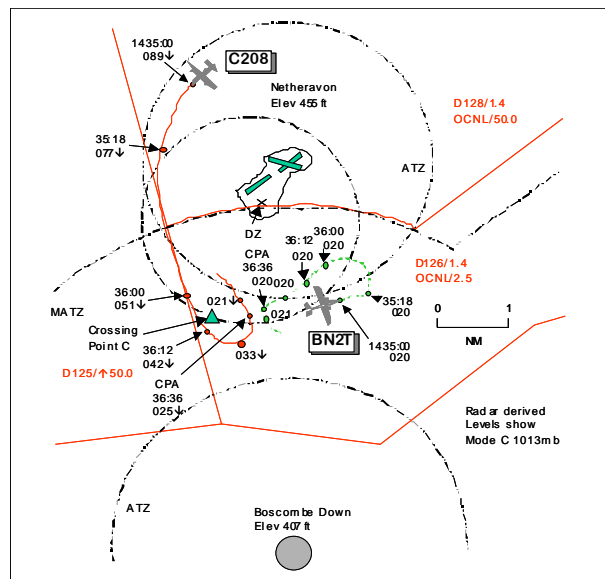
AIRPROX REPORT NO 2010165

Date/Time: 16 Oct 2010 1437Z (Saturday)
Position: 5113N 00146W
(2.25nm S Netheravon - elev 455ft)
Airspace: D126/Para DZ (Class: G)
Reporting Ac Reported Ac
Type: BN2T C208
Operator: Civ Comm Civ Club
Alt/FL: 2000ft ↓cct
(RPS)
Weather: VMC CLBC VMC CLOC
Visibility: >10km 10km
Reported Separation:
Nil V/200m H Not seen
Recorded Separation:
500ft V/0.2nm H

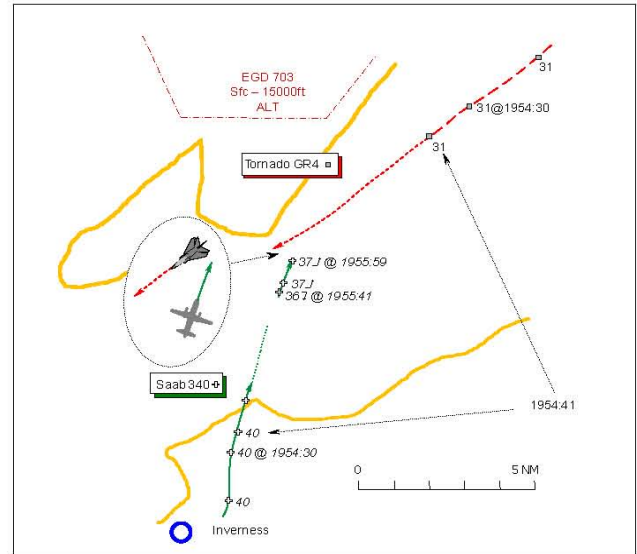
AIRPROX REPORT NO 2010166

Date/Time: 1 Nov 2010 1955Z NIGHT
Position: 5741N 00357W
 (8nm NNE of Inverness - elev 31ft)
Airspace: Scottish FIR (Class: G)
Reporting Ac Reporting Ac
Type: SAAB SF34 Tornado GR4
Operator: CAT HQ Air (Ops)
Alt/FL: 3000ft 2600ft
 QNH (992mb) (1002mb)
Weather: IMC IICL VMC
Visibility: NR 30km
Reported Separation:
 400ft V/1nm H 100ft V/O-7nm H
Recorded Separation:
 Not recorded

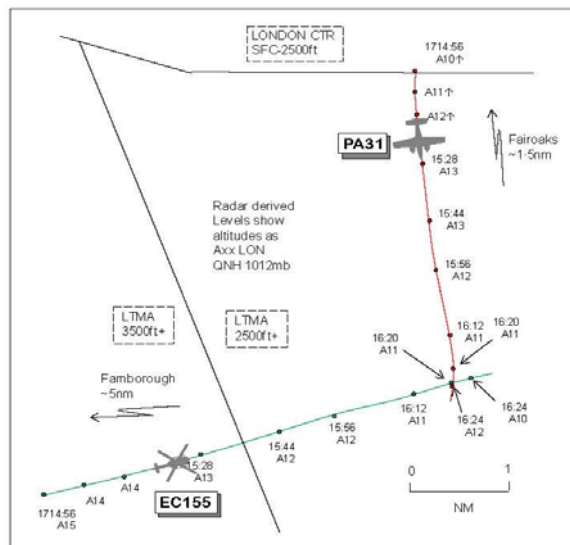
AIRPROX REPORT NO 2010167

Date/Time: 3 Nov 2010 1716Z NIGHT
Position: 5117N 00034W (4nm S Fairoaks)
Airspace: LFIR (Class: G)
Reporting Ac Reporting Ac
Type: EC155B PA31
Operator: Civ Pte Civ Pte
Alt/FL: 1100ft 1200ft
(QNH 1013mb) (QNH)
Weather: VMC CLBC VMC CLBC
Visibility: >20nm 10km
Reported Separation:
<100ft V/close H 100ft V/200ft H
Recorded Separation:
<100ft V/<0.1nm H
