UK AIRPROX BOARD

Analysis of Airprox in UK Airspace

**Report Number 25
July 2010 – December 2010**

Twenty-Fifth Report by the UK Airprox Board:

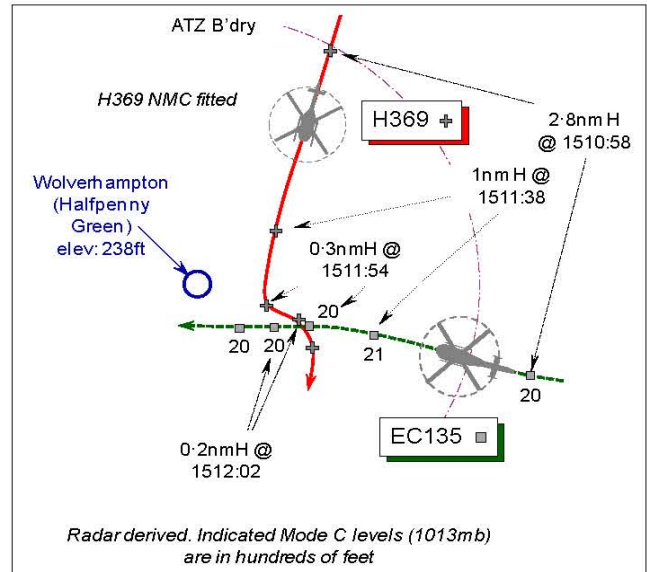
AIRPROX REPORT NO 2010169

Date/Time: 8 Nov 2010 1512Z
Position: 5231N 00214W (0.7nm ESE
 Wolverhampton A/D - elev 283ft)
Airspace: Wolverhampton ATZ (Class: G)
Reporting Ac Reported Ac
Type: EC135 H369E
Operator: Civ Comm Civ Pte
Alt/FL: 600ft 600ft
 QFE (955mb) QNH
Weather: VMC VMC
Visibility: 5km 5nm
Reported Separation:
 Nil V/500m H 100ft V/1nm H
Recorded Separation:
 0.2nm H (~370m)

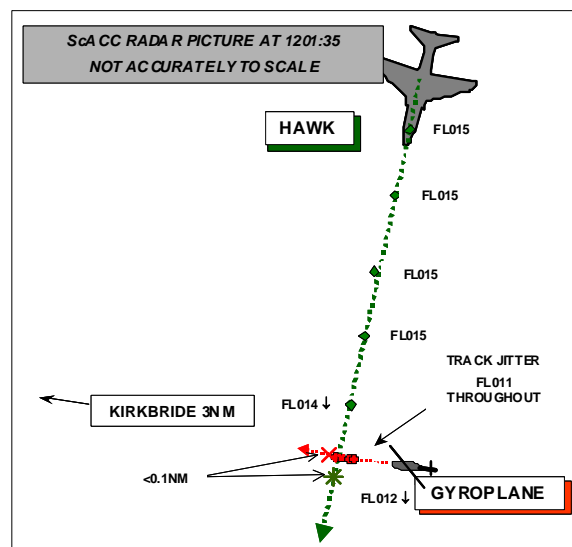
AIRPROX REPORT NO 2010170

Date/Time: 3 Nov 2010 1202Z
Position: 5452N 00308W (2nm N Wigton)
Airspace: LFA 17/Scot FIR (Class: G)
Reporting Ac Reported Ac
Type: Hawk Gyroplane
Operator: HQ Air (Trg) Civ Pte
Alt/FL: 1000ft 800ft
(RPS 998mb) (QFE NR)
Weather: VMC CLBC VMC HAZE
Visibility: 20km 8nm
Reported Separation:
0 V/100ft H 250ft V/ 200m H
Recorded Separation:
100ft V/ <0.1nm H

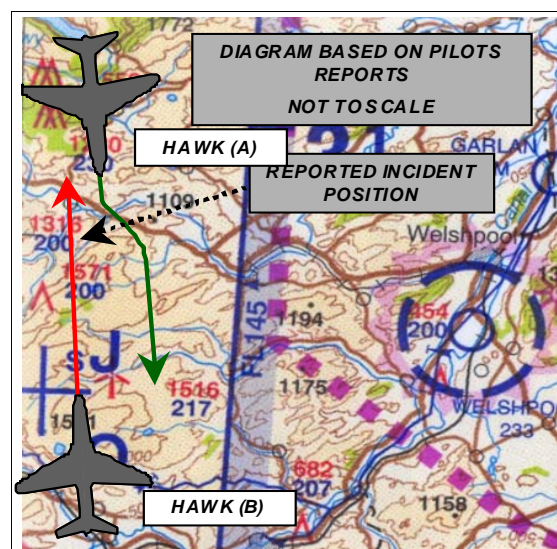
AIRPROX REPORT NO 2010171

Date/Time: 16 Nov 2010 1240Z
Position: 5240N 00328W (10nm W Welshpool)
Airspace: LFA 7 (Class: G)
Reporting Ac Reporting Ac
Type: Hawk T Mk1 Hawk T Mk 1
Operator: HQ Air (Trg) HQ Air (Trg)
Alt/FL: 250ft 250ft
(RPS 1009mb) (RPS 1009mb)
Weather: VMC CAVOK VMC CAVOK
Visibility: 30km 20km
Reported Separation:
500ft H 0 V/500ft H
Recorded Separation:
NR

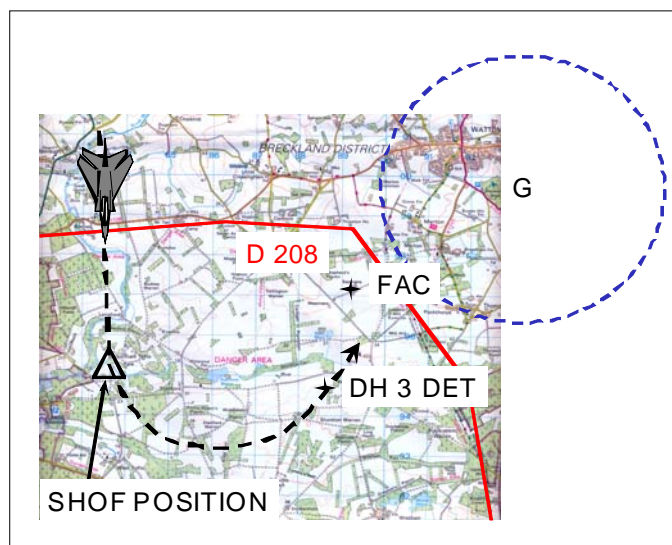
AIRPROX REPORT NO 2010173

Date/Time: 25 Nov 2010 1248Z
Position: 5231N 00043E (STANTA)
Airspace: D208 (Class: G)
Reporting Ac Reported Ac
Type: DH3 UAV Tornado GR4
Operator: RA HQ Air (Ops)
Alt/FL: NR 250ft
 (NK) (Rad Alt)
Weather: VMC CAVOK VMC CLBC
Visibility: 5.0km 5.0km
Reported Separation:
 100-200ft V/O H Not Seen
Recorded Separation:
 NR

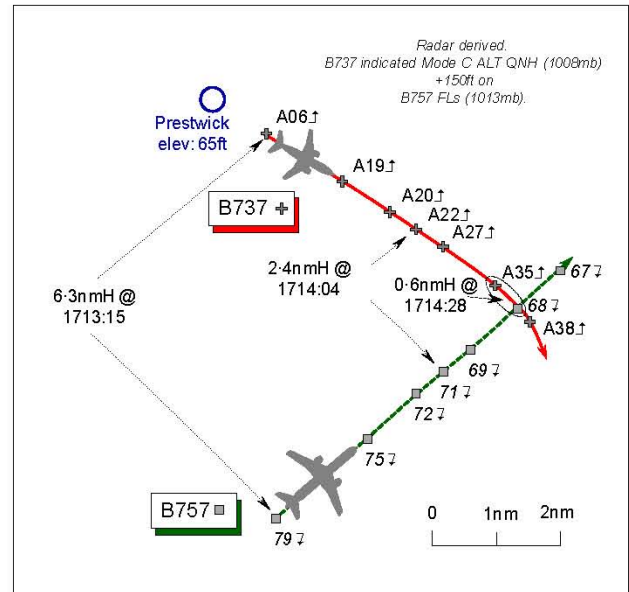
Date/Time: 16 Dec 2010 1714Z NIGHT
Position: 5527N 00426W
 (6nm SE of Prestwick Airport elev: 65ft)
Airspace: S TMA/Prestwick CTR (Class: D)
Reporter: SAC Galloway Sector

<u>1st Ac</u>	<u>2nd Ac</u>
<u>Type:</u>	B757	B737-800
<u>Operator:</u>	CAT	CAT
<u>Alt/FL:</u>	6000ft ↓	3000ft ↑
	QNH (1008mb)	QNH (1008mb)
<u>Weather:</u>	IMC In Cloud	NR
<u>Visibility:</u>	10km	NR
<u>Reported Separation:</u>	Not seen	NR
<u>Recorded Separation:</u>	3250ft V @ 0.5nm min H

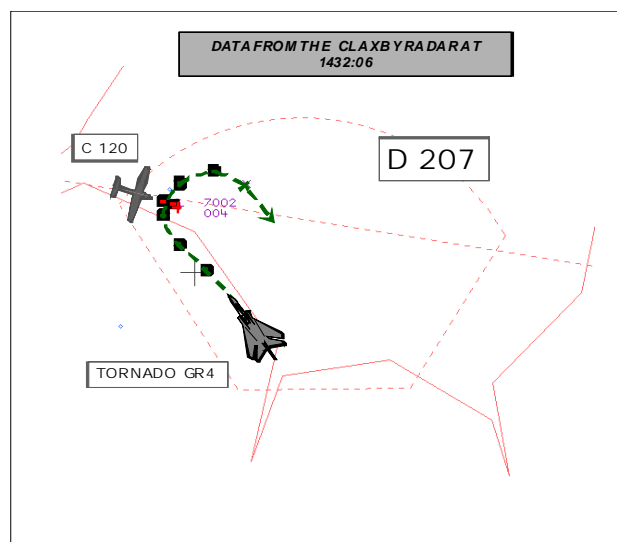
AIRPROX REPORT NO 2010176

Date/Time: 9 Dec 2010 1432Z
Position: 52.52N 000.10E (Holbeach AWR)
Airspace: D 207 (Class: G)
Reporting Ac Reported Ac
Type: Tornado GR4 C120
Operator: HQ Air (Ops) Civ Pte
Alt/FL: 200ft NR
 (Rad Alt)
Weather: VMC NR NR
Visibility: 30km NR
Reported Separation:
 V 800ft/H 200ft NR
Recorded Separation:
 NR
