UK AIRPROX BOARD

Analysis of Airprox in UK Airspace

**Report Number 14
January 2005 – June 2005**

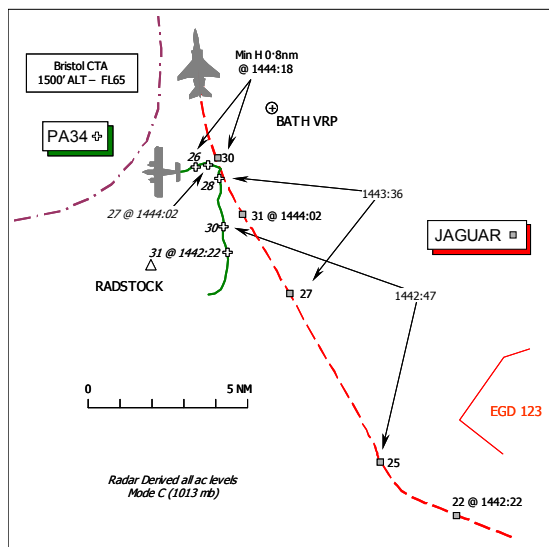
~500ft V/1nm H Not seen

Recorded Separation: 400 ft V/0.8nm H

THE BRISTOL APPROACH RADAR CONTROLLER (BRI RAD) reports that the PA34 was being vectored LH for an ILS approach to RW27 at Bristol International (number 5 in the pattern as the ac commenced the downwind leg) under a RAS outside CAS. After the PA34 turned L base, now number 3 in the landing sequence, he spotted a fast moving contact squawking A2624, some 7nm to the S of Bath tracking N at FL31. The A2624 squawk continued flying towards the PA34, which was now level at 2500ft Bristol QNH (1013mb), so he issued an avoiding action L turn into wind towards the Class D Bristol CTA and also passed traffic information. Prescribed separation was eroded as the A2624 contact passed about 1nm astern of the PA34 indicating 2900ft QNH - 400ft above the PA34 on Mode C - some 12nm ESE of Bristol Airport. He opined that there was no time to effect co-ordination with Boscombe Down ATC that would have afforded resolution of the conflict. The PA34 pilot reported visual contact with the other ac and when clear of it was vectored onto the ILS for RW27.

On a radar heading of 095°(M), he thought, flying at 128kt, some 12nm ESE of the airport, RADAR issued a change of heading as avoiding action against fast jet traffic. Once steady on the new heading they were informed that the jet was passing about 1nm behind and some 400ft above his ac. He turned to look out over his R shoulder and saw the jet for the first time about 1nm away at 5 o'clock as it passed some 400-500ft above his ac. Once the other ac was clear they were vectored into CAS and onto the final approach for the ILS. In assessing the risk he observed that it was "small" at the time of visual contact, but could have been "high" if no avoiding action had been taken.

THE JAGUAR T2A PILOT reports that the HISLs were on whilst flying VFR in VMC with broken cumulus/strato-cumulus cloud below and ahead of them with some vertical development. They were in receipt of a RIS from Boscombe Down APPROACH (APP) on UHF and squawking A2624 with Mode C. His navigator was occupying the rear seat of the jet. Neither TCAS nor any other form of CWS is fitted.

Although the Jaguar crew reported climbing to 2000ft on climbout, Mode C indications show that the Jaguar climbed further to 3000ft without advising the controller and without APP perceiving that the Jaguar's Mode C indications were outwith the regulated tolerance stipulated at JSP 552 601.115.2. However, this point is not deemed to be a factor within this Airprox as all traffic information passed by APP to the Jaguar crew was given in relation to indicated levels. APP had provided timely and accurate traffic information to the Jaguar regarding the proximity of the PA34 as per the conditions of a RIS at JSP 552 235.115.1. The traffic information was updated on 2 separate occasions and no upgrade of service was requested from the Jaguar crew. APP fulfilled their obligations under the RIS and there are no contributory Mil ATC factors apparent within this Airprox.

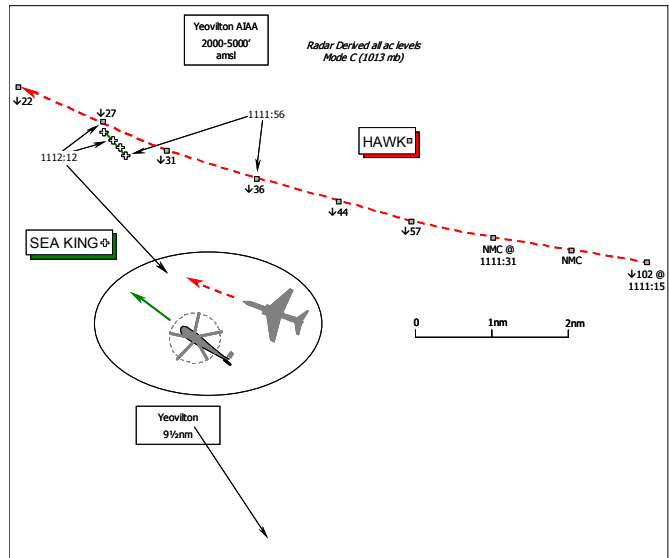
AIRPROX REPORT NO 005/05

Date/Time: 12 Jan 1112
Position: 5109N 00245W (9½nm NW of Yeovilton elev: 75ft)
Airspace: Yeovilton AIAA (Class: G)
Reporting Ac Reported Ac
Type: Sea King Mk4 Hawk Mk1
Operator: CinC Fleet DPA
Alt/FL: 2200ft 3000ft
RPS (1018mb) QNH (1017mb)
Weather VMC NR VMC Haze
Visibility: 25km Good
Reported Separation:
150-300ft H 3-400ft V/1500-2000 yd H
Recorded Separation:
<450m H

THE WESTLAND SEA KING MK4 PILOT reports his ac has a dark green colour scheme but the HISLs were on whilst carrying out a check test flight (CTF) within Yeovilton's Northern AIAA. His crew consisted of a co-pilot in the LHS and a maintainer. He was in receipt of a FIS from Yeovil RADAR (VLN RAD) [located at RNAS Yeovilton] on UHF 369-875MHz and squawking A0222; neither Mode C nor TCAS is fitted.

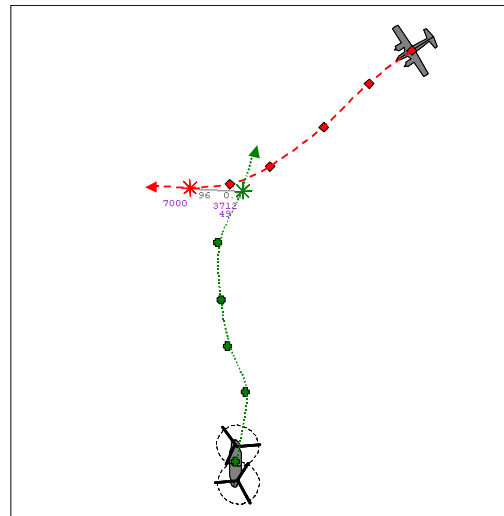
AIRPROX REPORT NO 006/05

Date/Time: 14 Jan 1148
Position: 5153N 00104W (3nm SE Bicester)
Airspace: LONDON FIR (Class: G)
Reporting Ac Reported Ac
Type: Chinook PA34
Operator: JHC Civ Trg
Alt/FL: FL46↑ 4500ft
(1013) (QNH 1026 mb)
Weather VMC VMC CAVOK
Visibility: >10km >10km
Reported Separation:
100ft V/150m H 200ft V/½nm H
Recorded Separation:
100ft V/0.2 nm (370m)H

THE CHINOOK PILOT reports flying a dark green ac with HISLs and Nav lights switched on but with no TCAS fitted, squawking as directed with Mode C and in receipt of a RIS from Brize Radar on a medium level transit flight to Linton on Ouse. The Captain was a QHI IRE in the LH seat and the co-pilot – the handling pilot - was under an IF hood in the RH seat. While heading 359° at 130kt overhead BSO (Benson) at 4400ft on the London RPS 1028mb, they requested a climb to FL50 to fly at the correct quadrantal for the next leg. Brize passed TI on an ac to their right indicating FL40 and cleared them to climb to FL50. As the ac climbed, the Captain (NH) observed a white and blue light twin 300m away, above and to their right, emerging from an area not visible due to the overhead console. The Captain took control, stopped the climb and broke right to pass behind the conflicting traffic. The co-pilot on the RH side did not see the traffic due to the IF visor and it was only seen by the Navigator when it was no longer masked by the RH windscreen wiper motor. He assessed the risk of collision as being high.

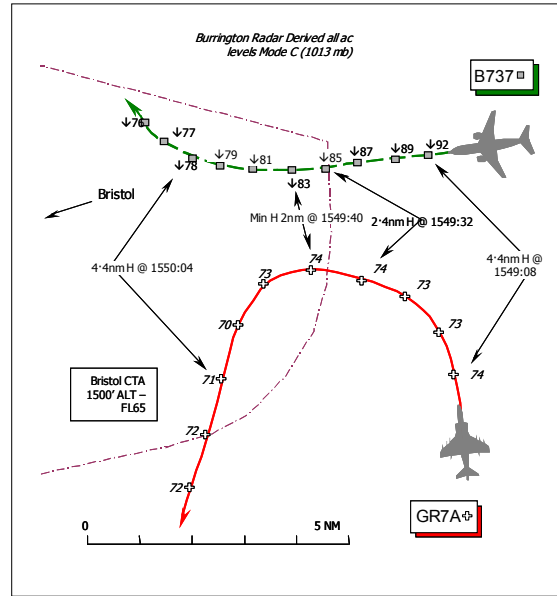
AIRPROX REPORT NO 007/05

Date/Time: 25 Jan 1549
Position: 5125N 00228W (9½nm E Bristol Airport - elev 622 ft)
Airspace: London FIR (Class: G)
Reporter: Bristol APR
First Ac Second Ac
Type: B737 Harrier
Operator: CAT HQ STC
Alt/FL: ↓FL40 FL80
Weather IMC In cloud VMC CLBL
Visibility: NR 15km
Reported Separation:
 APR: 800ft V/2½ nm H 800ft V/2½ nm H
Recorded Separation:
 Min H: 2nm @ Min V: 800ft @
 900ft V. 2.3nm H

THE BRISTOL APPROACH RADAR CONTROLLER (APR) reports that the B737 was being vectored into CAS at Bristol Airport. The Harrier was spotted SE of the Airport, he thought at low level and climbing towards the B737. Traffic information was passed to the B737 crew and descent issued into the CTA but the Harrier then turned towards the B737 so an avoiding action R turn onto a heading of 360° was passed. The Harrier continued the L turn into the Class G airspace immediately above the Bristol Airport CTA and standard separation was eroded as the Harrier passed about 2½nm away and 800ft below the B737, some 8nm E of the BRI. The pilot of the B737 advised that he had not sighted the traffic; he had however received a TCAS TA.

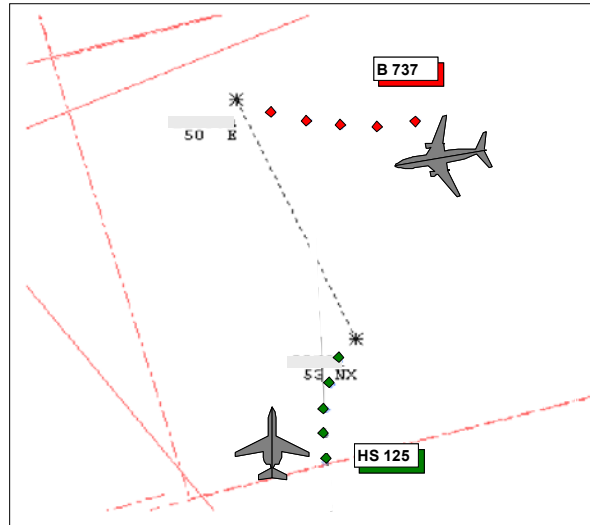
AIRPROX REPORT NO 009/05

Date/Time: 24 Jan 0741
Position: 5146N 00035W (4nm N BNN)
Airspace: LTCA (Class: A)
Reporting Ac Reported Ac
Type: B737-300 HS125-700
Operator: CAT HQ STC
Alt/FL: 5000ft about FL60
 (QNH)
Weather VMC CLBL VMC CLAC
Visibility: >10km 25km
Reported Separation:
 100ft V/4nm H 0 V/~2nm H
Recorded Separation:
 200ft V/2.3m H

THE B737-300 PILOT reports flying a passenger flight from Luton in contact with London Control. He was level at 5000ft and heading 257° at 275kt on a CPT3B SID inbound to HEN. The first alert they had to the incident was when ATC gave an avoiding action turn onto N. The other traffic was observed during the turn, just before they lost visual contact due to their limited field of vision, in their 8 o'clock position about 4nm away and slightly below them. They assessed the risk as being medium.

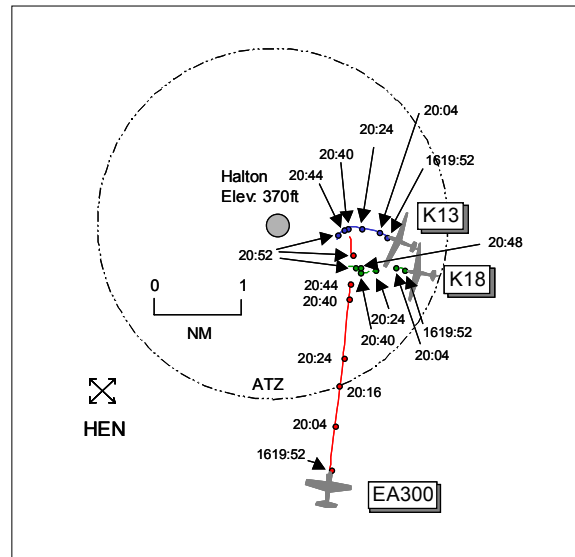
AIRPROX REPORT NO 010/05

Date/Time: 26 Jan 1621
Position: 5147N 00043W (1nm SE Halton
A/D - elev 370ft)
Airspace: ATZ (Class: G)
Reporting Ac Reported Ac
Type: K18 Glider Extra EA300
Operator: Civ Club Civ Pte
Alt/FL: 1300ft
(QFE 1019mb)
Weather VMC CLBC
Visibility: 15km
Reported Separation:
150ft H
Recorded Separation:
<0.1nm H

THE K18 GLIDER PILOT reports heading 300° at 1300ft QFE 1019mb and 45kt flying solo in weak lift over the N facing ridge to the E of Halton and in communication with Halton on 130.42Mhz. The visibility was 15km across sun, the white/orange glider flying 5000ft below cloud in VMC. About 0.5nm E of Halton, well within the ATZ and after he had just scanned L, he first saw a single engine low wing aerobatic monoplane as it crossed L to R through his 12 o'clock range 150ft at the same level. It was light coloured with dark horizontal stripes and was travelling very fast in a straight and level attitude. He thought the other ac had come from aft of his L wing tip and it had appeared too late to take any avoiding action. He opined that had the ac met 5sec later a collision would have been highly likely.

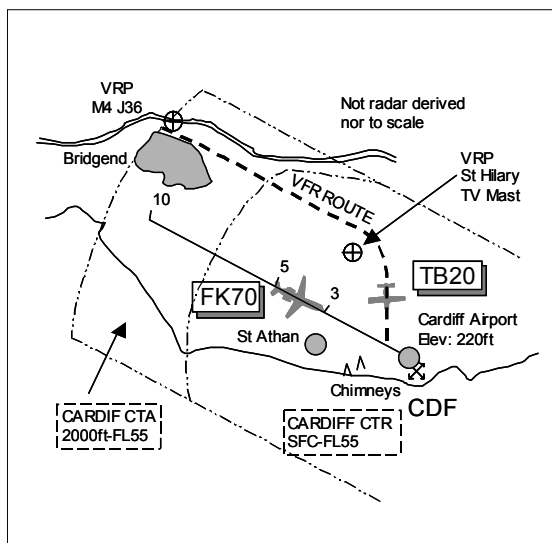
AIRPROX REPORT NO 011/05

Date/Time: 23 Jan 1408 (Sunday)
Position: 5154N 00325W (3nm FIN APP
RW12 Cardiff - elev 220ft)
Airspace: CTR/ATZ (Class: D)
Reporting Ac Reported Ac
Type: FK70 TB20GT
Operator: CAT Civ Pte
Alt/FL: 1000ft↓ 1500ft↓
(Rad Alt) (QNH 1032mb)
Weather VMC CLBC VMC CLBC
Visibility: 20km NR
Reported Separation:
nil V/0.25nm H not seen
Recorded Separation:
NR

THE FK70 PILOT reports on final RW12 at Cardiff flying an NDB approach and in receipt of an ATS from Cardiff TWR. Descending through 1000ft Rad Alt with the ac's attitude 3° pitch down and ROD 600fpm at 123kt fully configured for landing, TCAS gave a TA alert on traffic. This was sighted as a TB20 turning from L base onto final ahead of them, before an RA 'climb, climb now' warning was annunciated. An avoiding action L turn away from the ac was initiated by the FO, PF, followed by a 'go-around' because they were unsure if the RA would have provided enough separation. After the 'go-around' an uneventful ILS was made. They estimated the separation to be 0.25nm as the other ac turned in ahead at the same level.

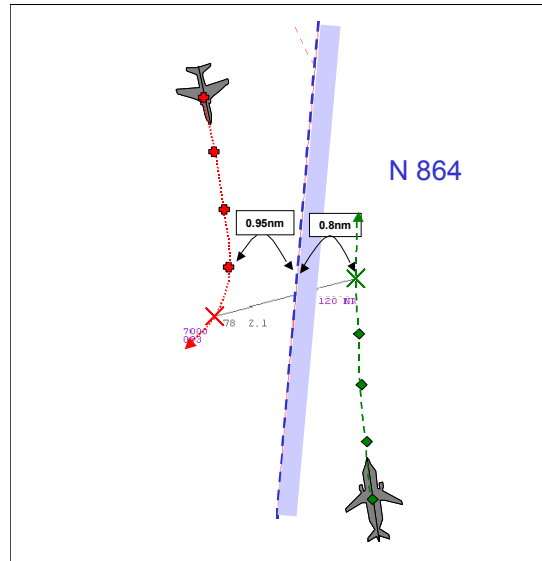
Reported Separation:
 5000ft V/3nm H Not seen

Recorded Separation:
 2700ft V/1.8nm H
 (estimated between sweeps)

THE A300-600ST PILOT reports flying a non-scheduled IFR freight flight from Toulouse to Hawarden with strobes switched on, squawking as directed with Mode C, and in receipt of an unspecified radar service from London Control [he thought]. While heading 005° at 12000ft in the descent and at 270kt, another ac passed through their nose from right to left generating a TCAS RA which he reacted to. He did not assess the risk.

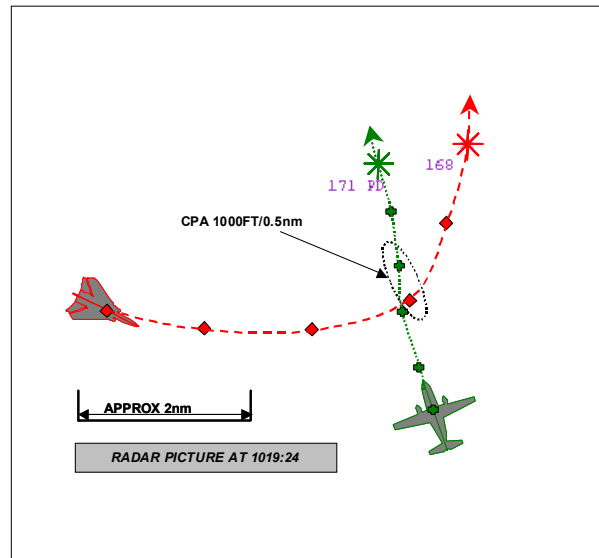
AIRPROX REPORT NO 013/05

Date/Time: 1 Feb 1019
Position: 5548N 00140W (10nm E Berwick)
Airspace: Scottish FIR (Class: G)
Reporting Ac Reported Ac
Type: Jetstream 41 Tornado F3
Operator: CAT HQ STC
Alt/FL: FL165 13000-17000ft
(RPS 1029 mb)
Weather VMC CLAC VMC CLAC
Visibility: >50km >10km
Reported Separation:
TCAS <100ft V/0H 0 V / .7nm H
(after CPA)
Recorded Separation:
1000ft V/ 0.5nm H

THE JETSTREAM 41 PILOT reports flying a scheduled flight from Teesside to Aberdeen squawking as directed with Mode C, in receipt of a RIS from ScOACC [TAY Sector]. While level at FL165 and heading 352° at 280kt, he received a TA showing an ac less than ½nm astern and climbing fast. Five seconds later a RA climb at 2000fpm was given which he followed. 'Clear of conflict' was given as the ac passed FL171 and they levelled off. At that point the other ac, identified as a Tornado, positioned itself alongside them to starboard at 100-200 yards, waggled its wings then rolled off. Scottish Radar was advised of the Jetstream's actions and had not been aware of the other traffic until the Jetstream pilot reported it. He assessed the risk of collision as being high.

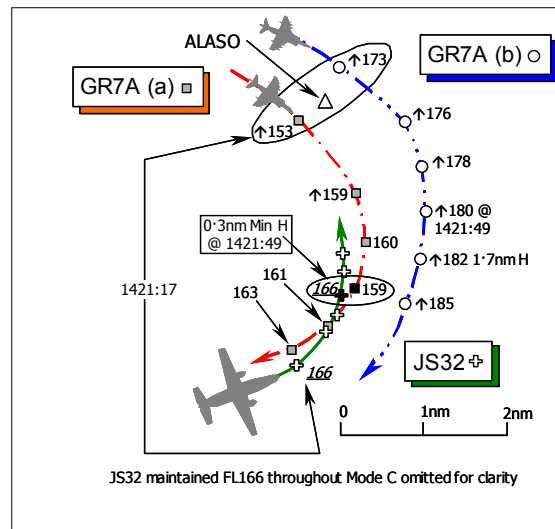
v GR7 (a) 700ft V @ 0.3nm min H

v GR7 (b) 1.7nm min H

THE JETSTREAM 32 (JS32) PILOT reports that he was bound for Aberdeen in VMC on an IFR FPL, having been offered and accepted a RIS by ScACC on a routeing between the NEW VOR and the ATF Aberdeen NDB. The allocated squawk was selected with Mode C, TCAS is not fitted.

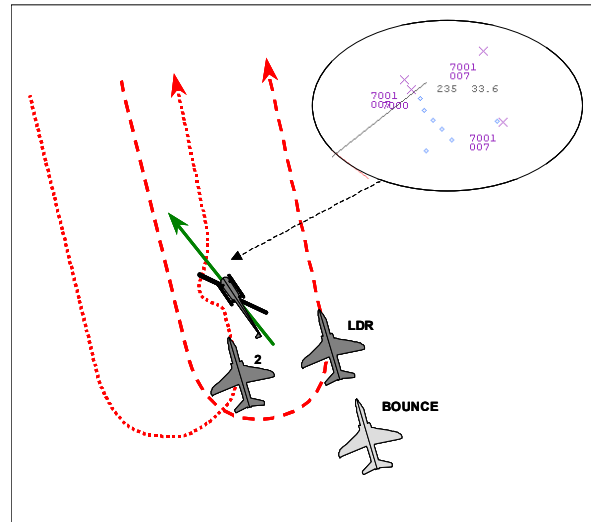
AIRPROX REPORT NO 015/05

Date/Time: 9 Feb 1512
Position: 5204N 00232W (5nm E Hereford)
Airspace: UKDLFS (Class: G)
Reporting Ac Reported Ac
Type: Hawk Robinson R22
Operator: HQ PTC Civ Trg
Alt/FL: 500ft agl 1000ft
 (QNH)
Weather VMC CLBC VMC CAVOK
Visibility: >10km >20km
Reported Separation:
 50ft V/400ft H 0 V/ <500ft H
Recorded Separation:
 NR V ~800ft H (See UKAB Note (1)).

THE HAWK PILOT reports flying a black Hawk with HISL selected on squawking 7001 with Mode C and on a Valley tactical frequency. He was instructing a student on a flying training sortie teaching evasion and was the LH man and No2 of a battle pair formation being attacked by a third Hawk. They had rolled out of a low-level battle turn onto 350° (out of sun) at 420kt when 3sec later they passed a blue and white helicopter, slightly below (50ft) and 400ft to their right. At the time the third ac was setting up behind the battle pair for a stern attack. The student in his front cockpit saw the helicopter a fraction before the instructor and he jinked to the left to increase the separation. The helicopter was heading away from them, so it was unlikely that the pilot would see them until after they had passed. He does not feel he was distracted by the teaching element of the sortie and both the instructor and student saw the helicopter after rolling out of the turn but their relative speed meant their closure rate led to a narrow lateral separation. He assessed the risk of collision as being medium.

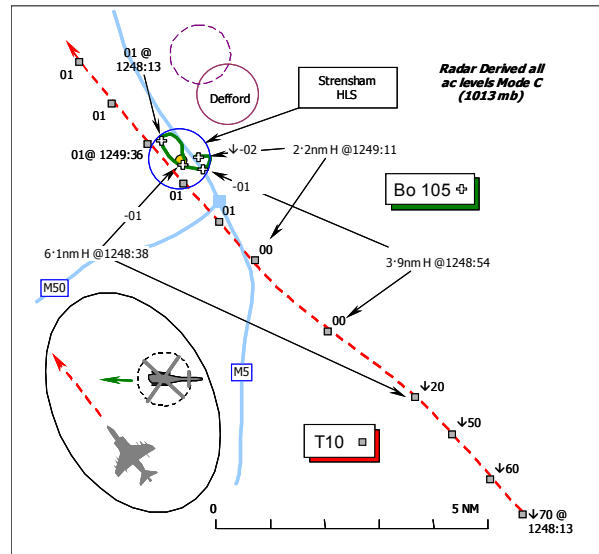
AIRPROX REPORT NO 016/05

Date/Time: 9 Feb 1249
Position: 5204N 00209W (Strensham HLS elev - 80ft)
Airspace: FIR/UKDLFS (Class: G)
Reporting Ac Reported Ac
Type: Bo105 Harrier T10
Operator: Civ Comm HQ STC
Alt/FL: 300ft 250ft
 (QNH 1026mb) (Rad Alt)
Weather VMC CLBC VMC CLBC
Visibility: 20km >10km
Reported Separation:
 50ft V/250m H Not seen
Recorded Separation:
 Not recorded

the T10 approaching from abaft the Bo105's port beam, unseen until it passed, and neither of the T10's pilots sighting the other ac, the Board determined that this Airprox had occurred as a result of a non-sighting by the Harrier T10 crew and effectively, a non-sighting by the Bolkow Bo105 pilot. Despite its red colour, the helicopter had not been seen and the Board noted the comments from STC regarding the use of odd coloured helicopter main rotor blades as an aid to visual conspicuity. The helicopter pilot Member was unsure if this had been tried in commercial practice so the Chairman undertook to research this topic with the BHAB outwith the Meeting.

In their assessment of risk the Board noted that the Bo105 pilot had reported that the jet underflew his helicopter by 50ft when he was descending through an altitude of 300ft. The radar recording did not replicate this geometry and suggested that the jet was indicating broadly 490ft amsl and some 300ft above the helicopter when the latter was last shown descending through about 190ft amsl. At these low altitudes with the indicated unverified Mode C of questionable accuracy, the Board agreed that any firm reliance on this data was unwise. The STC Member stressed that it would have been most unlikely that the T10 crew would have descended significantly below 250ft Rad Alt, which was the lowest they were permitted to fly, and invariably the Rad Alt 'bug' was set to warn pilots beforehand. With only one pilot's version of events and questionable radar data, the Board was briefed that attempts had been made to clarify the relative geometry with the Bo105 pilot. However, these were frustrated because the pilot was no longer contactable through the company and had moved abroad. Members agreed that it was unlikely that the Bo105 pilot had mistaken the relative vertical position of the jet when he spotted it flying away from him so on that basis Members accepted the Bo105 pilot's estimate of the separation that pertained but were unable to resolve beyond doubt the relative geometry, which was somewhat unsatisfactory. Despite this anomaly, as the T10 pilots had not seen the helicopter at all and the Bo105 pilot had not spotted the jet before it passed, in the Board's view the safety of the ac involved had been compromised.

Cause: A non-sighting by the Harrier T10 crew and effectively, a non-sighting by the Bolkow Bo105 pilot.

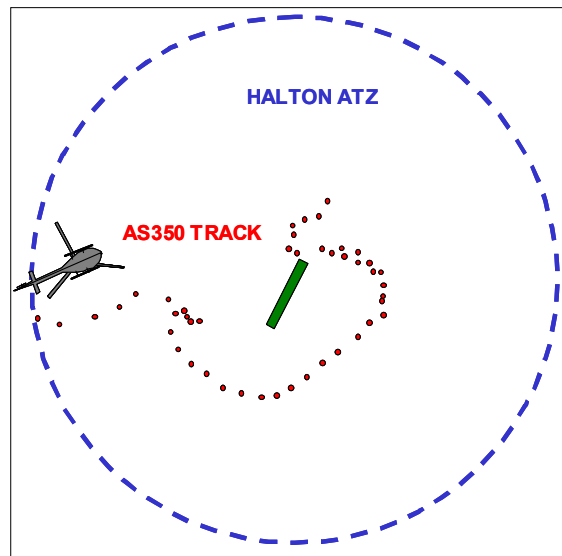
AIRPROX REPORT NO 018/05

Date/Time: 13 Feb 1702 (Sunday)
Position: 5147N 00044W (RAF Halton - elev 370ft)
Airspace: Halton ATZ (Class: G)
Reporting Ac Reported Ac
Type: Ask 21 Glider AS350 Helicopter
Operator: Civ Club Civ Pte
Alt/FL: 600ft NR
(QFE 999 mb)
Weather VMC CAVOK NR
Visibility: >20km NR
Reported Separation:
500m H NR
Recorded Separation:
Not Recorded

Cause: The AS350 entered the Halton ATZ without complying with the requirements of Rule 39 of the Rules of the Air and flew into conflict with the ASK21 glider.

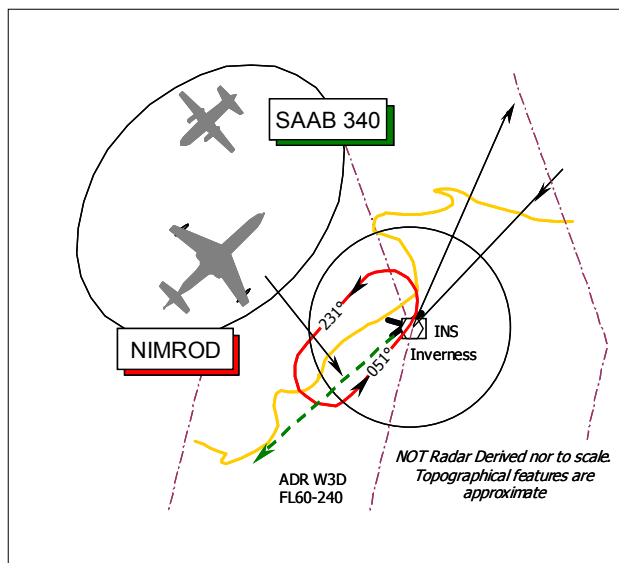
DPA comments that it would appear that the Inverness Approach Controller was using the VMC Climb and Descent procedure (MATS Part 1, Section 1, Chapter 3, Paragraph 5.5). From the information available it would also appear that all the conditions were met to enable the controller to do so. The crew of the Saab 340 do not seem to have appreciated the significance of accepting this VMC Climb procedure and that, even though conducting the flight under an IFR clearance, the responsibility for separation rested with the Saab 340 crew and not the Inverness ADC/APP Controller.

Cause: Following a TCAS RA, the combination of his visual separation from the Nimrod and high ground had caused the Saab 340 pilot concern.

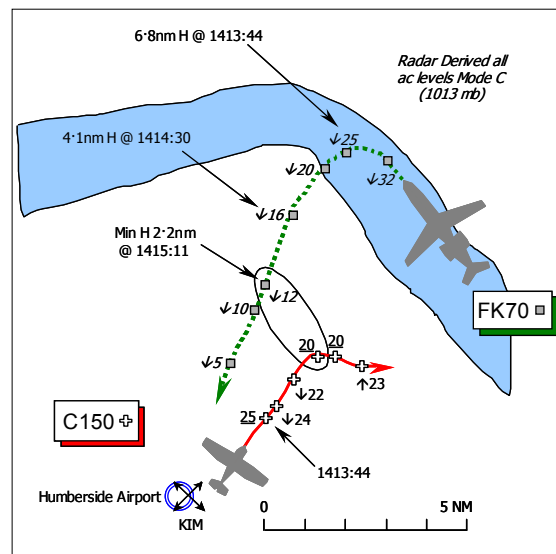
[UKAB Note (2): The Claxby radar recording shows the FK70 inbound to Humberside and turning onto the LLZ at 1413:44, descending through 2500ft Mode C (1013mb) which equates to about 3130ft Humberside QNH (1034mb). Simultaneously, the C150 is shown 6-8nm away at the same level. A review of the RT transcript (the Humberside RTF transcript gives only 30sec and 1min time injects) reveals that the C150 crew reported visual with the airliner just before 1414:30 whereupon a continuous descent becomes evident. As the FK70 descends on the ILS approach the ac converge. The APR first noted the C150's excursion below the assigned level after 1414:30, when the APR queried "[C150 C/S]..can you confirm you are maintaining altitude 3000", to which the C150 crew responded "*maintaining 3000ft*". Whereupon the APR then issued a R turn transmitting "[C150 C/S] *make a right turn heading 090° immediately acknowledge*", which the C150 crew read-back, just before the APR confirmed that the C150 crew was still visual with the FK70. The avoiding action turn becomes evident as the C150 eventually 'bottoms out' at an indicated 2000ft Mode C, which equates to about 2630ft QNH at 1415:11, when the minimum horizontal separation of 2.2nm occurs. Nonetheless, by this time the FK70 has descended and is shown 800ft below the C150, before the latter is shown in a climb back to their assigned altitude. The APR advised the FK70 crew of the C150's descent within traffic information transmitted at 1415:00, whereupon the crew confirmed that they "*have him in sight no problem*".]

The radar recording showed that the C150 student pilot had indeed descended some 370ft below the assigned altitude at the closest point and this was the fundamental reason for the erosion of standard separation. The C150 instructor pilot had reported that he had noted the descent below 3000ft QNH and had told his student to climb back to this altitude before the APR had instructed them to turn R onto 090°. Although the C150 instructor pilot had the FK70 in sight throughout, his student had taken some time to regain their assigned altitude and even 30 sec after the turn instruction was issued Members noted there was no evidence of a climb back to 3000ft. Vertical separation was based on strict compliance with controller's instructions and Members were concerned that the C150's assigned altitude of 3000ft QNH (1034mb) had not been regained as expeditiously as might have been warranted. Clearly there is a happy mean in allowing students to identify/rectify their own mistakes so that they can learn from them. Notwithstanding any learning point that might have arisen and which the instructor might

Cause: A sighting report.

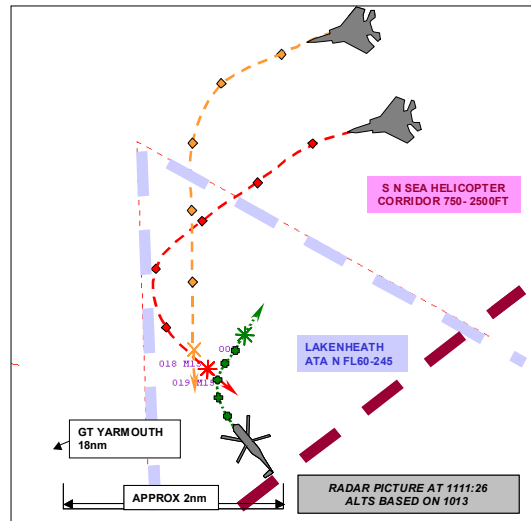
<u>Reporting Ac</u>	<u>Reported Ac</u>
Type:	SK76	F15 C (x2)
Operator:	Civ Comm	Foreign Mil
Alt/FL:	1000ft (RPS 1013 mb)	2000ft (N/K)
Weather	VMC CLOC	VMC
Visibility:	8-10km	Unlimited
Reported Separation:	<1nm H	1000ftV/1.5nm H
Recorded Separation:	1000ft V/ 0.5nm H

Cause: The appearance of the F15s in the S N Sea Helicopter Corridor caused concern to the S76 crew.

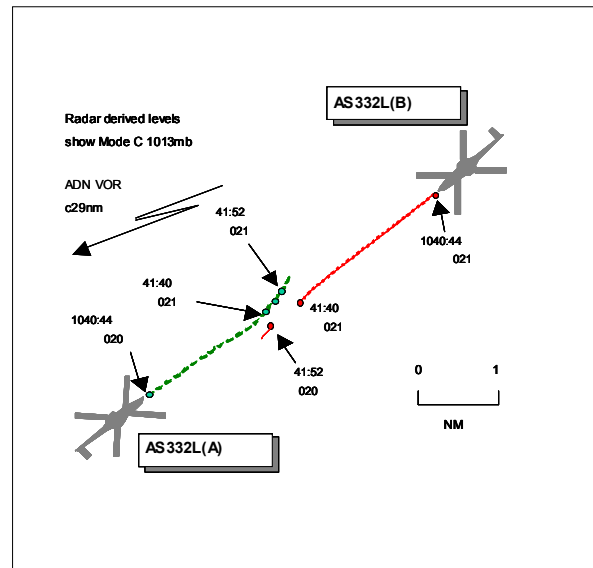
Recorded Separation:
0V/0.2nm H

ATC specialist Members stated that the practise of using 'opposite direction levels' (ODL) is discouraged in all types of airspace throughout the UK as it is never a failsafe procedure and, as in this case, is especially vulnerable if the controller becomes distracted and does not adequately monitor the situation. Best practise is always to build in lateral or vertical separation from the outset thereby ensuring no conflict arises in the first instance. In this Airprox the icing conditions had caused the controller to allocate an ODL initially. Had he carried out his plan to issue AS332L (B) with an early descent to 1000ft, normal separation standards would then have been applied. Regrettably, self-induced pressure and distraction had combined to degrade his attentiveness to an extent that he missed this vital action. The Board was advised that some of the distractions were perceived and avoidable. In the light of the controller's comments, Members considered the supervision aspects and level of support provided to the controller but on the basis of advice from ATSI and the NATS Advisor concluded that these had not been factors. At the time of the incident the Watch Manager was correctly located in his office and was on a pager. Other staff could have reset the Weather TV system. It would seem however, that the controller had allowed the busy military situation to assume an unnecessarily high significance and this had caused him to temporarily overlook his plan to separate the subject ac which were on conflicting flight paths.

Under the terms of the Modified RAS he was providing, the Aberdeen SC was required to ensure that the stipulated separation minima were maintained between these two helicopters. Notwithstanding the workload and distractions, that he did not do this allowed the ac to fly into conflict. Consequently the Board agreed that the cause of the Airprox was that the Aberdeen Hells SC did not ensure separation between the subject ac. Members agreed that the very prompt action taken by the pilot of AS332L (A) had done just enough to avert a collision. This together with the assessment by the pilot of AS332L (B) that as the other helicopter pilot had already effected an avoiding action steep turn and that they would miss each other clearly showed that the safety of these two ac had been compromised in this situation.

Cause: The Aberdeen Hells SC did not ensure separation between the subject ac.

It is understood that the Unit Management at Aberdeen are to review the procedures, whereby in icing conditions departing helicopters are cleared outbound at the same altitude as the inbound. As a result of the investigation into this Airprox, it is considered that this matter should be treated with some urgency. The present system is not 'fail-safe' in that it relies on the controller monitoring the situation to the extent that he would be able to intervene in a timely manner to ensure separation is maintained. Clearly, as on this occasion, the controller concerned could be distracted from this task and with the lack of any other safety back-up, apart from see and be seen by the helicopter crews involved, serious consequences could follow. Whereas it is realised that during icing conditions the altitudes available are severely restricted, the use of 1500ft offshore should be explored, not necessarily to provide only 500ft separation, but as an initial clearance whilst the progress of the relevant flights are monitored. Should, subsequently, the controller be distracted from his task, it would at least ensure a minimum vertical separation of 500ft.

023/05-1 The CAA should require NATS to devise and implement a standard procedure for use in the North Sea Area, under conditions agreed with the helicopter operators, such that in circumstances when helicopters would otherwise be obliged to fly at the same altitude on conflicting tracks, an acceptable form of separation is assured from the outset.

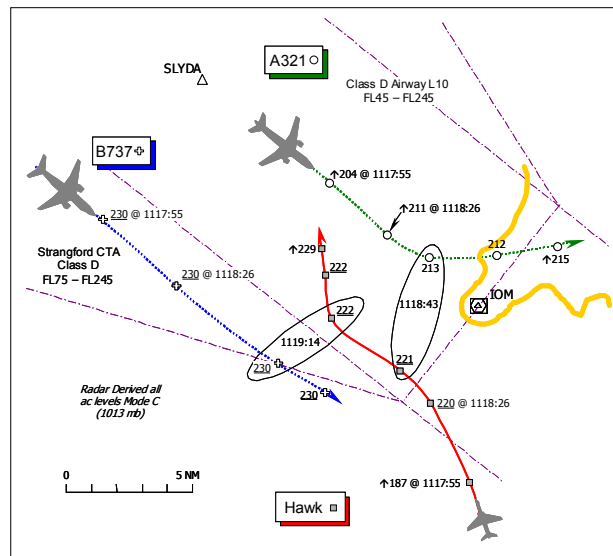
v A321: 800ft V/4.6nm H. v B737: 800ft V/2.8nmH

THE ScACC ANTRIM SECTOR CONTROLLER (ANTRIM SC) reports that the LJAO NW Controller (LJAO NW) phoned to co-ordinate the Hawk against the A321 and the B737. LJAO NW was given a crossing clearance of Airway L10 with the Hawk at FL180 and then to take 1000ft Mode C separation below the A321, which was still in the climb. Moments later the Hawk was observed in the vicinity of ISLE OF MAN (IOM), within L10, climbing through the level of the A321. The A321 crew was passed traffic information and a L turn before a further L turn was given as avoiding action. The Hawk was now pointing at the B737 and appeared level at FL220: as the Hawk's intentions were still unknown the B737 crew was given traffic information. When the Hawk cleared behind the A321 the crew was instructed to resume their own navigation to WAL. The A321 pilot reported he had reacted to a TCAS RA against the Hawk and was subsequently handed over to LACC. STCA was activated but he thought that prescribed separation was not lost and reported that the minimum horizontal was 5nm and the minimum vertical 800ft.

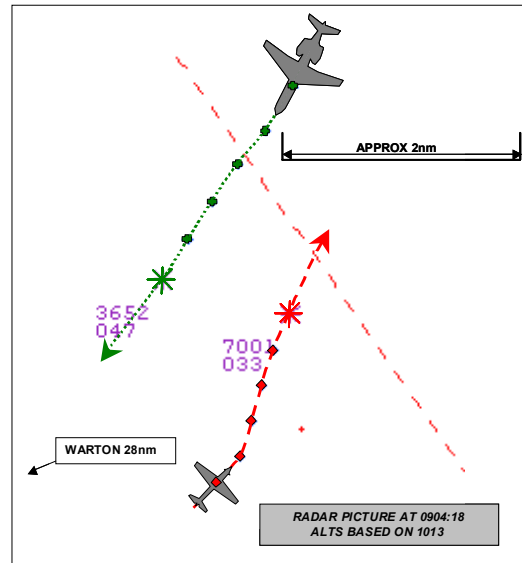
AIRPROX REPORT NO 027/05

Date/Time: 4 Mar 0904
Position: 5401N 00217W
 (27nm NE Warton)
Airspace: London FIR (Class: G)
Reporting Ac **Reported Ac**
Type: FA20 Tucano
Operator: Civ Comm HQ PTC
Alt/FL: 4000ft NR
 (QNH 1010 mb) NR
Weather IMC in Cloud VMC CLBC
Visibility: Nil
Reported Separation:
 1000ft V/<1nm H Not seen
Recorded Separation:
 1400ft V/0.9nm H

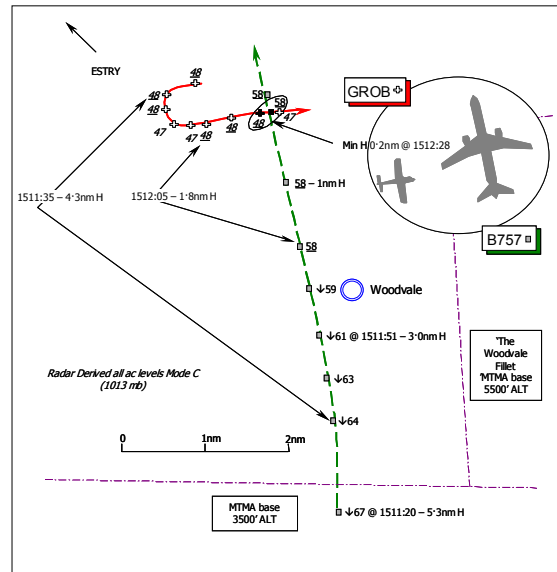
AIRPROX REPORT NO 028/05

Date/Time: 10 Mar 1512
Position: 5337N 00304W (2½nm NNW of Woodvale - elev 37ft)
Airspace: London FIR (Class: G)
Reporting Ac Reported Ac
Type: B757 Grob Tutor
Operator: CAT HQ PTC
Alt/FL: ↓4000ft FL48
(QNH 1028mb)
Weather VMC CLBL VMC CLAC
Visibility: NR Unlimited
Reported Separation:
1000ft V/nil H ~1000ft V/½nm H
Recorded Separation:
1000ft V/0.2nm H

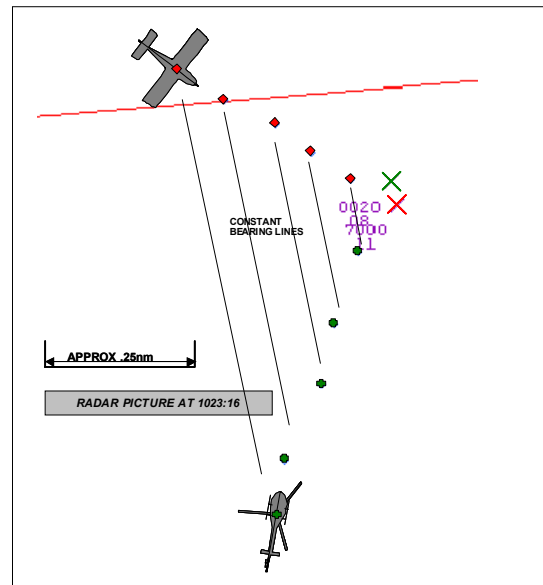
AIRPROX REPORT NO 030/05

Date/Time: 15 Mar 1023
Position: 5135N 00025E(1nm N Basildon Hospital - elev 70ft)
Airspace: London FIR (Class: G)
Reporting Ac Reported Ac
Type: EC135 T Aero AT-3 R100
Operator: Civ Comm Civ Pte
Alt/FL: 1100ft 1200ft
 (QNH 1017mb) (QNH 1018mb?)
Weather VMC CLBC VMC CLBC
Visibility: 5km >5km
Reported Separation:
 0-H/ <100ft V >100mH/150ft V
Recorded Separation:
 ~200ft V (See UKAB Note (1))

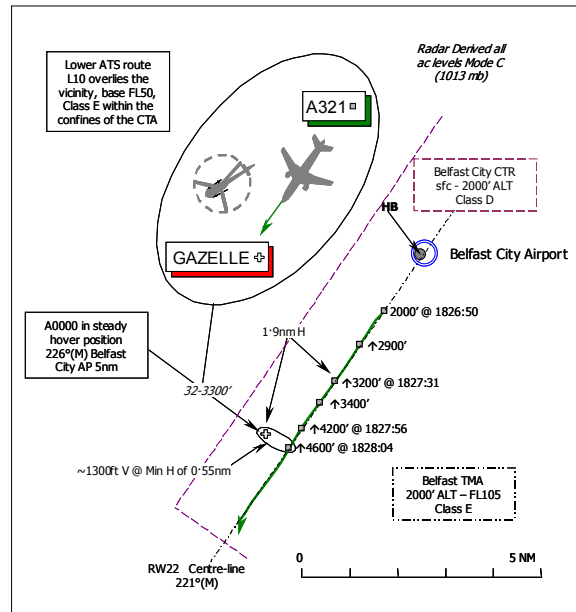
AIRPROX REPORT NO 031/05

Date/Time: 16 Mar 1828
Position: 5423N 00558W (5nm SW Belfast City Airport - elev 15ft)
Airspace: Belfast TMA (Class: E)
Reporting Ac **Reported Ac**
Type: A321 Gazelle AH1
Operator: CAT HQ JHC
Alt/FL: 3000ft↑ 2-3000ft
 QNH (1004mb) QNH (1004mb)
Weather NR VMC NR
Visibility: NR 10km+
Reported Separation:
 600ft V / 1/2nm H NR
Recorded Separation:
 ~nil V @ 1.9nm H
 0.55nm H @ ~1300ft V

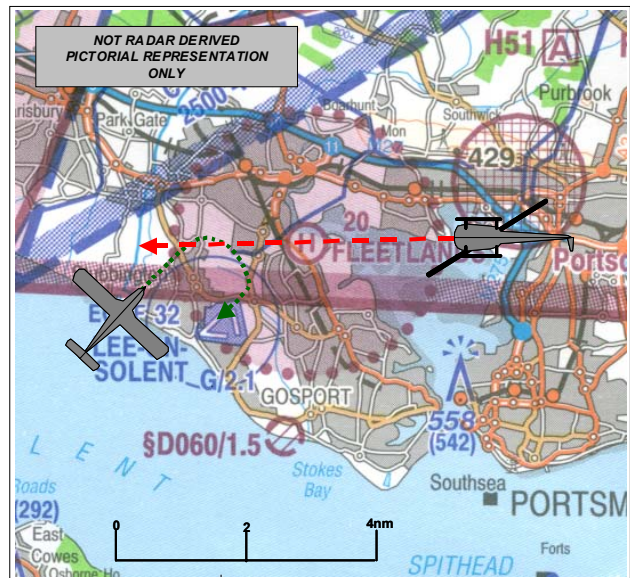
AIRPROX REPORT NO 032/05

Date/Time: 18 Mar 1310
Position: 5049N 00112W (Circuit Lee-on-Solent)
Airspace: Fleetlands ATZ (Class: G)
Reporting Ac Reported Ac
Type: PA28 Robinson R44
Operator: Civ Pte Civ Pte
Alt/FL: 700ft 1000ft
(QFE) (N/K)
Weather VMC CLBC VMC CLBC
Visibility: 10km >10km
Reported Separation:
0ft V/200-300ft H Not seen
Recorded Separation:
Not recorded

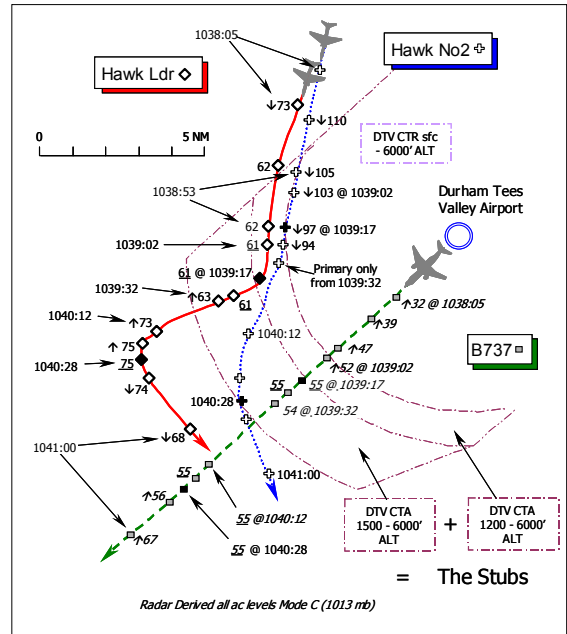
AIRPROX REPORT NO 034/05

Date/Time: 14 Mar 1039
Position: 5428N 00136W (5nm SW Teesside - elev 120ft)
Airspace: CTA/FIR (Class: D/G)
Reporter: Durham Tees Valley APR
First Ac Second Ac
Type: B737-200 Hawk x2
Operator: CAT HQ STC
Alt/FL: ↑FL130 7000ft
Weather IMC in cloud VMC CLOC
Visibility: NR 30km
Reported Separation:
 APR: 500ft V/3nm H 500ft V/3nm H Not seen
Recorded Separation:
 v Hawk Ldr: 600ft V 3·3nm H. v Hawk No 2: 3·17nm H.

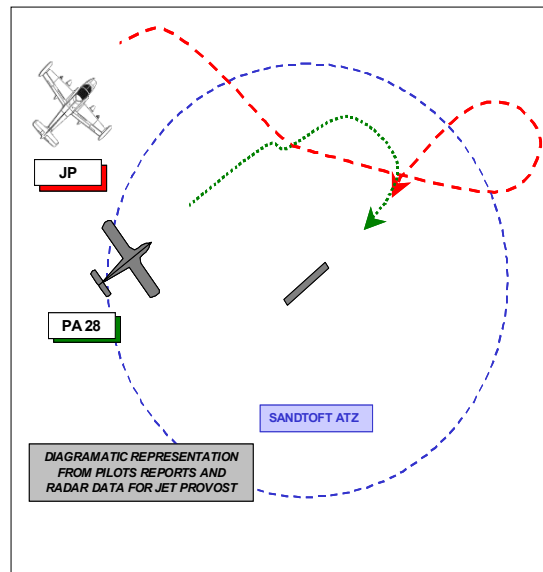
AIRPROX REPORT NO 035/05

Date/Time: 19 Mar 1122 (Saturday)
Position: 5336N 00052W (Overhead Sandtoft Airfield - elev 11ft)
Airspace: Sandtoft ATZ (Class: G)
Reporting Ac Reported Ac
Type: PA28 Jet Provost
Operator: Civ Trg Civ Pte
Alt/FL: 1000ft 1200ft
(QFE 1025 mb) (QFE)
Weather VMC CLBC VMC CLBC
Visibility: 5-7km 3nm
Reported Separation:
0 VI<50 yd H 0V /75-100ft H
Recorded Separation:
Not recorded.

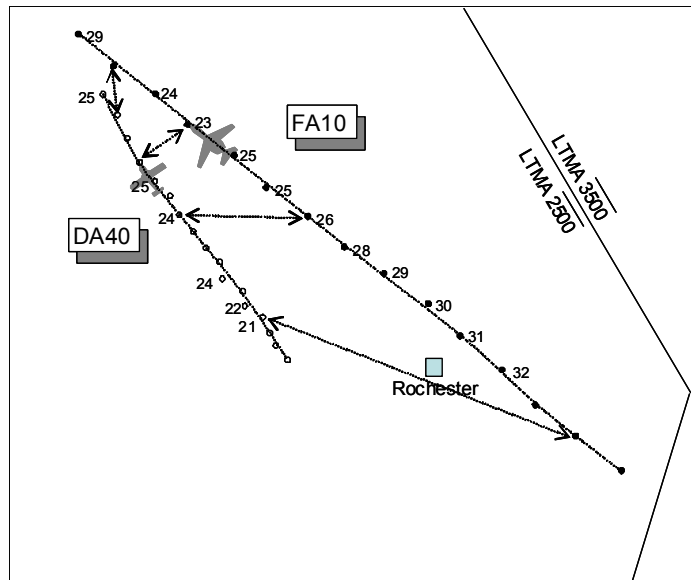
<u>First Ac</u>	<u>Second Ac</u>
<i>Type:</i> FA10	DA40D
<i>Operator:</i> Civ Comm	Civ Pte
<i>Alt/FL:</i> 2700ft (QNH 1027mb)	2300ft (QNH)
<i>Weather:</i> VMC CAVOK	VMC CLOC
<i>Visibility:</i> >10km	>10km
<i>Reported Separation:</i>	
5nm/700ft	500-600m
<i>Recorded Separation:</i>	
0.4nm/100ft

THE LTCC THAMES RADAR CONTROLLER reports that traffic loading was light to moderate. The FA10 was being vectored for an ILS approach to RW 28 at London City. Approaching DET, the ac was given descent to 3000ft QNH. Other tasks diverted his attention from the FA10's descent until he noticed a red STCA indication, a possible 'level bust'. His first reaction to the STCA (due to label garbling) was that it was a spurious activation due to traffic in the FIR setting the system off against a descent to 3000ft above. Other tasks continued to distract from close inspection of the garbled labels; however a further glance at the Mode C seemed to show the FA10 had descended below its cleared altitude. Rather than query the FA10's level, because of the proximity of the two ac he issued an immediate climb. This was amended to avoiding action during transmission as the Mode C data briefly became readable. The pilot was given traffic information and reported the other traffic in sight. A subsequent telephone conversation with the pilot highlighted confusion on the flight deck over the cleared altitude. The ac was not TCAS equipped.

STCA activated at 'low severity' as the FA10 was passing through 4000ft, at 1537:07. The controller then instructed the pilot to report established on the ILS at which time the FA10 was passing 3400ft and the other ac was indicating 2200ft.

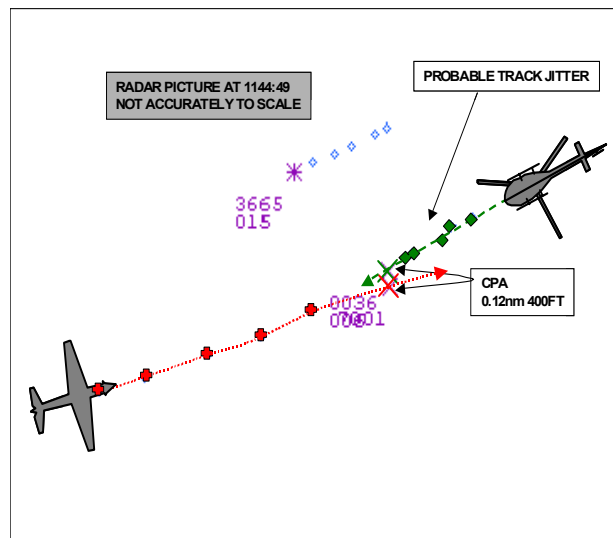
AIRPROX REPORT NO 038/05

Date/Time: 23 Mar 1145
Position 5236N 00005E (5nm SW Wisbech)
Airspace: London FIR/UKDLFS (Class: G)
Reporting Ac Reported Ac
Type: Schweizer 333 Tucano
Operator: Civ Comm HQ PTC
Alt/FL: 400ft 250ft
(QNH 1012 mb) (RPS 1008 mb)
Weather VMC CLBC) VMC HAZE
Visibility: 14nm 10km
Reported Separation:
150-200ft V/100-150ft H 100ft V/200ft H
Recorded Separation:
400ft V/0.12nm (220m) H
(Due to track jitter the horizontal distance may not be accurate)

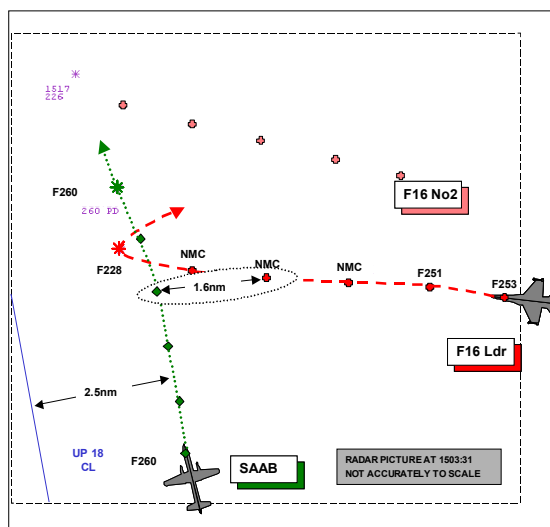
Analysis of the Gt Dun Fell radar shows the Saab 2000 ac 15 nm S of MADAD tracking 350°, indicating FL260. The F16 was NE of the Saab by 12.5 nm squawking Mode A 1520 with and indicating FL243. The F16 was one of a 2 ship manoeuvring to roll out on a W heading and was indicating a climb. At 1502:44 the F16 was in the Saab's 2 o'clock, 6.75 nm indicating FL250. The F16 continued to climb peaking at FL253 for one sweep and then a descent is observed, at 1503:00, indicating FL251. The F16's Mode C indication disappears at 1503:06 when the lateral separation between the ac was 3nm. The next sweep shows the lateral separation of 1.6 nm, reducing to 0.9nm as the F16 passes behind the Saab 2000 which at this stage is seen to initiate a left turn. The Mode C indication returns to the F16 at 1503:29, for one sweep, showing FL228 when it is in the Saab 2000's 7 o'clock 0.9nm. The F16 is seen initiating a hard right turn to pass behind the Saab 2000 by 1.1nm with no Mode C indication and the separation increases from this point onwards.

Cause: The ScACC Controller was concerned by the flight profile of the F16 which was in conflict with the Saab 2000.

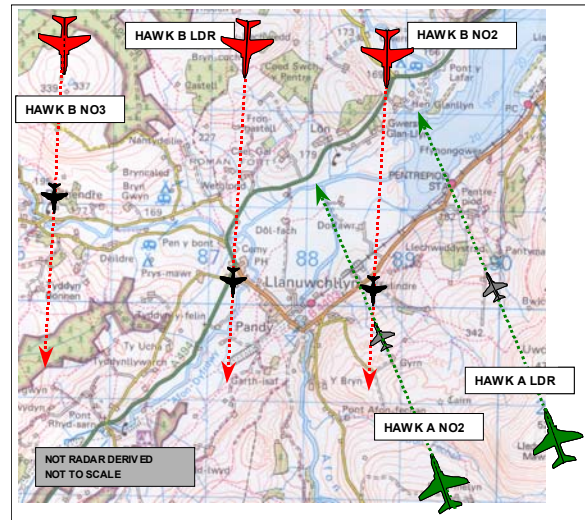
Cause: Effective non-sighting by the crews of Hawk A formation and a non-sighting by the crews of Hawk B formation.

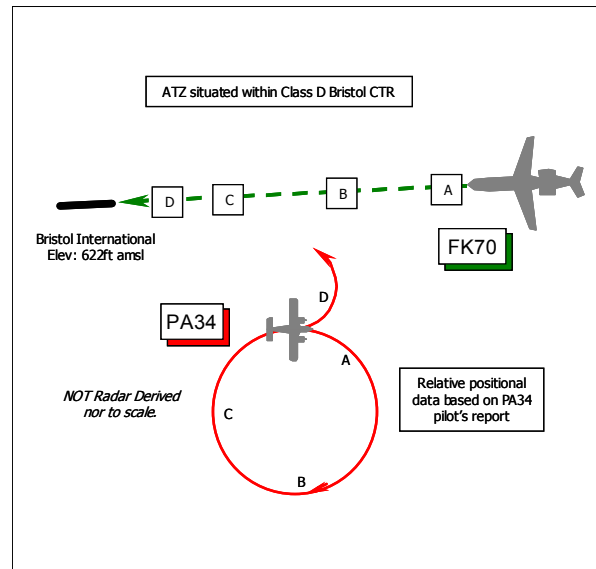
Cause: Bristol ATC did not separate the two IFR flights.

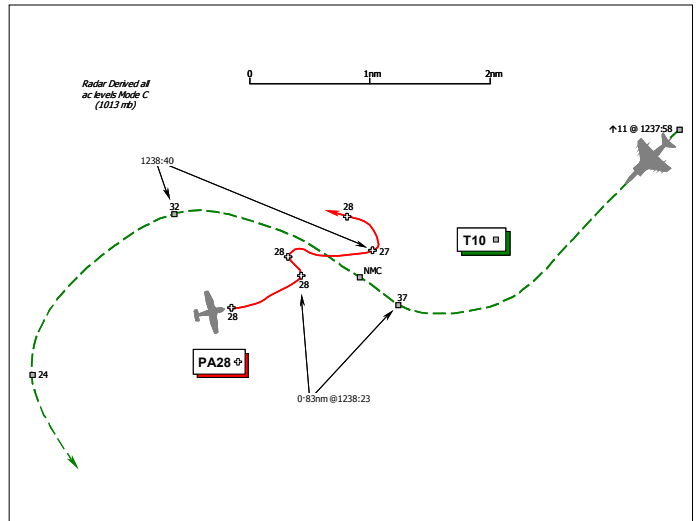
Cause: Effectively, a non-sighting by the Harrier T10 crew and the PA28 instructor.

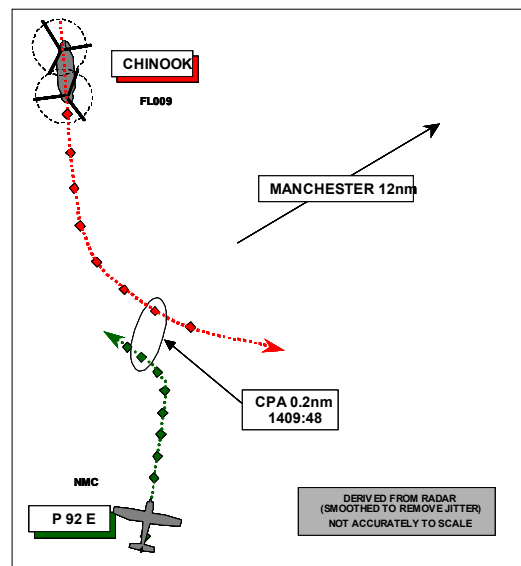
Cause: The Chinook turned into conflict with the P92E which the pilots did not see.

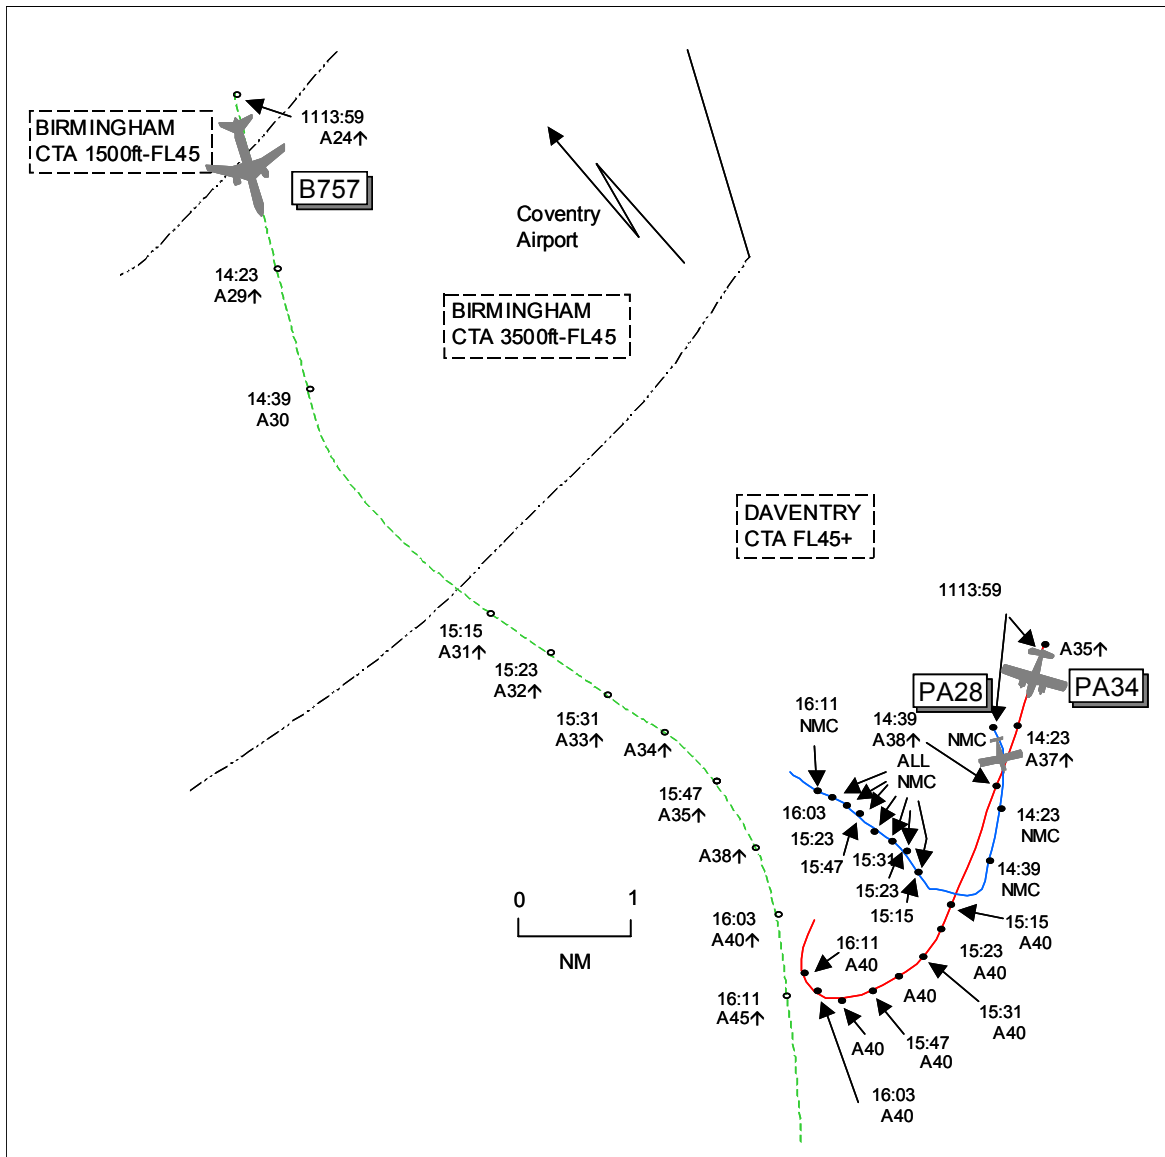
AIRPROX REPORT No 044/05

Cause: The Birmingham Radar 2 vectored the B757 into conflict with the PA34.

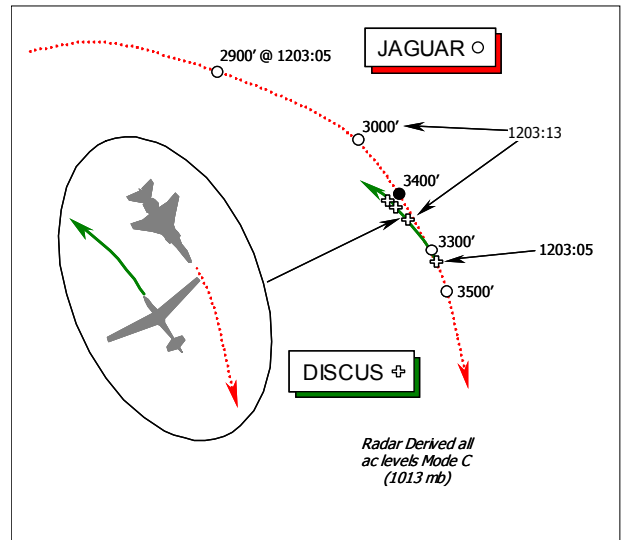
Cause: Effectively a non-sighting by the Jaguar crew and a late sighting by the Discus glider pilot.

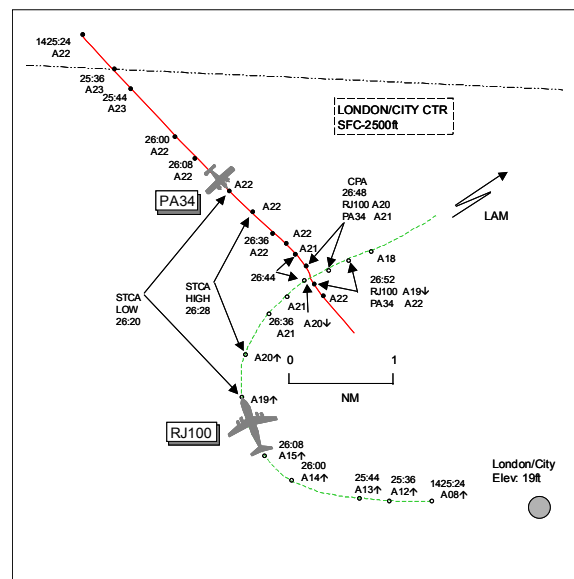
At this point the radar recording shows the PA34, wearing code 7050, tracking SE with 3nm to run to the CTR boundary and indicating at 2100ft Mode C. It was not, however, until over 1min later, at 1425:26, when the ac was about to cross the CTR boundary, that the Thames radar controller 'phoned the City ADC to warn him of the presence of this flight stating *"The 7050 is VFR and is going to come through the zone at 2000 feet"*. The ADC acknowledged this and asked if Thames would be *"...going to put him over or keep him"* to which the Thames controller responded that he would retain him and *"...pass the traffic"*. In his written report the Thames mentor states that he was surprised that the trainee had elected to 'keep' the PA34 on his frequency. He reports pointing out to him that it was preferable for VFR transits to be transferred to the Tower so that both ac would be on the same frequency. It would appear that the trainee was adopting the custom he used at the other TC APR Unit position. Nevertheless, it was now certainly too late to re-co-ordinate and transfer the flight. This unexpected decision by the trainee highlights the need for mentors to first establish the level of 'sector' knowledge and familiarity acquired before allowing a trainee to operate 'live'. This issue was identified in the LTCC Unit report and an internal recommendation made to draw attention to this need. By this time (1425:36), the recording shows the PA34 is entering the CTR at 2300ft Mode C and the RJ100 can be seen tracking W, climbing through 1200ft Mode C, before commencing a R turn in accordance with the SID.

Cause: Following TI and visual acquisition, the PA34 pilot flew into conflict with the RJ100 in Class D airspace.

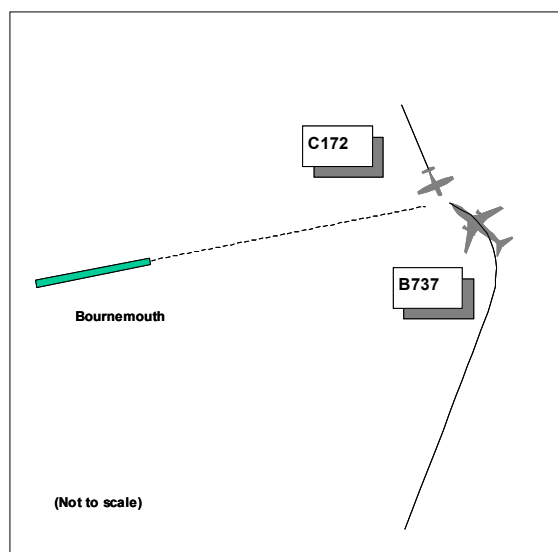
Cause: Contrary to MATS Part 1 advice, Bournemouth APR vectored the B737 into conflict with the C172 operating just below CAS.
