UK AIRPROX BOARD

Analysis of Airprox in UK Airspace

**Report Number 14
January 2005 – June 2005**

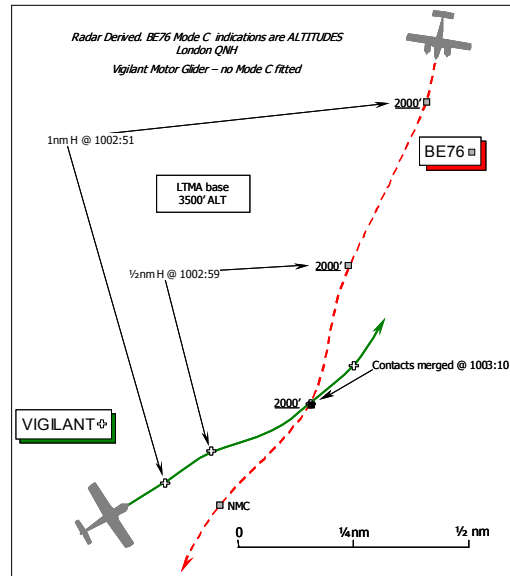
Cause: Effectively, a non-sighting by both pilots.

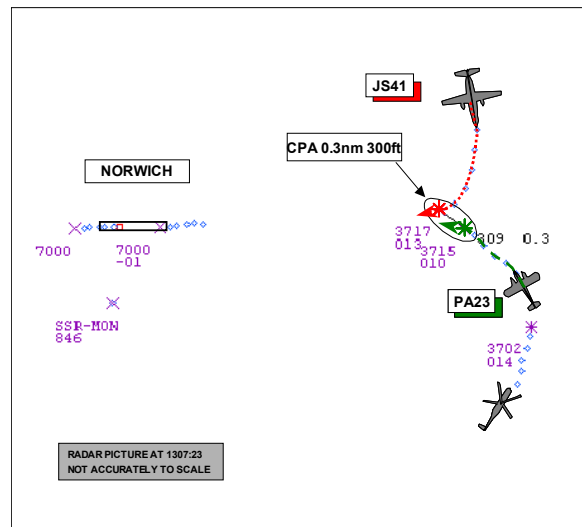
0.3nm (550m) H/300ft V

Cause: Norwich APR and ADC did not provide the separation required under IFR.

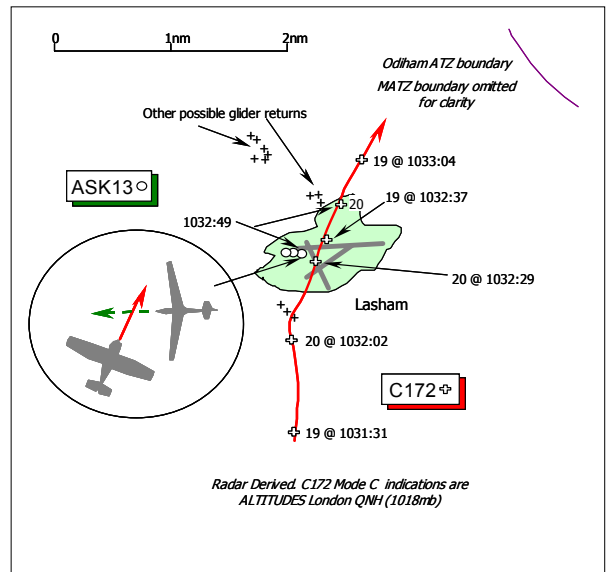
AIRPROX REPORT NO 061/05

Date/Time: 6 May 1032
Position: 5111N 00101W (Overhead Lasham
 - elev 618 ft)
Airspace: Odiham MATZ (Class: G)
Reporting Ac **Reported Ac**
Type: ASK 13 Glider C172
Operator: Civ Trg Foreign Private
Alt/FL: 1500ft 2000ft
 (QFE 996mb) (QNH)
Weather VMC CLBC NK NR
Visibility: >10nm 30nm
Reported Separation:
 20ftV (2000ft)
Recorded Separation:
 Not recorded

Cause: The C172 pilot overflew the Lasham Glider launching site, which was not marked on his chart as such, and flew into conflict with the ASK13 glider.

Recommendation: In the light of this Airprox, the chart production company should review its policy with respect to the depiction on its VFR GPS charts of aerodromes where glider winch launching take place.

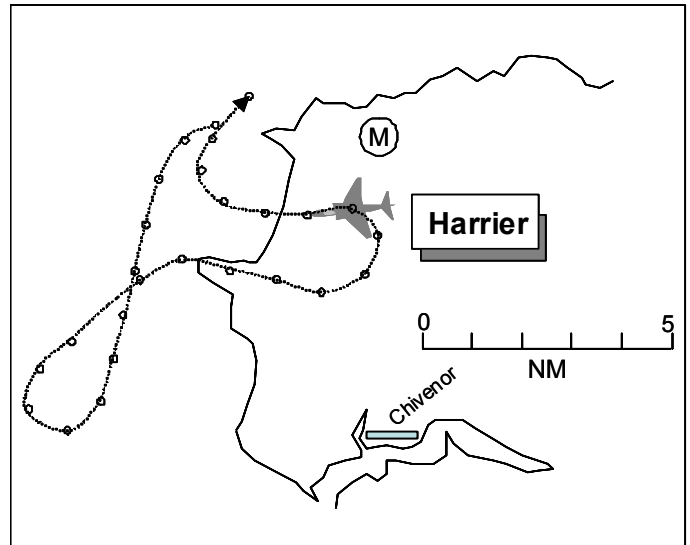
AIRPROX REPORT NO 062/05

Date/Time: 5 May 1416
Position: 5110N 00412W (5nm NNW Chivenor)
Airspace: LFIR/LFS (Class: G)
Reporting Ac Reported Ac
Type: Harrier GR7 Untraced M'Light
Operator: HQ STC N/K
Alt/FL: 1000ft (RPS) (N/K)
Weather VMC CLBC NK
Visibility: 5km
Reported Separation:
150ft V/800yds H
Recorded Separation:
NK

Cause: Conflict in Class G resolved by the Harrier pilot.

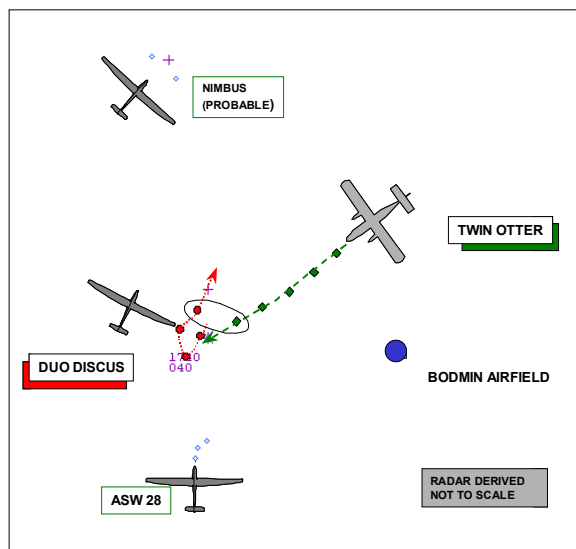
AIRPROX REPORT NO 063/05

Date/Time: 10 May 1238
Position: 5030N 00440W (Bodmin Airfield)
Airspace: London FIR (Class: G)
Reporting Ac Reported Ac
Type: DHC-6 Twin Otter Duo Discus Glider
Operator: CAT Civ Club
Alt/FL: FL40 ~5000ft (QNH)
Weather VMC CLBC VMC CLBC
Visibility: 20km >20km
Reported Separation:
200ft V 200ft H 1000ft V
Recorded Separation:
NR V ~450m H

Cause: Sighting report.

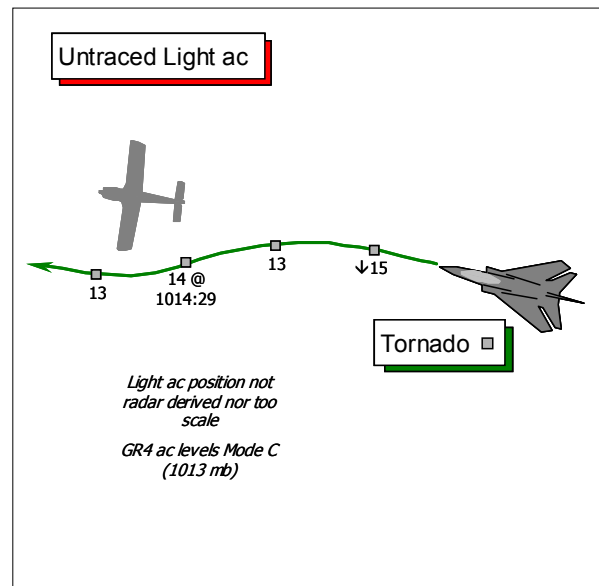
Date/Time: 10 May 1014
Position: 5159N 00202W (7nm NE of Gloucestershire Airport)
Airspace: UKDLFS/FIR (Class: G)
Type: Tornado GR4
Operator: HQ STC
Alt/FL: 1500ft↓ (Rad Alt)
Weather: VMC CLOC
Visibility: 50km
Reported Separation: 50ft V/50ft H
Recorded Separation: Not recorded

Cause: A very late sighting by the Tornado GR4 crew.

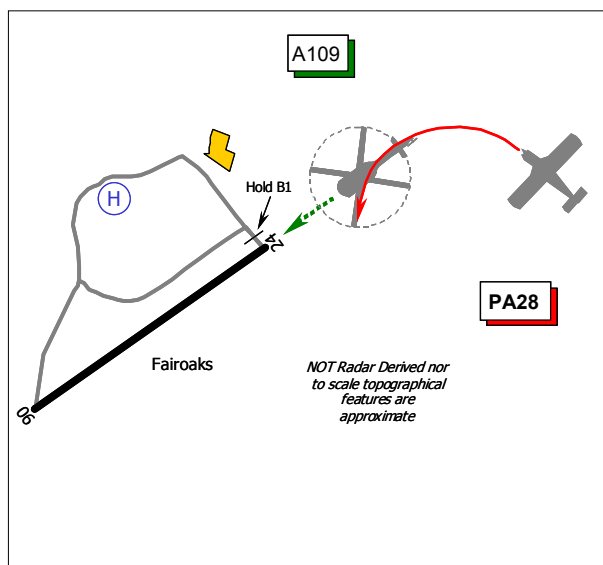
Date/Time: 30 Apr 1414 (Saturday)
Position: 5121N 00032W (1½nm FINALS to Fairoaks RW24 - elev: 80ft)
Airspace: Fairoaks ATZ (Class: A/G)
Type: Agusta A109C
Operator: Civ Pte
Alt/FL: NR
(NR)
Weather: VMC CAVOK
Visibility: >10km
Reported Separation:
NR
Recorded Separation:
Not recorded

Cause: A very late sighting by the PA28 instructor pilot and a non-sighting by the A109 pilot.

UKAB Note (2): ATSI report further that the aerodrome operator accepted their recommendation. Approaches by helicopters should normally be made to the grass to the north of the runway. The following note will be included in the Fair Oaks entry in the UK AIP at AIRAC 11 to be published on 27th October 2005.

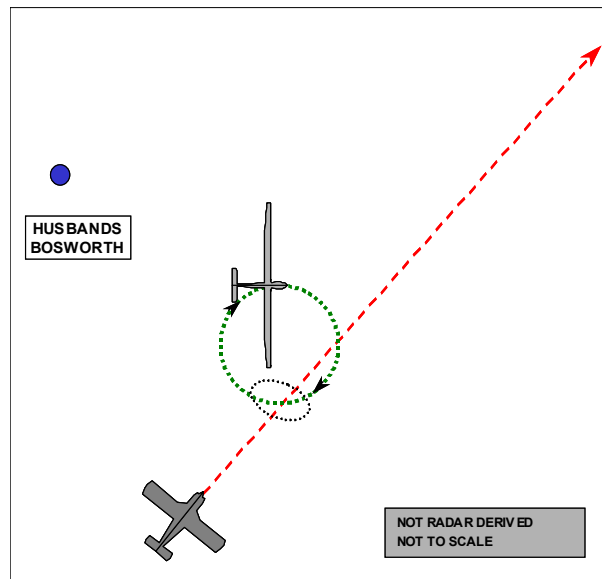
AIRPROX REPORT NO 066/05

Date/Time: 6 May 1315
Position: 5225N 00101W (1.5nm SE
Husbands Bosworth - elev 505ft)
Airspace: London FIR (Class: G)
Reporting Ac Reported Ac
Type: LS8 Glider PA28
Operator: Civ Pte Civ Pte
Alt/FL: 3500ft 4000ft
(QFE 999mb) (RPS)
Weather VMC CLBC VMC IN HAZE
Visibility: >30km 10km
Reported Separation:
50ft V/O H 50ft V/100ft H
Recorded Separation:
NR

Cause: Effective non-sighting by the glider pilot and a very late sighting by the PA28 pilot.

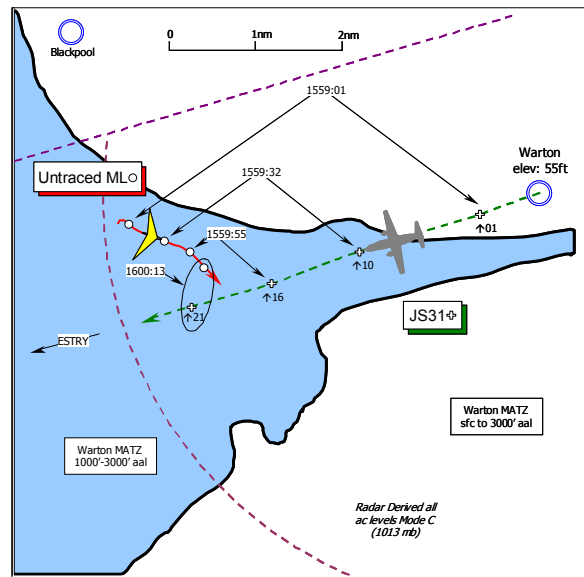
0.4nm @ 1600:13

Cause: Conflict with an untraced microlight in the Warton MATZ.

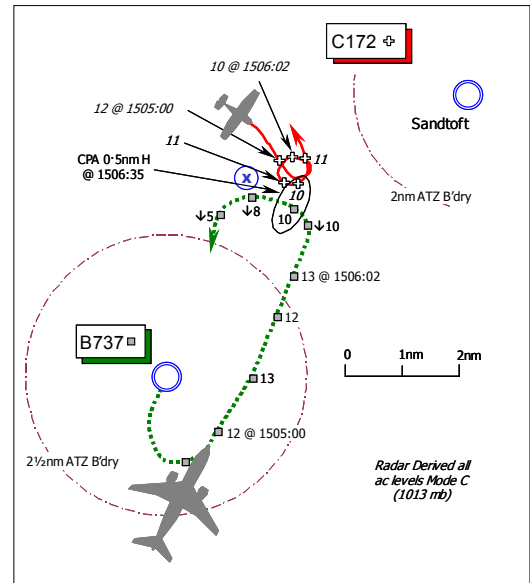
AIRPROX REPORT NO 069/05

Date/Time: 12 May 1506
Position: 5332N 00057W (4nm NE Doncaster
 Sheffield Airport - elev 55ft)
Airspace: FIR (Class: G
Reporting Ac Reported Ac
Type: B737-500 C172
Operator: CAT Civ Pte
Alt/FL: 1100ft 1200ft
 (QNH 1025mb) (QNH 1015mb)
Weather VMC CLOC VMC CLOC
Visibility: NR >10km
Reported Separation:
 3nm nil V/~1-1½nm H
Recorded Separation:
 Nil V/0.5nm H

Cause: Conflict in Class G airspace.

The ATSI Advisor added that a Letter of Agreement had now been drafted (and is in the process of being ratified) for use between the two units whereby DSA TOWER will inform Sandtoft of inbound traffic enabling the A/G operator to broadcast a warning on the Sandtoft frequency. It was not clear if this would cover such a situation as arose here with continuously circuiting traffic. The C172 pilot reported that he was in communication with Sandtoft RADIO whilst flying outside their ATZ which caused some Members to wonder whether this was the best option. Whilst recognising that the chosen option was perfectly reasonable and in no way questioning the autonomy of the service available from Sandtoft A/G Station, Members discussed whether communication with DSA TOWER would have been preferable whilst operating in the vicinity of this Airport especially when flying through or under the approach to RW20. In the opinion of some Members it would have been preferable whilst passing to have given DSA TOWER a call who might then have been able to provide an ATC service in the vicinity of the aerodrome and pass traffic information about any traffic that was circuiting outside the ATZ. Similarly this would have alerted DSA TOWER to the presence of any light ac that might be difficult to spot from the Tower, enabling the ADC then to pass on traffic information to other ac under their control.

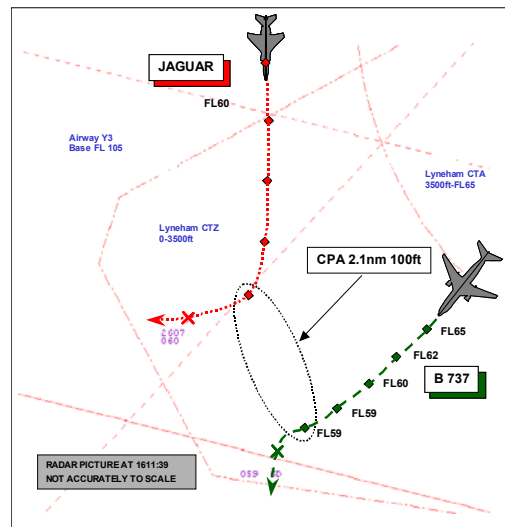
AIRPROX REPORT NO 070/05

Date/Time: 16 May 1612
Position: 5121N 00212W (10nm SW Lyneham)
Airspace: London FIR (Class: G)
Reporter: Bristol ATC
First Ac Second Ac
Type: B737 Jaguar
Operator: CAT DPA
Alt/FL: FL40[59] FL60
Weather IMC Rain VMC CLBL
Visibility: 10km 8km
Reported Separation:
0ft V/3.0nm H Not seen
Recorded Separation:
100ft V/2.1nm H

Cause: The Bristol APR controller did not achieve the separation required under a RAS.

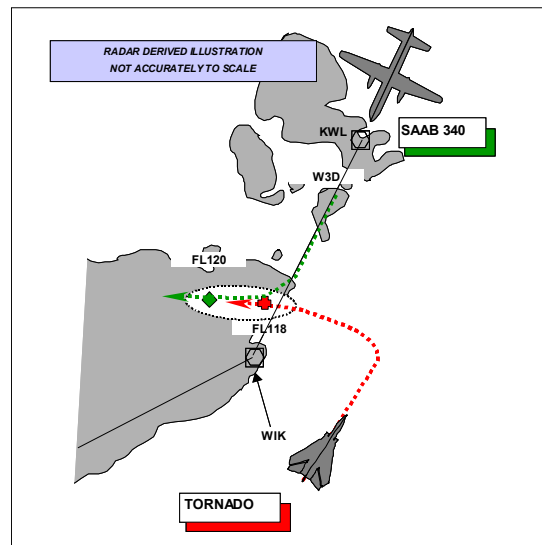
AIRPROX REPORT NO 072/05

Date/Time: 18 May 1344
Position: 5834N 00302W (5nm NNE Wick)
Airspace: ADR W3D (Class: F)
Reporting Ac Reported Ac
Type: Saab 340 Tornado F3
Operator: CAT HQ STC
Alt/FL: FL120 10000ft
(QNH 1018mb)
Weather VMC CLAC VMC
Visibility: 40km 20nm
Reported Separation:
0ft V/5nm H 1500ft V/1nm H
Recorded Separation:
200ft V/1.8nm H

Cause: Following an error of classification of the SF340 by the AWACS Controllers, the Tornado flew close enough to the SF340 to cause a TCAS RA.

Recommendation: The MoD should review VID procedures taking into account their influence on ACAS equipment.

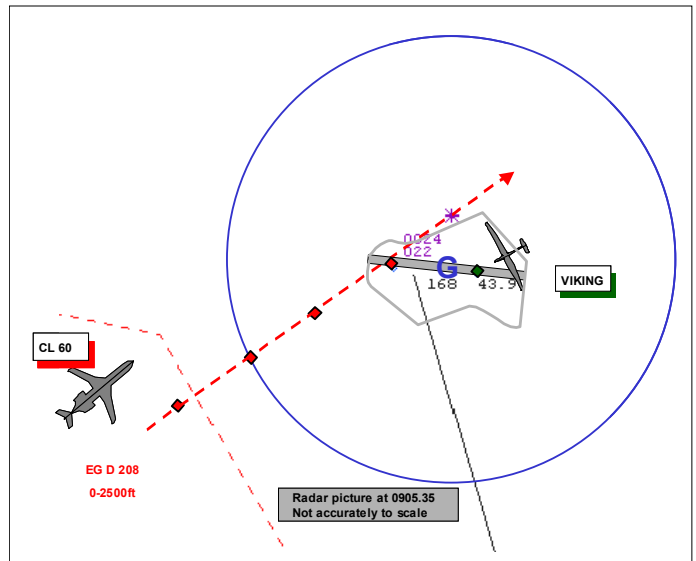
AIRPROX REPORT NO 073/05

Date/Time: 21 May 0905 (Saturday)
Position: 5233N 00051E (1nm SW Watton Airfield - elev 207ft)
Airspace: London FIR (Class: G)
Reporting Ac **Reported Ac**
Type: Viking Glider CL60
Operator: HQ PTC Civ Comm
Alt/FL: 1400ft 2000ft
 (QFE 1002 mb) (N/K)
Weather VMC CLBC VMC
Visibility: 25km >5nm
Reported Separation:
 50ft V/150ft H NR
Recorded Separation:
 Not Recorded

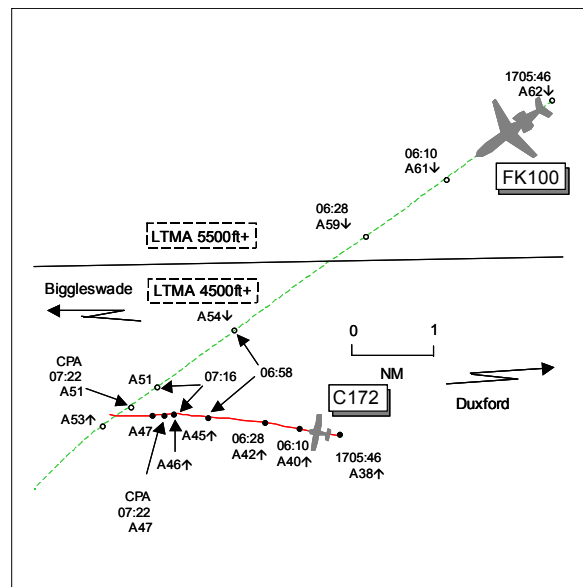
Date/Time: 29 May 1707 (Sunday)
Position: 5204N 00007W (15nm NE Luton)
Airspace: LTMA (Class: A)
Reporter: LTCC LUTON APR

<u>First Ac</u>	<u>Second Ac</u>
<u>Type:</u>	FK100	C172
<u>Operator:</u>	CAT	Civ Pte
<u>Alt/FL:</u>	↓5000ft (QNH)	FL43 (SAS)
<u>Weather</u>	VMC CLBC	VMC CLBC
<u>Visibility:</u>	10km	10km
<u>Reported Separation:</u>	400ft V/1nm H	200ft V/0.5nm H
<u>Recorded Separation:</u>	400ft V/0.4nm H

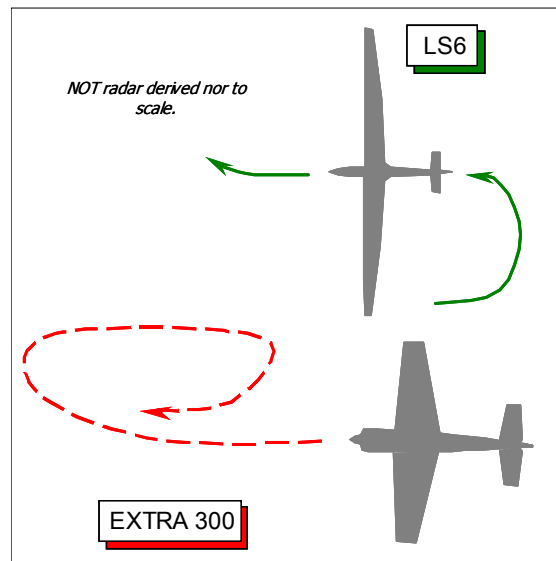
AIRPROX REPORT NO 075/05

Date/Time: 31 May 1103
Position: 5143N 00202W (4½nm N of Kemble)
Airspace: London FIR (Class: G)
Reporting Ac Reported Ac
Type: LS6 Glider Extra 300
Operator: Civ Pte Civ Pte
Alt/FL: 2300ft 2000ft
(QNH) (1026mb)
Weather VMC CLBC VMC CLBC
Visibility: 30km >10km
Reported Separation:
800ft >1000ft
Recorded Separation:
Not recorded

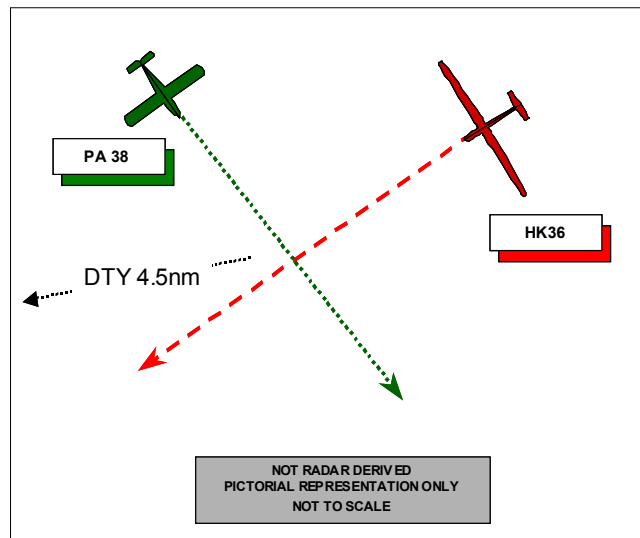
AIRPROX REPORT NO 076/05

Date/Time: 31 May 1500
Position: 5213N 00100W (4.5nm NE DTY)
Airspace: London FIR (Class: G)
Reporting Ac Reported Ac
Type: PA38 HK36
Operator: Civ Trg Civ Trg
Alt/FL: 2100ft approx 2500ft
(QFE 1011mb) (QNH)
Weather VMC CLBC VMC CLBC
Visibility: 20nm 20nm
Reported Separation:
0 V/50m H 0m V/ 50m H
Recorded Separation:
NR

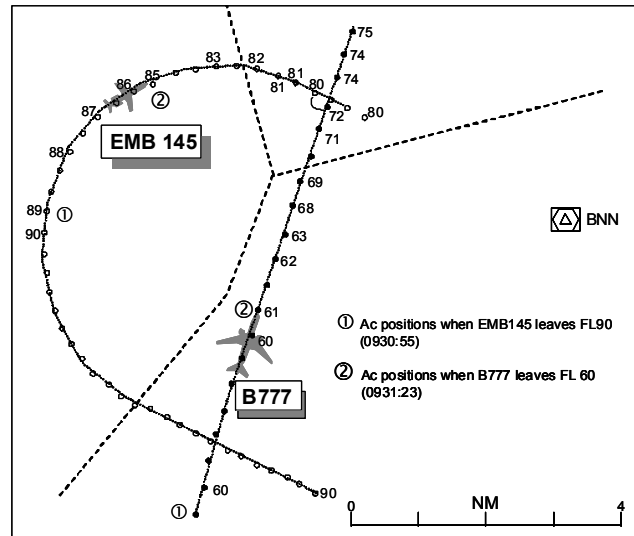
AIRPROX REPORT NO 078/05

Date/Time: 28 May 0932 (Saturday)
Position: 5154 N 0039 W (4nm NW Bovingdon VOR)
Airspace: LTMA Class: A
Reporting Ac Reported Ac
Type: EMB 145 B777-200
Operator: CAT CAT
Alt/FL: FL83 7200ft
 (SPS 1013 mb) (SPS 29.92in)
Weather VMC CLAC VMC
Visibility: >10km CAVU
Reported Separation:
 <700ft Approx 500ft V
Recorded Separation:
 0·18nm H 750ft V

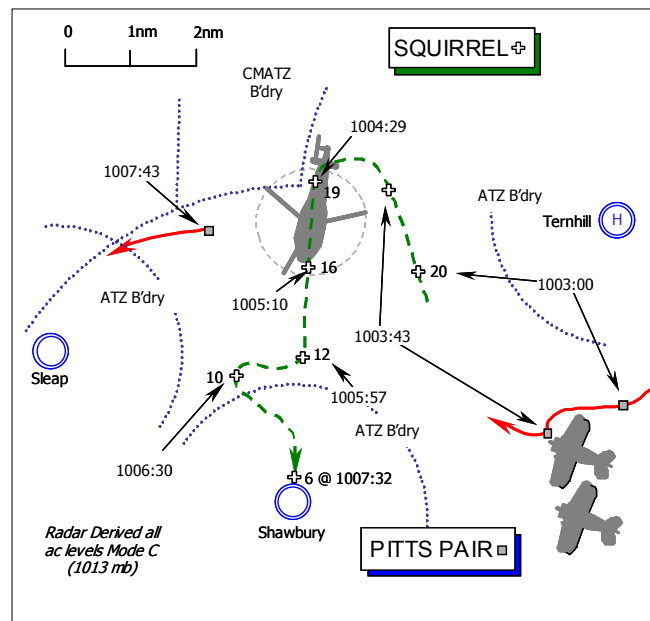
THE SHAWBURY LARS/LFA9 CONTROLLER No1 reports that the lead pilot of a formation of 2 Pitts ac first called some 10nm NE of Ternhill routing to Sleep aerodrome (5nm NW of Shawbury) at 1500ft QFE. The ac were non-squawking. When the Pitts leader reported descending to 1200ft he instructed him to remain N of the Ternhill ATZ and advised the Ternhill ADC of the position of the traffic. As the formation entered the MATZ they were still heading directly towards Ternhill so the leader was advised again to remain clear of the Ternhill ATZ, at which point they took up a southerly heading remaining just outside the ATZ boundary, which was the situation when he handed over the control position.

Cause: The lead pilot of the Pitts formation misunderstood the Shawbury controllers’ routeing instructions and flew close enough to the Squirrel to cause ATC concern for its safety.

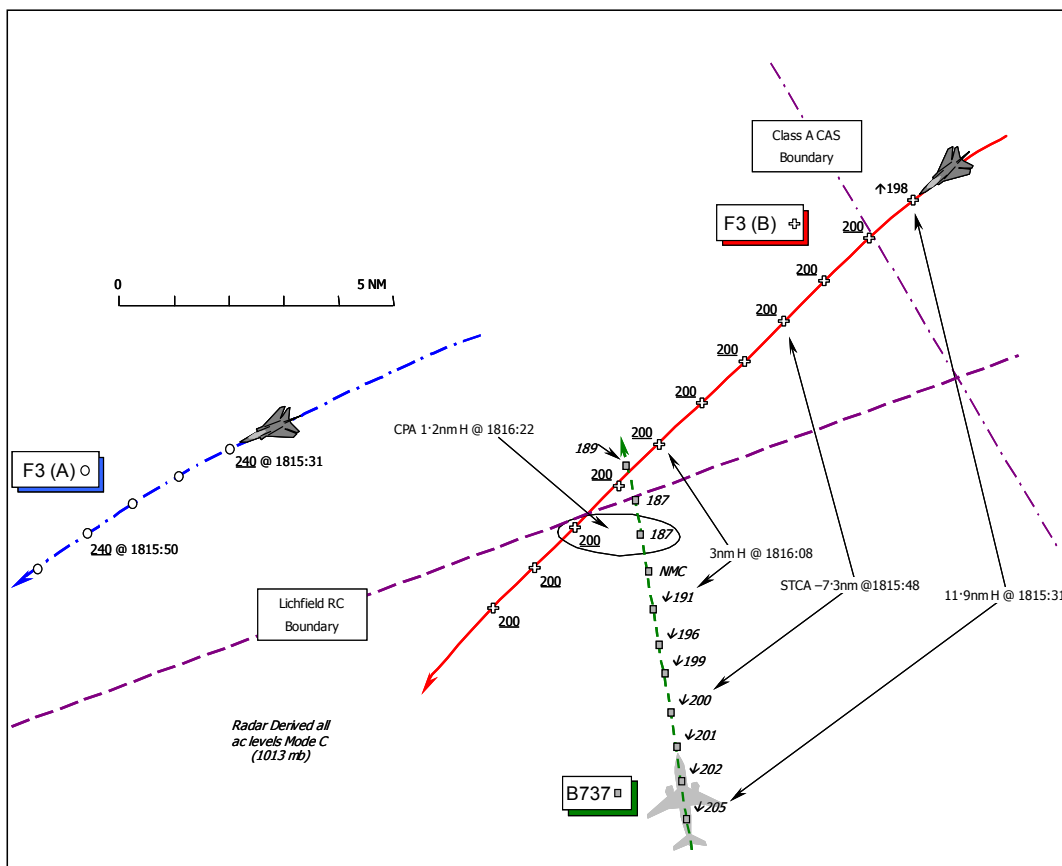
THE B737 PILOT reports he was descending en-route, under IFR but in VMC, some 5000ft and 5nm clear of cloud in between layers and in receipt of a RCS from Manchester CONTROL. The assigned squawk of A5511 was selected with Mode C and TCAS is fitted.

Cause: After confusion over the required level, F3B entered CAS at a level not expected by LJAO and flew into conflict with the B737.

As a result of this incident, the procedures have been reviewed and found to be generally sound. That said, it has been agreed with Swanwick (Mil) that ADPF ac will not be permitted to enter CAS unless a request has been agreed and that two flight levels will be blocked. Additionally, the presentation of the Track Data Blocks (TDBs) on the radar display for ADPF flights will be highlighted to provide a greater awareness than currently. Work on this is ongoing with no implementation date available at present.

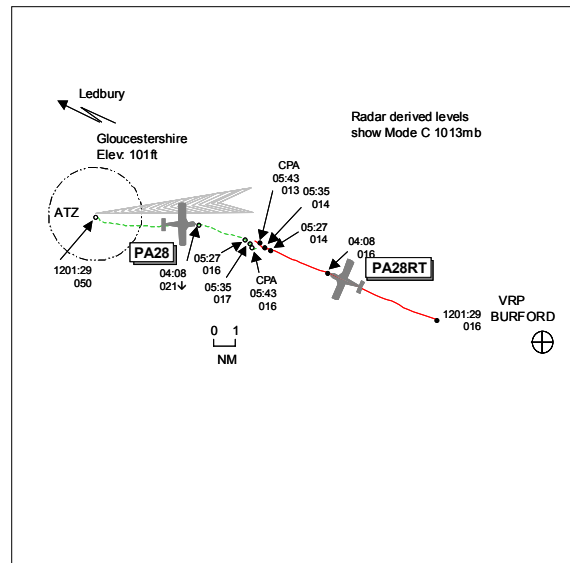
AIRPROX REPORT NO 083/05

Date/Time: 8 Jun 1206
Position: 5152N 00158W (7nm ESE
 Gloucestershire Airport - elev 101ft)
Airspace: LFIR (Class:G)
Reporting Ac **Reported Ac**
Type: PA28 PA28RT
Operator: Civ Trg Civ Trg
Alt/FL: 2300ft 2000ft
 (QNH 1037mb) (RPS 1033mb)
Weather VMC CLBC VMC CLBC
Visibility: 30nm 25km
Reported Separation:
 50ft V/200m H Nil V/200yd H
Recorded Separation:
 300ft V/0.3nm H

Cause: Late sighting by the PA28 pilot and an effective non-sighting by the PA28RT pilot.

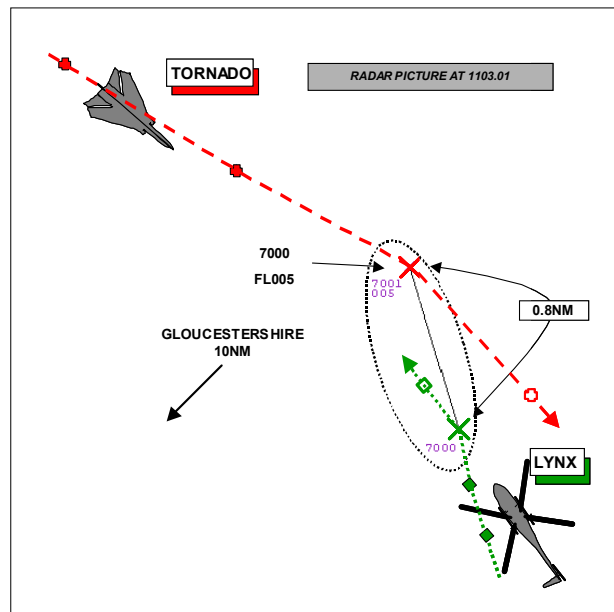
AIRPROX REPORT NO 084/05

Date/Time: 10 Jun 1102
Position: 5157N 00157W (10nm NE Gloucestershire Airport - elev 101ft)
Airspace: UKDLFS (Class: G)
Reporting Ac Reported Ac
Type: Lynx AH7 Tornado GR1
Operator: HQ DAAvn DPA
Alt/FL: 1100ft NR
(RPS 1020mb) (Rad Alt)
Weather VMC CLOC VMC CLBC
Visibility: 20km 8km
Reported Separation:
NR V/400m H Not seen
Recorded Separation:
NR V/ >0.8nm H (as ac passes thru 12o'clock)

Cause: Conflict in the UKDLFS.

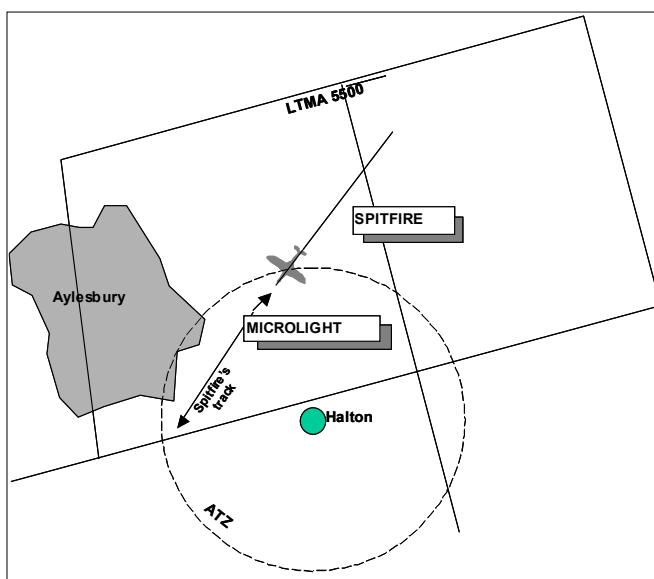
THE MICROLIGHT PILOT reports heading 020° downwind for RW 20 RH, at 60kt, 1000ft QFE in the Halton circuit; his student had control. He saw an ac 1nm ahead, believed to be a Spitfire with a large radiator under one wing and a small radiator under its other wing, travelling from NE straight and level towards Benson, through the Halton Zone at high speed, with no notice. It passed 50ft above and 500ft to the side as he took control and dived at 30°. Without his avoiding action there would have been a risk of collision. At about 2min before the Airprox he heard on Halton frequency 130.425 "Can you see me (name)?" and 5min after the Airprox "Well clear of Halton Zone now".

Cause: The Spitfire entered Halton ATZ without obtaining information from Halton A/G to enable the transit to be effected safely in accordance with the AIP.

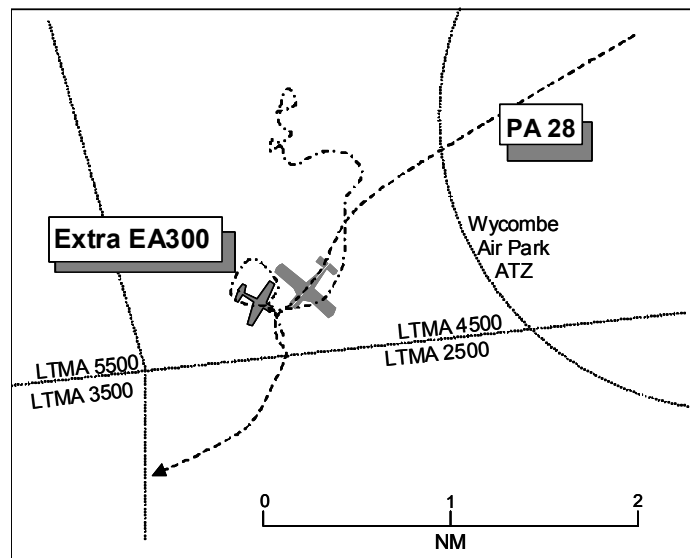
THE PA28 PILOT reports heading about 260° at 110kt, receiving a radar service from Benson on 120.9MHz and squawking as requested. She was flying at 2300ft and first saw a high wing ac 400-500ft above and to starboard, tracking towards her port side but above with adequate separation. A second ac was to their starboard side at a similar level to them but tracking parallel. She then saw the higher ac at her 11 o'clock tracking away and still high. The similar-level ac radioed that he was going to orbit. She looked again for the higher ac which had banked to the right and was now in her 1 o'clock and had changed attitude to nose down and turning. The ac seemed to be rapidly descending towards her; as it was slightly to her right she initiated a steep turn to the left and felt that had she not taken avoiding action a collision may have occurred. The ac passed within 100ft above and to the right. As she banked she vaguely remembered seeing the descending ac also pull out and turn to its left. She was only aware at the time that she and the similar-level ac were talking to Benson. She was not aware of the third ac in radio contact.

Cause Following a late sighting the Extra 300 pilot flew very close to the PA28 causing its pilot concern.

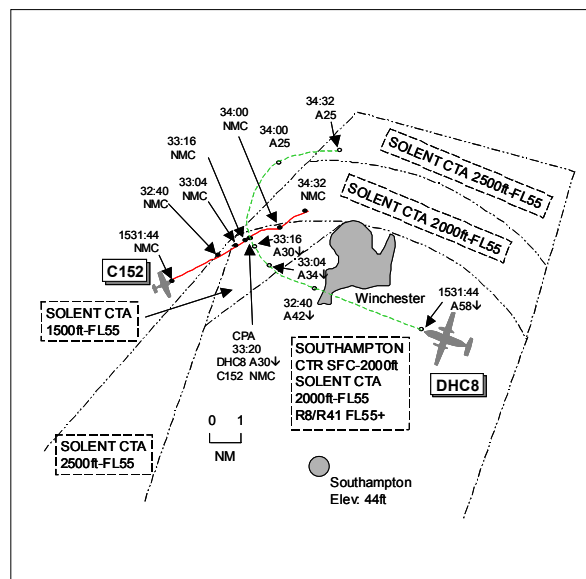
Date/Time: 19 Jun 1533 (Sunday)
Position: 5104N 00125W (8nm NNW Southampton - elev 44ft)
Airspace: Solent CTA (Class: D)
Type: DHC8
Operator: CAT
Alt/FL: 2700ft↓ (QNH 1016mb)
Weather: VMC CAVOK
Visibility: >10km
Reported Separation: 300ft V/Nil H
Recorded Separation: contacts merge

Cause: The C152 pilot entered Class D airspace without clearance and flew into conflict with the DHC8 which he did not see.

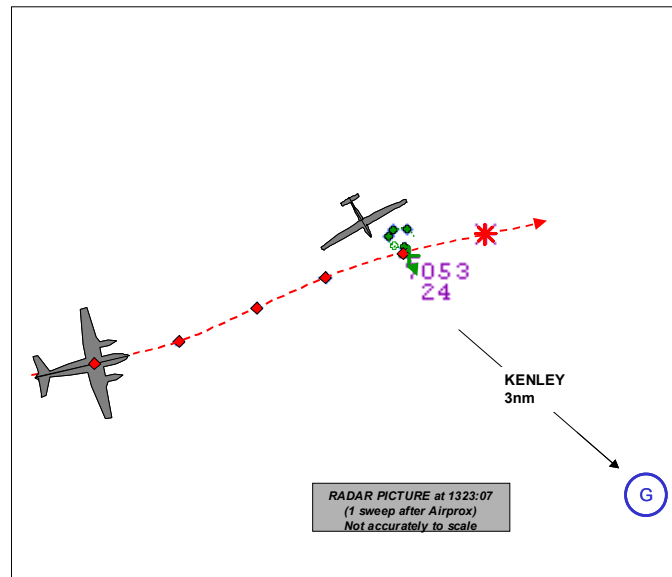
AIRPROX REPORT NO 089/05

Date/Time: 17 Jun 1323
Position: 5118N 00005W (3nm
 WNW Kenley - elev 566ft)
Airspace: London FIR (Class: G)
Reporting Ac Reported Ac
Type: Viking Glider BE200
Operator: HQ PTC Civ Comm
Alt/FL: 1520ft agl 2400ft
 (QFE NR) (QNH 1027 mb)
Weather VMC CLBC VMC CAVOK
Visibility: >10km >10km
Reported Separation:
 50ft V/Nil H 200ft V/O H
Recorded Separation:
 Contacts merge

Cause: Conflict in Class G airspace.

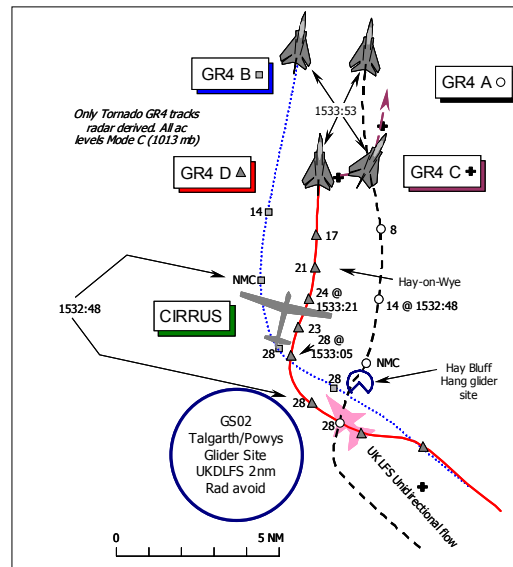
AIRPROX REPORT NO 090/05

Date/Time: 20 Jun 1533
Position: 5203N 00308W (5nm
 NNE of Talgarth - elev 970ft)
Airspace: FIR/LFS - LFA7 (Class: G)
Reporting Ac **Reported Ac**
Type: Cirrus Glider Tornado GR4
Operator: Civ Club HQ STC
Alt/FL: 4000-4200ft 2500-3500ft
 (SAS) (agl)
Weather VMC CLOC VMC CAVOK
Visibility: 30km 20km+
Reported Separation:
 "slightly below"/300m H nil V/½nm H
Recorded Separation:
 Not recorded

Cause: Conflict in Class G airspace.

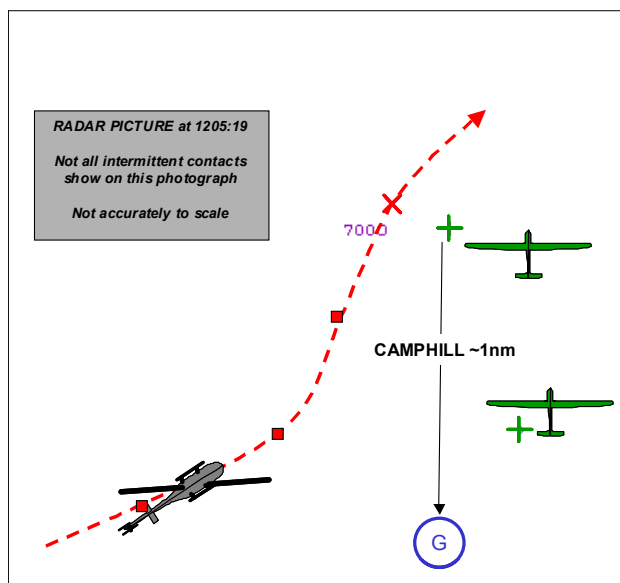
THE DG300 GLIDER PILOT reports flying a white glider soaring on a ridge just to the N of Camphill, heading N at 50kt and 700ft agl, when he heard an engine close by and then saw a helicopter about 50/100m away just off his port wingtip. The ac was a single rotor 4/6-seat helicopter and was white and red in colour. He turned a little (about 20°) right to increase the clearance since a larger turn might have put him in the path of another glider overtaking on the inside of the ridge i.e. on his RHS. The helicopter then turned about 30° to the right when it was about 200m ahead and flew across his flight path. He did not see the helicopter earlier because it had approached from his rear. Its course was about 030° towards Barnsley and it was seen by other glider pilots to be flying parallel to the ridge and to his left, in an overtaking position. The same helicopter returned close to the gliding site later in the afternoon but the time was not recorded.

Cause: Presumed non-sighting by the helicopter pilot and late sighting by the glider pilot.

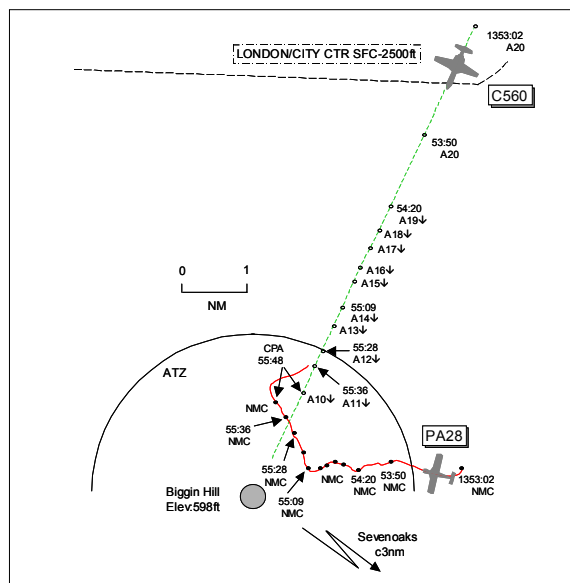
AIRPROX REPORT NO 092/05

Date/Time: 16 June 1356
Position: 5122N 00003E (1.5nm FIN APP
RW21 Biggin Hill - elev 598ft)
Airspace: ATZ (Class: G)
Reporting Ac Reported Ac
Type: C560 PA28
Operator: Civ Exec Civ Pte
Alt/FL: 400ft agl 300ft
(QNH 1020mb) (QFE)
Weather IMC KLWD VMC HAZE
Visibility: 3500m 3000m
Reported Separation:
10-100ft V Not seen
Recorded Separation:
0.4nm H

Cause: The PA28 pilot did not comply with clear instructions from ATC and flew into conflict with the C560 on ILS approach.

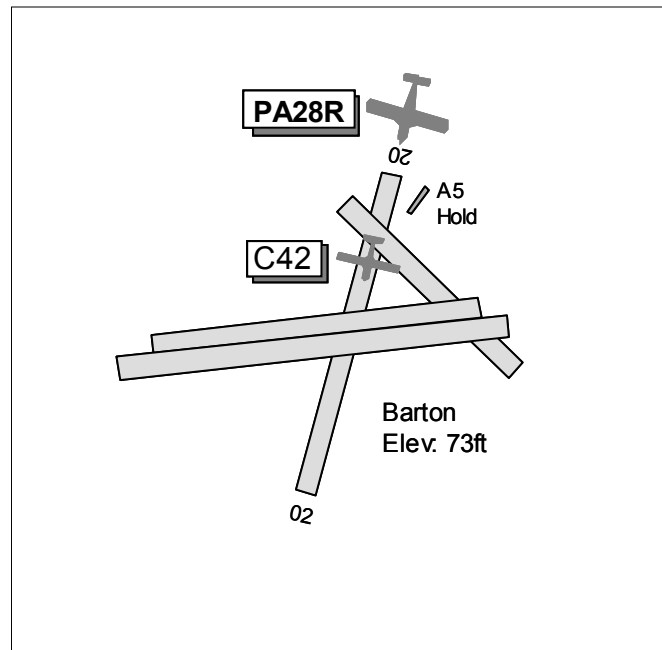
AIRPROX REPORT NO 093/05

Date/Time: 19 Jun 0911 (Sunday)
Position: 5327N 00223W (O/H RW20 at Manchester Barton - elev 73ft)
Airspace: ATZ (Class: G)
Reporter: Manchester Barton AFISO
First Ac Second Ac
Type: Ikarus C42 M/LightPA28R
Operator: Civ Trg Civ Club
Alt/FL: 10ft↑ 100ft
(N/K) (QFE 1014mb)
Weather VMC CLOC VMC IN HAZE
Visibility: 10km 5-7km
Reported Separation:
20ft eyewitness
seen 150-200ft V/100m H50-100ftV
Recorded Separation:
NR

THE BARTON AFISO reports the C42 pilot reported on final RW20 for a touch and go. The PA28R pilot also reported on final for RW20 with the intention of making a go-around owing to the C42 ahead. This was acknowledged by the AFISO who observed the PA28R continue down the approach at high speed, below the 200ft go-around height, and closing in on the Ikarus C42 which was beginning to climb out from its touch and go. The PA28R was seen to move slightly to its R onto the live side of the cct. The pilot of another M/Light, AC3, which was holding short of RW20 at Hold A5, told the C42 pilot that he had another ac directly above his C42 and to keep it low. This was followed by calls from himself also advising the C42 pilot to keep it low owing to the traffic in very close proximity. The C42 was seen to nosedive to approx 15ft agl and fly low along the RW until the pilot was told that the other ac was well clear and above him. He then called the PA28R pilot advising that all go-arounds must be made onto the deadside of the cct. Later, the PA28R pilot apologised to the Duty Aerodrome Officer and admitted to be suffering from 'brain overload' at the time of the incident.

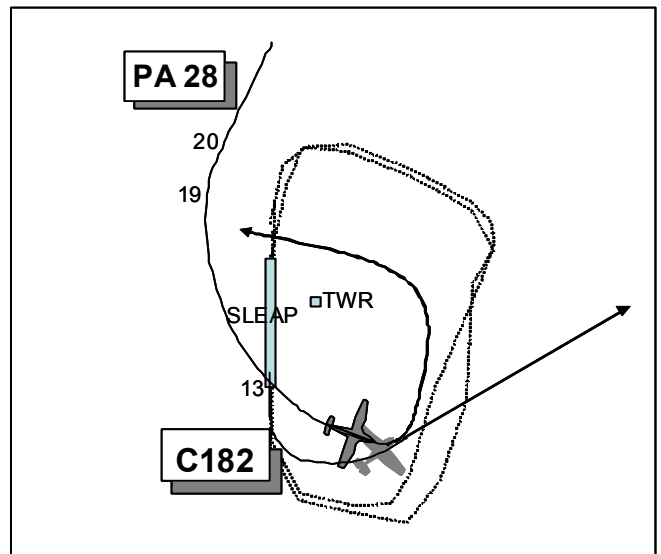
AIRPROX REPORT NO 094/05

Date/Time: 18 Jun 1223 (Saturday)
Position: 5249 N 0246 W (Sleep Airfield
 - elev 275ft)
Airspace: ATZ (Class: G)
Reporting Ac **Reported Ac**
Type: C182 PA28R-200
Operator: Civ Pte Civ Pte
Alt/FL: 1100ft 1000ft
 (QNH 1023mb) (QFE 1016mb)
Weather VMC VMC CLBC
Visibility: >50km 10nm
Reported Separation:
 20ft V/approx 40ft H NK
Recorded Separation:
 NK

THE C182 PILOT reports flying in the Sleep circuit, having taken off to depart for Tatenhill. A visiting PA28 from Barton flew over the control tower and carried out a steep descending LH turn on the live side of the active RW (18) as witnessed by two pilots from Shobdon, who were about to depart from Sleep. He saw it less than 50ft away just before it passed about 50ft in front and 20ft above. There was no time for avoiding action and the risk of collision was very high.

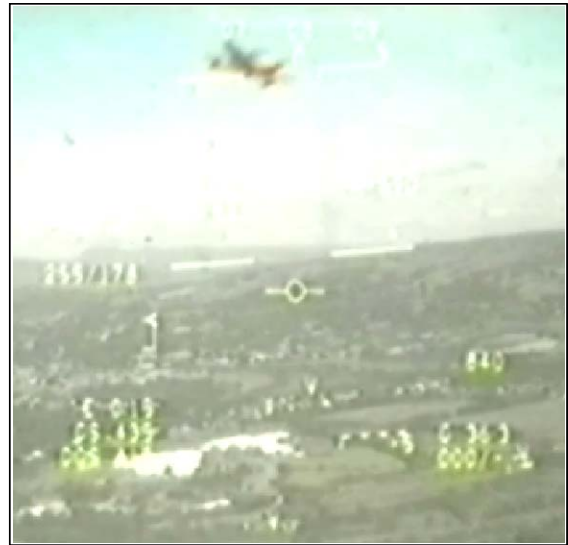
AIRPROX REPORT NO 095/05

Date/Time: 22 Jun 1500
Position: 5146N 00403W (10nm N Swansea)
Airspace: LFA 7/London FIR (Class: G)
Reporting Ac Reported Ac
Type: Tornado Zodiac
Operator: HQ STC Civ Pte
Alt/FL: 695ft 1200ft
 (Rad Alt) (AMSL)
Weather VMC CAVOK VMC CAVOK
Visibility: >30km >10km
Reported Separation:
 20ft V/Nil H Not seen
Recorded Separation:
 20-40ft V about 10m H

THE TORNADO PILOT reports leading a pair of Tornados on a low level tactical sortie in Wales. They were not in receipt of an ATS, were squawking 7001 and the HISLs were on. The formation was heading 080° at 420kt after departing from Pembrey AWR and he looked in the cockpit momentarily to select fuel transfer from the wing tanks. On looking up again he saw a yellow low wing light ac 200m ahead which appeared to be in a LH turn passing through approximately 240°. He saw the ac too late to take any avoiding action, passing 20-40ft below it, assessing the risk as being high. The number 2 ac was to the S of the Leader: its pilot did not see the conflicting ac.

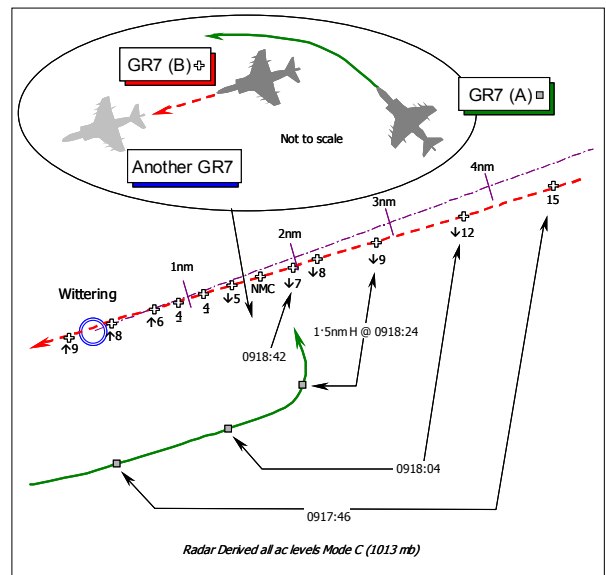
AIRPROX REPORT NO 097/05

Date/Time: 20 Jun 0918
Position: 5237N 00026W (1½nm Finals RW26 Wittering - elev 273ft)
Airspace: Wittering MATZ (Class: G)
Reporting Ac **Reported Ac**
Type: Harrier GR7 Harrier GR7
Operator: HQ STC HQ STC
Alt/FL: 500ft 500ft
 (QFE 1006mb) (QFE 1006mb)
Weather VMC CLBC VMC CLBC
Visibility: NR 10km+
Reported Separation:
 <100ft V/nil H 100ft V/50-100ft H
Recorded Separation:
 Not recorded

HARRIER GR7 PILOT (A) reports he had returned to base as the No4 of a '4-ship' formation of GR7 ac following a range detail and was flying independently under VFR in VMC in the Wittering aerodrome cct under the control of Wittering TOWER on 357.15MHz. His ac has a grey camouflage scheme, but the HISLs were on. Neither TCAS nor any other form of CWS is fitted. SSR was selected 'off' in the cct.

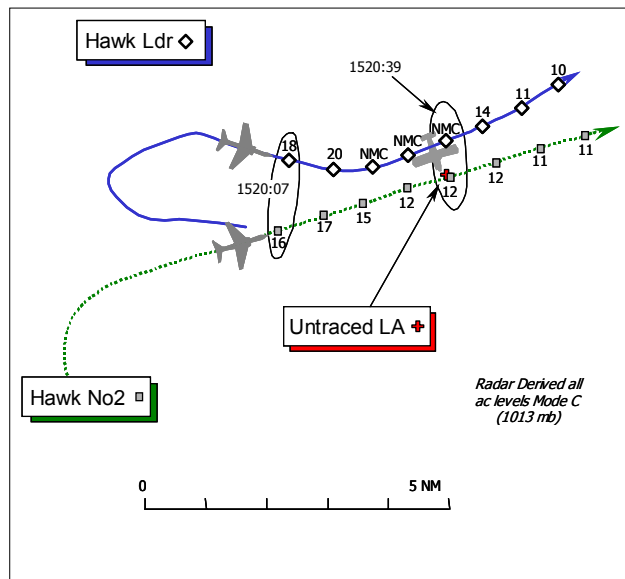
AIRPROX REPORT NO 100/05

Date/Time: 30 Jun 1520
Position: 5200N 00222W (3nm SE of Ledbury)
Airspace: UKDLFS (Class: G)
Reporting Ac Reported Ac
Type: Hawk T1A Untraced Light ac
Operator: HQ PTC NK
Alt/FL: 2000ft NK
(RPS 998mb)
Weather VMC CLBC NK
Visibility: 20nm+ NK
Reported Separation:
20ft V/100ftH NK
Recorded Separation:
Contacts merged

THE HAWK T1A PILOT, a QFI instructing a student, provided a very frank report stating that he was flying as the No2 of a two-ac 'Battle' formation conducting a low-level training sortie. The ac had a black colour-scheme, the HISLs and nose/landing light were on. A squawk of A7001 was selected with Mode C, neither TCAS nor any other form of CWS being fitted. They were flying VFR in VMC, some 2000ft clear below cloud with an in-flight visibility of 20nm+ but not in receipt of an ATS.

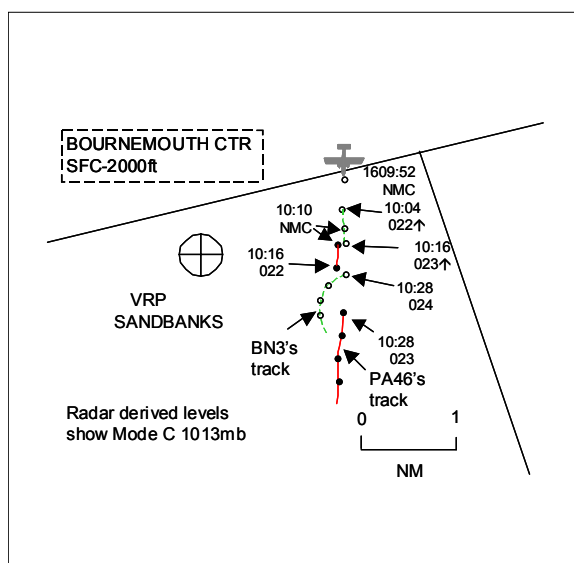
AIRPROX REPORT NO 102/05

Date/Time: 29 Jun 1610
Position: 5042N 00154W (5nm SSW
Bournemouth Airport - elev 38ft)
Airspace: Bournemouth CTR (Class: D)
Reporting Ac Reported Ac
Type: BN3 Trislander PA46
Operator: CAT Civ Pte
Alt/FL: 1500ft↑ 2000ft
(QNH) (QNH)
Weather VMC CLBC VMC CAVOK
Visibility: 25km >40nm
Reported Separation:
Nil V/100ft H >300ft H
Recorded Separation:
NR

THE BN3 TRISLANDER PILOT reports outbound from Bournemouth to Alderney VFR and in receipt of a RIS, he thought, from Bournemouth on 119.47MHz squawking 7371 with Mode C; TCAS is not fitted to the ac. The visibility was 35km and he was flying 2000ft below cloud in VMC. The ac was coloured blue/white/yellow with strobe lights switched on. About 5nm SW of Bournemouth heading 195° climbing at 100kt through 1500ft QNH, he was informed by ATC of traffic passing on his R. The other ac, a PA46 Malibu coloured blue/white, was first seen in his 4 o'clock with about 100ft lateral separation at the same level also climbing. No avoiding action was necessary as the other ac was only close for a very short time and overtaking at about 30kt faster, its pilot appearing to be waving and wagging his wings. The PA46 then moved directly in front of his ac which was very disconcerting owing to his poor forward view whilst in a nose-high climbing attitude. Since he was unaware of how close the other ac was he believed the risk was high should he have turned.

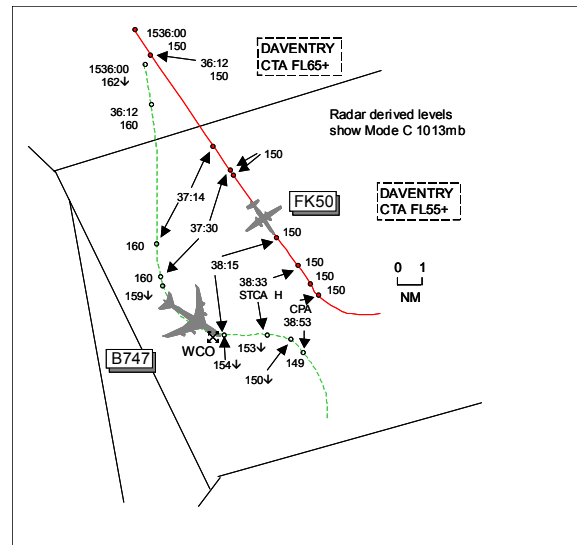
THE B747 PILOT reports inbound to Stansted in descent on a LOREL 3F STAR but following radar vectors from London ATC, owing to heavy traffic, on 133.07MHz. About 23nm E of BOMBO after levelling at FL150 at 250kt, the flight was given a radar heading of 105°, he thought, and transferred to London on 119.77MHz. An ac was noticed on TCAS, closing from behind them to their L at the same level, which rapidly became a TA. The new controller called them saying "B747 c/s avoiding action turn right now onto 180°". On receipt of these instructions, the Capt took control from the FO and disconnected the A/P and initiated a rapid turn to the R. Once established in the turn, he handed control back to the FO who re-engaged the A/P when the TA alert ceased. He did not visually acquire the other ac but estimated it passed 2nm clear on his LHS at the same level.

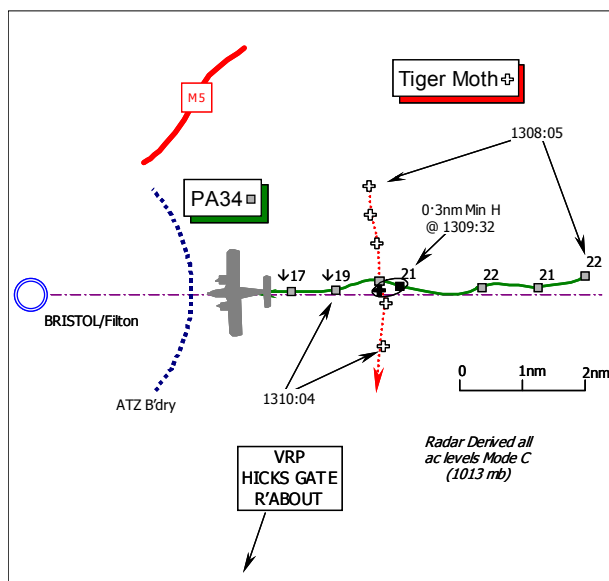
AIRPROX REPORT NO 123/05

Date/Time: 29 Jun 1309
Position: 5031N 00226W (5½nm E Bristol/Filton - elev 226ft)
Airspace: London FIR (Class: G)
Reporting Ac Reported Ac
Type: PA34 DH Tiger Moth
Operator: Civ Trg Civ Pte
Alt/FL: 2000ft 2000ft
(QNH 1007mb) (QNH 1007mb)
Weather VMC CLBC VMC CLBC
Visibility: >10km 15km
Reported Separation:
Nil VI~100m H ~200ft V
Recorded Separation:
0.3nm H

From the Tiger Moth pilot's perspective he had not detected the presence of the PA34 until after it had passed astern and therefore had no influence over the outcome of this close quarters encounter. Nevertheless, the reporting PA34 pilot himself had highlighted that under the 'Rules of the Air' the Tiger Moth pilot had 'Right-of-Way', placing the instructor in a difficult situation whilst flying an IFR approach under 'simulated IMC' conditions. The 'Rules' can only work if ac are seen in good time and it was fortunate that the PA34 safety pilot had spotted the Tiger Moth when he did, turning to avoid it and thereby resolving the conflict. But it was evident that both ac were there to be seen in the prevailing weather and each pilot could potentially have spotted each other's ac a lot sooner than they did. The Board agreed, therefore, that this Airprox had resulted from a non-sighting by the Tiger Moth pilot and a late sighting by the PA34 safety pilot.

Cause: A non-sighting by the Tiger Moth pilot and a late sighting by the PA34 safety pilot.
