UK AIRPROX BOARD

Analysis of Airprox in UK Airspace

Report Number 2

January 1999 to June 1999

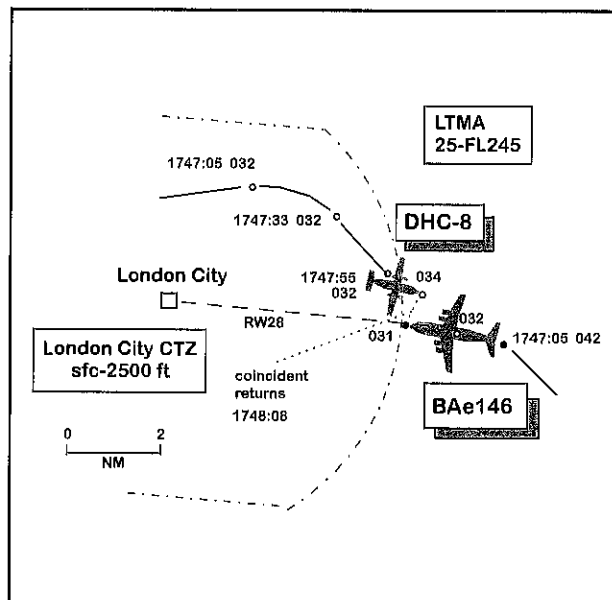
THE THAMES RADAR CONTROLLER reports that the Dash 8 had departed from London City on a DVR 3T SID and was turned onto a heading of 080° climbing to 3000 ft. The BAe146 had been vectored to the ILS for RW 28 at London City and was established on the localiser at 3000 ft. Owing to other inbound traffic, he turned the Dash 8 R onto a heading of 150° but then realised that this heading would take it into conflict with the BAe146, so he passed traffic information to the Dash 8 pilot, instructed him to turn L onto a northeasterly heading and to climb to 4000 ft to achieve a degree of vertical separation. The ac subsequently passed within 0.75 NM of each other.

The Board concluded that the Thames Radar Controller caused the Airprox by vectoring the DHC 8 into conflict with the BAe 146. Members were satisfied, however, that although standard separation was compromised, the ac were nevertheless sufficiently separated laterally to preclude any risk of collision.

Cause: The Thames Radar Controller vectored the DHC 8 into conflict with the BAe 146.

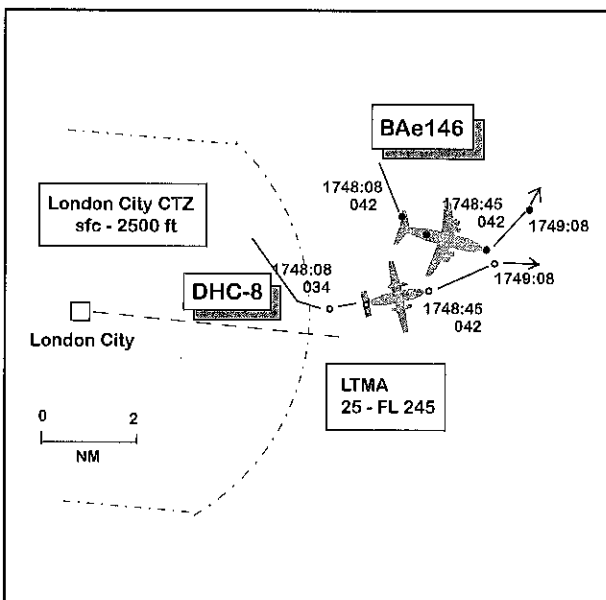
THE THAMES RADAR CONTROLLER reports that the Dash 8 had departed from London City Airport on a DVR 3T SID and was turned onto a heading of 080° climbing to 3000 ft. A BAe146 (the subject of a previous Airprox, No 1/99) had been vectored to the ILS for RW 28 and was established on the localiser at 3000 ft. To position the Dash 8 from further inbound ILS traffic, he turned it R onto a heading of 150° but then realised that this heading would take the ac into conflict with the BAe146; he therefore turned it L onto a north-easterly heading and climbed it to 4000 ft to achieve a degree of vertical separation. This brought the ac into conflict with a second BAe146 which was at 4000 ft southbound from LAM. Both the Dash 8 and the pilot of the BAe146 were given vectors to resolve the conflict but subsequently passed within 1.5 NM of each other.

Cause: While resolving the conflict with the first BAe 146, the Thames Radar controller vectored the DHC 8 into conflict with the second BAe 146.

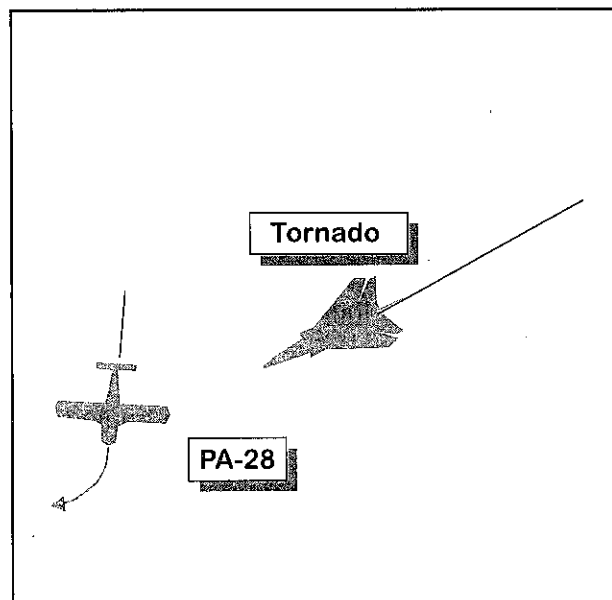
THE PA28 PILOT reports heading 210° at 105 kt established at 1500 ft on finals for RW 20 at Oxford when he spotted a Tornado closing from close in his 7:30 at the same level. He climbed, turning right, and the Tornado passed about 75 ft below him, tracking from his 7:30 to 1:30 with a high risk of collision. Later, he spoke with its pilot who said his on-board camera showed the Tornado had passed 100 ft directly beneath him, with a very late spot.

Cause: Late sighting by Tornado pilot.

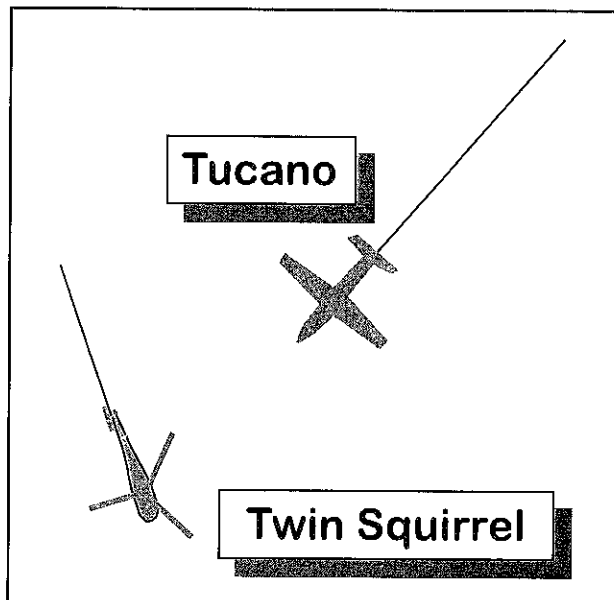
AIRPROX REPORT No 4/99

THE TUCANO PILOT reports heading 220° at 240 kt on a dual low level exercise, having deviated to the right of planned track to avoid weather. His student who was flying the ac pitched up sharply, banking to the right and he took control, seeing a white helicopter pass 100 m underneath on an easterly heading; he saw it bank right some 5-6 seconds later. The risk of collision would have been high without the avoiding action.

Cause: Late sighting by the Tucano pilot.

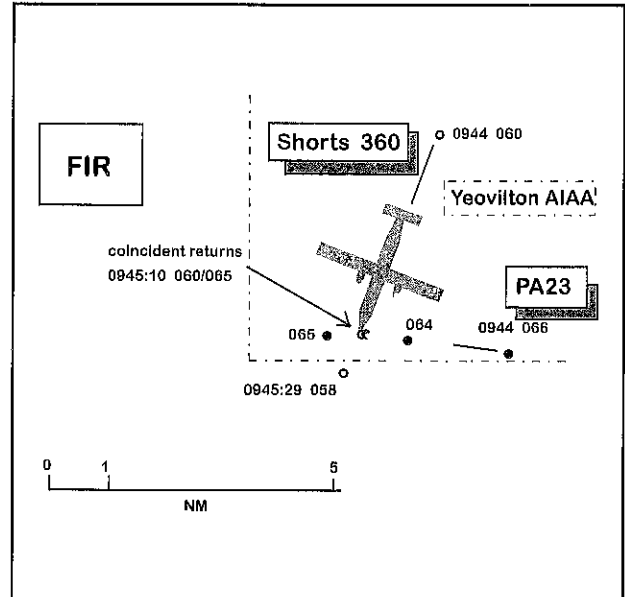
THE SHORTS 360 PILOT reports that he was heading about 220° at 180 kt and cruising at FL 60 en route from Birmingham to Exeter in the FIR. The visibility was over 15 km in VMC. He was receiving a RIS from Yeovilton LARS who advised him of traffic at his 9 o'clock position maintaining FL 65. The traffic was then signalled as a TA on his TCAS indicating 500 ft vertical separation. The pilot of the other ac was twice heard to request descent to FL 60 but was advised by Yeovilton to maintain FL 65 and subsequently the other pilot reported visual contact with the Shorts 360. The Shorts's TCAS showed reduced vertical separation and, though neither the Captain nor P2 could see the other ac at that point, the Captain instructed the P2 to descend. A TCAS RA followed instructing a descent which was carried out to 5750 ft, whereupon an Aztec was spotted above them about 500 - 600 ft away; they watched it fly overhead by an estimated 300 ft, confirmed by the TCAS reading. He asked Yeovilton if the other pilot was visual with him and they confirmed that he was.

Cause: Mistaken impression of vertical separation by the Shorts 360 pilot.

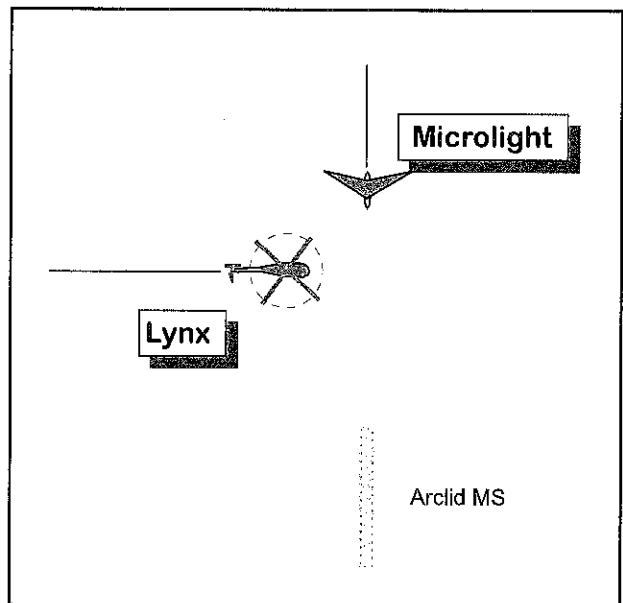
AIRPROX REPORT No 7/99

THE MICROLIGHT PILOT reports heading 180° at 50 kt descending towards finals to his airstrip at Arclid. Passing 760 ft he saw a helicopter approaching in his 2 o'clock 500 m away crossing right to left so he discontinued his descent and the helicopter passed 200 ft directly beneath with a medium to high risk of collision.

Cause: The Lynx flew close enough to the microlight to cause its pilot concern for the safety of his ac.

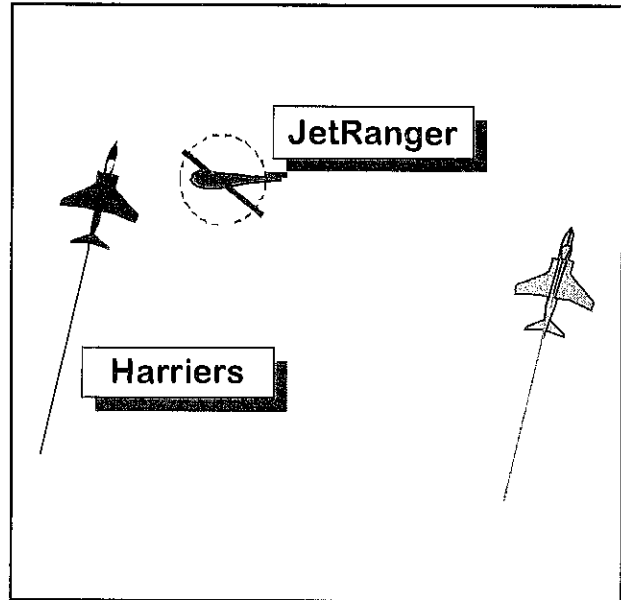
THE JETRANGER PILOT reports heading W at 40 kt on a powerline inspection at 100 ft agl with the wires on his left, the same side as his observer. He was receiving a FIS from Norwich Approach on 119.35. He saw a Harrier 200 m away in his 10 o'clock crossing left to right slightly higher; he instinctively lowered the collective fully to initiate a rapid descent and the Harrier passed some 75 M ahead with a high risk of collision. He expressed the need for a system by which his activity could be notified to the military since neither the CANP nor the PINS was applicable.

such as this will arise in which a fast jet pilot will find himself closer to a helicopter than is desirable for its comfort or safety and will do what he can to increase the separation if he sees it. In this case the Harrier pilot did not see the JetRanger and it did not appear on the Harrier's HUD recording; members wondered if it was in fact further off his track than suggested by the JetRanger pilot's report. If the pilots had seen the conflict earlier they would probably have manoeuvred to increase separation and the Board concluded that the cause of the Airprox was that the Harrier pilot had not seen the JetRanger. As to the risk level, the Board assessed that because the ac had passed fairly close without the Harrier pilot seeing the JetRanger, the safety of the ac had been compromised.

Cause: The Harrier pilot did not see the JetRanger.

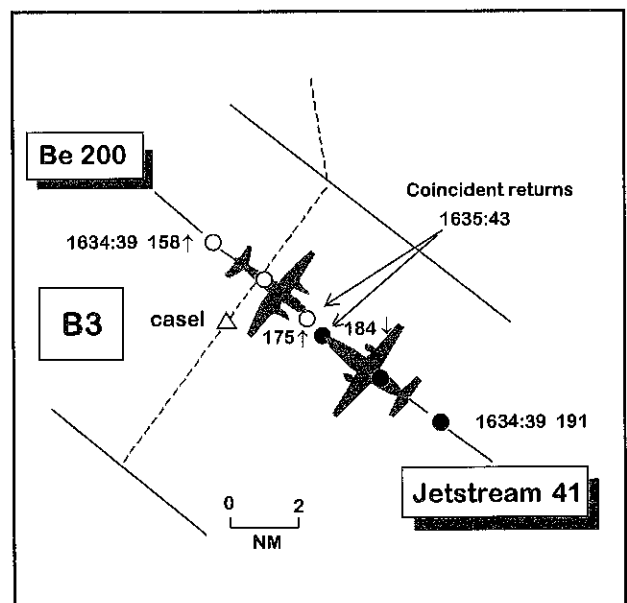
AIRPROX REPORT No 10/99

MACC reports that the Jetstream was tracking NW on airway B3 inbound to Belfast City. The ac had been cruising at LATCC assigned levels but requested a lower level and was accepted into W/IOM sector descending to FL 180. The Be 200 was climbing out from Ronaldsway on B3 to FL 170 in opposition to the Jetstream, and was given further climb clearance to FL 190 before the Jetstream reported on frequency in the descent. The Airprox occurred just as the Jetstream was levelling at FL 180 and being transferred to the Scottish Antrim sector. The Manchester Radar controller concerned did not recollect issuing the climb instruction to FL 190 to the Be 200 although he had annotated the FPS accordingly. Minimum separation was believed to be in the order of 0.6 NM and 600 ft.

The interviews with the MACC controllers did not provide any satisfactory explanation for the MACC 'R' Controller's error. He did not dispute the fact that the trainee 'C' Controller had pointed out that the Jetstream would be descending to FL 180 and acknowledged that an appropriate pink 'blocking' FPS had been provided. At the time of the Airprox, it appears that the 'R' controller had forgotten he had climbed the Be 200 to FL 190, despite having annotated the 'WAL' FPS to indicate this. It emerged that another controller, walking behind the sector, had observed the STCA alert but he, like the 'C' controllers, believed that the Be 200 was only climbing to FL 170 and dismissed it as a 'nuisance' alert. At interview, the MACC controllers all confirmed that there had been no undue distractions during the period preceding the Airprox which might have accounted for the 'R' Controller forgetting that he had cleared the Jetstream to FL 190 and failing to recognise the developing conflict.

In conclusion the Board assessed that the MACC W 'R' controller caused the Airprox by climbing the Be 200 into conflict with the Jetstream.

Cause: The MACC W Radar Controller climbed the Be 200 into conflict with the Jetstream.

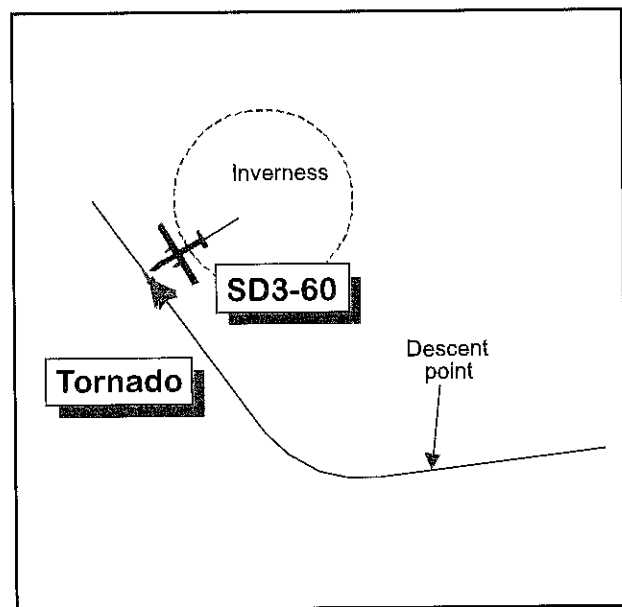
AIRPROX REPORT No 11/99

THE SD3-60 PILOT reports heading 240° at 150 kt in a climb after taking off from RW 24 at Inverness. He had been warned before take-off of a military jet routeing 5 NM S and then 2 NM W of Inverness and on departure had seen an ac at 9 o'clock whose relative bearing was changing slowly from L to R. He elected to continue climbing on runway heading and to delay a planned left turn onto the 194° radial. The military traffic which had been warned of his presence then turned right and descended; Inverness ATC transmitted a further warning of his position when the military ac continued its right turn and appeared to level off. Becoming increasingly concerned, he levelled at 1800 ft and maintained heading to watch the military ac pass directly overhead by about 200 ft. At the

Cause: The Tornado pilot did not see the SD3-60.

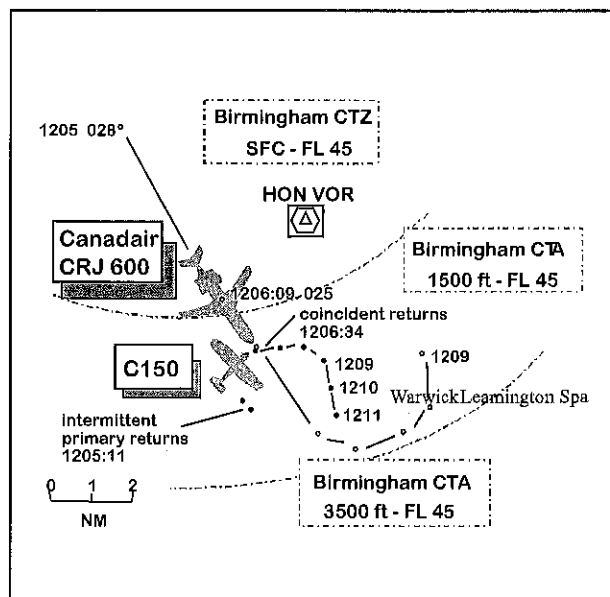
THE CRJ 600 PILOT reports heading 150° at 190 kt and level at 2500 ft (QNH 1011) while downwind in the radar pattern for RW 33 at Birmingham. He was receiving a radar control service from Birmingham APC on 118.05 and squawking 7433 with Mode C. The visibility was 40 km in VMC. Workload was slightly higher than normal due to pre-landing cockpit activities, with the Captain flying the ac and the FO operating the flight control panel and handling the RT. When about to turn L onto base leg about 6 NM SW of Birmingham airport, the Captain spotted a high wing Cessna-type ac at his 10 o'clock position range 200 - 300 m and about 200 ft below tracking away. As he would have flown directly over this ac by turning at that point, he delayed until it was well clear. It transpired that the FO had spotted the Cessna just before his Captain, in their 12 o'clock about 500 m away as it crossed from R to L.

awareness had led the C150 pilot inadvertently to penetrate the Birmingham CTA and cause the Airprox by flying into conflict with the CRJ 600, which he did not see. Opinions were divided on risk; some believed that the C150 was not, in effect, seen by the CRJ 600 crew until after it had passed through their 12 o'clock and therefore there had been a possible risk of collision. However, airline pilot members were satisfied that no collision risk existed as the C150 crossed some 500 m ahead and below the CRJ 600; there would have been time to spot and take avoiding action had the Cessna been higher. Most members accepted this and the majority conclusion was that there had been no risk of collision.

Cause: Following an inadvertent penetration without clearance of the Birmingham CTA, the C150 pilot flew into conflict with the CRJ 600 which he did not see.

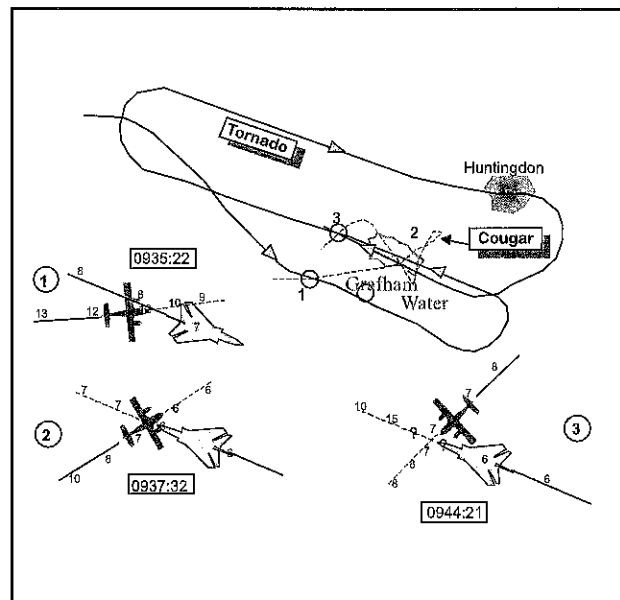
AIRPROX REPORT No 13/99

THE TORNADO CREW reports heading 291° at 420 kt on a LL exercise at 500 ft; while passing an IP the navigator spotted an ac 5 NM

Cause: Non-sighting of the other ac by both pilots, fortunately resolved by the Tornado navigator.

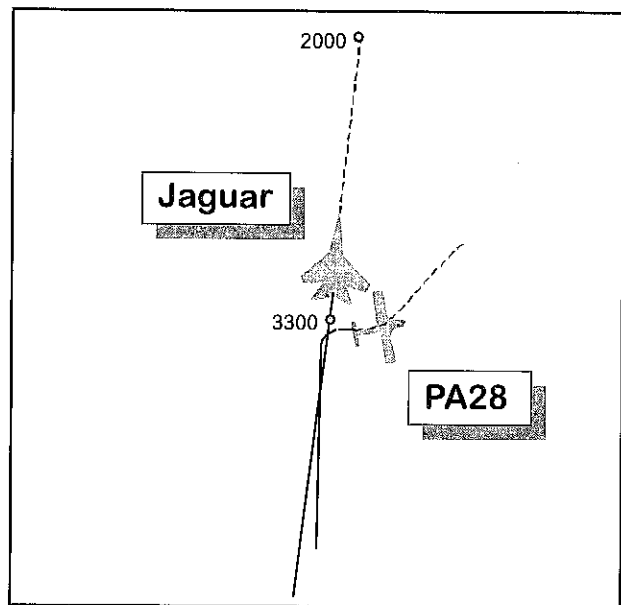
AIRPROX REPORT No 14/99

THE PA28 PILOT reports heading 340° at 75 kt in a climb on a general handling sortie. He was on the Oxford Approach frequency (125.32) but did not say what type of service he was receiving. He saw a Jaguar as it passed 200 ft below and 300 ft ahead, crossing from his 8 o'clock to his 1 o'clock in a descent. He continued his climb and assessed the risk of

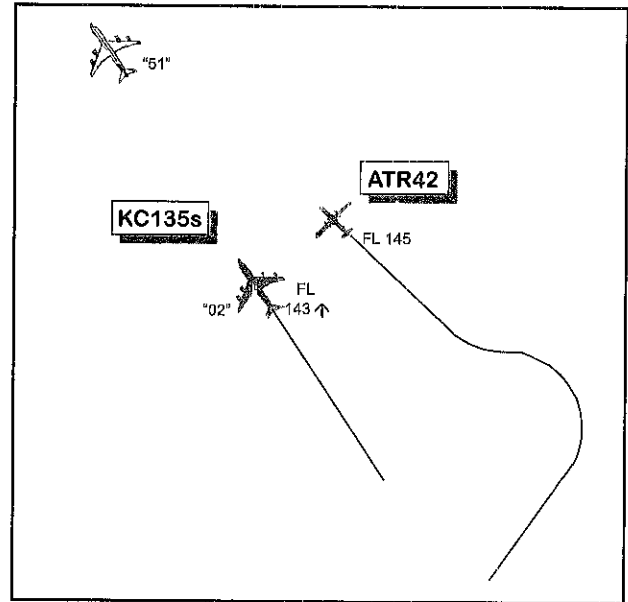
THE ATR42 PILOT reports heading 330° at 260 kt, level at FL 145 under a RAS from London Radar. He had been vectored R to avoid traffic and then back on track. He heard the KC135s' c/s being cleared to climb through his level and the controller then told him to turn immediate R onto 360° with traffic in his 9 o'clock climbing through his level. Having just become VMC he asked for the range of the other traffic and was told it was 2 NM, but it looked closer. He thought there had been a moderate risk of collision.

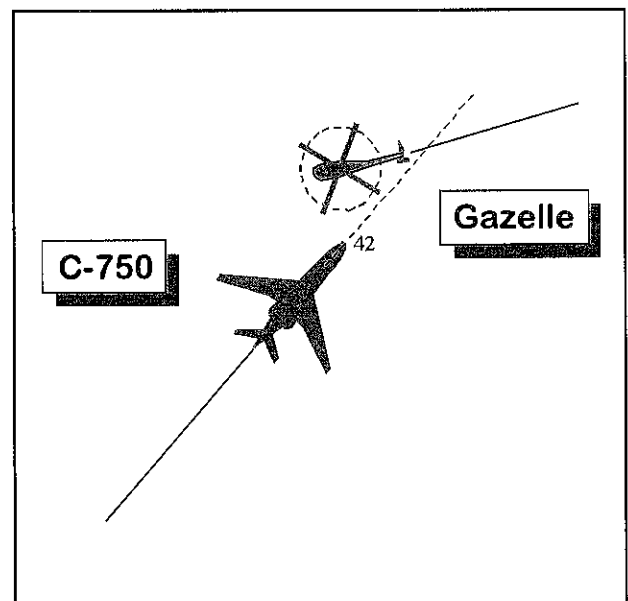
THE GAZELLE PILOT reports heading 265° at 100 kt and receiving a RIS from Wallop Radar at FL 40. At a very late stage he saw a low wing twin engined executive jet closing in his 10 o'clock. He made a descending right turn as it passed less than 100 ft above and 50-100 m to his left on a N easterly track with a high risk of collision. He reported the Airprox briefly to Wallop Radar. His workload had been high with his co-pilot under instruction and flying on instruments.

lower levels and was using TCAS generated targets and altitudes to adjust his rates of descent and vectors. Although many ac were spotted he did not recall anything that would have constituted a near miss. As for the future, he would delay his descent below FL 100 until closer to Farnborough.

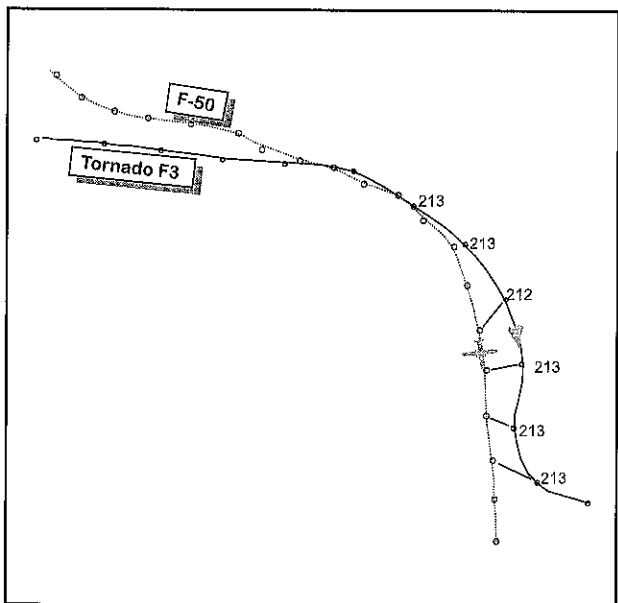
AIRPROX REPORT No 17/99

Date/Time: 10 Feb 1839 NIGHT
Position: N5420 W0003 (13 NM N of Flamborough Head)
Airspace: FIR (Class: G)
Type: Reporting Aircraft Reported Aircraft
 Fokker F50 Tornado F3
Operator: CAT HQ STC
Alt/FL: FL 210 22000 ft (RPS 1008 mb)
Weather VMC CLNC VMC CLOC
Visibility:
Reported Separation: 0.5-1 NM/1150 ft
Recorded Separation: 0.62 NM / 300 ft

Cause: The F3 flew close enough to the F50 for its pilot to be concerned for the safety of his ac, although the Neatishead IC knew the F50 was an airliner.

Recommendation: That HQ STC reviews its rules on interception training so that the conduct of such activity does not give non-military or non-exercise traffic any cause for concern on safety.

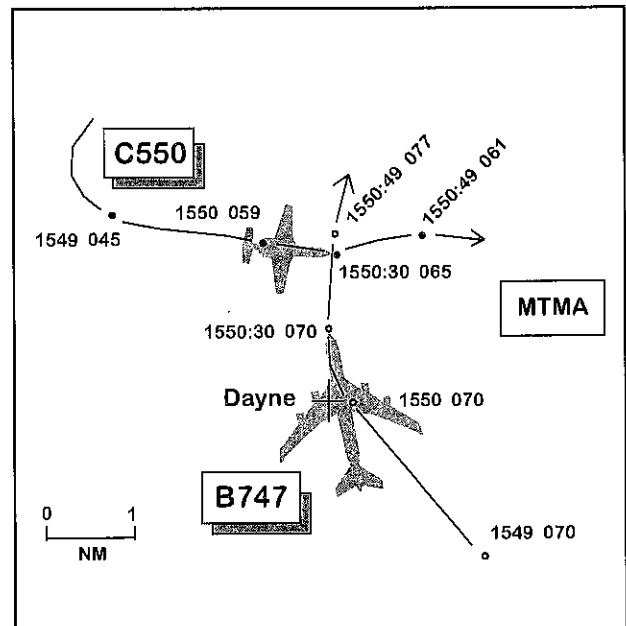
AIRPROX REPORT No 18/99

Date/Time: 18 Feb 1551
Position: N5316 W0201 (10 NM SE Manchester airport)
Airspace: MTMA (Class: A)
Reporting Aircraft Reported Aircraft
Type: B747 - 436 C550
Operator: CAT Civ Pte
Alt/FL: FL 70 ↑ FL 60
Weather IMC IMC
Visibility:
Reported Separation: Not reported
Recorded Separation: 1 NM/500 ft

Cause: The C550 pilot exceeded his cleared level

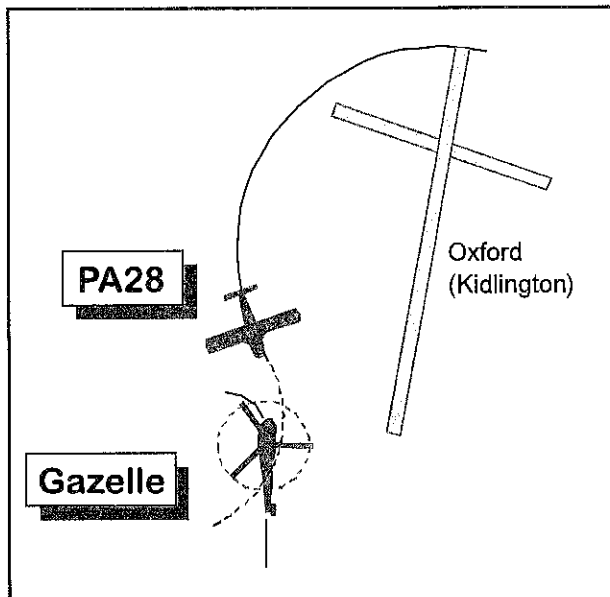
AIRPROX REPORT No 19/99

Date/Time: 16 Feb 1508
Position: N5150 W0119 (Kidlington - elev 270 ft)
Airspace: ATZ (Class: G)
Reporting Aircraft Reported Aircraft
Type: Gazelle PA28
Operator: HQ DAAvn Civ Trg
Alt/FL: 2100 ft 2100 ft ↓
(QNH) (QNH)
Weather VMC CLOC VMC CLNC
Visibility: 20 km 10 km+
Reported Separation: 60 ft/150 yd
Recorded Separation: N/K

Cause: Apparent lack of traffic information from Oxford ATC compounded by late sightings by the pilots of both ac.

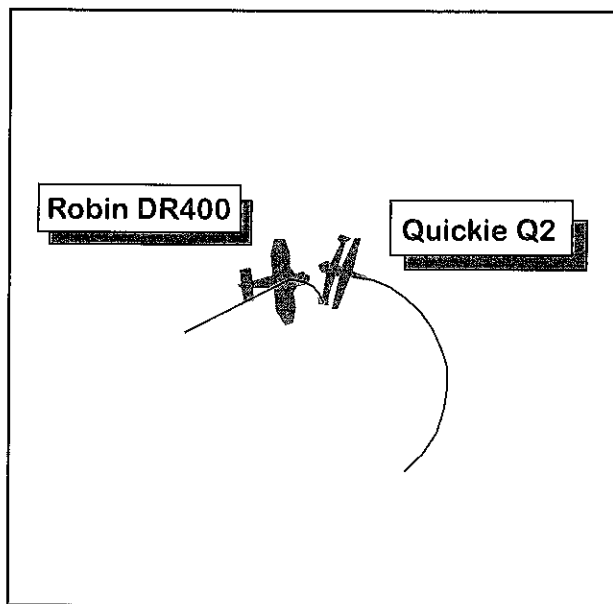
AIRPROX REPORT No 20/99

Date/Time: 23 Feb 1440
Position: N5200 W0228 (6 NM SW Banbury)
Airspace: FIR (Class: G)
Reporting Aircraft Reported Aircraft
Type: Quickie Q2 kitplane Robin DR400
Operator: Civ Pte Civ Trg
Alt/FL: 2000 ft 2500 ft
(QFE) (QNH 1015 mb)
Weather VMC HAZE VMC
Visibility: 10 NM >10 km
Reported separation: Hor 50 ft/ Hor 10 m/
Vert zero Vert zero
Recorded separation: Unrecorded

Cause: Late sighting by the Quickie pilot.

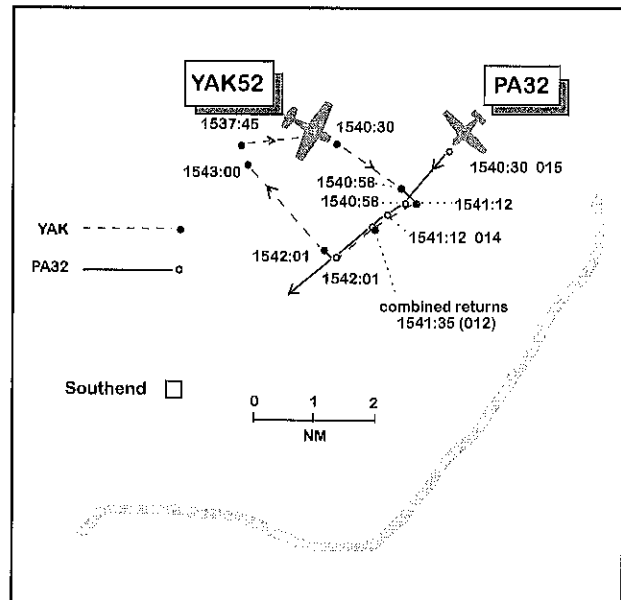
AIRPROX REPORT No 21/99

Date/Time: 23 Feb 1542
Position: N5137 E0047 (4 NM NE Southend)
Airspace: FIR (Class: G)
Reporting Aircraft Reported Aircraft
Type: PA32 YAK 52
Operator: Civ Pte Civ Pte
Alt/FL: 1050 ft ↓ 1500 ft ↑
(QNH 1015 mb) (QNH 1014 mb)
Weather VMC CAVOK VMC CAVOK
Visibility: 20 NM
Reported separation:
Horiz 100 m
Vert zero

Cause: The Yak crew flew sufficiently close to the PA32 to cause concern to its pilot.

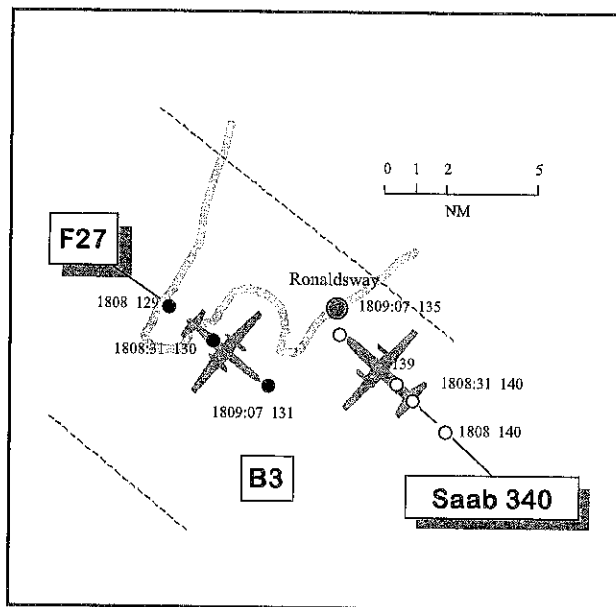
AIRPROX REPORT No 22/99

<u>Date/Time:</u>	24 Feb 1809	TWILIGHT
<u>Position:</u>	N5403 W0439 (2 NM SW Ronaldsway airport)	
<u>Airspace:</u>	AIRWAY B3	(Class: A)
<u>Reporter:</u>	ScACC	
	<u>First Aircraft</u>	<u>Second Aircraft</u>
<u>Type:</u>	Saab 340	F27
<u>Operator:</u>	CAT	CAT
<u>Alt/FL:</u>	FL 40 ↓	FL 130
<u>Weather:</u>	VMC	
<u>Visibility:</u>	10 km	
<u>Reported Separation:</u>		5 NM/1000 ft
<u>Recorded Separation:</u>		2.6 NM/400 ft

Cause: The Antrim and West Coast P and E Controller inadvertently issued a clearance to the wrong ac.

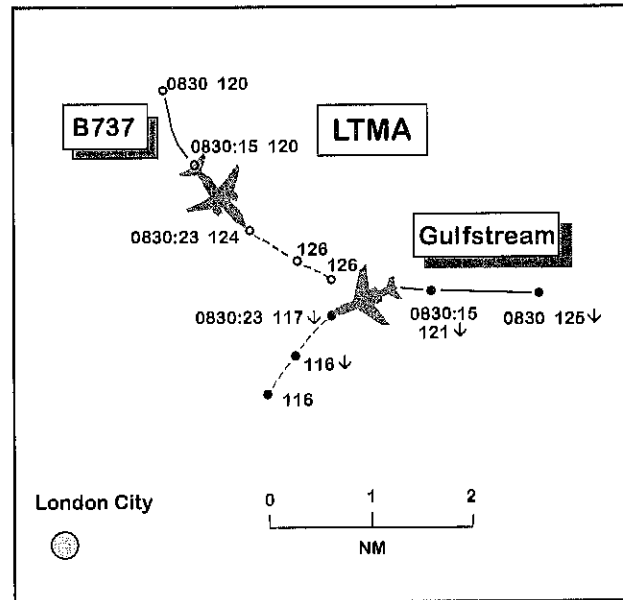
Cause: The LATCC TC LAM SC descended the Gulfstream to a level occupied by the B737.

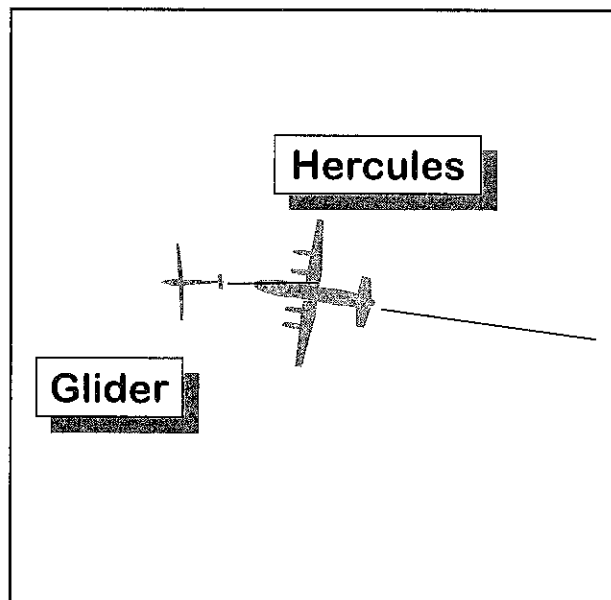
AIRPROX REPORT No 24/99

Date/Time: 27 Feb 1301 (Saturday)
Position: N5135 W0141 (1 NM W of Shrivvenham - elev 350 ft)
Airspace: FIR (Class: G)
Reporting Aircraft Reported Aircraft
Type: Hercules K18 glider
Operator: HQ STC Civ Club
Alt/FL: 2000 ft 2700 ft ↓
(QFE 991 mb) (QFE)
Weather VMC CLBC VMC CLBC
Visibility: 40 km 30 km
Reported Separation: 200 ft/500 ft
Recorded Separation: 450 ft

Cause: Confliction of flightpaths in Class G airspace, resolved by the Hercules pilot.

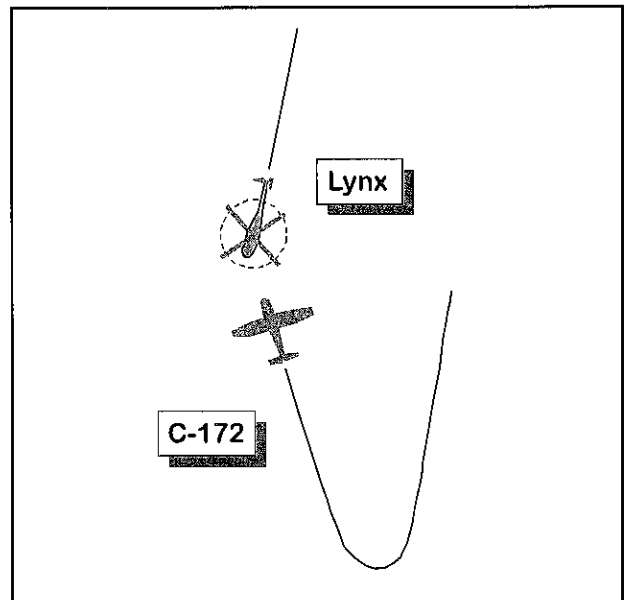
AIRPROX REPORT No 26/99

Date/Time: 2 Mar 1222
Position: N5217 W0050 (2 NM SW of Sywell)
Airspace: FIR (Class: G)
Reporting Aircraft Reported Aircraft
Type: Lynx Cessna 172
Operator: HQ DAAvn Civ Trg
Alt/FL: FL 40 4200 ft
 (QNH 1003 mb)
Weather IMC INCL IMC CLBL
Visibility: 1-200 m 1 - 1.5 km
Reported Separation: 50-100 ft/1-200 ft
Recorded Separation: N/K

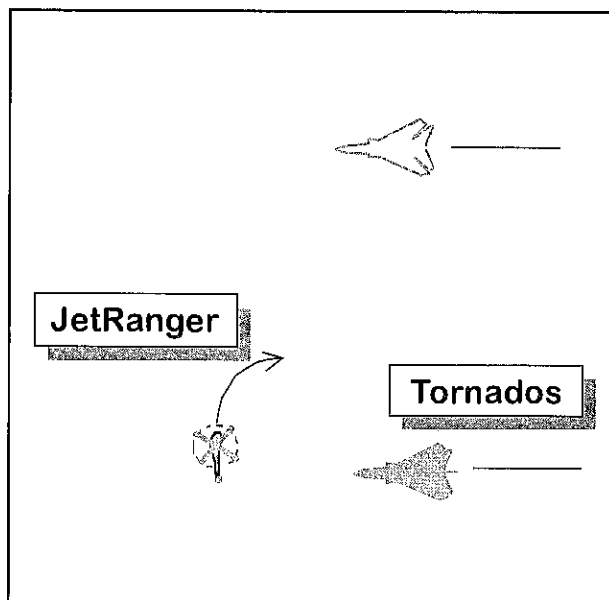
HQ STC comments that the JetRanger pilot appears to have taken his initial avoiding action on the northerly Tornado and whilst focused on this manoeuvre his observer acquired a late sighting of the southerly Tornado passing close astern, apparently without deviation. Meanwhile, the crew of the southerly Tornado, which was on a conflicting flightpath, had visually acquired the JetRanger and taken appropriate avoiding action – including the transmission of a warning to his wingman. Although the Tornado crew assessed that no

risk of collision existed and took calm and controlled avoiding action, it is clear that the miss distance of only 400 ft when allied to the late sighting by the JetRanger crew, contributed to the helicopter crew's assessment of a high risk of collision.

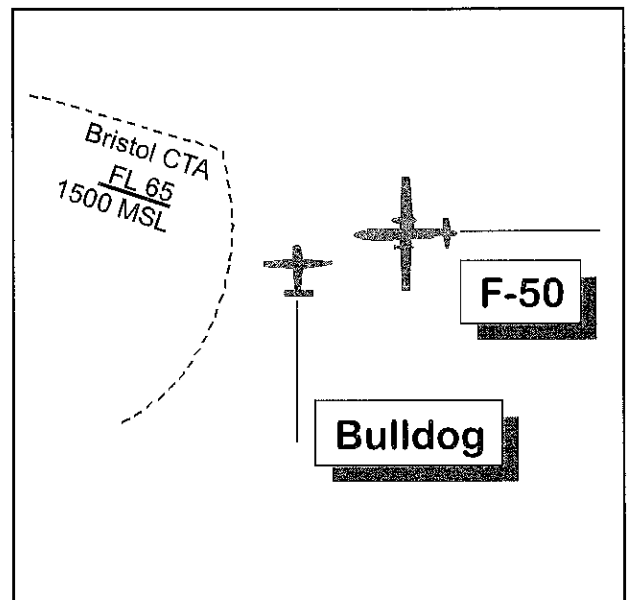
Date/Time: 31 Jan 1027 (Sunday)
 Position: N5124 W0226 (1 NM NW of Bath)
 Airspace: FIR (Class: G)

<u>Reporting Aircraft</u>	<u>Reported Aircraft</u>
Type:	F50	Bulldog
Operator:	CAT	HQ PTC
Alt/FL:	3500 ft ↓ (QNH 1041 mb)	2500 ft (QNH)
Weather	VMC HZBC	VMC CLBC
Visibility:	1.5 - 2 NM	
Reported Separation:	300 ft V, 200 m H	
Recorded Separation:	NK

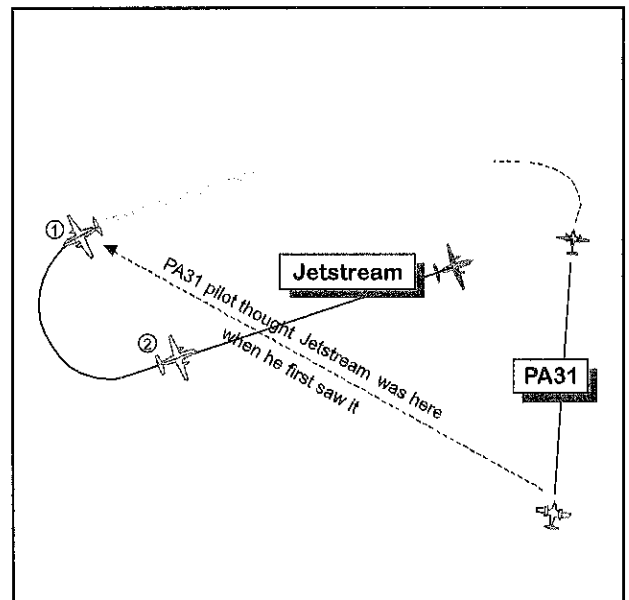
THE JETSTREAM PILOT reports heading 070° at 130 kt downwind in a LH circuit for RW 26 at Coningsby. Approaching the end of the downwind leg, and while carrying out the pre-landing checks, he was told by ATC that a PA31 was joining downwind. Before turning left onto finals he checked to the right and saw the PA31 700 m away joining on base leg and closing rapidly in his 1:30; it came across his nose 200 m away at the same level but the risk of collision was low because he had it in sight and could see it would not actually collide with him. It then turned left and descended with its gear down.

THE PA31 PILOT reports heading 345° at 170 kt having been cleared to join left base for RW 26. He had been advised that there was one other ac in the circuit which he saw starting a crosswind turn as he was approaching the airfield from the S but he was not told its type or

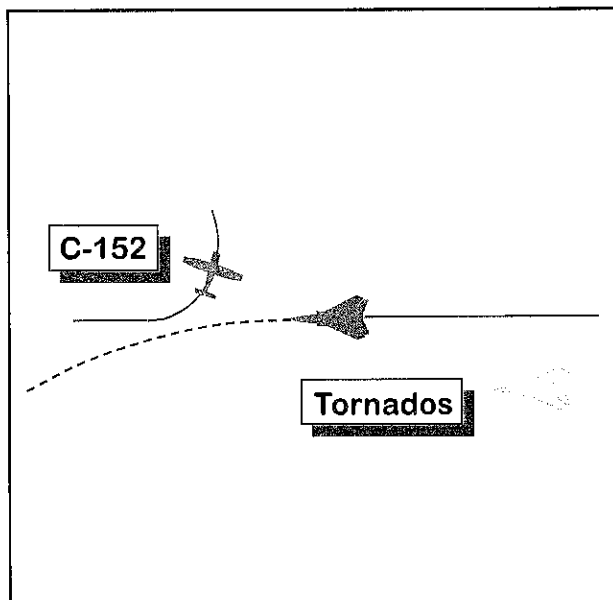
HQ STC comments that it is particularly difficult to see small, slow moving ac at low altitude. In this instance the Tornado crew saw the Cessna with sufficient time to take appropriate avoiding action and to warn their wingman. In their subsequent comment the Tornado crew have expressed surprise at encountering the Cessna below 500 ft. Clearly, operators of light ac have a right to the lower airspace within the context of the rules governing their operations and accordingly all RAF crews will be reminded of this fact via the IFS (RAF) Feedback publication.

The Cessna crew had been advised of Tornado traffic and knew that they were operating in an area where military fast jet traffic is not uncommon. Under circumstances such as this, it behoves all light ac operators to maintain optimum lookout, especially when ac performance is poor during manoeuvres such as PFLs.

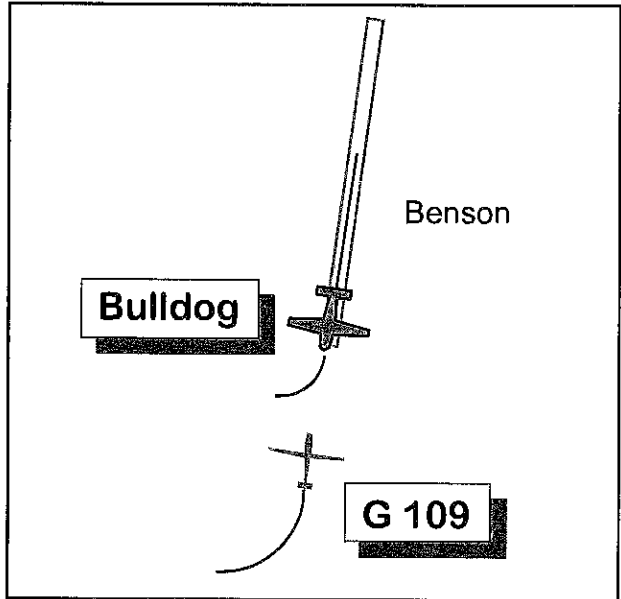
AIRPROX REPORT No 31/99

Date/Time: 9 Mar 1622
Position: N5137 W0106 (Benson - elev 203ft)
Airspace: ATZ (Class: G)
Reporting Aircraft Reported Aircraft
Type: Bulldog Grob 109
Operator: HQ PTC Civ Club
Alt/FL: 250-300 ft ↑ 100 ft ↓
 (QFE) (QFE 984 mb)
Weather VMC CLBC VMC CLBC
Visibility: Unltd 8 km+
Reported Separation: 50 ft V
 800 m H, 50 m V
Recorded Separation: NK

Members agreed with HQ PTC's opening comments about the Grob pilot's surprising lack of awareness of what the D & D cell at West Drayton would have been happy to provide to a pilot uncertain of his position. The result was very unprofessional conduct on his part and the Board concluded that the cause of the Airprox was that the Grob pilot had flown without authorisation into the Benson ATZ, contrary to Rule 39, and into conflict with the Bulldog. Members assessed that the safety of the ac had been compromised.

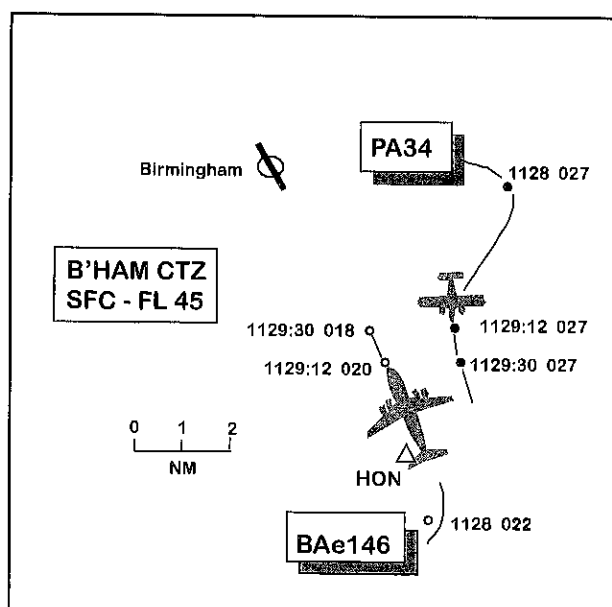
BIRMINGHAM ATC reports that traffic loading was medium. Following an ILS and missed approach to RW 33, the PA34 was flying a radar heading of 090° at 2500 ft (QNH) prior to setting course out of the CTZ to return to base. When at a point E of the airfield the pilot was instructed to resume his own navigation; at this time the BAe146, having been radar vectored for the ILS to RW 33, was on L base leg descending from 2500 ft to 2000 ft (QNH). The PA34 was then seen to be tracking directly towards Honiley; its pilot was instructed to turn L heading 110° to keep him clear of HON and the BAe146. However, the turn was slow, owing to the effect of an easterly wind prevailing, so the heading was amended to 090° together with an instruction to climb to 3500 ft. The ac passed with a separation of about 1.6 NM and 500 ft thereby triggering the SMF equipment.

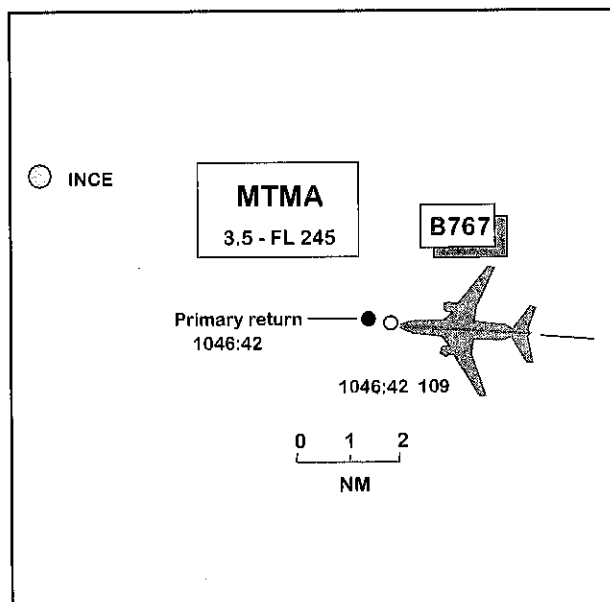
THE B767 PILOT reports that he departed from Manchester at 1041. At 1049, while climbing through FL 110 at 500 ft per min on a westerly heading within CAS, an ultralight ac was seen directly ahead and below them. They had less than a second to react and by the time the co-pilot, who was flying the ac, had instinctively begun to raise the nose, the ac passed less than 100 ft directly below them. Their main concern was that the other ac might have encountered turbulence from the B767's wake.

passing FL 70. At 1047, when 076°/12.5 NM from WAL and climbing through FL 110, the pilot reported passing overhead a microlight with less than 100 ft separation. A primary return was observed at the position and traced to the St Helens area.

Cause: While endeavouring to overcome engine difficulties the microlight pilot allowed his ac to fly into Class A Airspace and into conflict with the B767, which he did not see.

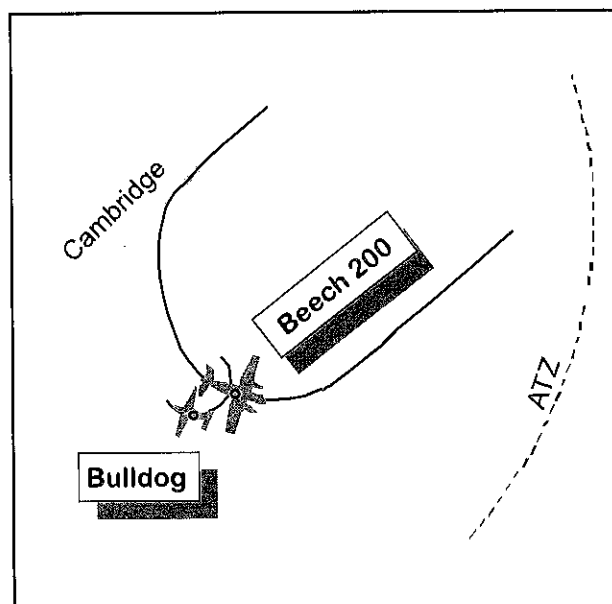
THE BULLDOG PILOT reports flying LH circuits for RW 23 at Cambridge at 800 ft. He was asked to orbit in the downwind position for an ILS calibration ac which was at 6 NM running in. Three quarters of the way round his second orbit, heading 320° at 80 kt, he suddenly saw a T-tailed twin-engined ac in a tight left hand turn at the same altitude about 200 ft away. There was no time for avoiding action as the speed of the twin took it rapidly past him with a high risk of collision. He said on RT that the Beech 200 had passed too close. He had not received any traffic information on it after the 6 mile call and reported the Airprox after landing.

Cause: The Kingair pilot flew close enough to the Bulldog to cause its pilot concern for the safety of his ac.

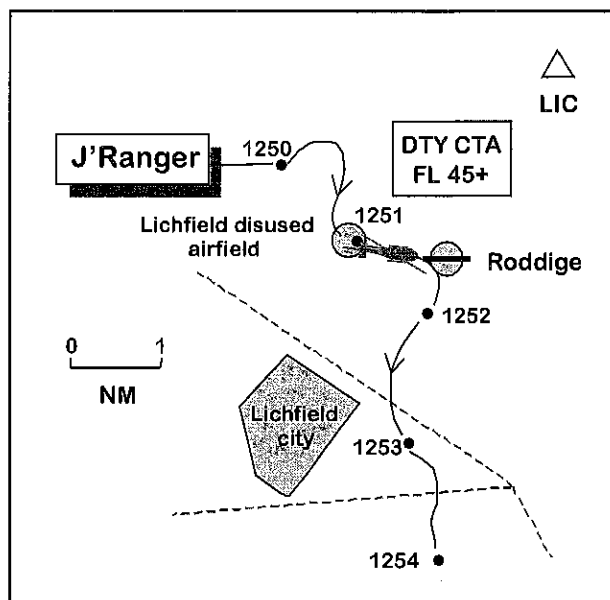
THE MICROLIGHT PILOT reports that he was heading 360° at 50 kt and descending through 300 ft agl while engaged in a circuit training detail on RW 09 at Roddige. The visibility was 30 km in VMC. He was listening out on Birmingham's radar frequency (118.05) and heard a helicopter reporting over Lichfield disused airfield (1.5 NM to the W). On looking in that direction, he saw the helicopter flying towards him at high speed and immediately initiated a full power climb in avoidance; the helicopter passed about 50 ft directly below him with no apparent change of heading and was then observed to turn R towards Lichfield city. He believed that had he not taken avoiding action there would have been a collision.

THE JETRANGER PILOT reports that he was NW of Lichfield in the descent from 1000 ft to 500 ft at 90 kt on a pipeline inspection flight. He was squawking 0036 with no Mode C. The visibility was 10 km in VMC. While calling Birmingham for a FIS on 118.05 he noticed a shadow on the ground and a microlight was then seen in level flight about 0.5 NM ahead tracking towards him at about co-altitude: he thought it must have climbed from under his horizon having just taken-off from a local field. A rapid powered descent and turn to the R was initiated and the microlight passed down his port side 150 m away and 200 ft above. The pilot does not give an assessment of risk but

Cause: Late sighting by the helicopter pilot in close proximity to an active microlight site.

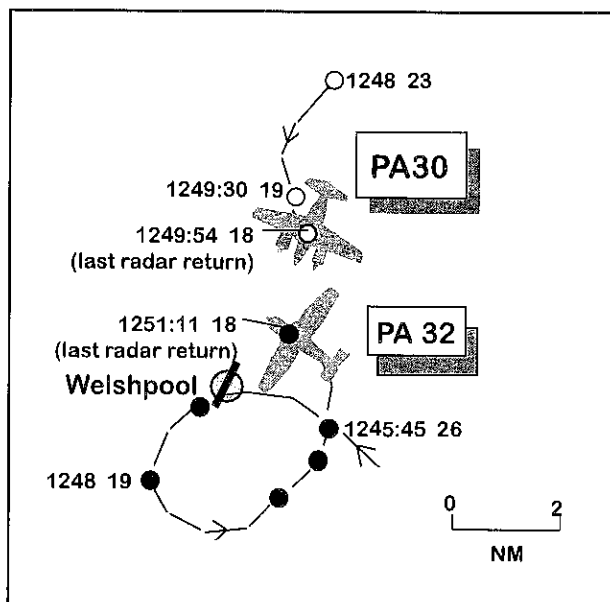
THE PA30 PILOT reports that he was inbound to Welshpool from Newcastle in VMC. The visibility, 2000 ft below cloud, was over 10 km. Approaching the airfield he changed from

Cause: The PA30 flew into conflict with the PA32, and the PA32 pilot did not see the PA30.

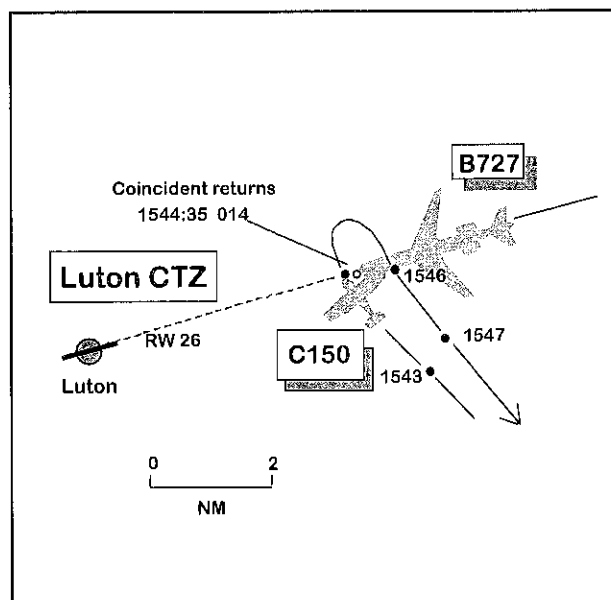
THE B727 PILOT reports that he was established on final approach for an ILS to RW 26 at Luton airport at 150 kt. Visibility directly ahead was severely degraded by haze and a low bright sun. When about 4 NM from touchdown and descending through 1800 ft (QNH), he suddenly noticed a high wing Cessna type ac at his 11 o'clock 500 m away tracking from L to R. He thought it had been climbing but had levelled off when its pilot spotted him. As the ac was 300-400 ft below and they were able to keep it in sight, except for a few seconds when it passed directly under their nose, no avoiding action was considered necessary. He did not think there had been a danger of collision provided the other pilot had spotted them, but felt the risk would have been much greater if he had not. He reported the incident to the Luton Tower controller.

Cause: The Student of C152 pilot inadvertently entered the Luton CTZ and flew into conflict with the B727 which he did not see.

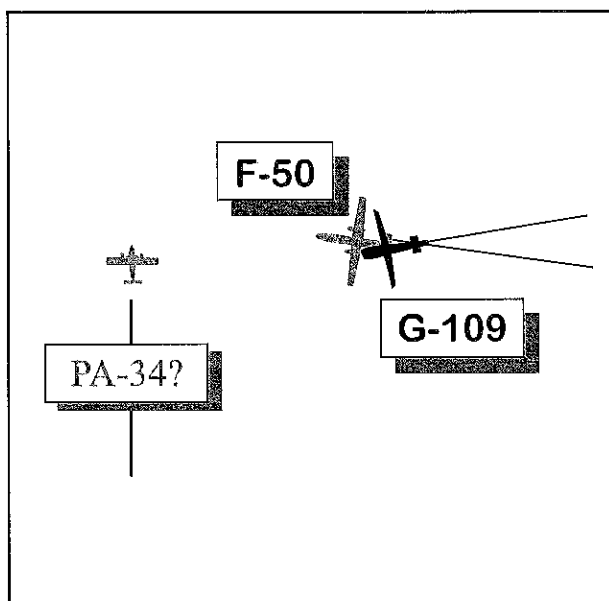
AIRPROX REPORT No 39/99

THE FOKKER PILOT reports heading 280° at 160 kt on the ILS centreline at 2500 ft for an approach to RW 28 at Sheffield with whom he was communicating on 128.52. He saw a glider about 0.25 NM ahead and above which was hard to see due to its slender line and the position of the sun. Within seconds he had passed less than 500 ft under it and slightly to its right; it was a motor glider on a similar heading. Just before passing under it he saw another ac akin to a Seneca at his 12 o'clock crossing S to N at high speed about 500 ft above and 0.5 NM ahead. He saw this ac late due to paying attention to the glider which he had passed before he could take any avoiding

Cause: Sighting report.

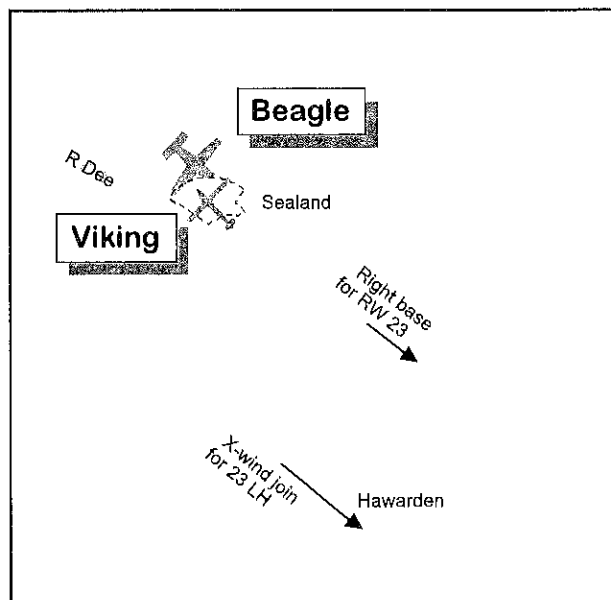
AIRPROX REPORT No 40/99

THE VIKING PILOT reports heading 300° at 62 kt on a winch launch from RAF Sealand when he was warned of an approaching ac and told by radio to release the cable; this he did at 750 ft. He levelled at 800 ft and saw a low wing single engined ac passing in the opposite direction 100 ft above and 150-200 ft to his right. The other ac took no avoiding action and

Cause: By not conforming to his joining instructions, the Beagle pilot flew into conflict with the glider which he did not see.

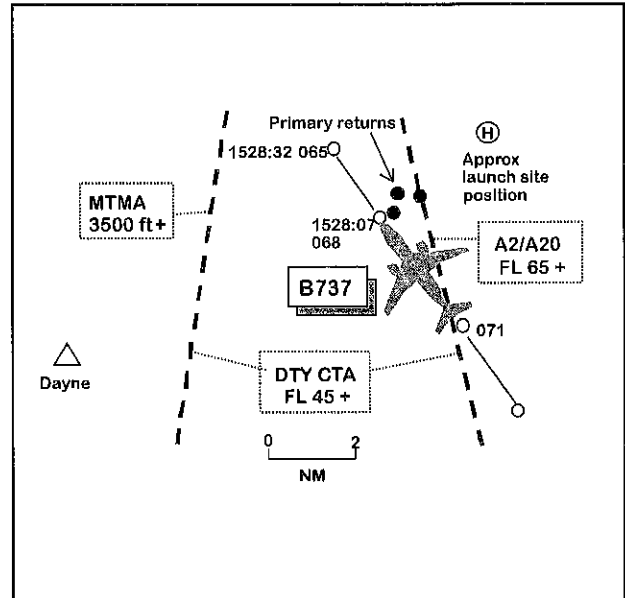
AIRPROX REPORT No 41/99

THE B737 PILOT reports that he was heading 300° at 310 kt and descending to FL 60 inbound to Manchester. When passing FL 65, 16 NM/100°R from the MCT, he saw a hang glider with bright orange wings at co-altitude as it tracked away from him at his 2 o'clock position 200 m away. He thought there had been a high risk of collision and reported the encounter to Manchester APC.

Cause: Confliction of flightpaths near the boundary of controlled airspace.

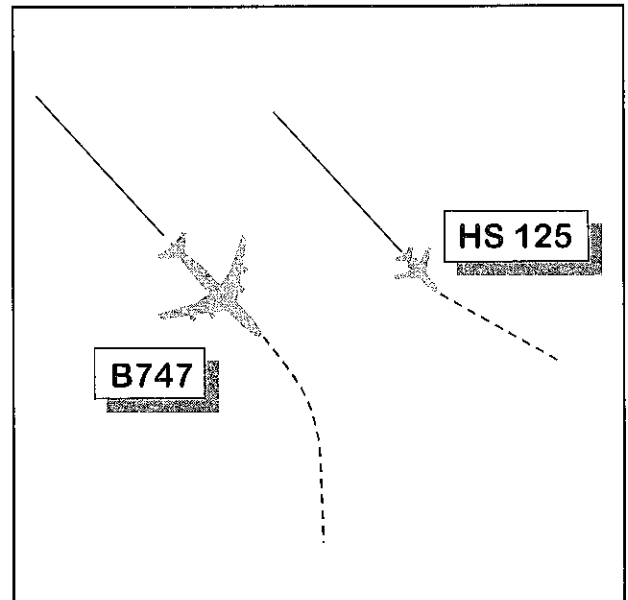
THE HS125 PILOT reports heading 140° at 210 kt, transiting the BNN hold at FL 70. He had seen the B747 earlier, in the hold about 1000 ft above. His co-pilot then saw the B747 paralleling their track about 0.5 NM to the right and somewhat behind and although it looked less than 1000 ft above he was content because it was not converging, and conditions were VMC. ATC asked the B747 pilot his passing level and the reply was FL 76; it was then given an immediate right turn onto S in avoidance and he was told to turn left. The risk was low but any further descent by the B747 could have produced a high risk.

Cause: The INT DIR N cleared the B747 to descend to the level occupied by the HS125.

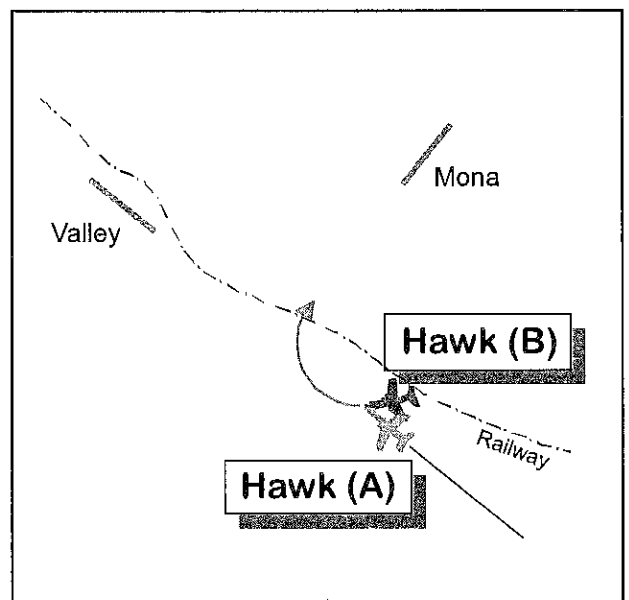
AIRPROX REPORT No 43/99

THE HAWK PILOT (A) reports heading 319° at 150 kt leading a pairs GCA to RW 32 at Valley. As he came out of the cloudbase at 1500 ft he saw another Hawk pass about 100 ft below in a right turn which continued towards Mona to join for RW 04. There was no time for avoiding action when he saw the Hawk and the risk of collision was high.

Cause: Hawk B flew across the final approach path for RW 32 at Valley.
