UK AIRPROX BOARD

Analysis of Airprox in UK Airspace

Report Number 2

January 1999 to June 1999

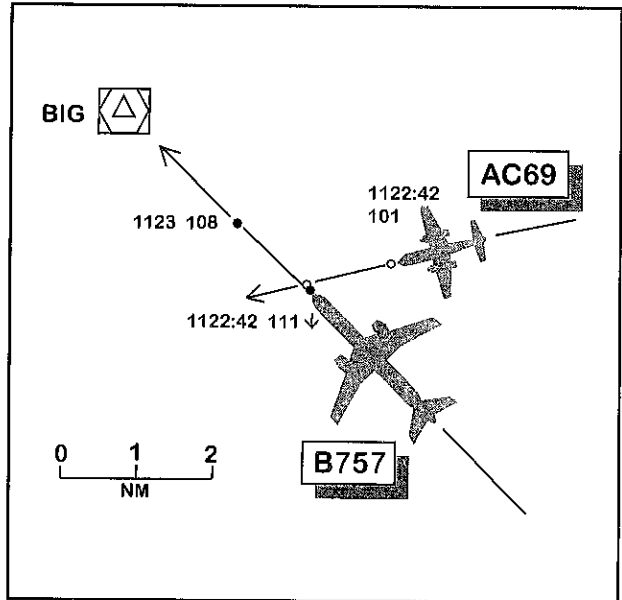
LATCC TC reports, with RT transcript, that the B757, inbound to Heathrow from Geneva, first called on the LATCC TC SE sector frequency at 1116 descending through FL 220 for FL 160; the ac was then further cleared to FL 140. The Rockwell Commander, conducting an aerial survey, was flying a radar heading of 260° at FL 100 to pass just S of BIG. At 1119:53 the B757 was instructed to descend to FL 110 which was clearly and correctly read back by the pilot who then asked if there was any speed restriction or holding delay. He was told "standard speeds" and "no delays expected". At 1121:29 the B757, now about 2 NM S of the survey ac and descending through FL 122, was instructed to leave BIG on a heading of 275° and at 1122:20 to contact the Heathrow Int S Director. The STCA triggered 'white' at 1122:46 as the B757, indicating FL 111 and descending, passed about 1 NM in front of the survey ac. After the ac paths crossed the alert almost immediately changed to red as lateral separation briefly reduced to 0.9 NM.

Cause: The B757 descended below its cleared level.

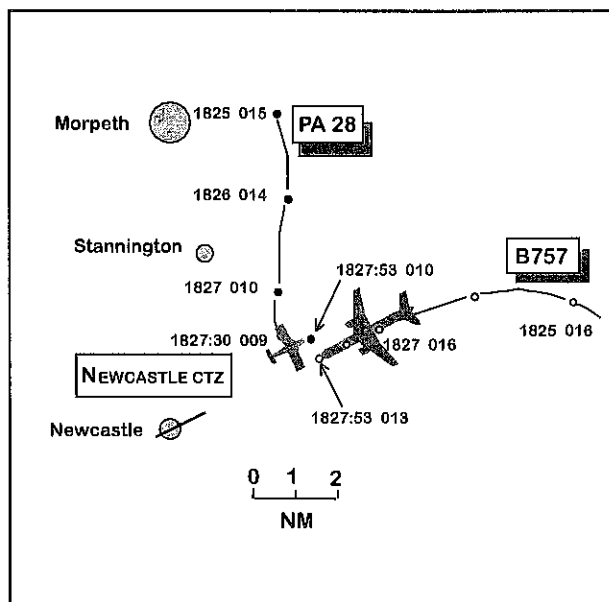
AIRPROX REPORT No 45/99

THE B757 PILOT reports that while heading 250° at 127 kt and descending through 1300 ft (QNH 1022) on final approach to RW 25 at Newcastle, a TCAS TA alerted him to traffic. At 1200 ft an RA demanded climb which was carried out to 2500 ft as per the published procedures. The other ac was not seen but was believed to have passed about 200 ft below and within 0.5 NM to their starboard side with a high

Cause: The PA28 pilot did not follow ATC instructions.

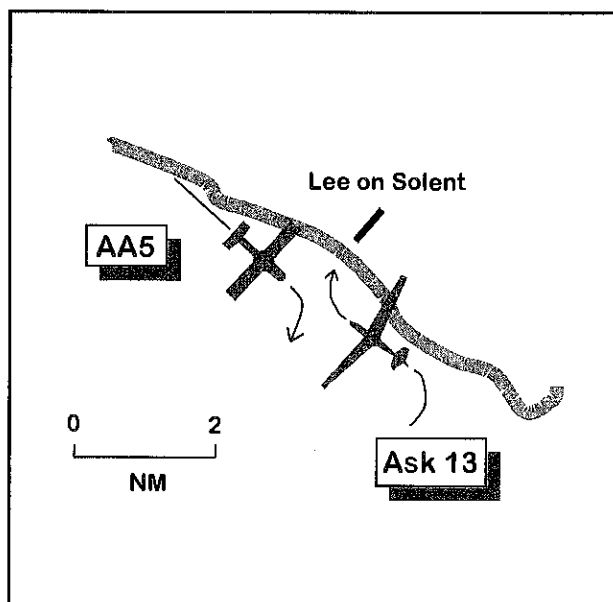
THE GLIDER PILOT reports that he was flying at 1200 - 1400 ft about 0.25 NM to the SW of Lee-on-Solent, from where he had launched earlier and with whom he was in contact on 135.7. The visibility was 5 - 10 NM in VMC. He had briefed his pupil to carry out clearing turns prior to spin training and they had just completed one of these to the L. On turning R at 45 - 50 kt, a low wing single engined ac, which had previously been obstructed by the glider's starboard wing during the L turn, was seen about 200 yd directly ahead of him flying on a reciprocal track at the same altitude. He thought the other pilot must have seen them first because his ac was already turning R, apparently in avoidance. He dived, continuing to turn R, and the other ac passed about 200 yd to his L. When subsequently asked by UKAB to assess the risk factor, the glider pilot said that he thought it had been medium to high.

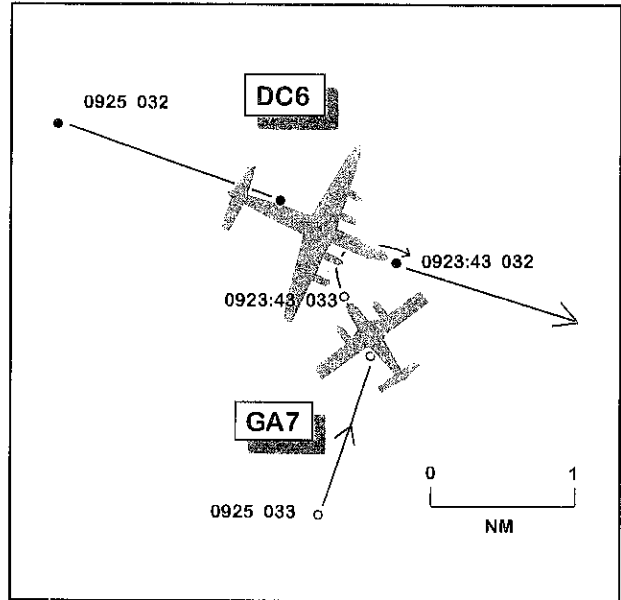
AIRPROX REPORT No 47/99

THE GA7 PILOT reports heading 025° at 135 kt while joining the CIT holding pattern at Cranfield at 3500 ft (QNH 1024). IF screens were in place. He was under an APC service from Cranfield on 122.85 and squawking 7000 with Mode C. The visibility, above cloud, was 25 km in VMC. As he approached the beacon, a DC6 appeared from behind the screen tracking L to R at his 10 o'clock, slightly above, about 1 NM away. He immediately turned hard L in avoidance and passed behind the other ac. In his opinion there had been a very high risk of collision and he reported an Airprox to Cranfield APC. He comments that this was yet another example of a pilot not calling on the Cranfield frequency despite apparently using the CIT NDB as a navigational beacon.

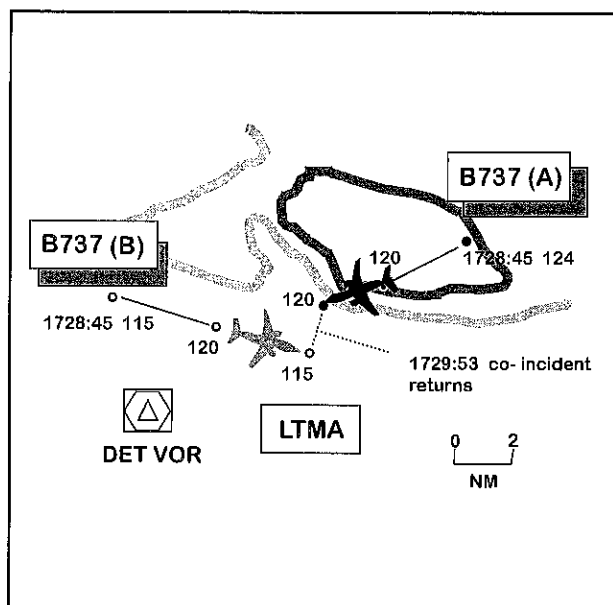
THE LATCC TC SE (inbound) SC reports that B737 (A), inbound to Gatwick from Kiev, entered his sector at FL 130 in accordance with the standing agreement. The ac was streamed with speed control due to another Gatwick inbound close behind it. The TC SE (outbound) controller was working an outbound ac (B737 (B)) whose track crossed the inbound route at DET. In these situations standard procedure was to keep B737 (A) at FL 130 until S of the MAY-DVR track unless co-ordinated otherwise. When the two B737s were still about 20 NM apart, with B737 (B) still at FL 80, the outbound SC pointed at the DET area and said something like 'twelve'. He interpreted this as meaning that he could descend the first inbound ac to FL 120. The two inbound ac were close together and he believed the outbound SC had suggested this to help him, by keeping B737 (B) on a radar heading to take it well ahead of B737 (A). He therefore descended B737 (A) to FL 120 and then turned his attention towards the BIG area where he was controlling 4 other inbound ac. When he next looked back at DET he saw that B737 (B) was at DET turning

towards B737 (A) at FL 120. He instructed B737 (A) to make an immediate R turn and gave traffic information (though the words 'avoiding action' were not used). He estimated the ac passed with a lateral separation of 1 NM. Subsequently he noticed that the SE outbound SC had not written the co-ordinated descent to FL 120 on his DET FPS, and that therefore his interpretation of the word 'twelve' had been incorrect.

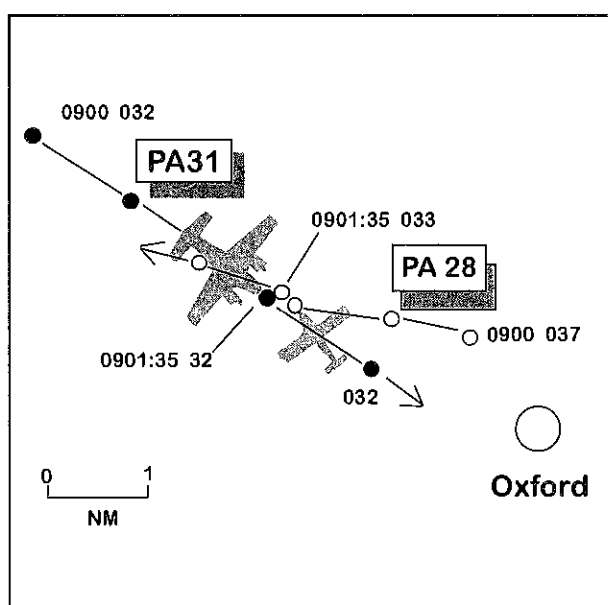
THE PA28 PILOT reports that he was conducting a simulated IMC training flight in the instrument procedure at Oxford with a student instructor. Although the visibility was greater than 10 km when clear of cloud, much of the flight was in IMC in or between layered cloud. Shortly after leaving 3500 ft (QNH 997) for 2000 ft, he heard the pilot of another ac call Oxford APC reporting routeing via the Oxford overhead to Chalgrove at 2500 ft; its pilot was given traffic information on all known Oxford traffic, including the PA28, and was instructed to "Maintain VFR". Just prior to entering cloud at 3000 ft the PA28 pilot saw the other ac, a PA31

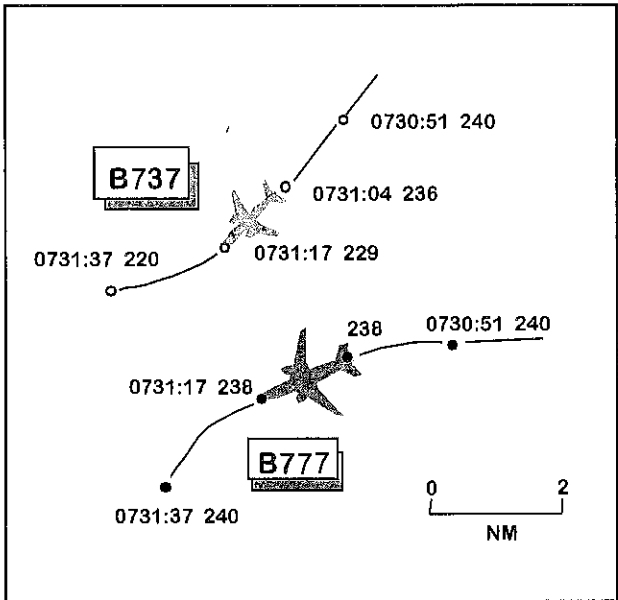
AIRPROX REPORT No 51/99

PART A: SUMMARY OF INFORMATION REPORTED TO UKAB

The Board was advised by ATSI that the Clacton sector 14 Sector Controller did not recognise in sufficient time that the descent clearance issued to the B737 took it to a level already occupied by the B777, which was on a conflicting track. Members agreed that this error caused the Airprox. Although the controller eventually successfully resolved the conflict, valuable time was lost because avoiding action phraseology was not used in the initial stages of the conflict. Radar evidence shows that although label overlapping was not a problem at the time the controller issued the descent clearance, it might later have hindered the identification of the conflicting traffic when the STCA activated.

Cause: The Clacton Sector 14 SC descended the B737 to a level already occupied by the B777.

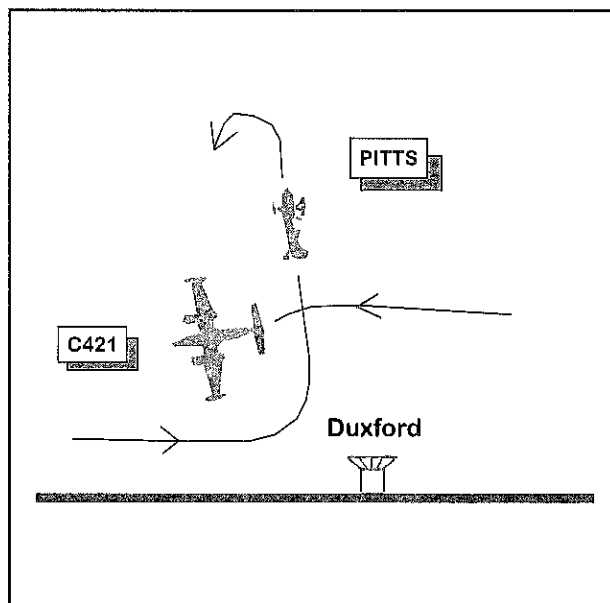
There was little discussion on this incident as the Board quickly concluded that the C421 pilot, by his own admission, had infringed the Duxford ATZ and thereby caused the Airprox. Several members commented on the short journey flown by the C421. They felt it was perhaps an inappropriate time to be familiarising with a new ac when the pilot should have been

Despite the C421's late avoiding action members noted that the ac still passed almost directly beneath the Pitts with very little lateral separation, therefore the manoeuvre appeared to have had little effect on deconflicting the ac. The Pitts pilot had virtually no directional control over his ac and was forced to rely on engine power alone to maintain his vertical attitude for a moment while the other ac passed underneath. Under these circumstances the Board concluded that neither pilot had been able to influence effective separation and that a collision was only avoided by chance.

Cause: The C421 pilot infringed the Duxford ATZ.

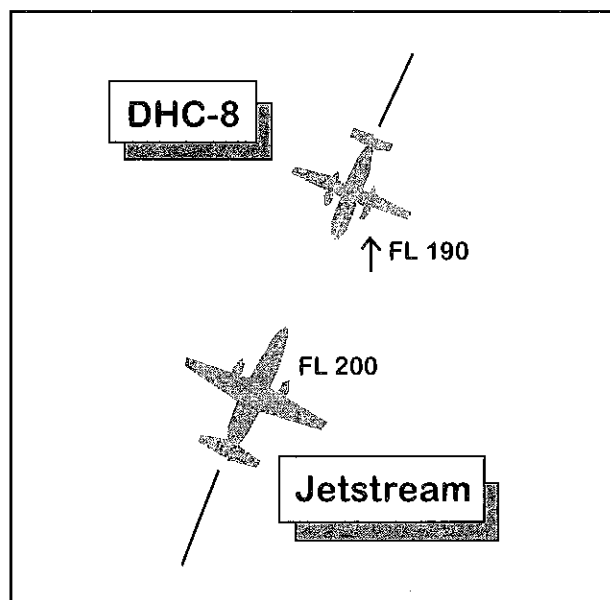
AIRPROX REPORT No 53/99

THE DHC-8's Company comments that the level bust was probably caused by the handling pilot adjusting the flight guidance pitch trim wheel as the ac approached the altitude capture envelope. This is a known trap and the crew is now the wiser for it. The incident also highlights the importance of the non-handling pilot adequately monitoring the ac flight path at all times, particularly at critical times of flight. The Company is conducting a "Level Bust" awareness campaign within the airline with particular emphasis on the importance of adherence to the check lists and SOPs in recent Flight Operations Department Communications.

There was little discussion on this incident as it was clear from the DHC 8 pilot's report and his Company's comments that the cause of the error had been recognised and addressed. The issue was essentially one of CRM and the Board concluded that inadequate monitoring and crew co-operation on the flight deck lay behind the ac climbing through its assigned level, so causing the Airprox. However, both radar and SMF data indicated that minimum separation was in the order of 3 NM and 600 ft and the Board was satisfied that there had not been a risk of collision.

Cause: The DHC 8 pilot climbed above his cleared level.

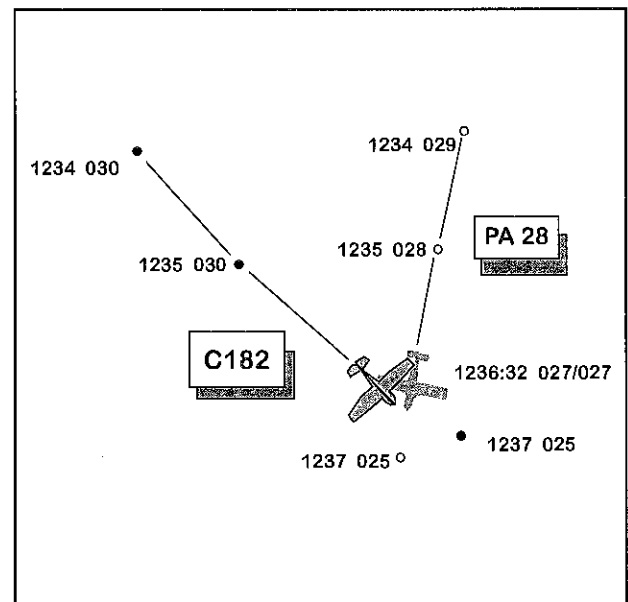
AIRPROX REPORT No 54/99

While theoretically the C182 pilot had right of way under the Rules of the Air, members noted that he was overtaking the PA28 and they felt that he therefore bore equal responsibility for giving way. There was agreement that both pilots were jointly responsible for seeing and avoiding each other in Class G airspace and, notwithstanding the geometrical aspects, they should have done so earlier in the excellent flying conditions reported. The Board concluded that the late sightings by both pilots caused the Airprox. Moreover, given the minimal miss distances estimated by both pilots, which were supported by the radar video recording, the Board concluded that there had been an actual risk of collision.

Cause: Late sighting by both pilots.

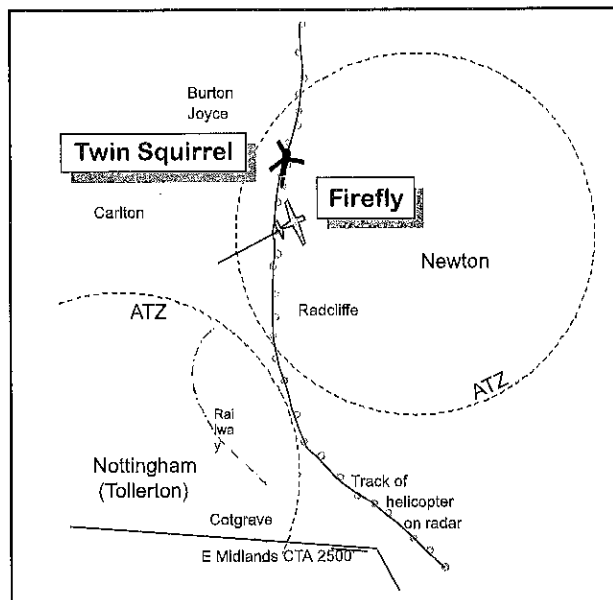
Members agreed that there was no reason to doubt the accuracy of the radar recording for two reasons. First, tracks of other East Midlands and Newton traffic were as expected. Second, if the helicopter pilot had tracked as suggested to FOI, it would not have been seen by Newton ADC and would have passed behind the Firefly, not in front of it. (Part of the helicopter operator's argument was that the helicopter had not been seen by Newton ATC but in fact it had been.) Although the Board agreed that the cause of the incident was that the Twin Squirrel pilot had flown through the Newton ATZ without calling on RT, members considered the encounter with the Firefly was hardly an Airprox; clearly there had been no risk of the ac actually colliding.

Cause: The Twin Squirrel infringed the Newton ATZ.

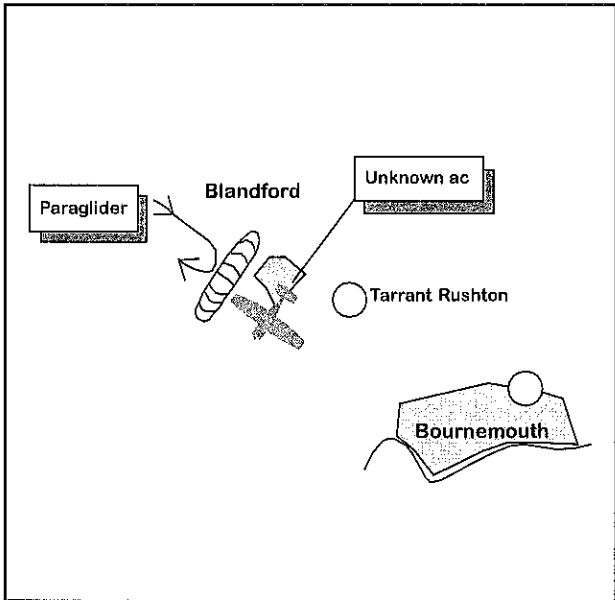
AIRPROX REPORT No 56/99

evidence to corroborate the paraglider's estimate of minimum distances, members nevertheless believed his account and concluded that his action, limited though it was owing to lack of speed and manoeuvrability, reduced the severity of the encounter and removed the risk of collision. Members noted that the paraglider pilot had time to assess the absence of avoiding action by the other pilot before he took action himself, indicating that the manoeuvre was a considered act rather than an instinctive reaction. Although this reduced the risk factor, members accepted the possible serious effects of downwash on the paraglider's canopy and concluded that the other ac passed sufficiently close to the paraglider to compromise its safety.

Cause: A confliction in Class G airspace resolved by the paraglider.

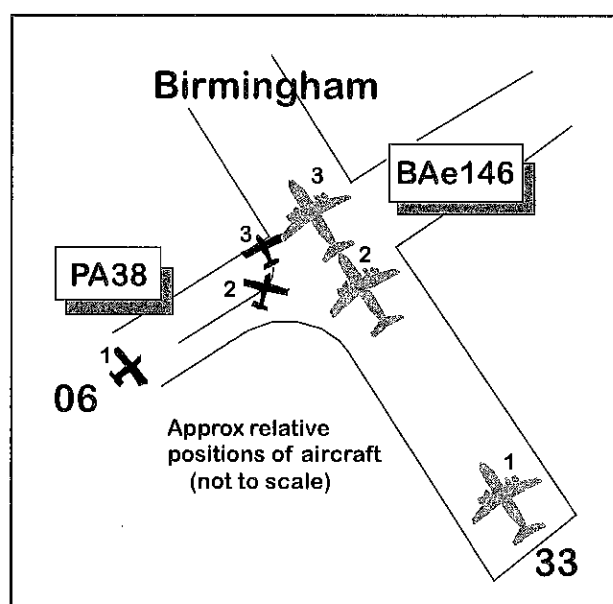
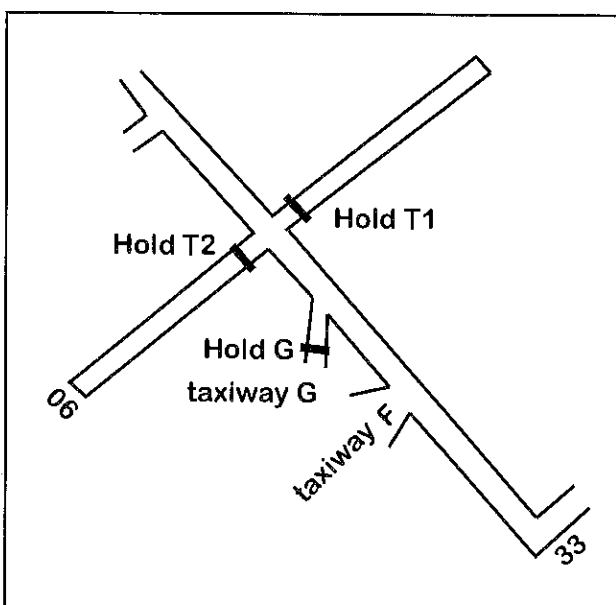
UKAB Note (3) Birmingham's SMR is equipped with a RW Incursion Monitoring and Conflict Alert Subsystem, but conflicts are not detected at the intersection until one ac crosses through the conflict alert area of the other RW . This is because the equipment monitors each RW independently.

The Board quickly concluded that the crew of the BAe 146 caused this very serious Airprox by commencing their take-off run without ATC take-off clearance. Members were in no doubt that the ac had come very close indeed to a collision.

Cause: The BAe 146 crew commenced take-off without clearance.

Recommendation That the CAA reviews the way ATC instructions are given in sequence to aircraft prior to take off so that post departure instructions are separated from the take off clearance.

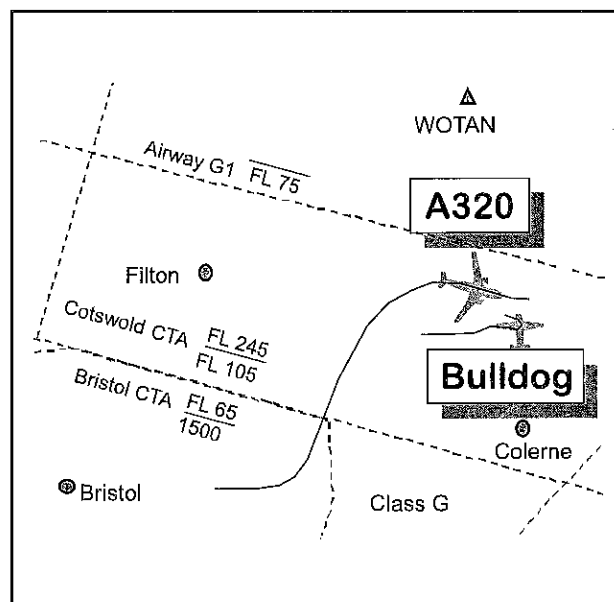
AIRPROX REPORT No 59/99

ATSI reports that the Bulldog unit is allocated the transponder code 4576 to be used by ac operating between surface level and FL 100 for conspicuity purposes only. Ac operating to the north of Colerne do not have to be pre-noted to Bristol ATC. Although Bristol Airport is situated within Class D Airspace i.e. the Bristol CTZ from surface to FL 65 and the Bristol CTA from 1500 ft altitude to FL 65, it is not directly connected to the airways system. The southern edge of Airway G1 is situated about 7 NM N of the CTA with a base of FL 75. Between the two is the Cotswold CTA, its base being FL 105. An abbreviated clearance procedure exists between Bristol ATC and the LATCC BRS Sector, whereby ac joining Airway G1 are to be level FL 80 at WOTAN, necessitating ac being outside CAS for about 7 NM.

Cause: The BRS SC vectored the A320 into conflict with the Bulldog outside controlled airspace.

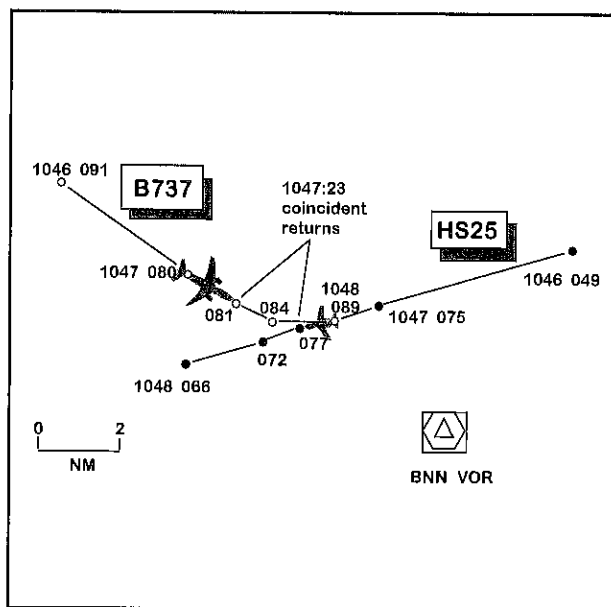
AIRPROX REPORT No 60/99

Cause: The HS125 pilot climbed above his cleared level.

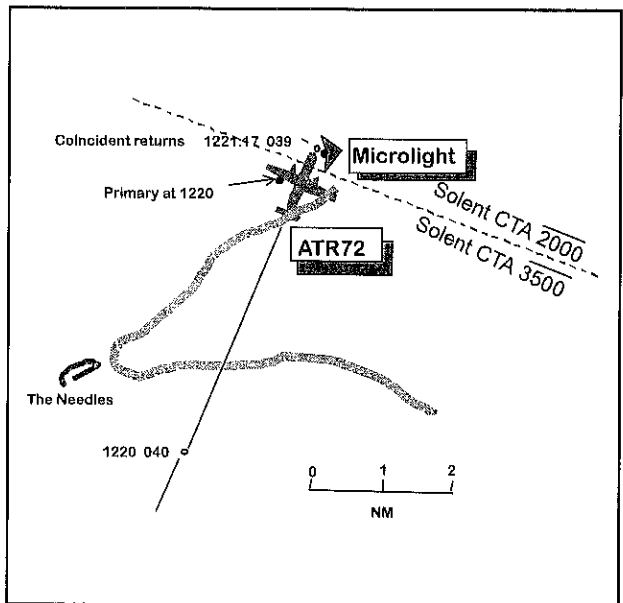
AIRPROX REPORT No 61/99

THE ATR 72 PILOT reports that he was routing from Jersey to Southampton at 4000 ft (QNH) under the control of Solent Radar on 120:22; he was heading 035° at 210 kt. The visibility was 5 km in VMC. When at position 5042N 0134W a microlight ac was seen at his 1230 0.5 NM away at co-altitude. There was no time to take avoiding action and the ac passed

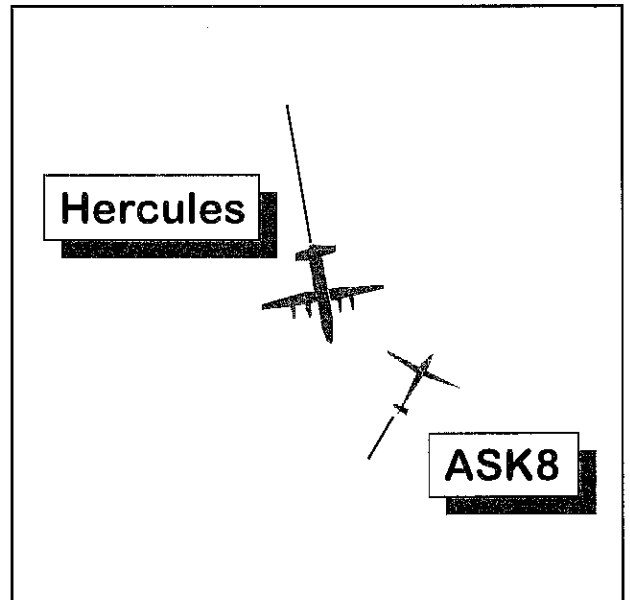
AIRPROX REPORT No 63/99

THE ASK 8 PILOT reports heading 030° at 55 kt on a reverse autotow launch from Aston Down. Approaching the top of the launch, he saw a Hercules closing from his 10 o'clock. He released the cable at about the same time as the Hercules made a small track correction to its right; he was then about 1700 ft above the airfield. The Hercules passed about 300 m away and about 200 ft higher; there had been a medium to high risk of collision.

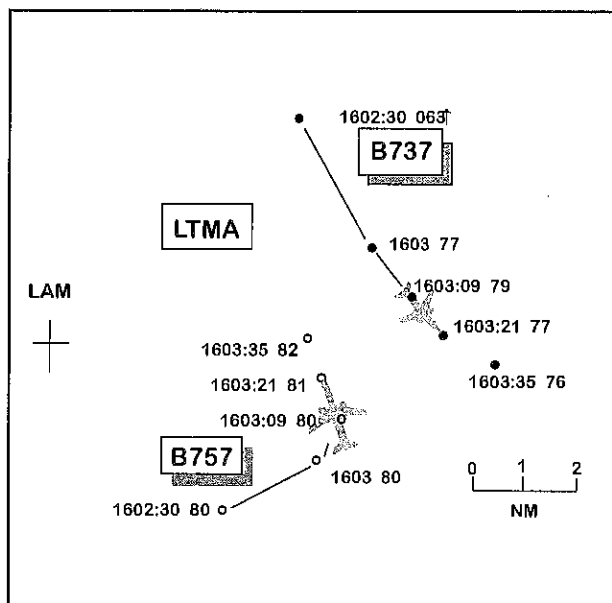
AIRPROX REPORT No 65/99

THE B757 PILOT reports that he was in the LAM holding pattern at FL 80 under radar control from LATCC on 119·77. His speed was 210 kt. When in a L turn through a northerly heading, ATC advised him of traffic at his 12 o'clock at the same level and instructed him to tighten his turn. The other ac was then seen and a TCAS RA followed demanding climb, which was carried out to FL 83. He estimated the other ac, a B737, passed about 1 NM to his starboard side at co-altitude and he thought

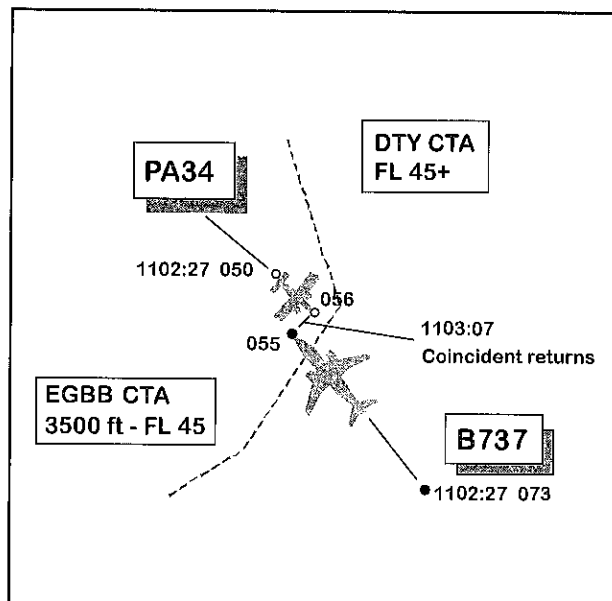
BIRMINGHAM ATC reports, with RT transcript, that the APR was carrying out the Joint function of APR/APC in a quiet traffic environment. A PA 34, outbound towards DTY from RW 23 at Coventry, was given climb clearance from its initial cleared altitude of 3000 ft to FL 60, while a B737, inbound to Birmingham from Paris, was being vectored for a LH circuit to RW 15 at Birmingham. The APR then descended the B737 to FL 50 having forgotten that he had previously climbed the Coventry outbound above 3000 ft. Information on other conflicting traffic was passed several times to the PA 34 pilot during his climb-out and the APR believes his pre-occupation with this might have contributed to his error. As soon as he became

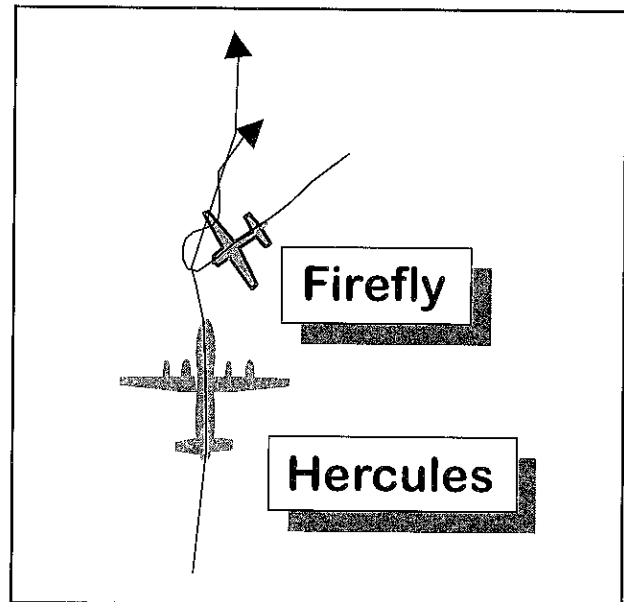
AIRPROX REPORT No 67/99

THE HERCULES PILOT reports heading 345° at 270 kt when he saw a Firefly 1 NM in his 12:30 crossing right to left at 90°. It then turned right which reduced the crossing component so he turned hard right and descended to avoid it. Just before the incident, Cottesmore, from whom he was receiving a LARS, called a contact in his 11 o'clock which made him look that way, but the call was intended for another ac. (Note: The RT transcript confirms neither part of the latter comment.)

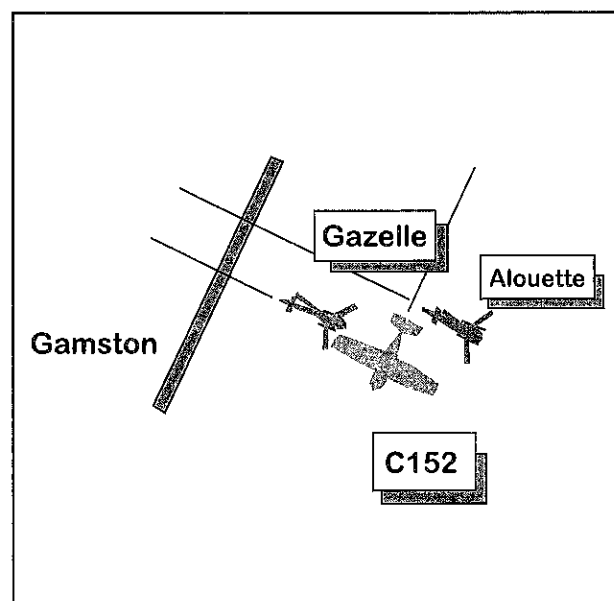
AIRPROX REPORT No 68/99

THE C152 PILOT reports that he was heading 210° at 90 kt while level at 1000 ft (QFE) downwind in a RH circuit for RW 03 at Gamston. The visibility, 3000 ft below cloud, was over 10 km in VMC and he was in contact with Gamston air/ground on 130.47. While abeam the RW he noticed a helicopter on a relative bearing of about 070° converging towards him several hundred ft below and maintained visual contact with it until it passed below him a few seconds later. Just as he was about to pass comment on separation to his student, he saw a second helicopter about 60 yd away also on a conflicting course from R to L. There was no time to take avoiding action

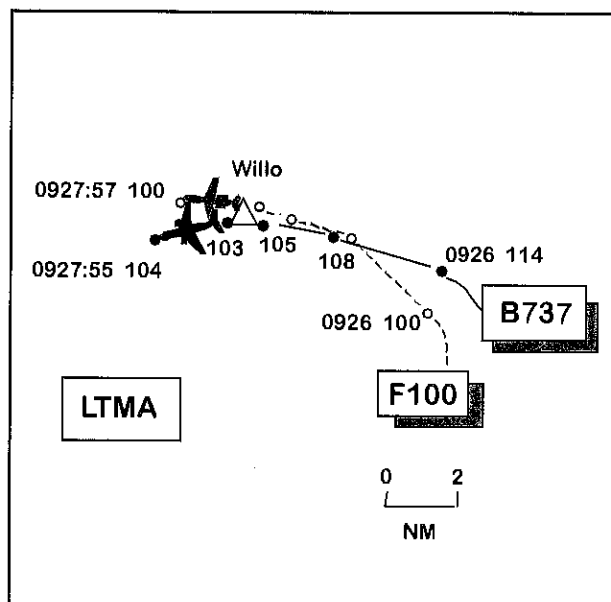
THE GATWICK INTERMEDIATE DIRECTOR (LATCC TC) reports that FL 80 to FL 120 were in use in the WILLO holding pattern, with the B737 at FL 120 and the F100 holding one level below at FL 110. The F100 was descended to FL 100 and, when FL 110 was vacant, the B737 was cleared to descend to FL 110. The STCA then flashed red. The pilot of the B737 was asked to check his cleared level to which he replied that he was descending to FL 100. An immediate avoiding action turn onto 180° was given to the B737 with an instruction to maintain FL 110. The F100 pilot was instructed to maintain his present heading until standard separation was re-established. Minimum separation distances were believed to be in the order of 400 ft and 0.5 NM. The controller states that his report was compiled without reference to the appropriate RT recording (126-82).

Cause: The Gatwick INT Director descended the B737 to the level occupied by the F100.

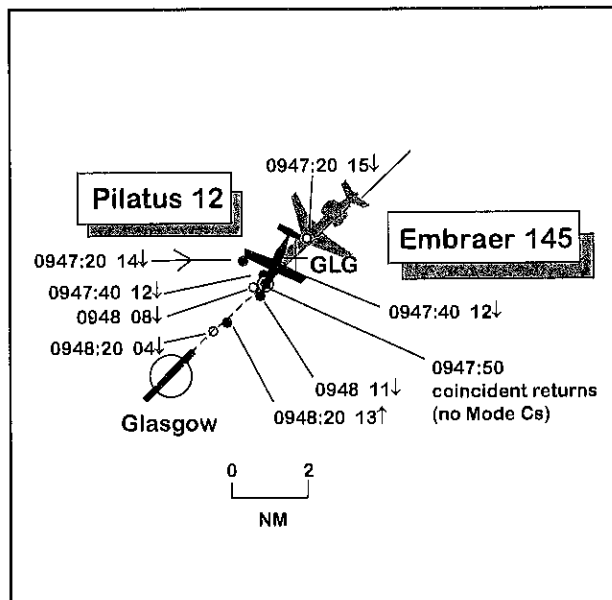
AIRPROX REPORT No 70/99

THE EMBRAER PILOT reports that he was in contact with Glasgow ADC heading 230° at 150 kt and descending through 1200 ft (QNH 1021) while on final approach to RW 23. The crew had previously heard Glasgow APR instructing VFR traffic to report at various VFR points towards RW 23. At range 5.5 NM ADC instructed him to continue approach. At about 4.5 NM from touchdown TCAS indicated traffic. A Pilatus was then immediately seen at his 11 o'clock and slightly above about 1 NM away. He began taking avoiding action while at the same time asking ADC whether the other ac was also positioning for RW 23. ADC responded by instructing the Pilatus to break L. The TCAS TA then changed rapidly to an RA but he was unable to be certain of the RA instruction because the glideslope warning was also active owing to his avoiding manoeuvre. He kept the Pilatus in sight and overtook it to its R. Landing clearance was issued when he was less than 1 NM from touchdown. He thought the other ac had been transferred to the ADC frequency slightly before them; however, although he was aware that it was in the vicinity, he was very surprised to see it appear ahead of them on final approach. He felt there had been a medium risk of collision.

Cause: The ADC mentor allowed his trainee to position the two ac into conflict on RW 23 compounded by a lack of traffic information to either ac.

The Unit investigation report, completed shortly after the incident, made a recommendation that controllers be reminded of the need to be extra vigilant when they are operating without the ATM for training purposes. Reflecting on the incident, the mentor has acknowledged that it was injudicious of him to allow the trainee to continue unchecked and that he should have intervened earlier to resolve the developing conflict.

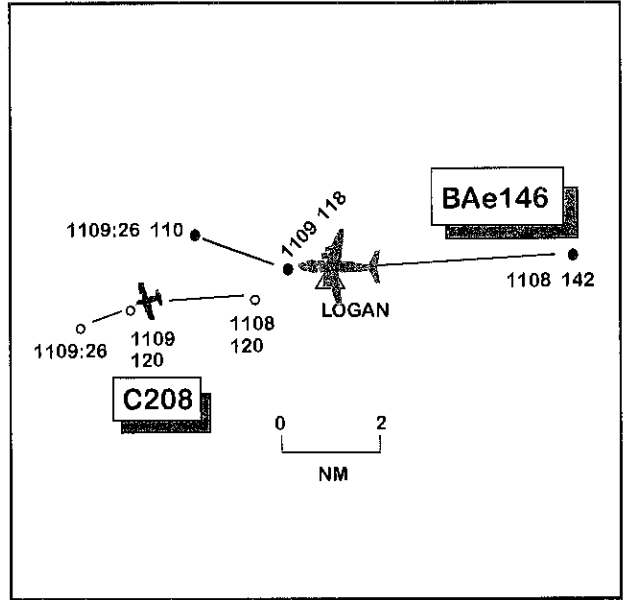
AIRPROX REPORT No 71/99

THE LATCC AC CLACTON S14 SC reports that he had been mentor to a trainee on S14 during a very busy and complex situation, but the trainee had transferred to another sector before the incident. Some time later he descended the BAe 146 to FL 180 above other traffic at FL 170; the BAe 146 was then given further clearance to descend to FL 70 and transferred to TC LOW. However, owing to its large catch-up speed the BAe 146 came into conflict with a C208 ahead of it at FL 120. He telephoned the LOW controller who instructed the BAe 146 to expedite its descent through FL 120.

Cause: The LATCC CLACTON S14 SC did not take the slower C208 into account when descending the BAe 146.

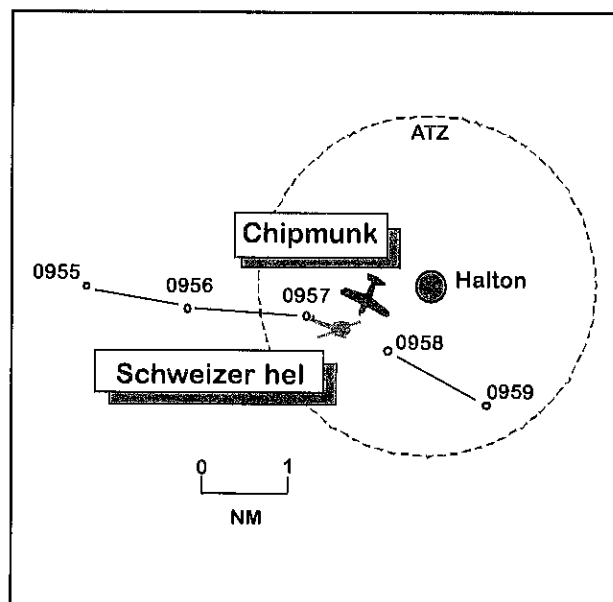
AIRPROX REPORT No 72/99

THE CHIPMUNK PILOT, an instructor with a student in the front seat, reports they were heading 200° at 90 kt and maintaining 1000 ft (QFE 999) in a LH circuit for RW 02 at Halton. He was in contact with Halton radio on 130.425. The visibility was 7 km in VMC. About half way along the downwind leg he saw a Schweizer helicopter 300-500m away at his 1 o'clock position on a conflicting course at co-altitude. He immediately took control and made a steep R turn. The helicopter passed about 300 m to his port side without any apparent avoiding action by its pilot, from whom there had been no radio call. He considered there had been a high risk of collision. Two other ac were operating in the circuit at the time of the incident. The instructor comments that forward vision from the rear seat of a Chipmunk is poor.

Cause: Unauthorised penetration of the Halton ATZ by the Schweizer.

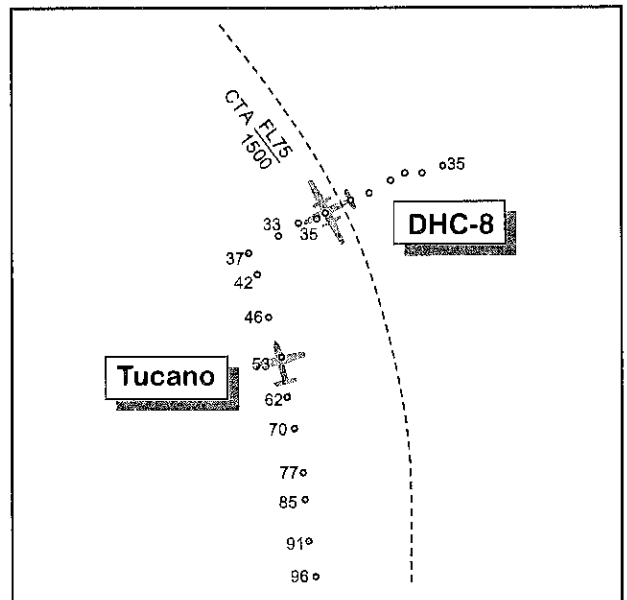
AIRPROX REPORT No 74/99

THE DHC-8 PILOT reports heading 250° at 160 kt on ILS finals to RW 25 at Newcastle. In the descent, passing 2600 ft at 8 NM he received a TCAS TA followed by an RA to increase vertical speed. He did so and the conflicting ac, blue, low wing single engined, passed about 200 ft overhead, crossing left to right. The other ac was on a different Newcastle frequency and was unknown to his controller; he thought there had been a medium risk of collision.

Cause: The Newcastle R2 controller cleared the Tucano to descend through the level of the DHC-8.

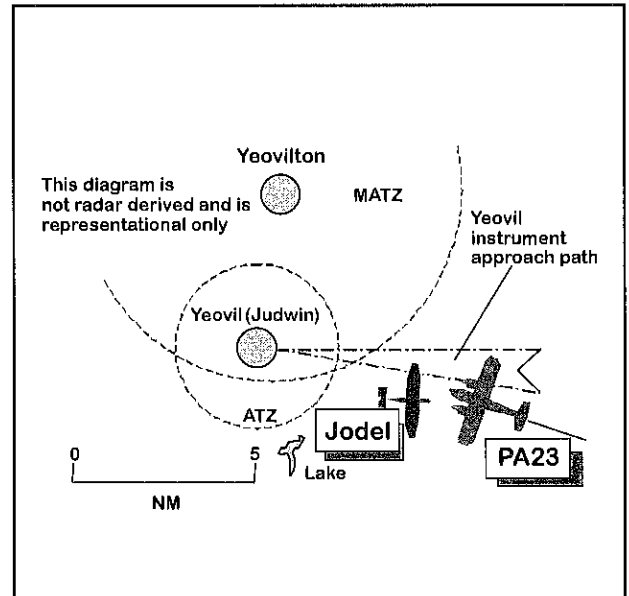
THE PA23 PILOT reports heading 290° at 120 kt and level at 2000 ft (QNH 1023) having just completed the base leg turn of an NDB/DME approach procedure at Yeovil, from whom he was receiving a FIS on 130.8. He was positioned 4.8 NM DME on the 100°R from Yeovil. On looking up after pointing out a drift error to the student, he saw a fixed undercarriage low wing ac with up-turned wing tips (similar to a Robin) about 100 yd away at his 11 o'clock not quite head-on passing from L to R. There was no time to take avoiding action and the ac passed 50 to 100 ft above him with a high risk of collision; he had seen it for about 2 seconds in all. The pilot comments that he was conducting a simulated instrument exercise and IF screens were in position. He reported the incident to Judwin (Yeovil) Approach on 130.8. They were unaware of the presence of the other ac.

Cause: Neither pilot saw the other in time to take avoiding action.

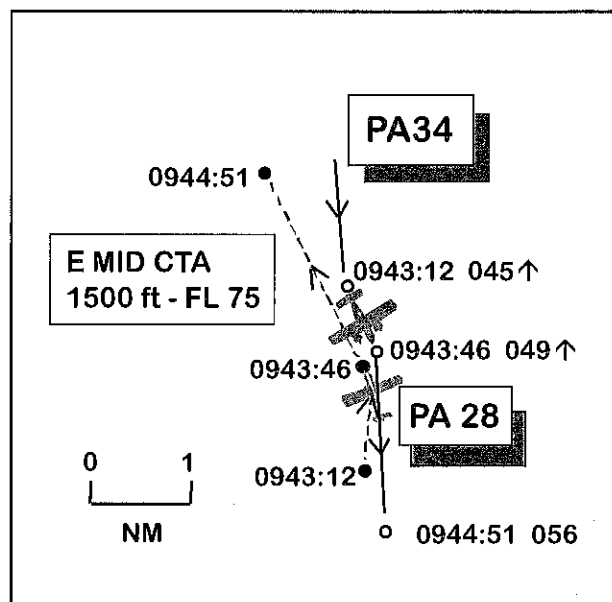
THE PA34 PILOT reports that he was heading 180° at 160 kt and cruising at FL 50 having recently departed from Nottingham (Tollerton) for Jersey. The visibility, 1500 ft above cloud, was over 10 km. He was squawking with Mode C selected. On leaving Tollerton he had switched to the East Midlands APC frequency (119.65) to request clearance to enter their

Cause: Unauthorised penetration of the East Midlands CTA by the PA28 which then flew into conflict with the PA34.

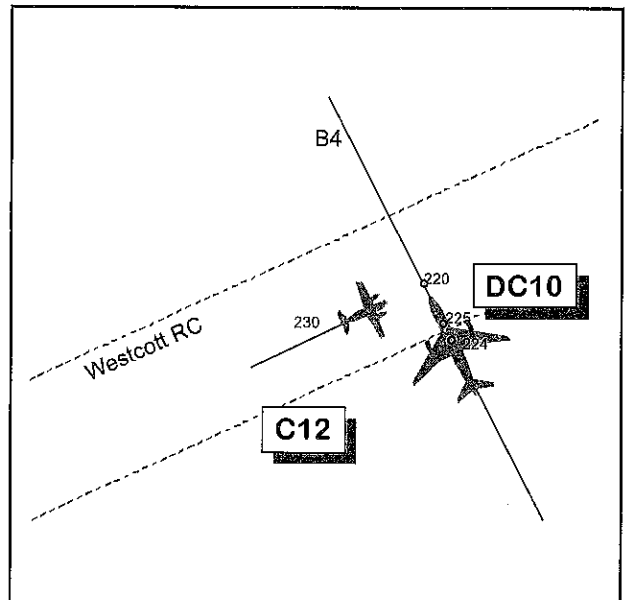
THE LATCC DAVENTRY SC reports that the DC10 was on a radar heading of 340°, cleared to climb to FL 220 to remain clear of traffic crossing the Westcott RC at FL 230. He noticed its Mode C reading FL 224 at the same time as the pilot asked about traffic on his TCAS. The SC asked the pilot what level he was climbing to as he had only been cleared to FL 220. By then the confliction had passed (the pilot was descending in response to a TCAS RA) and so no avoiding action was passed. The pilot responded that he was climbing to FL 240 and had acknowledged that level.

Cause: The DC10 crew climbed through their cleared level.

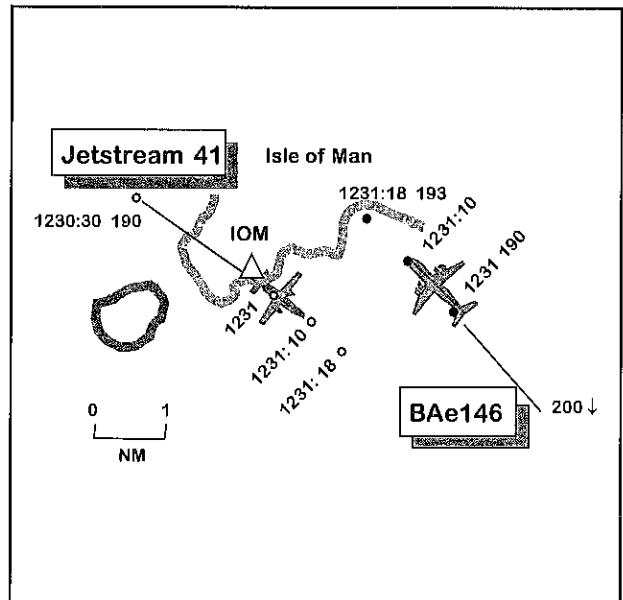
AIRPROX REPORT No 79/99

THE SCACC ANTRIM SC reports that the Jetstream was tracking airway B3 from Belfast towards the IOM VOR at FL 190 on its own navigation under the control of the Antrim Sector on 123.77. The BAe 146 was transferred to the frequency from London tracking airway B3 in the opposite direction at FL 220. Its pilot requested a route to centre fix

Cause: The BAe 146 pilot descended below his cleared level.

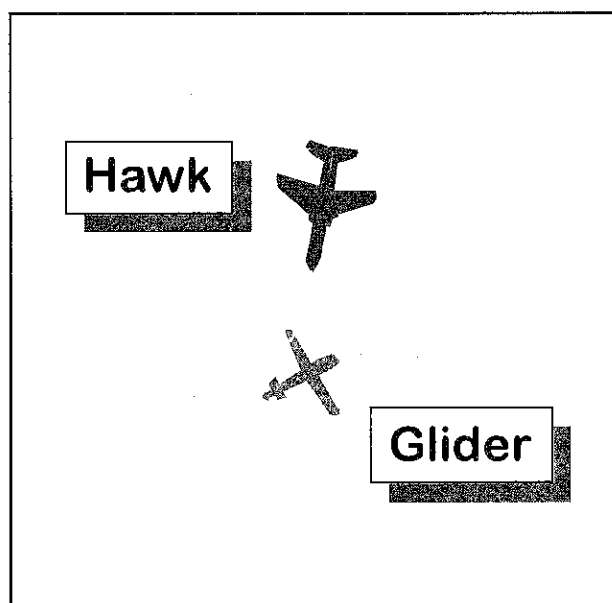
AIRPROX REPORT No 80/99

THE HAWK PILOT reports heading 193° at 360 kt in a transit at FL 30. Having called Cottesmore for a FIS but without making two-way RT contact, he then called Benson who asked him to change squawk. While doing so he looked up to see an ac just right of the nose, crossing right to left at the same level, about 0.5 NM away. He turned hard right, noticing that the glider did the same before he lost sight of it. On rolling out he saw the glider in his 8 o'clock about 100 ft below, rolling wings level. He estimated he had missed it by about 150 m and considered the risk of collision would have been high if avoiding action had not been taken.

Cause: Confliction of flightpaths resolved by the Hawk pilot.

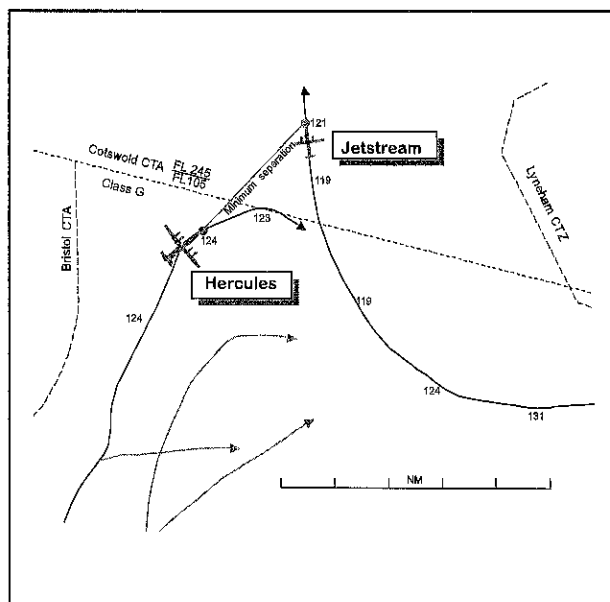
THE JETSTREAM PILOT reports heading 255° at 240 kt in a descent for Cardiff and receiving an ATS from Bristol ATC to whom he had given his preference for RW 30. Passing FL 123 he was told to maintain his present level; he levelled the ac at FL 120 and was then told to turn right onto 320°. In the turn he was advised to turn further onto 350° to avoid 4 Hercules in his 11 o'clock at the same level. On rolling out he saw 3 Hercules below heading NE and then saw one appear from behind a cloud at the same level on a closing heading. It then turned right to pass about 3 NM astern. He was in controlled airspace throughout (he believed) and acting on all ATC instructions; it appeared to him that the Hercules had entered controlled airspace (CAS) without permission.

A number of events linked together to cause this loss of separation. On the initial call, BR APR placed the Jetstream on a radar heading towards Bristol and cleared it for descent without co-ordinating with Lyneham; this action

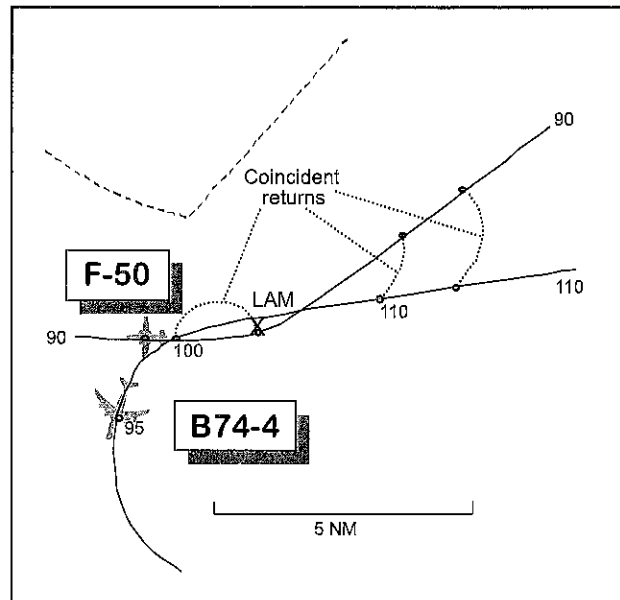
THE B747 PILOT reports approaching Lambourne at 230 kt, level at FL 100. The controller told him to make one left orbit at LAM and then roll out heading 270. The Captain (PNF) acknowledged while working on the FMS-CDU so he did not notice that his FO had set the autopilot altitude selector to FL 70 and the ac had begun to descend. The controller enquired and alerted him at FL 95 and he noticed and apologised for the unauthorised descent. Fortunately there was no conflicting traffic indicated on his Nav Display or TCAS; the controller told him to maintain FL 90 and continued to vector him. He was unaware at

LATCC reports, with RT transcript, that during a very quiet period (3 ac on frequency) the Heathrow Intermediate Director (N) was explaining a radar display problem to a systems engineer when another controller pointed out a conflict alert near Lambourne. The B747, whose cleared level was FL 100, was descending through FL 95. As it was already heading away from the F-50 at FL 90 he gave no traffic information or avoiding action.

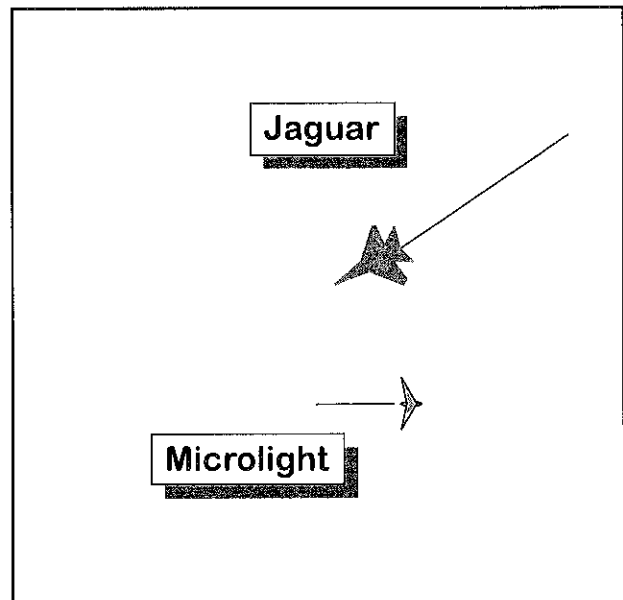
THE MICROLIGHT PILOT reports that having completed his first solo, he took off again to fly around the airfield area. He was heading 100° at 45 kt, cruising at 1200 ft, when he saw a military jet approaching from left of his nose 10 seconds before it passed 3-400 m to his left, banking sharply to its right. He saw its afterburner light as the ac turned sharply through about 150° and then noticed a strong smell of kerosene. He thought the risk of

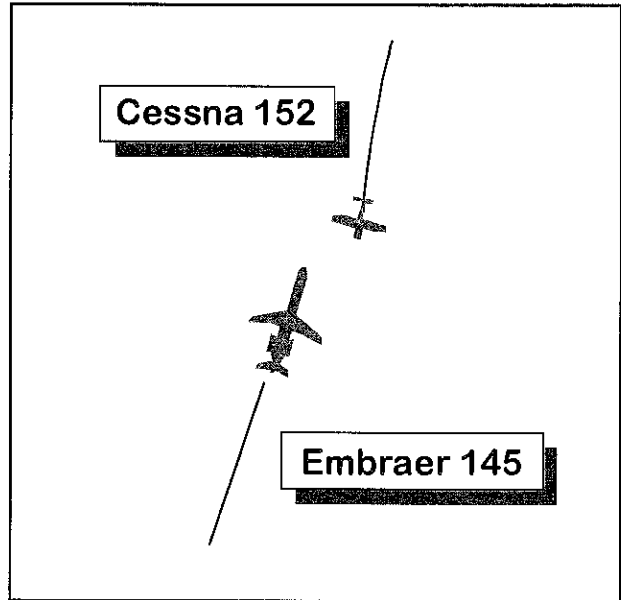
AIRPROX REPORT No 84/99

THE EMBRAER PILOT reports heading 020° at 240 kt after take-off from RW 02 at Southampton. He had been cleared to 2000 ft and told to expect VFR traffic in the same sector at 2500 ft and was in communication with Solent Radar on 120.22. While levelling at 2000 ft he received a TCAS TA with traffic 300 ft above, immediately followed by an RA to descend. He descended by 200 ft and while levelling saw the Cessna in his 12:30 turning left, seemingly unaware of his presence. It passed 300 ft above and 500 m to his right. The cloud was reported as scattered at 3000 ft but he estimated from his previous approach that it was 'SC 2500' with reduced visibility beneath. It appeared subsequently that the encounter was a result of an acceptable local SOP.

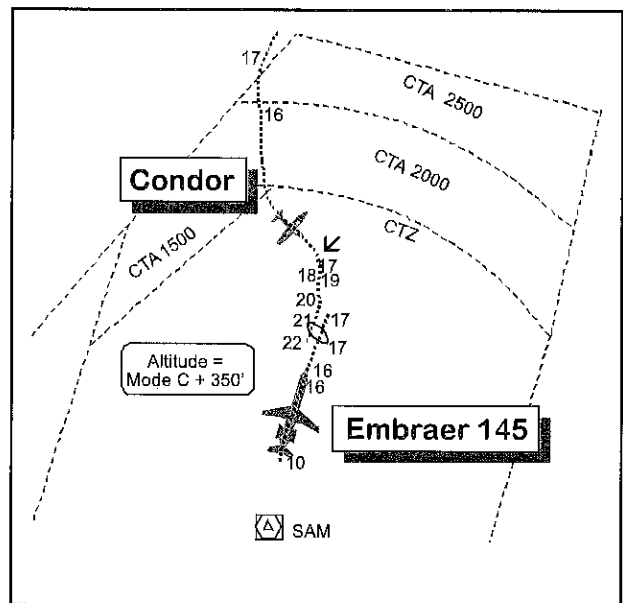
AIRPROX REPORT No 85/99

THE EMBRAER 145 PILOT reports heading 020° at 240 kt after take-off from RW 02 at Southampton. He had been cleared to 2000 ft and advised of 2 VFR ac N of the airfield, tracking S at 2500 ft and was in communication with Solent Radar on 120.22. His level out at 2000 ft took him between these ac; he noted from TCAS that the first was at 2300 ft and

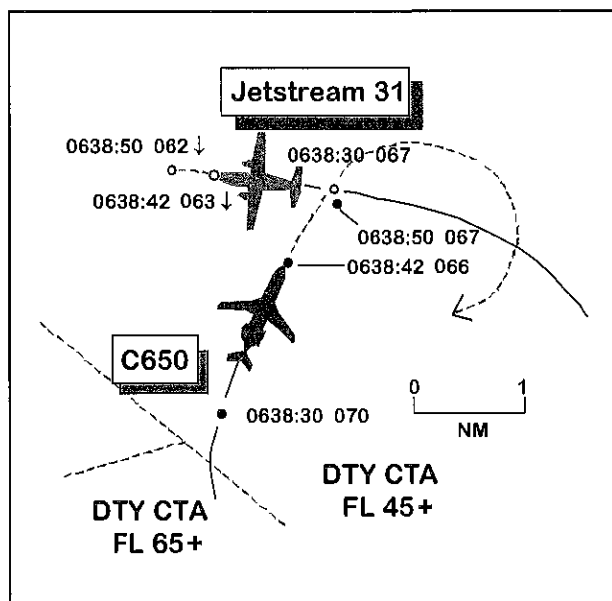
BIRMINGHAM ATC reports that the Jetstream had been released to Birmingham by TC COW/WEL. On first contact, descent clearance was given, initially to FL 80 and then, shortly afterwards, to FL 60 together with a radar vector of 280° for positioning to RW 33. At about the time the latter instructions were passed to the Jetstream, the C650 (seen to be wearing an airways squawk) was observed just outside CAS to the W but appeared to be closing towards the Jetstream and still climbing. TC was asked what the intentions of the C650 were; they advised that the ac was under a FIS and had been instructed to remain outside CAS. By this time the C650 had entered CAS and separation with the Jetstream was reducing rapidly. An avoiding action R turn onto 340° was given to the Jetstream and the C650 passed about 0.8 NM behind the Jetstream with 200 ft vertical clearance. TC was advised that Airprox reporting action would be taken.
