UK AIRPROX BOARD

Analysis of Airprox in UK Airspace

Report Number 2

January 1999 to June 1999

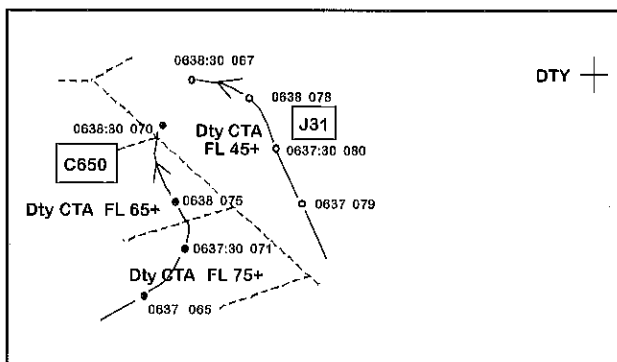
Following the clearance from London Information (at 0638.00 hrs), radar photographs show the C650 turning L onto a North Westerly heading and starting to converge with the Jetstream, which was tracking NW ahead of it inside CAS. Watching this unfold with some concern, the Birmingham APC became sufficiently worried 25 sec later to transmit to the Jetstream under his control "c/s turn R heading 340 avoiding action there's unknown traffic inside the airway (unreadable) ... correction closing left hand side seven o'clock range is one mile". As the turn instruction issued to the Jetstream started to take effect, the C650 commenced its RH orbit placing it in direct conflict with the Jetstream.

UKAB Note (2): A replay of the LATCC radars at 0638:30 shows the C650 in a R turn through a northerly heading indicating FL 70 Mode C; it has just entered the stepped portion of the DTY CTA 2 NM S of Gaydon where the base of CAS is FL 45. Simultaneously, the Jetstream has rolled out onto a westerly heading from a L turn and is descending through FL 67 Mode C in the C650's 1 o'clock position, range 2 NM. Twelve sec later the ac are at their closest (0.9 NM and 300 ft) as the C650 makes a gentle R turn through a heading of about 030° indicating FL 66, with the Jetstream out to its left at 0930, range 0.9 NM indicating FL 63. The C650 passed 1.7 NM behind and 500 ft above the Jetstream at about 0638:50, at which time the latter is seen to begin a R turn. In his report the C650 pilot stated that the visibility had been perfect and that he had seen the other ac from 6 NM away.

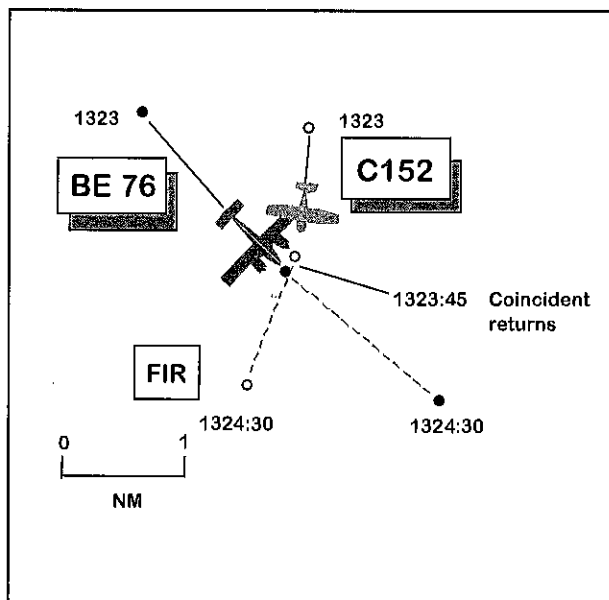
Date/Time: 15 Jun 1324
Position: N5141 W0054 (5 NM NW Wycombe Airpark)
Airspace: FIR (Class: G)
Reporting Aircraft **Reported Aircraft**
Type: C152 BE76
Operator: Civ Club Civ Trg
Alt/FL: 2200 ft 2000 ft
(QNH 1027 mb) (QNH)
Weather VMC CLBC VMC
Visibility: >10 km 10 km
Reported Separation:
100 m H/50 ft V 600 m H/200 ft V
Recorded Separation: 200 - 300 m H

Cause: The overtaking BE 76 flew close enough to the C152 to cause concern to its pilot.

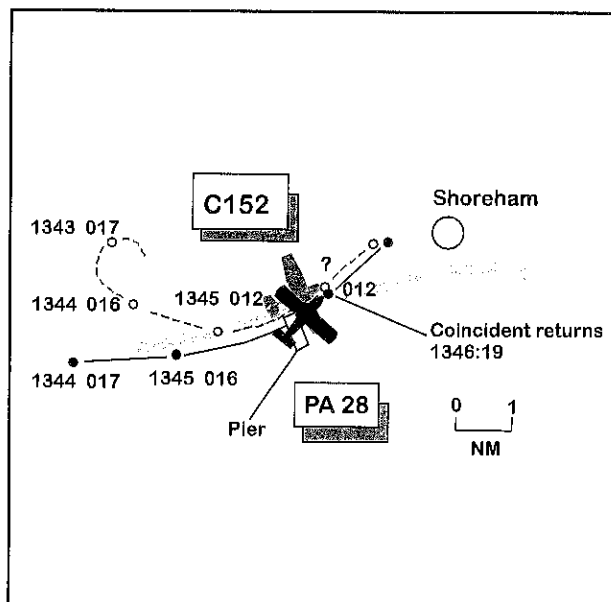
Cause: The PA28 pilot flew close enough to the C152 to cause concern to its pilot.

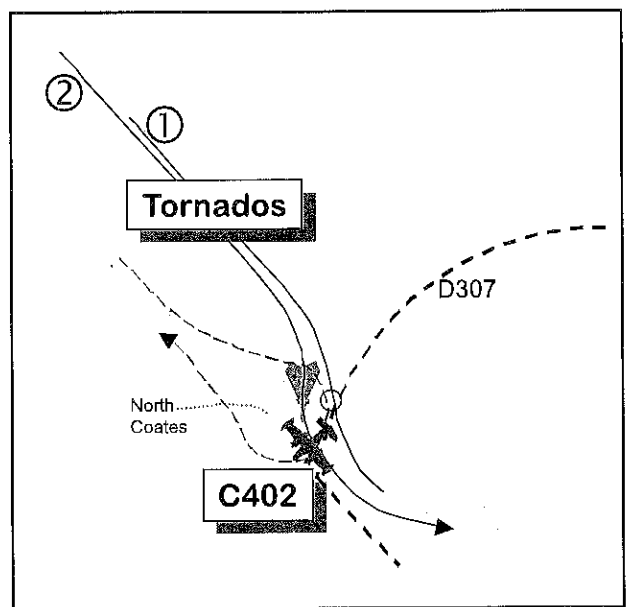
AIRPROX REPORT No 89/99

Date/Time: 16 Jun 1516
 Position: N5330 W0005 (4 NM ESE of Cleethorpes)
 Airspace: FIR (Class: G)
 Reporting Aircraft Reported Aircraft
 Type: Tornado GR Cessna 402
 Operator: HQ STC Civ Comm
 Alt/FL : ↑ 2000 ft ↓ 2600 ft
 (Rad Alt) (QNH 1021 mb)
 Weather VMC CLAH VMC
 Visibility: 20 km
 Reported Separation: 200 ft V
 Recorded Separation: NK

Cause: Late sighting of the Cessna by the Tornado pilot.

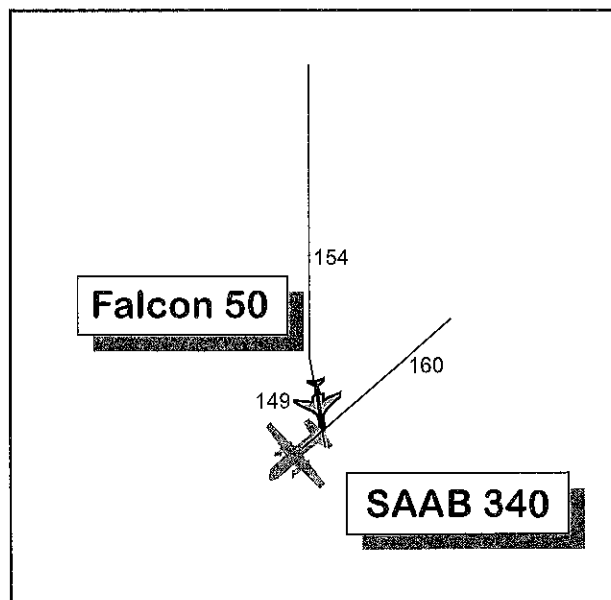
AIRPROX REPORT No 90/99

Date/Time: 17 Jun 1314
Position: N5115 W0114 (5 NM W of Basingstoke)
Airspace: Airway R41 (Class: A)
Reporter: LATCC
Type: Falcon 50 SAAB 340
Operator: Civ Pte CAT
Alt/FL: FL 150 FL 160
Weather: VMC CLNC VMC
Visibility: 50 km
Reported Separation: 2 NM/700 ft
Recorded Separation:

Cause: The Falcon pilot allowed his ac to exceed the level he had been cleared to.

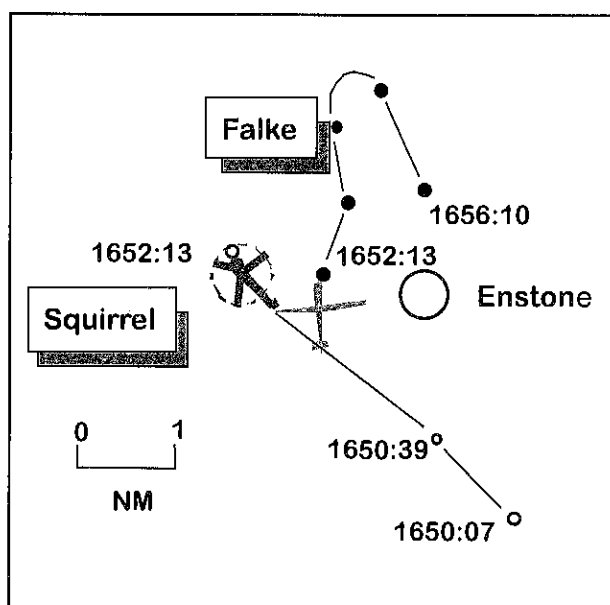
AIRPROX REPORT No 91/99

Date/Time: 17 Jun 1652
Position: N5155 W0127 (1 NM WSW Enstone - elev 550 ft)
Airspace: FIR (Class: G)
Reporting Aircraft Reported Aircraft
Type: Motorfalke Squirrel A350B
Operator: Civ Trg Civ Pte
Alt/FL: 400 ft 1200 ft
 (QFE 1004 mb)
Weather VMC sky clear VMC sky clear
Visibility: >20 NM >10 km
Reported Separation: 0 ft H/ 25 ft V not seen
Recorded Separation: N/K

Cause: In the vicinity of Enstone the Squirrel pilot flew into conflict with the Motorfalke, which he did not see.

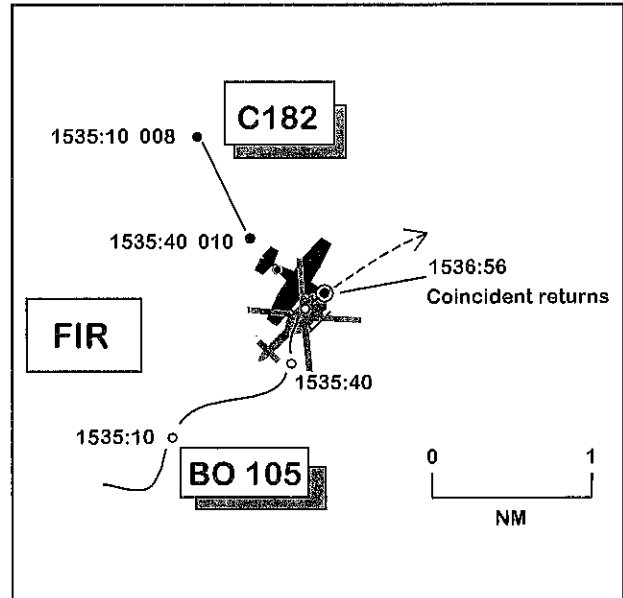
AIRPROX REPORT No 93/99

Date/Time: 19 Jun 1536 (Saturday)
Position: N5259 W0103 (3 NM NW
Newton - elev 182 ft)
Airspace: FIR (Class: G)
Reporting Aircraft Reported Aircraft
Type: Bo105 C182
Operator: Civ Exec Civ Pte
Alt/FL: 1000 ft (RPS) 800 ft (QFE)
Weather VMC CLBC VMC
Visibility: 40 NM >10 km
Reported 50 ft V 0.25 NM H/
Separation: 200 ft V
Recorded Separation: 0 ft H

Cause: The C182 pilot flew sufficiently close to the BO 105 to cause its crew concern.

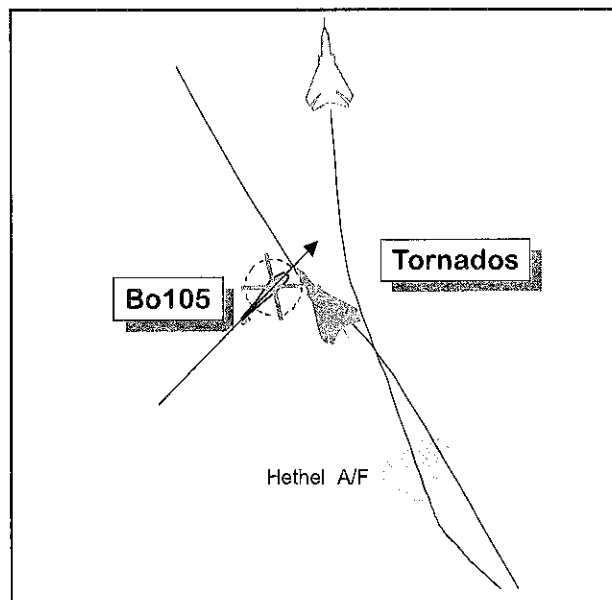
Note: The Cromer radar recording shows a primary return following the reporting pilot's track (his transponder was u/s). A primary/secondary return (7001) followed by an intermittent primary-only are seen on the Tornados' planned track; the first turns N at Hethel, passing 11/3 NM ahead of the helicopter, and the second continues NW, passing directly under the helicopter.

Cause: The Tornado pilot did not see the helicopter.

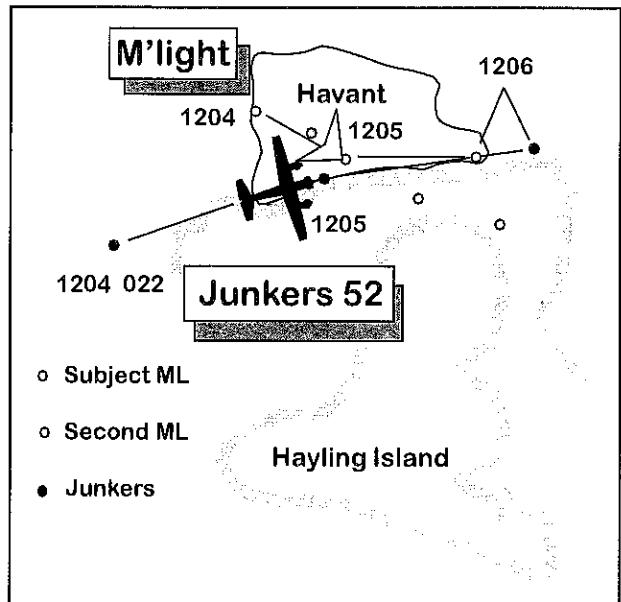
Cause: The overtaking Junkers pilot did not see the microlight.

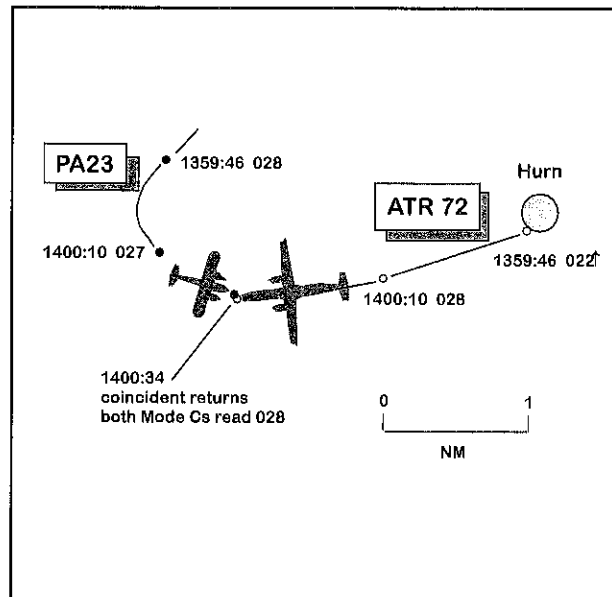
AIRPROX REPORT No 97/99

Date/Time: 22 Jun 1400
Position: N5046 W0154 (2.3 NM WSW Hurn - elev 36 ft)
Airspace: CTZ (Class: D)
Reporting Aircraft Reported Aircraft
Type: ATR 72 PA23 Aztec
Operator: CAT Civ Trg
Alt/FL: 2800 ft ↑ 3000 ft
(QNH 1023 mb) (QNH)
Weather VMC SCAT Cu VMC CLBC
Visibility: >10 NM >5 km
Reported Separation: <400 yd H/o ft V not seen
Recorded Separation: <200 m H/O ft V

Cause: ADC did not co-ordinate the missed approach by the ATR 72 with the approach radar controller.

Recommendation: That the CAA considers a review of current ATC practice at Bournemouth International Airport to ensure that aircraft conducting the standard missed approach procedure are deconflicted from other IFR inbound/holding aircraft.

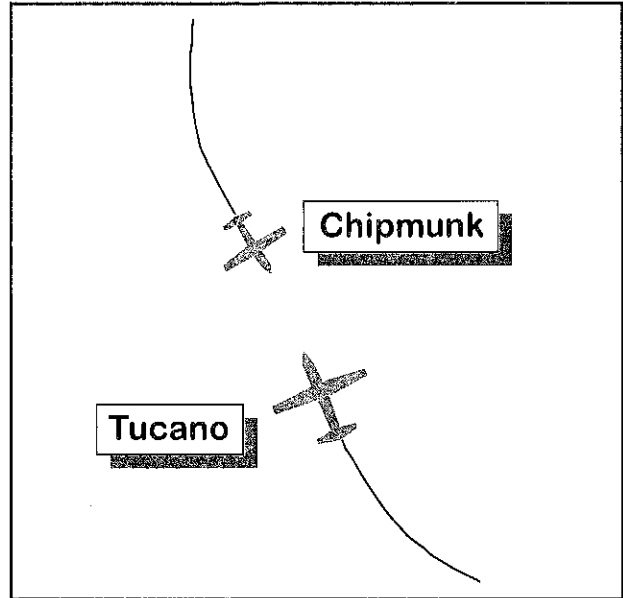
Cause: Very late sighting by both pilots.

Recommendation: That the CAA should reconsider the decision to exclude LFS 'flow arrows' from those civil charts commonly used by civilian pilots flying below 2000 ft outside controlled airspace.

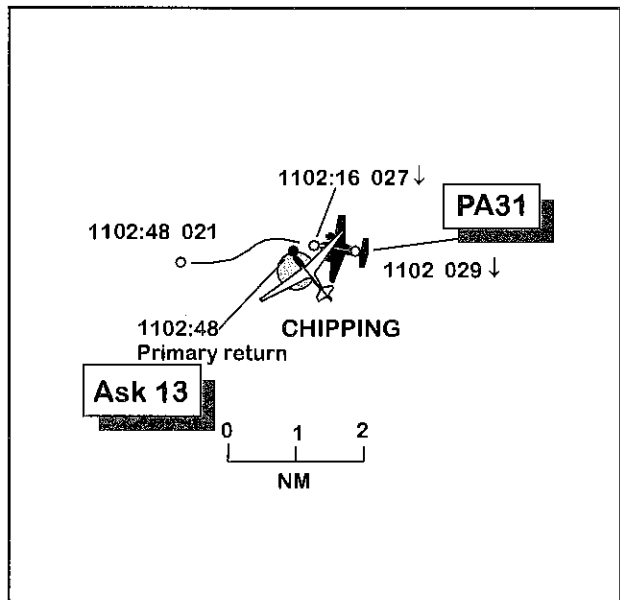
AIRPROX REPORT No 99/99

Date/Time: 25 Jun 1102
Position: N5354 W0236 (0.5 NM NE Chipping airfield - elev 600 ft)
Airspace: FIR (Class: G)
Reporting Aircraft Reported Aircraft
Type: Ask 13 glider PA31
Operator: Civ Club Civ Comm
Alt/FL: 1800 ft (QFE) 1800 ft ↓ (QNH)
Weather VMC CLBC VMC
Visibility: 2 - 3 NM >10 km
Reported Separation: 50 m H/0 ft V 0.5 NM/100 ft
Recorded Separation: N/K

Cause: A conflict near Chipping airfield resolved by the PA31 pilot.

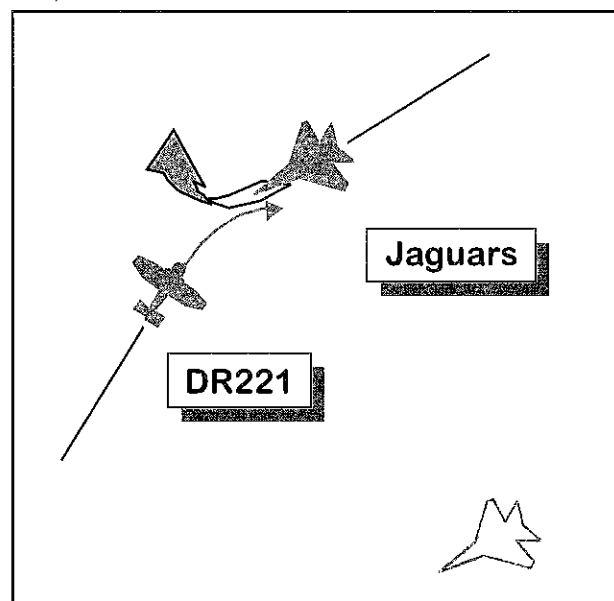
Cause: Late sighting by both pilots.

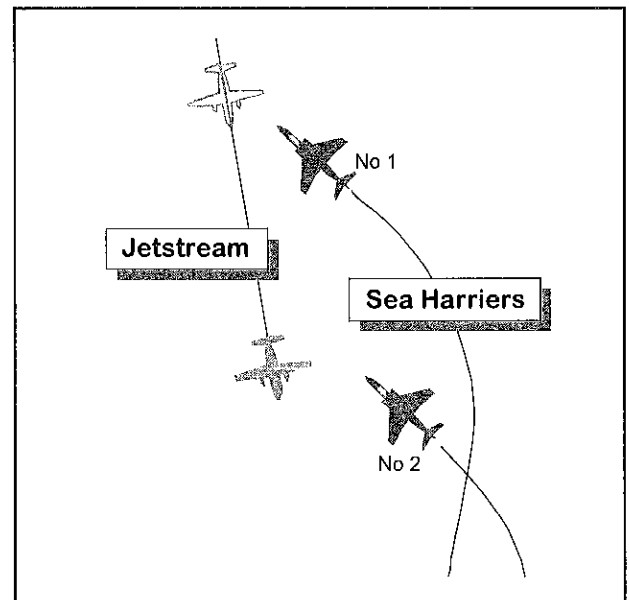
AIRPROX REPORT No 103/99

Date/Time: 30 Jun 1323
Position: N5626 W0140 (40 NM E of Leuchars)
Airspace: FIR (Class: G)
Reporting Aircraft Reported Aircraft
Type: Jetstream 31 Sea Harrier
Operator: CAT HQ FONA
Alt/FL: FL: 195 20000 ft ↑ (RPS)
Weather VMC CLAC VMC CLAC
Visibility: 30 NM+ 20 km
Reported Separation: 500 ft/500 ft
Recorded Separation: NK

Cause: Confliction of flightpaths in the FIR resolved by the Harrier pilots.

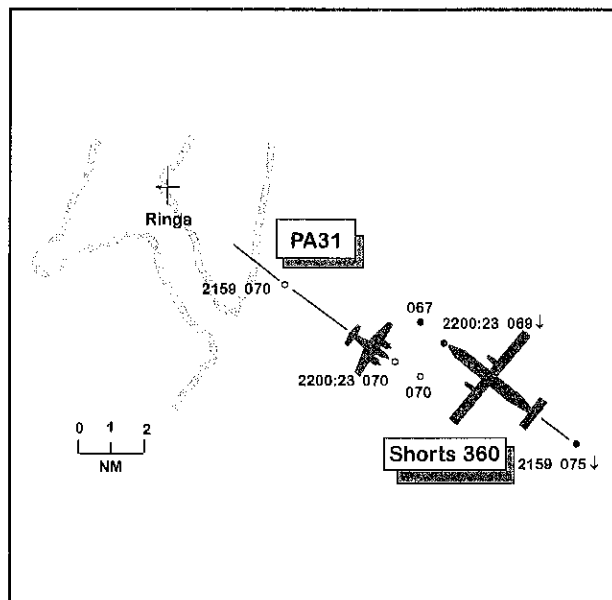
UKAB Note (1): The loss of separation was not detected at the time by the controllers concerned (Belfast APR/ScOACC TMA and Antrim SC). ScOACC submitted an Airprox the next day (1 July) when the incident came to light following routine examination of SMF data. The Airprox occurred when the Belfast APR descended an inbound Shorts 360 (SH 36), which was on airway B3 and had just been transferred from Scottish, through the level of an opposite direction PA31 which Belfast ADR had transferred to Scottish some minutes before.
