UK AIRPROX BOARD

Analysis of Airprox in UK Airspace

**Report Number 28
January 2012 – December 2012**

Twenty-Eighth Report by the UK Airprox Board:

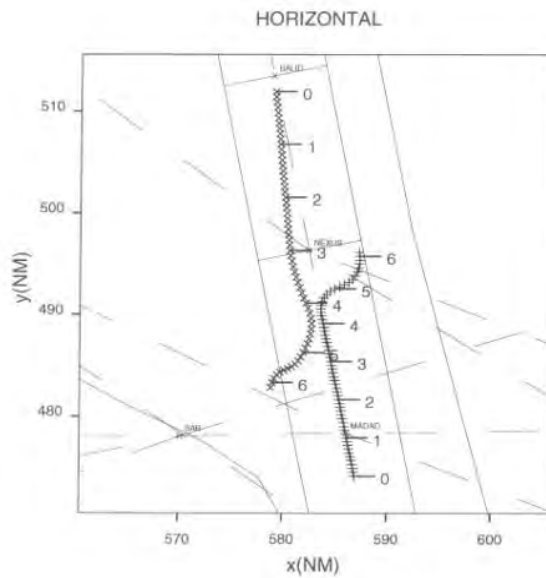
SMF data 1

The following data was produced by SMF (Separation Monitoring Function) which supports the minimum separation already assessed.

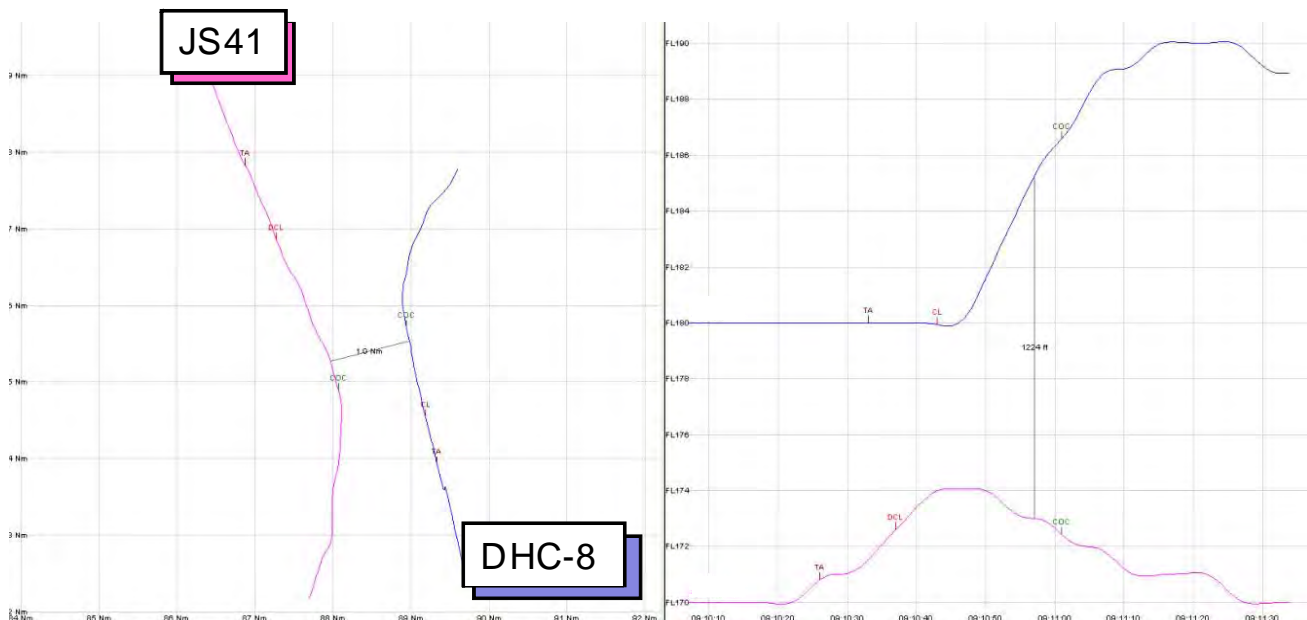
TCAS Simulation Data

This gives the closest lateral and vertical points as follows:-

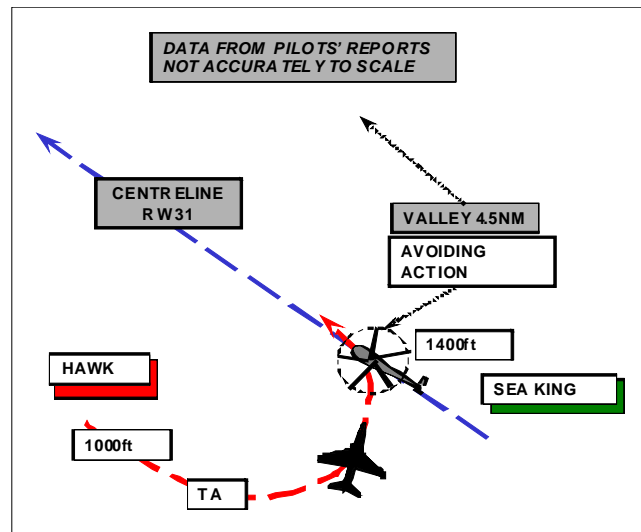
This Airprox appears to have been caused when the Hawk TMk2 underflew the Sea King which was conducting a PAR. The Hawk had been informed about rotary instrument traffic both directly by the ADC and again by hearing the information being passed to the Hawk formation on the same frequency. It is the responsibility of ac joining through initials to avoid PAR traffic by a safe margin; ATC assist in this process by passing TI on instrument traffic - this was done in this case.

Cause: By flying underneath the Sea King on a PAR approach, the Hawk crew caused its crew and the Talkdown Controller concern.

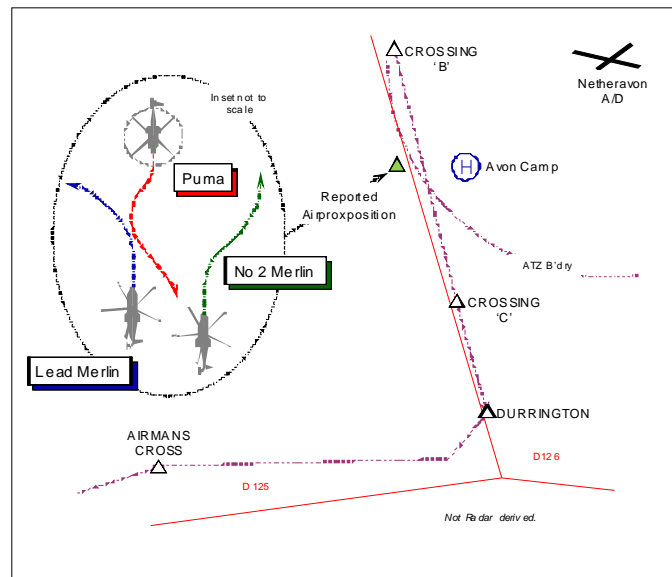
AIRPROX REPORT NO 2012016

Cause: 1. A non-sighting of the Puma by the lead Merlin crew.

This Airprox occurred during a particularly intense period of aerial activity as part of a recurring exercise to prepare crews and troops for deployment to Theatre and HQ JHC recommends that for future exercises the additional deconfliction measures are implemented;

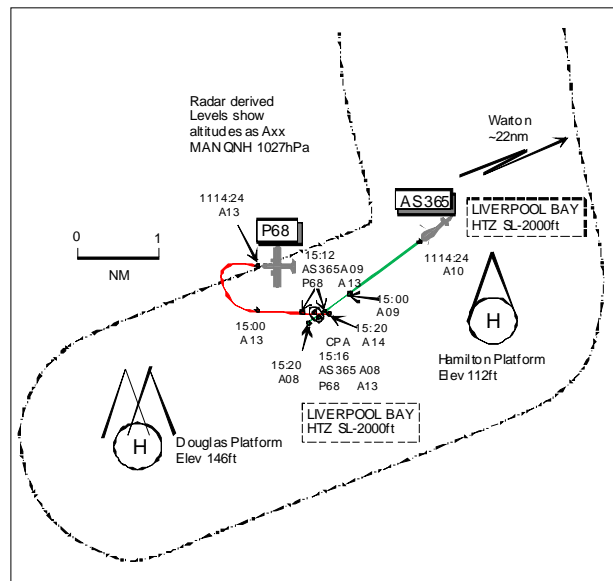
Cause: Sighting report in a HTZ.

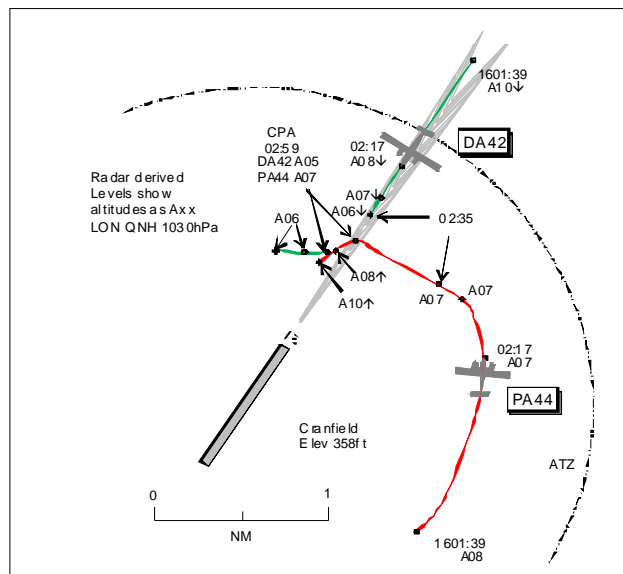
AIRPROX REPORT NO 2012018

Cause: The PA44 pilot did not comply with the ADC's instruction to position as No 2 and flew into conflict with the DA42 on final, which he had not seen.

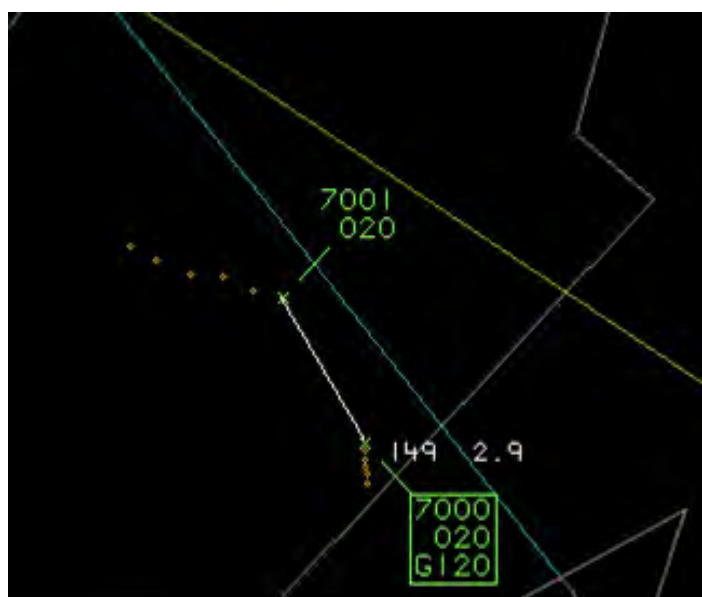
Figure 1. Scottish Controller passes TI to Coastguard XXX. (2007:40)

Cause: A non-sighting by the Tornado crew and effectively a non-sighting by the S92 crew.

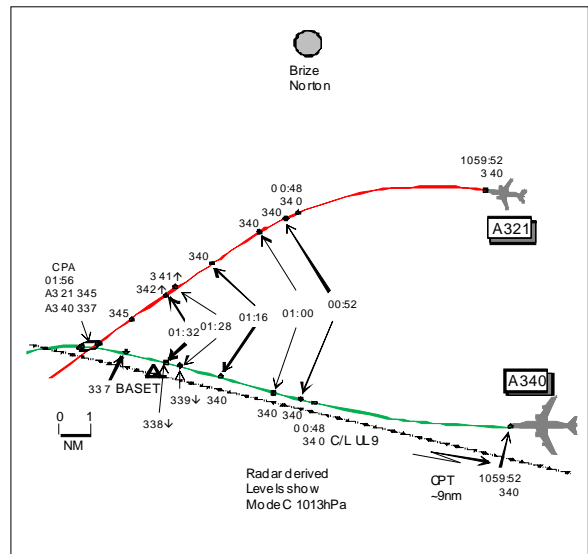
AIRPROX REPORT NO 2012020

The A321 was cleared to route direct BADSI-LIPGO when coincidentally BASET was the next waypoint in the FMS. This may have caused the A321 pilot's misperception and response, 'BASET-LIPGO.' It is considered likely that neither of the reporting points BASET or BADSI would have been familiar to the pilot.

The A321 pilot's accented read back, together with the controller's bias to hear what he was expecting to hear, caused the controller to accept the read back as being correct.

Cause: The S35T controller did not detect the A321 pilot’s incorrect read back.

CAA ATSI recommends that NATS Swanwick ATSU include this or a similar scenario, together with lessons learned in controllers' Training in Unusual Circumstances and Emergencies (TRUCE) module.

Recommendation: The CAA is recommended to review the 5-letter name-code designators in this area to avoid potential confusion between BASET, BADSI and BAKUR.

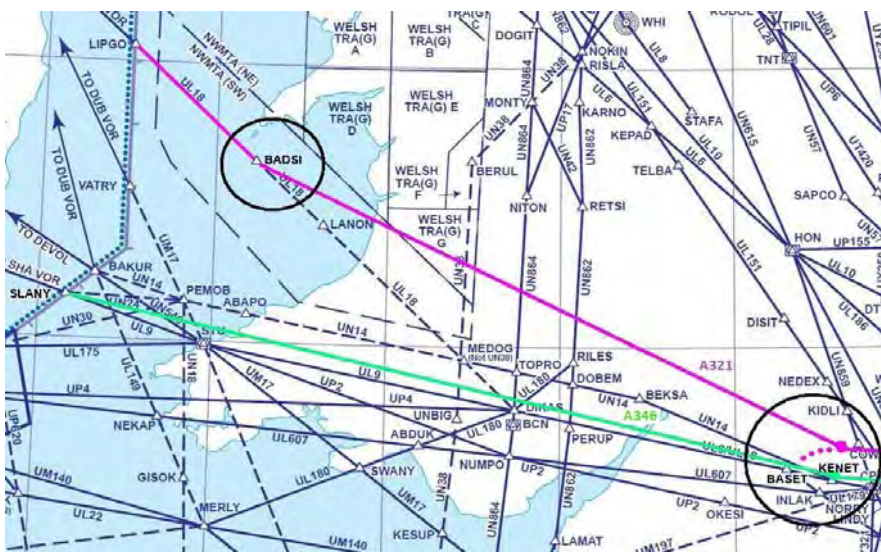
Fig 1

The A321 was operating IFR on a flight from Europe to Dublin and had flight planned to route UAR UL9/UL18 between CPT and DIKAS then UL18 DIKAS to LIPGO (Fig 1). UL18 is classified as a conditional route which was available on the Saturday of the Airprox.

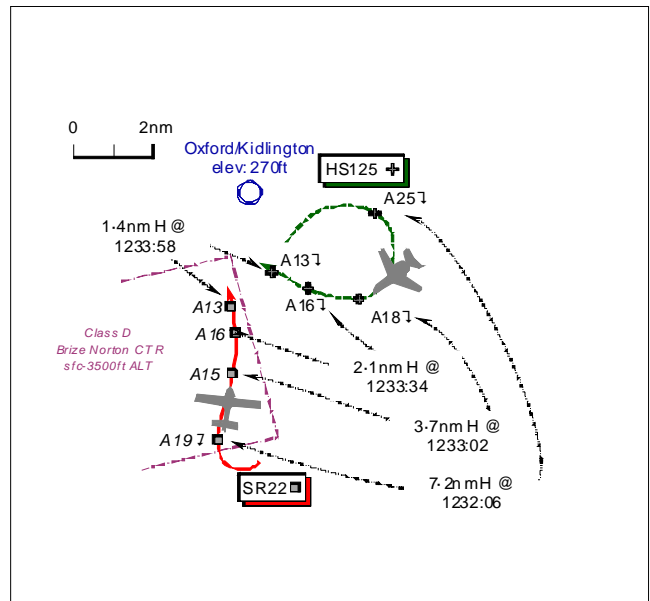
AIRPROX REPORT NO 2012021

Cause: The SR22 pilot did not fly the cleared procedure and flew into conflict with the HS125.

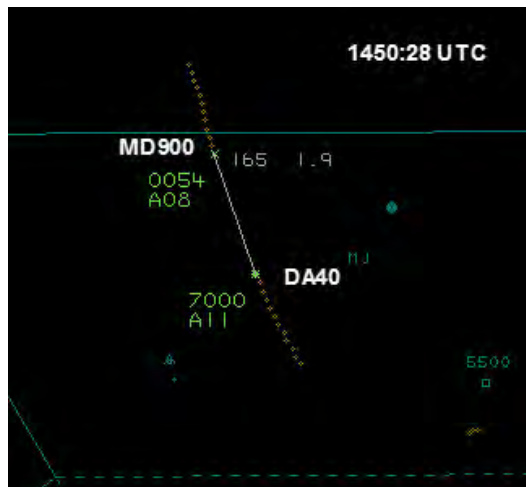
The distance between the two ac continued to decrease as each remained in the other's 12 o'clock on reciprocal tracks as shown below. Note: SSR code 0054 is considered unvalidated and unverified.

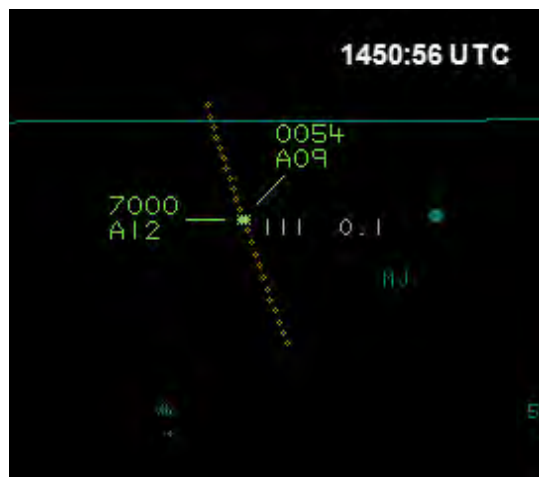
At 1450:56 the position indication symbols of the ac merged on the radar replay with the MD900 at altitude 900ft and the DA40 at altitude 1200ft (as shown below).

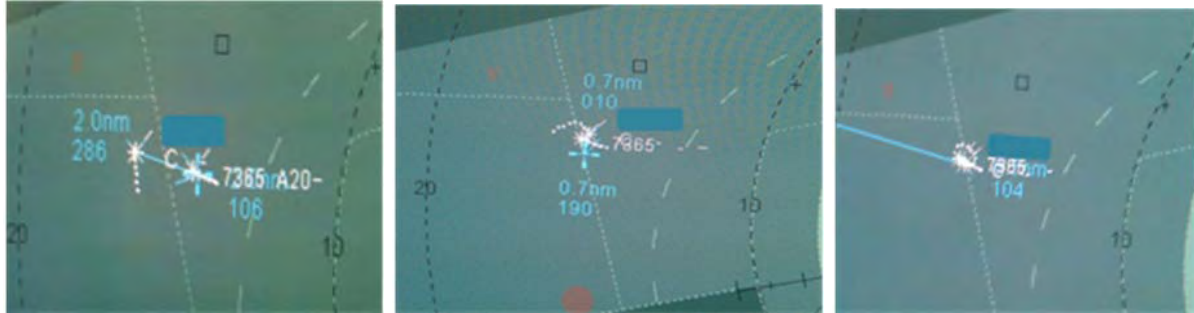
At 1727:50, when the PA28 was 18.7nm WSW of Bournemouth Airport, the controller downgraded the service to a BS due to the radar contact from the PA28 becoming intermittent. At 1742:57, when the PA28 was 14.2nm WNW of Bournemouth, a radar contact squawking A7000 with no Mode C, was shown 2nm WNW of the PA28. The A7000 squawk was identified as the RV-7 using the Bournemouth Radar Mode S function during the replay. Photographs of the Bournemouth Radar data (reproduced below) show the RV-7 turned to the R and orbited about the PA28.

The written report from the pilot of the RV-7 stated that he manoeuvred his ac to arrive 150m on the PA28's port side. The pilot of the RV-7 did not believe that the PA28 crew was visual with his RV-7; he continued past the PA28 and 'when well clear commenced a climbing turn to the R'.

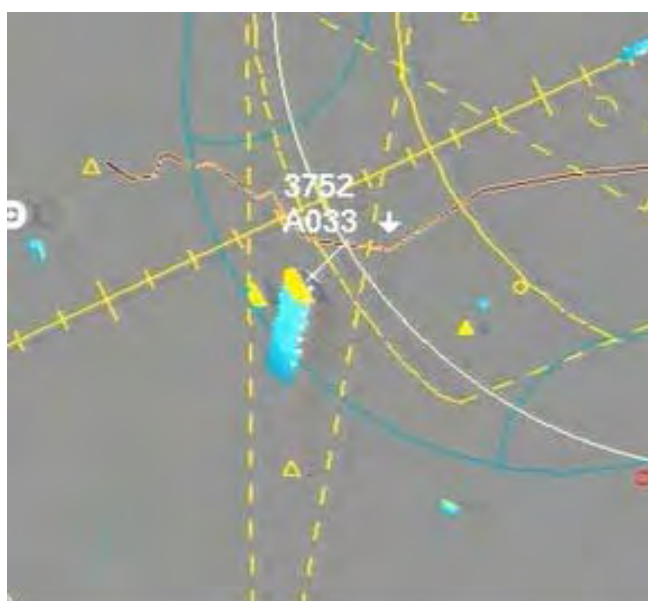
Fig 1. (1646:06)

The Newcastle radar display showed a number of spurious returns, (anomalous propagation) resulting from the high pressure atmospheric conditions; one of these contacts was subsequently believed to be the Hot Air Balloon.

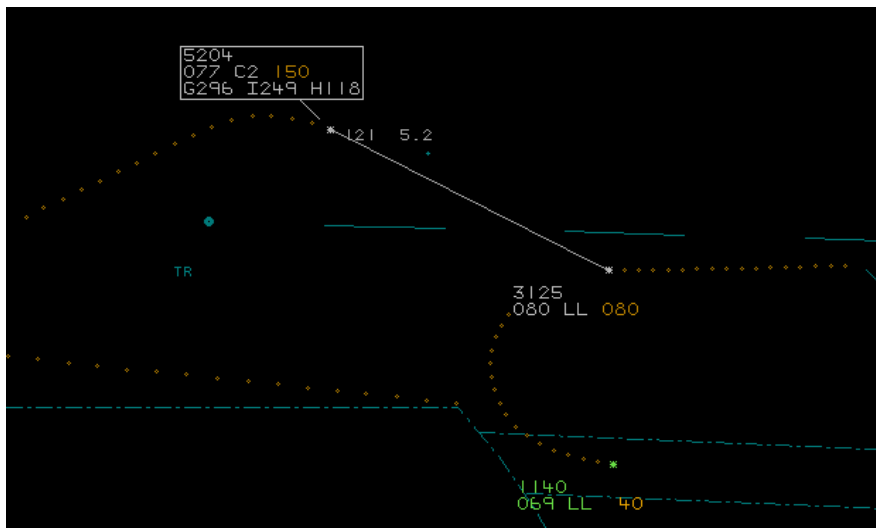
Figure 1: (Swanwick MRT) 1435:13 UTC

Low-Level STCA activated between the A340 and A320 at 1435:13. Separation between the 2 ac was 5.2nm/300ft (3nm or 1000ft required). See Figure 1.

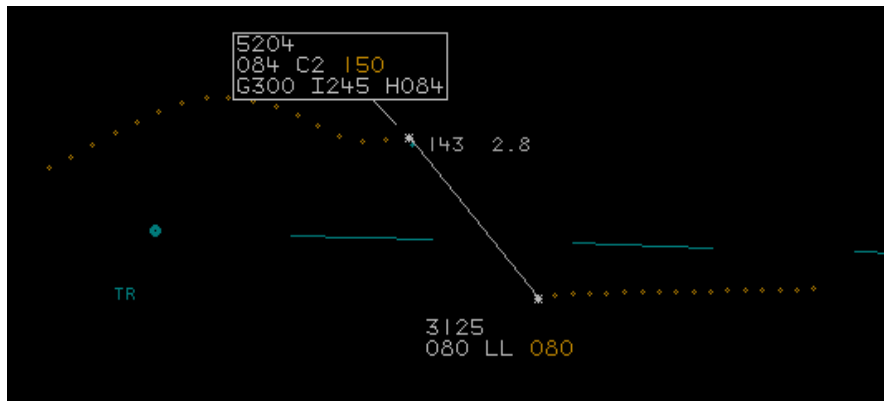
Figure 3: (Swanwick MRT) 1435:33

Separation was briefly lost at 1435:33 when the distance between the 2 ac fell to 2.8nm/400ft. (See Figure 3). At this time the A320 could be seen to be commencing its L turn and the A340 had turned L to heading 084°.

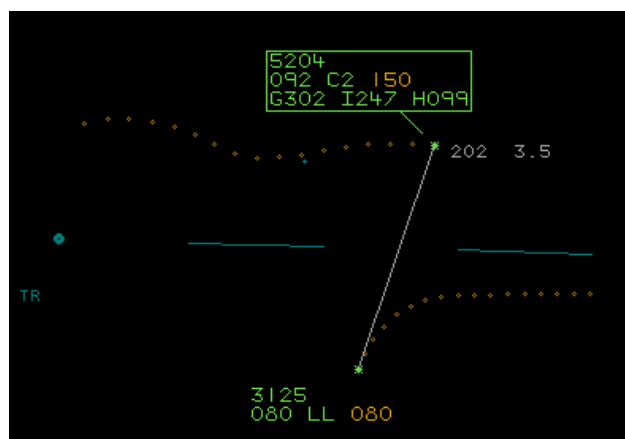
Figure 4: (Swanwick MRT) 1435:57

Surveillance Replay showed that STCA deactivated at 1435:41 but the A340's Mode S heading was beginning to show a R turn. The distance between the ac at 1435:41, the CPA, was 2.6nm/700ft.

Separation was restored at 1435:49 when the A340 passed FL090 (2.9nm/1000ft), the A320 now firmly established in its LH turn and moving away from the A340. At this time the A340's Mode S heading reported that the A340 had turned slightly further to the R onto heading 093° then onto 099°. (See Figure 4).

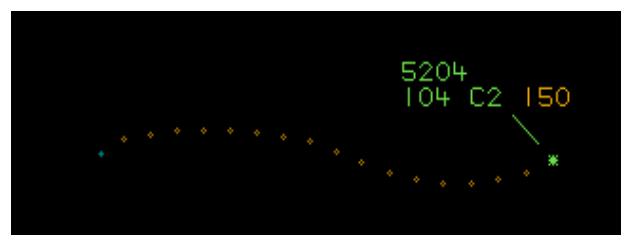
Figure 5: (Swanwick MRT) 1436:42

The A340 eventually reached a Mode S heading of 114° at 1436:13 before commencing a L turn. Figure 5 shows the 4sec interval trail history of the A340 at 1436:42.

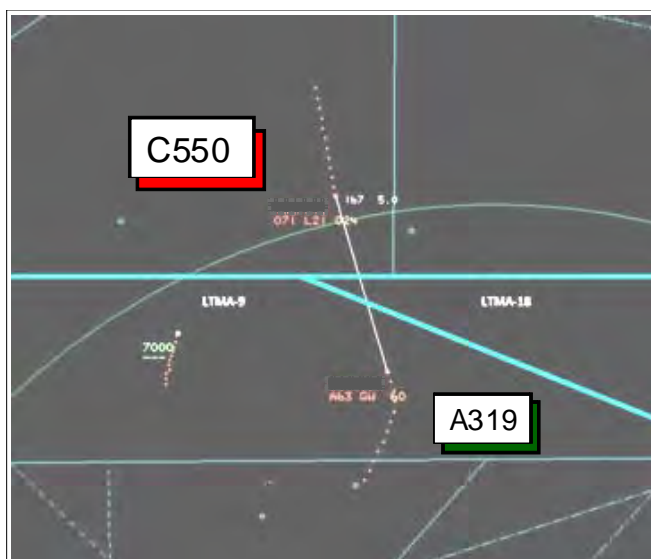
Fig 1 - 1446:32

At 1446:21, STCA activated at low level – white - and recorded radar data shows the distance between the two ac as 6.5nm. The controller immediately issued avoiding action, "[A319 C/S] *avoiding action continue that turn left heading 2-1-0 degrees there's unknown traffic 4 miles north of you 7 thousand 1 hundred feet descending.*" At 1446:32, STCA activated at high level - red (see Fig 1). The A319 pilot responded, "*Copied left heading 2-1-0*

degrees [A319 C/S]". The A319 is shown indicating an altitude of 6300ft with the C550 indicating FL71. [About 6650ft London QNH (998hPa).]

[UKAB Note (2): At 1446:51, the C550 is shown commencing a L turn onto a SE'y track. The CPA occurs at 1447:00, when the Stansted 10cm Radar recording shows the distance between the two ac as 2.4nm with vertical separation of 550ft. The A319 was indicating an altitude of 6100ft QNH (998hPa) and the C550 was indicating FL60 – equivalent to about 5550ft London QNH (998hPa).]

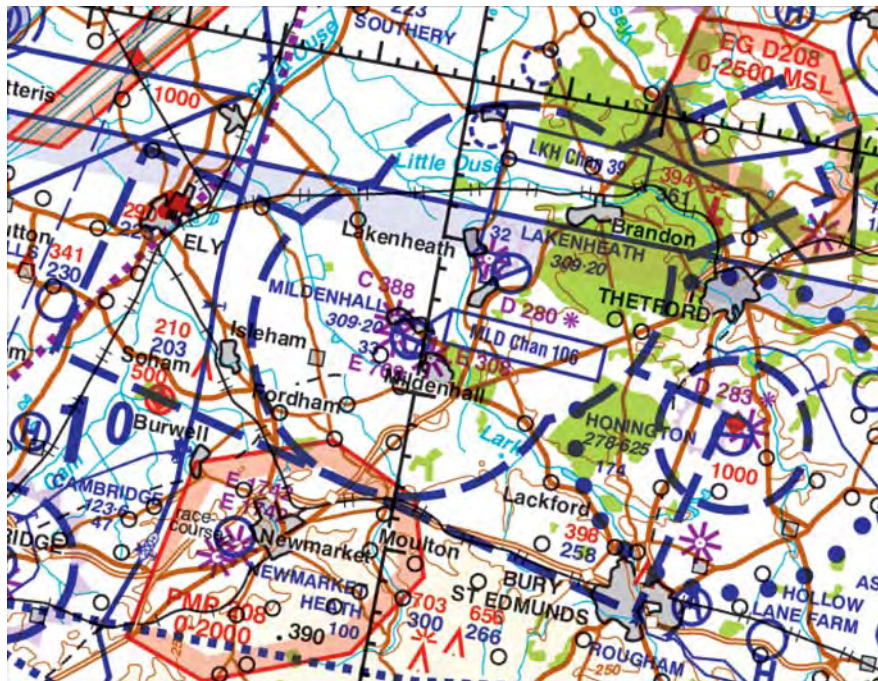
Figure 1: Combined MATZ RAF Lakenheath/RAF Mildenhall.

Following landline liaison with Luton RADAR, at 0905:30 NE TAC transmitted to the Typhoon crew, *“instructions from Luton, taking your own terrain clearance, descend 2 thousand 4 hundred feet, 1-0-0-9.”* Initially the descent instruction was readback incorrectly which was detected by NE TAC and a correct readback obtained from the crew; the exchange of RT was complete at 0905:53. At the point that the descent instruction was issued, the Typhoon was 10.8nm NNW of Mildenhall at FL100, and the KC-135 formation was not visible on the LJAO NE controllers' display. Extrapolation of the Typhoon's track demonstrates that it would have passed 6.3nm through the extended centre-line of RW29 at Mildenhall. The dimensions of that portion of the Combined MATZ directly relating to Mildenhall are a circle 5nm radius centred on the airfield and non-standard stubs extending 5nm either side of the RW centre-line (see Figure 1), extending from the surface to 3000ft above Lakenheath's A/D elevation of 32ft.

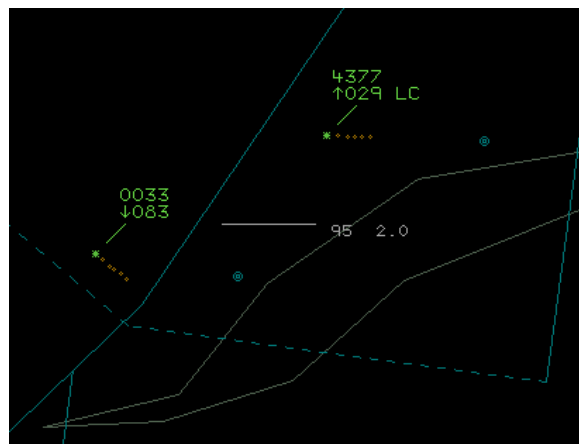
Figure 1: 1346:01UTC

The Do328 crew called Leuchars ZONE at 1346:01 (Figure 1), "...passing er flight level 3-3 climbing flight level 8-0 maintaining a runway heading runway 2-7 Dundee." The Leuchars controller responded, at 1346:15, stating, "...Leuchars ZONE identified, traffic service, traffic left 11 o'clock 4 miles crossing left right...parachuting aircraft flight level 8-0 descending." The pilot acknowledged the service level.

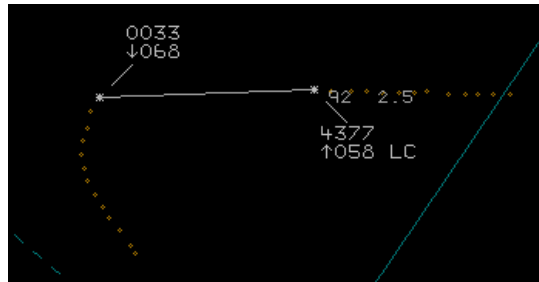
Figure 2: 1347:17UTC

The Do328 crew called the TAY Sector at 1346:58, passing FL54 for FL80. At 1347:23, the TAY trainee instructed the Do328 crew, "...squawk ident and..the believed to be you (sic) you've got traffic looks like a paratropper in your 12 o'clock range 2 miles if not seen turn left heading 1-8-0 degrees." (See Figure 2 below.) This was answered with the Do328 pilot stating, "er TCAS," and at 1347:40, "[Do328 C/S] TCAS RA."

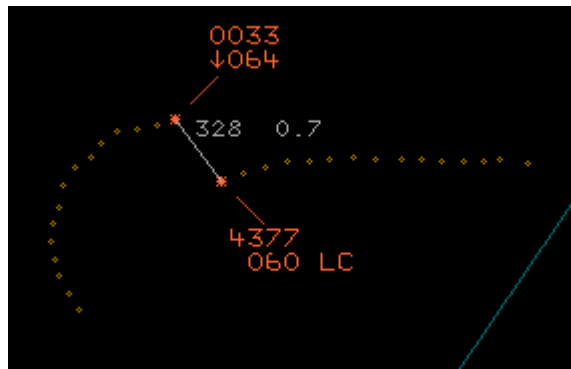
Figure 3: 1347:42UTC

High level STCA activated at 1347:24. The Do328 reached FL63 before descending to FL60 and turning to the L. At 1347:42, the CPA was reached when the separation between the ac was 0.7nm and 400ft. See Figure 3.

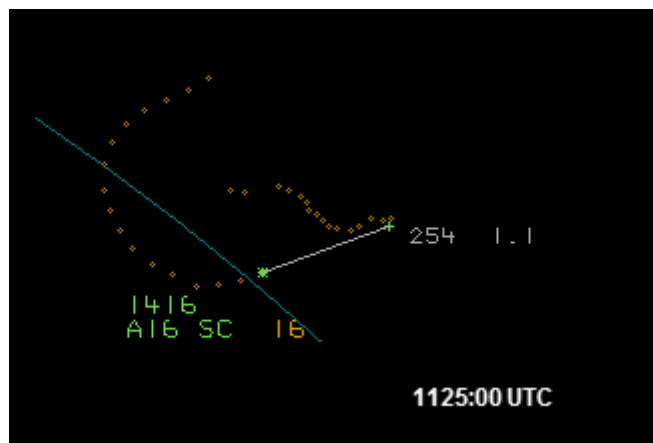
At 1125:00 the C560 pilot reported that the Tiger Moth was doing "acrobatics" in front of the C560. The relative positions of the 2 ac are shown in Figure 1 below, with the C560 transponding SSR code 1416.

The Tiger Moth's manoeuvres were such that its position could not be resolved by the available surveillance equipment and it disappeared from the surveillance replay at 1125:02. At 1125:20 the C560 pilot reported that the acrobatic manoeuvres and very close position of the Tiger Moth were not very safe.

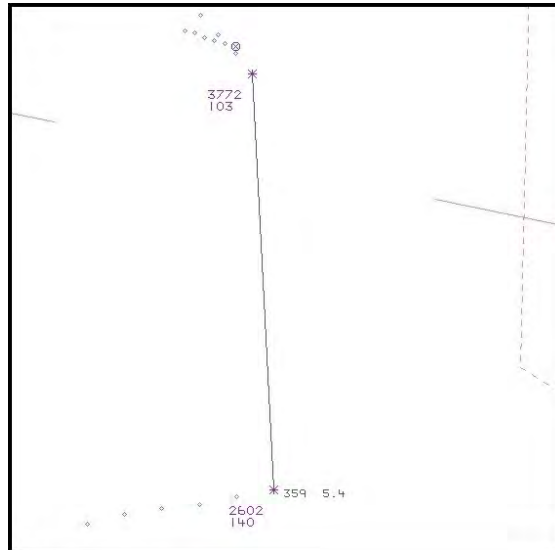
At 1444:50 Hawk (A) is passing FL140 in the ATR72's 1 o'clock position at a range of 5.4nm as shown in picture 1.

Picture 1 (1444:50) using Pease Radar & Gatwick 10cm

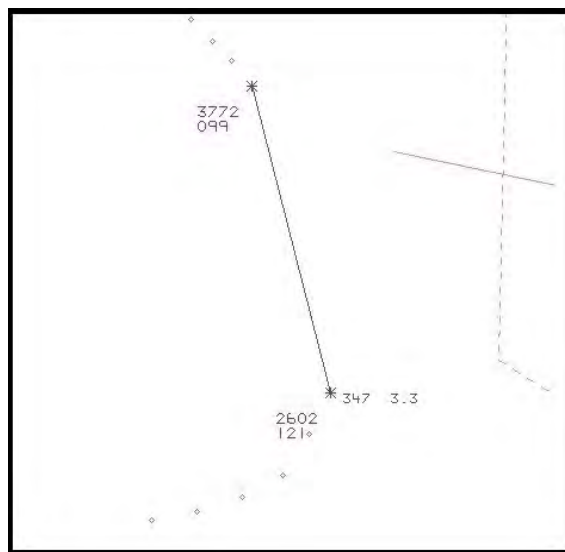
Picture 2 (1445:06)

At 1445:01 the Western controller transmitted, “(ATR72 c/s) there is traffic in your twelve o’clock in fact erm (ATR72 c/s) avoiding action turn right immediately heading er two five zero degrees.” The ATR72 crew responded, “Right heading two five zero (ATR72 c/s).” At 1445:06, picture 2 shows Hawk (A) continuing in the descent and turning L, with less than the required deconfliction minima.

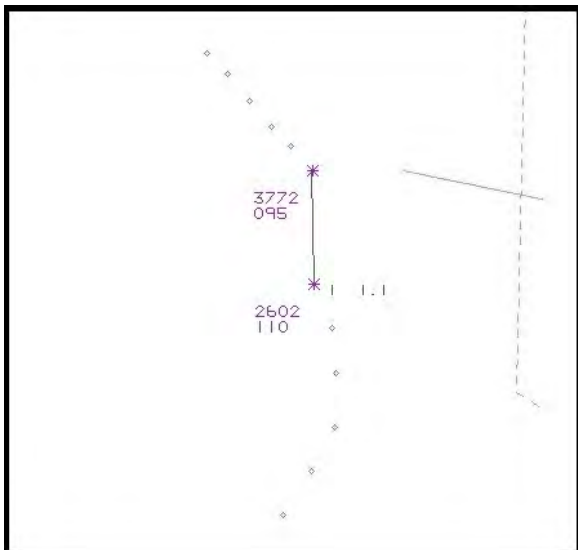
Picture 3 (1445:18)

At 1445:18 Hawk (A), at FL110, passes 1.1nm due S of the ATR72, at FL095, as shown in picture 3. This is considered to be the point at which the ATR72 received a TCAS RA as described in the ATR72 pilot’s written report.

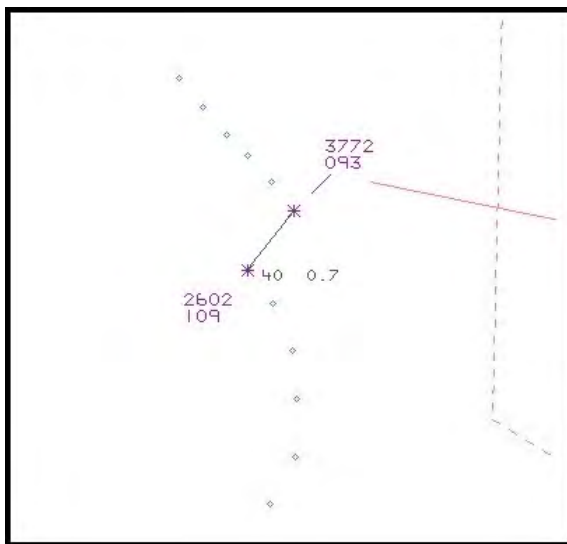
Picture 4 (1445:22)

At 1445:22 Hawk (A) continued in the L turn passing 0.7nm SW of the ATR72 on a reciprocal track (CPA) as shown in picture 4. The Western controller updated the ATR72 crew on the position of Hawk (A), amending the avoiding action turn by advising the ATR72 crew to fly S.

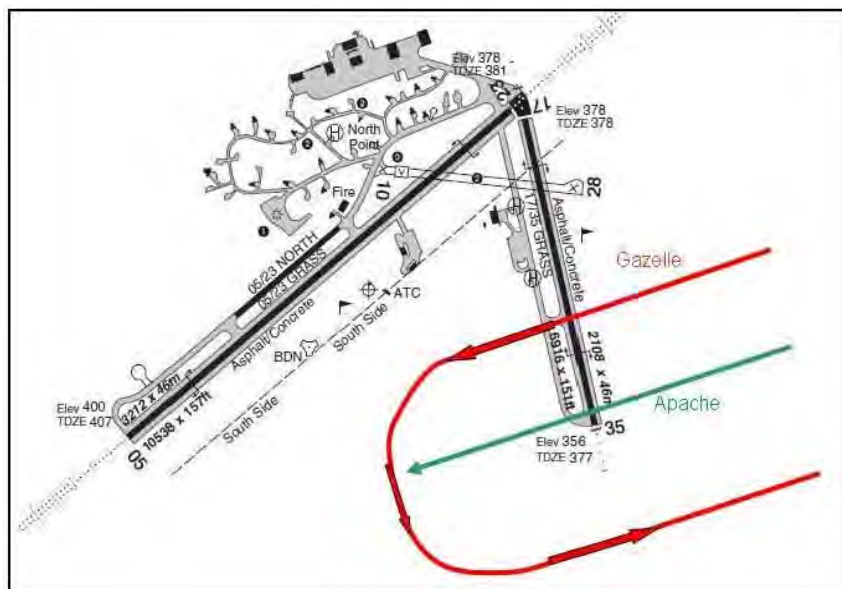
Figure 1: Boscombe Down with Operating Locations of Gazelle & Apache

At 2129:46, the Apache stated that they were, “*established south-side to operate threshold runway 35*” (see Figure 1). The ADC asked them to, “*confirm visual with the Gazelle*” to which the Apache replied, “[c/s] visual”. The ADC acknowledged this visual call and informed the Apache that they were, “*happy for you to work negative R-T south-side*”, which was read-back by the pilot.

Based upon the reports of the pilots and the R/T transcript, the Airprox occurred at some point between 2130:05 and 2138:36 as the Gazelle climbed over the Apache, which had recently transitioned to forward flight and was climbing through 250ft.

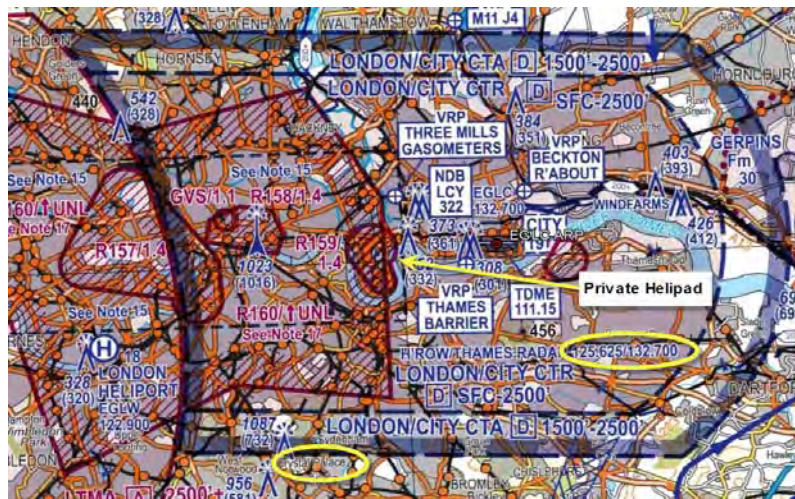
Figure 2: 1:250,000 VFR Chart

The private helipad at the O2 Arena is situated within the London City CTR and is unlicensed. Figure 2 below shows the location of the O2 Arena helipad ('Private Helipad') and Crystal Palace Masts. The notified frequencies are also highlighted. The private helipad is sited 140 metres from the W boundary of the London City ATZ.

Upon lifting from the helipad the EC155 pilot was within Class D airspace. Given the time of the lift the controlling authority for the airspace was Heathrow Director [119.725MHz]. However, it was noted that this option is not depicted on the 1:250,000 VFR chart graphic at Figure 2.

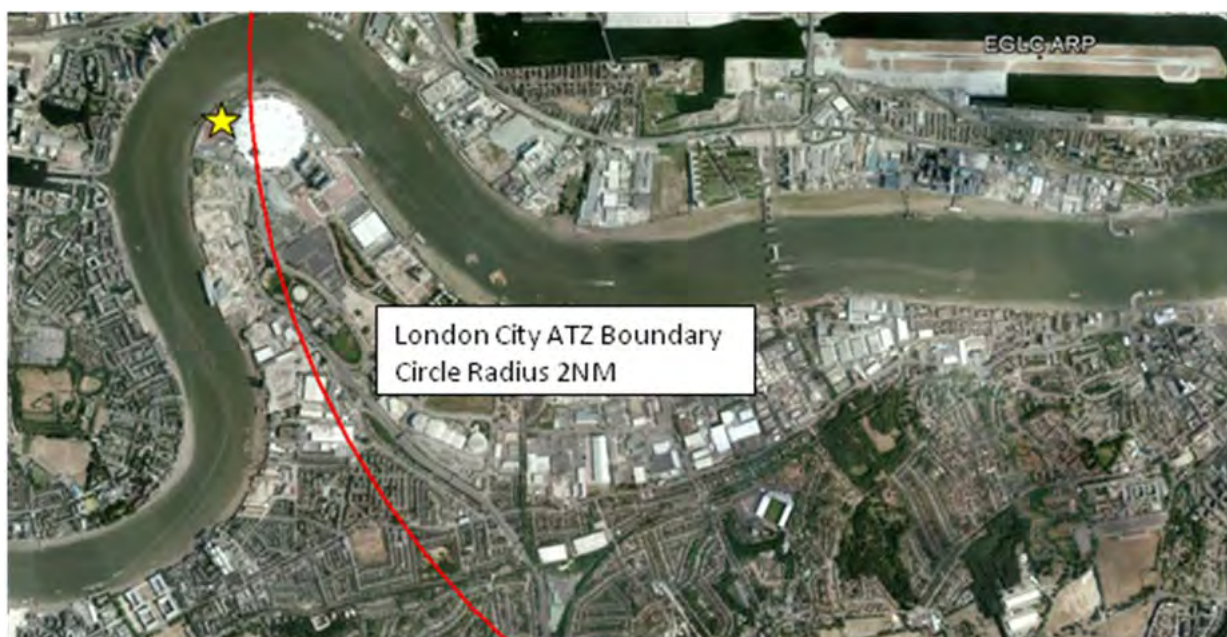
Additionally, a note in the ATS Airspace notification instructs pilots that 'Outside the hours of Heathrow Radar and Thames Radar the controlling authority is Heathrow Director'. The notified Local Traffic Regulations state that AIP EGLL AD 2.22 should be consulted for details of helicopter procedures within the CTR. The diagram below shows the boundary of the London City ATZ in relation to the helipad (denoted by the yellow star):

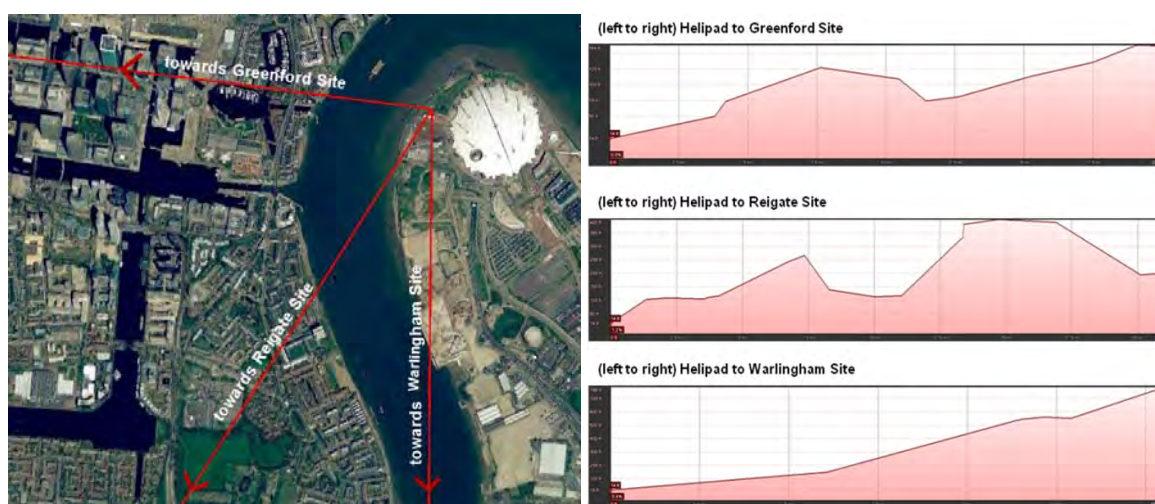
The diagram below shows the relative directions of the receiver sites for 119.725MHz and 125.625MHz and indicative elevation profiles, which commence at the helipad location and terminate at the specified Receiver site (site location data supplied by ANSP):

RTF frequency 119.725MHz (LL APC N) is transmitted/received at sites near Waringham and Greenford. RTF frequency 125.625MHz (LL SVFR) is transmitted/received at sites near Reigate and Greenford.

ATSI conducted a basic RTF test at ground level on the helipad at North Greenwich using a hand-held scanner. It was found that, on 119.725MHz, only ac transmission could be heard. Transmissions made by ATC were detected only as a high pitched pulse and were indistinguishable. Both ATC and ac transmissions were heard on 125.625MHz.

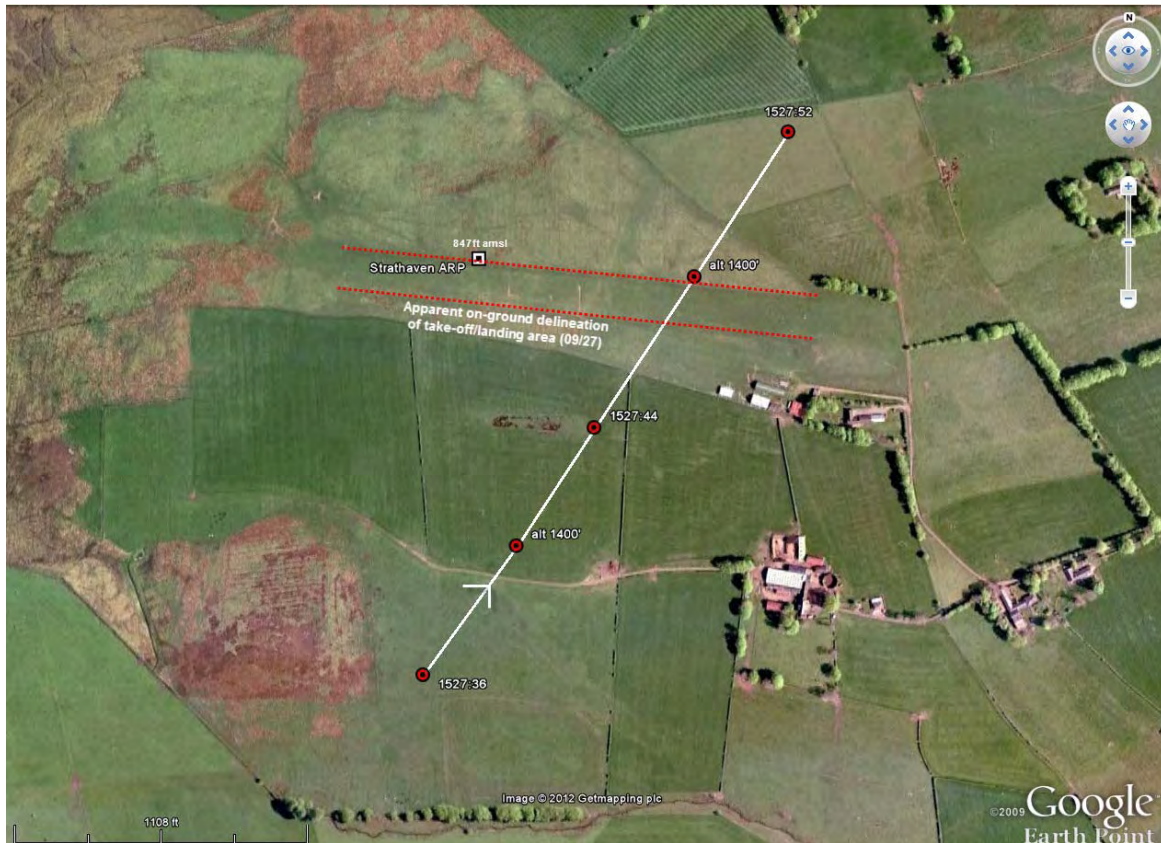
Between 1527:44 and 1527:52 the surveillance replay shows the R44 fly over the Strathaven grass strip at an altitude of 1400ft. The Strathaven ARP has an elevation of 847ft. (See image below)

The M/Light pilot reported to UKAB that he observed the R44 on his RHS as he lifted [from a RW09 departure, prevailing NE'ly winds]. The pilot cut power to the M/Light and landed to avoid flight through rotor wash.

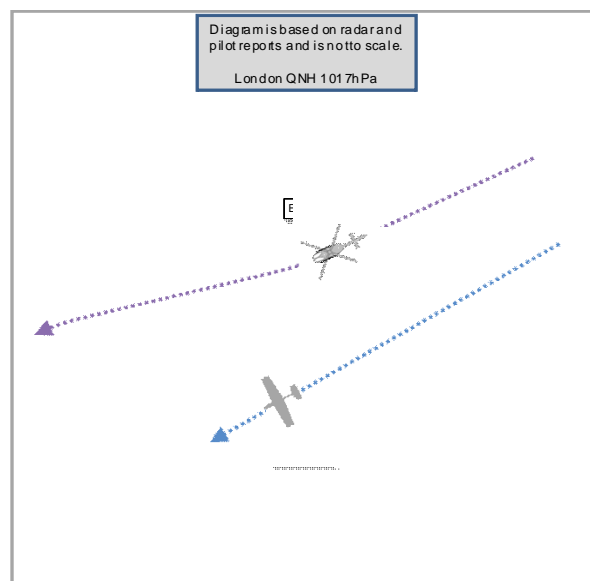
AIRPROX REPORT NO 2012072

Date/Time: 27 May 2012 1443Z (Sunday)
Position: 5012N 00515W (Near Redruth)
Airspace: Culdrose AIAA (Class: G)
Reporting Ac Reported Ac
Type: CFM Shadow D EC145
Operator: Civ Pte Civ Pol
Alt/FL: 1900ft 2000ft
NK NK
Weather: VMC CLBC VMC CLBC
Visibility: >20nm 8nm in Haze
Reported Separation:
50ft V/100ft H 500ft V/0.5nm H
Recorded Separation:
NK

THE SHADOW D MICROLIGHT PILOT reports flying a VFR private local flight in a red micro-light, with top and bottom strobes 'on'. A SSR transponder was not fitted but he was in receipt of a BS from Newquay LARS [133.400MHz]. While heading 240°, level at 1900ft [Newquay QNH 1019hPa] at 75kt a police helicopter passed him on the R side with a separation assessed as 100ft H and 50ft V. Although the police helicopter passed on the correct side, the close proximity gave the M/light pilot concern. He informed Newquay LARS that he was visual with the police helicopter that had just passed very close. Newquay informed him that the police helicopter had not called them despite crossing the extended centre line for RW30 [UKAB Note (1): Radar replay shows the police helicopter crossed the RW30 extended C/L at a range of 8nm]. Newquay LARS attempted to establish R/T communication with the helicopter on 2 occasions, but received no response to their calls. The Newquay Controller invited him to call on the land line on return to his home A/D if he wished, which he did.

Cause: The Shadow microlight pilot was concerned by the proximity of the overtaking EC145.

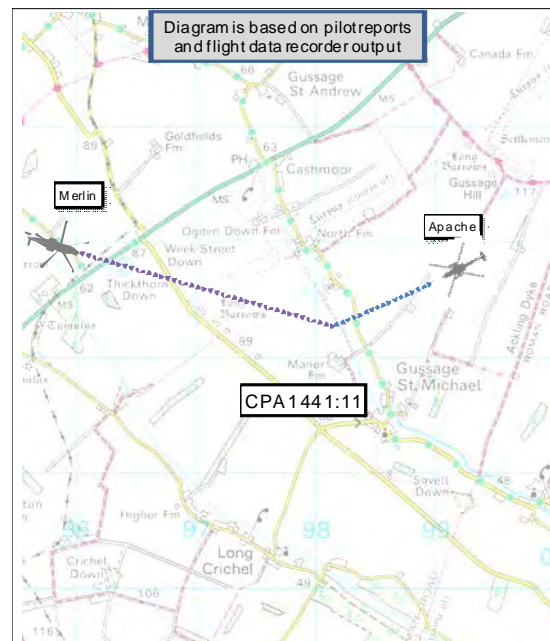
AIRPROX REPORT NO 2012073

Date/Time: 31 May 2012 1442Z
Position: 5054N 00202W (10nm SW Salisbury)
Airspace: Lon FIR-LFA2 (Class: G)
Reporting Ac Reporting Ac
Type: Apache Merlin
Operator: HQ JHC HQ JHC
Alt/FL: 75ft 100ft
RPS (1014hPa) RPS (1016hPa)
Weather: VMC CLBC VMC CLBC
Visibility: 30km 10km
Reported Separation:
25m 0ft V/60ft H
Recorded Separation:
NR

Cause: A late sighting by the Apache crew and effectively a non-sighting by the Merlin crew.

Recalling a previous Airprox between military helicopters and a formal Safety Recommendation to fit ACAS [Airprox 2011/006 dated 24th January 2011], Members considered that this incident could have been avoided if the ac had been fitted with ACAS. A civilian pilot Member informed the Board that FLARM (Flight Alarm), commonly fitted to gliders, is an inexpensive and relatively easy-to-fit option that has proved effective in helicopters in Europe. Members agreed that Director UKAB should write to HQ JHC to highlight this incident, lending weight to the requirement to fit ACAS.

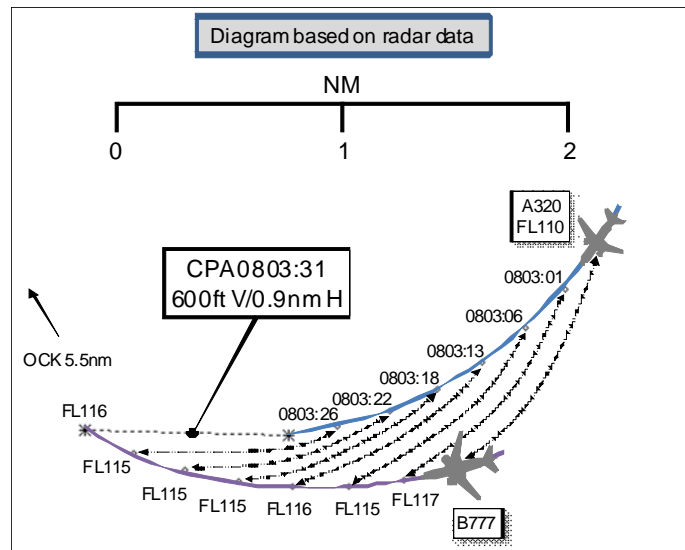
AIRPROX REPORT NO 2012075

Date/Time: 2 June 2012 0804Z (Saturday)
Position: 5114N 00021W (OCK HOLD)
Airspace: Lon TMA (Class: A)
Reporting Ac Reported Ac
Type: B777 A320
Operator: CAT CAT
Alt/FL: FL120↓ NR
(SPS 1013 hPa) (SPS 1013 hPa)
Weather: VMC NR VMC NR
Visibility: NR >20km
Reported Separation:
500ft V/0.5nm H >700ft V/
1nm-1.5nm H
Recorded Separation:
600ft V/0.9nm H

Cause: The B777 crew actioned an ATC instruction intended for another aircraft and descended into conflict with the A320.

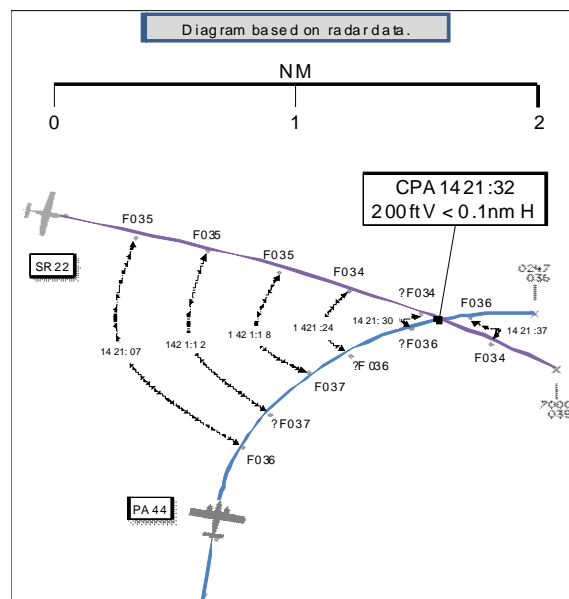
AIRPROX REPORT NO 2012076

Date/Time: 9 Jun 2012 1422Z (Saturday)
Position: 5211N 00033W (CIT NDB(L) Hold)
Airspace: London FIR (Class: G)
Reporting Ac Reported Ac
Type: PA44 SR22
Operator: Civ Trg Civ Pte
Alt/FL: 3500ft 3300ft
 QNH (1009hPa) (NR)
Weather: VMC CAVOK VMC CLBC
Visibility: >10km >10km
Reported Separation:
 100ft V/0nm H 200ft V/0.5nm H
Recorded Separation:
 200ft V/< 0.1nm H

Cause: A conflict resolved by the SR22 pilot.

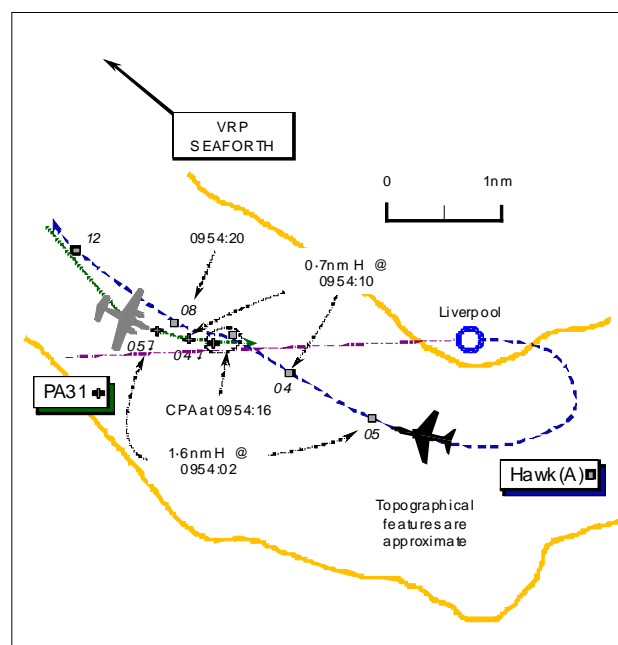
AIRPROX REPORT NO 2012077

Date/Time: 12 Jun 2012 0954Z
Position: 5320N 00253W (1.5nm W of Liverpool Airport - elev 81ft)
Airspace: Liverpool CTR/ATZ (Class: D)
Type: PA31-350 Hawk T Mk2
Operator: Civ Comm HQ Air (Trg)
Alt/FL: 300ft↓ 400ft
 QNH (1011hPa) QNH (1011hPa)
Weather: VMC CLBC VMC CLBC
Visibility: >10km 15km
Reported Separation:
 100ft V/100m H 100-150ft range
Recorded Separation:
 Nil V @ <0.3nm H

Cause: The crew of Hawk (A) did not comply with ATC instructions and flew into conflict with the PA31.

It is recommended that Liverpool ATC review their procedures for traffic conducting go-arounds for training purposes and give consideration to ensuring that all ac operating in the ATZ are transferred to the TOWER controller.

It is recommended that Liverpool ATC ensure that PDs by Hawk ac from Valley are discussed as part of unit training prior to validation.

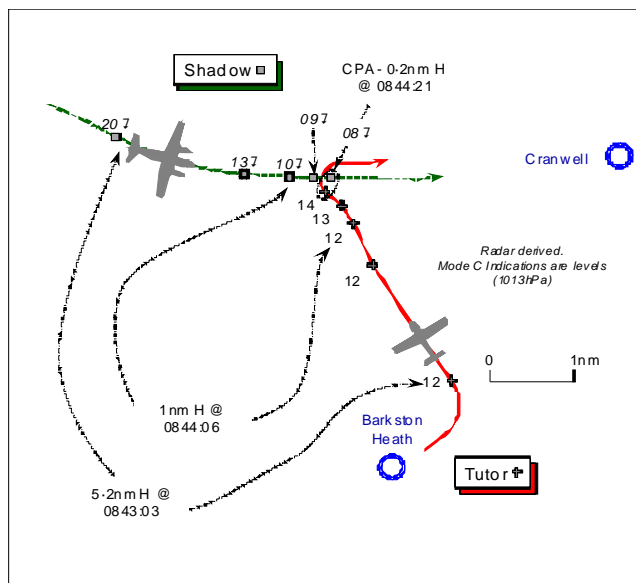
AIRPROX REPORT NO 2012079

Date/Time: 14 Jun 2012 0844Z
Position: 5301N 00035W
 (3-6nm W of Cranwell - elev 231ft)
Airspace: Cranwell CMATZ (Class: G)
Reporting Ac Reported Ac
Type: Beech Shadow Grob Tutor
Operator: HQ Air (Ops) HQ Air (Trg)
Alt/FL: 1500ft↓ 1300ft
 QFE (1010hPa) QFE (1010hPa)
Weather: VMC VMC
Visibility: 40km 30km
Reported Separation:
 200ft V/0.5nm H 300ft V
Recorded Separation:
 0-2nm H

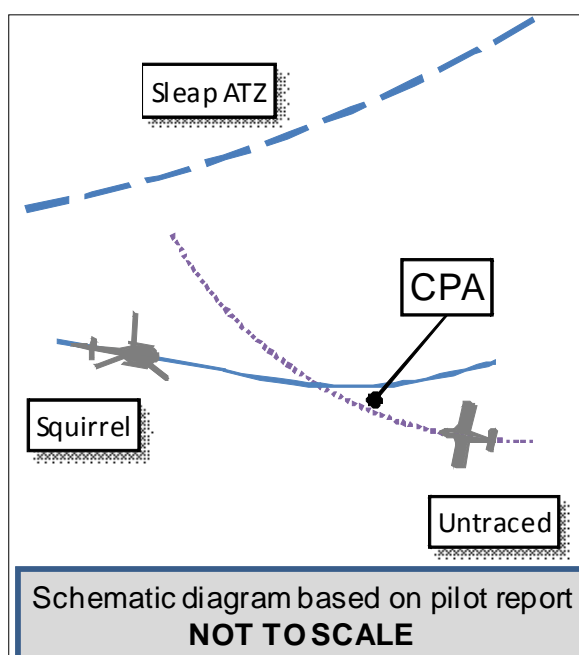
AIRPROX REPORT NO 2012080

Date/Time: 14 June 2012 1035Z
Position: 5248N 00246W
 (3nm W RAF Shawbury)
Airspace: Shawbury MATZ (Class: G)
Reporting Ac Reported Ac
Type: Squirrel Untraced ac
Operator: HQ Air (Trg) NK
Alt/FL: 1000ft NK
 QFE (1007hPa)
Weather: VMC CLBC NK
Visibility: 10km NK
Reported Separation:
 350ft V/100m H NK
Recorded Separation:
 NK

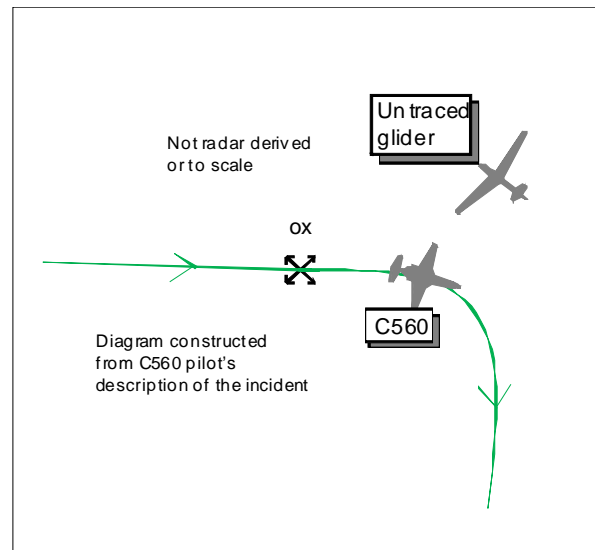
AIRPROX REPORT NO 2012082

Date/Time: 27 May 2012 1331Z (Sunday)
Position: 5150N 00119W (O/H OX NDB)
Airspace: Oxford AIAA (Class: G)
Reporting Ac Reported Ac
Type: C560XLS Untraced Glider
Operator: Civ Comm NK
Alt/FL: 3500ft NK
(QNH)
Weather: VMC NK NK
Visibility: 10km NK
Reported Separation:
0ft V/50m H NK
Recorded Separation:
NR

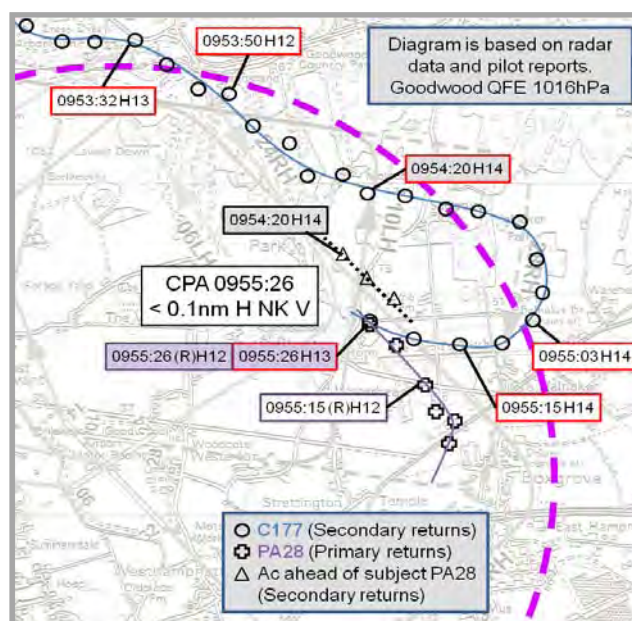
AIRPROX REPORT NO 2012084

Date/Time: 19 June 2012 0955Z
Position: 5052N 00043W
 (RW14 LHC Chichester/Goodwood - elev 110ft)
Airspace: ATZ (Class: G)
Reporting Ac Reported Ac
Type: PA28 C177
Operator: Civ Pte Civ Pte
Alt/FL: 1200ft 1200ft
 (QFE 1016hPa) (NK)
Weather: VMC OOS VMC OOS
Visibility: >10km 10km
Reported Separation:
 25ft V/0m H NR
Recorded Separation:
 NK V/<0.1nm H

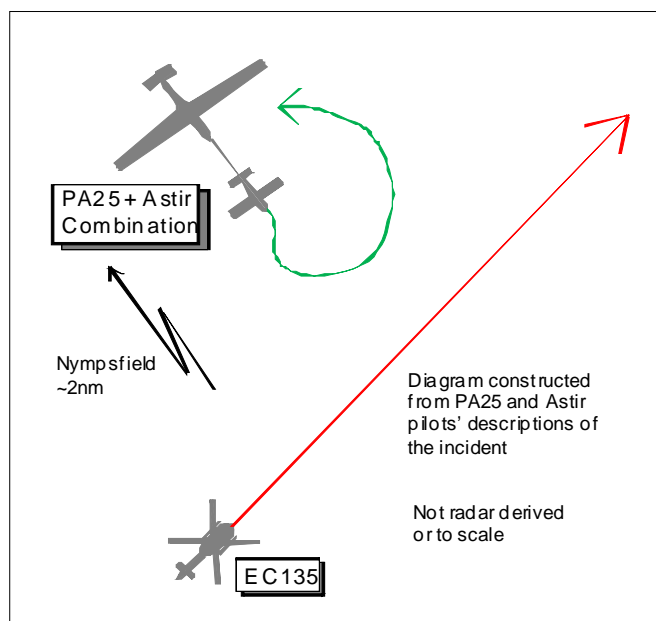
AIRPROX REPORT NO 2012085

Date/Time: 20 Jun 2012 0935Z
Position: 5141N 00215W
 (2nm SE Nympsfield G/S - elev 700ft)
Airspace: LFIR (Class: G)
Reporting Ac Reported Ac
Type: PA25+Grob Astir EC135
 Combination
Operator: Civ Club Civ Comm
Alt/FL: 1660ft↑ 1500ft
 (QNH) (QNH)
Weather: VMC CLBC VMC CLBC
Visibility: 50km >10km
Reported Separation:
 100m H Nil V/0.5nm H
Recorded Separation:
 Returns merge (See ATSI report)

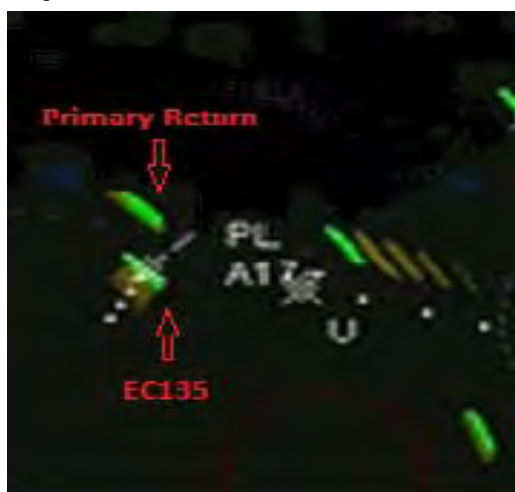
Figure 1

At 0933:27 the EC135 was approximately 4nm to the S of Nympsfield, tracking NE, at altitude 1700ft, while a faint primary return was showing in the vicinity of the Nympsfield gliding site. The primary return remained visible as the EC135 continued to track NE (Figure 1). By 0935:05 the EC135 was approximately 2nm SE of Nympsfield with the primary return in its 10 o'clock position at a range of approximately 0.5nm (Figure 2). At 0935:18 the primary return and the EC135 appeared to merge (Figure 3) before the primary return separated and tracked to the W at 0935:35 (Figure 4).
