UK AIRPROX BOARD

Analysis of Airprox in UK Airspace

**Report Number 28
January 2012 – December 2012**

Twenty-Eighth Report by the UK Airprox Board:

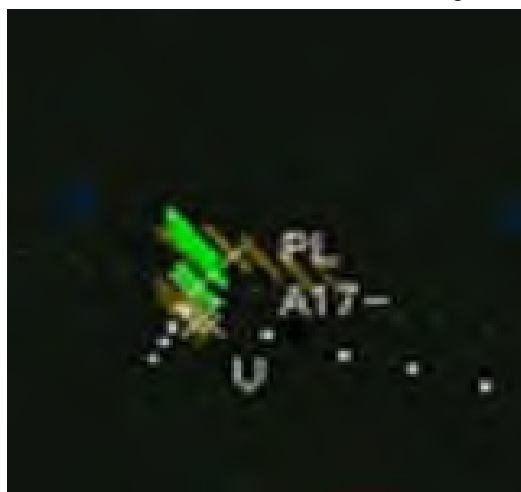
Figure 2

At 0933:27 the EC135 was approximately 4nm to the S of Nympsfield, tracking NE, at altitude 1700ft, while a faint primary return was showing in the vicinity of the Nympsfield gliding site. The primary return remained visible as the EC135 continued to track NE (Figure 1). By 0935:05 the EC135 was approximately 2nm SE of Nympsfield with the primary return in its 10 o'clock position at a range of approximately 0.5nm (Figure 2). At 0935:18 the primary return and the EC135 appeared to merge (Figure 3) before the primary return separated and tracked to the W at 0935:35 (Figure 4).

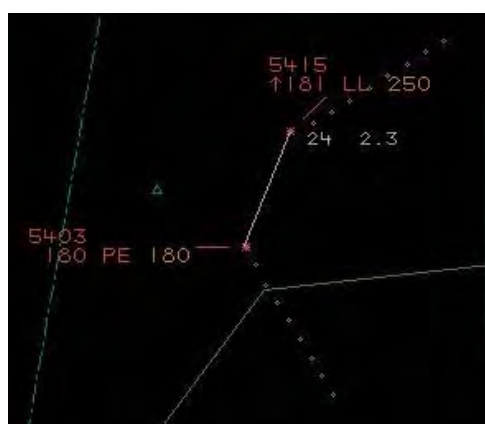
Figure 1: 0833:08 UTC (Prestwick Multi Radar Tracking)

Separation was lost at 0832:52 as the A319 climbed through FL175 in the Saab 2000 pilot’s half-past-one position at a range of 4.6nm. Minimum distance between the two aircraft occurred at 0833:08 as the A319 climbed through FL181, 2.3nm from the Saab 2000 (see Figure 1 below). Separation was restored at 0833:20 as the Saab 2000 pilot descended through FL175 with the A319 crossing right to left through its 12 o’clock climbing through FL188.

The Airprox occurred 13nm E of Glasgow at FL180 when the GAL controller climbed an A319 through the level of a Saab 2000 without ensuring standard separation would be maintained.

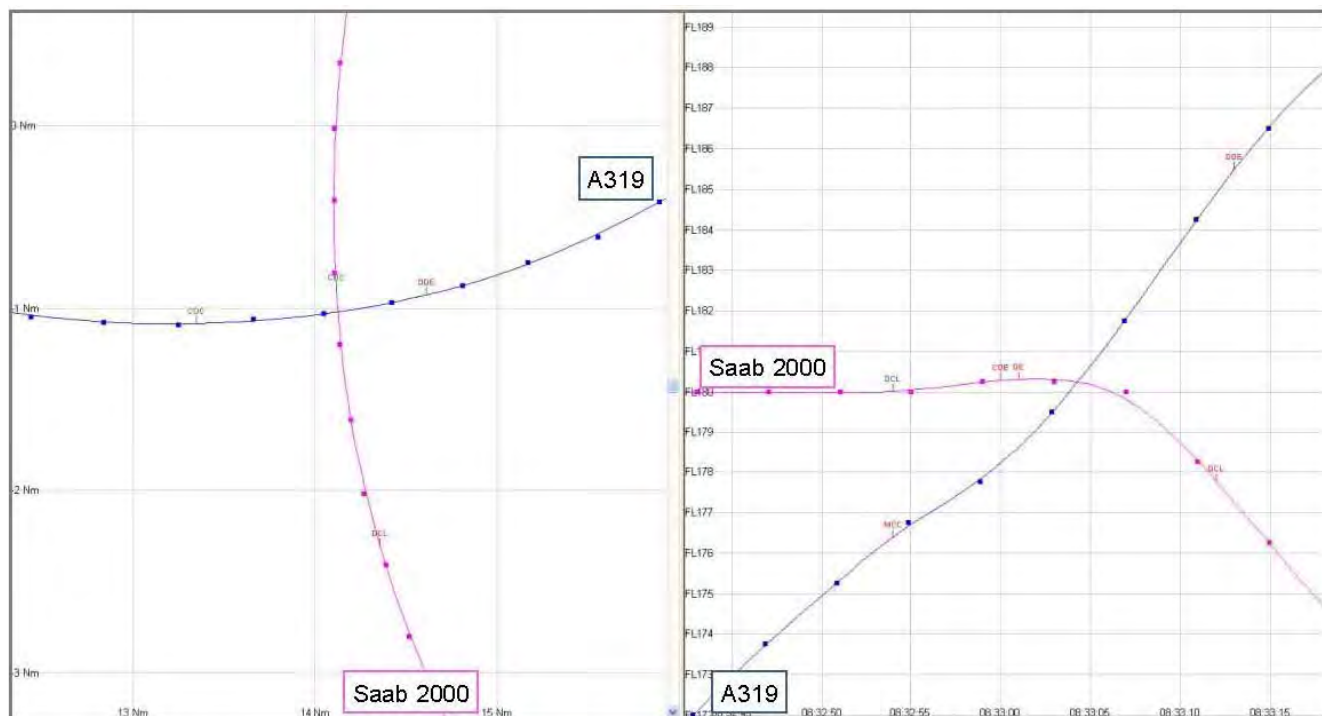
Encounter Diagram (Note that the square markers on the above image show the positions recorded by the Glasgow radar, while the solid lines show the InCAS-interpolated tracks)

Eurocontrol's Automatic Safety Monitoring Tool (ASMT) recorded several RAs relating to this encounter via Mode S downlink. [A319 C/S] received (in the following order) a Maintain Crossing Climb (MCC), a Keep Vertical Speed and an Adjust Vertical Speed. [Saab 2000 C/S] received an unknown type of RA, followed by Crossing Descend (CDE), Descend (DE) and finally an Adjust Vertical Speed.

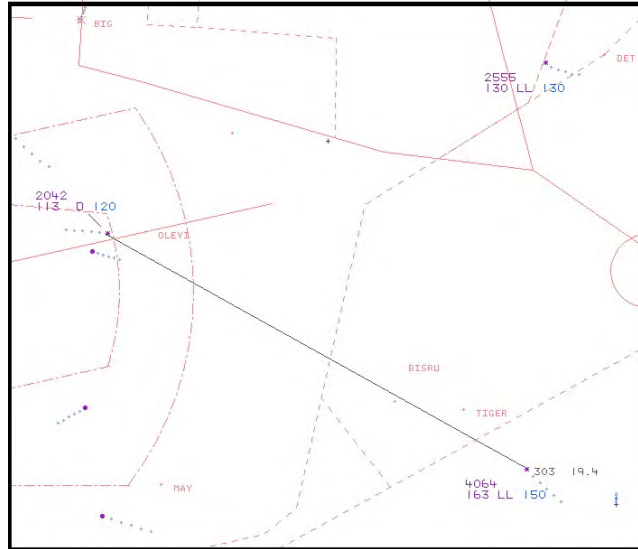
Print 2 – 1000:23

At 1000:23, 2min after the A321 flight had checked in on frequency, the A319 flight was instructed, "(A319 c/s) climb Flight Level one seven zero expedite through Flight Level one four zero." The A319 pilot replied, "Climb Flight Level one seven zero wilco (A319 c/s)." Print 2 below shows the B737 turning R at DET and the A319 on a track to route S of B737. The A321 is shown 19.4nm SE of the A319 and the BIG controller's written report indicated that the controller had forgotten about the A321.

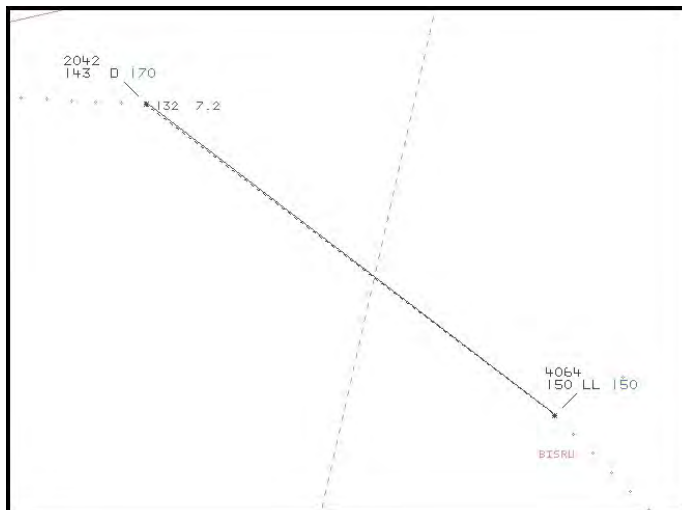
Print 3 – 1001:34

At 1001:33, the STCA activated as the range between the 2 ac reached 7.2nm as shown in print 3 below.

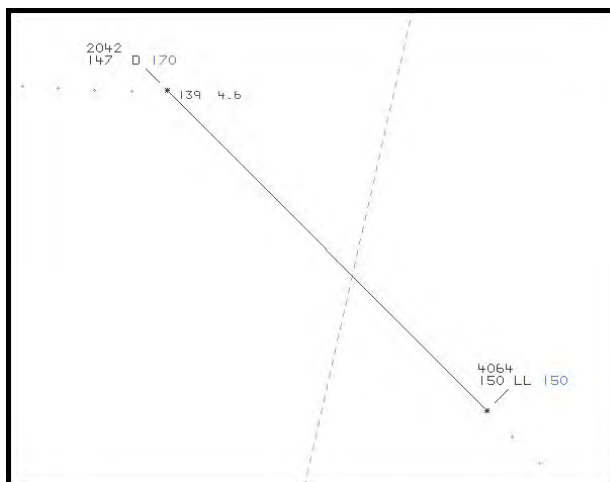
Print 4 – 1001:50

At 1001:52 the BIG controller passed TI, “(A321 c/s) traffic in your twelve o’clock range of three miles climbing through your level.” The A321 pilot responded, “Yes er we saw also TCAS also we saw contact.” The BIG controller replied “Roger.” Print 4 below shows the distance between the ac as 4.6nm.

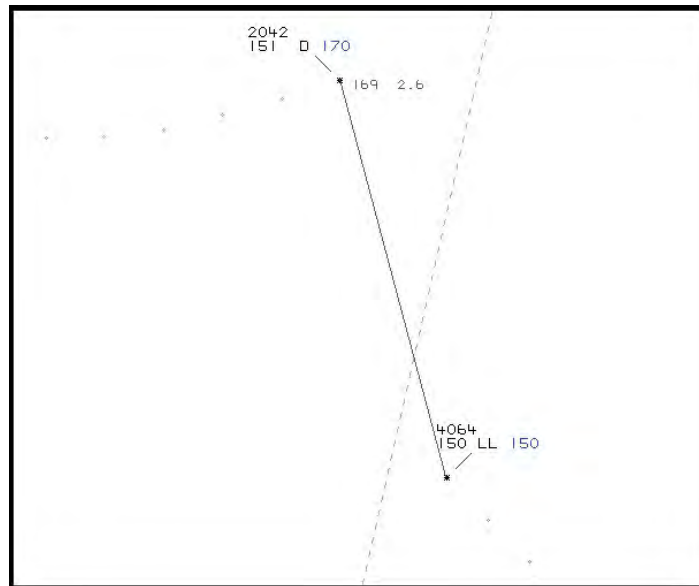
Print 5 – 1002:05

At 1002:05, print 5 below, shows separation as 2.6nm with a vertical distance of 100ft. The A319, turning L reported, “(A319 c/s) is expediting climb traffic just in sight passing behind” and shortly after reported clear of the traffic.

[UKAB Note (1): CPA occurs at 1002:13, the A319 climbing through FL156 and passing 2-3nm NNE of the A321 which is maintaining FL150 with tracks diverging.]

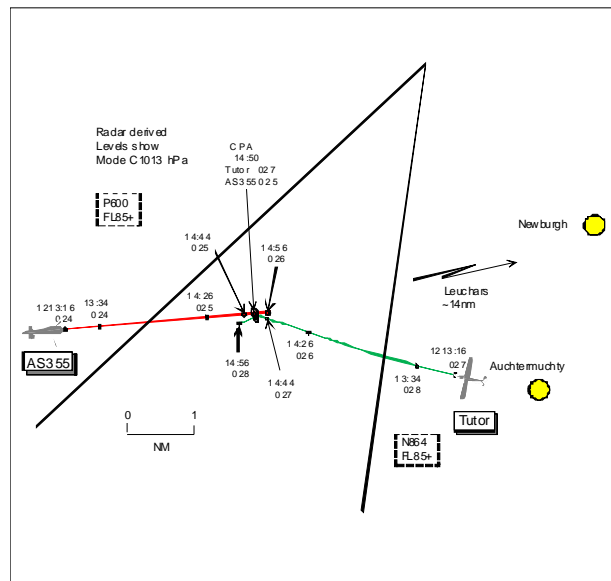
Date/Time: 12 Jul 2012 1215Z
Position: 5618N 00322W
(17nm WSW Leuchars - elev 38ft)
Airspace: SFIR (Class: G)
Reporting Ac Reported Ac
Type: Tutor T Mk1 AS355
Operator: HQ Air (Trg) Civ Comm
Alt/FL: 2500ft 2500ft
RPS (1004mb) QNH
Weather: VMC CLBC VMC CLNC
Visibility: 10km 10km
Reported Separation:
150ft V/200m Not seen
Recorded Separation:
200ft V/<0.1nm H

Cause: A non-sighting by the AS355 pilot and a late sighting by the Tutor pilot.

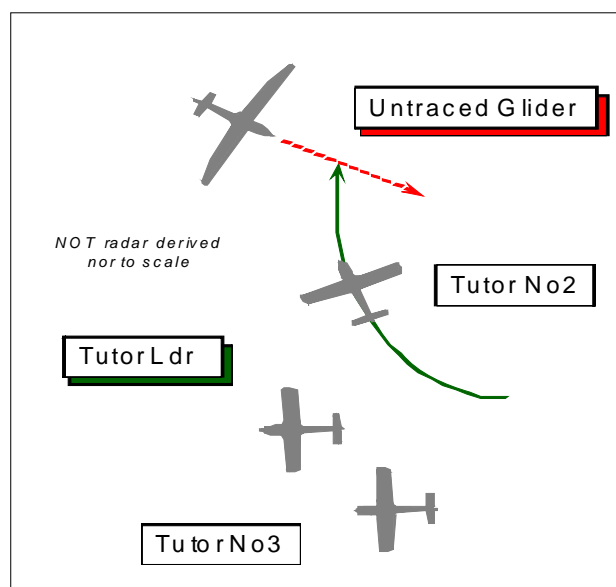
Date/Time: 12 Jul 2012 1355Z
Position: 5226N 00020W (2nm W Sawtry)
Airspace: London FIR (Class: G)
Reporting Ac Reported Ac
Type: Tutor T Mk1 x3 Untraced Glider
Operator: HQ Air (Trg) NK
Alt/FL: 2000ft+ NK
RPS (1008hPa) (NK)
Weather: NK CLBC NK
Visibility: 40km NK
Reported Separation:
50ft V/20yd H NK
Recorded Separation:
Not recorded

Cause: The Tutor leader instructed the No2 to break into conflict with the untraced glider, which he had not seen.

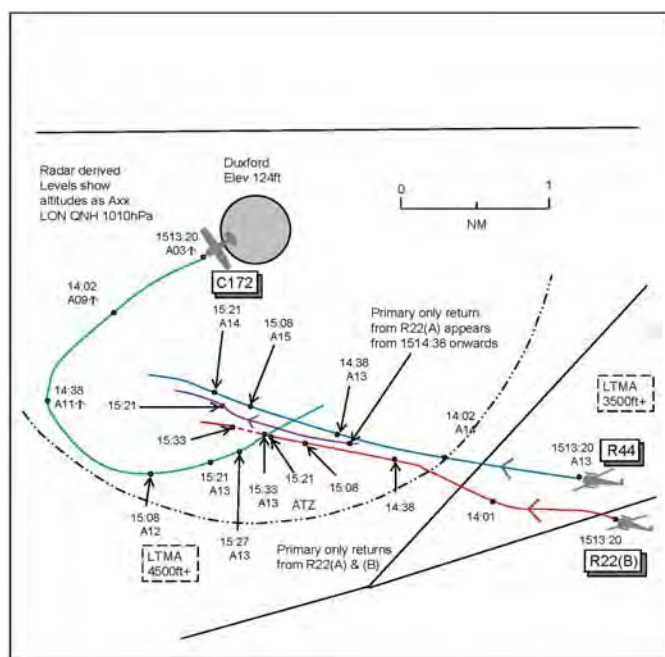
Date/Time: 18 Jul 2012 1515Z
Position: 5204N 00008E
 (1.5nm S Duxford - elev 124ft)
Airspace: ATZ/R112 (Class: G)
Reporting Ac Reported Ac
Type: C172 R44+2xR22s
Operator: Civ Trg Civ Trg
Alt/FL: 1300ft 1400ft
 QNH (1008hPa) QNH
Weather: VMC CLBC VMC CLBC
Visibility: >10km >10km
Reported Separation:
 200ft V/O-3m H R44 1km H
 R22(A) 1km H
 R22(B) Not seen
Recorded Separation:
 <0.2nm H

Cause: A conflict in the Duxford ATZ caused by an inappropriate procedure during the Olympic period.

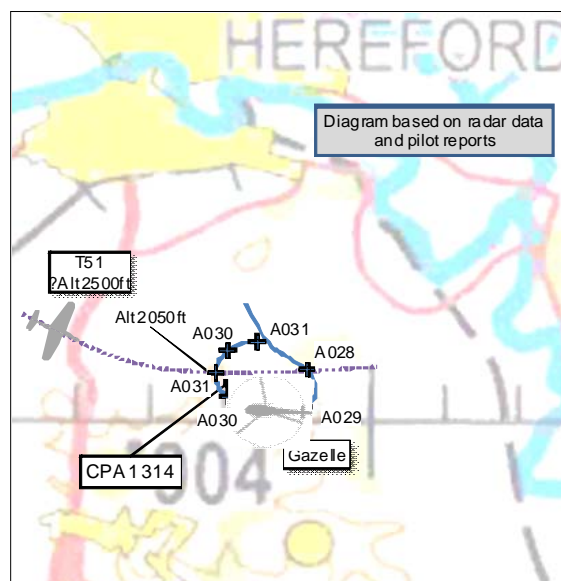
Date/Time: 9 Jul 2012 1314Z
Position: 5200N 00243W (3nm S Hereford)
Airspace: Lon FIR (Class: G)
Reporting Ac Reported Ac
Type: Gazelle Titan Mustang
Operator: HQ AAC Civ Pte
Alt/FL: 3300ft ↑1800ft↑
(RPS NR) (QFE)
Weather: VMC CLBC VMC CLBC
Visibility: 10km >20nm
Reported Separation:
300ft V 1500ft V1800ft H
Recorded Separation:
NK

Cause: The Gazelle pilot was concerned by the apparent proximity of the Titan Mustang.

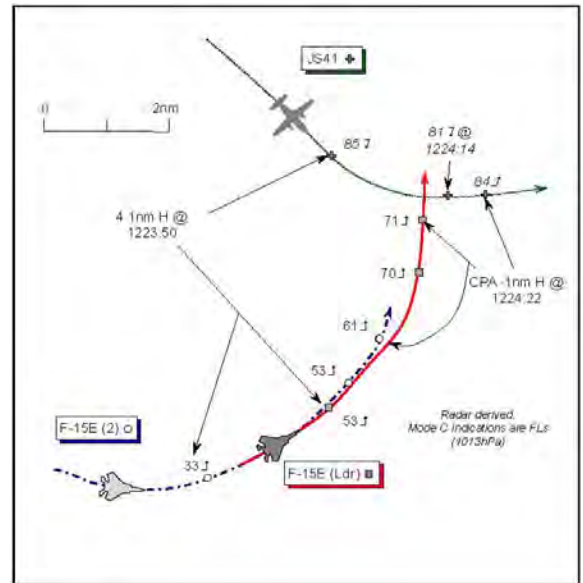
Date/Time: 19 Jul 2012 1224Z
Position: 5401N 00020W
 (26nm N of Humberside Airport)
Airspace: AIAA/FIR (Class: G)
Reporting Ac Reported Ac
Type: JS41 F-15E x2
Operator: CAT Foreign Mil
Alt/FL: FL80↓ FL66↑
 SAS SAS
Weather: IMC In Cloud VMC CLOC
Visibility: NR unlimited
Reported Separation:
 1000ft V/1nm H 1500ft V/1.3nm H
Recorded Separation:
 1300ft V @ 1nm min H

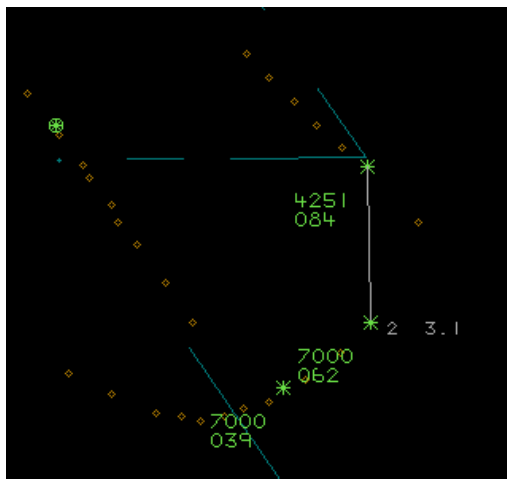
Figure 1: Claxby Radar 1224:00.

About 13secs later, at 1224:00, RADAR updated the TI to the JS41, to which the crew responded, at 1224:10, "TCAS R-A." RADAR responded, "roger." At this time the vertical distance between the JS41 and the F15 reduced below the 3000ft DM to 2200ft - see Figure 1.

As F-15E (Ldr) neared the JS41 its Mode A SSR code was recycled (hence Figure 1 above showing A7000) and at 1224:07, its SSR code became A4611.

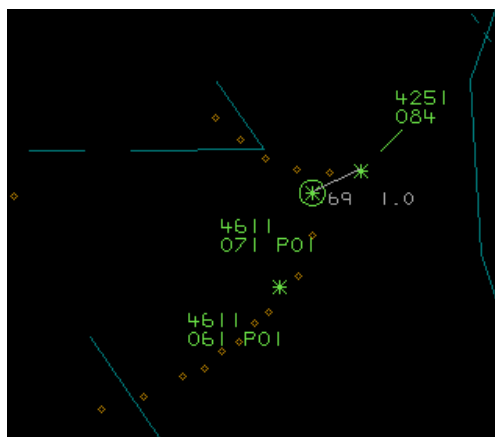
Figure 3: Claxby Radar 1224:23.

On the next update of the radar replay the JS41 had climbed 300ft, with F-15 (Ldr) passing 1nm behind and 1300ft below the JS41 - see Figure 3. Thereafter the lateral distance between the JS41 and the F-15E flight began to increase as the JS41 climbed to a maximum level of FL87.

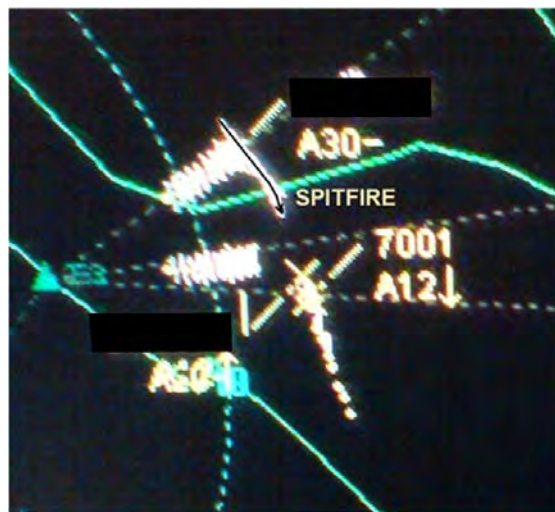
Picture 1: 1543:45 - Humberside radar

As the formation started the R turn, the Humberside radar showed the Spitfire commencing a R turn onto a S'ly heading, as shown in picture 1 below. For clarity, a black line and arrow has been added to highlight the track of the Spitfire. The Tucano formation is shown flying 0.4nm in trail.

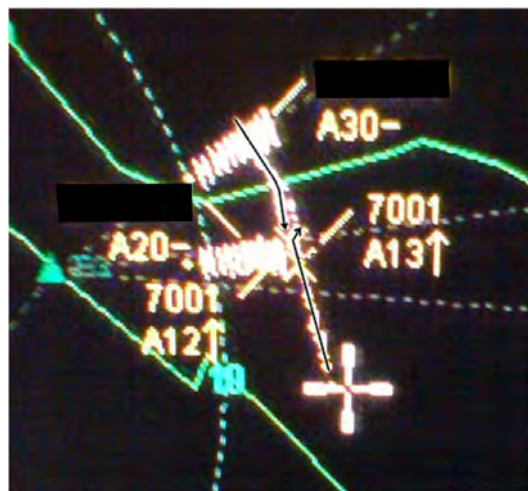
Picture 2: 1543:54 - Humberside radar

At 1543:54, the Humberside radar showed the Spitfire passing 0.25nm (CPA) NW of the formation, as shown on picture 2 below. For clarity, a black line and arrow has been added to highlight the tracks of the Spitfire and Tucano formation leader.

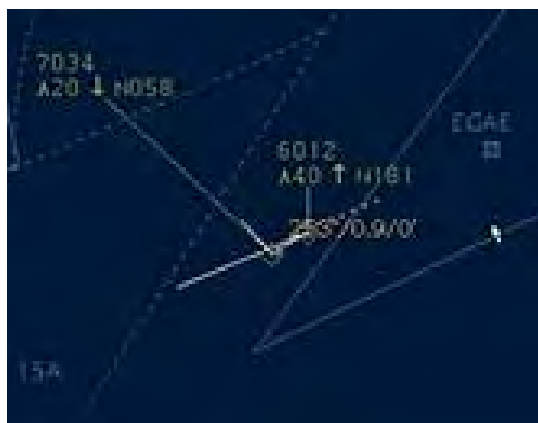
The next update of the MH radar at 1337:31 shows the C172 at 2000ft in the B737's 12 o'clock, range 0.9nm, as the B737 climbs through 4000ft. See *Figure 1 below*.

Figure 1. Malin Head Radar – 1337:33 UTC

[UKAB Note (1): CPA occurs on the next radar sweep at 1337:36 as the B737, climbing through altitude 4400ft, passes 0.6nm E of, and 2400ft above, the C172 indicating 2000ft.]

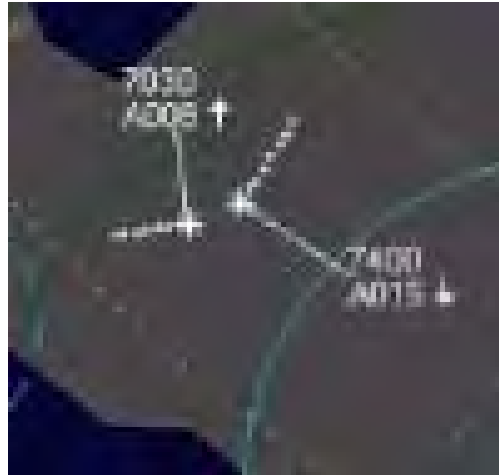
Picture 1 (0929:41)

At 0929:41, radar shows the 2 ac on converging/crossing tracks at a range of 1nm as shown in picture 1 below.

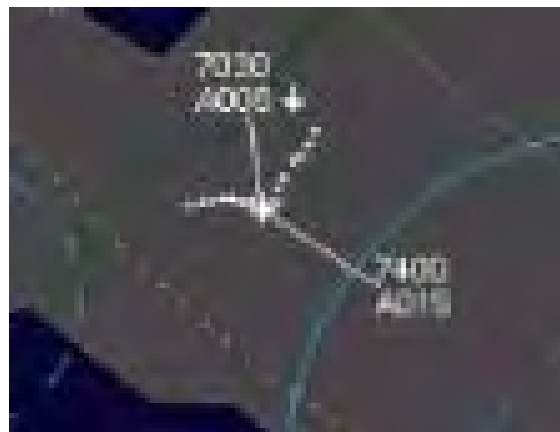
Picture 2 (0929:55)

At 0929:50 the DO228 pilot transmitted *“and we’re now er visual with the traffic as we pass overhead.”* Radar at 0929:55 shows the DO228 at an altitude of 1500ft and the Merlin at 800ft, as shown in picture 2 below.

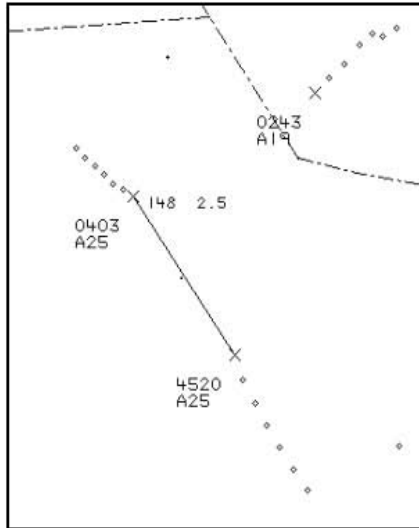
Figure 1: Clee Hill 1213:00 UTC

Figure 1 below shows the Clee Hill radar picture at 1213:00. The PA34 then commenced a gradual drift to the R, crossing through the G109's 12 o'clock at a range of 2nm, R to L. The G109 maintained 2500ft and the PA34 descended to 2400ft.

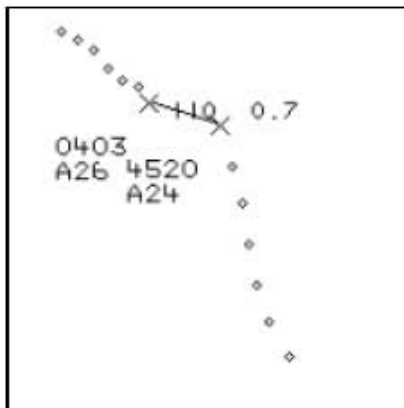
Figure 2: Clee Hill 1213:32

Figure 2 shows the Clee Hill radar picture at 1213:32. The distance between the two ac was 0.7nm and 200ft. At this time the recorded GS of the PA34 is 159kt; the G109 is 74kt.

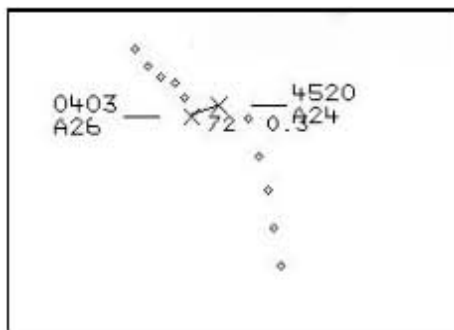
Figure 3: Clee Hill 1213:41

Minimum distance recorded by Clee Hill occurred at 1213:41 (Figure 3 below): 0.3nm/200ft.

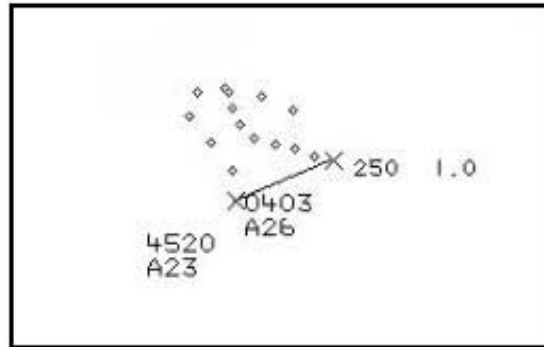
Figure 4: Cleve Hill 1214:30

The PA34 then turned L behind the G109, which made a L turn (in the direction of Wellesbourne). Figure 4 below shows the Cleve Hill radar picture at 1214:30; the PA34 is now 300ft below, in the G109's 5 o'clock at 1nm. The position of the ac at this time was just N of Alcester, some 10nm W of Wellesbourne Mountford in Class G airspace.

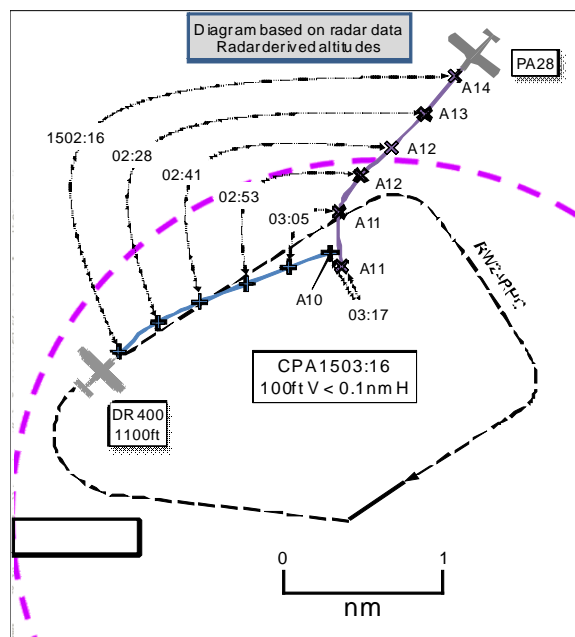
AIRPROX REPORT NO 2012128

Date/Time: 18 Aug 2012 1503Z (Saturday)
Position: 5054N 00046W
(Chichester/Goodwood A/D elev 110ft)
Airspace: Goodwood ATZ (Class: G)
Reporting Ac Reported Ac
Type: DR400 PA28
Operator: Civ Club Civ Pte
Alt/FL: 1250ft 1500ft
QFE (1011hPa) QNH (1014hPa)
Weather: VMC CAVOK VMC CLBC
Visibility: >10km 10km
Reported Separation:
100ft V/0ft H 100ft V/100ft H
Recorded Separation:
100ft V/<0.1nm H

Cause: The PA28 pilot entered the ATZ without first obtaining information from the FISO, in contravention of Rule 45, and flew into conflict with the DR400 downwind.

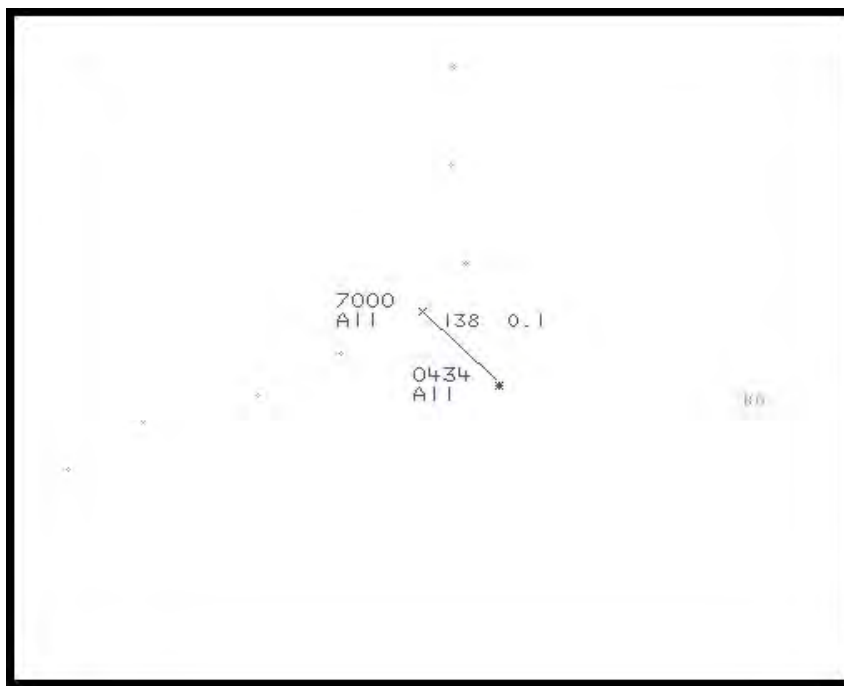
Print 3 – 1503:18

Print 3 below, shows the DR400 passing 0.1nm behind the PA28 at 1503:18 and the CPA was considered to have occurred between radar sweeps at 1503:16.

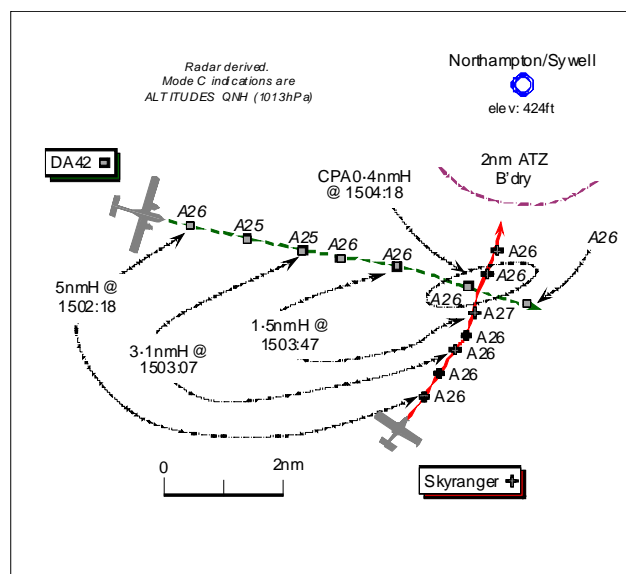
AIRPROX REPORT NO 2012129

Date/Time: 23 Aug 2012 1504Z
Position: 5215N 00049W
 (3.6nm S of Sywell - elev 424ft)
Airspace: London FIR (Class: G)
Reporting Ac **Reported Ac**
Type: Diamond DA42 SkyRanger ML
Operator: Civ Trg Civ Pte
Alt/FL: 2600ft 2600ft↓
 QNH (1013hPa) NK
Weather: VMC CLBC VMC CAVOK
Visibility: 10km >10km
Reported Separation:
 Nil V/500m H Not Seen
Recorded Separation:
 Nil V/0.4nm H

Cause: The DA42 crew did not manoeuvre upon sighting the SkyRanger.

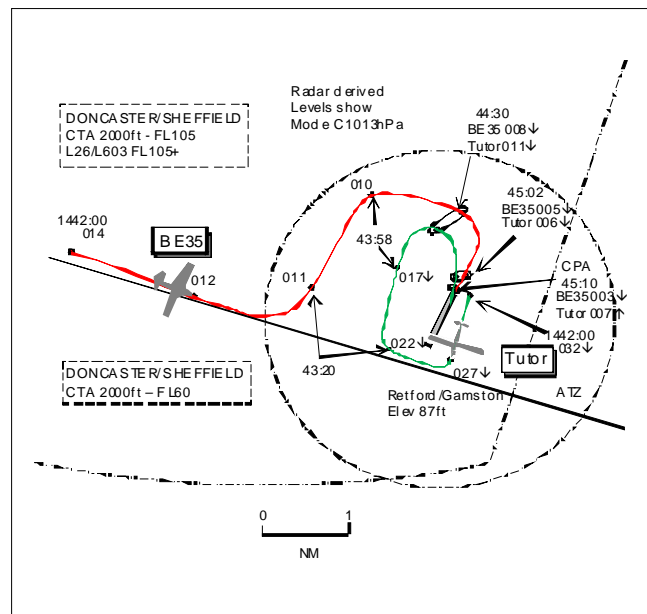
AIRPROX REPORT NO 2012130

Date/Time: 14 Aug 2012 1445Z
Position: 5317N 00057W (0.5nm FIN APP RW21
Gamston - elev 87ft)
Airspace: ATZ (Class: G)
Reporting Ac Reported Ac
Type: Tutor T Mk1 BE35
Operator: HQ Air (Trg) Civ Pte
Alt/FL: 700ft↓ 500ft↓
QFE (1006hPa) QFE
Weather: VMC CLOC VMC CLOC
Visibility: 40km >10km
Reported Separation:
300ft V 150ft V/300m H
Recorded Separation:
100ft V/0.1nm H
Or 400ft V/Nil H

Cause: A conflict caused by the use of military RT and procedures at a civilian airfield.

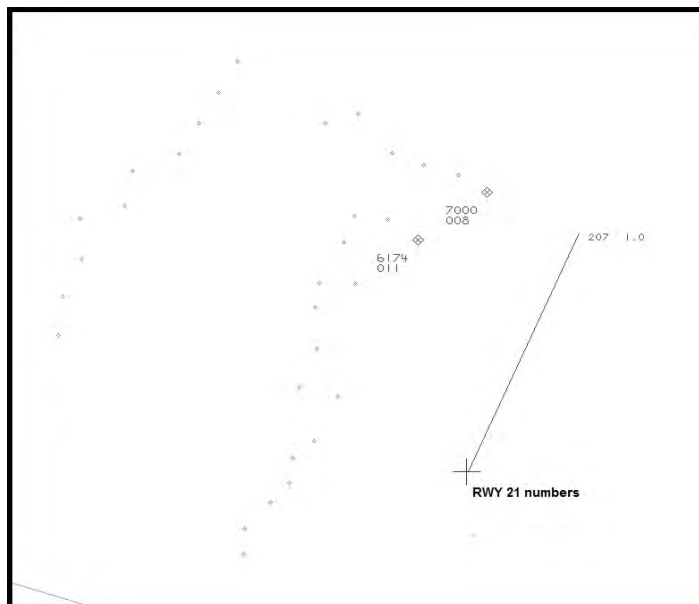
The Tutor pilot indicated that at 1500ft, when at 'Low Key' (downwind), another ac (BE35) was heard calling on frequency to join downwind. (Low Key is military specific phraseology). At 1443:58, radar shows the 2 ac downwind, with the Tutor on a short cct pattern and the BE35 on a normal cct 1nm NW of the Tutor and just commencing a R turn onto base leg. The 2 ac continued to base leg and at 1444:32 are shown in radar print 1 below. The GS of the BE35 was 106kt and the Tutor 80kt.

[UKAB Note (1): The radar recording at 1445:02 shows the 2 ac on short final, the Tutor at FL006 and the BE35 100ft lower at FL005, lateral separation 0.1nm. The CPA occurs on the next sweep 8sec later, the radar returns merge with the Tutor now climbing through FL007 and the BE35 descending through FL003. On the next sweep the BE35 has disappeared from radar with the Tutor continuing its climb on a SSW'yly heading.]

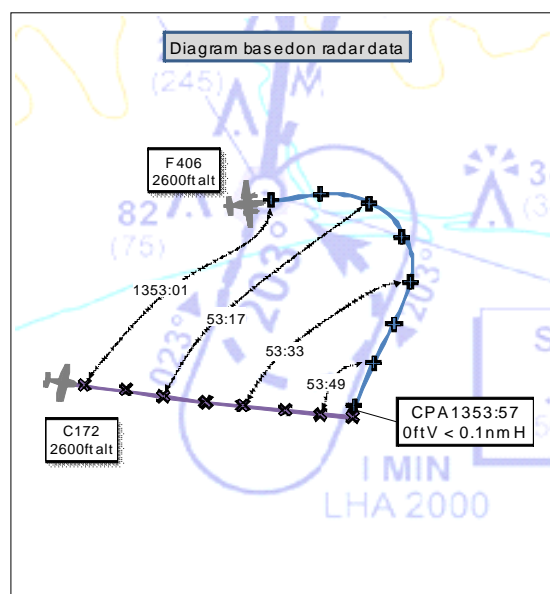
AIRPROX REPORT NO 2012131

Date/Time: 23 Aug 2012 1354Z
Position: 5047N 00016W
 (Shoreham NDB Hold)
Airspace: Lon FIR (Class: G)
Reporting Ac Reporting Ac
Type: Cessna F406 Cessna 172
Operator: Civ Trg Civ Pte
Alt/FL: 2500ft 2700ft
 QNH(1014hPa) QNH(1014hPa)
Weather: VMC CLBC VMC CAVOK
Visibility: >10km >10km
Reported Separation:
 50ft V/50m H 100ft V/50m H
Recorded Separation:
 0ft V/<0.1nm H

Cause: Late sighting by the F406 crew.

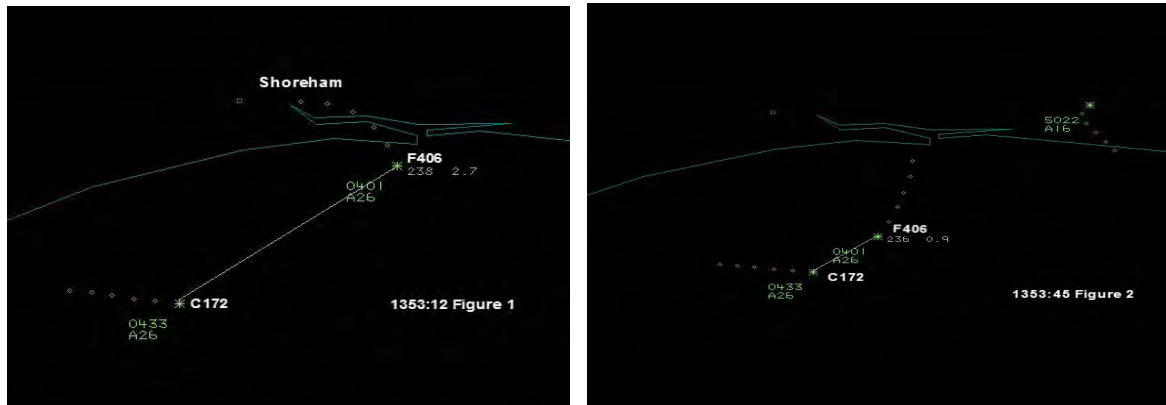
At 1353:45 the F406 was tracking SSW, joining for the NDB procedure while the C172 was tracking E, 0.9nm WSW of the F406 (see Figure 2 below).

The 2 ac continued to converge and at 1353:57 were both at 2600ft, 0.1nm apart (CPA). At 1354:01 the F406 was at 2400ft and had crossed 0.2nm behind the C172.

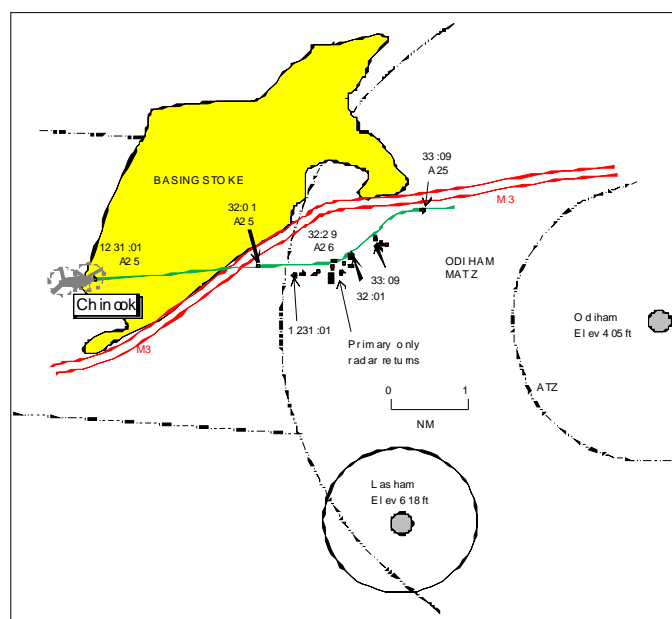
AIRPROX REPORT NO 2012132

Date/Time: 28 Aug 2012 1232Z
Position: 5115N 00103W
 (4nm WNW Odiham - elev 405ft)
Airspace: MATZ (Class: G)
Reporting Ac Reported Ac
Type: Chinook Grob103
 Glider
Operator: HQ JHC Civ Pte
Alt/FL: 2500ft 2300ft
 QNH (1014hPa) QFE
Weather: VMC CLBC VMC CLBC
Visibility: >10km >10nm
Reported Separation:
 250-300m H 100ft V/2nm H
Recorded Separation:
 NR

Cause: A conflict in the Odiham MATZ.

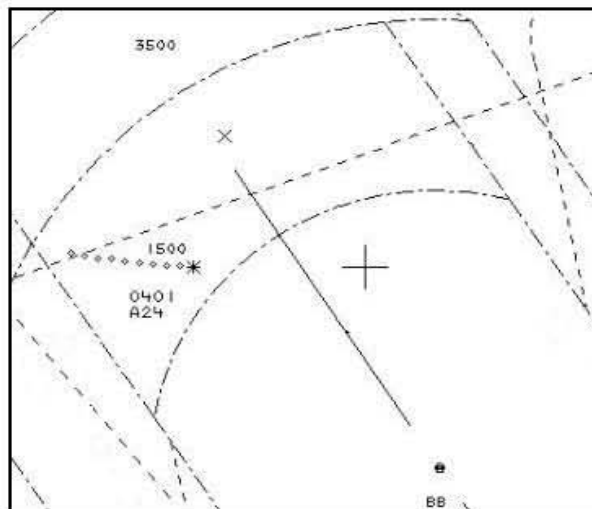
Figure 1: Cleve Hill 1752:20

At 1752:20, RADAR instructed the C208 crew, "no further right than your present track there is traffic rolling now to depart runway 3-3 it's a 7-3-7 will be climbing through your level." This was acknowledged by the C208 crew, "okay thanks we'll..look out". Figure 1 below shows the Cleve Hill radar picture at 1752:20. The DZ is marked with a cross to the E of the line depicting Birmingham's RW15/33 extended centreline.

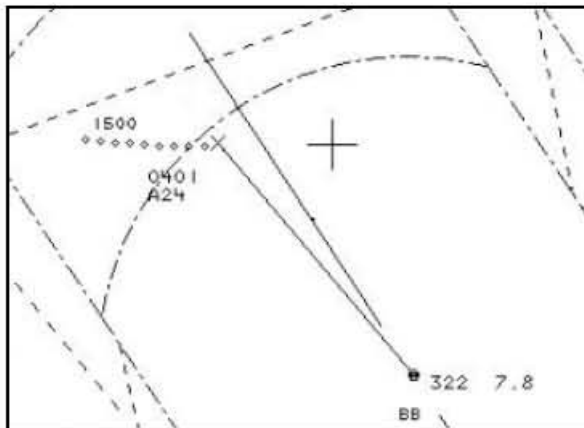
Figure 2: Clee Hill 1753:00

At 1753:00 RADAR updated the C208 crew about the B737, "the traffic 7-3-7 is just lifting off now and he'll be turning..right at a range of 3 miles when he's airborne climbing through your level report visual." The C208 was now inside the Birmingham CTR at 2400ft QNH, 7.8nm NW of the Airport (See Figure 2 below)

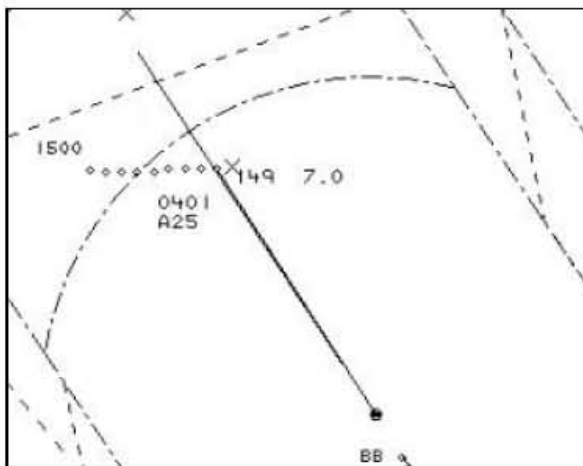
Figure 3: Clee Hill 1753:30

RADAR updated the C208 crew again at 1753:30, as the C208 flew through the RW33 climb-out 7nm from the Airport (Figure 3), “the traffic’s now just passing through 5 hundred feet in the climb,” to which the C208 crew replied, “we’re watching the traffic we have him in sight.”

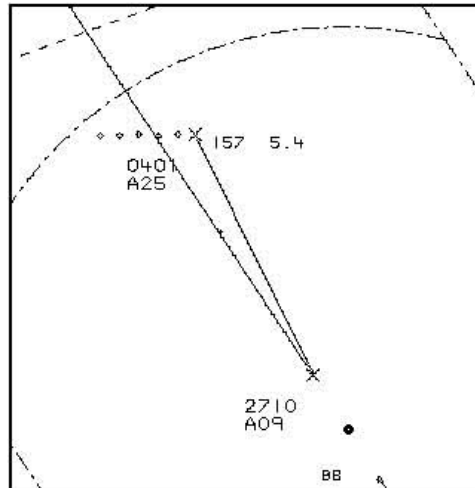
Figure 4: Cleve Hill 1753:34

The B737 first ‘painted’ on the Clee Hill Radar at 1753:34 (Figure 4) as it passed altitude 900ft. The B737’s initial rate of climb was in excess of 3000ft/min.

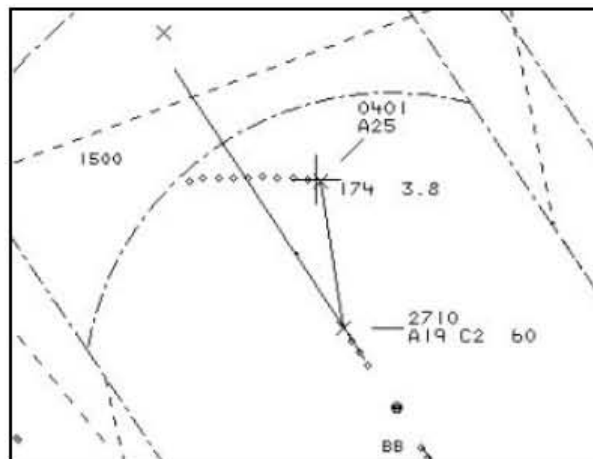
Figure 5: Cleve Hill 1754:00

At 1754:00, RADAR informed the C208 crew that the B737 would be turning R shortly and the C208 crew requested, "okay and I'd like to orbit here" (Figure 5), whereupon RADAR instructed the C208 crew, "roger orbit left".

Although the minimum lateral distance between the two ac was 2.4nm, the C208 had flown directly over its planned DZ at 1754:00 (Figure 5 above), ahead of the B737. As it flew over the DZ, the C208 was 1.69nm NW of the track about to be flown by the B737, as shown in Figure 8 below.

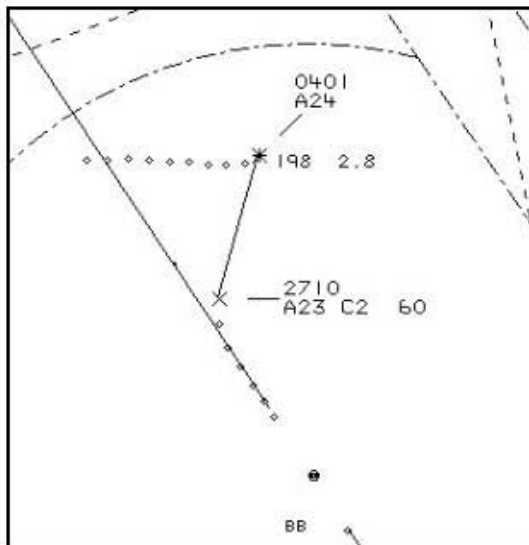
Figure 6: Cleve Hill 1754:24

The B737 crew called RADAR at 1754:10, "...turning onto heading 0-9-0 to avoid..proximate traffic at our level 2 and a half miles." RADAR responded, "Roger... that's the VFR traffic orbiting left you're cleared..right turn and climb to 6 thousand feet." The B737's ROC had now reduced to 512ft/min. By 1754:24, the B737 crew's R turn could be seen to be taking effect (Figure 6), as was the commencement of the C208's L orbit. The ac were indicating 2300ft and 2400ft ALT respectively with the C208 in the B737's 12 o'clock 2.8nm.

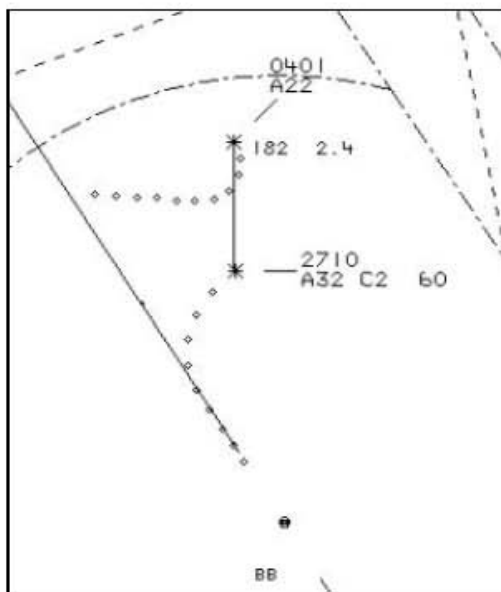
Figure 7: Cleve Hill 1754:46

On the next update of the surveillance replay, the B737 is shown climbed through 2600ft ALT, 300ft above the C208, which had descended to 2300ft ALT in its L turn. Lateral distance between the two ac had reduced to 2.7nm. The B737's ROC had increased to over 2000ft/min. Minimum lateral separation occurred at 1754:46, as the two ac turned away from each other with the C208 in the B737's 10 o'clock range 2.4nm, with 1000ft vertical distance between the two ac (see Figure 7).

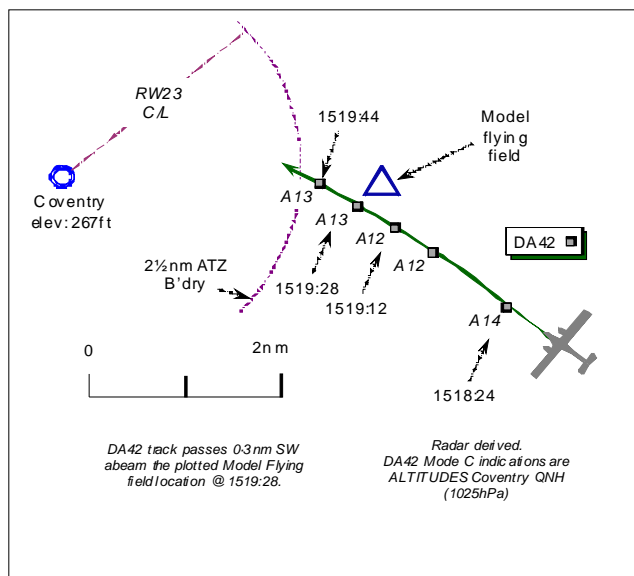
AIRPROX REPORT NO 2012134

Date/Time: 3 Sep 2012 1519Z
Position: 5221N 00123W
 (3½nm E of Coventry A/D - elev 267ft)
Airspace: London FIR (Class: G)
Reporting Ac Reported Ac
Type: DA42 Model Glider
Operator: Civ Trg Civ Club
Alt/FL: 1300ft 900ft
 QNH (1025hPa) agl
Weather: VMC No cloud NK NK
Visibility: >10km 20km
Reported Separation:
 100ft V/100m H 200ft V/50m H
Recorded Separation:
 Not recorded

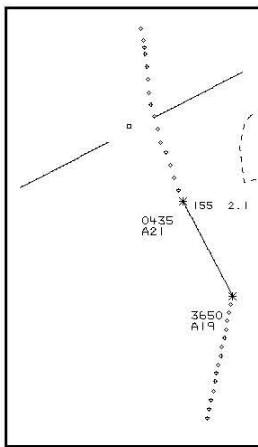
Figure 1: Pease Pottage 0903:26 UTC

Figure 1 below shows the Pease Pottage radar picture at 0903:26. The RC114 (#0435) is on track MID and the Griffin (#3650) was now slightly through the RC114's 12 o'clock at 2.1nm, altitude 1900ft.

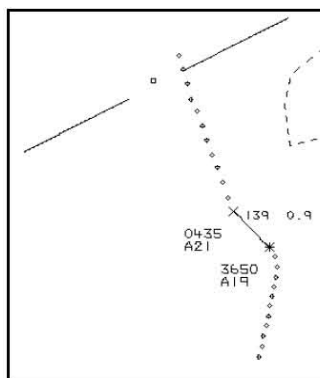
Figure 2: Pease Pottage 0903:44 UTC

At 0903:44 (Figure 2) the Griffin had begun to turn left towards the track of the RC114. Distance between the 2 ac was 0.9nm and 200ft.

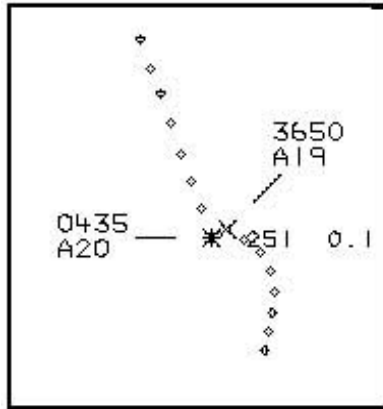
Figure 3: Pease P. 0903:57 UTC

At 0903:56 the ac were 3nm SSE of Farnborough at the CPA. The Griffin was now 0.1nm abeam the RC114 and 100ft below (Figure 3). The Griffin then passed behind the RC114 by 0.3nm (Figure 4). The Griffin pilot report indicates that the crew became visual with the RC114 as the Griffin turned to intercept the LOC. The RC114 pilot's report does not specifically note that the Griffin was sighted visually.

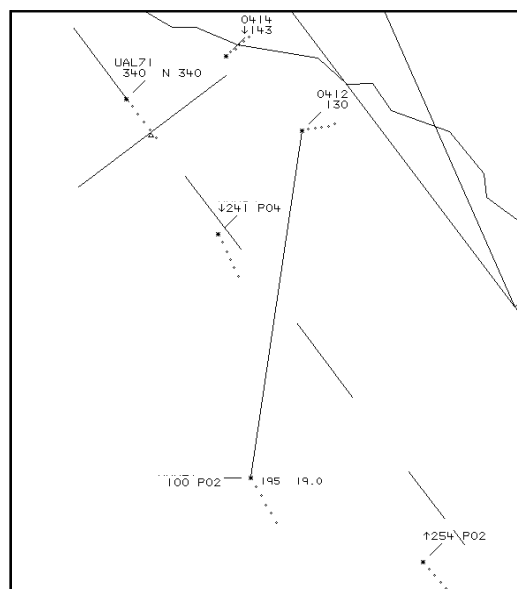
Figure 1: Radar Replay Screenshot at 1001:24

At 1001:24, DIR instructed the Hawk formation to, "*descend Flight Level 5-0*" which was acknowledged; at this point the GR4 was 19nm SSW of the Hawk formation (Figure 1 refers).

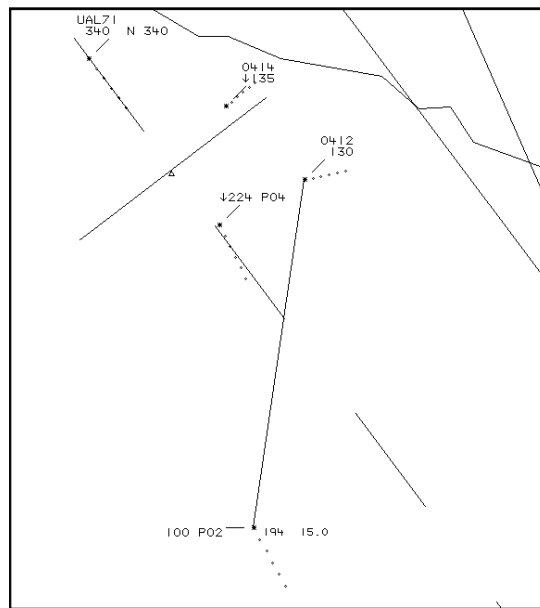
Figure 2: Radar Replay Screenshot at 1001:51

At 1001:51, DIR instructed the Hawk formation to, “turn left heading 2-3-0 degrees” which was acknowledged; at this point the GR4 was 15nm SSW of the Hawk formation (Figure 2 refers).

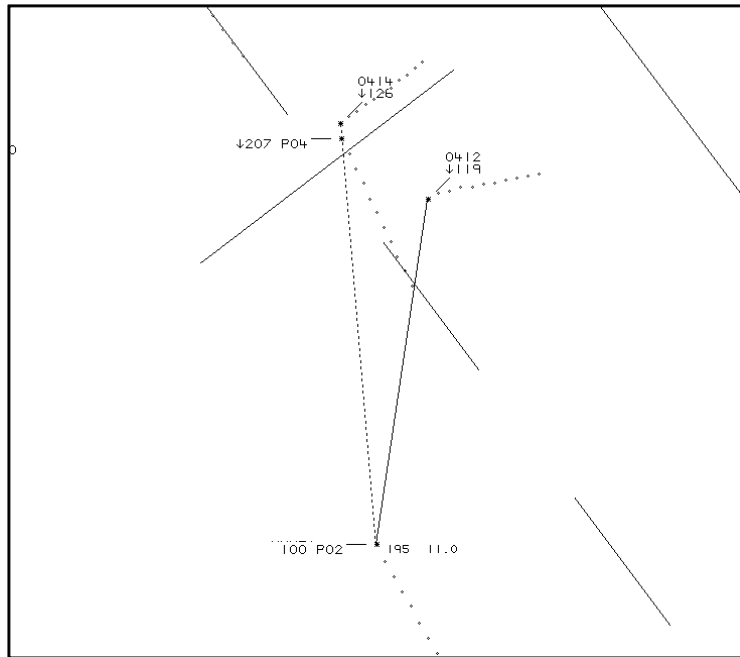
Figure 3: Radar Replay Screenshot at 1002:18

At 1001:55, Controller 2 initiated coordination with Leeming SUP to agree a course of action between the GR4 and the 2 formations of Hawks being ‘worked’ by DIR; at this point the GR4 was 14.4nm SSW of the Hawk formation [A], which had just commenced descent and was indicating FL129. Whilst neither causal nor contributory to the incident, the delay of 29 secs between the passing of the descent instruction (1001:24) and the initiation of the Hawk formation’s descent, was an aggravating factor in the magnitude of the subsequent loss of separation. Controller 2 first identified their traffic to the Leeming SUP, who replied, “Err, that’s not our traffic.” Controller 2 continued, “yeah, it’s my traffic” and Leeming SUP asked, “what do you want coordination on?” As STCA white activated on the Controller 2’s surveillance display at 1002:10, they replied, “he [the GR4] is maintaining Flight Level 100. Okay, your traffic, arr, 0-4-1-2, north-east of Leeming by 23 miles?” Leeming SUP replied, “roger, that traffic not above Flight Level 1-2-0.” Although a discrepancy can be expected between the NATS Radar replay and the information presented to the Leeming SUP, at this point, the SSR Mode C of the Hawk formation leader could be observed on the NATS radar replay to be indicating descent through FL119. The statement made by the Leeming SUP suggests that they were monitoring the Hawk formation’s descent. At 1002:18, the Hawk formation can be observed on radar to have commenced the L turn instructed by DIR at 1001:51 (Figure 3 refers).

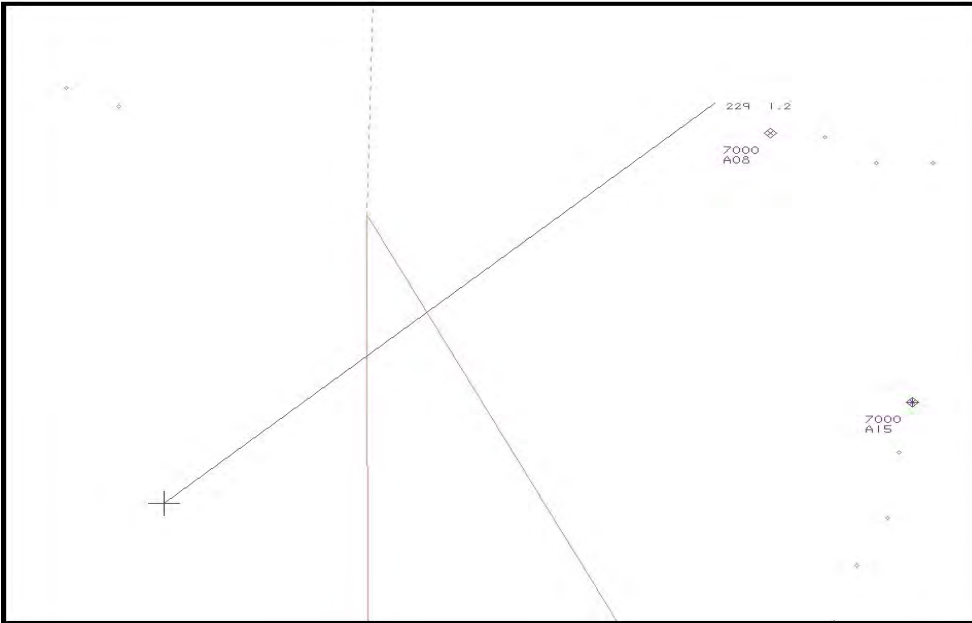
Picture 1 – 1036:10

The T67M pilot’s written report indicates that he may have heard another ac’s pilot call on final but as he turned L base, he wasn’t aware of another ac on final. At 1036:08, the C152 is shown at altitude 800ft (height 525ft) on a closing heading and 1.2nm from touchdown. The T67M is shown at altitude 1500ft (height 1225ft), on L base in a continuous L turn as shown in picture 1 below.

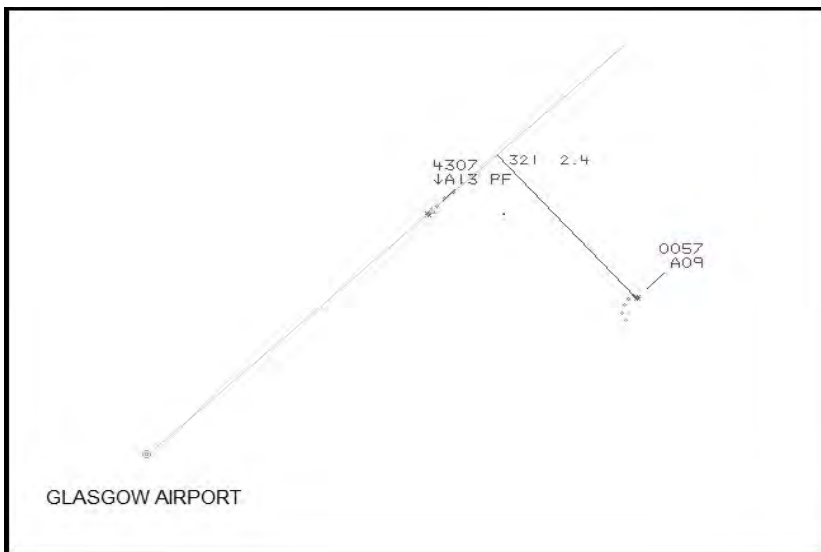
Picture 1. (0712:17)

At 0712:17, the EC135 (squawk 0057), is shown on task commencing a RH orbit over the lake at an altitude of 900ft and position, 2.4nm SE of the RW23 C/L. An earlier inbound (squawk 4307) is shown on the ILS (Picture 1).

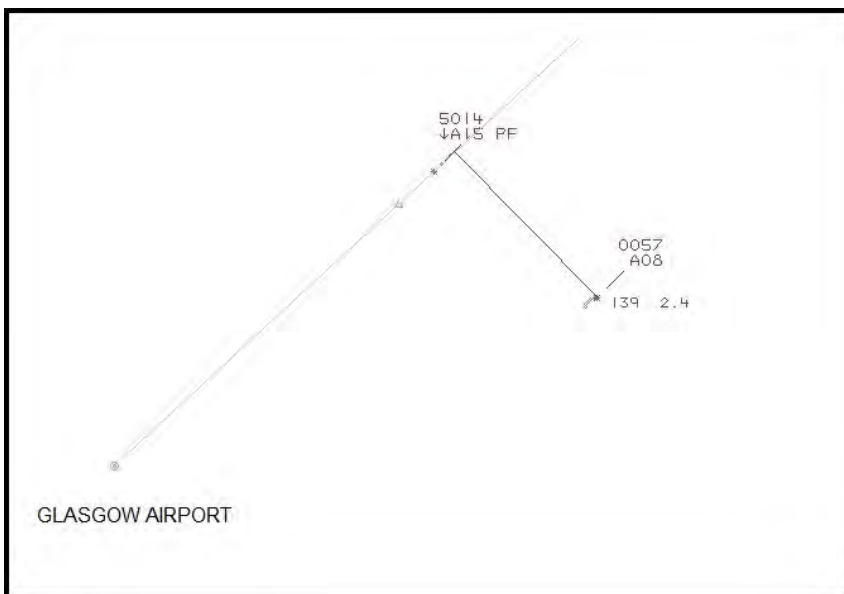
Picture 2. (0715:57)

At 0715:57, another earlier inbound (squawk 5014) is shown on the ILS, with the EC135, 2.4nm SE of the RW C/L at 800ft.

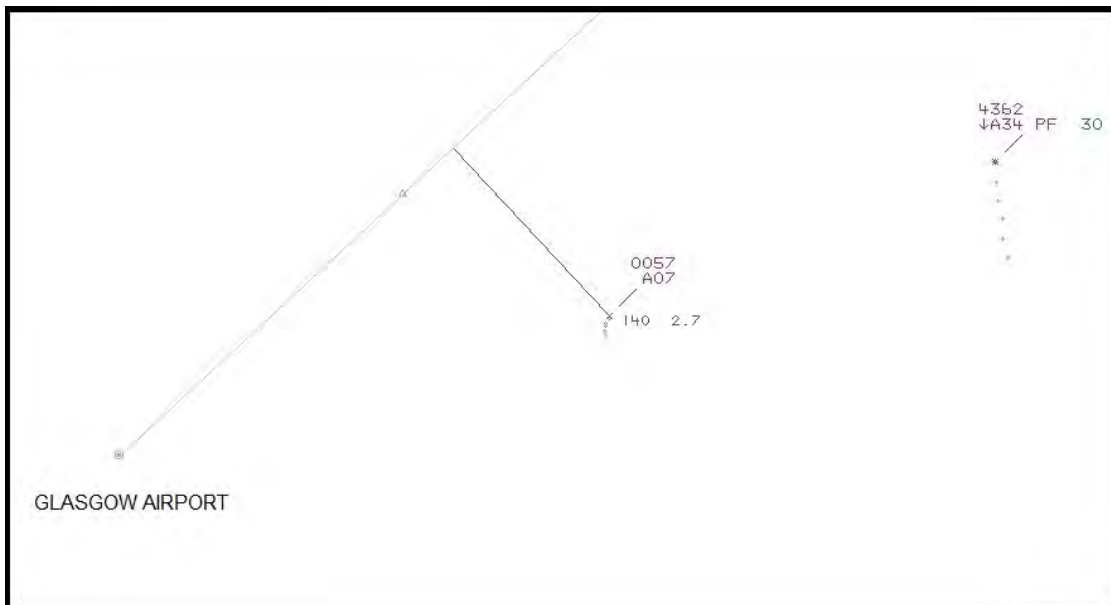
Picture 3. (0730.01)

At 0730:01, radar shows the A319 (squawk 4362) passing an altitude of 3400ft, 10.9nm NE of the airfield. The EC135 is shown in a RH orbit around the lake at 700ft and positioned 2.7nm SE of the RW C/L (Picture 3).

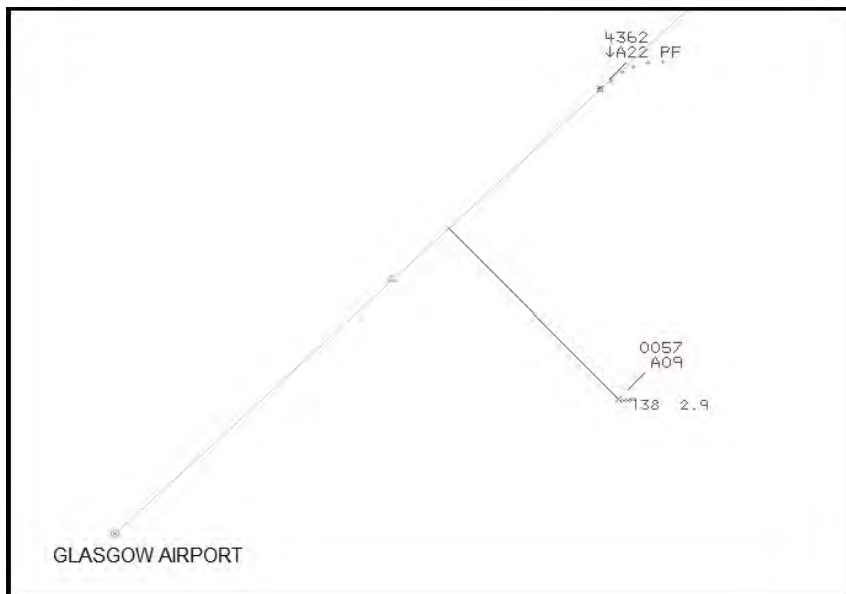
Picture 4. (0732:12)

At 0732:12, the A319 is established on the localiser 7.5nm from touchdown at 2200ft, with the EC135 in the A319's half past 10 at a range of 3.7nm. The EC135 is in the RH orbit around the lake at 900ft and positioned 2.9nm from the C/L (Picture 4).
