UK AIRPROX BOARD

Analysis of Airprox in UK Airspace

**Report Number 28
January 2012 – December 2012**

Twenty-Eighth Report by the UK Airprox Board:

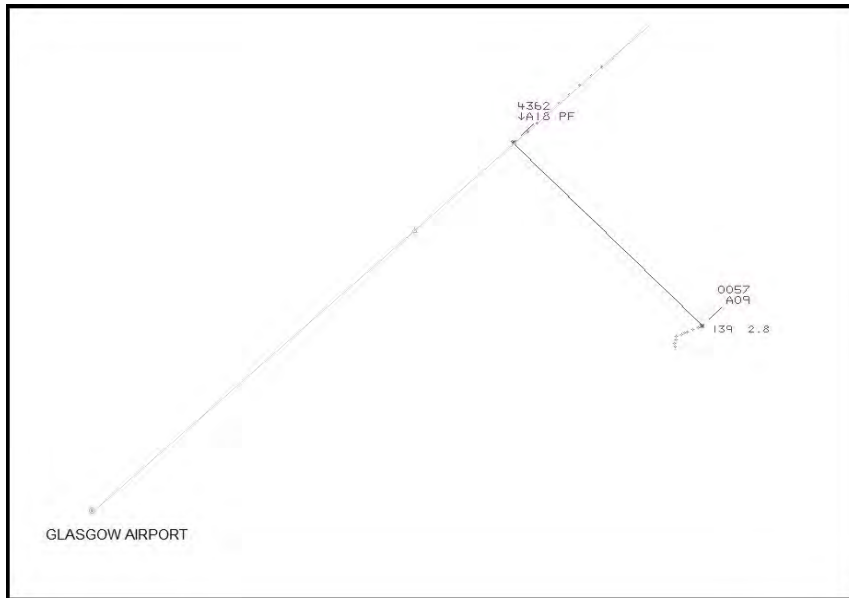
Picture 5. (0733:04)

At 0733:04, the A319 is 5.8nm from touchdown indicating 1800ft, with the EC135 in the A319's 9 o'clock at a range of 2.8nm (CPA), indicating 900ft. The EC135 is shown tracking NE (Picture 5).

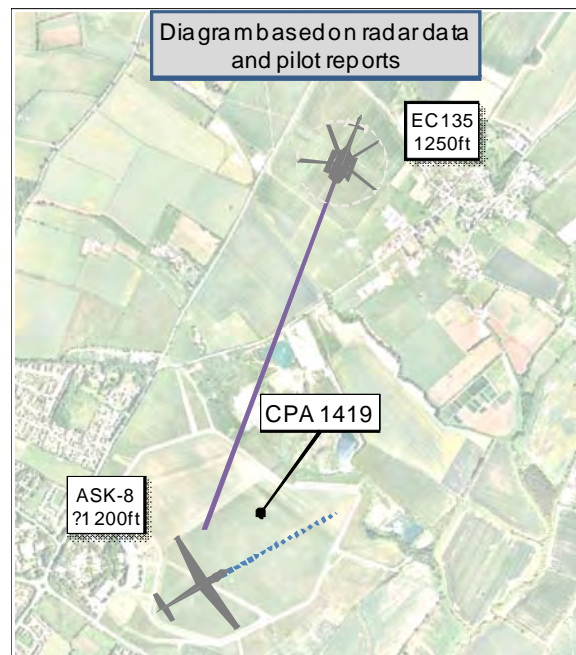
THE ASK-8 GLIDER PILOT reports climbing during a winch launch, heading 060° at 60kt in a steep nose-up attitude. She was operating in VMC under VFR and was in RT contact with the launch control point. The white and blue glider was not fitted with external lights, SSR transponder or an ACAS. Between 800-900ft she saw a helicopter in her 11 o'clock position at a range of 150m, flying towards her at a similar height. She banked to the R to increase separation and the helicopter passed behind her on the L, at the same level and with a minimum separation of 100m. She continued to climb on the winch launch and released from the cable at 1200ft.

Cause: The EC135 pilot, on a Cat A Medevac flight, flew through a promulgated and active glider launching site below the maximum level of the winch cable and close enough to cause the launching glider pilot concern.

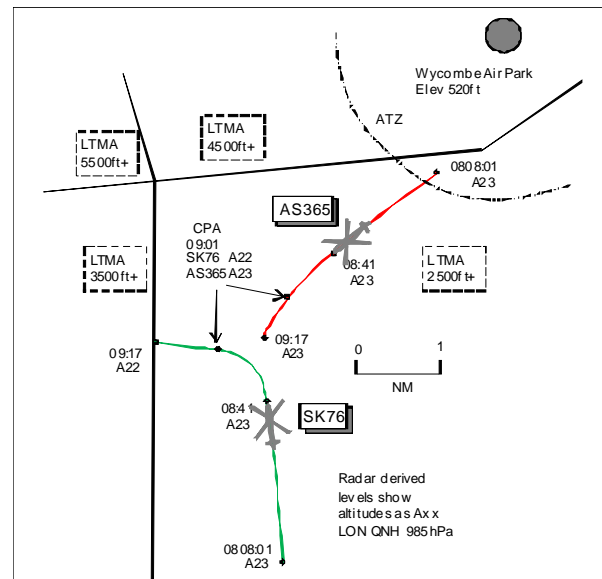
THE SK76 PILOT reports en-route from Blackbushe to Newcastle, IFR and in receipt of a RIS, he thought [actually a TS], from Farnborough LARS W on 125.25MHz, squawking an assigned code with Modes S and C; TCAS 1 was fitted. The Wx was IMC whilst flying in cloud at 2400ft QNH heading 360° at 145kt. He noticed traffic on TCAS in his 12 o'clock range 6nm but this was not called by Farnborough. He next received a TCAS TA when it was 12 o'clock range 2nm at the same level so he initiated a turn to the L (W'ly) and a descent whilst calling Farnborough for avoiding action. LARS W advised to turn further L onto 270° and the traffic passed <1nm to the E [on TCAS]. He assessed the risk as high.

Cause: In the absence of timely TI, a conflict in Class G airspace between IFR traffic in IMC resolved by both crews.

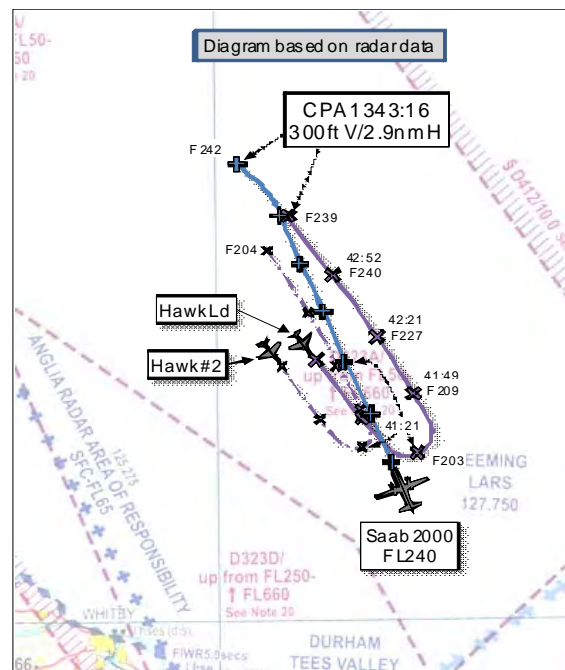
Cause: The Hawk Leader climbed above his coordinated altitude and into conflict with the Saab 2000.

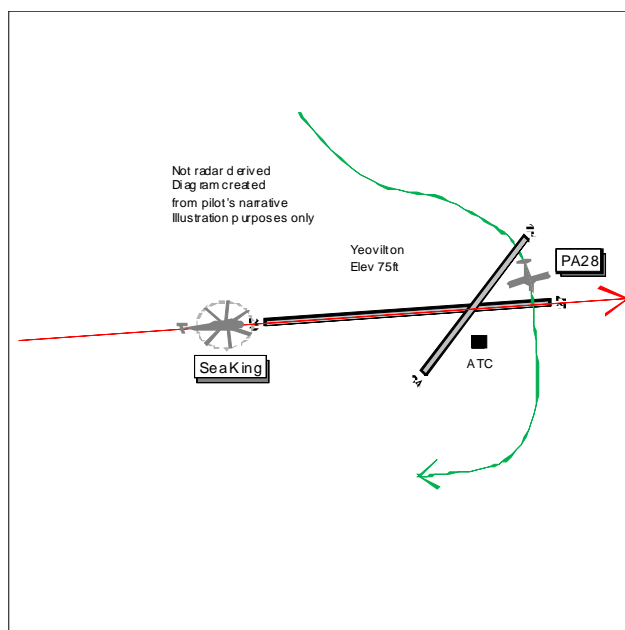
THE SEA KING PILOT reports flying a training flight using NVDs inbound from Poole HLS and in communication with Yeovilton Approach on UHF Channel 3, squawking 0222 with Modes S and C; TCAS was not fitted. The visibility was 10km flying 1000ft below cloud in VMC and the helicopter's red HISLs and flashing dim nav lights were switched on. Approaching decision height on a PAR approach and during the overshoot they saw traffic [the PA28] in their 9 o'clock to the N of their position. They initially thought the other ac may pass down their LHS and continue on its track. However, passing the RW09 midpoint approaching 1000ft QFE 994hPa heading 090° at 90kt they saw the other ac approach in a banking R turn from the N and cross the duty RW across their flightpath <500m ahead; they estimated the separation as 400m horizontally and 100ft vertically at the CPA. The ac continued its banked turn as it passed down their RHS. No avoiding action was taken as they were visual with the ac throughout. They had not heard the traffic on the Tower frequency or permission for the traffic to cross the duty RW. He assessed the risk as medium. Clearly the time for the ac to pass from L to R was a matter of seconds and had their helicopter been slightly higher or R of track and not visual with it then there would have been a high risk of collision.

Cause: The Yeovilton APP allowed the PA28 flight to carry out an O/H join, contrary to YAvOs, and fly into conflict with the Sea King on a go-around from PAR.

2) Recognition of unusual situation during low arousal. The progression of events from the approval of the PA28 pilot's request for an O/H join, to the point where the PA28 crossed the path of the overshooting helicopter, resulted from lack of SA by the ADC. Although visual with the PA28, clearly no contact had been established and this should have been questioned in a more robust manner as the situation developed. All controllers should be briefed on taking appropriate actions in the event of recognising an unusual circumstance that could lead to an unsafe situation developing, particularly during periods of low arousal such as during night flying. Action completed 10/12/2012. The results of the originating report have been highlighted to all ATC staff through formal training briefs (conducted 3 x weekly) and informally through Watch Leaders. Other ATC Incident reports have been promulgated for wider awareness and this has included populating the ATC crewroom with Accident/UKAB reports.

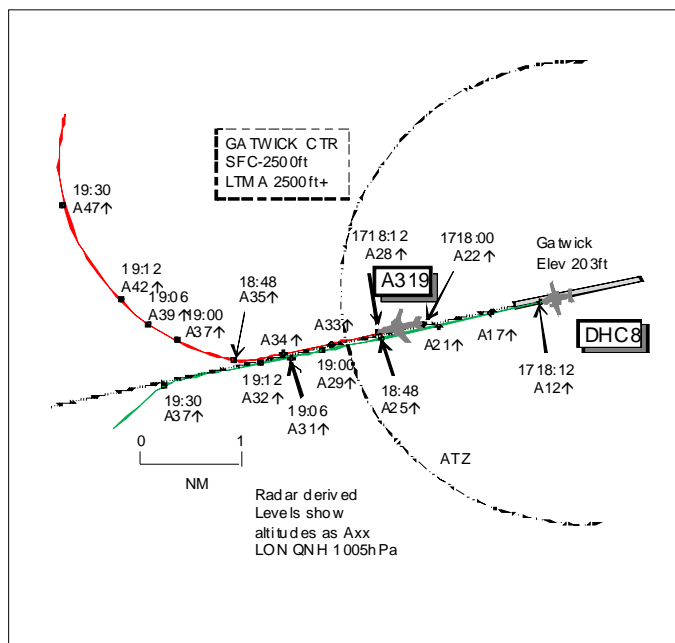
THE LTC SW DEPS reports that the DHC8 flight called on departure from Gatwick following a SAM SID. Without identifying the flight formally she observed the ac to be 400ft, she thought, and approximately 1nm from the previous departing A319 on a DVR SID which was in a R turn. She gave the DHC8 flight an avoiding action L turn onto heading 240° and the ac were seen to pull apart. She asked the DHC8 crew whether they had been visual with the ac ahead and they replied negative.

Cause: The Gatwick AIR controller did not ensure separation before transferring the DHC8 to LTC SW Deps.

It is recommended that both Gatwick and LTC review the wording of the Gatwick MATS Part 2, Air Section, Chapter 3 - ‘departing aircraft are not to be transferred to TC until suitable separation exists’ - to ensure that either both units have an understanding and acceptance of the term ‘suitable’ or alternative wording is used to clarify the conditions under which traffic will be transferred to TC.

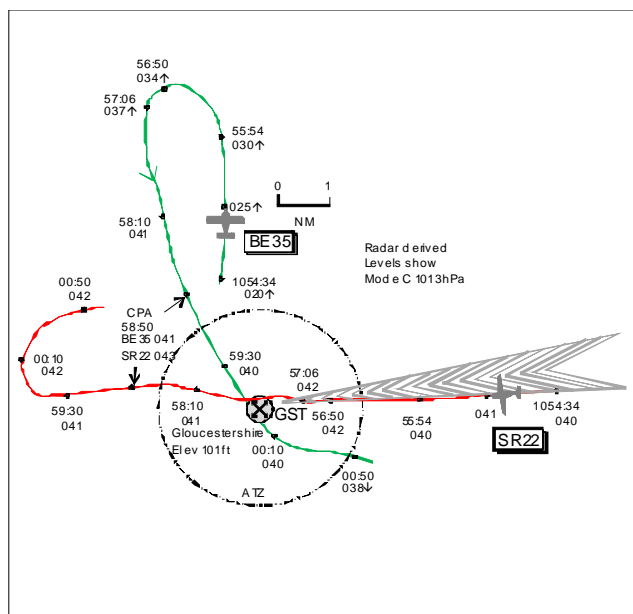
THE GLOUCESTERSHIRE APPROACH CONTROLLER reports that the BE35 pilot reported inbound to GST from the N at 4700ft for booked training NDB/DME approach after being in local area on a BS. The flight was placed under a PS and cleared to GST 4000ft QNH, no delay NDB/DME RW27. At 1041 the BE35 pilot was asked for his intentions and he replied direct outbound then touch and go into cct. At 1042:45 BE35 flight was believed to be beacon outbound, was cleared for the approach. At 1046 a new QNH 1009hPa passed to the BE35 flight which was acknowledged. About 1min later at 1047 the SR22 flight called inbound from Oxford at 4000ft QNH 1009hPa and after ascertaining the BE35's level as 2300ft (in base turn), the SR22 flight was cleared to the GST 4000ft QNH, no delay NDB/DME RW27 (holds required). At 1050 whilst on 4nm final, the BE35 pilot changed intentions for missed approach and back for another one which was acknowledged. Shortly afterwards the EAT for the SR22 was revised to 1111, based on BE35's 2nd approach. At 1054:30 the BE35 pilot recalled on 128.55MHz from the Tower and was placed under a PS and cleared NDB/DME RW27. At 1057 the BE35 pilot's intentions were sought and the pilot reported his distance to GST but on repeating the question, the pilot reported his intentions to touch and go into cct. At 1058 the SR22 was ascertained to be in the hold. Two minutes later at 1100 the BE35 pilot reported beacon outbound at 4000ft (missed approach procedure is to climb to 2800ft QNH). Clarification was sought of the ac's level and then essential TI was passed on SR22 and reciprocally. The SR22 pilot reported that he was 4nm W of GST - neither ac's pilots reported sighting each other.

Cause: The BE35 pilot did not follow the standard Missed Approach Procedure and climbed into conflict with the SR22.

The ATSU has recommended that as part of unit best practice controllers should, at an appropriate point, include the reiteration of the missed approach level, together with appropriate TI. Since the Airprox, controllers have been made aware of the requirement and the unit MATS Part 2 will reflect these changes at the next update due February 2013.

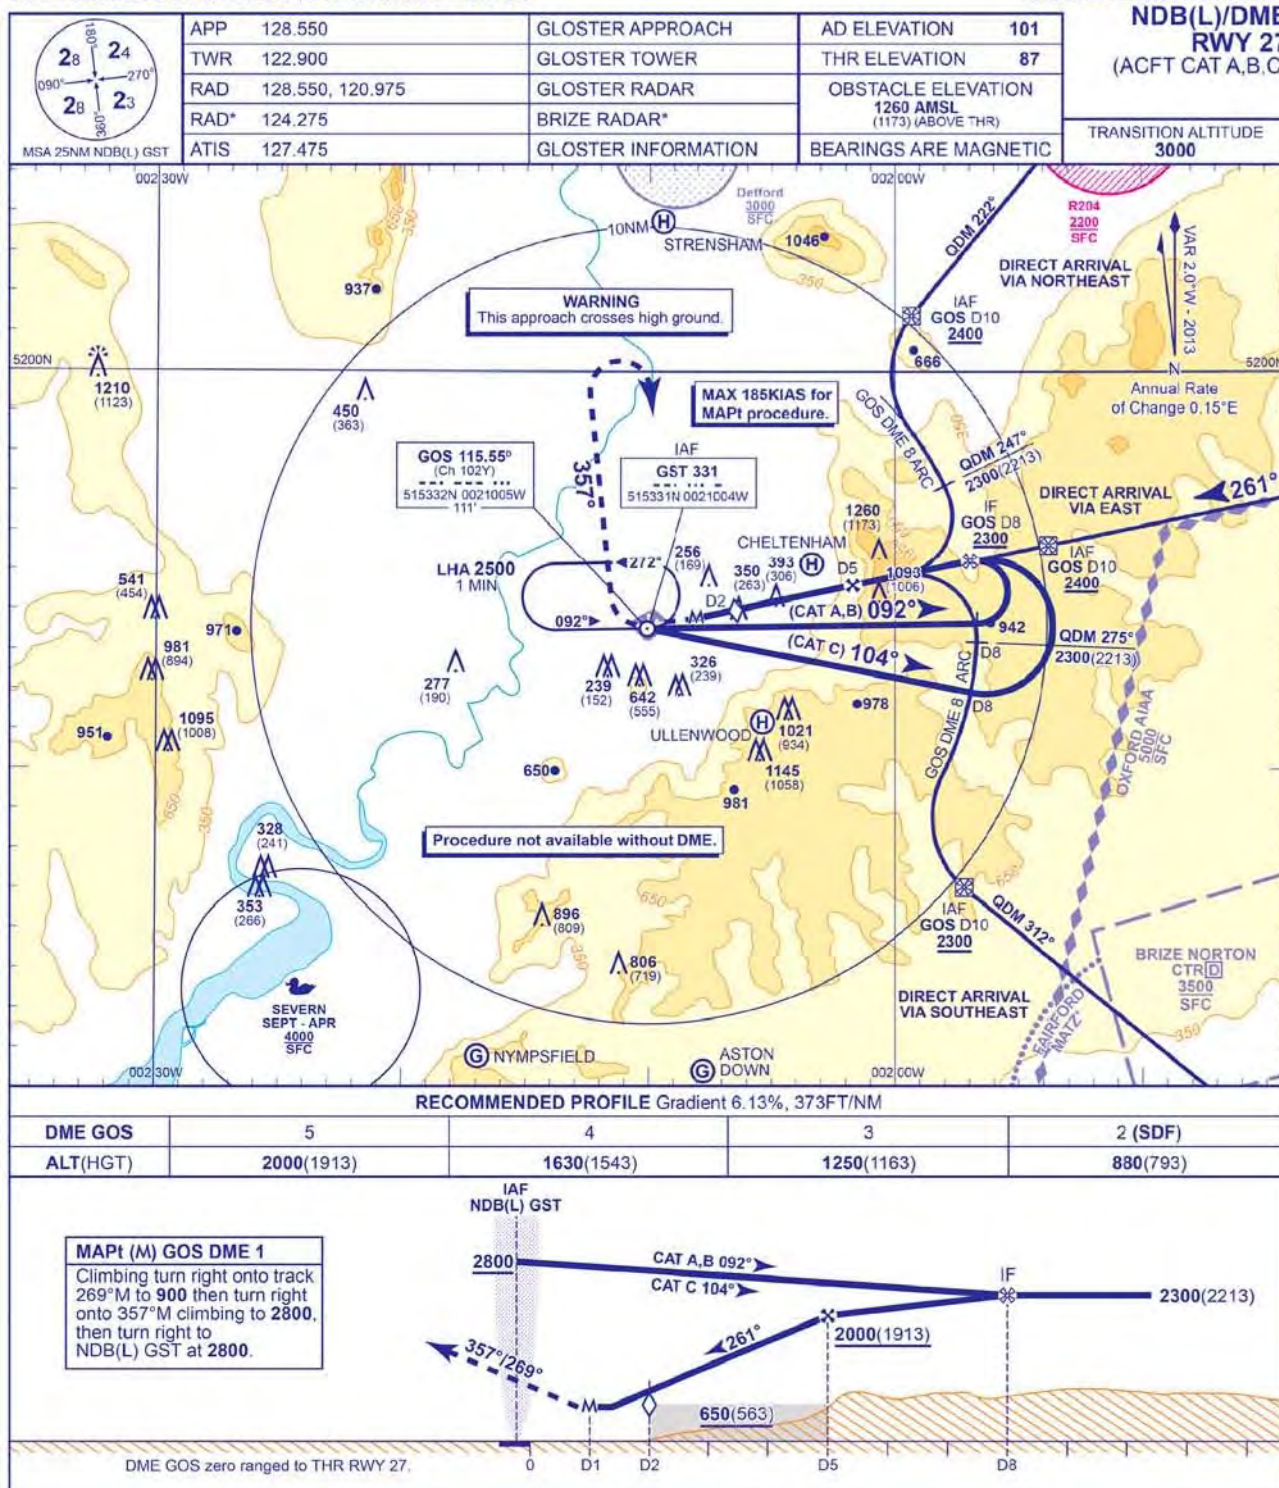
Fig (1)

At 1056:50, the radar recording shows the BE35 in the missed approach procedure 6-8nm N of the airfield in a non-standard L turn passing FL034 in the climb. The SR22 is approaching the GST on W'ly heading at FL042.

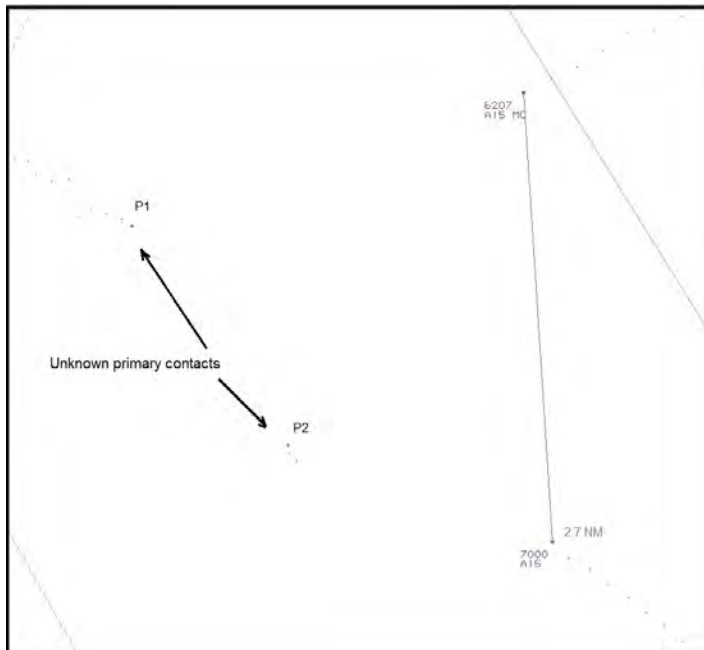
Figure 2 – area radar at 1534:42

At 1534:42 the area radar recording showed the A109 squawking 7000, 2.7nm S of the ATR 42 squawking 6207 (see figure 2 below). Also shown was another slow moving primary contact (P1) in the ATR 42's 12 o'clock position at a range of 2.5nm tracking SE together with an intermittent second primary contact (P2) tracking NW, 2.6nm SW of the ATR 42. Contact P2 faded from radar.

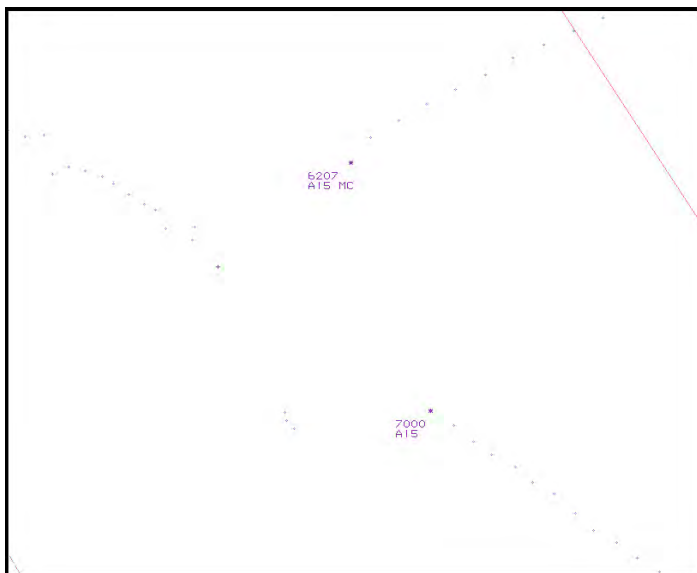
Figure 3 – area radar at 1535:10

At 1535:10, the A109 was in the ATR 42’s 10 o’clock position at a range of 1.5nm and the controller asked, “[ATR 42 C/S] are you visual with that traffic believed maybe on your left hand side.” The ATR 42 pilot responded, “Affirm [ATR 42 C/S]” and the controller replied, “Sorry was that affirm?” The ATR 42 pilot confirmed, “Visual with the traffic [ATR 42 C/S]”. The other unknown primary contact (P1) was in the ATR 42’s 12 o’clock position at a range of 0.9nm. At this point the ATR 42 was shown to commence the LH base turn (see Figure 3).

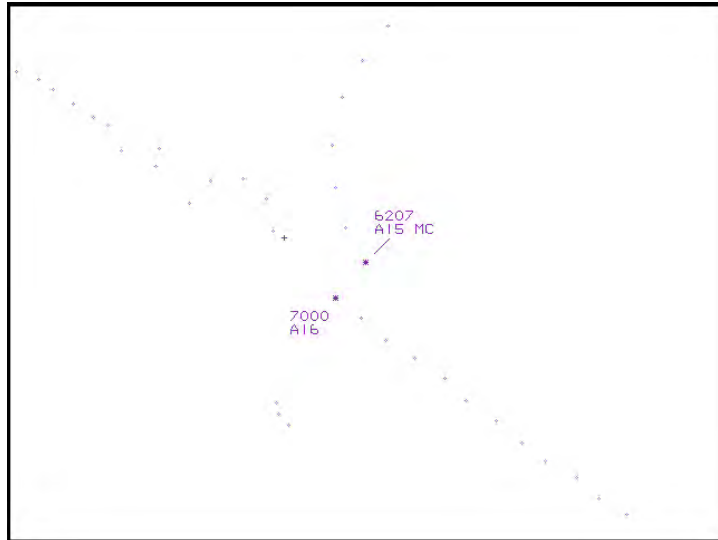
Figure 4 – area radar at 1535:31

At 1535:29, the unknown primary contact (P1) is shown 0.5nm W of the ATR 42 and turning away. The A109 is 0.5nm S of the ATR 42 at the same level. The ATR 42 continued in the L turn and at 1535:31 (CPA), the A109, at 1600ft, was shown passing 0.2nm SW of the ATR 42 at 1500ft (see Figure 4).

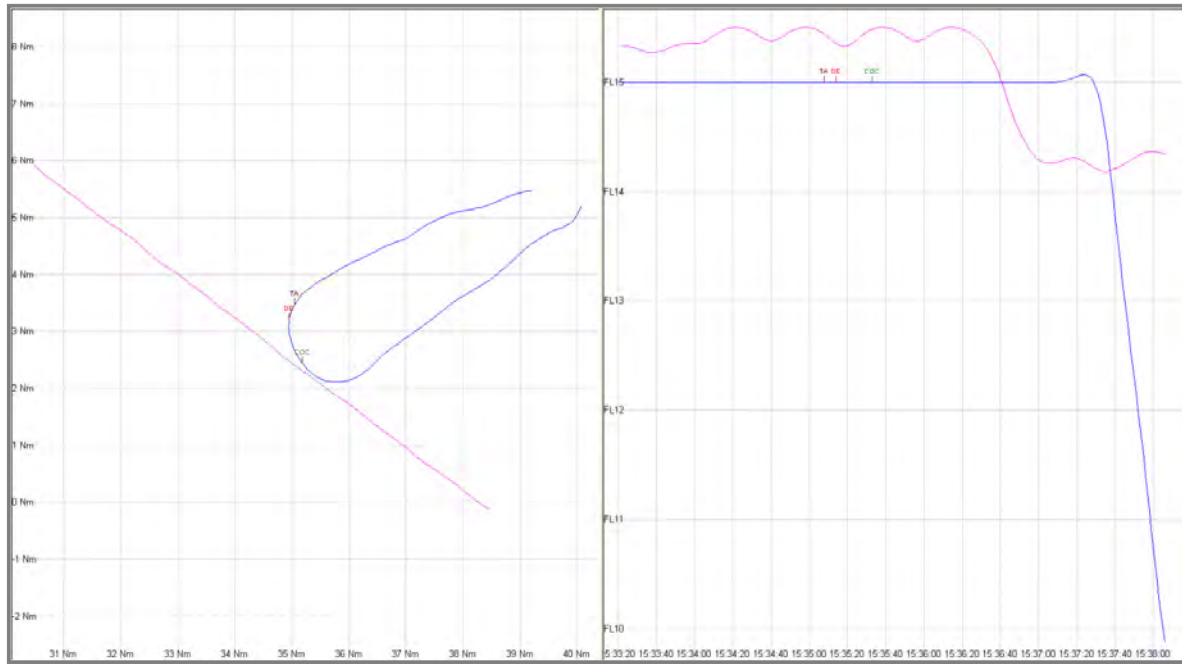
Encounter Diagram Based on Heathrow Single Source Radar Data

The Mode C data suggest that the ATR 42 pilot took no action in response to the RA. The A109 Mode C changes between 1525 and 1550 during the period when it is in approximately level flight. The InCAS simulation produces a smoothed trajectory based on these data, the effect of which is shown in the figure below. A different interpolation would not change the RA time or type.

Note that the small upturn in the vertical trajectory of the ATR 42 prior to descent is an artefact of the interpolation of radar data applied by the simulation; the Mode C data do not show a climb, only a descent.

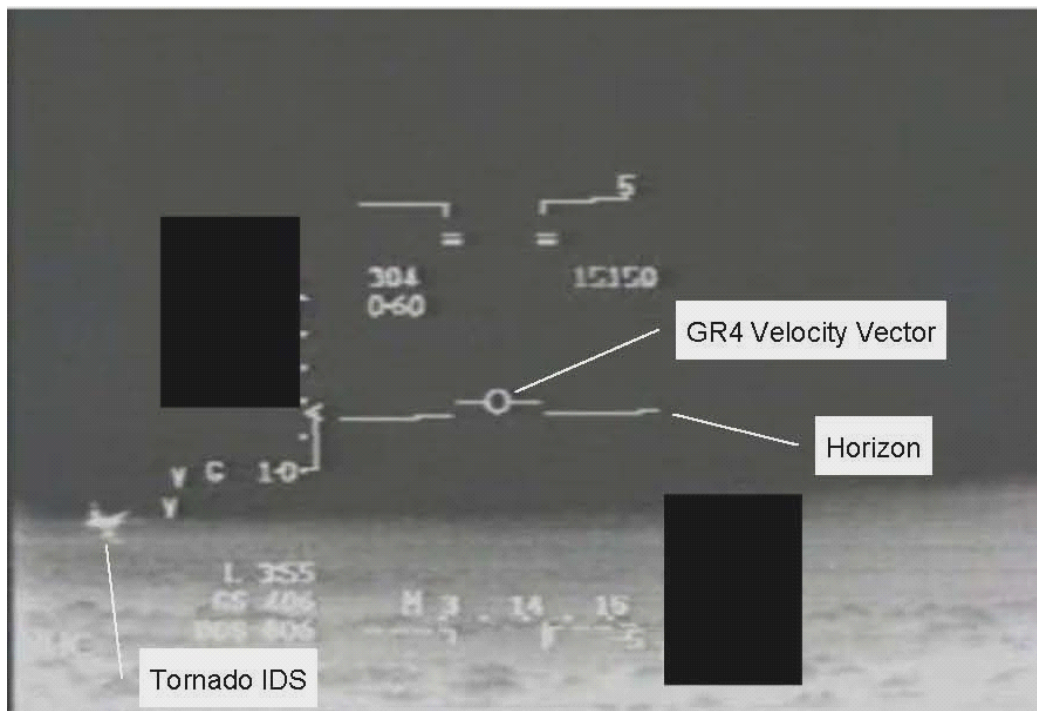
[UKAB Note(1): A still frame from the Tornado GR4 HUD video, taken shortly before CPA, is reproduced below:]

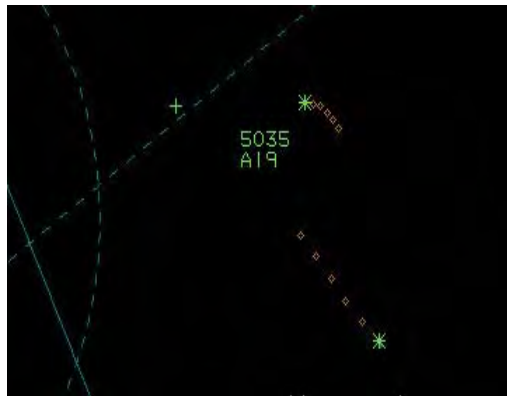
Figure 1

[UKAB Note (1): At 1329:00 a pop-up primary-only return appears, believed to be the SF25, 2.9nm to the ESE of Bicester gliding site (Figure 1). The C172 is seen 2.2nm to the E of the SF25 on a W'ly heading level at altitude 1900ft QNH 1016hPa having turned from a N'ly track. The SF25 remains on a track of 080° before fading from radar after the sweep at 1329:16 when 3.2nm ESE of Bicester with the C172, now indicating 2000ft, in its 1 o'clock range 1.5nm.]

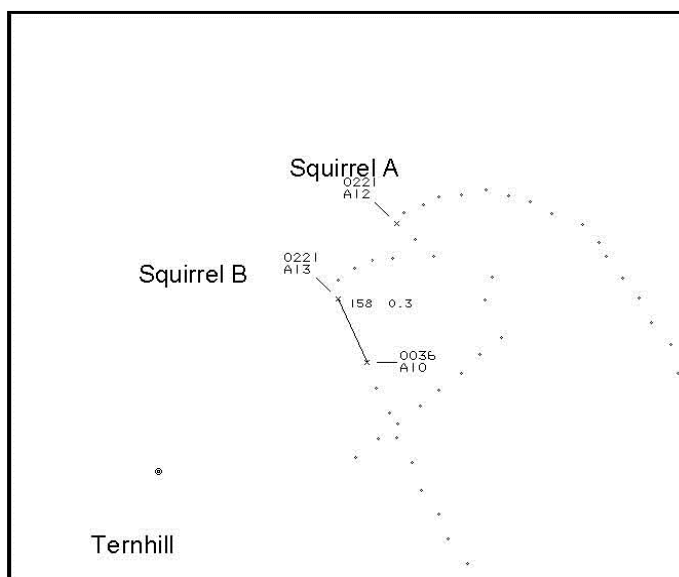
Recorded Separation:

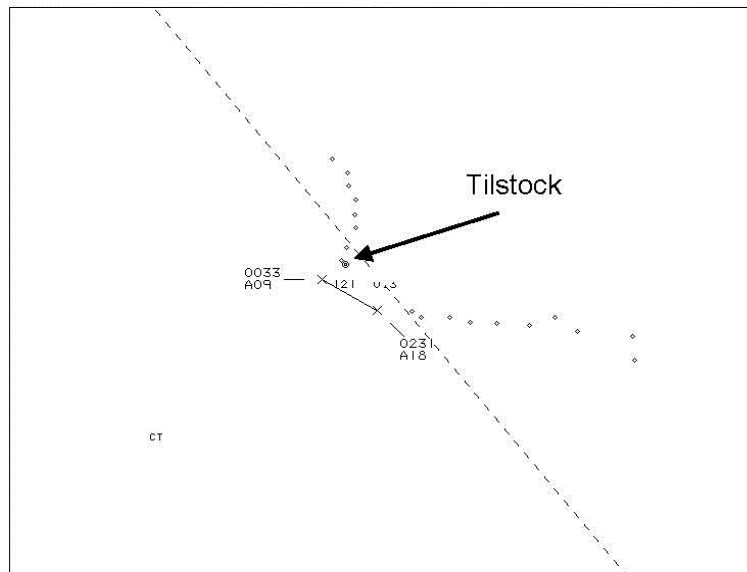
During the de-brief it was stated that whilst vertical separation alone is safe, more lateral separation would have been preferable to ensure there was no misunderstanding of the Hawk's intentions or flightpath from ATC or by the helicopter crew.

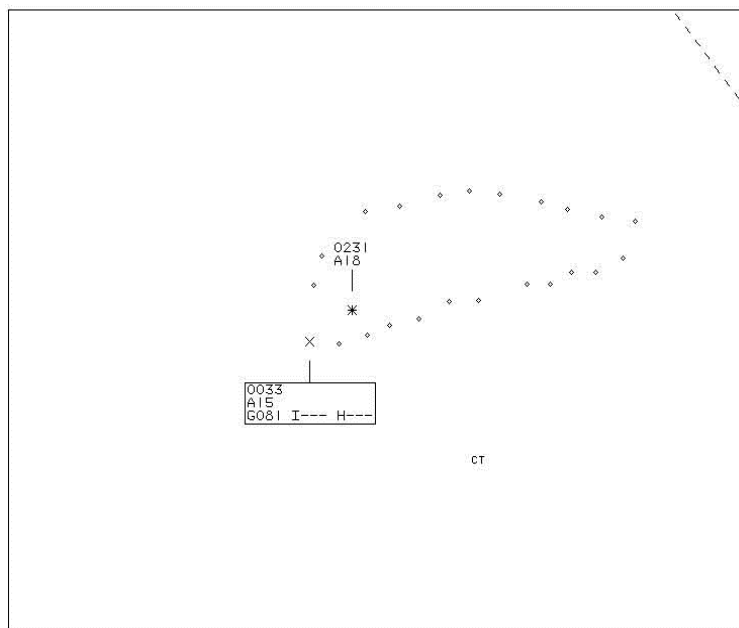
AIRPROX REPORT No 2012015

This Airprox appears to have been caused when the Hawk TMk2 underflew the Sea King which was conducting a PAR. The Hawk had been informed about rotary instrument traffic both directly by the ADC and again by hearing the information being passed to the Hawk formation on the same frequency. It is the responsibility of ac joining through initials to avoid PAR traffic by a safe margin; ATC assist in this process by passing TI on instrument traffic - this was done in this case.

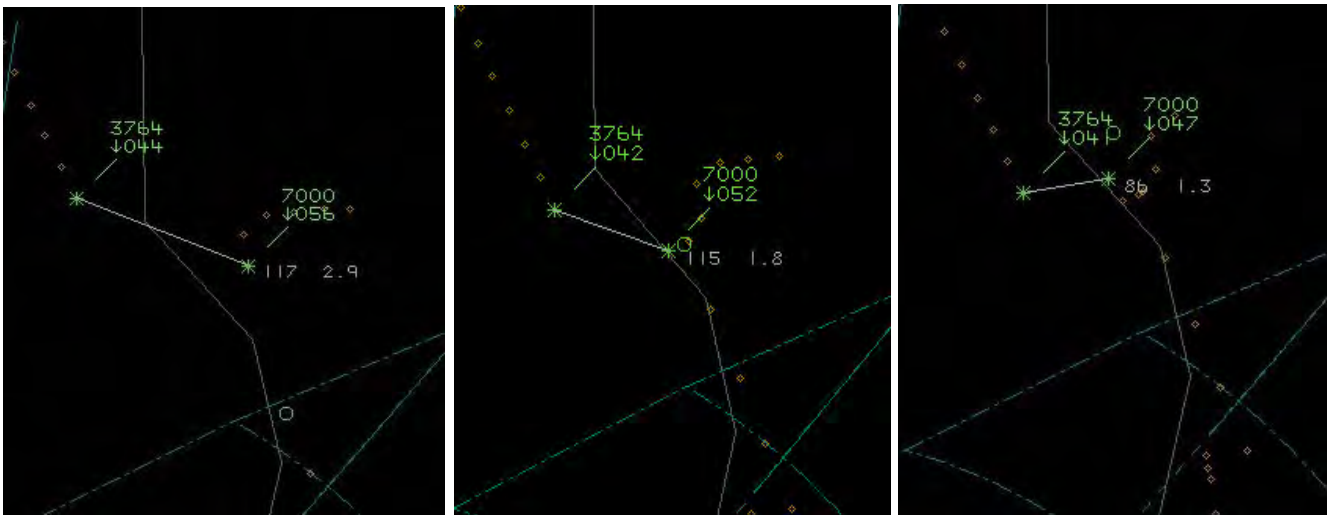
The controller acknowledged the TCAS RA by replying, "*roger*". At the end of that transmission the Tucano pilot was tracking N and passed down the LH side of the JS41 at a range of 1.3nm. The controller asked the Tucano pilot if he was still on frequency. The Tucano pilot replied that he was but that he was going en-route. The controller requested the Tucano pilot to remain on frequency due to the TCAS RA reported by the JS41 pilot.

The screenshots below, using the Great Dun Fell radar, show the sequence of events between 1201:20 and 1201:40.

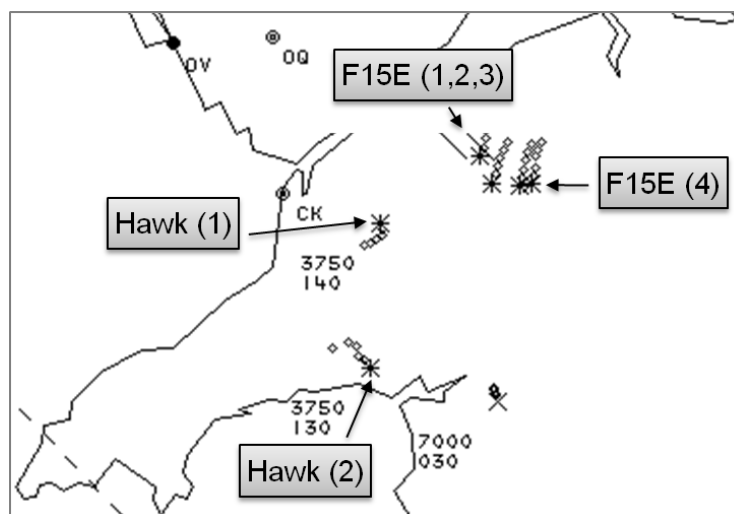
Figure 3: Incident Geometry at 1202:21.

The incident sequence commenced at 1202:21 as Hawk (2) free-called W Tac on the W ICF using his individual C/S. At this point, Hawk (2) was 22.6nm SE of Valley, tracking SE’y, indicating FL130. Hawk (1) was 8.6nm N of Hawk (2), tracking NW’y, indicating FL140. The incident F15E formation were operating between 7.1nm and 9.2nm NE and ENE of Hawk (1), tracking SSW’y, indicating between FL206 to FL212. The unrelated F15E formation was 69.3nm S of the incident F15E formation, tracking E’y, indicating between FL259 and FL287 within the NWMTA. Figure 3 depicts the incident geometry at this point.

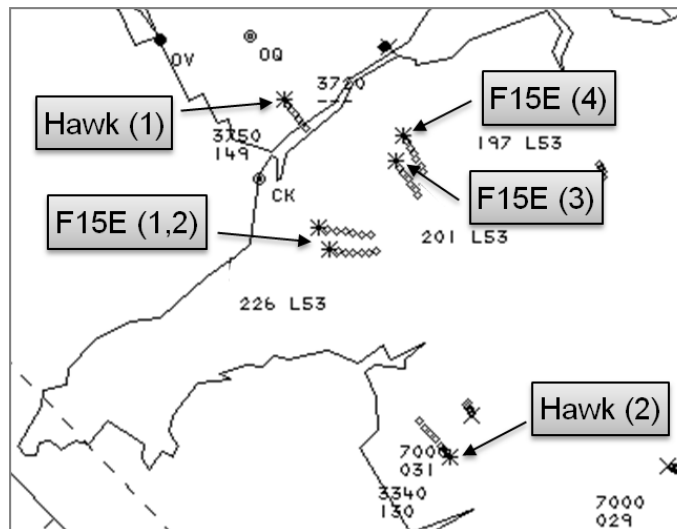
Figure 4: Incident Geometry at 1203:43.

completion. Be advised there's 7 F-15s operating within the North Wales M-T-A." This was acknowledged by Hawk (2) using the formation C/S. At this point Hawk (1) pilot had not commenced squawking the SSR3A code assigned to him and was 9.3nm WNW of F15E (4) and 25.7nm NNW of Hawk (2). Figure 4 depicts the incident geometry at this point.

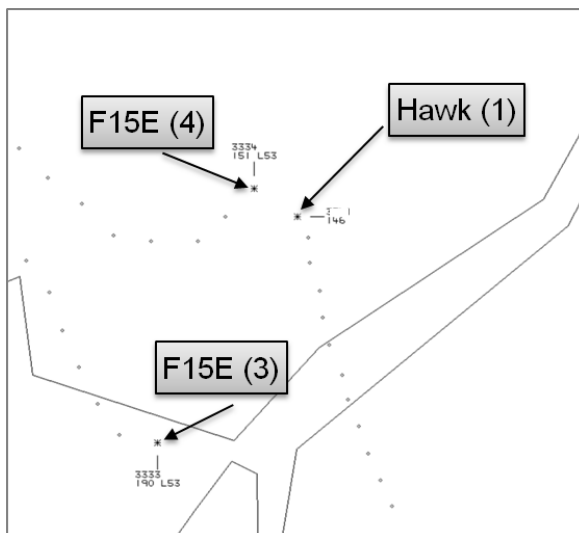
Figure 5: Incident Geometry at 1206:39 immediately prior to the CPA.

At 1206:16, transmitting on both the Hawk and F15E formation's frequencies, W Tac trainee attempted to provide TI to the N'ly F15E formation on Hawk (1); however, quoting the W Planner, the trainee 'stumbled' over his phraseology, prompting the instructor to step in. The instructor stated, "[F15E formation C/S] Hawk west...east 2 miles, manoeuvring, Flight Level 1-5-0, operating in the block Flight Level 300 Flight Level 100", which was acknowledged using the F15E formation C/S. However, based on the F15E formation's report, it was not the formation leader who acknowledged the TI, a point that will be examined later. At the time the W Tac trainee attempted to pass TI, F15E (3) and F15E (4) were 4.5nm and 4.8nm respectively NW of Hawk (1), tracking SE'ly, indicating FL180 and FL175 respectively. As the instructor passed TI to the F15E formation, at 1206:28, F15E (4) turned left approximately 30° introducing the conflict with Hawk (1), 2.3nm ESE of him. At 1206:36, F15E (4) turned left approximately a further 45° and commenced a rapid descent, further reducing the separation on Hawk (1). This detail can be seen in Figure 5. Extrapolation of the radar data demonstrated that approximately 2.1nm lateral separation would have existed between Hawk (1) and F15E (4), prior to this manoeuvre. Immediately after the F15E formation's acknowledgement of the TI, the W Tac instructor replied to an unrelated free-calling ac on the SW ICF, instructing them to, "standby". The CPA between Hawk (1) and F15E (4) occurred between radar sweeps at approximately 1206:42 as F15E (4) crossed 0.2nm L to R through Hawk (1)'s 12 o'clock. Figure 5 depicts the incident geometry at 1206:39 at the radar sweep immediately prior to the CPA. In the radar sweep immediately after the CPA, at 1206:43, the F15E is shown having made a tight R turn through 45° towards Hawk (1), indicating FL153. Hawk (1) was indicating FL135, after his 'avoiding action...descending to the left'; Figure 6 shows this detail with the flight path of F15E (4) highlighted in red and that of Hawk (1) highlighted in blue.

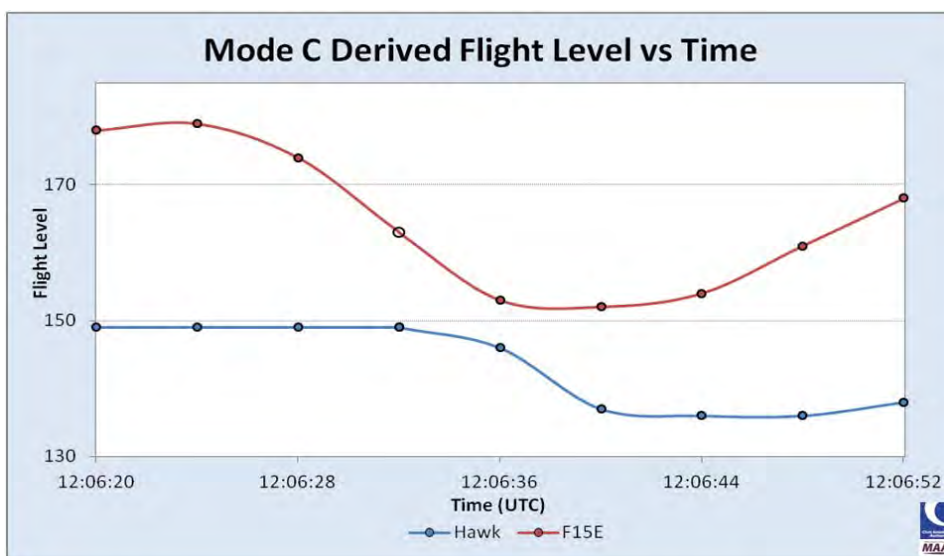
[UKAB Note(2): The vertical profile of the encounter, derived from Mode C data, is shown below:

Note that the F15E Flight Level is interpolated between 12:06:28 and 12:06:36 as its RoD exceeded the surveillance system parameters for processing height readout.]

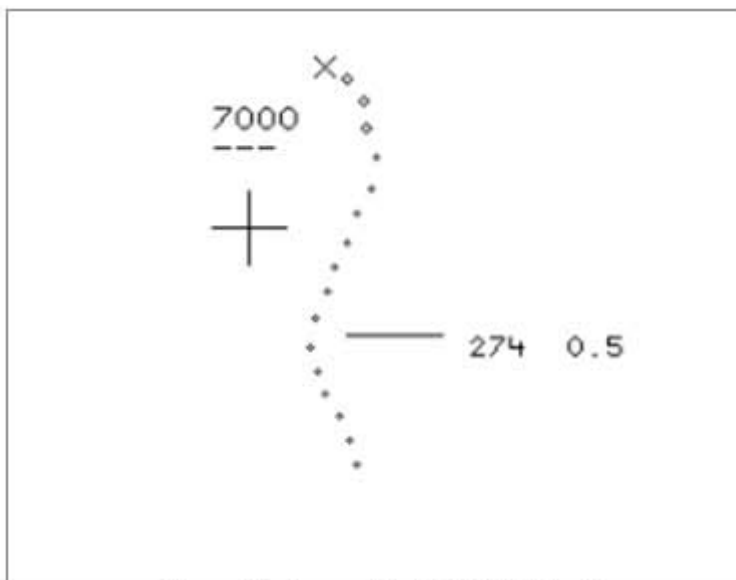
Figure 2: Swanwick MRT 1417:49

Figure 2 below shows the Swanwick MRT surveillance picture at 1417:49; the large cross denotes the Upwood RW06 threshold and the horizontal line shows ½nm range. The MD500 was displaying Mode A code 7000, with no Mode C; the ASK13 was not visible on the surveillance recording. Each track history update represents 4sec in time.

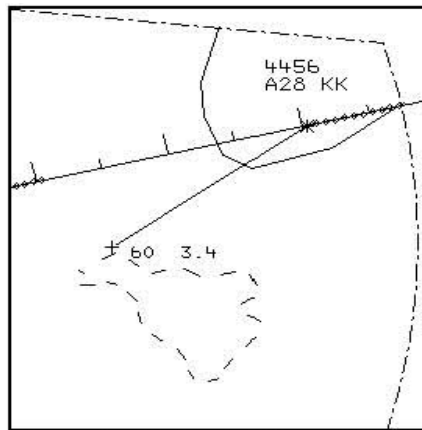
Figure 1: Gatwick 10cm: 0852:16 UTC

Figure 1 is taken from the Gatwick 10cm radar replay at 0852:16 when a primary position indication symbol appeared on the outskirts of East Grinstead in the B777's 11 o'clock range 3-4nm. The return disappeared on the next update of the replay.

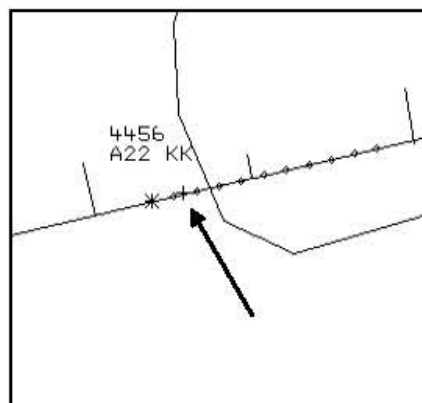
Figure 2: Gatwick 10cm: 0853:03 UTC

At 0853:02 the Gatwick 10cm replay showed the B777 at 6.4nm from touchdown, passing 2200ft and at this time another primary position indication symbol appears 0.1nm behind the B772 (Figure 2). The unknown target disappeared on the next update of the replay.

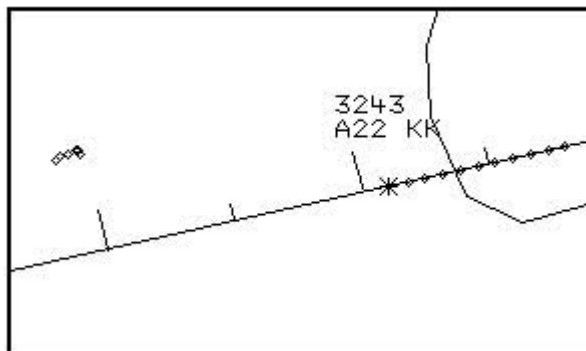
Figure 3: Gatwick 10cm: 0856:37 UTC

The surface wind (230/08KT) was passed to the B777 flight and it was cleared to land at 0856:16. After the read back the pilot stated that, at between 5–6nm from touchdown, a couple of man-made objects had passed underneath the ac. These were described as 'some sort of toy'. The report was acknowledged by the controller. At this time the B767 was at 6.3nm from touchdown passing through 2300ft.

As the B767 approached 6nm from touchdown (passing 2200ft) the Gatwick 10cm replay showed a sequence of 6 primary position indication symbols moving E'bound approximately 1nm N of the FAT (Figure 3).
