UK AIRPROX BOARD

Analysis of Airprox in UK Airspace

Report Number 12
January 2004 - June 2004

Twelfth Report by the UK Airprox Board:

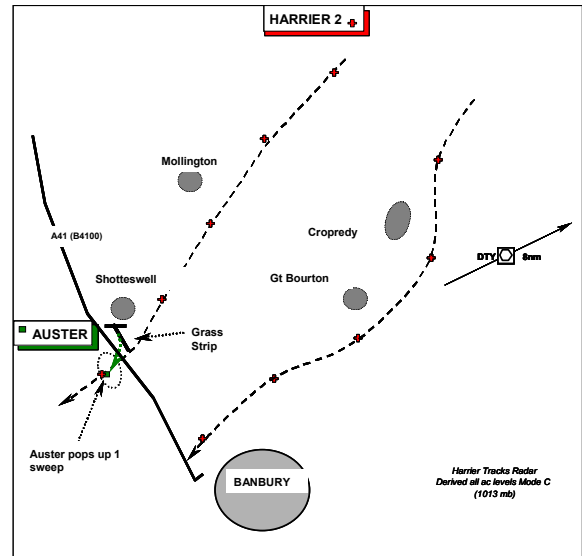
AIRPROX REPORT NO 003/04

Date/Time: 16 Jan 1635
Position: 5206 N 00123 W
 (Shotteswell Airfield)
Airspace: UKDLFS LFA4 (Class: G)
Reporting Ac Reported Ac
Type: Auster J5F Harrier GR7
Operator: Civ Pte HQ STC
Alt/FL: 750ft 400ft
 (QNH 1024mb) (Rad Alt)
Weather VMC CLBC VMC CAVOK
Visibility: 10km 20km
Reported Separation:
 30ft V 30ft H below V 0 H
Recorded Separation:
 About ¼ nm H NR V

THE AUSTER J5F PILOT reports flying a red and white ac with no lights in receipt of an FIS from Oxford (he thought). While heading 230° at 70kt and 750ft QNH (220ft agl) after take off from, Shotteswell, an active private airfield in Oxfordshire, he was overtaken from his 0730 position by a Tornado (subsequently traced to be a Harrier) slightly above his height in a left turn. He first saw the ac after it had passed him 30ft away and he therefore took no avoiding action but experienced severe turbulence and assessed the risk of collision as being high. The airfield suffers from, continued overflying of military jets, particularly on Wednesdays, so the residents avoid local flying on that day. This incident however occurred on a Friday afternoon so no military activity was expected. Since the airfield at Shotteswell is marked on the CAA VFR maps no traffic below 500ft should be expected except for the purpose of take-off and landing.

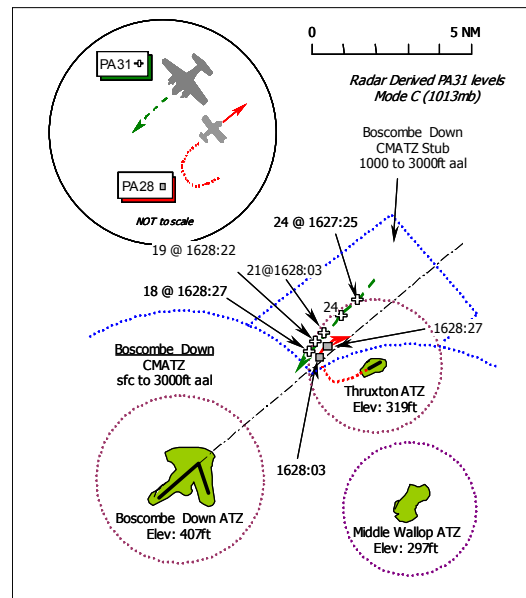
NR - about 0-33nm H

THE PA31 PILOT, a QFI, reports his ac has a red white & blue colour-scheme and the HISL was on. He was conducting a day/night check from the right hand seat of the Chieftain monitoring the LHS PF, whilst descending on an SRA to RW23 at Boscombe Down in receipt of a talkdown from Boscombe Down TALKDOWN (T/D) on 336.15MHz. A squawk of A2603 was selected with Mode C; TCAS is not fitted.

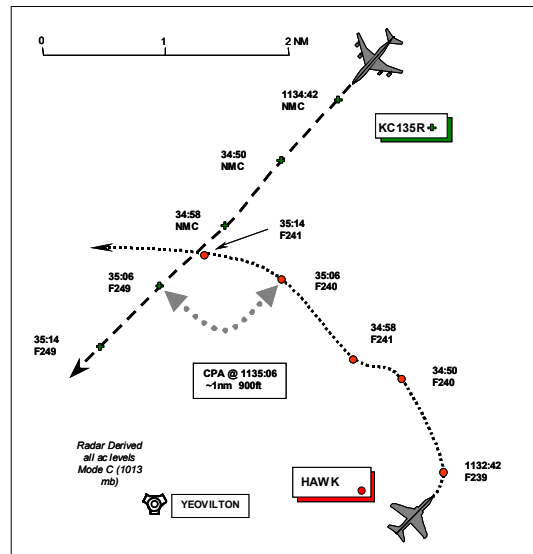
AIRPROX REPORT NO 005/04

Date/Time: 16 Jan 1135
Position: 5102N 00237W
 (Yeovilton Overhead)
Airspace: London FIR (Class: G)
Reporting Ac Reported Ac
Type: KC135R Hawk T1
Operator: Foreign Mil COMNA
Alt/FL: FL240 FL240
Weather VMC VMC Above
Visibility: NR NR
Reported Separation:
 1nm H 0 V 2nm H
Recorded Separation:
 1nm H 900ft V

THE KC-135R PILOT reports flying a grey ac under Radar Control, he thought, from LATCC (Mil), squawking as directed with HISLs selected on. While heading 235° at 430kt and FL240, en-route from BZN to VLN in the Swindon corridor, he thought, he was given TI “ eleven o’clock, 10 miles 1000ft below”. While visually searching for the traffic, they received a TCAS TA in the direction of the ATC TI. The traffic had climbed to co-altitude and changed direction to head straight toward their ac. He then received a TCAS RA at the same time as they visually acquired the ac. They complied with the RA, when the Hawk was approximately in their 9 o’clock, inside 2nm, co-altitude, by climbing to FL250 and watched the Hawk move into their 6o’clock position. The pilot called ATC stating that he was holding waiting for a climb. At the closest point the Hawk was seen inside 1nm, co-altitude, moving L to R behind them.

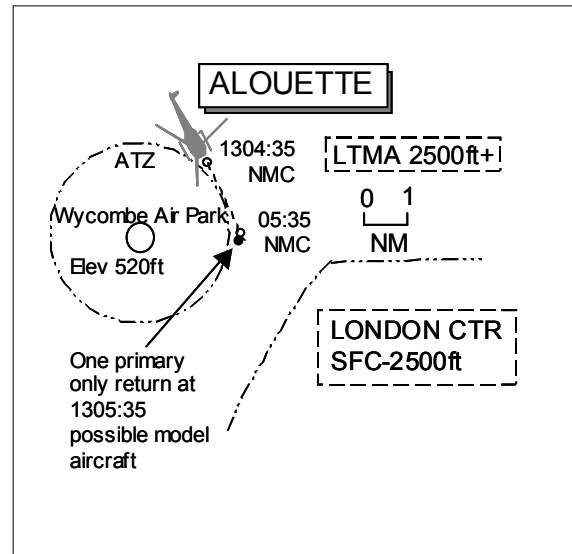
Recorded Separation:
0.18nm H

THE S313 ALOUETTE PILOT reports flying a local sortie from Wycombe Air Park with 4 passengers routing to Cookham to join the H10 London Heli-Route and was establishing communications with Heathrow on 125.62MHz squawking 7000 with Mode C, he thought. The visibility was 20nm 1000ft below cloud in VMC, the helicopter was coloured white with red/blue stripes with a strobe light switched on. About 1nm W of Flackwell Heath whilst heading 180° at 75kt cruising at 1700ft QNH 1024mb, he noticed a model ac in his 11 o'clock lower quarter <100m away about 200ft below in a vertical climb on a collision course. He immediately banked L keeping the model ac in sight, which passed vertically through his level in his 4 o'clock position 50ft away. It was a low wing aerobatic type with a 5-6ft wingspan, painted in a red/white scheme identical to that of an Extra Display team's colours/markings. The model was then seen to fly a lot higher before carrying out a loop. This high-risk incident occurred during his initial call to Heathrow and he had then reported it as an Airprox to the controller. He was aware of a radio controlled model ac club which operates in the area, close to Flackwell Heath, but he had never seen any such ac before when flying on this route. He expressed concern that the radio control operator should have seen his helicopter, as well as hearing its distinctive turbine engine noise, so should have avoided such an incident.

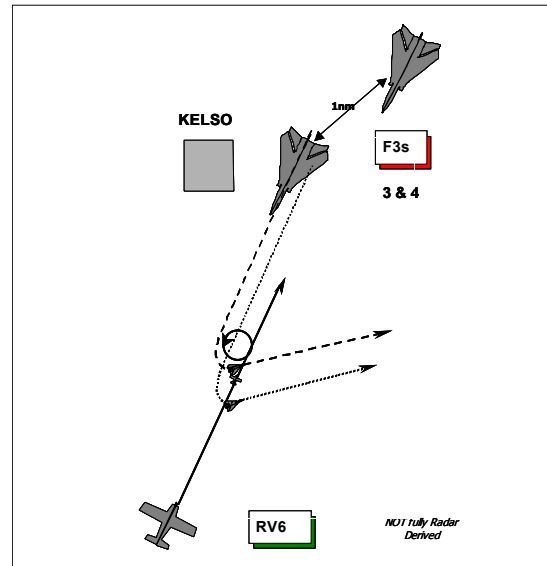
AIRPROX REPORT NO 009/04

Date/Time: 9 Feb 1045
Position: 5534N 00225W
 (1½ miles S of Kelso)
Airspace: Scottish FIR (Class: G)
Reporting Ac Reported Ac
Type: RV6 Tornado F3
Operator: Civ Pte HQ STC
Alt/FL: 3100ft NR
 (QNH 1031 mb)
Weather VMC CLBC VMC
Visibility: >10km NR
Reported Separation:
 100m H 0 V NR
Recorded Separation:
 NR

THE RV6 PILOT reports flying a white red and yellow ac with wing tip strobes switched on a local sortie from a strip near Selkirk. While heading 030° at 145kt and 3100ft amsl a Tornado approached from his 8 o'clock (he thought), and level with him and upon seeing him turned away at a range of 100m. He did not see the Tornado until it had passed him and was already turning away. As the ac passed he circled left in an attempt to see if there was another ac and a second Tornado passed astern of him at a range of 900m and well clear. Both ac then continued on track of approximately 090°. He believed that if he had turned away from the first ac he would have turned into the second. He assessed the risk as being Medium to High if the other ac had not seen him.

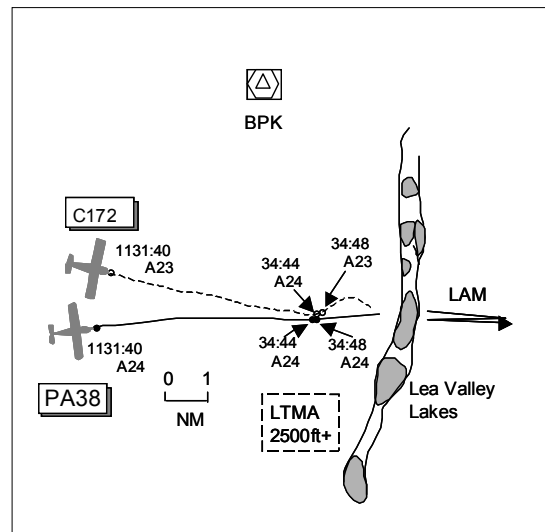
AIRPROX REPORT NO 010/04

Date/Time: 9 Feb 1135
Position: 5140N 0003W (8nm W LAM)
Airspace: FIR (Class: G)
Reporting Ac Reported Ac
Type: C172 PA38
Operator: Civ Pte Civ Pte
Alt/FL: 2300ft 2400ft
(QNH 1035mb) (QNH)
Weather VMC CLNC VMC CLNC
Visibility: >30km >30km
Reported Separation:
nil V 100m H nil V 300m H
Recorded Separation:
0.1nm H

THE C172 PILOT reports heading 095° at 95kt cruising at 2300ft QNH 1035mb and listening out with Elstree on 122.4MHz squawking 7000 with Mode C. The visibility was >30km in clear sky VMC, the ac was coloured white with red/blue stripes and the strobe lights were switched on. Passing over the Lea Valley lakes, his passenger spotted a PA38 Tomahawk ac, coloured white with a thin stripe, in their 5 o'clock position range 100m at the same level heading directly towards them. He immediately executed a descending L turn to avoid it and believed that had neither ac deviated at all, the risk of collision would have been high. After regaining his track towards LAM VOR, the Tomahawk was now in front and he watched it diverge away to the NE, apparently not having altered course or altitude.

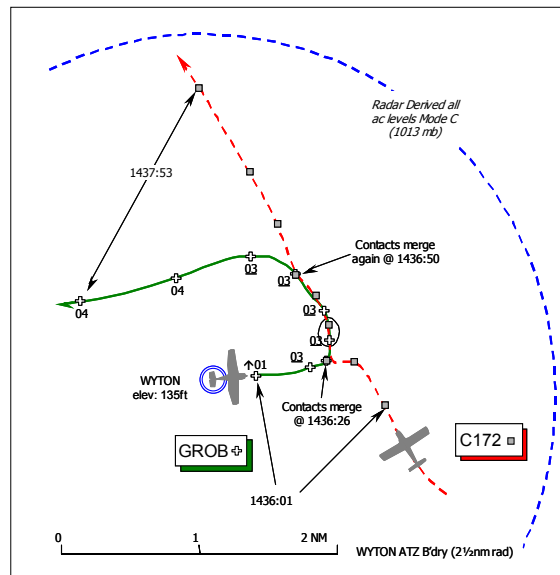
AIRPROX REPORT NO 011/04

Date/Time: 11 Feb 1436
Position: 5221N 0006W
 (Wyton A/D Cct - elev 135ft)
Airspace: Wyton ATZ (Class: G)
Reporting Ac Reported Ac
Type: Grob Tutor C172
Operator: HQ PTC Civ Pte
Alt/FL: 700ft↑ 1100ft
 (QFE 1026mb) (QNH 1027mb)
Weather VMC HAZE VMC CLOC
Visibility: 4000m 15km+
Reported Separation:
 50m H/50ft V 75yd H
Recorded Separation:
 Contacts merged

THE GROB TUTOR PILOT, a QFI instructing a student, reports that his aeroplane has a predominantly white colour scheme and the landing lamp and HISL were on, shortly after take off from RW09 into the aerodrome Cct at Wyton. He was in communication with Wyton TOWER on 245.375MHz and squawking A7000 with Mode C.

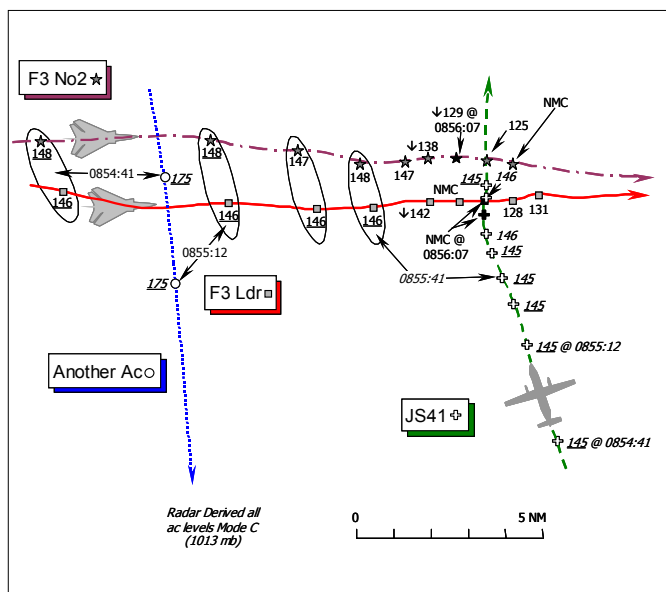
Recorded Separation:
JS41 v Lead F3: 0.32nm H
JS41 v No2 F3: 1.1nm H/2100ft V

THE JETSTREAM 41 PILOT reports that his ac has a white, red and blue livery and the HISLs were on whilst flying under IFR in “good” VMC between Humberside and Aberdeen at 280kt. He was in receipt of a RIS from SCOTTISH CONTROL on 124.5MHz and squawking the assigned code with Mode C; TCAS is not fitted.

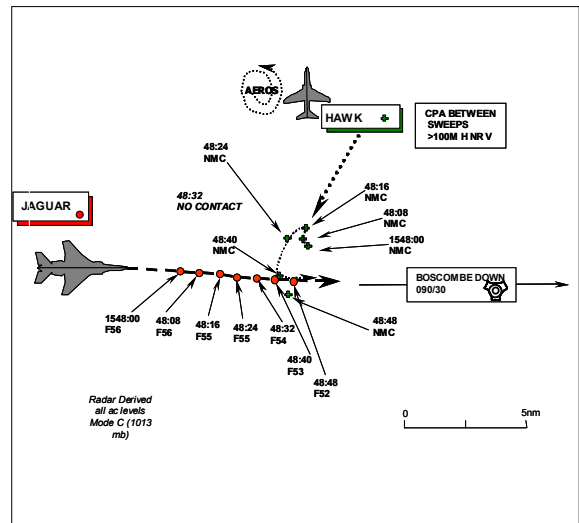
AIRPROX REPORT NO 015/04

Date/Time: 20 Feb 1548
Position: 5110N 00238W
 (30nm W of Boscombe)
Airspace: London FIR (Class: G)
Reporting Ac Reported Ac
Type: Hawk T MK1 Jaguar T MK2A
Operator: DPA DPA
Alt/FL: FL53 FL51
Weather VMC Above VMC Above
Visibility: >10km >10km
Reported Separation:
 0ft H 150ft V 0ft H 200ft V
Recorded Separation:
 >100m H

THE HAWK T MK1 PILOT reports flying a red, white and blue Hawk ac on a Test Pilot instructional sortie with anti collision and nav lights switched on, squawking with Mode C and in receipt of a RIS from Boscombe Down. While heading 170° at 430kt following the completion of aerobatic manoeuvres, and in a shallow descent passing FL53, a Jaguar was spotted coming from behind the canopy arch in the 1.30 position less than 1km away. It was at close range and on a constant bearing with a 90° aspect so avoiding action in the form of a high G pull was initiated to negate the potential collision and, as a result, the non-flying pilot in the rear cockpit suffered minor neck strain. After the avoiding action, the front cockpit G meter indicated 9.7G, and the rear cockpit 10.2G. The ac was recovered to Boscombe via a straight in approach having first completed a low speed handling check. Throughout the general handling phase of the sortie, RIS was being provided by Boscombe Radar.

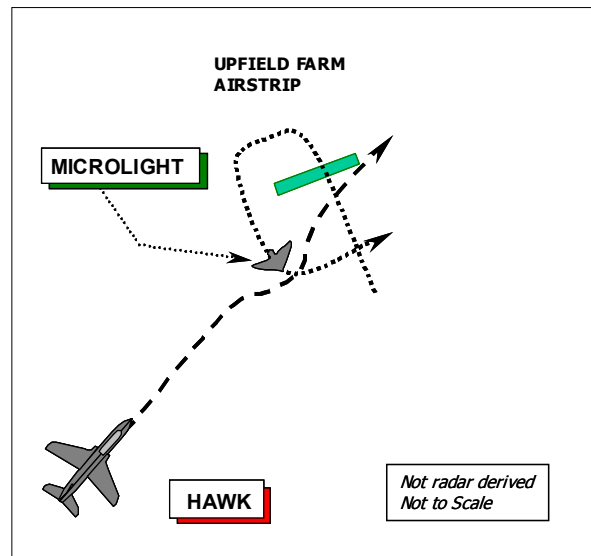
THE MICROLIGHT PILOT reports flying a yellow and purple fixed-wing microlight from a farm strip and not in communication with any agency. He had flown a standard overhead join and descended dead side for a left hand circuit and landing. He was crossing the upwind end at 800ft on QFE1037, heading 160° at 60kt and was about to turn onto the downwind leg when he saw a Hawk ac about 150ft away. The other ac had taken avoiding action and he noted that his starboard wing was down and he could see the underside of his port wing.

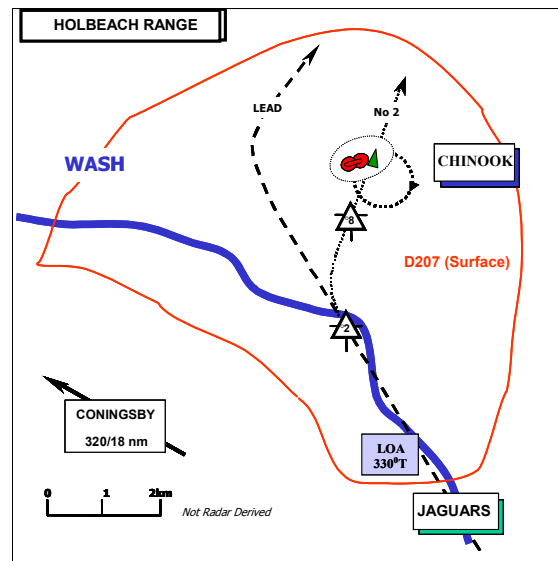
AIRPROX REPORT NO 020/04

Date/Time: 9 Mar 1822
Position: 5253N 00012E (Holbeach Range)
Airspace: EGD 207 Class G
Reporting Ac Reported Ac
Type: Chinook Jaguar
Operator: JHC STC
Alt/FL: 200ft 450ft
 (Rad Alt) (Rad Alt)
Weather VMC CLBC NR
Visibility: 25km NR
Reported Separation:
 50/100m H 0 V 100/200m H
 50/100ft V
Recorded Separation:
 NR

THE CHINOOK PILOT reports that he was flying a day into night, crewman currency training sortie with a Limited Combat-Ready co-pilot and 6 crewmen in a dark green ac with red strobes and both landing lamps on. They were a singleton sortie conducting air to ground gunnery on Target (Tgt) 8 at Holbeach Range, squawking 7002 and in contact with Range Control. During twilight they were instructed by the Range Control Officer (RCO) to hold to the N of Tgt 8 while 2 Jaguars conducted an FRA (First Run Attack) on Tgt 2 from the E. They stopped firing, made their weapons safe and held in orbit at 200ft amsl (Rad Alt) at 80kt. They elected to hold NE of Tgt 8 to afford more clearance on the Jaguars and chose a right-hand orbit to allow the handling pilot and the No2 crewman maximum visibility of the other ac. When established in the hold they informed the RCO and heard him warn the Jaguar leader of the presence of the Chinook which was acknowledged. They watched the first Jaguar's run and his bomb being dropped and shortly after the second ac dropping his; just after the release however, they turned to the E and lost sight of the [second] ac. The RCO then cleared them to re-engage Tgt 8 and they continued their turn on to the gunnery heading of SW. As they passed through an Easterly heading the 2nd Jaguar passed across their nose, at the same level, slightly right wing down. The captain then called to the RCO that they had just had an ac pass in front of them at 100m range and the Jaguar pilot replied that he had them visual. As he responded that it was very close they flew through the Jaguar's wake turbulence. He had no time to take any avoiding action and assessed the risk of collision as high.

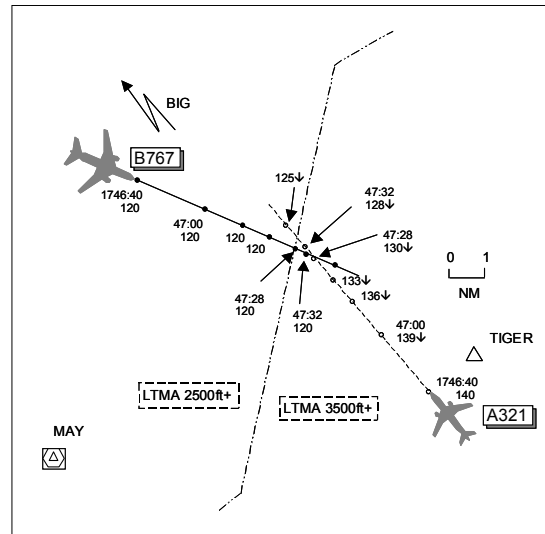
Date/Time: 18 Mar 1747
Position: 5107N 0019E (9nm NE MAY)
Airspace: TMA (Class: A)
Reporting Ac Reported Ac
Type: A321 B767-300
Operator: CAT CAT
Alt/FL: FL125↓ FL120

Weather IMC IICL NK NR
Visibility:
Reported Separation:
 500ft V 500ft V
Recorded Separation:
 900ft V 0.15nm

THE A321 PILOT reports flying inbound to Heathrow at 250kt in IMC and cleared to descend to FL110 by London on 120.52MHz. Descending through FL125, opposite direction traffic appeared very quickly on the Navigation Display (ND). It was 500ft below his level but climbing towards him, he thought; TCAS gave a TA alert. Immediately it appeared that he was heading towards a collision. The A/P was disconnected in anticipation of an RA warning, the Flight Directors were switched off and the ROD was reduced – separation became 700ft with the opposite direction traffic still climbing as they crossed. Although in IMC, he caught a glimpse of the other ac at this point, possibly a B747, which he identified from its tail shape. It had been obvious from the initial contact with ATC that they were very busy at the time and both he and his FO were reflecting on this just before the incident happened.

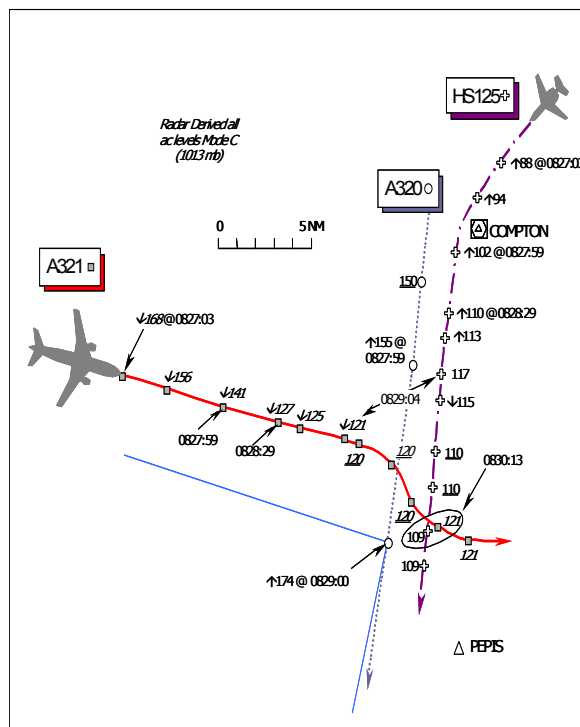
0.33nm H - 1200ft @ 0830:13

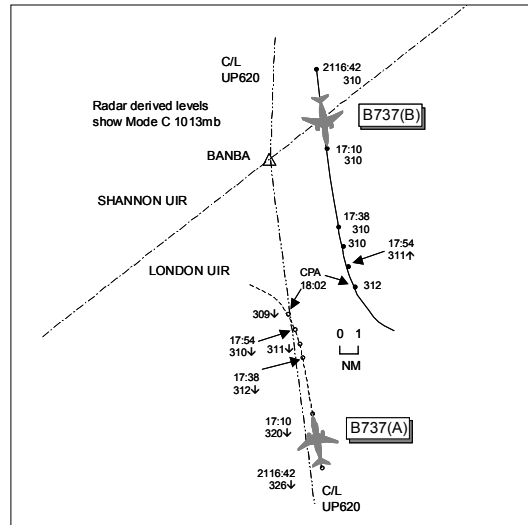
Date/Time: 25 Mar 2118 NIGHT
Position: 5150N 0608W (8nm S BANBA)
Airspace: UAR UP620 (Class: B)
Reporting Ac Reported Ac
Type: B737(A) B737(B)
Operator: CAT CAT
Alt/FL: FL310↓ FL310

Weather VMC CLAC VMC NR
Visibility: >10km NR
Reported Separation:
 nil V 5nm H NR
Recorded Separation:
 300ft V 3.9nm H

THE B737(A) PILOT reports heading 360° at 420kt en route to Dublin and in receipt of an ATS from London. When descending through FL325, having been cleared to FL260 to be level at BANBA, a TCAS TA alert was received on traffic in his 12 o'clock position range 10nm 2000ft below but climbing, he thought. Simultaneously, ATC issued a 90° L turn to him and to the other flight and the 'intruder' ac's lights were sighted in his 1 o'clock range 7-8nm. The other ac was seen to pass about 5nm abeam to his R at the same level, FL310.

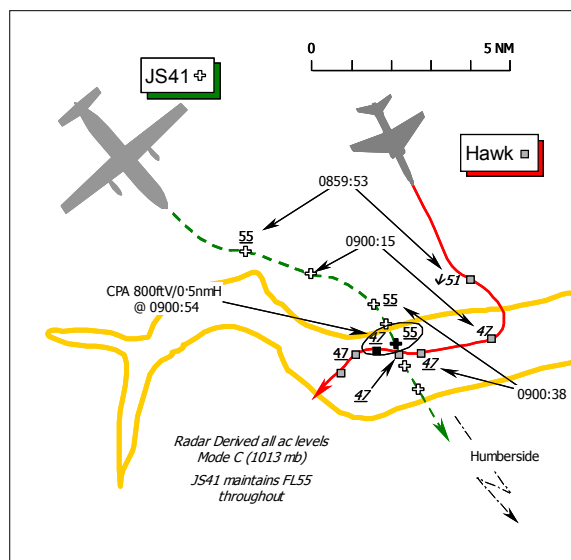
800ft V/0.5 nm H

THE JETSTREAM 41 PILOT reports his ac has a white colour scheme with blue & red stripes and that the HISL was on. TCAS is not, as yet, fitted. He was flying on a scheduled CAT flight from Teesside to Humberside under IFR, in level cruise at FL55. Whilst in receipt of a RAS from Linton RADAR, “knowing the area and the fact that there is a lot of military traffic”, he suggested to the controller that they might be routed “...at the coast down to Humberside as the fighter jets keep off the coast”. However, the controller said that there was no traffic to affect their flight. Approaching the Humber Bridge at 250kt, they were given an avoiding action turn onto a heading of 200° against an ac approaching from their 9 o’clock position, which maintained heading and altitude as they closed on each other. The other ac – a black or dark grey Hawk – was spotted about 5nm away and he was “expecting standard avoiding action” from the other aircraft’s pilot but nothing happened. To avoid the jet he turned hard left himself as the Hawk crossed 100m ahead of his ac from L – R some 500ft below his Jetstream, adding that he could see the Hawk pilot under the canopy. He tried to query Linton as to what had happened but the controller then instructed them to ‘free-call’ Humberside Radar on 119.12MHz, as Linton said they could not get a reply from Humberside ATC. He assessed the risk as “very high” and added that they were getting ready for the Approach phase into Humberside, to whom he reported the Airprox on RT.

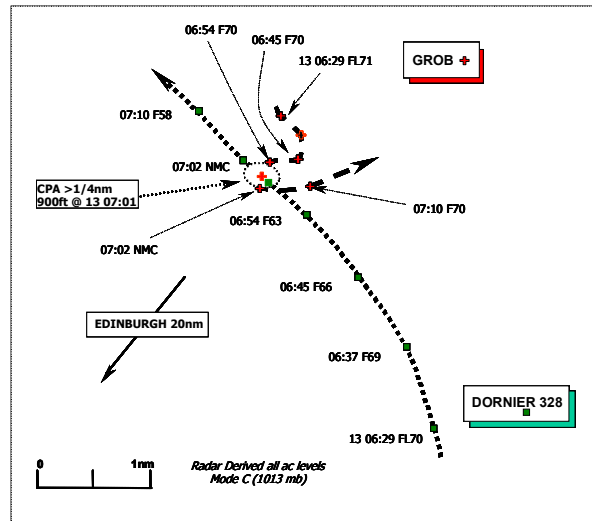
AIRPROX REPORT NO 033/04

Cause: The Edinburgh APR Controller allowed the Dornier to leave CAS on an assigned heading, which took it into conflict with the Grob.

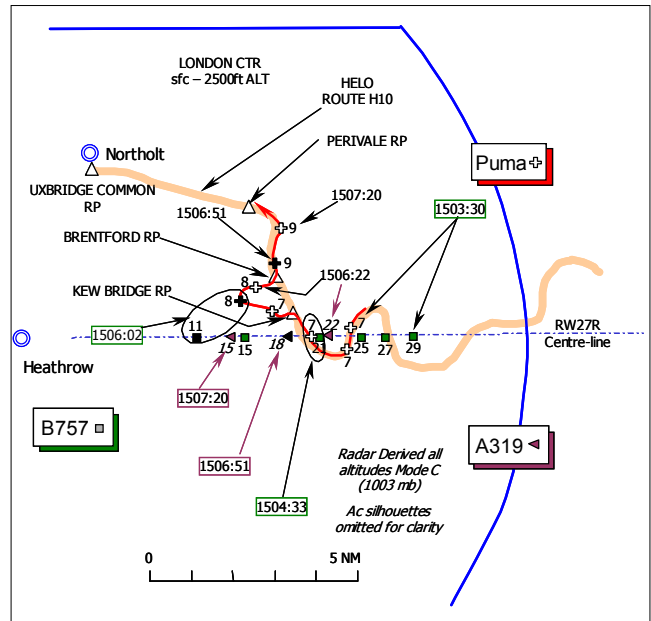
Cause: Loss of separation resulting from the Puma crew deviating from Helicopter Route H10.

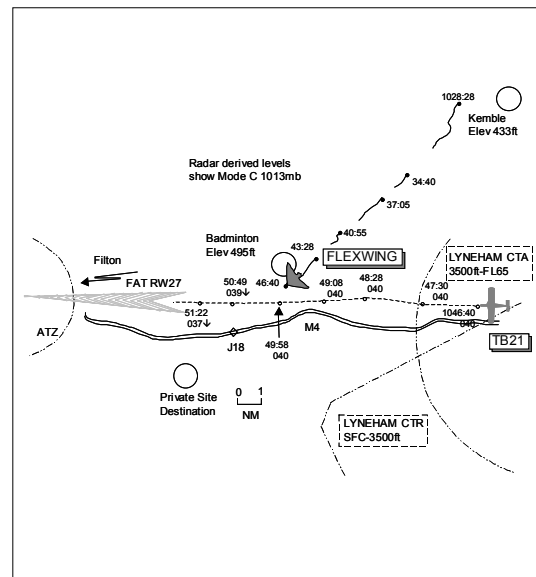
AIRPROX REPORT NO 036/04

Cause: Non-sighting by the Flexwing pilot and a late sighting by the TB21 pilot.

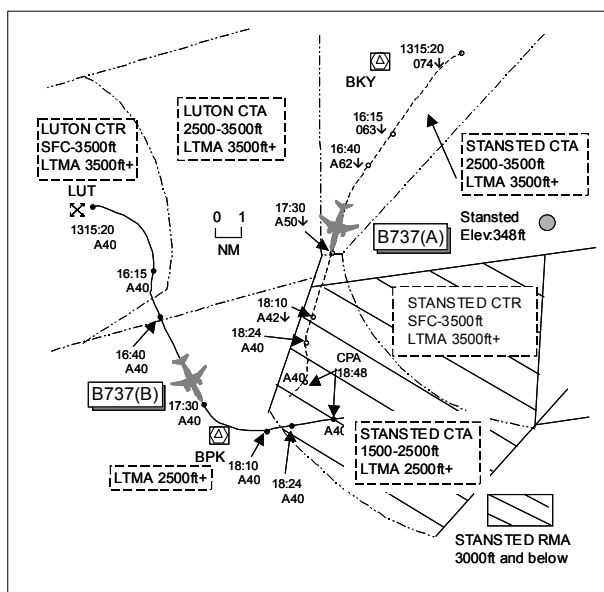
Cause: The Stansted mentor did not ensure that his trainee complied with the requirements for entering the Stansted RMA and did not monitor and avoid Luton SID traffic as required in MATS Pt 2.

ATSI RECOMMENDATIONS:

- 1) Given the evident frequency of ac failing to meet the level requirement on entering the SW segment of the RMA, NATS should review the procedure in order to establish whether it is feasible to achieve it on a reasonably consistent basis, and, if not, modify it as necessary.
- 2) Given the increasing traffic levels in the NE portion of the London TMA, NATS should review the procedures in place for ensuring separation between traffic being positioned for RW05 at Stansted and traffic outbound on SIDs, from Luton and London City which route via BPK, to assess whether they are sufficiently robust.

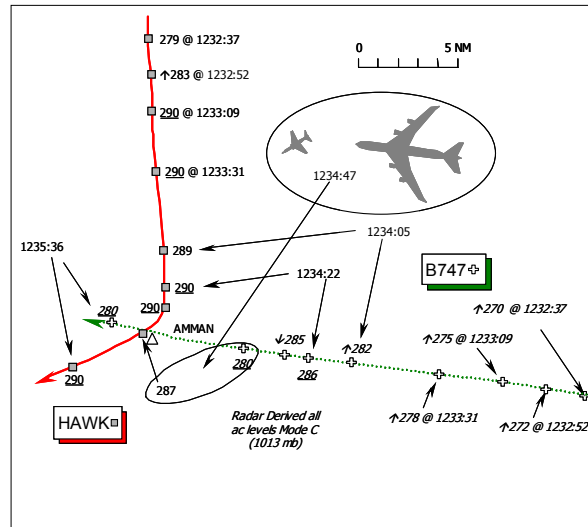
Cause: The LACC S5/8 PLANNER misunderstood the co-ordination he had agreed but not read back to MIL 32.

Recommendation: The MOD review the applicable instructions and procedures for military ATC and ASACS controllers, when effecting co-ordination, to establish whether a requirement to give/obtain a 'readback' is warranted at the conclusion of such agreements with the aim of ensuring compatibility with promulgated civilian procedures and a unified joint procedure for use by all controllers who interact with one another in UK airspace.

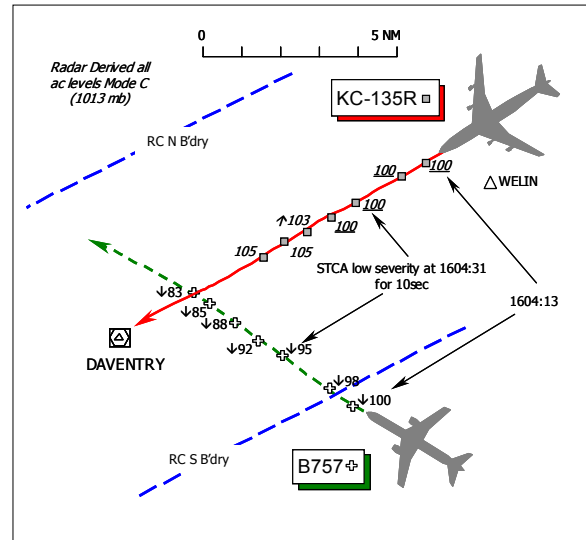
Cause: During a period of relatively high workload, the TC MID SC descended the B757 through the RC without taking the KC135 into account.

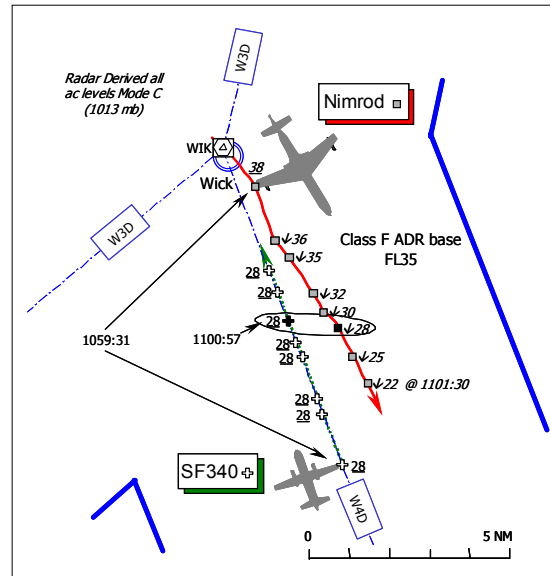
AIRPROX REPORT NO 066/04

Date/Time: 27 Apr 1100
Position: 5823N 00300W
 (5nm SSE of Wick - elev 126ft)
Airspace: Scottish FIR (Class: G)
Reporting Ac **Reported Ac**
Type: SF340 Nimrod MR2
Operator: CAT HQ STC
Alt/FL: 3000ft ↓2000ft
 (QNH 1019mb) (QNH 1019mb)
Weather NR IMC HAZE
Visibility: 10km 10km
Reported Separation:
 Nil V/1.5nm H <2nm H
 [TCAS]
Recorded Separation:
 Nil V/1.2nm H

Cause: The Nimrod pilots climbed above the standard altitude during the go-around, which was not detected by the APP controller who allowed the Nimrod to descend into conflict with the SF340.

Subsequent to ATSI's recommendation to the Wick Aerodrome operator about the telephone arrangements in the Wick VCR, the ATSI advisor briefed the Board that this review appears to have been carried out thoroughly. The Operator concluded that the current telephone arrangements are better than the alternative options considered. Additionally, a Supplementary Instruction (SI) was issued reminding controllers of their responsibility not to become distracted from their primary functions in the provision of an ATC service. As a small ATSU, the learning points from this Airprox have, no doubt, already been discussed between the operational staff. ATSI accepted the aerodrome operator's conclusions but, in conjunction with ATSSD, will continue to monitor the situation.

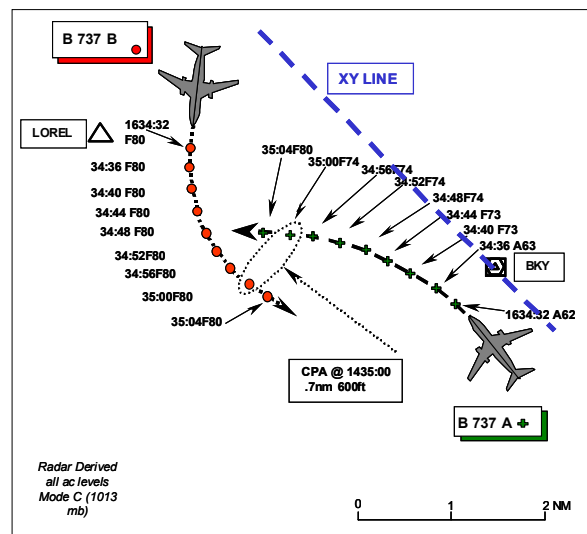
0.7nm H 600ft V

Cause: During a very complex and non-standard traffic situation caused by a bad weather, the Essex Radar Controller turned B737(B) into conflict with B737(A) without co-ordination.

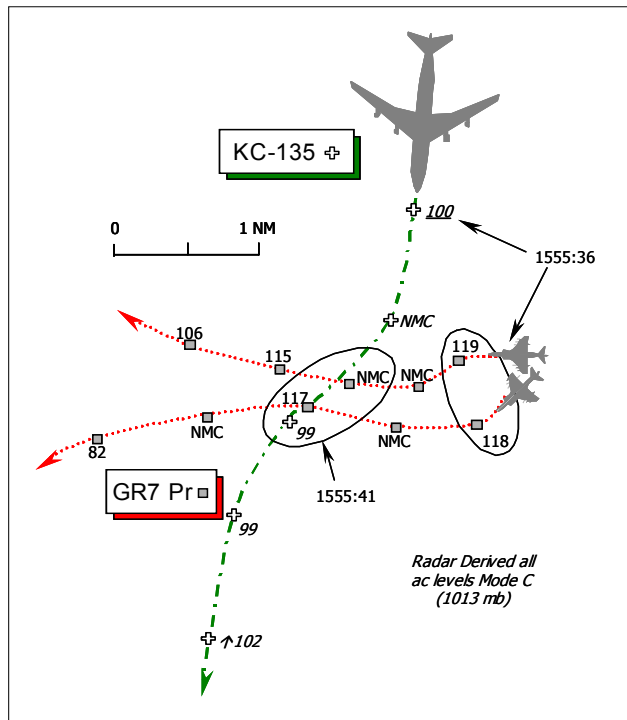
0.16nm H astern/V 1800ft (closest GR7)

Cause: Conflict in the FIR resolved by the KC-135 pilot and GR7 formation leader.

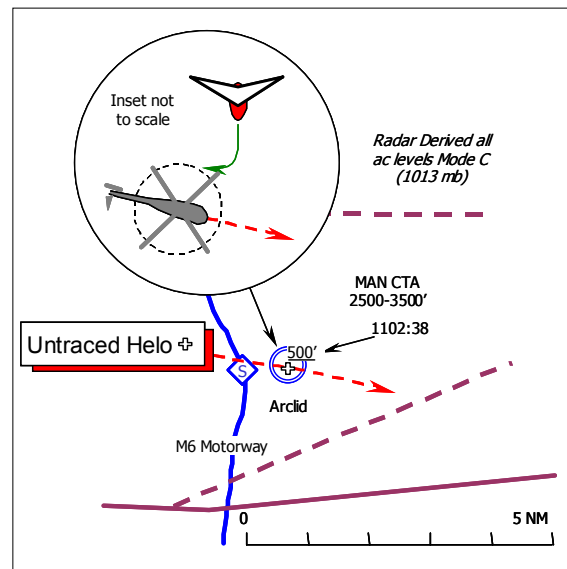
AIRPROX REPORT NO 069/04

Date/Time: 13 May 1102
Position: 5307N 00218W
(O/H Arclid microlight site elev 262ft)
Airspace: London FIR (Class: G)
Reporting Ac **Reported Ac**
Type: Microlight Untraced Helo
Operator: Civ Trg NK
Alt/FL: 500ft NR
agl
Weather VMC CLBC NR
Visibility: 10km NR
Reported Separation:
50ft V/100-150m H
Reported Separation:
NR

Cause: Conflict in Class G airspace with an untraced helicopter, resolved by the microlight pilot.

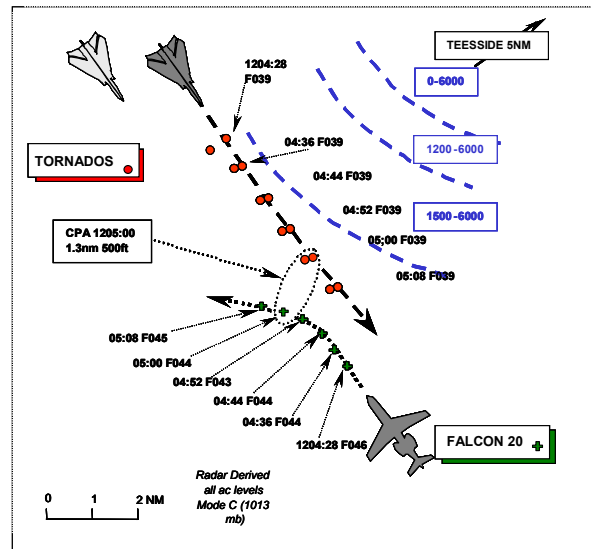
AIRPROX REPORT NO 070/04

Date/Time: 7 May 1205
Position: 5422N 00130W
 (10nm SW Teesside - elev 120ft)
Airspace: London FIR (Class: G)
Reporting Ac **Reported Ac**
Type: FA20 Tornado GR4
Operator: Civ Comm HQ STC
Alt/FL: 3900ft 3500ft
 (QNH 1004mb) (Rad Alt)
Weather VMC HAZE VMC CLOC
Visibility: 5km 10km
Reported Separation:
 1nm H 300ft V NR
Recorded Separation:
 ~1.3nm H 500ft V

Cause: Conflict between IFR and VFR traffic in Class G Airspace.

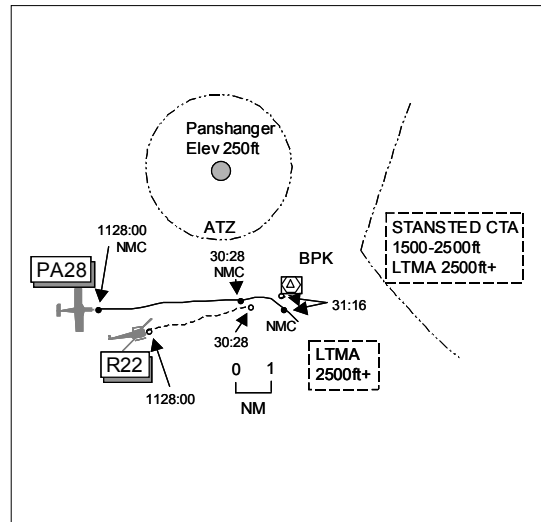
AIRPROX REPORT NO 071/04

Date/Time: 13 May 1131
Position: 5145N 00008W (1nm WSW BPK)
Airspace: FIR (Class: G)
Reporting Ac Reporting Ac
Type: R22 PA28
Operator: Civ Trg Civ Club
Alt/FL: 1800ft 2000ft
(QNH 1023mb) (QNH 1026mb)
Weather VMC CLBC VMC CLNC
Visibility: >30km >25nm
Reported Separation:
nil V 200ft H 200ft V 200ft H
Recorded Separation:
NR

Cause: A very late sighting by the PA28 pilot when overtaking the R22 on a converging course.

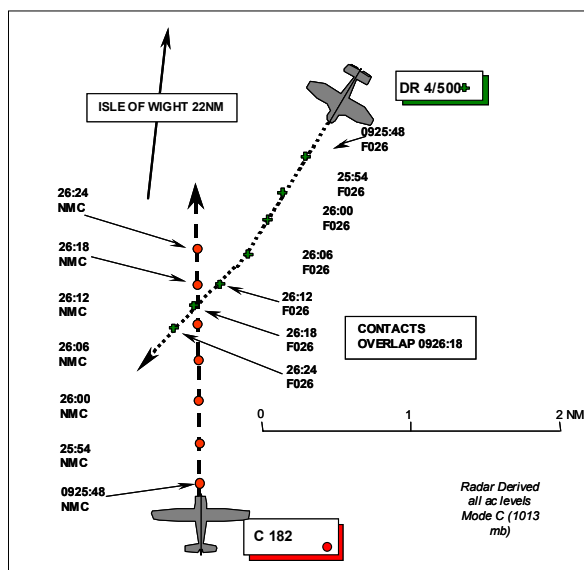
Contacts overlap

Cause: Effective non-sightings by both pilots.

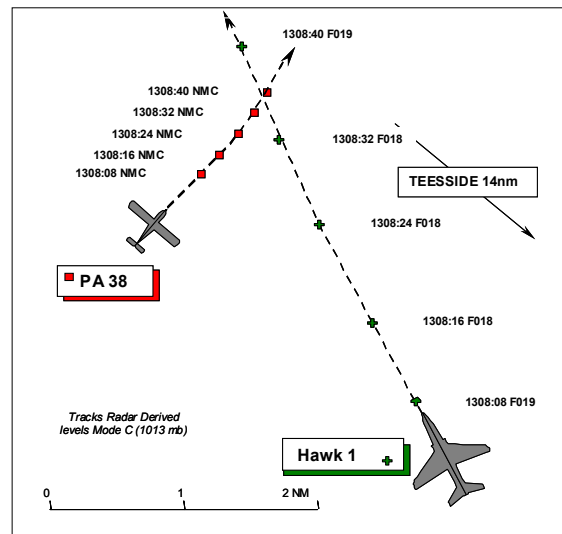
AIRPROX REPORT NO 074/04

Date/Time: 17 May 1308
Position: 5437N 00150W (14 NW Teesside)
Airspace: London FIR (Class: G)
Reporting Ac **Reported Ac**
Type: Hawk PA 38
Operator: HQ STC Civ Club
Alt/FL: 2000ft 2000ft
 (RPS 1018 mb) (Teesside QNH)
Weather VMC CLOC VMC CLBC
Visibility: 8km 10km
Reported Separation:
 30ft V 0 H NR
Recorded Separation:
 Contacts Merge

Cause: Non-sighting by the PA38 pilot and very late sighting by the Hawk pilot.

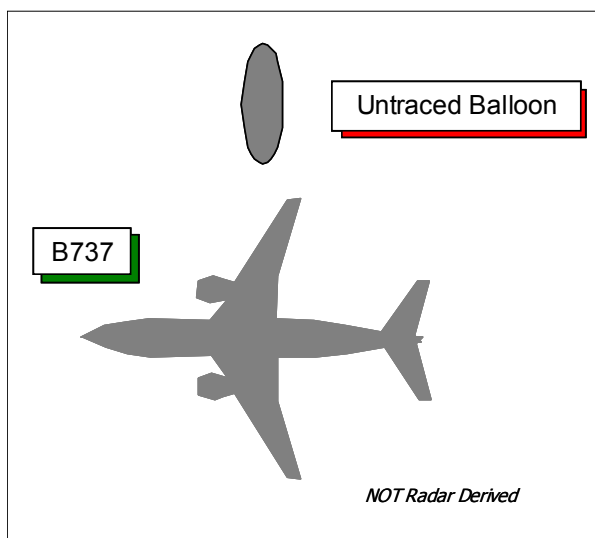
AIRPROX REPORT NO 78/04

Date/Time: 16 May 1242 (Sunday)
Position: 5145N 0045W (HENTON)
Airspace: LTMA (Class: A)
Reporting Ac Reported Ac
Type: B737-700 Balloon
Operator: CAT N/K
Alt/FL: FL52↑ ----
(SAS)
Weather VMC NR ----
Visibility: 30km ----
Reported Separation:
200m H/nil V ----
Recorded Separation:
NR

Cause: Conflict with an untraced balloon.

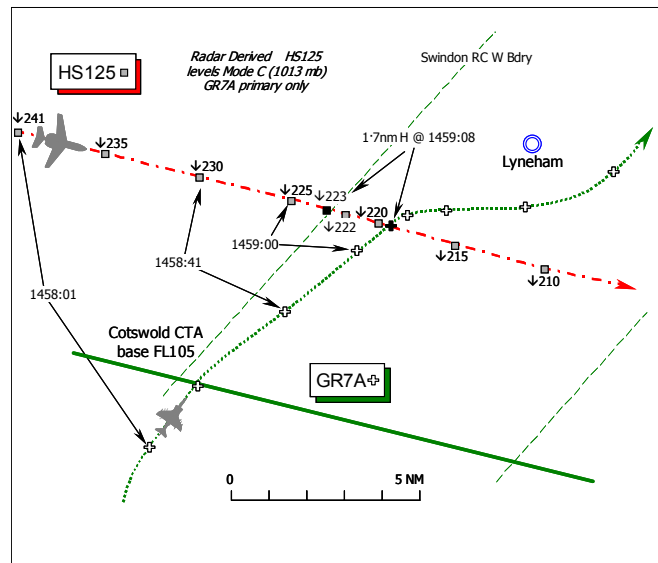
<u>Reported Separation:</u> 300-400m H	nil V/2nm H
---	-------------

<u>Recorded Separation:</u> 1.7nm H
--

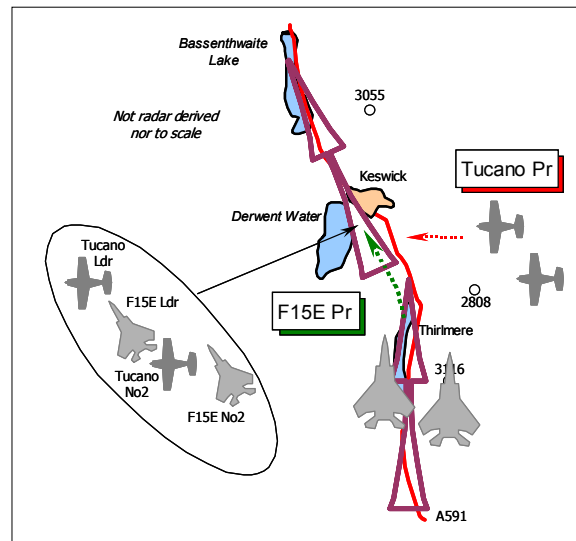
AIRPROX REPORT NO 081/04

Date/Time: 19 May 1254
Position: 5435N 0308W (1nm S of Keswick)
Airspace: UKDLFS - LFA17 (Class: G)
Reported Ac Reporting Ac
Type: F15E x2 Tucano x2
Operator: Foreign Mil HQ PTC
Alt/FL: 500ft 250ft
 Rad Alt msd
Weather VMC CLOC VMC CLOC
Visibility: >7nm 40km
Reported Separation:
 50ft V 100ft H/60ft V
Recorded Separation:
 NR

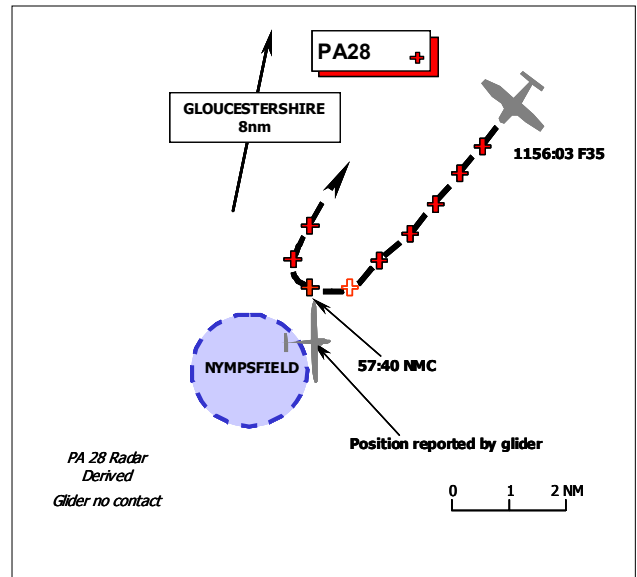
AIRPROX REPORT NO 082/04

Date/Time: 15 May 1157 (Saturday)
Position: 5144N 00215W
 (2nm ENE Nympsfield)
Airspace: London FIR (Class: G)
Reporting Ac Reported Ac
Type: LS4 Glider PA28R
Operator: Civ Club Civ Club
Alt/FL: 2600ft FL30
 (QFE)
Weather VMC CLBC VMC CLBC
Visibility: >5nm 15km
Reported Separation:
 100ft V 0 H NR
Recorded Separation:
 NR

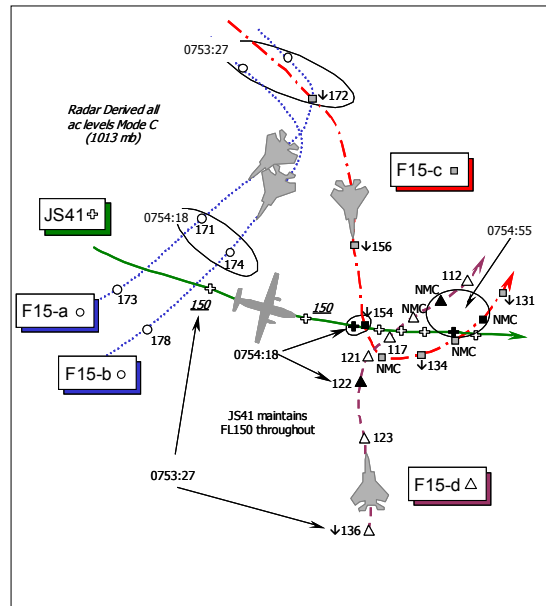
Weather VMC CAVOK VMC NR
Visibility: Unlimited NR
Reported Separation:
 30m H/nil V. F15-d: 2nmH/2000ft
 F15-c: 1nm H/1000ft

Recorded Separation:
 JS41 v F15-c: ¼nm H/400ft↓ @ 0754:18

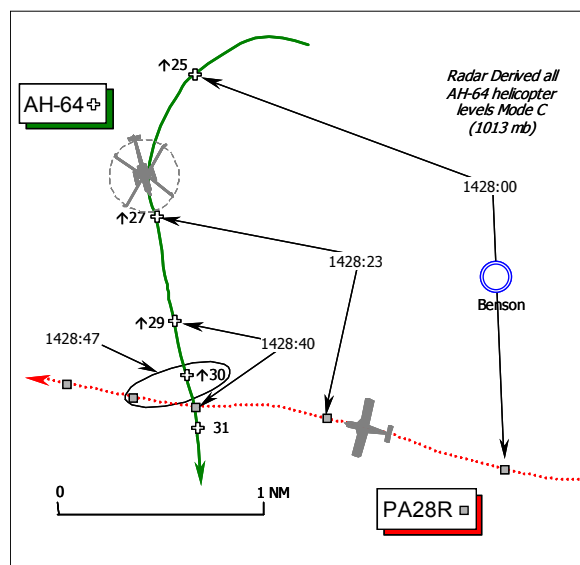
AIRPROX REPORT NO 84/04

Date/Time: 20 May 1427
Position: 5135N 00108W
(1½nm SW of Benson - elev 226ft)
Airspace: MATZ/Oxford AIAA (Class: G)
Reporting Ac Reported Ac
Type: Apache AH Mk1 PA28R
Operator: HQ DAAvn Civ Pte
Alt/FL: 3000ft 32-3300ft amsl
(QNH) (QNH 1016mb)
Weather VMC CLOC VMC NR
Visibility: Good >30nm
Reported Separation:
Nil V/400m H ¼nm H
Recorded Separation:
0.2nm H

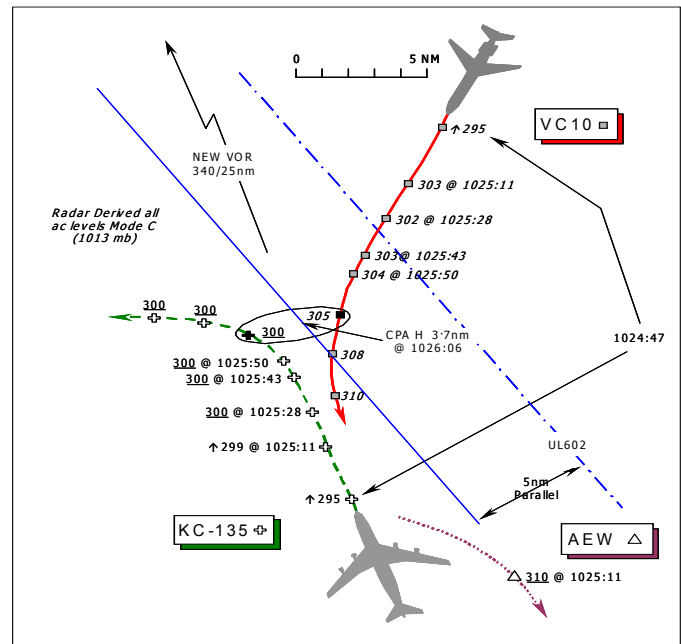
Date/Time: 21 May 1026
Position: 5539N 00128W
 (160° NEW VOR 25nm)
Airspace: UTA/MRSA (Class: B)
Reporter: ScACC MONTROSE SC
First Ac Second Ac
Type: KC-135E VC10
Operator: Foreign Mil HQ STC
Alt/FL: FL300 ↑FL320

Weather IMC VMC CLOC
Visibility: -- >10km
Reported Separation:
MON SC: 3½nmH/500ft V
 200ft H 2nm H
Recorded Separation:
 3·7nm H/400ft V

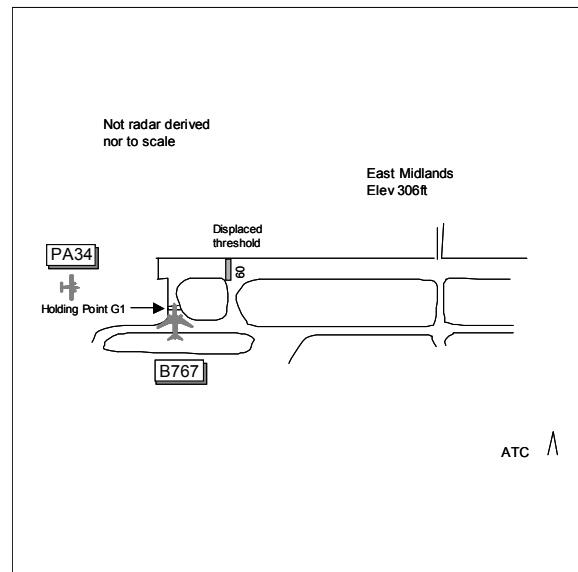
AIRPROX REPORT NO 086/04

Date/Time: 21 May 1407
Position: 5250N 00121W (RW09 Holding Point East Midlands - elev 306ft)
Airspace: ATZ (Class: D)
Reporting Ac Reported Ac
Type: B767-200 PA34
Operator: CAT Civ Trg
Alt/FL: surface 600ft↓
 (agl) (QNH 1025mb)
Weather VMC CLBC VMC CLBC
Visibility: 20km 20km
Reported Separation:
 40ft V >300ft V
Recorded Separation:
 NR

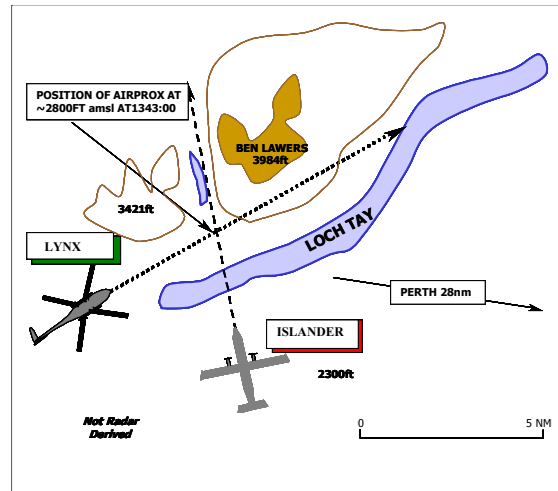
AIRPROX REPORT NO 087/04

Date/Time: 22 May 1347 (Saturday)
Position: 5630N 00415W (N Bank Loch Tay)
Airspace: Scottish FIR (Class: G)
Reporting Ac *Reported Ac*
Type: Lynx Islander
Operator: DAAvn Civ Pte
Alt/FL: 2800ft FL030
 (QNH 1030 mb)
Weather VMC CAVOK VMC CLBC
Visibility: >50nm 20km
Reported Separation:
 300m H 0 V 1-200yd H 0 V
Recorded Separation:
 NR

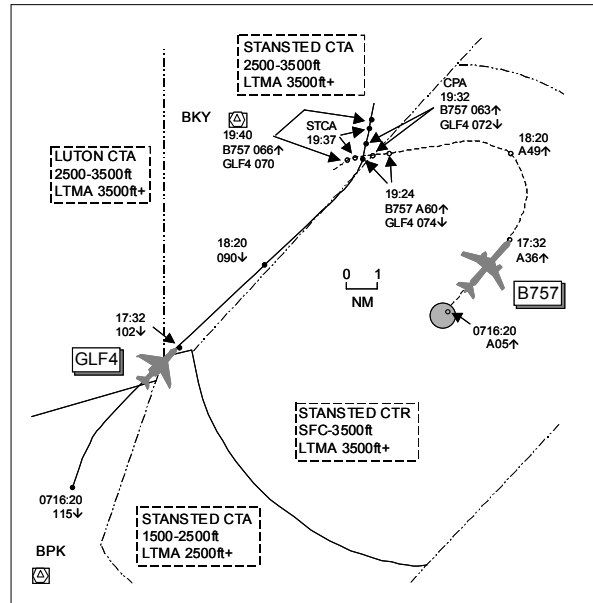
AIRPROX REPORT NO 088/04

Date/Time: 20 May 0719
Position: 5158N 00010E
 (5nm NNW Stansted)
Airspace: LTMA (Class: A)
Reporting Ac Reported Ac
Type: B757-200 GLF4
Operator: CAT Civ Exec
Alt/FL: FL65↑ FL76↓
Weather VMC CLBC VMC NR
Visibility: 60km >10km
Reported Separation:
 400ft V v.close H 1000ft V 0-5nm H
Recorded Separation:
 900ft V 0-4nm H

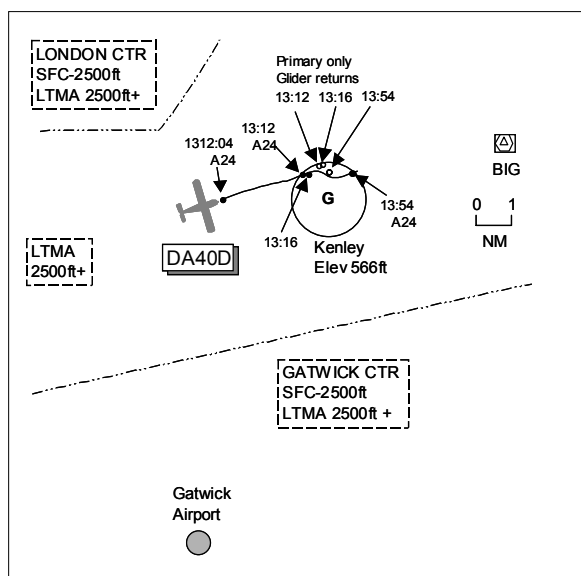
AIRPROX REPORT NO 089/04

THE KA8 GLIDER PILOT reports flying solo from Kenley at 1800ft agl thermalling in a RH orbit over the NW aerodrome boundary of Kenley. The visibility was 50km in SKC VMC and the ac was coloured red/white; no radio was fitted. Turning through E an ac was sighted about 1000m away approaching him from behind tracking E and after turning about, the other ac was seen still to be approaching. The geometry remained unchanged after completing 1 further orbit so he tightened his RH turn to avoid the conflicting ac, a white/blue coloured low wing T tail single engine type. Simultaneously it was seen to execute a RH wing-over to avoid him, passing 50ft below and 100m clear to his L, before it then turned back onto track towards Biggin Hill. He believed that there had been a risk of collision.

Cause: Conflict in the vicinity of a notified gliding site resolved by both crews.

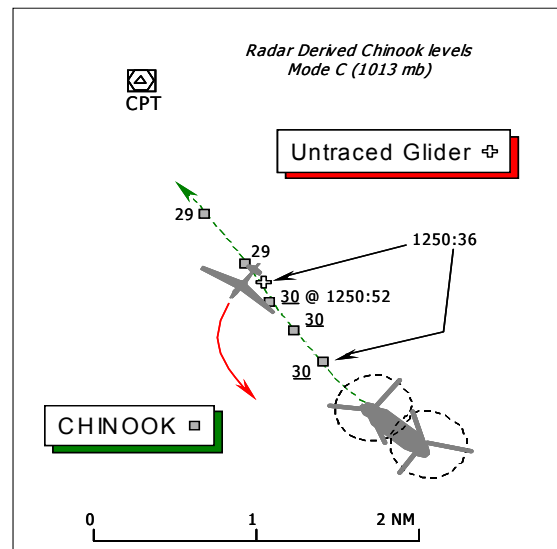
AIRPROX REPORT NO 090/04

THE CHINOOK MK2 PILOT reports that his helicopter has a green camouflage scheme, but the landing lights and HISL were on whilst outbound from Odiham after a SID 2 departure. He was in receipt of a RIS from Odiham APPROACH (APP) on UHF and squawking A4562 with Mode C, but neither TCAS nor any other form of CWS is fitted. Flying in level cruise at 3000ft London QNH (1025mb), the visibility was >10km in haze 'down sun', but reduced 'into sun' whilst operating some 1000ft below scattered/broken Cu with a base of about 4000ft.

This incident occurred in one of the worst hotspots for high VFR traffic density: the Compton VOR. In the conditions on this day, a glider would have been very difficult to spot until quite close. Similar problems occur in the western instrument approach lane, which is just N of Lasham Gliding Centre. Whilst this Airprox will remind aircrew of the importance of good lookout when under a RIS in a high-density area, could more be done by the glider pilots to look out for and keep clear of military ac? Additionally, more could be done to assist controllers in identifying glider returns; glider pilots have apparently resisted pressure to incorporate SSR equipment in their sailplanes on the grounds of cost and weight. But would the extra margin of safety that would be afforded, justify a call for gliders and other light ac in the busy skies over southeastern England to be fitted with SSR equipment as a mandatory requirement.

Cause: Conflict in Class G airspace with an untraced glider.

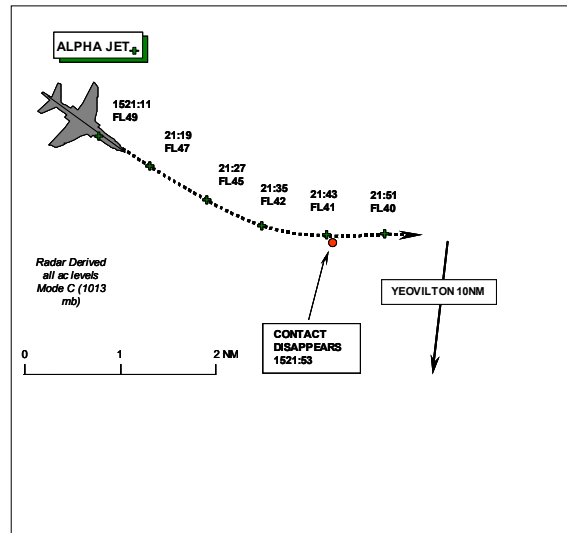
AIRPROX REPORT NO 091/04

THE ALPHA JET PILOT reports recovering to Boscombe Down from a local training sortie flying a camouflage ac squawking as directed and in receipt of a SSR-only RIS from Boscombe APR. While heading 120° at 300kts and at FL50, a stranger was called in their 12 o'clock. They turned to 090° and started searching for the stranger, descending to FL40 to maintain clear of cloud. Subsequently a white 2-seat glider was seen in his 12 o'clock 3/4nm away below the cloud and a slight turn away to avoid it was initiated. They thought that the glider was not the original stranger reported by APR and the turn onto 090° precipitated by the stranger call had turned them directly at the glider. He assessed the risk of collision as being high.

Boscombe APR did well in signalling traffic so the Alpha Jet crew who were already looking for of another ac or glider. However, if only some of the returns are displayed, then it can cause additional risk if avoiding action ends up causing a conflict with those that are not displayed. On soaring days such as this, there will be high concentration of gliders soaring or carrying out cross-countries together, so a single return may actually indicate the presence of several.

The glider pilots would have had little chance of seeing an Alpha Jet in poorish visibility at 300kts and without the benefit of any warning. Unfortunately it is unlikely that this situation can be improved until battery powered transponders become available but in the meantime it is worth reminding pilots to try and adjust their recoveries in thermal conditions to minimise the risk.

Cause: Presumed non-sighting by the glider pilot and late sighting by the Alpha Jet pilots.

HQ DPA comments that as observed in the Station Comments work is apace to remove the practise of SSR only operations at Boscombe Down which, as this Airprox as demonstrates, are not ideal. Undoubtedly, the good lookout and correct avoiding action by the Alpha Jet crew prevented this occurrence from being potentially far more serious.
