UK AIRPROX BOARD

Analysis of Airprox in UK Airspace

Report Number 12
January 2004 - June 2004

Twelfth Report by the UK Airprox Board:

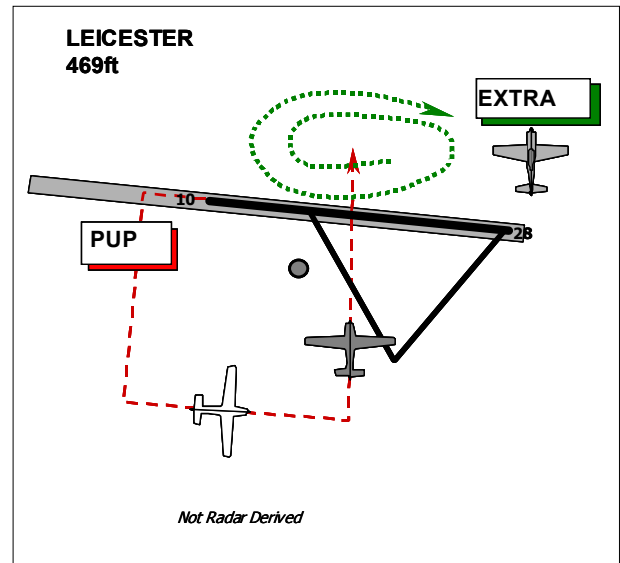
AIRPROX REPORT NO 092/04

THE BEAGLE B121 PUP PILOT reports flying a blue and white ac with no strobes or SSR fitted on a local flight from Leicester and in receipt of an A/G service from them. He took off from RW28 and climbed out to 700ft at 85kt and then turned onto a heading of 190°, continuing his climb to 1000ft. He made a radio call to A/G “climbing to overhead” and continued his climb. When he was in a position flying N back to the centre of the R/W he saw an ac at 3nm ahead of him on the dead-side of RW28 performing aerobatics. As he continued inbound the ac (an Extra) descended towards him and went out of his vision. While he still had RW28 in sight ahead of him the Extra came upwards in front of him appearing as big as his own ac. He then entered turbulence and his ac rocked considerably. He lost sight of the Extra as it climbed above him and he was concerned that it may be doing a second loop so he turned immediately to the W towards the city as he thought this would be the safest place to go. The Extra was doing an aerobatic display revalidation that was being observed from the ground. He assessed the risk as being high.

The Board unanimously considered however, that the prime responsibility for the incident lay with the Beagle Pup pilot. Members found it almost incomprehensible that, having seen the Extra performing its aerobatic sequence from some distance, he continued to fly towards it. By continuing to fly into conflict he displayed poor airmanship and bad judgement, putting both pilots and observers on the ground at some risk. At the precise moment that the 2 ac were at their closest, neither pilot was in sight of the other ac and it was therefore only by good fortune that they had not collided.

Cause: Having seen aerobatics in progress, the Beagle Pup pilot flew into conflict with the Extra 260.

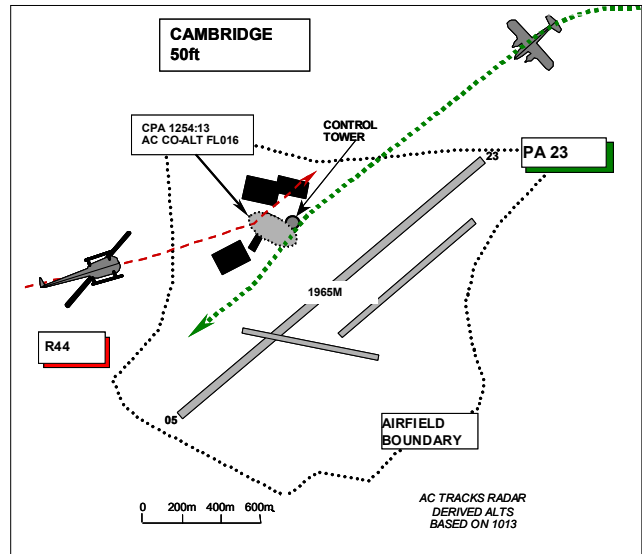
AIRPROX REPORT NO 093/04

THE R44 PILOT reports flying a white and blue ac from Milton Keynes to a private site near Mildenhall in receipt of a FIS from Cambridge and squawking 7000 with Mode C. He was heading 065° towards Cambridge Airport at 95kt and 1500ft on the QFE and asked Cambridge APP if he would like him to go over or around the airfield. Initially APP asked them to go to the N but shortly after changed this and cleared them through the Zone, overhead the threshold of RW23 at 1500ft (it may have been 1400 but whatever APP told him was the exact height that he flew – the report was written a week later). He saw a light coloured twin engined ac about 500m ahead climbing towards him from his 11o'clock. He turned to the left as soon as he saw it and was able to read the last two letters of the ac registration. The other ac had apparently been cleared for a “low approach go around”. He reported the Airprox to Cambridge APP.

Members familiar with the area were surprised at the planned routing of the R44 and suggested that it would have been wiser for a single engined helicopter to avoid the town, the hospital and the airfield by a substantial margin. Accepting the routeing however, the pilot’s actions had been proper and he had reacted appropriately to the instructions passed to him by APP. He therefore, had not contributed to the cause of incident.

Cause: Cambridge APP directed the R44 into conflict with the PA23.

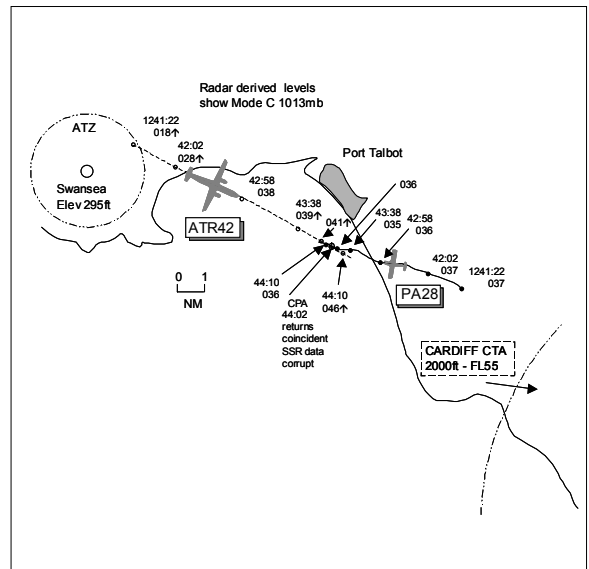
AIRPROX REPORT NO 94/04

THE ATR42 PILOT reports departing from Swansea on track to CDF NDB (120°) at 220kt and climbing to 4000ft QNH 1022mb. The Capt, PNF, had relayed information between Swansea ATC and a rescue helicopter inbound low-level to a hospital which had delayed their handover to Cardiff Radar when levelling-off at 4000ft. During his initial call to Cardiff, a TCAS TA alert was received on traffic in his 12 o'clock indicating -200ft which was followed almost immediately by a TCAS RA 'climb'. He interrupted his transmission to ATC, calling 'TCAS climb', and followed the TCAS guidance. During this manoeuvre the conflicting traffic was not acquired visually. Climbing through 4700ft, 'clear of traffic' was annunciated and he informed ATC that he was "...descending to 4000ft". The controller told him to "maintain altitude, do not descend, further traffic". He maintained 5000ft, he thought, and was formally radar identified and subsequently carried out an uneventful landing on RW12 at Cardiff.

Members could not understand the Cardiff R2's 'rationale' in instructing the PA28 to squawk 7000 'on standby' when he transferred the flight to Swansea. Thankfully the PA28 pilot ignored the instruction and switched his transponder on with 7000 and Mode C selected. The recommended guidance is to squawk 7000 with Mode C unless receiving an ATS from a unit, which requires a different setting, or when circumstances require the use of a Special Purposes Code or other specific conspicuity code.

Cause: Conflict in Class G resolved by the ATR42 crew.

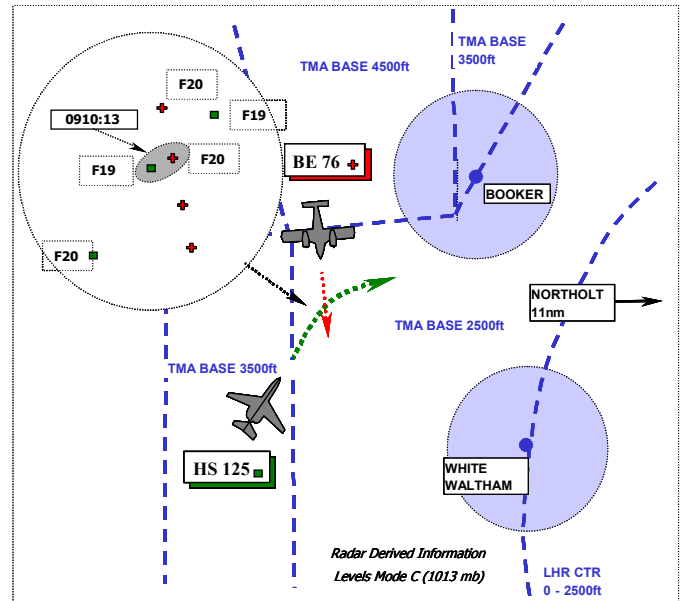
AIRPROX REPORT NO 095/04

THE BA 125-800 PILOT reports flying a white and silver ac with strobes and taxi lights selected on, on a positioning flight from Farnborough to Northolt, radar to radar, initially at 2400ft and 230kt on the London QNH. Headings were given by ATC to avoid the LONDON CTR. They were handed to Northolt radar at WOD and told to maintain 2400ft and a heading of 030°. At 2400ft they were IMC in cumulus cloud. Northolt [Director] reported a contact at 11 o'clock at a 'similar' altitude. Northolt Dir then instructed them to turn right onto 080° and descend to 2000ft QNH. At 2000ft they had good forward visibility and almost immediately saw a Kingair pass through their 12 o'clock, level or slightly descending, at a distance which they initially reported as 'a quarter of a mile' but which, on reflection was considerably less, perhaps 250yd and both ac were at exactly the same altitude. They reported to Northolt that they would be filing an Airprox. He was not able to take any avoiding action and assessed the risk of collision as being high.

CAA General Aviation Department comments that they believe that the HS125 pilot made an error when choosing to accept a RIS while flying in and out of IMC conditions outside of Controlled Airspace (CAS). The HS125 pilot should have requested a Radar Advisory Service or chosen a level to maintain VMC or requested a Radar Control Service within CAS.

Cause: Effective non-sighting by the BE76 pilot and a very late sighting the HS125 pilot.

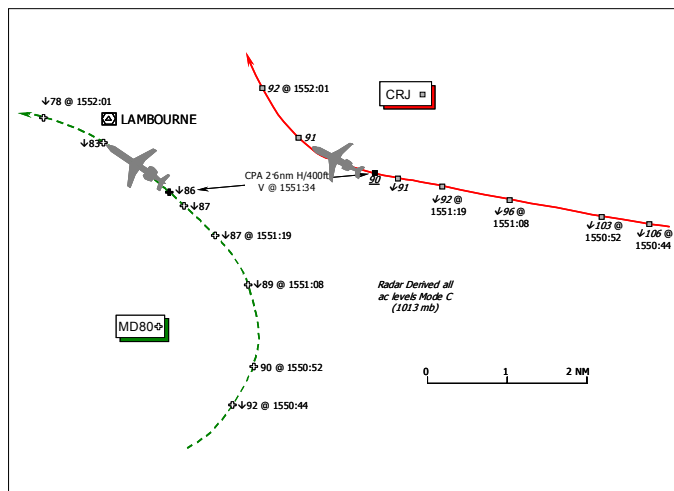
THE MD80 PILOT reports he was holding at LAMBOURNE (LAM) in IMC descending to FL80 whilst inbound to Heathrow. ATC instructed them to turn L to LAM, then after passing LAM fly heading 275° at 220kt, whereupon TCAS gave them an “advisory” at the 2 o’clock position in the inner circle of the VSI, shown at 600ft in descent. The controller gave an instruction first to the CRJ, telling the crew to stop descent immediately and to turn. Thereafter ATC told him to descend rapidly to FL70 and turn left onto 260°. Speedbrakes and the vertical speed were set to 2000ft/min and the instructions complied with. He assessed the minimum vertical separation as 300ft at 1-3nm, but did not give an assessment of the risk.

STCA activated against the MD80 below the CRJ at 1550:53. By 1551:08, the MD80 was descending through FL89 for FL80 and in a L turn back towards the LAM VOR in accordance with ATC instructions, with the CRJ having passed FL100 and descending through FL96. INT DIR observed the Mode C of the CRJ and instructed the crew to stop their descent, whereupon the controller requested confirmation of the flight's cleared flight level insofar as the crew understood it. The CRJ crew replied "*[C/S] flight level 60*". INT DIR repeated the instruction to the CRJ at 1551:20, "*negative stop descent now turn right heading 340*" for avoiding action. The crew acknowledged, "*heading 340 stopping descent now [C/S]*". Whereupon the INT DIR added traffic information on the MD80 below and ahead at 1551:30, "*that's avoiding action there's traffic in your 12 o'clock range 2 miles turning left west ahead of you*". Whence the CRJ crew reported level at "*90 for [C/S]*" just after 1551:30. The crew of CRJ have subsequently reported that they were IMC.

Cause: The CRJ crew descended below their assigned level into conflict with the MD80.

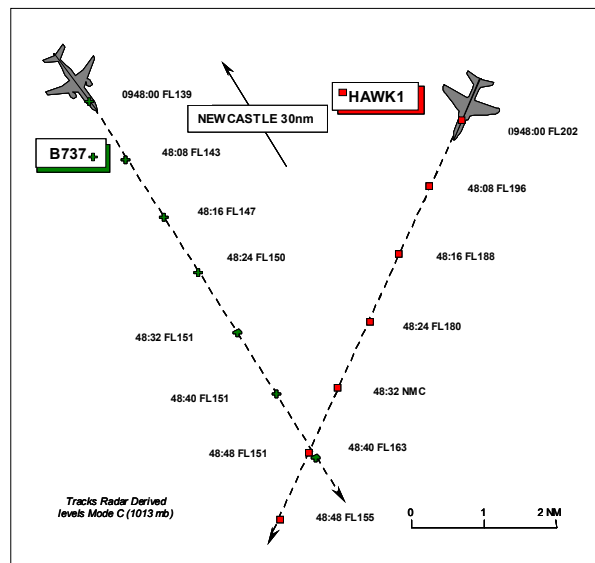
THE B737 PILOT reports flying a scheduled passenger service from Newcastle to Amsterdam in receipt of an ATS from Newcastle and squawking as directed with Mode C. He was passing FL140 in the climb to FL200 heading 150° at 310kt when he received a sudden TA and, seconds later, an RA with an “Adjust V/S” followed by “descend”. Two fighters were observed rapidly descending from FL200 through their level. He estimated the vertical separation as being nil and the horizontal separation as being approx ¼nm in their 2 o’clock position. The pilot informed ATC who had no contact with the fighters.

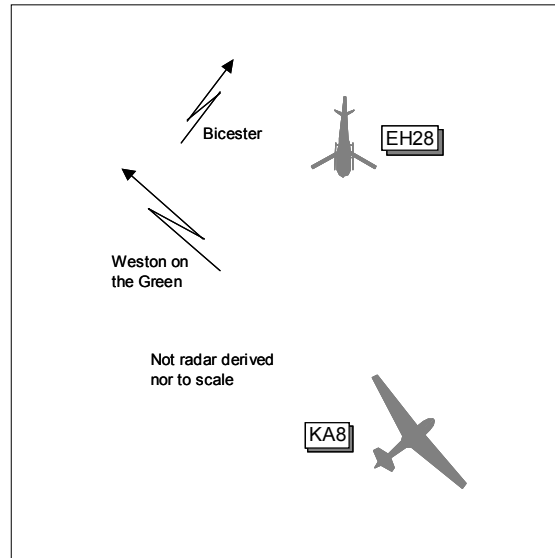
AIRPROX REPORT NO 101/04

THE KA8 GLIDER PILOT reports flying solo on a local sortie from Weston on the Green (WOTG) and in communication with Launch Control on the Glider Common frequency 130.1MHz. The glider fuselage was coloured red with white wings and red tips. He had planned his cct to land in between 2 stationary gliders, 1 parked at the launch point and the other about 150m away on the NE section of the airfield; the landing direction was NW'ly. The incident occurred when he was about 400m SE of the airfield boundary, about to carry out his final turn from base leg heading 045° at 55kt and 350-400ft agl. He saw a helicopter in his 11 o'clock position range 600ft, slightly below, heading in a southerly direction between him and the airfield. He aborted his final turn and continued on base leg until clear of the recently landed, stationary glider to give himself enough clear airfield to land in. The helicopter passed about 300-400ft horizontally clear to his L at about 300ft agl, 100ft below. He assessed the risk as high if he had not aborted his final turn but this encounter had increased his workload owing to him having to reassess his options on the landing area.

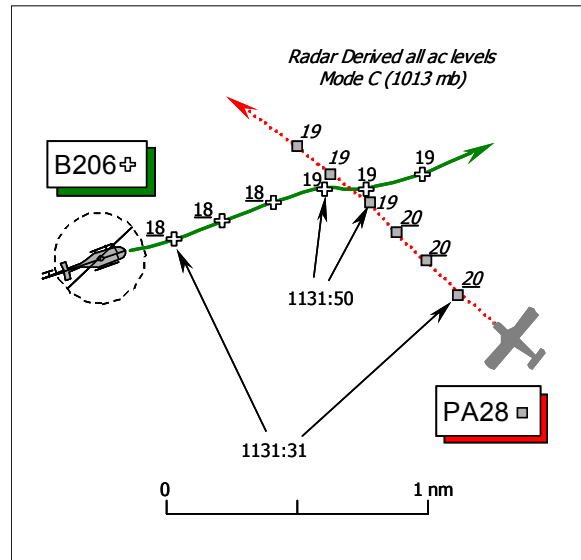
AIRPROX REPORT NO 102/04

THE JET RANGER B-206 PILOT reports his helicopter has a black/silver livery and the HISL & 'pulse-lights' were on whilst in transit from Droitwich Heliport to Norwich. Flying in level cruise at 2000ft RPS (1017mb), he was about 500ft below cloud with an in-flight visibility of >10nm. The helicopter is fitted with a Skywatch ACAS I.

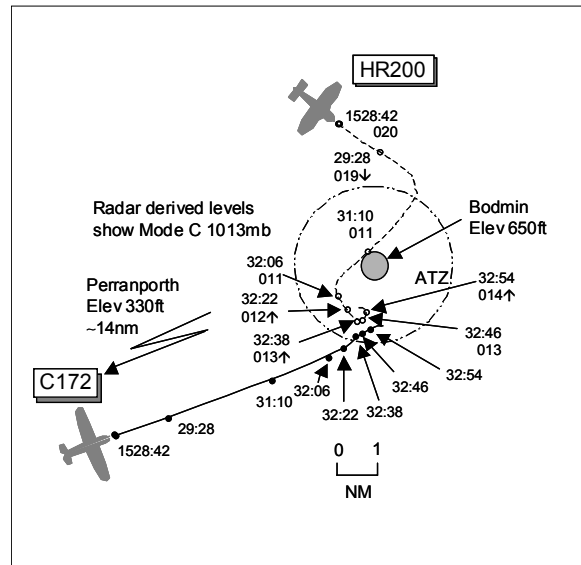
AIRPROX REPORT NO 103/04

THE HR200 PILOT reports flying solo on a local sortie from Bodmin and in communication with Bodmin RADIO on 122.7MHz squawking 7000 with Mode C. The visibility was >20km in clear sky VMC and the ac was coloured blue/white with strobe and landing lights switched on. He had entered the LH cct for RW31 via the 'deadside', making position reports on the Bodmin frequency. He started to turn L from downwind heading 130° onto base leg at 90kt and 800ft QFE when suddenly a white coloured C172 appeared from under his starboard wing in his 2.30 position <100yd away and about 75ft lower descending; it was entering the cct straight onto base leg on a crossing track R to L. He immediately applied power and initiated a climbing turn to avoid the Cessna and transmitted an appropriate warning on the radio. He vacated the cct to compose himself before returning to land. The Cessna passed about 70yd away tracking about 060°, he could see the last 3 letters of the Cessna's registration. After landing he spoke to the Airfield Manager who gave him the C172's full registration. He assessed the risk of collision as high.

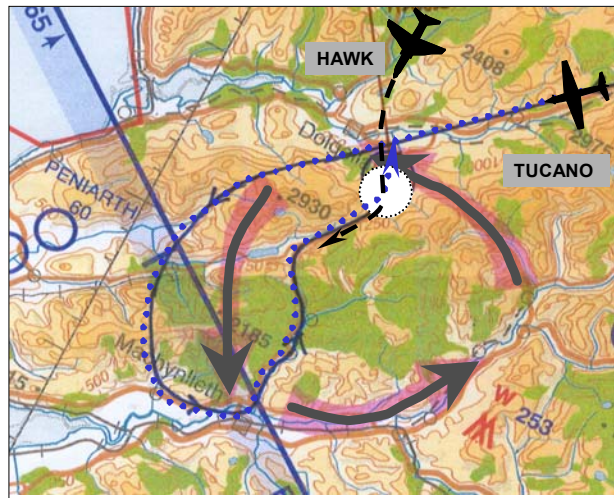
AIRPROX REPORT NO 104/04

THE HAWK T1 PILOT reports he was the rear seat QFI captain of a black Hawk ac on a low level Staff Continuing Training (SCT) sortie. Shortly after entering the Machynlleth Loop from the N entrance he rolled out heading 200° at 250ft agl and 450kt IAS. As he passed through the tight valley and as the terrain opened slightly, he saw the landing lights of a Tucano at approximately 1½ -2nm, heading NE against the SW flow. The Tucano was also at about 250ft agl but appeared beneath him because the valley floor descends. He pulled up sharply and passed 300ft overhead and then went into a climbing left hand turn to get out of the LFS and to remain tally. The Tucano continued on heading 020° approximately and then turned left toward Dolgellau.

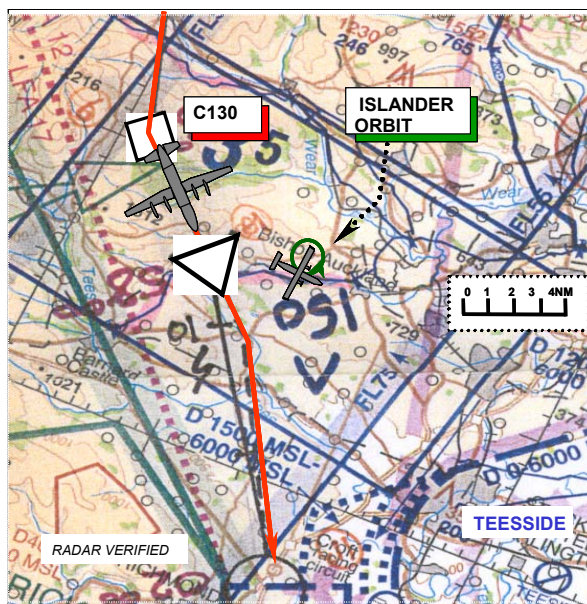
AIRPROX REPORT NO 105/04

THE BN2B ISLANDER PILOT reports flying a police air operations flight that involved a thermal image search of an area, with HISL, the tail beacon and the nav lights selected on and in receipt of a FIS from Teesside Radar while squawking as directed with Mode C. While passing heading 090° in an orbit at 80kt and at 2000ft amsl on the Teesside QNH, they were advised of a contact 5nm N of them tracking N to S at 200ft below their height. One minute later they were advised that the contact had not deviated and was then 1nm N of their position on a direct track towards them. [see transcript below] He initiated an immediate climb and rolled out onto an E'ly heading and after levelling his wings he looked left and saw a C130 with his lights out pass through their port rear quarter about 500m away flying straight and level but slightly below them.

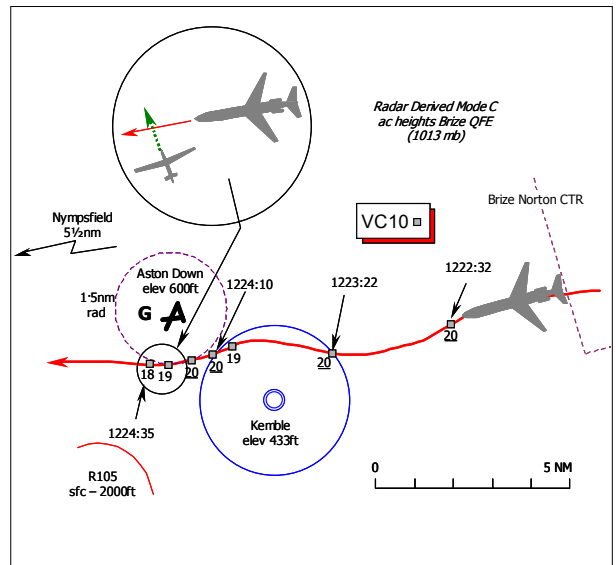
AIRPROX REPORT NO 106/04

THE ASW15 GLIDER PILOT reports his glider is coloured white overall. He was conducting general handling at an altitude of 2500ft just to the S of the Aston Down glider site boundary, and there were several other gliders from Aston Down and Nympsfield operating in the local area, soaring at all altitudes up to the cloud base of about 3500ft amsl. At the time of the Airprox he was flying straight and level heading 350° at 40kt just after straightening out from a circling L turn, with another glider 3-400ft above him and some 1000ft below cloud with an in-flight visibility of 20nm. Whereupon a greyish VC10 was spotted at 2 o'clock, some 500yd away, approaching obliquely from R – L. The jet passed about 200ft directly below his glider with a “considerable” risk of a collision, but no avoiding action was taken as he opined there was no point. He added that the VC10 flew close to both glider sites at some 15-1700ft agl.

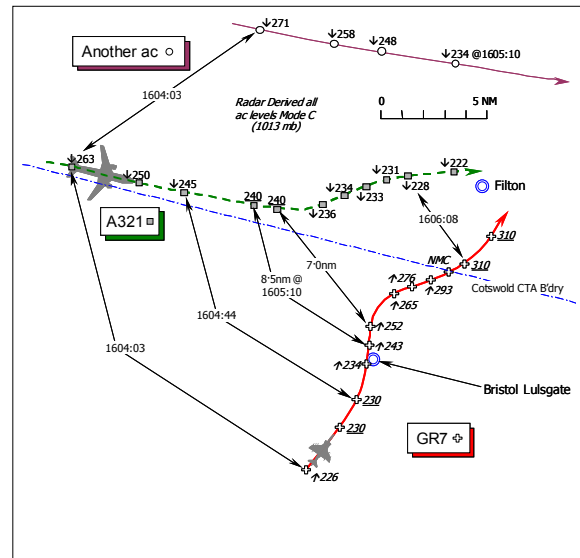
THE A321 PILOT, the PF, reports that he was inbound to London Heathrow and in receipt of an ATC service from LACC Swanwick whilst descending to FL240 at 300kt, when ATC called and instructed them to take immediate avoiding action. The controller advised them to turn L from their radar heading of 105° onto 060°. At the same time TCAS enunciated a TA "TRAFFIC TRAFFIC" and an ac appeared on TCAS, whereupon traffic information was given by ATC about a Harrier jet closing from the 2 o'clock position. When steady 060° the Harrier still appeared to be closing toward them "quickly" at a similar level, so although no RA was enunciated he elected to disconnect the autopilot and initiated a gentle descent down to FL236 to give separation as TCAS showed the airspace ahead and below was clear. The other ac was not acquired visually at all, but he assessed from TCAS that the Harrier had passed about 3nm away some 200ft above his ac. He reported that he would be filing an Airprox to ATC on RT and confirmed this by telephone later with the LACC SUPERVISOR.

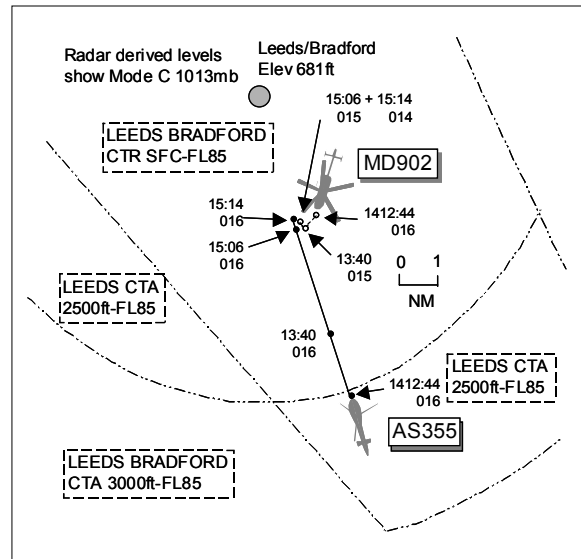
AIRPROX REPORT NO 108/04

THE MD902 PILOT reports heading 310° stationary in a hover at 1300ft QNH 1016mb 3nm SSE of Leeds/Bradford and in receipt of a FIS from Leeds/Bradford APPROACH on 123.75MHz squawking a discrete code with Mode C. The visibility was 30km 2700ft below cloud in VMC and helicopter was coloured white/blue with nav, anti-collision and strobe lights all switched on. ATC told him of helicopter traffic transiting to them from the S which was duly noted on TCAS. His focus of attention was out of the cockpit down to the starboard side. After an unknown length of time TCAS gave an alert and, upon looking in, the display indicated the other ac close to his port side. Upon looking L across the cockpit he saw a helicopter flying straight and level emerge from behind and slightly above (50ft) the front L door crossing L to R about 100m away. He did not manoeuvre but transmitted *"too close, too close"* on the approach frequency. The rear R observer saw a shadow passing the rear L door and looked up to see the helicopter continuing over the head of the front L observer who noted the type and colour (AS355 coloured blue/white). He assessed the risk as high.

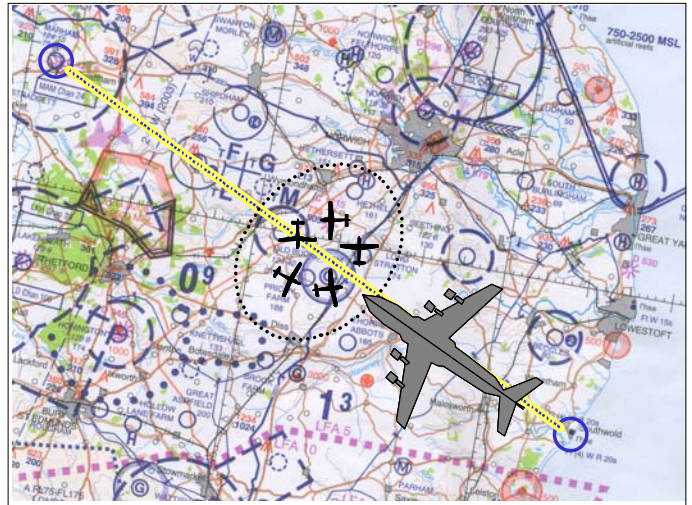
THE C17 PILOT reports that he was leader of a formation of 11 ac, operating as 5 elements with 2nm spacing, heading 300° at 280kt at 2000ft on a route leading to a timed formation flypast at RAF Waddington. Four gliders, he thought, were operating from Old Buckenham airfield, were spotted on the nose at a distance of 1nm and due to the size of the formation, they were unable to take avoiding action. The gliders flew right through all the elements of the formation.

Cause: A conflict in the vicinity of a notified gliding site which was on the route notified for a very large formation.

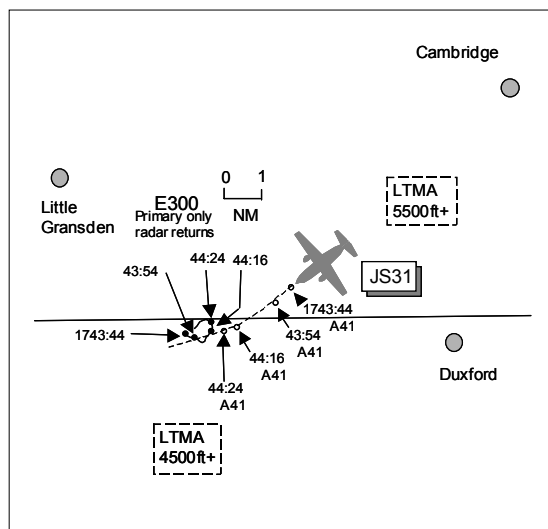
AIRPROX REPORT NO 110/04

THE JS31 PILOT reports outbound from Cambridge IFR climbing to 4000ft QNH 1016mb at 160kt and in receipt of a RIS from Stansted DIRECTOR on 126.95MHZ squawking 5030 with Mode C. During initial climb out on Cambridge RW heading 233° at 7nm, he was advised of pop-up traffic ahead at 0.5nm which was seen as low wing monoplane, possibly a YAK51, coloured white/red. On initial contact it was climbing and manoeuvring but then levelled at the same altitude and carried out aerobatic flick manoeuvres whilst it moved to their R, passing <0.5nm away flying in the opposite direction; it appeared that the other pilot was unaware of their presence. Next it was seen to manoeuvre to their R, back to their 4 o'clock position, apparently taking a look before peeling backwards and descending. He had not carried out avoiding action, keeping course whilst evaluating in which direction the other ac would manoeuvre next. He had been concerned that if they had manoeuvred it may have resulted in further conflict if he had become unsighted. Luckily the final manoeuvre taken by its pilot had taken it away from their flight path, which is when he thought that their ac had been sighted. He assessed the risk as very high.

Cause: Late sighting by the JS31 crew and probable non-sighting by the E300 pilot.

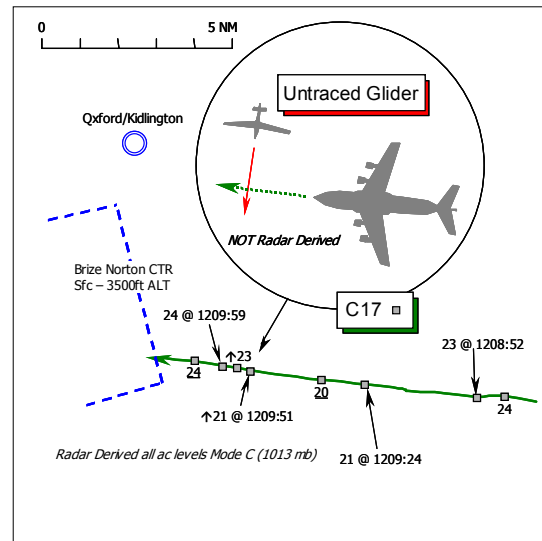
AIRPROX REPORT NO 111/04

THE C17 GLOBEMASTER PILOT reports that he was flying inbound to Brize Norton some 2000ft clear below cloud in VMC for a single ac recovery after participating in a formation flypast over London. He was in receipt of a RIS from Brize Norton on 133.75MHz and squawking A7040 with Mode C; TCAS is fitted but neither an RA nor TA was enunciated during the period of the Airprox. The ac has a grey camouflage scheme, but the HISLs were on.

Cause: Conflict with an untraced glider, resolved by the C17 crew.

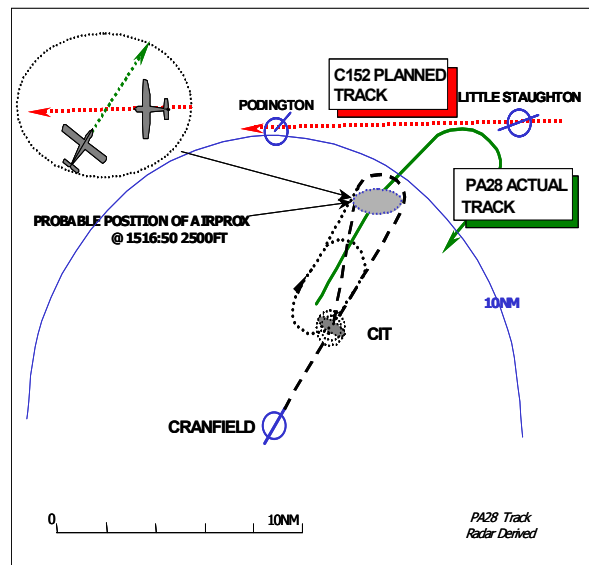
AIRPROX REPORT NO 113/04

THE PA28 PILOT reports flying a white ac with red and blue stripes with nav lights, beacon and landing lights selected on, on an IFR flight from Teesside to Cranfield. He was intermittently IMC in rain showers and was squawking 7017 [at the time Cranfield Conspicuity] with Mode C and was in receipt of an Approach Control Service from Cranfield APP. While heading 035° at 130kt and having just levelled at 2500ft 1min 30sec outbound on the ILS procedure for RW22, [the pilot reported his position as commencing the base turn on the RT] he saw a white C152 with blue stripes crossing from R to L, just above him at a slant range of approximately 30ft and on a track of 260°. [He was able to read the ac registration]. The ac transited the published IAP, he thought, which is clearly marked on ½mil GA charts with a chevron, without contacting the controlling ATSU. He immediately dived his ac and applied right bank and assessed the risk of collision as being imminent/high.

Cause: Non-sighting by the C152 pilot and very late sighting by the PA28 pilot.

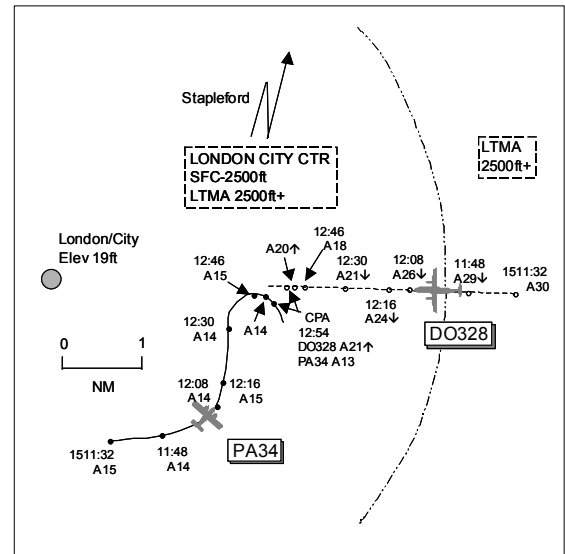
AIRPROX REPORT NO 114/04

THE Do328 PILOT reports established on the ILS at London/City descending from 3000ft QNH 1016mb heading 270° at 160kt and in receipt of an ATS from City TOWER on 118.07MHz squawking 5110 with Mode C. Approaching 2000ft a TCAS contact was observed in his 11 o'clock range 2nm. No warnings were received at this stage and the other ac, a white coloured PA34, was visually acquired at about 1500ft in level flight and in a R turn towards him on a reciprocal heading which he assessed to be on a collision course: he immediately initiated a go-around. By now, his altitude was 1750ft and separation had reduced to 1nm and TCAS indicated -200ft, during which an amber TA alert illuminated followed immediately by a red RA with aural "monitor vertical speed". Shortly afterwards a "climb" command was announced and the PA34 passed immediately underneath his ac, still in a R turn, with a very high risk of collision. He commented the TCAS RA had occurred very late, after his 'avoiding action' go-around had been taken.

Cause: The PA34 pilot did not comply with the ATC instruction and flew into conflict with the Do328.

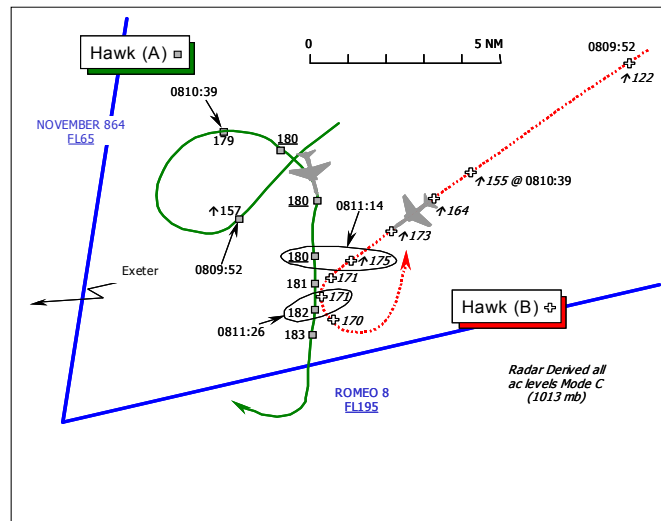
THE PILOT OF HAWK (A) reports his ac has a black colour scheme and the HISLs were on whilst outbound from Yeovilton for a sortie in the Plymouth Exercise Areas (EXAS). Neither TCAS nor any other form of CWS is fitted. His intended departure details had been passed to ATC on GROUND and encompassed a L turn after take-off onto a heading of 240° and climb to FL180, prior to a radar handover to PLYMOUTH MIL to commence his exercise. After take-off from RW27 at 0805, as planned, he departed under a RIS from Yeovilton APPROACH (APP) and levelled at FL180 in VMC some 10000ft clear of cloud and in unlimited visibility. Approximately 2nm NE of the boundary of N864, still SW bound, he was instructed to “contact” PLYMOUTH MILITARY. To stay outside of controlled airspace he immediately entered a right hand orbit at 350kt, maintaining FL180, before he contacted PLYMOUTH MIL and informed them of his intentions. Whilst turning R through S, another Hawk was spotted briefly ½nm away at the apex of a bunt as the pilot of the other ac - Hawk (B) - took avoiding action. Because of the “late spot” he was unable to take any avoiding action himself. The other Hawk passed ¼nm away some 400ft below his ac with an “actual” risk of a collision. He added that the late handover to PLYMOUTH MIL from APP without any clearance to cross CAS were all contributory factors.

Cause: Conflict in the FIR resolved by the pilot of Hawk (B).

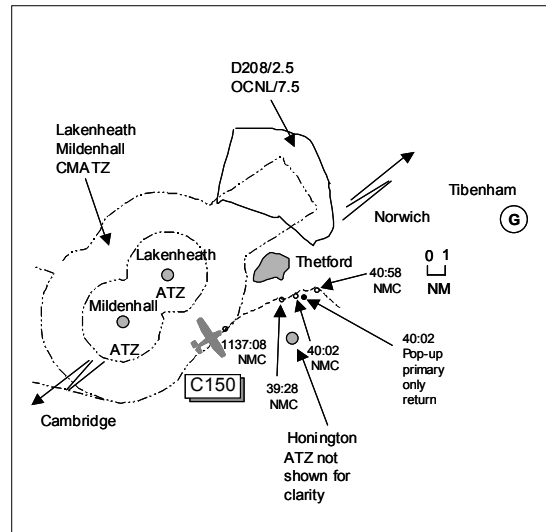
AIRPROX REPORT NO 116/04

THE C150 PILOT reports en route to Norwich heading 060° at 100kt and in receipt of a FIS from Lakenheath APPROACH on 128.9MHz squawking 0451 NMC. The visibility was 25km, 500-700ft below cloud in VMC and the ac was coloured red/white and blue. He had free-called Lakenheath passing Newmarket and was assigned a transponder code and given clearance to transit the MATZ, remaining clear of the Mildenhall and Lakenheath ATZs. Cruising at 2500ft QNH 1024mb the controller was very good and gave information on traffic in the area despite only requesting a FIS. About 3nm S of Thetford he spotted a glider 100m away just to his L, flying in the opposite direction and slightly above his level but descending, appearing as if it had descended from cloud or from behind a cloud. It was possible that he had not seen it earlier owing to its small profile and colour allowing it to blend into the cloud background. He pointed this glider out to his colleague, another instructor, as he turned R to avoid it, passing close enough to see that it was dumping water ballast. As the glider disappeared from view just above his LH wing, both he and his colleague became aware of multiple gliders head-on to them at various altitudes, just above and below. Over the next 15sec, he had to turn either way and at first climb then descend to remain clear of individual gliders, 2 of which passed within 50ft of them, 1 slightly L and below and the other slightly R and above, both once again dumping ballast. They were again difficult to spot because of their small frontal area and he believed he would have seen them earlier if he had not concentrated so much on the first glider. Despite the fact that they must have seen his ac, not one glider made any attempt at evasive manoeuvring, that he could detect, with all remaining on a steady reciprocal headings. It appeared that they were racing and were relying on him to avoid them. Once the gliders had cleared away, he reported their presence to Lakenheath.

Cause: Conflict in the FIR with multiple gliders.

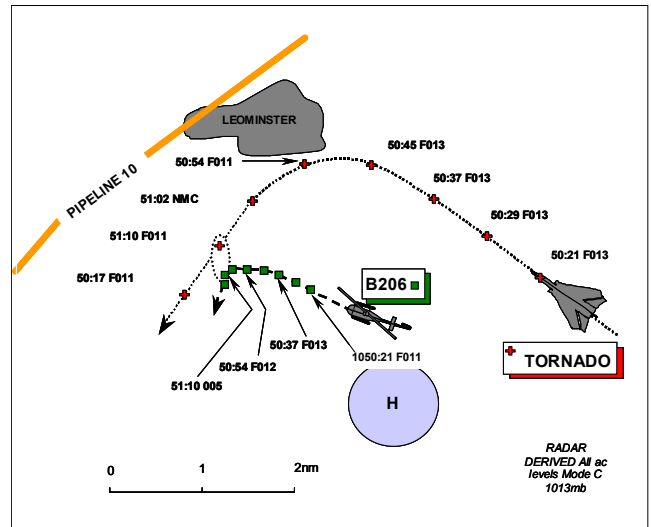
AIRPROX REPORT NO 117/04

THE B206 PILOT reports flying a black and silver ac with HISLs and nav lights selected on squawking 7000 with Mode C in receipt of an FIS from Shobdon, on a pipeline inspection in an area notified under the PINS system. He was heading 275° at 100kt and 500ft agl in reduced visibility (estimated 5km) in a rain shower when he received several non-audio TCAS indications from the area of Shobdon followed an audio TCAS warning. He then saw a Tornado in his 5 o'clock position at the same altitude in a level left turn towards his ac. He initiated a rapid descent to his left and the Tornado passed overhead and slightly to his starboard side. He assessed the risk of collision as being high.

Cause: Conflict in the FIR resolved by the B206 pilot following an ACAS warning.

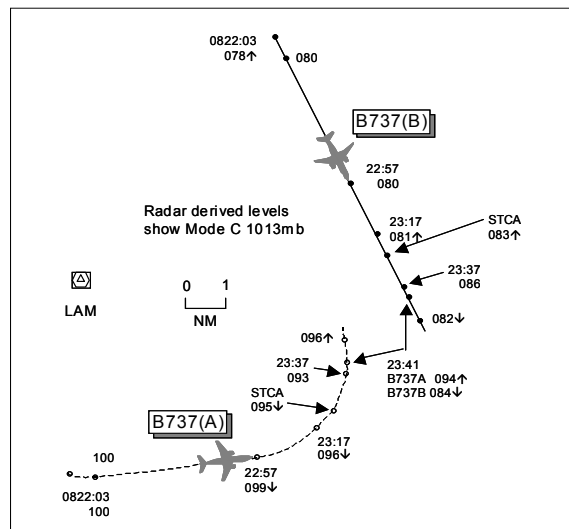
THE B737(A) PILOT reports turning from the outbound onto the inbound leg of the LAM hold at 210kt. Approaching FL94 in a descent in cloud, TCAS gave a TA alert followed by an RA 'climb', which was followed, levelling at FL98 as traffic was seen on TCAS to pass 1.5nm away. He did not assess the risk.

Cause: The TC NE DEPS SC climbed B737(B) into conflict with B737(A).

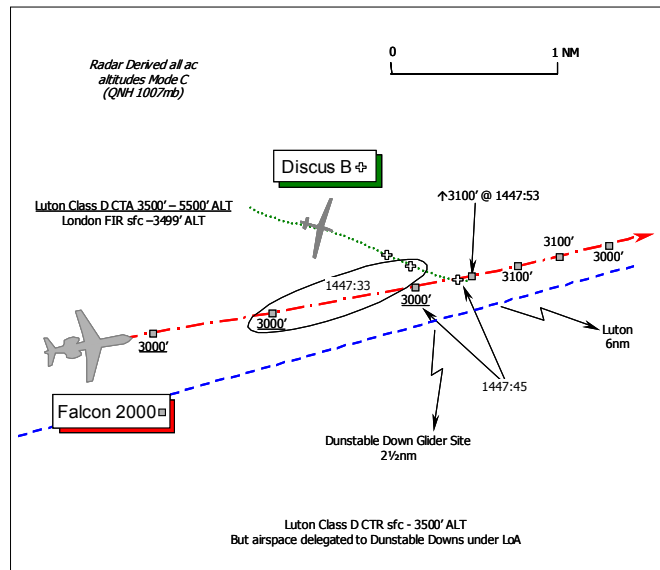
AIRPROX REPORT NO 119/04

THE DISCUS B GLIDER PILOT reports he was thermalling at a speed of 48kt in the vicinity of Houghton Regis, about 2½nm N of Dunstable Down Glider Site after launching in his single-seat glider from Dunstable Down for a general handling flight. He was flying at 2500ft above the site elevation of 500ft amsl [equating to an altitude of about 3000ft] some 1000ft clear below cloud with an in-flight visibility of 20nm and in communication with the club on 119.9MHz. The glider has an all-white finish; no transponder is carried.

Cause: Conflict in the FIR resolved by the Falcon 2000 crew.
