**UK AIRPROX BOARD**

# **Analysis of Airprox in UK Airspace**

**Report Number 15  
July 2005 – December 2005**

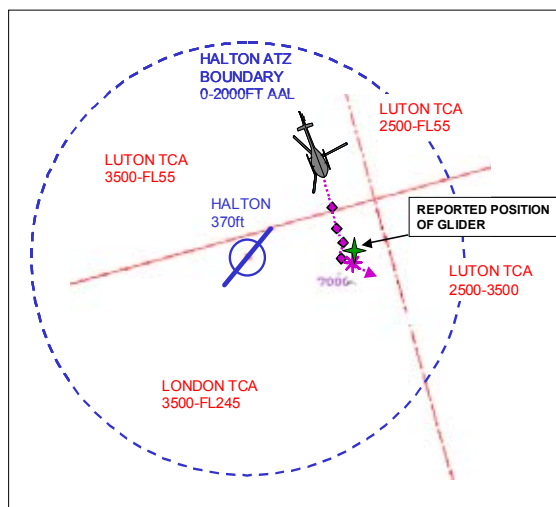
**AIRPROX REPORT NO 106/05**

**THE K-18 GLIDER PILOT** reports flying solo in a white and orange glider and was ridge soaring, heading 020° at 45kt, immediately following a winch launch to 1300ft AGL. He was sustaining a height of 1000ft QFE in weak lift over the N facing ridge to the E of Halton Airfield. He then made a 360° thermalling turn to the L and as he came round scanning ahead of his L wing he saw a dark single rotor 4/6 seat helicopter 150m away turning away to his left so he tightened his L turn to increase separation. He did not hear any call to Halton from the helicopter which appeared to be transiting through the Halton ATZ. He thought that both pilots had seen each other late and the helicopter had also taken avoiding action. He did not assess the risk of collision.

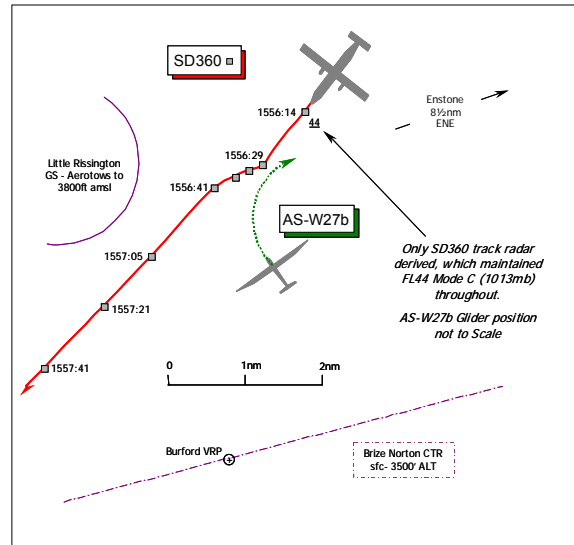
**AIRPROX REPORT NO 109/05**

**THE AS-W 27B GLIDER PILOT** provided a very comprehensive account reporting that he had winch-launched from Nympsfield at 1208UTC and flown a triangular cross-country course via turning points at Westbury and Membury, before returning to Nympsfield. That task was completed at 1442UTC and as it was good soaring weather he decided to remain airborne and execute a leg out to Enstone and back. The Airprox occurred on the return leg from Enstone, a few miles E of Little Rissington whilst he was monitoring 130-125MHz [a glider frequency].

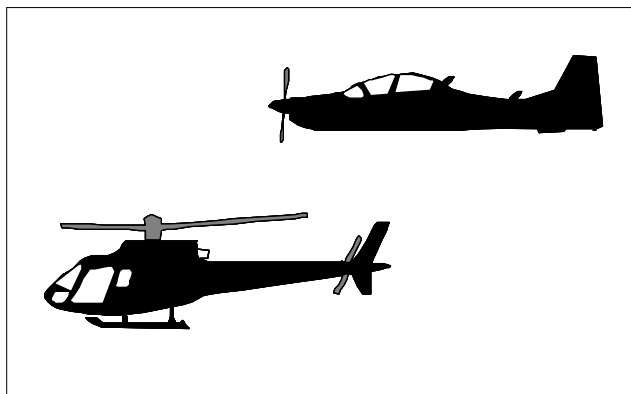
### AIRPROX REPORT NO 110/05

**THE SQUIRREL PILOT** reports flying a yellow and black ac with a student on a low level navigation instructional sortie from RAF Leeming to RAF Shawbury and squawking 7000 with Mode C. While teaching low-level techniques heading approximately SE at 200ft agl down Ryedale Valley towards Riveaux Abbey and just after turning to follow the valley floor, a black shadow passed over his cockpit. He looked up immediately and saw a Tucano wing tip pass approximately 10ft above his rotor disk as it overtook them, also flying down the valley. The Tucano was in a steep turn then rolled level in front of them to continue following the terrain. He estimated that the Tucano was flying at 250ft agl and considered that the risk was very high.

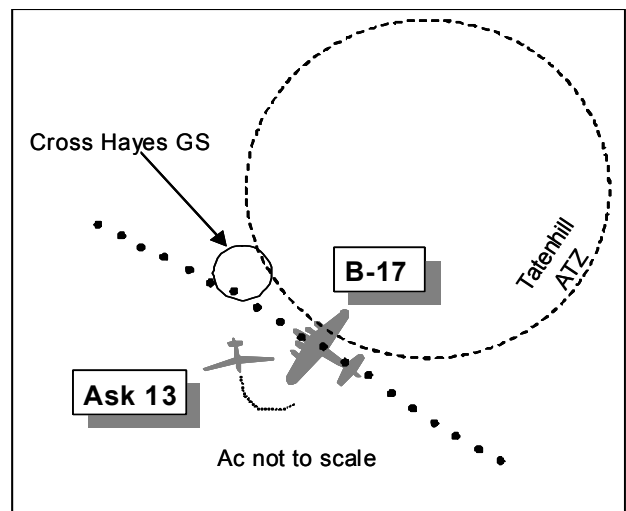
**AIRPROX REPORT NO 111/05**

**THE K13 GLIDER PILOT** reports circling at 45kt, he sighted the B17G 5-6nm out whilst thermalling at about 2000ft off to the SE of the Cross Hayes field. On the next turn the B17G was on the same heading set to overfly the site

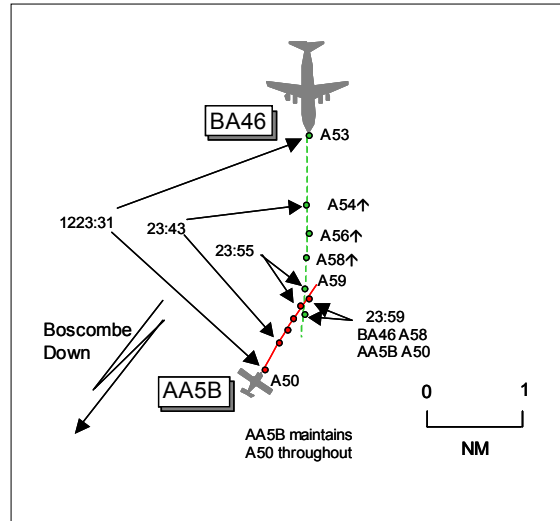
**AIRPROX REPORT NO 112/05**

**THE BA46 PILOT** reports heading 180° at 230kt and FL50 on a local sortie from Cranfield to the Boscombe Down area IFR in a white coloured ac with strobe lights on. After working Brize Radar under a RAS during their transit enroute, they were handed over to Boscombe Down and were told that they were under a RIS and that there was crossing traffic L to R, he thought, at 5000ft on QNH 1021mb. During this transmission they received a TCAS TA at range 4nm followed by an RA 'climb' at range 1.5nm with the other ac about 200ft below. The RA guidance was followed and ATC were informed of the manoeuvre, passing O/H the other ac by about 700ft. At the time they were flying in cloud in IMC so the other ac was not seen visually. He assessed that they would have passed within 200ft of the other ac if no climb had been taken.

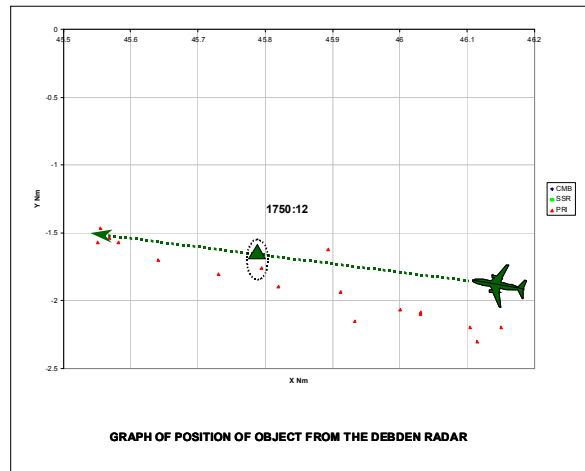
### AIRPROX REPORT NO 113/05

**THE B737 PILOT** reports flying a scheduled passenger flight from Germany to Stansted under IFR. With about 45nm to run to Stansted, heading 280° at 370kt and passing FL125 in the descent to FL90, he became aware of opposite direction traffic. At first it looked like a free fall parachutist in shape. The Captain said “*What is that?*” but by the time the FO looked up it had passed underneath; this took place in the space of about 2sec. He assessed that it passed under with a relative closing speed at least 3x faster than an opposite direction ac 1000ft beneath them. It was a small, dark, delta wing craft about 500ft beneath them and about 2000ft above their cleared [descent] level and they were descending through its level. The pilot reported it to radar control but they did not see anything at the time and there was nothing shown on TCAS.

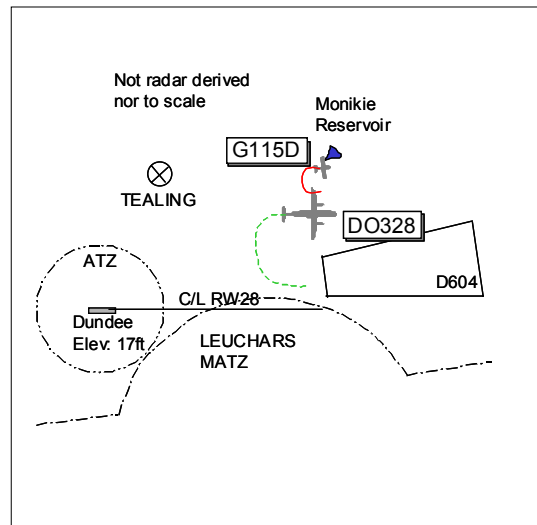
**AIRPROX REPORT NO 114/05**

**THE DO328 PILOT** reports inbound to Dundee IFR and in communication with Dundee on 122.9MHz squawking with Mode C. The visibility was 40km in SKC VMC and the ac was coloured white/red with taxi, landing, navigation and strobe lights all switched on. The flight had been transferred from Leuchars Radar heading 270°, which had placed the flight N of the FAT, at 3000ft QNH 1013mb at 220kt for a visual approach to RW28. Dundee ATC gave him a RH orbit to separate his flight from a landing HS25. They entered a descending RH turn about 10nm ENE of Dundee Airport and, on passing through N, a TCAS return squawking Mode C was noted in his 12 o'clock range 2.5nm. Turning through 045° and passing 2200ft, he thought, the other ac was sighted, a white single engine ac, 1.25nm on his LHS about 100ft above commencing a L turn away to the N; by now both ac were heading approx 090°. During this encounter a TA alert was received followed by an RA 'descend' which was actioned as their R turn was continued. A GPWS terrain 'pull up' alert was also received during this manoeuvre.

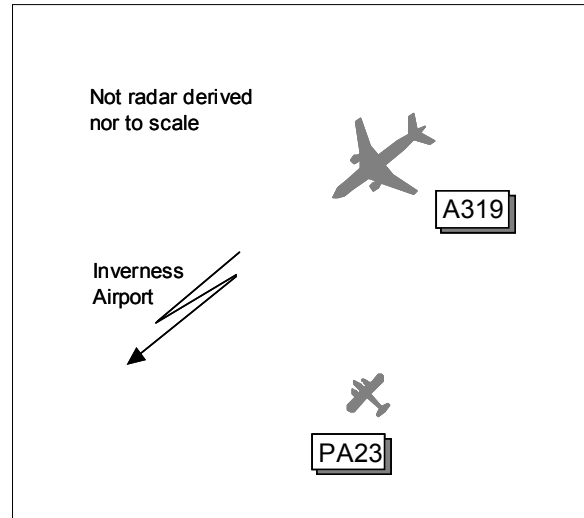
**AIRPROX REPORT NO 115/05**

**THE A319 PILOT** reports inbound to Inverness IFR and in receipt of a 'procedural' service from Inverness on 122.6MHz squawking 5153 with Mode C. The visibility was >40nm flying 1500ft below cloud in VMC. They had been cleared for a procedural VOR/DME approach to the ILS RW23 from O/H the INV VOR. When 10.5nm DME on the INV 040° RAD a R turn was commenced onto the base leg track of 160° at 180kt, level at 2000ft QNH 999mb. ATC gave TI on traffic working Lossie Radar to the NE of INV. The ac was seen on TCAS 10nm away coming from the Lossie direction indicating 2000ft altitude. They continued in accordance with the procedure and the traffic became 'proximate traffic' at about 5nm as it appeared to be travelling at high speed and catching up. A TA alert came at 3nm and visual contact was established at 2nm. As they were still turning away they continued in NAV but shortly after this an RA 'climb, climb now' was received and followed, levelling at 2500ft. The other ac, a low wing twin-engine ac, possibly a King Air, was seen to pass 500ft below and 1nm to their L. Once clear they visually manoeuvred back to the N and repositioned onto the ILS. He assessed the risk as moderate.

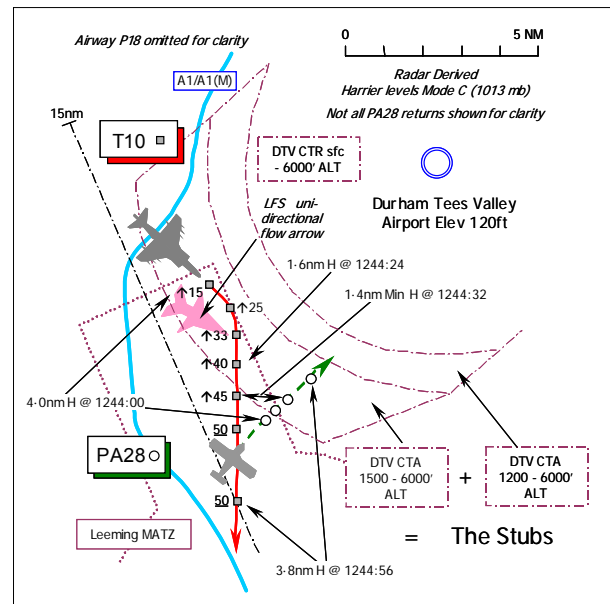
**AIRPROX REPORT NO 118/05**

**THE DURHAM TEES VALLEY APPROACH RADAR CONTROLLER (TEESSIDE APR)** reports that the PA28 pilot was inbound to Durham Tees Valley Airport (DTVA), flying under VFR from Manchester/Barton with a squawk of A7052 allocated. The PA28 had previously been 'handed-over' to him from Leeming and had been cleared for a straight-in approach to RW05. A Leeming assigned squawk - A0405 - was then observed 8nm W of DTVA climbing on a SE track towards the PA28. Traffic information was passed to the PA28 pilot about the unknown traffic whereupon the contact passed down the port side of the PA28 at a range of about 1½nm, he thought climbing through the PA28's altitude, in the CTA. The PA28 pilot did not see the other ac. Leeming ATC advised that a Harrier had called them climbing out of low-level with a "problem" but by the time Leeming identified the Harrier on radar it had entered CAS and was inside the Class D DTV CTA.

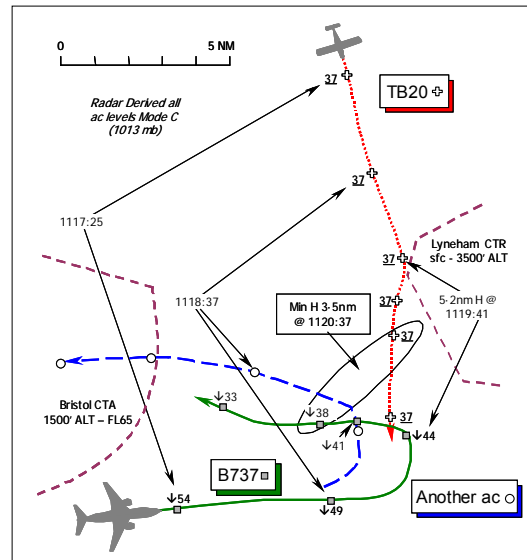
**AIRPROX REPORT NO 119/05**

Date/Time: 18 Jul 1120  
Position: 5123N 00217W (16½nm E of Bristol - elev 622ft)  
Airspace: London FIR (Class: G)  
Reporting Ac Reported Ac  
Type: B737-700 TB20  
Operator: CAT Civ Pte  
Alt/FL: 3500ft 2000ft  
 QNH (1008mb) QNH  
Weather IMC NR VMC NR  
Visibility: NR >10km  
Reported Separation:  
 600ft V/2.5nm H Not seen  
Recorded Separation:  
 100ft V @ 3.5nm min H

identified, the APR allowed the situation to continue before turning the B737 onto a heading parallel to the LLZ course. No level of service was specified by the APR nor requested by the pilot; the APR effectively provided a RAS but the crew of the B737 believed that they were in receipt of RCS. Whilst it is accepted that the CAS surrounding Bristol Airport is not contiguous with the nearby airways, so traffic is frequently vectored outside CAS, by adopting different techniques this time could be minimised. Whilst doing this, and providing the B737 crew with a RAS, the conditions were not satisfied as the APR did not seek to achieve the requisite 5nm horizontal separation against the 'unknown traffic'.

Cause: Sighting report (TCAS).

Although it is understood that an airspace change proposal is being processed at present, this will not be in place until early 2006 and accordingly, the following recommendation is made by ATSI:-

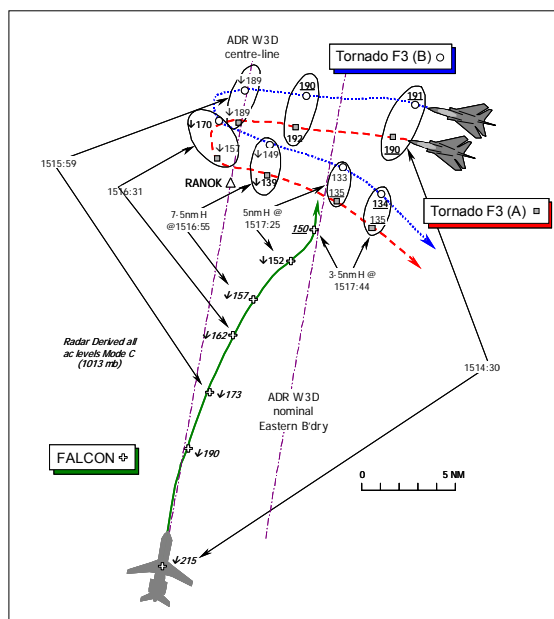
Date/Time: 25 Jul 1517  
Position: 5640N 00410W (vicinity of RANOK)  
Airspace: ADR W3D/FIR (Class: F/G)  
Reporter: ScACC W Coast Sector

<u>First Ac</u>	<u>Second Ac</u>
<u>Type:</u> Falcon 2000	Tornado
<u>Operator:</u> Civ Comm	HQ STC
<u>Alt/FL:</u> ↓FL150	13000ft (RPS 1001mb)
<u>Weather</u> VMC SKC	VMC CLOC
<u>Visibility:</u> >30km	>40nm
<u>Reported Separation:</u>	
ScACC W Coast SC: <1000ft V/2nm H	
1500ft V/3nm H	2000ft V/7nm H
<u>Recorded Separation:</u>	
1500ft V/3-5nm H

Cause: The Tornado F3's unexpected turn back across the ADR caused the W COAST SC concern.

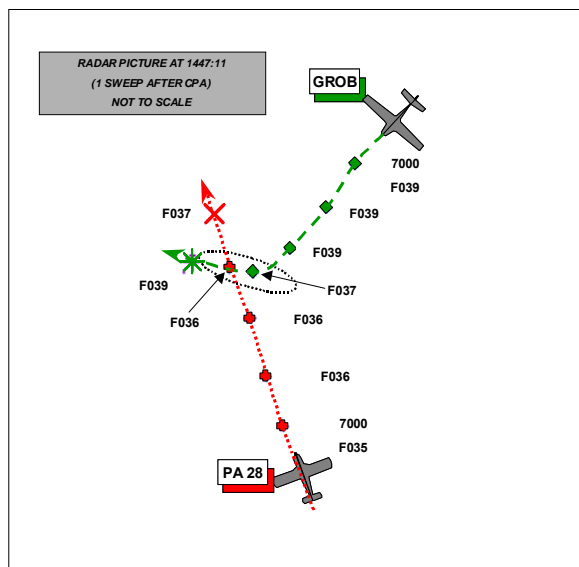
**AIRPROX REPORT NO 122/05**

Date/Time: 26 Jul 1447  
Position: 5218N 00008W  
 (S of Godmanchester)  
Airspace: London FIR (Class: G)  
Reporting Ac Reported Ac  
Type: Grob Tutor PA28  
Operator: HQ PTC Civ Pte  
Alt/FL: 4000ft 3500ft  
 (QNH 1007 mb) (RPS)  
Weather VMC CAVOK VMC CLBC  
Visibility: 50km ~15km  
Reported Separation:  
 70ft V/110ft H Not Seen  
Recorded Separation:  
 100ft V/0.1nm H

Cause: Very late sighting by the Grob pilot and non-sighting by the PA28 pilot.

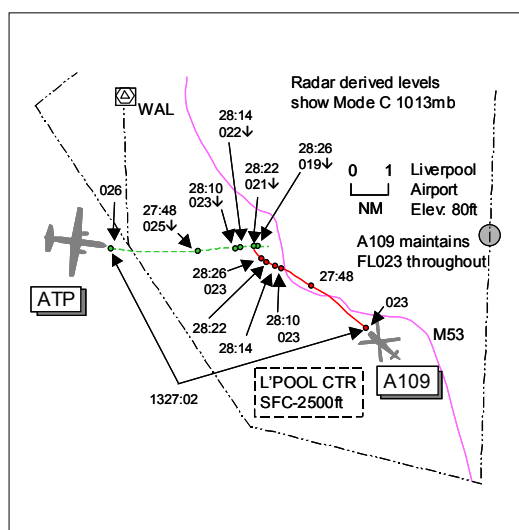
## AIRPROX REPORT NO 125/05

Date/Time: 27 Jul 1328  
Position: 5319N 00302W (6nm W of Liverpool Airport - elev 80ft)  
Airspace: CTR (Class: D)  
Reporting Ac Reported Ac  
Type: ATP A109  
Operator: CAT Civ Pte  
Alt/FL: 1600ft↓ NR  
(QNH 1010mb) (QNH)  
Weather VMC CLOC VMC CLBC  
Visibility: >10km >10km  
Reported Separation:  
<200ft V/<2.5nm H NR  
Recorded Separation:  
400ft V/0.3nm H

Cause: The A109 pilot's chosen flight path triggered a TCAS RA and also caused the ATP crew concern.

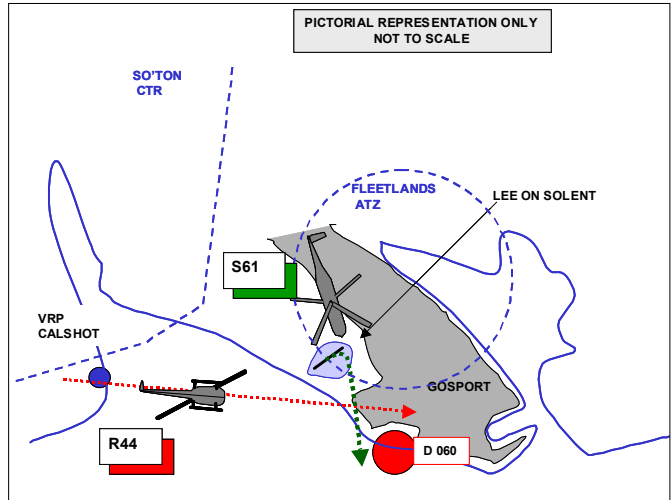
**AIRPROX REPORT NO 126/05**

Date/Time: 27 Jul 0938 (Wednesday)  
Position: 5048N 00111W  
 (Lee-on-Solent - elev 32ft)  
Airspace: London FIR (Class: G)  
Reporting Ac Reported Ac  
Type: Sikorsky S61N Robinson R44  
Operator: Civ Comm Civ Pte  
Alt/FL: 300ft 500ft  
 (QNH 1008 mb) (QNH)  
Weather VMC RAIN VMC RAIN/MIST  
Visibility: 3-4km 2km  
Reported Separation:  
 Nil V/100ft H Nil V/300m H  
Recorded Separation:  
 Not recorded

Cause: Conflict in Class G airspace in marginal weather conditions resolved by the S61N captain.

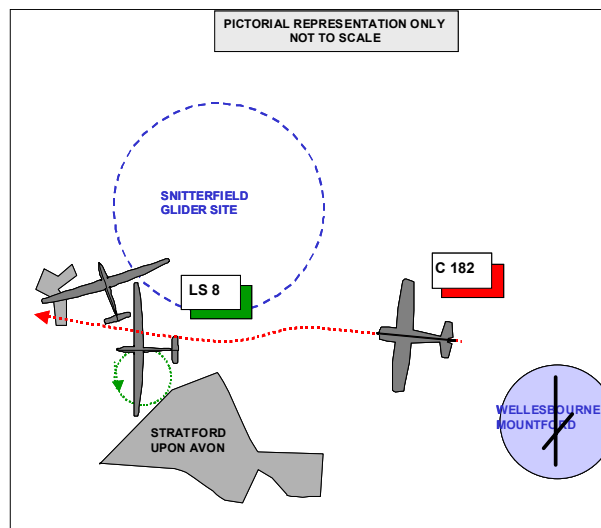
**AIRPROX REPORT NO 127/05**

Date/Time: 31 Jul 1603 (Sunday)  
Position: 5212N 00143W (Snitterfield - elev 375ft)  
Airspace: London FIR (Class: G)  
Reporting Ac Reported Ac  
Type: LS8 Glider C182  
Operator: Civ Pte Civ Pte  
Alt/FL: 1780ft 2000ft  
(QFE 1004 mb) (QNH 1014 mb)  
Weather VMC VMC  
Visibility: 20km >10km  
Reported Separation:  
0 VI~200ft H 500yd H  
Recorded Separation:  
Not recorded

Cause: Conflict in Class G airspace resolved by the C182 pilot.

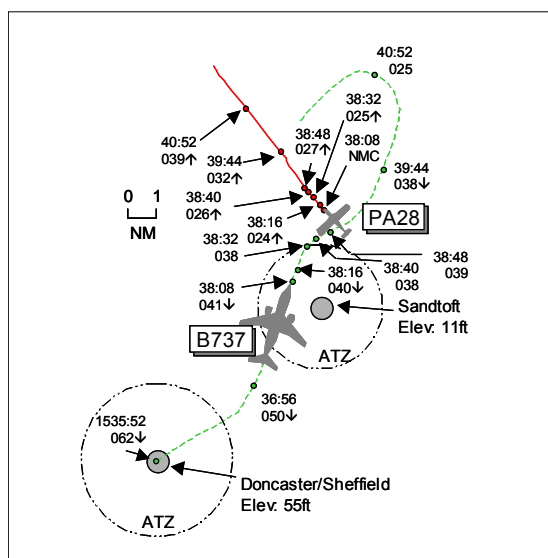
## AIRPROX REPORT NO 128/05

Date/Time: 30 Jul 1539 (Saturday)  
Position: 5336N 00052W (9nm NNE  
Doncaster/Sheffield - elev 55ft)  
Airspace: LFIR (Class: G)  
Reporting Ac Reported Ac  
Type: B737-300 PA28  
Operator: CAT Civ Pte  
Alt/FL: ↓2500ft ↑  
(QNH) NK  
Weather IMC KLWD NK  
Visibility: NK  
Reported Separation:  
1000ft V/2nm H NK  
Recorded Separation:  
1200ft/1.5nm H

Cause: Sighting report (TCAS).

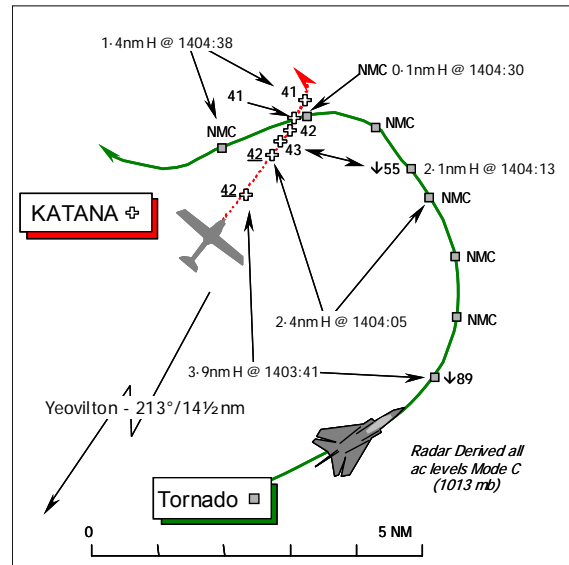
**AIRPROX REPORT NO 129/05**

Date/Time: 2 Aug 1404  
Position: 5113N 00225W (14½nm NE of Yeovilton)  
Airspace: Yeovilton AIAA (Class: G)  
Reporting Ac Reported Ac  
Type: Tornado GR1 Katana DA20  
Operator: MOD DPA Civ Club  
Alt/FL: 4500ft↓ FL42  
(RPS 1018mb)  
Weather VMC NR VMC NR  
Visibility: >25km >10km  
Reported Separation:  
50ft V/Nil H Nil V/½nm H  
Recorded Separation:  
<0.1nmH

Cause: Conflict in the Yeovilton AIAA resolved by the Tornado student test pilot.

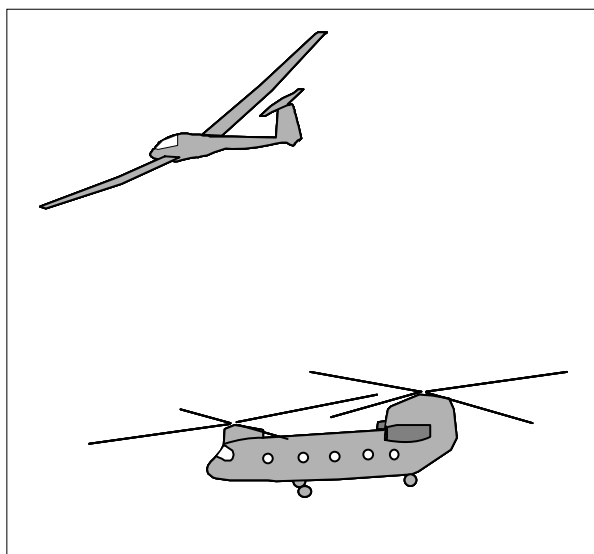
### AIRPROX REPORT NO 130/05

Date/Time: 3 Aug 1400  
Position: 5114 N 00102W(4nm W Odiham - elev 405ft)  
Airspace: London FIR (Class: Class G)  
Reporting Ac Reported Ac  
Type: ASW 19B Chinook  
Operator: Civ Pte JHC  
Alt/FL: 3600ft 4200ft  
(QFE 1000 mb) (1013mb)  
Weather VMC CLBC VMC  
Visibility: >30km >10km  
Reported Separation:  
200ftV/0ft H 200ft V/500m H  
Recorded Separation:  
Not Recorded

Cause: Effective non-sighting by both crews.

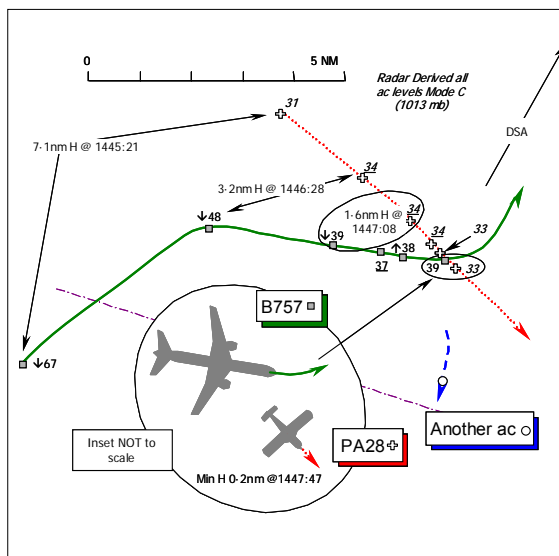
## AIRPROX REPORT NO 131/05

**Date/Time:** 7 Aug 1447 (Sunday)  
**Position:** 5321N 00107W (8.3nm SSW  
Doncaster Sheffield Airport - elev 55ft)  
**Airspace:** London FIR (Class: G)  
**Reporting Ac** **Reported Ac**  
**Type:** B757 PA28  
**Operator:** CAT Civ Pte  
**Alt/FL:** 4000ft↓ 3500ft  
(QNH 1020mb) (QNH 1020mb)  
**Weather** VMC CLBC VMC CLBC  
**Visibility:** 10nm+ 70km  
**Reported Separation:**  
500ft V/1nm H 300m H  
**Recorded Separation:**  
300ft V/0.2nm H

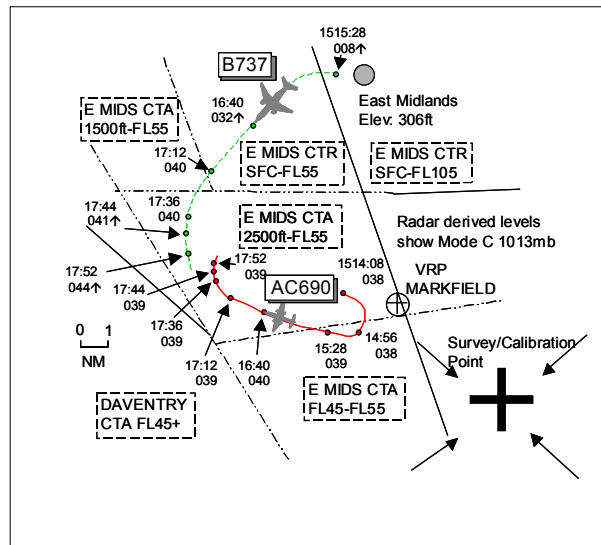
**AIRPROX REPORT NO 132/05**

Date/Time: 9 Aug 1518  
Position: 5243N 00129W (9nm SW East Midlands - elev 306ft)  
Airspace: E MID CTA (Class: D)  
Reporting Ac Reported Ac  
Type: B737-300 AC690  
Operator: CAT Civ Pte  
Alt/FL: ↑5000ft 4000ft  
(QNH 1015mb) (QNH)  
Weather VMC CAVK VMC CLBC  
Visibility: >10km >10km  
Reported Separation:  
600ft V/800m H 300ft V/1nm H  
Recorded Separation:  
500ft V/1nm H

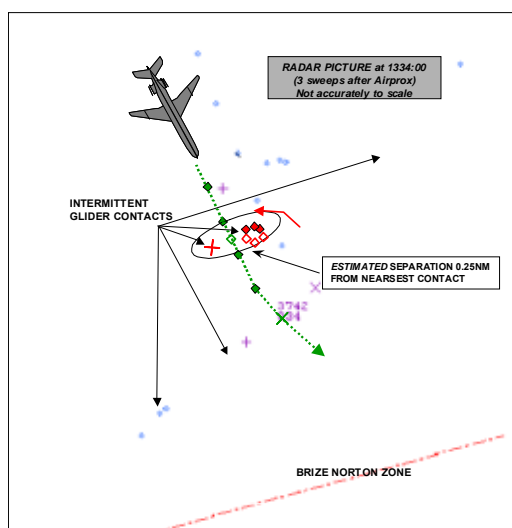
Reported Separation:  
200ft V/200ft H NR

Recorded Separation:  
NR V/Estimated at .25nm H

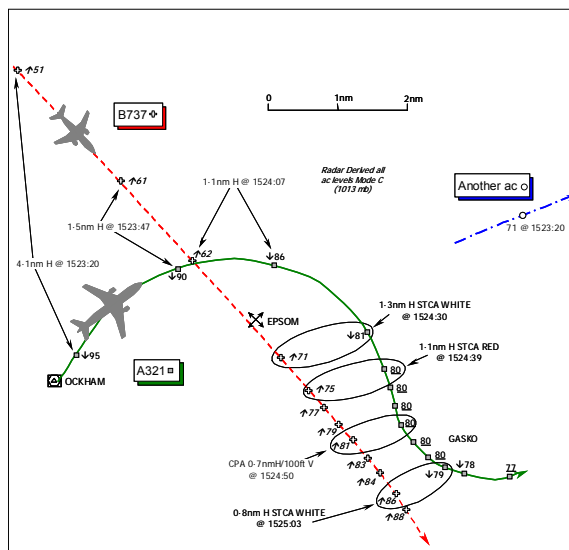
## AIRPROX REPORT NO 138/05

**Date/Time:** 15 Aug 1524  
**Position:** 5118N 00020W (4nm E of Ockham VOR)  
**Airspace:** London TMA (Class: A)  
**Reporting Ac** **Reported Ac**  
**Type:** A321 B737-400  
**Operator:** CAT CAT  
**Alt/FL:** FL80 ↑FL120  
**Weather** VMC CLAC VMC NR  
**Visibility:** Unrestricted 40km  
**Reported Separation:**  
300ft V/1nm H nil V @ <1nm H  
**Recorded Separation:**  
Nil V/0.7nm H

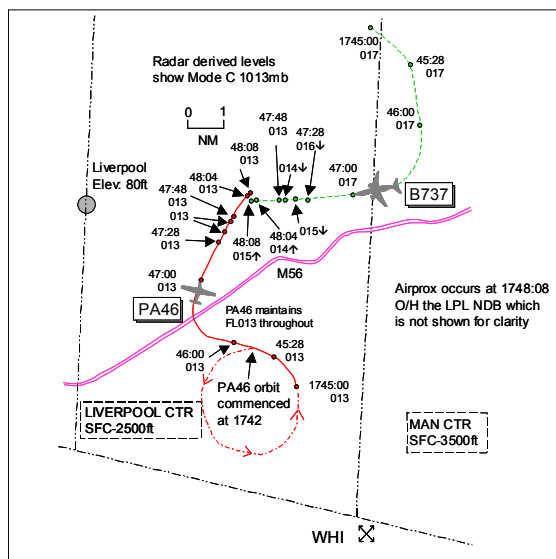
## AIRPROX REPORT NO 139/05

Date/Time: 15 Aug 1748  
Position: 5320N 00243W (5nm E Liverpool - elev 80ft)  
Airspace: CTR (Class: D)  
Reporting Ac Reported Ac  
Type: B737-300 PA46  
Operator: CAT Civ Pte  
Alt/FL: 2000ft↓ 1500ft  
(QNH) (QNH 1024mb)  
Weather IMC KLWD VMC CLBC  
Visibility: 7km  
Reported Separation:  
Nil V/<1nm H Not seen  
Recorded Separation:  
200ft V/0-2nm H

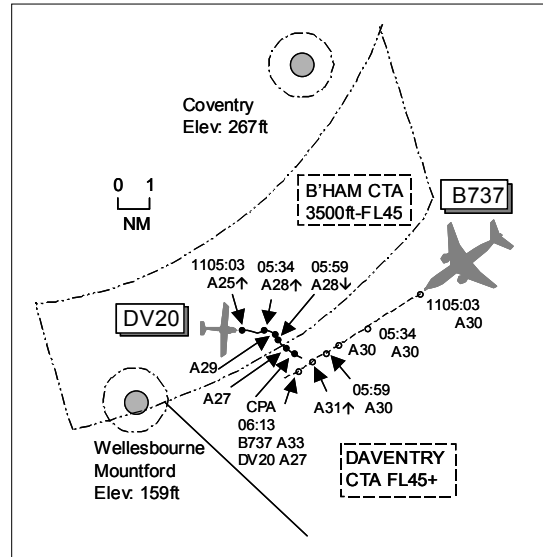
**AIRPROX REPORT NO 140/05**

Date/Time: 14 Aug 1106 (Sunday)  
Position: 5212N 00129W (10nm S Coventry Airport - elev 267ft)  
Airspace: LFIR (Class: G)  
Reporting Ac Reported Ac  
Type: B737-500 DV20 Katana  
Operator: CAT Civ Trg  
Alt/FL: 3000ft ↑3000ft  
(QNH 1017mb) (QNH)  
Weather VMC VMC  
Visibility: >10km 20km  
Reported Separation:  
300m H 300ft V/800m H  
Recorded Separation:  
600ft V/0.6nm H

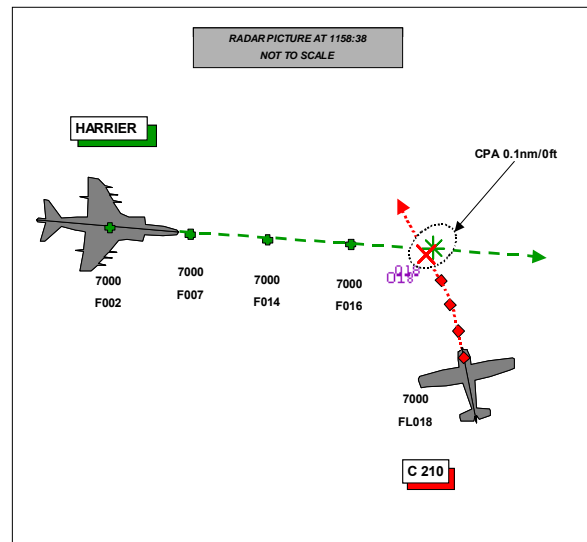
**AIRPROX REPORT NO 141/05**

Date/Time: 16 Aug 1159  
Position: 5238N 00001E (15nm E Wittering - elev 273ft)  
Airspace: London FIR (Class: G)  
Reporting Ac Reported Ac  
Type: Harrier T10 C210  
Operator: HQ STC Civ Pte  
Alt/FL: 2120ft 2000ft  
(Rad Alt) (QNH)  
Weather: VMC CLBC VMC CLOC  
Visibility: 20km >10km  
Reported Separation:  
Nil V/50m H 100-200ft V/400ft H  
Recorded Separation:  
0ft V/0.1nm (200) yd H

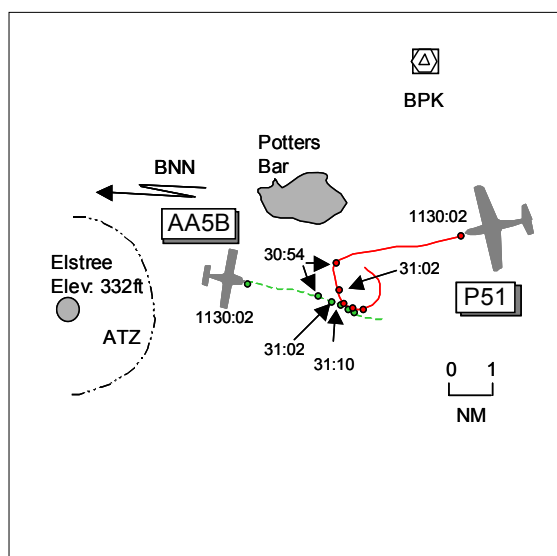
## AIRPROX REPORT NO 143/05

Date/Time: 6 Aug 1131 (Saturday)  
Position: 5140N 00009W (6nm E Elstree - elev 332ft)  
Airspace: LFIR (Class: G)  
Reporting Ac: AA5B  
Reported Ac: P51 Mustang  
Type: AA5B  
Operator: Civ Club  
Alt/FL: 2300ft (QNH)  
Weather: VMC CLBC  
Visibility: >10km  
Reported Separation: 10ft V/70m H not seen  
Recorded Separation: <0.1nm H

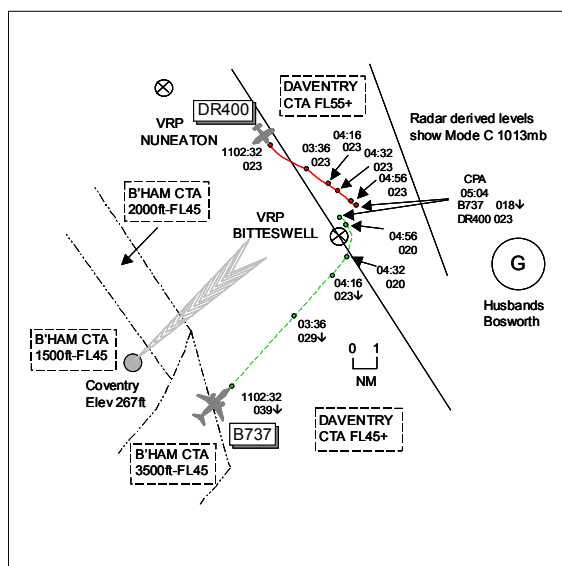
### AIRPROX REPORT NO 145/05

Date/Time: 18 Aug 1105  
Position: 5228N 00114W (10nm NE Coventry - elev 267ft)  
Airspace: LFIR (Class: G)  
Reporting Ac Reported Ac  
Type: B737 Robin DR400  
Operator: CAT Civ Pte  
Alt/FL: 2000ft 2400ft  
(QNH 1014mb) (QNH 1014mb)  
Weather VMC HAZE VMC CLBC  
Visibility: 3500m >8km  
Reported Separation:  
300ft V/<1nm H c0-8-1.5nm H  
Recorded Separation:  
500ft V/0-9nm H

equipment is designed for conflict resolution only in the vertical plane. This azimuth information had led the B737 crew astray and after a further prompt from the APR on the converging DR400, they elected to take the 'hard L turn'. It was noted that this was executed with the A/P engaged which would have increased the turn radius owing to the ac's flight performance with A/P engaged. However, ATCO Members thought the APR should have been trying to achieve 5nm separation from the outset when providing a RAS, so that the first transmission to the B737 flight when TI was actually given, should have been 'avoiding action', as opposed to 'an early turn in' and when this was declined the service should have been downgraded to RIS with further TI. The APR would have been used to these traffic scenarios, operating in the FIR without the benefit of CAS, but he did not turn the B737 early to avoid the DR400 nor did he stop its descent after the B737 crew reported the other traffic about 300ft below (recorded radar showed 600ft difference). One reason mooted was that the APR was looking at the situation in plan view with primary-only returns whereas the B737 crew had the benefit of vertical information from the DR400's Mode C. One Member thought that the offer of an early turn in by the APR may have been the controller's idea of avoiding action but this was apparently not clear from his report. Although the APR's options were limited, owing to other ac in the area, the L turn instruction issued towards final approach given to the B737 flight had brought it into conflict with the DR400 and this had caused the Airprox.

Cause: The Coventry APR vectored the B737 into conflict with the DR400.

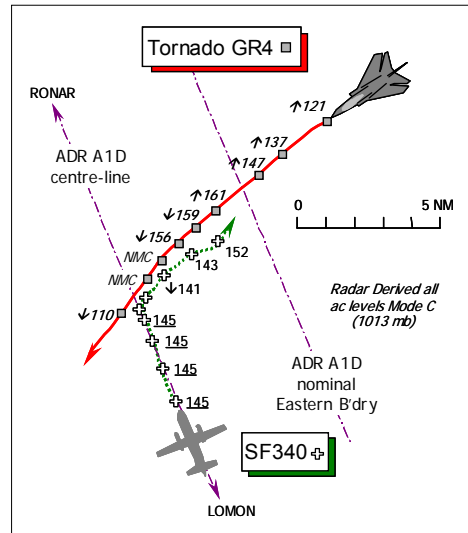
**AIRPROX REPORT NO 146/05**

Date/Time: 19 Aug 1335  
Position: 5623N 00448W (21nm NNW LOMON)  
Airspace: ADR A1D (Class: F)  
Reporting Ac Reported Ac  
Type: Saab 340 Tornado  
Operator: CAT HQ STC  
Alt/FL: FL145 NR  
(SAS) NR  
Weather VMC CLBL VMC CLOC  
Visibility: >75km 30nm  
Reported Separation:  
50ft V/20m H 100ft V/¼nm H  
Recorded Separation:  
½nm H

**HQ STC** comments that whilst agreeing with the sentiments expressed by the Stn, the Tornado was, again, close enough to the other ac to cause concern to the crew and to TCAS. Although not that early a spot by the GR4 crew, we believe they had time to avoid the Saab by a greater margin than they did.

Cause: The Tornado GR4 crew crossed the ADR inappropriately and following a late sighting flew into conflict with the SAAB.

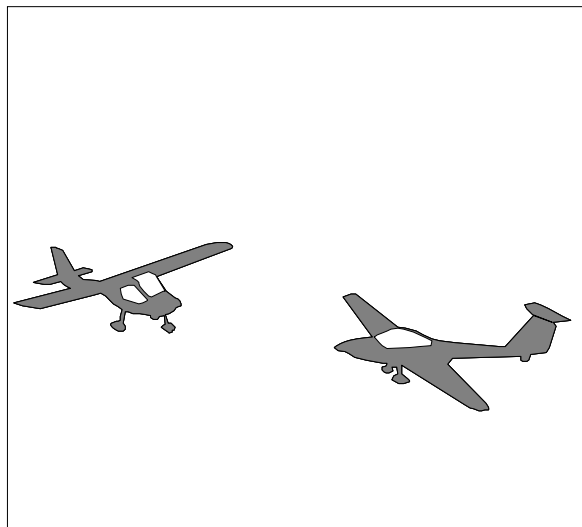
**AIRPROX REPORT NO 147/05**

Date/Time: 21 Aug 1506 (Sunday)  
Position: 5152N 00145W (2.5nm W Little Rissington - elev 730ft)  
Airspace: London FIR (Class: G)  
Reporting Ac Reported Ac  
Type: Vigilant Motor Glider CT2K  
Operator: HQ PTC Civ Club  
Alt/FL: 2000ft 2650ft  
 (QFE ) (RPS )  
Weather VMC CLOC VMC  
Visibility: >40km 10km  
Reported Separation:  
 70-100ft V/0ft H Not seen  
Recorded Separation:  
 Not Recorded

For whatever reason, perhaps that it was below the engine cowling, perhaps because of its colour, the CT2K pilot had not seen the Vigilant at any stage. However the vigilant Vigilant pilot saw the CT2K just in time to take late but nonetheless effective avoiding action as soon as he became aware of the approaching CT2K. The Board noted and commended the honest report by the Vigilant pilot: he may have been distracted, paying over-much attention to the glider which appeared to be getting too close to the glider operating site.

Cause: Non-sighting by the CT2K pilot and late sighting by the Vigilant pilot.

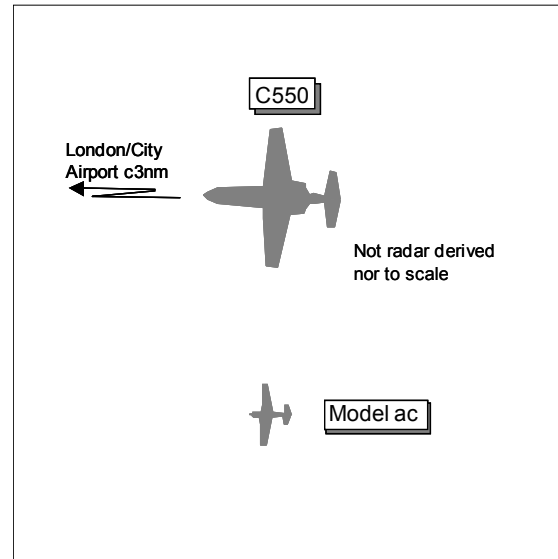
**AIRPROX REPORT NO 148/05**

Date/Time: 21 Aug 1407 (Sunday)  
Position: 5130N 00008E (3nm E London City - elev 19ft)  
Airspace: CTR (Class: D)  
Reporting Ac Reported Ac  
Type: C550 Citation Model ac  
Operator: Civ Comm Civ Club  
Alt/FL: 1500ft↓  
 (QNH) (NK)  
Weather: VMC CAVK NK  
Visibility: >10km  
Reported Separation:  
 Nil V/70-100m H NK  
Recorded Separation:  
 NR

Members applauded the actions taken by the Model Flying Club Committee following this incident. It was clear that the operator had flown his model ac at excessive height and into conflict with the C550 which had caused the Airprox. Looking at risk, with only one viewpoint of the incident - that from the C550 cockpit - the crew were undoubtedly surprised to encounter a model ac at their level on final approach. They had visually acquired the model ac about 500m away, monitored its manoeuvring and had elected to continue their approach as the model ac was maintaining a position to the S of their flight path until it was seen passing clear on their LHS. This sighting was felt to be timely enough for the C550 crew to have taken any avoiding action, if necessary should the situation have deteriorated, and was enough to persuade the Board that safety had been assured during the encounter.

Cause: The model ac operator flew his model at excessive height into conflict with the C550.

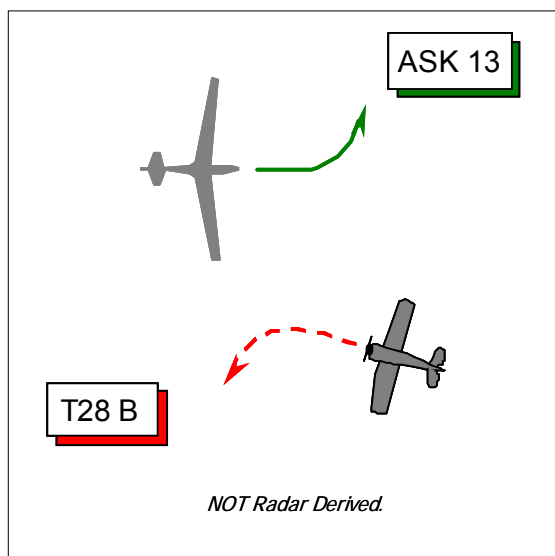
## AIRPROX REPORT NO 149/05

Date/Time: 7 Aug 1352 (Sunday)  
Position: 5141N 00210W (1½nm SW of Aston  
Down Glider Site - elev 600ft)  
Airspace: London FIR (Class: G)  
Reporting Ac Reported Ac  
Type: ASK 13 Glider N American T28  
Operator: Civ Club Civ Pte  
Alt/FL: 1200ft 2000ft  
(aal) amsl  
Weather VMC CLBL VMC CAVOK  
Visibility: 50km 30nm  
Reported Separation:  
Nil V/250m H 200ft V/400ft H  
Recorded Separation:  
Not recorded

Whilst the reporting ASK 13 glider pilot in this Airprox was actually on recovery back to Aston Down when he encountered the T28B, the Board's glider pilot Member was keen to emphasise that the detail contained in the UK AIP (UKAB Note (1) above) concerning Aston Down's winch launching parameters should not be taken as an indication that gliders could only be encountered below that height. Clearly aerotows could take place to any appropriate altitude – sometimes many thousands of feet above that of the winch launch - as dictated by the nature of the sortie and the prevailing weather conditions, a point worth emphasising here for the general edification of pilots who have little or no experience of gliding. Moreover, other Members added that the entry in the UK AIP and graphics on CAA VFR charts was to highlight the dangers inherent at winch launching glider sites – specifically that associated with the cable - and not that it was merely a glider operating area.

Cause: Late sightings by both pilots in the vicinity of a glider launching site.

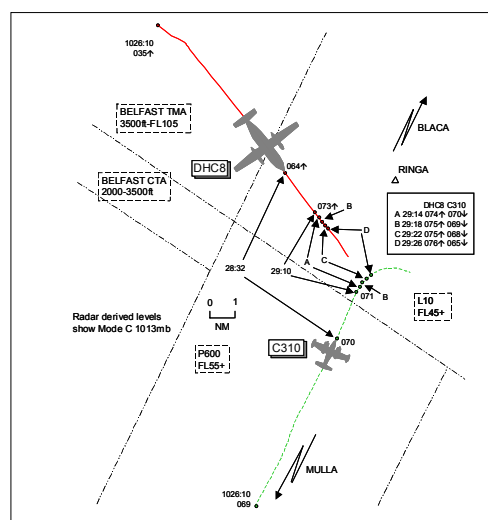
**THE BELFAST INTERNATIONAL APR** reports that as the DHC8 was climbing out from Belfast/City its track put it into conflict with the subject C310. As the DHC8 was passing FL65 he transferred the flight to ScOACC but a few seconds later realised that standard separation would be lost. He gave avoiding action to the C310 and after separation had been restored he cleared the C310 pilot to resume his own navigation.

TI on the C310 was not passed to the DHC8 crew but Members believed that it would have been useful, owing to the known deficiencies/inaccuracies of the TCAS equipment in azimuth, as it may have aided the DHC8 crew to visually acquire the crossing C310. However, at the end of the day, both flights were operating under IFR where standard separation was to be afforded by ATC and the Belfast International APR's turn issued to the DHC8 onto 150° had vectored the subject ac into conflict which had caused the Airprox.

Cause: The Belfast APR vectored the DHC8 into conflict with the C310.

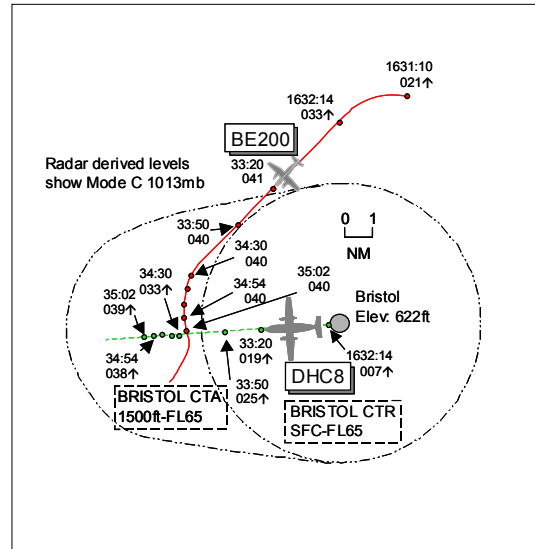
**AIRPROX REPORT NO 152/05**

Date/Time: 23 Aug 1635  
Position: 5122N 00253W (6nm W Bristol - elev 622ft)  
Airspace: Bristol CTA (Class: D)  
Reporter: Cardiff APR  
First Ac Second Ac  
Type: DHC8 BE200  
Operator: CAT Civ Comm  
Alt/FL: ↑FL50  
Weather NK VMC CLNC  
Visibility: >10km  
Reported Separation:  
 'Adequate' Nil V/2nm H  
Recorded Separation:  
 200ft V/1.3nm H

Members could add little to the ATSI report. The Bristol APR had earlier turned the BE200 onto a converging SW'ly track, in accordance with his plan that the DHC8 would pass ahead of it, but believed, erroneously, that 3nm separation should be applied between the subject IFR ac. He had not realised the deteriorating situation until just under 4nm separation existed, only then turning the BE200 L onto a S'ly heading to "...take you behind him". ATCO Members agreed that various options had been open to the Bristol APR from the outset to ensure the subject ac were afforded the requisite separation in accordance with MATS Part 2, one of which was to work the departing DHC8, thereby having both ac on the same frequency. However, the course of action taken by the Bristol APR had led to him vectoring the BE200 into conflict with the DHC8 which had caused the Airprox.

Cause: The Bristol APR vectored the BE200 into conflict with the DHC8.

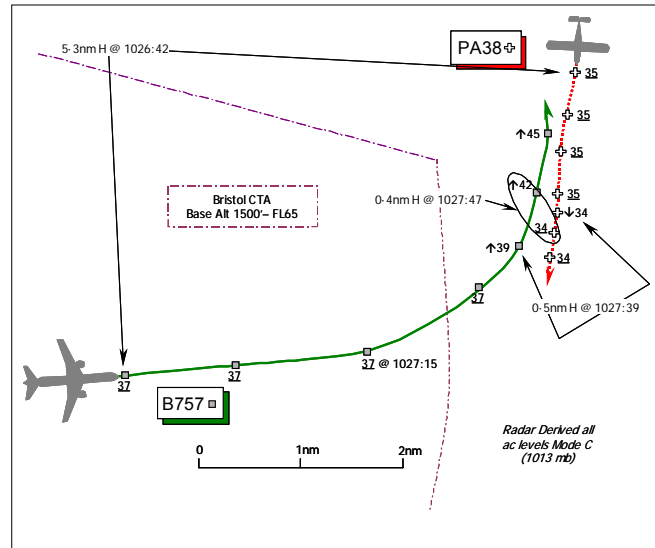
**Date/Time:** 30 Aug 1027  
**Position:** 5125N 00225W (3½nm W of Charmy Down)  
**Airspace:** London FIR (Class: D/G)  
**Reporter:** Bristol APR

<u>First Ac</u>	<u>Second Ac</u>
<b>Type:</b> B757-200	PA38
<b>Operator:</b> CAT	Civ Pte
<b>Alt/FL:</b> ↑FL40	3500ft
	QNH (1021mb)
<b>Weather:</b> NR	VMC CLBC
<b>Visibility:</b> NR	>10km
<b>Reported Separation:</b>	
500ft V/0.5nm H	500ft V/500ft H
<b>Recorded Separation:</b>	
0.4nm H

It was readily apparent to the Board that the difficulties reported by the APR stemmed from the problems encountered by the B757 crew with the auto throttles, which was the catalyst to this Airprox and ultimately delayed the crew's frequency change. From the B757 pilot's account the rectification of this issue had apparently caused a significant distraction to the B757 crew at a critical stage during their departure from Bristol. CAT pilot Members suggested that there was an underlying CRM issue here because difficulties with the auto throttles should not have diverted both pilots' attention to the point that it did. An experienced CAT pilot postulated that if there was any training going on in the B757's flight deck and if the Captain was trying to emphasise a training point to the other pilot when the auto throttle problem was detected then this might have had some impact on the overall time that it took to correct this abnormal situation. However, this was speculation and the end result of this reported difficulty was the considerable amount of time that it took the crew to finally establish RT communication with RADAR.

Cause: Whilst distracted by a technical issue, the B757 crew did not comply with ATC instructions thereby leaving CAS and flying into conflict with the PA38.

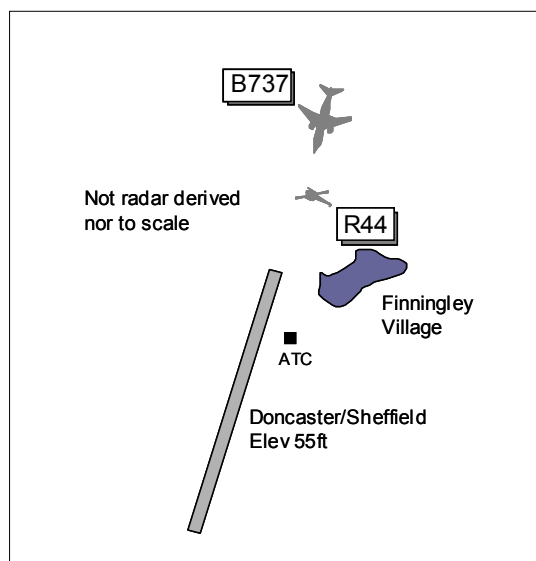
## AIRPROX REPORT NO 154/05

Date/Time: 31 Aug 0912  
Position: 5330N 00100W (1.2nm FIN APP RW20  
Doncaster/Sheffield - elev 55ft)  
Airspace: ATZ (Class: G)  
Reporting Ac Reported Ac  
Type: B737-300 Robinson R44  
Operator: CAT Civ Pte  
Alt/FL: 450ft↓ 500ft  
(QNH 1013mb) (QNH)  
Weather VMC HAZE VMC HAZE  
Visibility: 5000m 2000m  
Reported Separation:  
Nil V/300ft H Not seen  
Recorded Separation:  
NR

**ATSI** reports that the RT transcript appears to corroborate the DSA ADC's report. TI was issued to both flights and positive instructions were passed to the pilot of the R44 i.e. *"...just remain to the east of the field until visual with that traffic (the B737)"*. The only comment to make is that no read back of the instruction was obtained from the R44 pilot, only an acknowledgement. In view of his written comments did the R44 pilot fully assimilate what he was being instructed to do? Readbacks, MATS Part 1, Appendix E, Page 8/9 refers.

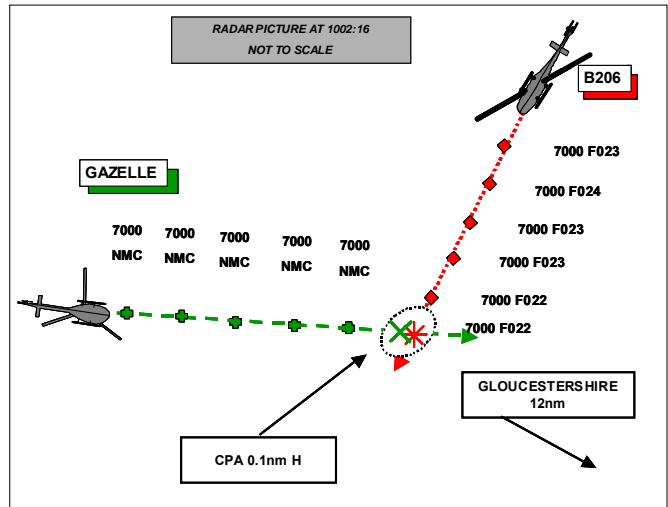
**AIRPROX REPORT NO 155/05**

Date/Time: 1 Sep 1002  
Position: 5204N 00220W (3nm NE Ledbury)  
Airspace: London FIR (Class: G)  
Reporting Ac Reported Ac  
Type: Gazelle B206 JetRanger  
Operator: HQ DAAvn Civ Pte  
Alt/FL: 2000ft 2500ft  
(RPS 1009 mb) (1019 mb)  
Weather VMC CAVOK VMC CAVOK  
Visibility: >40km unl  
Reported Separation:  
Level V/50ft H Not Seen  
Recorded Separation:  
NR V/0.1nm H

**THE GAZELLE PILOT** reports flying a camouflage grey/green ac with HISLs and all other lights on, squawking 7000 but with no mode C fitted and in receipt of a FIS from Gloster APR. He was flying straight and level on a dual, simulated IF transit, heading 100° at 120kt and at an altitude of 2000ft on the RPS (1009mb) when suddenly he saw a JetRanger in the 1030 position appearing from behind the canopy frame. It was at the same level about 300m away and on a collision course. He immediately took control from the handling pilot and banked hard to the left and descended. He reported the incident to Gloucester who confirmed that the JetRanger had not seen him. He assessed that had he not taken avoiding action the ac would have collided.

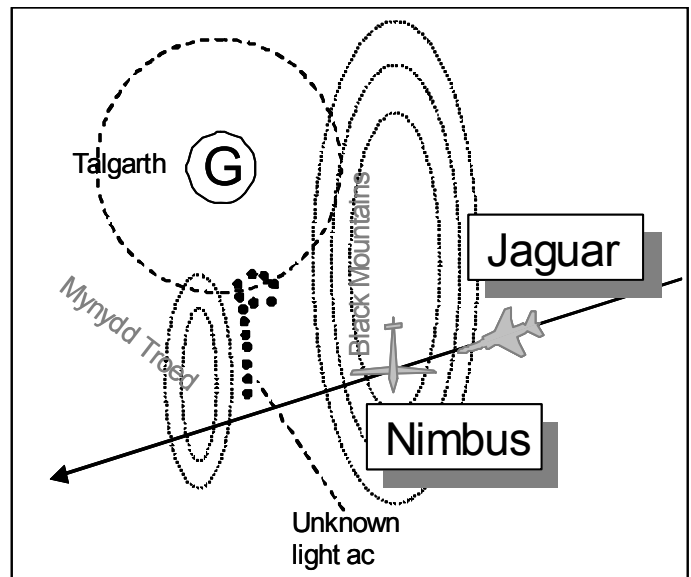
**AIRPROX REPORT NO 156/05**

Date/Time: 2 Sep 1035  
Position: 5156N 0308W (5nm SE Talgarth  
 Gliding Site - elev 970ft)  
Airspace: FIR/LFS (Class: G)  
Reporting Ac Reported Ac  
Type: Nimbus 2C Jaguar  
Operator: Civ Club HQ STC  
Alt/FL: 2000ft 1190ft  
 (QFE) (Rad Alt)  
Weather: VMC CLBC VMC  
Visibility: >20nm >10km  
Reported Separation:  
 150ft V/200 yds H 300ft V/0.5nm H  
Recorded Separation:  
 NK

**THE GLIDER PILOT** reports heading 172° at 62kt flying in a generally southerly direction above the most western ridge of the Black Mountains at 300ft agl. He saw a shadow ½ nm E of him and a dark coloured jet passed directly below him from left to right between him and the ground. There was no time for avoiding action and it was too close for comfort. He advised that there was a competition in progress at the time with the club CFI aerotowing gliders onto the lower ridge to the S of Talgarth (Mynydd Troed); the tug ac was not fitted with a transponder and nor is his glider.

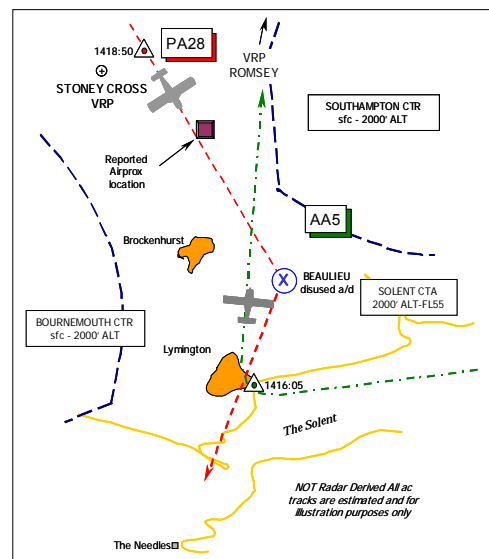
## AIRPROX REPORT NO 157/05

Date/Time: 3 Sep 1420 (Saturday)  
Position: 5053N 00134W (Between Lymington and Romsey VRP)  
Airspace: London FIR (Class: G)  
Reporting Ac Reported Ac  
Type: AA5 PA28  
Operator: Civ Pte Civ Club  
Alt/FL: 1800ft 1800ft  
(QNH 1026mb) (QNH 1025mb)  
Weather VMC Haze VMC Haze  
Visibility: >10nm 5km  
Reported Separation:  
50ft V Not seen  
Recorded Separation:  
Not recorded

**THE AA5 PILOT** reports his ac is coloured white with brown accents and the wing-tip strobes were on whilst in transit on a solo VFR flight from Bembridge to Thruxton in VMC under high cloud and a hazy sun with an in-flight visibility of 10km+. He was in receipt of a FIS from SOLENT APPROACH on 120.225MHz whilst squawking A7000 with Mode C. TCAS is not fitted.

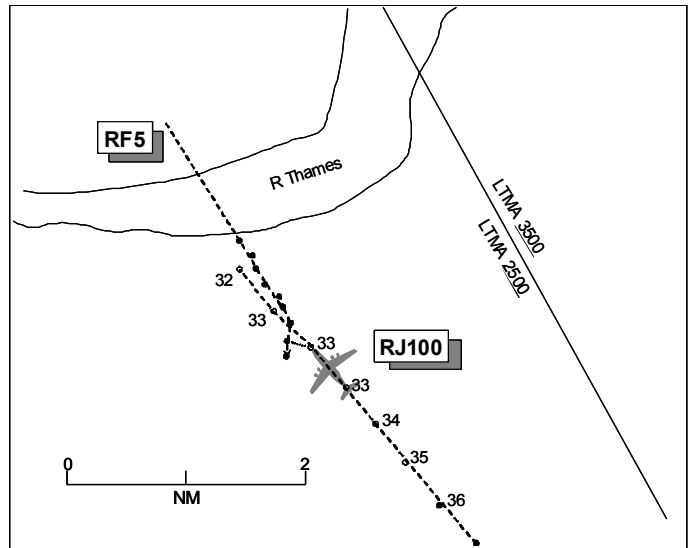
**AIRPROX REPORT NO 158/05**

Date/Time: 5 Sep 1703  
Position: 5126 N 0025 E (10nm NW of Detling)  
Airspace: LTMA (Class: A)  
Reporting Ac Reported Ac  
Type: RJ100 Fournier RF5  
Operator: CAT Civ Pte  
Alt/FL: ↓3000ft 3300ft  
(QNH 1011mb) (QNH)  
Weather VMC VMC HAZE  
Visibility: 50km 10nm  
Reported Separation:  
100ft V/0.3nm H Little V/1/2nm H  
Recorded Separation:  
0.2nm H / V NK

**THE RJ100 PILOT** reports heading 320° at 240kt; while on a radar heading to intercept the localizer at London City, cleared to 3000ft, he received a TCAS TA at 12 o'clock and 2nm. He saw the traffic and disconnected the autopilot. The other ac was seen to take avoiding action so he continued as cleared, passing 100ft below and 0.3nm to the right of the other ac which looked like a Grob. ATC issued no avoiding action.

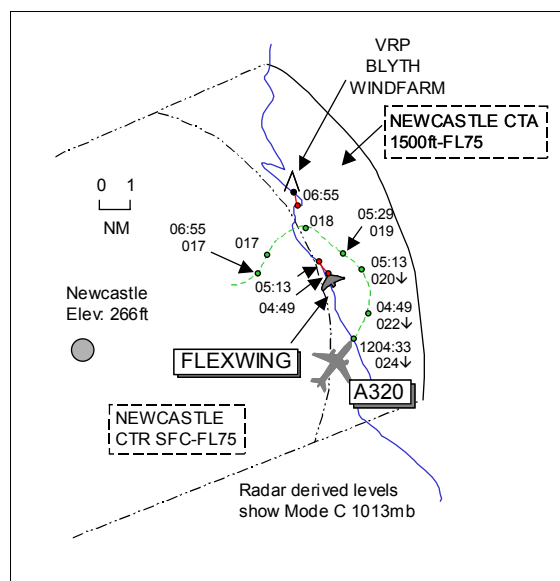
## AIRPROX REPORT NO 159/05

Date/Time: 4 Sep 1206 (Sunday)  
Position: 5506N 00129W (8nm FIN APP RW25 Newcastle - elev 266ft)  
Airspace: CTA (Class: D)  
Reporting Ac Reported Ac  
Type: A320 Pegasus Quantum  
Flexwing M/Light  
Operator: CAT Civ Trg  
Alt/FL: ↓2000ft 1400ft  
(QNH) (QNH 1023mb)  
Weather VMC HZBC VMC CLOC  
Visibility: 5000m >10km  
Reported Separation:  
250-500ft V/0.25nm H 100ft V/500m H  
Recorded Separation:  
NR

**THE A320 PILOT** reports heading 280° at 200kt inbound to Newcastle and in receipt of an ATS from Newcastle Approach on 118.5MHz squawking an assigned code with Mode C. The visibility was 5000m 1000ft below cloud in VMC and the ac's nav, anti-collision and strobe lights were all switched on. During vectors in CAS for an ILS to RW25 descending to 2000ft QNH they were given an intercept heading of 280° and were advised of the presence of a M/Light. During the turn a white coloured Flexwing M/Light was spotted by both crew members 2nm ahead and estimated to be at 1500-1800ft. The PF used the A/P and turned R onto 360° for avoiding action, flying through the LLZ, to initially parallel the M/Light before turning L in a safe arc to pass 0.25nm ahead of and 250-500ft above it, onto a heading of 180° to close the LLZ from the N. The PNF advised ATC of the manoeuvre which was acknowledged. ATC had RT and primary radar contact with the M/Light which was suggested to be outside CAS by its altitude. The Capt's concern was the affect of downwash from his ac with flap2 on the M/Light close below and he assessed the risk as low.

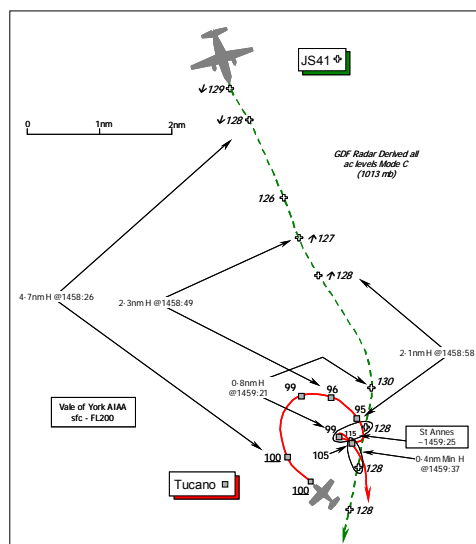
Reported Separation:  
Nil V/1/2nm      2000ft V/1/2nm H

Recorded Separation:  
1300ft V/0-4nm H

**THE JETSTREAM 41 PILOT** reports he was flying from Aberdeen to Humberside and in receipt of a RAS from LONDON MILITARY on 135.42MHz. The assigned squawk was selected with Mode C and TCAS is fitted.
