**UK AIRPROX BOARD**

# **Analysis of Airprox in UK Airspace**

**Report Number 15  
July 2005 – December 2005**

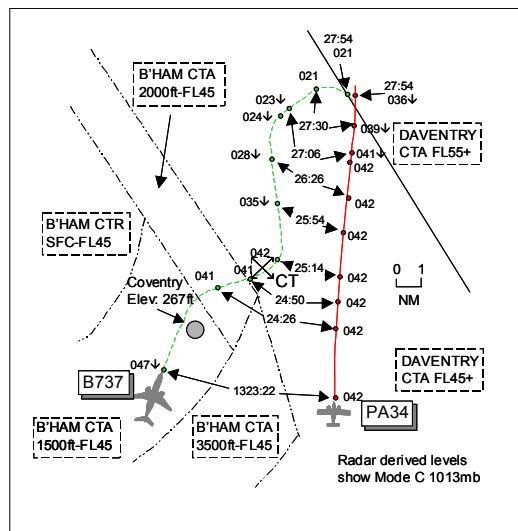
## AIRPROX REPORT NO 161/05

Date/Time: 6 Sep 1325  
Position: 5225N 00119W (7nm NE Coventry - elev 267ft)  
Airspace: FIR (Class: G)  
Reporting Ac Reported Ac  
Type: B737-500 PA34  
Operator: CAT Civ Comm  
Alt/FL: 4000ft↓ 4000ft  
(QNH 1009mb) (RPS 1005mb)  
Weather VMC CLOC VMC CAVK  
Visibility: 30km NR  
Reported Separation:  
Nil V/2.5nm H 1000ft V/2nm H  
Recorded Separation:  
Nil V/2.6nm H

**THE B737 PILOT** reports inbound to Coventry IFR and in receipt of a RAS from Coventry Radar on 119.25MHz squawking an assigned code with Mode C. The latter part of their descent was complicated by many radar contacts both with and without Mode C and a late handover by Birmingham Radar was given in the Coventry O/H descending to 4000ft and a heading of 090° at 200kt. When steady on this heading and still not identified by Coventry Approach, a TCAS contact was seen in their 1 o'clock indicating at the same level. The busy RT precluded any query over the status of this traffic as the TCAS contact aspect remained constant. Despite intensive lookout by both crew members, no visual contact was made. At 2.5nm TCAS range it was obvious that any lack of flight path change was going to result in an RA so the A/P was disconnected and a positive 40° turn away from the contact was made. At this point the FO visually acquired the other ac, the visibility was >30km, and confirmed that it was at their level and then Coventry Radar was able to coordinate the position of both ac and give a further turn away and a descent to 2000ft QNH. At a suitable point a turn back R onto a closing heading for the RW23 ILS was made. By now the other ac was in their vicinity and had also commenced a descent, passing over the top of their ac by 1500ft showing a descent on TCAS and the Capt also saw the ac and identified it as a low wing twin piston engined type. The other ac's pilot then contacted Coventry and identified himself reporting his descent which the controller urgently stopped. The other pilot said that he had been working Brize Radar and had then been advised to contact East Midlands, his destination.

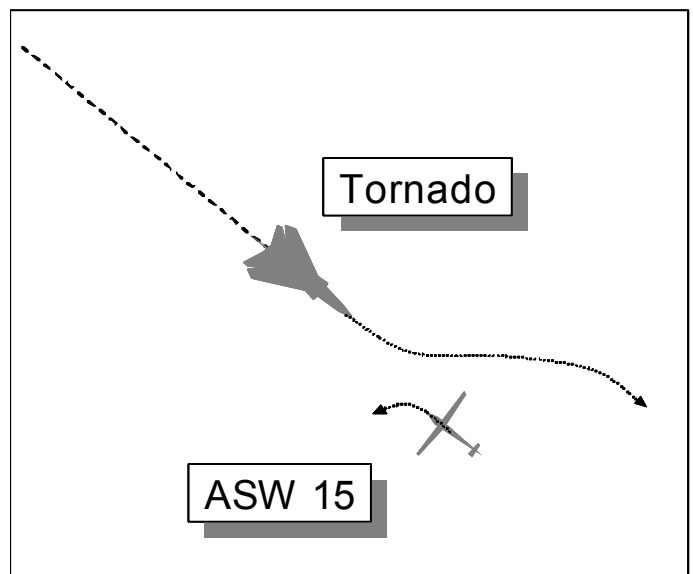
**AIRPROX REPORT NO 162/05**

Date/Time: 7 Sep 1302  
Position: 5534N 0202W (3nm SE Milfield GS - elev 150ft)  
Airspace: LFIR (Class: G)  
First Ac Second Ac  
Type: Tornado ASW 15  
Operator: HQ STC Civ Pte  
Alt/FL: FL130 9826ft (QFE 1001mb)  
Weather VMC CLBL VMC CLBL  
Visibility: Unltd >50km  
Reported Separation:  
 100ft V/500ft H 0ft V/300m H  
Recorded Separation:  
 NK

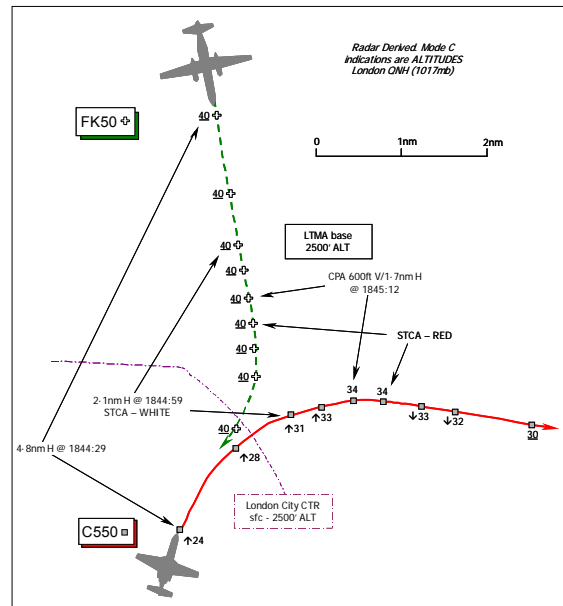
**AIRPROX REPORT NO 163/05**

**THE LTCC THAMES RADAR CONTROLLER** reports that Heathrow SVFR was bandboxed onto the Thames RADAR Control position. The C550 was departing IFR from RW10 at London City with a FK50 inbound from Liverpool IFR, level at 4000ft QNH. As the C550 pilot reported airborne passing 2000ft, climbing to an altitude of 3000ft London QNH (1017mb), he asked the C550 pilot to squawk 'ident' and instructed him to maintain 3000ft followed by an instruction to fly a heading of 110°. A short time later he observed the C550's Mode C indicating an altitude of 3400ft and so he again instructed the pilot to maintain 3000ft. The C550 pilot replied that he was now descending and he then issued an avoiding action R turn onto 270° to the FK50 pilot, who was some 5nm NE of London City. Vertical separation was eroded between the C550 and FK50 down to 600ft and the minimum horizontal separation 1.7nm. STCA was triggered but no TCAS advisories were reported. A short while later standard separation was restored and both flights continued normally.

Cause: The C550 crew climbed above their cleared altitude into conflict with the FK50.

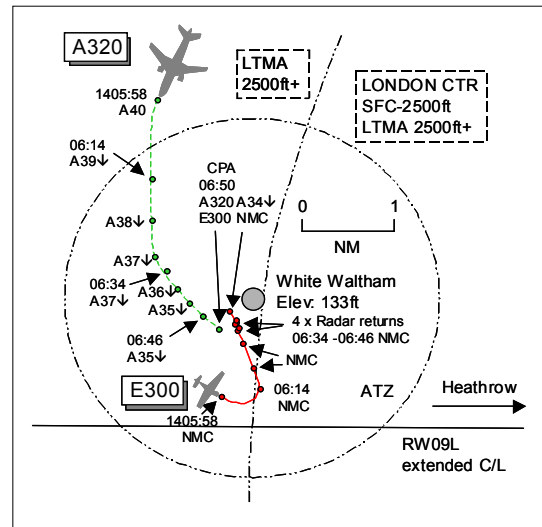
**AIRPROX REPORT NO 164/05**

**THE A320 PILOT** reports inbound to Heathrow at 180kt and in communication with Heathrow Director on 120.4MHz squawking 5016 with Mode C. Descending through 3400ft for 3000ft, 2 TCAS TA alerts were received and a light ac was observed, a yellow/black coloured Extra, climbing towards them at the top of a loop. At the closest point the Extra was approximately 700ft [RT transcript shows pilot reporting 500ft] below their level and operating O/H White Waltham doing aerobatics, passing 400m clear to their L. At the time they were heading 120° on an intercept heading for an approach to RW09L from the N just under the G/S readout.

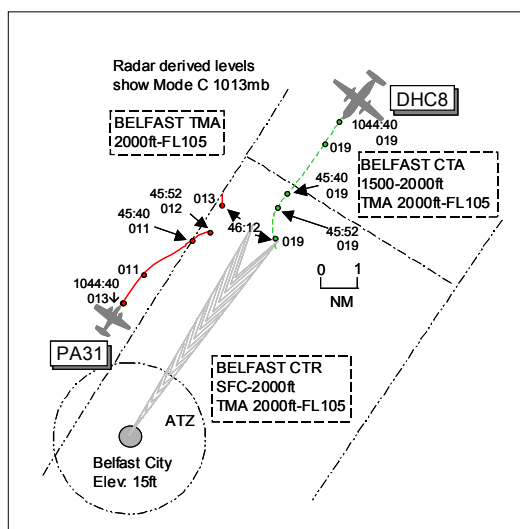
**THE DHC8 PILOT** reports heading 225° at 170kt inbound to Belfast City IFR and in receipt of an ATS from Belfast City Approach then Tower squawking an assigned code with Mode C. They were informed by ATC that traffic was extending visual downwind RH to position behind them; they were LLZ established RW22 and about 0.5nm from the G/P. Flying in and out of cloud, without visual contact with the traffic, TCAS showed traffic -800ft range 3nm converging then -600ft and very close in azimuth (<2nm), which they knew to be imprecise/unreliable, as they approached G/P intercept. The PF disconnected the A/P and initiated a 30° AOB level to climbing L turn through 30°. The other ac was not seen, he thought, but TCAS showed 300-600ft separation vertically. Very shortly after this, they became visual with the airfield and continued to an uneventful landing. He assessed the risk as low but opined that if the ILS descent had been commenced it would have been potentially high as the other ac was converging in elevation and azimuth.

On its extended downwind leg, the PA31 had then flown on a track which converged with the FAT, not parallel to it. An orbit would have kept the PA31 in a position from where its pilot could more easily maintain station relative to the RW and traffic/cct pattern. By extending downwind it would have been difficult for the PA31 pilot to judge the required track, with the airfield and RW behind his ac at range. Members unanimously agreed that the PA31 pilot did not comply with the ATC instructions and flew into conflict with the DHC8 which had caused the Airprox.

Cause: The PA31 pilot did not comply with ATC instructions and flew into conflict with the DHC8.

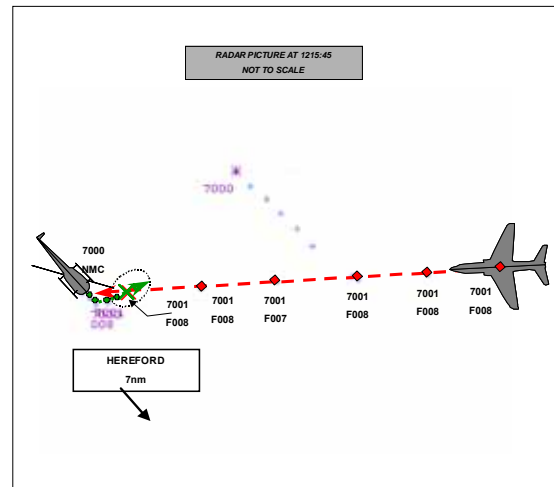
**AIRPROX REPORT NO 167/05**

**THE HAWK PILOT** reports flying a singleton GH sortie with a passenger in a black Hawk ac with HISLs and anti colls selected on, squawking 7001 but with no ACAS fitted. He climbed to 1000ft prior to exiting LFA 4 at the end of low level phase and was heading 260° at 420kt and had been looking right to clear the airspace ahead before a further climb. When he returned his lookout to straight ahead he saw a small red and white R22 helicopter pass 100ft down his LHS. Since he had passed the ac he took no avoiding action but a further climb was initiated and he reported the incident to London Military on contact with them. He assessed the risk as being high.

Members considered that there were several factors that had combined to prevent the Hawk pilot from seeing the R22 earlier: it is very small, it was almost head on, it was dark in colour against a similar background in overcast conditions and it was below the horizon. These, the Board concluded, had combined to thwart an earlier sighting by the Hawk pilot. In following this line of reasoning they considered that both pilots had seen the opposing ac almost as early as physically possible and that the sightings had not been 'late'; that being the case the incident had been a conflict in the FIR. The separation was small (~100m) and Members were unable to determine positively whether the R22 pilot's avoiding action had been conducted in time to have any effect (this would have resolved the conflict). Following that reasoning again the Board considered that safety had not been assured.

Cause: Conflict in the FIR.

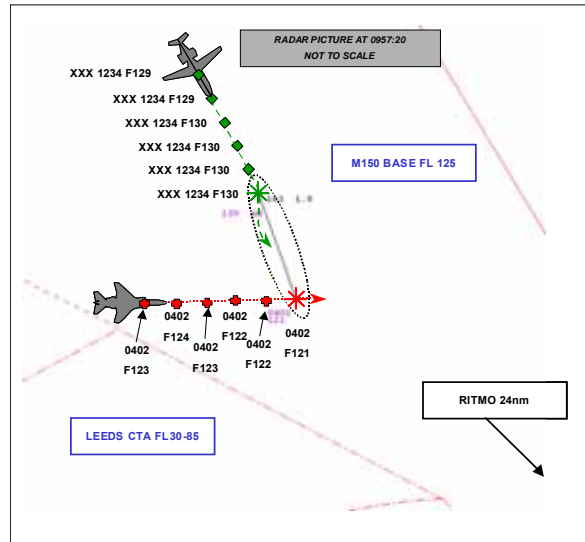
**AIRPROX REPORT NO 168/05**

**THE FK70 PILOT** reports flying a scheduled passenger flight from Durham Tees Valley to Amsterdam. They were heading 156° at 310kt on airway M150, climbing inbound RIMTO, when they got a TCAS TA and ATC reported unidentified military traffic. The traffic came from R to L climbing towards them and immediately ATC gave them avoiding action “Turn right now, heading 270°, avoiding action”. They cleared the military jet by 300ft above and 0.5nm behind it, he thought [recorded separation 900ft and 1.7nm]. The FK70 pilot requested the data of the military ac but none was provided before they were handed over to Amsterdam ATC. However, on landing he called Manchester Radar and details of the other ac were given. He did not assess the degree of risk.

Cause: Sighting report (TCAS).

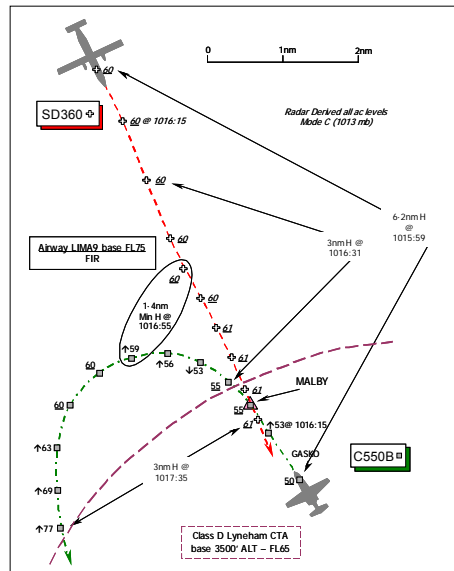
**THE LACC SECTOR23 TACTICAL CONTROLLER (S23TAC)** reports that the C550 departed Lyneham on a SIREN departure and first contacted S23 on a NW'ly track passing FL50 climbing to FL70 squawking A6357. A background track was seen indicating FL60 heading SE towards Lyneham below airway L9 and "almost head-on" to the C550 so an avoiding action L turn instruction was issued and traffic information given to the crew. Whereupon the C550 pilot reported traffic on his TCAS 600ft above his ac and stopped his climb at FL54. Although prescribed separation was lost he did not quantify that which pertained, but added that at the closest point both ac were outside the Lyneham CTR and below the base of LIMA9. After the conflict was resolved the C550 joined CAS without further incident.

Cause: The Lyneham APR permitted the C550B to climb into conflict with the SD360.

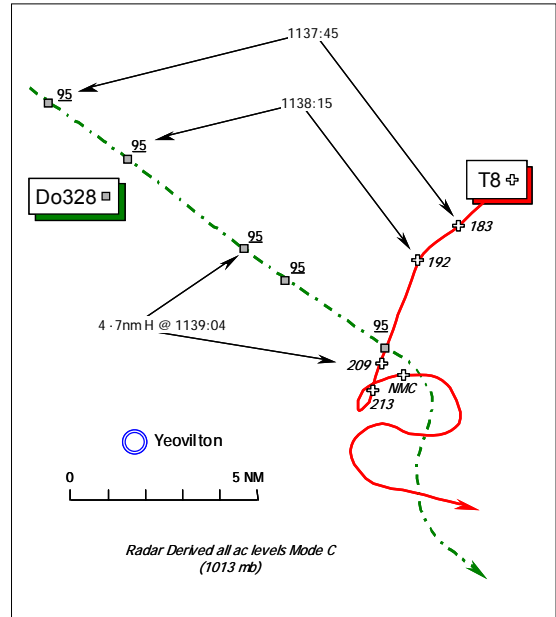
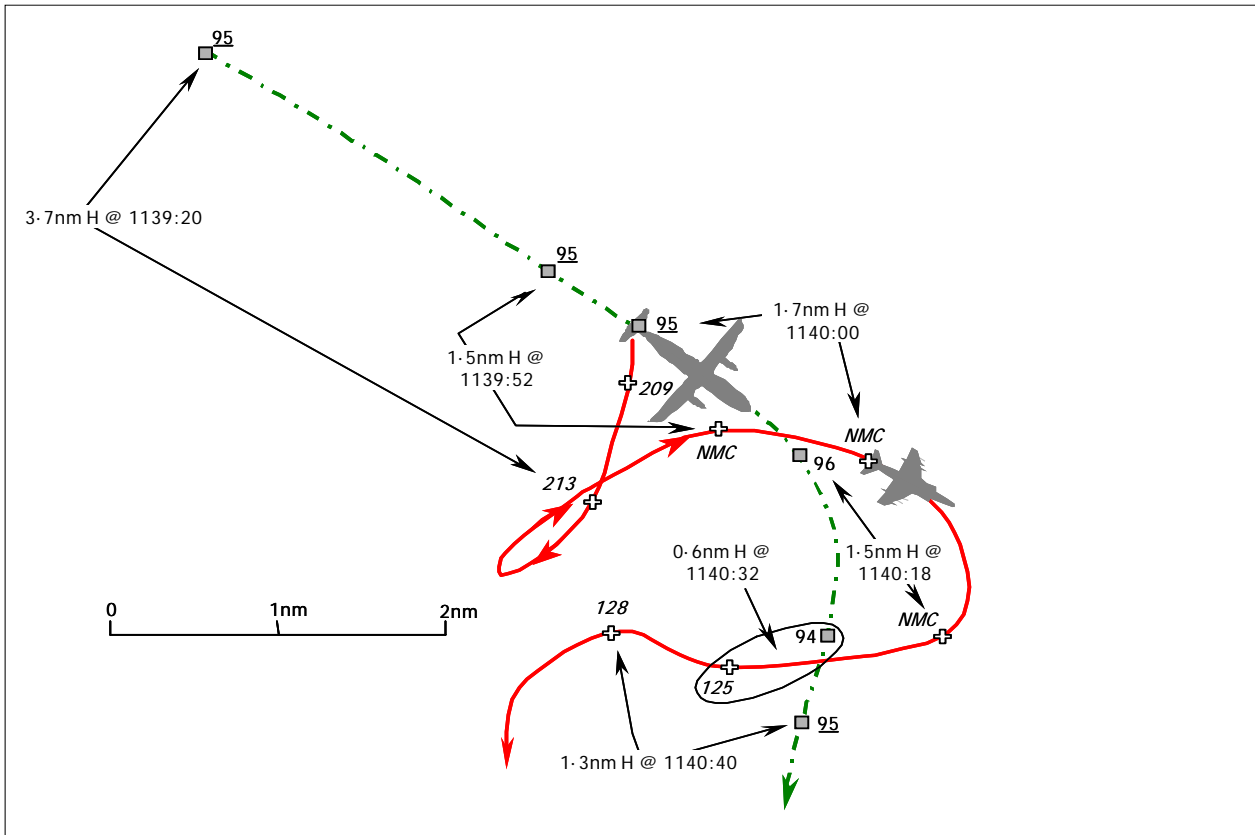
## AIRPROX REPORT No 172/05

Cause: The Harrier T8 crew descended below their co-ordinated level into conflict with the Do328 which they did not see.

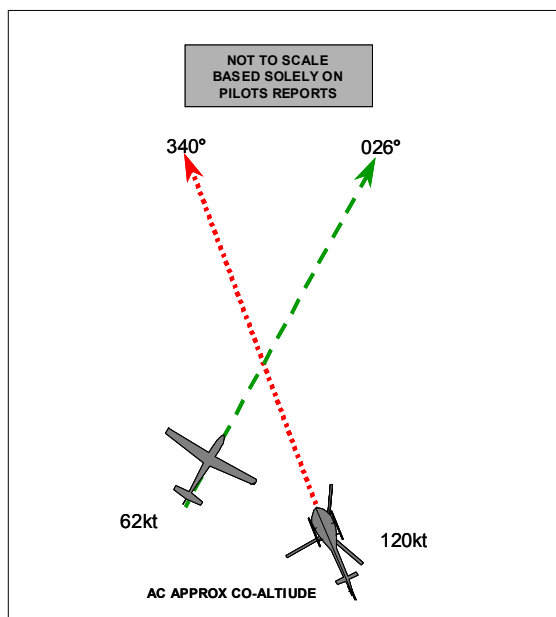
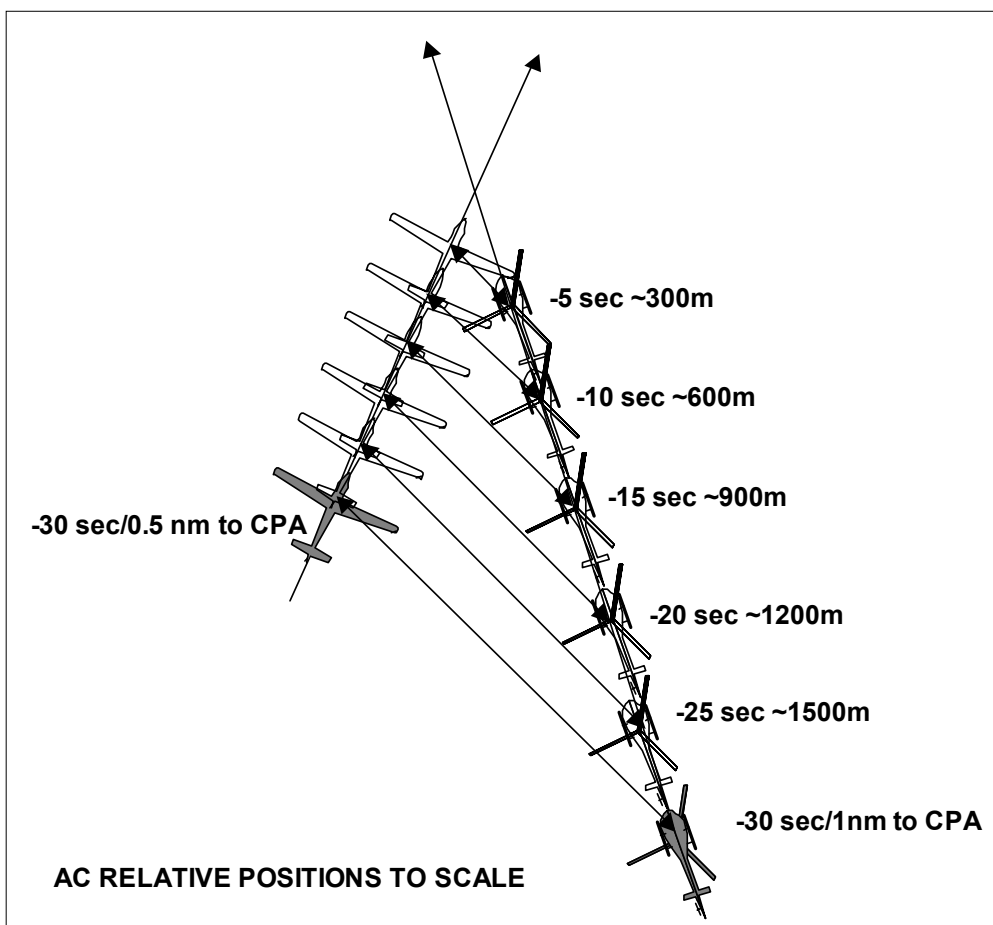
**AIRPROX REPORT NO 173/05**

**THE ASK 21 GLIDER PILOT** reports flying a white and red glider returning to Seighford airfield heading 023° at 62kt following an unsuccessful attempt to find wave with the second pilot flying the glider from the front cockpit. They were in heavy sink at the time and unsure if they would make it to the airfield when the HP exclaimed “*Helicopter*” and started a moderate descent and 1-2sec later he saw the helicopter on his R about 100yd away and slightly above them, clearing them by 20–30ft vertically. He only saw the front view and underside so he could not determine the colour of the fuselage but its underside was blue, it was single rotor and had skids. The HP first saw the helicopter in their 3 o’clock position, 200yd away and assessed that only the avoiding action had prevented a collision; the helicopter did not alter course and showed no sign of having seen him.

Cause: Effective non-sighting by the AS350 pilot and a late sighting by the glider pilot.

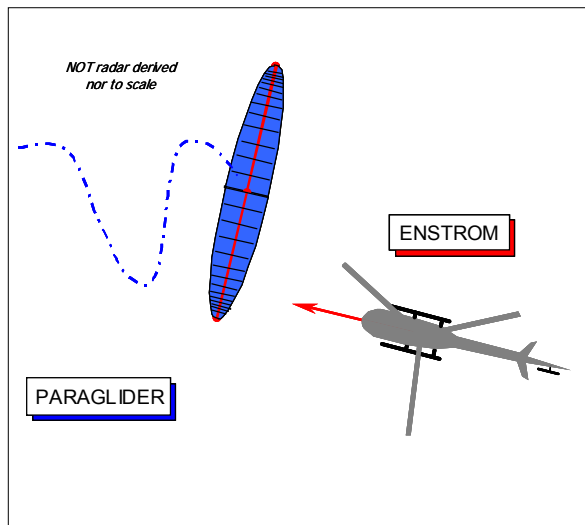
### AIRPROX REPORT NO 174/05

**THE OZONE ELECTRON (MEDIUM) PARAGLIDER PILOT** reports his paraglider has a blue upper wing surface with a red longitudinal stripe and white underneath. He was soaring above the cliffs between Charmouth (Dorset) and Golden Cap near West Bay, either crabbing along the cliffs W to E - i.e. at 45° to the wind - or trying to gain a bit of height, when he first saw the black helicopter as it approached from over the top of the cliffs at Golden Cap about 2nm away to the E. At the point where he was soaring at the time the cliffs are not sheer, they actually slope and shelve back a couple of hundred yards or more, in a couple of steps to their highest point. The wind was giving him plenty of lift in this area between the front cliffs and the highest point to landward but he was not over the sea. As the helicopter approached, he turned directly toward it [E]ly and made some 'S' turns both to avoid the helicopter and to try and make himself more conspicuous but the helicopter pilot made no alteration at all to his course. The helicopter passed 100-150ft directly overhead and as it did so the paraglider pilot recalled he was most definitely facing the helicopter's direction of approach and waving his arms frantically to show that he was concerned and even shouting - not that the helicopter pilot would have heard him! He assessed the risk of his wing collapsing as "high".

Cause: The Enstrom 280 helicopter pilot flew sufficiently close to cause the paraglider pilot concern for his safety.

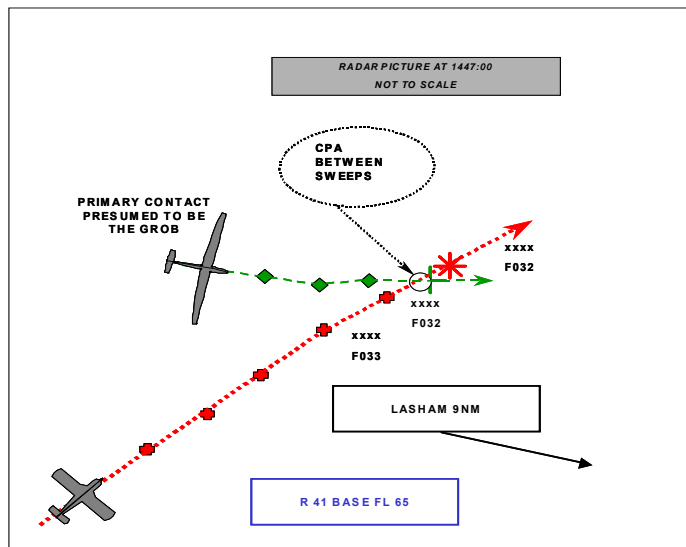
### AIRPROX REPORT NO 175/05

**THE GROB GLIDER PILOT** reports flying a white glider, dual, on a cross-country flight returning to Lasham and listening out on a gliding frequency. While 9nm W of the field on a heading of 193° at 52.4kt, the HP in the rear seat first saw an ac come into view from under the starboard wing, approximately midway between root and tip. The ac - a low-wing, single engine, 4-seater - was white and blue or brown in colour and it was in level flight. From his perspective it seemed that the other ac yawed markedly to starboard as it passed underneath and slightly in front. The heading of the other ac was estimated to be approximately 025° +/- 005°. From a front seat (P2) perspective, the other ac appeared to pass in front of them and below. The entire fuselage could be seen but the glider nose obscured some of the port wing. As the ac was overtaking him from behind he did not take any avoiding action but considered the risk of collision as being severe. He provided a snapshot from the datalogger to verify the ac position, height and speed.

Cause: Effective non-sighting by both pilots.

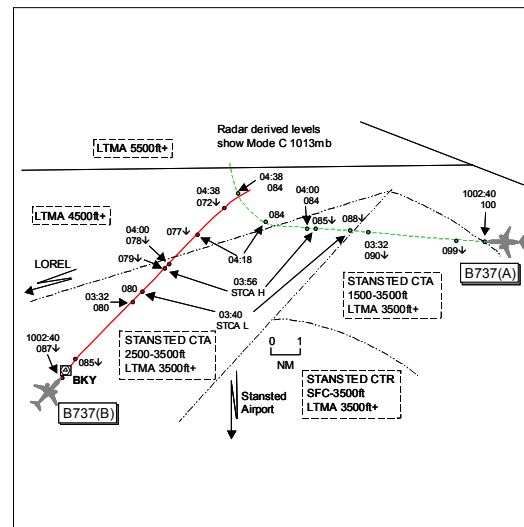
## AIRPROX REPORT NO 177/05

**THE B737(A) PILOT** reports inbound to Luton IFR heading 285° at 220kt and in receipt of an ATS from Essex Radar on 120.62MHz squawking 4106 with Mode C. Passing FL87 having been cleared for descent to FL80, the Capt observed a potential conflict and immediately reduced the ROD to 300fpm. A TA alert was received and almost immediately ATC gave an avoiding action instruction to "maintain altitude, turn right heading 360°". The descent was arrested at FL83 and the other ac was seen in the CAVOK VMC, believed to an XYZ company B737, to pass 2nm away and 700ft below. He assessed the risk as high. The controller stated that their cleared level was FL90 but both crewmembers heard FL80 and read this level back without being challenged.

Cause: The LTCC Stansted INT vectored B737(A) into conflict with B737(B).

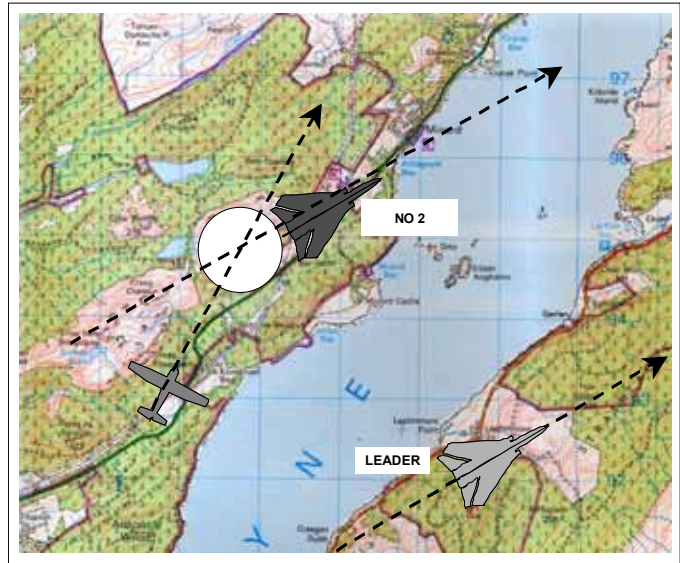
**THE TORNADO PILOT** reports flying a grey ac with HISLs and nav lights switched on as part of a 3-ship evasion sortie on a return from RAF Leuchars to RAF Lossiemouth. Just prior to the incident, his ac was steady at 1180ft, regional QNH, 700ft RAD ALT, 504 KIAS and heading 060° (all confirmed from the HUD tape). At 1502:25 his leader, who was flying 4km battle formation to the S [his right], called '*pull up climb climb*' on the intra-formation frequency. He immediately responded by climbing and as he did so saw the light civil ac (high wing, white, possibly a Cessna 152/172) pass just L of and directly beneath him at 1502:27.

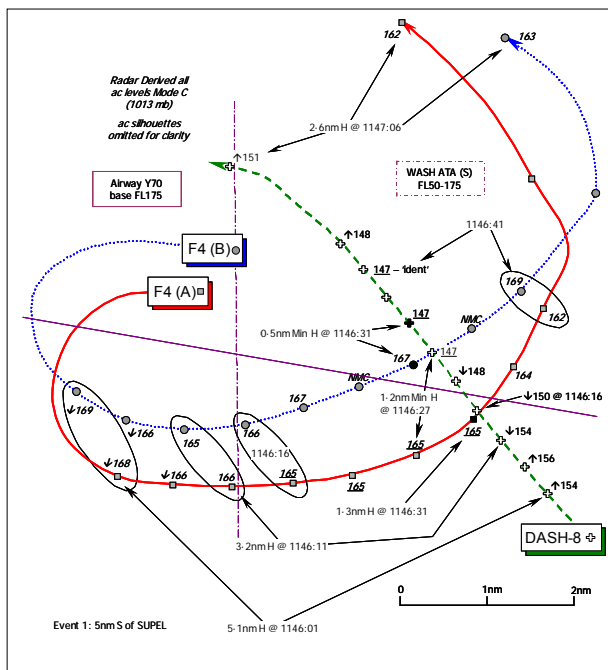
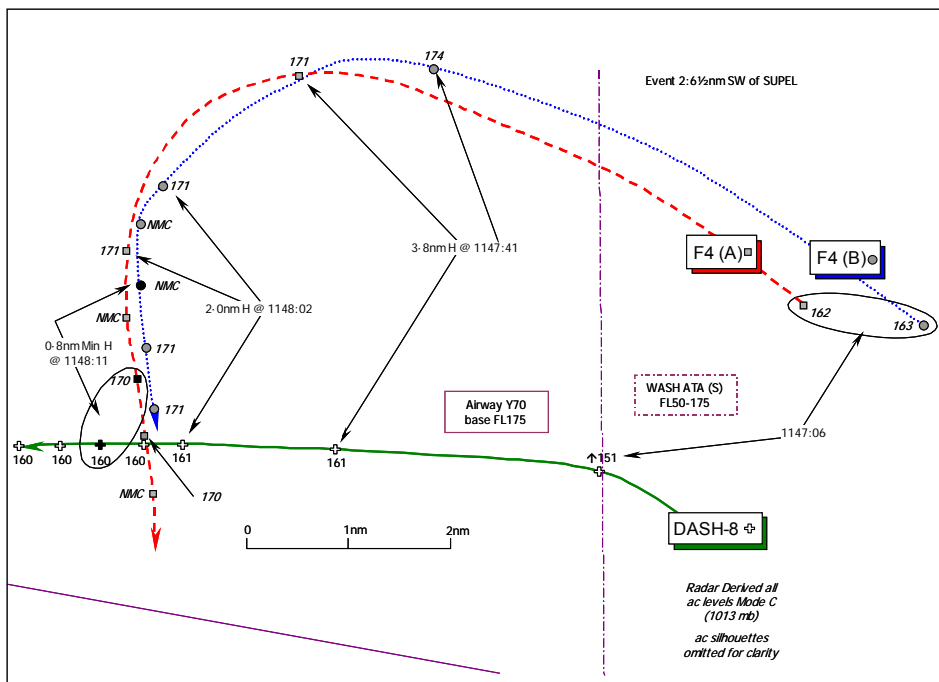
### AIRPROX REPORT NO 182/05

**THE DHC-8 SERIES 400 PILOT** reports that he was in transit from Norwich to Edinburgh on an IFR FPL but flying in VMC some 3000ft above cloud. TCAS is fitted. Climbing to FL170 they had departed from Norwich and had been in receipt of an ATS from Norwich ATC who handed them over to LONDON MILITARY. It was during this frequency change that the Airprox occurred. Heading he thought 360°, at 210kt they were first alerted to the presence of other ac by a TCAS TA on traffic at 11 o'clock about 4nm away. TCAS indicated that the other ac were 500ft above them with the vertical separation reducing, whereupon the TA rapidly changed to an DESCEND RA at about 2000ft/min, which was followed with a level excursion of about 2000ft. They were just calling LONDON MILITARY on handover from Norwich ATC but had not established contact with the controller until after the TCAS RA, when one of the two ac - he identified them as F4 fighters - passed behind them in a descending L turn. This first ac seemed to be joined by his wingman and they appeared to turn towards his DHC-8 causing a second TCAS TA - but no RA was enunciated this time. After contact had been established with LONDON MILITARY, who passed avoiding action in both heading and level with a L turn of 60-90° as the F4's closed from starboard, the controller said they were European fighters on an exercise and not talking to anyone. Minimum separation was about 1nm horizontally, 100ft vertically. Once he had spotted the ac the risk was "low" - because he could see that visual separation was going to be maintained, but with no TCAS warning "medium - high". He added that during this leg the 1<sup>st</sup> Officer was the PF who remained "eyes inside following the TCAS RA" whilst he looked for the ac and called the separation.

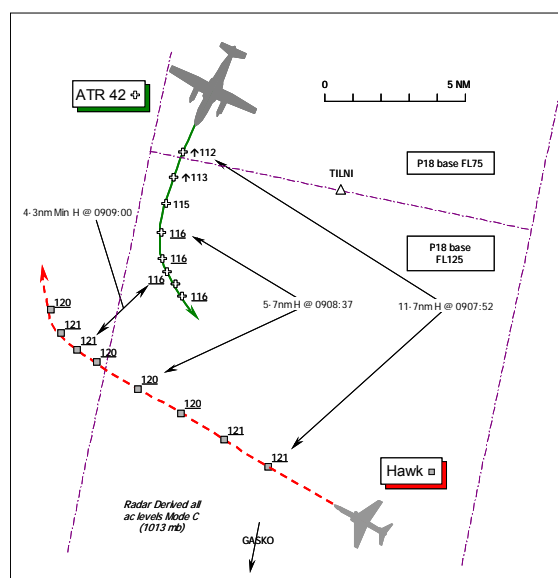
**THE ATR42 PILOT** reports that he was enroute from Newcastle to Cardiff under IFR and had just switched to Manchester ACC on 125.95MHz. A squawk of A5414 was selected with Mode C; TCAS is fitted. About 10nm N of GASKO, heading 200° at 180kt climbing through FL116 in VMC, a dark coloured military jet – the Hawk - was spotted 3nm away. To avoid the Hawk he turned L onto 090° and stopped the climb as the jet crossed 3nm ahead from L – R with vertical separation of about 300ft as the Hawk climbed above them. He assessed the risk as “low”. He added that their departure from Newcastle was in “uncontrolled” Class G airspace. Furthermore Newcastle RADAR could not visually confirm that they had reached CAS because Newcastle’s SSR was u/s and thus the controllers could not see his ATR42’s indicated level on their radar display.

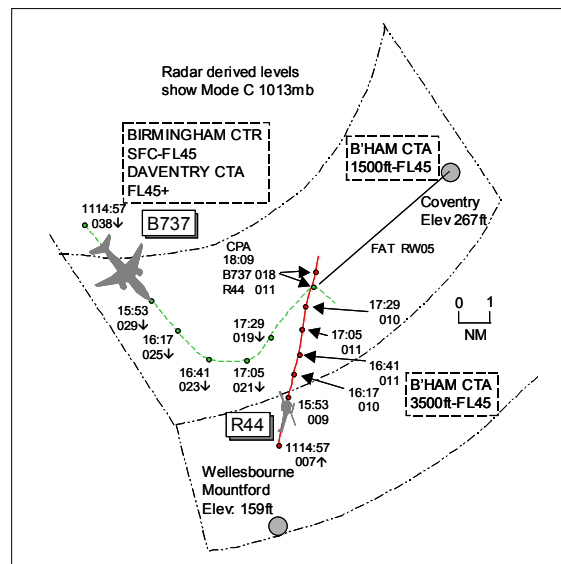
**AIRPROX REPORT NO 185/05**

**THE B737 PILOT** reports inbound to Coventry IFR and in communication with Coventry Approach on 119.25MHz squawking 1050 with Mode C. During radar vectors towards final approach, TCAS indicated proximate traffic ahead. On a LLZ intercept heading at 2000ft, flaps 5 at 170kt in IMC, the proximate traffic was still on final approach indicating 1300ft and at approximately 6nm from the threshold RW05. ATC informed them of the traffic, possibly an R22 helicopter, but they were unable to identify it visually as they were flying in and out of cloud at 2000ft. ATC then cleared them for descent to 1500ft. The offer was declined but they asked to turn L to avoid and maintain 2000ft. They were instructed to turn R onto 150°; a TA alert was then received with vertical separation showing 700ft. They believed they flew directly over the top of the other ac (TCAS showed <0.5nm separation) and once clear they asked for further vectors to RW05. The Approach controller informed them that he would be filing a report.

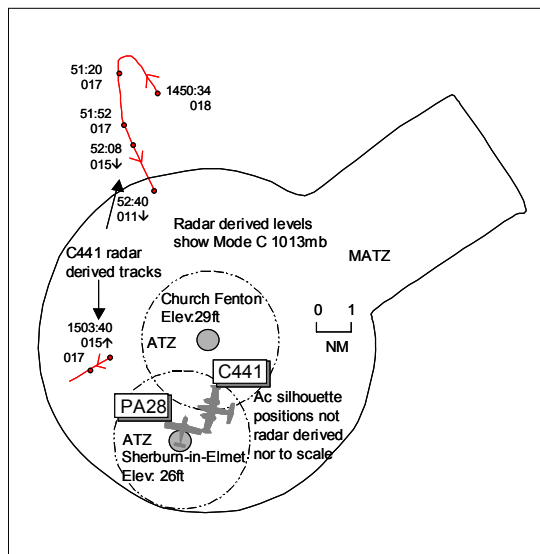
## AIRPROX REPORT NO 187/05

**THE PA28 PILOT** reports flying a dual training sortie from Sherburn-in-Elmet and in communication with Sherburn Radio on 122.6MHz, squawking standby. The visibility was 20km; he was flying 1000ft below cloud in VMC and the ac was coloured white with strobe lights on. Initially he was circling L O/H Sherburn-in-Elmet at 80kt on a standard O/H join at 1500ft Church Fenton QFE, explaining the significance of the signal square and the deadside descent to his student. He then began to track 020° to position the ac well to the deadside of RW29, the intention being to begin a descent to 1000ft. The student pointed out an ac in their 1-2 o'clock at a similar level which had hitherto been obscured by the windscreen pillar and which was on a constant relative bearing about 600-800m away and converging. It was a light twin-engine type with its gear retracted. He immediately dived the ac and turned L to avoid it. The next time he saw the twin it was on the same course as themselves, about 270°, about 200ft above and 500m clear on the R; he thought the other pilot had not seen his ac. After landing he contacted Church Fenton ATC who informed him that the twin was a 'calibrator' which had been instructed to turn L on going around but had turned R and consequently flown through the Sherburn-in-Elmet ATZ. He went on to say that he had become concerned about the situation at Sherburn. Flying 4-5 days a week, in the previous 9 months he had experienced 5 incidents involving other ac joining the cct inappropriately which had required prompt action to avoid collision. His experiences had also been shared by other instructors at the airfield.

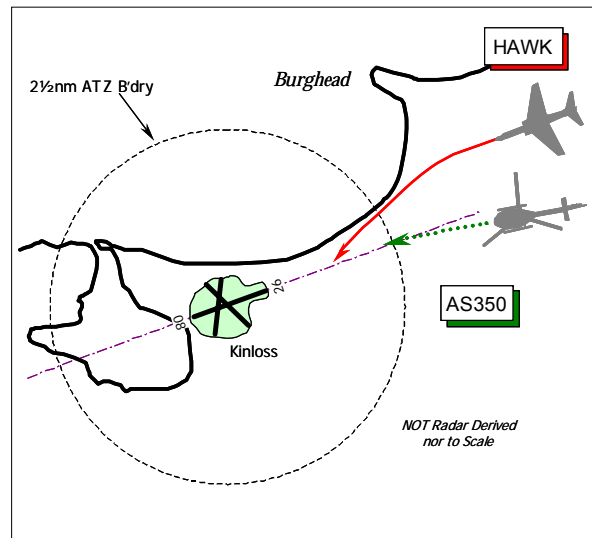
**AIRPROX REPORT NO 188/05**

**THE AS350 SINGLE SQUIRREL HELICOPTER PILOT** reports his ac has a dark colour-scheme and the HISLs were on whilst in transit from E of Kinloss to Inverness. Flying some 1500ft clear below cloud with an in-flight visibility of >10km, he was in communication with KINLOSS TOWER on 122.1MHz whilst executing the MATZ penetration. A squawk of A0036 was selected with Mode C but neither TCAS nor any other form of CWS is fitted.

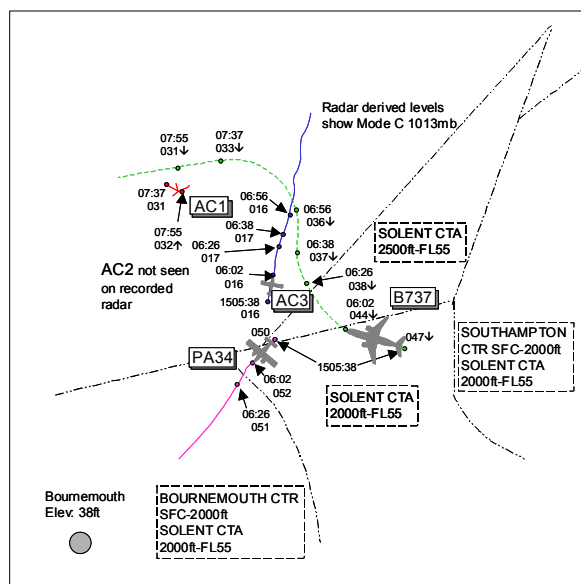
## AIRPROX REPORT NO 189/05

Date/Time: 17 Oct 1508  
Position: 5059N 00145W (13nm NNE Bournemouth - elev 38ft)  
Airspace: LFIR (Class: G)  
Reporting Ac Reported Ac  
Type: B737-300 Untraced ac x2  
 AC1 and AC2  
Operator: CAT N/K  
Alt/FL: 3300ft↓  
 (QNH 1019mb)  
Weather VMC CLOC NK  
Visibility: 10km  
Reported Separation:  
 AC1 NR AC2 500ft V/2nm H  
Recorded Separation:  
 AC1 200ft V/0.9nm H, AC2 NR

Cause: The Solent APR vectored the B737 outside CAS and into conflict with an untraced ac and subsequently with a further, undisplayed ac.

The NATS Advisor informed Members that there were Human Factor issues relating to this incident and that recommendations and actions had subsequently been made and taken. Solent ATC will be creating scenarios within the Unit Training Plan to gain practise in dealing with similar situations. Also, Operational Notices (OPNOTs) have been produced to: a) remind controllers of the necessity to advise ac crews when they are positioned outside CAS and b) highlight the need for careful consideration to be given of all options before changing a plan.

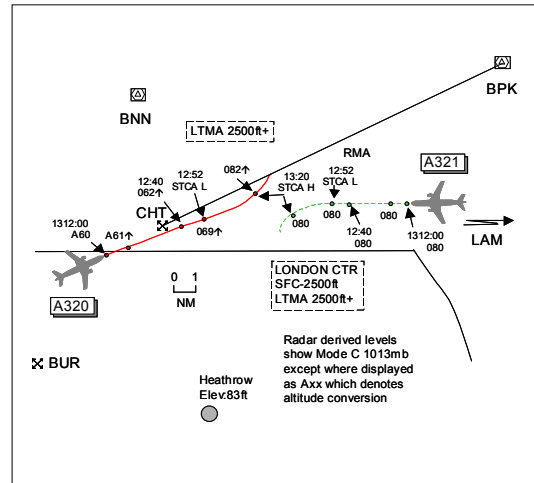
**AIRPROX REPORT NO 190/05**

Date/Time: 3 Oct 1310  
Position: 5139N 00023W (11nm N Heathrow)  
Airspace: LTMA (Class: A)  
Reporting Ac Reported Ac  
Type: A321 A320  
Operator: CAT CAT  
Alt/FL: FL80 ↑FL110  
Weather VMC CLBC VMC CLOC  
Visibility: 10km 50km  
Reported Separation:  
 nil V/2nm H NR  
Recorded Separation:  
 200ft V/1.9nm H

Cause: The LTCC NE Deps SC dispensed with vertical separation without ensuring lateral separation.

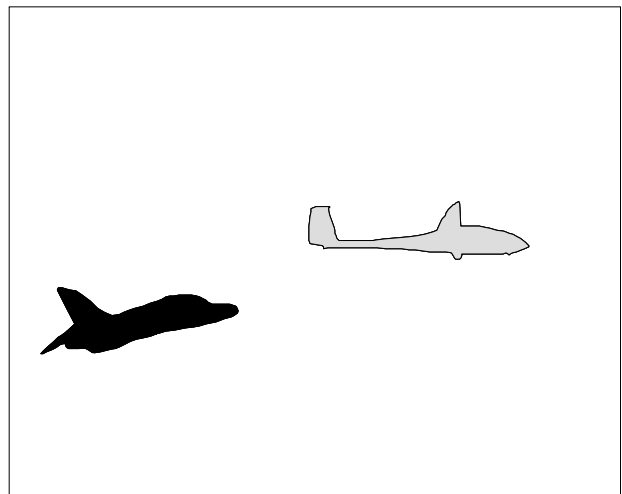
**AIRPROX REPORT NO 191/05**

Date/Time: 27 Oct 1045  
Position: 5537N 00155W (7nm ENE Milfield)  
Airspace: Scottish FIR (Class: G)  
Reporting Ac Reporting Ac  
Type: Hawk Janus Glider  
Operator: HQ STC Civ Pte  
Alt/FL: 5500ft 4500-5000ft  
(QNH 983 mb) (QFE Milfield)  
Weather VMC HAZE VMC CAVOK  
Visibility: >8km 20-30km  
Reported Separation:  
50ft V/ >20 yards H <200ft V  
Recorded Separation:  
NR

Cause: Effective non-sighting by the Hawk pilot.

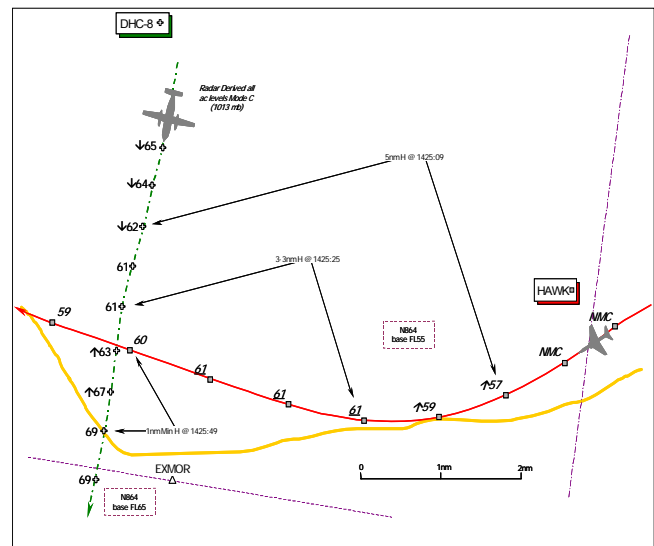
**AIRPROX REPORT NO 192/05**

Date/Time: 27 Oct 1425  
Position: 5112N 00322W (1¼nm NW of EXMOR)  
Airspace: Airway N864 (Class: A)  
Type: DHC-8  
Operator: CAT  
Alt/FL: FL60↓ SAS (RPS 995mb)  
Weather: VMC CLAC VMC CLOC  
Visibility: 10km 8km  
Reported Separation: 200ft V/4-500m H 1000ft V/2nm H  
Recorded Separation: Nil V @ 3.3nm H  
 1nm Min H @ 900ft V

Cause: The Hawk student pilot penetrated Class A CAS without clearance and flew into conflict with the DHC-8.

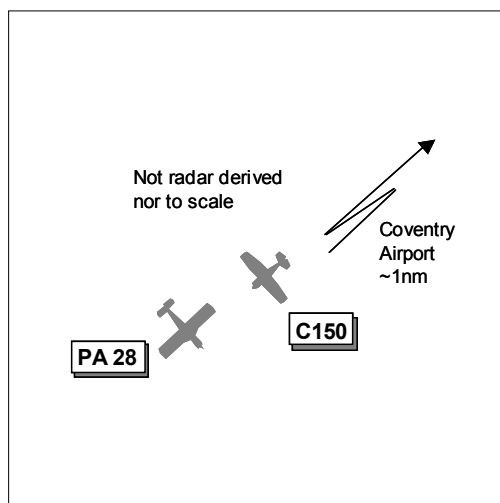
## AIRPROX REPORT NO 193/05

Date/Time: 23 Oct 1528 (Sunday)  
Position: 5221N 00130W (1nm SW Coventry - elev 267ft)  
Airspace: ATZ (Class: G)  
Reporting Ac Reported Ac  
Type: C150 PA28  
Operator: Civ Trg Civ Trg  
Alt/FL: 400ft↑ 1000ft  
(QFE 1002mb) (QFE)  
Weather VMC NR VMC CLBC  
Visibility: 8km 'good'  
Reported Separation:  
10-15m 250ft V  
Recorded Separation:  
NR

Cause: Following a go-around, the PA28 pilot did not integrate safely into the visual cct.

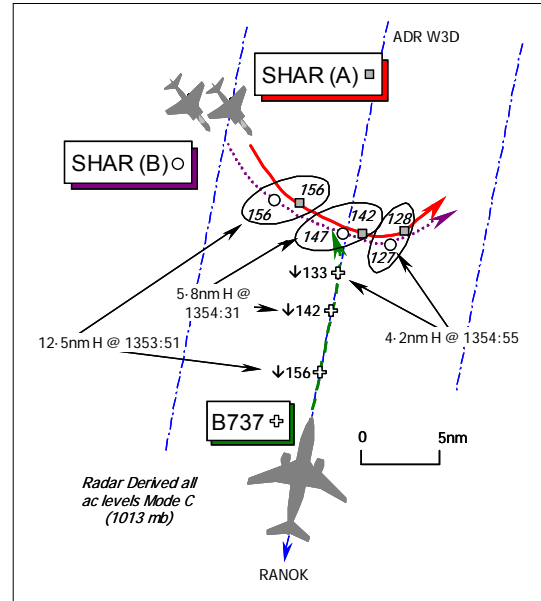
Reported Separation:  
 W Coast TAC: 500ft V/3-6nm H  
 Slightly below/3-5nm H 5nm H

Recorded Separation:  
 B737 v SHAR (B)600ft V @ 4-2nm MinH  
 200ft Min V @ 4-8nm H

Cause: Whilst crossing the ADR, the descent of the SHAR pair caused the controller concern.

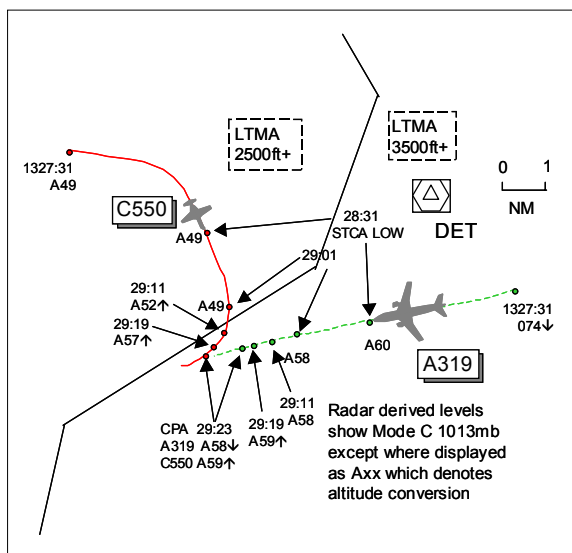
## AIRPROX REPORT NO 195/05

Date/Time: 21 Oct 1329  
Position: 5113N 00026E (7nm SW DET)  
Airspace: LTMA (Class: A)  
Reporting Ac Reported Ac  
Type: A319 C550  
Operator: CAT Civ Comm  
Alt/FL: 6000ft↓ 5800ft↑  
(QNH) (QNH)  
Weather VMC CLOC VMC CLOC  
Visibility: >10km NR  
Reported Separation:  
700ft V/1-2nm H 2nm H  
Recorded Separation:  
100ftV/1nm H

Cause: The LTCC BIG/TIMBA SC did not take the A319 into account when vectoring the C550.

The NATS Advisor informed Members of two recommendations, which have been made by NATS. Firstly, the operation of priority telephone lines between sectors is highlighted in LTCC student training and to controllers via Local Competency Exam (LCE) bulletins. Secondly, the Head of LTCC Training should consider a means of providing simulator opportunities for controllers to practise avoiding action skills.

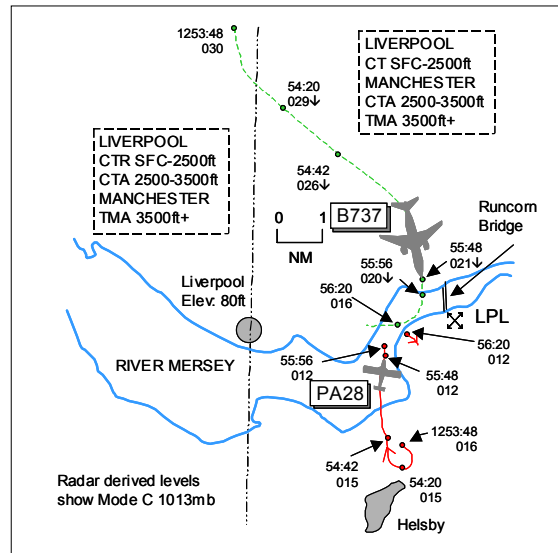
**AIRPROX REPORT NO 196/05**

Date/Time: 2 Nov 1256  
Position: 5320N 00245W (3nm FIN APP RW26  
 Liverpool - elev 80ft)  
Airspace: CTR (Class: D)  
Reporting Ac Reported Ac  
Type: B737-800 PA28  
Operator: CAT Civ Pte  
Alt/FL: 1400ft↓ 1000ft  
 (QNH 997mb) (QFE 994mb)  
Weather VMC CLOC VMC CLOC  
Visibility: >10km  
Reported Separation:  
 300ft V/600-700ft H 400ft V/1000m H  
Recorded Separation:  
 400ft V/0-3nm H

Cause: The Liverpool ADC cleared the B737 and PA28 into conflict.

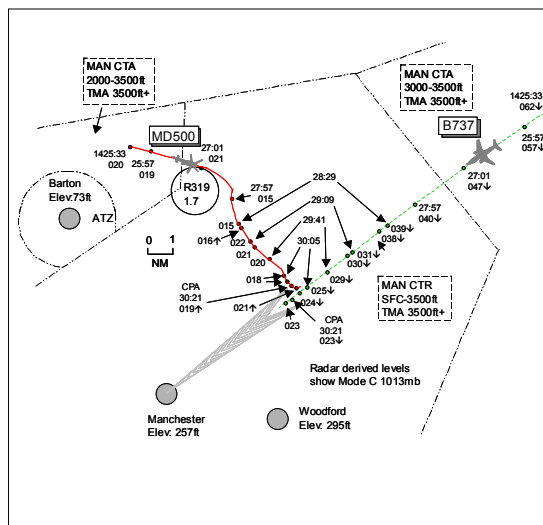
## AIRPROX REPORT NO 197/05

**Date/Time:** 23 Oct 1430 (Sunday)  
**Position:** 5325N 00208W (6nm FIN APP  
RW24R Manchester - elev 257ft)  
**Airspace:** CTR (Class: D)  
**Reporting Ac** **Reported Ac**  
**Type:** B737-400 MD500  
**Operator:** CAT Civ Pte  
**Alt/FL:** 2000ft↓ NR  
(QNH 1011mb) (N/K)  
**Weather** IMC KLWD VMC CLOC  
**Visibility:** >10km  
**Reported Separation:**  
300ft V/1nm H 500ft V/3nm H  
**Recorded Separation:**  
400ft V/0.5nm H

Cause: The MD500 pilot entered the Manchester CTR without clearance and then did not comply with his ATC instructions and flew into conflict with the B737.

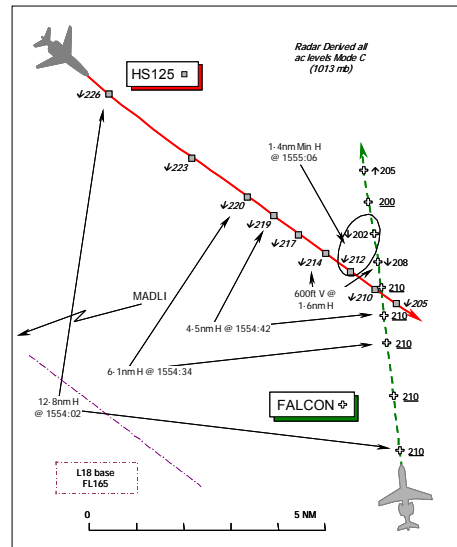
**AIRPROX REPORT NO 198/05**

Date/Time: 9 Nov 1555  
Position: 5215N 00232W (17nm ENE of MADLI)  
Airspace: London FIR (Class: G)  
Reporting Ac Reported Ac  
Type: Falcon 20 HS125-700  
Operator: Civ Comm HQ STC  
Alt/FL: FL210 FL210↓  
Weather: VMC Nil cloud VMC Nil cloud  
Visibility: 10km+ Unlimited  
Reported Separation:  
Not seen 500-1000ft V/1-2nm H  
Recorded Separation:  
600ft Min V @ 1.6nm H  
1.4nm Min H @ 1000ft V

Cause: The HS125 crew flew close enough to the Falcon to induce a TCAS RA.

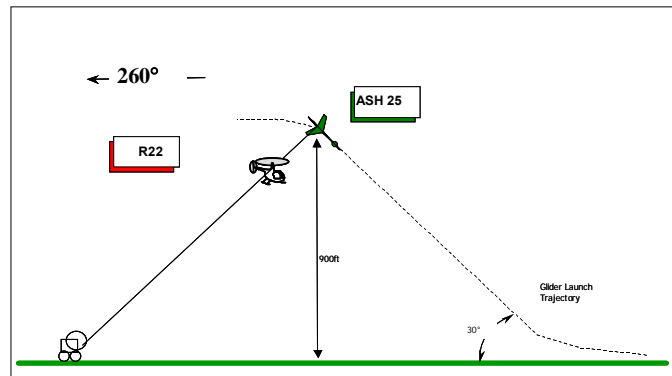
## AIRPROX REPORT NO 199/05

Date/Time: 13 Nov 1408 (Sunday)  
Position: 5611N 00320W (Portmoak Airfield - elev 360 ft)  
Airspace: Scottish FIR (Class: G)  
Reporting Ac Reported Ac  
Type: ASH 25 Robinson R22  
Operator: Civ Club Civ Pte  
Alt/FL: 900ft 1500ft  
(QFE ) (N/K)  
Weather VMC CLOC VMC  
Visibility: 50nm 30km  
Reported Separation:  
200ft V/200m H NR  
Recorded Separation:  
NR

Having considered all the information available, the Board concluded that the sole cause of the incident had been the R22 pilot overflying the glider site without seeing the glider. Members also agreed unanimously that this action had compromised the safety of both his helicopter and the glider but by good fortune the flightpath of the R22 had been such that it was not in direct conflict with that of the glider, the pilot of which had little opportunity to take any avoidance.

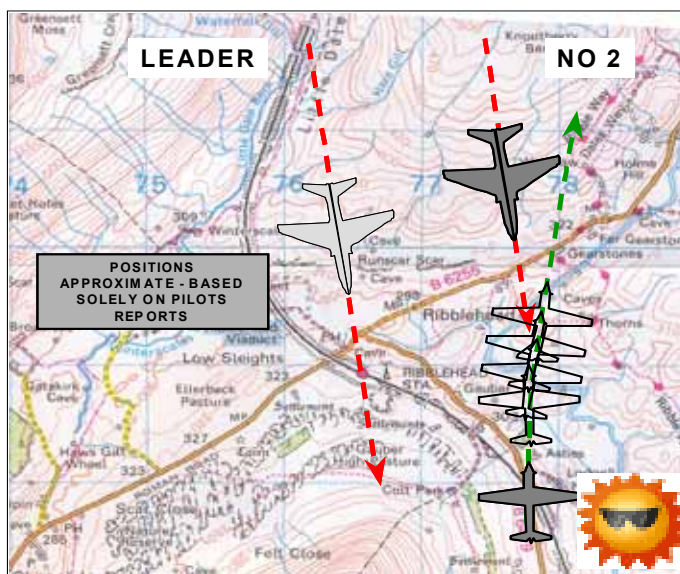
## AIRPROX REPORT NO 200/05

Date/Time: 18 Nov 1055  
Position: 5413N 00220W (1nm E Ribblehead Viaduct)  
Airspace: UKDLFS LFA17 (Class: G)  
Reporting Ac Reported Ac  
Type: Tucano Hawk  
Operator: HQ PTC HQ PTC  
Alt/FL: 300ft agl 250ft agl  
(RPS 1020 mb) (RPS 1023 mb)  
Weather VMC CLOC VMC CLOC  
Visibility: >50km >10km  
Reported Separation:  
100ft V/0ft H 0ft V/200m H  
Recorded Separation:  
NR

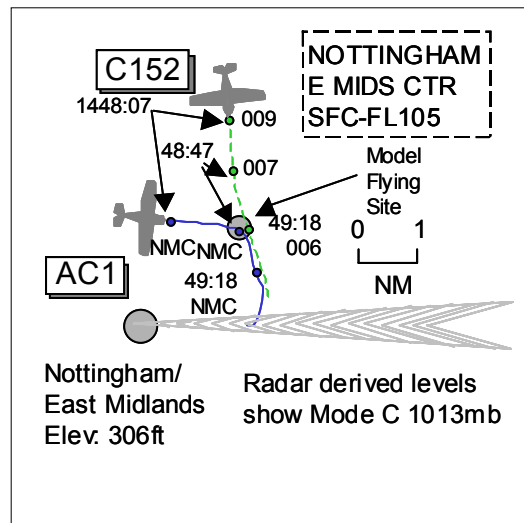
## AIRPROX REPORT NO 201/05

Date/Time: 19 Nov 1449 (Saturday)  
Position: 5252N 00117W (2.5nm NE East Midlands - elev 306ft)  
Airspace: CTR/ATZ (Class: D)  
Reporting Ac Reported Ac  
Type: C152 Model ac  
Operator: Civ Trg N/K  
Alt/FL: 1000ft↓  
(QFE 1022mb) (N/K)  
Weather VMC SKC  
Visibility: 9km  
Reported Separation:  
Nil V/30ft H  
Recorded Separation:  
NR

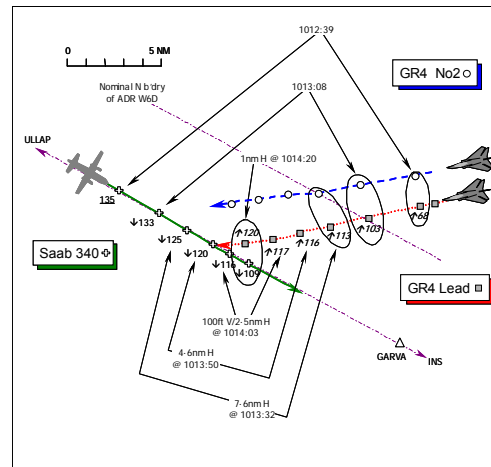
## AIRPROX REPORT NO 202/05

**Date/Time:** 22 Nov 1014  
**Position:** 5747N 00446W (27nm NW of INS)  
**Airspace:** ADR W6D (Class: F)  
**Reporting Ac** **Reported Ac**  
**Type:** Saab 340B Tornado GR4 pr  
**Operator:** CAT HQ STC  
**Alt/FL:** ↓FL115 FL120↑  
**Weather** VMC CLOC VMC NR  
**Visibility:** 50km 20km  
**Reported Separation:**  
Nil V/300-500m H Nil V/2nm H  
**Recorded Separation:**  
100ft V @ 2.5nm H  
1nm Min H @ 1100ftV

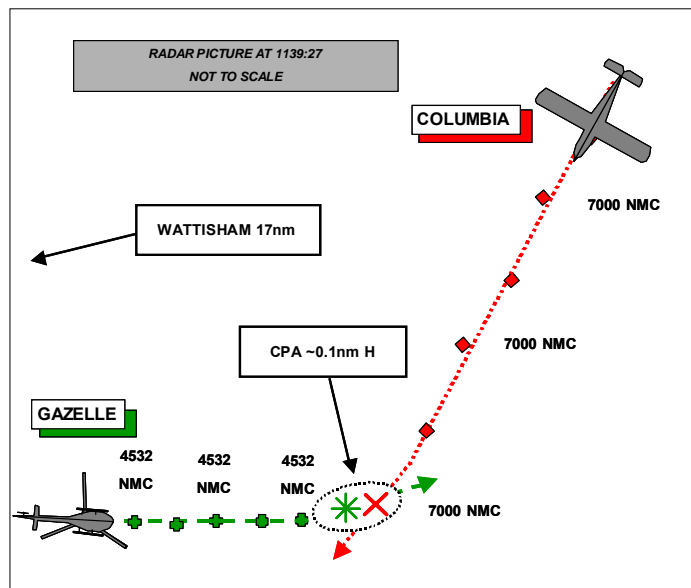
### AIRPROX REPORT NO 203/05

Date/Time: 22 Nov 1139  
Position: 5207N 00126E (Bentwaters Disused Airfield)  
Airspace: London FIR (Class: G)  
Reporting Ac Reported Ac  
Type: Gazelle Columbia 400  
Operator: JHC Civ Pte  
Alt/FL: 2300ft 2250ft  
(QNH 1038 mb) (QNH 1037 mb)  
Weather VMC VMC HAZE BC  
Visibility: unltd 9km  
Reported Separation:  
0ft V/150ft H 600ft V/0ft H  
Recorded Separation:  
~0.1nm (600ft) H/NR V

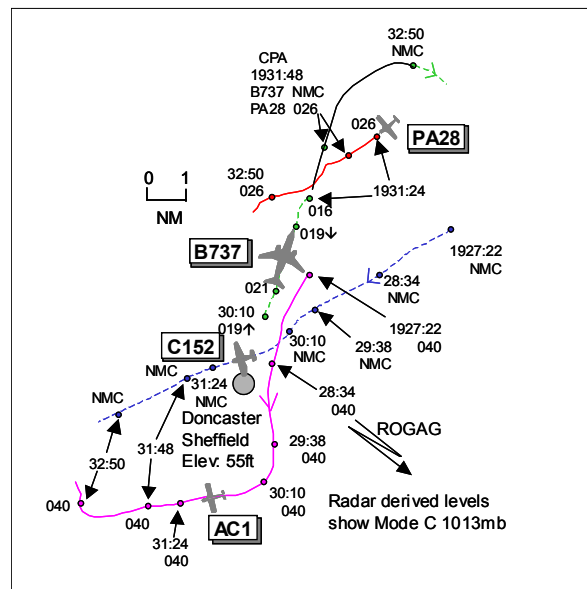
**AIRPROX REPORT NO 204/05**

Date/Time: NIGHT17 Nov 1932  
Position: 5334 N00057W (6nm NNE Doncaster/Sheffield - elev 55ft)  
Airspace: FIR (Class: G)  
Reporter: Doncaster/Sheffield ADC/APP  
First Ac Second Ac  
Type: B737-500 PA28  
Operator: CAT Civ Pte  
Alt/FL: ↑FL50 NR (QNH)  
Weather VMC CLOC VMC  
Visibility:  
Reported Separation:  
 1000ft V NR  
Recorded Separation:  
 0.6nm H

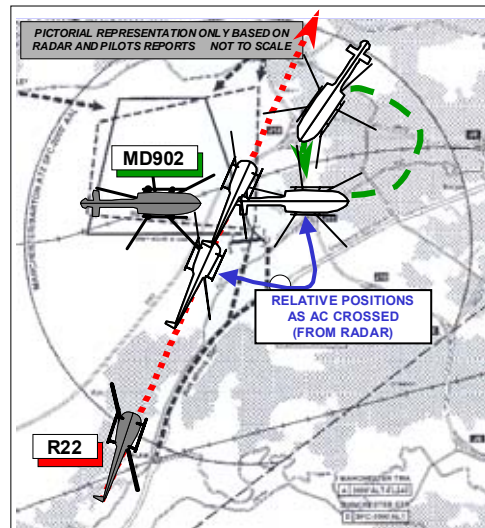
**AIRPROX REPORT NO 205/05**

Date/Time: 17 Nov 1325  
Position: 5329N 00222W (2nm NE Barton- elev 73ft)  
Airspace: Barton ATZ (Class: G)  
Reporting Ac Reported Ac  
Type: MD902 Explorer Robinson R22  
Operator: Civ Comm Civ Pte  
Alt/FL: 1000ft 1400ft  
 (QNH) (QNH 1018 mb)  
Weather VMC VMC CLBC  
Visibility: NR >10km  
Reported Separation:  
 200ft V/100m H 300ft V/300ft H  
Recorded Separation:  
 NR

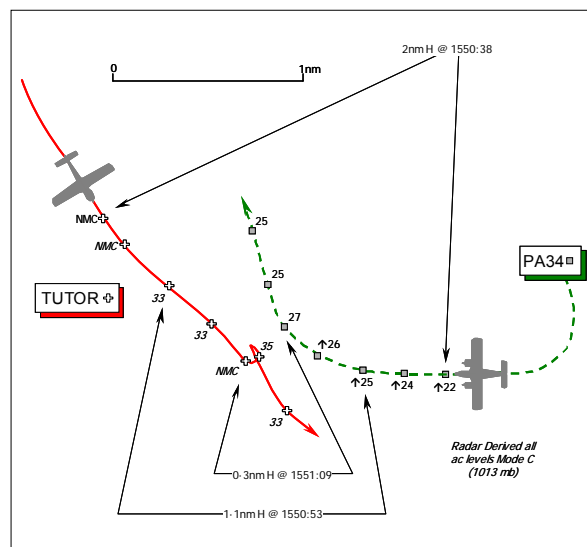
**AIRPROX REPORT NO 206/05**

Cause: Late sighting by the Grob Tutor pilot.
