**UK AIRPROX BOARD**

# **Analysis of Airprox in UK Airspace**

**Report Number 15  
July 2005 – December 2005**

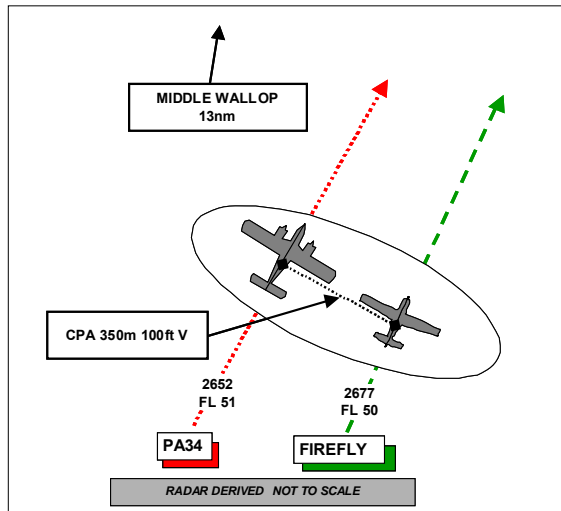
## AIRPROX REPORT NO 207/05

Cause: Following timely and accurate TI, the PA34 pilot flew sufficiently close to the Firefly to cause its pilot concern.

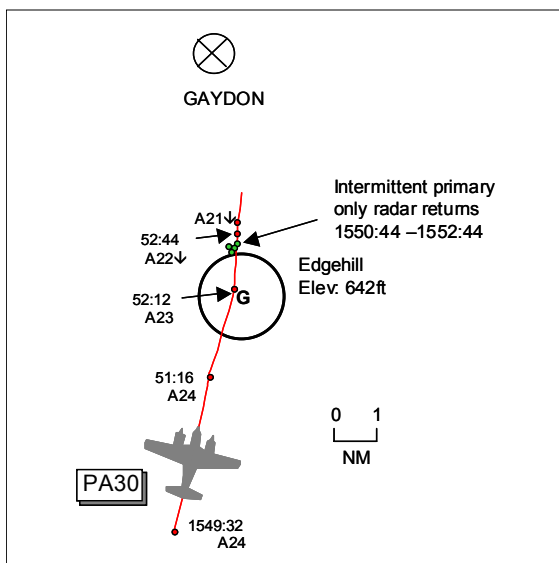
### AIRPROX REPORT NO 208/05

Cause: Sighting report.

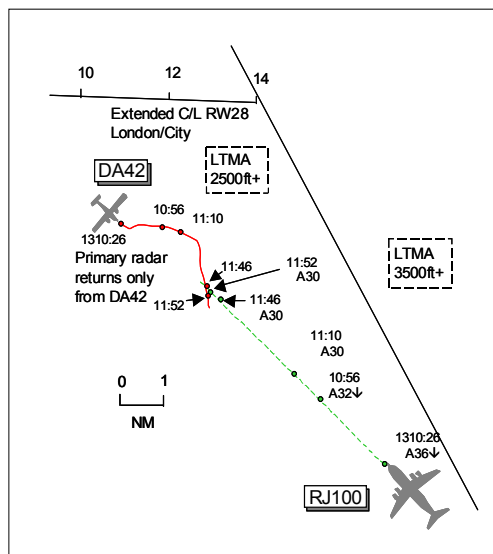
## AIRPROX REPORT NO 210/05

Cause: Sighting report.

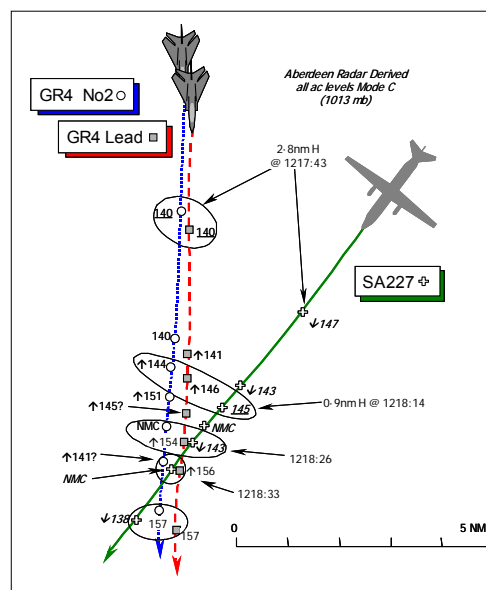
Min V 100ft @ 0.9nm

0.22nm H @ 1100ft V

Cause: The Metroliner crew descended into conflict with the Tornado GR4 pair.

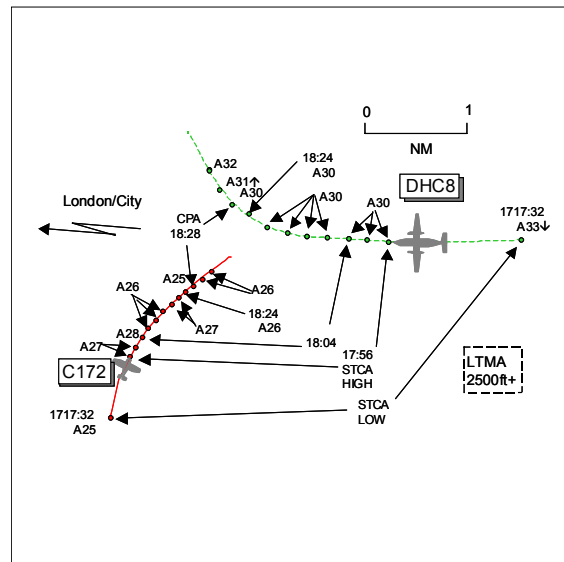
**AIRPROX REPORT NO 212/05**

Cause: The C172's unverified Mode C indicated a penetration of CAS.

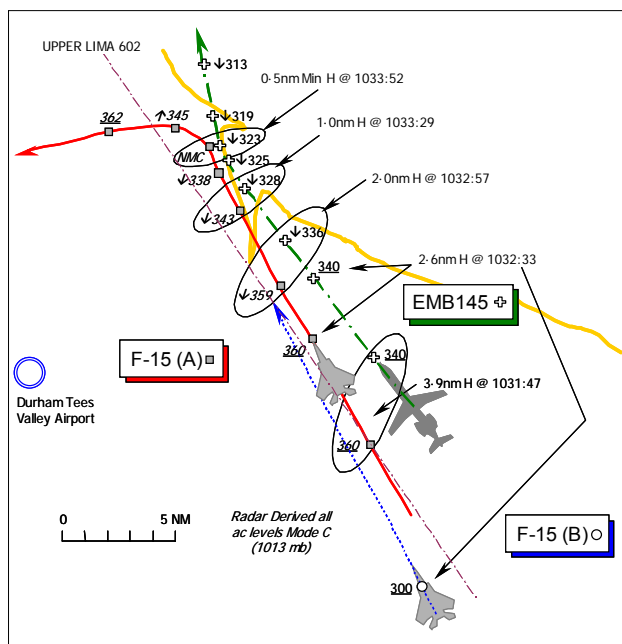
1300ft V @ 0.7nm H

0.5nm Min H

Cause: During a period of poor RT reception, the crew of F-15 (A) misinterpreted a transmission intended for F-15 (B) and descended into conflict with the EMB145.

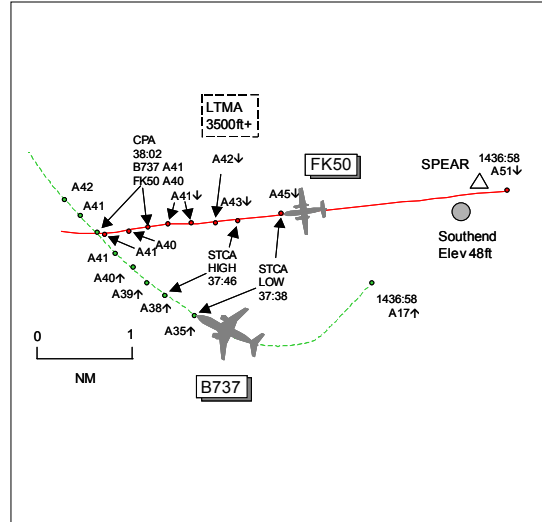
**AIRPROX REPORT NO 216/05**

Cause: The LTCC BIG/TIMBA SC did not take the B737 into account when descending the FK50.
