UK AIRPROX BOARD

Analysis of Airprox in UK Airspace

**Report Number 8
January 2002 - June 2002**

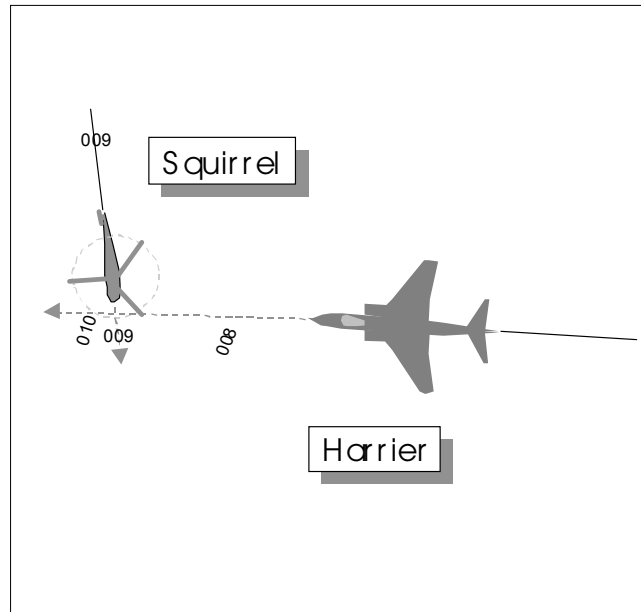
THE HARRIER PILOT reports heading 270° at 420 kt on a LL SAP sortie. After glancing into the cockpit twice for periods of about 1 second each he looked up to become immediately aware of a black and yellow helicopter in his 12:30, very close, crossing R to L. He instinctively pulled up achieving 5.3 g to avoid the helicopter, although it was about 100 ft below his level. He reckoned he would have passed no more than 200 ft over the helicopter; if he had been flying at his MSD (250 ft) there would have been a very real risk of collision. After passing it he looked back to see the helicopter continuing on track.

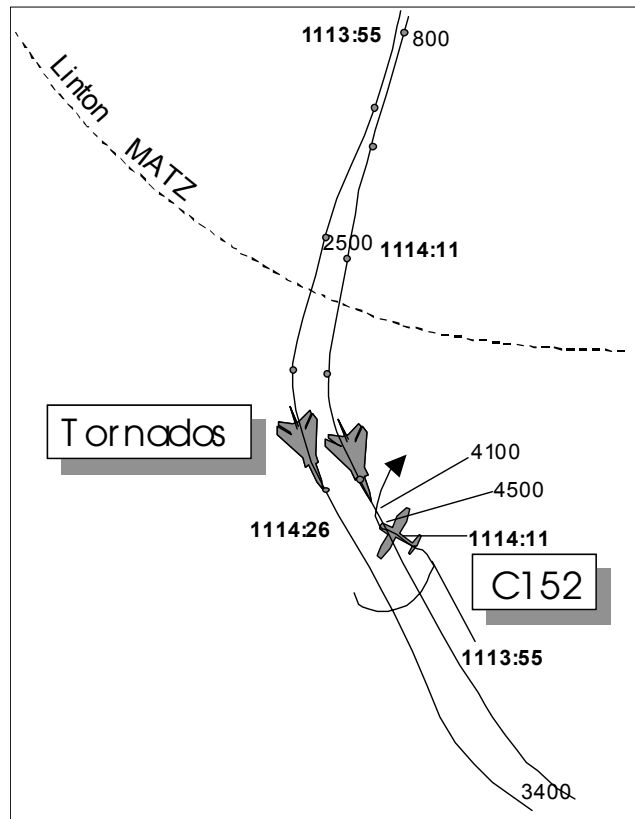
THE C152 PILOT reports flying an instructor training sortie covering spinning. He was receiving a VHF FIS from Linton on Ouse whose controller he had advised he would be operating between 2-4000 ft RPS and who had agreed that the Wetherby area would be suitable, bearing in mind flypast activity at Linton. Having performed several spins between 4000 ft and about 3500 ft, during which period he had received traffic information from Linton, he performed a 360° lookout turn and entered a spin to the left from West. After about 1 turn he saw an ac passing very quickly almost directly below by 2-300 ft. Being in a spin he had no opportunity for avoiding action; the risk of collision was moderate to high. He filed an Airprox with the controller. In a later discussion with ATC he was told there were 2 ac; the Tornado pilots apparently had considered they were safe at 3000 ft. He had hoped, however, that they had been told he was operating between 2000 and 4000 ft, which could be traversed quickly in a spin, and that in future, consideration should be given to lateral avoidance.

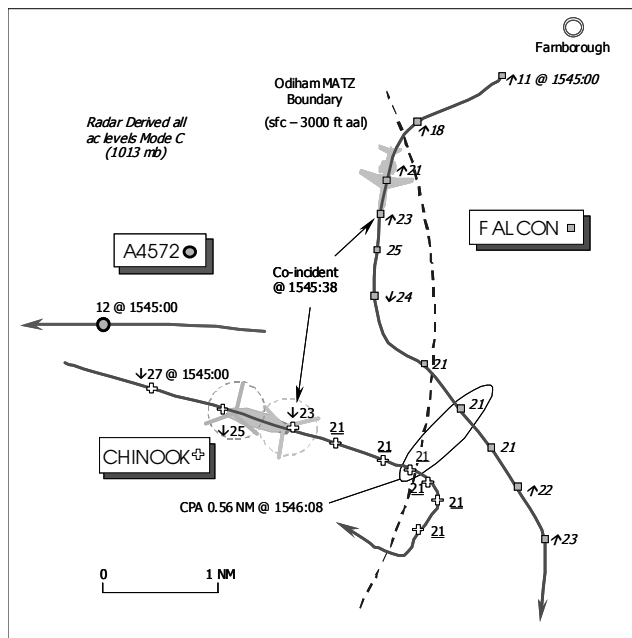
THE FARNBOROUGH APPROACH RADAR CONTROLLER (APR) provided a very comprehensive report, stating that she was notified by the Farnborough ADC that the Falcon was taxiing for departure from RW24 to join CAS at GOODWOOD (GWC). A 'release' was obtained from the LTCC SC and the ADC advised of the assigned squawk - A0337. Shortly afterwards she called Odiham to pass them traffic information on the departing Falcon, advising that the jet would depart behind their traffic, which she had observed squawking A4572 in their RW28 instrument pattern. A few minutes later Odiham DIRECTOR (DIR) rang to pass traffic information on another ac about 1 NM W of Odiham, squawking A4570 – the Chinook helicopter – then at 3000 ft ALT carrying out an instrument procedure into Odiham. She advised that the Falcon would be departing in about 2 min time to route behind the A4572 squawk and then direct to the GWC, climbing to 2000 ft ALT and asked if they would maintain 3000 ft ALT with the Chinook, which DIR agreed to do until clear of the Falcon. Just as the jet took off, DIR rang to advise that the Chinook which was now about 2 NM SE of Odiham was descending. The helicopter's Mode C indicated about 2700 ft and she advised DIR that the Falcon was now airborne and asked for confirmation that the Chinook was descending to 2000 ft, which DIR said it was. Immediately, she rang the Farnborough ADC to pass avoiding action and at the same time selected the TOWER frequency and heard the ADC instructing the Falcon pilot to contact her on APPROACH. She called the Falcon pilot but there was no response; after a second call the pilot responded and she passed an avoiding action R turn onto 275° and gave traffic information about the Chinook. There was no response from the Falcon pilots so she queried if they were turning R, but the pilot then reported that he had turned L in response to a TCAS RA (sic). She instructed the Falcon crew to climb to 3400 ft ALT, whereupon DIR rang to ask if she could climb the Falcon further, but advised them that she was taking horizontal avoiding action and turning the jet onto 275°. Odiham then rang again to say that their Chinook pilot was visual with the Falcon. During the TCAS RA, the Falcon pilots reported an ac in the base of the cloud at 2000 ft in close proximity and tracking

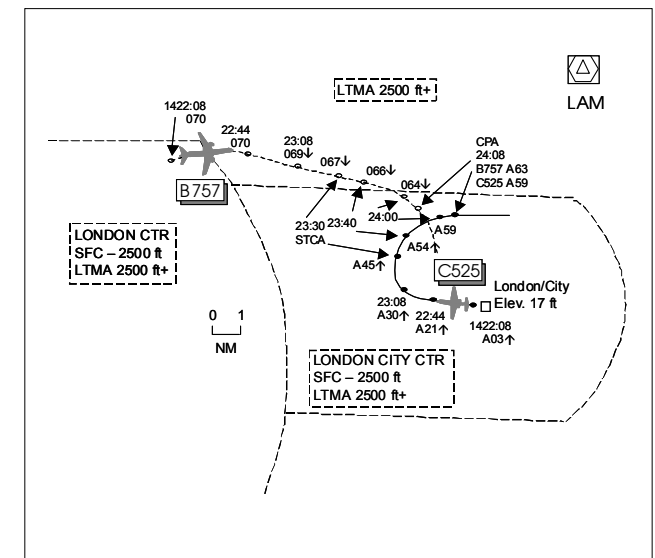
THE B757 PILOT reports descending into Heathrow in IMC cleared to 4000 ft QNH 1015

mb, at 180 kt. Passing approx. 7000 ft he became aware of traffic on TCAS in his 2 o'clock range 5

NM climbing through 4500 ft; a TA alert was then received. He reduced his ROD to 300 ft/min. finally levelling-off at 6300 ft as the target crossed ahead, at a range of 0.5 NM, level at 6000 ft. He had been given a R turn of 40° and an instruction to stop his descent at 5000 ft, he thought, as the traffic passed his 1230 position 800 ft below. He thought that this 'avoiding action' had been insufficient and his use of 30° bank angle and levelling-off had aided his avoidance/deconfliction. He assessed the risk of collision as medium.

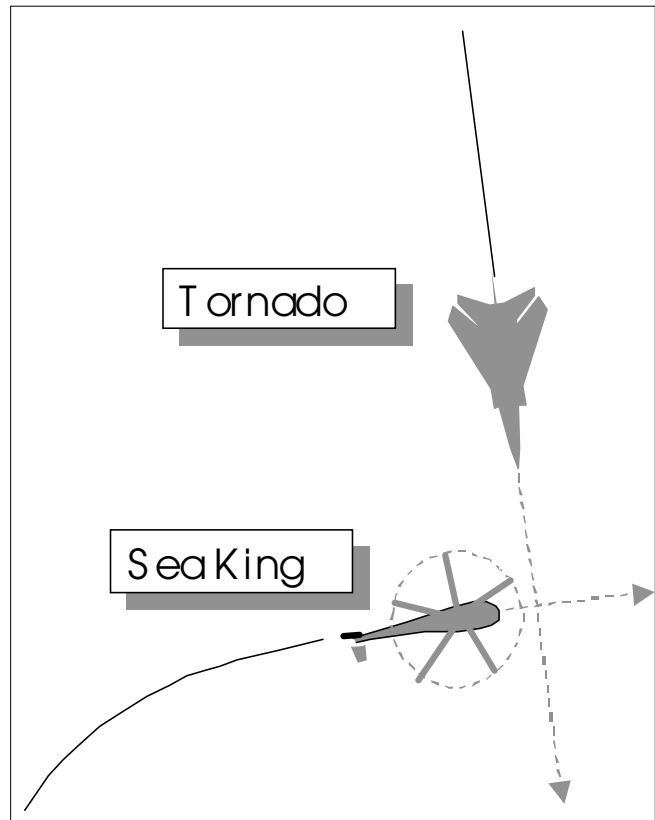
THE SEA KING PILOT reports heading 080° at 90 kt in a gentle descent over the sea to carry out role training. While descending from 300 ft to deploy a drum, the winchman called an ac at 9:00, half a mile, same level and closing. The handling pilot initiated a rapid descent and a Tornado, heading S, passed 100 ft overhead. The risk of collision was high; if avoiding action had not been taken there would almost certainly have been a collision.

THE TORNADO PILOT reports heading 170° at 407 kt carrying out a low level transit over the sea towards Wainfleet range when he noticed a Sea King very close to and just below the nose of his ac. He pulled up and banked left to clear it and check that it was unharmed. He estimated that it passed 100 ft below. Mission recordings showed the helicopter in the HUD from about 3 seconds to go and a thermal cue from the Sea King, generated by the FLIR which was not in use at the

time, from about 20 seconds to go to CPA. The yellow paint scheme of the Sea King did not provide the conspicuity that might be expected. The risk of collision was high.

The Gt Dun Fell Radar recording shows the ac approaching each other as described by the pilots; the Sea King shows NMC and has rolled out of a gentle turn from a NNE track. The Tornado shows 003 Mode C until the 2 returns merge, followed by a 100 ft increase.

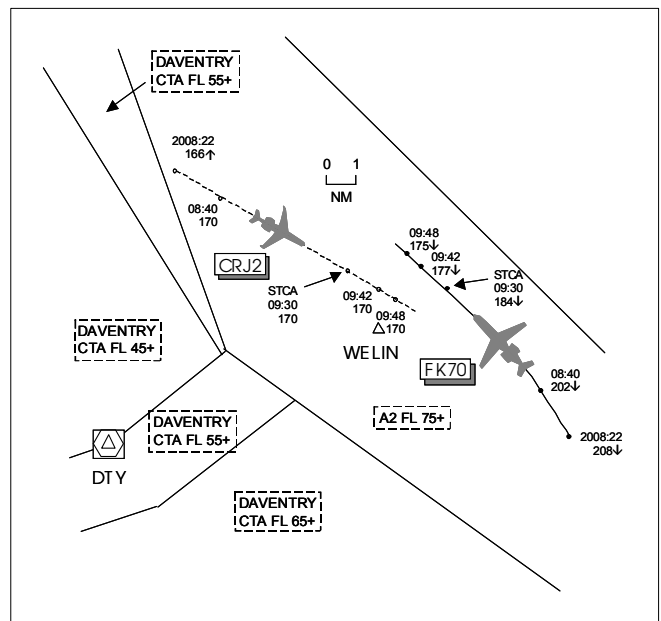
THE CRJ2 PILOT reports heading 105° at 290 kt level at FL 170 and awaiting further climb clearance from London ATC on 130.92 MHz. The FK70 was first seen on TCAS and then visually by acquiring the other ac's lights, even though he was intermittently in cloud in IMC, to pass about

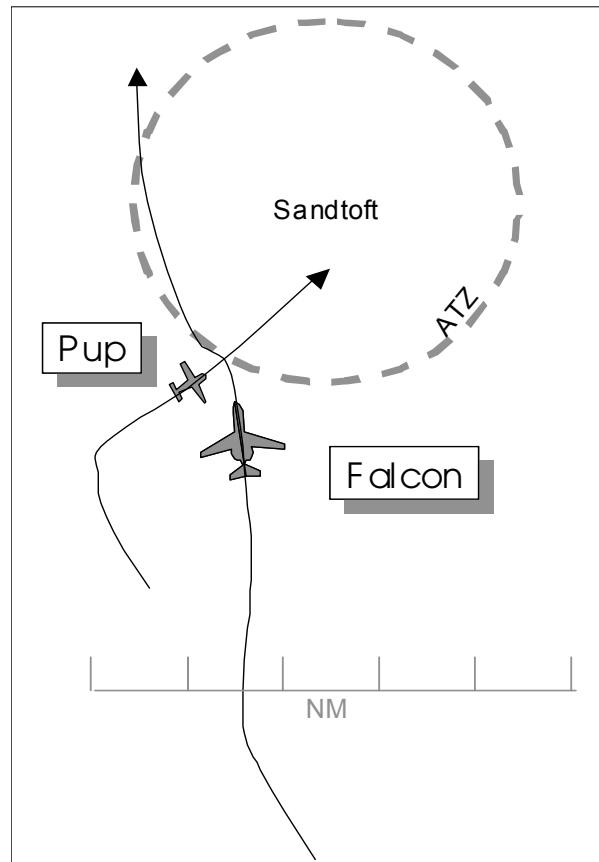
THE BEAGLE PUP PILOT reports heading 045° at 70 kt on a straight-in final to RW 05 at Sandtoft, in communication with Sandtoft Radio. He was squawking 7000 with no Mode C fitted. At 1.5 NM from the threshold, passing about 1000 ft, a jet appeared in his 1 o'clock about 100 m in front and crossed R to L about 50 m away and some 200 ft below. He went around from the approach. The jet was on a northerly track and had approached him from his 4 o'clock; if he had been on a 3° glidepath, the jet would have hit him. He considered the ac had been inside the ATZ. After landing he found that Sandtoft had been notified of the Falcon, a 'met survey' ac. A map was attached to the notification showing that Sandtoft was outside the area of the survey; the activity was not on the daily NOTAMS.

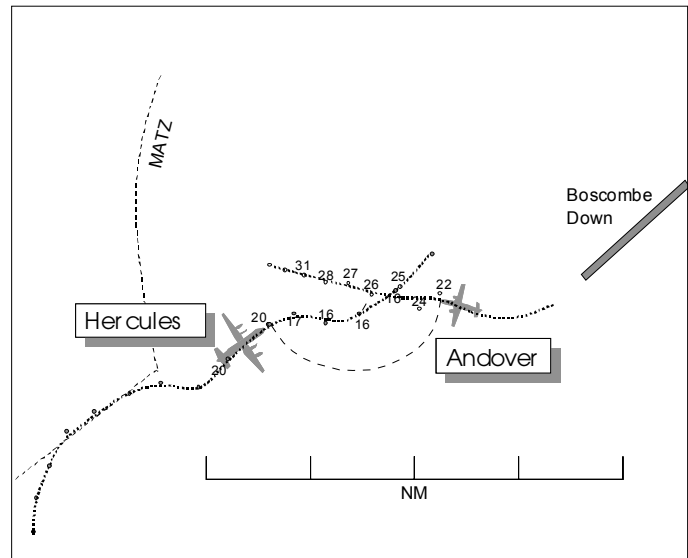
THE HERCULES PILOT reports heading 085° at 170 kt in the instrument pattern at Boscombe Down, at 2000 ft. He saw an Andover in his 1 o'clock slightly low but climbing; after a short while he realised it was on or close to a collision course so he began a descent. ATC had called other traffic to him, but not the Andover until he began the descent, receiving a TCAS TA at the same time, closely followed by an RA. He told ATC he was descending to 1500 ft and the Andover appeared to pass 500 ft directly overhead. In the CAVOK conditions, the risk of collision was low.

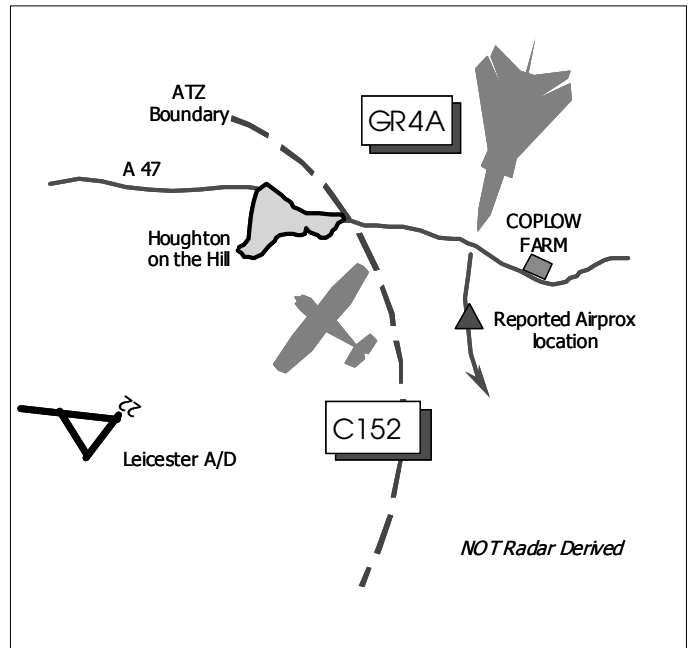
AIRPROX REPORT NO 14/02

THE TORNADO GR4A PILOT reports his ac is camouflaged grey, HISLs were on and they were squawking 3/A 7001 with Mode C when operating as the bounce ac for a pair of GR4s on a low-level sortie. Whilst in a slight L turn through 190°, climbing through 520 ft Rad Alt, he thought about 4 NM E of Leicester, (but reported a Lat. & Long. 2.6 NM ENE of the A/D) setting up an intercept on the other jets at 380 kt, his navigator spotted a white, high-wing monoplane, just L of the nose at

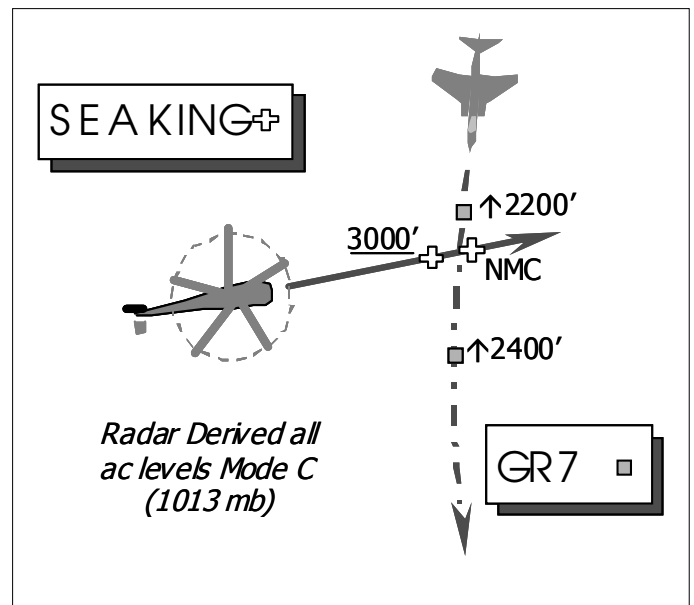
THE SEA KING SAR HELICOPTER PILOT provided a comprehensive report stating he was en route from Belfast to Newcastle Hospital on a night SAR mission, with a crew of 4; the patient in the rear cabin was suffering from collapsed lungs and attended by 3 medical personnel. Red anti-collision beacons, together with forward and port side spotlights were all on; the crew was also using Night Vision Goggles (NVG). A SAR operational mission squawk of A0023 was selected with Mode C.

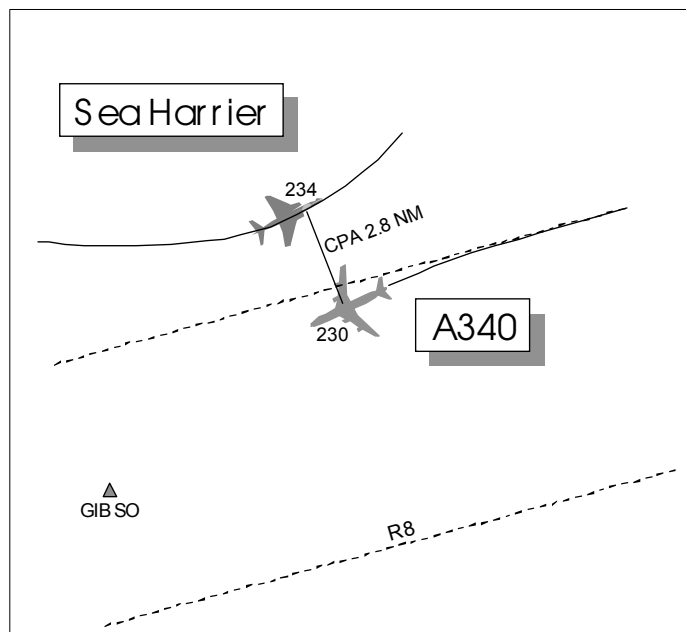
LACC controllers report that the A340 was handed over from London TC to LACC heading 270° on the N side of R8 as per standing agreement; there were 2 opposite direction tracks on the S side of R8. Once through their level, the A340 was cleared to FL 250; passing FL 180 it was cleared 'own navigation' to LND and transferred to Sector 6/9T. The Sector S 6/9 controller noticed a STCA alert on the A340 and a Yeovilton return outside the airway; the A340 was passing FL 222 when the SC told the pilot to stop climb at FL 230 and turn L 10°. The SC passed traffic information on the other traffic, at FL 240. The A340 had been flying on the N edge of R8, routing direct to LND. The pilot advised that he had seen the traffic and that the stop climb had been a good call.

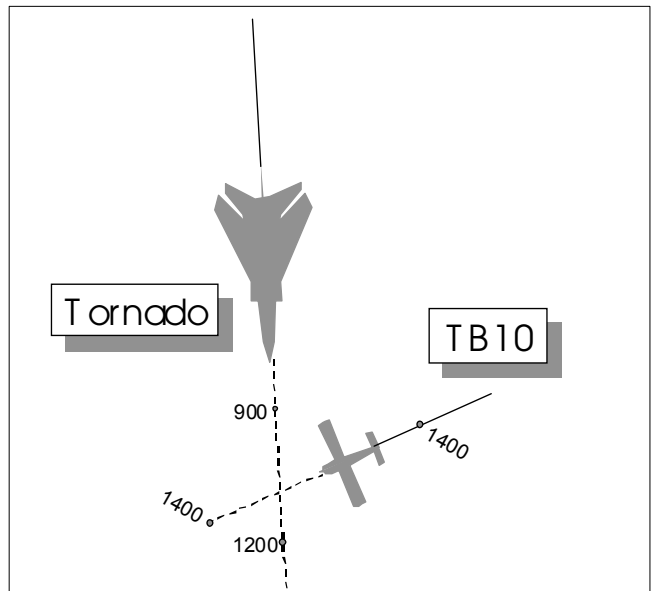
AIRPROX REPORT NO 17/02

THE TORNADO PILOT reports heading 170° at 350 kt while climbing out of the LFS when he saw a light ac at very close range, 500 m ahead, just left of the nose, crossing L to R. He bunted to avoid it, topping at 1470 ft Rad Alt, and passing 100 ft below it and less than 100 m ahead of it. There had been an extremely high risk of collision. He had left Waddington's LARS frequency some 30 seconds before the incident.

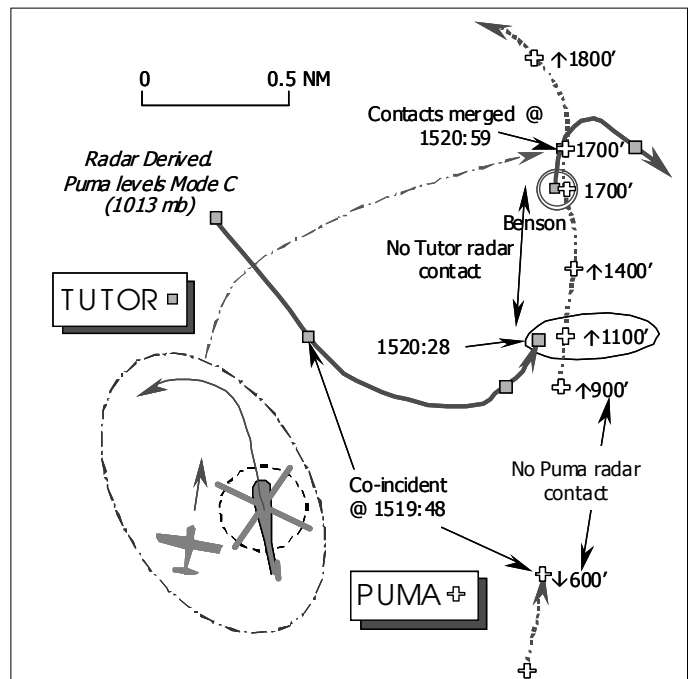
THE PUMA HC1 PILOT reports HISLs were on, during a TACAN approach to overshoot on RW 01RHC at Benson, flying at 100 kt in receipt of a RIS From Benson DIRECTOR (DIR) on UHF - 315.75 MHz and squawking A7372 with Mode C. He executed the overshoot on RW heading, as cleared, at his MDH of 500 ft QFE. Passing 1600 ft in the climb for his cleared height of 1800 ft QFE – VMC – and turning L through 350° for 220° as instructed by DIR, the aircrewman called "stop turn - descend" after he had sighted a Tutor emerging from their 6 o'clock position. The Tutor was about 50 yd to port - at about 8 o'clock - and 150-200 ft above his helicopter commencing a descending R turn. To avoid the Tutor he levelled his helicopter and turned R, whereupon it disappeared from view in his 6 o'clock in a descending turn. He assessed the risk of a collision as high and reported an Airprox to the ATC Supervisor after landing.

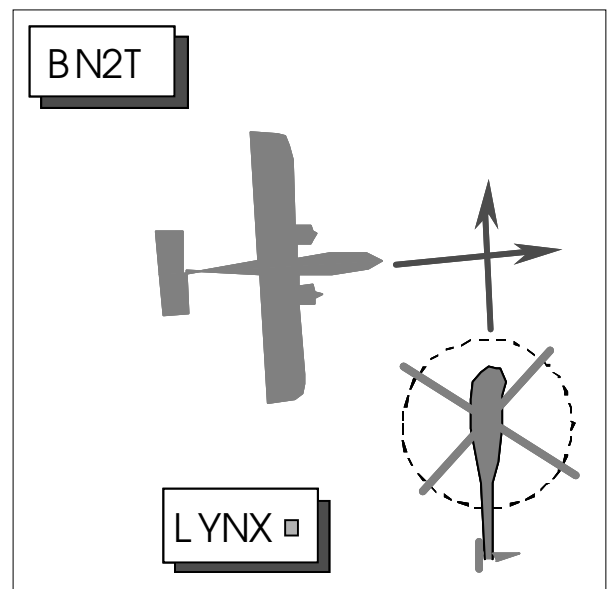
THE BN2T DEFENDER PILOT reports that his ac is camouflage drab green and black with light grey undersurfaces, but the anti-collision beacon was on, whilst outbound from Bembridge IOW into the English Channel for a radar equipment trial, VFR at 120 kt. A 7000 squawk was selected with Mode C. Approaching Nab Tower, heading 090° (M) at 350 ft asl they had just switched to London INFORMATION when one of the radar operators called a contact. He spotted a Lynx helicopter at R 1 o'clock about 50 – 100 ft away,

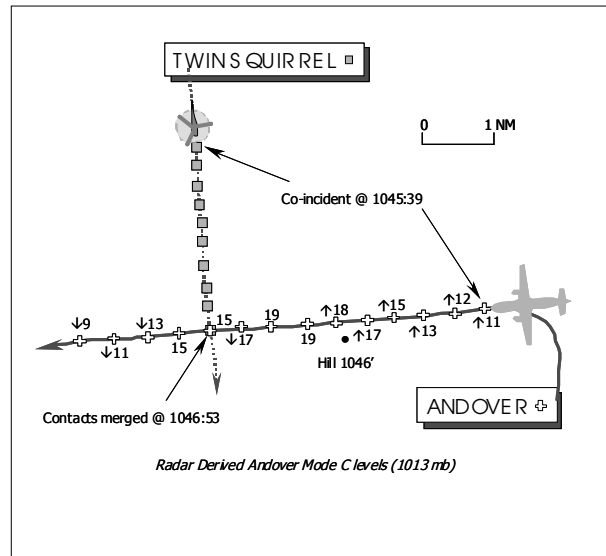
AIRPROX REPORT NO 20/02

Date/Time: 14 March 1046
Position: 5204 N 0207 W (3 NM NNE of Tewkesbury)
Airspace: UKDLFS - LFA 4 (*Class: G*)
Reporting Aircraft Reported Aircraft
Type: Andover Twin Squirrel
Operator: MOD DPA Civ Pte
Alt/FL: 800 ft ↓ 1500 ft
 (Rad Alt) (amsl)
Weather VMC NO CLOUD VMC
Visibility: >10 km >10 km
Reported Separation:
 3 - 400ft V 200 ft
Recorded Separation:
 Contacts merged

Cause: Late sighting by the Twin Squirrel pilot and the Andover crew.

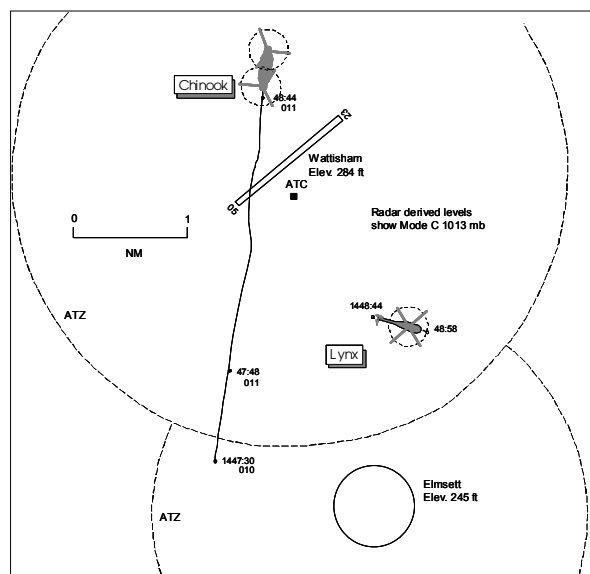
AIRPROX REPORT NO 21/02

Date/Time: 18 Mar 1448
Position: 5207 N 0057 E (0.5 NM SSW of Wattisham - elev 284 ft)
Airspace: ATZ (Class: G)
Reporting Aircraft Reported Aircraft
Type: Lynx Chinook
Operator: JHC JHC
Alt/FL: 500 ft ↑ 100 ft
 (QFE 977 mb) (agl)
Weather VMC RAIN VMC CBLC
Visibility: 6 km+ >10 km
Reported Separation:
 400 ft V 700-800 ft V 100 m H
Recorded Separation:
 not recorded

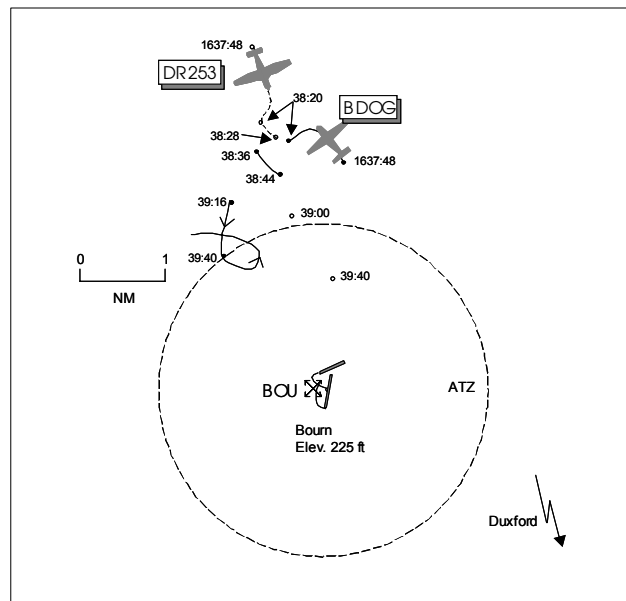
Cause: The Bulldog pilot flew close enough to cause concern to the DR253 pilot.

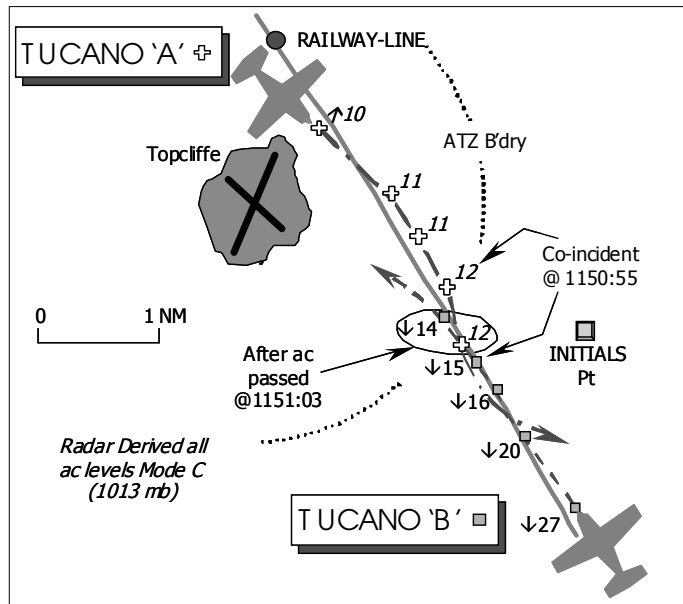
AIRPROX REPORT NO 23/02

Date/Time: 22 March 1150
Position: 5411 N 0120 W (2 NM SE of Topcliffe - elev 92 ft)
Airspace: MATZ (Class: G)
Reporting Aircraft Reported Aircraft
Type: Tucano T Mk1 Tucano T Mk1
Operator: HQ PTC HQ PTC
Alt/FL: 1400 ft 2000 ft
 (QFE 1021 mb) (QFE 1021 mb)
Weather VMC CLOC VMC NR
Visibility: 30 km + 10 km +
Reported Separation:
 5-10 ft V, 50-100 ft Not seen
 H
Recorded Separation:
 2 - 300 ft V

Cause: A non sighting by the crew of Tucano B and a late sighting by the crew of Tucano A.

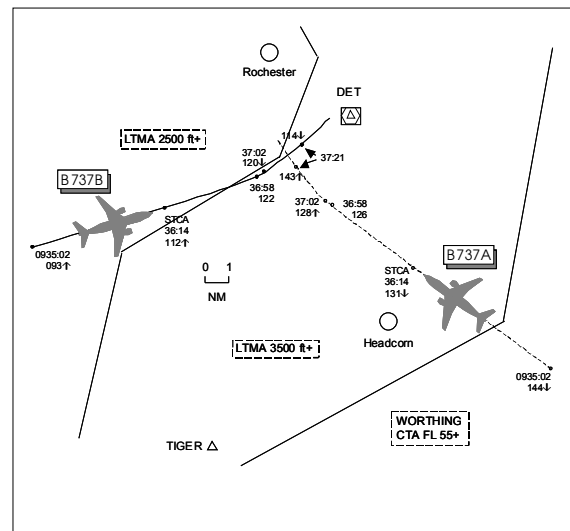
Date/Time: 25 Mar 0937
Position: 5115 N 0032 E (4 NM SW DET)
Airspace: TMA (Class: A)
Reporting Aircraft Reporting Aircraft
Type: B737 (A) B737 (B)
Operator: CAT CAT
Alt/FL: ↓ FL 120 ↑ FL 170

Weather IMC KLWD IMC KLWD
Visibility: NK NK
Reported Separation:
 300 ft V, 2 NM H 300 ft V, <2 NM H
Recorded Separation:
 900 ft V 2.9 NM H

Cause: The TC SE SC dispensed with vertical separation without ensuring adequate lateral separation was maintained.

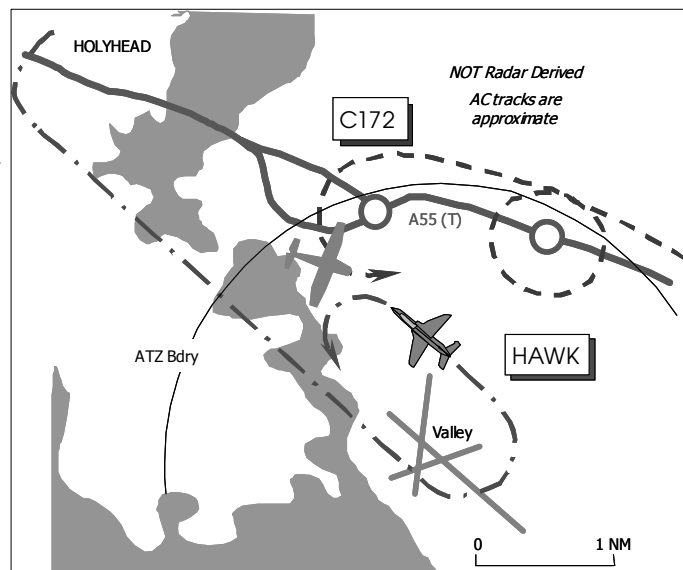
Cause: An impression by the Hawk pilot, of reduced vertical separation in the ATZ.

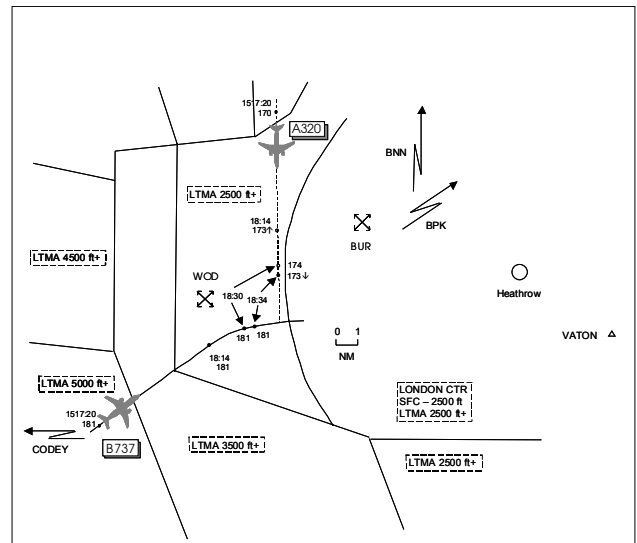
Cause: The TC Capital SC did not take the B737 into account when he cleared the A320 to climb on a conflicting track.

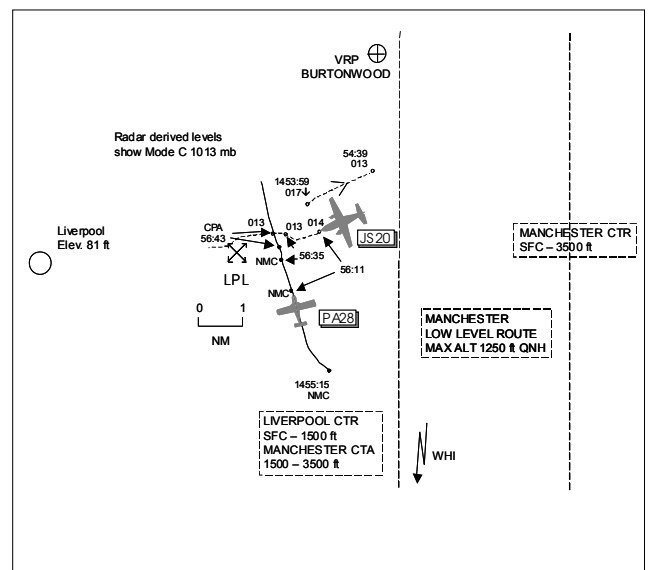
AIRPROX REPORT NO 27/02

Date/Time: 27 Mar 1457
Position: 5321 N 0242 W (5 NM E of Liverpool)
Airspace: Manchester CTA (Class: D)
Reporting Aircraft Reported Aircraft
Type: Jetstream JS20 PA28
Operator: HQ PTC Civ Club
Alt/FL: 1750 ft 1220 ft
 (QNH 1029 mb) (QNH NK)
Weather VMC CLOC VMC HZBC
Visibility: 50 km NK
Reported Separation:
 250 ft V 0.5 NM H not seen
Recorded Separation:
 NK V 0.35 NM H

Cause: Inadvertent penetration of the Liverpool CTR by the PA28 pilot, who did not see the Jetstream.

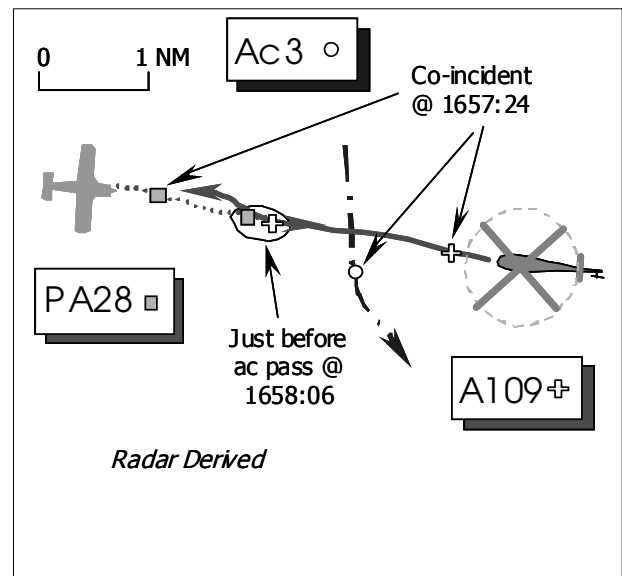
AIRPROX REPORT NO 28/02

Date/Time: 27 Mar 1658
Position: 5154 N 0130 W (7½ NM WNW Oxford/Kidlington - elev 270 ft)
Airspace: Oxford AIAA (Class: G)
Reporting Aircraft Reported Aircraft
Type: Agusta 109 PA28
Operator: HQ JHC Civ Training
Alt/FL: 3000 ft 2200 ft↓
(RPS 1025 mb) (QNH 1030 mb)
Weather VMC HAZE VMC
Visibility: 1500 m into sun > 10 km
Reported Separation:
100 ft V 150 - 250 ft V
Recorded Separation:
<0.1 NM

Cause: Late sighting by both pilots.

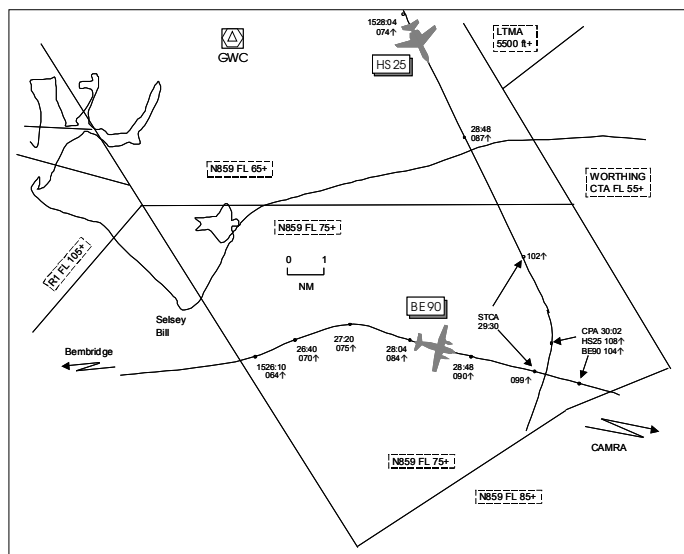
Cause: Unauthorised penetration of Class A airspace by the BE90 pilot.

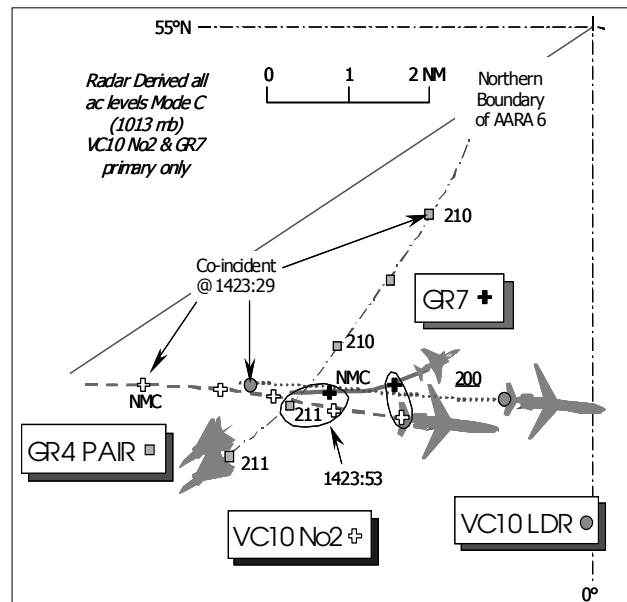
Date/Time: 4 April 1423
Position: 5456 N 0010 W (AARA 6)
Airspace: AARA6 (Class: G)
Reporting Aircraft Reported Aircraft
Type: VC10 K formation Tornado GR4 pr
Operator: HQ STC HQ STC
Alt/FL: FL 200/FL 205 FL 210

Weather VMC CLOC VMC CLOC
Visibility: 'Excellent' '10 km +'
Reported Separation:
 3-500 ft V 1000 ft V
Recorded Separation:
 <0.5 NM H

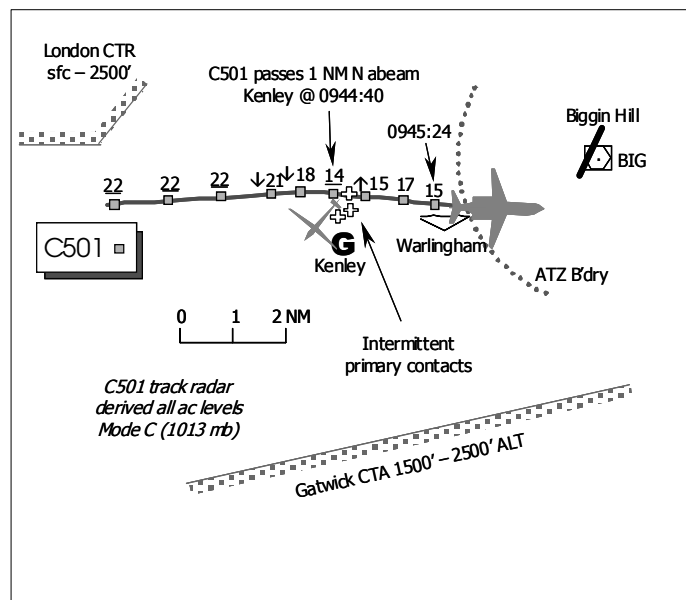
AIRPROX REPORT NO 34/02

Date/Time: 5 April 0944
Position: 5119 N 0006 W (1 NM N of Kenley - elev 566 ft)
Airspace: London FIR (Class: G)
Reporting Aircraft Reported Aircraft
Type: Viking Glider C501 Citation
Operator: HQ PTC Civ Pte
Alt/FL: 900 ft 2400 ft↓
 (QFE 986 mb) (QNH 1006 mb)
Weather VMC No Cloud VMC
Visibility: 6 km in Haze 5000 m Haze
Reported Separation:
 200 m H/200 ft V 3-400 m H
 250-300 ft V
Recorded Separation:
 Not recorded

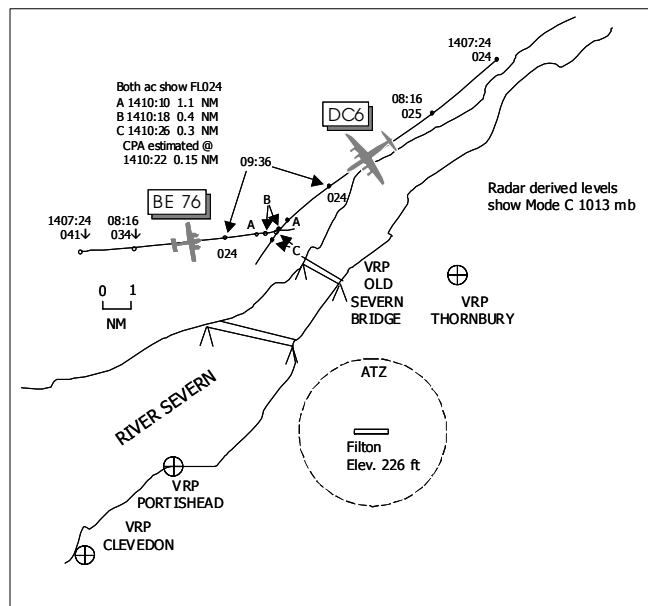
AIRPROX REPORT NO 37/02

Date/Time: 3 Apr 1410
Position: 5138 N 0241 W (8 NM NW Filton - elev 226 ft)
Airspace: FIR (Class: G)
Reporting Aircraft Reported Aircraft
Type: BE76 DC6
Operator: Civ Trg CAT
Alt/FL: ↓2000 ft 2000 ft
(QNH 1005 mb) (QNH 1006 mb)
Weather VMC HZBC VMC HZBC
Visibility: 5000 m 7 km
Reported Separation:
0 ft V 0.25 NM H 200 ft V >500 ft H
Recorded Separation:
0 ft V 0.15 NM H

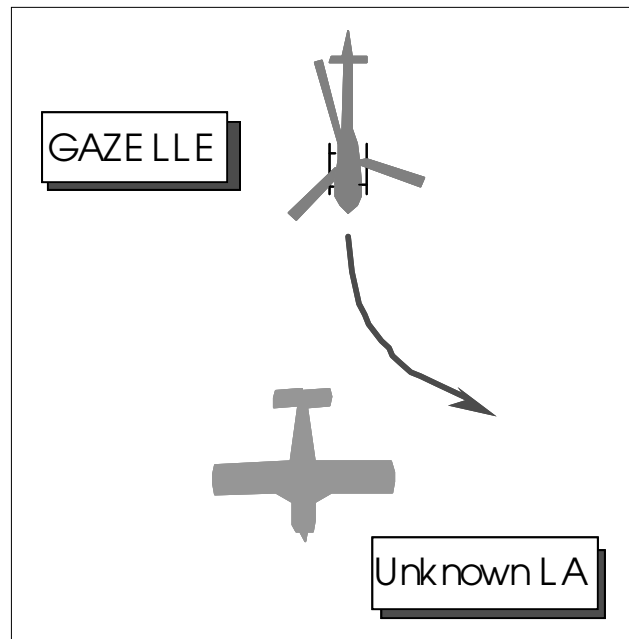
AIRPROX REPORT NO 39/02

Date/Time: 14 Apr 1119 (Sunday)
Position: 5340 N 0201 W (4 NM S of Hebden Bridge)
Airspace: London FIR (Class: G)
Reporting Aircraft Reported Aircraft
Type: Gazelle Untraced
Operator: JHC NK
Alt/FL: 2500 ft NK
(QNH)
Weather VMC CLOC NK
Visibility: >10 km NK
Reported Separation:
NR NK
Reported Separation:
Not recorded

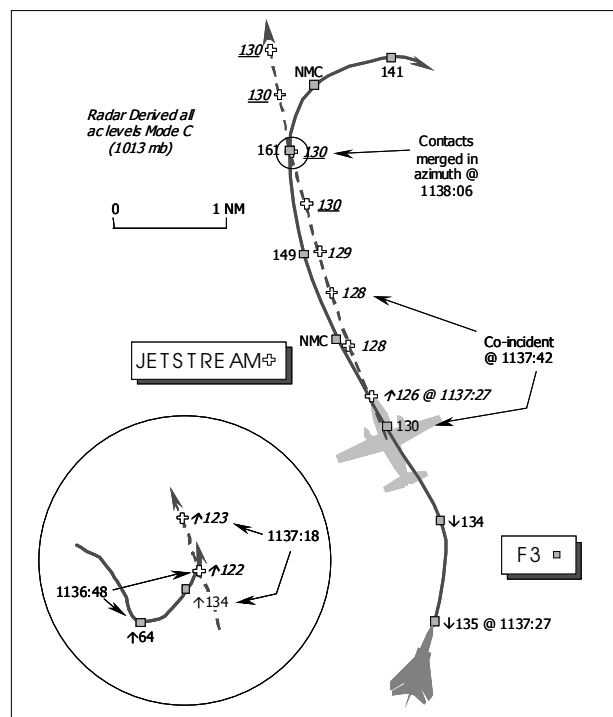
AIRPROX REPORT NO 40/02

Date/Time: 15 April 1140
Position: 5408 N 0025 W (12 NM W of Flamborough Head)
Airspace: Vale of York AIAA (Class: G)
Reporting Aircraft Reported Aircraft
Type: Jetstream 32 Tornado F3
Operator: CAT HQ STC
Alt/FL: FL 120 12000 ft (RPS)
Weather VMC VMC CLAC
Visibility: 10 km 'Unrestricted'
Reported Separation:
600 ft H 1500 ft V, 1000 ft H
Recorded Separation:
200 ft V @ 1¼ NM H
3100 ft V @ merge

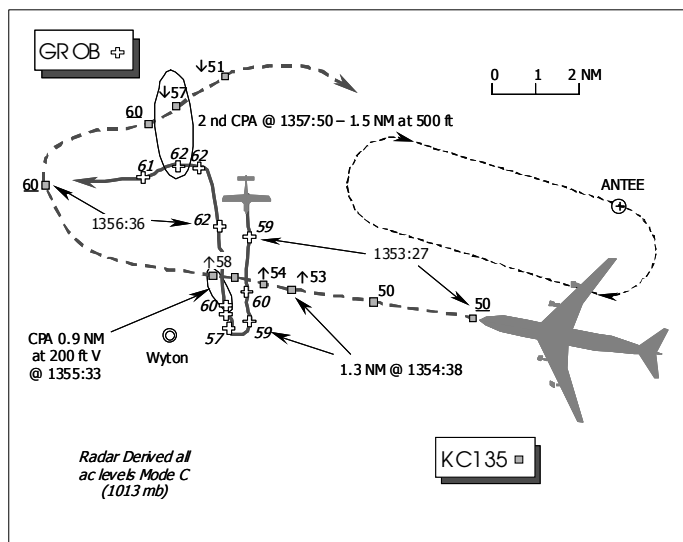
AIRPROX REPORT NO 41/02

UKAB Note (3): The Debden radar recording at 1353:27, shows the KC135 outbound heading 288° level at FL 50 Mode C, with the Tutor at R 12:30 - 5.5 NM, squawking A7000 and indicating FL 59 unverified Mode C. The Tutor continues southbound crossing ahead of the KC135; the LA ascended to FL 60 at a range of 3 NM, where the KC135 pilot reported the TCAS TA and subsequent sighting occurred. The Tutor makes a tight R turn of over 180°, descending to its minimum observed level during the occurrence of FL 57 and then reverses the turn L onto 350° and ascends to FL 60. Meanwhile, the KC135 is shown in the climb. The CPA of 0.9 NM and 200 ft occurred at 1355:33, as the KC 135 climbed through FL 58 and passed through the 12 o'clock of the Tutor, which then begins to draw aft of the tanker. The 45° AOB avoiding action R turn reported by the KC135 pilot is not evident on the recording and it is difficult to reconcile a climbing RA in this situation. At 1356:36, the KC135 is level at FL 60 and shown turning about through N – probably in response to the instruction from APPROACH to set course for CHIPP – as the Tutor maintains its northerly track. The second encounter occurs as the Tutor steadies westbound indicating FL 62 - the 2nd CPA at 1357:50, is 1.5 NM and 500 ft - as the Tanker descends through FL 57, apparently in response to the RA, before it turned L away from the Tutor.

Cause: Sighting Report

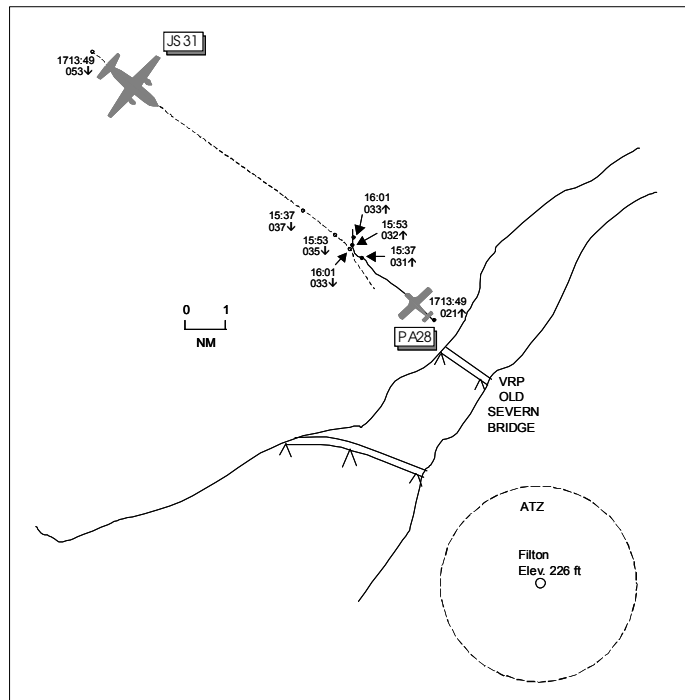
THE JS31 PILOT reports flying inbound to Filton at 220 kt squawking 5427 with Mode C and in receipt of a RAS from Filton RADAR on 122.72 MHz. The visibility was 20 km 1500 ft below cloud in VMC, the ac was coloured white with three coloured stripes, anti-collision and strobe lights were switched on and TCAS was not fitted. Approaching the Old Severn Bridge on a radar heading of 130° and descending through 3500 ft for 3000 ft Filton QNH (1016 mb) in accordance with his ATC clearance, the controller told him about conflicting traffic in his 12 o'clock. Simultaneously, he saw a PA28 in his 12 o'clock range 0.5 NM and about 300 ft below; the co-pilot, the PF, turned R to avoid the PA28 as its pilot also commenced a R turn at the same time. The PA28 was seen to pass 200 ft below and 0.25 NM clear on his LHS and he assessed the risk of collision as high.

The provision of an ATSA in the Approach Control Room, would, undoubtedly, have helped the APR Controller carry out his tasks. In view of this incident and another, which occurred in similar circumstances during April 2002, it has been decided, by ATC Management, that priority is to be given to ensuring that an ATSA is available in the Filton Approach Control Room when rostering support staff.

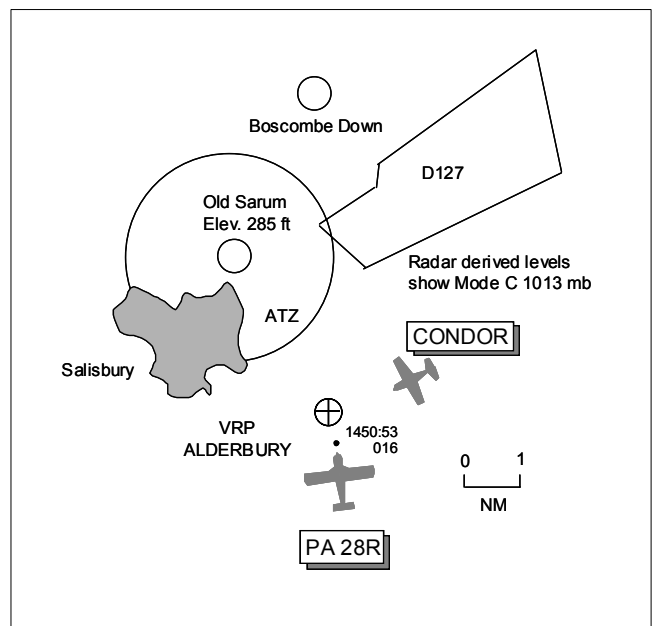
THE ROLLASON CONDOR PILOT reports heading 260° at 1700 ft QNH 1013 mb and 95 kt en route from Popham to Devon and he was listening out with Old Sarum RADIO on 123.2 MHz. The visibility was 15 km 3000 ft below overcast cloud in VMC, the ac was coloured white with red/orange/yellow trim lines, twin fuselage strobe lights were switched on and no transponder was fitted to the ac. When passing Alderbury VRP both he and his PPL passenger commented on how visible the IOW Needles were when he spotted a PA28R in his 10 o'clock, he thought <500 m away, at about the same level. He watched it for 1-2 seconds and realised that the bearing aspect was constant and that a risk of collision was high. He initiated a steep descending L turn whilst keeping the other ac in sight which passed 100 ft above and 50 ft ahead

Cause: The PA28R pilot flew sufficiently close to cause concern to the Condor pilot, who saw the PA28R late.

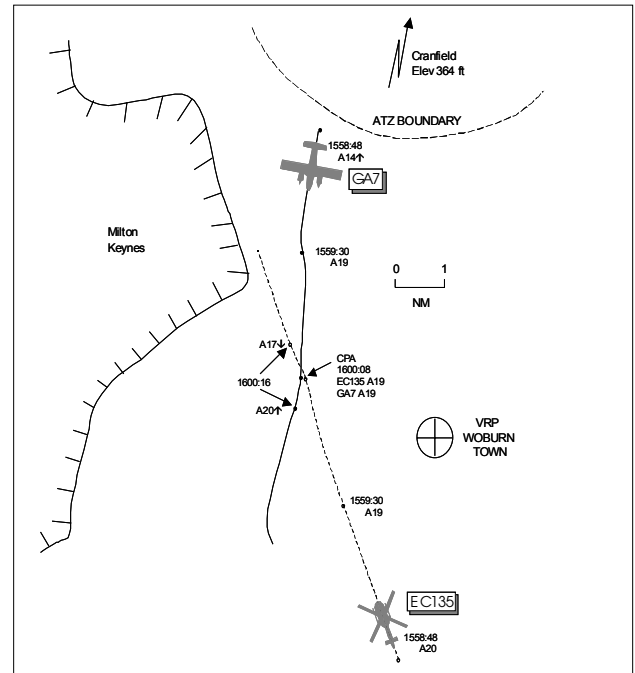
THE EC135 PILOT reports flying with 2 crew en route from Hayes to a private site in Yorkshire heading 340° at 130 kt, 2000 ft Cranfield QNH 1022 mb and in receipt of a FIS from Cranfield APPROACH on 122.85 MHz squawking 7000 with Mode C. The visibility was 5-7 km in haze below cloud in VMC, the ac was coloured silver/blue and his anti-collision and 2 strobe lights were switched on. He had contacted Cranfield APPROACH after leaving the Luton CTR and requested TI and a FIS as he planned to fly to the W of the Cranfield ATZ via Milton Keynes. He, the PNF, suddenly saw a twin-engined ac less than 0.5 NM away approaching quickly from the R 1 o'clock position at the same level; it was obviously on a collision course. The PF and it appears the conflicting ac's pilot also must have visually acquired each other

Cause: Late sightings by both pilots.

- Lack of TI to either pilot by Cranfield ATC
- Hazy, into sun flight condition for the GA7 pilot.

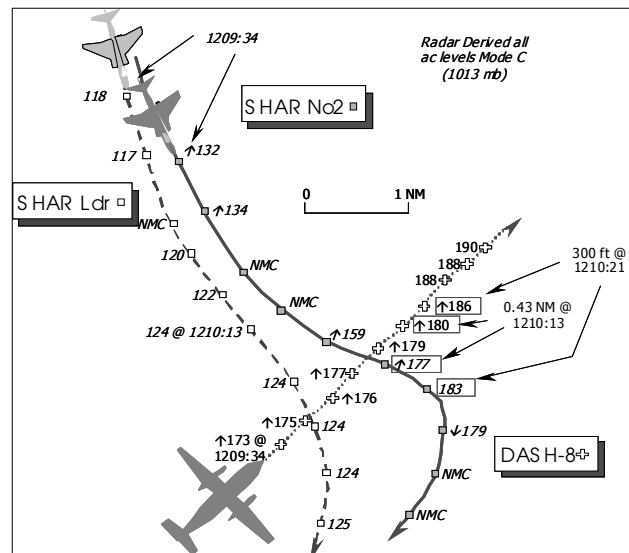
THE DASH-8 PILOT reports that he was outbound from Newcastle to Stavanger, heading 035° at 165 kt, climbing through FL 170, IMC, under an ATS from ScACC. Traffic information was received about unidentified traffic, which was "found" on TCAS when selected, 4100 – 5100 ft below his ac at about 10:30 – 10 NM away, which seemed to be on an opposite track. The observed traffic then changed direction and started to climb and further traffic information was received from ATC that the unknown ac was closing. TCAS enunciated "TRAFFIC", followed shortly afterwards by an RA commanding a 2000 ft/min climb, which he complied with immediately, by

Cause: During an intercept to identify the DASH-8 visually, the No2 SHAR FA2 pilot flew close enough to cause concern to the DASH-8 pilot.

an air picture would have been available to the cell either. It seemed to members that the sophisticated equipment and communications available to the ASACS, could be used to advantage to help prevent a recurrence. Members ventured that if a safety controller was located at a CRC to oversee an exercise – as routinely occurs for OST in the Plymouth Sea areas overseen by Plymouth RADAR – with the ability to intervene to prevent unwarranted intercepts on CAT ac, this would be a great advantage. The Board concurred and recommended further, that the RN considers the feasibility of including an independent air safety cell ashore for each RN AD exercise at sea, within UK airspace.

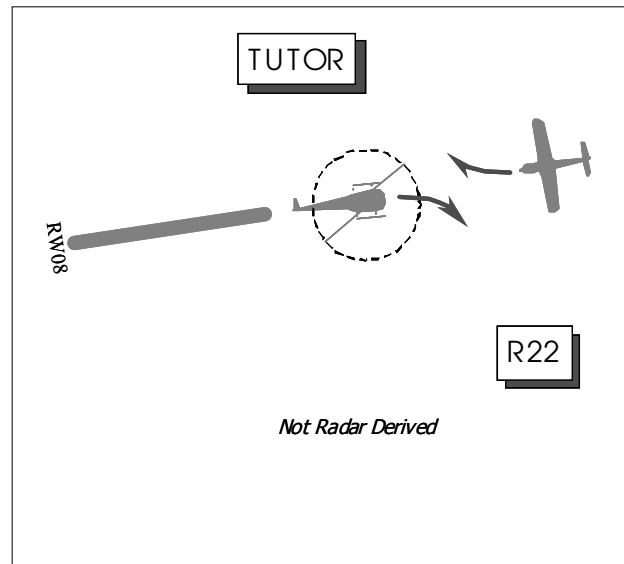
THE GROB TUTOR PILOT, a QFI flying with a student, reports his ac has a white colour scheme, but the landing light and HISL was on whilst circuiting RHD to Cumbernauld RW26RHC at 70 kt and in communication with Cumbernauld RADIO on 120.6 MHz. After initially sighting the R22 helicopter on the ground whilst downwind, he was heading 260° in a straight descent on short finals when the helicopter took off and headed towards his ac. To avoid it he overshot and rolled right as the helicopter passed down his port side, about 200 ft below his ac with a "high" risk of a collision. He added that his workload at the time was high, whilst teaching the student to fly the final approach.

Cause: Inattention by the R22 pilot, who took off from the wrong runway into the path of the Grob on final approach.

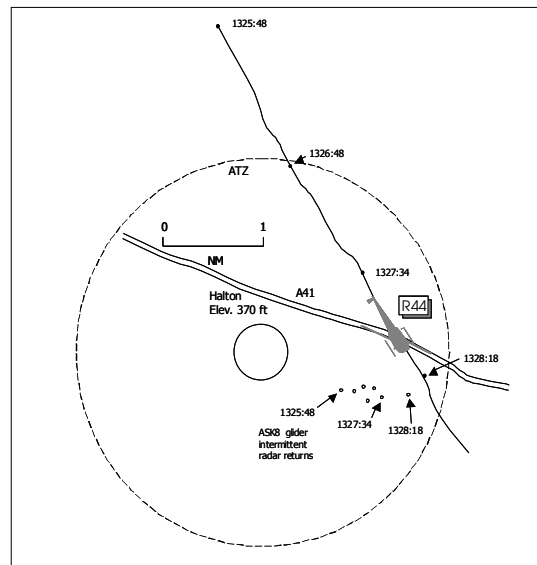
AIRPROX REPORT NO 50/02

THE ASK8 GLIDER PILOT reports heading 090° at 45 kt and 900 ft Halton QFE 1005 mb on a solo local sortie from Halton; he was listening out with Halton RADIO on 130.42 MHz. The visibility was 30 km 1000 ft below broken cloud in VMC and the ac was coloured green with cream wings and tail. He had been ridge soaring and was on an easterly 'beat' when he sighted a red helicopter 100 m on his LHS, flying straight and level, overtaking him at the same level; it had approached from behind, his 'blind' region, and was converging with his extended track. He took no avoiding action as the risk had passed at the point of first sighting but it appeared from the close separation distance that the other pilot was not aware of the proximity to his ac. The helicopter had come from within the Halton ATZ

Cause: The R44 pilot entered the Halton ATZ inadvertently and flew into conflict with the ASK8 glider, which he did not see.

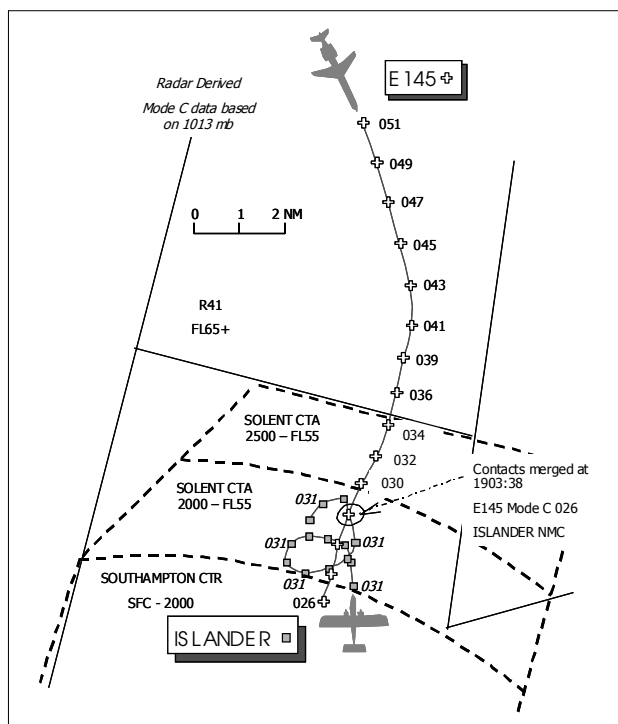
THE EMBRAER 145 PILOT reports that he was inbound to Southampton from Edinburgh positioning for an ILS on approach to RW 20. Following radar vectors the E145, squawking 7461, was cleared to descend to 3000 ft, he thought, and at 3000 ft to establish on the LLZ. Having established on the LLZ the E145, heading 205° at 200 kt, was then cleared to descend on the glideslope. However, before glideslope interception, a proximate target appeared on the TCAS at the same level, at 1 o'clock crossing right to left. PNF queried this with ATC who simply confirmed that the traffic was at 3000 ft. However, before any further queries could take place the proximate target became a TA followed rapidly by an RA with a TCAS descent; this was followed in accordance with company standard operating procedures. The E145 passed directly beneath the other ac, which by this time had turned back onto a westerly heading. At this point the E145 was at 2800 ft with a 200 ft separation on the TCAS display. The risk of collision was assessed as high.

Cause: The Solent RAD/Southampton APR controller vectored the E145 into conflict with the Islander.

Recommendation: That the CAA considers publishing clarification on the meaning of "Radar Control" within Class D airspace for ac operating to different flight rules.
