UK AIRPROX BOARD

Analysis of Airprox in UK Airspace

**Report Number 8
January 2002 - June 2002**

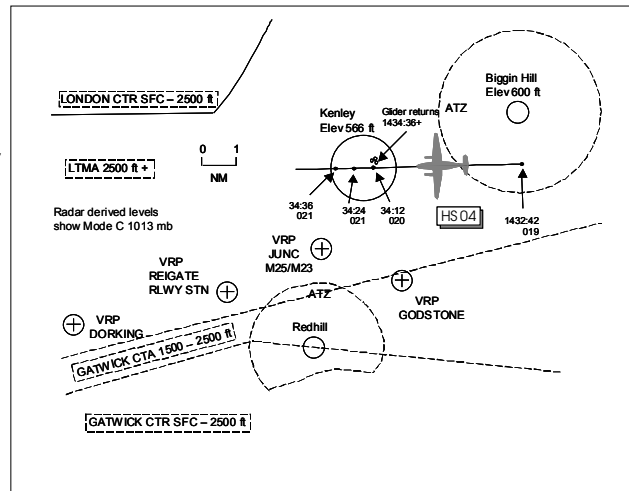
AIRPROX REPORT NO 68/02

THE KA7 GLIDER PILOT reports flying a dual training sortie from Kenley with a visibility of 10 km in haze in VMC. The glider was coloured red/white and was not fitted with a radio. During a winch launch heading 090° at 57 kt and climbing through 1000 ft QFE, he spotted a twin engined ac approaching head-on just as he was lowering the nose; he was seated in the rear cockpit. He immediately terminated the launch by releasing the cable and at the same time the twin altered course to port, passing 3-400 ft above and just down his RHS <50 m away. He assessed the risk of collision as considerable.

Members were dismayed that the HS04 pilot had declined to complete an Airprox form. Kenley Glider site is shown clearly on topographical charts and is notified within the UK AIP, with winch launches up to 1700 ft agl (2266 ft amsl). The Pease Pottage radar shows the HS04 tracking through the Kenley O/H, with Mode C indicating a climb from 1780 ft amsl, finally levelling at 1980 ft QNH; this was below the max launch height 1700 ft agl (2266 ft amsl) being attained on the day at Kenley. In doing so, the HS04 pilot had flown into conflict with the launching KA7 Glider and this had caused the Airprox. Pilot members wondered whether the ground launching party at Kenley should have heard or seen the Dove approaching when they had cleared the area above and behind the winch prior to launch but there was little information to go on in this respect. The weather at the time towards the E

Cause: The Dove pilot flew through a notified Glider launch site into conflict with a launching glider.

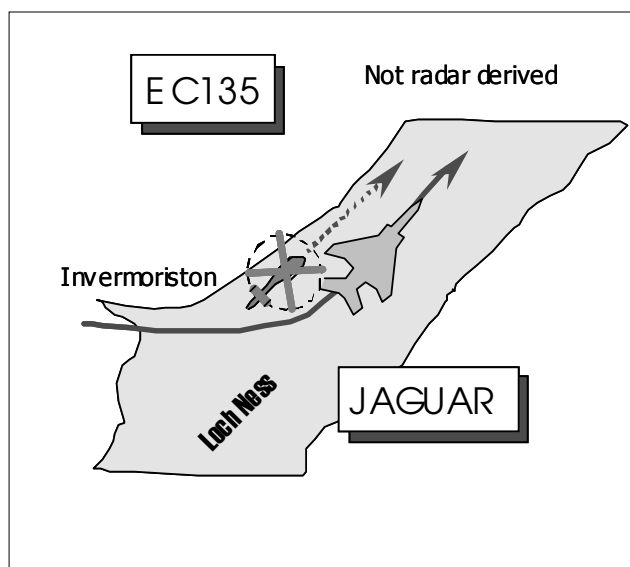
AIRPROX REPORT NO 69/02

THE JAGUAR PILOT, reports his ac is camouflage grey, but HISLs were on whilst flying a low-level sortie up Loch Ness at 500 ft Rad Alt. A squawk of A7001 was selected with Mode C, but neither TCAS nor any other form of CWS is fitted. He was not in receipt of an ATS. The in-flight visibility was 15 km and at the time he was flying 2000 ft clear below cloud.

THE EC135 PILOT reports his helicopter has a yellow colour scheme. HISLs and the landing light were on because of the weather conditions, which he reports were a variable visibility of between 2-3000 m in showers and 8 km; 150 ft clear below and 3 km horizontally clear of cloud. A squawk of A0020 was selected with Mode C, but neither TCAS nor any other form of CWS is fitted. He was not in communication with any ATSU.

Cause: Effectively, a non-sighting by the Jaguar pilot.

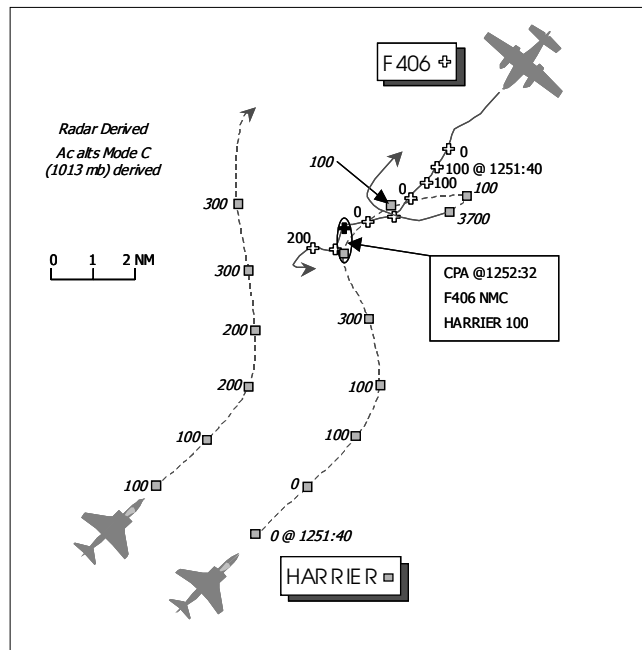
THE REIMS F406 PILOT reports that he was conducting a fisheries’ protection sortie at 500 ft (Rad Alt), with SSR code 4100 and Mode C selected on and was in receipt of a FIS from London Mil on 135.15 MHz and, he thought, from Culdrose ATC on 373.7 MHz. He was also in contact with Culdrose Operations on H/F. When heading 220° at 140 kt and tracking towards a ship contact, he saw a Harrier in his 11 o’clock at about 0.5 NM coming towards him approximately 200 ft above but descending. He turned right and descended and as he did so the Harrier banked into a steep right turn and climbed towards another Harrier seen as he turned which, he assumed, was his playmate.

Cause: Confliction resolved by both pilots.

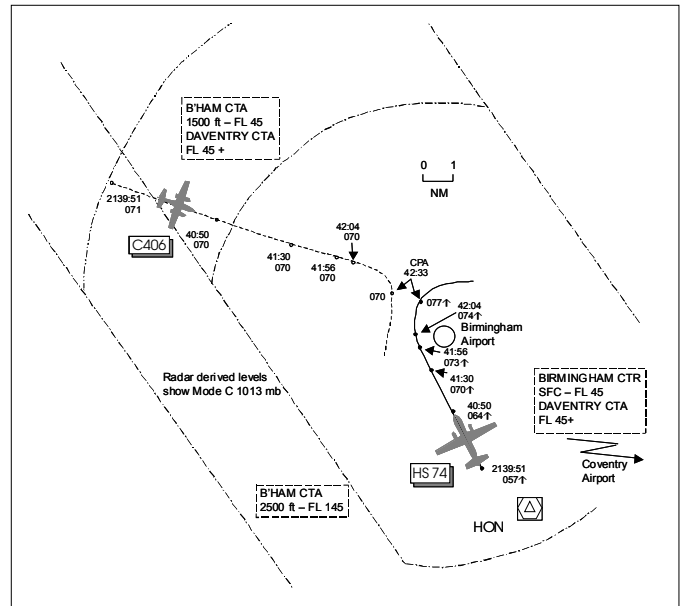
THE BIRMINGHAM APR reports working the subject C406 inbound to Coventry from the W, the subject HS74 departing Coventry to the N and another ac inbound to Birmingham for RW 33 from the SW. The HS74 had been given an ATC clearance to climb straight ahead from RW 23 to 2500 ft but called on frequency climbing through 2100 ft for FL 30. His cleared level was queried and he was subsequently cleared to climb to FL 60. The APR then turned the HS74 R onto heading 280° then further R onto 330° and, following co-ordination with MACC, cleared it to climb to FL 80. By now, the C406 was entering CAS from the W descending to FL 70 and was given a RCS and instructed to continue on its present heading. When the subject ac were 10 NM apart, MACC telephoned to draw attention to the subject acs' flight paths but the APR, whose plan was to climb the HS74 through the level of the C406 before horizontal separation was lost, believed matters were under control. However, the HS74 was climbing at a very slow rate so it was turned R onto 060°, she thought, which its pilot acknowledged. After a short pause the pilot queried the heading change. The APR confirmed the turn to the R and changed the issued heading to 090° to increase separation. At this stage the quality of the primary radar was very poor and it

Cause: The Birmingham APR dispensed with vertical separation without ensuring horizontal separation.

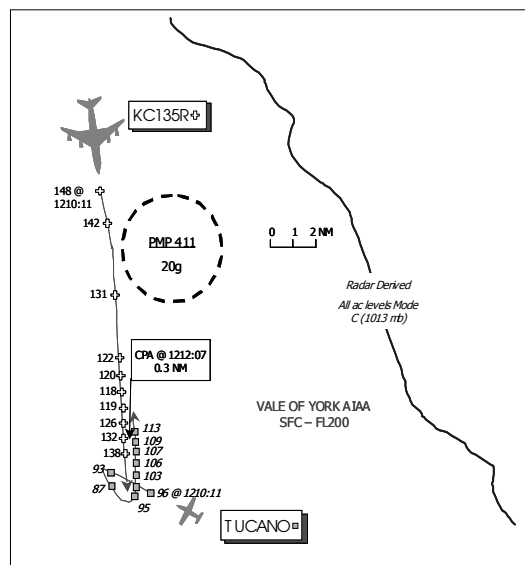
THE KC 135R PILOT reports heading 160° at 250 kt, in descent from FL 240 to FL 110. Although in receipt of a RIS from London Mil, RAS had been requested originally. The ac was coloured grey and nav lights and HISLs were selected on. Passing FL 130, London Mil reported traffic at 2 o'clock. Just after identifying this traffic on TCAS, further traffic indicated at 12 o'clock. Within seconds this changed from proximate traffic to a TA, and then, when passing FL 120, to an RA commanding a 4000 FPM climb. A climb was initiated and the ac levelled at FL 140 when TCAS showed traffic clear. The conflicting traffic was never visually acquired.

Cause: Confliction resolved by both pilots.

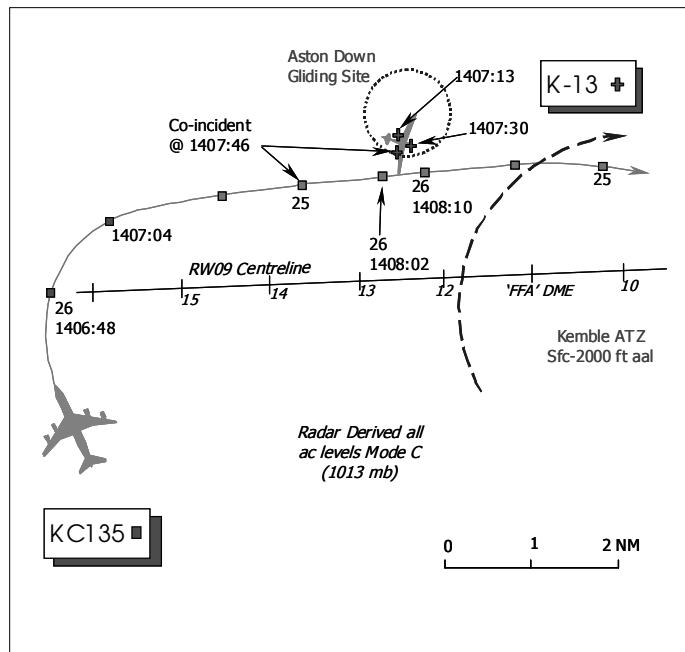
AIRPROX REPORT NO 73/02

THE KC 135-R PILOT reports that he was inbound to Fairford under a RIS from Brize Norton APPROACH (APP), squawking A3750 with Mode C; TCAS was fitted and HISLs were on. Whilst on finals for RW09 at 14 NM DME, LLZ established heading 095° at 210 kt level, and at 2000 ft Fairford QFE, traffic information was given by APP. The pilot in the LHS spotted a glider off the port wing climbing with "moderate" left bank applied. The glider appeared to be at the same height and about 0.5-1 NM away, pointing towards them so power was increased to pull ahead and increase horizontal separation. The approach was continued.

Cause: Sighting Report.

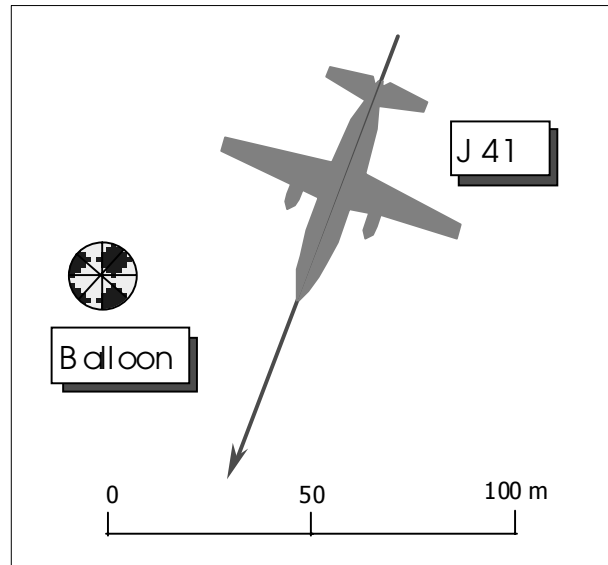
THE JETSTREAM 41 PILOT reports heading 190° at 170 kt, climbing through cloud at first towards FL 170. He was in contact with Newcastle Radar (APR) who were supplying a RAS. Just as the ac broke through the cloud tops, at about FL 115, a blue and yellow balloon of about 10 ft diameter was seen to pass about 50 m under the starboard wing. A yellow capsule was attached to the balloon and the crew believed that it may have been a weather balloon.

Cause: Conflict in the "open FIR" with an untraced balloon.

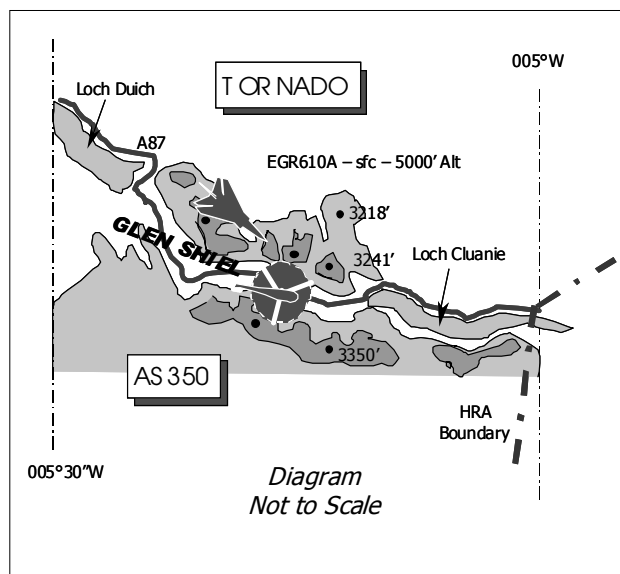
THE TORNADO GR4 PILOT reports his ac is camouflaged grey/green, but HISLs were on whilst operating independently in LFA 14T – EGR610A - down to 100 ft msd in CAVOK conditions. A squawk of A7001 was selected with Mode C, but neither TCAS nor any other form of

CWS is fitted. Descending over a ridge into a valley about 3.5 NM W of the western end of Loch Cluanie, heading 110° at 420 kt, he spotted a red and blue coloured helicopter just R of the nose on a similar heading. A climbing L turn was immediately initiated to avoid the helicopter,

which passed about 300 m to starboard at about the same height. He assessed the risk of a collision as "high".

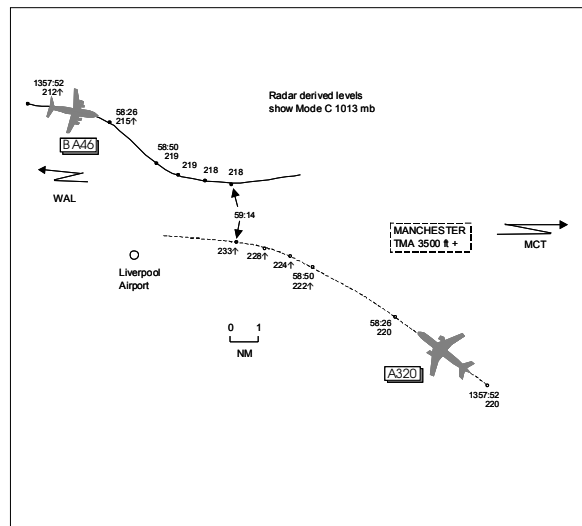
AIRPROX REPORT NO 76/02

THE A320 PILOT reports flying en route to Dublin at 330 kt and FL 220 and receiving an ATC service from MACC on 118.77 MHz. The flight had been 'level capped' earlier at FL 180 but had subsequently been given climb by MACC to FL

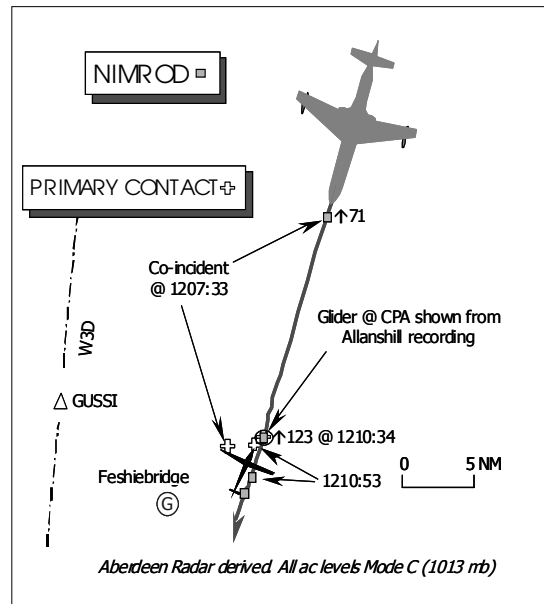
AIRPROX REPORT NO 77/02

THE NIMROD MK2 PILOT reports he was outbound from Kinloss, under a RIS from Scottish MILITARY and squawking A4601 with Mode C. Neither TCAS nor any other form of CWS is fitted.

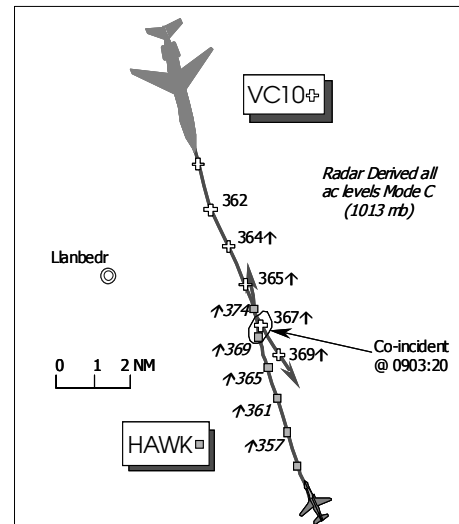
THE VC10 PILOT reports his ac has a low conspicuity grey colour scheme, but HISLs were on whilst operating in the WELSH MTA, VMC with unlimited visibility under a RIS from London MILITARY. The assigned squawk of A3327 was selected with Mode C, but neither TCAS nor any other form of CWS is fitted.

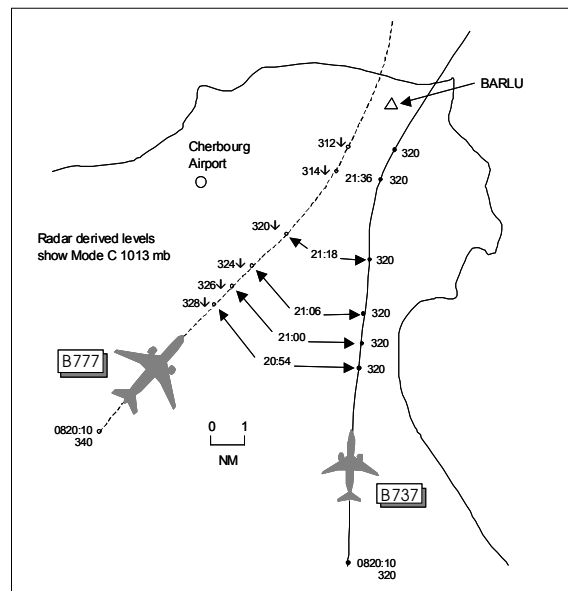
THE B777 PILOT reports flying inbound to Heathrow from S. America heading 040° and in the descent to FL 310 at 260 kt. He received a TCAS TA on traffic converging from the SE of BARLU simultaneously with LONDON ATC requesting him to stop his descent at FL 330; by now he was already passing through FL 325. ATC then gave him an instruction to expedite a turn onto N during which time he saw the other traffic, 200 ft above and descending (he thought), 2 NM away to his R.

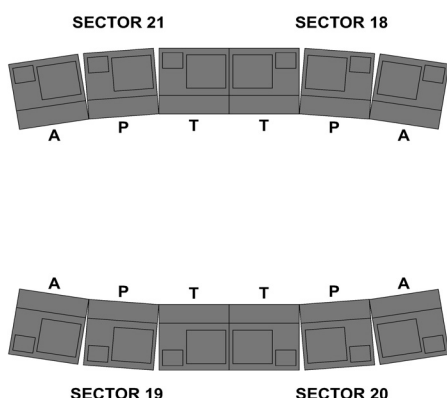
At the time of the Airprox, the staff were seated at the Sector 18-21 'banana' as follows: The sector assistant sat at the far L end of Sector 21, alongside and to the R were the two Planning controllers. To the R of them in the usual position for the Sector 21 and Sector 18 tactical positions, were, respectively, the trainee Tactical controller and his mentor.

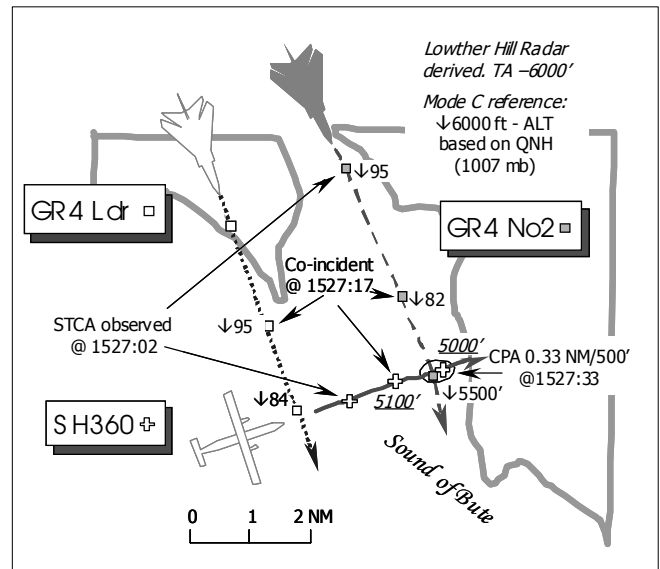
THE SHORTS SH360 PILOT reports he was inbound to Glasgow from Islay at an altitude of 5000 ft and under a RAS from Glasgow APPROACH (APP) on 119.1 MHz. A squawk of A5014 was selected with Mode C, but TCAS was unserviceable. Heading 090° at 175 kt, about 22 NM W of the GOW VOR, a fast jet – possibly a Tornado – crossed from L – R 100 ft directly above his ac, descending from the 10:30 position to his 4:30, with a "high" risk of a collision.

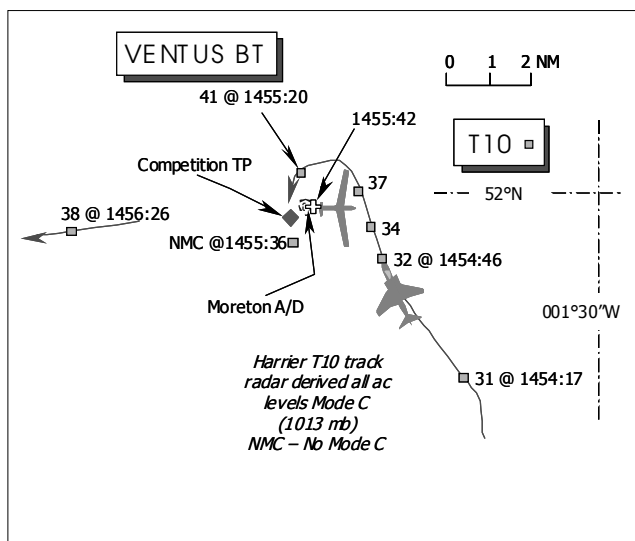
Heading 095° at 75 kt, after a competition turning point – centred on the A44 road bridge over the railway line at Moreton-in-the-Marsh station (the TP) – whilst passing overhead Moreton-in-the-Marsh disused aerodrome, in level cruise at 3900 ft QNH (1017 mb), a military jet was spotted 400 m away crossing in front of his glider from R – L. The jet - that he originally thought might have been a midwing ac with two engines, but subsequently identified from recognition profiles later as a Harrier - then performed a knife edge turn off his port wing tip and disappeared from view astern, before reappearing in his 5 o'clock position, flying directly towards his glider. It appeared as though his ac was "being used as a target" and that the Harrier pilot was going to take avoiding action. However, when the Harrier had closed to about 200 m, he dived his glider L "to avoid being hit" he opined, but then lost sight of the jet.

The risk was assessed as very high unless it was a "deliberate attack" by the military pilot intending to take late avoiding action. He added that the area was "busy", with a number of gliders flying in a NOTAM'd competition. Even if the jet pilot had seen him, there would have been a high risk to others.

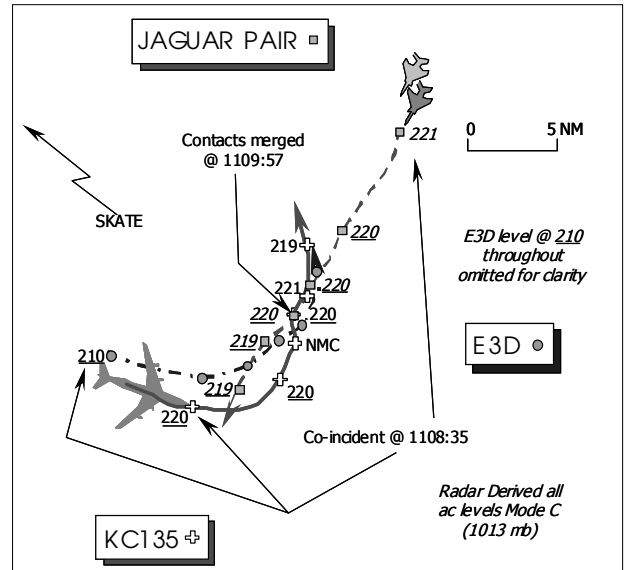
THE KC 135 PILOT reports he was tasked to provide Air-Air Refuelling (AAR) support for Exercise CLEAN HUNTER and was established at FL 220, flying at 300 kt under an Air Defence Service (ADS) from CRC Neatishead. The assigned squawk was selected with Mode C and TCAS is fitted.

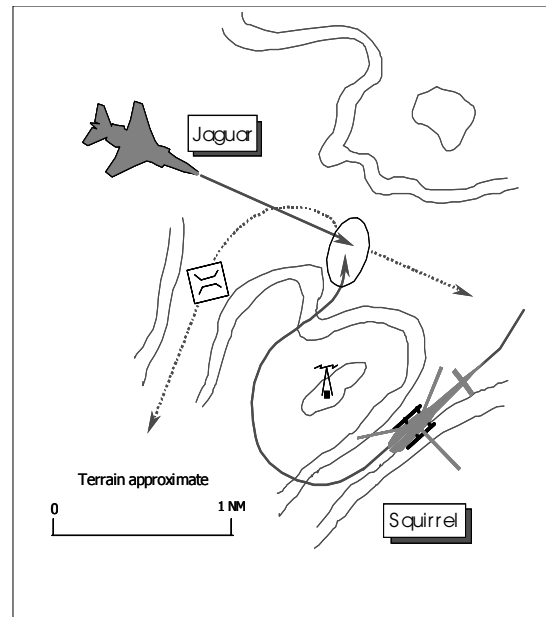
THE SQUIRREL PILOT reports that he was conducting an instructional low level sortie with a student navigator occupying the left seat and a nav instructor in one of the rear seats. His ac was painted black/yellow, HISL and transponder were all on and he was squawking 7000 with Mode C. TCAS was not fitted. He was not receiving an ATS but was monitoring Guard frequencies and the UKLFS common frequency. The ac had just crossed a main E-W valley at 90 kt, tracking about 190° whilst searching for a navigational feature (a bridge) in a small subsidiary valley. Realising an error, the student asked for a right turn whilst attempting to identify the feature. While stabilised on a heading of 040° [flying back towards the main valley] the student identified the feature just to the left of the ac. A descending turn left was started to overfly the feature, but as the ac turned through about North, a Jaguar was seen to pass left to right about 100 – 200 ft in front of the Squirrel. The Jaguar did not appear to take any avoiding action. He assessed the risk as "very high".

Cause: Late sighting by the Squirrel crew and non-sighting by the Jaguar pilot.

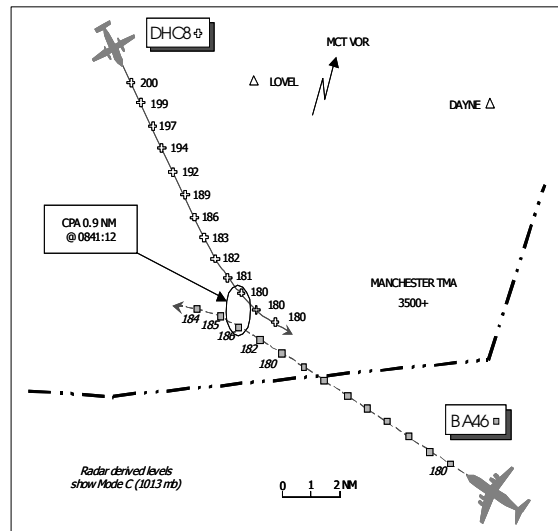
THE DHC8 PILOT reports that he was inbound to Birmingham from Edinburgh, squawking 5167 with Mode C and in contact with Manchester on 134.42 MHz. Whilst in descent to FL 170, in VMC, on radar heading 170° at 280 kt, TCAS enunciated with a RA to monitor vertical speed. Simultaneously, a left turn to heading 130° was given by Manchester, although this was not notified as avoiding action. A BA46, first seen at approximately 3 NM, passed down the right hand side, at approximately one NM and above. He assessed the risk as high.

Cause: STAFA Radar controller descended the DHC8 into conflict with the BA46.

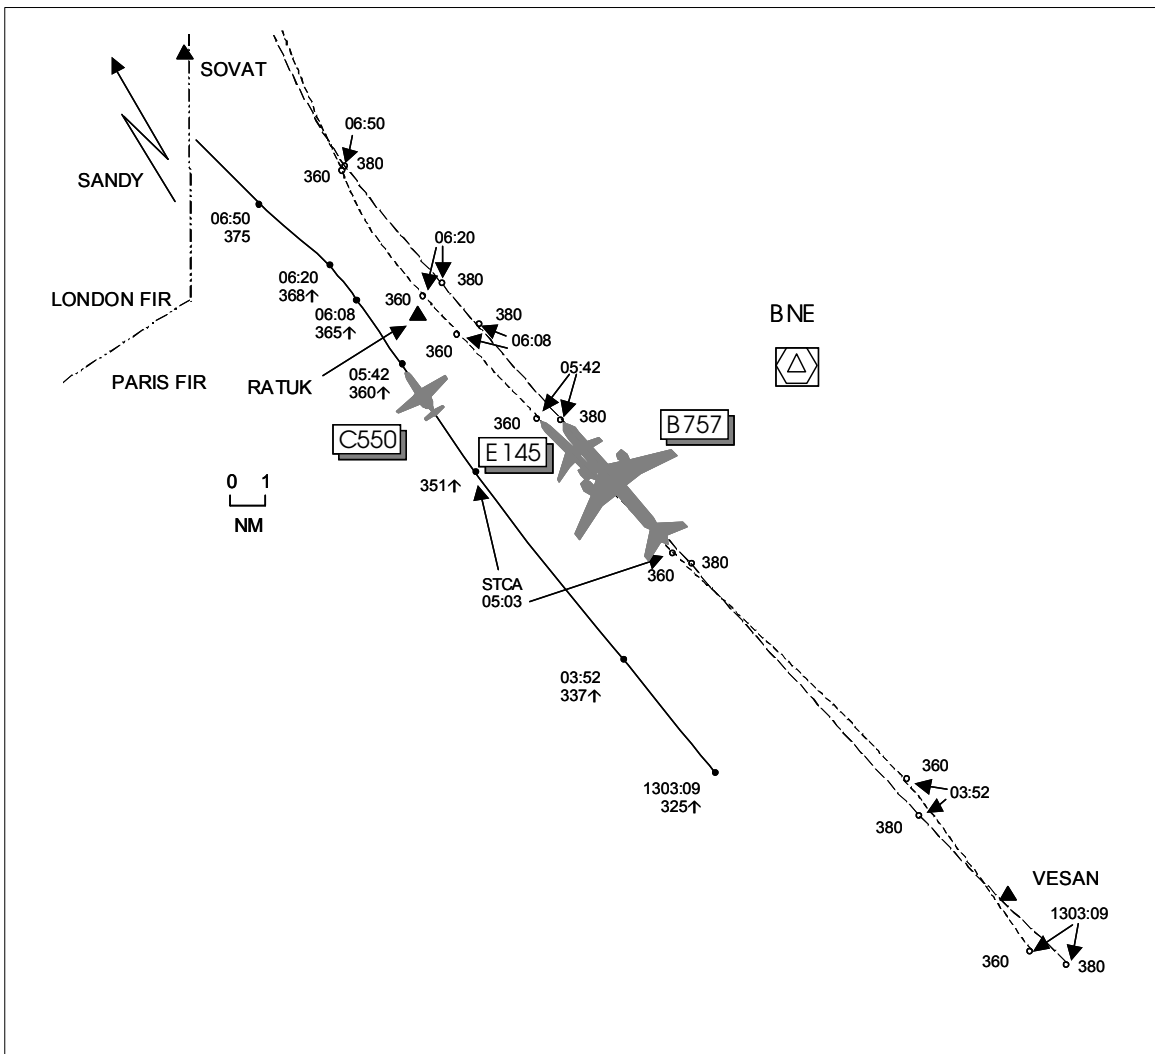
THE LACC S1/2 TACTICAL CONTROLLER reports that the C550 called approaching RATUK at FL 340 requesting FL 390 with another ac (AC4) to the E at FL 360 cruising speed M 0.78. He gave both ac radar headings, the C550 315° and AC4 325°. 12 miles behind AC4 was an E145 at FL 360 M 0.76 and a B757 at FL 380. Not believing these two following ac to be conflicting traffic to the C550, he cleared the C550 to climb to FL 400 (the level agreed with C550 pilot for the ac's route) as he anticipated the C550 would be level well before lateral separation would be lost. Thereafter several other ac called on frequency, which were acknowledged, whilst he was monitoring a couple of other traffic scenarios elsewhere on the sector. At that stage the S1/2 Planner began pointing out other traffic that would be climbing into his sector in the SANDY area. Looking back at the C550 he noticed it was climbing through FL 360 abeam the E145 so he instructed the Citation pilot to expedite his climb. However, he immediately realised the B757 was flying at FL 380 almost exactly above the E145 but this was difficult to see from the radar picture as the radar labels were superimposed and only the E145 was visible owing to his previous 'hooking' of the ac label. He then instructed the C550 pilot to fly heading 300° and to stop climb at FL 370, the radar showed it climbing through FL 365, followed by radar headings of 335° and 330° to the E145 and B757 respectively. The C550 climbed up to FL 375 before descending back to FL 370.

Cause: The LACC Tactical Controller climbed the C550 into conflict with the E145 and the B757.

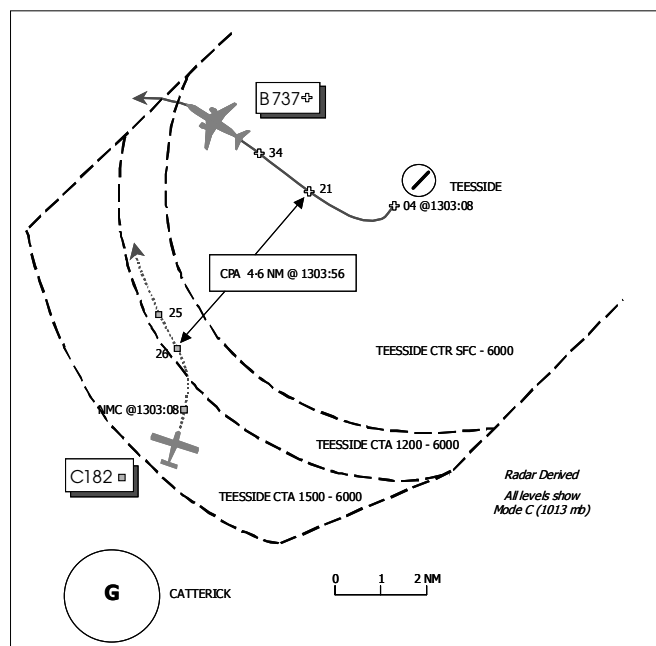
THE TEESSIDE APPROACH CONTROLLER (APP/APR) reports that the C182 was orbiting Catterick Airfield conducting a parachute drop under FIS from Leeming Zone controller. The B737 taxied for departure from RW 23 and was instructed to depart on heading 260° climbing to FL 110 with SSR code 4462. At 1258 Leeming was informed of the impending departure, iaw the Teesside/Leeming LOA. The C182 (SSR code 0033) was then observed to have left Catterick and seen to be tracking NNW into the Teesside CTA. Leeming was immediately contacted and, simultaneously, Teesside Tower controller, via intercom, to try and stop the B737 departing; but it was too late. So Teesside Tower was told to turn the B737 on to a heading of 310° in order to remain clear of the C182. Leeming Zone was instructed to turn the C182 immediately on to E in order to clear RW 23's climbout area. The C182 continued to track NNW and separation reduced to 0 ft V/ 2 NM H. Once separation was regained, the B737 was turned, initially onto 270°, and then direct RIBEL. The C182 contacted Teesside APP/APR after the incident was over.

Cause: C182 pilot entered the Teesside CTA without clearance.

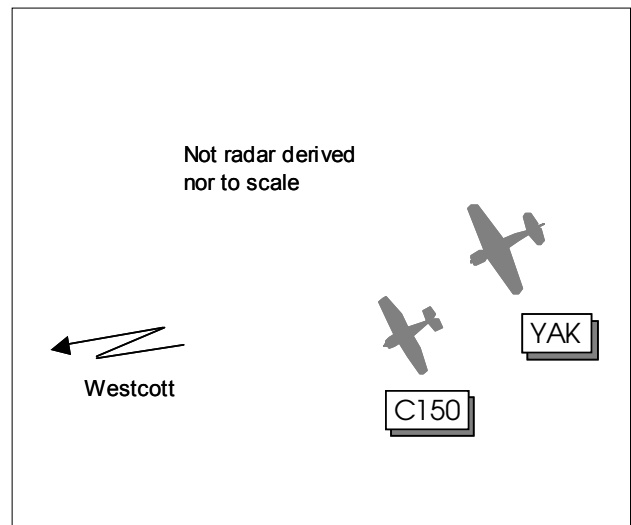
AIRPROX REPORT NO 92/02

THE C150 PILOT reports flying solo returning to Old Sarum from the PFA Rally at Cranfield heading 245° at 85 kt and 3000 ft QNH 1021 mb squawking 7000 with Mode C. The visibility was >10 km 1000 ft below cloud in VMC, the ac was coloured white/red and strobe lights were not fitted. He had planned a route to pass over

Cause:The untraced YAK pilot flew in formation behind the C150 without the C150 pilot's agreement in contravention of ANO Rule 17 (1) (b) and (c).

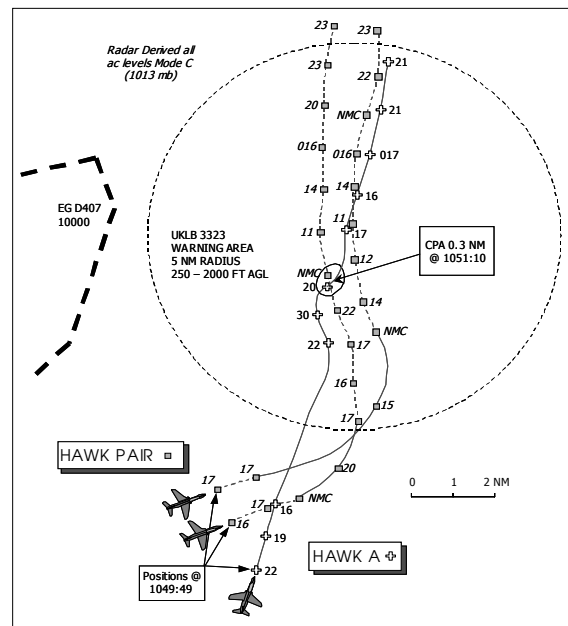
AIRPROX REPORT NO 93/02

HAWK (A) PILOT reports that he was conducting a 'pop' attack on a simulated target whilst engaged in a Close Air Support (CAS)/ Forward Air Controller (FAC) training exercise centred on a position 6 NM NW of Barnard Castle and working with a FAC on 340.35 MHz. On leaving the nominated Initial Point (IP) heading 018°(T) for the run into the target area, he saw a pair of Hawks out to his left in battle formation heading E; these crossed the nose of his ac

Cause: Confliction in a NOTAMed exercise area resolved by the Hawk Pair Leader.

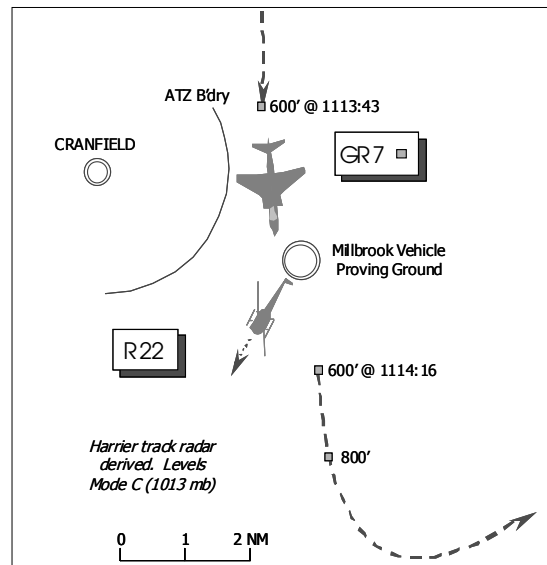
AIRPROX REPORT NO 94/02

THE ROBINSON R22 PILOT reports his helicopter has a blue colour scheme, but HISLs are not fitted. He was flying one of three Robinson R22s which were all engaged in training flights in CAVOK conditions at a temporary licensed aerodrome established at Millbrook circuit.

Cause: A non-sighting by the Harrier GR7 pilot.

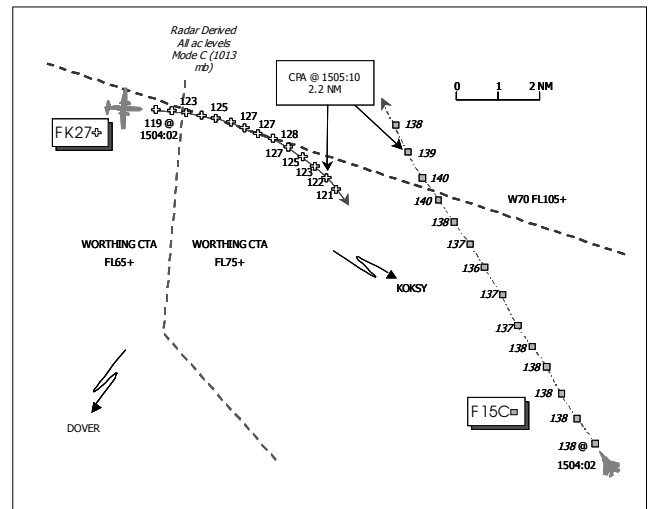
AIRPROX REPORT NO 95/02

LACC SECTOR15/16 TACTICAL CONTROLLER reports that at the time of the incident RTF and traffic was assessed as medium to high. At approximately 1500 the FK27 was climbing out of Southend towards KOKSY. Several Cleared Flight Path requests were submitted by a military sector in quick succession and, after

Cause: The F15 formation flew below their assigned level.

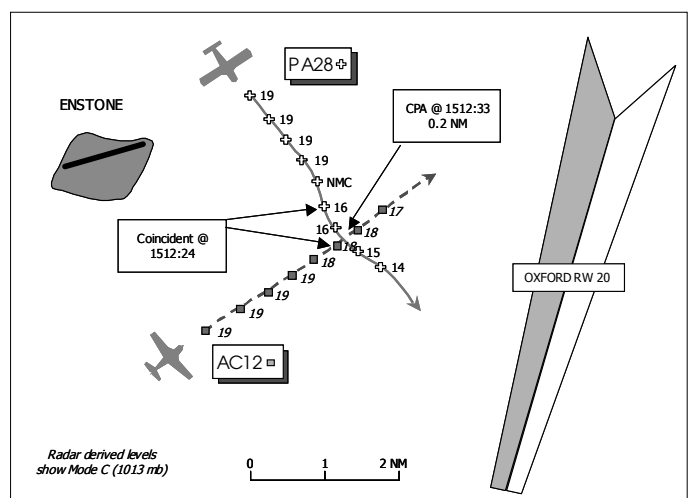
THE PA28R PILOT, a QFI, reports that he was inbound to Oxford from Coventry on an instructional sortie and was in contact with Oxford Tower on 133.42 MHz squawking SSR code 7000 with Mode C. Whilst heading 200° at 4.2 DME on final approach to Oxford RW 20, he thought, at 90 kt and passing 1800 ft (Oxford QNH 1027 mb) in descent, another ac, similar to a Rockwell Commander, was first seen at the same altitude, approximately 150 to 200 m closing from R to L. He immediately took control and dived below the conflicting ac. He assessed that there was a high risk of collision. He adds that his ac was white and orange with black trim and that HISLs and landing light were selected on.

Cause: Late sighting by the PA28R pilots.

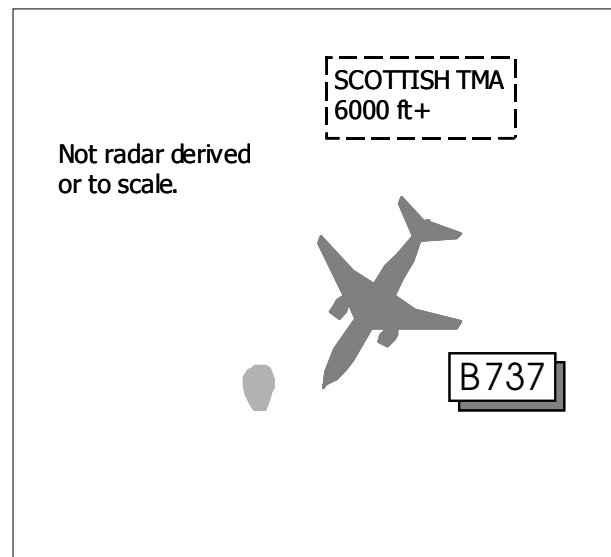
THE B737 PILOT reports heading 210° at 320 kt inbound to Prestwick, descending to FL 140, and in receipt of an ATC service from ScACC. When approx 5 NM S of GRICE descending in VMC through FL 155, he thought, the FO noticed a red coloured weather balloon pass 20 ft to his R over the RH wing. He informed ATC of the encounter and assessed the risk of collision as high.

Cause: Conflict with an untraced balloon in Class D airspace.

Recommendation: In light of 3 incidents during the months May - July 2002, involving encounters with untraced balloons, the CAA and MoD should consider conducting a review of arrangements on:

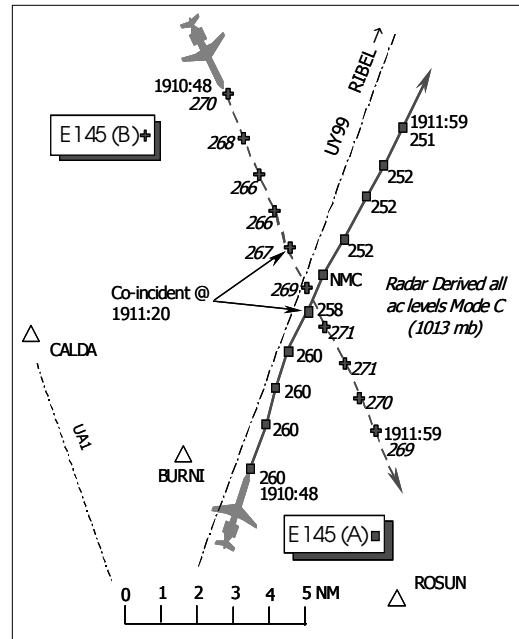
THE EMBRAER 145 (A) PILOT reports that he was approaching RIBEL heading, he thought, 340° towards MARGO at FL 260 and M 0.76 whilst receiving an ATS from Manchester. [UKAB Note (1): The Airprox actually occurred at an earlier stage of the flight, whilst it was still inbound RIBEL, tracking about 020°] He was aware of opposite direction traffic at FL 270 which was given descent clearance to FL 240. This was followed by a TCAS Resolution Advisory (RA) with "DESCEND" aural warning, and this was complied with promptly. The other ac was not sighted, but TCAS indicated that it passed close overhead with 500 ft vertical separation. During the encounter, ATC cleared his ac to descend to FL 240. The TCAS alert was considered "necessary" and the risk was assessed as "high".

Cause: MACC Sector 29 Area Radar Controller issued a descent clearance to E145(B) without taking E145(A) into account.

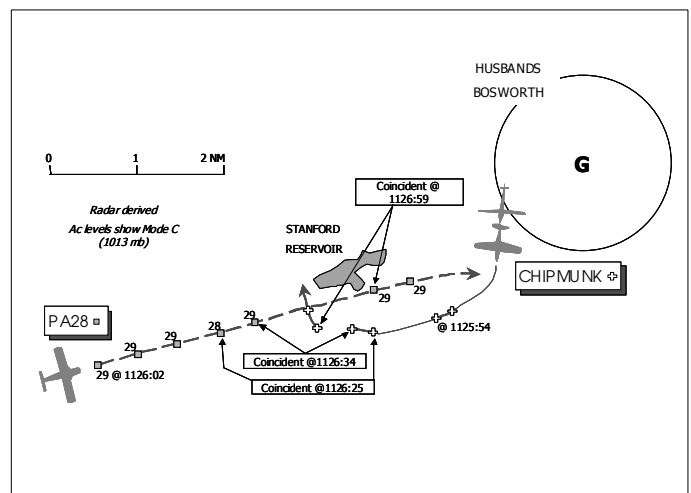
THE CHIPMUNK PILOT reports that he was towing a Puchacz glider at 2800 ft ASL, he thought, about 0.5 NM S of the E end of Stanford Reservoir and heading about 270° at 65 kt when he saw a large blue single-engine ac in his 1

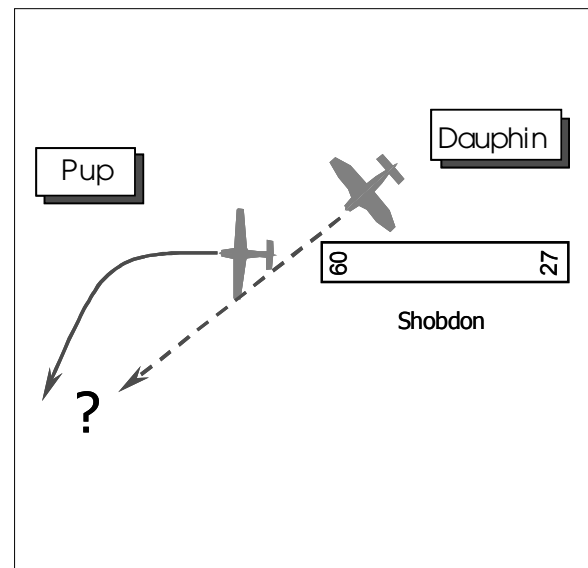
AIRPROX REPORT NO 101/02

THE B121 PUP PILOT reports that he was crosswind in the Shobdon circuit, having just departed from RW27 (left hand circuit) and prior to clearing the circuit. He was heading 210°,

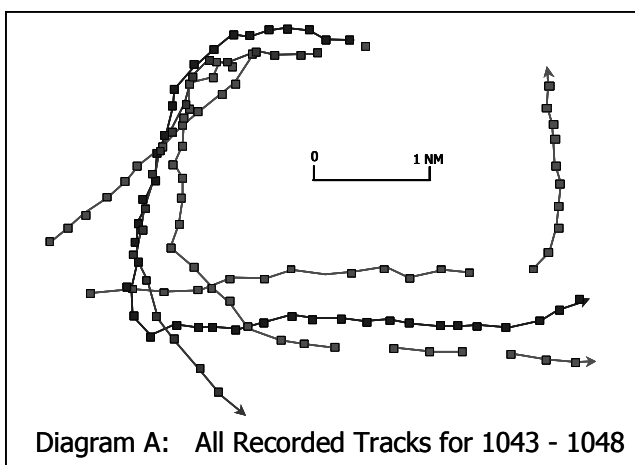
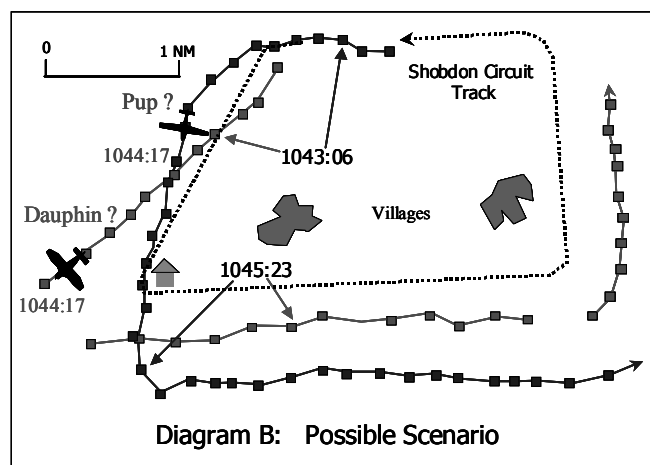
UKAB Note (1): Analysis of the Clee Hill radar recording shows four returns in the Shobdon area between the times of 1042:30 and 1047:50, all of which are squawking 7000 and are shown in diagram A. It is not possible to determine which, if any, of these returns are the Airprox ac but one shows intermittent Mode C and so can be discounted. Of the other three tracks, two show some similarities to the Dauphin pilot's report, and these are shown in Diagram B. In this case separation between these ac is around 1 NM in the general crosswind area, reducing to 0.6 NM as the leading ac establishes downwind. None of the tracks record less separation crosswind, nor do any reflect the Pup pilot's report of an ac turning right to downwind. All tracks comply with the Shobdon noise abatement procedures and achieve at least the minimum spacing downwind. It must be stressed that this limited analysis assumes an accurate reported time of the Airprox of 1045z.

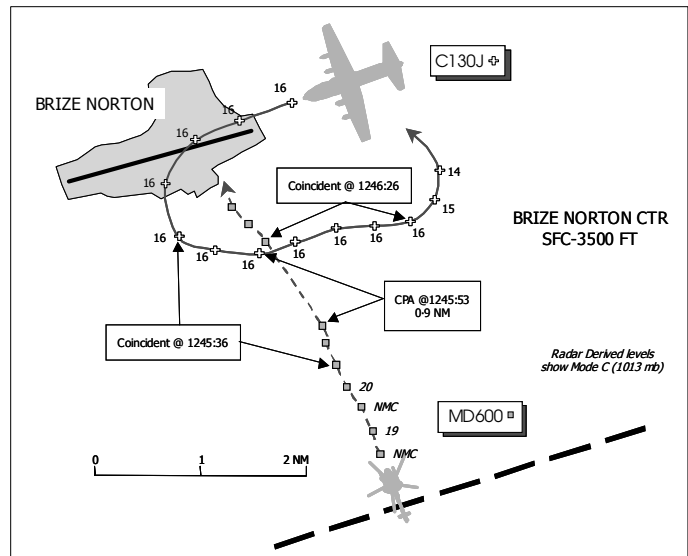
THE C130J (HERCULES MK5) PILOT reports that during a left-hand break into the Brize Norton RW 26 circuit at 1500 ft and 240 kt, TCAS enunciated with an RA "*Climb, climb*" against traffic passing S to N through the Brize overhead. Both pilots then saw a helicopter, a NOTAR type, 500 ft away at the same height. Because of the attitude of his ac, 60° AOB, deconfliction was achieved by tightening the turn rather than climbing. The crossing traffic had been advised by Brize Approach to be at 2000 ft QFE and was monitored on TCAS from 8 NM. However, the helicopter, which was not reported by Brize Tower, was operating on a separate frequency.

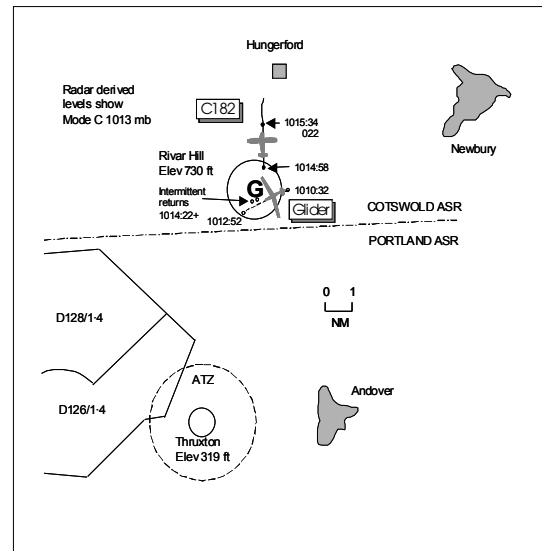
AIRPROX REPORT NO 109/02

THE PUCHACZ GLIDER PILOT reports thermalling at 50 kt during a dual local training sortie from Rivar Hill. The visibility was >10 NM 1000 ft below cloud in VMC, his ac was coloured white and was not fitted with a radio. About 0.5 NM SSW of the glider site and whilst circling to the R at 1500 ft agl (Rivar Hill QFE), he suddenly noticed a high wing single engined ac, coloured white, converging at 100 kt+ and heading directly towards him about 200 ft below. The conflicting ac passed directly beneath him without taking any avoiding action and apparently without seeing him. He had seen the other ac too late to take any avoiding action and he assessed the risk of collision as very high, particularly as the other ac had flown close to the active airfield. Subsequently, the glider site ground party saw the other ac fly directly along the RW C/L maintaining approx 1200 ft agl and they had expressed concern as the airfield was active with winch launching operations.
