**UK AIRPROX BOARD**

# **Analysis of Airprox in UK Airspace**

**Report Number 7  
July 2001 to December 2001**

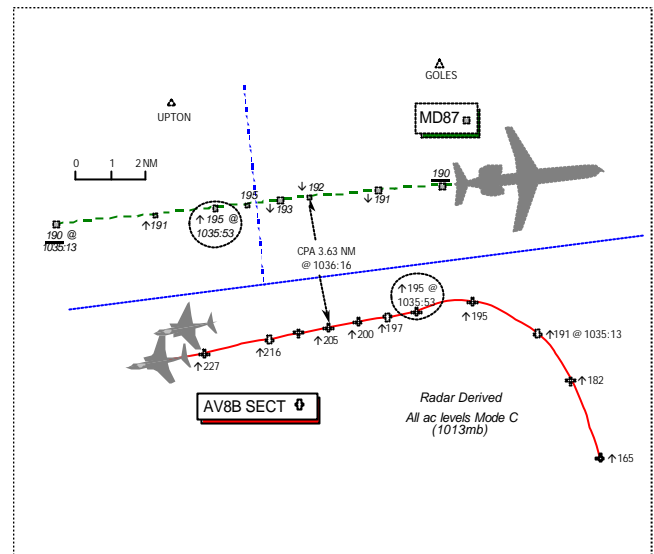
**THE LATCC N SEA SECTOR 10 CONTROLLER** reports that he was acting as mentor to a trainee controller on S10. The MD87 had levelled at FL 190 outbound from Manchester and in accordance with the LATCC/MACC standing agreement, was eastbound to the S of the L975 centreline. Just as his trainee instructed the MD87 to climb to FL 230, he noticed another ac S of GOLES indicating about FL 194. Realising that this unknown ac was northbound, he issued avoiding action to the MD87 crew first to turn hard L onto 055° and next, seeing the unknown ac was climbing, he gave further avoiding action by stopping the MD87's climb immediately. The MD87 crew did not appear to take the turn, but they did stop the climb and descended back to FL 190. Traffic information was given and the MD87 crew did detect the traffic on TCAS. However, no RA was declared.

**THE LATCC N SEA CSC** reports that the MACC S29 controller called to advise they were turning the AV8B section (the unknown ac) hard L. He looked down to the radar display and heard the S10 controller also issuing avoiding action to the MD87. As both flights were being turned L he assessed that standard separation would be maintained or, if lost, only by about 0.5 NM. The

Cause: A potential unauthorised penetration of Class A CAS (L975) by the AV8Bs, prevented by the MACC S29 SC.

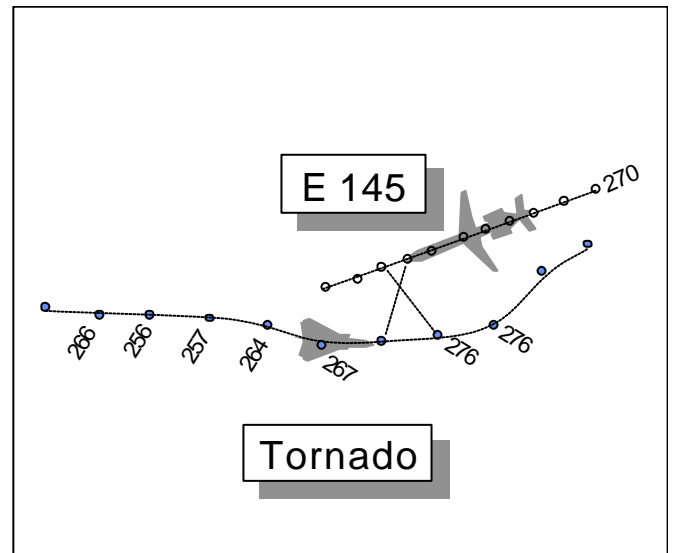
**THE EMBRAER 145 PILOT** reports heading 250° at 300 kt under radar control having been cleared by ScACC to descend from FL 350 to FL 270. Passing FL 273 the controller instructed him to level immediately at FL 270. Moments later military fast jet traffic passed in the opposite direction to port by 1.8 NM and 500 ft above. TCAS gave a 'Descend Now' RA and he complied, but the RA cleared almost immediately, after only 100 ft of descent. After landing he was told that the fast jet had climbed well through its cleared level.

situational awareness regarding the Emb145, on which they were twice given traffic information. The Board also agreed that part of the cause was that the Buchan WC did not ensure that the required 2000 ft separation between the ac was maintained. Members felt that he had exercised insufficiently positive control over the F3, particularly when it stopped performing according to his expectations. In assessing the risk level, members accepted that although the ac passed almost 2 NM apart, this appeared to be more by luck than anything else as the situation appeared to have been largely uncontrolled. The Board assessed that the safety of the ac had not been assured.

Cause: The Buchan WC did not maintain the required 2000 ft vertical separation, and the F3 crew did not take sufficient account of the TI provided on the Emb145.

As a result of this regrettable incident the Buchan WC underwent a period of local remedial training. This HQ is issuing instructions to all ASACS units stressing the need to include greater exposure to the control of high level supersonic sorties during continuation training programmes. The lack of a direct line from Montrose Sector to Buchan, which caused additional delay on this occasion, is also being addressed within this HQ. This unfortunate incident and the lessons learnt will be the subject of a detailed ASSU Roadshow presentation to ASACS units.

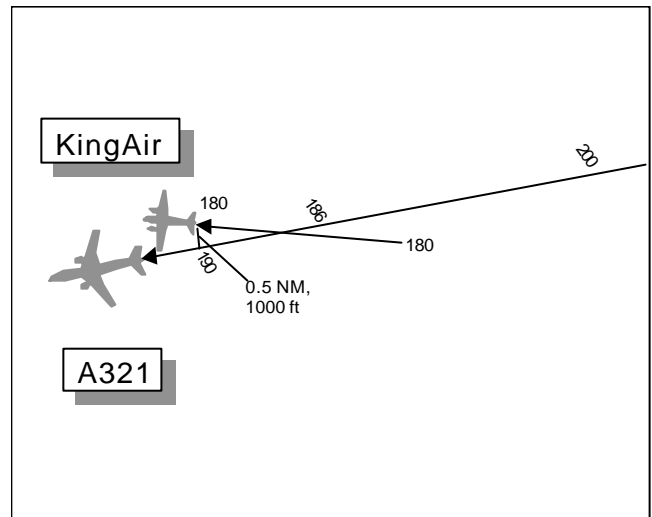
**AIRPROX REPORT No 110/01**

**THE A321 PILOT** reports heading W at 330 kt inbound to Gatwick in IMC under the control of LATCC, cleared to descend to FL 140. During the descent he received a TCAS RA at about FL 185 and followed the instruction to climb, passing an indicated 600 ft vertical and about 2.7 NM from the other traffic. He did not assess the risk of collision. He did not see the conflicting traffic. On TCAS it was from left to right about 3 NM ahead and there was no immediate or real risk of collision.

Members agreed that the cause of the Airprox was that the SABER SC did not take the King Air into account when he issued the descent clearance to the A321. In assessing the risk, the Board noted that once again TCAS had provided timely warning and safe resolution guidance, removing any risk of the ac actually colliding.

Cause: The SABER SC did not take the King Air into account when he issued descent clearance to the A321.

neither have had any extra help from that quarter while settling in, nor did he have a co-ordinator to assist. The Board had made earlier recommendations on the topics of providing co-ordinators, and of watching traffic levels at supervisory levels so that sector manning could be arranged in a more timely manner. Members were advised that NATS has recently (since this Airprox) reviewed procedures for sector splitting and for the introduction of co-ordinators in Terminal Control. Two instructions have subsequently been issued: LATCC (TC) SI 119/01 details general guidance on the placement and removal of a co-ordinator on TC sectors. The guidance includes issues such as complexity, amount of traffic as well as weather. LATCC (TC) SI 115/01 details general guidance and instructions on when a TC sector should be split or band boxed.

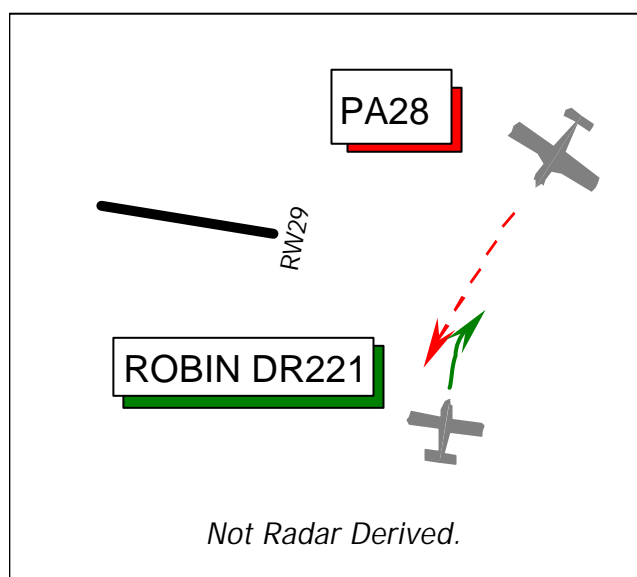
**THE ROBIN DR221B PILOT** reports his ac has a red/white colour scheme; neither SSR nor HISLs are fitted. He was flying a dual circuit training detail at 85 kt, 1000 ft Hucknall QFE (998 mb) and in communication with Hucknall RADIO A/G Station. Following the turn from the downwind leg onto a L base for RW29, another ac was spotted 200 m away directly ahead crossing at a very shallow angle almost on a reciprocal heading from R – L and apparently descending wings level. He took control of the ac and initiated a shallow descending R turn to avoid the other ac, which passed 30 ft to port and 200 ft clear above his ac with a “high” risk of a collision. He turned to track the other ac, which he identified as a PA28 and changed frequency to East Midlands APPROACH on 119.65, whereupon the PA28 pilot called abeam TROWELL VRP. East Midlands APPROACH was advised of his intention to file an Airprox and he requested the other pilot be so informed. Upon turning back to Hucknall he climbed to check the cloud base which was 1300 ft QFE.

Cause: Conflict close to the boundary of the Hucknall ATZ, resolved by the Robin DR221B pilot.

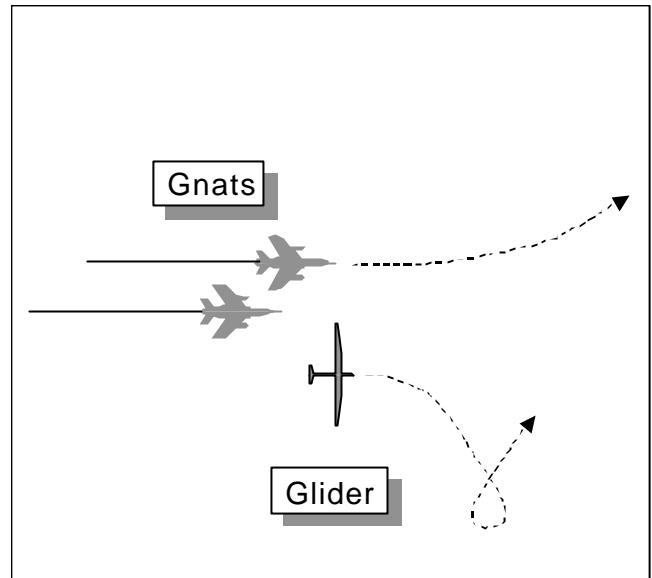
**THE GNAT PILOT** reports heading 090° at 260 kt, leading a pair of ac at 2500 ft with his No 2 in loose echelon to the R. His No 2 saw a glider tail on at a similar level, but he, the leader, did not see the glider at all. He was looking ahead into the impending left turn, scanning for gliders near the glider site N of that position. He turned left; his No 2 passed about 100 ft below and 200 ft left of the glider. There was a moderate to high risk of collision; the glider had been very difficult to see against the grey cloud. His No 2 said he caught a glimpse of it as it passed about 100 ft away and 100 ft above; it was a modern high performance glider with a large wingspan.

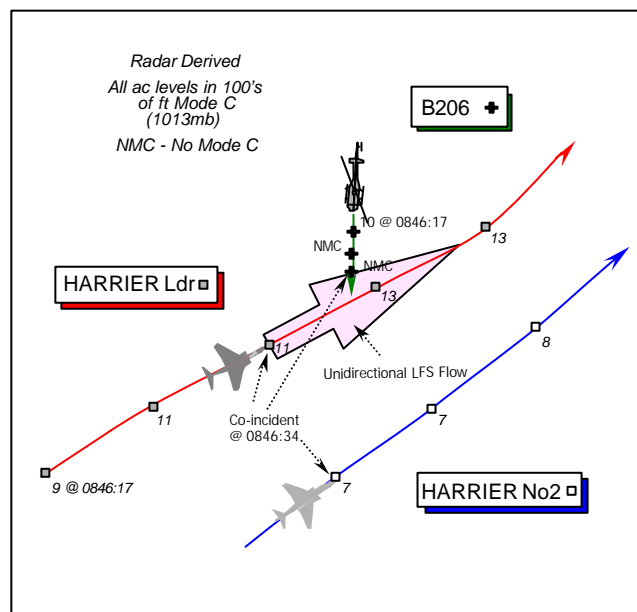
**THE BELL 206 JETRANGER PILOT** provided a very comprehensive report stating that his helicopter has silver upperworks and a black underside; upper and lower HISLs, navigation lights, red anti-collision beacon and the landing light were all on. He had notified his flight to Low Flying

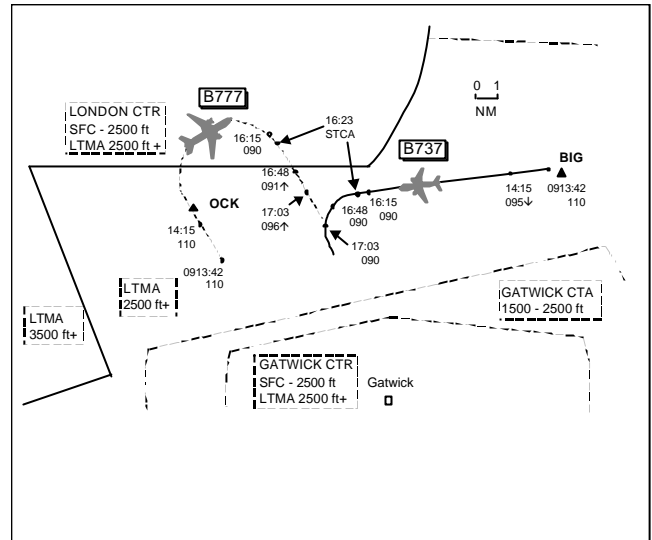
## AIRPROX REPORT NO 117/01

**THE LATCC TC HEATHROW INT DIR S** reports that he was on duty during a busy period with the B777 in the OCK hold awaiting an Expected Approach Time (EAT). He descended the B777 to FL 100 from FL 110 which he believed the crew correctly readback. The B737 was heading 270° from BIG VOR at FL 90 prior to positioning downwind LH for RW 27L. As the B777 emerged from a cluster of SSR labels in the hold, he realised that it was at FL 90 and in conflict with the B737 to its SE. As he was about to pass avoiding action instructions, another ac called on frequency. He ignored this transmission and passed the B737 crew an avoiding action turn onto heading 180° which was unfortunately missed so had to be repeated. He then passed an avoiding action climb to the B777 crew which was also missed and had to be repeated; TI was then given to both crews. Further turns were then given to the B737 crew to reposition the ac back towards the Heathrow Radar Manoeuvring Area (RMA) from where an uneventful landing was accomplished.

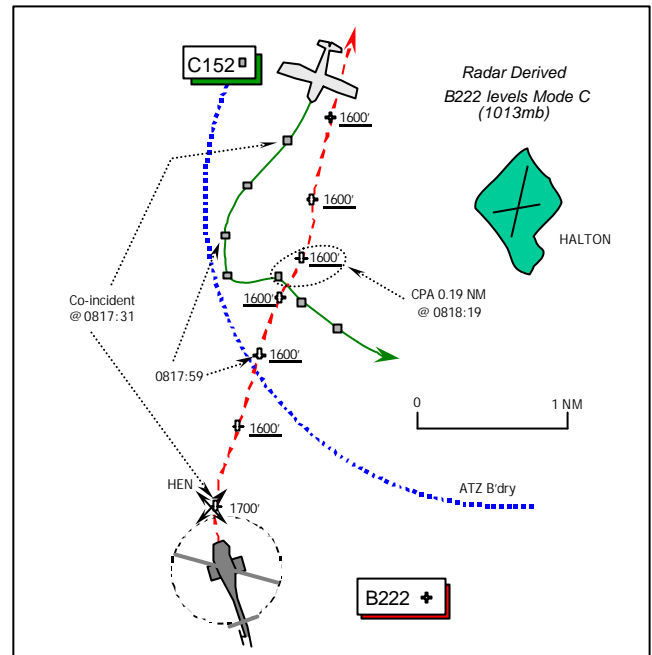
**THE CESSNA C152 PILOT** reports that he was instructing on a circuit (Cct) training detail in the RW02 Cct at Halton, with a student flying at 90 kt at the Cct height of 1000 ft Halton QFE (990 mb). Heading 200°, as they were about to turn onto base leg, he spotted a large, black helicopter at L 11 o'clock flying in the opposite direction at the same height. He delayed the turn until the helicopter had passed abeam – he estimated it passed about 400 m or so to port i.e. inside airfield circuit – and he broadcast a warning on 130.42 MHz, the Halton A/G station frequency that an unknown helicopter was passing through the ATZ at 1000 ft S to N. He assessed the risk as low due to his visual sighting, but he contended that if they had turned onto base leg a few seconds earlier the helicopter would have been out of sight in a blind area. He added that the Airprox occurred during the Grand Prix weekend at Silverstone and several other helicopter pilots had called passing outside the ATZ.

Cause: The B222 pilot did not conform to Rule 17 (5)(a), and flew into conflict with the C152.

Recommendation: That MOD/HQ PTC review arrangements for providing an Air/Ground Service at government aerodromes where an ATZ is established, but where no formal ATC is provided.

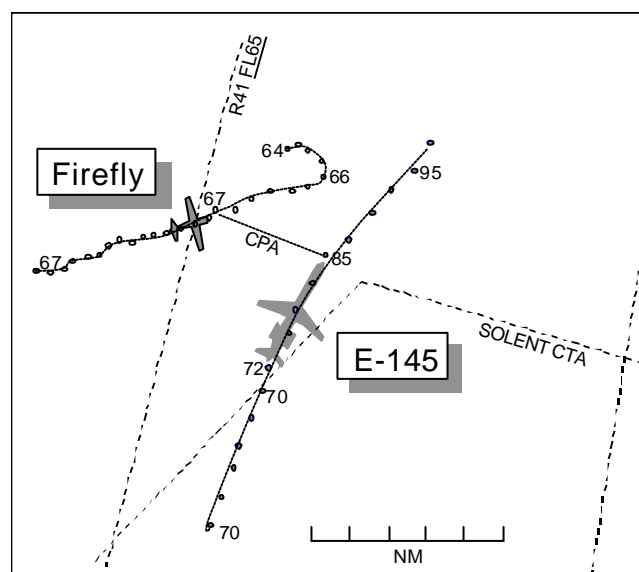
### **AIRPROX REPORT No 120/01**

**THE EMBRAER 145 PILOT** reports heading 020° at 240 kt, level at FL 70 on R41 under radar control from LATCC. He saw traffic on TCAS closing in his 1030 at 5 NM and 200 ft below; ATC advised that it was outside controlled airspace. When the traffic was 3 NM abeam him he was cleared to climb to FL 100; as he started the climb the controller advised that the traffic had entered controlled airspace without clearance. He saw it briefly - it was a small ac with yellow upper surfaces. He was cleared to make a precautionary right turn of 20°; the risk of collision was low.

Cause: Sighting report.

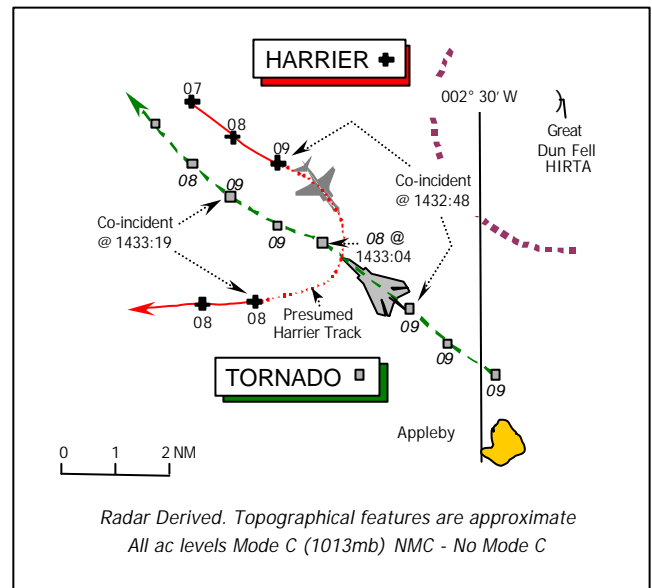
**THE TORNADO GR4A PILOT** reports that HISLs were on whilst flying at 420 kt straight and level at 250 ft Rad Alt on a heading of 310° just after completing a reconnaissance line search. His navigator first spotted the Harrier GR7 at 3-4 o'clock at range of 500 ft, southbound toward his Tornado,

Contributory factors: The camouflage colour scheme of both ac; Small cross-section presented by the Harrier 'head-on'; Adverse light conditions.

Cause: Very late sightings by the Tornado crew and the Harrier pilot, too late to take avoiding action.

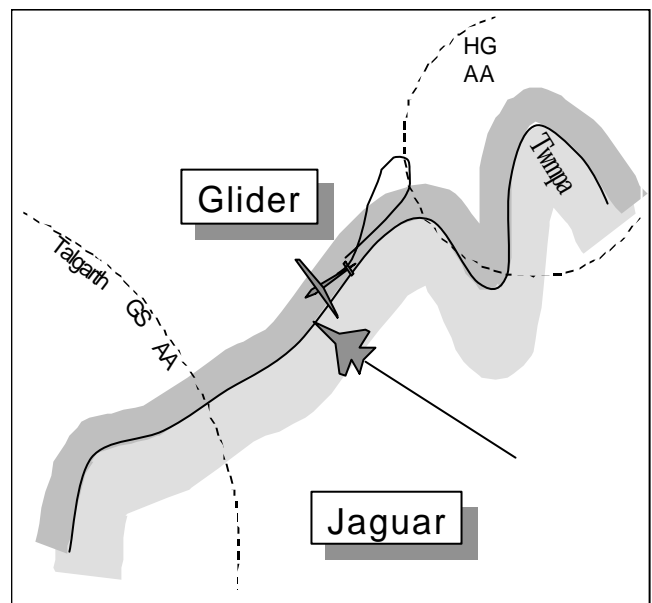
**AIRPROX REPORT No 122/01**

**THE PÉGASE GLIDER PILOT** reports heading 260° at 45 kt in his white ac, ridge soaring between Twmpa and the glider site at Talgarth. He gave his altitude as 2915 ft amsl; the ridge rises to 2100-2300 ft amsl. The club 2-seat glider was about 1 NM ahead on the ridge and he was paying attention to it when a Jaguar appeared in his peripheral vision to the left. It quickly passed about 150 m in front at the same level rolling to the R onto a more northerly heading, passing between him and the 2-seater. There was no time for avoiding action and the risk of collision was high.

Cause: The Jaguar pilot did not see the glider, and the glider pilot saw the Jaguar too late to avoid it.

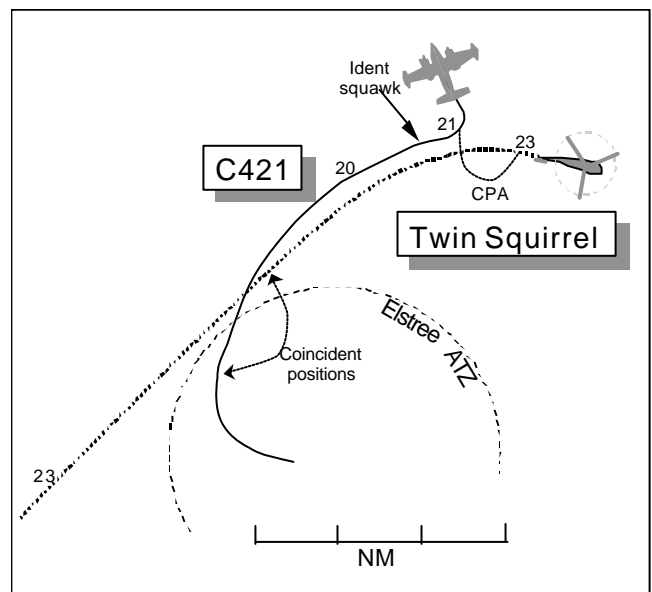
**AIRPROX REPORT No 123/01**

**THE LATCC TC** reports that the C421 from Elstree contacted NE Deps SC at 0923 and requested a joining clearance at BPK. Traffic loading was not reported and all systems were serviceable. The SC asked the pilot to squawk ident, which revealed that the Cessna had traffic 1 NM ahead on a similar track and about 200 ft above. Considering the situation to be dangerous, the SC gave an avoiding action turn to the north and traffic information to the C421, even though it was not under any form of radar service. The ac took the turn and moved away clear of the traffic to the north; the pilot reported that he did not see the other ac involved.

Cause: Potential conflict of flightpaths in Class G airspace, resolved by the avoiding action given by the NE Deps controller.

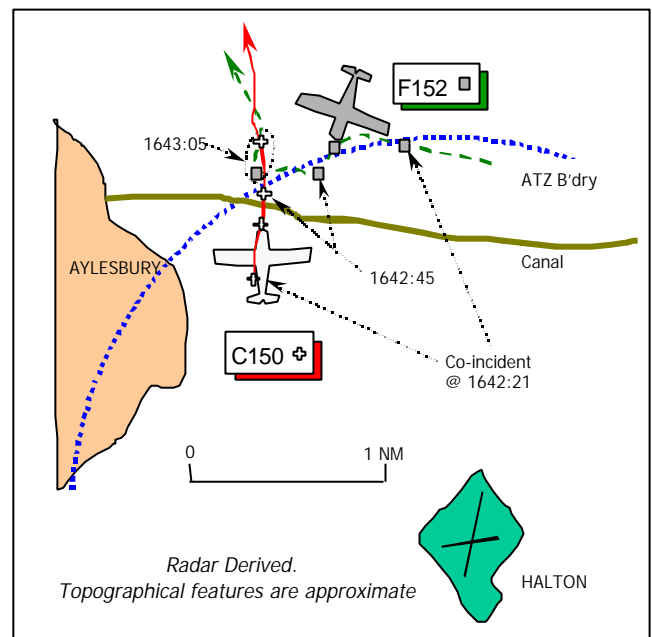
**THE REIMS F152 (C152) PILOT** reports his ac has a white/green colour scheme and HISLs were on whilst flying at 90 kt in the visual circuit to RW02 at Halton aerodrome; no SSR was selected. Just after rolling out downwind on 200°, at 1000 ft QFE (984 mb) - about 400 ft below the SCT cloud-base of 1500 ft (with occasional showers) - another ac was spotted 400 m away to starboard flying a reciprocal track. He turned L to avoid the other

Cause: The C150 pilot inadvertently penetrated the Halton ATZ and flew into conflict with the F152.

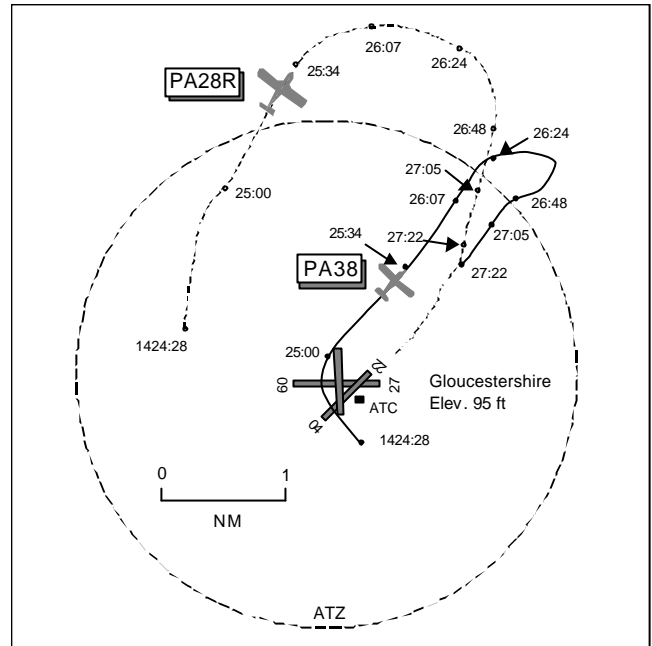
**THE PA28R PILOT** reports joining the visual cct at Gloucestershire Airport inbound from Welshpool at 100 kt and receiving an ADC service from Gloster Tower on frequency 122.9 MHz. The visibility was unlimited in VMC and the ac was coloured white with a grey stripe with anti-collision light switched on. When he reported downwind, ATC cleared him "number 2 call final" and he then heard an ac (the PA38) make a strange call "left base for right hand". As he turned final RW 22 at 700 ft QFE 1015 mb, he saw a PA38 about 150 yd away on what appeared to be a L base position in a steep L turn at his level turning on to final approach. He called ATC to ask what was happening and was then told to become No 2 to the PA38 – the previous ac to which he had been No 2 had already landed. He considered that it was impossible to comply with that instruction as the PA38 was too close and he would have caught up with it well before the RW threshold. He executed a steep R turn to avoid the other ac, applied full power and called "going around". He assessed the risk of collision as high.

Cause: The PA38 pilot did not integrate safely into the cct compounded by lack of positive control by the ADC.

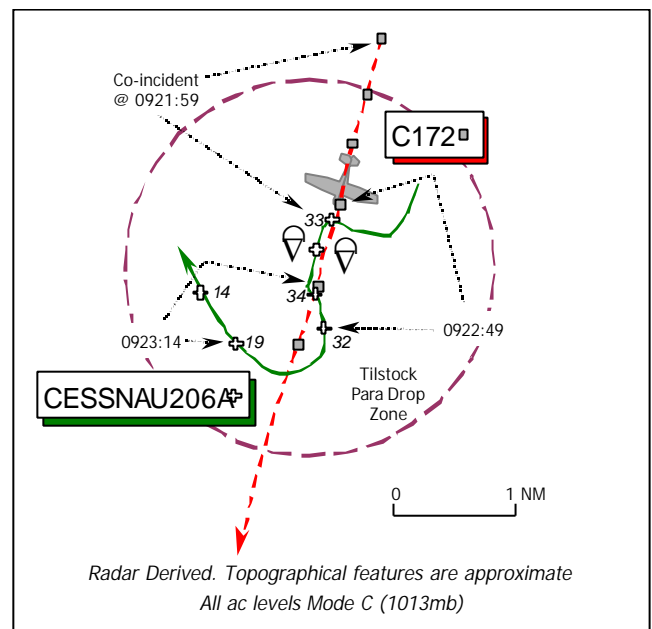
**AIRPROX REPORT No 126/01**

**THE CESSNA U206A PILOT** reports that his ac has a blue livery and HISLs were on whilst conducting a parachute drop overhead Tilstock Free-Fall Parachute Drop Zone (DZ) from 3000 ft QFE (1001 mb), about 500 ft below and ½ NM horizontally clear of cloud. He was in communication with Tilstock RADIO on 122.07MHz and squawking the parachute dropping conspicuity code of A0033 with Mode C.

Cause: The C172 pilot flew through an active Parachute Drop Zone and into conflict with the parachutists whom he did not see.

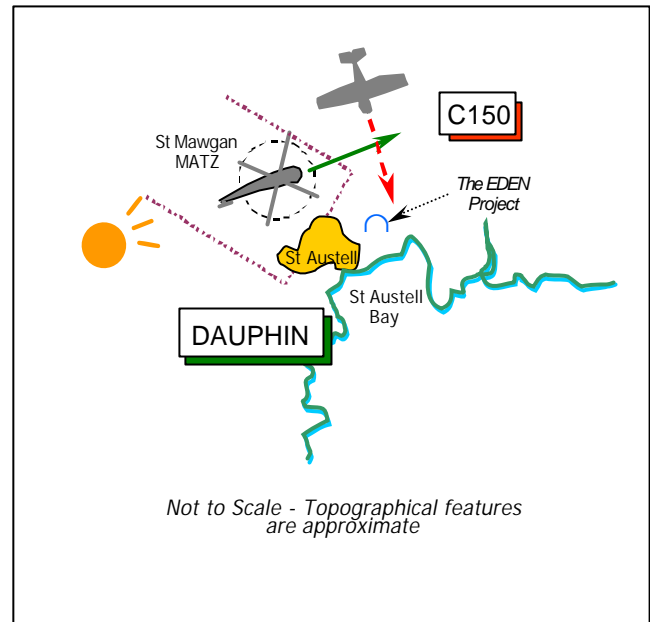
**THE AS365N2 DAUPHIN PILOT** reports he was flying his helicopter 'single pilot' at 135 kt from Culdrose to Yeovilton at 1000 ft Wessex RPS (1013 mb), whilst under a FIS from St Mawgan APPROACH (APP) on 126.5 MHz. His helicopter has a red livery, HISLs were on and a A7000 squawk was selected with Mode C. Flying in good VMC, heading 075° just to the NW of St Austell, APP reported an ac in the vicinity of the EDEN Project at 1500 ft. He turned to fly to the N of St Austell at 1000 ft, but did not see the other ac, a high-wing Cessna, until after his passenger pointed it out, "close" in their 3:30 – 4 o'clock. It was about 200 m away to starboard and flying away, after it had overflowed his helicopter by about 100 ft. He judged it had probably approached from his 10:30 position and assessed there had been a "high" risk of a collision – there was no time to take avoiding action although he had started to bank to the R and descend. He reported the Airprox to APPROACH on RT.

Cause: Effectively, a non-sighting by both pilots.

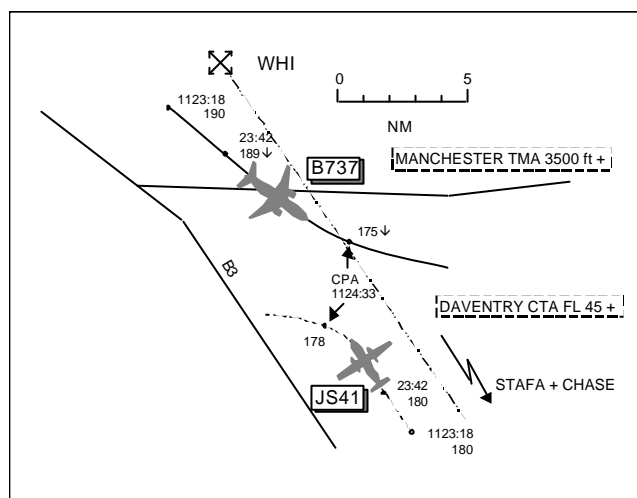
**THE JS41 PILOT** reports heading 330° at M0.47 (approx. 290 kt) and FL 180 en route to Belfast. The visibility was 40 km in VMC and he was receiving a radar control service from Manchester on frequency 124.2 MHz. When about 30 NM SE

Cause: The MACC TMA SE SC allowed his trainee to descend the B737 through the JS41's level.

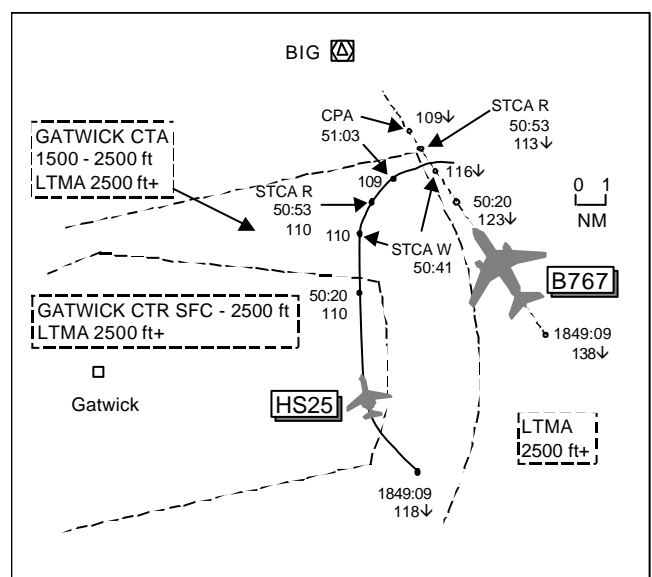
**THE B767 PILOT** reports heading 325° inbound to BIG descending to FL 70. The visibility was 10 km in VMC and he was receiving an approach radar control service from Heathrow on 134.97 MHz. On passing through FL 110 (he thought), he was asked to expedite his descent so he selected the speedbrakes in order to comply. ATC then issued instructions to fly after passing BIG a heading change onto 270° and a speed reduction to 220 kt. Shortly thereafter, he received a TCAS TA on traffic 10 o'clock (he thought) range 1 NM 600 ft below followed 2 seconds later by an RA alert "*monitor vertical descent*". The ac symbol was on the bottom of the 'trapeze' which was coming down from the top of the ADI. He disconnected the AP, the autothrottle was at flight idle in 'FLCH' descent mode and the ROD was increased; the TCAS alert ceased after a few seconds. He assessed the risk of collision as high as the conflicting ac passed only 200 ft above him.

Cause: The TC SE SC did not control adequately the flight paths of the B767 and the HS25.

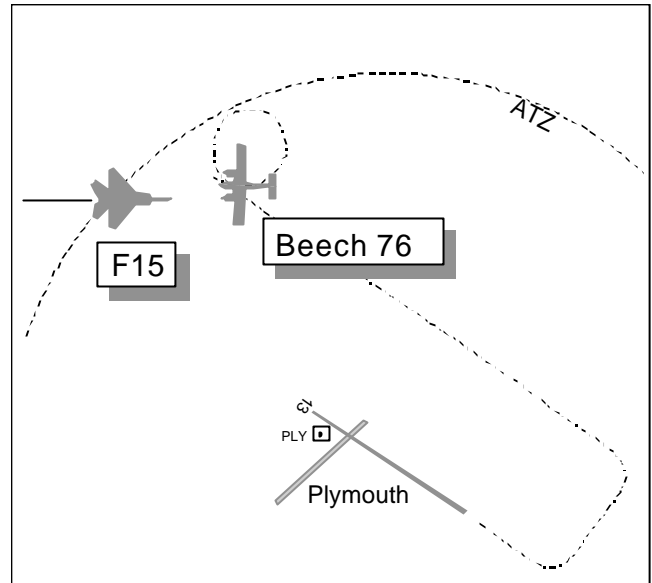
**THE BEECH 76 PILOT** reports flying training circuits to RW 13 LH at Plymouth at 800 ft QFE. He had been asked to hold at the end of the downwind leg to allow other traffic to clear the runway. As he was coming out of his right orbit, at 110 kt, he found himself head-on to an F15. It was closing from 0.75 NM ahead and passed 300 m to his left at the same level as he made a diving turn to the right. He described the risk of collision as moderate, but high if he had not been seen. His DME showed 1.5 NM from the PLY; both ac were certainly inside the ATZ at the time.

The other point which could not be conclusively resolved was whether or not the F15 crew had seen the Be76. The F15s' report that they had by radar and visual means identified other traffic, and avoided it, could only be relevant to traffic which they had spotted. 'No near misses were noted' suggested in this case that they had not seen the Be76 and no avoiding action by the F15 was seen. Another possibility was that the F15 crew had seen the Be76 but had not been asked about it and had not volunteered the information, but that was pure supposition; from the information available, members concluded that the F15 crew had not seen the Be76 in time to avoid it. The Board concluded that this was also part of the cause, and the possibility of the ac passing that close with one unsighted led to the conclusion that the safety of the ac had been compromised.

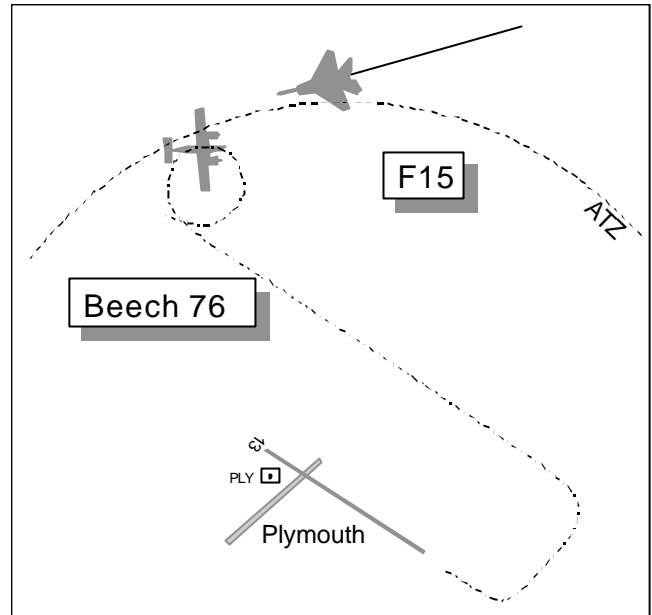
**THE BEECH 76 PILOT** reports flying training circuits to RW 13 LH at Plymouth at 800 ft QFE. He was asked to hold at the end of the downwind leg to allow a DHC-8 to land on RW 31 and was circling right at 110 kt when he found himself head-on to an F15. It was closing from 1 NM ahead and passed 500 m to his left and 150 ft above as he made a diving turn to the right. He described the risk of collision as 'lowish' but since his DME gave 1.5 NM, he was certainly inside the ATZ at the time.

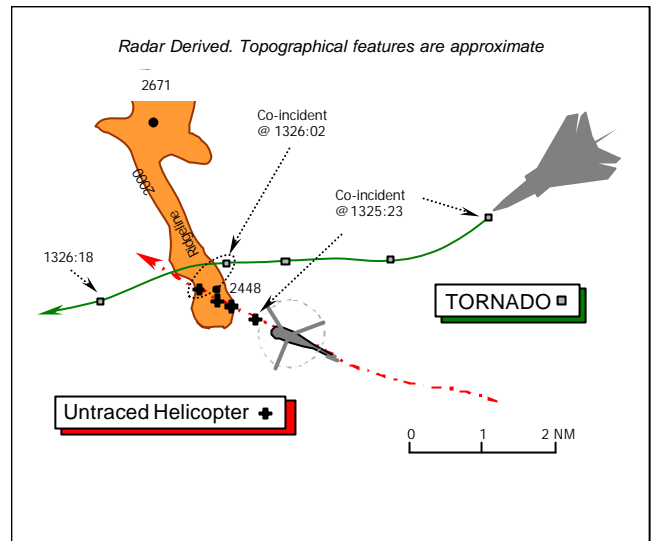
**THE TORNADO GR4 PILOT** reports he was the rear L element of a 3-ship Tornado GR4 escort formation executing an OLF affiliation sortie in LFA 20T. The ac is camouflage grey but HISLs were on and a squawk of 3/A 7001 selected with Mode C. About 27 NM NE of W Freugh, heading 253° at 400 kt, when bunting over a ridge with the RadAlt indicating 615 ft, he suddenly spotted what he perceived to be a Lynx helicopter slightly L of the nose crossing their track. There was no time to take avoiding action as they crossed about 50 m ahead of the helicopter. He added that both he and his navigator were working hard but would have been unable to spot the Lynx any earlier as it was on the far side of a ridge. If it had been 50-100 m further along its track they would have collided.

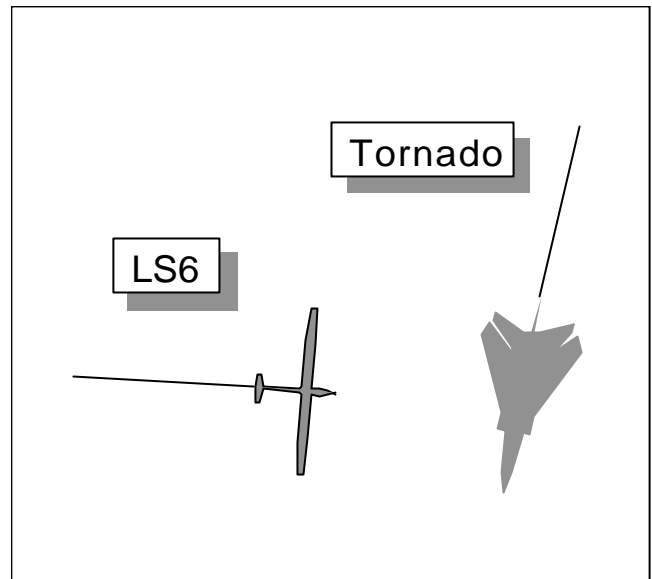
**THE LS6 GLIDER PILOT** reports heading 093° at 60 kt on a cross country flight. Just NW of St Neots, at 2100 ft, she saw a swept wing fighter 30 m away as it passed L to R across her nose at the same level, tracking from her 8 o'clock to her 1:30. There was no time for avoiding action and the risk of collision was high.

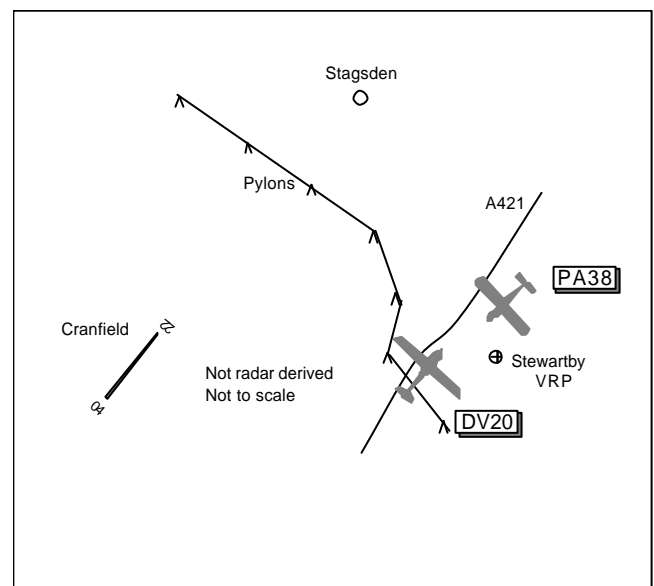
**THE CRANFIELD ADC** reports that during a busy cct pattern two ac were joining from Stewartby VRP onto a L base position for RW 22; the first was a DV20 (not the one involved in the incident) followed by the subject PA38. The subject DV20 reported downwind and was informed of the joining traffic and was asked to report ready to turn L base. The PA38, which had an instructor on board, then asked for a RH orbit, which he approved, and recognising that the DV 20 would conflict with the joining PA38, he passed TI to him. He then observed the DV20 leaving the cct, by heading towards the PA38, so he passed TI and requested the pilot's intentions; no reply was forthcoming. This request was repeated but to no avail. He again passed TI to the PA38 pilot who reported visual with the DV20 and offered to follow the Katana onto base leg.

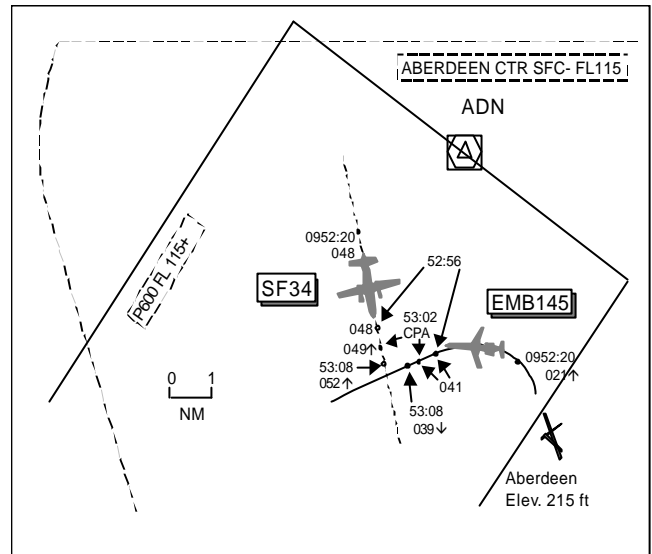
**THE SAAB 340 PILOT** reports flying inbound to Aberdeen heading 180° at 200 kt and cleared to descend to 3000 ft QNH. The visibility was 10 km in VMC and he was receiving an approach radar control service from Aberdeen on 119.05 MHz. ATC then changed the cleared level to 5000 ft and, as they approached that level, they were asked to confirm that they were about to level off. He continued as directed and looked out for the aerodrome which was partly obscured by patchy low cloud. He saw a company EMB145 climbing out from Aberdeen, which turned L towards him, and assumed that it would pass clear below. However, it quickly produced a TCAS TA alert followed by an RA "climb, climb now"; he disconnected the AP and commenced a climb following the TCAS indications. He informed ATC who had also issued climb instructions to level at

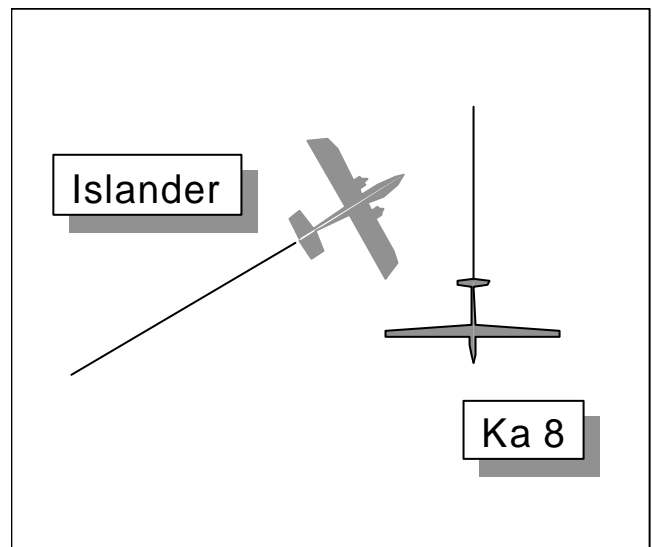
**THE KA 8 GLIDER PILOT** reports heading 180° at 56 kt on a winch launch from Rivar Hill when, passing 1500 ft, he saw a red Islander approaching from his 2:30 600 ft away, coming out of the sun. He released the launch cable and maintained his heading; the Islander passed 300 ft astern at the same level. He considered the risk of collision had been high and there was the additional danger from the winch cable even after release from the glider. He pointed out that Rivar Hill glider site is clearly marked on charts with its elevation, and a warning of cables to 3000 ft above that.

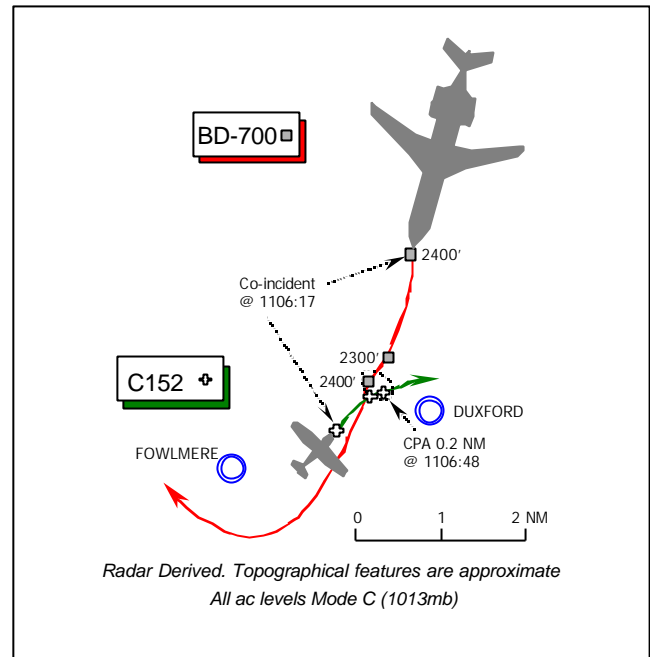
**THE C152 PILOT** reports he was inbound to Newmarket Heath from Denham cruising at 86 kt. The ac colour scheme is white with blue/red stripes, HISLs were on and a A7000 squawk selected with Mode C (though neither is evident on the radar recording), whilst 'listening-out' with Duxford AFIS on 122.075MHz. Flying at 2300 ft QNH (1015 mb) about 2000 ft below 2/8 cloud, overhead Duxford aerodrome heading 035°, a dark coloured business jet – like a Learjet – was sighted about 1 NM away flying toward his ac at the same altitude. A 30° AoB R turn was made to avoid the other ac, which passed 100 ft down the port side at the same altitude with a "high" risk of collision. The pilot of the other ac did not appear to take any avoiding action.

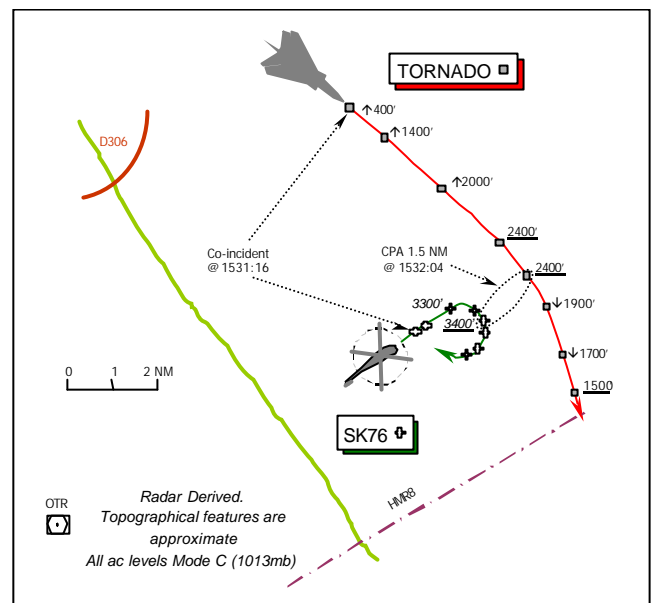
**THE SK76 PILOT** reports he was flying outbound from Humberside to the Ravenspurn ST3 Gas Rig at 140 kt. A squawk of A0242 was selected with Mode C, whilst in receipt of a RAS from Anglia RADAR, IMC at 3000 ft HUMBER RPS (1003 mb). Shortly after establishing two way RT contact with RADAR, the Anglia controller advised him of pop-up traffic from the N and the best course of action was to maintain his heading of 055°. At 068° OTR 11 NM, Anglia instructed him to turn R immediately onto 090° and then to continue the R turn onto 310°. The other ac was not seen. After it was reported to be clear he was instructed to resume his own navigation. He was informed that the other ac was a Tornado, whose crew were not

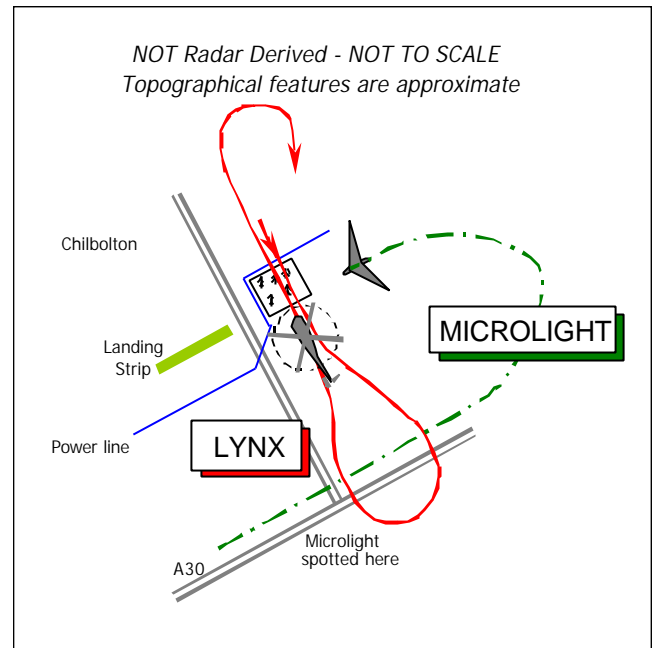
**THE KOLB TWINSTAR MK3 MICROLIGHT PILOT** reports that his flying machine is coloured blue/white, but has neither lighting nor radio fitted. He was inbound to Chilbolton aerodrome from the SE and had descended to 800 ft agl to fly below the Middle Wallop MATZ stub on the usual preferred noise abatement route to Chilbolton, which he had flown many times before. As he approached Chilbolton he became aware of an Army helicopter in the area, which he identified as a Lynx. It appeared to come from behind and beneath him and he watched the Lynx come to a slow forward creeping hover some 700 ft or more below his ac at 11 o'clock - 400 m away - to the S of the A30 and W of the A3420 roads. Continuing his approach to Chilbolton, initially for a base leg join to land, he watched the helicopter climb and turn R across his path and depart to the N at low level about 500 m E of the threshold of Chilbolton RW24.

Although the microlight pilot had elected to continue with his approach and land his machine, some thought this unwise. It should have been readily apparent to him that the air would have been significantly disturbed by the passage of the helicopter – as he subsequently found out – and a further circuit to allow time for the wake vortex to dissipate would probably have been wise. Turning to the risk of a collision between the two ac, unlike the helicopter pilot the microlight pilot had the Lynx in view as it crossed ahead and he could have altered course to avoid it or elected to 'go around' if necessary but he did neither. Consequently, the

Cause: Both pilots lost sight of each other's ac and flew into conflict, whilst the microlight was on final approach to land.

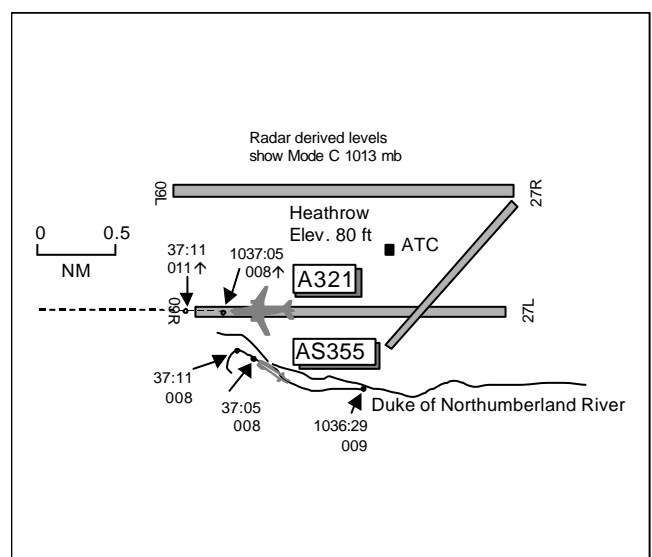
**AIRPROX REPORT No 141/01**

**THE HEATHROW DEPS** reports that the AS355 was carrying out security checks on the area S of the departure RW 27L and he was providing reduced visual separation. After the Twin Squirrel passed the end of RW 27L, it was seen to turn 30° R and into conflict with the departing A321; the ATM showed the ac co-incidental, with the AS355 at 800 ft and the A321 at 1100 ft, which was also confirmed by the VCR Supervisor.

**CAA FLIGHT OPERATIONS INSPECTORATE (FOI)** reports that security flights like the one in question here are conducted daily at Heathrow, flown by crews who are both familiar with the area and 'checked out' for the task. These pilots are required to remain over the Duke of Northumberland river, which, at its closest point, is some 0.25 NM S of RW 27L/09R. It may be noted that towards the western end of the DoNR route, the track kinks slightly to the N and it is presumed that this is the 30° turn witnessed by the controller.

Cause: Mistaken impression by the Heathrow DEPS controller of loss of horizontal separation.

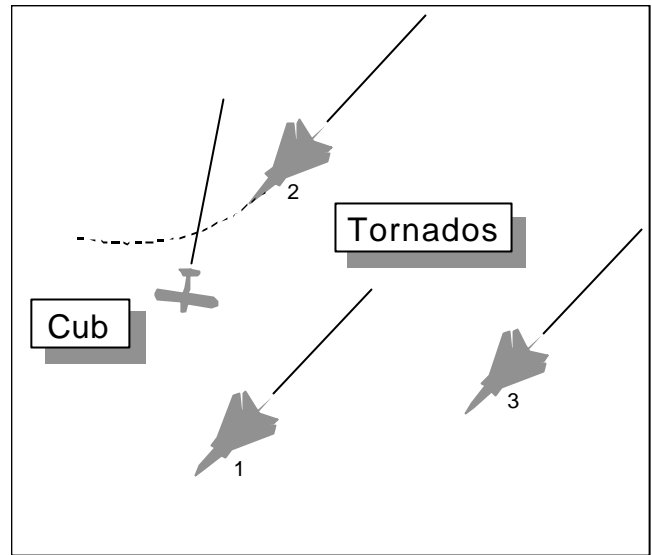
**THE TORNADO PILOT** reports heading 227° at 420 kt while descending in a relatively tight escort formation to low level with the No 2 on the right; a service from Scottish Military had been terminated at 7000 ft. A Piper Cub was seen simultaneously by all 3 pilots; it was 500 m ahead, crossing from right to left and passed below and to the right of the leader before he could react. The No 2 broke right and up, passing about 300 ft above the Cub. There had been a high risk of collision with the leader and No 2.

The Board commended the Cub pilot for his presence of mind in manoeuvring his ac to increase its conspicuity which may well have avoided a collision. Members noted that both pilots had considered there had been a high risk; this and the fact that the lead Tornado had passed the Cub before he could react led the Board to agree that there had been a risk of collision.

Cause: Late sighting by the Tornado formation of the inconspicuous Cub over the sea.

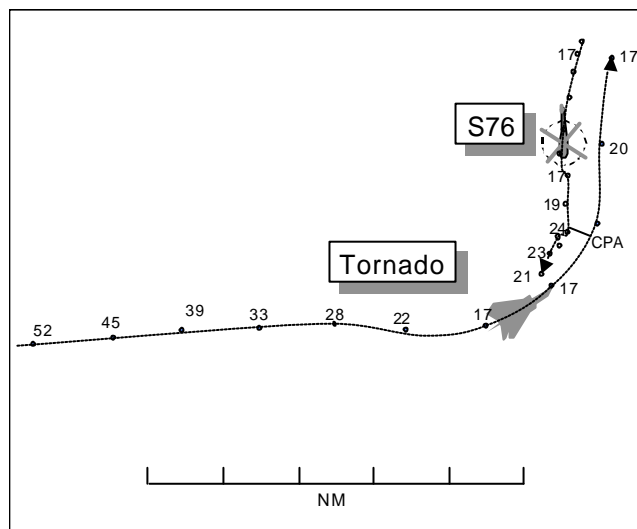
**THE S76 PILOT** reports heading 170° at 142 kt and receiving a RIS from Anglia Radar on 125.275. Anglia warned him of 2 contacts at 5 NM in his 2 o'clock crossing R to L. His co-pilot saw one and he was advised to turn 30° L, which he did immediately. He then saw the traffic 1.5 - 2 NM away at the same level (he thought it was a Jaguar) in his 11:30 turning left towards him. He turned

This was an unfortunate sequence of events that typifies the hazards of operating close to or below the limit of radar cover and it is fortunate that the Tornado crew picked up the helicopter in time to take avoiding action, albeit at a late stage. This is a good and timely lesson to all of the importance of careful and continuous visual lookout and radar search.

The F3s were not where their leader thought they were; they were in fact crossing between HMRS 3 and 4 at the time of the Airprox. Members agreed that because helicopters can be found anywhere over the N Sea and would not necessarily be following an HMR (the S76 was not), the F3s' uncertainty over their position was not considered to be a direct factor in this Airprox. It was always necessary to keep a lookout for helicopters, on or off HMRS, particularly in the 1000-2500 ft band, and the Board concluded that the cause of this Airprox was the late sighting of the helicopter by the Tornado crew.

Cause: Late sighting by the Tornado F3 crew in the vicinity of an HMR.

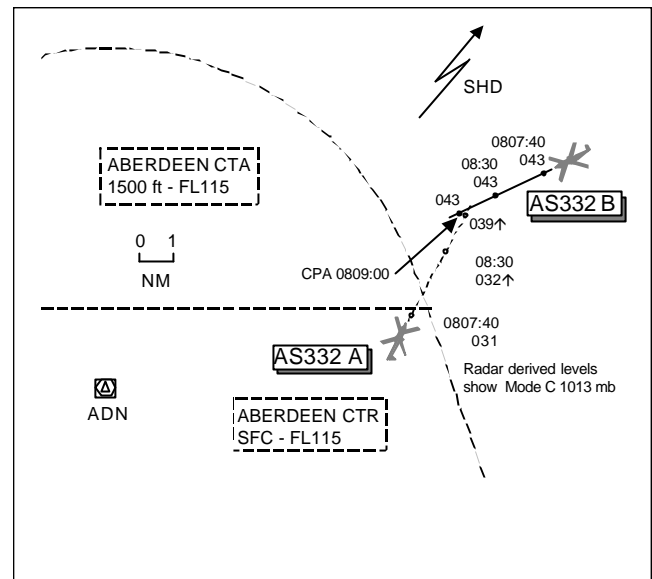
**THE AS332 (A) PILOT** reports departing Aberdeen RW 16 en route to Magnus Offshore Platform on a radar heading 030° at 100 kt and cleared to climb to 3000 ft. The commander, a training captain, was NH in the LH seat with a FO, PH, undergoing RH seat familiarisation prior to a command course. The visibility was 20 NM in VMC and he was receiving a radar control service from Aberdeen on frequency 119.05 MHz. The ac was coloured red/white/blue with Mode C and HISLs switched on. He was transferred to Aberdeen radar on 134.1 MHz and he requested a climb to FL 50 which was granted. While in the climb at 1000 ft/min he was advised of training traffic holding at SHD and was told to 'expect own navigation' on passing 4000 ft. As he passed FL 39 (3800 ft QNH), the PH in the RH seat saw another AS332 helicopter suddenly appear very large crossing R to L in the right then front OH (eyebrow) windows. It had come into his field of view just where the leading edge of the RH cockpit crew door frame joined the OH window and crossed through into the centre screen; the RH sunvisor had partly obscured the initial view. The PH prepared to turn R but realised that they were not going to collide. It took about 5 seconds from first sighting until CPA and there had been almost no time to take avoiding action. He estimated the two helicopters passed 200 ft

Cause: Following inadequate co-ordination between the HELS and INT controllers, HELS cleared AS332 (A) to climb into conflict with AS332 (B).

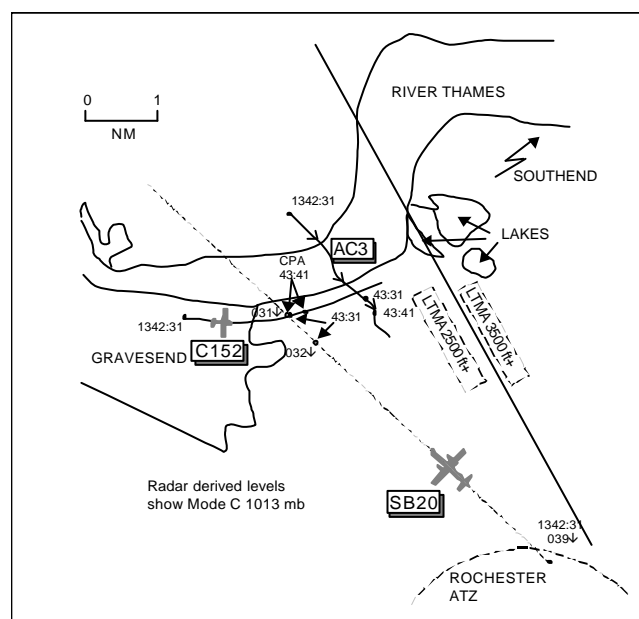
**THE SAAB 2000 PILOT** reports flying inbound to London City from Switzerland at 3000 ft QNH and 180 kt. The visibility was 15 km 1000 ft below cloud in VMC and he was receiving an ATC service from Thames Radar on frequency 132.7 MHz. His TCAS gave a TA warning on traffic in his 1 o'clock range 2 NM so he scanned the area ahead and saw an ac, almost immediately, about 500 ft below. Fortuitously, whilst he monitored the TCAS traffic, he also noticed another ac in about the same direction but only 100 ft lower, much closer (about 900 m)- it passed quickly on his RHS about 300 m away. Only 15 seconds elapsed between sighting the second ac and it passing clear. The second one was a C152 coloured white/red/blue flying in a nose-up climbing attitude and heading approx. 090°; it did not appear to be taking any avoiding action. The ac was not squawking so it was not showing on TCAS but he had seen it early enough to judge that no avoiding action was needed, as it appeared to be on an opposite direction parallel track. He assessed the risk of collision as high.

**ATSI** comments that the SB20 was given descent to an altitude 500 ft above the base level of the LTMA in accordance with MATS Pt 1, Page 1-58. The conflicting ac was not transponding therefore the controller had no way of knowing its altitude and whether it had penetrated CAS. MATS Pt 1, Page 1-51 states, with reference to unknown ac "*Within Class A airspace – neither avoiding action nor traffic information shall be passed unless radar derived or other information indicates that an aircraft is lost, has experienced a radio failure, or has made an unauthorised penetration of the airspace*".

Cause: Unauthorised penetration of the London TMA owing to a navigation error by the C152 pilot.

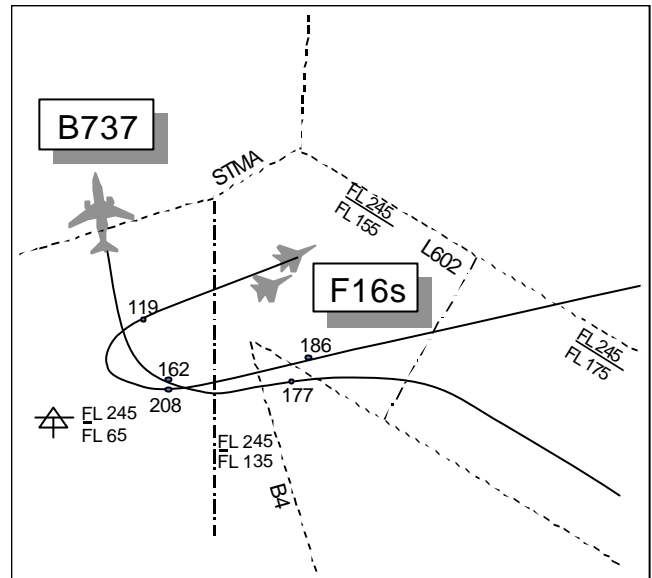
**THE B737 PILOT** reports heading 290° at 300 kt, descending on Airway L602 for Glasgow, IMC. He heard ScACC advising other ac about unidentified high speed multiple contacts and he was given an immediate left turn for separation. He complied but the traffic closed and he received a TCAS TA. ScACC recommended a further left turn, but he requested an immediate right turn and increased his rate of descent considerably. The traffic cleared for 20 seconds but then closed again triggering a further TA before clearing. The traffic had followed him through 3 heading changes and he appreciated the latitude he was given by ScACC to take avoiding action. He considered the risk of collision may not have been high if the intruders were using airborne radar, but the avoiding action he was having to take was hazardous for his passengers and crew.

Members concluded that the cause of the Airprox was the unauthorised penetration of Class A airspace (Airways L602, B4 and A1) by the F16s which flew into repeated conflict with the B737. The Board agreed that there had been no risk of collision in the incident since the F16 pilots were aware of the B737, and the latter's TCAS was giving good directions to its pilot to avoid the F16s.

Cause: Unauthorised penetration of Class A airspace (Airways L602, B4 and A1) by the F16s which flew into repeated conflict with the B737.

Recommendation: That the UK MOD considers a review of supervisory arrangements attaching to mission planning by foreign military aircrew taking part in Exercises in UK airspace.
