**UK AIRPROX BOARD**

# **Analysis of Airprox in UK Airspace**

**Report Number 7  
July 2001 to December 2001**

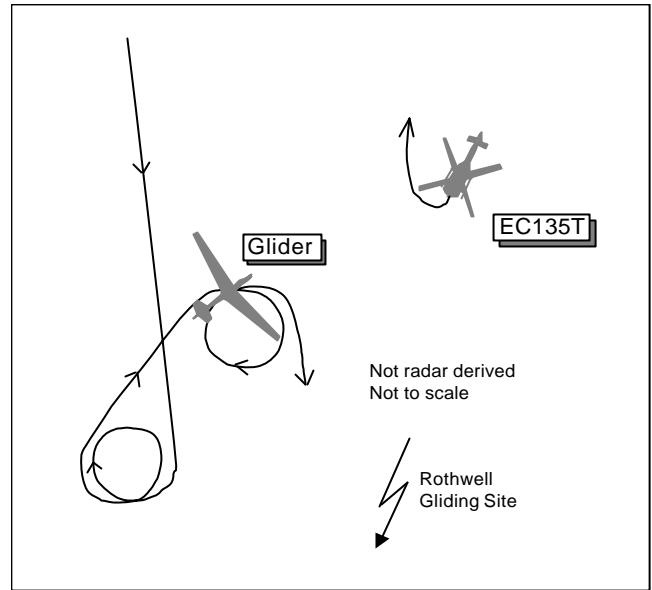
**THE EC135T PILOT** reports flying on a local photographic sortie from Husbands Bosworth Gliding Site approx. 0.5 NM N of Rothwell village. The visibility was >10 km, 1500 ft below cloud, in VMC and he was receiving a FIS/listening watch from Sywell Information on 122.7 MHz. The helicopter was coloured blue/yellow, Mode C and HISLs were switched on. He manoeuvred the helicopter into a 'free-air' hover heading 210° at 2500 ft QNH 1016 mb and noticed a glider in his 3-4 o'clock position range 0.5 NM at the same level tracking S. The glider initially passed clear but it was then observed to begin circling on the Northern edge of Rothwell in RH orbits. During its second orbit, owing to the prevailing wind (210/15 kt), the glider drifted downwind and closed to within 200 m of him at the same level. As the glider turned through about 040° towards him, he pedal-turned the helicopter to the R and dived clear on a Northerly heading subsequently returning to the same spot at 1000 ft to complete the task. It was then he observed another glider in the vicinity, at the same level as the first one, but he subsequently lost sight of both gliders in the bright sunlight conditions. He opined that the first glider had probably been riding a thermal over Rothwell and the pilot had possibly been concentrating on his ground position. He assessed the risk of collision as moderate to high.

Cause: Conflict with an untraced glider resolved by the EC135T pilot.

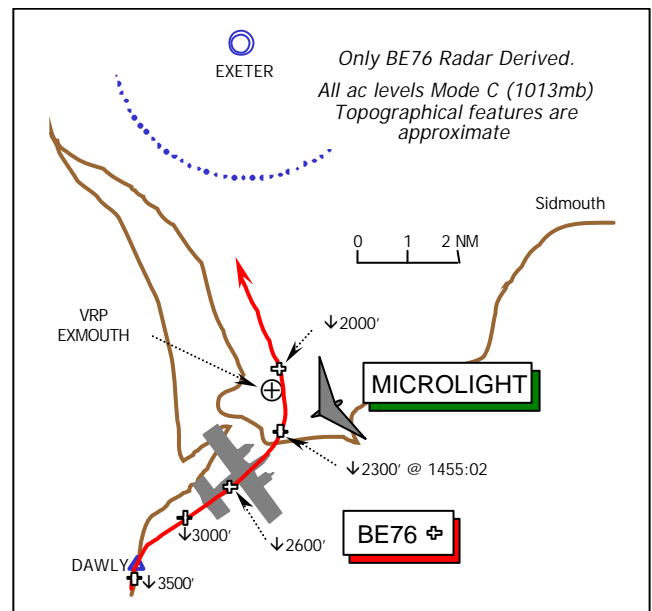
**THE PEGASUS QUANTUM 912 PILOT** reports his microlight has a red, white and black colour scheme; neither SSR nor HISLs are fitted. He was in receipt of a FIS from Exeter APPROACH on 119-05

MHz. Flying westbound along the coast at Exmouth in a level cruise at 3000 ft QNH (1016 mb) at 50 kt under a clear sky, a low-wing twin engine ac was spotted about 0.5 - 0.75 NM away crossing from L - R. The other ac was also descending and its pilot did not appear to have seen his microlight as it descended through his altitude. To avoid the twin he made a climbing L turn and it passed 100 ft directly below his ac. He had been looking for traffic reported at 4000 ft, but had not spotted it earlier because it had been obscured behind the front strut and he had been looking higher than necessary - it had not been readily apparent to him that the other ac had been descending.

Cause: Conflict in the FIR resolved by both pilots.

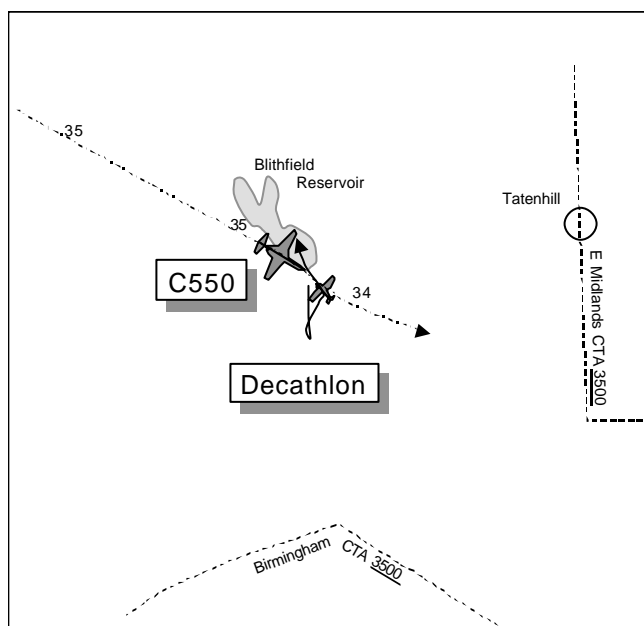
**AIRPROX REPORT No 150/01**

**THE DECATHLON PILOT** reports that having completed some aerobatics he levelled at 3000 ft, heading NW at 120 kt, and saw a civil twin jet in his 11:30 500 m away on a reciprocal track at the same level. He turned hard right, as did the jet which passed 100 m away at the same level. The risk of collision would have been high if avoiding action had not been taken, but was low because both ac turned. He was flying on the Tatenhill (elev 450 ft) QFE. He believed he was squawking 7000, no Mode C fitted.

While the traffic information supplied by E Midlands was, arguably to a small extent, technically deficient, the Board agreed that it had got the C550 pilot looking in the right direction and had assisted his sighting of a fairly small ac. Members discussed whether or not the Decathlon pilot should have obtained an ATS from E Midlands. While in this case it might have helped, members were not sure of the extent to which the unit might become swamped by local GA in Class G airspace. The Board was advised that a member had suggested to the pilot that at least it would be helpful if he was to inform E Midlands that he was about to perform aerobatics and give his location. At the same time he could get his transponder checked; on this occasion while he thought it was on, and may have been, a check could have triggered a recycling or at least made the pilot aware of the problem with it. Members also pointed out that 7004 is a squawk which will indicate to a controller that an ac is performing aerobatics.

Cause: Conflict of flightpaths resolved by both pilots.

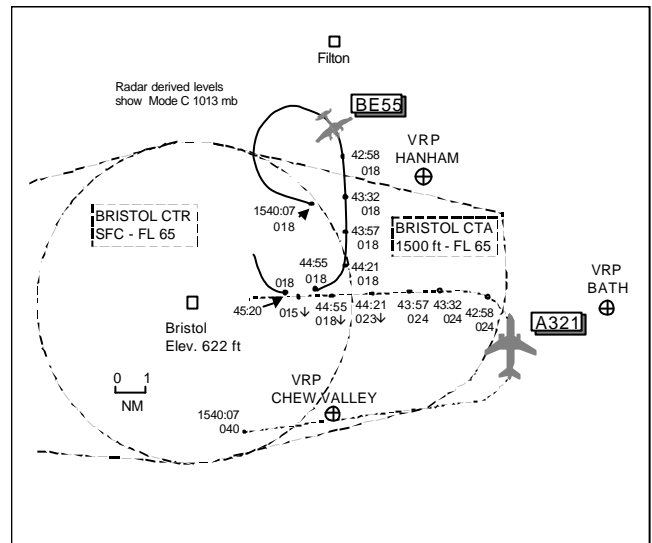
**THE A321 PILOT** reports heading 271° at 150 kt established on the RW 27 ILS at Bristol and he was receiving an ATC service from Bristol TOWER on frequency 133.85 MHz. The visibility was 9 km in VMC, strobe and landing lights were switched on and he was squawking 5304 with Mode C. When he approached 4 NM DME on final approach with AP and autothrust engaged, ATC informed him of a light twin engine ac that was approaching the extended C/L from the N. TCAS annunciated a TA alert showing the traffic, initially 500 ft below, and he acquired it visually to his R in a 10° banked R turn. ATC was heard to issue instructions to the conflicting ac to turn onto a Northerly heading; it slowly diverged from the C/L as he descended below its level. He estimated the other ac passed 1000 m clear at the same level and he assessed the risk of collision as low.

effect re-iterated the ADC's previous instruction to the BE55 pilot to hold on R base. Much discussion followed as to whether the ADC's actions had contributed to the incident, first by not ensuring that the BE55 was held at a more suitable position for better integration and second by not ensuring that the BE55 had started to turn as instructed. However, members acknowledged the ADC had endeavoured to exercise 'positive control' of the VFR BE55, but its pilot had not complied with ATC instructions and this had caused the Airprox.

Cause: The BE55 pilot did not comply with ATC instructions and flew into conflict with the A321.

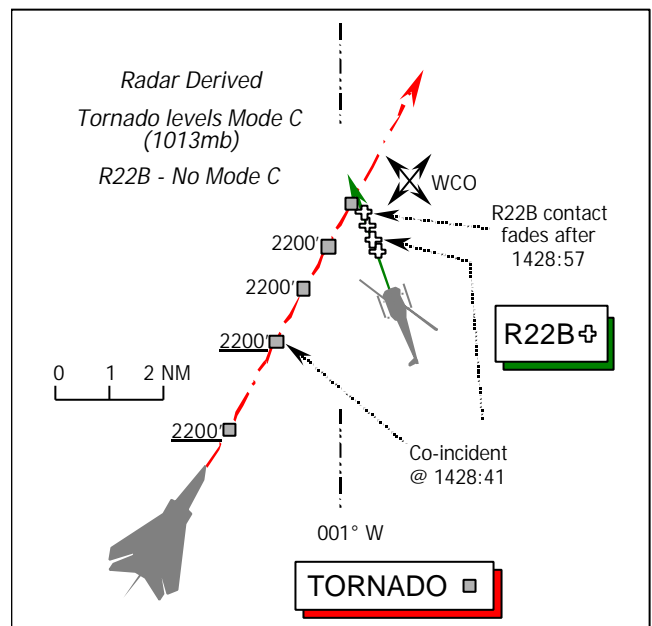
**THE ROBINSON R22B HELICOPTER PILOT** reports his ac has a white livery and HISLs were on whilst conducting a navigation exercise with a student pilot in the RHS. He was in communication with Wycombe TOWER on 126.55 MHz and squawking A7000, but Mode C is not fitted.

Cause: The Tornado pilot flew close enough to cause considerable concern to the Robinson R22B helicopter pilot.

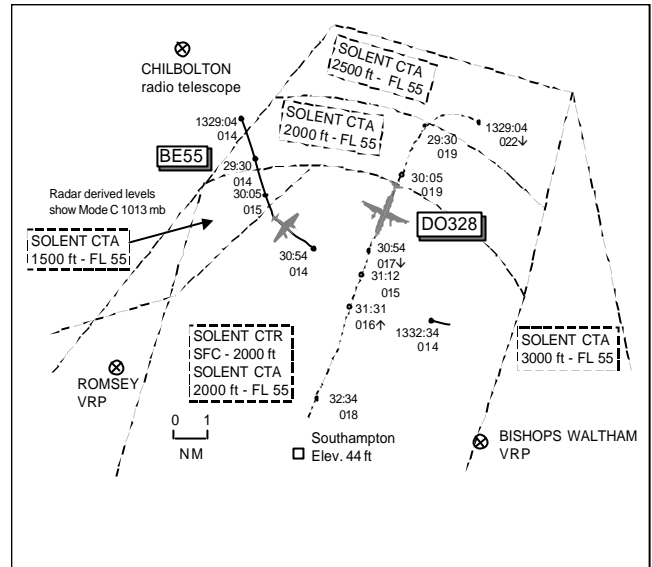
**THE DORNIER328 PILOT** reports flying inbound to Southampton from Amsterdam established on the ILS RW 20. The visibility was >10 km with no cloud in VMC and he had just been transferred to Southampton TOWER on 118.2 MHz. The ac was coloured white/red with landing anti-collision and strobe lights switched on and he was squawking 7332 with Mode C. TCAS was displaying several cyan diamonds but it was only after he had commenced descent from 2000 ft on the GP heading 205° and reducing speed through 150 kt that a TA alert drew his attention to a conflicting ac. The traffic, a light twin-engined ac, was sighted by the FO, PNF on the RHS, at about his 2 o'clock, range 2.5 NM and below. He continued descent and passing about 1600 ft QNH 1017 mb he came abeam the traffic, now at 2-3 o'clock range 1000 m. The TCAS alert changed to an RA "climb, climb" with which he complied and he saw the traffic pass about 0.5 NM behind. After completing the RA manoeuvre, he judged that he could no longer continue the approach so he commenced a go-around. He assessed the risk of collision as low owing to the TCAS alert even though he remained unsighted from the LH seat on the conflicting ac.

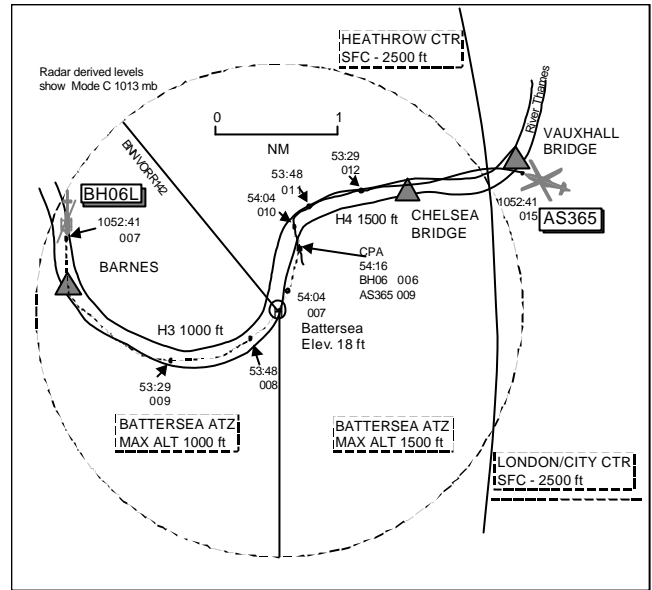
**THE BATTERSEA ADC** reports that the BH06L had been co-ordinated with Heathrow to join D/W LH for RW 21 and was seen from the VCR as it passed Barnes reporting point. He passed TI on the subject AS365, which was joining from Vauxhall Bridge and which had been co-ordinated earlier with Thames Radar, to the Long Ranger pilot who had called on frequency first. The AS365 pilot called and was cleared to join straight-in for RW 21 to position No 2 to the BH06L, which was by now D/W LH and No 1 in traffic. The ADC saw the Dauphin, which appeared too high (he estimated about 1500 ft) to complete a straight-in approach and too close to 'fit in' behind the BH06L, which was now commencing a turn onto base leg. He instructed the AS365 to continue on the Northern side of the river Westbound, which would have given the Dauphin pilot more space to position behind the BH06L; he passed this instruction twice. The AS365 pilot then turned to position himself No 2 behind the Long Ranger, both helicopters landing safely thereafter. He later spoke to the Co-pilot of the AS365 who apologised for the incident, citing poor command of the English language by the Capt. He also believed that neither crew members carried out their D/W or final calls as instructed by ATC

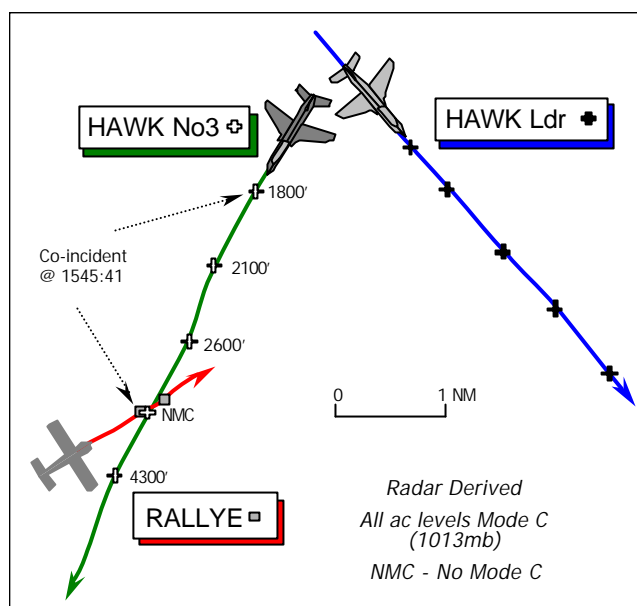
**THE HAWK PILOT** reports he was the No3 of a formation of 3 Hawks conducting practice intercepts (PI) in the Vale of York under an Air Defence Information Service (ADIS) from CRC Buchan. HISLs were on. After completing a low level run whilst acting as target, heading SW about 8 NM NW of Leconfield, he was climbing to 5000 ft RPS (1014 mb) in good visibility with no cloud. Passing 2000 ft at 400 kt, he spotted a light ac - blue in colour - heading E, at R 1 o'clock about 400 m away at the same altitude; he pulled up sharply to avoid the other ac, which he overflew by about 100 ft with a "medium" risk of a collision. The Airprox was reported to CRC Buchan.

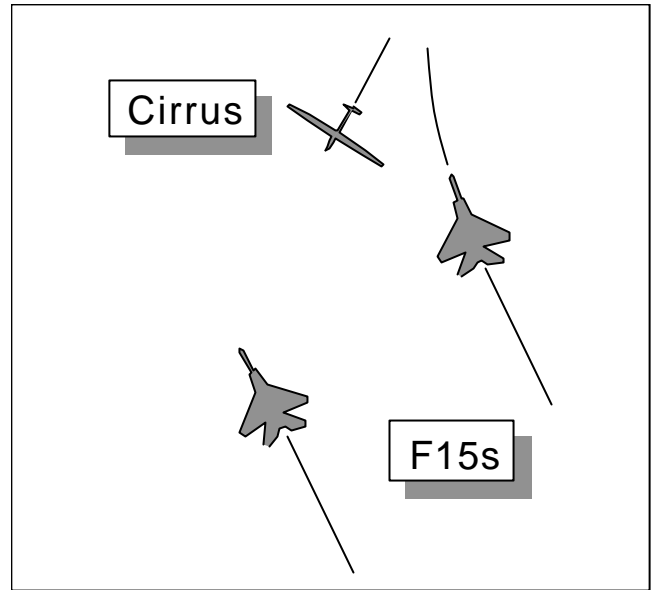
**THE CIRRUS GLIDER PILOT** reports heading 225° at 50 kt in a gentle descent some 500 ft below and 0.5 NM from cloud. He saw 2 F15s closing fast from his left about 1.5 NM away and banked right to increase his visual profile. The F15s passed either side of him some 5 – 10 seconds later; the one on his left/astern 300 m away in a left climbing turn, and the one ahead some 500 m away, also pulling into a climb. It felt as if the ac had passed close and the noise was very loud; he assessed the degree of risk as 'reasonable'. The ac had been somewhat below him, against the mountains, and he did not think he could have seen them earlier.

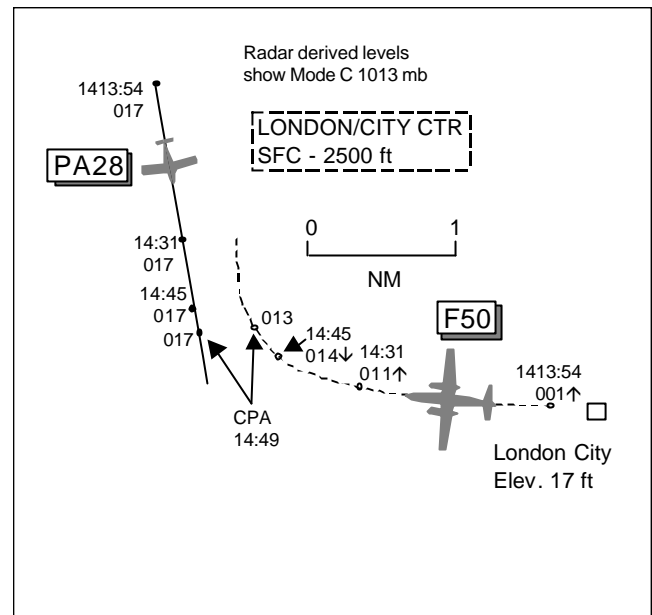
**THE F50 PILOT** reports on departure from London/City RW 28 following a CLN 5T SID and in communication with City TOWER on frequency 118.07 MHz. The visibility was >10 km in VMC, his strobe lights were switched on and he was squawking 6253 with Mode C. He commenced a R turn at DME 1.5 NM whilst climbing at 140 kt through 1300 ft QNH 1023 mb. On turning through 310°, having just completed the acceleration phase and after T/O checks (flaps and power), he received a TCAS TA alert; the F/O, PNF on the RHS, saw the conflicting ac in his 1 o'clock about 300 ft above. TCAS very quickly gave an RA "descend, descend", between 1000-1200 ft/min commanded, so he lowered the nose and reduced power to 30% torque and continued to turn keeping the ac in sight. London/City ADC tried to pass TI on the traffic which he thought had been passed far too late and wondered why this TI had not been passed before T/O or why they had not had their departure delayed. The other traffic, a red/beige PA28, was seen to pass 300-400 m clear on the LHS 300 ft above; he could almost read the registration. TCAS announced "adjust vertical speed", showing a green arc between 0 and 200 ft/min, followed quickly by "clear of conflict"; he then adjusted his flight profile to regain the SID. Only 8-12 seconds

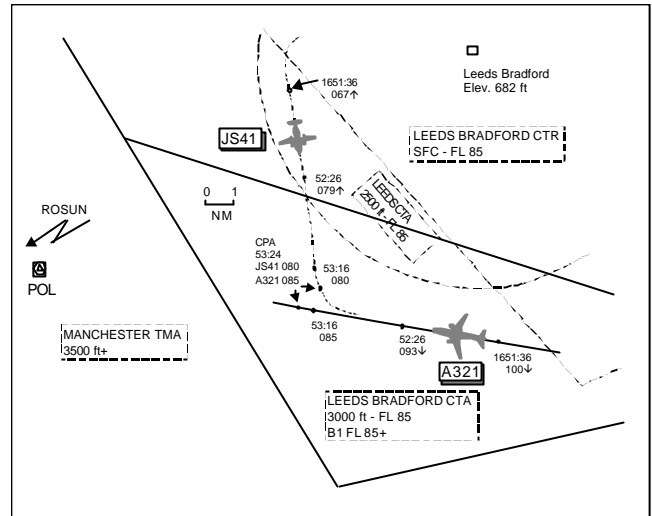
**THE A321 PILOT** reports flying inbound to Manchester from Greece routeing direct to POL descending to FL 70, he thought, at 220 kt and he was receiving a radar control service from Manchester. When about 8 NM E of POL passing FL 77, he thought, he saw traffic on TCAS in his 2 o'clock range 2 NM and 700 ft below. TCAS quickly annunciated "traffic, traffic" followed by "monitor vertical speed"; during these alerts he had instructed the FO (PF) to level-off which he did by applying TOGA thrust and disconnecting the AP. The other ac passed 500 ft below on TCAS, it was not seen visually as they were approaching the top of a cloud layer and he estimated the conflicting ac was within it. No warning was received from ATC and he assessed the risk of collision as high.

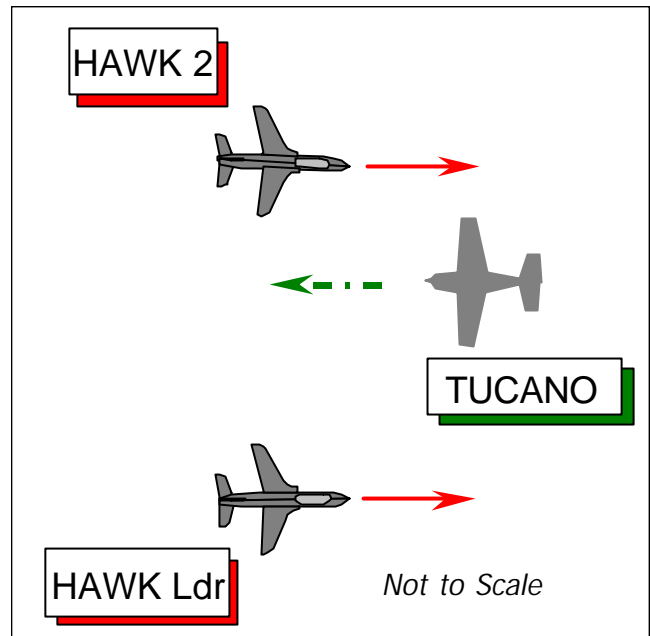
**THE TUCANO PILOT** reports his ac has a 'high conspicuity' black/yellow PTC colour scheme and the landing light and HISLs were on whilst flying a low-level sortie in LFA 17 from the rear seat with another pilot in the front seat. He was monitoring the LFS frequency of 300.8 MHz and squawking 7001 with Mode C.

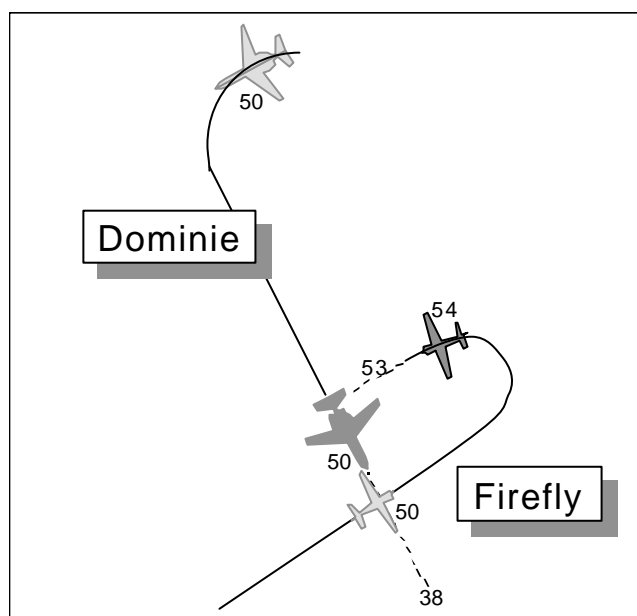
**THE DOMINIE PILOT** reports heading 151° at 180 kt, inbound to the fix in the Cranwell RW 27 Tacan hold, at FL 50. His ac was red and white and his HISL was on. He saw a Firefly in his 9 o'clock about 500 ft above, starting aerobatics. As it descended towards him he was forced to start a rapid descent as it passed about 500 ft above. He considered the risk of collision was high.

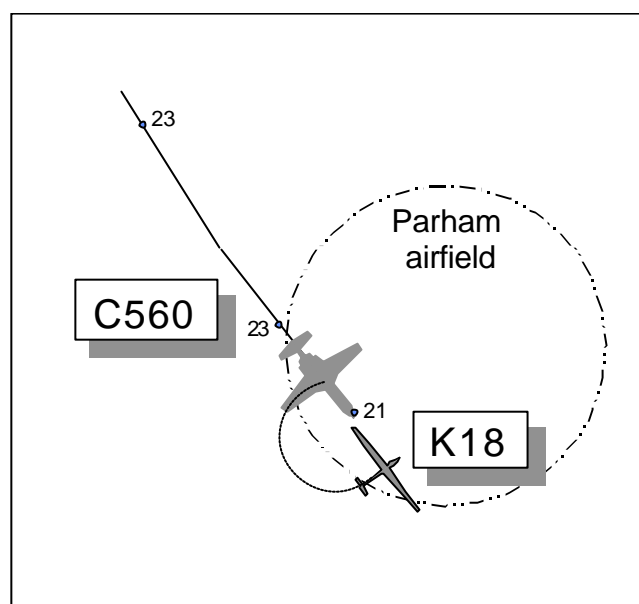
**THE K18 GLIDER PILOT** reports circling to the left at 42 kt over Parham airfield at 2300 ft in clear air when an executive jet passed directly beneath him by 300 ft on a track towards Shoreham. It had approached while he was mainly tail on to it in his orbit so he was not able to see it earlier or take avoiding action. He considered the incident to be 'potentially fatal'.

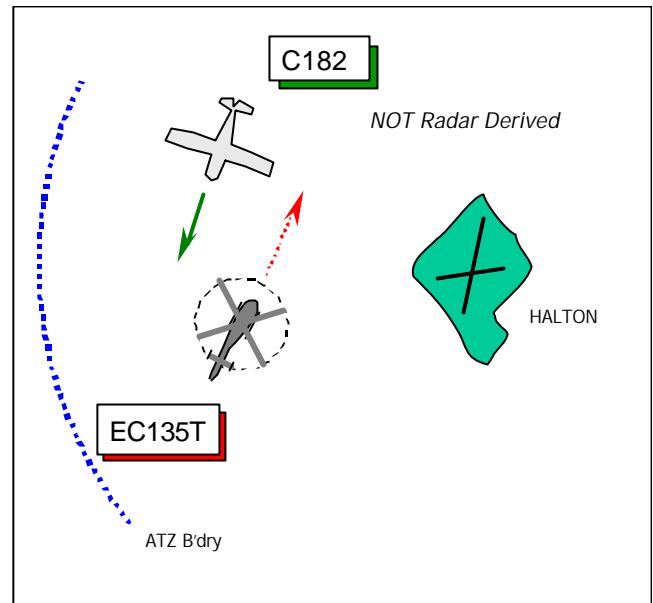
**THE C182 PILOT** reports his ac has a white/blue colour scheme; the landing light and red anti-collision beacon were on but HISLs are not fitted. He was inbound to Halton from Hinton-in-the-Hedges and in communication with Halton RADIO on 130.425MHz. Whilst flying downwind for RW02, heading 200° at 100 kt, a helicopter was spotted about 2 NM away and appeared to be within the ATZ, but its pilot had not called on the RT. The helicopter, which had a blue/yellow livery, then proceeded to fly below circuit height on the live side in between the active runway and the downwind leg, maintaining straight and level flight heading about 020°. No avoiding action was taken and he stated there was "little" risk of a collision.

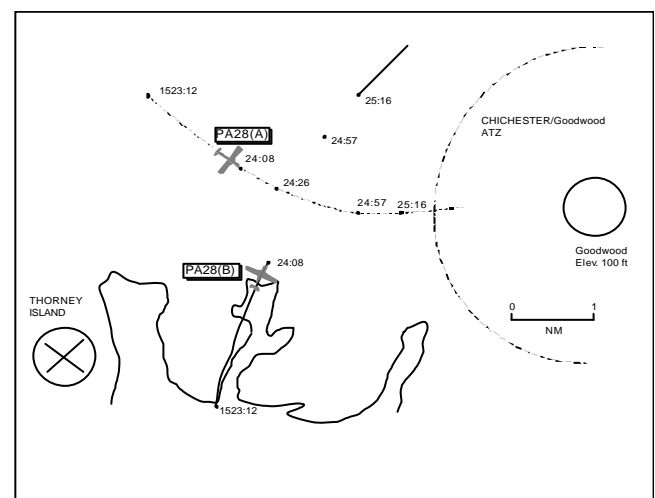
**THE PA28 (A) PILOT** reports flying on a dual training sortie from Fairoaks to Goodwood at 2000 ft QNH and he was receiving a FIS from Goodwood Information on frequency 122.45 MHz. The visibility was 40 km in VMC, the ac was coloured blue/yellow with anti-collision light switched on and he was squawking 7000 with Mode C, he thought. When about 4 NM W of Goodwood heading 100° at 100 kt, he saw a white low wing single engined ac, possibly a PA28, 200 m off to his RHS, nose-on heading directly towards him, at the same level. He entered a rapid descent to avoid and saw the conflicting ac pass 20-30 ft above and 100 m behind and he assessed the risk of collision as extremely high.

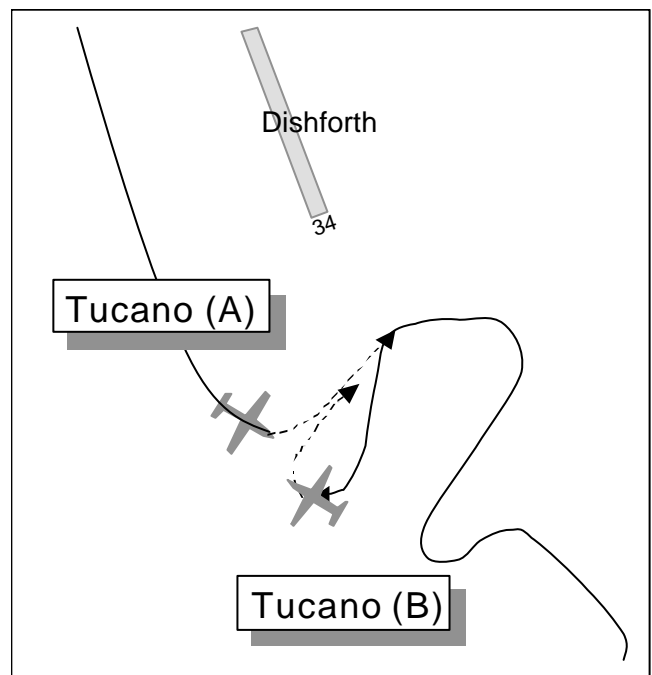
**AIRPROX REPORT No 165/01**

Members agreed that the cause of the Airprox was that the pilot of Tucano (B) did not conform with the circuit joining pattern and flew into conflict with Tucano (A), and concurred with HQ PTC's initial comment. However, it was always vital to get the joining pattern straight in one's mind before embarking upon it and if uncertainty exists, an orbit outside initials is a better place to sort it out than zig-zagging across the final approach path.

Cause: Tucano pilot (B) did not conform with the circuit joining pattern and flew into conflict with Tucano (A).

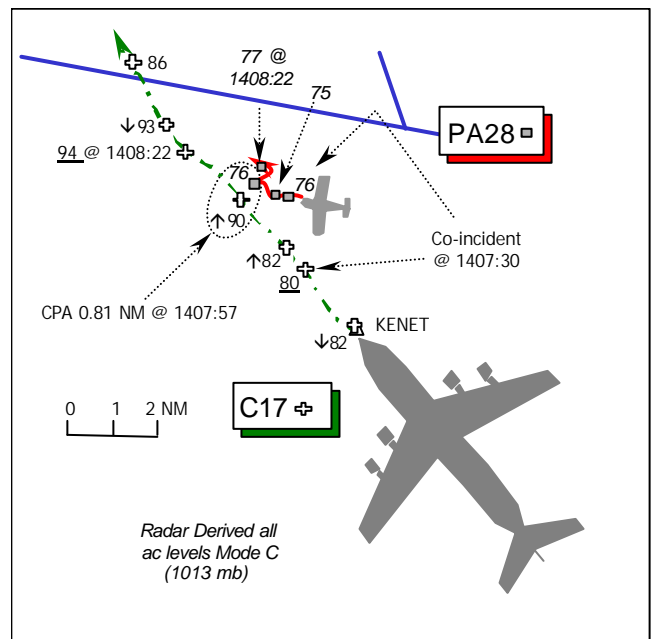
Turning to risk, several safety nets had come into play to prevent this situation from deteriorating further. TCAS had alerted the C17 crew to the presence of the PA28 at about the same time that DIR spotted it and proffered avoiding action. Although they had not seen it, this enabled the C17 crew to climb some 1400 ft above the PA28 at the closest point. Furthermore the PA28 pilot had also seen the C17 and was taking avoiding action himself. Consequently, members agreed unanimously that no risk of a collision had existed.

Cause: Inadvertent unauthorised penetration of Class A CAS by the PA28 pilot.

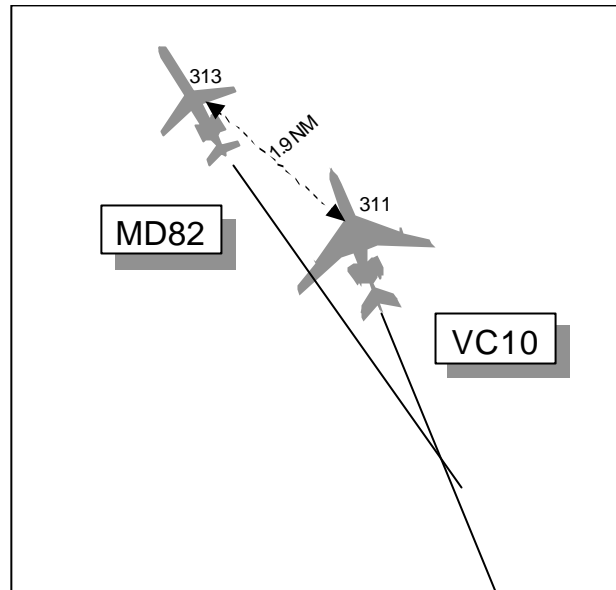
Members noted the high workload of the combined ATC sectors as described by the VC10 pilot and queried whether this had a bearing on the Airprox. However, the controller had been asked about this and had described her workload as low to moderate at the time of the incident. The request to split the sectors had been in anticipation of a further increase in traffic loading and the controller's request had in turn been anticipated by the CSC. The Board concluded that the cause of the Airprox was that the SC had overlooked the presence of the VC10 when clearing the MD82 to FL 150 and had cleared the latter to descend through the former's level with inadequate horizontal separation. Members noted that she had subsequently noticed and had told the MD82 pilot to stop his descent at FL 320 with 400 ft to go to that level. The radar recording showed a rate of descent of 3000 ft/min at that point but members considered that in allowing the ac to descend a further 1000 ft, the MD82 pilot had not reacted very promptly to the controller's repeated instruction to stop his descent.

Cause: The DVR/LYD SC cleared the MD82 to descend through the VC10's level.

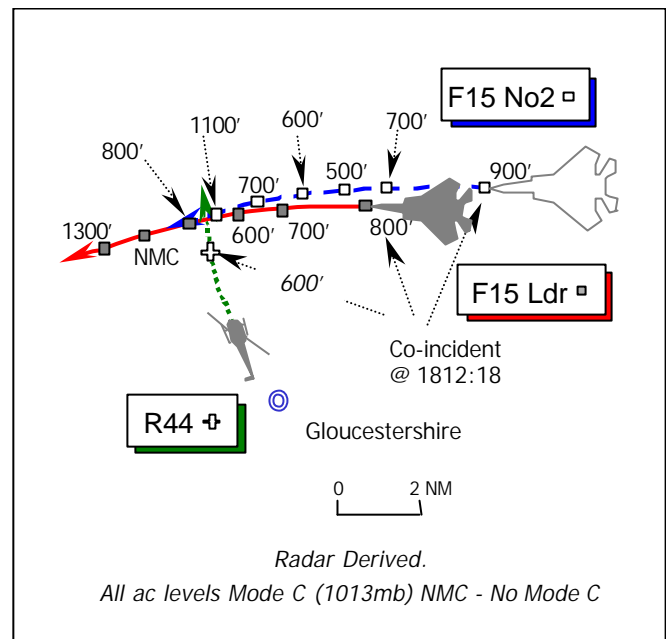
F15E is a large ac in relative terms to the R44 and should have been visible – albeit at a head-on aspect - whereas the small R44 is often extremely difficult to spot visually. In this 'see and avoid' environment, members recognised that if the helicopter pilot had not seen the lead jet until it had overflown his helicopter there was nothing that he could have done at all to effect the outcome of this encounter. Here then was part of the cause of this Airprox – a non-sighting by the R44 pilot. Given the slow relative speed of the helicopter, from the F15 pilot's perspective members believed there would have been little to highlight the other ac's presence as they flew into the setting sun, where the helicopter's HISLs would have had little visual impact. Some military pilot members thought it was unwise to let down at 450 kt, into a setting sun because it left little time for any avoidance manoeuvres as shown here. They thought a slower speed was more appropriate in these circumstances. Others wondered if the F15 pilots were relying on their ac 'sensors' too much and the inability of the F15's air to air radar to detect the squawking R44 was noted. Furthermore, some military pilot members familiar with TFR wondered what mode the F15 leader was using and why his ac's TFR had not detected the R44 and taken the F15 'over' the slow moving helicopter.

Cause: A non-sighting by the R44 pilot and effectively, a non-sighting by the lead F15 pilot.

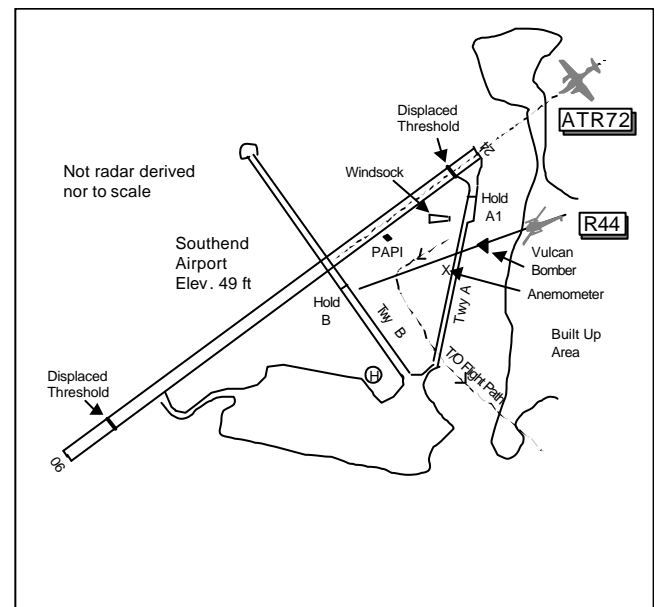
to, or departure from, an airport. So in this incident, the ATC TI was the only information available to the subject acs' crews to supplement their visual lookout. Similar operations to these occur at many aerodromes where ATC integrates mixed traffic, flying within the ATZ, using procedures designed to maximise the use of airspace and aerodrome surfaces. Members agreed that the ATR crew had perceived that the R44 helicopter was not going to stop short/clear of the RW on its adopted flight path and this situation had, quite understandably, caused them sufficient concern to file an Airprox.

Cause: The perceived flight path of the R44 caused concern to the ATR72 pilot.

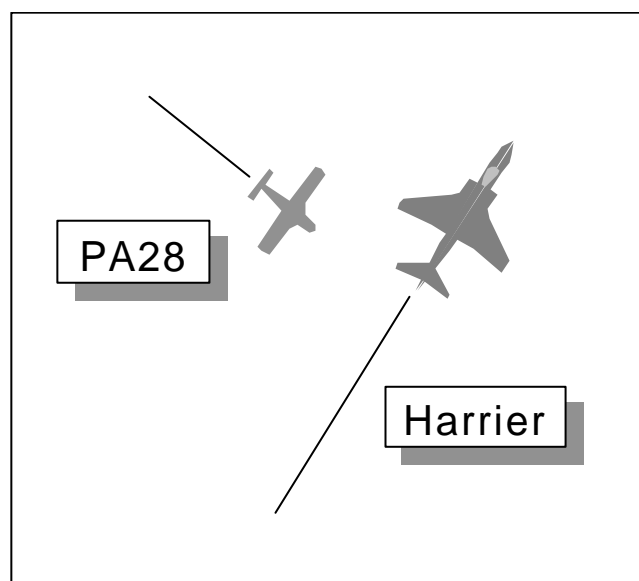
Members had a great deal of sympathy for the Harrier pilot, for whom a combination of circumstances had conspired to reduce his ability to look out at the very moment of the conflict. It was acknowledged that there are split seconds when the eyes have to check something inside a cockpit, and also that the only means of collision avoidance available to him at that moment was 'see and avoid'. A balance had to be struck but this time it did not work. He did not see the PA28 in time to take avoiding action and the Board concluded that this was part of the cause of the Airprox. From the PA28 pilot's perspective, perhaps he was not expecting fast jet activity on a Sunday; perhaps he was concentrating his lookout towards his student on the left. In any case the Harrier had been approaching for some time from his 2 o'clock and he only saw it when it was some 500 m away. The Board concluded that the PA28 pilot's late sighting was also part of the cause.

Cause: Late sighting by both pilots

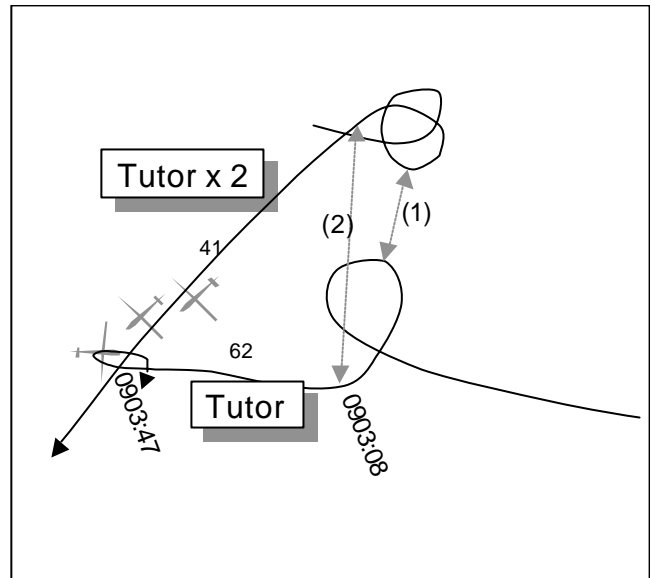
The question of when an instructor should take over from a student was discussed; it appeared that the student in the single Tutor had proceeded in a straight line for over 30 sec after the clearing turn before entering the spin, demonstrating clearly why such a turn should be continued to within a very few seconds of starting a spin. The Board agreed that the primary responsibility for avoiding incidents such as this lay in the cockpit of the spinning ac and that the main cause of the incident was that its pilots had spun into conflict with the Tutor formation below them which their clearing turn had not revealed. The Board also considered that the formation leader had a responsibility to

see and avoid conflicts; his aim should have been to be aware of any other ac entering a sphere around him of a size commensurate with the avoiding action he could take while leading a pair. The single Tutor was closing in his 11 o'clock 2000 ft above before it started its spin and should have been within his area of scan. While members were aware that a white tutor against the sky, with little relative angular motion, would not have been easy to spot, the fact was that it was not seen by the formation leader and the Board concluded that this was also part of the cause.

Cause: The single Tutor span into conflict with the formation which his clearing turn had not revealed, and the formation leader did not see the spinning tutor.

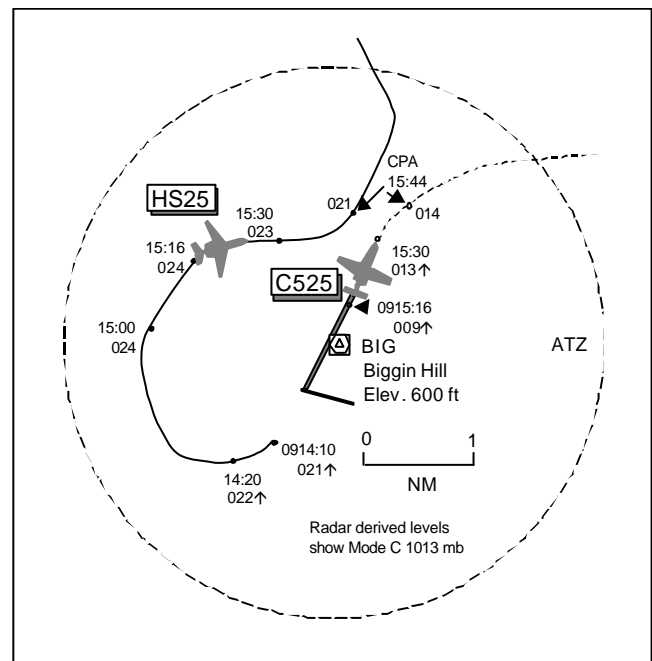
**AIRPROX REPORT No 173/01**

plan to separate the subject ac, although less than ideal owing to the confusion between Biggin Hill ADC/APP and Thames Radar, should have kept them apart. The missed approach instructions, a R turn onto heading 350° and a climb to 2100 ft, had been passed and acknowledged. It was clear, however, that the HS25 crew, for whatever reason, had not complied with the ATC instructions on the go-around and had turned through heading 350° onto an Easterly track and into conflict with the C525. It was this action that had caused the Airprox. Although the ATC aspects were untidy, the only person who could see the situation unfolding was the Thames Radar controller and he had eventually resolved matters safely. Unfortunately, he had been denied 'instant access' to the pilots owing to the subject ac remaining on the Biggin Hill frequency throughout the encounter, despite having requested the Biggin Hill controller to transfer them to his frequency. In the end the incident had been sorted out using the Biggin Hill controller as a 'relay' to forward the instructions to the subject pilots.

Cause: The HS25 crew did not comply with ATC instructions and flew into conflict with the C525.

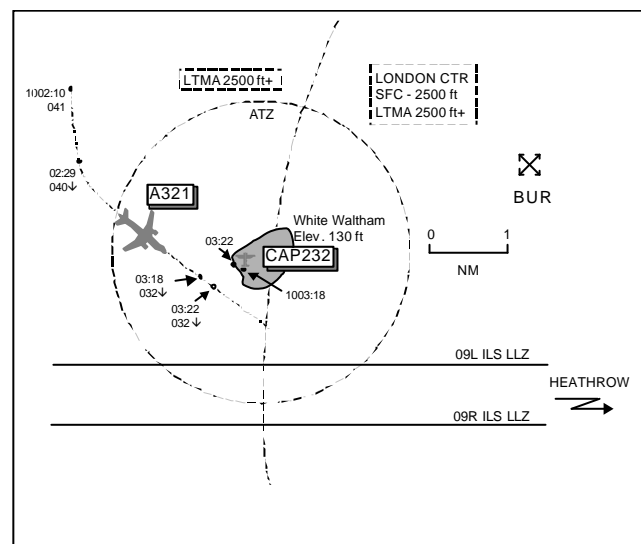
Members went on to discuss the wider implications from the incident in terms of other areas where CAS was undercut by Class G airspace. The generation of TCAS alerts during encounters like this one could become more prevalent with the wider use of Mode C and high-energy vertical manoeuvres would probably cause RA alerts. It was a watchpoint to be aware of in TCAS operations close to CAS boundaries. Finally, members wondered why the radar filters set at the FIN DIR position removed the 7004 aerobatic code used by the CAP232. Filtering out of 7000 codes was known to remove label clutter from the display but showing the 7004 code would have alerted the ATCO to the aerobatic ac thereby enabling him to pass accurate TI, when necessary, to inbound/outbound ac.

Cause: Sighting report.

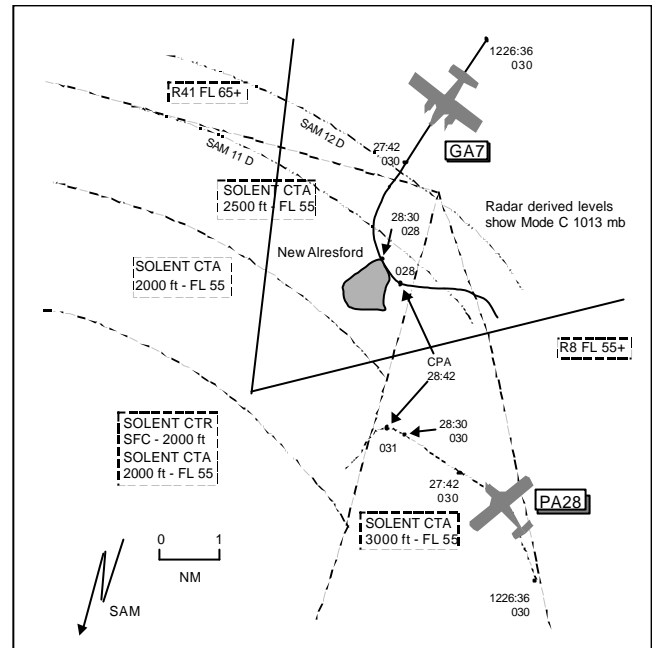
## AIRPROX REPORT No 176/01

The GA7 pilot had called Solent about 2 minutes before the CTA boundary but ATC had instructed him to remain outside CAS and await a further RT call; the onus was then on the pilot to ensure he complied with the instruction. During the subsequent delay in establishing two-way communications and agreeing a ‘contract’ with ATC, the GA7 pilot had continued on his original track, probably anticipating clearance into CAS at 3000 ft. However, it was clear that on completion of his subsequent RT call, the GA7 pilot had entered CAS without clearance, contrary to ATC instructions, and this had caused the Airprox.

Cause: The GA7 pilot entered CAS without clearance and contrary to ATC instructions.

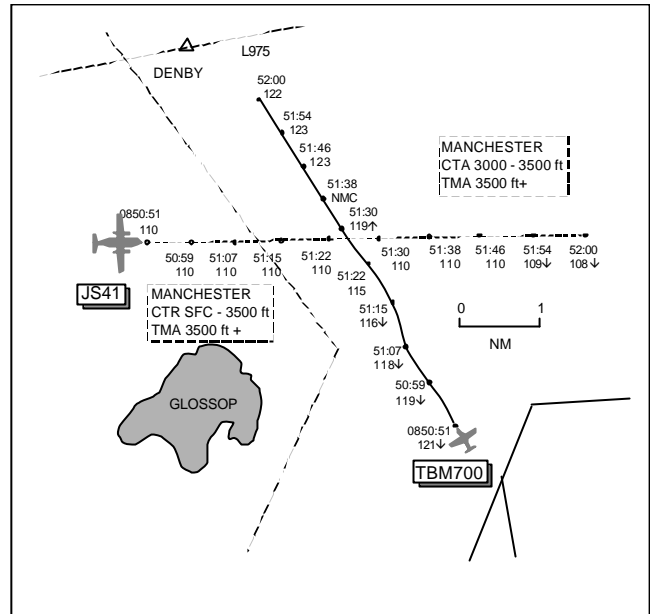
It was clear to members that this incident had been caused by the TBM700 pilot descending below his cleared level but they were surprised at the events that followed. Having inadvertently tripped-off the AP ALT hold, the TBM pilot had descended through FL 120 by some 500 ft before starting to recover. The TMA NE ATCO saw the 'level bust' about the time STCA would have activated and had instructed the TBM pilot to maintain FL 120, which was acknowledged, but not achieved at that point. Seeing the TBM still descending, the ATCO had then switched his attention to the JS41 crew but unfortunately had used the wrong c/s when passing them 'avoiding action' instructions. Further delay came when the JS41 crew queried the controller's instruction and the subject ac's tracks had crossed by the time the JS41 started to descend. Members fully understood the JS41 crew's concern as to the whereabouts of the conflicting traffic, particularly in the absence of ATC TI and TCAS but between them, the ATCO and crew had rendered impotent the 'avoiding action'. Meanwhile, the TBM700 pilot had reacted so sharply to recover his 'level' that he shot through it, again. In spite of all of this the ATCO/crew inter-play had little adverse effect on the outcome, which was determined more by the TBM700's flight path. In the end the Board assessed there had been no risk of collision.

Cause: The TBM700 pilot descended below his cleared level.

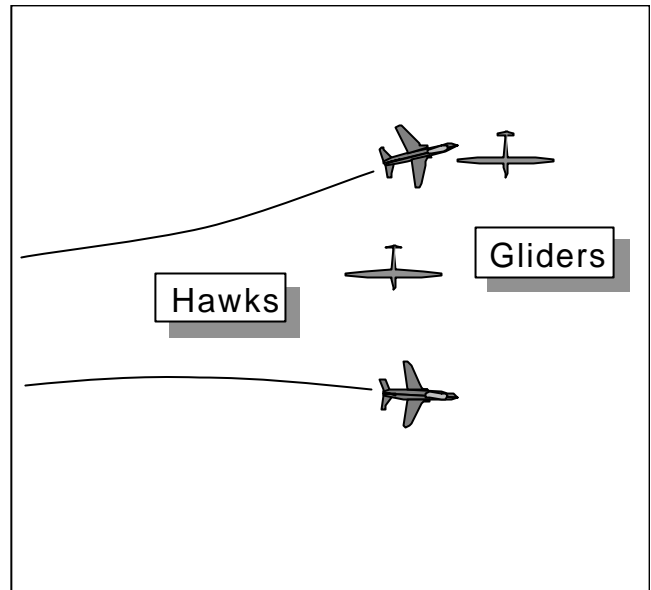
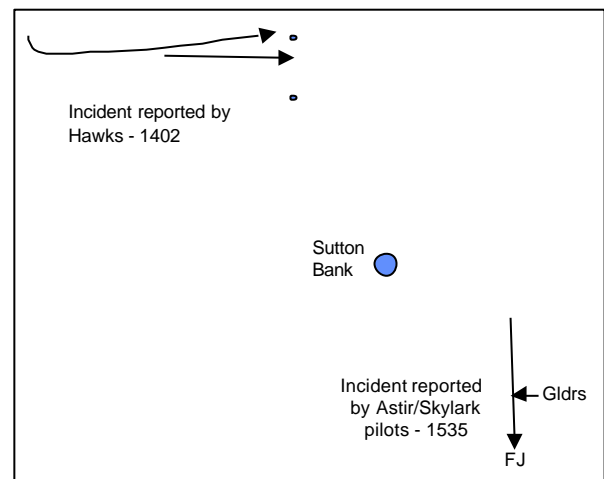
LATCC radar recordings show the 2 Hawks climbing on an easterly track from Leeming in a close battle formation. Ahead of them is a primary only contact with another about 2 NM to its S, tracking slowly S. The Hawks close on the former, and as they pass it they split into a wider formation and their rate of climb increases. The formation passes clear to the N of the second primary-only contact. This incident occurs at 1402:52. However, the Skylark

Cause: Effectively a non sighting of the gliders by the Hawk pilots.

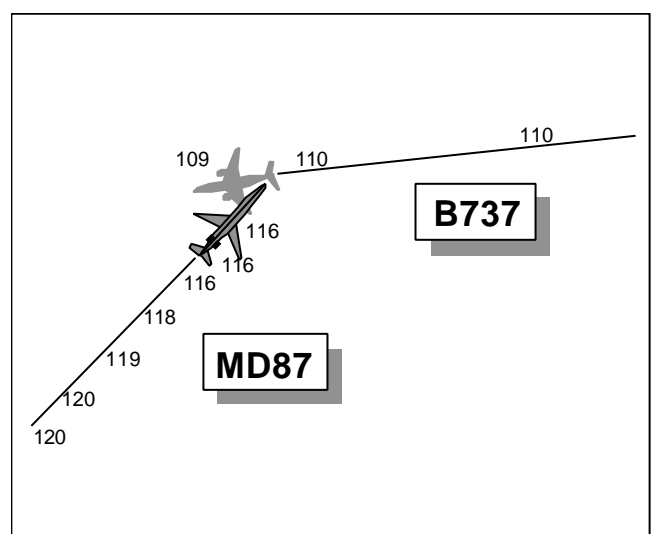
**THE B737 PILOT** reports heading 265° at 300 kt, level at FL 110 under Radar Control from LATCC. He had traffic on TCAS closing from 11 o'clock in a descent; it appeared to level 1000 ft above, but then continued to descend. He received a TCAS 'Descend' and followed it; the other ac, an MD80, passed 600 ft directly above. The risk of collision was moderate to high; in the absence of avoiding action from ATC the TCAS RA had been necessary.

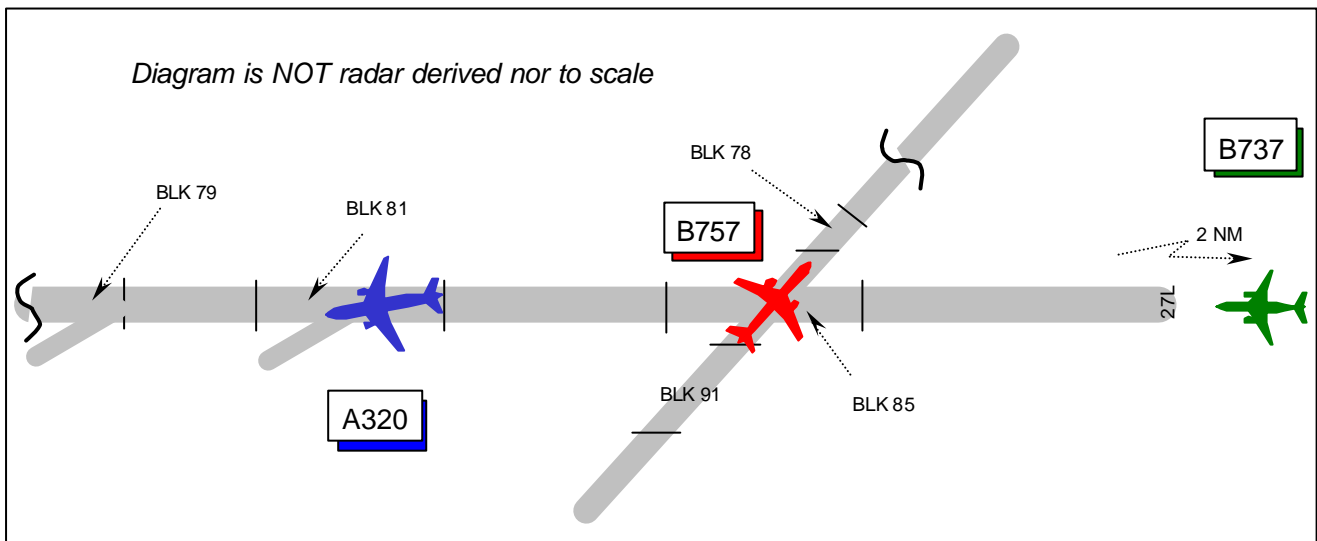
**THE B737 PILOT** reports he was approaching to land at London Heathrow flying at 130 kt and in contact with Heathrow TOWER. At 2 NM finals for RW27L, he spotted another ac – he thought a B757 or A321 – taxiing across the runway from L – R which did not vacate the RW until they had passed 200 ft London QNH (1007 mb). No avoiding action was taken and he elected to continue the approach, but he landed ‘long’, which resulted in late vacating of the RW and caused the following ac in the landing sequence to ‘go-around’.

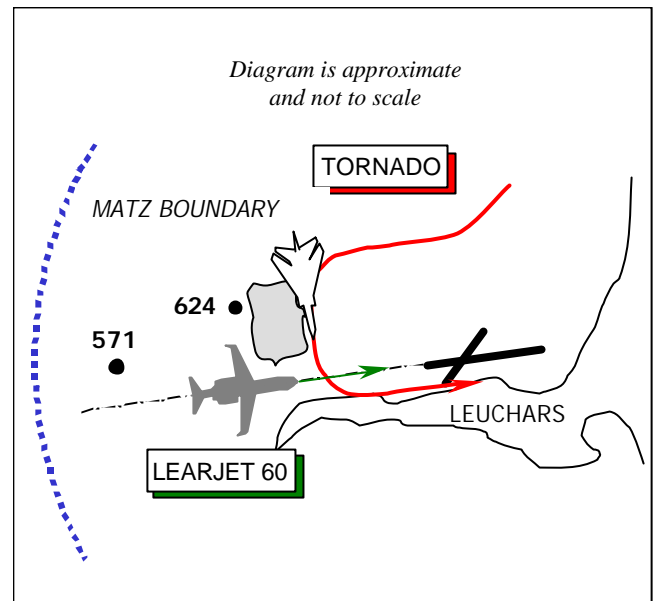
The F3, therefore, was flown in accordance with local orders and the pilot's 'delaying dog-leg' downwind so as to sequence No2 behind the Learjet were well intentioned. The pilot had been required to go around from his previous Cct because of the conflict with the landing F3 pair, which he had seen in good time and he was no doubt also expecting to be able to see the Learjet in sufficient time to position himself accordingly. However, as reported, the F3 pilot's first go around corresponded with a rapid weather deterioration as the cloudbase lowered. This probably prompted the second pair to land from their approach rather than overshooting into the Cct. Throughout the PAR, the Learjet was well above the glidepath, correcting slowly, the descent having been started just over 1 NM beyond the normal descent point. Although it is not clear precisely how far above the glidepath the Learjet actually was, but at 1.5 NM from touchdown - the range the pilot reported on RT sighting the F3 - an ac on the glidepath should have been passing about 450 ft QFE.

Circumstances produced a situation where the F3 pilot had been baulked twice in worsening weather conditions. Despite making an attempt at spacing his ac behind the radar traffic, he arrived at the end of the downwind leg probably expecting to see the Learjet, but couldn't because it was higher than normal and still in cloud. Extending - even slightly - downwind to sequence behind the Learjet was not an option because of Lucklaw Hill (elev 624 ft, 586 ft aal) 2.5 NM WNW of the aerodrome. Therefore, the F3 pilot probably had little option other than to fly the track that he did. Furthermore, he reports that he climbed from 500 ft at the end of the downwind leg to 800 ft during the go-around to stay as high as possible while still remaining visual with the ground. Unfortunately, this probably brought the two ac even closer together but having been informed by TWR that the Learjet was at 2 NM as the go around was being commenced, the F3 pilot was probably anticipating that the Learjet would pass beneath him.

on finals. He was complying with ATC instructions, but was mistaken in thinking that he had not been told about the circuit traffic. The Leuchars Talkdown transcript revealed the salient words – *"one in"* - indicating that there was one ac in the visual Cct - but the Learjet pilot may have been unfamiliar with this terminology. However, the STC member questioned the F3 pilot's decision to continue in the visual Cct when the weather deteriorated. But this was with the benefit of hindsight and having been baulked from completing his earlier Cct by the returning Tornado pair, the approaching Learjet on radar had then put him in an awkward situation with few options. Some wondered if there had been a pressing need to practise Ccts in these conditions if they were not essential. Indeed, here was a salutary supervision lesson - mixing visual training Ccts with IFR traffic in marginal weather invites difficulties unnecessarily. It was not clear if the F3 pilot had sufficient fuel to climb out of the visual Cct into the radar pattern for an instrument approach, or whether fuel constraints had forced him to continue circuiting after being baulked. If fuel was short he could have declared it and been given priority over the radar traffic to land. As it was the F3 pilot was pushed into a corner – literally at the end of the downwind leg - approaching rising ground of 624 ft at a height of 800 ft QFE in 'GREEN' conditions. Moreover, despite attempts at spacing he found himself flying in opposition to another ac known to be somewhere on final but unseen. Some wondered if the F3 had extended downwind – this was not completely clear – but experienced pilot members were in no doubt that this should not be done. It appeared to the Board that with nowhere else to go (apart from clearing the Cct), the F3 pilot had turned base leg and crossed the approach from N to S to gain the deadside – evidently without sighting the Learjet and apparently just as it emerged from the cloud. Some reasoned that if forced to do so, it would have been better to have turned onto base leg earlier so as to cross directly above the RW threshold, where separation would have been at its greatest with landing traffic. Others contended however, that it was no safer as the Learjet pilot – possibly unfamiliar with the aerodrome and high on the glidepath in poor weather - could very easily have initiated a missed approach. The Board concentrated on what had taken place and agreed, that this Airprox happened because the F3 pilot had flown into conflict with the approaching Learjet, which he could not see.

Turning to risk, the Board noted that Talkdown had initiated the Learjet's descent at a late stage. Hence, it was well above the glidepath and higher than the 450 ft nominal height expected at 1.5 NM from touchdown, when the F3 crossed ahead, as the ac emerged from the cloud. Unfortunately the lack of recorded radar coverage in this area prevented independent assessment of the minimum separation that pertained. The Learjet pilot's estimate that both ac were at the same height tallied and there was no reason to doubt his estimate of 50-100 ft horizontal separation. With "no time to take avoiding action" by the Learjet pilot and the unsighted F3 pilot belly up in a turn

Cause: The F3 pilot flew into conflict with the approaching Learjet which he could not see.

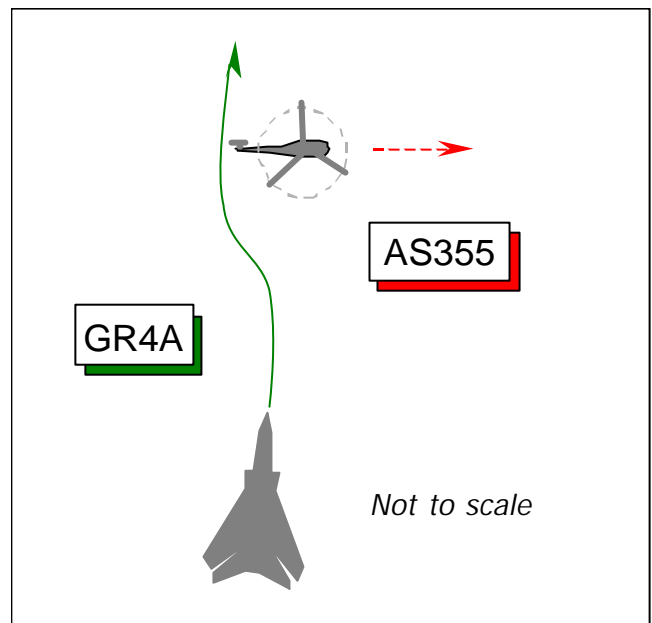
helicopter – late - directly ahead about 1 NM away and slightly above his ac. The helicopter appeared to be moving from L – R, so to avoid it he bunted and turned to port as the helicopter passed about 1 - 200 ft above and 30 - 60 m to starboard, with a medium risk of collision. He estimated the helicopter was flying E at about 450 - 500 ft agl and added that no CANP had been noted for any helicopter activity in the area.

Cause: Non-sighting by the AS355 pilot, and a late sighting by the Tornado pilot.
