**UK AIRPROX BOARD**

# **Analysis of Airprox in UK Airspace**

**Report Number 7  
July 2001 to December 2001**

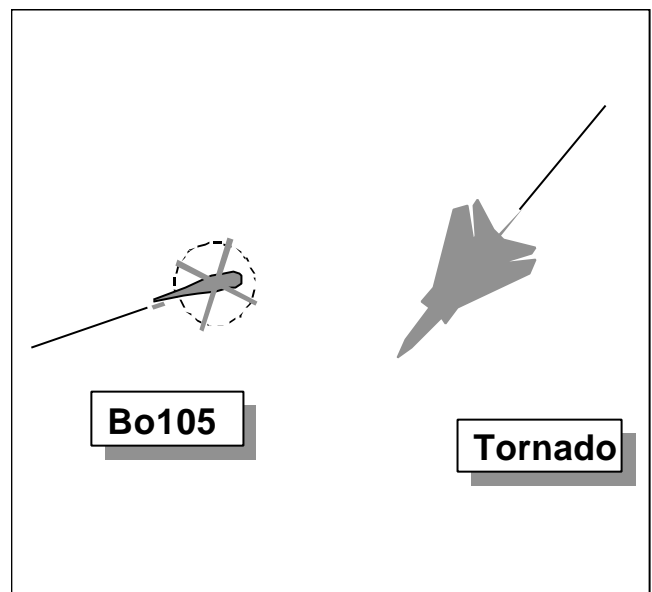
**THE TORNADO PILOT** reports heading 190° at 420 kt on a TF training sortie; while the navigator was heads-in taking a radar fix he cleared the area ahead visually and performed a TF step down from 500 to 300 ft and completed routine checks. On looking up he saw a red helicopter closing at the same level in his 2 o'clock in a hard left turn; his navigator saw it at the same time but it was too late for avoiding action. The risk of collision had been high but the helicopter's avoiding action prevented a collision. The helicopter passed about 50 ft above and 300 m away.

Cause: Late sighting of the other ac by both crews.

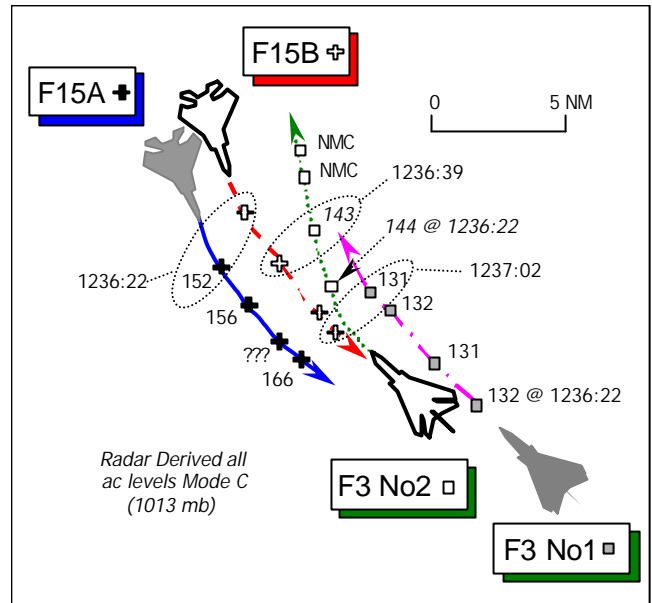
With regard to the Airprox report itself it was clear that the F3 pilots had been warned of the presence of the F15s by NEAT3; the No2 Tornado pilot had detected the pair on AI radar at 5 NM and subsequently sighted F15s A & B. It was not clear if he had warned his No1 whose radar was u/s but who, nonetheless, should have been looking out for them after NEAT3's traffic information in the good weather conditions that pertained. The F15 pilots had also received pertinent traffic information from CON2 and F15B took avoiding action to maintain separation on the F3 pair. Whereas the F3 pilot reported ½ NM horizontal separation, the radar recording showed that a minimum of 2 NM was maintained throughout. In the end it seemed to military pilot members that the 'system' had worked to provide appropriate warning to all the pilots involved, so that they could take appropriate action to avoid each other by a suitable margin. This view led the Board to conclude that this was a sighting report and no more. Hence, in the circumstances that pertained, the Board assessed that no risk of a collision had existed.

Cause: Sighting report.

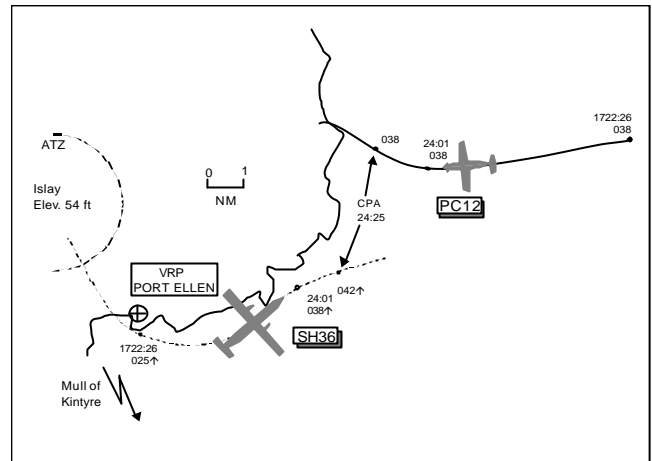
From the outset, there appeared to have been some assumptions and misunderstandings by all parties and these had caused the incident. The Antrim/West Coast Radar Controller was expecting the

Cause: Misinterpretation of the Air Traffic service being provided.

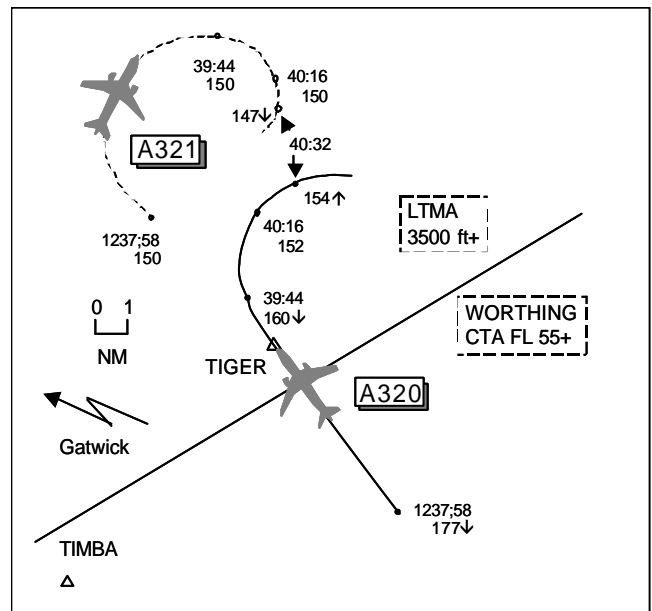
**AIRPROX REPORT No 190/01**

which was another part cause of the Airprox. Thirdly and crucially, the SC had missed the A320 pilot saying he was descending to FL 150 on his initial RT call. Irrespective of the previous assumptions by both ATCOs, if the SE SC had assimilated the A320 pilot's level report, it would have enabled her to take earlier remedial 'stopping-off' action. This omission was the final part cause of the Airprox.

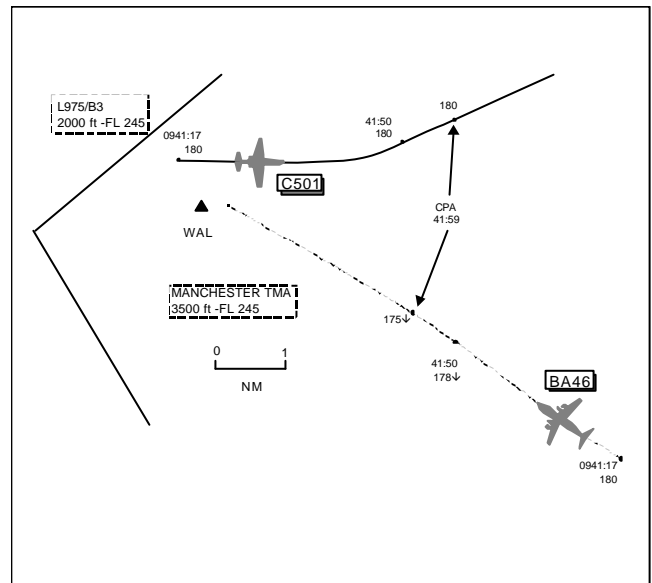
the situation. In the absence of any further concrete information and having exhausted possible hypothesis to fit ‘the picture’, members agreed that the West/IOM radar controller had inexplicably descended the C501 to the same level as the BA46 and this had caused the Airprox.

Looking at risk, after noticing the confliction the controller had initially given the C501 pilot a 30° L turn and TI on the BA46; the pilot saw it passing 2-3 NM clear on his RHS. The controller then followed up with a L turn and descent instructions to the BA46 crew, who by that stage had already received TCAS TA and RA alerts and were following the RA “*descend*” instructions; the BA46 crew saw the C501 as it passed abeam by 2-3 NM. Members noted the lack of turn by the BA46 but understood the crew’s primary preoccupation of manoeuvring in the vertical plane in response to TCAS. However, ATCOs felt that the words ‘avoiding action’ should have been used to elicit a more rapid response from both pilots in the circumstances. At the end of the day, the combined actions by all parties to recover the situation had led to only a marginal loss of standard separation. From this the Board concluded that any risk of collision had been effectively removed.

Cause: The MACC West/IOM Radar controller inexplicably descended the C501 to the same level as the BA46.

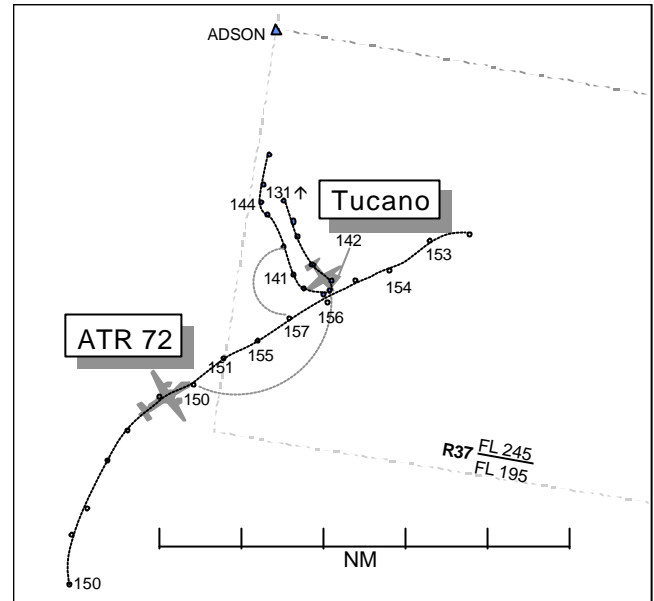
previous sweep). The closest point of approach observed on radar occurs in the next sweep, at 0847:27, with the Tucano, tracking 320°, in the ATR72's 11 o'clock at a range of just under 1 NM and 1400 ft below (ATR FL 155, Tucano FL 141). Both ac have maintained track in the following sweep, with the Tucano now 1 NM N of the ATR72 (9:30 position) and 1500 ft below, after which the tracks continue to diverge.

Cause: Conflict in Class G airspace, resolved by both pilots.

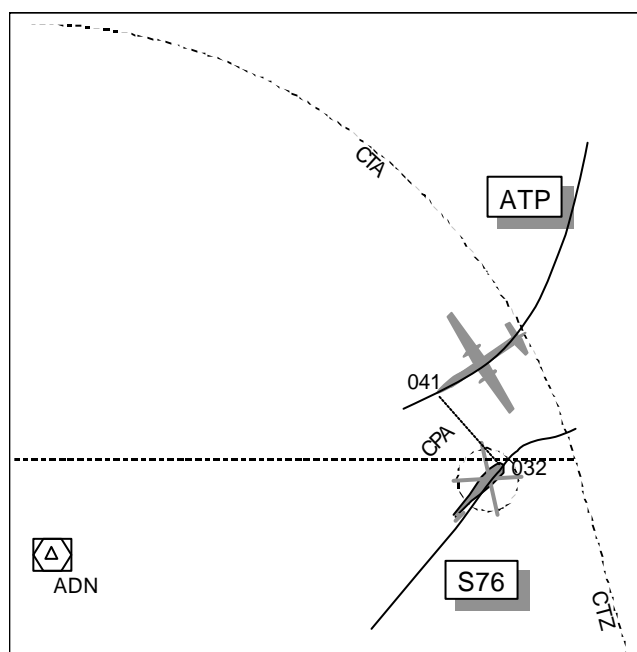
**AIRPROX REPORT No 193/01**

Controller members of the Board were quick to point out that the FIN controller had dispensed with vertical separation between the ac before ensuring that horizontal separation would be maintained, and that this was a cause of the Airprox. Members also wondered why FIN had not amended the plan when it became apparent that it was not being complied with. All members agreed that the ATP pilots were unusually slow to comply with the controller’s instructions and that this was also part of the cause. Fortuitously, however, it was their slowness to start descending which allowed FIN eventually to stop their descent while some vertical separation remained. The ac eventually passed by 8-900 ft and over 1.5 NM, and the Board assessed that there had been no risk of collision.

Cause: The Aberdeen FIN controller dispensed with vertical separation between the ac before ensuring that horizontal separation would be maintained, and the ATP pilots were slow to comply with ATC instructions.

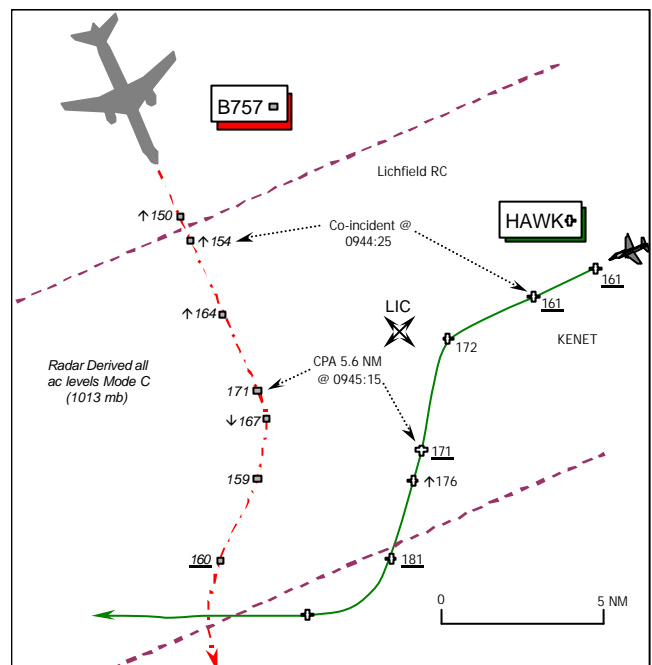
**THE B757 PILOT** reports he was climbing outbound from Manchester heading 160° at 305 kt and under a RCS from MACC on 124.2 MHz. Passing through FL 159 for his assigned level of FL 190, he was instructed to level off at FL 150. He had already passed this level and advised MACC who then instructed him to expedite the climb to FL 190. Immediately thereafter, MACC passed avoiding action instructions to turn R onto 230° and descend to FL 150. The autopilot and autothrottle were disconnected, the ac turned manually onto the heading of 230° and descended to FL 150, as instructed. Traffic information was given on another ac at 11 o'clock – 5 NM climbing

to FL 180, but it was directly into the sun and not seen at all. After about 20 sec he was instructed to turn L direct HON VOR and stop descent at FL 160, whereupon the autopilot and autothrottle were re-engaged.

**MIL ATC OPS** reports that the Hawk pilot was routing from E - W through the LICHFIELD RC at FL 160, under a RCS from London MILITARY Controller 31 (CON31). The RC had been booked with Manchester in the normal way, and a clearance at FL 160 obtained. CON31 observed the B757 in the Hawk's 2 o'clock at a range of about 10 NM, tracking S and climbing through FL 154 Mode C. CON31 instructed the Hawk pilot "...avoiding action, climb Flight Level one seven zero" which was acknowledged, followed by "...expedite your climb, turn left avoiding action, turn left heading two zero zero, traffic right, one o'clock, ten miles crossing right left climbing." The Hawk pilot acknowledged this and shortly afterwards called "Steady and level...and I'm visual with that traffic." While CON31 was transmitting the avoiding action to the Hawk pilot, he opened the landline to MACC and then attracted the Supervisor's (SUP) attention. While waiting for the line to be answered, he advised the SUP "Got a level buster...I've avoided...and I'm just about to co-ordinate it out." When the landline was answered, CON31 then exchanged information on the quickly changing dynamics of the situation with an unidentified MACC controller - believed to be the STAFA CO-ORD. Between them the two controllers after slight confusion agreed the action needed to resolve matters safely. Subsequently, the SUP used the landline to Manchester to discuss what had happened. At 0945, CON31 transmitted to the Hawk "C/S maintain (heading) two zero zero I'll keep you clear of traffic, it's now co-ordinated descending" and the Hawk pilot replied "Copied and visual." Seeing the B757's Mode C passing FL 160 however, CON31 issued the Hawk pilot with a further climb to FL 180, to which the pilot responded. SUP noticed the B757 continue to climb while he was talking on the landline and said to the Manchester controller "We we're, I mean is he climbing ex- is he expediting up through one seven 'cause we've gone up to one seven" to which the Manchester controller replied "Hang on a minute, I think he asked him to descend, he's he's descending." In confirmation, SUP asked "Did you say descending?" and, on receiving confirmation

of this, advised Manchester *"Okay, we're going up to one eight and we'll turn back."* Shortly afterwards, the B757 was observed to be descending on radar. Both CON31 and the London MILITARY Supervisor believed that separation of 5 NM and 1000 ft had just been maintained.

Nevertheless, none of this would have been necessary if the STAFA co-ordinator had brought the activation of the RC to the controller's attention immediately; delay, in the end, led him to forget, and the absence of the appropriate tick mark (*ü*) evinced this omission. The Board agreed what had caused the Airprox; the MACC SE STAFA Co-ordinator did not ensure that the STAFA SC and his trainee were aware of the co-ordination agreed for the activation of the RC for the Hawk, as he should have done. It was explained by the ATSI advisor that two blocking strips were required here – one in the STAFA fps bay and one in the LIC bay. This system normally works satisfactorily, except here where it did not and, its omission was a contributory factor to this occurrence.

In assessing the risk the Board noted that the Hawk pilot was aware of the situation and was monitoring the B757 throughout; moreover, standard separation had been maintained. Therefore, the Board concluded unanimously, that no risk of a collision had existed.

Cause: The MACC SE STAFA Co-ordinator did not ensure that the STAFA SC and his trainee were aware of the co-ordination agreed.
