**UK AIRPROX BOARD**

# **Analysis of Airprox in UK Airspace**

**Report Number 27  
July 2011 – December 2011**

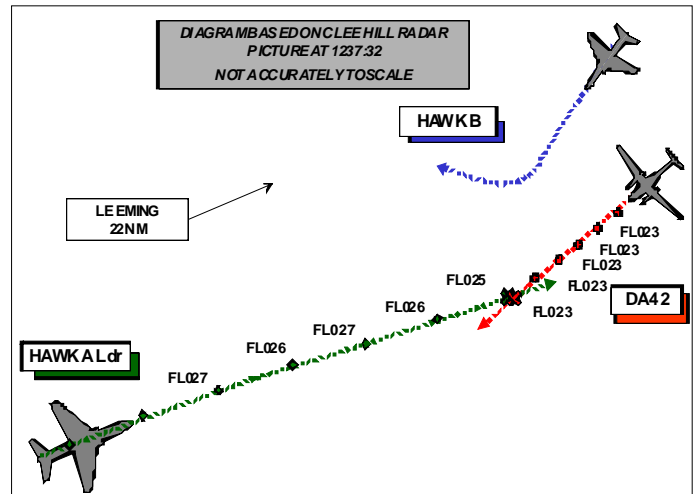
**AIRPROX REPORT NO 2011068**

Date/Time: 1 Jul 2011 1237Z  
Position: 5410N 00205W (22nm SW Leeming)  
Airspace: London FIR (Class: G)  
Reporting Ac Reported Ac  
Type: Hawk T1 DA42  
Operator: HQ Air (Ops) Civ Pte  
Alt/FL: 2900ft 3000ft  
(QFE 1022mb) (QNH 1026mb)  
Weather: VMC NR  
Visibility: 50km 50km  
Reported Separation:  
0 V/300-400ft H 200ft V/500m H  
Recorded Separation:  
200ft V/<0.1nm H

Cause: A conflict in Class G airspace resolved by Hawk A Ldr.

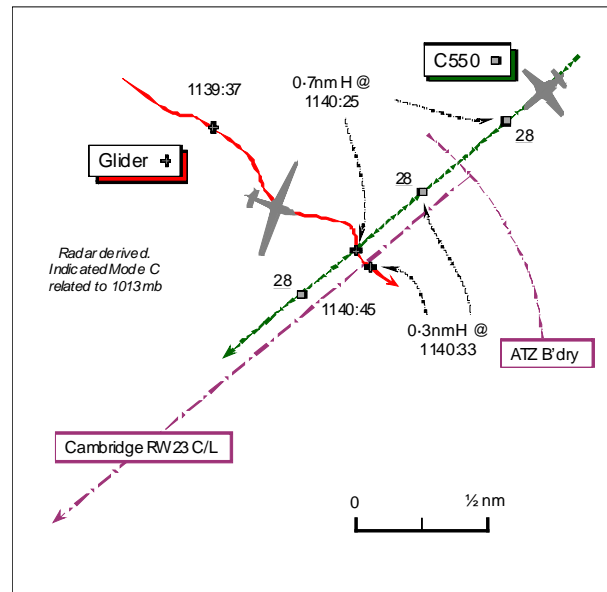
**THE CESSNA CITATION II C550B PILOT (C550)** reports he was inbound to Cambridge Airport at 160kt under IFR in VMC and in receipt of a 'Radar Control' service, he thought, from Cambridge ATC. Flying the LLZ course for RW23 level at 3000ft a glider appeared very close overhead about 200-300ft above his ac in what seemed like a diving turn with a nose-down attitude. The glider was not evident on his ac's TCAS and its pilot was not in RT contact with ATC. The glider was seen too late and was already astern before avoiding action could be taken. He reported the Airprox to TWR on RT.

Cause: A conflict in Class G airspace.

ATSI recommended that Cambridge ATSU in consultation with the CAA ATSD Southern Regional Inspectorate, urgently review the provision and promulgation of the Unit's radar services. A number of recent Airprox events have occurred when pilots had an expectation that radar services would be available in accordance with the promulgated periods of availability. In these instances pilots were advised on initial contact, that radar was not available, often in circumstances when a number of gliders were operating in the vicinity of Cambridge Airport without controllers being aware of their presence.

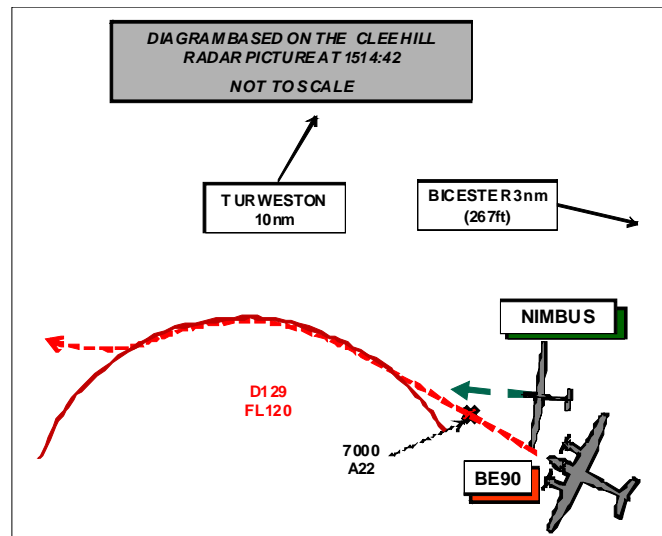
### AIRPROX REPORT NO 2011073

Date/Time: 10 Jul 2011 1515Z (Sunday)  
Position: 5155N 00111W (3nm WNW Bicester)  
Airspace: Oxford AIAA (Class: G)  
Reporting Ac Reported Ac  
Type: Nimbus 3 Glider BE90  
Operator: Civ Pte Civ Pte  
Alt/FL: 2500ft NR  
QNH (1011mb)  
Weather: VMC CLBC NR  
Visibility: 20nm NR  
Reported Separation:  
0ft V/50-100ft H 200ft V/1.5nm H  
Recorded Separation:  
NR

**THE NIMBUS 3 GLIDER PILOT** reports soaring in a white glider while listening out on a gliding frequency. While he was just to the N of D129, heading 270° at 55kt, a BE90 flying over the W edge of Bicester Town, overtook him very close to his L wing at the same height. [2nm SW of the centre of Bicester Glider Launch Site]. He first saw the BE90, which was brown with 'cheat' lines, 50-100ft away just behind his L wing tip and overtaking him, but it had passed before he had time to react.

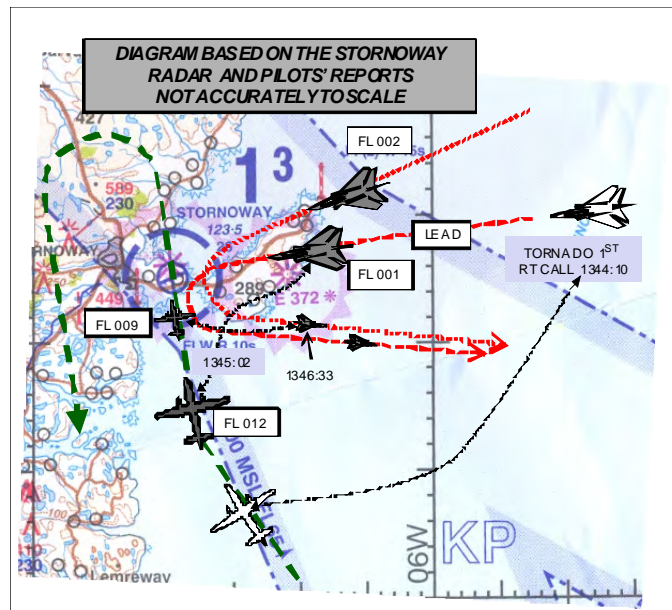
## AIRPROX REPORT NO 2011075

Date/Time: 12 Jul 2011 1346Z  
Position: 5810N 00610W  
(2.5nm S Stornoway - elev 26ft)  
Airspace: Scot FIR (Class: G)  
Reporting Ac Reported Ac  
Type: SF340B Tornado GR4  
Operator: CAT HQ Air (Ops)  
Alt/FL: 1100ft↓ 600ft  
QNH (1025mb) RPS (1018mb)  
Weather: VMC VMC  
Visibility: 60km 20km  
Reported Separation:  
0ft V/0.5nm H 1000ft V/1.5nm (Ld)  
0 V 1.5nm H (No2)  
Recorded Separation:  
300ft V / 1nm H

**THE SF340B PILOT** reports flying a scheduled passenger flight to Stornoway in receipt of a Procedural Service (PS) from Stornoway APP and squawking 7000 with Modes C and S; TCAS was fitted. While heading 360° at 130kt on the instrument approach, 4xTornado ac called ATC to say they were E of the airfield. ATC advised them that a SF340 ac was on a visual final approach to RW36 and to remain to the E. At 1100ft on the approach they saw 2 grey Tornado ac straight ahead and coming towards them. A few sec later they had a TCAS RA climb command quickly followed by a monitor vertical speed command; the Tornado was then seen to pull up and away from them aggressively but they informed ATC they were going around due to the TCAS commands. They climbed to 2000ft and elected to turn left downwind to try and remain visual with ac and as they approached late downwind position they then saw two black Hawk ac underneath them also manoeuvring aggressively so they advised ATC of the other ac; ATC was not aware that they were there. ATC advised them to continue downwind at 2000ft until advised, which they complied with.

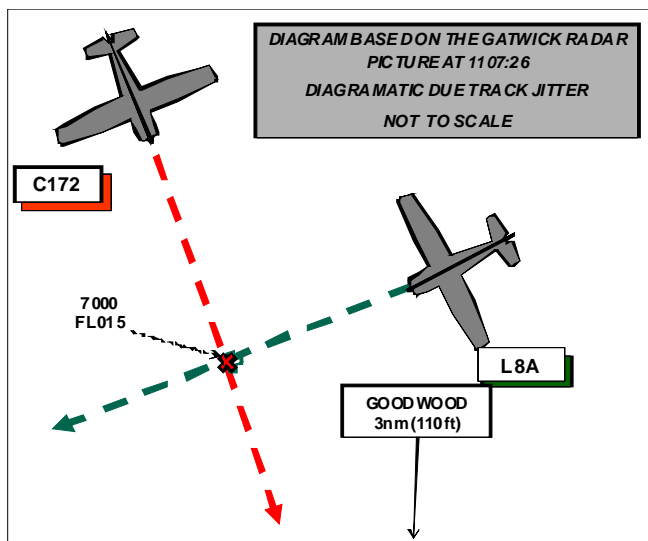
**AIRPROX REPORT NO 2011076**

Date/Time: 10 Jul 2011 11075Z (Sunday)  
Position: 5055N 00046W (3nm N Goodwood)  
Airspace: Lon FIR (Class: G)  
Reporting Ac Reported Ac  
Type: Luscombe 8A Cessna 172  
Operator: Civ Pte Civ Pte  
Alt/FL: 2000ft 1600ft↓  
 QNH (1018mb) QFE  
Weather: VMC CAVOK VMC NR  
Visibility: 35km >10km  
Reported Separation:  
 100ft V/200m H NR  
Recorded Separation:  
 NR V/0 H

**THE LUSCOMBE 8A PILOT** reports flying a pleasure flight, from a farm near Horsham to Sandown, I.O.W. in a white ac with a belly strobe switched on, in receipt of a BS from Farnborough radar (West) but no transponder was fitted. He was tracking about 250° at 90kt from Billingshurst and when he was between Cocking & Singleton (North East of Goodwood horse racing track) at 2000ft QNH, he looked to his right, through RH door window and saw an ac less than 200m away and slightly lower. He pulled back on the control stick but probably did not achieve much more separation before the ac crossed. The other ac which he thought might have been a white C152/172 with a dark blue stripe, continued on its track of about 160°. He thought that the ac might be Goodwood based and he did not see it until very late, as he it came from his rear RH quarter. He reported the incident to Farnborough after landing and assessed the risk as being high.

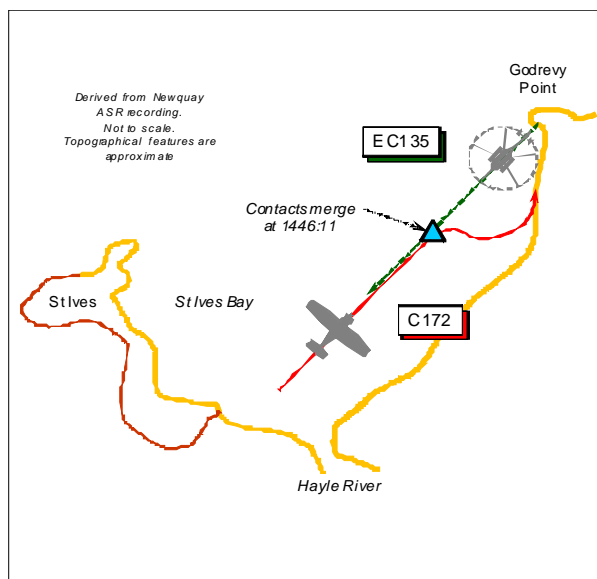
**AIRPROX REPORT NO 2011077**

Date/Time: 13 Jul 2011 1446Z  
Position: 5013N 00525W  
 (1¼nm SW of Godrevy Point)  
Airspace: London FIR (Class: G)  
Reporting Ac Reported Ac  
Type: EC135 C172  
Operator: Civ Comm Civ Trg  
Alt/FL: 1200ft 1000-1200ft  
 RPS (1018mb) (1022mb)  
Weather: VMC CLBC VMC NR  
Visibility: 10km >10k  
Reported Separation:  
 Nil V/50m H 0-50ft V  
Recorded Separation:  
 100ft V/contacts merged

**THE EUROCOPTER EC135 HELICOPTER PILOT** reports that he was in transit to Penzance, VFR and in receipt of a BS from Culdrose APP; a squawk of A0020 was selected with Modes C and S on. The helicopter is coloured yellow and red; the white HISLs and two landing lights were all on.

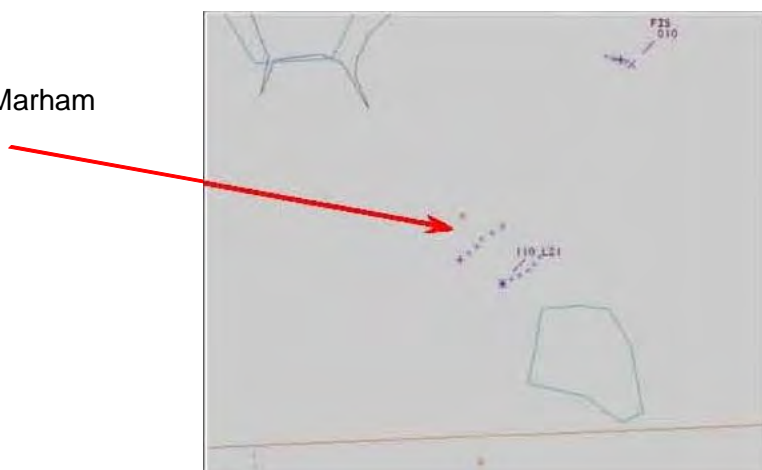
At 2144:42 LJAO EAST passed TI to what they believed to be Tornado (A), stating, "*traffic believed to be your number 1 west 1 mile tracking southwest no height information.*" Given this TI and subsequent events, LJAO EAST believed that Tornado (A) was the south-easterly of the two ac and the ac that had retained the SSR Mode 3A. In reality, as depicted in fig 1 below, Tornado (A) was the north-westerly PSR-only contact S of Marham, whilst Tornado (B) was the combined (SSR & PSR) contact SE of Marham. The TI issued was acknowledged by the crew of Tornado (A).

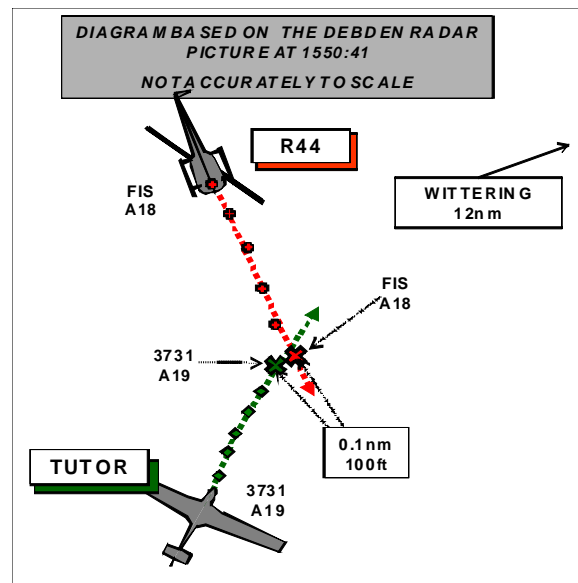
**THE TUTOR PILOT** reports that the Airprox occurred during a mixed profile pre Final Handling Test (FHT) sortie in a white ac with all external lights switched on. The student had successfully carried out a simulated Low-Level Abort and during the climb to above MSA he had obtained a TS from Wittering APP. At 3000ft on the RPS, heading N, squawking 3731 with Mode C, Wittering QFE (1009) was set and ATC instructed them to descend to 1600ft QFE. The radar headings kept them clear of Corby en-route for a PAR for Wittering RW08; ATC also provided regular TI which was all acknowledged. At 1600ft the pre-landing checks were completed and they were on a heading of 060° at 100kt, about 12nm WSW of Wittering (to the S of Eyebrook Reservoir) when ATC gave urgent TI on an unidentified ac, at a similar alt tracking SE, 2nm N of their position. Since the student was under an IF hood, he (the Instructor) took control in case evasive action was required. The Tutor's TAS indicated a target to the right of their track 100ft lower in white symbology. Bearing in mind recent history of the unreliability of TAS in azimuth, he carried out a full lookout scan which was impeded by the broad canopy structure, the student's helmet and the IF hood. ATC made further Traffic calls to the effect that targets were merging. Seconds later TAS changed to yellow symbology and announced "Traffic, Right, Low, 1 o'clock less than 1 mile". He caught a glimpse of a yellow helicopter 250m away, moving left to right, slightly lower and just appearing from behind the left-hand canopy arch so he immediately pulled up and rolled slightly to the left of the threat (the flaps were at take-off and the G meter indicated 2G post event). The helicopter was identified as a Robinson R44 and it did not appear to take any evasive action.

The poor view is well documented (by AAIB/RAF SI) and deficiencies in Tutor Canopy design (wide canopy arches) with added restrictions to right hand side caused by side by side seating, helmets and in this case student I/F visor were contributory factors as was Tutor visibility to others (White aircraft against Light Grey/white background); a Cranfield University report into Grob ac paint schemes detailed visibility issues. The R44 was working in the London FIR and took no avoiding action as it appears that the pilot did not see the Tutor throughout the incident.

Cause: A non-sighting by the R44 pilot and a late sighting by the Tutor instructor.

Despite degraded radar performance, TI updates were given by ATC and were accurate; however, had the Tutor been kept higher (2500 to 3000ft) until closer to the MATZ, the Airprox may have been avoided.

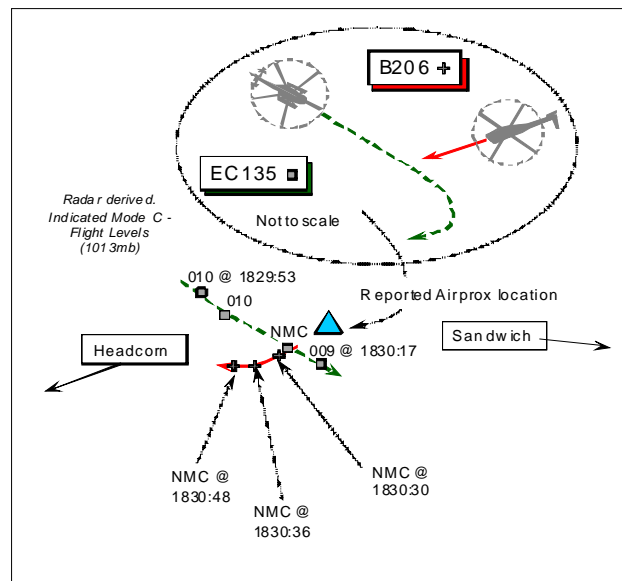
### AIRPROX REPORT NO 2011080

Over Ash village on a direct track from Whitstable to the Southern tip of Sandwich village, heading 120°, level at 1000ft Chatham RPS, and 130kt he observed a contact out to port in their 10 o'clock position after it had lifted out of Sandwich about 3nm away. The helicopter contact remained on a constant bearing and both he and his observer were monitoring it – a red and white Bell 206 JetRanger - for signs of the pilot having sighted their EC135 to starboard in his 1 o'clock. He expected the B206 pilot to turn at any moment, given the B206 pilot's obligation to take avoiding action to go behind his EC135 if seen, which he opined, given his helicopter's size, blue and yellow colour-scheme, lights and position in the other pilot's field of view, at most 50ft above the B206's altitude, should not have been difficult. Whilst working two frequencies, he was unsure which frequency the B206 pilot was using, or his callsign, as there appeared to be two ac talking to Sandwich RADIO, which he had expected to be busy. As the B206 closed to a range of about 400-500m, it appeared that the pilot had not seen his EC135 so he elected to take his own avoiding action by turning to the R and diving ahead of the B206. Minimum separation was about 20ft vertically and 400m horizontally and after he crossed ahead of the B206, he turned back towards it. Now off its port quarter, they used his helicopter's camera to view the B206's registration - which was given. He assessed the Risk as 'high'. He stated that he called Sandwich RADIO to ask if they knew the B206's registration, but they were only aware of company callsigns. Nav lights, strobes & white HISLs were on.

The ATSI report shows that the Manston controller had issued TI about the EC135 to the B206 pilot, who advised he was looking for the other helicopter thereby confirming that the B206 was definitely aware that the EC135 was in the vicinity. Whilst it was unclear if the EC135 pilot had received the TI about the B206, because there was no reply to the controller's transmission recorded, with the advantage of looking down sun in CAVOK conditions he was able to spot the B206 3nm away and recognise the potential for a conflict.

Cause: A conflict in Class G airspace resolved by the EC135 pilot.

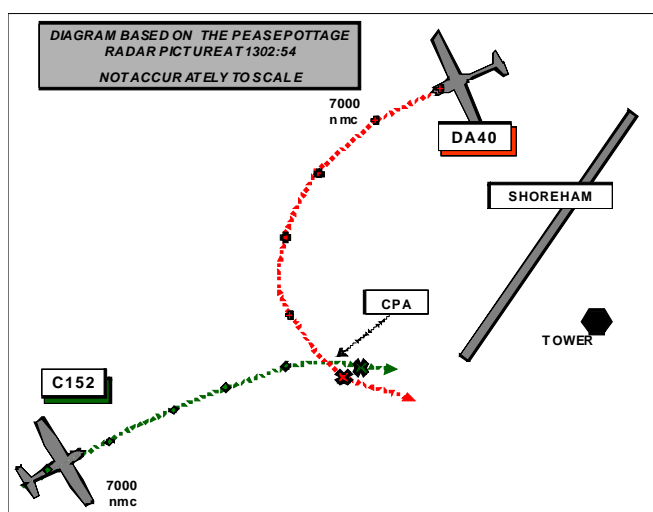
**AIRPROX REPORT NO 2011081**

**THE C152 PILOT** reports flying a VFR dual training flight with the student as HP in a white ac with the anti-collision light switched on, at the time in receipt of a BS from Shoreham APP, squawking 7000 but Mode C was not fitted. They were heading 110° at 90kt to join the cct for RW20 (L hand) having been instructed to join crosswind at cct height. When approaching crosswind (0.3 DME) he noticed an ac 100m away, turning towards them and descending from the overhead; its pilot then called 'descending dead side' and ATC replied that they should not have descended because they were told to report overhead. (The ac had not been cleared to descend). The ac then appeared in a position some 200ft vertically and at a similar distance horizontally, in his 10 o'clock position so the instructor took control and initiated immediate avoiding action by diving, as the other pilot had clearly not seen them.

Cause: The DA40 pilot did not follow the Shoreham joining procedure and descended into conflict with the C152, which he did not see.

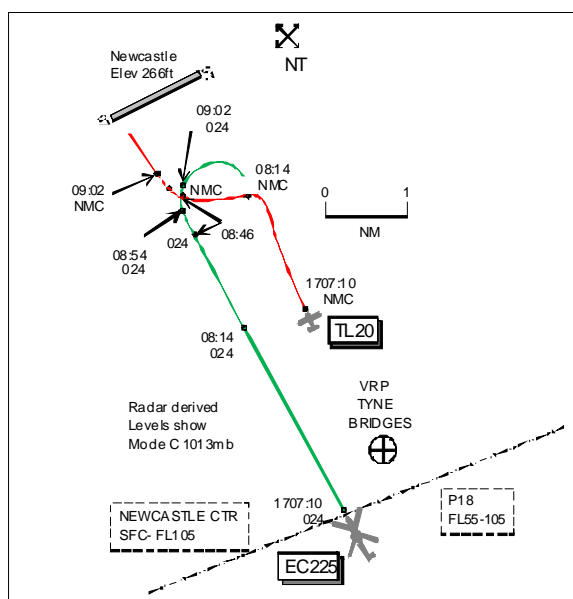
**AIRPROX REPORT NO 2011082**

**THE EC225 PILOT** reports en-route to Aberdeen, VFR and in receipt of a RCS from Newcastle Approach on 124.375MHz squawking an assigned code with Modes S and C; TCAS was not fitted. The visibility was >10km flying 5000ft below cloud in VMC and the helicopter was green/yellow in colour; no lighting was mentioned. The helicopter was on a ferry flight from France with 2 pilots and 2 engineers on board. The crew had started work at 0745 UK local time and had accumulated 7hr flight time at the time of the Airprox so they were approaching fatigue. As the EC225 is certified for single pilot VFR the co-pilot had moved to the cabin for a rest and his seat was occupied by one of the engineers. Initially they were under a TS from Newcastle at 2500ft QNH before requesting transit of the Class D CTR. Initially their clearance limit was the 'Bridges' VRP but prior to arrival at this point the controller issued transit clearance via the RW07 threshold at 2500ft. On entering CAS the controller advised "RCS" which he acknowledged. He set the 07 threshold into the FMS and routed towards that point. Around this time he became aware of a light ac that had similarly requested to cross Class D and the flight was given a similar routeing i.e. cross O/H threshold 07. He couldn't remember if ATC specifically gave him TI, he thought they did, but only to the extent that there was another ac routeing to the same point. This other flight was a "not above 2500ft" clearance and he heard its pilot state he was at 2300ft. He was not aware of its inbound or outbound track but he was comfortable that with good VMC and in receipt of a RCS he was being looked after and didn't have too much to worry about. He couldn't see the other ac and it soon became apparent why, when ATC restated to the other pilot that the crossing point was the 07 threshold then shortly after informed the other pilot that his ac was heading for the wrong threshold (25). The other pilot apologised and said he would route to the correct threshold. Alarm bells started ringing and he asked ATC for climb to 3000ft but this was refused and he was instructed to remain at 2500ft. The frequency was very quiet and he was not aware of any other traffic on frequency though he didn't have the 'big picture'. Heading 340° at 155kt he then saw the other ac visually in his 2 o'clock. Being a small light ac it was probably by then only a little over 1nm away, that being realistically the maximum distance a light ac can be seen even in good conditions. Its relative bearing was changing so he was not overly worried but was keeping a continuous watch on it. He would have preferred to change heading to increase separation but since he was only about 0.5nm from the threshold to do so would mean he would not comply with his clearance. He determined the other ac's heading was roughly 90° to his and somewhere around this time ATC offered that he could make 1 orbit to the R if needed. Since there seemed at this time no risk of getting uncomfortably close and by making an orbit he would have lost sight of the traffic he declined. What happened next, with hindsight, was predictable. On reaching his 12 o'clock about 500m ahead the other ac banked sharply to the R (probably 45°) and was suddenly in his 12 o'clock a few hundred metres ahead and 200ft below on the same heading. At his cruising speed he was going much faster than the other ac and closing rapidly. He took evasive action by banking 30° to the R and made an orbit and having done so he could not see the other ac so he continued to O/H the 07 threshold, as instructed, and then on track SAB. He spotted the other ac a minute or two later as it was

Cause: A conflict resulting from a misunderstanding by the EC225 pilot about the rules for VFR traffic in Class D airspace.

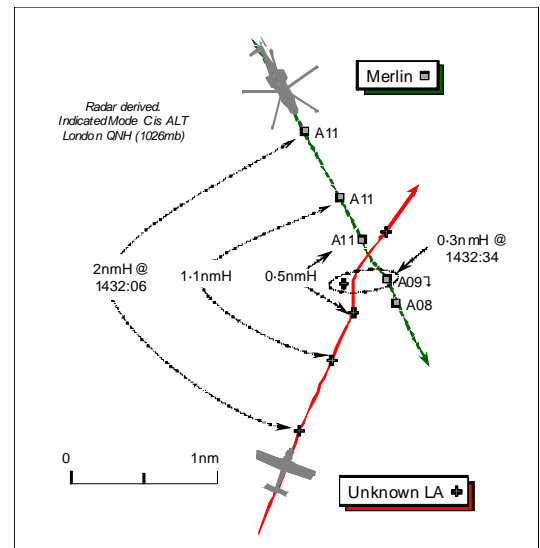
**AIRPROX REPORT NO 2011083**

Because the LA was in a high AoB turn when first seen by the Merlin pilot, it seems that the LA pilot might have spotted the large Merlin helicopter slightly earlier and was already effecting his own avoiding action turn to the L. Whilst the Board was unable to draw definite conclusions on this aspect, the robust nature of the LA's turn, which is evident on the radar recording, suggests that this was, in all probability, also a late sighting by its pilot. In the absence of an account from the LA pilot, the Board could only conclude that the Cause of the Airprox was a late sighting by the Merlin crew and probably a late sighting by the untraced LA pilot.

Cause: A late sighting by the Merlin crew and probably a late sighting by the untraced LA pilot.

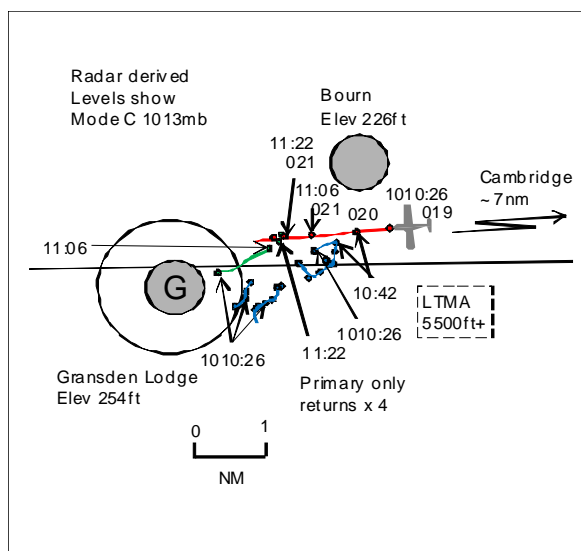
**AIRPROX REPORT NO 2011084**

**THE ASW27B PILOT** reports, 3 weeks post incident, flying a cross-country flight from Gransden Lodge and in communication with Gransden Lodge Radio on 131.275MHz. She was thermalling, banked to R about 5km SE of Bourn airfield [actually SW], at about 3000ft Gransden Lodge QFE in a bid to climb to cloudbase which was around 4000ft. The visibility was 15km in VMC and the ac was coloured white. Turning through heading 045° at 65kt she suddenly saw a red/white single-engine ac heading SW from the direction of Cambridge and then changing course to a more W'ly direction at approximately the same height. She banked sharply L and flew towards Bourn airfield and observed the ac pass about 300m to her R and 200ft below where she had been thermalling. She believed the other ac's pilot had not seen her glider. She assessed the risk as medium. There were a number of gliders in the same area as it was a good gliding day.

Cause: A conflict in Class G airspace resolved by the ASW27B pilot.

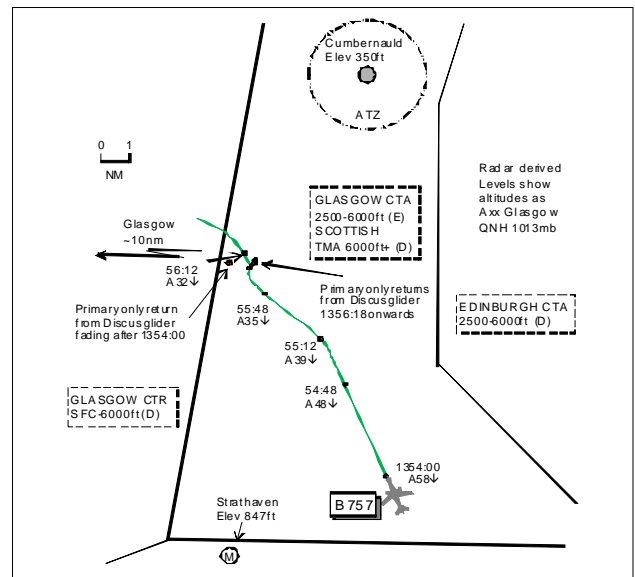
**AIRPROX REPORT NO 2011085**

**THE B757 PILOT** reports inbound to Glasgow IFR and in receipt of a RCS from Glasgow Approach on 128.75MHz, squawking 2746 with Modes S and C. They were operating in excellent visibility below scattered cloud and had requested and received clearance for a visual approach but not to descend below 3000ft. Radar had advised that a primary return had been seen in the area previously but had now disappeared, having believed that the ac had descended below radar cover. About 12nm SE Glasgow heading 300° at 230kt, level at 3000ft, he thought, he saw a glider directly ahead range 1.5nm and at the same level. The A/P was disconnected and a R turn was commenced. The glider appeared to fly straight and level in the opposite direction passing 100m to their L at the CPA. ATC was informed and the approach was continued normally. He assessed the risk as high.

Cause: A conflict between IFR and VFR traffic in Class E airspace, resolved by the B757 crew.

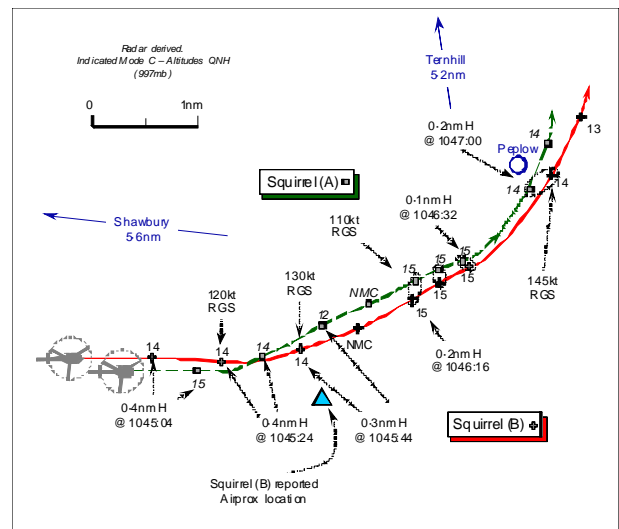
**AIRPROX REPORT NO 2011086**

**THE PILOT OF EUROCOPTER SQUIRREL HT1 HELICOPTER (A)**, a QHI, reports that he was in transit VFR at 1200ft QFE (985mb), on an instructional sortie from Shawbury to Ternhill. As the PIC he was in the LH seat, with the student in the RH seat; they were in receipt of a BS from Ternhill TOWER on 376.400MHz. A squawk of A0221 was selected with Mode C; neither TCAS nor Mode S are fitted. The helicopter has a black fuselage with yellow engine cowlings; white upper and lower strobes, landing lamps and the nav lights were all on.

**HQ AIR (TRG)** comments that the overtake manoeuvre was flown close enough to cause concern to the pilot of Squirrel (A). The radar trace does not accord with the statement that the overtake was flown on opening headings so the situational awareness of Squirrel (B) must be in doubt. This highlights the need to afford ample lateral separation when overtaking a non-cooperating aircraft, which may still manoeuvre unpredictably.

Cause: Squirrel (B) crew flew close enough to cause Squirrel (A) crew concern.

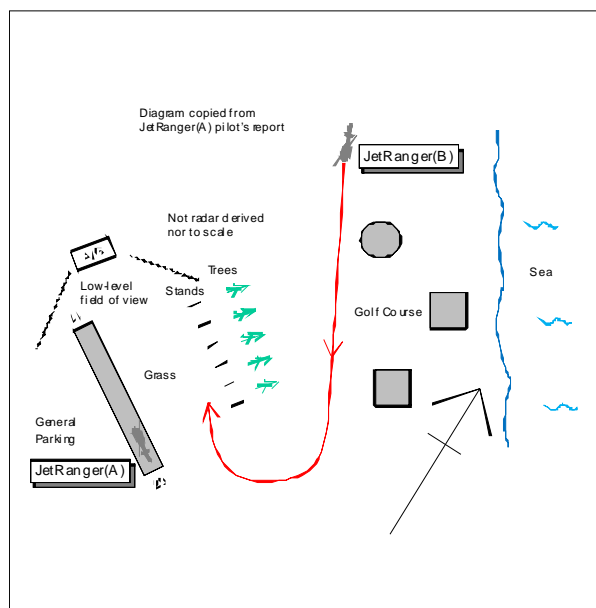
The converging nature of the downwind leg caused by the need to not overfly the adjacent seaward golf course meant base leg was probably no more than 200m long. This funnelling effect definitely was a contributory factor. There was no question of fatigue or either pilot being inexperienced/low hours or any haphazard behaviour. A lesson had been learnt but he was unsure how it would best be disseminated to other company pilots.

Cause: Bell 206 JetRanger(B) pilot flew close enough to cause Bell 206 JetRanger(A) pilot concern.

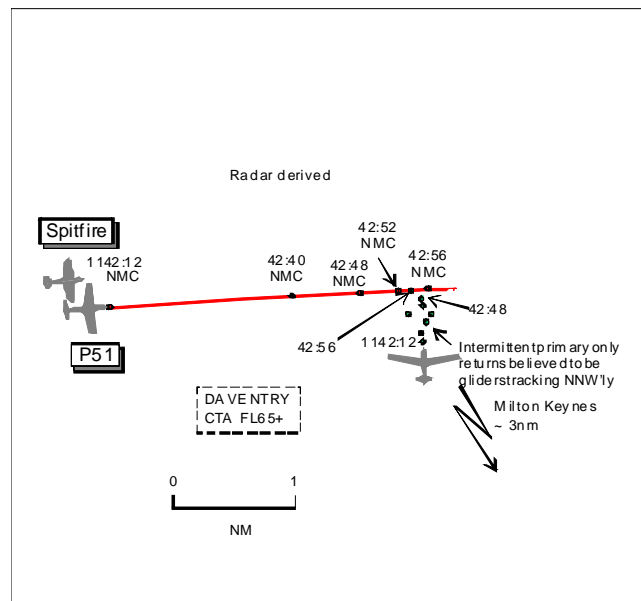
## AIRPROX REPORT NO 2011088

**THE DISCUS B PILOT** reports thermalling with 2 other gliders 4nm W of Cranfield at 2500ft agl and not in communication with any ATSU. The visibility was >40km flying clear below cloud in VMC and the ac was coloured white; no lighting was fitted. The ASK21 glider in front turned N and a glider behind his ac turned W. He followed the ASK21 approximately 600ft behind, 200ft to its R and 400ft below. About 3nm N of Newport Pagnell whilst OH the M1 heading 330° at 60kt he noticed a movement to his L 9 o'clock and slightly low. He looked just in time to see a P51 Mustang, coloured dark gloss green on the upper surfaces, about 100ft away and 50ft or less below which was in formation with a Spitfire, coloured glossy 2-tone grey, positioned to the Mustang's L and slightly behind. He only had a brief second or less to violently pull-up, his glider's nose was just beginning to lift as the pair passed underneath diverging in his 3 o'clock. He assessed the risk as high.

Cause: The P-51 and Spitfire flew close enough to cause the Discus pilot concern.

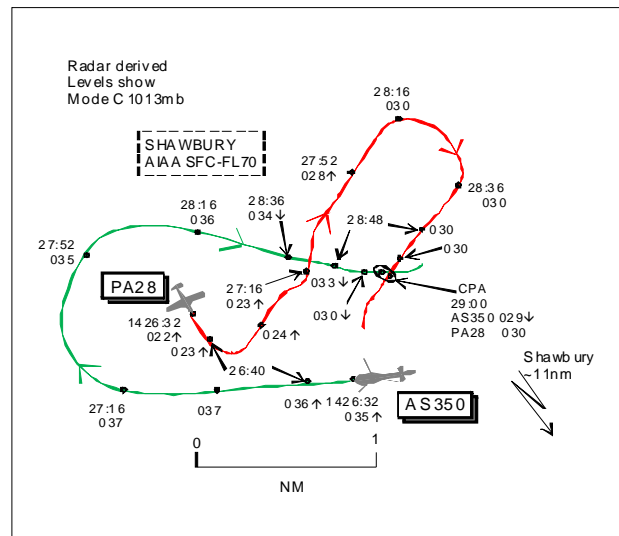
**THE AS350 PILOT** reports flying a dual Instrument Flying (IF) test from Shawbury in IF Box A and in receipt of a TS from Shawbury Approach on Stud 10, squawking 0233 with Mode C. The visibility was 10km clear of cloud in VMC and the helicopter was coloured black/yellow with HISLs, landing and position lights all switched on. The student was directed to carry out a PFL (autorotation) which was initiated at 3500ft RPS. They had been advised that a fixed-wing ac was in the vicinity and he, the QHI, was responsible for lookout and was seeking to establish visual contact. Heading 100° at 65kt descending through 2800ft RPS he spotted the fixed-wing ac in his 10 o'clock, slightly low and close. He took control and initiated avoiding action by turning L onto 070° and the fixed-wing ac, coloured white/orange/brown, was then seen to pass down their RHS by 100m at the same level. The fixed-wing ac's attitude was wings level suggesting they had not seen his helicopter. He assessed the risk as very high.

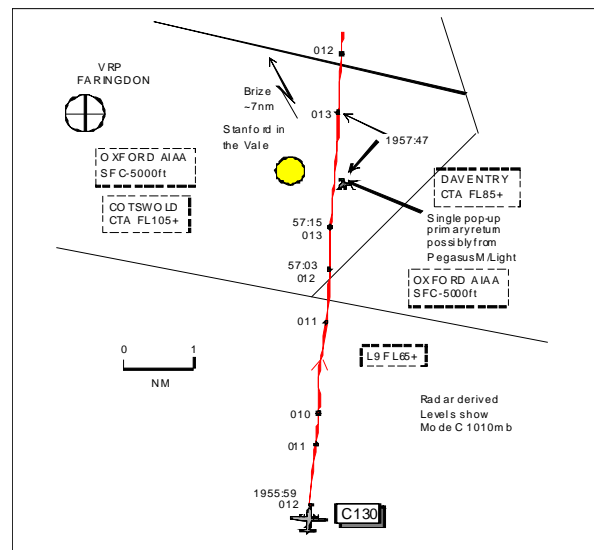
## AIRPROX REPORT NO 2011091

**THE PEGASUS M/LIGHT PILOT** reports flying a local sortie non-radio from a private site near Swindon, VFR. The visibility was 50km in VMC and the ac was coloured black/green/white and no lighting was fitted. Passing E abeam Stanford in the Vale [7.5nm SSE Brize] heading 340° at 45kt level 1200ft QNH 1010mb he was overtaken from behind and directly above, by 30ft, by a C130. The event happened too quickly to take any avoiding action and he assessed the risk a high.

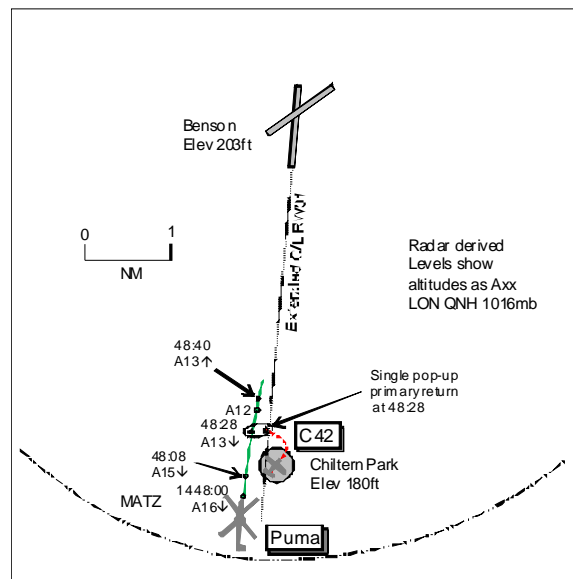
The Ikarus pilot reported that they departed RW04 at Chiltern Park, before turning cross-wind onto a heading of 310°, maintaining a climb, and rolling wings level. It was at that point that “the helicopter was immediately revealed.”

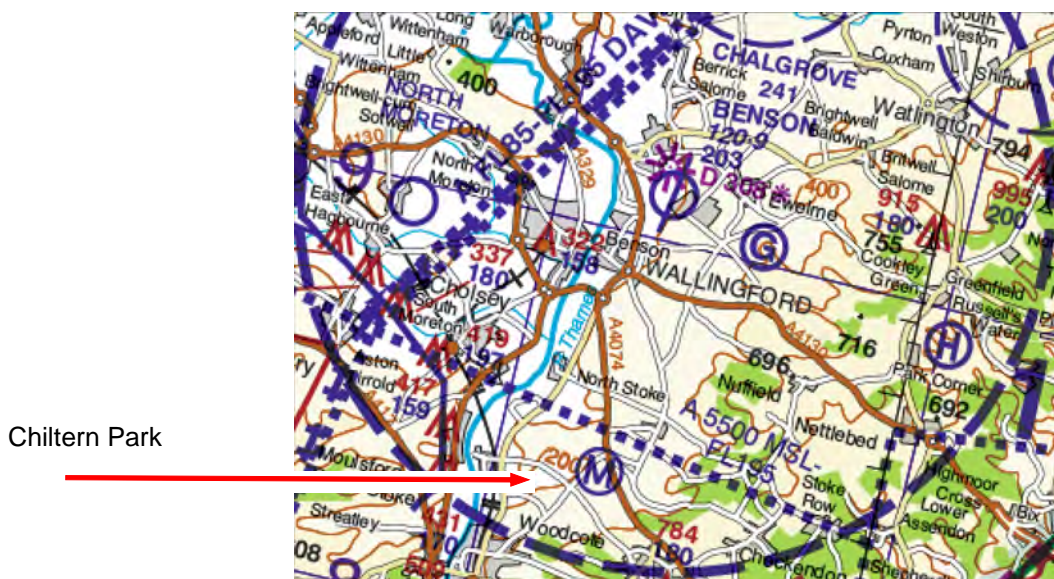
**Figure 1: RAF Benson Local Area**

Chiltern Park is situated 3.5nm S of RAF Benson and slightly to the E of the extended C/L to RW01 RH (see Figure 1 below), with a visual cct height of 700ft QFE. Published within the AIP as a microlight site, there is no avoidance criteria associated with the site. Chiltern Park and RAF Benson are signatories to a LoA which states that ac wishing to depart above the Chiltern Park cct height of 700ft are advised to contact Benson Zone prior to leaving the cct; it is not a mandatory requirement. The Ikarus flight did not contact Zone in this instance. In the Ikarus pilot’s written report, he stated that the Airprox occurred at 800ft QNH, whereas during their later report of the Airprox to Zone on frequency at 1452:23, he stated that they “*we’re climbing through approximately a thousand or ish seven hundred feet QNH.*”

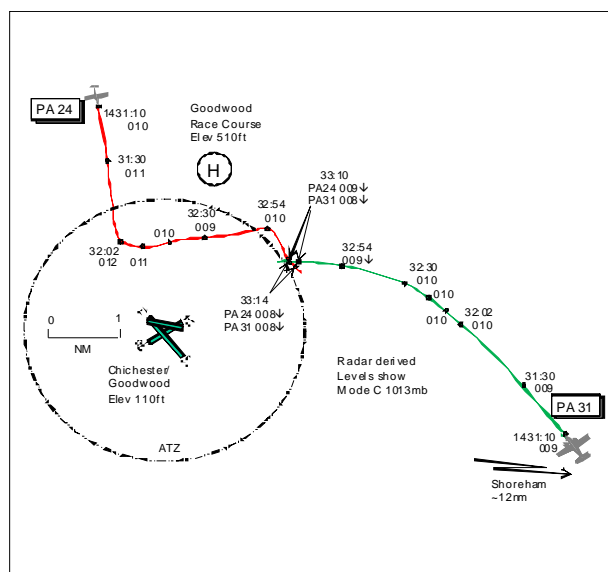
**AIRPROX REPORT NO 2011093**

**THE PA31 PILOT** reports inbound to Chichester/Goodwood VFR and in receipt of a BS from Goodwood Information on 122.45MHz, squawking 7000 with Modes S and C. The visibility was 10km in VMC and the ac was coloured white/red; no lighting was mentioned. On approaching Goodwood from the ESE he was advised that RW24 was in use and that 3 ac were in the cct. He elected to join for a straight-in approach while listening to other traffic position reports and adjusting his speed accordingly. ATC advised him to join at 4nm and on reporting at 4nm he was asked to report at 2nm. The only traffic when calling at 4nm was on short final and sufficient space was available for his approach. At 2nm heading 240° at 110kt descending through 1000ft QNH 1022mb an ac appeared in his windscreen in his 2 o'clock range 30-40m and 50ft above passing from R to L just in front. He took avoiding action by increasing his ROD and reported the 'near miss' to Goodwood Information with the other ac's registration, possibly a PA28 type. He initially stated separation was 100ft but he was a little shocked and later thought it was definitely a lot closer. The other ac's pilot, when asked by ATC, confirmed that it was his ac that had flown in front of his PA31. He had not heard any radio calls from this flight stating its position or intentions prior to the 'near-miss'. He assessed the risk as high. He believed the other ac's pilot showed poor airmanship by not communicating his position and intentions to ATC, by flying across the FAT of a busy active RW at cct height, by showing a total disregard for the safety of his PA31 and that of others and dismissing the seriousness of the situation with no apology or offer of discussing the incident. He felt the other pilot will cause a similar situation in the future as he showed poor airmanship, poor judgement and dangerous flying.

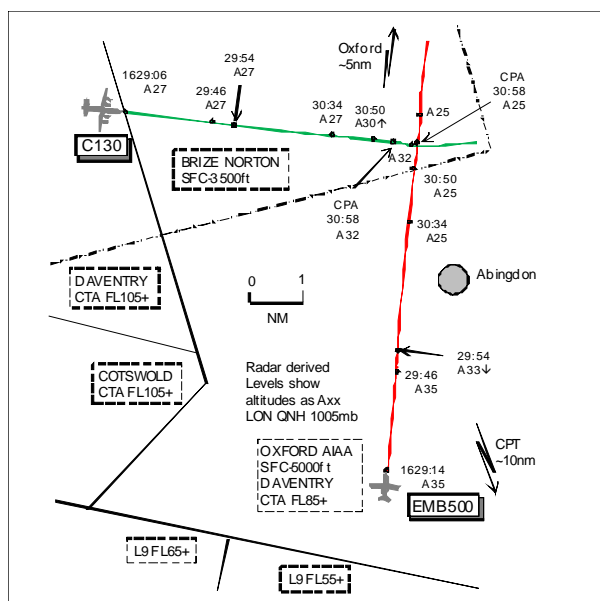
**AIRPROX REPORT NO 2011095**

**THE C130 PILOT** reports flying a local CT sortie from Brize Norton, IFR and in receipt of a TS from Brize on 124-275MHz, squawking an assigned code with Modes S and C. The flight was IMC approaching the end of the outbound leg of a TACAN procedure heading 100° at 170kt and level at 2500ft QFE 994mb. At BZN 100R 9D, just prior to commencing the inbound turn and associated descent, a TCAS contact appeared on their display at the same height approximately 1nm in front. The controller initiated avoiding action by vectoring the flight to the N at the same time as a TCAS RA climb was commanded. The RA was followed, the climb initiated without changing heading, during which time the ac broke cloud and they became visual with the conflicting ac, a low-wing twin engine type possibly a BE200 or similar type, which was crossing from R to L 0.5nm ahead and just below. The controller subsequently provided vectors to enable the flight to resume the procedure and the sortie was continued without further incident.

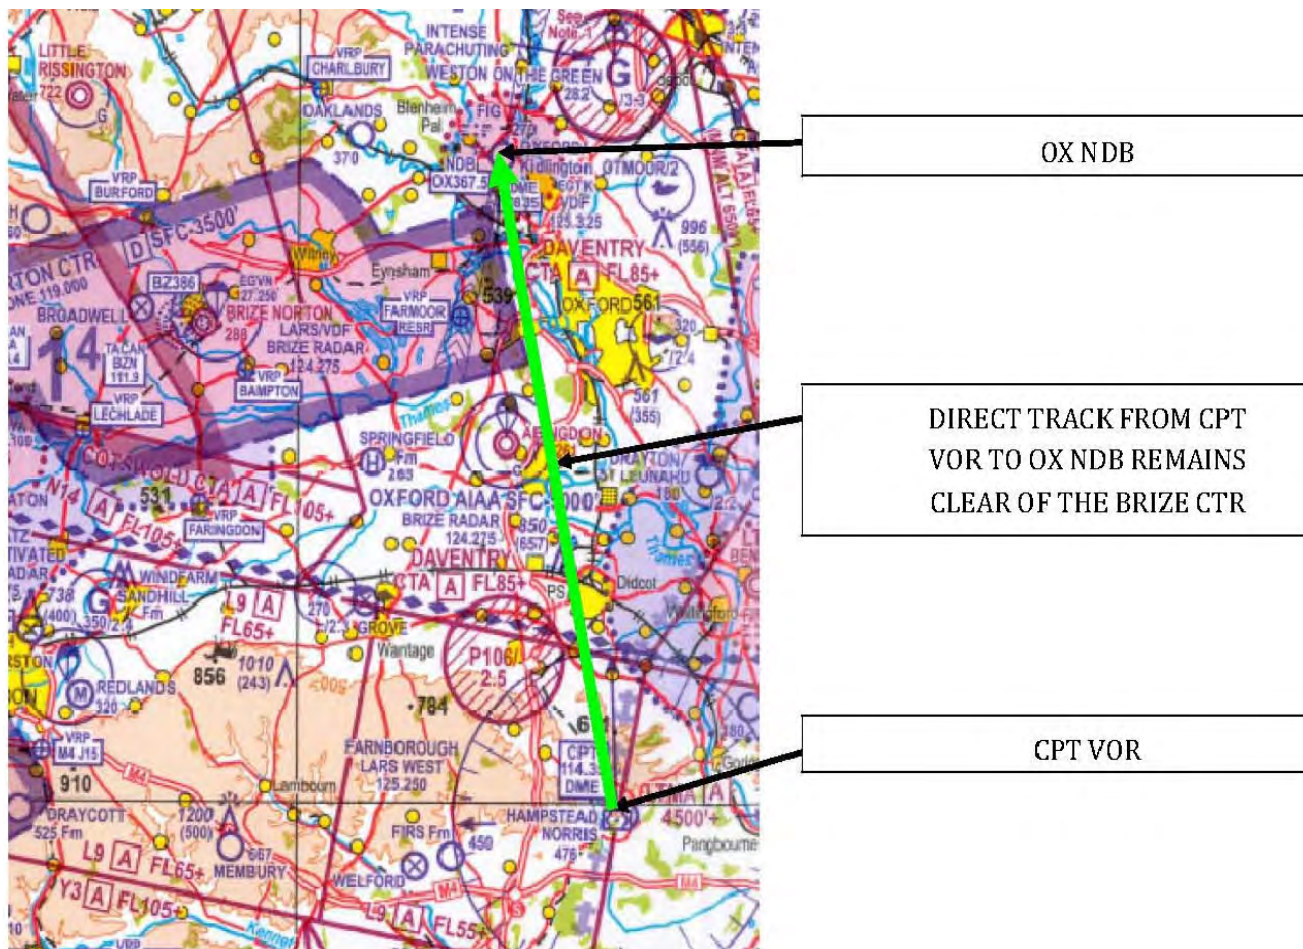
## AIRPROX REPORT No 2011095

The timing of the release is important to this investigation since the direct track from the CPT VOR to the OX NDB ensures that the ac remains clear to the E of the Brize Norton CTR. If the turn towards the OX NDB is delayed to any degree and the ac passes the CPT VOR to the W then the direct track towards the OX NDB will overfly the Brize Norton CTR and any descent below 3500ft amsl on track to the OX NDB will require a clearance to enter the Brize Norton CTR.

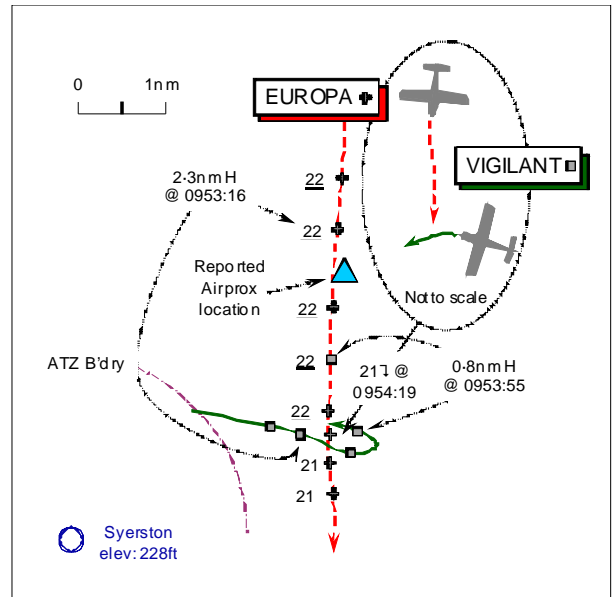
**AIRPROX REPORT NO 2011096**

Date/Time: 26 Jul 2011 0954Z  
Position: 5303N 00050W  
 (3nm ENE of Syerston - elev 228ft)  
Airspace: Lincolnshire AIAA (Class: G)  
Reporting Ac Reported Ac  
Type: Vigilant MG Europa  
Operator: HQ Air (Trg) Civ Pte  
Alt/FL: 2000ft 2300ft  
 QFE (1008mb) QNH (1016mb)  
Weather: VMC CLBC VMC CLBC  
Visibility: 30km >10km  
Reported Separation:  
 50ft V/50m H 50ft V/50m H  
Recorded Separation:  
 Not recorded

Cause: Late sightings by both pilots.

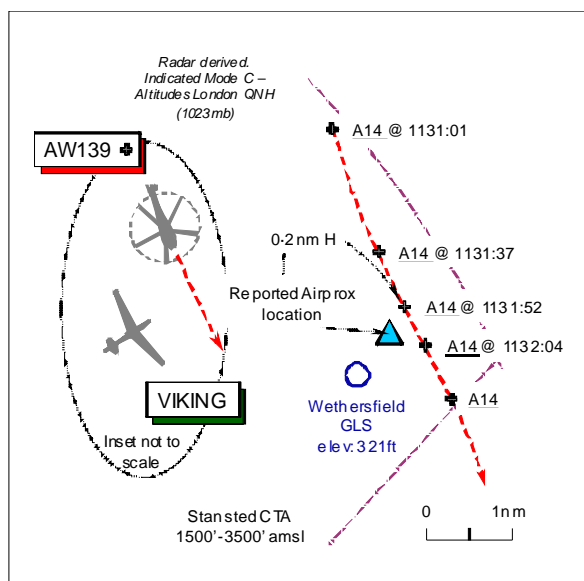
**AIRPROX REPORT NO 2011098**

Date/Time: 29 Jul 2011 1131Z  
Position: 5158N 00031E  
 (0.75nm NE of Wethersfield GLS)  
Airspace: London FIR (Class: G)  
Reporting Ac Reported Ac  
Type: Viking Glider AW 139  
Operator: HQ Air (Trg) Civ Exec  
Alt/FL: 950ft↓ 1400ft  
 QFE QNH (1023mb)  
Weather: VMC CLBC VMC NR  
Visibility: 10km 8km  
Reported Separation:  
 <100ft V/<100m H 200ft V/500m H  
Recorded Separation:  
 Not recorded - see Note (1)

Cause: A Conflict in the vicinity of a promulgated and active glider launching site resolved by the Viking pilot.

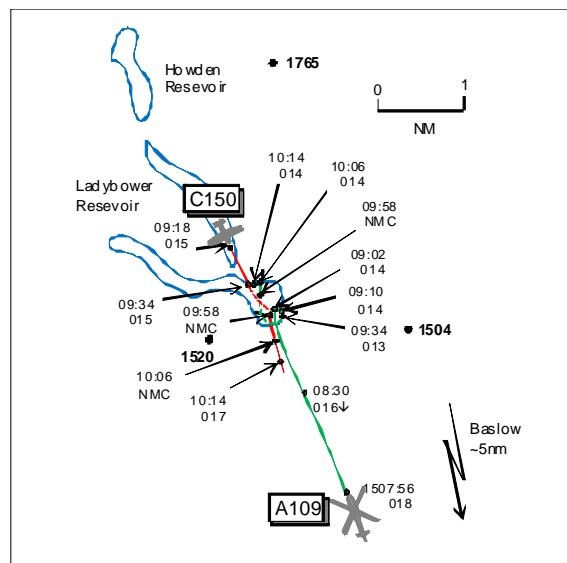
**AIRPROX REPORT NO 2011099**

Date/Time: 5 Aug 2011 1510Z  
Position: 5322N 00142W (9nm W Sheffield)  
Airspace: LFIR (Class: G)  
Reporting Ac Reported Ac  
Type: A109 C150  
Operator: Civ Comm Civ Pte  
Alt/FL: 1700ft↓ 700-1000ft  
 QNH (1010mb) RPS  
Weather: VMC CLBC VMC CLNC  
Visibility: 40nm >10km  
Reported Separation:  
 75ft V/100m H NR  
Recorded Separation:  
 NR

Cause: Conflict in Class G airspace.

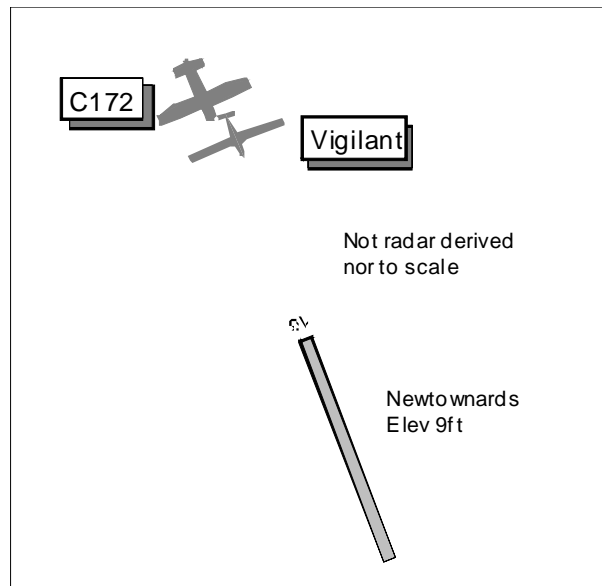
### AIRPROX REPORT NO 2011102

Date/Time: 30 Jul 2011 1545Z (Saturday)  
Position: 5436N 00542W (0.5nm FIN  
APP RW16 Newtownards - elev 9ft)  
Airspace: ATZ (Class: G)  
Reporting Ac Reported Ac  
Type: Vigilant C172  
Operator: HQ Air (Trg) Civ Pte  
Alt/FL: 150ft↓ 300ft↓  
QFE (1020mb) QNH  
Weather: VMC CLBC VMC CAVOK  
Visibility: 5000m 10km  
Reported Separation:  
20ft V/10ft H 25ft slant  
Recorded Separation:  
NR

Cause: The C172 pilot flew into conflict with the Vigilant on final approach.

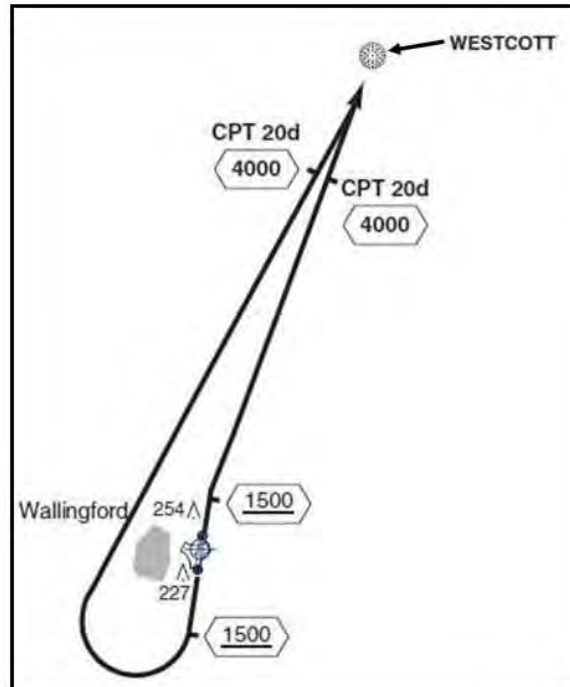
Figure 1. NE SID Benson

The NE SID RW19 procedure requires a climb on RW track (189° M), calling approach by 1000ft; on passing 1500ft (QFE) turn R to WCO, continuing climb to 4000ft (illustrated at Figure 1).

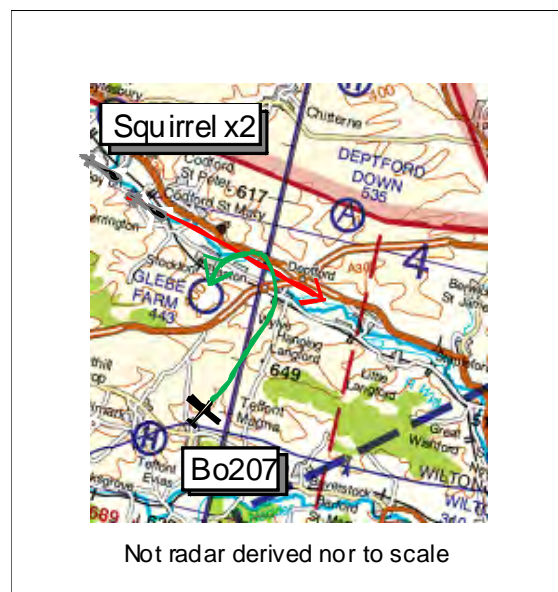
**AIRPROX REPORT NO 2011104**

Date/Time: 2 Aug 2011 1001Z  
Position: 5108N 00201W  
 (10nm W Boscombe Down)  
Airspace: LFIR/LFA1 (Class: G)  
Reporting Ac Reported Ac  
Type: Bolkow Bo207 Squirrel x 2  
Operator: Civ Pte AAC  
Alt/FL: 150ft↓ 100ft  
 aal agl  
Weather: VMC CLOC VMC CLBC  
Visibility: >10km 30km  
Reported Separation:  
 50-100ft V 800m H  
Recorded Separation:  
 NR

Cause: The Squirrel flight flew close enough to cause the Bo207 pilot concern.

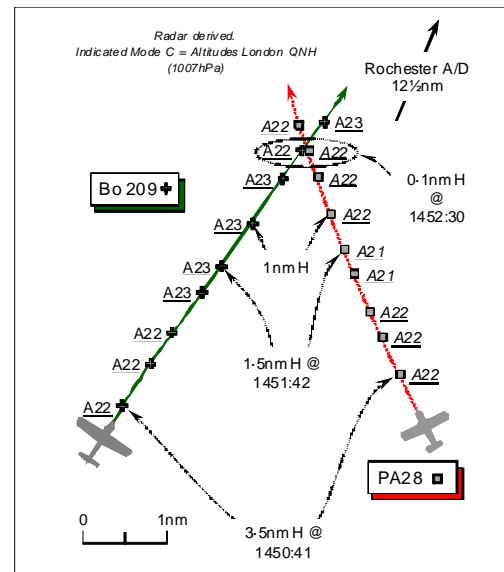
### AIRPROX REPORT NO 2011105

Date/Time: 14 Aug 2011 1452Z (Sunday)  
Position: 5111N 00018E  
(12½nm SW of Rochester A/D)  
Airspace: London FIR (Class: G)  
Reporting Ac Reported Ac  
Type: Bolkow 209 PA28  
Operator: Civ Pte Civ Trg  
Alt/FL: 2300ft 2200ft  
QNH (1008hPa) QNH (1007hPa)  
Weather: VMC No Cloud NR  
Visibility: 20km+ NR  
Reported Separation:  
10ft V/100m H NR  
Recorded Separation:  
<0.1nm H

Cause: Effectively, a non-sighting by the Bo209 pilot and possibly a late sighting by the PA28 pilot.

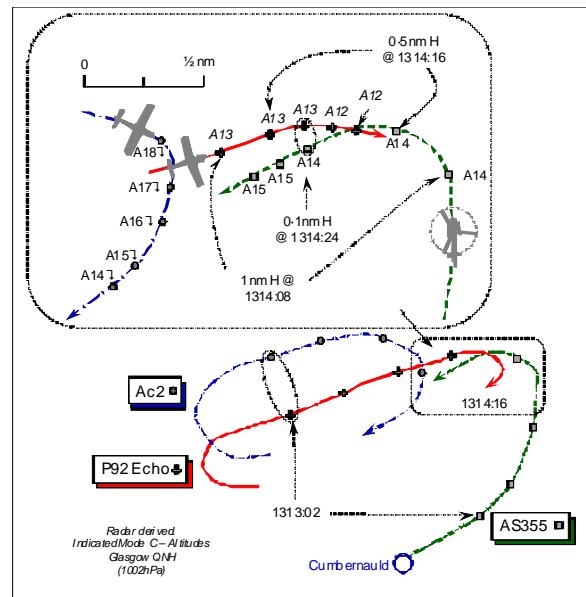
### AIRPROX REPORT NO 2011106

Date/Time: 6 Aug 2011 1314Z (Saturday)  
Position: 5600N 00357W (2.3nm  
NNE of Cumbernauld A/D - elev 350ft)  
Airspace: FIR/ATZ (Class: G)  
Reporting Ac Reported Ac  
Type: AS355 Tecnam P92  
Operator: Civ Trg Civ Pte  
Alt/FL: 1000ft 950ft  
QFE QFE  
Weather: VMC NK VMC CLOC  
Visibility: 10km 10km  
Reported Separation:  
100ft V/nil H Not seen  
Recorded Separation:  
100ft V/0.1nm H

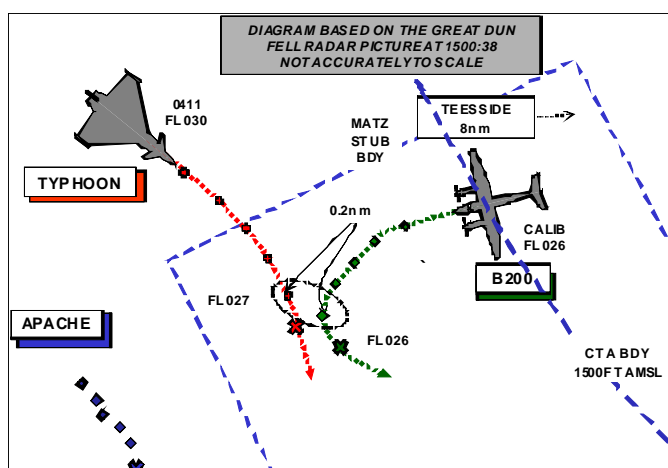
**AIRPROX REPORT NO 2011109**

Date/Time: 24 Aug 2011 1501Z  
Position: 5425N 00138W (9nm Final 05  
Durham Tees Valley- elev 120ft)  
Airspace: Leeming MATZ (Class: G)  
Reporting Ac Reported Ac  
Type: BE200 Typhoon  
Operator: Civ Comm HQ Air (Ops)  
Alt/FL: 2500ft NK  
QNH (1009mb) NK  
Weather: VMC CLBC VMC CLBC  
Visibility: 8nm 30km  
Reported Separation:  
0ft V/2-300m H  
200ft V 0.25nm H  
Recorded Separation:  
100ft V/0.2nm H

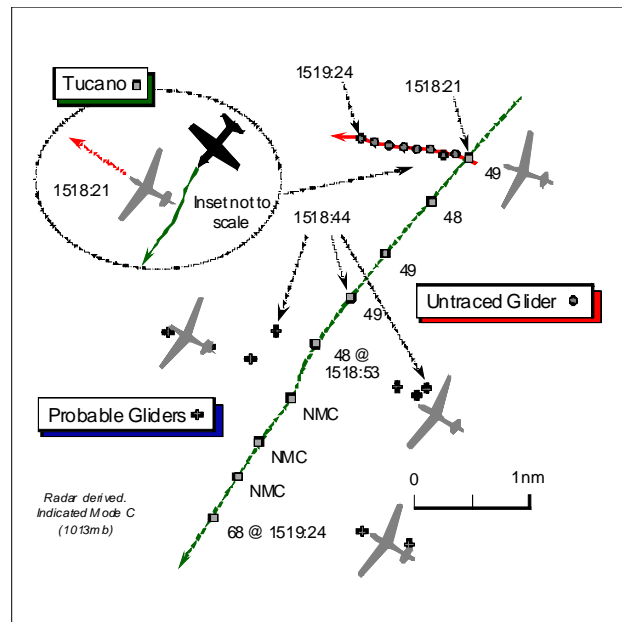
## AIRPROX REPORT NO 2011110

Date/Time: 22 Aug 2011 1518Z  
Position: 5410N 00059W  
(12nm NE Linton-On-Ouse - elev 53ft)  
Airspace: Vale of York AIAA (Class: G)  
Reporting Ac Reported Ac  
Type: Tucano T Mk1 Untraced Glider  
Operator: HQ Air (Trg) NK  
Alt/FL: 5000ft NK  
QFE (1017hPa) NK  
Weather: VMC CLOC NK  
Visibility: 40km NK  
Reported Separation:  
Nil V/50yd H NK  
Recorded Separation:  
Not recorded
