**UK AIRPROX BOARD**

# **Analysis of Airprox in UK Airspace**

**Report Number 27  
July 2011 – December 2011**

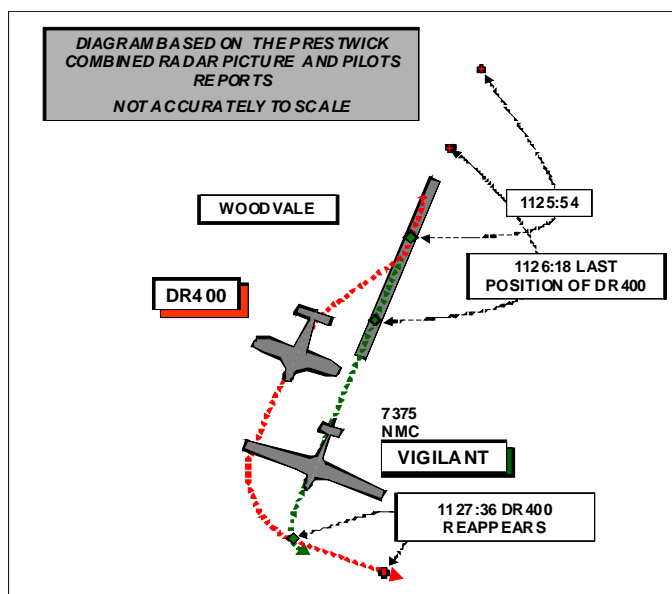
Cause: The DR400 pilot flew close enough to cause the Vigilant instructor concern.

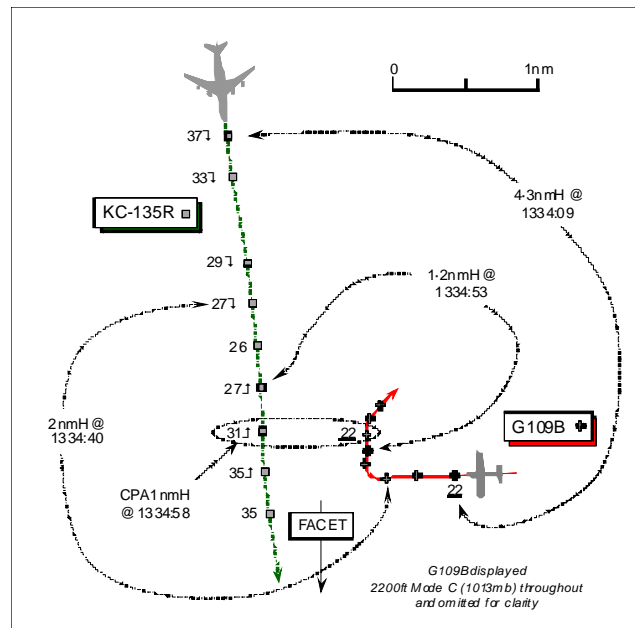
Cause: A conflict in Class G airspace resolved by the Grob G109B pilot.

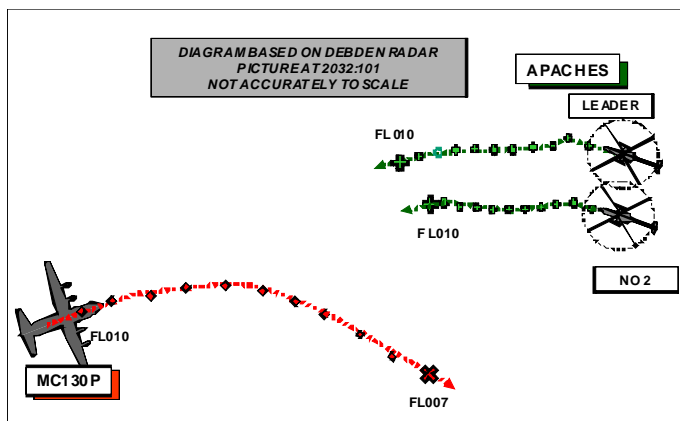
**AIRPROX REPORT NO 2011114**

The unit conducted an internal investigation of the incident and determined the root cause as failure to identify the specific NOTAM for the airspace. As a result, administrative actions were taken to ensure this situation does not occur again.

Cause: A breakdown in the Night Low Flying deconfliction process.

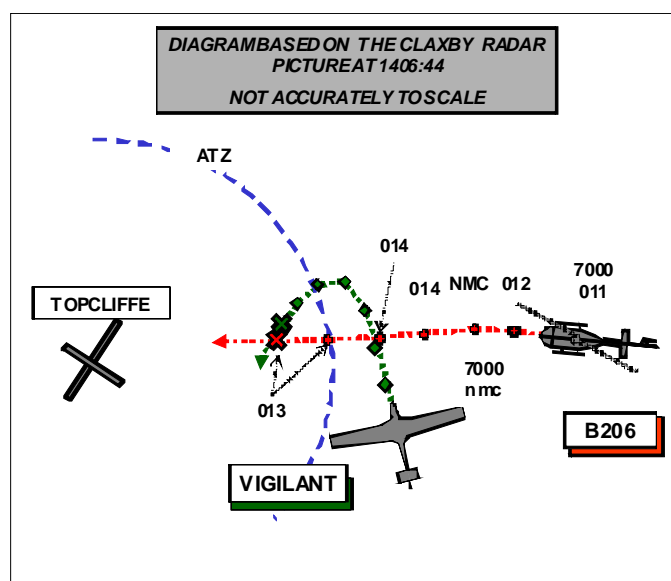
**AIRPROX REPORT NO 2011115**

Cause: The Bell 206 JetRanger pilot entered the ATZ and flew into conflict with the Vigilant, which he might not have seen at its closest point.

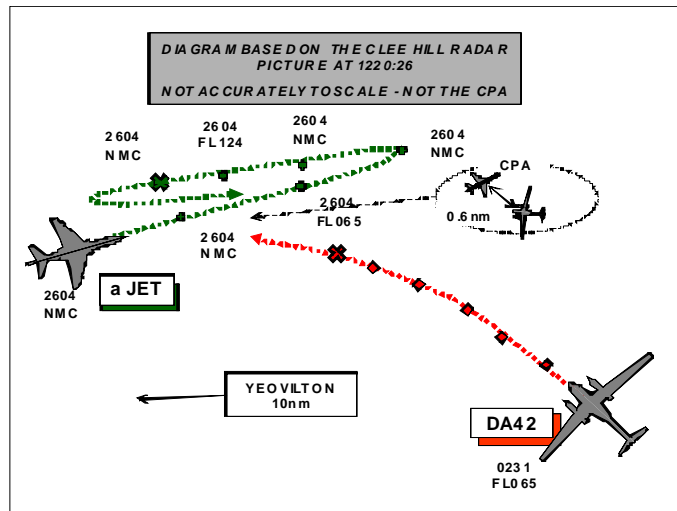
Cause: Effectively a non-sighting by the Alpha-Jet pilot.

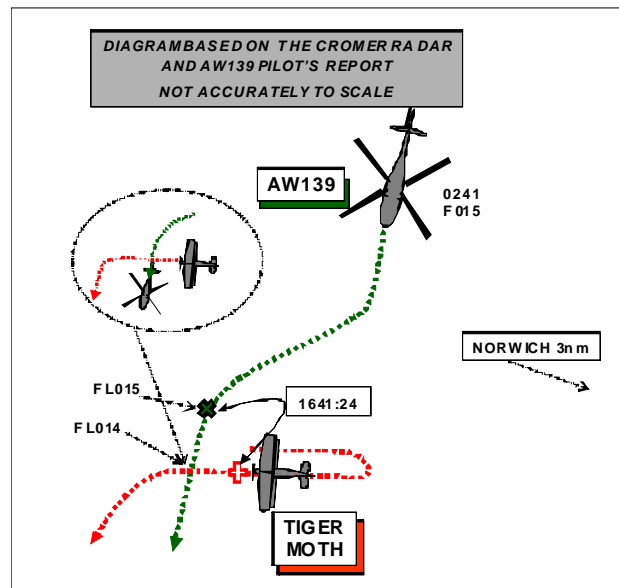
### AIRPROX REPORT NO 2011118

Cause: A conflict in Class G airspace resolved by the AW139 crew.

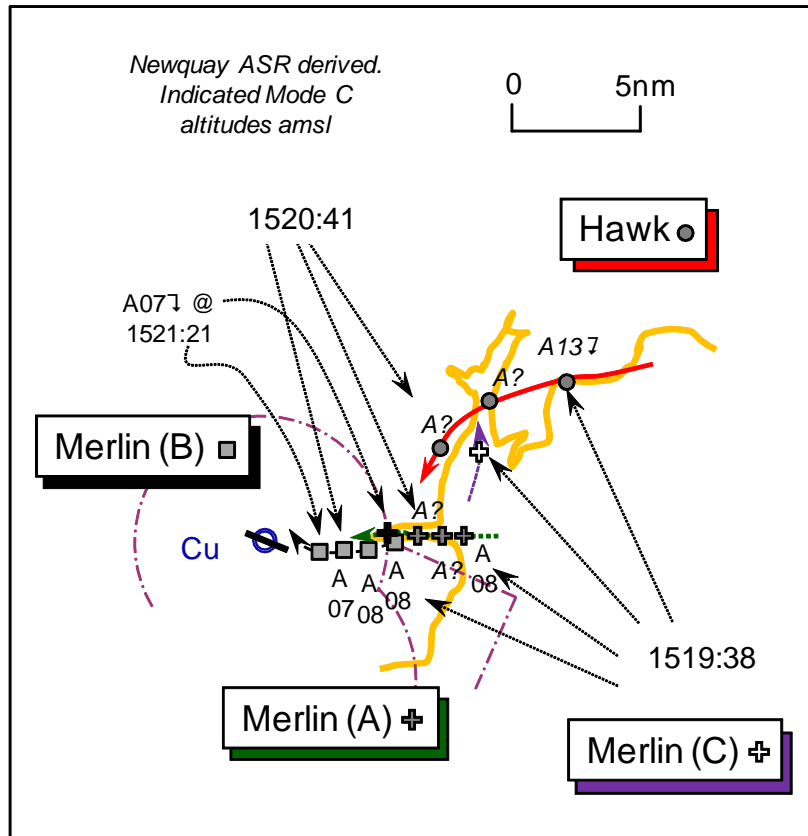
UKAB Note (2): A copy of the Newquay Cornwall Airport ASR recording was helpfully provided for the investigation of this Airprox; however, the incident is not captured at the CPA. The Hawk is shown approaching Culdrose from the NE descending through 1300ft passing to the N of Merlin (C), which is operating between Pendennis Point and Falmouth at 700-800ft ALT. However, the Hawk's contact fades just after 1520:41, 3nm N of Merlin (A) before the Hawk arrives in the vicinity of the Helford River. Both Merlin (A) and the preceding Merlin (B) are shown inbound along the S bank of Helford River between 700-800ft ALT. Merlin (A) is shown at the reported Airprox location 5nm E of the A/D at 1521:21, the helicopter's Mode C indicating a descent through 700ft ALT. Thereafter no Mode C is shown and perhaps indicative of the pilot's reported descent. Merlin (A)'s Mode C is next shown at 800ft ALT climbing and then levelling at 900ft ALT about 3nm E of the A/D.

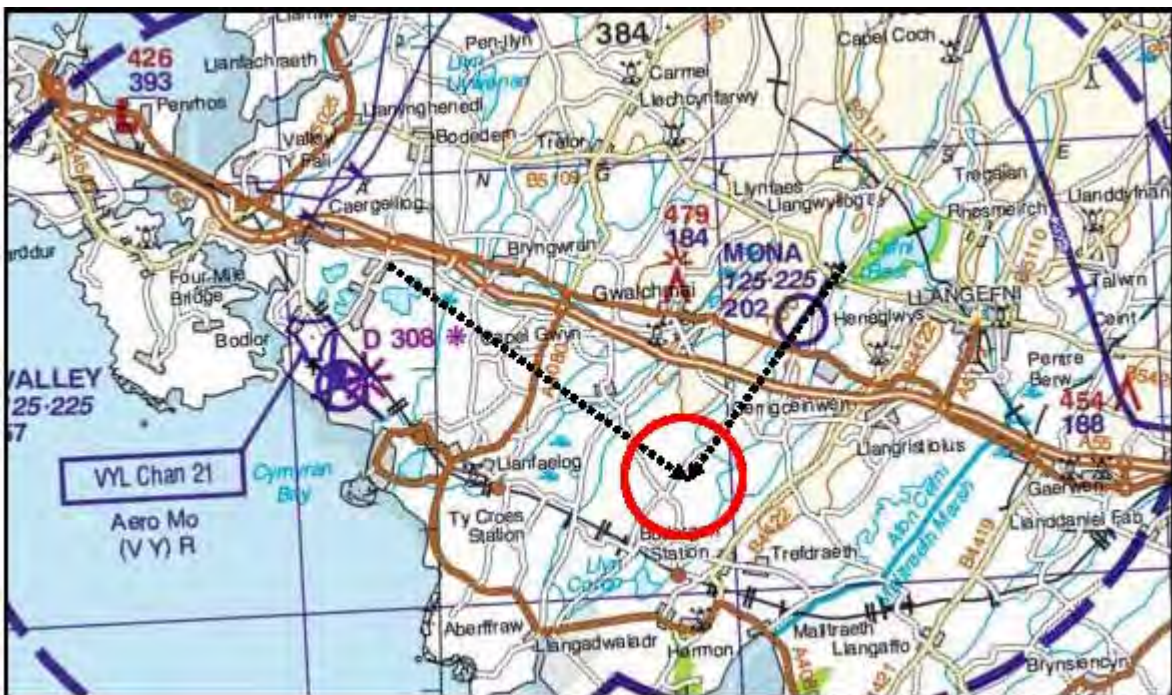
Figure 1: Valley and Mona Local Area

At the time of the occurrence, Valley was operating to RW31 RH cct, whilst Mona was operating to RW22 (see Fig 1). Mona receives a feed for its High-Brite display from the Valley PSR/SSR; however, at the time of the occurrence, Valley's SSR was unserviceable and the performance of the PSR close to Valley and Mona is known to be poor and highlighted as such in the Valley FOB. The ATC Tower at Valley is sited N of RW31/13 and E of RW19/01, with the layout of the VCR favouring the main instrument RW, RW31/13, with the cct behind the Tower. The ATC Tower at Mona is sited W of RW22/04.

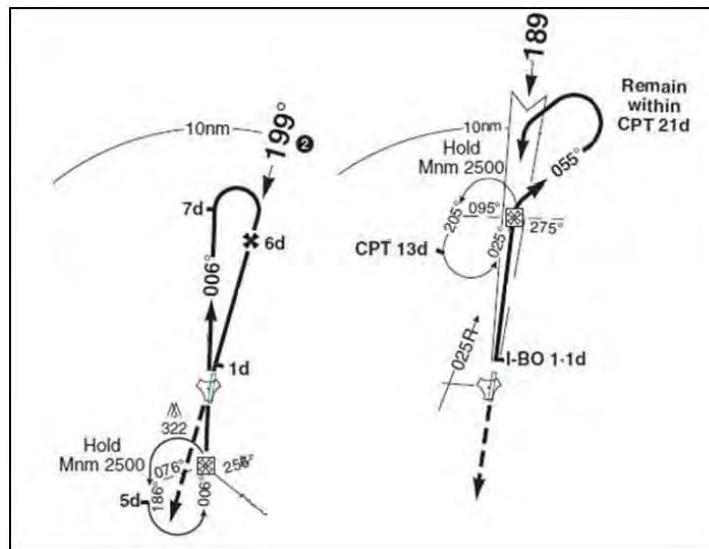
Figure 1: RAF Benson COPTAC (left) and VOR ILS/DME Procedure (right) RW19.

Given the height of the outbound leg of the COPTAC procedure and the base height of the VOR ILS/DME hold, there is no procedural deconfliction between these procedures. RAF Benson ATC has confirmed that there is a local procedure to deconflict level allocation between the two holds. The specific scenario encountered in this Airprox is covered in local training material and Benson controllers receive synthetic based training and consolidation on IFR hold deconfliction.

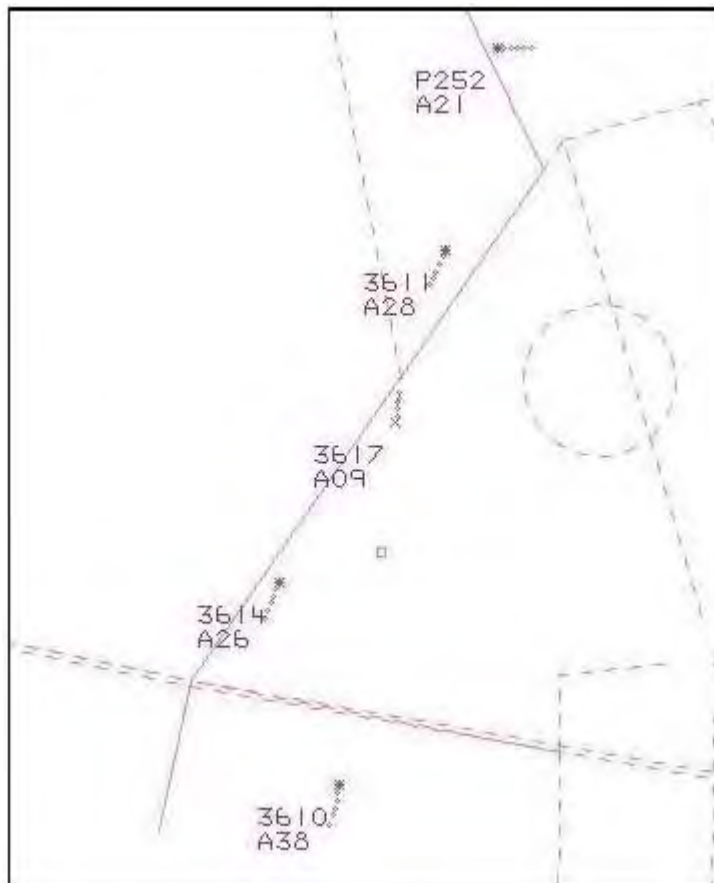
Figure 3. Position of DIRs Traffic at 1001:20.

At 1001:20, DIR had five ac on freq in the positions at Figure 3 and described their workload and task complexity as high. The incident ac were a Puma in the VOR ILS/DME hold at 2500ft QFE, SSR 3A 3611, and a Merlin departing the COPTAC hold at 3500 ft QFE, SSR 3A 3610. There were three further unconnected ac: a Chinook flying towards the VOR ILS/DME hold at 2500ft QFE, SSR 3A 3614; a Squirrel in the RTC, SSR 3A 3617 and a Police helicopter, SSR 3A code-callsign converted to P252.

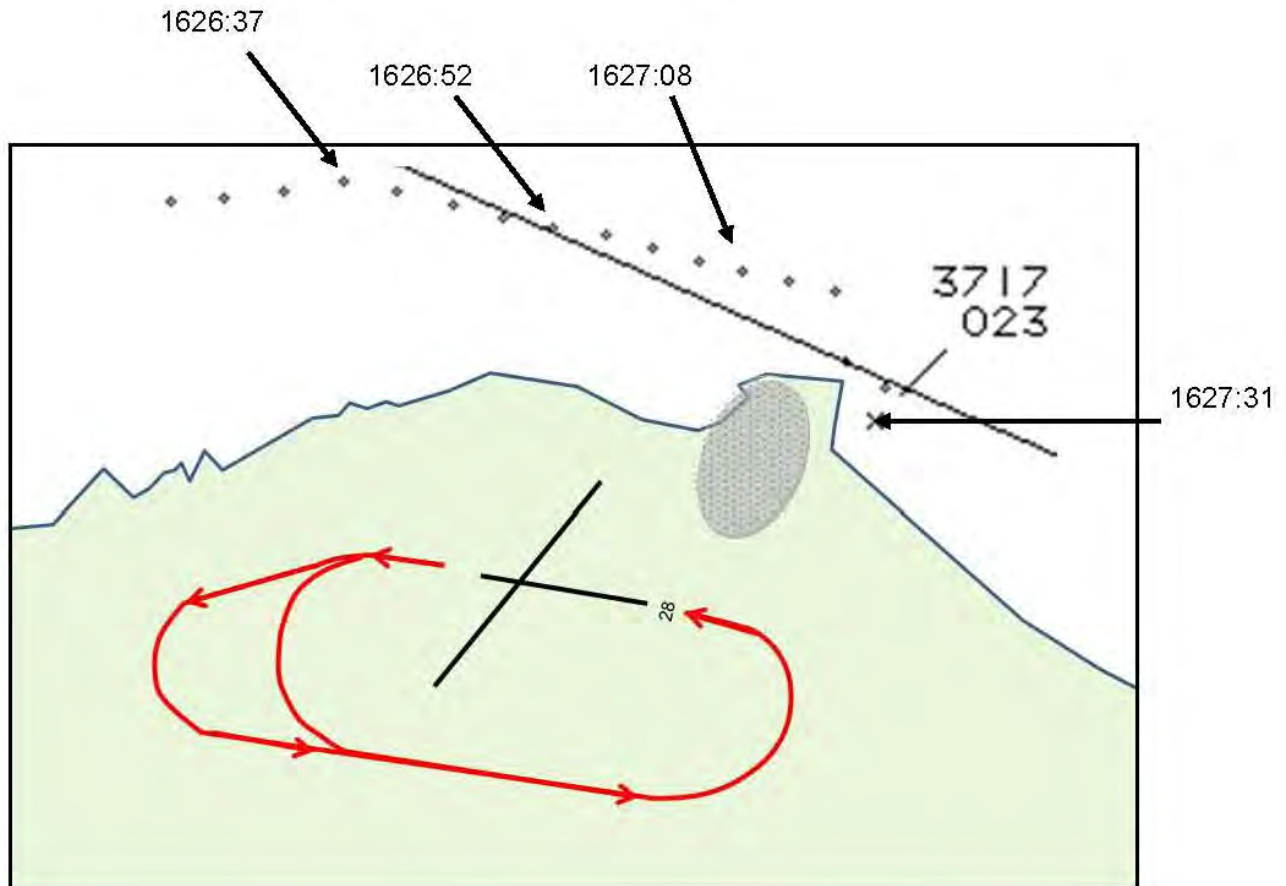
Fig 2: Approximate ground track of Hawk

Figure 2 depicts the Hawk's approximate ground track, based upon the radar replay; the grey shaded area is Lossiemouth village which is a noise-abatement avoid. At 1626:29, at a position 3.1nm NNW of Lossiemouth, the

[UKAB Note (1): Fig 2 Indicated Hawk Mode C of 2300ft is based on 1013mb and equates to a height of about 1640ft Clutch QFE (991mb).]

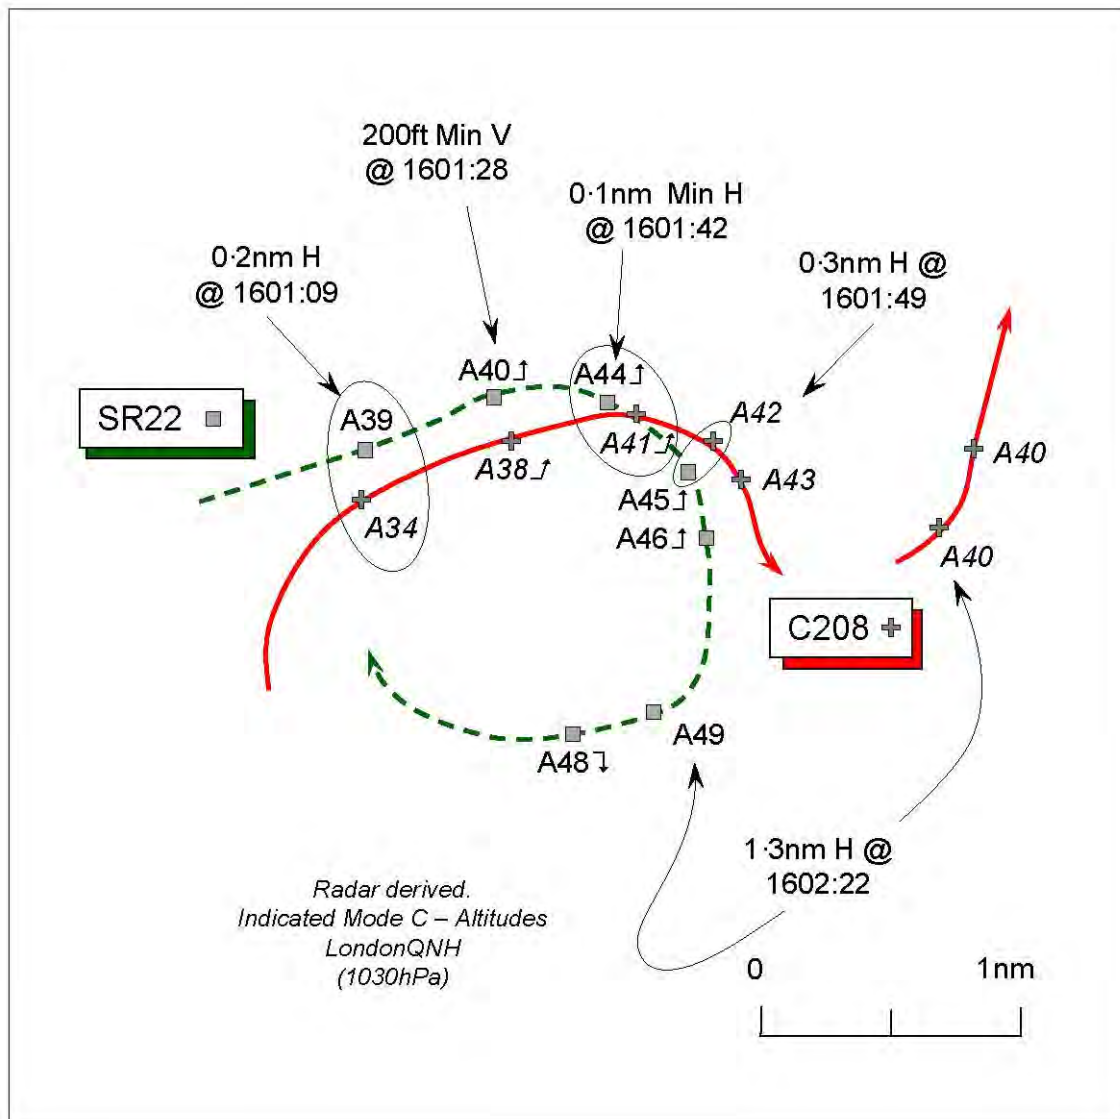
Fig 2

[UKAB Note 1: In Fig 1 the LAC radar recording shows the SR22 on a steady ENE'ly track indicating 3700ft QNH (1030mb) and converging with the C208, which is ahead at 2 o'clock on a NE'ly course climbing slowly through 2800ft QNH (1025mb) to 3000ft. As the ac close to a range of 2.4nm the C208 turns R into an orbit, rolling out on its original course 0.5nm off the SR22's starboard wing, as the latter, which had already climbed slightly indicates 3900ft, some 800ft above the C208. As the C208 steadies NE'ly at 1601:09, the ac's Mode C indicates a climb through 3400ft in the SR22's 4 o'clock at a range of 0.2nm. Moving to Fig 2, the C208 starts to overhaul the SR22 and climbs to 200ft beneath it; the SR22 then turns R into an orbit climbing at a higher rate through 4400ft with the C208 300ft below indicating 4100ft. At 1601:42, the C208 was at a range of 0.1nm from the SR22 still climbing and turning R, crossing 300ft above and slightly astern of the C208 in between sweeps at the CPA. The C208 commences a L turn but contact is then lost for several sweeps as the SR22 continues the R orbit, ascending to a maximum altitude of 4900ft at 1602:22, when the C208 is shown once more at 4000ft on a NNE'ly course.]

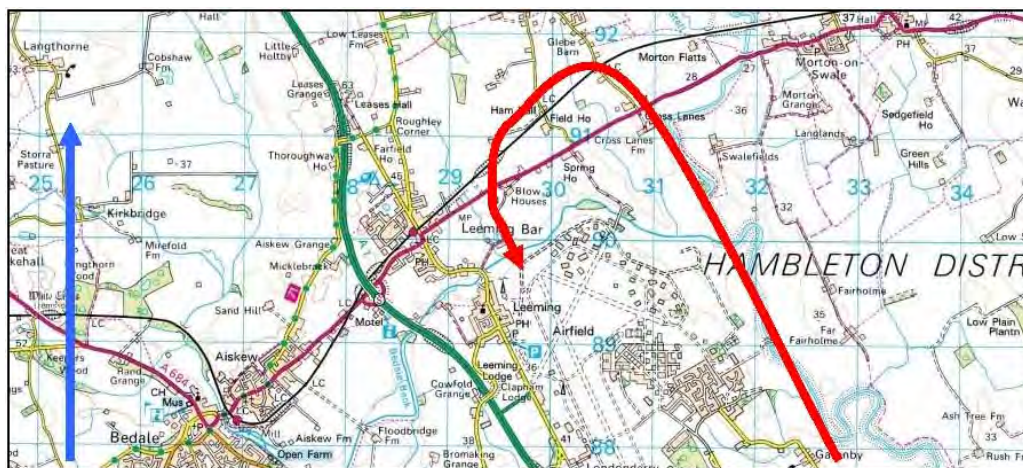
Fig: 1

Based upon the information provided to TWR by Zone at 1457:06, that the MD902 would be routing N from Bedale, TWR had no reason to suspect that the MD902 would conflict with the visual cct; as illustrated at Figure 1.

Moreover, the obstructions to the N and NW of the airfield would have precluded TWR from visually acquiring the MD902 until a late stage. Finally, whilst given their low workload it is reasonable to suggest that TWR could have scanned their Hi-Brite VRD, it is just as reasonable to argue that with nothing to prompt TWR to do this, their visual focus would have remained on the Hawk.

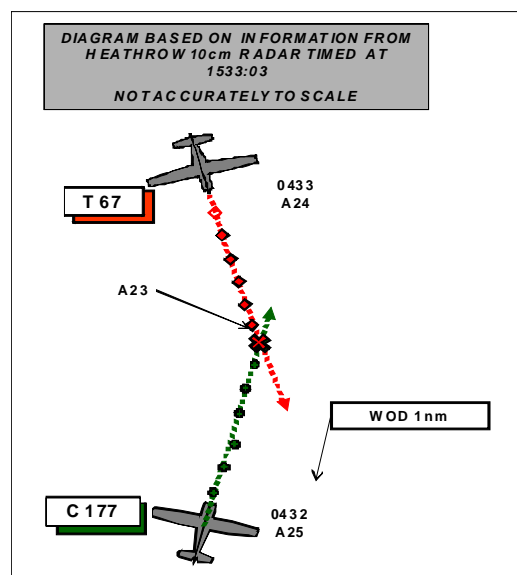
Date/Time: 1 Nov 2011 1533Z  
Position: 5130N 00051W (1nm N WOD)  
Airspace: London FIR (Class: G)  
Reporting Ac Reporting Ac  
Type: C177 RG T67M  
Operator: Civ Pte Civ Pte  
Alt/FL: 2500ft 2500ft  
QNH (1010mb) QNH  
Weather: VMC VMC  
Visibility: 10km 10km  
Reported Separation:  
100ft V/50m H 10ft V/120m H  
Recorded Separation:  
200ft V/0 H

Cause: Effectively a non-sighting by the C177 pilot and a late sighting by the T67 pilot.

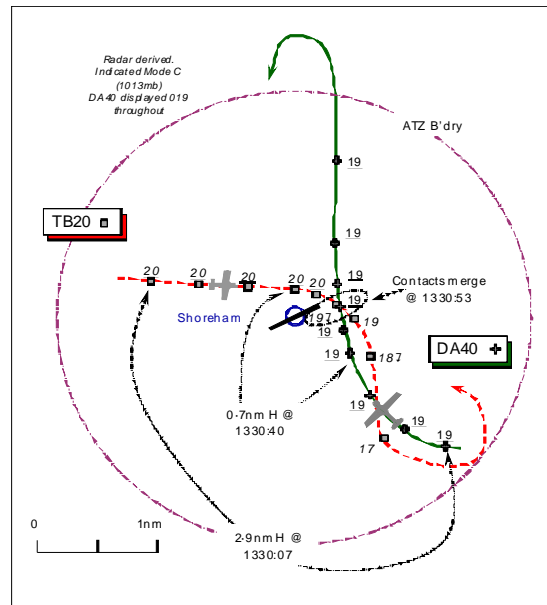
Date/Time: 19 Nov 2011 1330Z (Saturday)  
Position: 5050N 00017W  
(0.4nm E of Shoreham Airport - elev 7ft)  
Airspace: Shoreham ATZ (Class: G)  
Reporting Ac Reported Ac  
Type: Diamond DA40 TB20  
Operator: Civ Pte Civ Pte  
Alt/FL: 2000ft 1800ft↓  
QFE (1015hPa) QFE (1015hPa)  
Weather: VMC CAVOK VMC CAVOK  
Visibility: >10km >10km  
Reported Separation:  
Nil V/20ft H 'Very close'  
Recorded Separation:  
Contacts merged

Cause:1. The overloaded controller did not pass T1 to either pilot.

It is recommended that the ATSU in consultation with SRG, review the levels of staffing and service provision, to ensure that Aerodrome and Approach control services can be provided from split positions when warranted.

It is recommended that the ATSU review the guidance for operational staff in predicting, managing and limiting traffic levels, with an emphasis on the human factors aspects of overloads, highlighting the need for early planning and preventative measures.

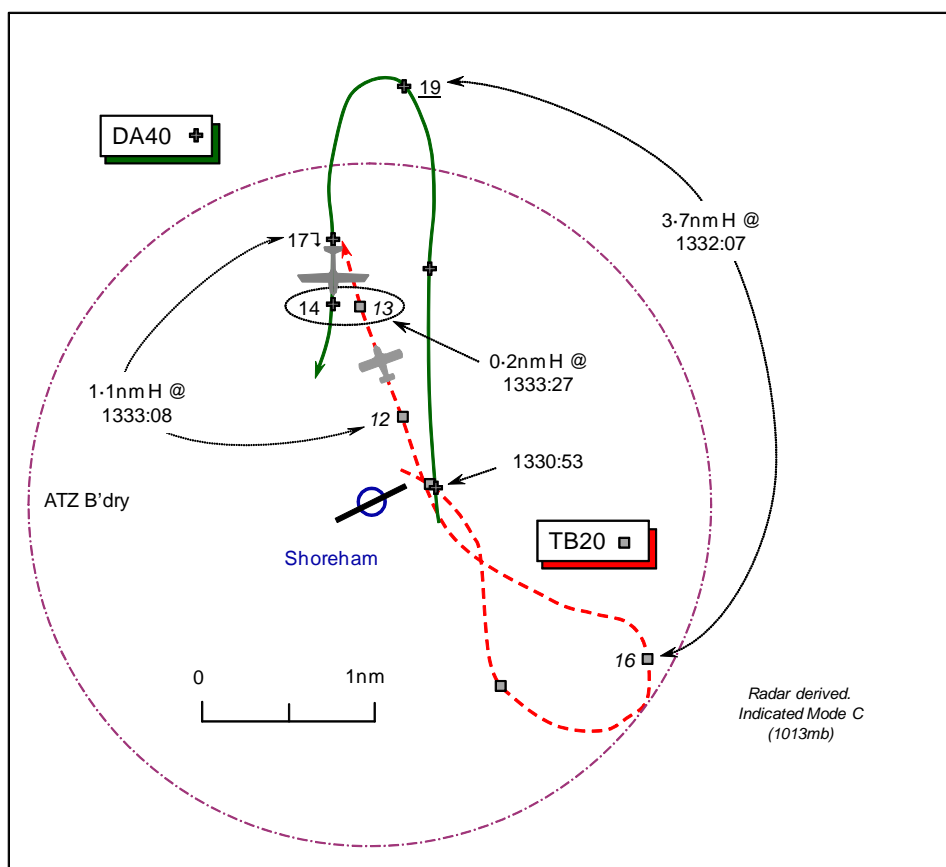
Fig 2

[UKAB Note (2): After the Airprox had occurred at 1330:53, both ac opened from the A/D overhead as illustrated at Fig 2. The two ac then turn toward the A/D and converge on broadly reciprocal headings to a range of 1.1nm at 1333:08; the TB20 indicating level at 1200ft Mode C as the DA40 descends through 1700ft Mode C. The two ac pass for the second time - port-to-port - about 1.1nm N of the A/D, the TB20 indicating 1300ft, 100ft below the DA40 that is shown descending through 1400ft Mode C.]

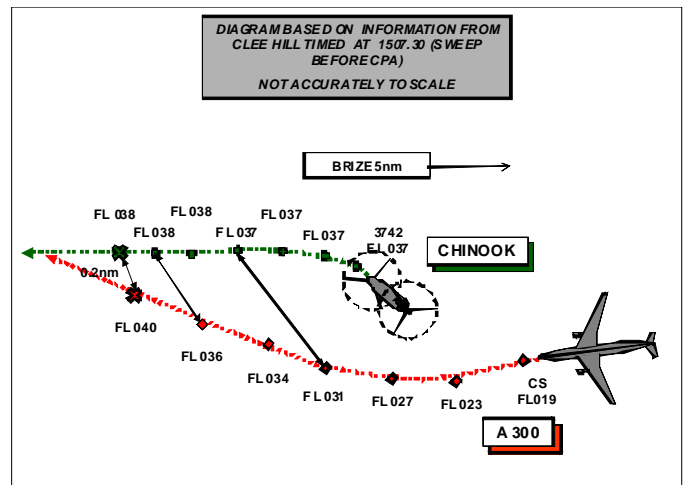
Date/Time: 18 Nov 2011 1507Z  
Position: 5145N 00144W  
 (5nm W Brize Norton - elev 287ft)  
Airspace: Oxford AIAA (Class: G)  
Reporting Ac Reported Ac  
Type: Chinook A300  
Operator: HQ JHC CAT  
Alt/FL: 3500ft 5000ft  
 QFE (1005hPa) 1015hPa  
Weather: VMC NR VMC NR  
Visibility: 20km NR  
Reported Separation:  
 NR V/ 100ft H 300ft V/ NR H  
Recorded Separation:  
 501ft V/0.05nm (90m) H

Cause: The A300 crew climbed above the altitude assigned by Brize Norton ATC.

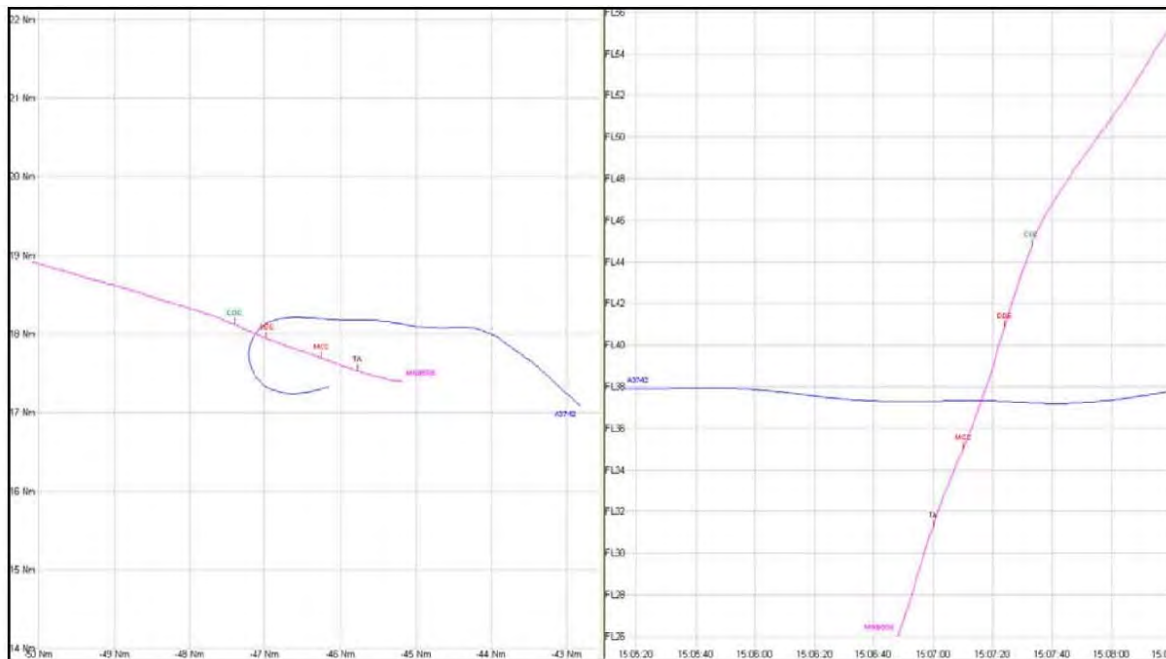
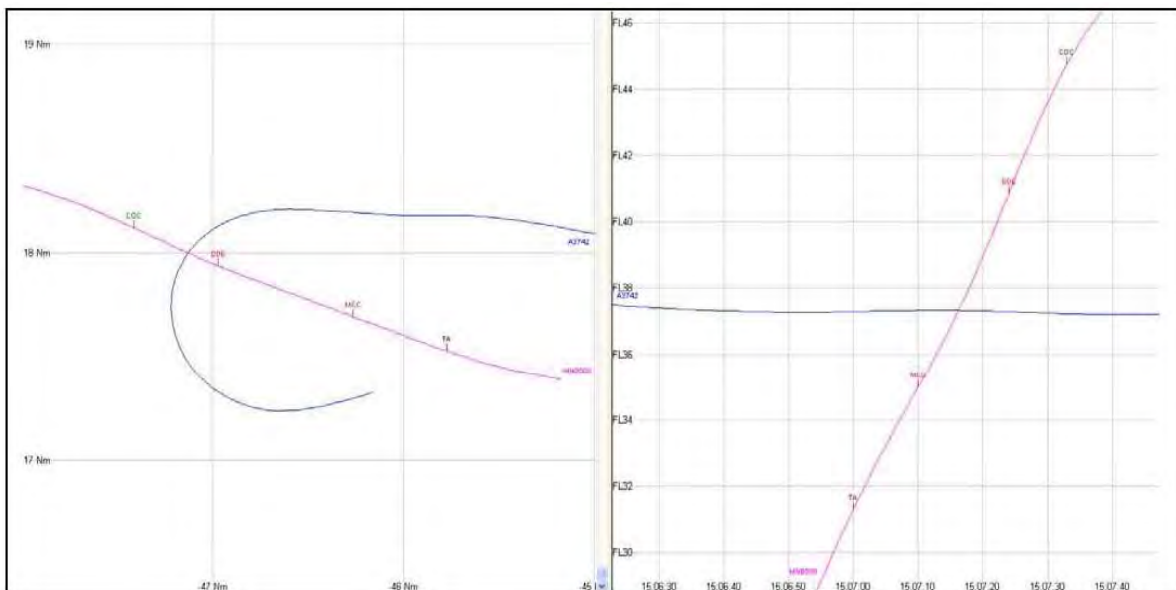
Encounter Diagram Based on Heathrow Single Source Radar Data

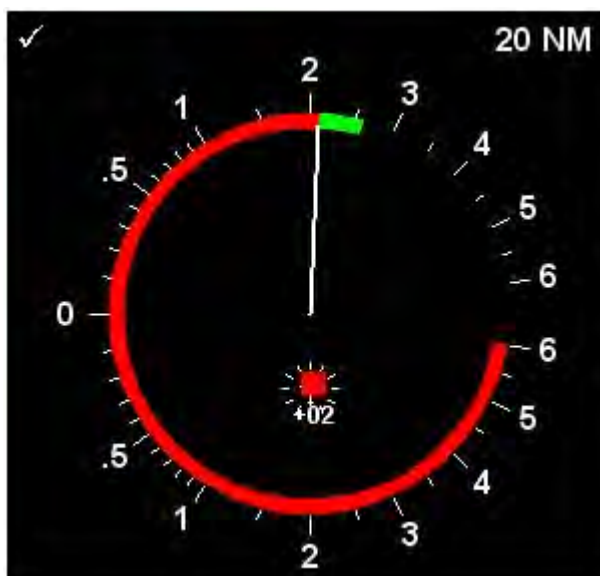
The *maintain crossing climb* RA is labelled red in InCAS simulation to indicate that it is considered to be a corrective RA. The IVSI for the A300 at the point at which the MCC was issued is shown below; the pilot was able to comply with the RA with only a very minor change in vertical speed.

IVSI for the A 300 at 15:07:10'

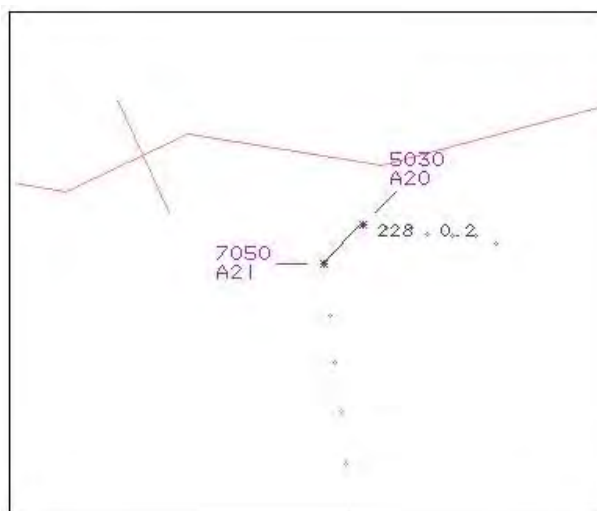
At 1957:54 the ac were 7nm E of Elstree with the C425 was in the Dauphin's 11 o'clock at a range of 0.2nm, crossing left to right; the C425 was at 2100ft and the Dauphin at 2000ft (see Figure 1).

**Figure 1: Swanwick MRT at 1957:54**

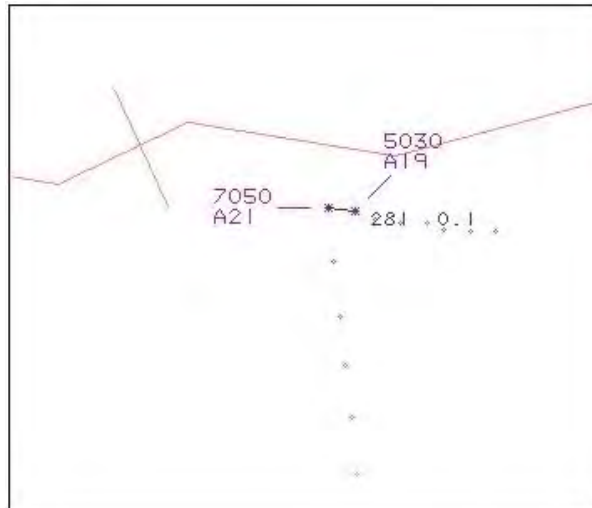
The C425 crossed through the Dauphin's 12 o'clock, left to right, at 1957:58. The C425 was at 2100ft, 0.1nm ahead of the Dauphin, which was at 1900ft (see Figure 2).

Figure 2: Swanwick MRT at 1957:58

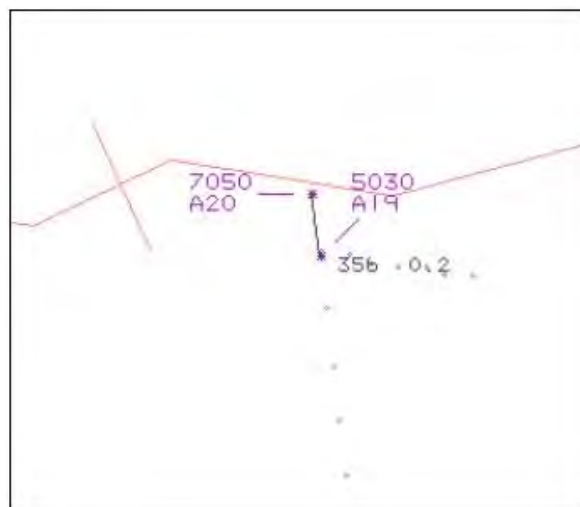
The next update of the MRT replay, at 1958:02, showed the C425 in the Dauphin's 3 o'clock, range 0.2nm (see Figure 3).

Figure 3: Swanwick MRT at 1958:02
