UK AIRPROX BOARD

Analysis of Airprox in UK Airspace

Report Number 10
January 2003 - June 2003

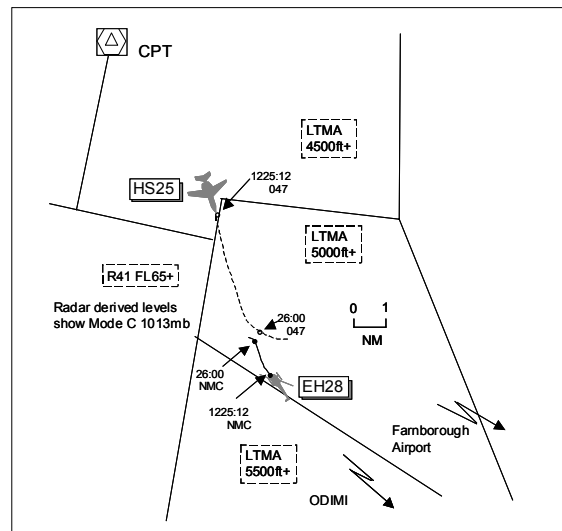
AIRPROX REPORT NO 6/03

Date/Time: 31 Jan 1226
Position: 5121N 0105W (9nm SE CPT)
Airspace: LTMA (Class: A)
Reporting Aircraft Reported Aircraft
Type: HS25 EH28
Operator: Civ Pte Civ Pte
Alt/FL: 5000ft 5000ft
 (QNH 1023mb) (QNH 1023mb)
Weather VMC CAVOK VMC CLNC
Visibility: 40km 50nm
Reported Separation:
 nil V 400-500m H, <100ft V 0.5nm H
Recorded Separation:
 0.4nm H

THE HS25 PILOT reports heading 165° at 220kt inbound to Farnborough squawking an assigned code with Mode C and in receipt of a RCS from London on 134.12MHz. The visibility was 40km in CAVOK, the ac was coloured white/silver and his nav, strobe and landing lights were all switched on. TCAS was not fitted to the ac. After passing CPT at 5000ft QNH, he was issued an immediate avoiding action L turn owing to traffic dead ahead. The PNF saw the conflicting ac, a helicopter, at the same altitude in his 12 o'clock range 1.5-2nm. The dark coloured helicopter had only shown a small target aspect in the head-on geometry of the encounter. The hard L turn executed allowed him to achieve about 400m separation as the helicopter passed to his R, at the same altitude as his ac and it did not appear to take any avoiding action. He reported the Airprox to Farnborough

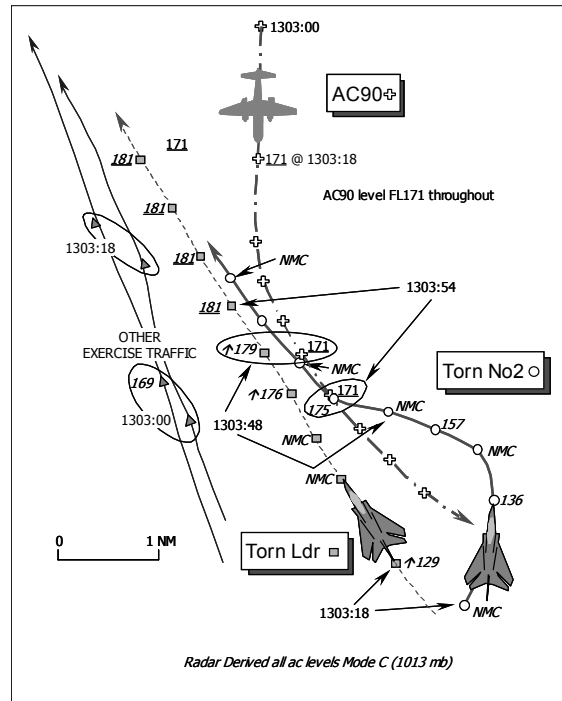
Reported Separation:
 Torn Ldr: 800m H,300ft V 1500ft V
 Torn No2: nil H,400ft V

Recorded Separation:
 v Torn Ldr 0.4nm H
 v Torn No2 nil H, 400ft V

THE AC90 PILOT reports that his ac has a white & green colour scheme and the two white HISLs and anti-collision beacon were on whilst in transit from Perth to Southend at 300kt, in good VMC. He was in receipt of a RAS from London MILITARY and was squawking the assigned code with Mode C; a 'Skywatch' traffic avoidance system is fitted. A descent from his cruising level of FL235 down to FL60 was requested, but the controller requested that he level off at FL170 and head 140° direct to BARKWAY to avoid a military exercise that was taking place. On reaching FL170, some 12000ft clear of cloud, the controller passed traffic information on an ac crossing from L to R, [shown as other exercise traffic] which he spotted straight away. About 20sec later a second fast moving military ac [the Tornado Leader] was suddenly spotted at 2 o'clock about 600m away, but he was unable to take avoiding action before it passed down his starboard side about 800m away and 300ft above him. As this ac passed he spotted a third fast moving military ac [the No2 Tornado] on the nose, but it was difficult to determine in which direction it was headed. When this traffic came within 600m he received a

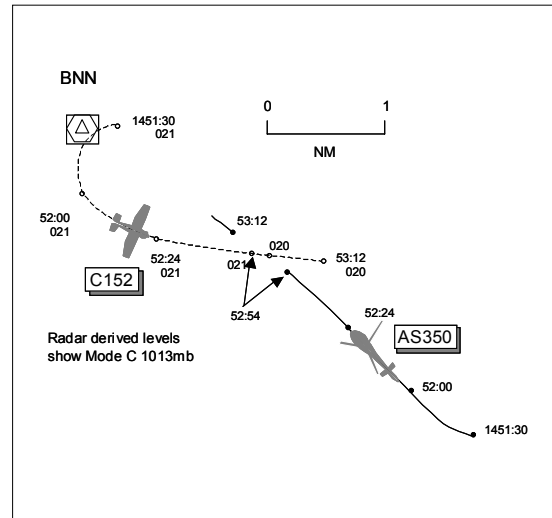
AIRPROX REPORT NO 8/03

Date/Time: 7 Feb 1453
Position: 5142N 0031W (2nm SE BNN)
Airspace: FIR (Class: G)
Reporting Aircraft Reported Aircraft
Type: C152 AS350
Operator: Civ Trg Civ Pte
Alt/FL: 2300ft
(QNH 1019mb)
Weather IMC IICL NK
Visibility: 3000m NK
Reported Separation:
50ft V NK H NK
Recorded Separation:
NR

THE C152 PILOT reports flying a local dual ‘instrument appreciation’ sortie from Denham and receiving a RIS from Northolt on 126.45MHz. Flying about 2nm S of BNN VOR, in and out of broken cloud, level at 2300ft QNH 1019mb at 85kt, ATC warned him of unknown traffic. Turning L onto 090° to avoid, he ‘popped’ out of cloud into a gap and, on looking to his R, he was surprised to see a conflicting ac, a dark blue coloured twin/single squirrel helicopter, in his 2-3 o’clock very close and 50ft below; it was then seen to turn L to avoid him. As he was already turning L and heading away from the helicopter, no further avoiding action was required, and it was seen to pass very close to his R and behind about 50ft below. He assessed the risk of collision as high. Although the TI passed had been timely, no height information had been given, as the other ac did not have Mode C selected, which would have helped with his collision avoidance manoeuvre.

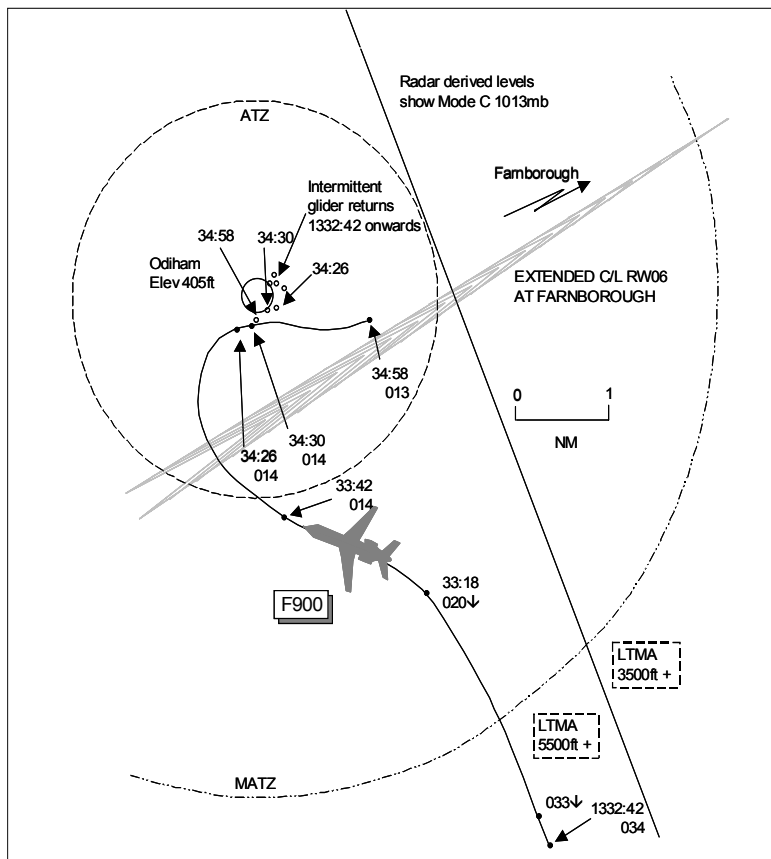
THE SZD BOCIAN PILOT reports flying a dual instructional sortie climbing in a thermal within the aerodrome boundary at Odiham at 45kt and he was listening out with Odiham Base on 129.97MHz. The visibility was 10km below a 2300ft cloudbase and the glider was coloured white with 8ft wide red bands displayed on both wings. At 2000ft QFE in a R turn, he saw a light coloured executive jet break cloud 300-400m away slightly R of his nose flying in the opposite direction. There was no time to react, his R turn was taking him away from the 'head on' situation and the jet then passed about 100m to his L, 250ft below, within a few seconds, heading towards Farnborough. He was also concerned that winch operations were in progress with cables up to 2500ft.

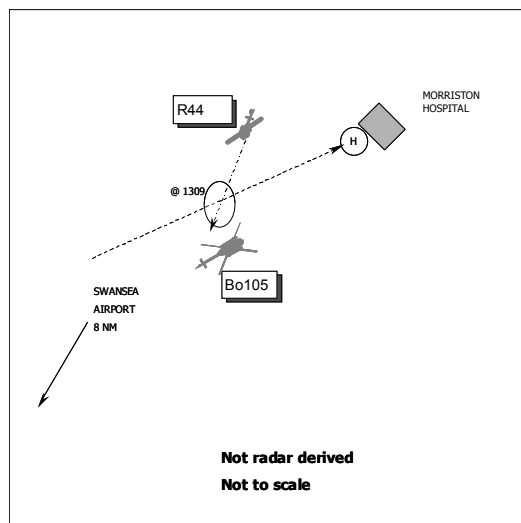
AIRPROX REPORT NO 10/03

Date/Time: 15 Feb 1309 (Saturday)
Position: 5141N 0356W (8nm NE Swansea)
Airspace: FIR (Class: G)
Reporting Aircraft Reported Aircraft
Type: Bo105 R44
Operator: Civ Com Civ Pte
Alt/FL: 600ft 800ft
(QNH 1036mb) (N/K)
Weather VMC CAVOK VMC CAVOK
Visibility: 30km Excellent
Reported Separation:
75ft V 50m H 0.75nm
Recorded Separation:
NR

THE Bo 105 PILOT reports that he departed from Swansea Airport in a red air ambulance ac to an incident. Following the incident he was on final approach to the Morriston Hospital Swansea helipad in 30km visibility, heading out of sun, in a wire dense environment with strobes and landing lights on and in receipt of a FIS from Swansea with SSR and Mode C selected.

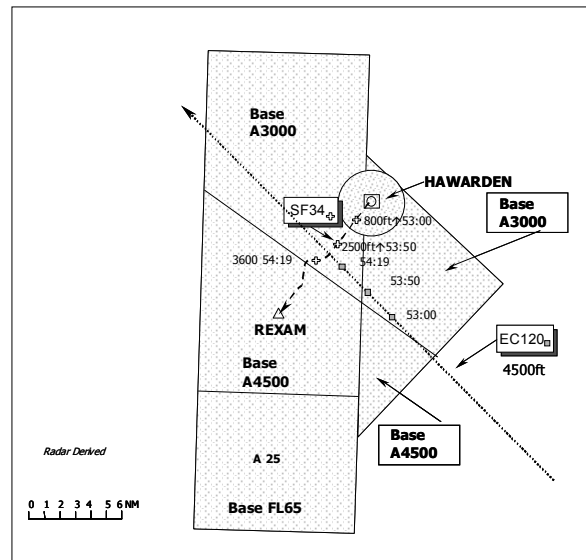
AIRPROX REPORT NO 11/03

Date/Time: 19 Feb 1254
Position: 5306N 0306W (5nm SW Hawarden)
Airspace: A25 (Class: A)
Reporter: Hawarden ADC
First Aircraft Second Aircraft
Type: SF 34 EC120
Operator: Civ Comm Civ Exec
Alt/FL: 4500ft FL45
 (QNH ???? mb)
Weather VMC HAZE VMC NIL
Visibility: 8000M 100k
Reported Separation:
 2.5nm H 600ft V
Recorded Separation:
 2.2nm H 500ft V

THE HAWARDEN ADC reports that the weather at 1250z was VMC with a visibility of 8000m in

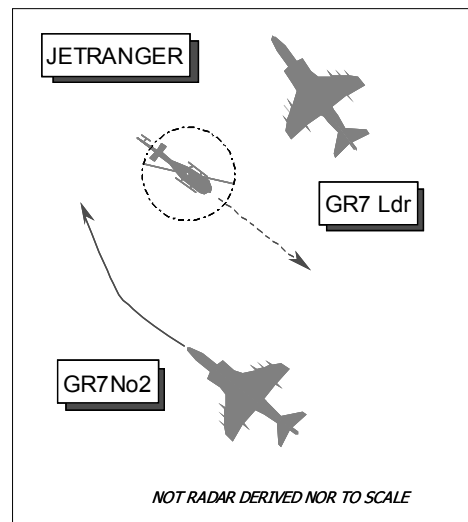
AIRPROX REPORT NO 12/03

Date/Time: 25 Feb 1443
Position: 5232N 0329W (Clatter - Wales)
Airspace: UKDLFS (Class: G)
Reporting Aircraft Reported Aircraft
Type: JetRanger Harrier x 2
Operator: Civ Comm HQ STC
Alt/FL: 600ft 350ft
agl Rad Alt
Weather VMC CLBC VMC HAZE
Visibility: 10km 8km
Reported Separation:
100m H, 50ft V 500ft H, 50ft V
Recorded Separation:
NR

THE JETRANGER PILOT reports his ac has a silver colour scheme and the HISL and landing lamp were on. He was operating in an area of poor RT reception and thus was not in receipt of an ATS, but was squawking the assigned PINS squawk of A0036 with Mode C; TCAS is not fitted. His inspection flight had been notified under the Pipeline Inspection Notification System (PINS).

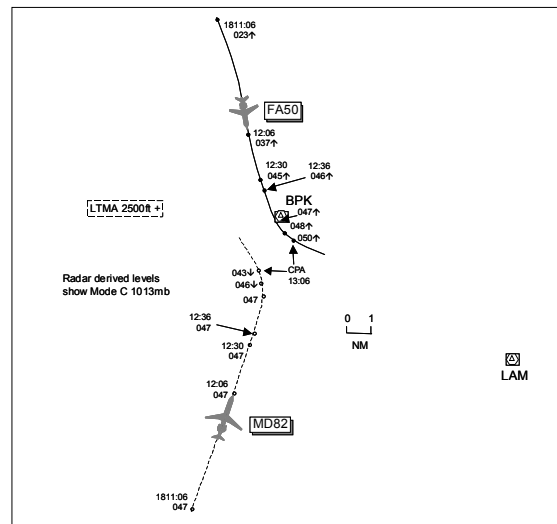
AIRPROX REPORT NO 13/03

Date/Time: 13 Feb 1813 NIGHT
Position: 5143N 0008W (1.5nm S BPK)
Airspace: LTMA (Class: A)
Reporting Aircraft Reported Aircraft
Type: MD82 FA50
Operator: CAT Civ Pte
Alt/FL: 5000ft 5000ft↑
(QNH) (QNH)
Weather VMC NK VMC NK
Visibility: NK NK
Reported Separation:
600ft V 3-5nm H NK
Recorded Separation:
700ft V 1.85nm H

THE MD82 PILOT reports flying outbound from Heathrow following a BPK 5J SID with clearance to climb and maintain 5000ft QNH not 6000ft, the standard initial altitude. Approaching BPK at 300kt, he noticed an ac target on TCAS in his 12 o'clock indicating the same level. Whilst informing the other two crew members (line check flight) about the indication, ATC called "avoiding action turn left immediately to heading 290 degrees". He disconnected the A/P and banked the ac 30° to

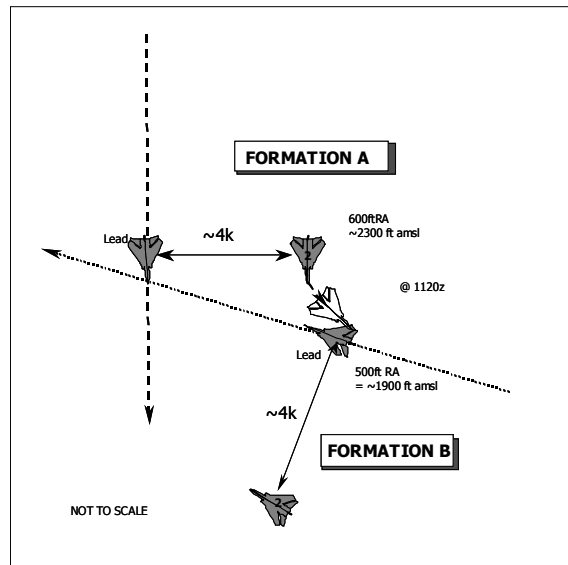
THE TORNADO GR4 PILOT (Formation A) reports that he was leading a 2-ship tactical formation at low-level from N to S in hilly terrain in LFA 14 as a 'battle pair' separated by 4km with lead on right side. The weather was good VMC with a visibility of >10km in light haze into sun. The ac was dark grey with HISLs, anti-collision lights and the nav lights on both ac were on, but TCAS was not fitted. They were heading into sun, at 450 kt, clearing high ground in a left hand descending turn at approx 600ft agl. As the ac recovered to straight and level the no 2 navigator called another Tornado, left 11 o'clock, on the formation tactical frequency. The No 2 pilot looked around the canopy arch and immediately spotted the other ac on a collision course and on seeing the other ac he initiated a hard climbing turn to the left. The No2 pilot considered that there was an actual risk of collision and he pulled up hard to avoid the other ac. On recovery to base 5G had been recorded.

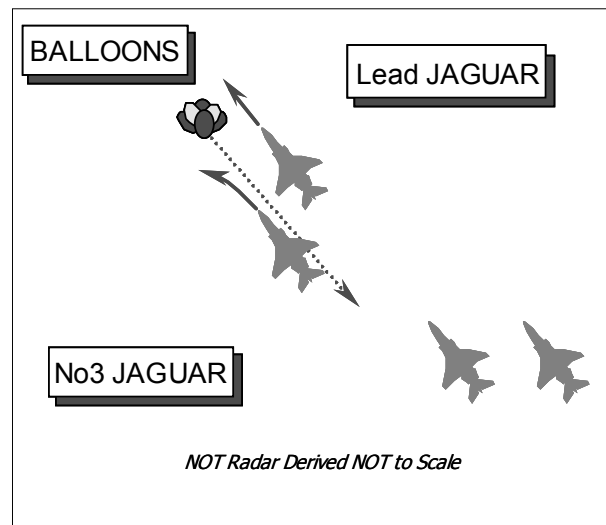
Reported Separation:
Nil ---

THE No3 JAGUAR PILOT reports that he was flying as the left hand rear ac within the leading section of a formation of 4 Jaguars, flying in loose arrow formation at FL165. They were under a RIS from London MILITARY and flying at 450kt in a clear sky, out of sun, with an in-flight visibility of 10km+; his workload was low.

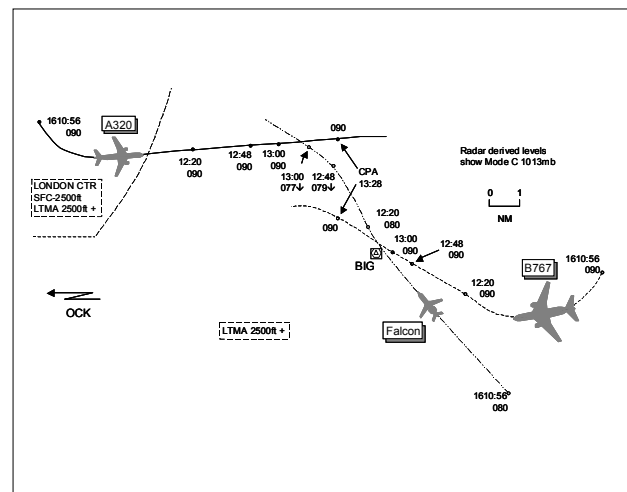
AIRPROX REPORT NO 16/03

Date/Time: 28 Feb 1613
Position: 5121N 0001E (2nm NNW BIG)
Airspace: LTMA (Class: A)
Reporting Aircraft Reported Aircraft
Type: B767 A320
Operator: CAT CAT
Alt/FL: FL90 FL90
Weather IMC NK IMC NK
Visibility: NK NK
Reported Separation:
 nil V 3nm H nil V >2.5nm H
Recorded Separation:
 nil V 2.5nm H

THE B767 PILOT reports flying inbound to Heathrow holding at BIG level at FL90 and 220kt in IMC. Heading 303° inbound to the VOR, he noticed another ac on TCAS to his L, the subject A320, which was being vectored towards him at the same level. He called ATC, told them of the conflicting traffic, and was issued an avoiding L turn onto 270° and descent down to FL80, which he complied with. TCAS gave a TA alert as the other ac was 'seen' on TCAS to pass about 3nm away and he assessed the risk as medium/high.

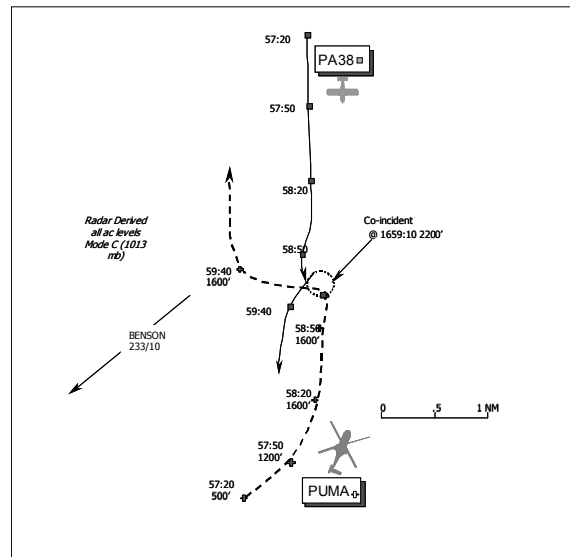
Contacts merged for 20 Sec

THE PUMA PILOT reports that he was conducting an Airtest from RAF Benson in a camouflage green coloured ac with HISLs, Nav Lights and Landing Lights on but TCAS was not fitted. He was in receipt of a FIS from Benson and was squawking. He was about to pull the throttles as part of the test and was heading 012° (out of sun) at 2000ft at 100kt just to the SE of Thame (Benson 050/10) when he saw a white 2-seat trainer, with logo markings on the tail which he recognised, at the same level on an opposite track but with lateral separation. He called the ac to the crew as it was passing down the left hand side. The ac then turned to face them directly at which point he climbed, losing sight from the right hand seat. Under direction from the crewman, they turned left in order that the crewman could remain sighted. The other ac then began climb and tightened its left turn in order to follow, then broke and headed away eastwards.

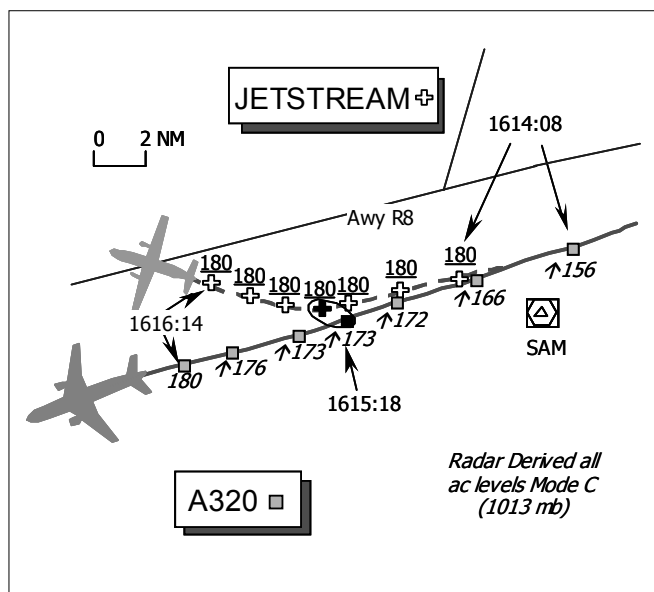
0.9nm H/700ft V @ 1615:18

nil V/3.45nm H @ 1616:14

Cause: The A320 crew climbed through their cleared level and were slow to follow corrective instructions.

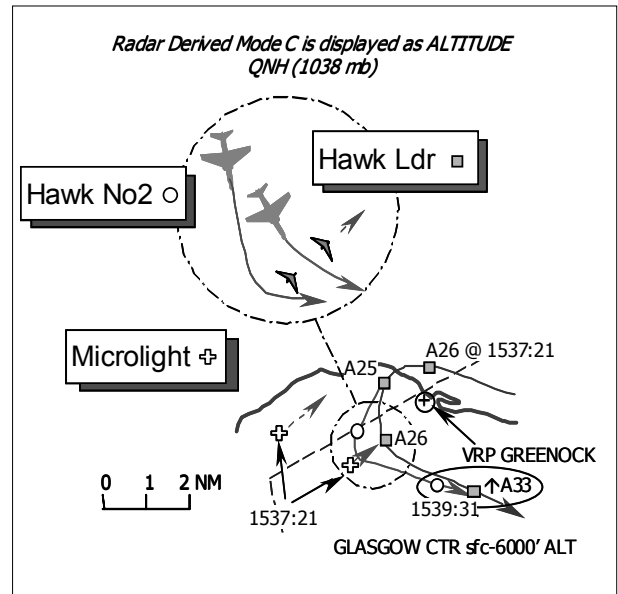
AIRPROX REPORT NO 21/03

Date/Time: 13 Mar 1538
Position: 5555N 0448W (1½nm SW of GREENOCK VRP)
Airspace: Glasgow CTR/FIR (Class: D/G)
Reporting Aircraft **Reported Aircraft**
Type: Hawk x2 Untraced Microlight pair
Operator: HQ PTC NR
Alt/FL: 2500ft NR
 (QNH 1038mb)
Weather VMC CLBC NR
Visibility: 30km+ NR
Reported Separation:
 150-200m, nil V NR
Recorded Separation:
 NR

Cause: The microlight pilots flew into CAS without clearance, which resulted in a conflict near the CTR boundary.

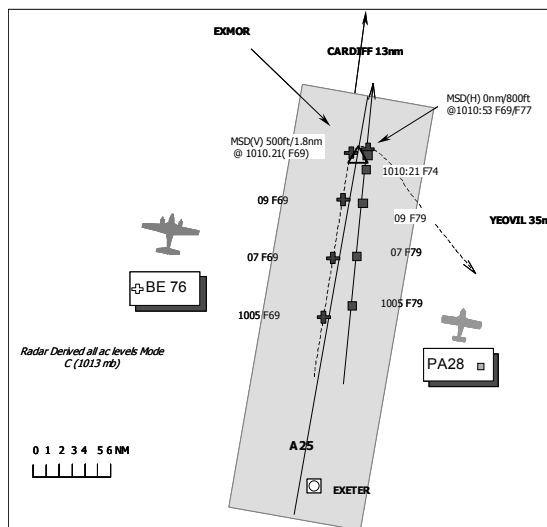
1.8nm H 500ft V

Cause: The Cardiff Radar Controller cleared the PA28 to descend through the level already occupied by the BE76.

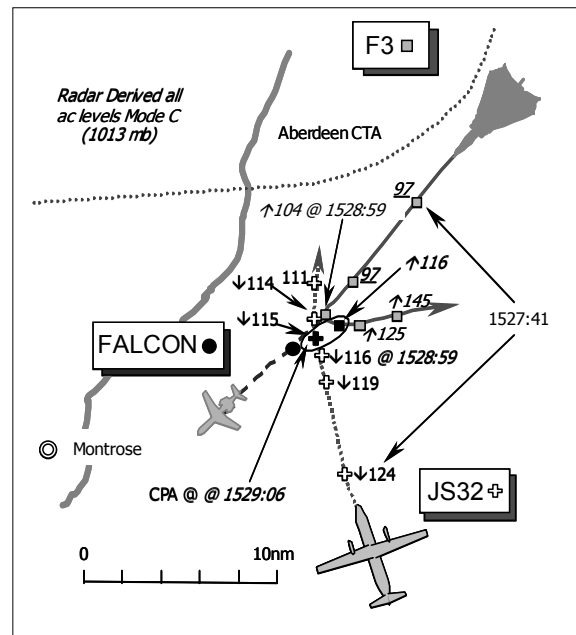
100ft V @ 1-16nm

Cause: The F3 crew breached co-ordination and climbed through the level of the Jetstream, which they did not see.

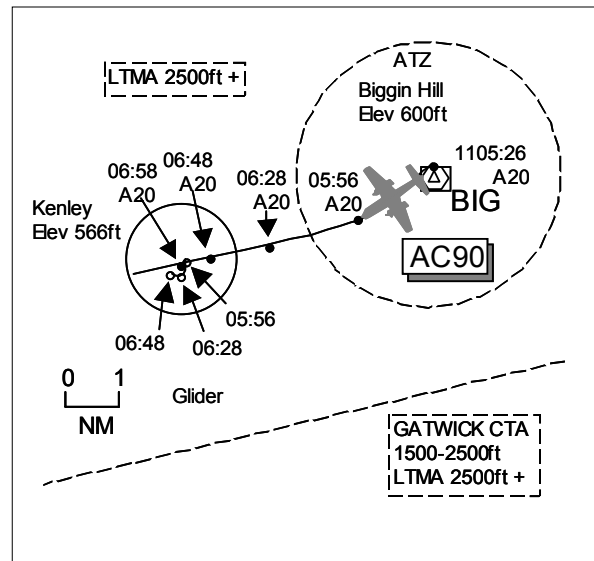
Cause: The AC90 pilot overflew Kenley, a notified Glider Site, below the maximum winch cable release height, into conflict with the KA8 glider, which he did not see.

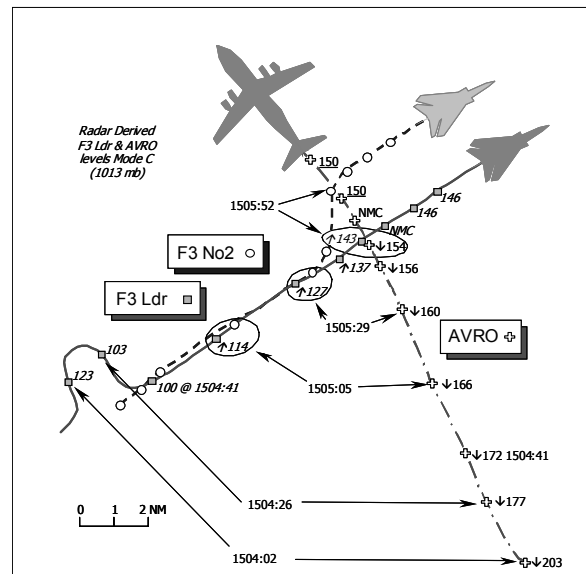
Date/Time: 26 Mar 1505
Position: 5430N 0100W (SID E of Leeming)
Airspace: Vale of York AIAA (Class: G)
Reporting Aircraft Reported Aircraft
Type: Tornado F3x2 AVRO RJ
Operator: HQ STC CAT
Alt/FL: FL135↑ ↓FL150

Weather VMC CLAH VMC NR
Visibility: Unlimited NR
Reported Separation:
 1000ft V, 100ft H nil V, 2nm H
Recorded Separation:
 F3 Ldr V AVRO
 400ft V/contacts merged

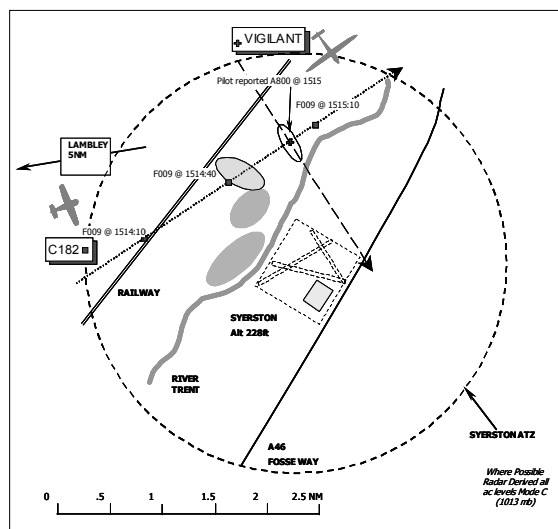
AIRPROX REPORT NO 26/03

Date/Time: 30 Mar 1515 (Sunday)
Position: 5403N 0056W (Syerston)
Airspace: Syerston ATZ (Class: G)
Reporting Aircraft Reporting Aircraft
Type: Vigilant T1 Glider C182
Operator: HQ PTC Civ Pte
Alt/FL: 800ft
(QFE 1012 mb) (N/K)
Weather VMC HAZE VMC HAZE
Visibility: 5km into Sun
Reported Separation:
50ft V 200m H c200ft V ~1/4nm H
Recorded Separation:
NR

Cause: Unauthorised penetration of the Syerston ATZ, in hazy conditions, by the C182 pilot, who flew into conflict with the Vigilant.

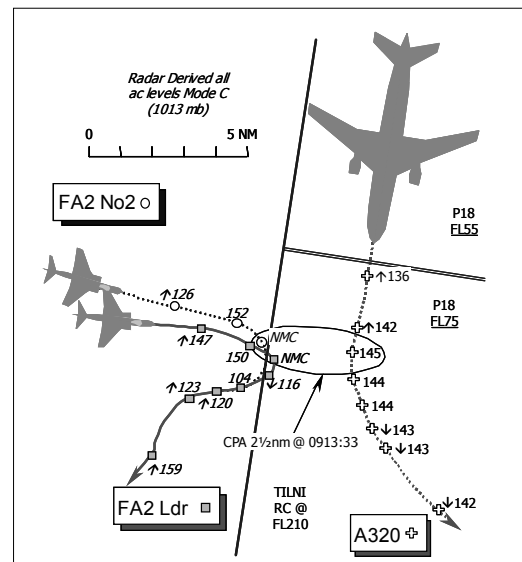
AIRPROX REPORT NO 28/03

Date/Time: 31 Mar 0913
Position: 5440N 0200W (7nm NW of TILNI)
Airspace: Airway P18 (Class: A)
Reporting Aircraft Reported Aircraft
Type: A320 Sea Harrier
 FA2x2
Operator: CAT HQ STC
Alt/FL: FL147↑ ↑FL190
Weather NR VMC nil Cloud
Visibility: 10km+ 10km+
Reported Separation:
 200ft V/2nm H Not seen
Recorded Separation:
 2.5mn H

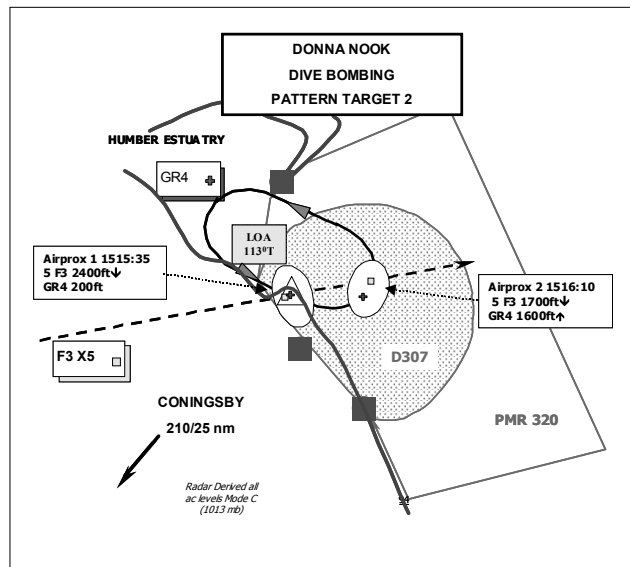
AIRPROX REPORT NO 29/03

Date/Time: 27 Mar 1515
Position: 5330N 0010E (Donna Nook Range)
Airspace: D307/PMR320
Reporting Aircraft Reported Aircraft
Type: Tornado F3x5 Tornado GR4
Operator: HQ STC HQ STC
Alt/FL: 2000ft 2500ft
 (QFE 1018 mb) (Rad Alt)
Weather VMC HAZE VMC HAZE
Visibility: 8KM 5KM
Reported Separation:
 0ft V ½ nm H 0ft V 1 nm H
Recorded Separation:
 1: 2200ft V 0H
 2: 100ft V 1nm H

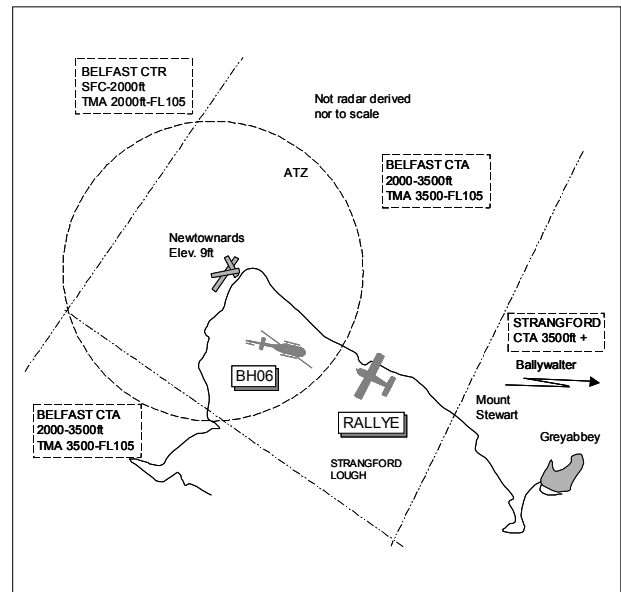
AIRPROX REPORT NO 30/03

Date/Time: 22 Mar 1705 (Saturday)
Position: 5434N 0540W (1nm SE Newtownards A/D - elev 9ft)
Airspace: ATZ (Class: G)
Reporting Aircraft Reported Aircraft
Type: BH06 JetRanger Rallye110
Operator: Civ Trg Civ Pte
Alt/FL: 1000ft 1200-1500ft
 (QFE 1020mb) (QNH)
Weather VMC HZBC VMC HZBC
Visibility: 4000m 1-2nm
Reported Separation:
 nil V 100ft H 200-400ft V
 0.25-0.33nm H
Recorded Separation:
 NR

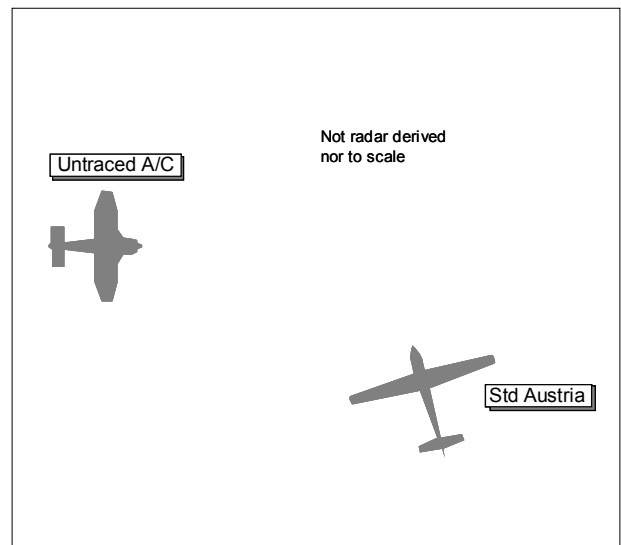
AIRPROX REPORT NO 31/03

Date/Time: 30 Mar 1208 (Sunday)
Position: 5346N 0105W (1.2nm N of Burn G/S - elev 20ft)
Airspace: FIR/AIAA (Class: G)
Reporting Aircraft Reported Aircraft
Type: Std Austria Glider Untraced
Operator: Civ Pte NK
Alt/FL: 1300ft
 (QFE 1016mb) (NK)
Weather VMC CLBC NK
Visibility: >30nm
Reported Separation:
 300-400ft V
Recorded Separation:
 NR

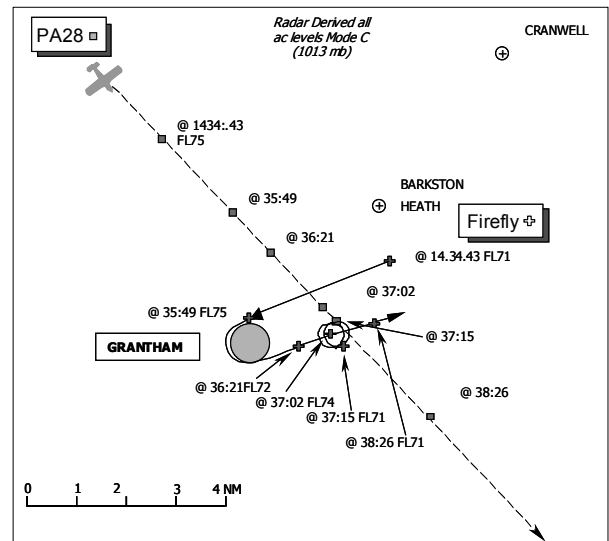
Date/Time: 4 Apr 1437
Position: 5257N 0033 W (Grantham Lincs)
Airspace: Lincs AIAA (Class: G)
Reporting Aircraft Reported Aircraft
Type: PA28-161 Firefly 260
Operator: Civ Pte HQ PTC
Alt/FL: FL75 FL75

Weather VMC VMC
Visibility: 30km 10km+
Reported Separation:
0 V < 1nm H 100ft V 1nm H
Recorded Separation:
100ft V 0.75nm H

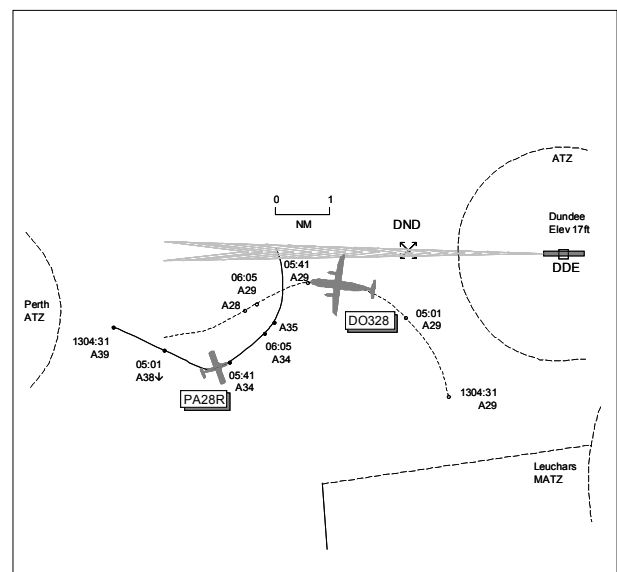
AIRPROX REPORT NO 33/03

Date/Time: 14 Apr 1306
Position: 5626N 0312W (3nm WSW DND NDB)
Airspace: FIR (Class: G)
Reporting Aircraft Reported Aircraft
Type: DO328 PA28R
Operator: CAT Civ Trg
Alt/FL: 3000ft↓ 3500ft
 (QNH 1015mb) (QNH 1015mb)
Weather IMC HZBL VMC CLAH
Visibility: 6km 8km
Reported Separation:
 300ft V nil H 1000ft V 2nm H
Recorded Separation:
 500ft V 0.56nm H

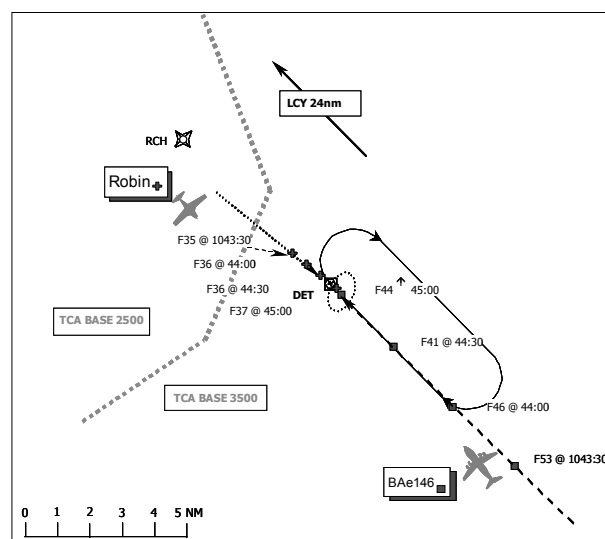
AIRPROX REPORT NO 35/03

Date/Time: 14 Apr 1045
Position 5121N 0036E (3nm SE DET)
Airspace: London TCA (Class: A)
Reporting Aircraft Reported Aircraft
Type: BAE146-200 Robin DR500
Operator: CAT Civ Trg
Alt/FL: 4000ft FL39
(QNH 1012mb)
Weather VMC HAZE VMC
Visibility: 5km
Reported Separation:
200ft V 0 H NK
Recorded Separation:
0 H 700ft V

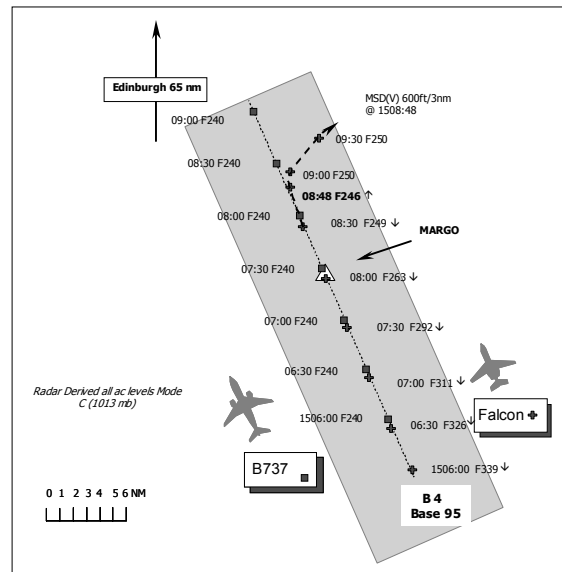
Date/Time: 22 Apr 1509
Position: 5450N 0248W (10nm S Carlisle)
Airspace: UIR/Airway B4 (Class: A/B)
Reporter: ScACC

<u>First Aircraft</u>	<u>Second Aircraft</u>
<u>Type:</u> Falcon10	B737-500
<u>Operator:</u> Civ Exec	CAT
<u>Alt/FL:</u> FL246	FL240
<u>Weather</u> VMC CAVOK	NK
<u>Visibility:</u> Unlimited	NK
<u>Reported Separation:</u>	
NK	NK
<u>Recorded Separation:</u>	
600ftV c3nmH

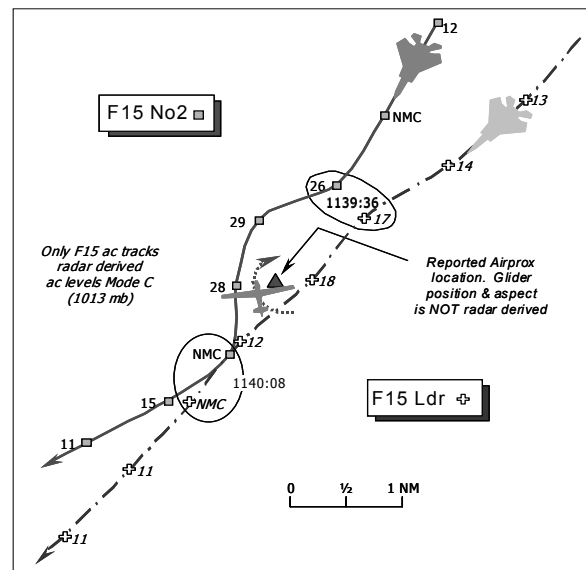
AIRPROX REPORT NO 38/03

Date/Time: 23 Apr 1139
Position: 5141 N 0213 W (Minchinhampton Common)
Airspace: London FIR (Class: G)
Reporting Aircraft **Reported Aircraft**
Type: K8 Glider F15E x 2
Operator: Civ Club Foreign Mil
Alt/FL: 2400ft NK
 (QFE) (Rad Alt)
Weather VMC Haze VMC Slight Haze
Visibility: 9-10nm 15km
Reported Separation:
 Not quantified 500ft H
Recorded Separation:
 NR

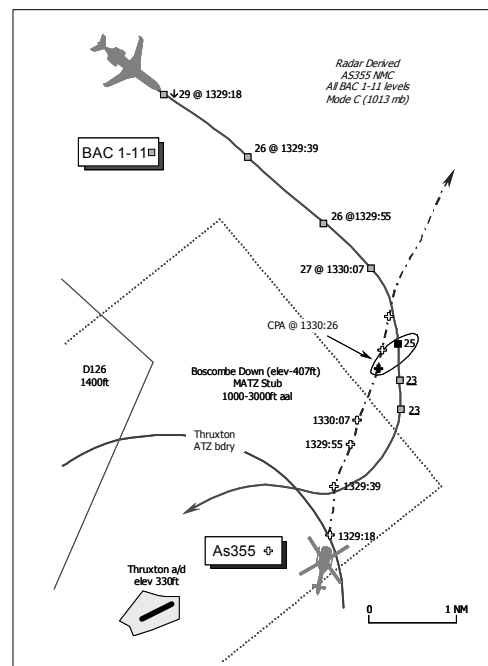
Cause: Conflict on the approach to RW23 at Boscombe Down.

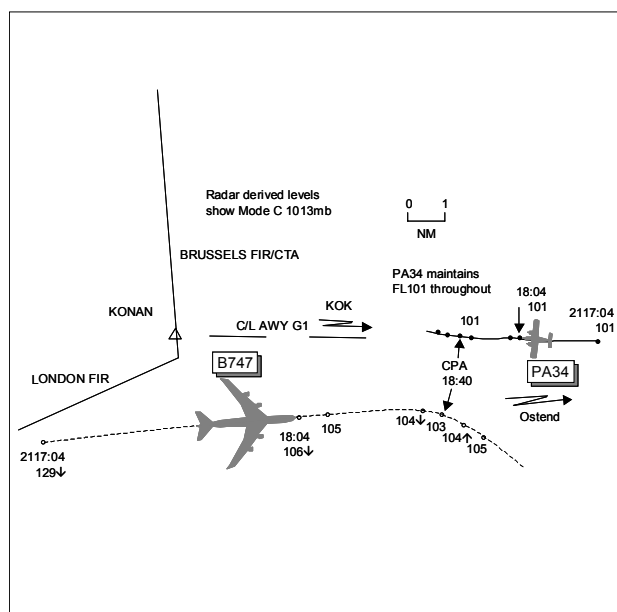
- a. The S15-18T DVR Mentor allowed her trainee to descend the B747 through the level occupied by the PA34.
- b. The developing conflict went undetected during a handover that was both inadequate and contrary to MATS Part 1.

It is recommended that NATS Management review the activation process of STCA on the Tactical Controller position at LACC. Not only should this consider the appropriateness and positioning of the ‘Alert Indicator’ but also investigate the possibility of the ‘flashing SSR labels’, associated with STCA activation, being able to show through any displayed window on the radar display. If this is discovered not to be feasible, it is suggested that a system similar to that in use at LTCC be considered. This unit’s equipment displays information on the ac concerned i.e. their callsigns and respective levels, in a box at the edge of the screen, this being in addition to their actual SSR labels flashing.

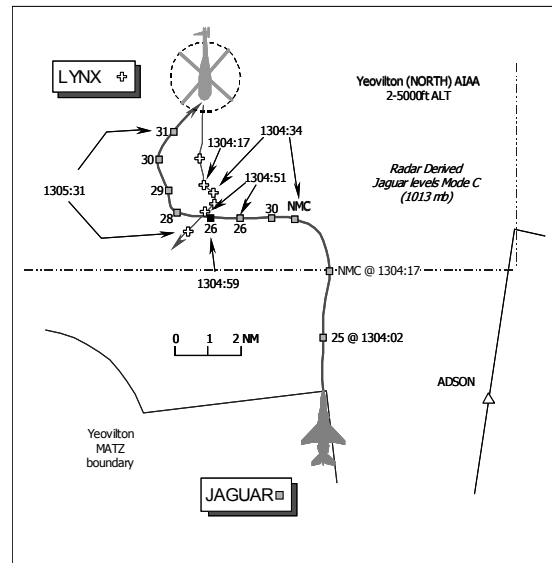
AIRPROX REPORT NO 42/03

Cause: The Jaguar pilot turned into conflict with the Lynx.

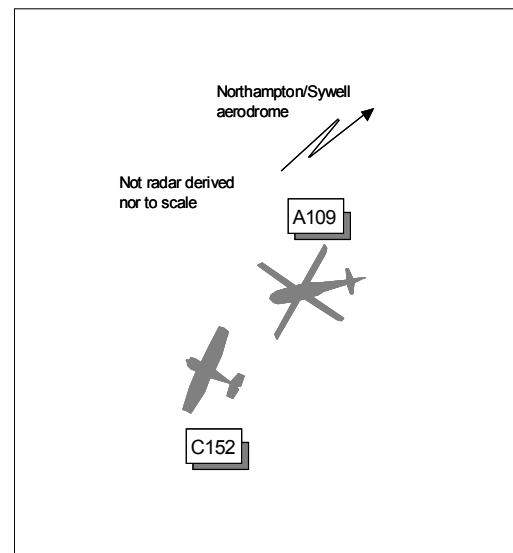
AIRPROX REPORT NO 43/03

Cause: The A109 pilot flew into conflict with the C152.

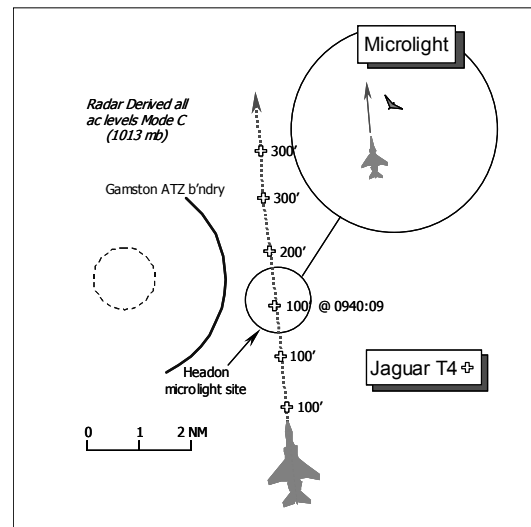
AIRPROX REPORT NO 44/03

Cause: A conflict in the LFS/FIR.

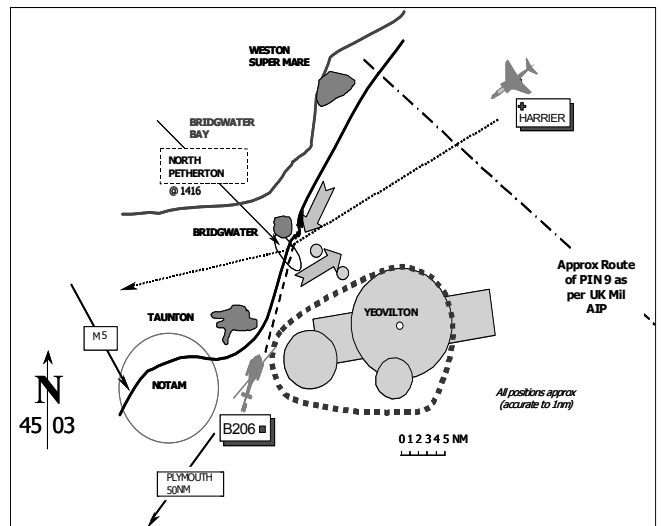
AIRPROX REPORT NO 45/03

Cause: The Harrier pilot flew close enough to the JetRanger to cause concern to its pilot who did not see the Harrier until it passed below his helicopter.

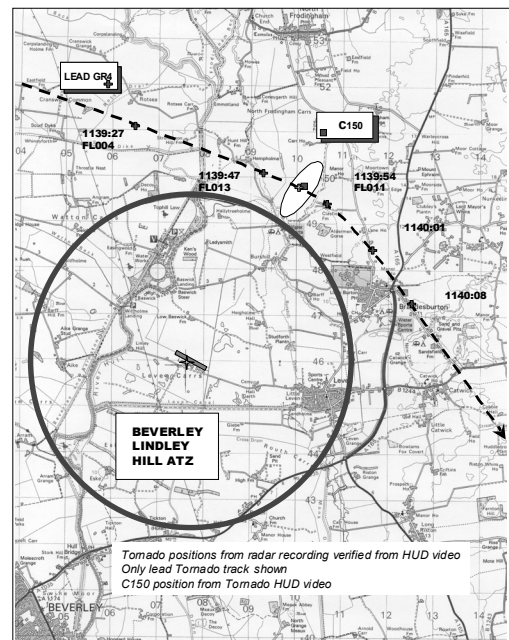
THE C150 PILOT reports that he was on an instructional sortie from Beverley Linley Hill in a white C150 with red stripes in receipt of an Air Ground service from Beverley squawking 7000 but Mode C was not fitted. While heading 300° at 78 kt on the downwind leg of a visual circuit he had an Airprox with 4 Tornados, later identified by Humberside. First sighting was at 350m range with the Tornado passing 7m above. No further details were given.

The C150 pilot thought that the circuit he was flying was within the confines of the ATZ, whereas the actual pattern flown was considered by GA specialists on the Board to be excessively wide. Although the wind was from the SW, it was not deemed to be of a strength such that it was a significant factor. It was therefore most likely that the pilot was primarily concentrating on instructing his student which may have degraded his routine lookout. Further it appeared from his report that although he saw the leader, he was not aware of the number 2 and 3 ac in 2 and 4nm trail respectively which were also a threat to him, albeit with slightly more lateral displacement.

Given these conditions, neither the Tornado pilot nor the C150 pilot had been in a position to influence in any way the final separation distance between them as they passed each other in opposing directions. What little separation that had existed was a matter of chance and for that reason members concluded that there had been an actual risk of collision.

Cause: A non-sighting by the Tornado lead crew and a very late sighting by the C150 pilot, too late to take any avoiding action.

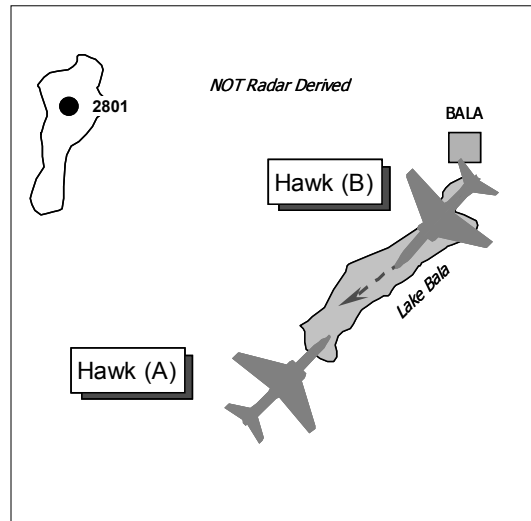
AIRPROX REPORT NO 65/03

Date/Time: 2 Jun 1305
Position: 5254N 0337W (Lake Bala)
Airspace: UKDLFS - LFA7 (Class: G)
Reporting Aircraft Reported Aircraft
Type: Hawk Hawk
Operator: HQ PTC HQ PTC
Alt/FL: 250ft 400ft
(msd) (msd)
Weather VMC CLBC VMC CLBC
Visibility: +20km 15KM
Reported Separation:
nil H, 100ft V 100ft V
Recorded Separation:
NR

THE PILOT OF HAWK (A), a QFI instructing a student seated in the front seat, reports that his ac has a black colour scheme and the HISL and 'nose' light were on whilst conducting a low-level instructional sortie in LFA 7 as a singleton at 420kt. The low-level conspicuity squawk of A7001 was selected with Mode C but TCAS is not fitted and they were listening out on the LFS frequency of 300.8MHz.

Cause: A High speed head-on conflict resolved in the final stages by the student pilot of Hawk (B) and the QFI of Hawk (A).

The extension to the lateral limits of EG-R218 in 2001 has affected the flow of low-level ac in the northern half of LFA7. As it is located in low ground with higher ground around, it has become more difficult to pass it in poorer weather conditions. Alternative routeing is either through D202, when inactive, or via the 'Northern plain' or Snowdonia. In this latter case, the Bala Valley (Between Lake Bala and Machynlleth loop) is often preferred routing for ac flying both N and S. Accordingly, the wider implications of extending restricted areas needs to be considered and, in particular, the dimensions of EG R218 should be reviewed.

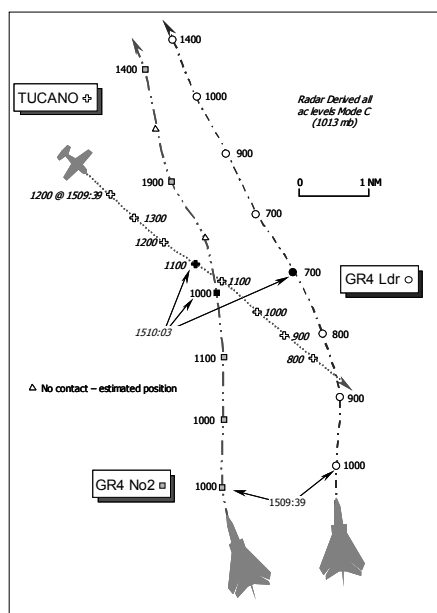
THE TUCANO PILOT, a QFI with another QFI in the front seat, reports his ac has a black and yellow colour scheme and the landing lights were on whilst conducting a low-level sortie as a singleton in LFA 17. They were flying in VMC, 2000ft below HAZE, monitoring the LFS frequency of 300-8MHz, squawking A7001 with Mode C, but neither TCAS nor any other form of CWS is fitted.

Although the Tucano pilot reported he had detected the GR4 at 500m and had bunted underneath, it was evident that, exceptionally, the radar recording had not captured this geometry. Given the tolerances applicable to unverified Mode C, as both pilots' reports agreed in this respect, the Board accepted that the Tornado had indeed over flown the turboprop. Fast jet pilot members observed that in these situations with an almost head-on aspect and with a closing speed in the order of 660kt – 11nm/min - the human eye/brain was not able to judge range accurately. Here the GR4 navigator had first seen and called the Tucano (where perhaps understandably he had mistaken the ac's colour scheme in the momentary period that he saw it) 200m away at the same time as the pilot pulled up to climb above it. At these closing speeds, a distance of 200m would be covered in about two thirds of a second and it is generally accepted that the time required to see another ac, take action to avoid it and actually alter the jet's flight path would take in the order of 2sec. Notwithstanding the No2 GR4 pilot's candid account, members thought that the crew had probably seen the Tucano at a range greater than 200m, though this did not diminish the seriousness of the encounter in any way. The Board agreed unanimously that an extremely late sighting by both the Tucano and No2 Tornado crews had caused this Airprox.

Cause: Extremely late sighting by both the Tucano and No2 Tornado crews.

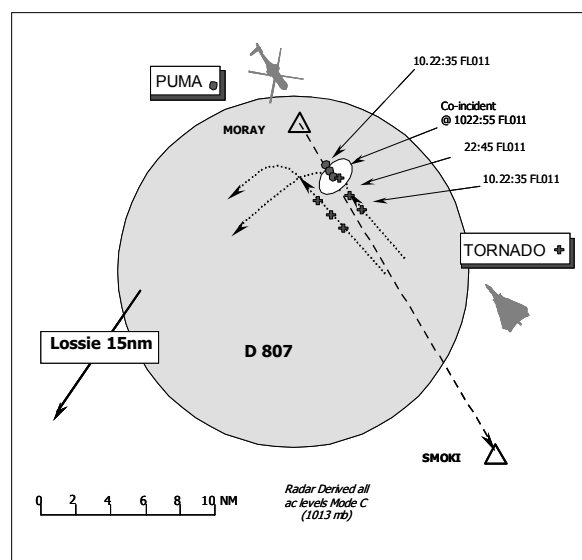
THE AS332 PILOT reports heading 165° at 1000ft on a RPS of 1004 and at 125 kt on a transit from an oilrig ~120nm NNW of Wick to Aberdeen in an orange, blue and white AS332. He was in receipt of a FIS from Lossiemouth and was squawking a Lossiemouth code with Mode C. Both the pilot and the co-pilot saw 2 Tornados manoeuvring at approx 5/6nm in their 12 o'clock and saw one turn and head directly towards them at the same height. The pilot asked Lossiemouth if they had any 'fast movers' on radar and the controller replied that he had not. He then told Lossiemouth that he had an ac coming straight towards him "on the nose" but the controller again replied that he had nothing showing on his radar.

The reason for this error was that Lossiemouth ATC had not received notification of the booking from Kinloss (who control D807) due to a broken fax and a lack of communication. This breakdown in communication has already been investigated and procedures have been put in place to prevent a recurrence.

Cause A conflict within D 807 resolved by both pilots.

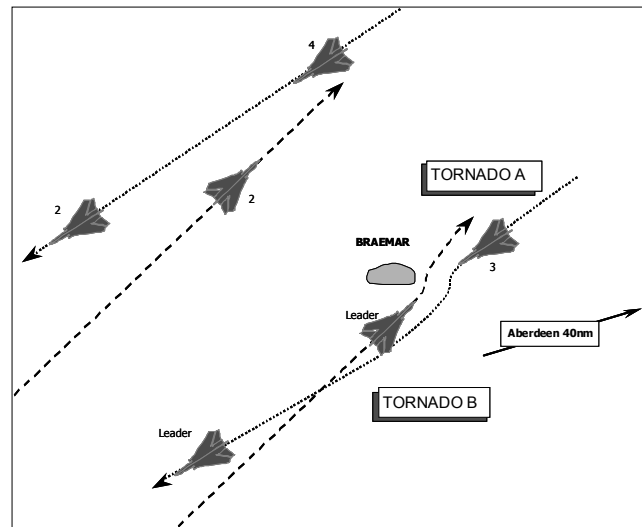
THE TORNADO GR4 PILOT (Formation A) reports that he was the back left ac in a 4-ship of grey ac squawking 7001C, with HISLs on, flying in card formation in good visibility on a tactical sortie in LFA 14 and not in receipt of an ATC service. While heading 240° at 470kt and 430ft AGL he saw the lead ac of another Tornado GR4 formation exiting a valley in a right hand turn at the same height 1km ahead. He manoeuvred hard into a climbing left hand break and the ac passed right-right. He assessed the risk of collision as high.

The acquisition conditions in this encounter were most demanding in that the aspect was head-on and the closing speed was about 900kt which equates to >15nm/min. Both pilots, however, saw the other ac and took successful, albeit late, avoiding action. While this removed the risk of an actual collision, the Board agreed unanimously that the safety of the ac concerned had not been assured.

Cause: Terrain masking prevented earlier sightings by all crews.

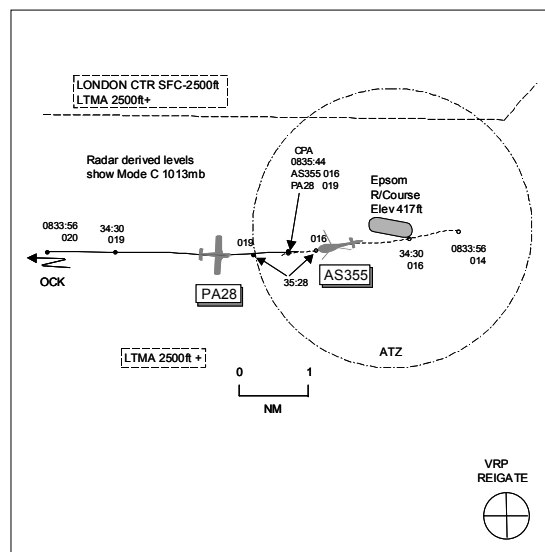
THE AS355 PILOT reports heading 275° at 90kt flying solo en route from Norwich to Fairoaks at 1750ft QNH and in receipt of a FIS from Farnborough on 125.25MHz, he thought. The visibility was 15km, 2000ft below cloud in VMC, the ac was coloured silver/black and the anti-collision, strobe, position and landing lights were all switched on. Having passed through the Epsom temporary ATZ, he thought, whilst in two-way communications with Epsom and Farnborough, he spotted a blue/white low winged single engine ac 250m ahead. He executed a descending L turn through 30° to avoid it, passing 200ft below and almost directly underneath the other ac. As the traffic passed he made a R banked turn, with increasing torque to create a loud 'blade slap' which produced no reaction from the other ac's pilot. He assessed the risk of collision as high.

Clearly there had been a misunderstanding by the AS355 pilot about being afforded some protection (i.e. flying in an ATZ promulgated by NOTAM), which was subsequently found to be incorrect - the NOTAM showed an activation time of 0900Z. Although the PA28 pilot had not obtained the correct NOTAM information prior to departure, as chance would have it, this had not affected the outcome during his transit of the area. Consequently, in the absence of promulgated airspace, this had been an encounter in the 'open' FIR (Class G airspace) and the Airprox was assessed accordingly. Both pilots had been going about their 'lawful business', whilst flying under VFR, and had flown into conflict which had caused the Airprox.

Cause: Conflict in the FIR

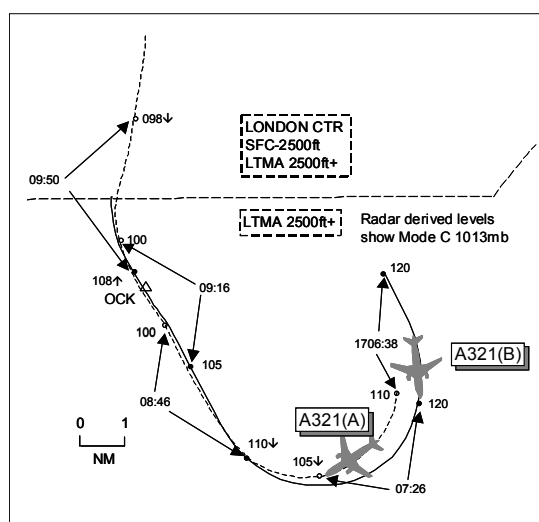
THE A321(A) PILOT reports flying inbound to Heathrow holding at OCK at FL100, at 220kt and in receipt of an ATS from Heathrow DIRECTOR on 119.72MHz. The visibility was unlimited whilst flying in VMC on top of a cloud layer and the ac's nav and strobes were switched on. He noticed an 'intruder' ac on TCAS 1000ft above and behind descending into conflict which was subsequently given climb and turn clearance by ATC. This clearance was misread by the 'intruder' pilot who seemed pre-occupied, possibly with a TCAS RA alert, he thought. At this point, flying inbound to the VOR on a 332° heading, he asked his co-pilot to disconnect the A/P and to be ready to take avoiding action. He received clearance for an immediate turn onto heading 360° and descent

It was clear that this Airprox had been caused by those on the flight deck of A321(B), who descended below their cleared flight level. Although the FO had been distracted by the Check Pilot at a critical time, when the descent clearance had been given, members were critical of the Capt, in that he could and should have

Cause: The crew of A321(B) descended below their cleared flight level.

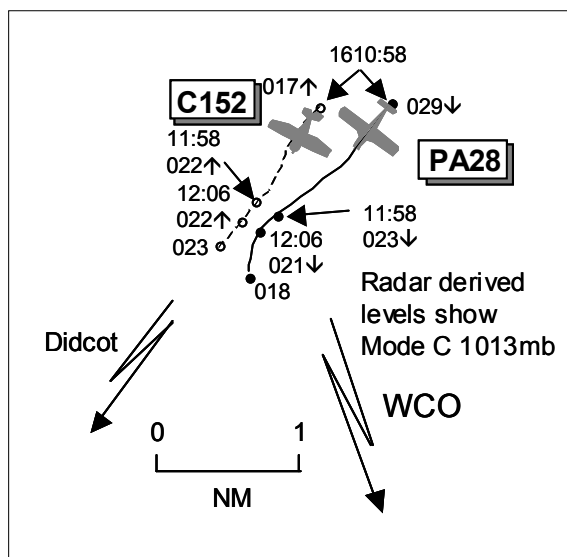
THE C152 PILOT reports flying a dual training sortie from Halton and in communication with Halton RADIO on 130.42MHz squawking 7000 with Mode C. The visibility was 40km 2000ft below cloud in VMC, the ac was coloured white/green and the nav, landing and strobe lights were all switched on. The student was carrying out a climbing/descending exercise and, prior to commencing climb, was using Didcot Power

Members found it hard to believe that the PA28 pilot had not seen the C152, particularly when the C152 student and instructor could see the PA28 clearly close by. Both flights were being conducted in the student-training regime where 'in-cockpit' teaching requires good CRM to be exercised - to balance the 'heads-in' monitoring with maintaining a lookout scan. The opportunity had been there to see the Cessna ahead, whilst descending on a slowly converging track at a slow overtaking speed; a good lookout scan should have disclosed the conflicting Cessna's presence. However, from the information given to the Board, it was agreed that the PA28 pilot had flown into conflict with the C152, which she did not see.

Cause: The PA28 pilot flew into conflict with the C152 which she did not see.

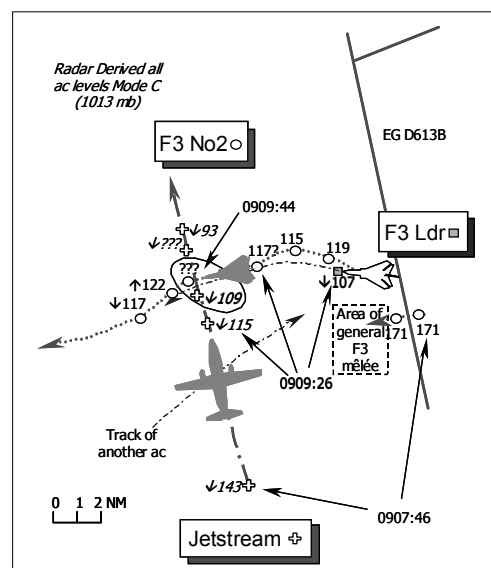
THE TORNADO F3 PILOT reports he was flying as the No2 of a pair of camouflage grey F3s that had been conducting air combat training in the vicinity of D613B, but which had not been specifically activated for their use. They were operating under a RIS from Scottish MILITARY and the assigned squawk was selected with Mode C, but neither TCAS nor any other form of CWS is fitted; the HISL was on.

Cause: A conflict in the FIR resolved by the No2 F3 crew after traffic information had been passed.
