UK AIRPROX BOARD

Analysis of Airprox in UK Airspace

Report Number 10
January 2003 - June 2003

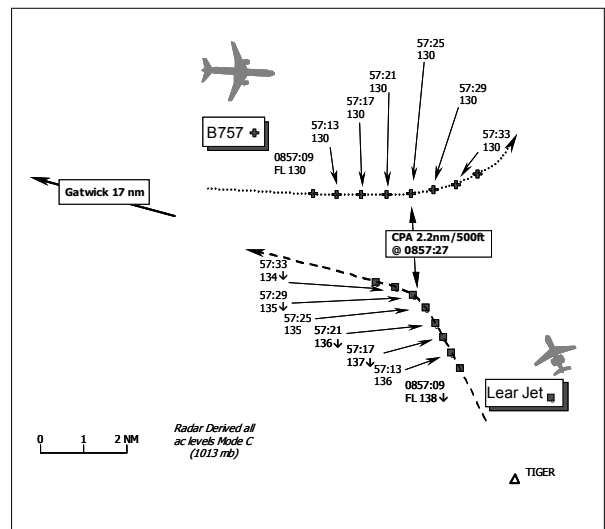
THE B757 PILOT reports heading 090° at 300kt shortly after take off from Gatwick and was instructed to route direct to DVR climbing to FL140. When passing FL120 he noted a target on the TCAS at FL140 in his 2 o’clock at approx 10nm showing FL140 descending. He selected VS 0ft, levelled at FL130 and a TCAS TA was

Having recognised his error he issued avoiding action to the B757 but there was no reply so reissued it with TI. The Learjet was then given an avoiding turn to the left. There was no mention of TCAS by either ac but the B757 was noted in level flight at FL130 at some stage, which he thought may have affected the minimum vertical separation achieved.

Cause: The LTCC TC SE SC vectored the B757 and Learjet into conflict.

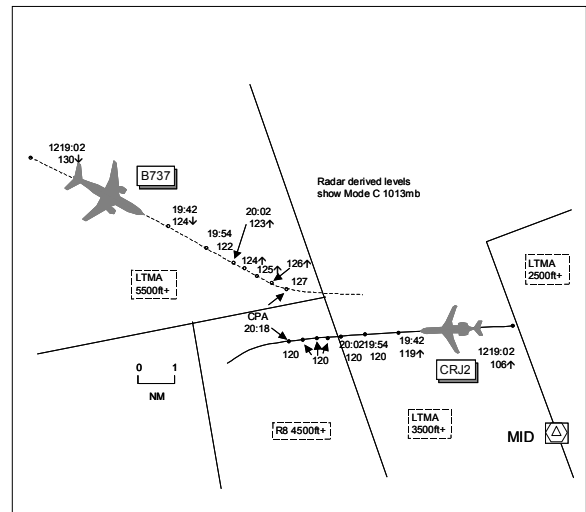
Date/Time: 12 Jun 1220
Position: 5106N 0051W (8nm NW MID)
Airspace: LTMA (Class: A)
Reporter: LTCC OCK SC

THE LTCC OCK SC reports that at the time of the incident the situation had been complex, involving Farnborough and Bournemouth traffic, further compounded by other ac entering the Sector 'high' and descending. The B737 was co-ordinated with the WILLO Sector from FL140 to FL110 and was issued with descent clearance. The CRJ2 outbound from Gatwick was given a step climb to 5000ft, FL100, FL120 and eventually FL150 after he assessed that the projected tracks of the subject ac were suitable. However, the B737 pilot reported "TCAS" and, although he had no time to give 'avoiding action', he gave turns to both ac to improve the situation during the separation loss. He assessed the ac passed 400ft vertically and 2nm horizontally apart.

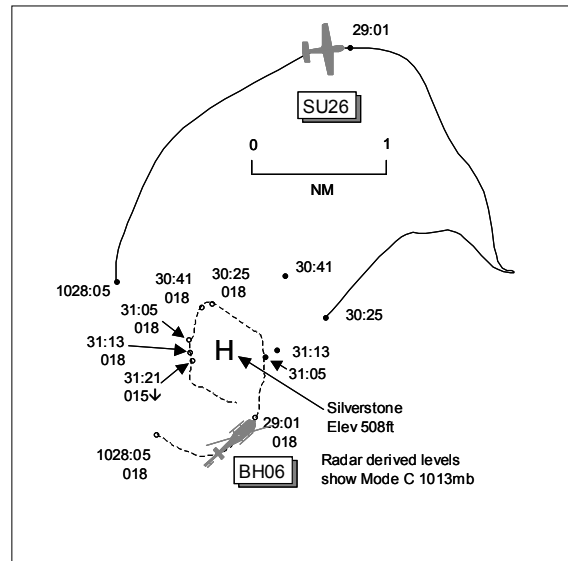
AIRPROX REPORT NO 78/03

Date/Time: 15 Jun 1031
Position: 5204N 0101W (O/H Silverstone - elev 508ft)
Airspace: FIR (Class: G)
Reporting Aircraft Reported Aircraft
Type: BH06 JetRanger Sukhoi SU26
Operator: Civ Comm Civ Comm
Alt/FL: 2000ft AEROS
 (QNH 1020mb) (N/K)
Weather VMC CLNC VMC CAVOK
Visibility: 30km NK
Reported Separation:
 300m H 0.5nm H
Recorded Separation:
 0.5nm H

THE BH06 JETRANGER PILOT reports flying on a local sortie (rebroadcast of racing) from Silverstone making blind calls on Silverstone frequency 121.07MHz and being in receipt of a FIS from Cranfield on 122.85MHz squawking 7000 with Mode C. The visibility was 30km in VMC, the helicopter was coloured black/silver and the strobe, position, pulse, landing and anti-collision lights were all switched on. His activity had been NOTAM'd. Flying at 2000ft QNH (Cranfield 1020mb) in a 5° AOB L turn, passing through 180°, at 60kt, he saw a blue/red coloured Sukhoi aerobatic ac in his 9 o'clock position range 300m in a vertical climb passing through his level streaming white smoke. The sortie was abandoned and an autorotation was entered to land at Silverstone whilst the Sukhoi continued to display. As he made his approach to the heliport, the Sukhoi's lowest altitude was seen to be 350ft agl and it continued to display for 15min in the Silverstone overhead. No blind calls were made by any other ac during his sortie and no squawk was observed on TCAS. Also, no other activity had been NOTAM'd to take place nor notified by the event organisers. He assessed the risk as medium.

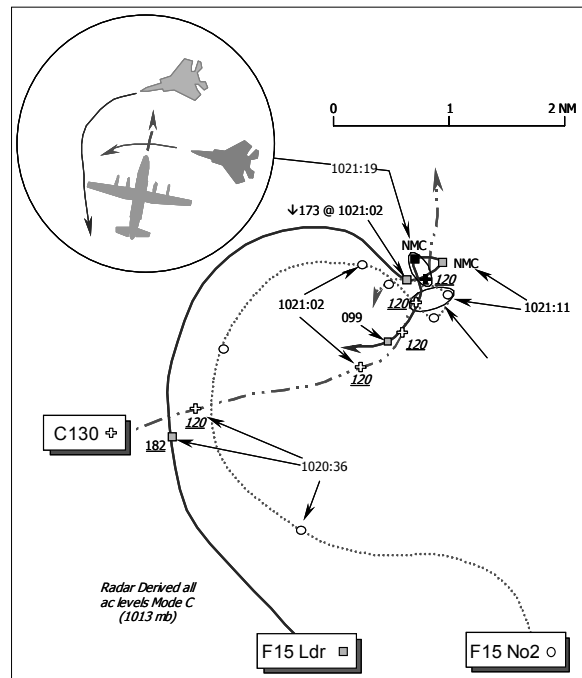
AIRPROX REPORT NO 79/03

Date/Time: 18 Jun 1021
Position: 5251N 0100E (8nm E of Sculthorpe elev - 214ft)
Airspace: London FIR (Class: G)
Reporting Aircraft Reported Aircraft
Type: C130 F15Cx2
Operator: HQ STC Foreign Mil
Alt/FL: 12200ft FL140
 (QNH 1017mb)
Weather VMC VMC NR
Visibility: 40km NR
Reported Separation:
 vF15 Ldr/300m H, nil V 3000ft
 vF15 No2/100m H, nil V
Recorded Separation:
 vF15 Ldr >400m vF15 No2 NR

THE C130 PILOT reports his ac has a grey camouflage scheme but the HISL was on whilst inbound to Sculthorpe Drop Zone (DZ) at 190kt for a paratroop drop and was in receipt of a RIS from Marham on 362.75MHz. A squawk of A0033 was selected with Mode C, but neither TCAS nor any other form of CWS is fitted.

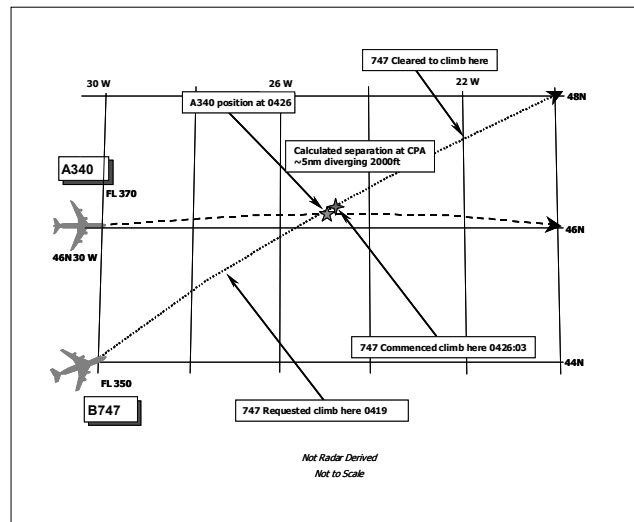
SCOACC reports that a B747 was routing French Antilles to Paris. When it was at position 4615N 2450W he cleared the pilot to climb from FL350 to FL370 after passing 22W. The pilot, however, initiated a climb immediately and came into conflict with an A340 at FL370. As soon as he was aware that the ac had commenced a climb he issued an avoiding action, immediate descent instruction. He informed the pilot that reporting action would be taken. He estimated that the separation at the CPA was 8nm and 0ft vertically.

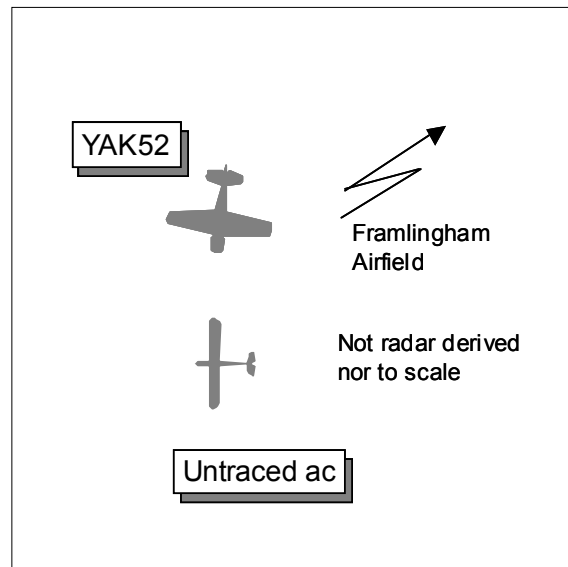
AIRPROX REPORT NO 81/03

Date/Time: 15 Jun 1337 (Sunday)
Position: 5210N 0120E Easton (13nm E Wattisham)
Airspace: FIR (Class: G)
Reporting Aircraft *Reported Aircraft*
Type: YAK52 Untraced light ac
Operator: Civ Pte NK
Alt/FL: 500ft NK
 (QFE) (NK)
Weather VMC CLNC NK
Visibility: 10km NK
Reported Separation:
 <50ft V NK
Recorded Separation:
 NR

THE YAK52 PILOT reports flying an aerobatic display with Article 70 permission at Easton and he was listening out with Elmsett RADIO on 130.9MHz; no transponder was fitted. The visibility was 10km in VMC and the ac was coloured white/yellow and black and carried no lighting. Heading 190° at 160kt rolling out of a 45° dive during the 'pull up' recovery from a 'Cuban eight' manoeuvre, a white coloured high wing single engine ac with tricycle u/c and thin fuselage, possibly a Jabiru or similar type, was seen about 25-30m ahead, crossing the display line L to R (E to W) at the same height (500ft agl). He took 'severe' avoiding action by diving his ac, passing <50ft immediately underneath the other ac, whose pilot appeared to be unaware of the occurrence, and he assessed the risk as serious. The incident was witnessed by other pilots on the ground who thought the offending ac might have been from Framlingham airfield close by (3nm to the NE). This had been the second time that this sort of encounter had happened to him and he believed that a major factor in the incident was that, although all the paperwork had been completed and permission granted (CAA Ref 9/99/15-1027/2003), no NOTAM had been issued for this single item display/event. Bearing in mind the ease of NOTAM information gathering available to pilots via on-line systems (internet),

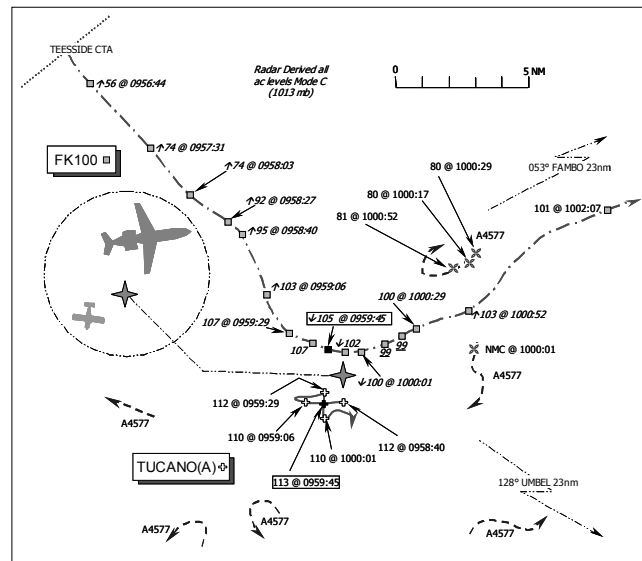
AIRPROX REPORT NO 82/03

Date/Time: 16 Jun 0959
Position: 5416N 0100W (233°(T) FAMBO 23nm)
Airspace: Vale of York AIAA (Class: G)
Reporting Ac **Reported Ac**
Type: FK100 Tucano
Operator: CAT HQ PTC
Alt/FL: FL100↑ Manoeuvring (NK)
Weather VMC NR VMC
Visibility: 10km+ NR
Reported Separation:
 Not seen Not seen
Recorded Separation:
 v Tucano (A): 2.03nm H, 800ft V

THE FK100 PILOT reports [some three weeks after the event] that his ac has a blue & white livery and the HISL was on whilst climbing outbound under IFR from Teesside for Amsterdam. He was in receipt of a RAS from Teesside RADAR and squawking the assigned code of A7310 with Mode C; TCAS is fitted.

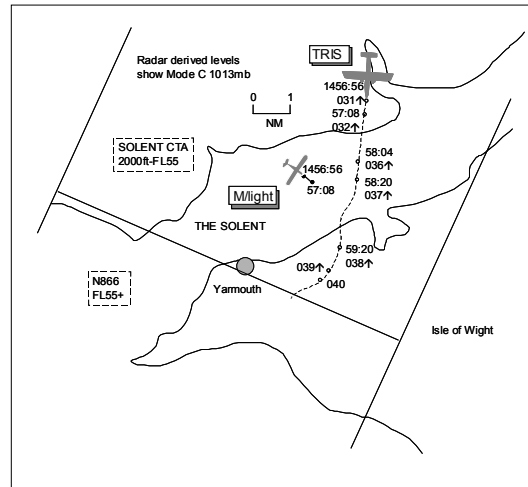
AIRPROX REPORT NO 83/03

Date/Time: 21 Jun 1159 (Saturday)
Position: 5043N 0126W (15nm SSW SAM)
Airspace: Solent CTA (Class: D)
Reporting Aircraft **Reported Aircraft**
Type: TRIS Untraced M/Light
Operator: CAT NK
Alt/FL: FL037↑ NK
Weather VMC CLNC NK
Visibility: >30km
Reported Separation:
 100ft V
Recorded Separation:
 NR

THE TRIS PILOT reports en route from Southampton to the Channel Islands heading 180° climbing to FL40 at 100kt and in receipt of a RCS from Solent RADAR on 120.22MHz squawking 0334 with Mode C. The visibility was >30km with no cloud in VMC, the ac was coloured yellow/blue and the anti-collision and landing lights were switched on. Climbing through FL037, he saw a high wing 'pusher' type Microlight to the R of his nose 150m away crossing R to L in level flight. He increased his ROC and passed 100ft above the conflicting ac which had white wings and a yellow cabin. He assessed the risk of collision as moderate to high.

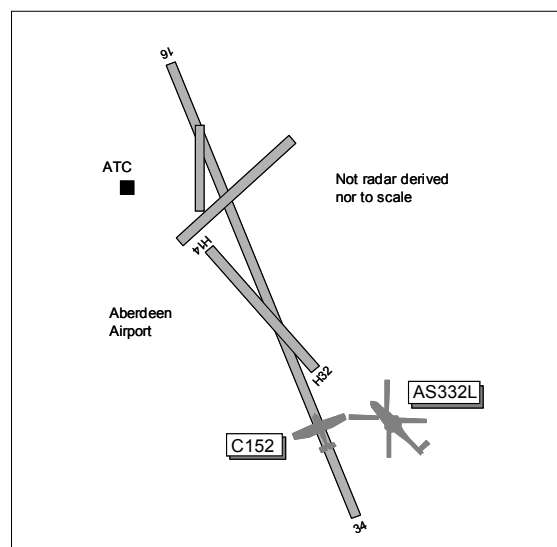
THE C152 PILOT reports he was a student PPL flying a solo cct training sortie from Aberdeen on RW34 RH and in receipt of an ATS from Aberdeen TOWER on 118.1MHz. The visibility was 40km beneath an overcast cloudbase in VMC and the anti-collision, landing and nav lights were all switched on. He had been cleared for a touch and go on RW34 and was aware, from the RT, of inbound helicopter traffic which he heard call 'visual with the landing'; he completed his approach and landing. On raising the flaps and applying full power, he became aware of a helicopter overhead and close to his port side. At this point, he felt it was unsafe to abort his take-off so carried on into a shallow climb. When passing the RW34/32 intersection at 100ft QFE and 70kt, he asked ATC for an early R turn, as the helicopter, estimated to be 50ft above him, appeared to be turning back across his path from L to R. The request was denied, ATC asking him to carry on as the helicopter was accelerating away; the remainder of the cct was completed without incident. He assessed the risk of collision as high with a potential vortex wake hazard.

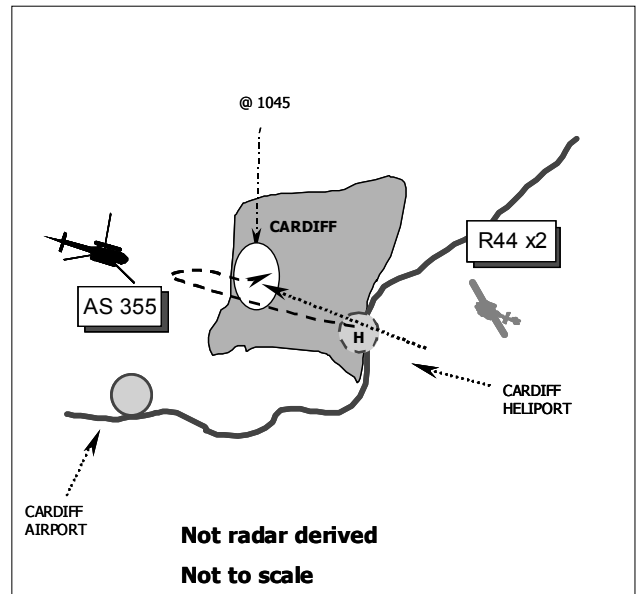
AIRPROX REPORT NO 85/03

Date/Time: 18 Jun 1045
Position: 5132N 0313W (Cardiff City (West) - elev 220ft)
Airspace: London FIR (Class: G)
Reporting Aircraft Reported Aircraft
Type: Twin Squirrel R44 x2
Operator: Civ Comm Civ Pte
Alt/FL: 700ft N/K
 (QNH 1017mb)
Weather VMC below cloud N/K
Visibility: 2 - 5km in Mist N/K
Reported Separation:
 c500m H c200ft V N/K
Recorded Separation:
 NR

THE TWIN SQUIRREL PILOT reports flying a police task in a dark blue and yellow ac squawking 7015C with HISLs on, in receipt of a FIS from Cardiff. While heading 110° at 70kt, 5 minutes

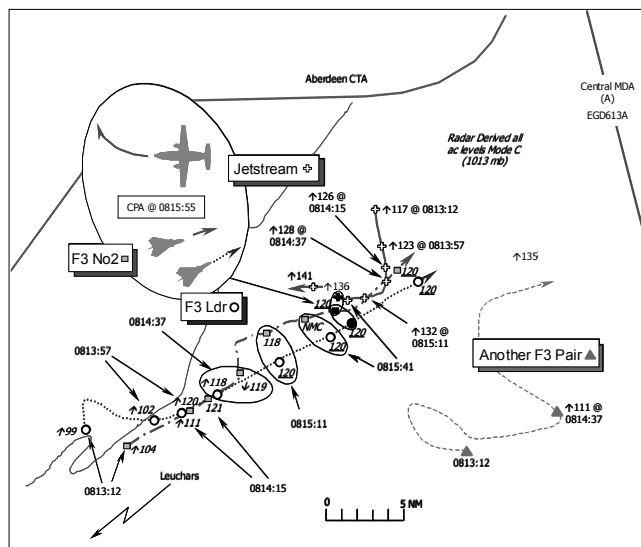
AIRPROX REPORT NO 86/03

Date/Time: 24 Jun 0815
Position: 5653N 0212W (29nm NE of Leuchars)
Airspace: Scottish FIR (Class: G)
Reporter: Aberdeen APR
First Ac Second Ac
Type: Jetstream JS32 Tornado F3 pr
Operator: CAT HQ STC
Alt/FL: ↑FL195 FL120
Weather VMC CLBL VMC NR
Visibility: 30km 40km+
Reported Separation:
Aberdeen APR: 1.5nm H, 1200ft V
500 yd H, 1-2000ft V 2nm H, 2000ft V
Recorded Separation:
Jetstream v No2 F3: 0.75nm H, 1600ft V

THE ABERDEEN APPROACH RADAR CONTROLLER (APR) reports that the Jetstream departed Aberdeen bound for Leeds/Bradford squawking A5077 with Mode C and was turned L onto a radar heading of 180°. When leaving the CTA the flight was placed under a RAS and the crew's flight conditions were confirmed as "good VMC". He had observed 2 military contacts squawking A0206/7 operating on a racetrack pattern between 25nm SE and 40nm S of the Airport at FL120 [shown as another F3 pair]. Then 2 further contacts squawking A0214 & 0215 – the subject F3s - appeared climbing out from Leuchars heading NE so he elected to co-ordinate the Jetstream's transit with Leuchars against their departing ac. When the intentions of the 0214/5 were queried he was told they would head E so he stated that he would take the Jetstream W and then S 'round the back' of the Leuchars traffic. An easterly routeing was not an option due to the other jet traffic. Consequently, the Jetstream crew was instructed to turn R heading 270°, but the 0214/5 continued NE and so he issued a further turn onto 310° with traffic information. The military jets were intermittently indicating FL120 Mode C at a range of 5nm from the Jetstream as it climbed through FL120. The SSR track data blocks then merged and he issued an 'avoiding action' turn onto 330°. As the Jetstream crew read this back

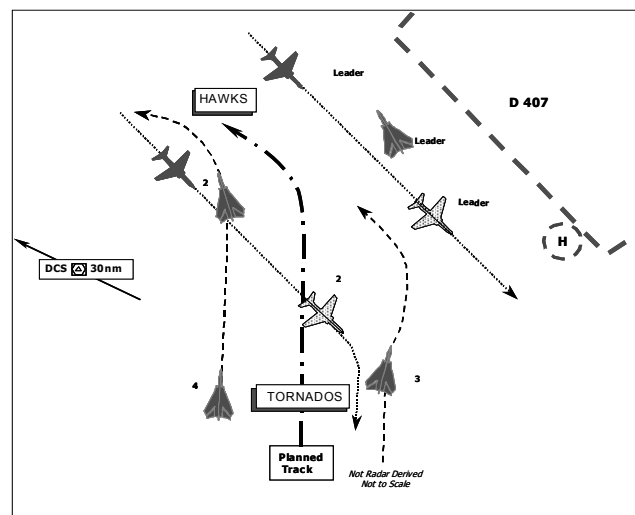
THE HAWK PILOT reports flying a black Hawk ac as No 2 of a pair on tactical sortie in the UKLFS with HISLs on, squawking 7001C. While heading

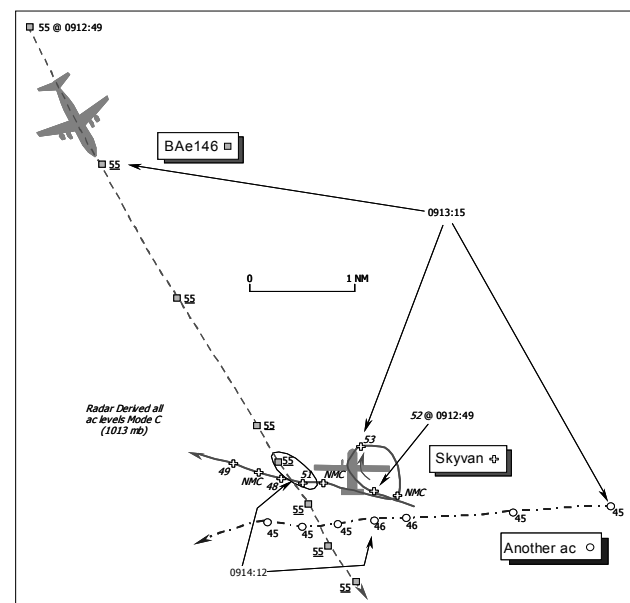
THE SHORTS SC7 SKYVAN PILOT, the PNF provided a very frank account reporting that he was conducting a conversion to type training sortie. His ac has a red/white & blue colour scheme, the HISL was on and he was in receipt of a FIS from Oxford APPROACH, squawking A7000 with Mode C; TCAS is not fitted.

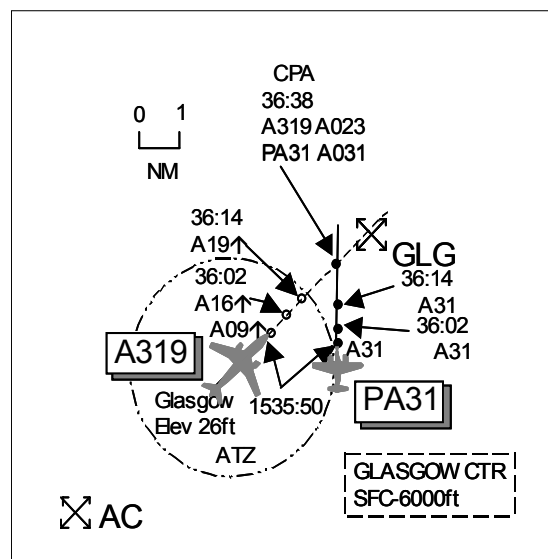
Returns merge 800ft V

THE A319 PILOT reports heading 053° at 210kt on initial climb out from RW05 at Glasgow and in receipt of an ATS from Glasgow TOWER on 118.8MHz. He was advised of other traffic which was 2nm E of the airport at 3000ft working Glasgow APP; his initial cleared altitude after departure was 6000ft. As he was climbing through 1800-1900ft, visual contact was established with the other ac (the subject PA31) and he levelled off at 2300ft. The PA31 then passed directly overhead, 700ft above, northbound which triggered a TCAS TA alert. No TI had been passed prior to departure and he assessed the risk of collision as high.

Cause: Glasgow ATC released the A319 into conflict with the PA31, without timely TI.

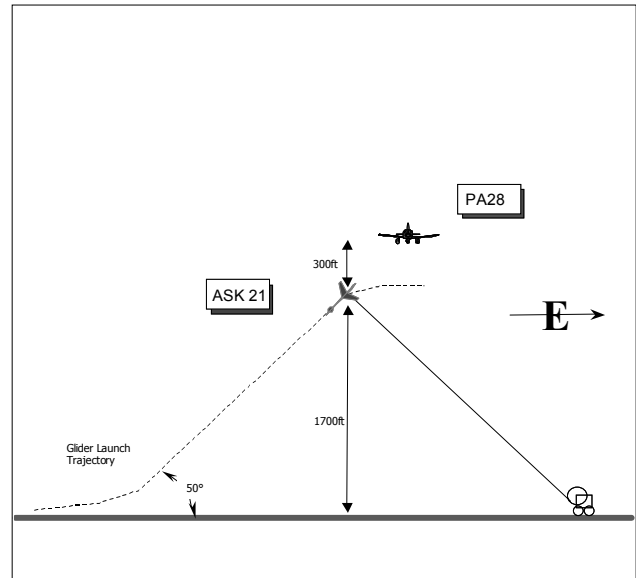
(Glider pilot's diagram of the incident)

Date/Time: 29 Jun 1453z (Sunday)
Position: 5111N 0103W (Overhead Lasham - elev 618 ft)
Airspace: Lasham Glider Site (Class: G)
Reporting Aircraft Reported Aircraft
Type: Ask 21 Glider PA28
Operator: Civ Club Civ Club
Alt/FL: 1700ft 2300ft
 (QFE 994 mb) (QNH 1006mb)
Weather VMC CAVOK VMC Below
Visibility: 20km 10km
Reported Separation:
 0H 300ft V NR
Recorded Separation:
 NR

Cause: The PA28 pilot flew over a notified active Glider Launching Site, below the maximum height of the cable, into conflict with a launching glider, which he did not see.

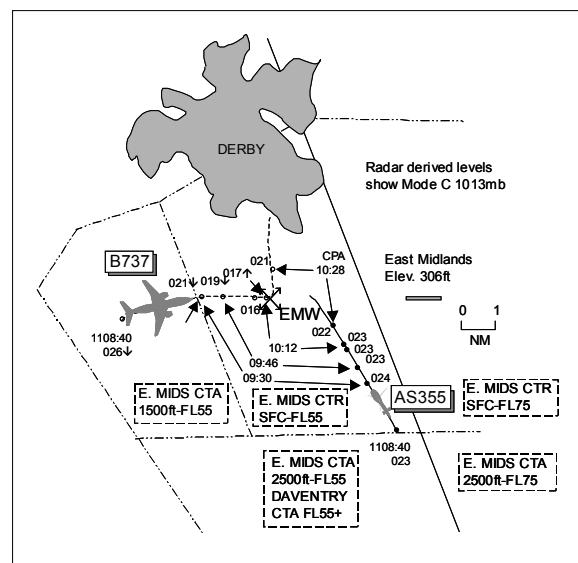
Date/Time: 29 May 1110
Position: 5250N 0127W (4.5nm W East Midlands - elev 306ft)
Airspace: CTR (Class: D)
Reporting Aircraft Reported Aircraft
Type: B737-300 AS355
Operator: CAT Civ Comm
Alt/FL: 2000ft↓ 2500ft
(QNH) (QNH)
Weather VMC NK VMC CAVOK
Visibility: NK >10km
Reported Separation:
2-3nm H 3-4nm H
Recorded Separation:
100ft V 2.5nm H

Cause: Unauthorised penetration of East Midlands Class D airspace by the AS355 pilot, who flew into conflict with the B737.

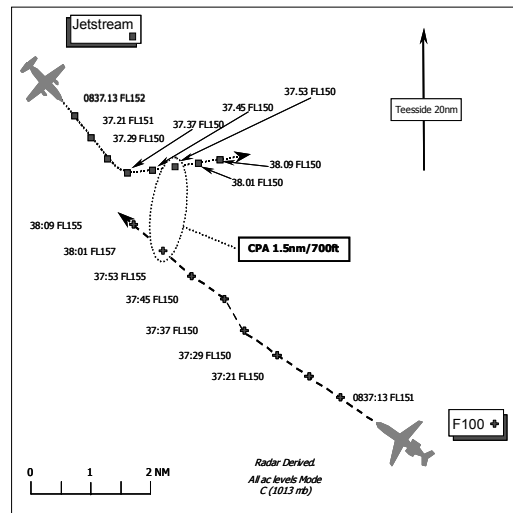
1.5nm H 700ft V

Cause: The F100 pilot did not follow the avoiding action turn instructions given by the London Military Controller 10.

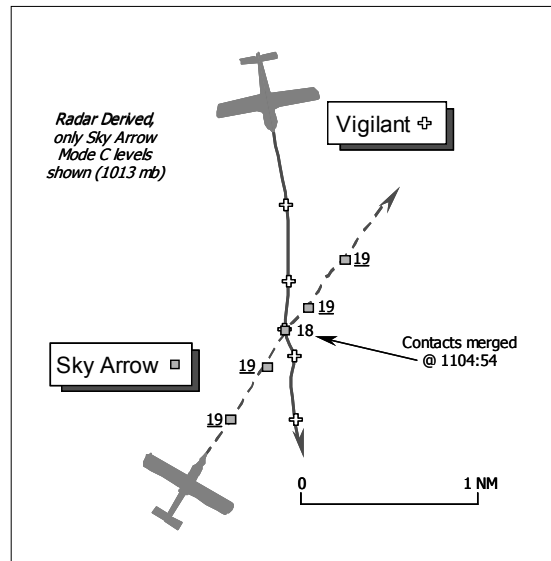
Date/Time: 20 Jun 1104
Position: 5313N 0101 W (4½nm SSW of Gamston - elev 91ft)
Airspace: London FIR (Class: G)
Reporting Aircraft **Reported Aircraft**
Type: Vigilant M-Glider Sky Arrow 650TC
Operator: HQ PTC Civ Pte
Alt/FL: 2100ft 2500ft
 (QFE 1014mb) (RPS)
Weather VMC CLBC VMC Below Cloud
Visibility: 20km 25nm
Reported Separation:
 20-30ft V, nil H 100ft V
Recorded Separation:
 Contacts merged

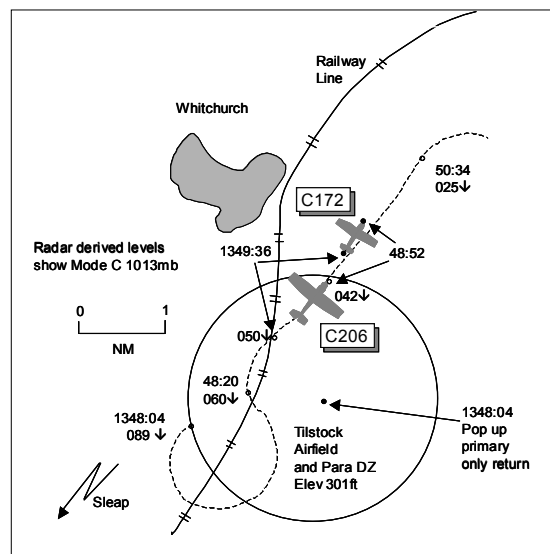
Date/Time: 28 Jun 1351 (Saturday)
Position: 5259N 0238W (3.5nm NNE Tilstock A/D - elev 301ft)
Airspace: FIR (Class: G)
Reporting Aircraft Reported Aircraft
Type: C172 C206
Operator: Civ Pte Civ Club
Alt/FL: 2500ft 3000ft↓
 (QNH 1015mb) (N/K)
Weather VMC CLBC VMC CAVOK
Visibility: 25km >10km
Reported Separation:
 nil V 50ft H nil V 300m H
Recorded Separation:
 not recorded
