UK AIRPROX BOARD

Analysis of Airprox in UK Airspace

Report Number 11
July 2003 to December 2003

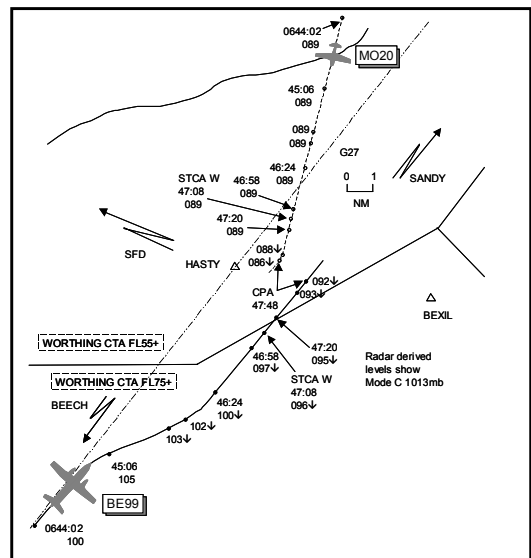
THE LTCC SE SC reports that he was working the MO20 on a routing direct to ETRAT at FL90 and expecting the BE99 to be coming in the opposite direction descending from FL100 to FL80. The BE99 was seen to descend to FL95 30nm before the subject ac were going to cross so he descended another ac, a Gatwick I/B, to FL100. However, he then noticed the BE99 climb back up to FL100 so he stopped the descent of the I/B at FL110 but the BE99 was seen to continue its climb up to FL105. On contacting the LACC LYD Sector to enquire what was happening, he was informed that the SFD Sector was working the Beech but on calling SFD they told him that LYD was working the ac. The BE99 was then seen to descend when 3nm from the Mooney so he descended the MO20 to FL70, passed TI and avoiding action, the Beech eventually levelled at FL80. A long time before the incident he had noticed the BE99's Mode C level fluctuating, which was why he had called the LYD and SFD Sectors, but in the end he still did not know who was controlling the Beech at the time of the incident.

Cause: The BE99 pilot descended below his cleared level and into conflict with the MO20.

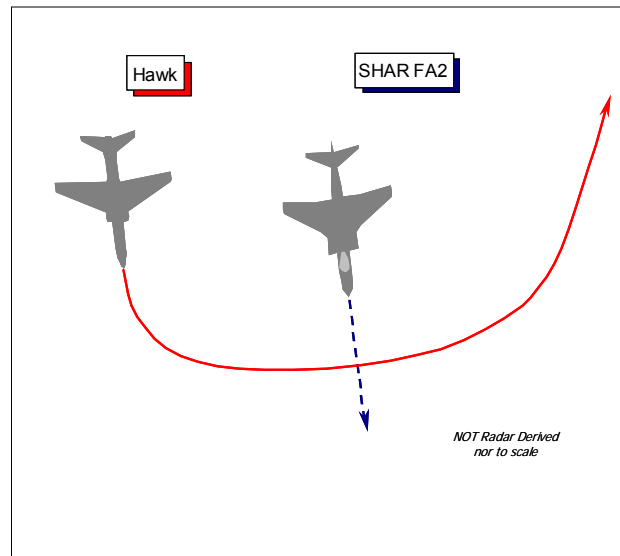
THE SEA HARRIER FA2 (SHAR) PILOT, a student pilot, provided a very comprehensive account reporting that he was flying a solo low-level navigation exercise through LFA7, whilst listening out on the LFS frequency of 300.8MHz and squawking A7001 with Mode C. Neither TCAS nor any other form of CWS is fitted, but his ac's radar was selected 'on'; the ac has a grey camouflage scheme but HISLs are not fitted.

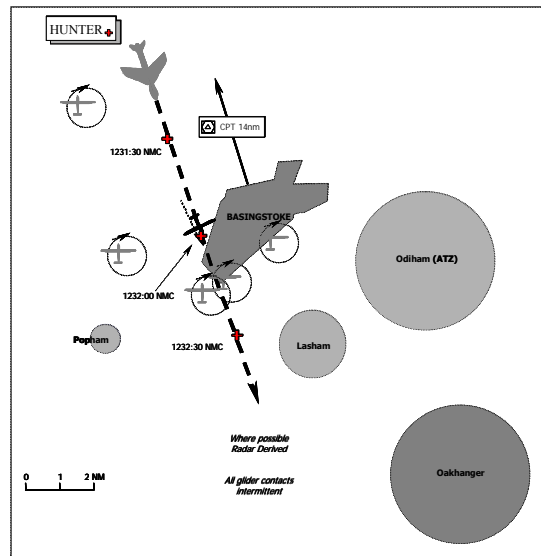
AIRPROX REPORT NO 103/03

THE GLIDER PILOT reports heading 170° at 55kt about 1nm N of Basingstoke, listening out on the general gliding frequency, when he heard a very loud noise, which he initially thought, was caused by a major part of the ac falling off. He then saw the tail pipe of a dark coloured Hunter after it had overtaken him 100m to his left, at about the same height, and going at high speed on a similar heading. Since Lasham was very busy at the time and he had been thermalling up to about a minute before, he had been maintaining a good lookout but he still did not see the Hunter prior to its passing him. He did not take any avoiding action since the Hunter had overtaken him, but assessed the risk of collision had been very high.

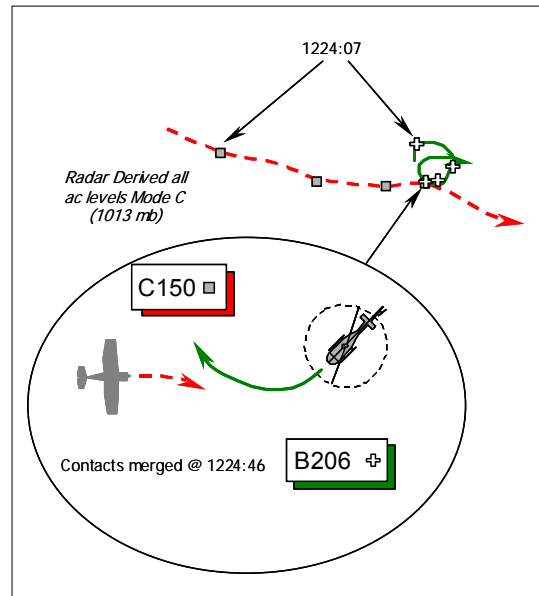
AIRPROX REPORT NO 104/03

THE B206 JETRANGER PILOT reports his helicopter has a silver & black colour scheme, but did not state if a HISL was fitted. A squawk of A7000 was selected with Mode C and a Skywatch CWS was fitted. He was tasked with the re-broadcast of a race meeting at Rockingham racetrack N of Corby this Sunday afternoon and was in receipt of a FIS from Northampton/Sywell on 122.7MHz, whilst operating VFR some 2000ft below cloud in excellent visibility flying out of sun. This evolution had been promulgated to other airspace users by NOTAM.

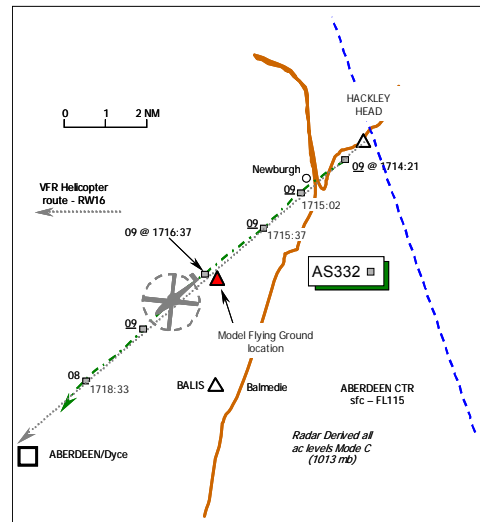
AIRPROX REPORT NO 105/03

THE AS332L PILOT reports his helicopter has a red, white & blue livery and the HISSL was on whilst flying VFR inbound to Aberdeen at 130kt and in communication with Aberdeen TOWER on 118.1MHz; a squawk of A7057 was selected with Mode C.

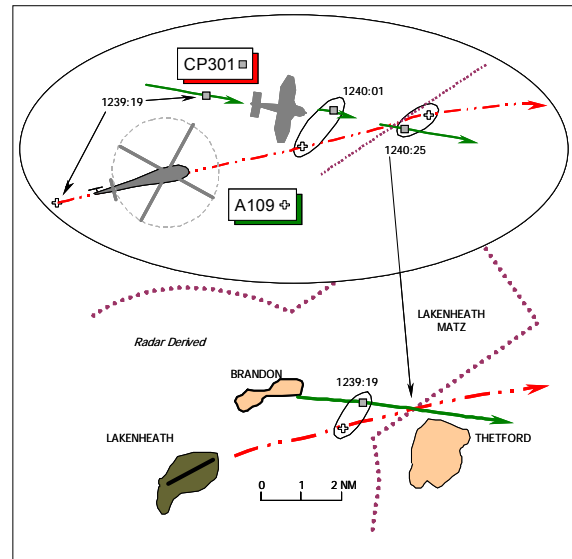
THE CP301 C-3 EMERALD PILOT reports he was in transit from Bakersfield to Beccles and in receipt of a FIS from Lakenheath APPROACH on 128.9MHz. His ac has a blue & yellow colour scheme; neither lights nor SSR is fitted to his ac.

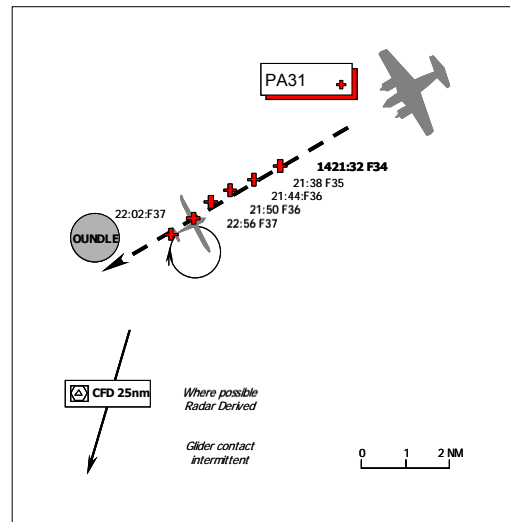
AIRPROX REPORT NO 107/03

THE SHEIBE SF27 PILOT reports flying a white glider with red wing tips thermalling just to the E of Oundle. While turning at 40kt and climbing in a thermal with a rate of climb of approx 300ft/min and approaching 3900ft agl, turning to the right with 40–50° of bank, he saw an ac approaching and immediately took evasive action to avoid a collision. The avoiding action he took was a steep diving turn to the right levelling out some 100ft below his previous position so that he could further assess the situation.

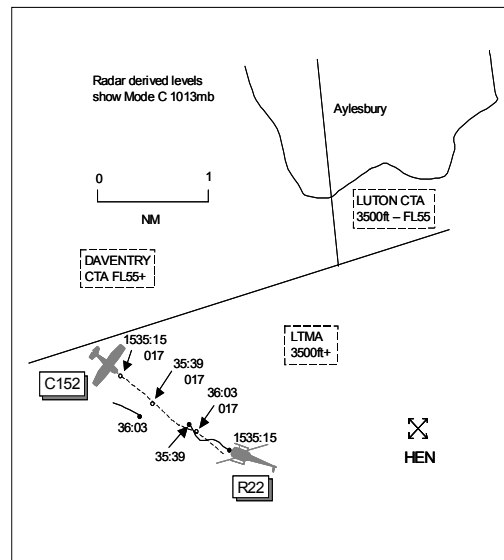
AIRPROX REPORT NO 108/03

THE C152 PILOT reports flying a local dual training sortie from Halton heading 130° and in communication with Halton RADIO on 120.9MHz squawking 7000 with Mode C. The visibility was >40km with sky clear in VMC, the ac was coloured white/red and the landing and strobe lights were switched on. The student had just finished returning the ac to normal cruise speed of 90kt at 1900ft QNH 1015mb, he thought, having been operating in a slow cruise configuration of 70kt with a nose high attitude. A white coloured R22 helicopter appeared in view on his side (RHS) of the engine cowling <10m below and 50m in front, having crossed from the student's side of the cockpit flying towards his R rear quarter. The helicopter was on a track of 280/290°, in level flight, and was gone before avoiding action could be taken, having passed close to his R. He assessed the risk of collision as medium. It appeared the helicopter pilot had not seen his ac and had not given way in accordance with the Rules of the Air.

Cause: Effectively a non-sighting by the C152 pilot on an untraced R22.

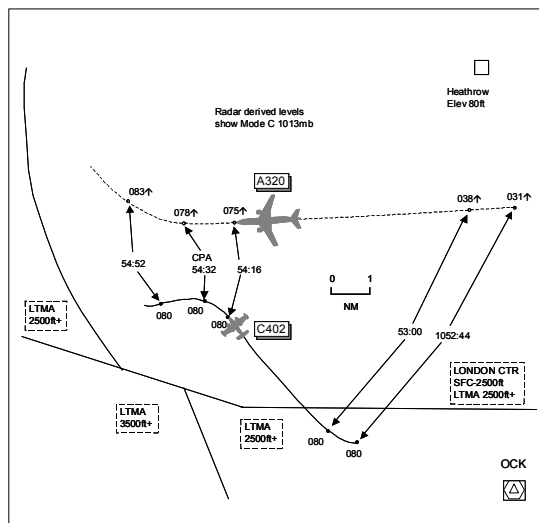
THE LTCC OCK SC reports that the C402 was operating in the OCK area at FL80 and had been for some time, working another SC on a different frequency. The A320 pilot called on his frequency at 6000ft heading 270° and was given climb to FL90; the OCK SC said he had forgotten about the C402. He added that the C402 fps was in the fps display although not in the same bay as the fps on the A320. At the time of the incident he was trying to explain the airspace and procedures to a visitor which may have caused a distraction. He gave avoiding action and TI to the A320 pilot who reported “visual” and later said no TCAS alerts had been received.

Members noted that the incident occurred 3min after the OCK SC had taken over the sector and that there was a trainee controller ‘plugged in’ for familiarisation. The OCK SC had admitted to being cognisant to the C402’s presence when he took over the Sector via the pink fps and having previously worked the subject ac on the BIG sector. However, it was thought that the exchange of information between the BIG and OCK SCs, through the S Coordinator, on the C402’s turn towards Cranfield, had been less than ideal, as it appeared the OCK SC had not correctly assimilated the Cessna pilot’s intentions. This unrecorded verbal exchange occurred about the time the A320 pilot was issued with climb clearance to FL90. The pink fps was in place on the fps board as an ‘aide memoir’, reinforcing the fact that FL80 was blocked in the OCK area. ATCO members believed that even if the C402 had been turning for another W-E run, it was still operating within its planned area and the OCK SC should have found out which direction it was going to turn. The OCK SC had formulated a plan to climb the Airbus, subject to a conflicting Challenger ac, but inexplicably he had not taken the C402 into account when he issued the clearance. This had caused the Airprox.

Cause: The TC OCK SC did not take the C402 into account when he climbed the A320 into conflict.

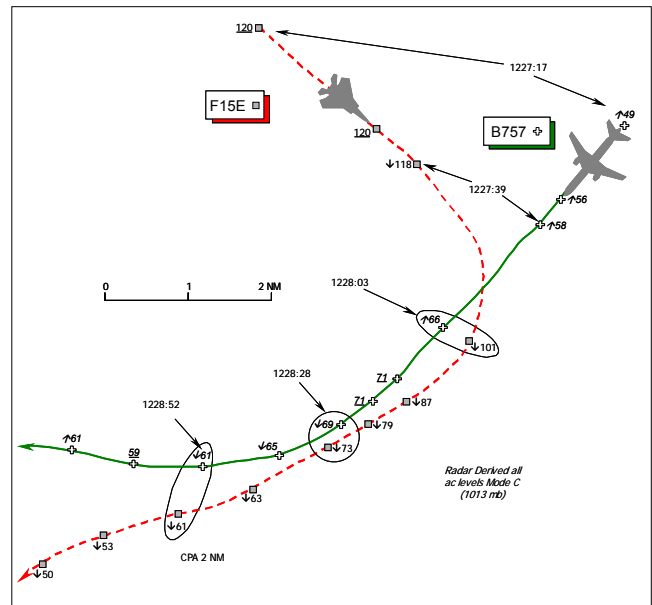
THE B757-200 PILOT, the PNF, provided a comprehensive report stating that he was departing from Norwich IFR, outbound to join CAS at BARKWAY (BKY) at 250kt, under a RAS from Norwich APPROACH on 119.35MHz and squawking A3702 with Mode C; TCAS is fitted. His jet has a red/white & blue livery and the landing lamps, HISLs and anti-collision beacon were all on. The 1st officer was the PF, with the autopilot engaged. Approaching a position about 12-15nm SSW of the airport, on course to BKY heading 230° and climbing through FL60 for their assigned level of FL80, TCAS enunciated a TA with an aural warning of "TRAFFIC" that was depicted on the vertical speed indicator at 10 o'clock at "close range" - 2700ft above them. Almost immediately thereafter, the Norwich controller issued an avoiding action R turn onto a heading of 270°. The PF initiated the R turn using the autopilot, whilst he looked for the traffic. The controller's R turn instruction was followed immediately by a TCAS RA to "DESCEND", so the PF disengaged the autopilot and followed the commanded descent, which was almost immediately followed by an "INCREASE DESCENT" RA, before TCAS then enunciated "CLEAR OF TRAFFIC". By this stage they were rolling out on 270°(M) at FL65, when a dark coloured F15 jet was spotted at the 11:30 position 200-400yd away descending "slightly" through their level and pulling away. He assessed the risk of a collision as "high".

Although the F15 pilot's microphone was inoperative this was not in itself an emergency and though certainly not desirable, a normal recovery to base was achievable in these circumstances given adequate crew co-operation and a reasonable degree of training. However, it would certainly have entailed a higher workload on their part and some suggested that lookout scan might have been impaired. One fast jet pilot member observed that the F15 was descending toward the B757, which would have been obscured underneath the fighter's right wing whilst overtaking it slowly. Therefore, after the F15 had rolled out of the turn, the airliner was always abaft the beam and the fighter crew would have been unable to see it unless they took positive action to check for other ac, which evidently they did not. The STC member was concerned about this and believed the F15 crew was not absolved from looking for other ac – adding that in the combat environment not to 'check 6' astern could be a deadly mistake. However, they were flying IFR and had a reasonable expectation under the RAS that RAPCON

said was being provided that standard separation would be afforded against other traffic. The absence of any action by RAPCON – for whatever reason - to forestall this close quarters situation should not have occurred. A part of the ‘system’ provided to ensure a safe ATS to the F15 crew had not performed as it should have done, whether it was an equipment deficiency or lack of appreciation by the controller concerned. Therefore, members agreed that this Airprox had resulted because the F15 was vectored by RAPCON into conflict with the B757 whilst under a RAS.

Cause: Whilst under a RAS the F15 was vectored by RAPCON into conflict with the B757.

Controller members were concerned about the unresolved suggestion that the Lakenheath SRE was not up to the task and in their view this should be investigated more thoroughly. Therefore, the Board recommended that HQ 3AF investigate fully the unsubstantiated reports of Lakenheath SRE/SSR unreliability, to ensure that the equipment is operating to a satisfactory level for the ATSS provided by Lakenheath RAPCON.

Recommendation: That HQ 3AF investigate fully the unsubstantiated reports of the Lakenheath SRE/SSR unreliability, to ensure that the equipment is operating to a satisfactory level for the ATSS provided by Lakenheath RAPCON.

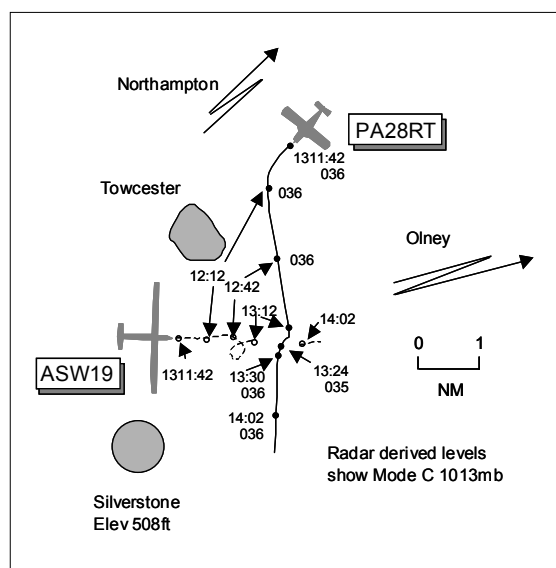
THE ASW19 GLIDER PILOT reports flying solo on a planned closed circuit cross-country from Gransden Lodge with a route via Silverstone, Bury St Edmunds and Olney. Frequency 130.4MHz was selected on the radio but it was switched off as it was very busy with RT transmissions. The visibility was >15km 1000ft below cloud in VMC and the ac was coloured white. An extensive blanket of cirrostratus to the S of Gransden had been causing concern, its presence meant that gliding conditions in the tasked area were initially not good. At 1307, he turned around Silverstone and then set course to the E. At 1312 he carried out 1 RH orbit and as the cirrostratus had thickened considerably, he was concerned that the preferred direct track to Bury would be in dying gliding conditions. As it happened, what he did next nearly set up conditions for dying. He steadied on a 040° heading towards the SE corner of Northampton and looking ahead he saw another glider about 2nm away to the N but nothing else. Looking to the R towards Cranfield, he tried to decide whether he should go in that direction and pick out a possible route. This took about 10-15sec (far too long as it turned out) for when he next looked ahead, a single engined ac (possibly a Rockwell Commander type) was directly in front of him, about 200yd away, heading straight towards him. He realised that even though he knew what had happened and what needed to be done about it, getting his body to respond with appropriate velocity was like trying to rush treacle through a straw. The other pilot must have seen him first because a split second after seeing him, the other ac was seen to roll rapidly to the R and climb slightly, to shoot past in a near vertical banked attitude, 20ft above and displaced by about 60ft to his L. He pushed and dived and although this may not have been the recommended response, as the ASW19 does roll reasonably fast, there didn't seem to be enough time to roll. Post flight the data logger showed a fairly rapid increase in G/S from 56kt to 83kt but surprisingly with no large loss of height; this might be explained by thermal activity which showed on the variometer log at the time. After it had passed, he saw the other ac roll level and then turn L before disappearing from view. He was disappointed that even though there had been good visibility, he had not seen the piston ac at the time he had first seen the other glider. Both his ac and the piston were white and the geometry was almost head-on presenting a small target aspect to acquire. Nevertheless, he felt that he owed the other pilot a serious apology for allowing himself to become distracted by tactical considerations. He assessed the risk of collision as near fatal.

Members agreed that the ASW19 pilot should have seen the PA28RT earlier but had allowed his lookout scan to be degraded for the reasons he had explained so honestly. The attitude taken by the glider pilot in accepting some responsibility for the incident was commendable, but ultimately the PA28RT Capt was responsible to see and avoid the glider under the Rules of the Air Regulations. Despite an early visual acquisition of the glider, the PA28RT Capt had flown his ac into conflict with it and this had caused the Airprox.

Cause: The PA28RT Capt flew into conflict with the ASW19 Glider.

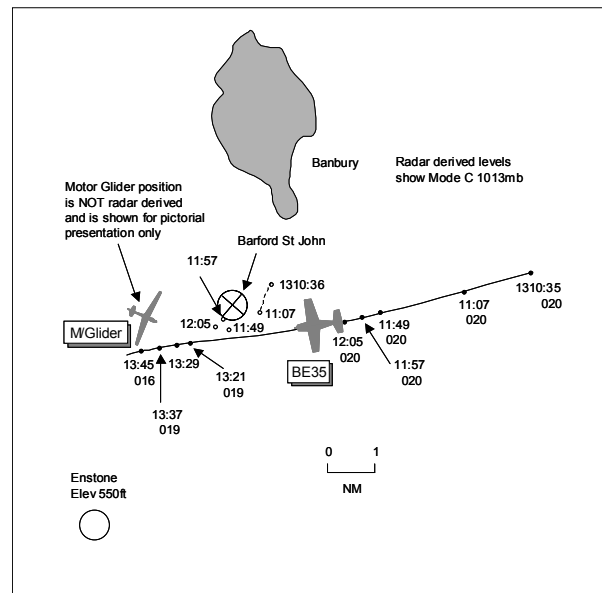
AIRPROX REPORT NO 112/03

THE VENTURE MOTOR GLIDER PILOT reports flying a dual training sortie from Enstone and in communication with Enstone RADIO on 129-87MHz; no transponder was fitted. The visibility was 15-20km in clear sky/no cloud conditions and the ac was coloured blue/white. About 2nm W of Barford St John disused airfield after having closed the throttle and selected carb heat on to simulate a practice engine failure, the student was busy selecting a suitable landing area and carrying out cockpit drills whilst he monitored the student's performance and kept a lookout. Heading about 170° and descending through 1800ft QNH 1016mb, he thought, in a 15-20° low AOB R turn at 60kt, he suddenly heard an engine increasing power followed by a blur of a blue/white ac diving in the opposite direction; the other ac's fin passed 20-30ft under his port wing. He took control and quickly turned starboard to see a V-tailed Beech Bonanza flying away at great speed in a westerly direction, believing that the Beech pilot had been trying to avoid his ac. Both he and his student were badly shaken and considered themselves extremely lucky that they had escaped a collision. Neither of them had been aware of any other ac in the vicinity even though they were heads up in the cockpit during the exercise; no other ac had been seen prior to commencing the turn. He assessed the risk of collision as extremely high as he had only seen the other ac at the point of near impact.

Cause: Effectively a non-sighting by the Venture Motor Glider crew and a very late sighting by the BE35 pilot.

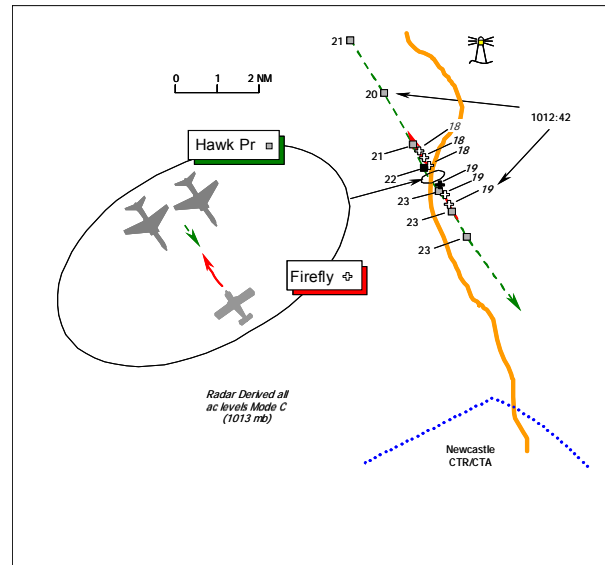
AIRPROX REPORT NO 113/03

THE HAWK PILOT, a Qualified Pilot Navigator Instructor (QPNI), reports he was flying as the No2 of a pair of black Hawk ac engaged on a low-level pairs sortie instructing a prospective Navigator Training Unit Instructor who was flying in the rear seat of the No1 ac. The HISL and nose landing light were switched on in both ac. Though they had just called Newcastle ATC, they were not in receipt of an ATS, but a squawk of A7001 was selected with Mode C; neither TCAS nor any other form of CWS is fitted.

Approaching 3nm S of Amble light, heading 180° a practice bird strike on the No1 was initiated. Both ac pulled up from low-level to 500ft below the cloud base, which was between 2600 - 3000ft. Flying at an altitude of 2200ft RPS (1007mb) after decelerating to a speed of 280kt, a visual inspection was initiated by the No2 to confirm any signs of 'simulated damage'. As the No2 closed to echelon starboard, both front seat pilots simultaneously saw a light ac 300-500ft ahead – he believed immediately in front of and below the No1 Hawk ac. No avoiding action was taken - there was no time available - as the other ac (a light single engined bubble canopy type, painted white) passed 50ft below the leading jet with no horizontal separation. The Airprox was reported to Newcastle ATC from whom the formation was in the process of obtaining an ATS. He assessed the risk of a collision as "high".

THE HAWK PILOT’S STATION comments that this “very close miss” happened, not unusually, at a period of high cockpit workload when the attention of both crews was focused elsewhere concentrating on the close formation join. This resulted in degraded lookout and they did not spot the light ac that would have ordinarily been difficult to see in the prevailing conditions. This is a salutary lesson for all on the requirement to maintain a good lookout, whatever the cockpit workload.

Cause: A very late sighting by the Hawk formation and a late sighting by the Firefly pilot.

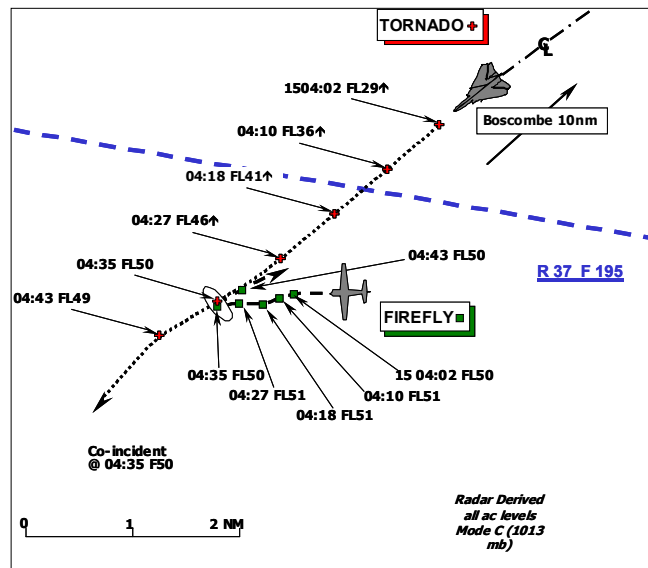
AIRPROX REPORT NO 114/03

THE FIREFLY PILOT reports heading 270° at 100kt and had just levelled off at FL50 over the W side of Salisbury on an instructional sortie from Middle Wallop when a red, white and blue Tornado passed under his right wing from the rear on a similar heading in level flight. He estimated that it had passed approx 50–100ft below and 100ft horizontally to his right. He was squawking 2677C and monitoring a tactical frequency. He did not see the ac until it was passing him as it had approached from his rear and he was not able to take any avoiding action. He considered the risk of collision was high.

Although Members noted that there were several procedural and integration factors between Boscombe Down and Middle Wallop, and some minor points of Airmanship, they had been overemphasised in the comments above and none had contributed directly to this incident; however, in order to ensure that procedures continue to meet the needs of both units, HQ DAAvn agreed to consult with DPA and determine whether any change is required.

Cause: The Tornado flew close enough to cause concern to the Firefly pilot.

HQ STC have recommended that Boscombe Down review their IFR procedures to make them more robust and to allow ATC to afford departing ac more protection.

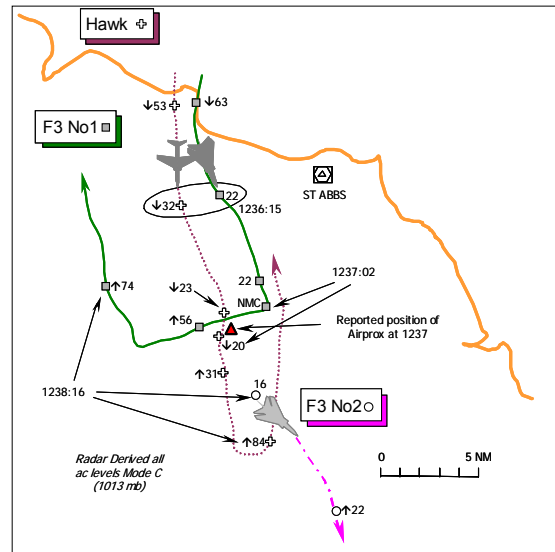
AIRPROX REPORT NO 115/03

THE TORNADO F3 PILOT reports his ac has a grey camouflage scheme and the HISL was on whilst leading a pair of Tornado F3s during the final stages of a 2v1 intercept against a Hawk. They were in receipt of an Air Defence Information Service (ADIS) from CRC Buchan [equivalent to an ATS of a FIS below 5000ft ALT] on 300.55MHz and squawking the assigned code with Mode C. Neither TCAS nor any other form of CWS is fitted.

Some 1200ft below cloud descending through 2200ft RPS (1002mb) at 500kt in a R turn passing 200°, he suddenly saw a white high-wing single engine light aircraft (LA) 500ft away at 11 o'clock in his peripheral vision, so he pulled up hard and rolled to avoid it. Both he and his navigator saw the LA 100ft away crossing obliquely from L – R, 400ft beneath their jet before it opened to starboard. He assessed that the risk of a collision was “*very high*” and added that they were close enough to be concerned that their jet’s wake might have caused the other ac some problems.

Cause: Conflict with an untraced light ac resolved by the F3 crew.

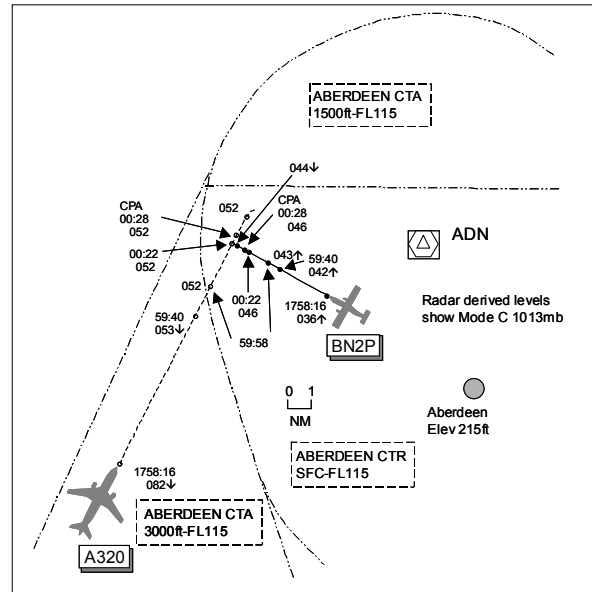
AIRPROX REPORT NO 116/03

THE ABERDEEN APR reports that the ADC had requested a departure release for a BN2P to Inverness, its fps had just been placed in front of him as the ac's destination had changed. The clearance issued initially was for the ac to depart on a heading of 300° climbing to FL65. The A320 had called descending to FL90 heading 050° which he cleared for further descent to 5000ft. As the BN2P was an ambulance flight, he decided to put the ac on a tactical heading of 290° for a direct routing but he instructed the pilot to stop his climb at 4000ft which was correctly read back. The A320 was seen to level at 5000ft and he continued coordination with Lossiemouth and vectoring other ac. The BN2P was seen at 4000ft and it was estimated that the subject ac would cross over at a distance of <1nm. Again he gave vectors to other ac and when he looked back to the situation, he saw the BN2P had climbed to 4400ft as the A320 was crossing L to R at 5000ft. He asked the BN2P pilot if he was maintaining 4000ft to which the pilot replied "affirm" as the ac had descended rapidly to 4000ft. He asked the pilot if he had 'level busted' to which he said "briefly" but he had corrected rapidly back to his cleared level and he had seen the Airbus.

CAA FLIGHT OPERATIONS INSPECTORATE (FOI) reports that the BN2P operator established that the pilot concerned had 'simply allowed himself to become distracted in the climb and had briefly taken his eye off the ball'. The pilot was subsequently counselled as to his future management of the flying task. The operator's procedures are sufficiently robust to prevent incidents of this nature, this being an isolated occurrence caused by inadequate prioritising of tasks by an individual pilot.

Cause: The BN2P pilot climbed through his cleared level and into conflict with the A320.

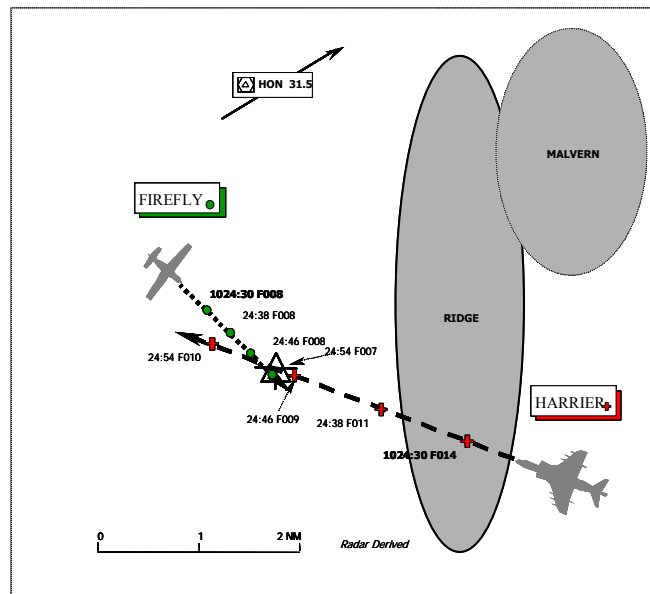
THE FIREFLY PILOT reports that he was about 5nm from the Malvern Ridge flying an instructional sortie from Cosford to Barkston Heath in the UKLFS at 500ft, squawking 7001 with Mode C and HISLs switched on. While flying straight and level at 500ft MSD heading approximately 140° at 120kt, a Harrier came over the Malvern Ridge very fast, level with him in a left banked turn and passed 100ft down his left side and 50ft above on a reciprocal heading. He banked to the right so that he would become visual with him again, and saw another Harrier ½nm behind the first on a similar heading.

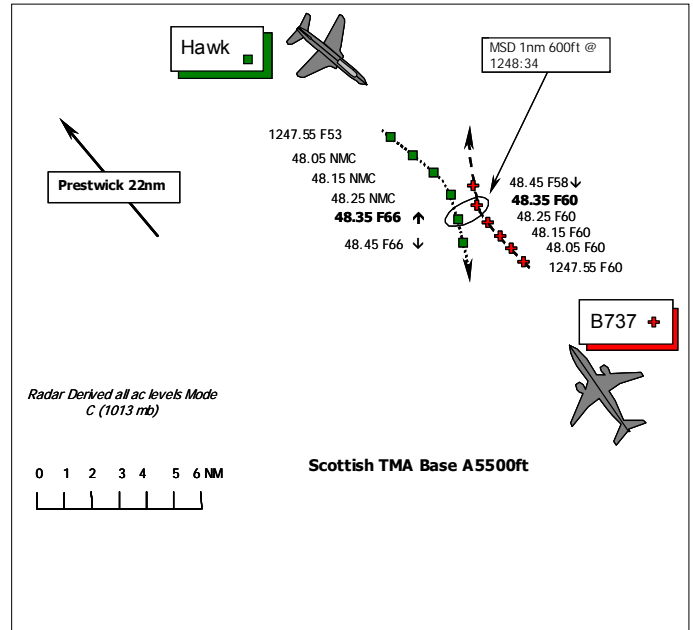
THE PRESTWICK APR CONTROLLER reports that a military Hawk ac climbed into CAS of the Scottish TMA 22nm SE of Prestwick and into conflict with a B737 inbound IFR to Prestwick. Following transfer from ScACC the B737 was being radar vectored for an ILS approach to RW31. His descent was stopped at 6000ft Alt to remain inside the Scottish TMA and TI was passed on 4 low level contacts manoeuvring approx 15nm ahead up to 3000ft displaying squawks of 2632/2633/7000/7001. The B737 was turned left on to a heading of 320° to route to the W of the contacts, 2 of which at this stage were heading NE and the other 2 appeared to be joining up, he thought to follow the others to NE; he subsequently updated the TI. Shortly after the ac squawking 7000 was seen on radar ½ nm to the W of the B737 at FL66. (UKAB Note (1): Radar software converts Mode C heights to FL above transition altitude based on local QNH). The B737 pilot was given an avoiding action turn right on to a heading of 360° as the traffic passed down his left hand side. TI was again passed and the pilot reported a TCAS RA to descend, and that he was IMC. The ac squawking 7000 continued on a southerly direction descending and rejoined with others who were heading E. Following the incident he requested Scottish Military Radar to trace the ac.

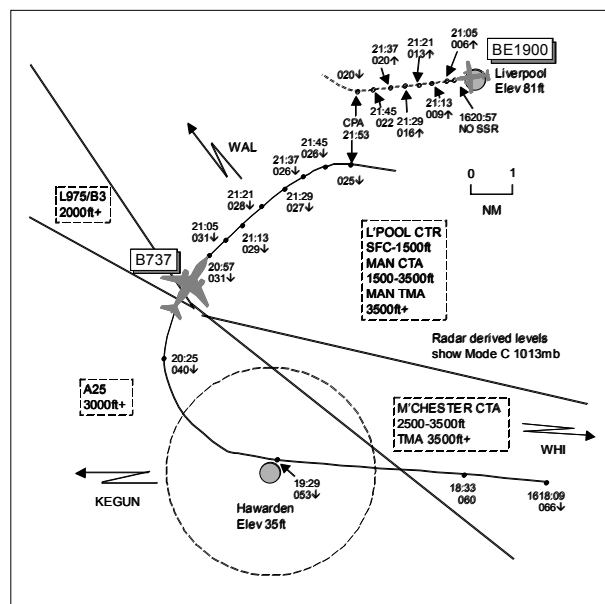
THE LIVERPOOL APR reports that MACC TMA called to coordinate an inbound B737 and she told them that there was a WAL2T SID to depart and that she would separate the ac. The MACC controller said that if she could allocate a lower level, they would turn the B737 downwind LH to resolve the conflict; she allocated 2500ft altitude. The ADC then requested 2 further releases on WAL2T departures (the 1st one being the BE1900), which she approved, as she assumed the inbound B737 traffic would be positioned downwind LH. The B737 called on frequency when it was 2nm SW of the airfield, level at 2500ft on a heading of 050°, which was in direct conflict with the BE1900 just airborne approaching 2000ft climbing. The TMA controller levelled the BE1900 at 2000ft and she turned the B737 onto heading 100°, both crews reported that they could see each other.

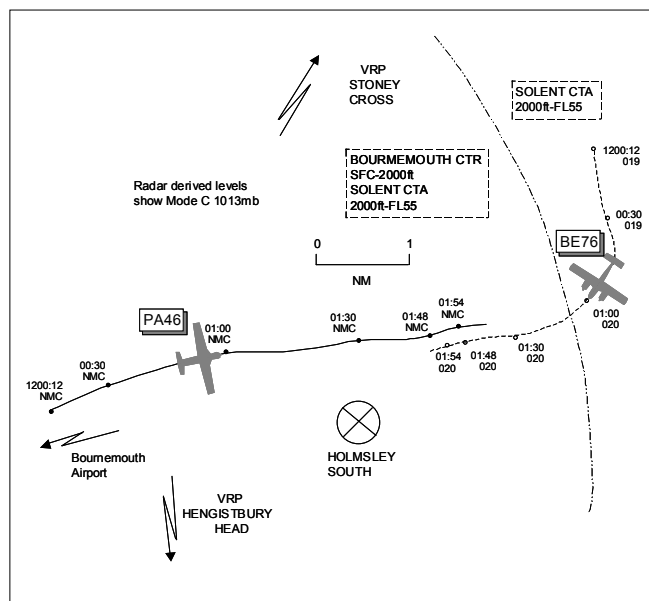
THE BOURNEMOUTH APR reports that he was vectoring an IFR BE76 onto the final approach track (FAT) for RW26. As the ac established on the NDB procedure, a 7000 squawk appeared in its 12 o'clock range 1nm flying in the opposite direction. He passed TI to the BE76 pilot who visually acquired the ac passing <0.5nm away from them. He was then able to identify the ac as the PA46 that had been instructed to leave CAS to the NE and avoid the RW26 FAT. The PA46 pilot later admitted that he was tracking direct to GWC VOR and was given further instructions to prevent him infringing the Southampton CTR.

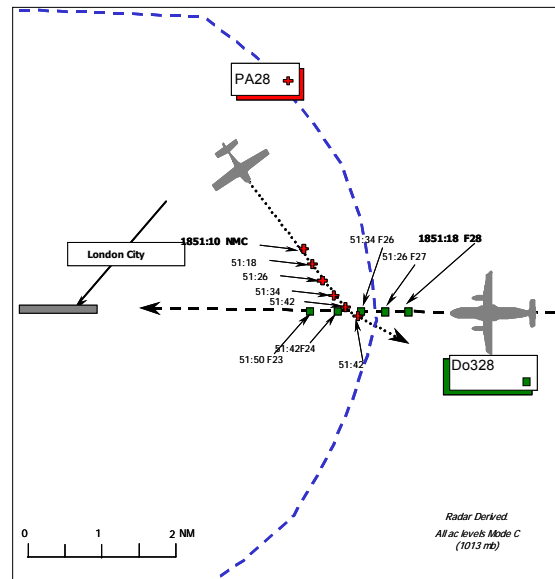
AIRPROX REPORT NO 122/03

THE DO328-110 PILOT reports that he was heading 276° at 120kt, having just begun his final ILS approach to RW28 at London City Airport, when he was alerted by City Tower about an unidentified contact in their 1 o'clock position at a range of approx 3nm, tracking S with no height information. This contact was in a similar relative position to a TCAS contact that he had previously identified, also with no height information.

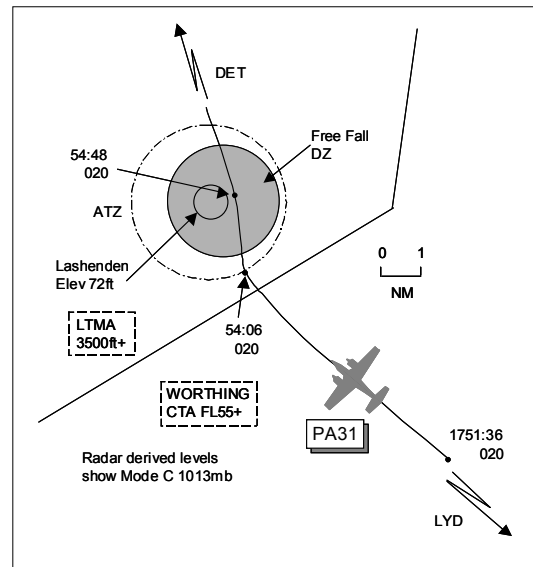
AIRPROX REPORT NO 123/03

THE PARACHUTIST reports exiting the drop ac at 12000ft and practising several manoeuvres before pulling (deploying the parachute) at between 4500-4000ft. After checking the canopy was without malfunction and having completed 1 or 2 turns, he heard the sound of an ac nearby. He looked around to try and locate it and saw a white coloured ac pass just below him; at that time he was directly overhead the RW at Headcorn. He immediately made his way towards the landing area.

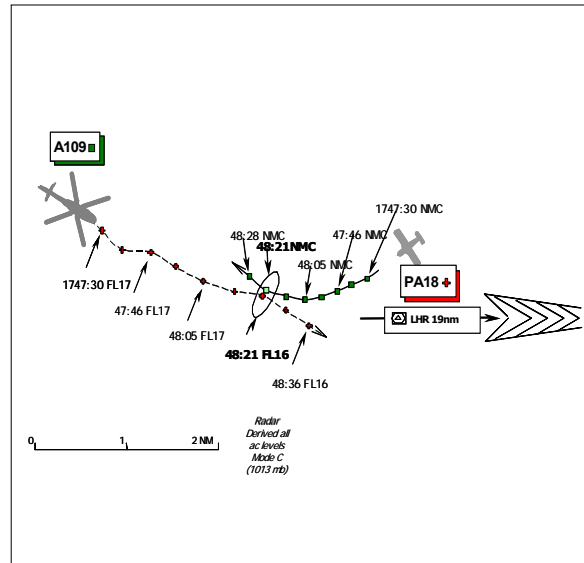
AIRPROX REPORT NO 124/03

THE PA18 SUPER CUB PILOT reports flying a white and blue ac on a local sortie from North Moreton near Wallingford on a listening watch on the Benson App frequency and, he thought, squawking 7000A. While cruising at 80kt on a westerly heading at an alt of 1800ft on the QNH, 2nm N of Reading, a helicopter emerged from haze on his left side, slightly above and in a right turn at a distance of ½nm. He initiated a right turn to increase separation passing ¼ nm from the helicopter and 50ft above it. As the visibility into sun was very poor, he assessed the risk of collision to be medium. Since he was not in communication with any ATC agency, he reported the incident by telephone to AIS Mil the following day.

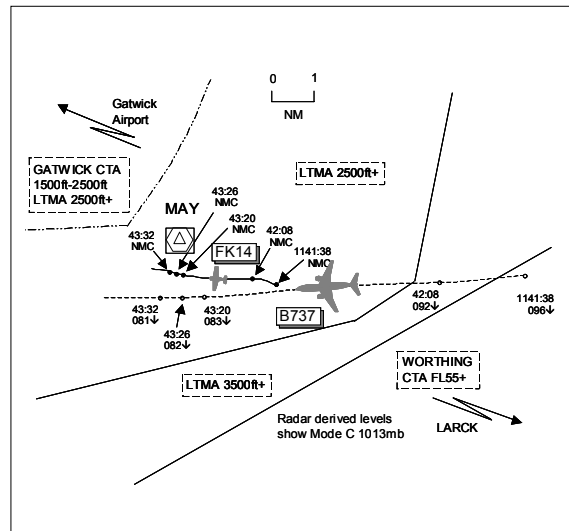
AIRPROX REPORT NO 125/03

THE B737 PILOT reports heading 270° at 250kt inbound to Gatwick squawking 6663 with Mode C and in receipt of an ATS from Gatwick on 126.82MHz. The visibility was >10km in CAVOK VMC. Near to MAY when levelling at FL80, TCAS annunciated “traffic” on an ac with no altitude readout. The traffic was visually acquired, a white coloured single engine ac, in his 3 o’clock position range 1-2nm at FL81 on a similar heading. The other ac was overtaken and ATC informed that an Airprox would be filed, the flight continued without further incident. He assessed the risk of collision as medium.

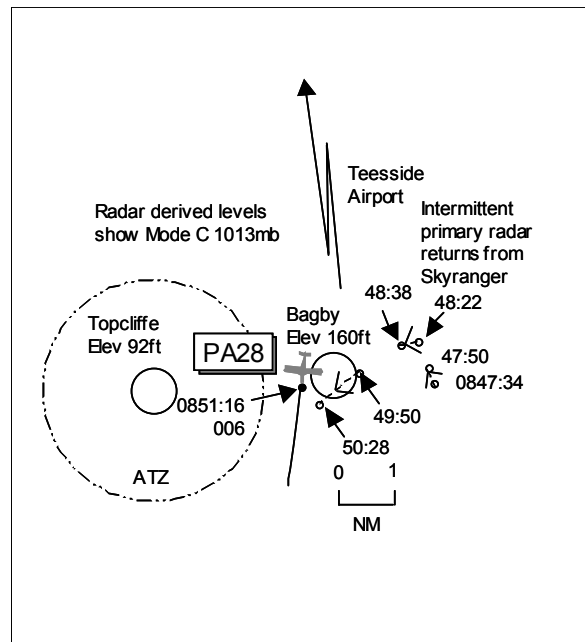
THE BAGBY A/G OPERATOR reports that he heard a loud engine noise approaching from the N which he thought might be either an ac or motorcycle. He then saw a red/white ac crossing just to the W of the RW06 threshold tracking S at an estimated height of 300-500ft agl which was passing about 300m ahead of a Skyranger, without altering course; the Skyranger was turning in from a tight RH cct onto finals to land. After broadcasting a warning to the Skyranger pilot on the A/G frequency 123.25MHz, whose pilot did not see the conflicting traffic, he tried calling the offending ac but received no response. At the time, the visibility was about 3000m in haze below cloud and he assessed the risk of collision as high. Teesside ATC were contacted by telephone and provided him some details of a PA28 which had departed from the airport routing to Southampton.

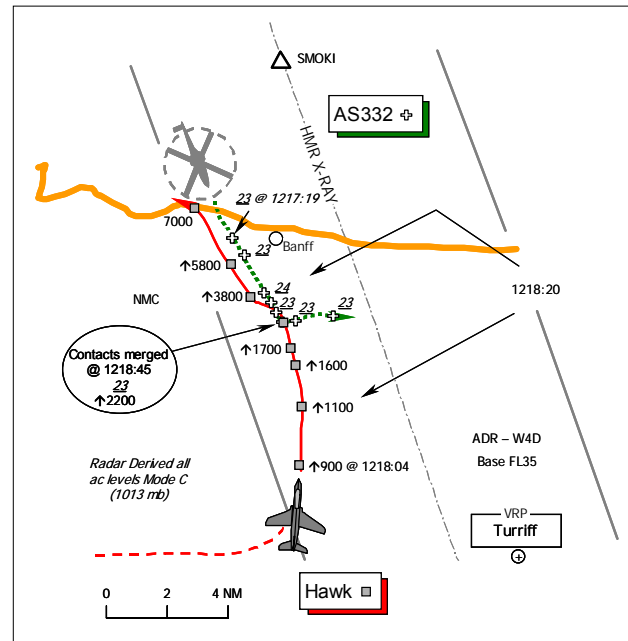
THE ABERDEEN APPROACH RADAR CONTROLLER (APR) reports that the AS332 crew made first contact on 119.05MHz as they coasted in at 2500ft ALT near Banff, which is the normal transfer point for inbound helicopters that have been working Lossiemouth ATC. The crew was instructed to squawk 'ident', whereupon another squawk - A7001 – was spotted that had not been observed before, to the S of the AS332. The unknown ac indicated 1000ft Mode C initially and then 1300ft climbing as it tracked northwards towards the AS332, so immediately the traffic was called to the AS332 crew who responded that they were flying in IMC. A turn to the E was issued as she continued to update the AS332 crew with traffic information and placed the flight under a RAS. The unknown ac appeared to "brush" down the right hand side of the AS332 and the next clear Mode C readout indicated it was at 3000ft, after it had passed to the N of the AS332.

Cause: Conflict in IMC, in Class G airspace, between the AS332 that was receiving a RAS from the Aberdeen APR and the Hawk that was aborting from low level.

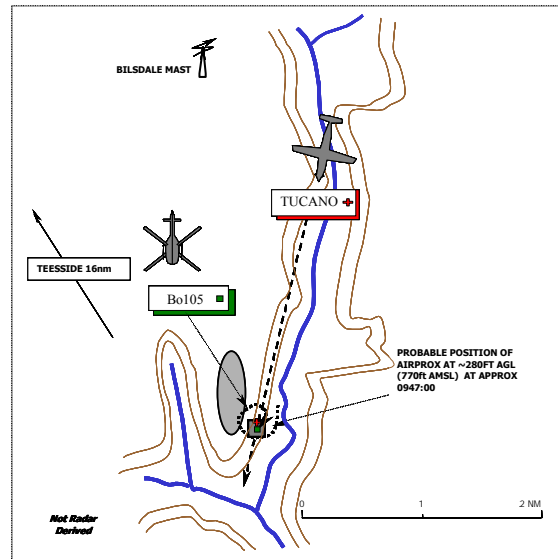
THE BO105 PILOT reports flying a green and white helicopter on an air ambulance emergency mission to an isolated farm in the N York Moors. TCAS was not fitted. He had strobes and anti collision lights selected on, was squawking 0020 with Mode C and had been in receipt of a FIS from Teesside 16nm to the N, but had lost RT contact due to the high terrain and because he was in a spiral descent to land in a farmyard. While passing through a heading of 200° at 80kt with all his crew concentrating on wires/obstacles which would affect his landing and subsequent take-off, he spotted a dark blue Tucano ac about 200m departing to his 1 o'clock just above his height, having overtaken him, while he conducted the spiral descent.

Cause: A non-sighting by the crews of both ac.

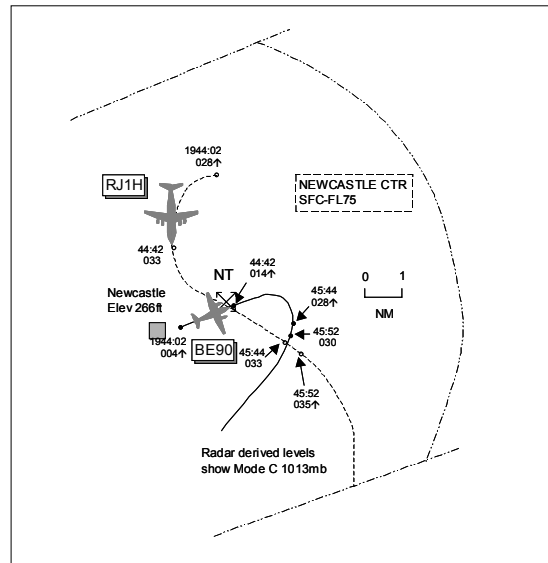
AIRPROX REPORT NO 129/03

THE RJ1H PILOT reports following a go-around on RW07 Newcastle, owing to a hydraulics problem, TOWER cleared him to climb straight ahead to 2500ft. On transfer to APPROACH, climb clearance was given to 3500ft with a L turn and then he was transferred to DIRECTOR who cleared him to enter the NT NDB hold. Just before entering the hold heading 100°, DIRECTOR informed him that an ac was departing Newcastle climbing to 2500ft, but on passing the NDB he noticed on TCAS the ac, which was on another radio frequency, climbing rapidly through its altitude just below his ac. Simultaneously with ATC asking him urgently to turn R onto heading 270°, he thought, TCAS gave an RA “climb, climb”. He disconnected the A/P and autothrottle and climbed the ac, with the conflicting ac indicating -300ft, he put his v/s into the TCAS demanded ‘green band’, and started a gentle turn with 10-15° AOB. He told ATC of his TCAS climb to 4500ft, who recleared him to climb to FL60 and gave vectors to remain clear of the departure area. He assessed the risk of collision as medium.

Cause: The BE90 pilot climbed through the level he had acknowledged.

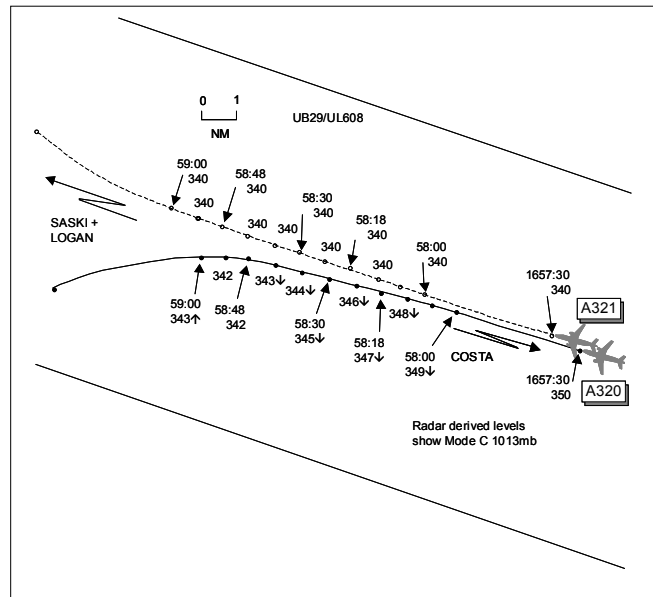
THE LACC S13/14 TACTICAL CONTROLLER reports that the A320 and A321 were both routing from COA to LOGAN, the A320 was 1000ft above and directly overhead the other Airbus. Believing that the A320 was below the A321, he cleared the A320 to descend to FL310 from FL350 and gave it a radar heading to split the two ac radar returns. He noticed his mistake as the A320 was descending through FL345 approaching the A321 at FL340 and gave avoiding action. Both ac received TCAS RAs, he thought, and the A320 was seen to reach FL343 before stopping its descent and commencing climb.

Cause: The LACC S13/14 Tactical controller descended the A320 into conflict with the A321.

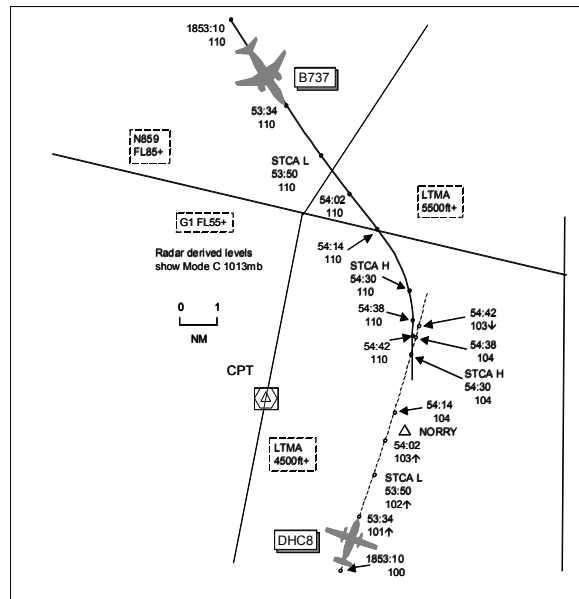
AIRPROX REPORT NO 131/03

THE LTCC NW SC reports that the Sector was bandboxed when the B737 pilot called on frequency and reported flying on a radar heading. He issued descent clearance to FL110 to be level at CPT, leaving the ac on its heading but later realised he should have put it on its own navigation to CPT. He then issued climb clearance to the DHC8 pilot from FL100 to FL110, keeping this ac underneath another ac, but forgot about the B737. When he noticed the confliction and was about to give avoiding action descent, the DHC8 pilot reported he was TCAS descending.

Cause: The LTCC NW SC climbed the DHC8 into conflict with the B737.

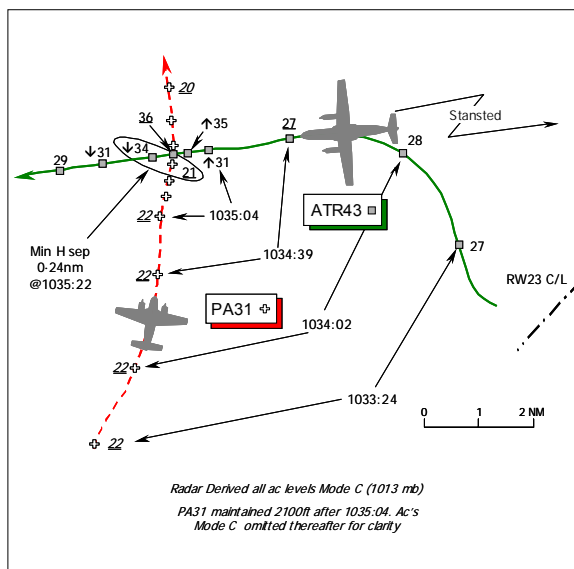
THE ATR 43 PILOT reports that he had departed Stansted and was inbound to Luton, IFR, under a RCS initially from Essex RADAR on 120-62MHz. The ac has a white & blue livery and all lighting was selected on including the HISLs and landing lamps. Heading W at 200kt, flying in level cruise at 3000ft London QNH (1023mb), RADAR informed him of traffic at 11 o'clock but he could not remember the exact range [it was 8nm]. Looking out, no other ac was seen, whereupon TCAS enunciated a TA with "TRAFFIC TRAFFIC"; yet again nothing could be seen. Essex RADAR then instructed them to contact Luton DIRECTOR on 129-55MHz. Whilst the 1st Officer was selecting the Luton frequency, TCAS enunciated a "CLIMB" RA, which was complied with. Whilst climbing, conflicting traffic was seen to pass between 500-1000ft directly underneath from L-R at what appeared to be their previous cruising altitude. Once clear of the traffic – a low-wing white twin - a descent back to 3000ft was initiated. On initial contact Luton DIRECTOR was informed of the TCAS RA, whereupon he was advised that the conflicting traffic was squawking with Mode C and that it was maintaining 2400ft ALT beneath CAS. He assessed the risk as "high".

Cause: Sighting report.

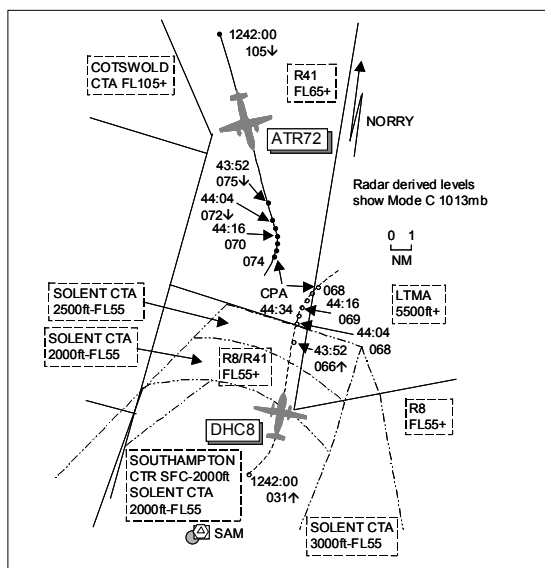
THE SOLENT APR reports that the DHC8 was climbing out from Southampton on a NORRY departure and, once clear of conflicting traffic, was given climb to FL70 in accordance with the clearance given by TC SW. As the ac was climbing through FL64 he noticed the inbound subject ATR72 descending through FL78 which had not called on his frequency and which should have been subject to a standard release descending to FL80, as the Silent Handover Procedures were in force. He stopped off the DHC8 and gave it an avoiding action turn onto an easterly heading as well as passing TI. The subject ac passed about 600ft vertically and 3nm horizontally apart with neither crews reporting TCAS warnings.

Cause: The LTCC OCK SC descended the ATR72 below the agreed Silent Handover Procedure level without coordination.

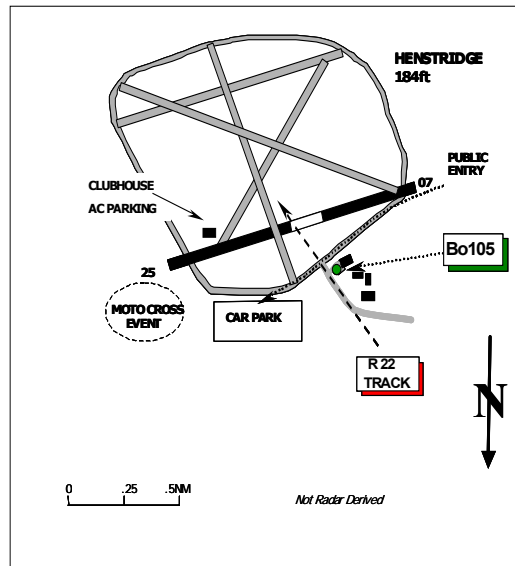
AIRPROX REPORT NO 135/03

THE BO105 PILOT reports that he was duty Air Ambulance pilot for the Dorset and Somerset Air Ambulance, bright yellow Bo105 from Henstridge. When he arrived at the airfield he was surprised to find a large number of caravans, trucks and other vehicles parked on the N side not far from his hangar (photograph provided) supporting a motocross event. Locally based gyrocopters, some 5 to 6 in number, were active on RW 07/25 and the taxiways, with fixed wing ac landing between the gyros. The N taxiway (passing very close to his location) was also being used by members of the public to gain access to the motocross event.

Cause: The R22 pilot flew close enough to the Bo105 to cause concern.

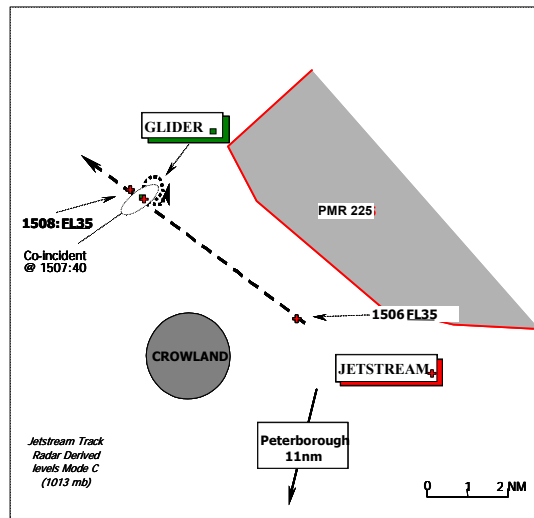
AIRPROX REPORT NO 136/03

THE JETSTREAM PILOT reports flying a red and white Jetstream ac on a training sortie from RAF Marham to RAF Cranwell with HISLs selected on in receipt of a RIS from Cranwell. While heading 300° at FL35 and 180kt, ATC reported a contact: '12 o'clock at 5nm, possibly clutter' and subsequently reported at 3nm as intermittent. A glider was then spotted at approx 0.5nm and 100ft below at which point the ac was turned hard left and climbed to avoid impact. The glider appeared unaware of the Jetstream's proximity and continued on its original track. The Jetstream pilot reported to ATC that 'the previously reported ac was a glider, which I missed by 100ft'. The ac was recovered to RAF Cranwell without further incident. The pilot considered that there was a possible risk of collision.

Cause: A conflict with an untraced glider in Class G airspace resolved by the Jetstream pilot.

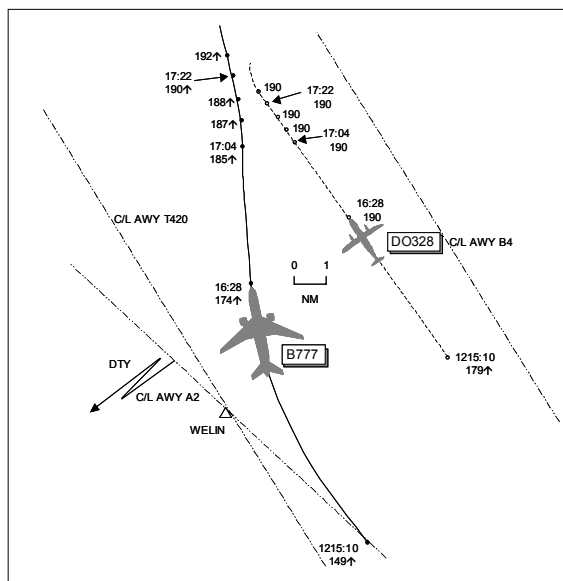
THE LACC S28/34 TACTICAL CONTROLLER reports that prior to the Airprox, an ac (A/C1) called on frequency on a radar heading which would take it underneath a Manchester inbound so he issued its crew a turn onto heading 350°. He thought the crew read back 250° so he tried to ensure that the pilot had acknowledged the correct heading. During this period, the subject B777 pilot called on frequency on heading 330° and he issued climb clearance to FL280; A/C1's crew then confirmed the correct assigned heading. His attention was next drawn to the climbing B777 that was tracking towards the DO328 which was level at FL190. He gave the B777 pilot an avoiding action L turn onto heading 280° and later gave him descent to FL180 as the ac was slow to start turning. The DO328 pilot then called on frequency and was given an avoiding action R turn onto 360°.

Cause: The B777 FO read back the wrong heading instruction that went undetected by the ac Capt and the LACC S28/34 Tactical controller.
