UK AIRPROX BOARD

Analysis of Airprox in UK Airspace

Report Number 11
July 2003 to December 2003

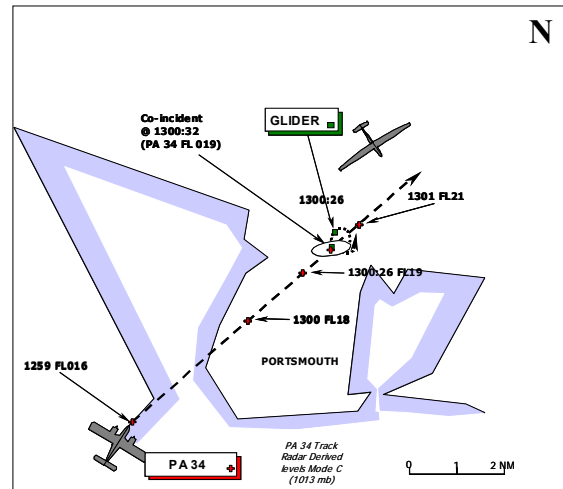
AIRPROX REPORT NO 138/03

THE GLIDER PILOT reports flying a white SHK1 glider with red wing tips, solo on a local sortie from Bembridge IoW. While overhead Gosport [UKAB Note (1): The position recorded on the radar is over the N edge of Portsmouth as shown on the diagram] at about 2200ft and heading 120° at 55kt in communication with Lee on Solent glider base, he had a very brief glimpse of another ac and considered that a collision was imminent so he made an instinctive steep climbing turn to the left, without time for thought. As the glider's nose was raised he lost sight of the other ac but he thought the pilot would have had a full plan view of the glider as it climbed. In the very brief time that he had him in sight he saw no sign of evasive action by the other ac. He was very shocked and landed at the nearest airfield which was Lee on Solent.

UKAB Note (2): The Pease Pottage radar recording shows the PA 34 tracking NNE over Portsmouth in a gentle climb from FL016. At about 1300:26 a primary return believed to be the subject glider pops up in a left hand orbit in the PA 34's (now indicating FL019) 1130 position just inside ½ nm head on, and turning towards it. At that aspect it would have presented a very small visual target, coloured white with some Cu cloud in the background, for the PA34 pilot to acquire even in very good visibility conditions. At this time the ac are closing at about 210kt i.e. it took est 8.5sec to travel ½ nm. From the glider pilot's cockpit the PA34 would have initially been head on before disappearing out of view below his nose as

Cause: A non-sighting by the PA 34 pilot and a very late sighting by the SHK1 pilot.

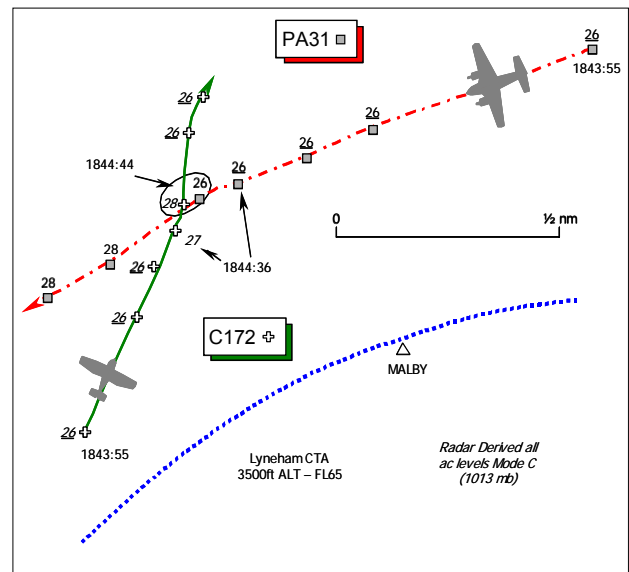
AIRPROX REPORT NO 139/03

THE CESSNA C172 PILOT reports, over 5 weeks after the occurrence, that his aeroplane has a white colour scheme and the red anti-collision beacon, wing tip HISLs and navigation lights were all on, whilst inbound to Kemble for an overhead Cct join. He was not in receipt of an ATS after leaving Lyneham's frequency about 1½ min before the Airprox occurred, squawking A7000 with Mode C, but he was listening out on both the Kemble and Bristol frequencies. About 4nm S of Kemble, heading 020° at 110kt, he was descending from 3000ft RPS (1011mb), he thought, and had just completed an external lookout scan from L – R, whereupon he raised the right wing slightly to expose the airspace at 2-4 o'clock slightly above his high-wing monoplane. This revealed a low-wing twin [the PA31] flying straight and level towards him about 200m away at the same altitude. To avoid the other ac, he pushed the nose down and banked 50° to the L, whilst adding L rudder to increase his descent, as the PA31 passed 10-15m away to starboard and crossed obliquely astern from R – L about 20ft above his aeroplane with a "very high" risk of a collision. He opined that his ac's high-wing had obscured the other ac during his normal scan, adding that the only thing that "saved" him was a disciplined lookout and he "...now believes in TCAS for light ac".

Cause: Very late sightings by both the C172 pilot and the PA31 pilot.

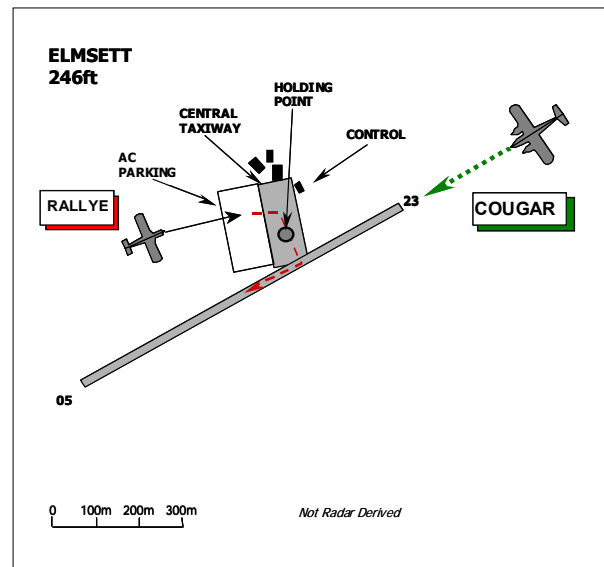
AIRPROX REPORT NO 141/03

THE RALLYE PILOT reports flying in a white and maroon ac, which was not SSR equipped but the beacon was selected on. He had landed at Elmsett from Wattisham to refuel and was preparing to return to Wattisham on a Sunday when no ATC service was available at Elmsett [See UKAB Note(1)] but in very good weather and visibility conditions. Since Elmsett is within the Wattisham MATZ and their ATZs overlap, the published procedures, he thought, required notice of arrival/departure to be transmitted on Wattisham App (125.8) when no ATC service was available at Elmsett. He transmitted his intention to taxi to the RW and then, after looking in both directions, his intention to enter the RW for departure. He thought that either the other pilot was not listening on 125.8 or did not hear his transmissions. Shortly after lift off at about 50ft agl he saw another ac overtake him 150ft on his left and 40ft above him banking to the left. He did not take any avoiding action as he saw that the other ac was banking away from him and he assessed the risk of collision as low since the other pilot had seen him throughout.

Although there were many secondary factors, this was in essence a very straightforward occurrence caused primarily by the Rallye pilot entering an active runway without checking that it was safe to do so. Specialist members considered that he made many mistakes in the lead-up to the incident. The video recording shows that he did not stop at the holding point and apparently did not conduct full pre-take off checks. Further, he did not transmit his intentions on the published frequency for Elmsett.

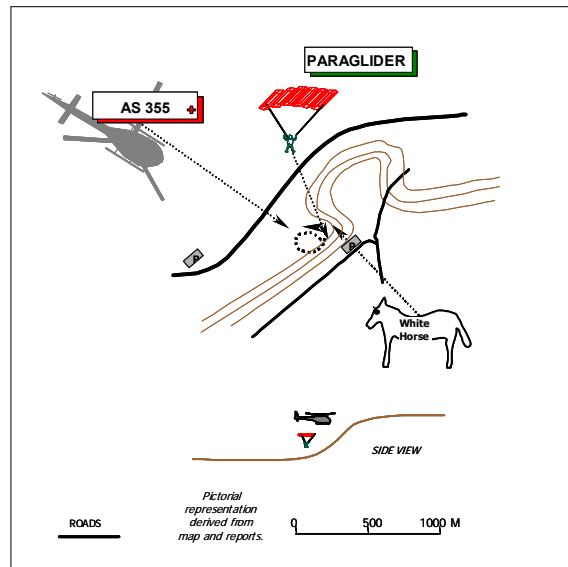
AIRPROX REPORT NO 142/03

THE PARAGLIDER PILOT reports flying a red paraglider from a ridge launch site near Westbury, planning to soar the ridge and land in the car park at the bottom. He was flying on a N heading at about 10kt parallel to the ridge when a helicopter approached and circled near the launch site while several other paragliders and hang gliders were soaring. It came very close to several non-powered soaring ac.

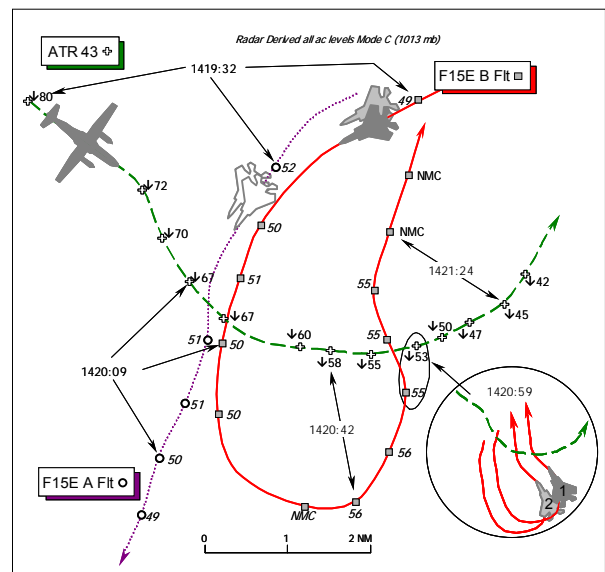
AIRPROX REPORT NO 143/03

THE ATR42-300 (ATR43) PILOT reports his ac has a predominantly white company livery but did not specify whether the HISL was on. Inbound to Swansea from Cork IFR, he was in communication with SWANSEA APPROACH on 119.7MHz squawking A1430 with Mode C; TCAS is fitted. Flying at 235kt, descending through 8000ft Swansea QNH (1015mb) VMC 'on top', heading SE about 12nm N of Swansea he thought, to intercept the 8d arc of the SWS for a direct arrival to RW22, 2 F15 ac were suddenly spotted as they crossed ahead from L to R descending to 1000ft below his ac. The F15 jets then banked left, turned about and crossed back again from R - L about 1nm ahead he thought, and 500ft above his ac as he turned L to avoid them. TCAS enunciated an RA to "MAINTAIN VERTICAL SPEED" twice, which he did until the F15 pair opened to port and the conflict was resolved. He assessed the risk as "low to medium".

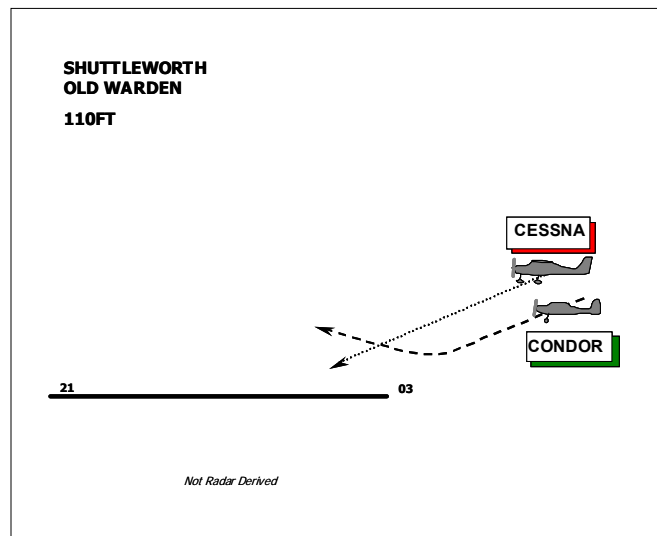
THE CONDOR D62C PILOT reports flying a cream and purple ac, with no lights or SSR fitted, from Andrewsfield to Old Warden to visit the aviation museum and since the airfield is non-radio except on flying display days he was not in radio communication with any agency. Following a standard overhead join and a right hand circuit for R/W 03 and while heading 30° at 60kt and 250ft on short finals he suddenly became aware of another ac directly above him (estimated 10–20ft) also descending on its final approach. The other ac's approach speed was greater than his and it continued to descend and landed directly in front of him. His immediate reaction was to turn left on to the dead side of the R/W and execute an emergency "go-around" from which he completed another circuit and landed safely. In conversation later the other pilot stated he did not see the Condor at the time; aero modellers who were at the airfield however witnessed the incident. He reported the incident to the staff at the museum and sent in a CHIRP report.

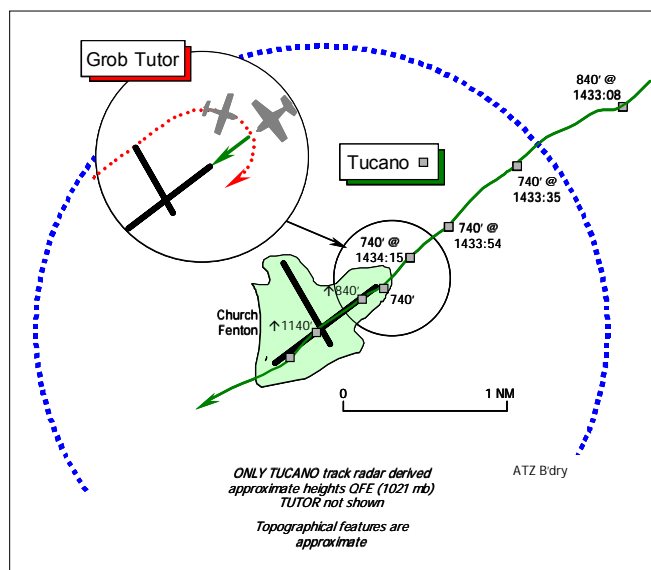
AIRPROX REPORT NO 145/03

THE TUCANO T1 PILOT, a QFI reports he was acting as the safety pilot with a refresher student flying an IF sortie under an IF visor from the front seat. They were flying a PAR 'azimuth only' approach to RW24 [RHC] at Church Fenton with a MDH of 670ft, whilst in receipt of a TALKDOWN from Church Fenton on 386.725MHz. A squawk of A4541 was selected with Mode C, but neither TCAS nor any other form of CWS is fitted. The ac has a black/yellow colour scheme and the landing lamps, HISLs and nosewheel lights were all on.

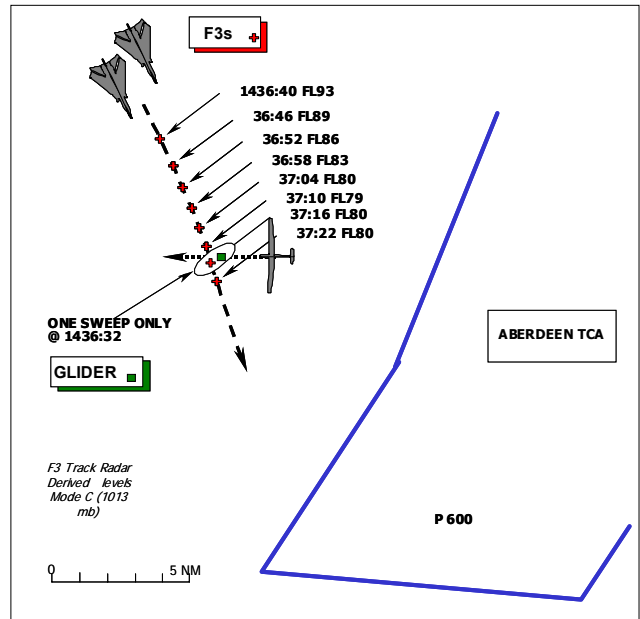
AIRPROX REPORT NO 146/03

THE TORNADO F3 PILOT reports leading a 2-ship of grey F3 ac in close formation with HISLs selected on 40nm N of, and on recovery to RAF Leuchars, squawking 7000C in receipt of a RIS from Scottish Military Radar. While heading 170° into sun at 400kt and level at 6000ft he first saw a white low wing glider at 1nm on his nose, at approximately the same height, but on an opposite heading, and on a collision course with his formation. He initiated a climb immediately and missed the glider by 500ft vertically and a similar distance horizontally.

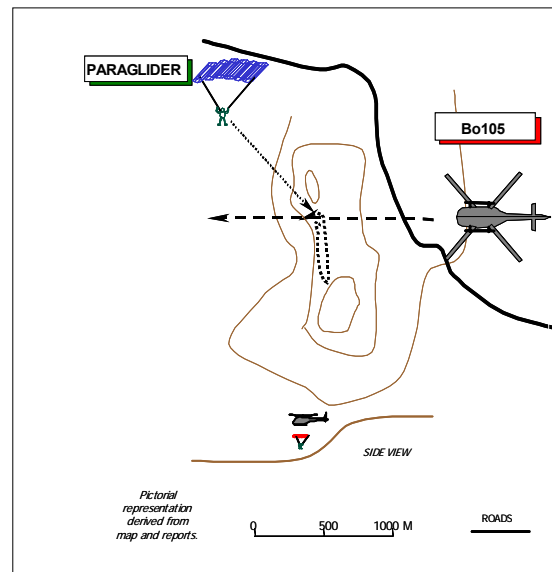
AIRPROX REPORT NO 148/03

Date/Time: 14 Sep 1532 (Sunday)
Position: 5304 N 00314 W (Moel Y Waun)
Airspace: London FIR (Class: G)
Reporting Ac Reported Ac
Type: Paraglider Bo105
Operator: Civ Pte Civ Comm
Alt/FL: 1450ft 500ft agl
(50ft agl)
Weather VMC CAVOK VMC CAVOK
Visibility: 40km >10km
Reported Separation:
0 H 35m V NR
Recorded Separation:
NR

Cause: A non-sighting of the paraglider by the Bo105 pilot.

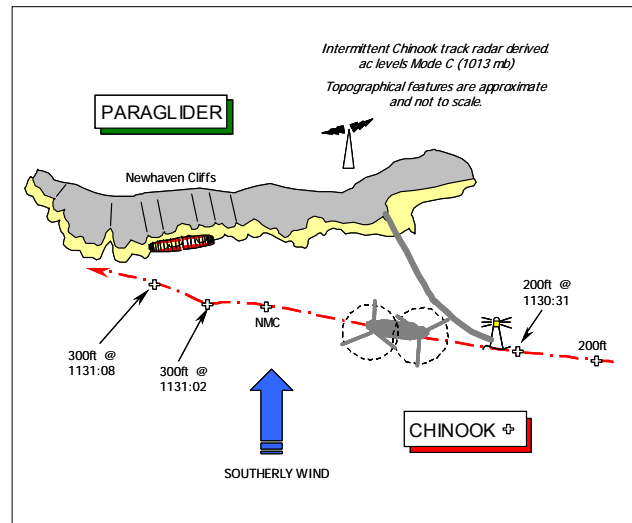
AIRPROX REPORT NO 149/03

Date/Time: 19 Sep 1131
Position: 5047N 0003E (Newhaven Cliffs)
Airspace: London FIR (Class: G)
Reporting Ac Reported Ac
Type: Paraglider Boeing CH47D
Operator: Civ Pte Foreign Mil
Alt/FL: 220-250ft 500ft
amsl (Rad Alt)
Weather NR VMC NR
Visibility: "Good". >10km
Reported Separation:
100m H/50-100ft VNot reported
Recorded Separation:
NR

Cause: The Chinook crew flew close enough to cause a partial collapse of the paraglider pilot's wing.

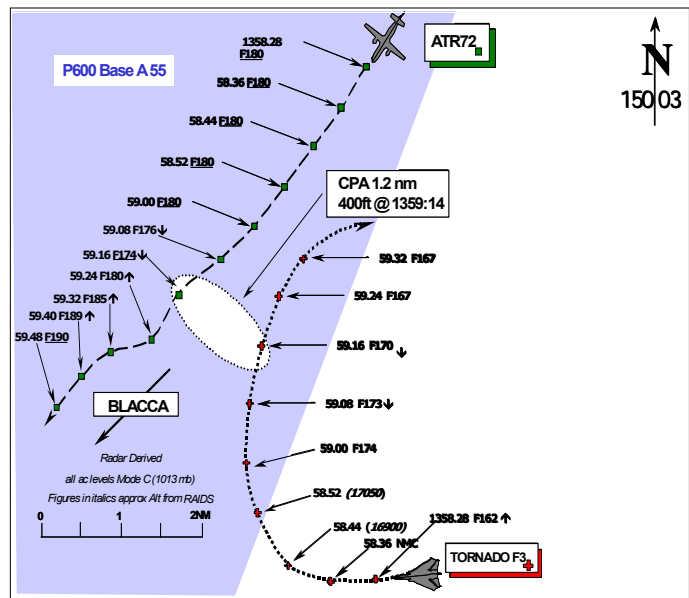
Reported Separation:
NR 1nm H

Recorded Separation:
1.2nm H 400ft V

Cause: The F3 formation entered CAS without clearance and flew into conflict with the ATR72.

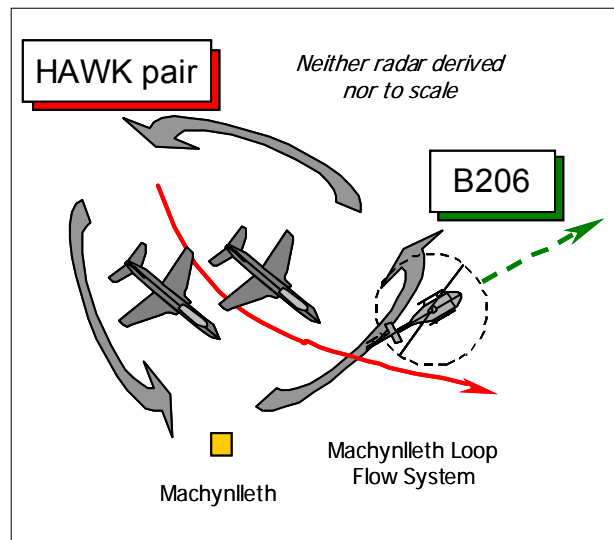
AIRPROX REPORT NO 151/03

Date/Time: 23 Sep 0946
Position: 5236N 0348W (2nm NE of Machynlleth)
Airspace: FIR/UKDLFS (Class: G)
Reporting Ac Reported Ac
Type: B206 JetRanger Hawk pair
Operator: Civ Comm HQ PTC
Alt/FL: 600ft ↓250ft
 QNH (1017mb) (msd)
Weather VMC CLBC VMC CLBC
Visibility: 30nm 10km +
Reported Separation:
 nil H/200ft V 100ft H/300ft V
Recorded Separation:
 NR

Cause: The Hawk leader flew sufficiently close to cause concern to the JetRanger pilot.

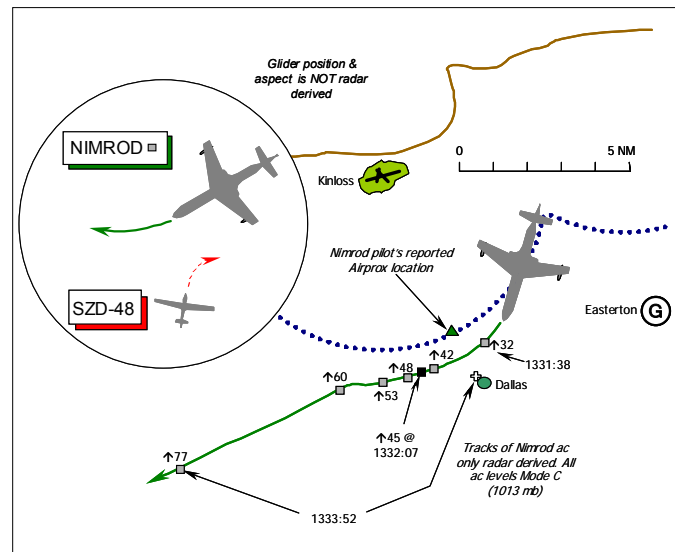
AIRPROX REPORT NO 152/03

Date/Time: 27 Sep 1332 (Saturday)
Position: 5733N 0333W (6nm S of Kinloss - elev: 22ft)
Airspace: Scottish FIR (Class: G)
Reporting Ac Reported Ac
Type: Nimrod MR2 Standard Jantar
Operator: HQ STC Civ Pte
Alt/FL: FL45 3000ft (QFE)
Weather VMC CLBL VMC
Visibility: >10km >30nm
Reported Separation:
400yd 400yd
Recorded Separation:
NR

Cause: Conflict in the FIR.

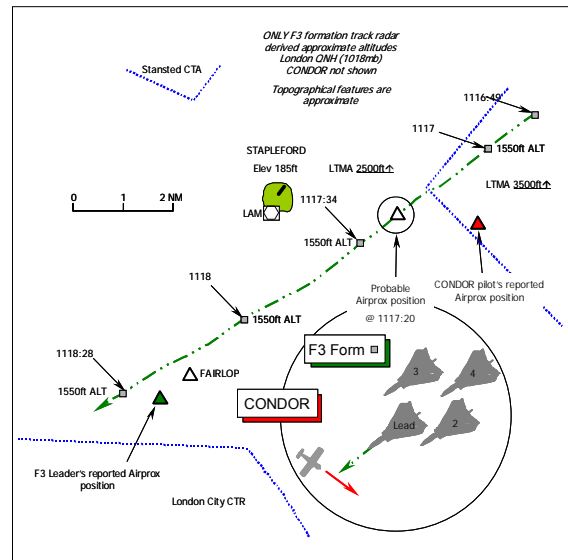
AIRPROX REPORT NO 154/03

Date/Time: 21 Sep 1117 (Sunday)
Position: 5138 N 0014E (3nm E of Stapleford - elev 185ft)
Airspace: London FIR (Class: G)
Reporting Ac Reported Ac
Type: Tornado F3 Condor
Operator: HQ STC Civ Pte
Alt/FL: 1500ft 1400ft
 (QNH 1018mb) (QNH 1018mb)
Weather NK HAZE VMC Nil cloud
Visibility: 8km 30km+
Reported Separation:
 100ft V, nil H 100ft V, 300m H
Recorded Separation:
 NR

Cause: Effectively, a non-sighting by the F3 formation and a late sighting by the Condor pilot

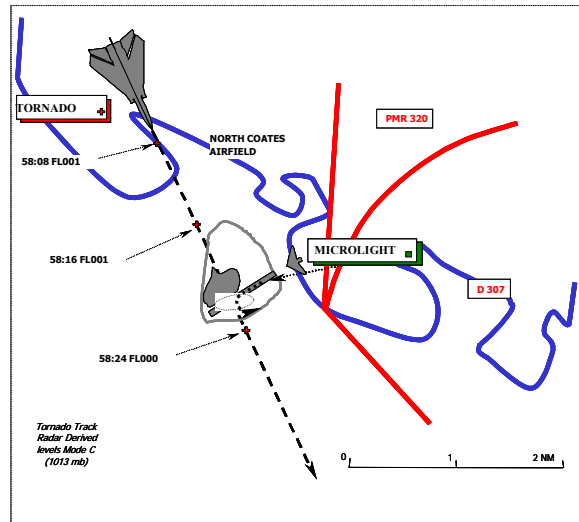
AIRPROX REPORT NO 155/03

Date/Time: 24 Sep 1659 (Wednesday)
Position: 5332N 0005E (N Coates Lincs)
Airspace: UKDLFS LFA 11 (Class: G)
Reporting Ac Reported Ac
Type: Microlight Tornado GR4
Operator: Civ Pte HQ STC
Alt/FL: 300ft 400ft
(QFE) (QFE)
Weather VMC CAVOK VMC CAVOK
Visibility: 5nm >20km
Reported Separation:
100ft H 0 V NR
Recorded Separation:
NR

Cause: A non-sighting by the Tornado crew.

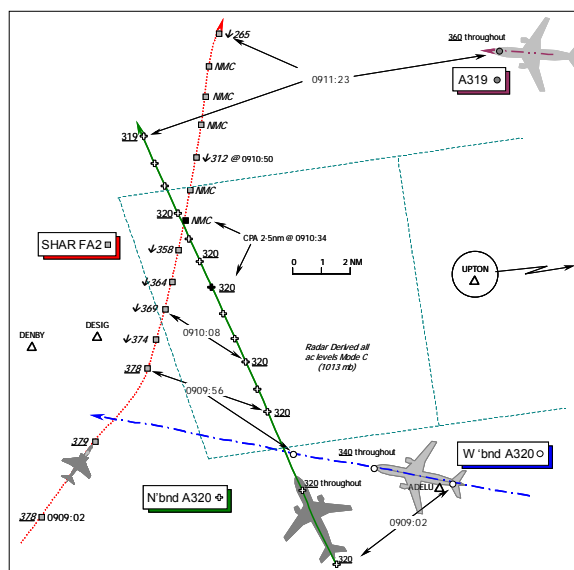
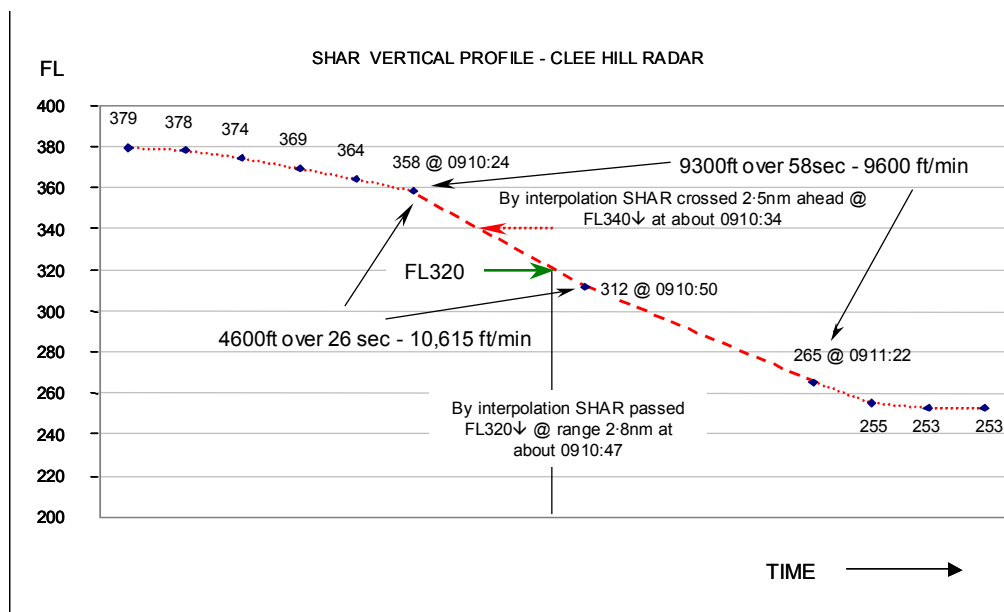
By interpolation the descent profile of the SHAR shows it was descending at about 10,000ft/min with the rate as it crossed through the A320's level of about 11000ft/min. SMF records the horizontal separation as 2.8nm ahead when the SHAR descended through the level of the northbound A320 at FL320. [UKAB Note (2): By interpolation, this was at about 0910:47 if the SHAR maintained a continuous rate of descent of 11000ft/min. The minimum horizontal separation from the radar recording was about 2.5nm when the SHAR crossed ahead of the A320 at 0910:34, descending through about FL340 by interpolation.] Enquiries with the A320 operator confirmed that the TCAS equipment fitted does not capture rates of descent in excess of 10000ft/min and apparently the SHAR was not displayed on the subject A320's TCAS nor did the flight crew see it.

Cause: MIL NW descended the SHAR through the level of the A320, unaware of its presence.

It is recommended that NATS requests that the CAA consider the imposition of a maximum rate of vertical change in Class A airspace and within Upper ATS routes in Class B airspace. The maximum

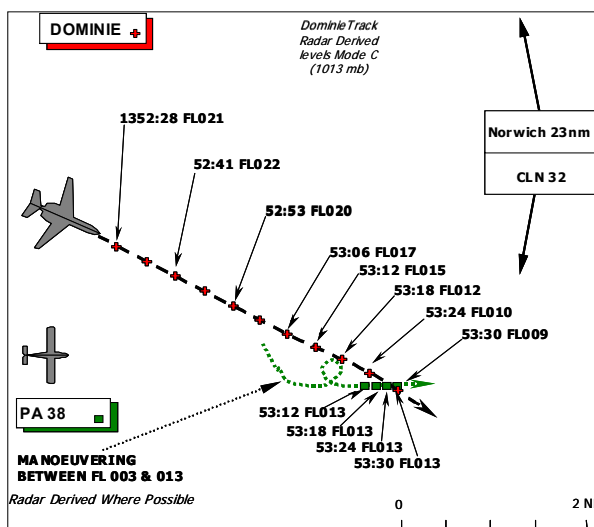
AIRPROX REPORT NO 157/03

Date/Time: 30 Sep 1353
Position: 5222N 00122 E (23nm S Norwich)
Airspace: London FIR (Class: G)
Reporting Ac Reported Ac
Type: Dominie T1 PA38
Operator: HQ PTC Civ Club
Alt/FL: 720ft 1000ft
(RPS 1005 mb) (RPS)
Weather VMC HAZE VMC
Visibility: 10nm >10km
Reported Separation:
100ft H 150ft V NR
Recorded Separation:
Contacts Overlap H 400ft V

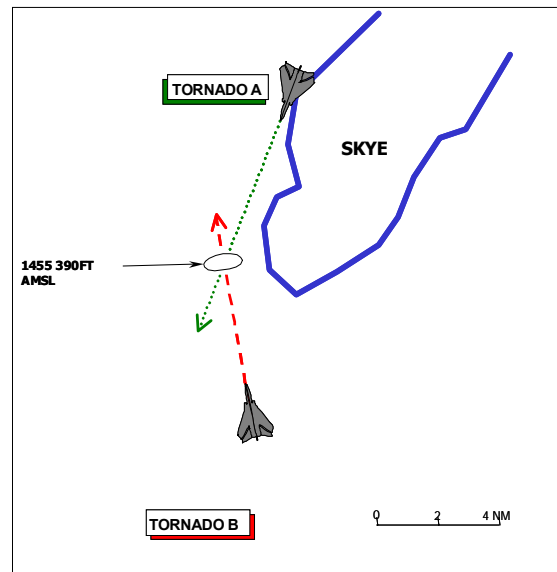
AIRPROX REPORT NO 161/03

Date/Time: 15 Oct 1455
Position: 5702N 00604W (5NM S Skye)
Airspace: UKDLFS A 14 (Class: G)
Reporting Ac Reported Ac
Type: Tornado GR4 Tornado GR4
Operator: HQ STC HQ STC
Alt/FL: 390ft 420ft
 (Rad Alt) (Rad Alt)
Weather VMC CAVOK VMC CAVOK
Visibility: 30km >50km
Reported Separation:
 50ft H 0ft V 150ft H 50ft V
Recorded Separation:
 NR

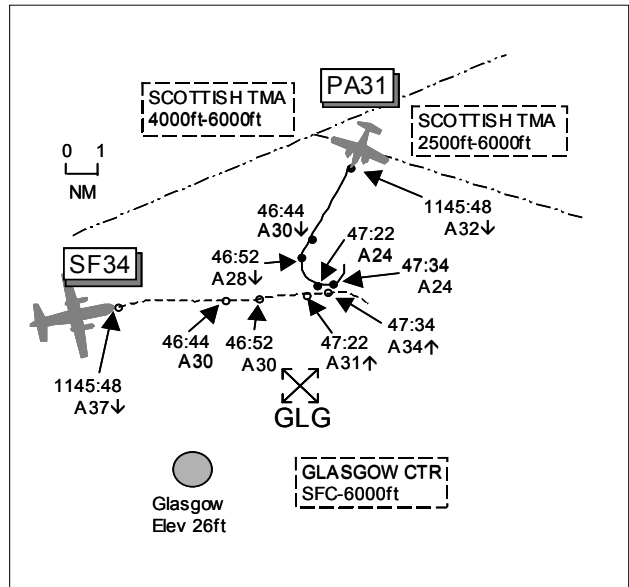
AIRPROX REPORT NO 166/03

Date/Time: 24 Oct 1147
Position: 5558N 0420W (7nm NE Glasgow Airport - elev 26ft)
Airspace: CTR (Class: D)
Reporting Ac Reported Ac
Type: SF34 PA31
Operator: CAT Civ Comm
Alt/FL: 3500ft↓ 2500ft↓
 (QNH 1025mb) (QNH 1025mb)
Weather VMC CLOC VMC CLNC
Visibility: 60km >10km
Reported Separation:
 500ft V 0.5nm H 800ft V
Recorded Separation:
 700ft V 0.5nm H

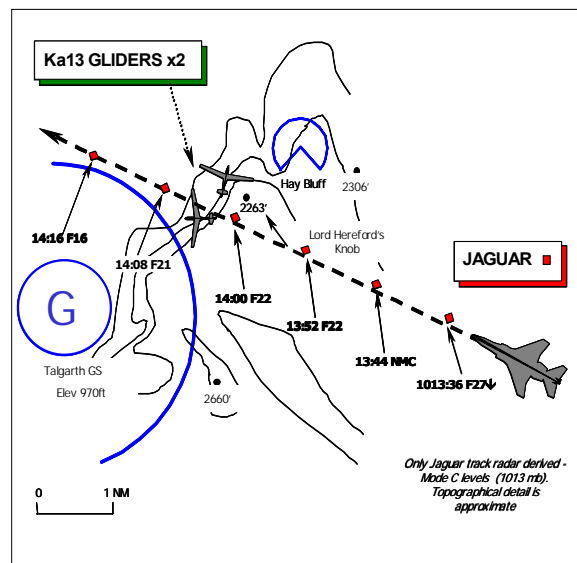
AIRPROX REPORT NO 167/03

Date/Time: 24 Oct 1012
Position: 5200N 00308W (6km NE Talgarth Glider Site)
Airspace: UKDLFS LFA7 Class: G
Reporting Ac Reported Ac
Type: Gliders K13&T10 Jaguar
Operator: Civ Club HQ STC
Alt/FL: 2570ft 500ft
(QNH) (Rad Alt)
Weather VMC Below Cl VMC Below Cl
Visibility: >20km 20km
Reported Separation:
100m H 0 V 100ft H 50ft V
Recorded Separation:
NR

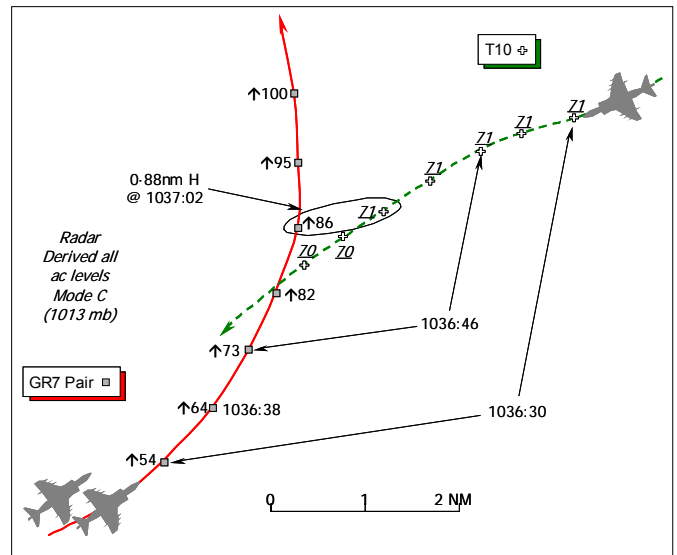
AIRPROX REPORT NO 168/03

Cause: The GR7 instructor pilot (No2) allowed his student to climb through their assigned level.

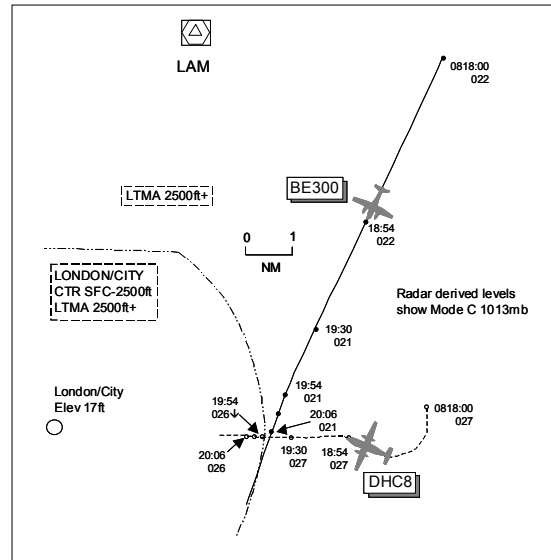
AIRPROX REPORT NO 169/03

Cause: Sighting report (TCAS).

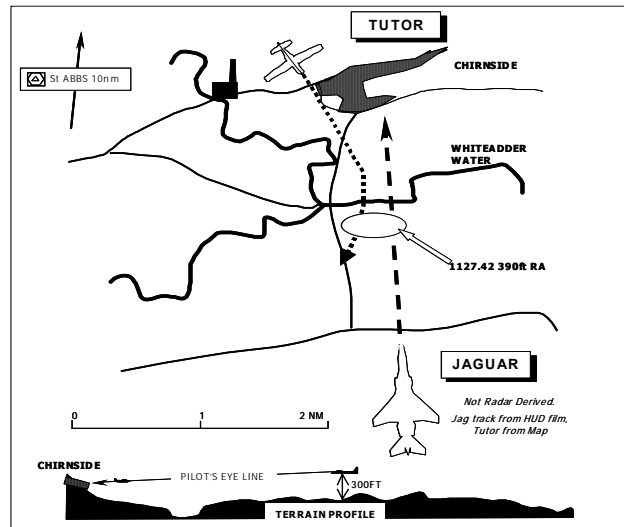
AIRPROX REPORT NO 170/03

Cause: A non-sighting by the Jaguar pilot and a very late sighting by the Tutor crew.

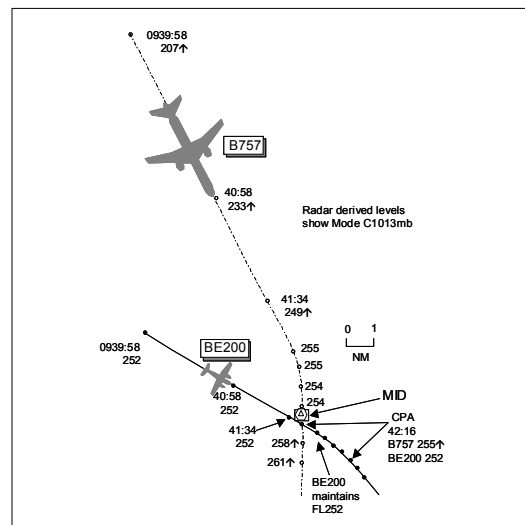
Cause: The S18T did not take the BE200 into account when he instructed the B757 to climb.

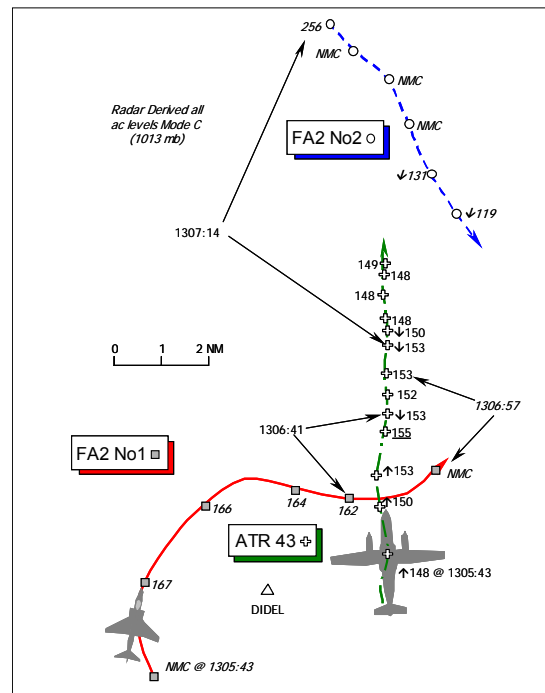
Cause: Sighting Report.

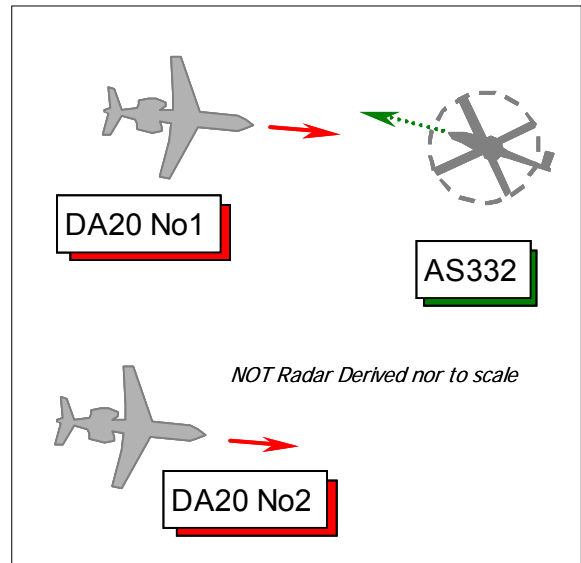
AIRPROX REPORT NO 173/03

Cause: The Falcon DA20 crew flew sufficiently close to cause concern to the AS332 crew.

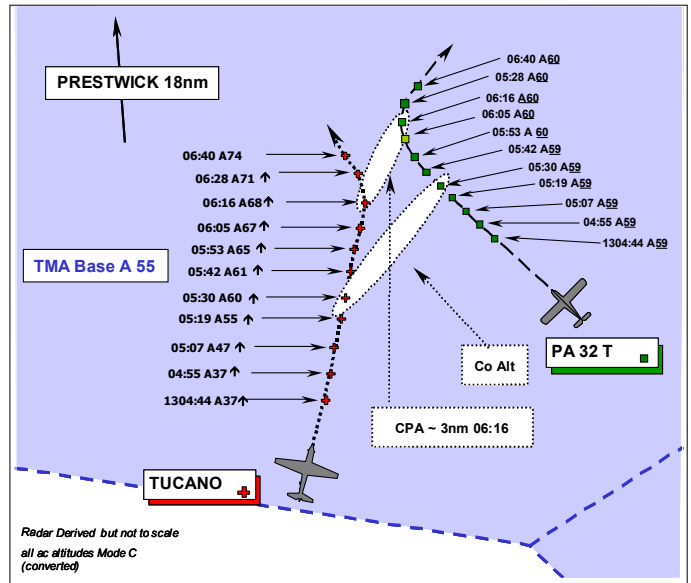
AIRPROX REPORT NO 176/03

Cause: The Tucano pilot entered Class D CAS without clearance and flew into conflict with the PA32T which he did not see.

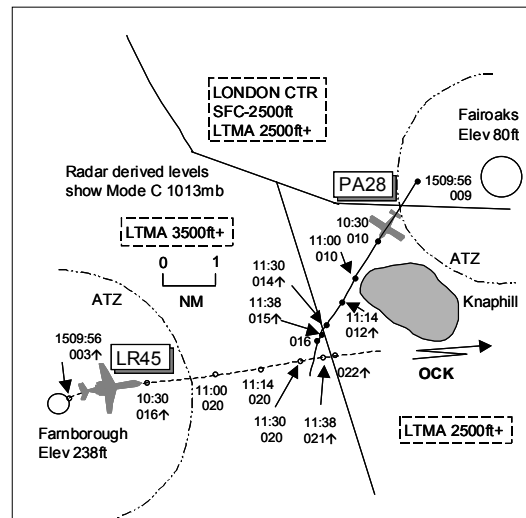
Cause: Sighting report (TCAS)

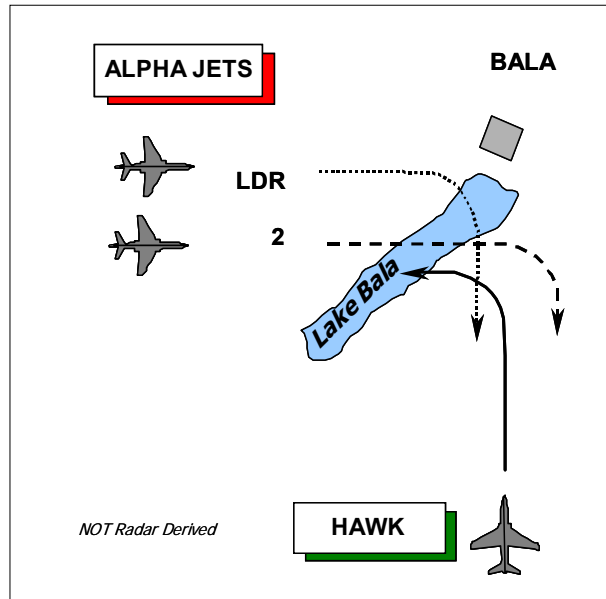
AIRPROX REPORT NO 180/03

Cause: A non-sighting by the Hawk pilot and an effective non-sighting by the Alpha Jet pilots.

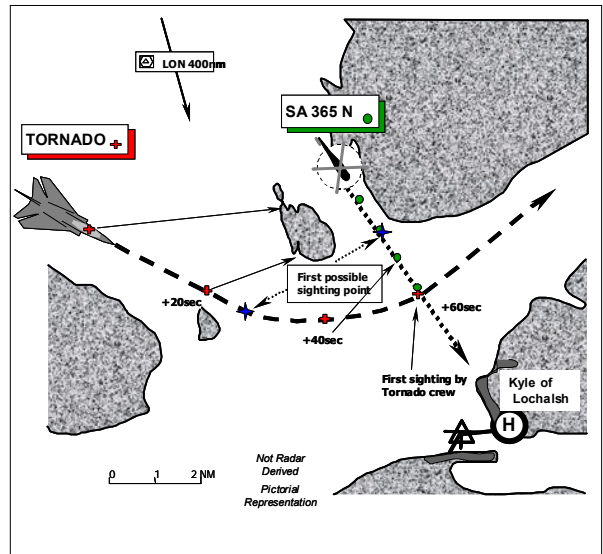
AIRPROX REPORT NO 181/03

Cause: A non-sighting by the Tornado crew and a very late sighting by the SA365 pilot.

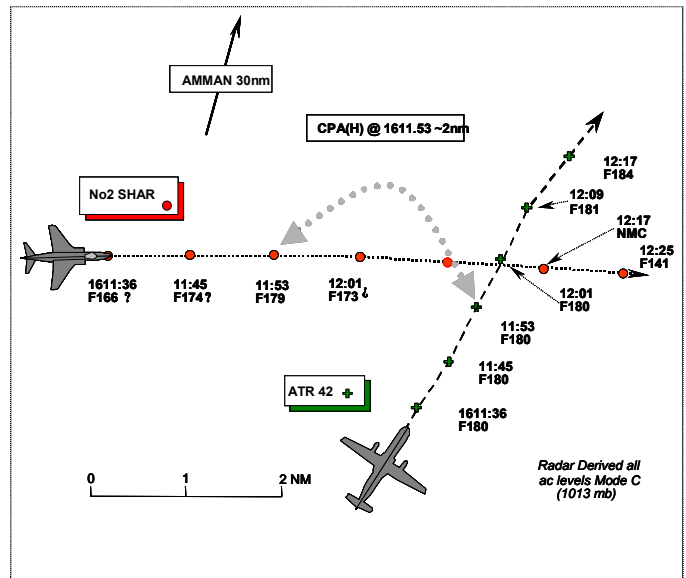
THE ATR 42 300 PILOT reports flying a scheduled passenger sortie on a route through class G airspace from Plymouth to Dublin. While receiving a RAS from London Military Radar, heading 005° at 230kts and FL180 he received a TCAS TA followed by an RA as he was given avoiding action. He initiated a TCAS climb during the avoiding action turn and assessed the risk of collision as being high. The Lon Mil Controller apologised for the conflict stating that they were co-ordinated with the other traffic that had been told to remain below FL170. Lon Mil also stated that it was a student pilot.

THE SEA HARRIER STATION comments that this Airprox was caused by the student pilot not complying with the level restriction imposed by the Fighter Controller (FC). The pilot wrongly thought that the level restriction imposed was solely for his leader. This was contrary to SOPs for Harriers operating under a FC. Following TI from the FC, the student pilot gained visual contact with the conflicting traffic at around 4nm, he thought, and therefore there was never any risk of collision. His subsequent rapid descent was made after he was given the avoiding action descent following advice that he should not be above FL170 (he was at FL178 at the time). The FC had previously been unable to co-ordinate her traffic due to the nature of the sortie however, when she identified the opportunity to do so without adversely affecting the sortie, she imposed a level restriction and initiated co-ordination with London Mil. After passing the restriction to her ac with the leader acknowledging the call, iaw SOPs, she was alarmed to see the No2 climbing towards the now co-ordinated traffic. She immediately reiterated the level restriction and followed with an 'avoiding action descent' as the pilot did not seem to respond instantly to the initial call. It is considered that the FC did all she could to resolve the situation given the unexpected 'level bust'. This Airprox has highlighted a potential deficiency in the SOPs concerning acknowledgement of requirements.

The actual cause of the Airprox, Members thought, was that the No2 SHAR pilot misunderstood the height limitation instruction passed by the Fighter Controller and climbed through his co-ordinated level into conflict with the ATR42. Both pilots had however, seen the respective opposing ac throughout and there had not been a risk of the ac colliding.

Cause: The No2 SHAR pilot climbed above his co-ordinated level into conflict with the ATR42.

Recommendation: MOD reviews regulations with a view to ensuring that all parties concerned acknowledge safety instructions.

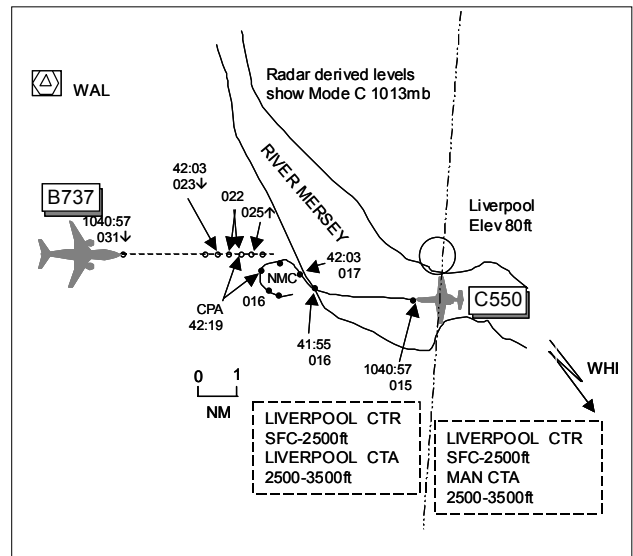
AIRPROX REPORT NO 192/03

THE B737 PILOT reports on an ILS approach to Liverpool RW09 in landing configuration with the speed 'bug' set at 145kt (+20kt) owing to the wind (200/52KT). Liverpool ATC advised him that he was No2 to a Citation jet, which had joined the RH visual cct, and to continue approach. He was then told that the Citation would extend downwind to position behind his ac. The Citation did not appear on TCAS until just before a TA alert was received; the display indicated that the ac had cut across in front of him - it was never seen visually - causing an RA warning to be received and a go-around was commenced from 1200ft QNH, he thought. The warning disappeared almost immediately but the missed approach was carried out and this was followed by an uneventful approach and landing from a further ILS. He estimated that the Citation passed within 0.5nm of his track and 400ft below. It appears that the Citation pilot had not appreciated the strength of the southerly wind or made allowance for it downwind.

It was clear that the C550 pilot had positioned his ac pointing downwind in the visual cct but at a distance too close in to the RW without making sufficient allowance for the unusually strong southerly wind and subsequent turn onto final approach. After declining the offer of positioning No1 in traffic, the Citation pilot had then turned R towards the FAT without permission instead of continuing downwind and, in doing so, had flown into conflict with the B737 on final approach which he did not see. This had caused the Airprox.

Cause: Whilst flying a visual circuit, the C550 pilot flew into conflict with the B737 on the final approach, and which he did not see.

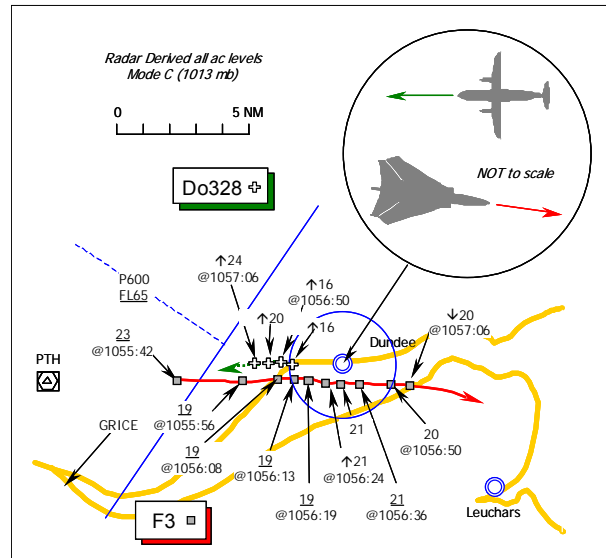
AIRPROX REPORT NO 193/03

THE DORNIER (Do) 328 PILOT reports that his ac has a white and red livery. He was outbound from Dundee IFR to join CAS and in receipt of an ATS from Dundee TOWER on 122.9MHz. The assigned squawk of A5065 was selected with Mode C and TCAS is fitted, but neither a TA nor RA was enunciated during the encounter.

Cause: The Tornado F3 crew entered the Dundee ATZ without permission.

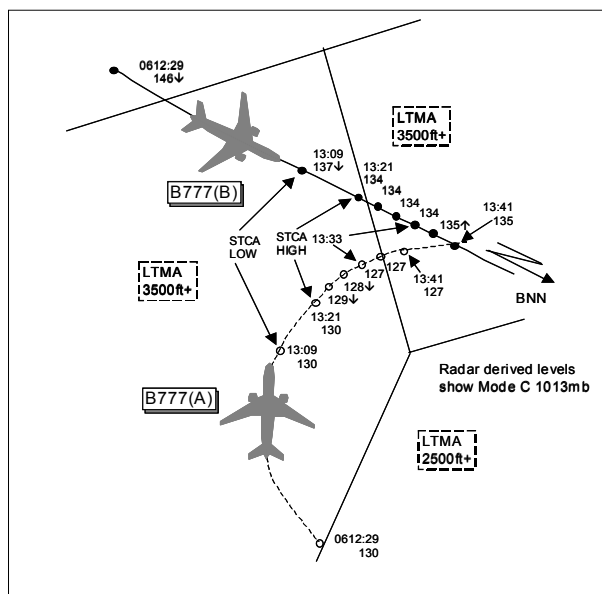
AIRPROX REPORT NO 194/03

THE B777(A) PILOT reports turning R onto the inbound leg of the BNN hold level at FL130 at 210kt. He noticed on TCAS another ac descending and flying towards him from L to R, it appeared that ATC had cleared this ac into the BNN hold at the same level. TCAS commanded an RA 'descend', which was followed, but this immediately conflicted with another ac in the hold below, generating another RA. ATC gave an avoiding action turn, the long way around, back towards BNN, a significant turn, whilst TCAS manoeuvring required that he flew 'wings level'. TCAS then gave a 'monitor vertical speed', the display was indicating that the 1st ac passed 700ft above and the second one 800ft below.

instructed the B777(B) pilot to descend to FL130 i.e. the same level as the B777(A). The radar shows that, at the time, B777(A) was holding at BNN, passing FL132, whilst B777(B) was still approaching BNN, passing FL146, 7.4nm to the NNW of B777(A). The SC said that the only explanation he could offer, in descending B777(B) to an occupied level, was that he must have observed what he thought was a Mode C readout from B777(A) which indicated that it had vacated FL130 and assumed he had cleared it to a lower level. He commented that, owing to the number of ac holding at BNN, the labels of the various ac were overlapping, making it difficult to decipher them individually and this is born out by the radar recordings of the event. He reasoned that he must have picked out a Mode C readout at FL120 and associated it erroneously with B777(A). He admitted that he had not checked the fpss, which were correctly annotated and would have shown the confliction.

Members could add nothing to the ATSI report and agreed that the Airprox had been caused by the TC N SC descending B777(B) to the level occupied by B777(A). Although the TC N SC may have misread the SSR information of B777(A), owing to overlapping labels from other ac holding at BNN, the fpps would have shown the confliction.

Cause: The TC N SC descended B777(B) to the level occupied by B777(A).

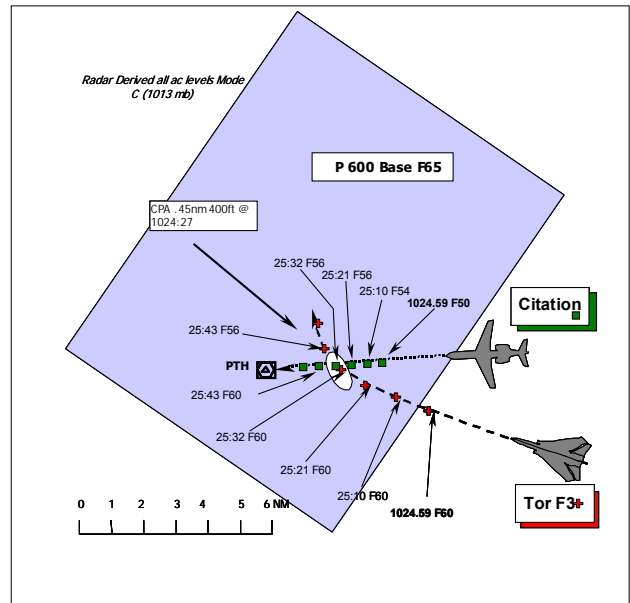
THE ScACC CONTROLLER reports that he was acting as Tay Sector Controller and traffic was light with only 3-5 ac on frequency. Dundee requested an airways joining clearance on a Citation and he passed clearance to join on track PTH climbing to FL150, when instructed by Radar FL350. Shortly afterwards Leuchars called requesting the Leuchars corridors N and S, up to FL120. He informed Leuchars that he could not grant this as he had a Dundee departure. The call was protracted, as the Leuchars Controller had to answer several RT calls and a couple of his own ac called. Leuchars again requested the corridor and at that point the Citation got airborne from Dundee. He told Leuchars this and passed the Citation squawk; Leuchars said their traffic was 'well above him' and again requested the corridor. He did not feel that he could procedurally give the corridor away as he still did not have radar contact on the Citation. During the call, the Citation painted on radar and was clearly in conflict with the Leuchars F3. The Citation then called, but the Leuchars Controller had hung up, and although he had not positively identified the Citation, nor given him a particular service, he felt it necessary to pass avoiding action (stop climb immediately as he passed FL53 climbing) and TI. The F3 was at FL60 and passed overhead above the Citation, but the Citation had stopped his climb at FL55/56. The Airprox occurred beneath the Airway in class G airspace.

Cause: A conflict in the FIR resolved by the TAY Sector Controller and the F3 pilot.

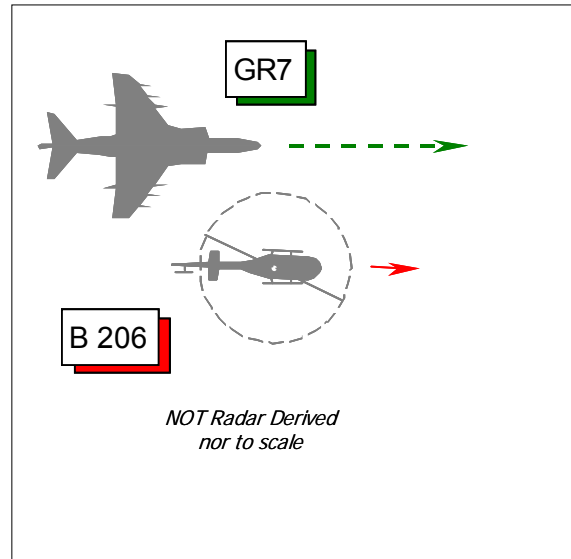
AIRPROX REPORT NO 196/03

THE HARRIER GR7 PILOT reports his ac has a grey camouflage scheme, but the HISL was on whilst flying a routine low-level training sortie through LFA4. A squawk of A7001 was selected with Mode C; but neither TCAS nor any other form of CWS is fitted.

THE HARRIER GR7 PILOT’S STATION comments that the circumstances of this Airprox are simple and require no further comment. The pilot assiduously checked all the NOTAM/CANP/PINS warnings etc before flight and noted a CANP at this exact position. However, the warning expired at 1200 UTC - over 2 hours before the Airprox occurred. There was a concern that the CANP might have been extended but not notified to flying units.

Cause: A very late sighting by the Harrier GR7 pilot

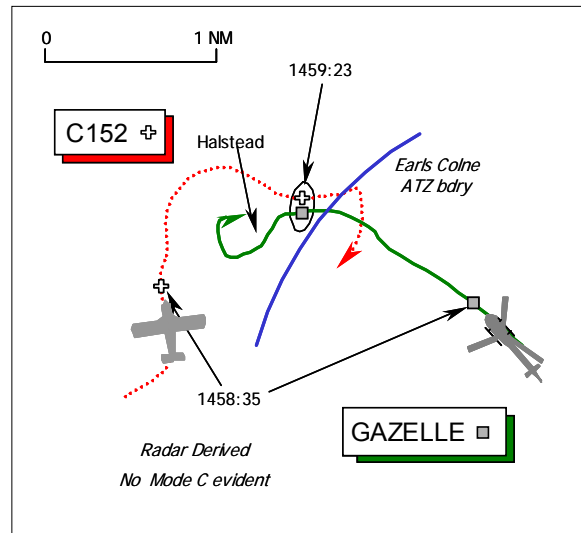
AIRPROX REPORT NO 197/03

THE GAZELLE AH1 PILOT reports his helicopter has a grey & green camouflage scheme and the HISLs were on whilst operating VFR under a FIS from WATTISHAM APPROACH (APP) on 291·12MHz in hazy conditions with a visibility of 6-8 km. A squawk of A4535 was selected, but neither Mode C nor TCAS is fitted.

Cause: Conflict resolved by both pilots.

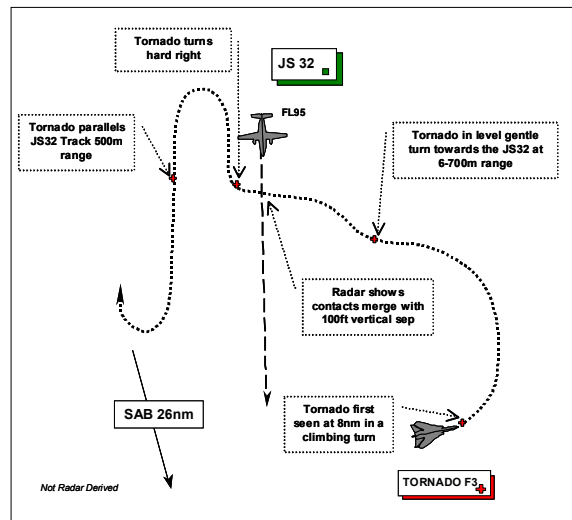
AIRPROX REPORT NO 198/03

THE JETSTREAM 32 PILOT reports flying a red white and blue ac with nav lights, strobe lights and beacons selected on squawking the assigned code with mode C, but with no TCAS fitted, on a scheduled passenger flight from Aberdeen to Teesside under a RIS from ScACC. While heading 172° at 180kt and level at FL95, following TI, they gained visual contact with another ac, subsequently identified as a Tornado, at 8nm in their 10 o'clock at about the same level. The Tornado was performing unpredictable high-energy manoeuvres and appeared to be a single ship. It appeared that he altered his course and performed a climbing turn as if he had seen them then entered a level gentle turn towards them at a distance estimated to be 6-700m and at 100ft above them he rocked his wings and then again level passed directly over the nose of our ac still 100ft above. He performed a "sharp" turn to the right before turning again to fly parallel to our track at the same height and speed. He maintained this for a few minutes before turning right.

When some 26nm N of the SAB, the controller observed unknown traffic at FL91, tracking E, approximately 15nm to the S of the JS32. This was the subject Tornado which shortly afterwards turned left on to a heading of N. The JS32 pilot was given updated TI and he reported seeing the Tornado when it was at a range of 8nm. The Mode C showed the Tornado climbing from FL91 to FL94 before turning head-on towards the JS32. The Mode C increased to FL102 before dropping to FL94 as it passed 100 feet directly overhead the JS32.

The Board thought that there were two equally weighted causes of this Airprox emanating from the crews of both ac involved. Both ac had been operating quite legitimately in Class G airspace and had a responsibility to see and avoid other ac. The F3 pilot became aware of the presence of another ac at a late stage from onboard sensors; the Jetstream pilot sensibly opted for a radar service which disclosed the presence of the F3 much earlier. Despite this the conflict still occurred.

Specialists considered that there had been a breakdown in the inter-cockpit information flow in the F3, which allowed the student navigator to 'dump' the safety critical track of the Jetstream from the ac computer. This resulted in the pilot not being given full displayed information on the other ac, he was however aware of its presence and approximate position although not whether it was civil or military or its heading. This being the case it would have been prudent to take earlier action to establish its identity and having found it to be a non-player, give it a much wider margin. Although this was an instructional sortie for a student navigator the instructor pilot should assume a wider than normal responsibility for the safety aspects of the sortie. It is often difficult to determine the relative priorities between operating in a quiet environment and obtaining radar information, but there is little doubt that, in this case, a RIS would have disclosed the Jetstream earlier and that it was a non-participating civilian ac.

Cause: a. Very late sighting by the F3 crew.

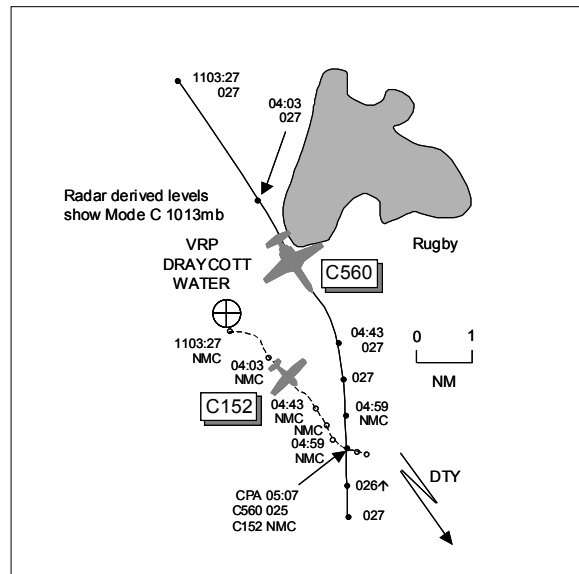
AIRPROX REPORT NO 199/03

THE C152 PILOT reports flying a dual Flying Instructor's Course (FIC) sortie from Coventry and in receipt of a FIS from Coventry on 119.25MHz squawking 4650 NMC. The visibility was >20km in clear sky VMC the ac was coloured white and the anti-collision light was switched on. About 5nm S of Rugby he had almost completed HASELL checks prior to stalling, with lookout as the only outstanding check. Heading 130° at 90kt and 3125ft QNH 1030mb, he looked over his L shoulder - he was seated on the LH side - prior to the lookout turn, and saw a white Citation jet appear from behind the door post in his 7 o'clock position, only 300-400yd away in level flight about 150-200ft below. He had seen it too late to take any avoiding action as it had emerged from a blind spot behind and below his ac. As the Citation passed underneath he recognised the registration letters as a Coventry based ac. He thought that had the ac carried an unknown registration, he doubted if would have had time to read it fully as the ac was only in sight for about 2sec before it disappeared underneath his ac. He had been about to draw his student's attention to their present altitude, which was 125ft above their intended level of 3000ft. The student saw the Citation exit from below in his 1-1:30 position without altering its heading and shortly thereafter it commenced a climb. He thought the other ac was probably cruising at 200-250kt TAS and assessed the risk as high had the Citation crew not seen him or low if they had.

Cause: Conflict resolved by the C560 crew.
