UK AIRPROX BOARD

Analysis of Airprox in UK Airspace

Report Number 11
July 2003 to December 2003

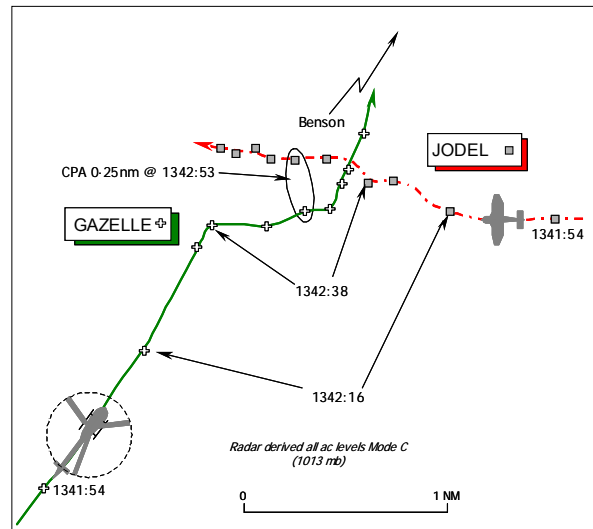
AIRPROX REPORT NO 200/03

THE GAZELLE PILOT reports his helicopter has a grey-green camouflage scheme but the HISL was on whilst conveying three aircrew passengers from Middle Wallop to Wattisham. He was flying out of sun and in receipt of a FIS from Benson ZONE, squawking the assigned code but neither Mode C nor TCAS is fitted.

The Heathrow radar video recording shows the Gazelle 4nm SW of Benson at 1341:54, tracking 020° as the Jodel appears on radar at 1341:46 on the Benson 170° radial 2nm; neither ac is fitted with Mode C. The helicopter continues to track towards the Benson overhead whereas the Jodel is observed in a right turn onto 280°. The subject ac converge until 1342:45, when the Gazelle pilot executes a hard R turn onto E before passing 0.25nm 'port to port' with the aeroplane. After turning L to regain track the Gazelle then passes astern of the Jodel.

HQ JHC comments that this Airprox occurred in good weather conditions, and it would appear within the Benson MATZ. If this is the case, it is surprising that the Gazelle was not warned of the Jodel's presence by ATC. Whilst the difficulty in making contact with Benson ATC may have precluded traffic information being passed to the Jodel pilot, there is little substitute for good lookout when operating VFR. In this case, lookout was hindered by the Jodel pilot flying into sun, and by the Jodel being masked by the Gazelle ac structure. It is fortunate that the Gazelle pilot saw the Jodel in time to take appropriate avoiding action.

Cause: The Jodel pilot did not comply with the Benson departure procedures and climbed into conflict with the Gazelle, which he did not see.

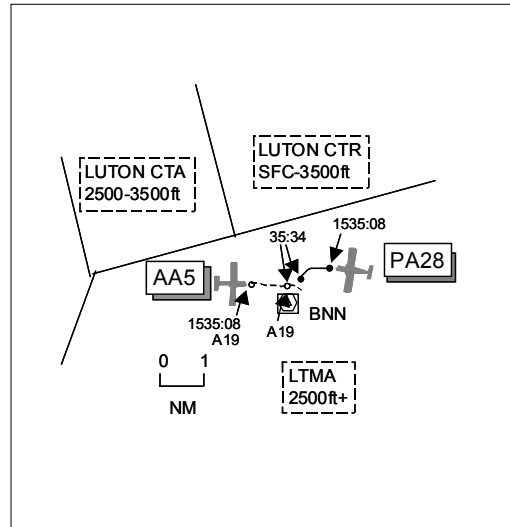
AIRPROX REPORT NO 202/03

THE AA5 PILOT reports flying en route from Enstone to Elstree VFR with a passenger in the RH seat and in receipt of a AFIS from Elstree on 122.4MHz squawking 7000 with Mode C. The visibility was >10km in clear sky VMC and the ac was coloured white/blue with nav and landing lights switched on. At BNN VOR while listening to other joining traffic on the Elstree frequency, he was visual with one ac and was intending to maintain appropriate spacing from it before establishing himself on a 4nm final for RW26 and reporting his position. Steady heading 120° at 100kt and 1800ft QNH 1022mb, suddenly a white/red coloured PA28 crossed ahead from L to R at the same level, very close estimated to be 50m away; he immediately felt a jolt from the other ac's wake. There had been no time for him to take avoiding action and it appeared that neither had the PA28 pilot. He assessed the risk as very high. Subsequently, he thought that 2 factors had been relevant to this incident. Firstly, his attention had been too focussed on the other traffic ahead. Secondly, although the pilot of the conflicting ac had been responsible for giving way (having his ac on the R), the sun was low and would have been partly in the pilot's field of view. This had been a very sobering experience and certainly the closest encounter he ever wanted to have.

Members wondered how the subject ac could have flown in such close proximity before both pilots had sighted each other. The PA28 pilot had been flying towards a low setting sun in hazy conditions and this would have made visual acquisition of the light coloured AA5 more difficult. Also, the PA28 crew had been engaged in a dual training sortie which is known at times to involve a busy 'heads-in' cockpit environment, perhaps to the detriment of maintaining a good lookout. For his part, the AA5 pilot had been distracted, focussing his attention on following another ac, flying ahead, inbound to join the cct at Elstree. Crucially, both ac were flying near a VOR beacon situated between 2 CTRs; beacons are known to create a 'honey pot' effect where ac are likely to be encountered as pilots use the nav aid for tracking purposes and to ensure they remain clear of CAS. The first time the AA5 pilot saw the conflicting PA28 was as it crossed 50m ahead at the same level with no time to take avoiding action; he immediately passed through its wake. Similarly, the PA28 pilot only saw the AA5 as it appeared on his RH side, he estimated 0.5nm away, at the same level as the cross occurred and it was seen to pass behind. The radar recording shows the PA28 closing on the AA5 at 0.33nm range before fading. This led members to agree that, on the balance of probability, the PA28 pilot's estimation of separation had probably been overly optimistic in the hazy conditions. Understandably, his very late visual acquisition of the AA5 combined with the geometry of the encounter would have left him too little time to gauge distances before the other ac crossed behind. Taking all of these elements into consideration, the Board agreed that the cause of the Airprox had been effectively non-sightings by both pilots, as they had only seen each other as their tracks were about to cross. The separation distances involved had been purely fortuitous, with no time for either pilot to affect the outcome. The Board therefore concluded that in this instance, there had been an actual risk of collision. A lesson for all pilots to take away from this incident is to be extra vigilant when flying near to or approaching VOR beacons while in Class G airspace.

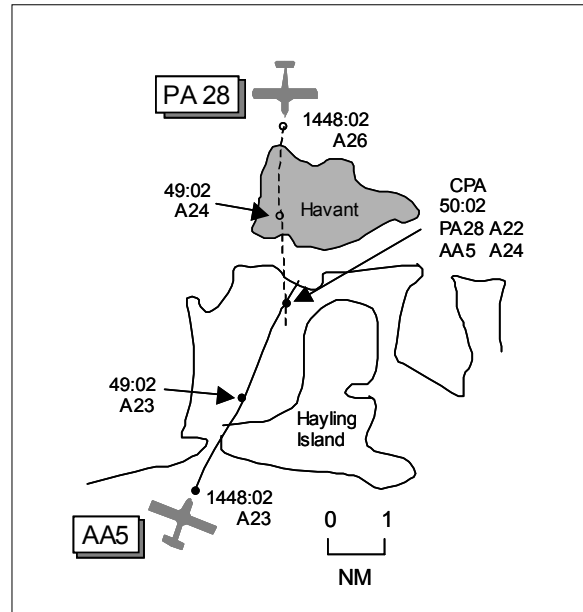
AIRPROX REPORT NO 203/03

THE PA28 PILOT reports flying a solo local cross-country flight from Blackbushe and he was 'listening out' with Goodwood on 122.45MHz squawking 0444 with Mode C. The weather was essentially CAVOK, the coast was visible from Petersfield, but slight haze/inversion was degrading the visibility when flying into sun. The ac was coloured white with blue/red stripes and the strobe lights were switched on. Near to Hayling Island heading 180° at 90-100kt and 2000-2500ft QNH 1022mb, he had put the map aside and was navigating by reference to the coast having just completed a frequency change from Farnborough to Goodwood. Unusually he had lowered the sun visor because of the low sun angle. He first sighted a conflicting ac, a low wing single engine fixed gear type, possibly white/navy, as it emerged from the sun, from just R of his 12 o'clock range 150-200ft, slightly above him on an almost reciprocal heading; it filled one third of the windscreen horizontally. As he could see the other ac's wheels ahead of him he instinctively pushed hard/forward on the control column causing his map, flight guide and other equipment all to hit the roof; the other ac immediately disappeared upwards from his view. He didn't see it for long enough to gauge whether they would have collided or if the other pilot had taken avoiding action but he estimated it passed 50-100ft overhead, assessing the risk of collision as high.
