UK AIRPROX BOARD

**Analysis of  
Airprox in UK Airspace**  
Report Number 4  
January 2000 to June 2000

Report by the UK Airprox Board,  
'Analysis of Airprox in UK Airspace'

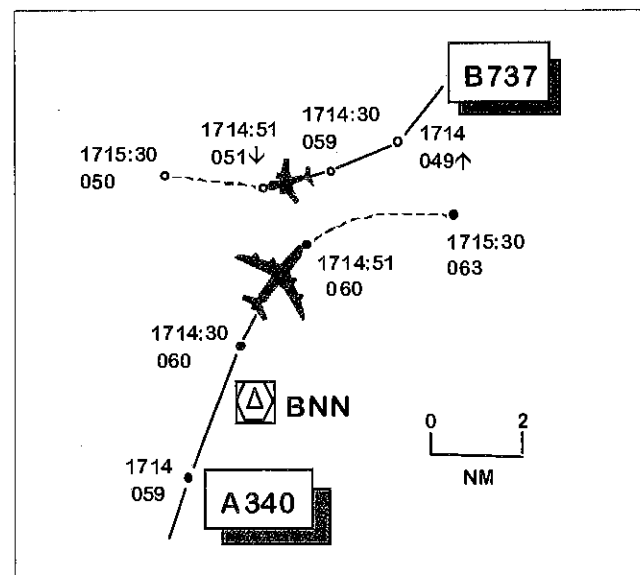
### **AIRPROX REPORT No 2/00**

**THE B737 PILOT** reports that he was in contact with LATCC on 119x77 having departed from Luton on an OLNEY 1B SID. The visibility was 30 km, albeit in darkness. While levelling at 6000 ft at 210 kt and tracking 259°, another ac at a similar level was spotted tracking towards them from their 10 o'clock position about 5 NM away. The traffic triggered a TCAS TA and at the same time ATC told him to descend to 5000 ft. As he complied with this instruction, the TA became an RA giving "climb crossing climb". However, being in visual contact, he followed the ATC descent instruction and at the same time turned R 30° in avoidance. The other ac, which had been given a heading of 095° by ATC, passed about 2 NM to his port side and 200 ft above; he felt there had been a high risk of collision. The controller apologised for the error.

no apparent reason for this uncharacteristic mistake. Members concurred, and the Board concluded that the TC SC caused the Airprox by clearing the B737 to a level assigned to the A340. Radar recordings showed that the ac were well apart, both vertically and laterally, as they passed and members agreed there had not been a risk of collision.

Cause: The TC SC cleared the B737 to a level assigned to the A340.

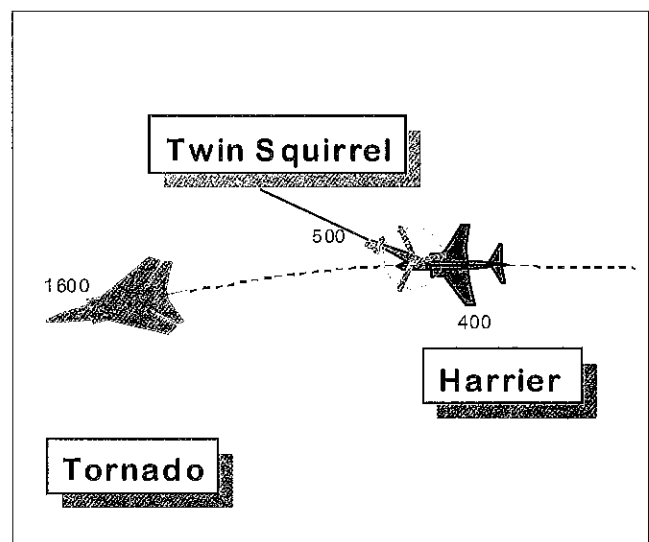
**AIRPROX REPORT No 4/00**

**THE HARRIER PILOT** reports heading 270° at 420 kt using NVG on a night LL training exercise as No 2 to a Tornado which was 2 NM ahead. The Tornado pulled up from LL to turn left onto S towards Brize Norton; using the Tornado's lights for reference he also started to pull up and turn gently left. However the lights turned out to be a helicopter; there was no depth perception on the NVGs and the closure rate was not evident until very late. He passed 1-200 ft below and behind the helicopter at 650 ft Rad Alt. He made a last second bunt when he saw it was a helicopter, and there was a moderate risk of collision. The helicopter was unknown traffic in the night LFS.

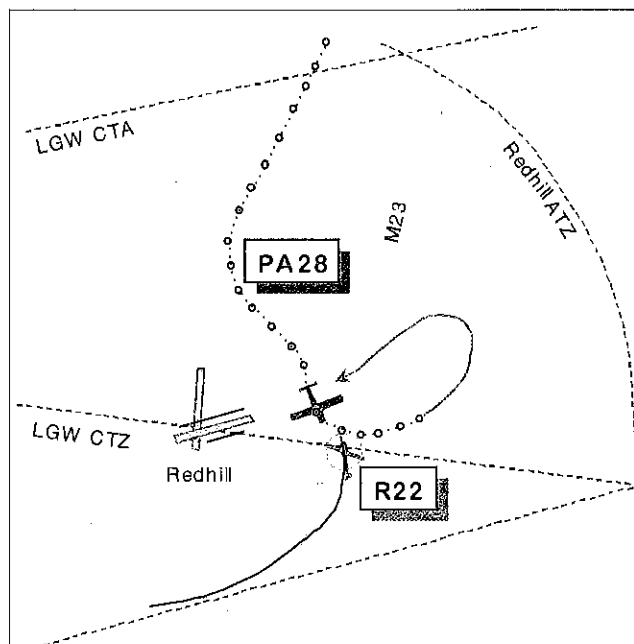
**THE REDHILL FISO** reports that at about 0947 the PA28 pilot reported just N of Caterham inbound to Redhill from the N with 10 NM to run. Joining information was given; he was requested to advise passing the motorway junction (M23/M25) and was advised that there was no fixed wing circuit traffic and that the L/H helicopter circuit was active. At about 0948 the PA28 reported passing the motorway junction, and therefore was asked to report right base for RW 26 R. At about 0949 he reported downwind but was seen well south of the downwind position for RW 26 R, turning E bound slightly N of the VCR at about 600' on QFE 1027. He was advised that in his current position he was overflying a noise sensitive area and was requested to report final for RW 26 R. At the time there were two R22 helicopters training in the L/H circuit; one dual training and the other a solo student. The first was on the 26 helistrap facing W and the other had turned base leg when the PA28 was observed flying southbound just W of the M23 and just S of RW 26 L. It was within the helicopter circuit at about 600' in direct conflict with the R22. The two ac appeared to be at a similar height. The PA28 pilot was immediately requested to turn left and given further

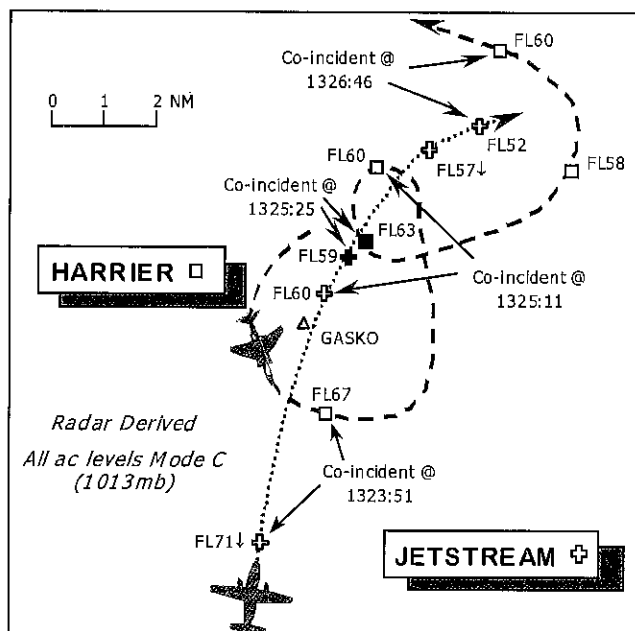
**THE JETSTREAM PILOT** reports heading 045° out of sun at 235 kt, flying straight and level at FL 60. The ac colour scheme was red/white and HISLs were on. Whilst under a RIS from Pennine RADAR in the vicinity of GASKO, the controller reported conflicting traffic ahead which was acquired visually at about 4 NM and determined to be a 'Fast-Jet' in a L hand orbit at about the same level. He descended the ac with the intention of achieving about 200 ft vertical separation. Whereupon, the jet turned across their track from L to R, 'belly up' to the Jetstream, rolled out of the turn heading NW and entered a steep descent to low-level. It was not apparent that its pilot had seen the Jetstream, but at the CPA he estimates that the Jet passed about

0.25 NM ahead and 200 ft above his ac. Just after the Airprox they were handed over to Teesside who were informed of the occurrence.

**THE HARRIER PILOT** reports flying at 330 kt and orbiting L at FL 80, he thought, whilst receiving a RIS from London RADAR, who initially reported traffic to the S, 15 – 20 NM away. As he was preparing to descend to low-level he elected to descend to about FL 55 - 60 to increase separation. When the RIS was cancelled the other traffic was reported 10 NM to the S, descending through FL 95. He did not believe that there had been a conflict with the Jetstream, which he thought was 3500 ft above his ac, but he did not see it because he was concentrating on a rendezvous with his formation at low-level. It was not until he landed back at Cottesmore that he was informed that an Airprox had been filed.

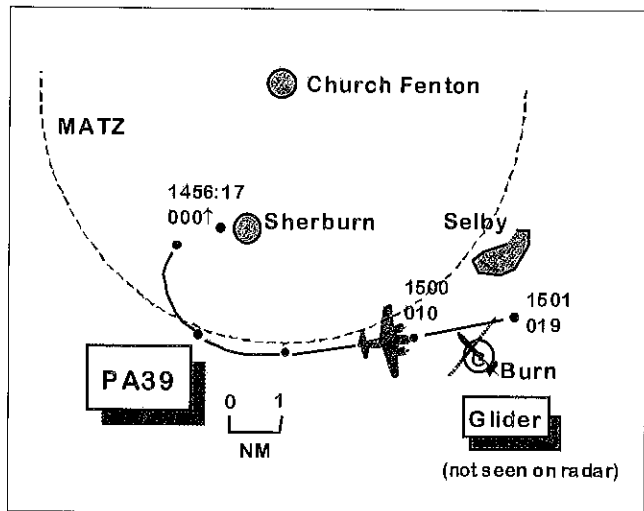
**THE GLIDER PILOT** reports that he was being winch-launched from Burn on a heading of 330° at

55 kt. Church Fenton had been advised of the gliding activity. Radio was not fitted to his ac. The visibility was 18 NM in VMC. His pupil saw another ac and aborted the launch at 1300 ft. On levelling out, he saw a low wing twin engine ac at their 1130 position about 200 m away crossing from L to R at the same level. The pupil turned the glider L and the other ac, which had been in view for only 3 – 4 sec, passed about 50 m away on an easterly track

with no apparent avoiding action by its pilot. He felt there had been a very high risk of collision. The encounter was witnessed by ground observers.

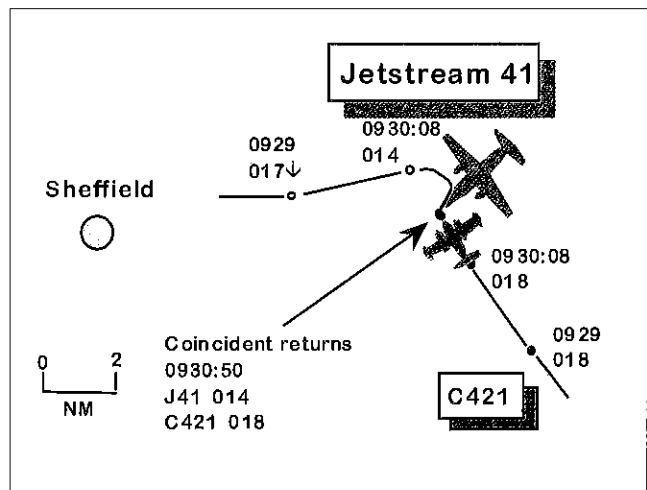
**THE JETSTREAM PILOT** reports that he had been cleared by Sheffield ATC on 128x52 for an NDB approach to RW 28. The Captain monitored the FO as he flew the instrument procedure; cockpit workload was medium. The visibility was over 10 km in VMC. When level at 1900 ft (QNH 1032) 8x5 NM E of the airport and turning R inbound at 160 kt, a Seneca type ac was seen at his 9 o'clock less than half a mile away, about 100 ft above his level; it quickly passed about 100 m behind him and he observed it tracking away to the NW at 2000 ft. He did not take avoiding action because his turn was taking him away from the other ac, but he thought there had been a high risk of collision and reported the incident to Sheffield ATC, who had no knowledge of the other ac.

The pilot comments that this appears to be a classic scenario where the published instrument procedure of an airfield which has no radar capability is situated outside CAS.

**THE C421 PILOT** reports that he was cruising 175 kt at 2000 ft (RPS) on a flight from Peterborough to Leeds. The visibility was better than 10 km in VMC. He was receiving a RIS from Waddington on 127x35 and squawking 2675 with Mode C. Shortly after passing Gamston, Waddington called an ac at his 1 o'clock range 5 NM and 10 sec later both he and his co pilot sighted a Jetstream which was slightly above their level. While keeping the other ac in sight, he reached to switch off the auto-pilot when he realised that it was now below in a steady descent and would track behind them. He therefore left the autopilot connected and continuously monitored the other ac which then passed at least

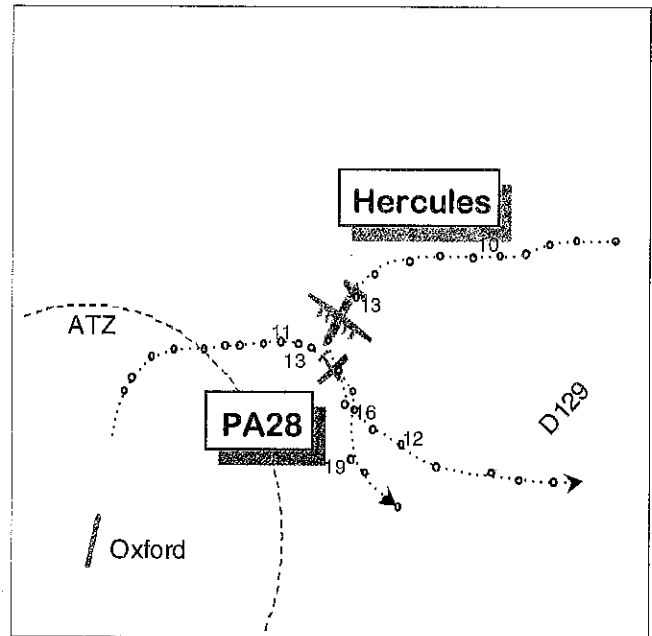
**THE HERCULES PILOT** reports heading 180° at 148 kt in a climbing left turn after a para-dropping run at 1500 ft over Weston on the Green (WOG) airfield when he encountered a low wing single-engined ac. It was in his 10 o'clock also in a left turn, 50-75 m away and 100 ft above. There was no time for avoiding action and the risk of collision was high.

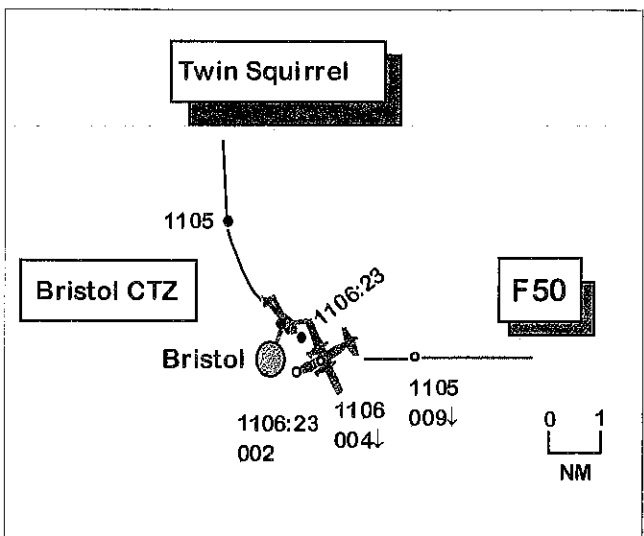
**THE F50 PILOT** reports that he was descending through about 1100 ft at 140 kt (QNH 1034) while on a 2 NM approach for the ILS to RW 27 at Bristol. The visibility was 10 km in VMC. He was in contact with ADC on 133x85 and heard the pilot of a helicopter being cleared to follow the F50 visually for RW 27. However, the helicopter closed to less than half a mile from him which was, by his standards, too close for comfort. Although no avoiding action was necessary, the helicopter distracted him while he was concentrating on flying the ILS.

**THE AS355 PILOT** reports that he was approaching the airfield from the N at 70 kt at 500 ft

(QNH 1034). The visibility, 1500 ft below cloud, was 10 km. The F50 was cleared to land on RW 27 by the Tower and he was then cleared to land on the N side of the airfield. He had watched the F50 from 3 – 4 NM out and informed ADC that he would make a westerly approach for taxiway G, which is the main taxiway parallel to the N of RW 27. Approaching base leg, No 2, he reduced speed in order to position behind the F50 and, as it passed about 300 m ahead of him and 200 ft below, he turned finals onto the N side. At no time did he consider there had been a risk of collision.

**BRISTOL ATC** reports that the F50 pilot was given traffic information on the helicopter by APC prior to being transferred to ADC. The helicopter pilot was given standard joining instructions and reported visual with the F50. Subsequently the helicopter turned finals onto taxiway G, N abeam the F50. The F50 pilot, however, was not satisfied with the separation between the ac and reported that he would be submitting an Airprox report.

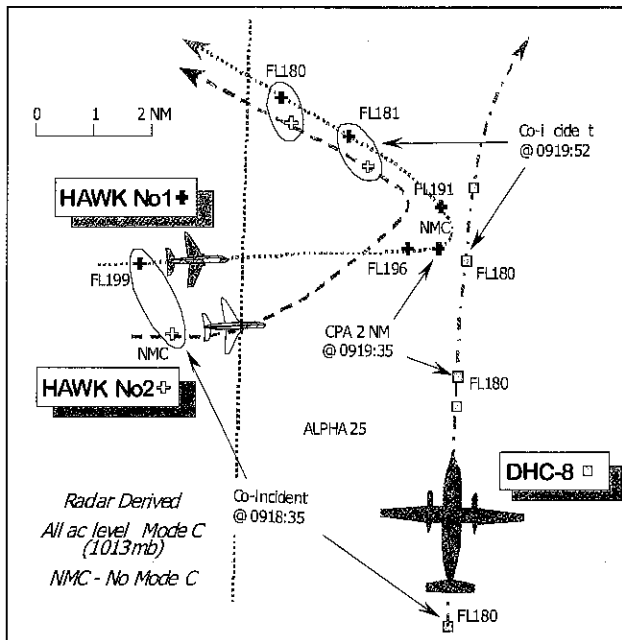
**THE MANCHESTER WEST SC** reports being the OJTI to a 10-week familiarisation student who was operating the RT. The DHC-8 was routing toward MONTY, northbound on A25 at FL 180, when a 3/A 7000 squawk was observed at FL 200 on the western edge of the Awy heading E. Another ac's climb was stopped and she immediately took over the RT from the student and issued a R turn to the DHC-8 crew. The unknown ac squawking 3/A 7000, descended rapidly and levelled at FL 180 Mode C she thought, before executing a very tight L turn onto W. Traffic information was issued to the DHC-8 crew, who reported visual with a pair of military jets.

UKAB Note (1): A review of the MACC W sector RT transcript reveals that at 0919:50, the SC instructed the DHC-8 crew to "...turn R 20 degrees", who acknowledged heading 015°. The SC then reported 10 sec later, "...traffic information for you 7000 squawk unverified height readout showing 180 currently in your 10 o'clock range of 4 miles came in the airway at 190 turned just before you and has descended to your level now". The DHC-8 crew responded that they were visual, whereupon the SC added that the traffic was now "...9 o'clock range of 7 miles still at 180 heading W". The crew

reaffirmed visual contact with the two ac and at 0921, the SC advised that they had cleared W of the airway and instructed the DHC-8 crew to resume their own navigation for WALLASEY.

**THE DHC-8 CAPTAIN** reports heading 005° at 275 kt in VMC, when 2 low wing military fast-jets were spotted at 10 o'clock 3 – 4 NM away. It was evident that the pair had infringed the airway but neither he nor the F/O were alarmed as the jets descended to a similar level, whilst closing L - R to 11 - 12 o'clock – about 2 miles away, before turning abruptly sharp L through N onto W. ATC then advised them to alter course, to the R, which was complied with, but by then the other ac had already turned away.

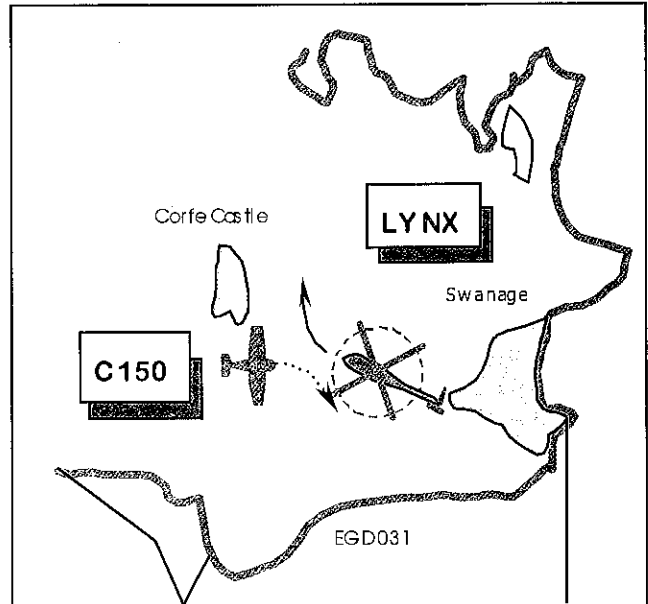
**THE LYNX MK 8 PILOT** reports heading 315° at 120 kt, returning VFR from the south coast danger areas to RNAS Yeovilton, at 1500 ft RPS under a FIS from Plymouth Military Radar during a student conversion sortie. The weather was good VMC with scattered cloud about 1000 ft above the ac. His helicopter was camouflage grey, the anti collision light was on, but HISLs are not fitted. About 1 NM W of Swanage, a white Cessna was sighted at 11 o'clock 500 yd away down sun at the same altitude and heading in the opposite direction. Both ac immediately broke R and passed about 3-400 yd apart. The windscreen central pillar and the GPS unit on top of the instrument console, port side, had obscured his view. Consequently, he saw the other ac late, as did the rest of the crew, including those in the rear of the ac looking forward. A QOI was seated between the front seat crew members, whilst the ac Captain sat directly behind the handling pilot with zero forward visibility due to the seating arrangement. An Airprox was not reported immediately, but was filed after landing because he considered there had been a certain risk of a collision if no avoiding action had been taken.

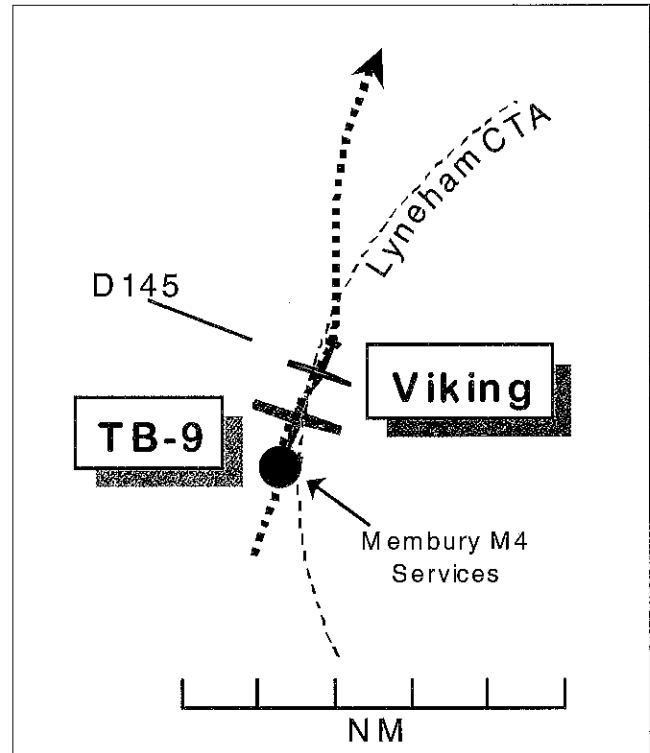
**THE VIKING GLIDER PILOT** reports heading 230° at 55 kt and had just completed a winch launch to 1400 ft above Hullavington (elev 343 ft) when the captain spotted a light ac less than 500 m ahead, heading about 020°. He initiated a descending left turn and the light ac passed about 100 ft away and 50 ft above with a high risk of collision.

**THE TB9 PILOT** reports heading 014° at 105 kt en route to Kemble and receiving a FIS from Lyneham on 123.4. He was cruising at 1700 ft, about 200 ft below broken stratus, having been forced down from his preferred altitude by the lowering cloud. Lyneham had cleared him through the W edge of the zone and he advised them as he passed the service station on the M4. He had turned more northerly to avoid Hullavington when a glider appeared from below and to his right. It was turning away to its port and passed 50-100 m away. He thought the risk of collision depended on whether the glider pilot had seen him; it approached from below and its pilot probably saw him before he saw it. He was using GPS and carried a map; on his outbound journey he had routed closer to Bath and was not sure why he had not done so on this return leg. He had seen Colerne and judged that his distance from it would keep him clear of Hullavington.

UKAB Note: Hullavington is a site notified for glider winch launching up to 2000 ft agl in the UK AIP ENR 5-5-1-3. LATCC radar recordings show the TB9, identified from its Lyneham squawk (no Mode C), tracking as in the diagram, directly over Hullavington. The glider does not show, although an intermittent primary-only contact is seen slightly SW of the reported Airprox position some 30 sec after the TB9 has passed.

**HQ MATO** reports that the TB9 pilot was in transit to Kemble at a reported altitude of 1400 ft Cotswold RPS and receiving a FIS from Lyneham Zone on frequency 123.4. At 1624:11, Zone transmitted, "*C/s as you approach Hullavington area, Hullavington are active with gliders,*" and the pilot replied "*...roger...I'll steer off to the left of it then.*" About three min later, Zone asked the pilot to report visual with Kemble and in his reply at 1627:37, the pilot added "*By the way, those gliders are active, one of them passed me just now about, only about 300 ft away.*" The pilot changed frequency to Kemble at 1628:59. Later that day, Hullavington contacted the Lyneham Supervisor to advise of the incident, although an Airprox was not mentioned in the call.

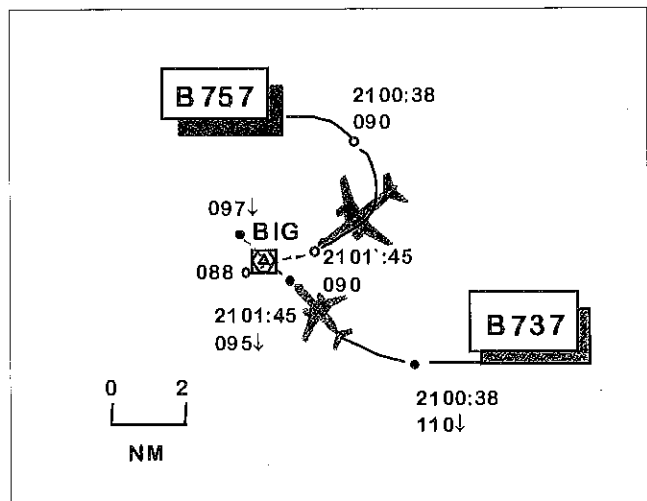
<u>Reporting Aircraft</u>	<u>Reported Aircraft</u>
<u>Type:</u>	B757	B73-4
<u>Operator:</u>	CAT	CAT
<u>Alt/FL:</u>	FL 90	FL 80
<u>Weather</u>	VMC NIGHT	VMC NIGHT
<u>Visibility:</u>	10 km	10 km +
<u>Reported Separation:</u>	zero H 300-500 ft V	
<u>Recorded Separation:</u>	0x5-1 NM / 600 ft

**THE B757 PILOT** reports that he was in a level R turn at FL 90 in the BIG holding pattern at 200 kt, the visibility was over 10 km in VMC. A TCAS TA indicated traffic descending about 600 ft above at his 10 o'clock and this was quickly followed by an RA demanding descent. As he initiated a 300 ft descent, ATC instructed him to descend to FL 80. The other ac passed 300 – 500 ft above him descending from L to R. He thought there had been a medium risk of collision.

The Board concluded that the Airprox was caused by the Heathrow Director's inadvertent descent clearance to the B737, which took it through the level occupied by the B757. However, members agreed that the TCAS in the B757, together with the somewhat confused ATC instructions to both pilots, combined to provide sufficient vertical and lateral separation (supported by the radar recording) to preclude a risk of collision.

Cause: The Heathrow Intermediate Director South inadvertently cleared the B737 to descend through the level occupied by the B757.

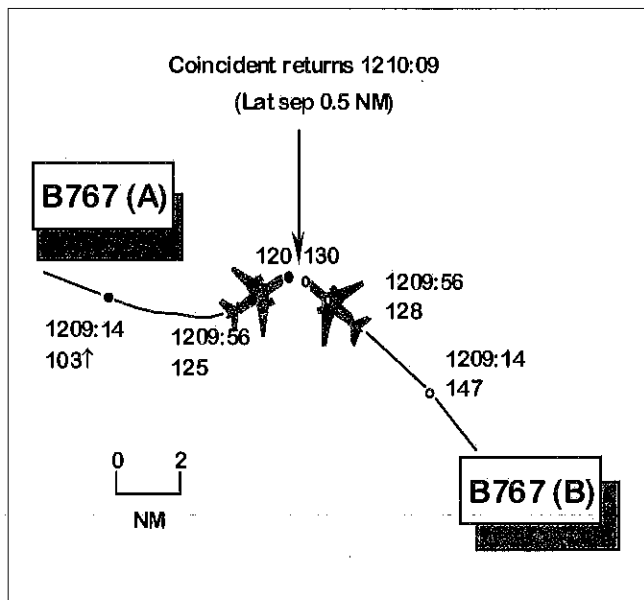
<u>Recorded Separation:</u>	d 2 NM / 300 ft
-----------------------------	-----------------

LATCC TC reports that a trainee SC and mentor were operating the Biggin/Timba sectors in banded configuration. Traffic loading was assessed as moderate. The trainee climbed B767(A) to FL 130 against other traffic above. When B767(B) called on the frequency descending to FL 160, the trainee established what heading the ac was on and then instructed the pilot to 'maintain FL 160'. While not appreciated at the time, however, it appears that the pilot of B767(B) read back 'maintain FL 120' and continued descending, with the result that he came into conflict with B767(A) some 10 NM SE of Biggin. The mentor immediately assumed control of the RT in an attempt to provide vertical separation. There was insufficient time to use the words 'avoiding action', and the ac were not given turn instructions because their tracks were crossing almost at right angles. The weather was clear and the crews were in visual contact with each other during the encounter. Minimum separation was in the order of 1x38 NM and 300 ft. No TCAS alerts were reported at the time and the STCA activated directly at the red stage.

Cause: The pilot of B767(B) misunderstood his cleared level and his subsequent distorted read-back went unchallenged by ATC.

Members were sufficiently concerned by the word "maintain" having different usages in USA and UK ATC phraseology to ask the Director to convey their concerns to the appropriate department of the CAA. The Director agreed to do this as an official observation. The ATM and PD adviser noted the confusion surrounding the word "maintain" and said that the matter would be raised at the Level Bust Working Group and also with SRG who are the policy holders for RTF.

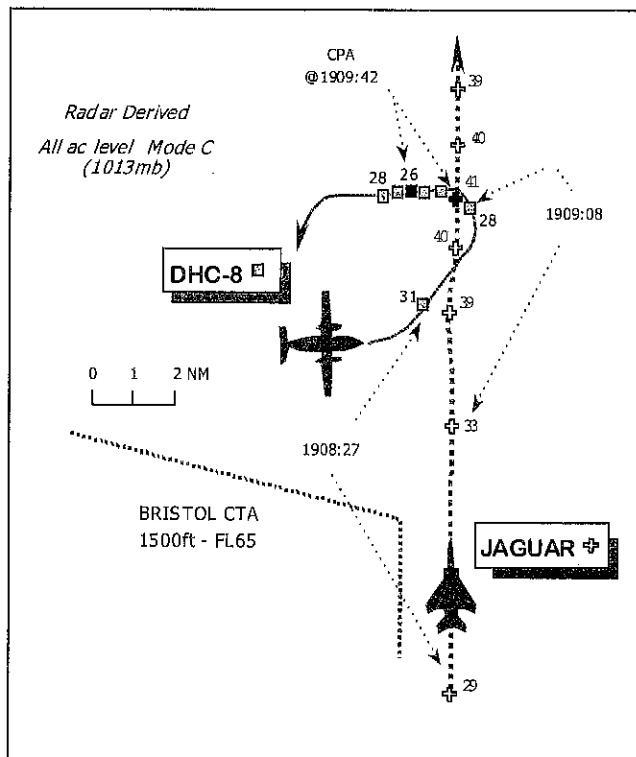
Recorded Separation: 1 NM H & 1500 ft V

**THE BRISTOL APPROACH RADAR CONTROLLER (APR)** reports that the DHC-8 crew was descending to 3000 ft Bristol QNH and on a radar vector of 090° under RAS, wide downwind R for an ILS to RW27 and No 2 to traffic on finals. High-speed traffic, squawking 3/A 7000, was observed approaching from the SE at about 3000 ft, which had previously been transponding a Boscombe Down squawk. The unknown ac passed astern of No 1 on the ILS at 10 NM finals, and then turned N in the vicinity of Bath into conflict with the DHC-8. A hard L avoiding action turn onto a heading of 270° was given to the DHC-8 crew but as horizontal separation reduced to 2 – 3 NM the unknown ac appeared to climb above the DHC-8 and then descend after it had passed it. In a subsequent telephone conversation the pilot of Jaguar confirmed that he had seen an ac at Yate and maintained visual separation using night vision goggles (NVG).

Cause: Conflict in Class G airspace at night between IFR and VFR traffic.

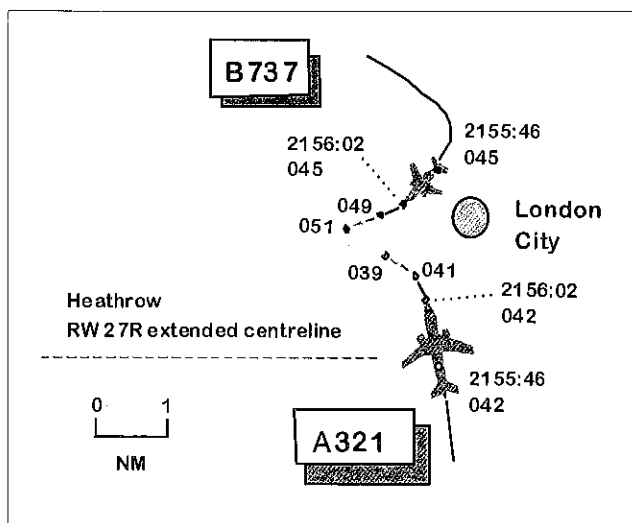
**AIRPROX REPORT No 18/00**

Date/Time: 28 Jan 2156 NIGHT  
Position: N5130 E0001 (17 NM E Heathrow)  
Airspace: LTMA (Class: A)  
Reporting Aircraft Reported Aircraft  
Type: A321 Airbus B73-5  
Operator: CAT CAT  
Alt/FL: 4000 ft 4300 ft  
(QNH) (QNH 1005 mb)  
Weather IMC IMC  
Reported Separation: 1.5 NM 0.5 NM 200 ft  
Recorded Separation: 1.2 NM 300 ft

**THE A321 PILOT** reports that he was on a L base leg for the ILS to RW 27 R at Heathrow in IMC, heading 350° at 4000 ft (QNH); ATC had not cleared him to intercept the localiser. Cockpit workload was high as he managed the approach in strong wind conditions. He suddenly saw the lights of another ac about 1x5 NM ahead, apparently converging towards him. He then heard ATC instruct the pilot of another ac to alter heading to avoid him and immediately afterwards he also received instructions, to descend to 3000 ft and turn, first onto 280° and then, as avoiding action, onto 250°. ATC advised him that reporting action would be taken.

Cause: Distracted by the handover process, the Heathrow Final Director did not ensure standard separation between the A321 and the B737.

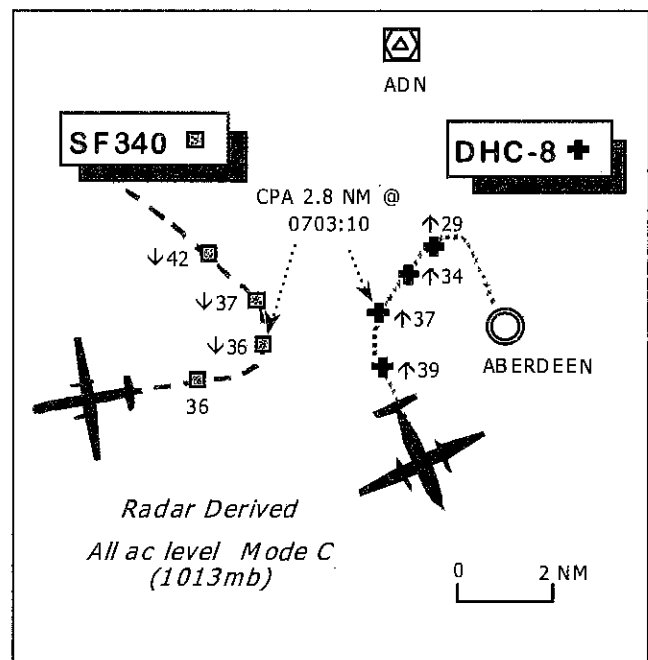
<u>First Aircraft</u>	<u>Second Aircraft</u>
<u>Type:</u>	DHC-8	SAAB 340
<u>Operator:</u>	CAT	CAT
<u>Alt/FL:</u>	3600 ft (QNH 991mb)	3000 ft (QNH 991mb)
<u>Weather</u>	VMC CAVOK	VMC CAVOK
<u>Visibility:</u>	>10 km	>10km
<u>Reported Separation:</u>	2 NM H (by ATC)	
<u>Recorded Separation:</u>	2.8 NM H & 100 ft V

**THE ABERDEEN APPROACH RADAR CONTROLLER (APR)** reports that the SAAB 340 was inbound direct to the 'ATF' (7.5 NM finals to RW34 at Aberdeen) descending to 3000 ft QNH (991mb) under a RCS at 'night'. Approval for a

Cause: The DHC-8 crew did not comply with their ATC clearance.

the heading 'bug', made by the SF340 pilot. These ideas were ac type dependent to some extent and it was acknowledged that no system was infallible. What was important was to have a practical 'system' in place to 'trap' the sort of errors made in this case. The members agreed unanimously that the cause of this avoidable Airprox was that the DHC-8 crew did not comply with their ATC clearance. Nevertheless, the alert APR quickly spotted the mistake and took immediate steps to retrieve the situation with highly effective avoiding action instructions, firstly to the SF340 crew who reacted with commendable speed and vigour when instructed, and secondly to the DHC-8 crew

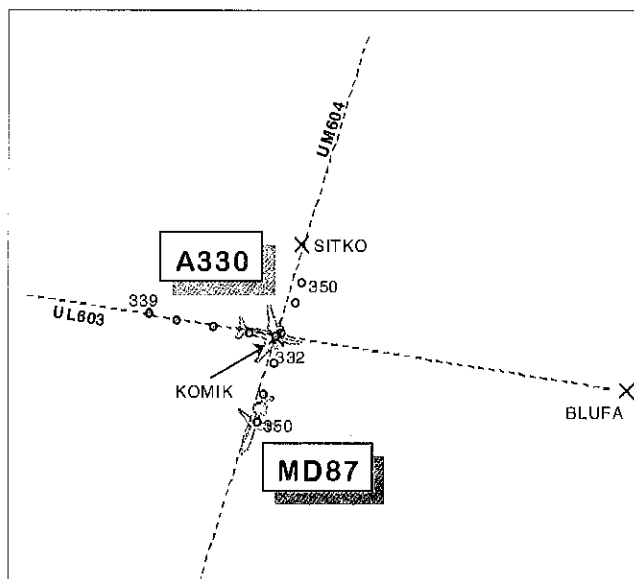
**THE LATCC NS SECTOR 33 SC** reports that the MD87 was southbound on UM604 at FL 350 and the A330 was eastbound on UL603 at FL 390 (en route to Düsseldorf, requiring it to be not above FL 330 on transfer). He had noticed the potential confliction between the ac early and instructed the A330 to descend to FL 330 assessing that its rate of descent would resolve the confliction and his attention was then drawn to other conflictions on the sector which was busy. He was later alerted by STCA to the fact that both ac were at FL 350

and although he asked the A330 pilot to increase his rate of descent he did not pass traffic information.

**THE MD87 PILOT** reports heading 209° at FL 350 when TCAS gave a TA on an ac approaching from 4-5 NM away to his right and 600 ft below. He saw it and that it was descending, confirmed by TCAS, and it passed 1300 ft below and behind by 3-4 NM. He informed the controller but considered the risk of collision was low because of TCAS and his visual sighting.

Cause: The NS Sector 11/33 SC did not take positive action to ensure separation between the ac.

Subsequently, the SC agreed that a better course of action would have been to issue a conditional descent clearance to the A330 to ensure it was level at FL 330 a suitable distance before reaching the projected track of the MD87 or, possibly, to use headings to ensure separation.

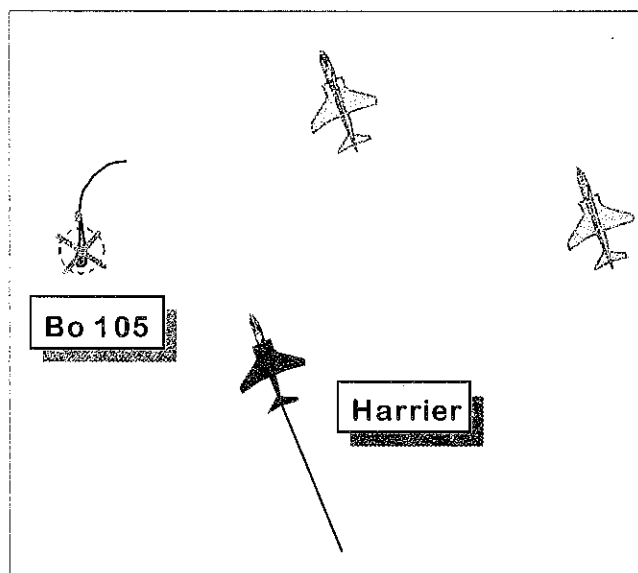
**THE Bo105 PILOT** reports climbing out of a wood at 60 kt, while searching for an armed man. Passing 400 ft, he saw the smoke trail from an ac in his 8 o'clock, a Harrier on a northerly track; he turned onto S to find its wingman whilst descending to below 250 ft agl and saw it 3 NM away in his 11 o'clock. He assessed that it passed 2-300 m away and slightly above; by then he was at about 100 ft

agl. He considered the risk of collision was moderate.

**THE HARRIER PILOT** reports heading 337° at 420 kt as the LH ac in a 3-ac escort formation on an OLF sortie. He was at 110 ft when he saw an ac skylined at his 10 o'clock 6 NM away. By the time they had closed to 4 NM the whole formation could see it. He recognised it as a helicopter; no avoiding action was called because he was the closest ac and he could see there was not the remotest chance of a collision. It passed 1400 m away and about 50 ft above.

Cause: Percieved confliction of flightpaths in Class G airspace.

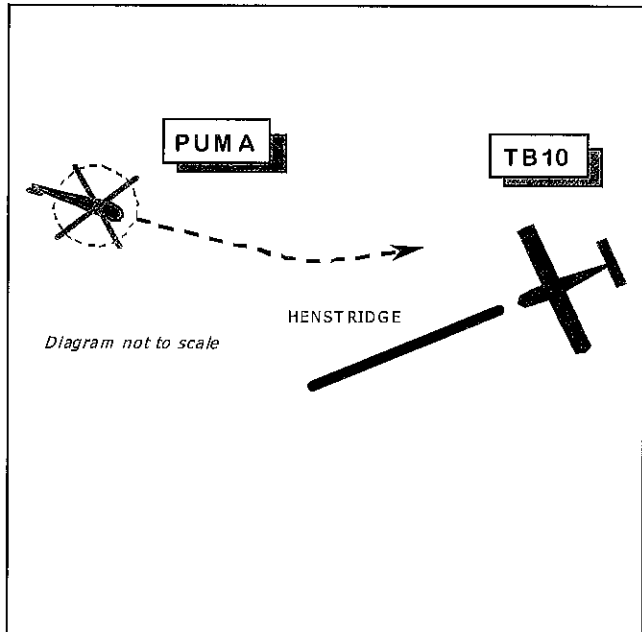
300 m H & 100 ft V 800 m H

**THE TB10 PILOT** reports heading 255° at 83 kt on short finals to RW 25 at Henstridge. His ac livery is predominantly white; the landing light, wing tip and tail HISLs were on. After he reported finals the A/G Stn operator advised that there was no known traffic and transmitted the surface wind of 300°- 20 kt. Whilst descending through 200 ft QFE, he became aware of a helicopter about 700 m ahead and to the R and realised that it was heading straight towards him at 1-200 ft. His only option to avoid the helicopter, he thought, was to land, which was accomplished as the helicopter turned away; its relative position made any attempt at a 'go-around' impossible. As his ac touched down the helicopter appeared to be over the RW pavement at the mid-point, before it turned L and passed N abeam of his ac as he was slowing down after landing. The helicopter then turned southbound around the eastern end of the RW and cleared to the E whilst he backtracked the TB10 down the RW. He believed the risk to be very high and aware of how manoeuvrable the helicopter was he did not know what it was going to do next. He adds that the workload was high in the 12 kt crosswind landing and a call on the A/G frequency would have helped let him know that the helicopter pilot had spotted his ac.

**Cause:** The Puma crew flew close enough to the TB10 to cause its pilot concern.

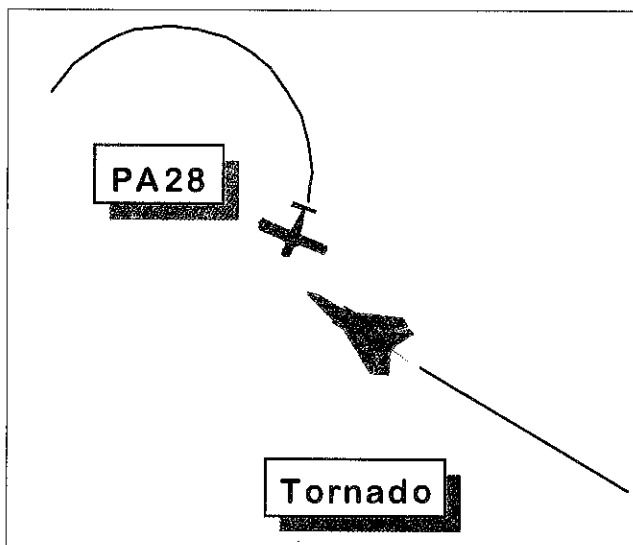
**THE TORNADO GR PILOT** reports heading 300° at 450 kt on a line-search at 300 ft agl when he saw a light ac about 1.5 NM in his 12:30 heading L to R across his track, about 200 ft above. At that point there was no conflict but the light ac then turned hard about in the vicinity of Newby village. Initially he could not determine its direction of turn but when it became apparent that it was turning R, towards him, there was little he could do but duck down underneath it. In attempting to avoid it by as much as possible he passed about 350 ft below it; his recce recordings show his height was 188 ft agl at that point. In hindsight he realised he could have avoided the situation by breaking off to the left as

soon as he saw the other ac but at that point it was right of his track and moving right. The light ac gave no indication that its pilot had seen him.

Cause: The PA28 pilot did not see the Tornado and turned into conflict with it.

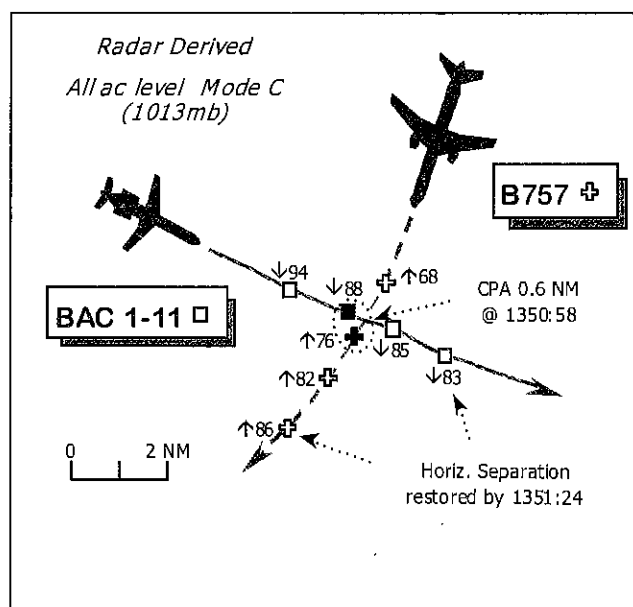
**THE LATCC TC OCKHAM/WILLO SECTOR CONTROLLER (SC)** reports that he had just taken over the bandboxed sector and had been controlling the sector for about 2 min; the traffic was quite busy and he was considering a sector split, but did not believe that it was urgent. The B757 was outbound from Gatwick on a BOGNA departure, climbing to the cleared altitude of 6000 ft, as assigned by the previous SC just prior to watch hand-over. The BAC1-11 was inbound to Gatwick via MAYFIELD, descending to FL 80, as cleared. A climb clearance was then issued to an L1011 crew, but of the same company as the B757, in another part of the sector to expedite climb through FL 130 for their cleared level of FL 150. As both ac were about to cross he re-iterated the altitude limit to the B757 crew. Moments later when he looked at the radar display prior to transferring the BAC 1-11 to Director he observed the B757 Mode C climbing through FL 74. He immediately questioned the crew, who responded they were climbing to FL 150 and expediting through FL 130. The B757 crew was informed that they had incorrectly responded to a clearance issued to another crew of the same company; the ac passed clear of one another. He said that if the B757 crew had read-back a clearance addressed to another, he did not detect

it at the time. There was no STCA alert, he thought, and neither traffic information nor avoiding action was issued.

Members quickly recognised that poor RT discipline on the part of the B757 crew had precipitated this complex occurrence, which had subsequently caught out the SC. The ATSI adviser emphasised that whilst the SC had astutely recognised the initial incorrect readback from the B757 to a clearance addressed to the L1011, he did not detect that it had emanated from the wrong crew. There was no doubt that the B757 crew had reacted to an ATC instruction addressed to another ac and this had been one part of the 'Airprox' cause. In mitigation,

response by insisting upon a full read-back from the B757 crew. This omission was determined to be the fourth and final part of the cause of this Airprox.

Turning to risk assessment, Board members noted that the SC had not seen the STCA indication, but observed also that standard vertical separation was not eroded until after the B757 had crossed ahead of the BAC 1-11; this probably explains why TCAS did not react. Moreover, the BAC 1-11 pilot had watched the B757 climb towards him and was always in a position to turn away if necessary. When all these factors were taken into account members agreed that no risk of collision had existed.

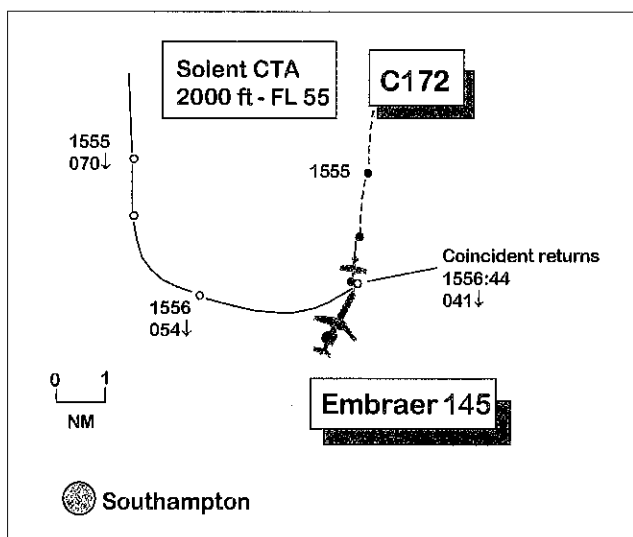
**THE EMBRAER 145 PILOT** reports that he was descending in IMC from FL 70 to 3000 ft at 220 kt under radar control from Southampton on 128x85 while positioning to the ILS for RW 20 at Southampton. On passing 4200 ft (QNH 1032) and turning L through 030° onto a northerly heading, TCAS indicated 2 contacts at his 11 o'clock range

5 NM but with no altitude indication. Both pilots searched for the traffic, initially scanning predominantly in a downward direction, but nothing was seen. Shortly afterwards a TCAS TA was received and the Captain then spotted a light ac, thought to be a C172, as it tracked in a southerly direction towards them, subsequently passing about 500 ft directly overhead. Although there had been only a low risk of collision, had they been at a slightly slower rate of descent he thought the risk would have been much greater. ATC advised him

Cause: Unauthorised penetration of the Solent CTA by the C172

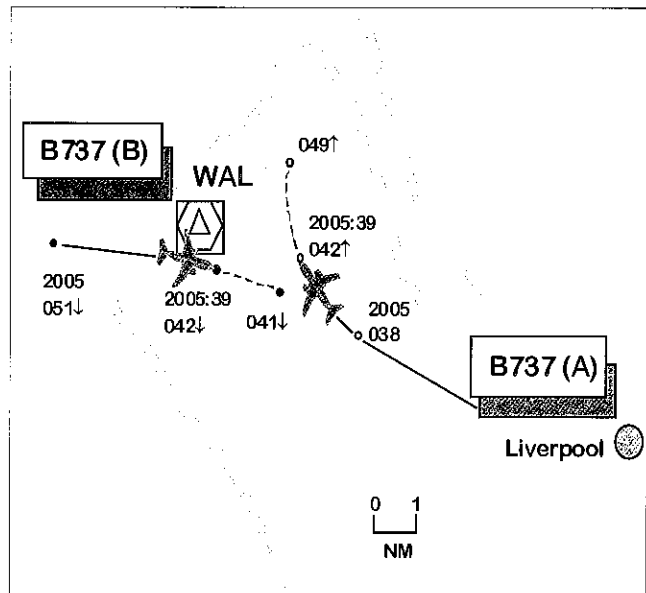
**THE B737 (A) PILOT** reports that he had been cleared outbound to Belfast on a WAL 2T SID from Liverpool. Having reached his initial cleared altitude

of 4000 ft (Liverpool QNH) at 240 kt, heading 300°, the navigation and landing lights of another ac were seen approaching WAL from the W at about co-altitude. This traffic was also indicated by his TCAS some 500 ft above and descending. At this point, the non-handling pilot prompted Liverpool ATC for a frequency change to Manchester, which was normally done when passing 1500 – 2500 ft. On

changing to Manchester radar, he was instructed to turn R onto 360°, and to climb, expediting through the first 1000 ft. He complied immediately and, while turning, received a TCAS TA on the other ac. Manchester ATC advised him that reporting action would be taken because standard separation had been compromised. The other ac, which he could not identify owing to the darkness, passed about 3 NM behind him at a similar altitude. As he had watched it from about 1500 ft following departure until it passed behind them about 4 min later, he considered the risk of collision had been only low.

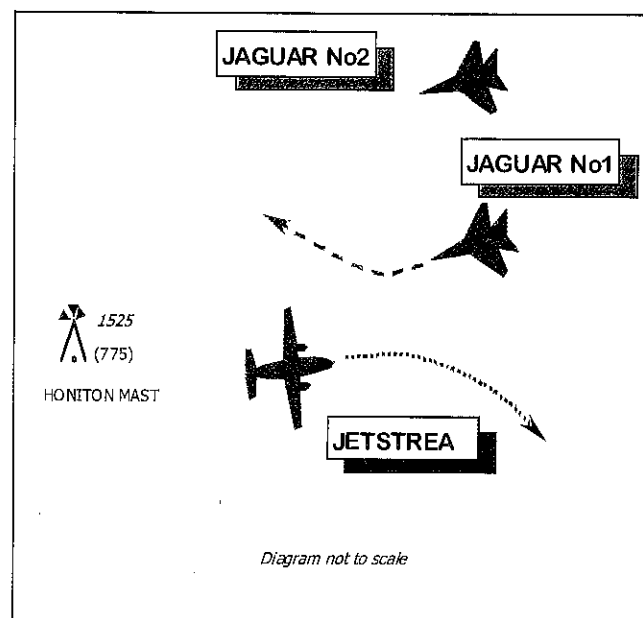
**THE JETSTREAM PILOT** reports conducting a VFR low-level student map reading exercise in LFA 3 & 2. The ac has a blue and white colour scheme; HISLs are not fitted but the landing lights were on to aid conspicuity. They were receiving a FIS from Yeovil Approach, he thought, about 2 NM E of Honiton mast, heading 085° (T) at 180 kt, whilst cruising at 250 ft msd straight and level. Simultaneously, he and the observer, who was occupying the jump seat, spotted a single Jaguar ac at 11 o'clock less than a mile away in a hard R turn at the same altitude and on a collision course. The Jetstream was turned immediately hard R and dived as the Jaguar passed about 100 ft above them displaced about 100 ft to the L with a very high risk

of a collision. He adds that earlier visual acquisition of the Jaguar had been impeded by the LH vertical windscreen support.

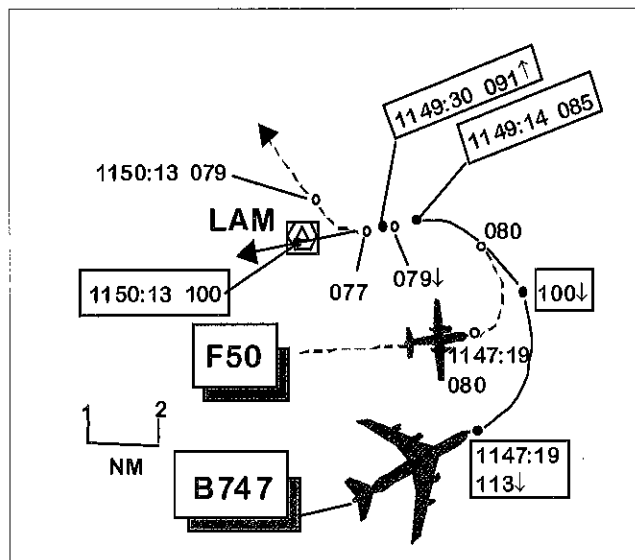
Recorded Separation: 0.6 NM/600 ft

**THE F50 PILOT** reports that he was maintaining FL 80 in the LAM holding pattern in VMC; the visibility was in excess of 10 km. When on the 086° radial at about 3 NM, he heard ATC instructing the pilot of another ac to maintain his level. At almost the same time TCAS indicated traffic 900 ft above him at about 5 – 6 o'clock and an RA then demanded descent. As he complied, descending to FL 77, he informed ATC of his action and was instructed to leave the holding pattern on a heading of 310°. He believed the conflicting traffic had been above them and had descended below its cleared level. When the confliction was over he resumed his assigned level of FL 80 with the approval of ATC. The pilot gives no estimates of miss distance nor any assessment of risk.

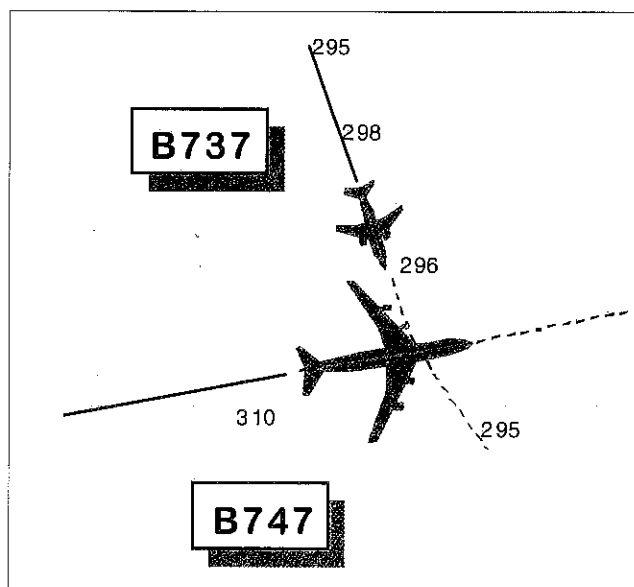
Recorded Separation: 1400 ft V

**THE B737 PILOT** reports heading 160° at M 0.74 when, approaching WOD, he was cleared to climb from FL 290 to FL 330. Passing FL 295 he saw traffic in his 1 o'clock crossing right to left. At the same time as TCAS gave a 'Traffic' warning, ATC gave him avoiding action to descend immediately to FL 290 and turn left with traffic at FL 310. The autopilot was disconnected and the ac was descended and turned. TCAS showed a minimum of 1200 ft but a TCAS RA was not triggered.

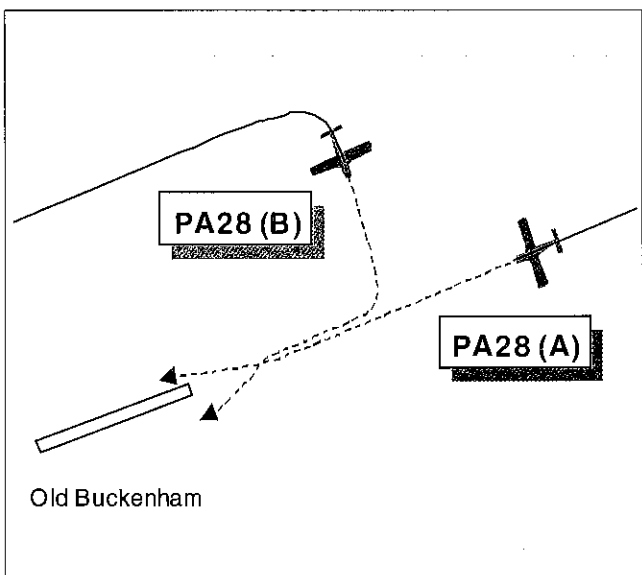
**AIRPROX REPORT No 31/00**

Date/Time: 12 Mar 1325 (Sunday)  
Position: 5230 N 0104 E (Old Buckenham - elev 216 ft)  
Airspace: ATZ (Class: G)  
Reporting Aircraft    Reporting Aircraft  
Type: PA28 (A) PA28 (B)  
Operator: Civ Pte Civ Club  
Alt/FL: 50 ft 200 ft  
(QFE 1021 mb) (QFE 1019 mb)  
Weather VMC CLOC VMC CLOC  
Visibility: 8 NM 8 NM  
Reporting Separation: 4 m/50 ft  
Recorded Separation: NK

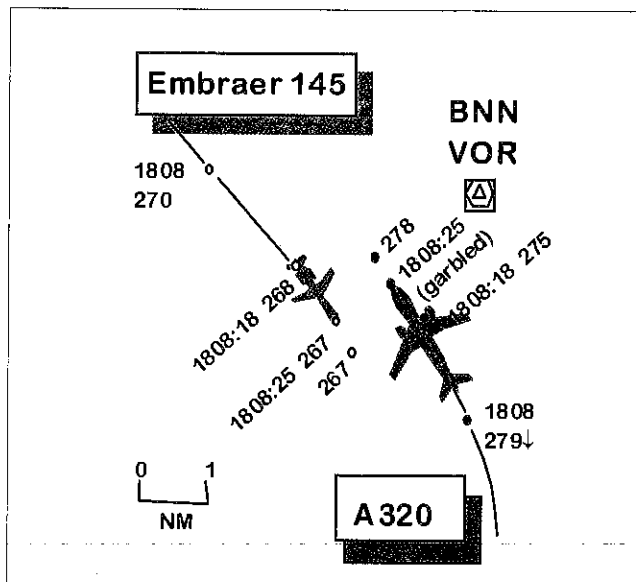
**LATCC (AC)** reports that the Airbus, from Las Palmas to East Midlands, had been handed to the Daventry (DTY) sector from London Upper sector (LUS) at the agreed level of FL 280. The Embraer 145, outbound from East Midlands to Brussels, was cruising at FL 270 under the control of London Middle Sector (LMS). At 1807:04, the Airbus pilot requested further descent; he was cleared to route direct to SAPCO and told to expect descent in about 2 min. However, after only another 34 sec the DTY SC instructed the Airbus pilot to descend to FL 200. At this time the ac were some 10 NM apart and on conflicting tracks. At 1808:09, after the Airbus had left FL 280 and separation had reduced to 500 ft and 3x7 NM, its pilot reported "reacting to TCAS". The pilot was instructed to "*stop descent immediately and climb back up again please*". A few sec later the pilot of the Embraer reported leaving FL 270 in response to a TCAS RA to descend. At 1808:16 the Airbus pilot reported visual contact with the Embraer passing down his port side, at which point separation was at its minimum of 2x1 NM and 700 ft. As lateral separation further reduced thereafter, vertical separation increased and the ac were 1000 ft apart as they passed in opposite directions at a range of 1 NM.

**THE EMBRAER PILOT** reports that he was cruising at M 0x73 at FL 270 on a heading of 140° under the control of LATCC. When in the vicinity of the Bovingdon (BNN) VOR a TCAS RA signalled "Descend Now"; he complied, and then saw an Airbus as it passed down his port side about 1 NM away and 500 ft above in the opposite direction. He thought there had been a medium risk of collision. ATC subsequently advised him that the other ac had descended below its cleared level.

**THE AIRBUS PILOT** reports that he was under the control of LATCC who had cleared him to route direct to SAPCO and to descend from FL 280 to FL 200. The visibility was over 10 km in VMC. When near the BNN VOR at 310 kt, TCAS indicated traffic and then an RA demanded climb. He immediately disconnected the autopilot and auto-throttle, informed ATC of the conflict and complied. The other ac, believed to be an Embraer, passed down his port side about 1 NM away and 500 ft below in the opposite direction. He thought there had been a high risk of collision. ATC accepted responsibility for the error.

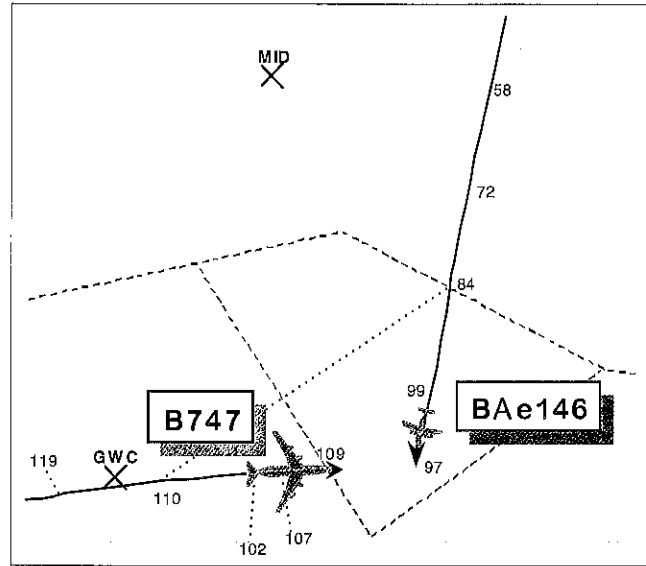
**THE LATCC TC (WILLO) SC** controller reports that the traffic level was light; the B747 was inbound from the western USA to Gatwick and cleared to descend to FL 110 while the BAe146, having been on a BOGNA SID, was on a radar heading and cleared to FL 100. She noticed the STCA flashing and saw the B747 passing FL 108 with the BAe146 climbing through FL 95. She told the B747 pilot to climb immediately to FL 110 and when this was acknowledged, told the BAe146 pilot to stop his climb. Traffic information was passed to both pilots. The RT recording confirms that at 1018:10 the B747 pilot was told "C/s descend flight level one one zero", to which the pilot replied "Descend one one zero, standard speed control c/s". The controller advised the pilot he could "maintain two eighty after Goodwood". At 1018:30 the controller placed the BAe146 on a heading of 195°, clearing it to climb to FL 80 and to "Flight level one hundred" at 1020. Just after 1020:30 the controller told the B747 pilot "C/s climb immediately, flight level one one zero was your cleared level" to which the pilot replied "One one zero c/s". The BAe146 pilot was told to stop his climb immediately and given traffic information.

UKAB Note (1): LATCC radar recordings show the B747 descending through FL 110 at 1020:23 while the BAe146 climbs through FL 84. The B747 arrests its descent at FL 102 with the BAe146 passing FL 95; STCA starts flashing (white) as the B747 climbs through FL 105. The BAe146 arrests its climb at FL 99 and crosses through the B747's 12 o'clock 2.2 NM ahead of it at FL 97 as it passes FL 109, at 1021:30. Minimum lateral separation (1.3 NM) occurs shortly afterwards.

The Board agreed the cause of the incident was the descent of the B747 through its cleared level

Cause: The B747 pilots descended through their cleared level.

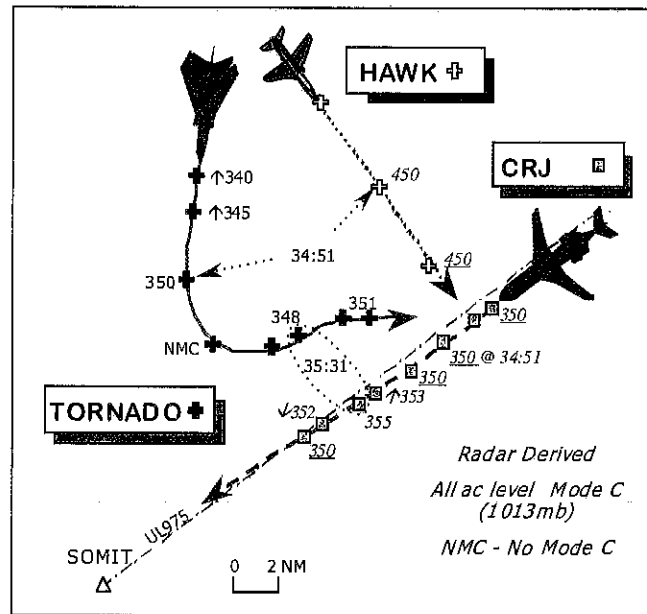
Recorded Separation: 3.85 NM H & 700 ft V

climbing. The pilot was informed that there was no other GAT to affect the climb and continuous traffic information was given. When the CRJ2 climbed through FL 353 its pilot reported that he was visual with the other ac. Traffic information on the fighter was continued until the CRJ2 was well past the military ac. Standard separation was eroded to 2.5 NM, he thought.

**THE TAKING OVER N SEA CSC** adds that when he took over the Sector the off-going CSC advised him of the extant co-ordination agreed with CRC Neatishead. The conflict had triggered the STCA and resulted in a TCAS RA, which was followed by the CRJ2 pilot. He called Neatishead and was told that they were already taking avoiding action with their traffic.

Cause: The CRC Neatishead WC did not ensure standard separation was maintained as co-ordinated.
