UK AIRPROX BOARD

**Analysis of  
Airprox in UK Airspace**  
Report Number 4  
January 2000 to June 2000

Report by the UK Airprox Board,  
'Analysis of Airprox in UK Airspace'

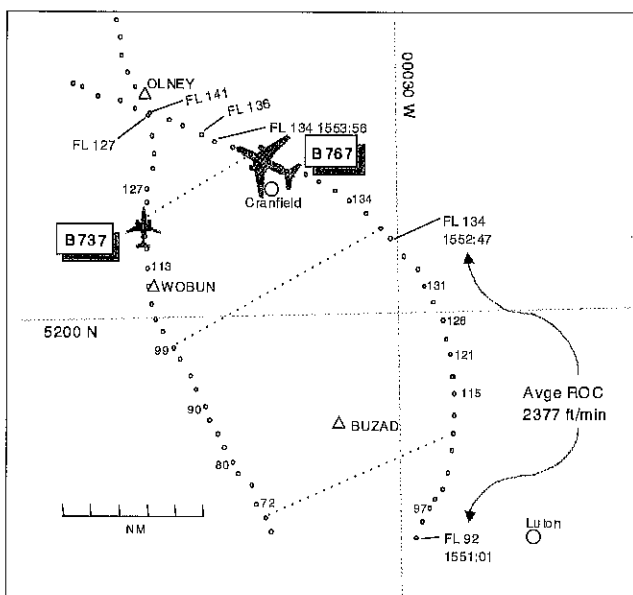
Recorded Separation: 1400 ft

**THE B737 PILOT** reports following a heading of 020° at 280 kt in a climb. Approaching FL 130, he received a TCAS TA followed rapidly by a 'Descend' RA which he followed down to FL 122 and at the same time ATC passed an avoiding action left turn. He saw the conflicting traffic, a B767, pass directly overhead at less than 1000 ft separation. He reported the RA event to ATC and heard the other

**THE B767'S COMPANY CHIEF PILOT** comments that he believed that the level-off observed on radar was caused by a selection of VNAV vertical mode on the autopilot/flight director mode control panel (MCP) at about FL130. This flight had been radar vectored off the assigned SID. If the crew had not revised the Flight Management Computer (FMC), waypoints which had been passed abeam during the vectoring would still form part of the FMC's flight plan route. In other words, waypoints that, in fact, lay behind the ac would remain in the active computer flight plan. These bypassed waypoints would retain any vertical constraints that had been assigned to them. Most of the LHR SIDs are capped at 5000 or 6000 ft. The restrictions are associated with waypoints, for example, 6000 ft at BPK on the BPK 5J/4K SID.

Cause: Un-notified level-off by the B767.

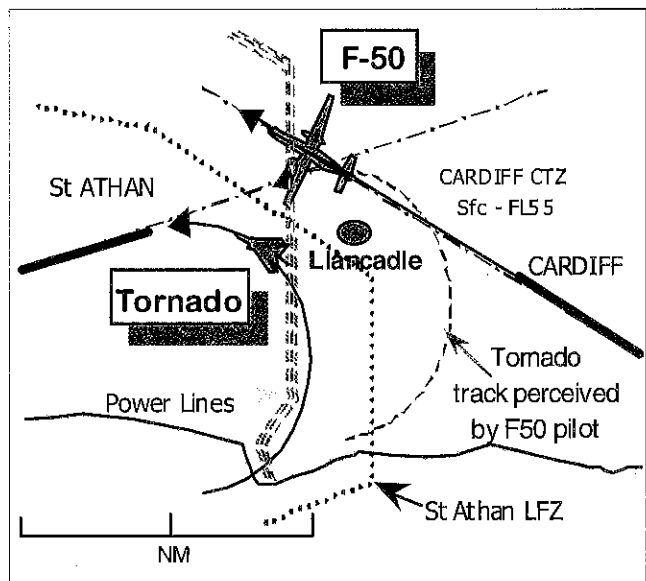
**THE F50 PILOT** reports heading 300° at 145 kt after take-off from RW 30 at Cardiff having been told to maintain RW heading. Passing 1000 ft QNH (800 ft agl) he received a TCAS TA and ATC warned him of military jet traffic on left downwind for RW 26 at St Athan. He saw this and decided to climb at his best rate to avoid it. It apparently took no avoiding action and passed beneath him by 300 ft as shown on TCAS and by his estimation. He considered that a take-off should not have been allowed with jet traffic downwind at St Athan. (UKAB Note: The pilot's diagram of the incident showed the Tornado's track crossing beneath his to a position on his

All that the Board could conclude was that the tracks of the 2 ac were close enough to cause the F50 pilot concern. Members were advised that discussions were taking place between Cardiff and St Athan to find ways of ensuring that ac were not

Cause: The tracks of the 2 ac were close enough to cause the F50 pilot concern.

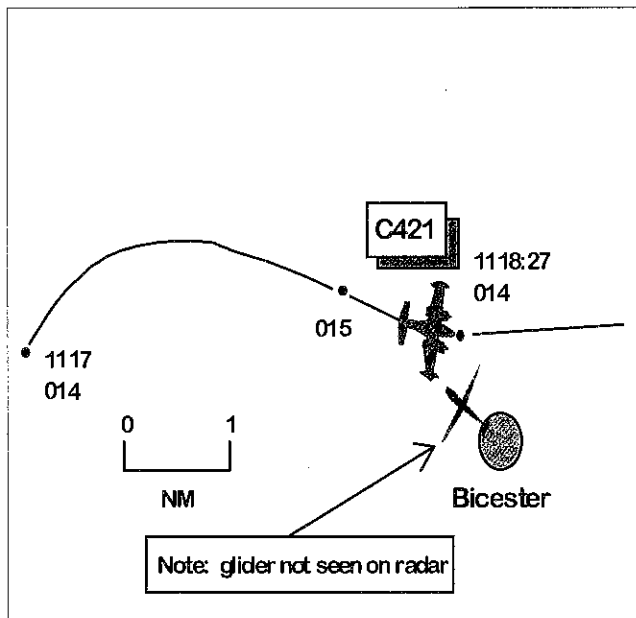
**THE SCHLEICHER PILOT** reports that whilst in the final stages of an aerotow to 1500 ft QFE (about 1727 ft altitude) from Bicester, heading 300° at 50 kt, he saw a low wing twin engined ac at his 1 o'clock less than 2 NM away tracking in the opposite direction at high speed. His student released from the tow and was decelerating to

normal gliding speed when it became apparent that the other ac was on a conflicting course. He took control of the glider and dived, and the other ac passed about 150 ft above him to the R with its starboard wing overlapping his. Without his avoiding action he considered that the risk of collision would have been very high. He then watched the ac, which was tracking about 100°, as it passed between Bicester airfield and the village of Stratton Audley. It did not appear to have taken any avoiding

Cause: Probable non-sighting by the C421 pilot.

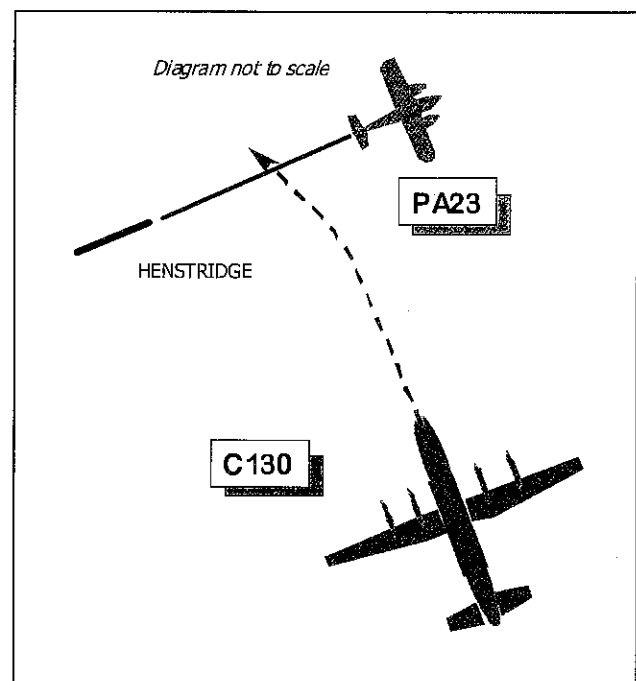
**THE PA23 PILOT** reports he was climbing through 200 ft aal cleaning up after take-off as he departed Henstridge RW07 at 90 kt. At the mid point of the RW a C130 was spotted in level flight at 2 o'clock – 0.5 NM on a constant bearing, which appeared to have made a L turn towards the airfield. Avoiding action was immediately taken; at that height and speed his only choice was to descend towards rising ground as the C130 passed about 0.2 NM astern and 100 ft above the PA23. His attention was drawn to the C130 by his passenger who saw it just after lift off, otherwise there would have been

a high risk of collision. He reported sighting the other ac to the Henstridge A/G Stn operator who

Cause: The C130 crew flew close enough to the PA23 to cause its pilot concern.

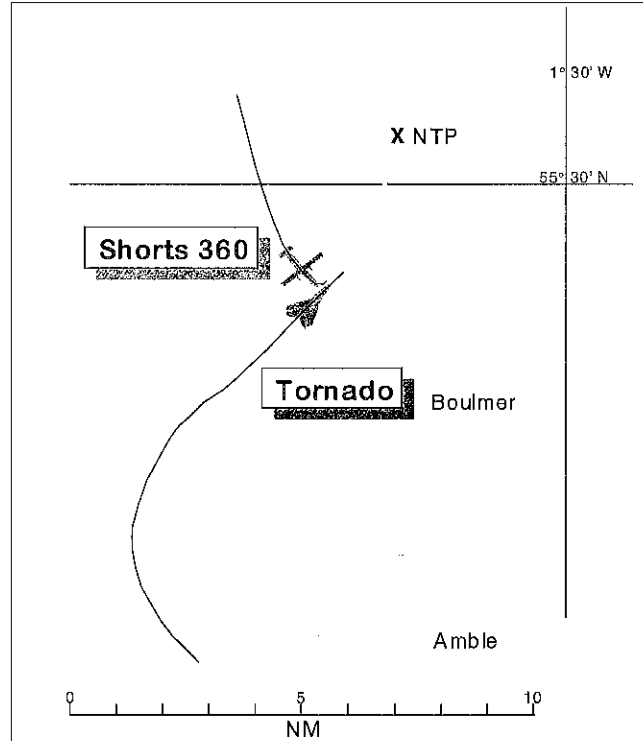
**THE SHORTS 360 PILOT** reports receiving a RAS from Newcastle on 124.375 while descending inbound. He had been cleared to FL 50 and after levelling, heading 170° at 180 kt, he was advised of military contacts about 10 NM W of his position with advisory avoiding action onto 100°, which he followed. He was in IMC with 1 km visibility. ATC then advised that the contacts were turning towards him and climbing. A further, 'avoiding action' turn was given onto 090°. As this turn was completed his F/O saw a grey Tornado in his 1 o'clock at the same level, crossing R to L. It crossed their 12 o'clock 50 m away and almost immediately a severe jolt was felt as they crossed its wake. He saw it departing at the same level in his 9 o'clock. TCAS was not fitted to his ac. Navigation, anti-collision and strobe lights were all on.

**THE AAIB** investigated the incident and reported that the Tornado formation were tasked to participate in a medium scale Tactical Leadership Training night exercise, TLT 1/00. This exercise involved up to 32 fast jets including the flight of four Tornado F3s. Also taking part were an AEW E3D ac, Air-to air refuelling tankers and Falcon EW ac. The scale of the exercise was such that it was notified as an unusual aerial activity via an Airspace Co-ordination Notice (ACN), whose distribution included the ATC

The Board concluded that the cause of the Airprox was that the Tornado crew had turned into confliction with the SD360, which was IMC, and which they did not see, and that there had been a real risk of collision in the incident. If they had believed they were VMC, they had a duty to see and avoid such traffic.

Cause: The Tornado crew turned into confliction with the SD360, which was IMC, and which they did not see.

Recommendation: That the MOD should consider including a 'Minimum risk corridor/s' for non-exercise traffic, including CAT, as a standard part of the planning process for major exercises.

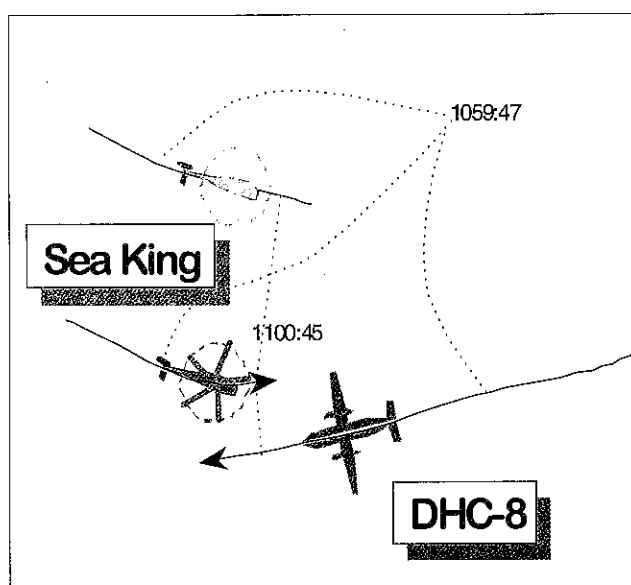
<u>Recorded Separation:</u>	0.95 NM, 100 ft
-----------------------------	-----------------

**THE DHC-8 PILOT** reports heading 270° at 180 kt while self positioning for an ILS approach to RW 31 at St Mawgan; he had been cleared by the Director on 125.55 to descend to 2400 ft QNH. While passing through 3000 ft – technically IMC on top of Strato-cumulus cloud (though quite good visibility – 5K or more) the TCAS gave a “Traffic” warning. Traffic showed at 12:30, 400 ft below, range approx 2 NM. He told the F/O (handling pilot) to stop at 2900 ft which was actioned by disconnecting the auto pilot and pressing “ALT HOLD”. Several things then happened together; ATC gave a 10° heading change onto 260° as the TCAS gave a ‘descend descend’ call (about 1500 ft/min) and he observed the traffic at 12:30 slightly below. To descend immediately would have meant going IMC and the TCAS still showed traffic 200 ft below. The TCAS then gave ‘climb climb’ but as the traffic – a Sea King helicopter – was clear on his Starboard side, the TCAS was ignored. The helicopter passed about 0.5 NM down their starboard side at the same level with a second SAR helicopter slightly higher about 1.5 to 2 NM from them on a similar heading to the conflicting helicopter. ATC then advised him that traffic was at 2500 ft which he queried to be told it was 2500 ft QFE. He advised ATC of the TCAS RA and that a report would be submitted.

Cause: The DHC-8 pilot did not fully absorb the significance of the 2 altimeter settings being used when he levelled off and this was uncorrected by ATC.

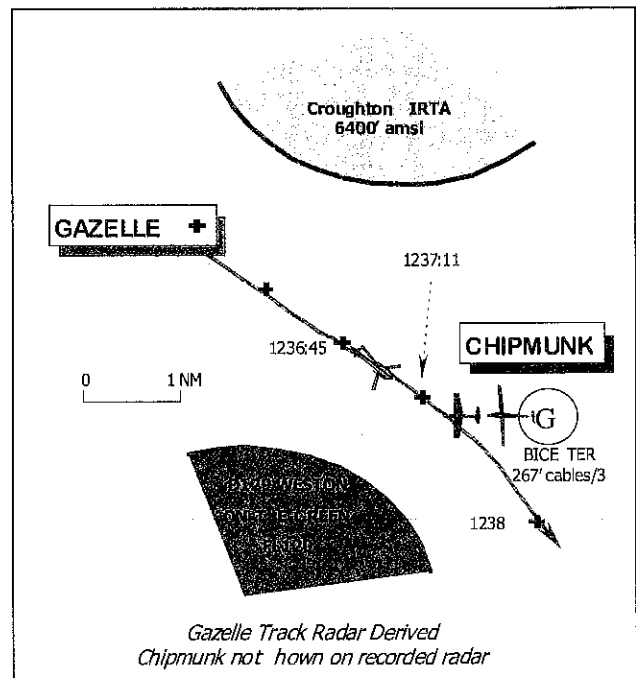
**THE CHIPMUNK PILOT** reports heading 270° at 60 kt climbing out from Bicester, aerotowing an ASK 21 glider whilst conducting early training for its inexperienced student pilot and in communication with Bicester Radio. The ac colour scheme is red/white and landing lights and HISLs were on; SSR is not fitted. Whilst passing 1100 ft QFE, about 1 NM W of the glider site, just as he had started a gentle R turn, a dark green Gazelle helicopter was first spotted at a range of 200 m and about the same height. He quickly assessed that a collision would result if the climb was maintained, so he bunted the ac to avoid the helicopter, gently at first then somewhat faster as the glider was released from the tow. The Gazelle passed slightly astern, between the Chipmunk and the glider and about 100 ft above them. He adds that the helicopter was spotted late because the relative geometry caused it to be obscured by the canopy arch until he commenced the turn. He adds that the close proximity of D129, Weston-on-the-Green, results in the GA community - and now it would appear military pilots - using Bicester as a turning point.

**Cause:** Late sighting by both pilots near a notified glider site.

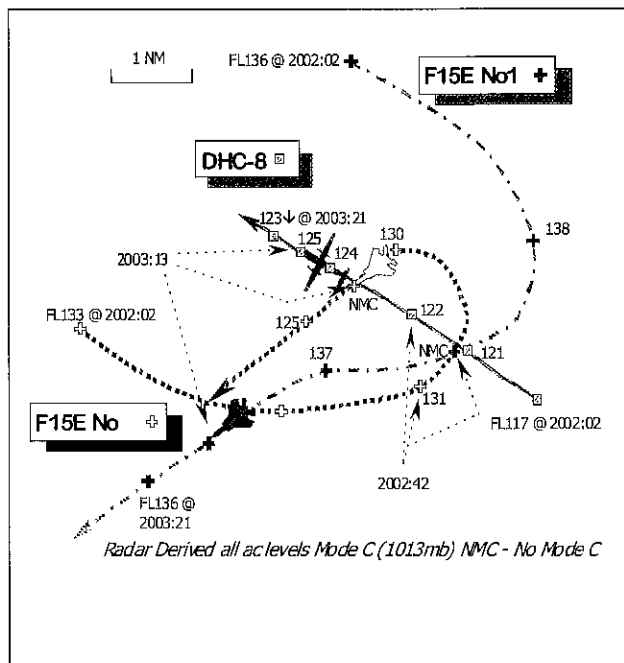
**Recorded Separation:** 2-300 ft V/0.82 NM H

**THE DHC-8 PILOT** reports that they had departed from Newcastle on track to HAVEN in receipt of a RAS from Newcastle Approach, squawking the

Cause: The No2 F15E pilot flew sufficiently close to cause the DHC-8 pilot concern.

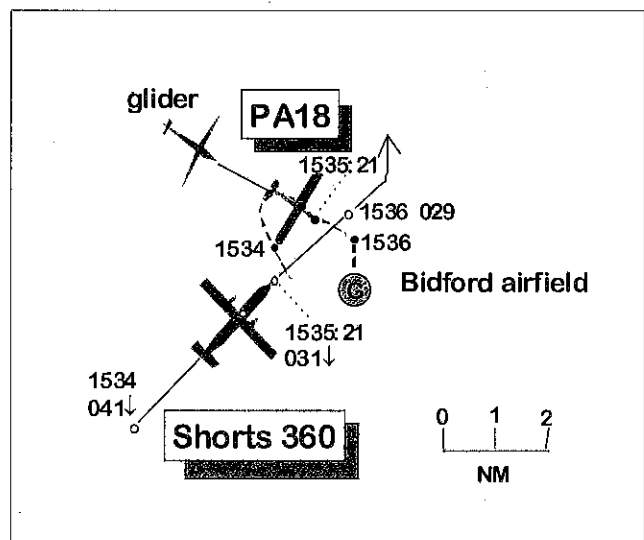
<u>Reporting Aircraft</u>	<u>Reported Aircraft</u>
<u>Type:</u>	Shorts 360	PA18 - 180
<u>Operator:</u>	CAT	Civ Club
<u>Alt/FL:</u>	3000 ft (QNH 1028 mb)	3000 ft
<u>Weather</u>	VMC	VMC
<u>Visibility:</u>	8 km	10 km
<u>Reported Separation:</u>	500 m	300 ft
<u>Recorded Separation:</u>	unmeasurable

**THE SHORTS 360 PILOT** reports that he was in descent to 3000 ft (QNH 1028) at 170 kt while being radar vectored for an ILS approach to RW 33 at Birmingham. The visibility was 8 km in VMC. On breaking cloud at 3600 ft, 18 NM S of Birmingham Airport, a Piper Cub ac towing a white high wing glider passed about 500 – 600 m ahead of him from L to R and 300 ft below. Descent was arrested to enable them to pass above the conflicting traffic; he felt there had been a medium risk of collision and reported the incident to Birmingham ATC who advised him that no primary radar returns were observed in his vicinity.

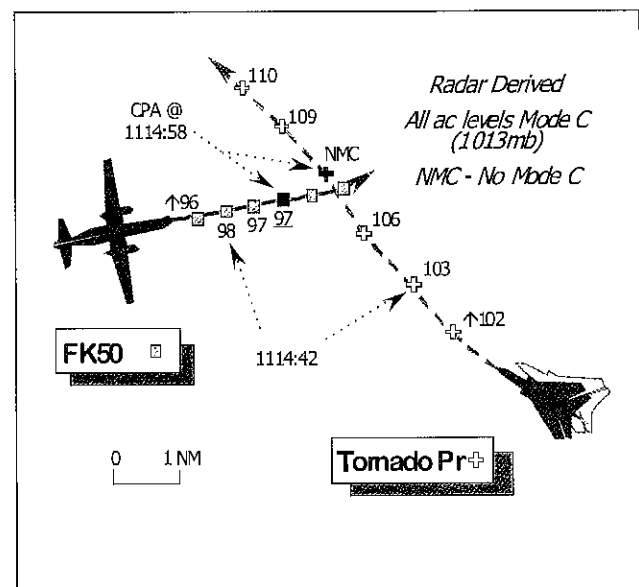
**THE F50 PILOT** reports that after departure from Teesside they were IMC in cloud, climbing to their assigned level of FL 210 routeing direct DOGGA,

under a RAS from Pennine RADAR. As they climbed through FL 85 Pennine instructed them to turn L onto 090° to avoid a possible conflict with military traffic, which was observed on TCAS about 8 – 10 NM away. About 8 NM SSW of Fylingdales whilst heading 090° at 160 kt, TCAS indicated a TA

that was followed by an RA several sec later, requiring a reduction in the ROC to zero, which was complied with. He thought that the other pilot might have initiated a high energy manoeuvre, causing the rapid RA as the other ac overflew about 500 ft above his ac, as indicated on TCAS. Afterward, traffic information on several other ac was received from Pennine who then downgraded the ATS to a RIS. The other ac was not seen and he did not proffer any comment on risk.

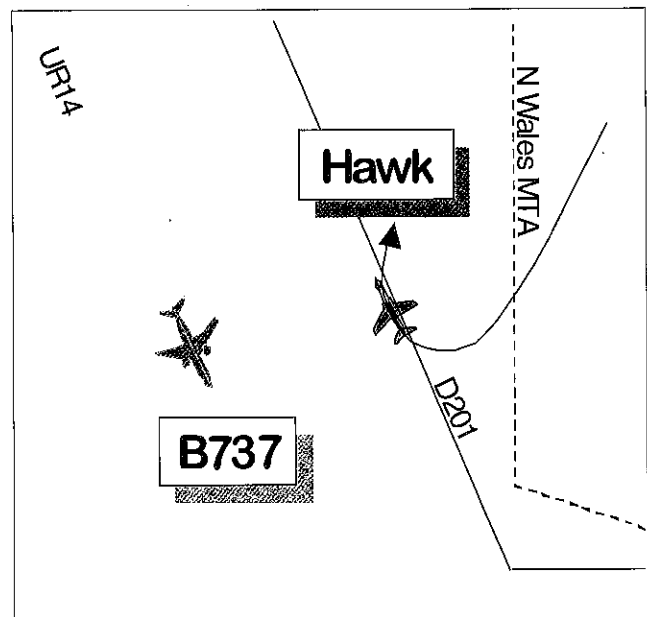
**THE LATCC STRUMBLE SC** reports that the B737 crossed VATRY southbound at 1217, level at FL 290. He noticed an unverified 7000 squawk (later identified as a Hawk) descending below FL 310 and closing from the N on the B737. The unknown traffic was coming from D201; it was also threatening traffic at FL 310 NW-bound from Strumble. The Hawk had been operating in the North Wales Military Training Area, but its track had taken

it outside, thus the ac was in Class B airspace, and subject to obtaining a radar control or procedural service under the terms of operating within the Military Mandatory Radar Service Area (MRSA). The pilot had not complied with this requirement.

The SC began to pass traffic information to the B737 as the unknown ac continued to converge and descended through FL 305. By 1218:40 it was in the 10 o'clock of the B737 at a range of 6.8 NM, passing FL 293 in descent, and still on a conflicting heading, with 1.7 NM to run to the edge UR14. The B737 pilot, given information on the traffic which he did not see was next passed avoiding action, to

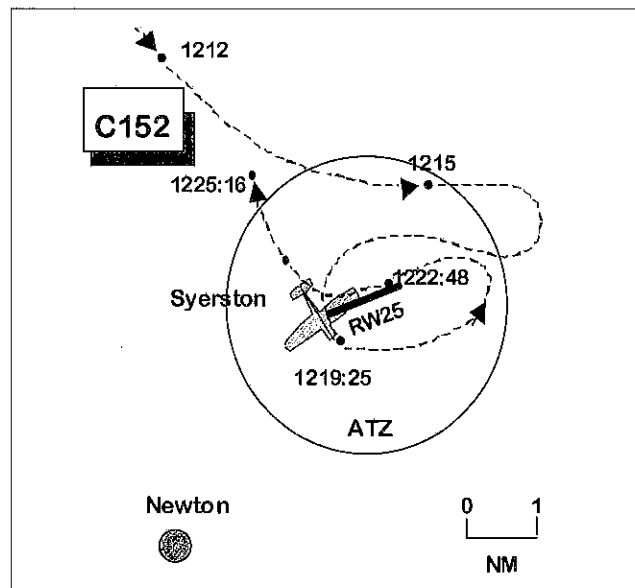
Recorded Separation: not seen on radar

**THE GLIDER PILOT** reports that he had just winch-launched from RW 25 at Syerston on an instructional sortie. The visibility was 25 km in VMC. On releasing the cable at 1200 ft (QFE) and 50 kt in clear air, below well broken cloud, he turned L 90° and a C150 type, whose registration he could read, approached from the rear and flew past 100 ft below him and 100 ft to his L. The pilot comments that had the other ac been about 5 sec earlier on its flight path it would have come very close to the launch cable. He felt there had been a high risk of collision.

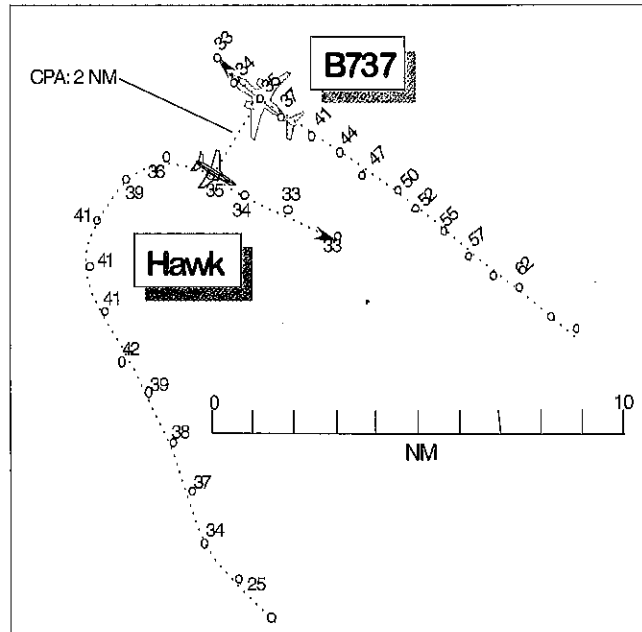
Recorded Separation: 2 NM

**THE PRESTWICK APPROACH CONTROLLER (APR)** reports that while the B737 was descending for RW 31 at Prestwick it had been receiving a RAS in Class G airspace. When it was passing about 3000 ft, he saw pop up traffic 1 NM W of it, now descending and turning right, indicating 3000 ft Mode C. It then turned away to the right before any avoiding action could be given but traffic information was passed via TWR, to whom the B737 had just been transferred.

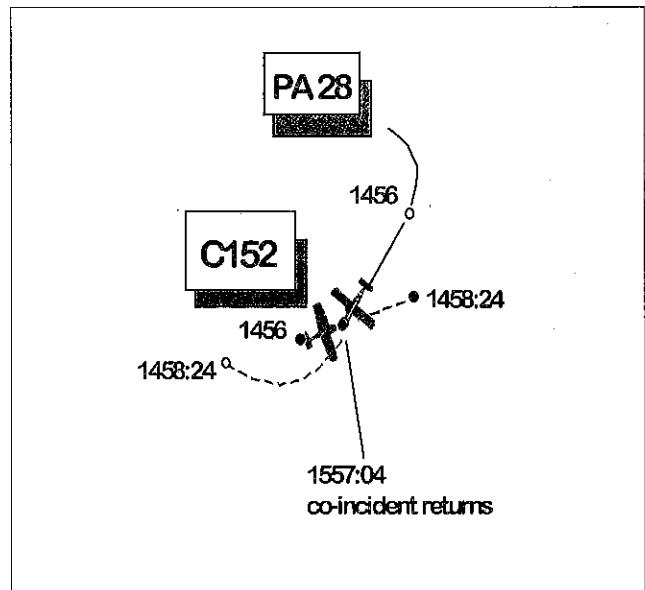
<u>Reporting Aircraft</u>	<u>Reported Aircraft</u>
<u>Type:</u>	PA28	C152
<u>Operator:</u>	Civ Trg	Civ Trg
<u>Alt/FL:</u>	2000 ft (QNH 1017 mb)	2400 ft (QNH 1017 mb)
<u>Weather</u>	VMC CLBC	VMC
<u>Visibility:</u>	>10 km	25 km
<u>Reported Separation:</u>	300 ft V/not seen	
<u>Recorded Separation:</u>	0 ft Hor

**THE PA28 PILOT** reports that he was holding at 2000 ft (QNH 1017) in the ALKIN holding pattern on an IF detail, with 2 students on board. The visibility was over 10 km in VMC. He was squawking, probably 7050, and receiving a RIS from Thames Radar on 132.7. Mode C was not fitted. Traffic information on 2 ac had been passed to him during the previous 5 min and he had spotted both. When about 8 NM DME on the BIG 063°R, heading 245° at 95 kt, he saw another ac (a Cessna152/172) 1 to 2 NM ahead at a similar level as it climbed towards him on a reciprocal course. No avoiding action was necessary as he could see that the ac

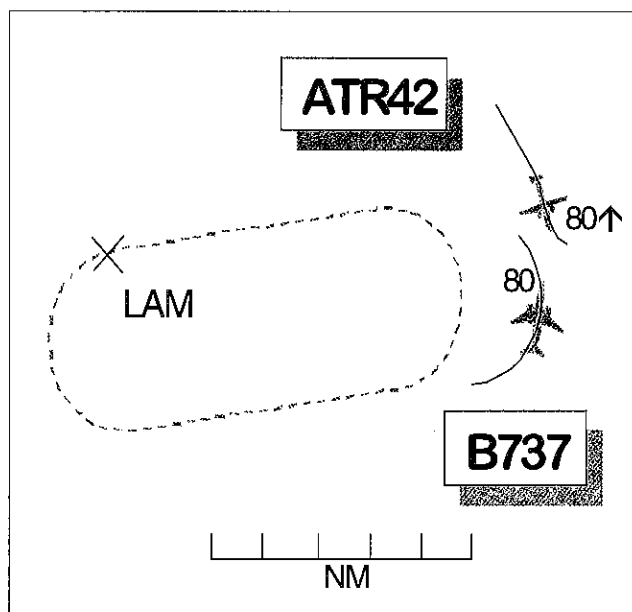
**THE B737 PILOT** reports heading N at 210 kt in a left turn at FL 80, inbound to LAM having been cleared to leave the fix heading 270°. In the turn the ATR was seen closing in his 2 o'clock at the same level. At the same time he was given an avoiding action left turn onto 240° and he saw the ATR begin a left turn before passing astern of him about 0.5 NM away.

Cause: The ATR42 pilots responded to a climb instruction passed to another ac, and the NE DEPS controller did not correct the readback error.

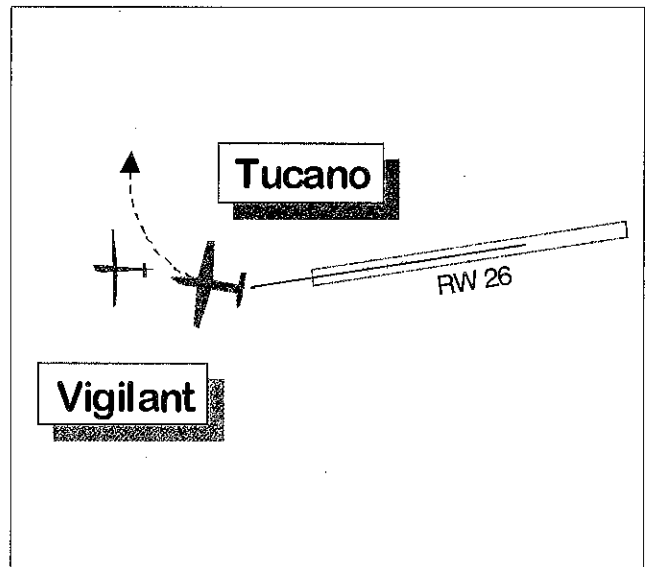
**THE VIGILANT PILOT** reports heading 280° at 60 kt, climbing after take-off from RW 26 at Kinloss; he was in communication with Kinloss tower on 122.1. Passing 750 ft he saw a Tucano closing from his left, slightly lower, in a climbing right turn. It passed very close (about 50 ft) behind him still in a climbing turn while he turned slightly right to keep it in sight. There was a high risk of collision; he had not seen the Tucano in time to take avoiding action. His ac was white with red rudder and wing tips and his wing tip strobes and HISL were on; the incident occurred 1000 ft below cloud.

Cause: The Tucano pilot did not see the Vigilant, compounded by a lack of traffic information from TWR.

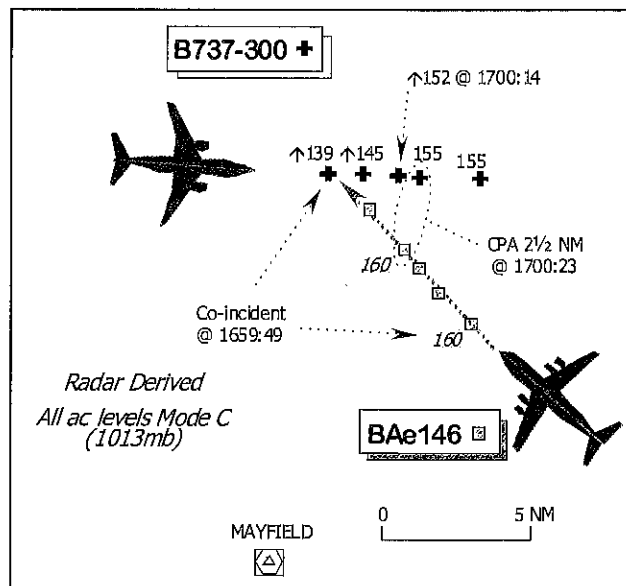
to FL 160. The B737 departed from Gatwick for Brussels, established contact with the BIGGIN SC at 1656 and was climbed in stages to FL 90 and then to FL 150 against the descending BAe146. At 1659:49, as the BAe146 levelled at FL 160, the B737 was crossing from left to right through its 12 o'clock at a range of 7 NM and climbing through FL 137 for FL 150. At 1700:14, the SC observed that the B737 was climbing above its cleared level of FL 150, as the crew reported a "TCAS climb". The SC acknowledged the call from the B737 crew and advised them of the BAe146, 1000 ft above and maintaining FL 160, which was about to pass astern. The SC confirmed that the B737 crew were aware their assigned level was FL 150 and then queried why they had climbed above it, whereupon the crew reiterated that they had received a TCAS climb instruction. The B737 exceeded its assigned level by 500 ft and reached FL 155. Once the controller assessed that it was no longer in conflict with BAe146 he issued a further climb to FL 170. The CPA occurred at 1700:23, as the B737 passed through the BAe146's 2 o'clock - 2.5 NM, 500 ft below it. The BAe146 maintained FL 160, passed astern of the B737 and separation was restored within 20 sec.

Cause: The B737 crew climbed above their cleared level whilst responding to a TCAS RA.

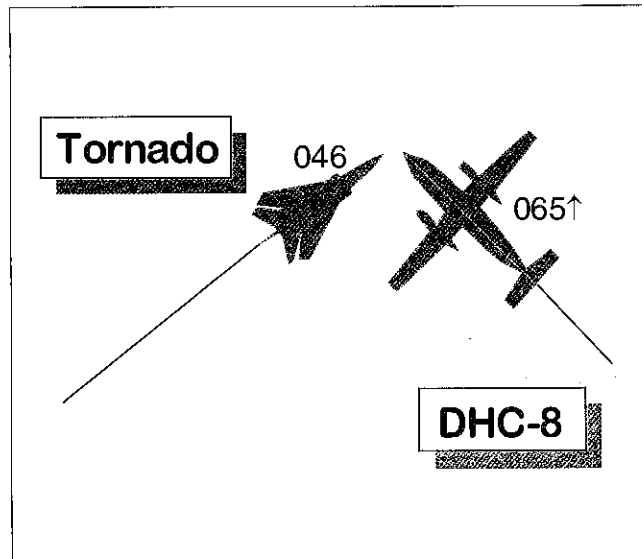
ask another ac its altitude and its pilot replied that he was at 6000 ft and that the Tornado was indicating 2000 ft below on TCAS. The DHC-8 then passed directly overhead at about 4100 ft, heading NW. Both Tornado crew members checked their altitude and agreed that the DHC-8 passed above by about 400 ft. Had he been IMC and levelled at his cleared level there would have been a strong chance of collision.

Cause: Mistaken impression of vertical separation between the ac by both Tornado crew members.

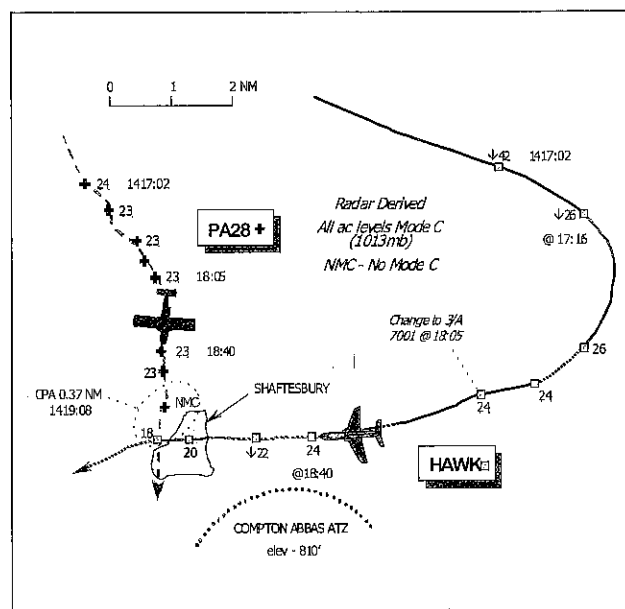
**THE PIPER PA28R ARROW IV PILOT** reports he was under a limited RIS from Yeovil RADAR, in transit at 120 kt from Gloucestershire aerodrome (Staverton) to Bournemouth (Hurn) at 2000 ft Portland RPS (1004 mb) in CAVOK. The ac has a white colour scheme with green trim; anti collision lights and HISLs were on and he was squawking the assigned code of 3/A 0230 with Mode C. Whilst approaching Shaftesbury, heading 195° (M), a black Hawk jet was first sighted closing from the L at a range of about 1 NM, flying westbound straight and level. No avoiding action was taken as the jet passed from L to R about 200 m ahead of his ac, he thought, at the same altitude. He did not assess the risk.

believed that at the reported range of 1 NM, it was at a late stage. In his initial airborne report by RT the PA28 pilot told Yeovil RADAR that minimum horizontal separation was 400 m but he changed this subsequently to 200 m in his written report. The Board noted that the former figure was more in line with the horizontal separation shown on the radar recording. Some members thought that a '1 NM pick up' amounted to a late sighting, but this was understandable given the small size of the Hawk and perhaps reduced relative motion had also played a part - which also applied equally to the Hawk pilot. However, others contended that, notwithstanding the 'Rules of the Air', having seen the Hawk, the PA28 pilot did not appear to take any avoiding action at all and allowed himself to fly too close to it. Members believed that it was usually safer to take positive action quickly to maintain or improve separation against another observed ac, that might otherwise get too close. The PA28 pilot might have thought, quite reasonably, that the Hawk pilot should have seen and avoided his ac by a greater margin. However, the 'Rules of the Air' can only work when both pilots sight each other's ac, which was not the case here. The members agreed, therefore, that this Airprox resulted from a non-sighting by the Hawk pilot and a late sighting by the PA28 pilot.

Cause: Non sighting by the Hawk pilot and a late sighting by the PA28 pilot.

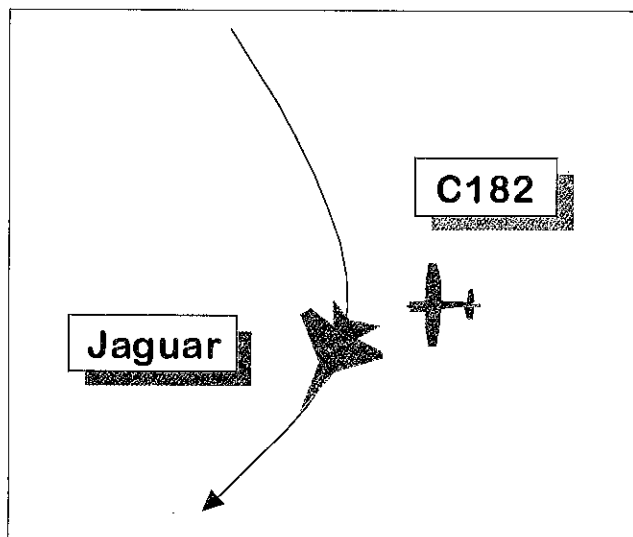
**THE CESSNA 182 PILOT** reports heading 260° at 70 kt on take off from Brunton airfield in his mainly white ac. When passing 200 ft, while still over the runway, a military jet passed right to left 2-300 ft ahead and above with a medium to high risk of collision. It was turning right and he could hear its engine noise above his own full power and max rpm. He took no avoiding action because it was already passing when he saw it.

NW. A single return of 7001 at 800 ft Mode C appears overhead Brunton airfield at 1426:41 to be replaced at the same location 8 seconds later by a 0033 return at 600 ft Mode C. (The Cessna was on a paradropping sortie.) The 7001 squawk reappears shortly afterwards, tracking SW.

little more to add to these lesson points and the Board agreed that the cause of the Airprox was the non-sighting of the C182 by the Jaguar pilots, and their flightpath right over the runway at Brunton.

**Cause:** The Jaguar pilots did not see the C182 over a notified airfield/paradrop zone.

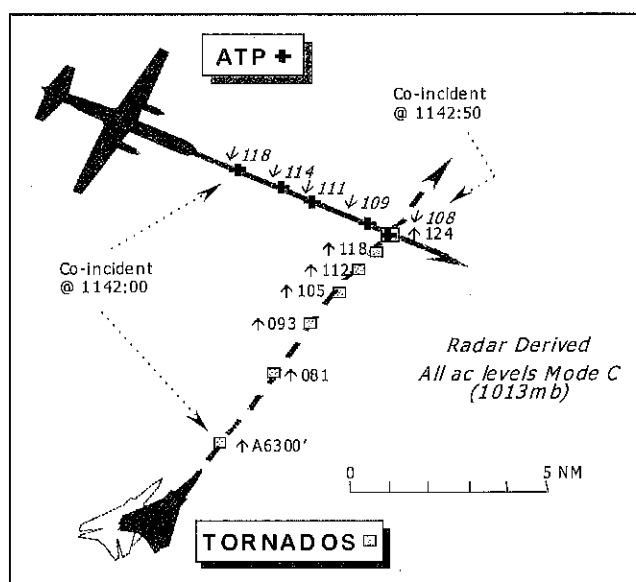
**THE GLASGOW APPROACH CONTROLLER (APR)** reports that he had received a radar handover on the ATP from the ScACC WESTCOAST SC, which was inbound to Glasgow, via ADR N573D. Before the crew called him on the RT, the WESTCOAST SC called again on the landline and pointed out conflicting OAT, squawking 3/A 4647, heading toward the ATP and climbing. The ATP

crew then called on 119.1 MHz and by the end of the initial transmission the ac were so close that no effective avoiding action could be issued. The only course of action he believed was to advise the ATP crew to increase their rate of descent, which he did before passing traffic information. The crew then reported spotting a pair of fast-jets, subsequently identified as Tornados, which were at least 3000 ft above the ATP and climbing rapidly. The ATP pilot was informed that an Airprox report would be raised when he declined to file one himself.

**THE GLASGOW ATC WATCH MANAGER** added that the ScATCC (Mil) controller could have notified the WESTCOAST SC, especially as they have direct line communications between consoles in the same Ops Room. This would at least have pre-warned the SC, who could have pre-warned the APR who could then have passed traffic information to the ATP crew. More co-ordination of this nature would prevent unnecessary Airprox of this sort in the "Open FIR" (sic).

The ATSI adviser explained that the Tornados should have been displayed to the WESTCOAST SC before he transferred the ATP to the Glasgow APR. However, it seemed that the WESTCOAST SC had not seen them and consequently took no action until alerted to their presence by the STCA, (a facility not available to the APR) some 12 sec after the ATP crew had switched frequency. An ATCO member found this whole situation rather surprising, as controllers will generally look at ac on radar, or the fps, when transmitting to them. Nonetheless, it was explained that the WESTCOAST Sector covered a large geographical area and the SC would have been using several radar sources, which might explain why he just did not spot it at the time. Some controller members wondered if the handover to the APR had been complete. However, it was explained that this transaction would probably have been limited to an ident on the ATP and the level it was descending to. Nevertheless, it was clear to the Board that when the handover was accepted, neither the WESTCOAST SC, nor the APR spotted the

Cause: A conflict in Class F airspace resolved by the Allocator and Tornado pilot.

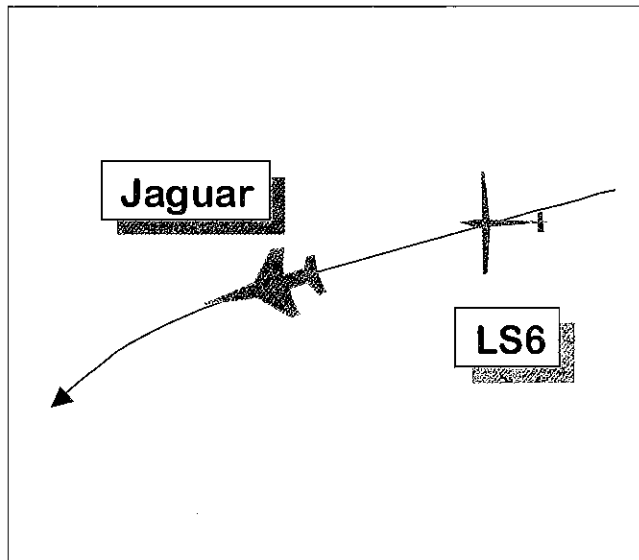
At about 1330Z the Jaguar departed Coltishall VFR to the W and established a FIS with Coltishall Approach (APP). Very shortly afterwards, and before the ac had left the MATZ, the pilot indicated that he was happy to change to his en-route frequency. APP had observed several radar

contacts in the area between Shipdham and Swanton Morley and warned the pilot accordingly. As he left the frequency, the pilot indicated that he intended to route further to the N of Swanton Morley; the Jaguar however, appeared to maintain heading and passed to the S. APP's workload was assessed as being low and all radars were serviceable.

Later that afternoon, a glider pilot telephoned to inform Coltishall ATC that his ac had been underflown by a Jaguar, which he estimated had passed between 100 and 200 ft below and slightly displaced; the details of the incident, as described, fitted in with the above transit.

The Board agreed that the cause of the Airprox was that the Jaguar pilot did not see the glider. The ac passed very close without the Jaguar pilot's knowledge, and the glider pilot not in a position to affect the outcome; these factors led the Board to conclude that there had been a risk of collision.

Cause: The Jaguar pilot did not see the glider.

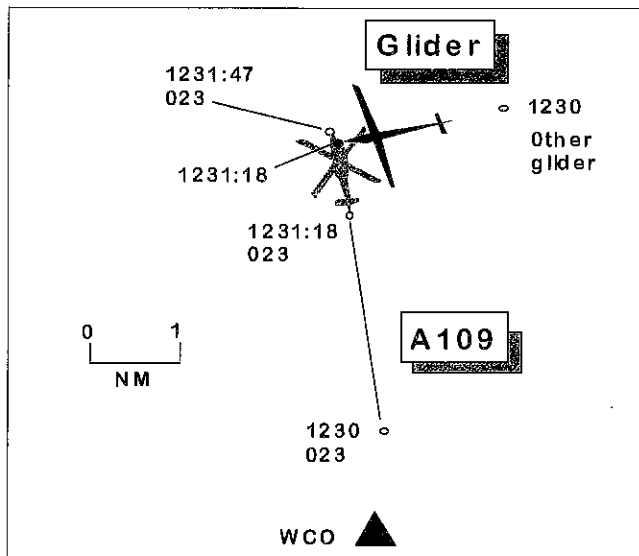
**THE GLIDER PILOT** reports that he was operating out of Gransden Lodge (elev 254 ft) and at the time of the Airprox was thermalling to the E of Bicester at about 2000 ft in VMC; visibility was good. While passing through S in a R turn at 60 kt, a small dark helicopter appeared 300 yd away and slightly below him on a northerly heading; it appeared to be

heading directly for the centre of his thermal turn so he immediately straightened out onto a westerly heading and descended sharply to gain speed to avoid the helicopter's flight path. He did not think the other pilot had seen him at this stage. Shortly afterwards he lost sight of the helicopter but thought it had passed some 300 m to his L and slightly below. The pilot does not give an estimate of risk.

**UKAB Note:** A recording of the Heathrow radar for the time of the Airprox shows a 7000 return, believed to be the A109, indicating 2300 ft Mode C (equivalent to about 2500 ft QNH 1020) as it tracks N from WCO at 1230. At the same time, two intermittent slow moving primary returns, believed to be gliders, are seen operating to the SE of Buckingham. These returns disappear until 1231:18, when one pops up for 1 sweep of the radar at the helicopter's 12 o'clock, within 0.5 NM. Though not seen on radar, the Airprox is believed to have occurred at about 1231:40.

pilot saw the A109 late, and the A109 crew saw the glider later still; the Board concluded that these late sightings had caused the Airprox. A GA member commented that, having the benefit of two pairs of eyes, the A109 crew might have been expected to spot the glider in time to initiate avoiding action, as was required of them under the Rules of the Air. However, the difficulty often experienced in spotting white gliders against a bright background was well known.

Cause: A late sighting by the glider pilot and a very late sighting by the A109 pilot.

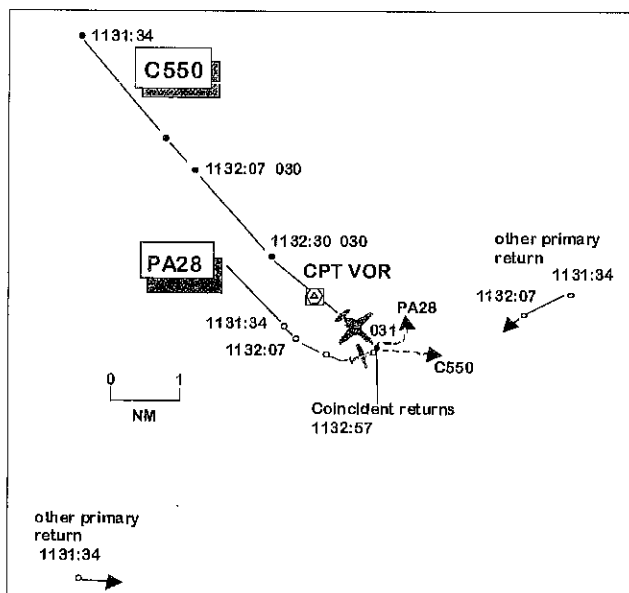
<u>Reporting Aircraft</u>	<u>Reported Aircraft</u>
<u>Type:</u>	PA28	C550
<u>Operator:</u>	Civ Club	Civ Exec
<u>Alt/FL:</u>	4000 ft (RPS 1013 mb)	3000 ft (QNH)
<u>Weather</u>	VMC HAZE	VMC CAVOK
<u>Visibility:</u>	40 km	>30 km
<u>Reported Separation:</u>	300-400 m / 2.5 NM	
<u>Recorded Separation:</u>	<500 m

**THE PA28 PILOT** reports that he was on a general handling training flight from White Waltham with a student and receiving a FIS from Brize Norton LARS on 134.3. He was squawking 3713 (he could not remember whether he had selected Mode C). The visibility was 40 km in VMC. He had instructed his student to climb to 4000 ft and turn L 90° onto due

Members noted that in the initial stages of the encounter the tracks of the ac were paralleling about 1 NM apart, with the C550 overtaking on the L with a high-speed differential. This situation continued until about 1132:30, when the C550 was about 1 NM NW of CPT, still with no discernible track alteration, and the PA28 had begun its turn onto E, some 1.75 NM away at its 12:30 position. Subsequently the C550's track quickly converged on the PA28 which was by now tracking ENE. Members could not fit this geometry with the C550 pilot's statement that he had seen the PA28 from 4 NM and turned to avoid it by 2.5 NM. Three possibilities were postulated by members: one was that the C550 pilot had seen another ac. However, this was thought unlikely because no other possibilities were apparent on the radar recording at the time. Secondly, the traffic information passed to the C550 pilot (possibly inaccurately) may have led him to underestimate the potential for conflict. Thirdly, and thought to be the more likely explanation, was that the C550 pilot saw the PA28 ahead and to his R, paralleling his track, so he altered heading a few degrees to port in order to overtake it, assuming that he was giving it a wide enough berth. Meanwhile, the PA28's L turn, possibly unseen, then quickly eroded the planned separation. Subsequent analysis of the radar showed that the ac actually passed within about 400 m of each other. The Board concluded that, whatever his reported perception of events, the C550 pilot did not take adequate steps to ensure

Cause: Inadequate avoiding action by the C550 pilot.

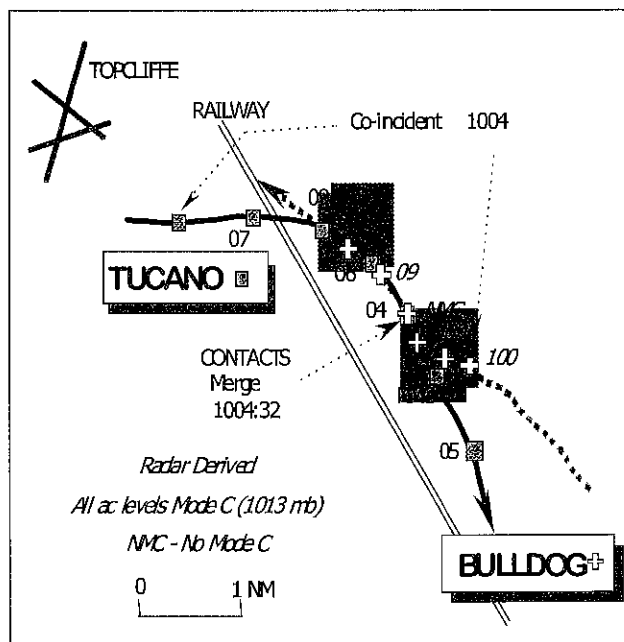
**THE BULLDOG PILOT** reports he was heading 300° at 100 kt, flying a PAR to RW 31 at Topcliffe, to circle subsequently onto RW 03. He had specifically asked for a RAS from Linton Approach because of the weather conditions and was squawking the assigned code with Mode C. Whilst descending IMC through about 1000 ft Topcliffe QFE (1017 mb) on the final approach with Topcliffe TALKDOWN, he cleared the base of the cloud just in time to become visual with the ground and see a

black Tucano pass about 200 ft directly beneath his ac on a reciprocal course. He immediately pulled back on the control column and climbed about 100 ft to avoid the other ac, with which there had been a high risk of a collision. At the time of the Airprox, TALKDOWN's instructions had ceased, prompting him to request a radio check. Whilst still visual with the ground he continued with the approach and was subsequently given clearance to land on RW 31. He adds that Topcliffe were in the process of changing from RW 03 to RW 31 and the circling minima was 460 ft QFE. The second crewmember, an experienced navigator, also estimated the vertical separation above the Tucano had been about 200 ft.

**THE TUCANO PILOT**, a solo student, reports that after positioning for a downwind join for RW 03 at Topcliffe, the Duty RW was changed to RW 31, whereupon he elected to depart the circuit and recover to Linton. He informed Topcliffe TOWER (TWR) of his intentions and was instructed to report when changing frequency to Linton. At the end of the downwind leg for RW 03 he turned SE, and when clear of the Topcliffe circuit changed to the Linton Tower frequency and proceeded to climb to 1400 ft QFE. He then realised that the weather conditions would not permit a normal VFR transit and informed Linton TOWER that he was transiting at 1000 ft Linton QFE. Whilst establishing on the RHD side of the railway lines, heading 150° (T) at 180 kt, he saw the Bulldog descending down through the cloud. To increase separation he pitched down, descended and turned L, whereupon the Bulldog passed about 300 ft above him and about 2-400 m to starboard. No information was received from any ATC agency about the proximity of the Bulldog.

The Tucano pilot was aware of the dual runway operations at Topcliffe. Therefore, his decision to depart the visual circuit on a reciprocal heading and very close to the approach lane to RW 31 was surprising, especially in such marginal weather conditions. Moreover, he was unable to maintain the normal transit height of 1400 ft QFE and descended to 1000 ft, which was not communicated to Topcliffe TWR. Whilst timely traffic information from Topcliffe TWR may well have prompted the Tucano pilot to give inbound radar traffic a wider berth, he was, nonetheless, flying a VFR procedure and was responsible to 'see and avoid' conflicting traffic. The 'Tower-to-Tower' procedure provides an expeditious and convenient means of transit between local airfields. Because the Tucano pilot appears to have crossed E of the railway line, contrary to the procedure, this placed him in close proximity to the instrument approach of RW 31.

Cause: The Tucano pilot did not fly the Topcliffe – Linton 'Tower to Tower' procedure correctly, compounded by a lack of a timely traffic broadcast by Topcliffe TOWER.

**HQ PTC** concurred with the Tucano pilot's Unit, who believed the conflict stemmed not from a poorly designed procedure but rather from its improper use in unsuitable weather and, after a review, was satisfied that the transit procedures required no amendment. They commented that the Tucano pilot had made an error of judgement by attempting a visual tower-to-tower transit procedure in marginal weather conditions, leading to a late visual sighting of the Bulldog. His decision may not have been helped by his inexperience (240 Hrs total). Had he remained with Topcliffe Tower he may also have been able to maintain better situational awareness of the Topcliffe circuit area. The Tucano departed the visual circuit from what was effectively a down wind position on RW 31 and the pilot chose to change frequency whilst still inside Topcliffe MATZ, albeit clear of the visual circuit pattern, but he had not been made aware of the instrument traffic inbound before changing frequency. ATC might have been able to prevent the incident by providing traffic information on the Bulldog enabling timely avoiding action. Although the runway change did not contribute to the had apparently strayed to the East of the railway line, a dead straight feature and difficult to miss, thereby bringing the Tucano into conflict with the Bulldog. However, the radar recording had been examined carefully and compared closely with relevant charts to ensure accurate interpretation. A member

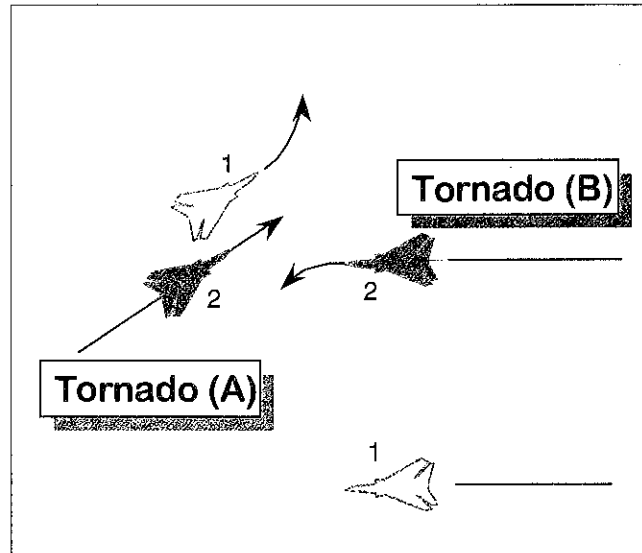
**THE TORNADO GR PILOT (A)** reports heading 060° at 380 kt while climbing from low level in a formation join-up. He saw a Tornado head-on about 300 m away and broke hard left; he did not see it pass but estimated a 200 m miss distance from his HUD video. His No 2 did not see it and did not react; the risk of him colliding with the other ac was high. They had partaken in an Exercise Clean Hunter sortie from RAF Brüggen to the UK. The booked low level times were 0845-0945 and during these times no other non-exercise traffic was allowed in that part of the UKLFS. The Tornado (B) formation was booked into LFA5 from 0945 and entered low level on time. If he (A) had maintained his original time on target (TOT), he would have exited at Southwold at 0930. Unfortunately his TOT had been delayed by 15 min which allowed the Airprox to take place. A buffer needs to be built into future exercise low level bookings such that exercise traffic exiting low level is deconflicted from non-ex traffic entering low level.

**THE TORNADO GR PILOT (B)** reports heading 270° at 420 kt entering the UK LFS at 1000 ft over Southwold; displaced to the right of his leader. He saw 2 ac in close formation very close in his 1 o'clock and slightly below. He broke hard left and

saw the leader of the other pair do the same. The No 2 of the pair passed 80 ft below and about 150 ft to his right.

The Board agreed that this had been a very close call indeed with a high risk of collision and that the cause had been that no member of either formation had seen the other formation in time to prevent such a close encounter. Although this indicated a breakdown in formation cross-cover, particularly for the Tornado (B) formation, at 800 kt closing speed such late sightings become more likely. This is why the LFS has so many flow restrictions in it to reduce the likelihood of head-on encounters. In this case the Sqns at Brüggeren had been unwisely using the same point routinely for coasting in and out,

Cause: Late sightings by both Tornado formations.

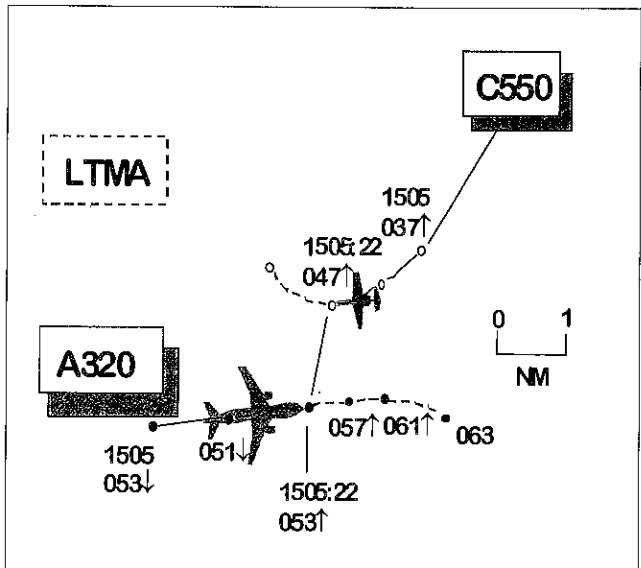
**THE AIRBUS PILOT** reports that he was heading 080° and descending from 7000 ft to 5000 ft at 240 kt in IMC while positioning downwind LH for RW 26 at Luton. He had just been transferred by LATCC to Luton Radar on 129.55. Two initial calls to Luton were unanswered but on the third the QNH (1018) was confirmed. On passing 5500 ft, a TCAS RA demanded “descend descend” followed instantly by “climb climb” – the VSI showed that a max rate climb was required. TCAS showed a target at 11 o’clock 1 NM, 800 ft below and climbing. Simultaneously, Luton ATC instructed an immediate

R turn onto 180°, with which he complied. The other ac appeared to be climbing with them about 400 ft below. He climbed to 6100 ft to comply with TCAS and the target disappeared. Normal descent and vectors were then resumed under the control of Luton Radar. He felt there had been a high risk of collision.

At 1505, the A320 pilot reported a TCAS event to which the Intermediate Director responded with an instruction to make an avoiding action R turn onto heading 180°. The pilot complied. It was not clear whether the TCAS report was a TA or RA as the end of the transmission was broken. The Director agreed at interview that the ATC instructions were inappropriate once the ac had declared a TCAS manoeuvre. At 1505:30 the A320 pilot reported turning onto the heading and descending from 6000 ft to 5000 ft, and at 1505:45 reported ready to take radar vectors. Normal vectoring was then resumed for an ILS approach. Simultaneously, there was a telephone exchange between the ADC and the Intermediate Director as to whether the requirement to "Check all" departures had been imposed. Meanwhile, at 1505:10 the C550 pilot had finally succeeded in making contact with TC NW Deps, whose first transmission was to issue an avoiding action turn onto heading 360° owing to traffic in the ac's 11 o'clock at 2 NM. At 1505:40 the controller informed the pilot that the reported traffic had now passed clear down his left-hand side. The C550 then resumed normal navigation.

Cause: The Luton ADC allowed the C550 to take off into conflict with the descending A320.

ATSI recommend that Luton ATC reviews departure "Free Flow" and "Check" procedures from the point of view of simplification and their safe operation.

An ATSI adviser said that the Luton procedures should be examined with a view to simplification. ATCO members agreed, and commented that in addition to the procedures, the responsibilities of individuals involved in the information chain also needed clarification, particularly those with respect to the ATSA. The Board endorsed the ATSI recommendation, as quoted in Part A, together with the question of individual responsibility, and the Director agreed to forward a UKAB recommendation accordingly. An adviser from ATM P & P advised the Board that proposed route changes in the Luton area during the early part of next year (2001) would obviate this type of error.

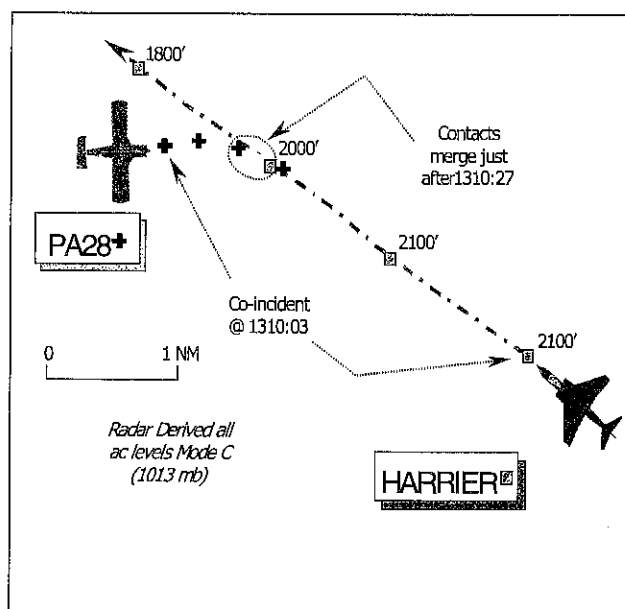
**THE HARRIER PILOT** reports that he was heading 310° at 2000 ft RAD ALT after climbing out of the LFS at 420 kt to the south east of Clacton and squawking, he thought, 3/A 7001 with Mode C. Cloud prevented him from climbing any higher than 2000 ft Rad Alt initially. He tried unsuccessfully to contact London (Mil) on the ICF until he realised that he had used the wrong frequency. About 13 NM W of Wattisham, after finally contacting London (Mil) he was asked to change Squawk, he thought, and as he was carrying out the code change he saw a dark flash or shadow of an aeroplane go down the port side co-altitude or possibly slightly above. The whole shape of the ac could not be determined but he estimated it was about 100 ft away as it flashed by, possibly heading eastbound, with a high risk of a collision. He was unable to take any avoiding action as it occurred too quickly. The incident was reported to London (Mil). Though his ac is camouflage grey, HISLs were selected on during the flight. He thought that the other ac might have appeared from below the canopy arch.
