UK AIRPROX BOARD

**Analysis of  
Airprox in UK Airspace**  
Report Number 4  
January 2000 to June 2000

Report by the UK Airprox Board,  
'Analysis of Airprox in UK Airspace'

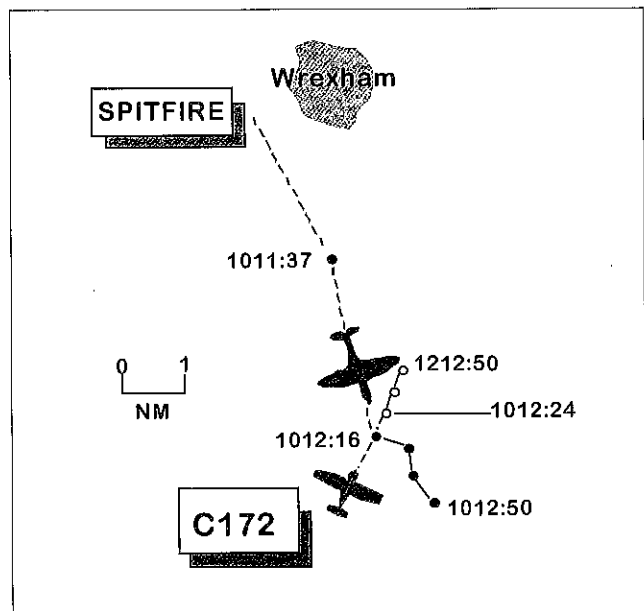
**THE C172 PILOT** reports that he was conducting a VFR navigational training flight from Welshpool

to Liverpool with a student, who was occupying the LHS. There was no low cloud and the visibility was 30 km in VMC. At the time of the incident he was listening to Liverpool’s ATIS prior to requesting zone entry clearance. His SSR transponder was switched off. When about 5 NM SE of Wrexham, heading 010° and cruising at 2000 ft (QNH 1016) at

105 kt, he saw a Spitfire less than 1 NM away approaching him head-on at a similar level. He began a R turn in avoidance but, on seeing the Spitfire turn L, he reversed this and climbed; he assumed that the other pilot had seen him. The Spitfire passed about 150 ft directly beneath him with a high risk of collision. After landing he reported an Airprox to the UK Airprox Board by telephone.

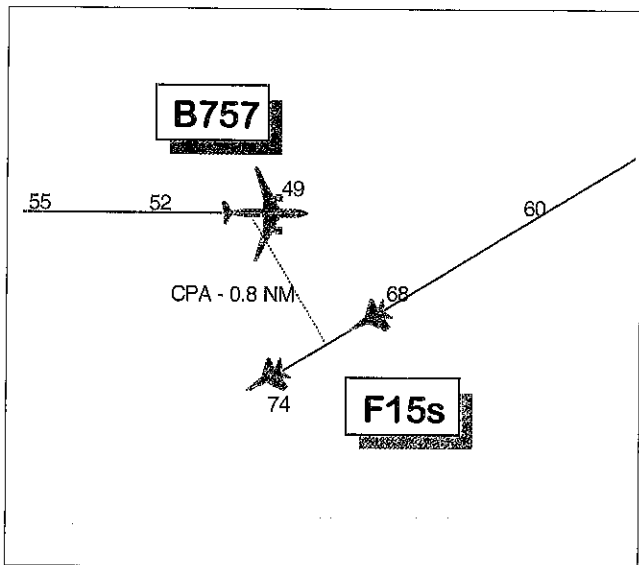
**THE B757 PILOT** reports heading 100° at 250 kt under 'Radar Control' from Norwich Airport and descending to the S of the airport for an approach to RW 27. He saw traffic on TCAS 10° L of the nose at 5 NM and closing rapidly. There was a call from Norwich about avoiding action which was unclear and his TCAS gave him a climb RA and then a descend, which he followed. The traffic was a pair of F15s which crossed his nose 500 ft above and 1 NM away, from his 11 o'clock to 4 o'clock. He considered the risk of collision was moderate.

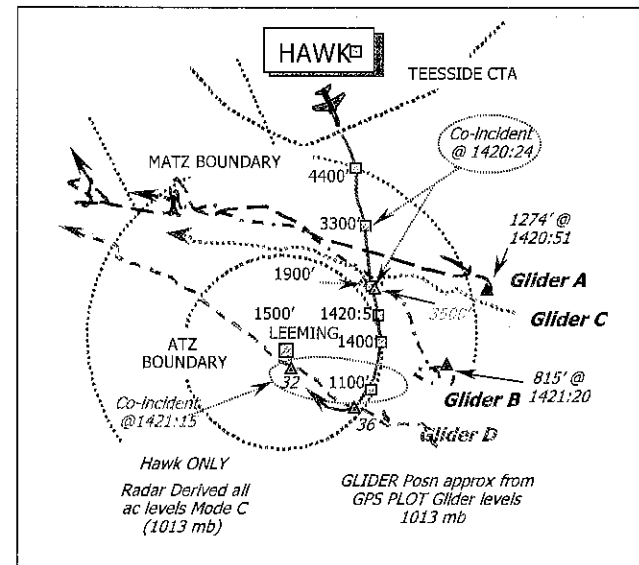
**THE HAWK PILOT** provided a detailed narrative and reports that he was inbound to Leeming from Lossiemouth flying a radar to visual recovery for RW34RHC at 390 kt, under a RIS from Leeming APPROACH (APP). He was aware of the NOTAM'd gliding activity from Pocklington and was advised on recovery by APP that activity was mainly to the W of Leeming but there were also some contacts to the E. He elected, therefore, to turn L and approach the airfield from the E. Unusually, he was cleared to continue his descent through the Teesside CTR, but was informed of a number of radar contacts ahead. Whilst in descent he saw 2 gliders at 2 – 3 NM circling ahead of him at 2 –

3000 ft and avoided them by turning R onto about 210°. When clear he turned L back onto 180° to be confronted by 2 more gliders circling at 2 – 3000 ft 1 NM ahead. He again turned R and continued descending to 1500 ft QFE. APP then informed him of further contacts at about 3 NM final, height unknown and a Bulldog in the visual circuit at 500 ft. He started a tight turn to the visual circuit deadside for (W) but did not initially see the reported contact at 3 NM final approach path, although he was visual with the Bulldog in the RW34RHC. The TWR frequency was selected and SSR deselected during the turn. Just before rolling out on RW heading (340°) at 500 ft QFE - 1 NM from the threshold he spotted a glider, again circling, over the IP for RW 34 at about 2000 ft. He avoided it by about 1 NM and 500 ft, but thought it represented a high risk of a collision because it was so difficult to see. He added that once he was established in the

visual circuit gliders were visible on most points of the compass. He believed that all of the reported gliders were inside the Leeming MATZ.

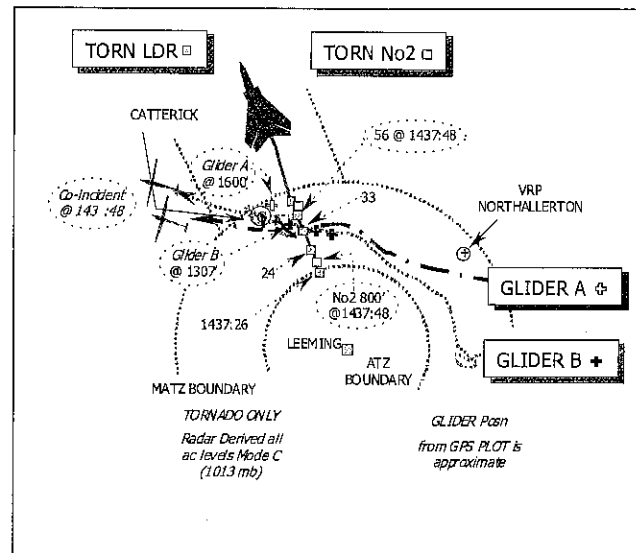
**THE TORNADO F3 PILOT** reports that he was leading a formation of 3 F3s on departure from Leeming RW34 RHC, under a RIS from Leeming APPROACH. The ac are camouflage grey and HISLs were on. Very shortly after take-off, on RW heading of 340° at 350 kt, he reported a pair of gliders at 1800 ft, 0.5 NM to his R. He initiated a zoom climb to get above cloud quickly and saw one glider at 3000 ft agl 0.5 NM to his L. The Nos 2 & 3, on receipt of his RT warning stayed low and encountered the same gliders just above them to L and R. He believed that the risk of a collision was moderate to high, because the gliders were in the Leeming climb-out lane. Their white colour scheme was indistinct against a white cloud background, they were difficult to spot and they were not in RT contact with ATC. He believed the gliders may have been from Pocklington who were holding a gliding competition.

**UKAB Note (1):** Despite extensive tracing action AIS (Mil) were unable to resolve the identity of the reported gliders and enquiries with the organising committee of the Pocklington competition proved entirely unproductive. Thereafter, UKAB staff requested the assistance of the BGA who were able to conduct an analysis of the competition GPS plots. These indicated the identity of two of the reported Gliders A and B, but there appear to have been others; the pilot of Glider B provided a narrative

**UKAB Note (2):** The cross-country Glider competition was the subject of NOTAM UKLB 2997, transmitted by ALFENS Ops at 0923:43. This NOTAM promulgated a warning of up to 35 gliders and 6 ac between 10 – 1700 UTC, following a route: Pocklington – Barnard Castle – Lanchester Mast – Masham, flying at altitudes up to the cloudbase.

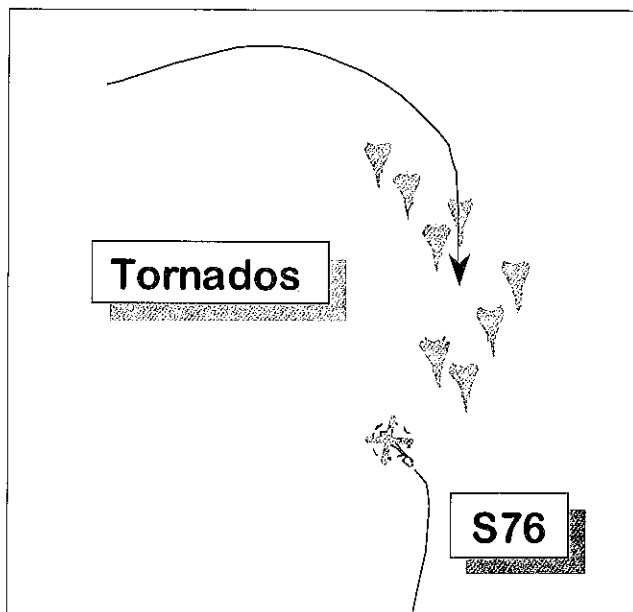
**THE S76 PILOT** reports heading 017° at 145 kt en route at 2000 ft from Norwich. He was receiving a modified RAS from Anglia Radar who warned him of 3 returns crossing left to right at 8 NM with a Mode C of 1600 ft. He replied that he could see 4 Tornados. He saw the formation turn right towards him, joined by 2 further formations, all of which continued to turn until head on to him at the same level. Due to their proximity and rate of closure he departed from the rules of the air by turning left and descending, informing Anglia. The formations passed above and to his right, the closest ac was 400 m away at the same level. If he had not taken avoiding action there would have been a collision. NOTAMs were generally available before flight but he advised later that he had not been aware of a NOTAM for this formation activity.

As to the risk of collision, members observed that the S76 pilot had seen the formation in good time and was always in a position to descend out of their way earlier had he considered it necessary. The Tornado pilots, although they saw the helicopter later, saw it in time to remove any risk of actually colliding with it.

**Cause:** The S76 pilot flew into conflict with the NOTAMed Tornado formation.

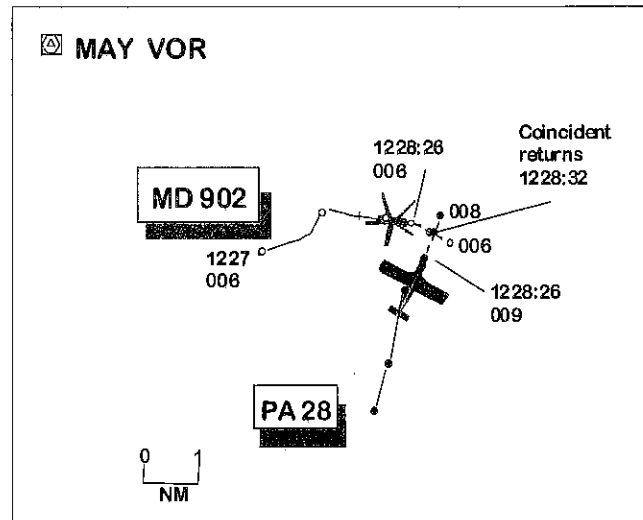
**THE PA28 PILOT** reports flying from Goodwood to Redhill via the Eastbourne area with one passenger on board. His ac is painted white on top and blue underneath. Wing tip anti-collision lights were on (plus nav lights) and he was squawking 7000 with Mode C. Prior to departure, he had listened out on Goodwood's frequency and

Turning to the helicopter, it was felt that the crew should have seen the PA28 earlier in the reasonable visibility they reported, notwithstanding the demands of their operational role. A member ventured, however, that they would probably not have expected to encounter a light ac flying at such low altitude in the prevailing weather conditions. Others accepted this suggestion, but it did not alter the criticism. Although both pilots reported seeing each other, their sightings were very late and the Board concluded that this was the cause of the Airprox. Moreover, neither pilot had then had any time to take avoiding action and any separation had been entirely fortuitous. This persuaded the Board to conclude that there had been an actual risk of collision.

Cause: Very late sightings by both pilots.

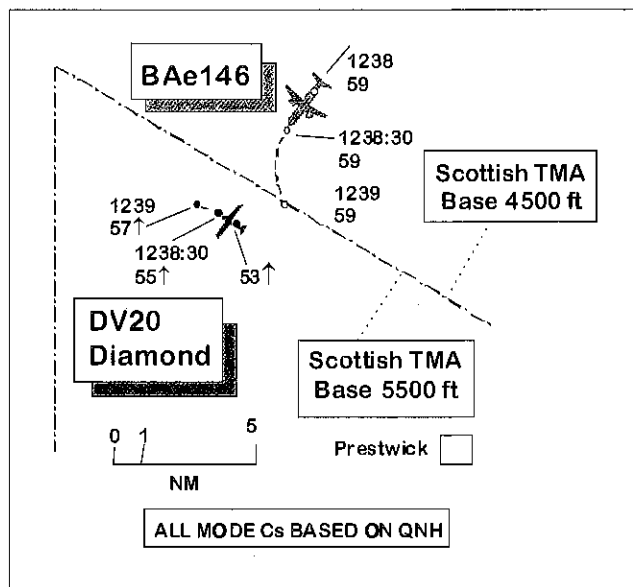
**UKAB Note:** Pictures of the Scottish radar at 1238 show the BA46 as it tracks SW of Glasgow maintaining 5900 ft Mode C. At the same time another return is observed moving slowly NW and squawking 7000 about 14 NM NW of Prestwick climbing through 5300 ft. At 1238:30 this return, believed to be the DV20, passes 3-6 NM in front of the BA 46 from L to R indicating 5500 ft. The latter commences a L turn at this point and by 1239 is passing through SSE some 2-8 NM behind the DV20, which is now indicating 5700 ft. At the time of the incident the DV20 is within the portion of the Scottish TMA where the base of CAS is 5500 ft, and about 2 NM SW of the boundary where it steps down to 4500 ft. Minimum separation was therefore of the order of 3-6 NM and 400 ft, albeit it did briefly reduce to 2-8 NM and 200 ft but this was after the ac's tracks had crossed.

Members found it difficult to formulate a cause because the DV20 was not actually inside the TMA at the moment of the Airprox. Nevertheless, the DV20 pilot had generated a situation by continuing his climb which necessitated the Galloway SC taking avoiding action with the BA46. The Board concluded that the Airprox was the result of a confliction near the base of CAS which was resolved by the Scottish Galloway SC.

Cause: A confliction near the base of CAS which the DV20 Diamond pilot subsequently entered without a clearance, resolved by the Galloway SC.

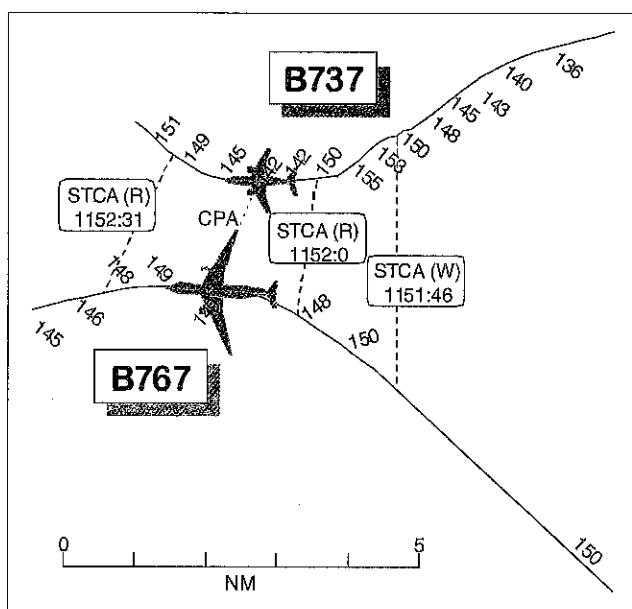
**THE B767 PILOT** reports heading 330° at 380 kt on a positioning flight to Birmingham; he was cruising at FL 150 under the radar control of LATCC on 118.825. TCAS showed conflicting traffic at 1-2 o'clock at about 5 NM which he then saw. It was a B737 which appeared to be climbing. When it reached FL 148 TCAS produced a TA at the same time as ATC gave an avoiding action left turn and descent. There was a low risk of collision; the B737 closed to a minimum of 1.5 NM as it passed through his level and he filed the Airprox by phone to LATCC after landing.

The Board concluded that the cause of this Airprox was that the TC NW Deps mentor had allowed his trainee to climb the B737 into conflict with the B767. Although the FPS were there to display the conflict, the mentor and his trainee both missed it; members were advised that the mentor would have been able to see the FPS display from where he was sitting. Note was taken that traffic from Gatwick on the B767's route would normally be above FL 160, and that it was not in communication with the sector, and that both factors had contributed to the incident. It was also pointed out that the mentor should have been plugged in with the trainee all the time to hear any telephoned co-ordination, but he had done so before the Airprox occurred.

Cause: The TC NW Deps mentor allowed his trainee to climb the B737 into conflict with the B767.

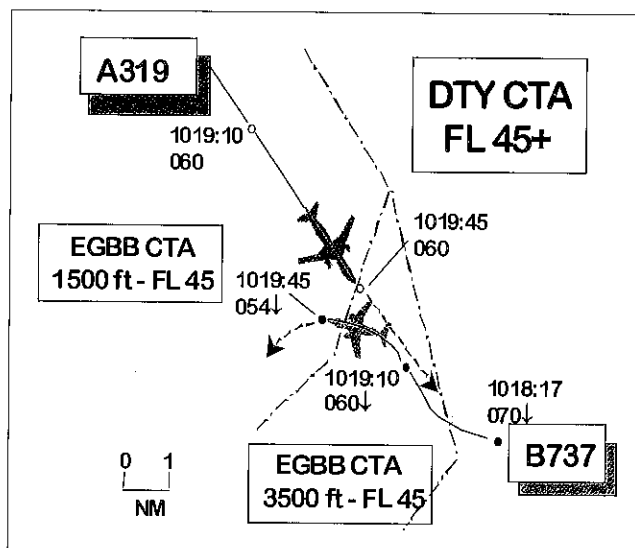
**THE A319 PILOT** reports that following take-off from RW 33 at Birmingham he was maintaining FL 60 on a radar heading of 150° as instructed by APR. His speed, which had been approved by ATC, was

There was little discussion about the mechanics of this Airprox which, members quickly agreed, was caused by inadequate monitoring by the Birmingham APR mentor. The chain of events leading to the incident was started by the mentor who did not connect his headset to the training box when his trainee plugged in. He then did not notice his trainee give the B737 pilot 2 alterations of heading, first onto 330°, which took it head-on to the Airbus, and then left 240° onto base leg (both these omissions were presumably owing to the mentor being in discussion with the R2). Consequently, the mentor's avoiding instructions to the ac, had they succeeded in being transmitted, would have compounded the confliction, as he had not recognised his trainee's (entirely fortuitous) second turn instruction (onto 240°) which had the effect, unintentionally, of deconflicting the tracks. As events unfolded, the Airbus pilot fortunately did not take up the trainee's re-transmitted instruction to turn R which would have taken his ac towards the B737. At 1019:10, immediately prior to the second turn instruction to the B737, the ac had been head-on, about 5.5 NM apart, at a closing speed of some 560 kt with no vertical separation (the B737 indicating FL 60 descending). Had the B737 not turned L when it did, the ac would have passed in opposite directions less than 1 min later with minimal horizontal separation and probably less than 500 ft of vertical separation. The Board was in no doubt that under such circumstances the safety of both ac had been compromised.

Cause: The Birmingham APR mentor did not monitor adequately his trainee's instructions which put the B737 into conflict with the Air bus.

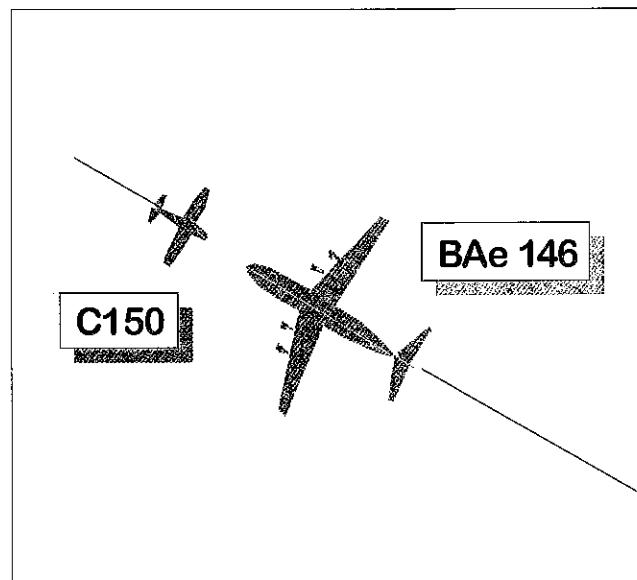
**THE CESSNA 150 PILOT** reports heading 105° at 100 kt on an IF instructional sortie; he was receiving a FIS from Cranfield on 122.85 at 4000 ft QNH; his transponder was not fitted with Mode C. While explaining instrument readings he saw a BAe 146 approaching head-on from ¼ - ½ NM ahead and just above. He lowered the nose and the airliner passed 100 ft directly overhead and his ac was then disturbed by its wake. Although he quickly saw the ac would miss him he assessed the risk of collision had been very high. Cranfield advised that they had no knowledge of it. He initially considered that the incident was a normal FIR hazard but decided to file the report because of the potential danger to the airliner.

In Class G airspace the primary means of deconfliction is by lookout and avoiding action, and members agreed that this appeared to have been lacking from both ac. While the Board agreed that the Cessna pilot acted responsibly in filing the Airprox, members thought he might be the first to admit that he should have seen something as big as a BAe146, head on at a similar level, somewhat earlier than 'just in time'. This late sighting was considered to be part of the cause of the Airprox. From the BAe146 pilot's standpoint, members thought that keeping an 'FIR' standard of lookout would not have been a normal mode of operation for the crew and that it was a bold decision to take a passenger ac through a busy piece of GA airspace without maintaining an appropriate quadrantal level. This situation should have had both pilots sitting forward in their seats scanning continuously for ac such as the Cessna. Members concluded that while it was impossible to tell if the BAe146 crew had seen this C150, the fact that the BAe146 had flown close enough to the Cessna to cause it flight-path disturbance by wake was also part of the cause of the Airprox.

**Cause:** A late sighting by the Cessna pilot, and the BAe146 flying close enough to the Cessna to cause it flight-path disturbance by wake.

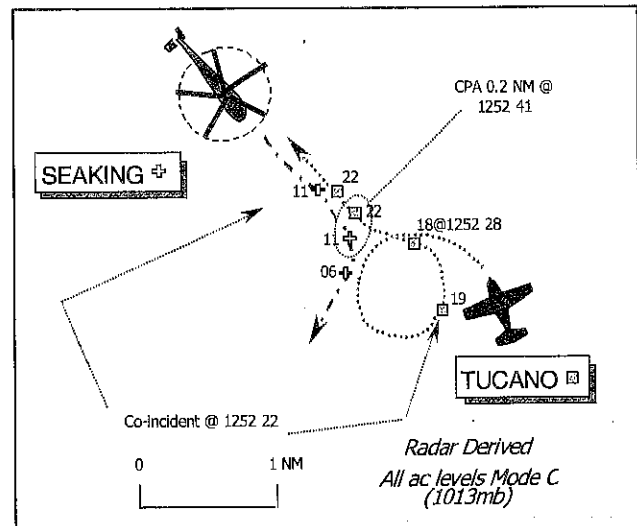
**THE SEA KING PILOT** reports heading 140° at 90 kt whilst flying at 1000 ft QNH (1008 mb) between Boulmer and Blyth for an SAR training sortie about 500 ft below cloud. The helicopter has a yellow colour scheme; forward facing lamps and HISLs were on and they were squawking 3/A 7000 with Mode C. The transit was conducted under simulated IF conditions with a safety lookout provided by the crew who first spotted the black Tucano through the port bubble window at 8 o'clock, 5 – 600 m away. He broke R and descended to avoid the Tucano, which also turned R and climbed as it passed astern. At the closest point the Tucano was about 1 – 300 m away and 150 ft above his helicopter, before the Tucano pilot reversed his turn, climbed, and then descended to low level N of Amble Light. An Airprox was reported to Boulmer RADIO. He adds that there had been a high probability of a collision up until the point that avoiding action was taken by both pilots.

**THE TUCANO PILOT** reports that the ac colour scheme is black, HISLs were on and he was squawking 3/A 7001 with Mode C whilst descending through 1500 ft RPS, to enter low level at 240 kt in the vicinity of Coquet Island, just to the E of Amble Light. Whilst turning L from N through to W at 45° aob some 3000 ft below cloud, a yellow Sea King

Cause: Conflict resolved by the Tucano crew, but unobserved by the Sea King safety pilot.

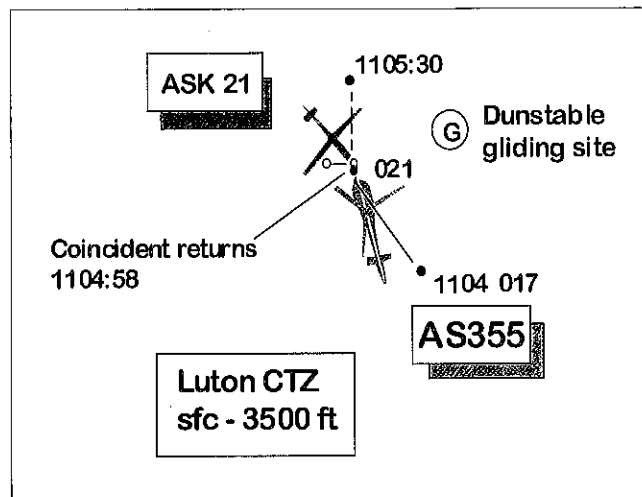
**THE ASK 21 GLIDER PILOT** reports that he was conducting a training flight from Dunstable in VMC while in contact with Dunstable tower on 129.9. The visibility was about 15 km. Prior to joining the circuit he instructed his pupil to attempt continuous 360° turns to demonstrate his ability to control speed. When over Eddlesborough church (2 NM SW of the gliding site) at 1000 ft (QFE 991) almost two turns had been completed when he saw a black and yellow helicopter 1 to 1.5 km away at his 1 o'clock at a similar level approaching him at speed. He immediately took control, levelled the wings and descended to increase speed, while keeping the other ac in sight; it passed 50 ft to his R and 50 ft above on a northerly heading with no alteration of heading. He turned to look for the registration but was unable to read it. He thought there had been a high risk of collision.

glider had been somewhat higher at the time of the encounter than its pilot had perhaps realised. Members noted that both pilots had said they were at similar levels when they first saw each other. The glider was spotted first from a range of 2 to 3 NM and the helicopter pilot had climbed (confirmed on radar) to fly over it. While this was taking place the glider pilot then saw the helicopter – at a similar height – only 1 to 1.5 km away. A gliding specialist said there would not have been any specific reason, at that point in the glider's flight, for the pilot to note his height with any particular accuracy. Members accepted this but were conscious that glider pilots are, by the nature of the type of flying they do, adept at estimating distances. In this instance the glider pilot, conceded that he might have underestimated the separation up to a point, but he remained convinced the helicopter had passed him much closer than the margin reported. In the absence of any further information the matter could not be resolved conclusively and in the end members suspected that the actual separation was probably somewhere between the estimates given by both pilots.

Cause: A confliction in Class D airspace resolved by both pilots.

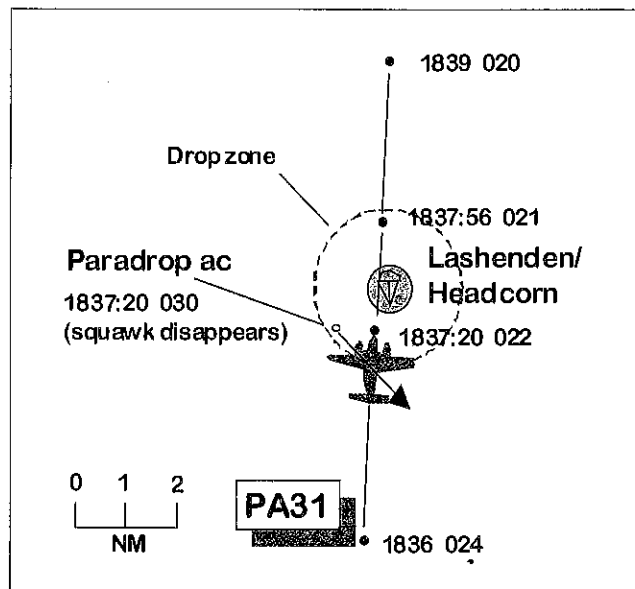
**THE PARACHUTIST** reports that he checked his canopy at 2900 ft after making a 5 sec delayed free-fall jump over Headcorn. Shortly afterwards, while manoeuvring over the drop zone, he was advised by radio of an ac tracking through the area. He started a slow 360° turn and about halfway round it spotted a low wing twin engined ac coming towards him at co altitude. He remained facing towards the ac in order to present as large a view of his canopy as possible and judged that it would pass to his L, which it did by about 100 m, at exactly his altitude, giving no indication that its pilot had spotted him. Without the warning by radio he thought he might have come a lot closer to it. Had a large number of parachutists been deployed the ac's presence would have constituted an even greater hazard. He would like to see this incident given prominence in the GASIL to alert GA pilots to the dangers inherent in overflying notified parachute sites.

Cause: The PA 31 pilot flew through an active and promulgated paradrop site without communication and close to a parachutist who he did not see in time to avoid.

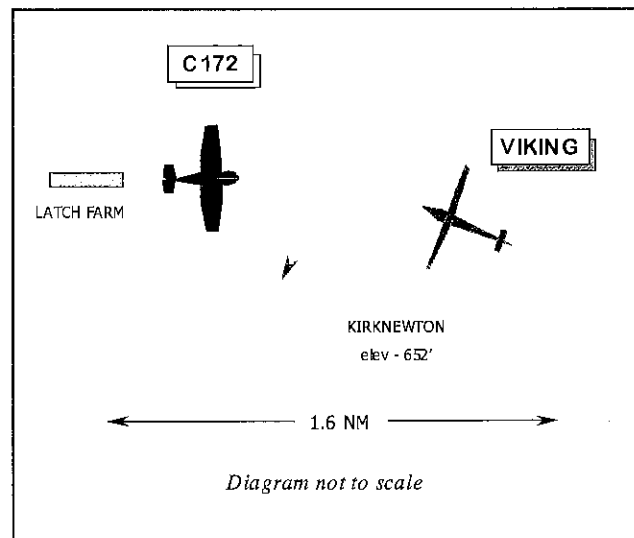
**THE VIKING T Mk 1 GLIDER PILOT** reports ascending to 800 ft QFE at the top of a winch launch from RW31 at Kirknewton Glider site. He did not detect any other ac during his lookout prior to the L crosswind turn and he had not been aware of any other ac in the vicinity whilst in the climb. However, when he turned L through 260° at 50 kt another ac, subsequently identified as a C172, was observed climbing out from Latch Farm light ac landing strip. The other ac was veering to starboard of his glider and its pilot did not appear to have spotted him, so he dived and turned L to avoid it. He estimated that at the closest point of approach the minimum horizontal separation was about 100 ft as the C172 crossed ahead from L to R and 100 ft above him when it passed down the starboard side in a climb with a high risk of collision.

climbing out from Latch farm after releasing the cable and turning crosswind. Members quickly agreed that the fundamental cause of this Airprox was a non-sighting of the glider by the C172 pilot. With regard to risk, the Board had no reason to doubt the accuracy of the Glider pilot's report who was the only one to witness the event; members accepted that the C172 had passed 100 ft to the R and 100 ft above the glider after it had dived in avoidance. This had been a close call in which the

Cause: Non-sighting by the C172 pilot.

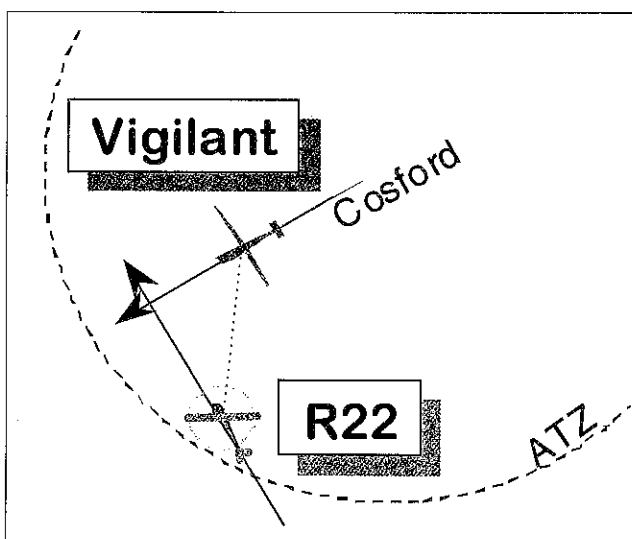
**THE VIGILANT GLIDER PILOT** reports heading 240° at 60 kt after take off from RW 24 at Cosford. While passing 500 ft, 1 NM upwind of the runway, an R22 was seen about 1 NM away in the 10:30 tracking about 330° at about 800 ft. He took control from his student, levelled at 700 ft and the R22 passed about 100 ft almost directly overhead; he remained wings-level to keep it in sight. The risk of collision would have been high if the climb had been continued. The duty instructor confirmed that no call had been heard from the R22 on 128-82.

**THE R22 PILOT** reports flying a solo navex at 80 kt from Halfpenny Green via Stafford, Telford and Bridgenorth at 1500 ft RPS, having previously completed the route dual. He thought he had turned early at Telford and made a track correction

and track. The Board concluded that while there was some slight possibility that the flightpaths might have crossed just outside the ATZ, it was clear that the R22 pilot had flown into conflict with the Vigilant which he did not see, and that this was the cause of the Airprox.

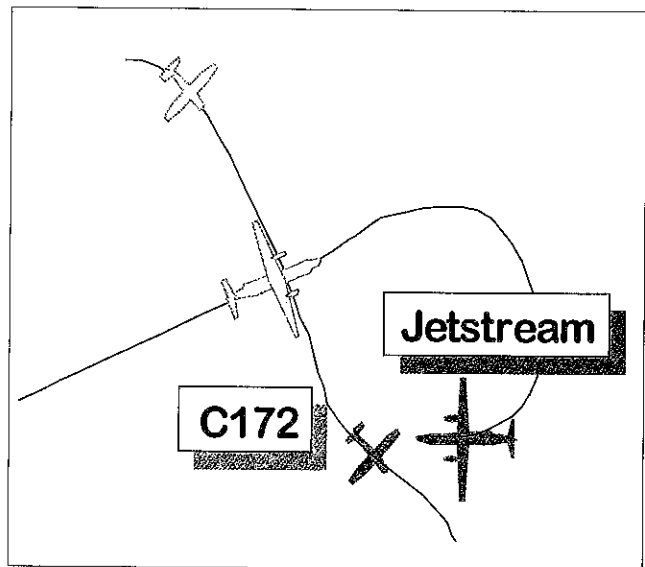
**THE JETSTREAM 41 PILOT** reports heading 280° at 130 kt on the approach to Sheffield with whom he was communicating on 128.52, at 1900 ft. A Cessna appeared in his 12:30, slightly above and crossed R to L about 0.25 NM ahead and 100 ft above as he started taking avoiding action. TCAS

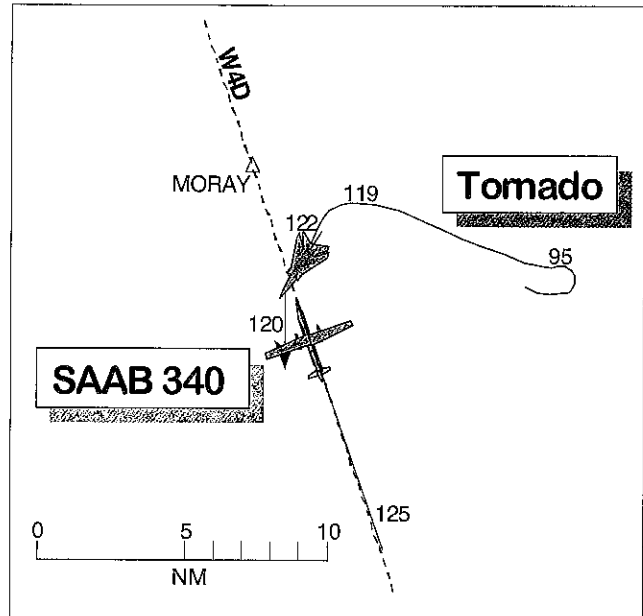
**THE SAAB 340 PILOT** reports heading 345° at 220 kt and receiving a RAS from ScACC on ADR W4D at FL 125. With no warning from ATC a Tornado was seen in the right windscreen, banked in a descending left turn, passing R to L across the nose about 80 to 100 ft away. Both its crew members were looking at the SAAB as it passed, and it then entered a near vertical descent. There was no time for avoiding action. TCAS was not operational on the ac at the time.

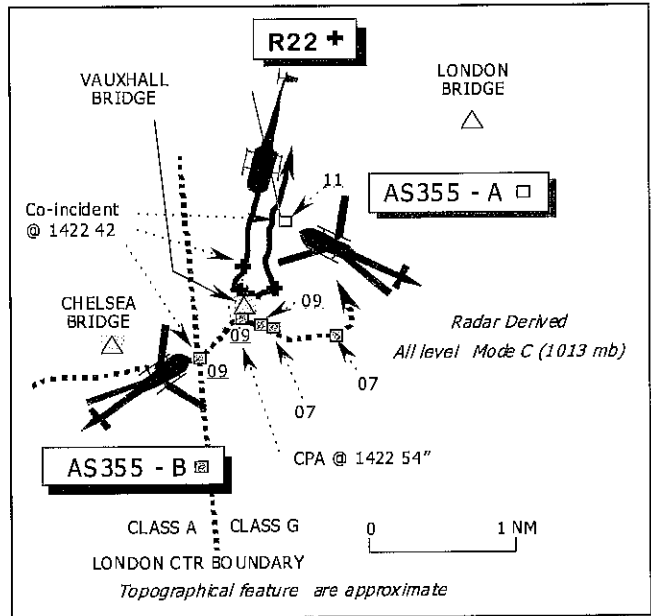
**THE AS355N TWIN SQUIRREL PILOT**, Twin Squirrel (B), reports that he had been tasked to relieve another AS355, Twin Squirrel (A), which was in attendance at an incident in the vicinity of the Imperial War Museum (IWM). The helicopter was white with distinctive markings; HISLs and the 2 landing lights were on. He had launched from Fairoaks and joined H3 just W of SUNBURY LOCK and thence via WESTLAND HELIPORT onto H4, with the intention of leaving the route just past VAUXHALL BRIDGE to operate in the same area as Twin Squirrel (A). Thames RADAR informed him of two conflicting ac, one being Twin Squirrel (A) S of the River and the other, which was subsequently identified as the subject R22 helicopter, flying in the opposite direction to him, westbound on H4. He acquired both ac visually at BARNES reporting point, at least 6 NM away and advised Thames RADAR. Twin Squirrel (A) was in the hover 'on scene' at the IWM and the R22 westbound at LONDON BRIDGE. Thames RADAR informed the R22 pilot of the two Twin Squirrels and to remain on the N bank of the river. Whereas he was required to remain along the S bank. After passing LONDON WESTLAND HELIPORT he maintained 1000 ft London QNH (1018 mb) to provide a degree of vertical separation

As he approached VAUXHALL BRIDGE heading 050° at 100 kt, the R22, which was at 11 o'clock about 900 m, turned L directly towards his ac, no radio calls were heard from its pilot as it left the N Bank of the river only slightly above his helicopter. He immediately entered a descending autorotative R turn and avoided the R22 by about 200 m as it overflew less than 200 ft above. If he had not taken avoiding action then the risk of a "close quarters" situation would have been high, as the R22 turned onto a reciprocal track and proceeded eastbound. The Airprox was immediately reported to Thames RADAR on RT. He believed that when asked by Thames RADAR, the R22 pilot said he was at 1500 ft and visual with the Twin Squirrel in the hover over the park.

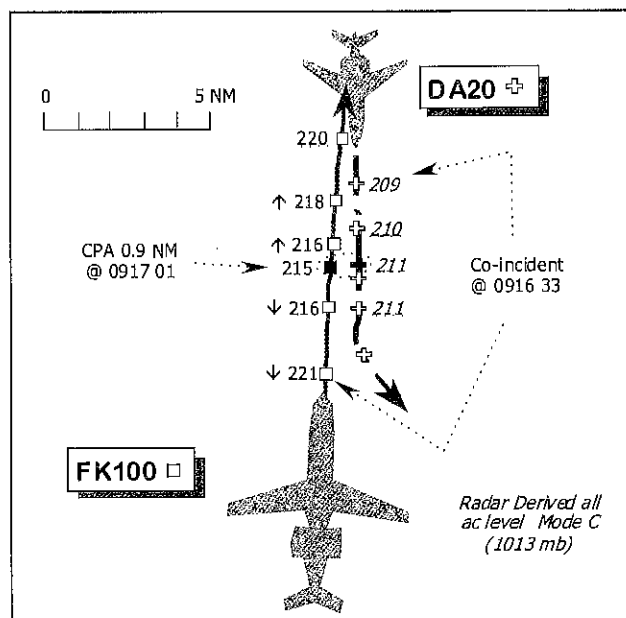
**THE LATCC HURN SECTOR CONTROLLER** reports that Danger Area EGD 036 within the Portsmouth Danger Area complex was notified

active up to 21000 ft, and that the minimum FL available for use on B11 was agreed at FL 220. The FK100 was inbound to Gatwick, heading N on B11 and the crew had been instructed by him to descend to FL 220 when ready. He observed the FK100 Mode C approaching FL 220 and transmitted traffic information on an ac squawking A0021, which was operating in the Danger Area. At that point he

reiterated that the FK100 crew should maintain FL 220, whereupon the crew reported they were climbing back up to FL 220. Further traffic information was passed to the FK100 crew about the DA20 and the cleared level of FL 220 reaffirmed. The FK100 crew subsequently levelled their ac at the assigned level.

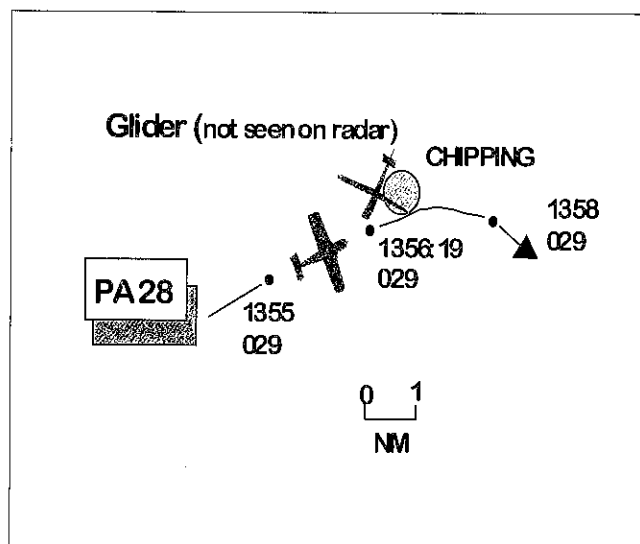
**THE GLIDER PILOT** reports that he was circling LH in a weak thermal at 2600 ft (Chipping QFE) about 0.5 NM SW of Chipping airfield in VMC. The visibility was 5 NM. After 3 or 4 orbits, at a speed of around 40 kt, he was turning through a SSW heading when he saw another ac 100 yd away approaching from the opposite direction at a similar height and on a heading which he estimated would take it through the centre of his turning circle; he immediately turned hard R to avoid what he believed would have been an imminent collision. He noted the registration of the ac, a PA28, as it passed some 50 - 75 yd to his L at the same level with no observable avoiding action. He felt there had been a very high risk of collision.

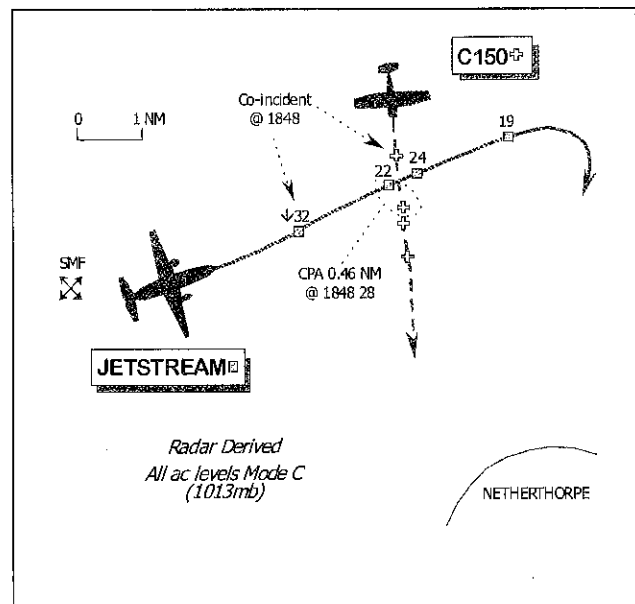
**THE JETSTREAM 41 PILOT** reports he was conducting an instrument approach to RW 28 at Sheffield City Aerodrome, tracking 083° at 170 kt

with autopilot engaged, outbound from the SMF NDB at about 6 NM flying at 2000 ft QNH (1023 mb). Simultaneously, both pilots saw a Cessna type ac at 1 o'clock about 400 m away southbound on a diverging track, 500 ft below their ac. No avoiding action was taken and TCAS did not enunciate an alert. A report was made by RT to

Sheffield City ATC, who advised that the other ac was not in contact with Sheffield. The risk was assessed as "low" and the pilot added that 'good airmanship' dictated that the other pilot should have called Sheffield ATC.

Cause: Non sighting by the C150 pilot and, effectively a non-sighting by the Jetstream crew.
