**UK AIRPROX BOARD**

# **Analysis of Airprox in UK Airspace**

**Report Number 1**

**January 1998 to December 1998**

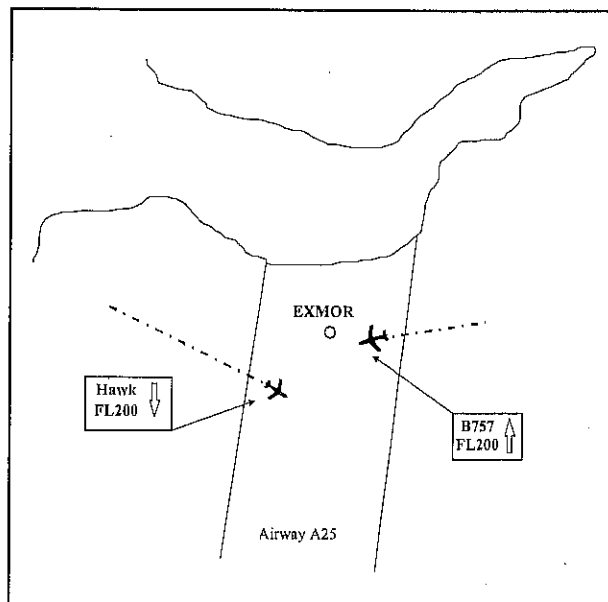
Occ No. 98/00033

The B757 was enroute from Bristol Lulsgate to Tenerife, under the control of the LATCC Berry Head (BHD) Sector controller (SC) and was in the climb to FL270 to join Airway A25 at EXMOR. The Hawk was one of a pair of aircraft, which had just completed a practice intercept sortie for the benefit of a student Fighter controller (FC), and was returning to Yeovilton from the exercise area to the West of A25. It was in the descent from FL230 to FL150 and was under the control of the student FC who was being supervised by a mentor controller, who was also under training (u/t) and was being monitored by a supervising mentor instructor controller.

The Hawk was, at this point, approximately 5 miles West of the airway's western boundary and the B757 was just about to enter the airway from the East as it climbed through approximately FL185 on a South-westerly track towards its airway joining point at EXMOR. About this time the supervising instructor FC pointed out the presence of the B757 to the u/t mentor who also noted other traffic at FL70 in the airway. However, only traffic information on the aircraft at FL70 was given to the Hawk pilot by the student FC until, at 0955.20, he instructed the pilot, "(callsign) starboard West traffic avoidance". This instruction was queried by the Hawk pilot who asked, "(callsign) confirm starboard west?". The student FC confirmed the instruction with, "confirmed starboard West" and followed this at 0955.50 with, "stranger North of you heading South indicating Flight Level one nine zero (FL190)". Note:- This level does not equate with that shown in the radar pictures and may have been due to a mismatch in timings on the RTF recordings as against the

Earlier, as the B757 passed FL180 in the climb, the BHD SC had observed the Hawk's radar return indicating FL230 and approaching the airway therefore, as a precaution, he instructed the B757 pilot to stop his climb at FL220. The controller followed this with traffic information on the Hawk. At the same time the BHD Chief SC attempted to co-ordinate with the Yeovilton FC on the direct line but, as his call was routed through a number of assistants, he was unable to talk to the controllers concerned until after the incident had occurred.

at FL230 and that although these aircraft normally turn away before the airway, he stopped the B757 at FL220 as a precaution. As the B757 entered the airway its height readout became garbled with a slow moving low level contact. Simultaneously, the Hawk's height readout indicated that it was descending, so he asked the CSC to co-ordinate his traffic with Yeovilton's observed squawk. At the same time he was informed of a TCAS Traffic Advisory (TA) by the B757 pilot. The SC was unable to assess the vertical separation between the two aircraft due to the garbling of the B757's secondary radar return.

### **4 Recommendations** The Panel had no recommendations to make.

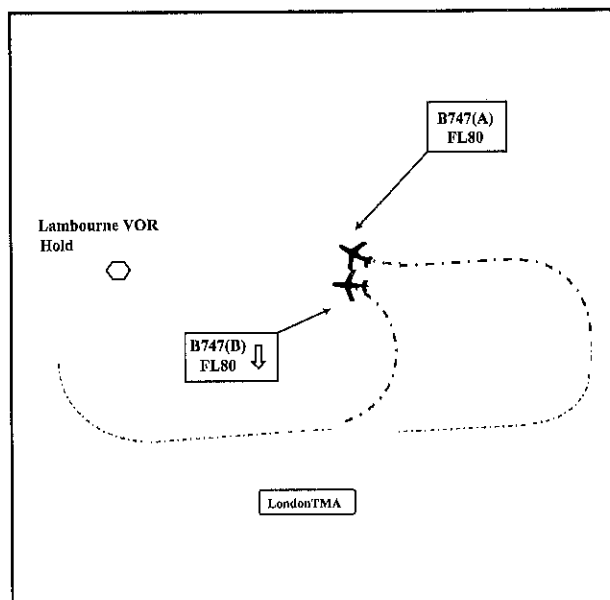
### Occ No. 98/00078

The two aircraft involved in this AIRPROX were B747s, inbound to Heathrow under the control of the LATCC Heathrow Intermediate North (INT N) Director. B747(A) from Kansai in Japan and B747(B) from Beijing, China, were in the Lambourne (LAM) hold and in descent to FL80 at the time of the incident. The controller involved had been in position for less than four minutes and he assessed his workload as light to medium. Due to equipment unserviceabilities the INT N Support position was unmanned at the time, however it was the judgement, both of the controller and the Group Supervisor, that the traffic loading did not warrant the position being activated.

Meanwhile the controller, who was not monitoring the aircraft in the LAM hold on radar, did not realise that he had issued an unsafe clearance. Consequently, at 1437.14, standard separation was compromised as the B747(B) descended through FL90 in the inbound turn. The B747(A) was now in its 2 o'clock position (from the B747(B)) at a range of 2.8nm, still level at FL80. At 1437.19, the pilot of the B747(A) called, "Director.....maintain flight level eight zero have traffic on the left side". This was the first indication to the controller that separation had been eroded. He responded to the pilot of the B747(A) with, "(callsign) roger 'avoiding action' turn right forty degrees right forty degrees immediately". This instruction was based upon the pilot's transmission as the controller was not able to assess the situation

The pilot of the B747(B) reported that they were descending to FL80 in the hold and that when passing FL86 in a left turn, they received a TCAS warning of an aircraft at one to two o'clock range 4km and showing FL80. They continued in the left turn and observed on TCAS that the other aircraft was coming nearer. On passing FL84 the crew of the B747(B) saw the other aircraft "*coming straight towards us*" and received a TCAS Resolution Advisory (RA). The pilot reported then taking avoiding action by increasing the turn from 15° to 30° and promptly halting the aircraft's descent. He reported the minimum level he descended to was 8250 feet at which point the other aircraft was approximately 1km to starboard and about 250 feet lower. Note:- Radar pictures show the B747(B) descending to FL80 and maintaining this level.

The AIRPROX was caused by the Heathrow INT N Director who inexplicably cleared the B747(B) to the same level as the B747(A) without the required horizontal separation being provided. Consequently, it was assessed that the Director must take full responsibility for the occurrence.

### 4 Recommendations The Panel had no recommendations to make.

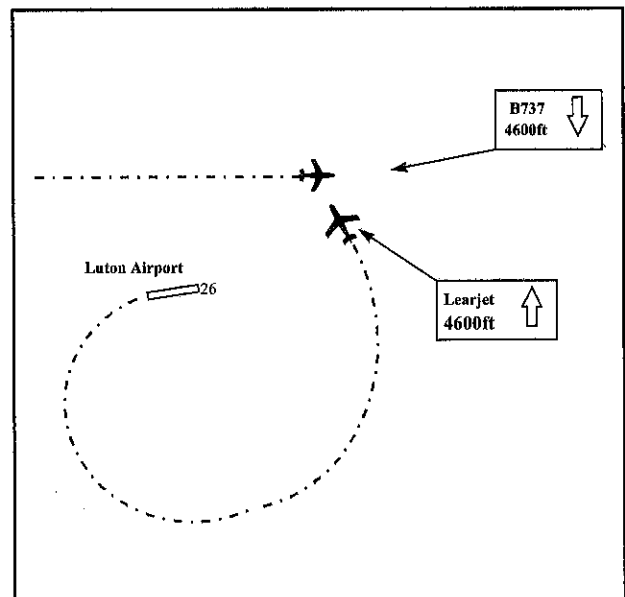
### Occ No. 98/00097

Both aircraft involved in this AIRPROX were receiving an Approach Radar Control service from Luton ATC. The B737 was inbound to Luton from Glasgow and was in descent to altitude 3000 feet on a radar heading of 090° to position it right hand downwind for runway 26. The Learjet had departed from runway 26 at Luton on a Daventry (DTY) 2B Standard Instrument Departure (SID) enroute to Manchester and had been cleared to climb to altitude 6000 feet. The routing for this SID requires a left turn outbound and an aircraft would normally be expected to route just to the East of Luton Airport before turning onto a northerly track for Daventry.

The controller had noticed the Learjet going very wide in the turn and not following the SID therefore she instructed the pilot to tighten the turn. When this was observed not to be effective, a further heading instruction was given. Later the controller stated that, as the incident progressed, she considered that the Learjet would still be able to turn inside the track of the B737 but that with hindsight she should have passed avoiding action instructions and traffic information to the pilots of both aircraft.

The Airprox was caused by the Luton Approach controller who did not ensure that horizontal separation was maintained between the B737 and the Learjet whilst clearing them through each others level.

However, whilst the consequences of the Learjet's excessive speed contributed to the AIRPROX, the Panel agreed that the Approach controller needed to have taken more positive steps to remedy the situation and to have passed avoiding action instructions and traffic information to the crews of both aircraft.
- 2 Causal Factors**      The Luton Approach controller did not ensure that horizontal separation was maintained between the B737 and the Learjet.
- 3 Risk Classification**      B
- 4 Recommendations**      The Panel had no recommendations to make.

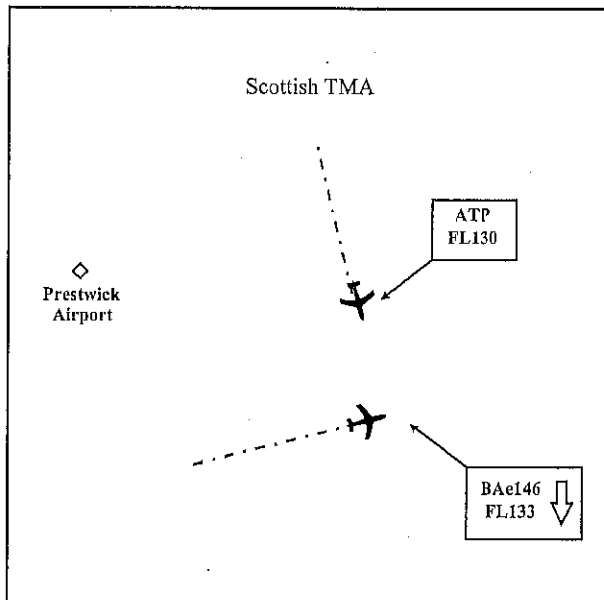
### Occ No. 98/00138

Both aircraft involved in this AIRPROX were receiving a service from ScACC, the BAe146 from the 'TMA In' controller and the ATP from the 'TMA Out' controller. The BAe146 was in descent inbound to Edinburgh from Dublin and the ATP was in the climb enroute to Manchester from Glasgow.

The AIRPROX was caused by the crew of the BAe146 who allowed the aircraft to descend below their cleared level of FL140 to FL133 and into conflict with the ATP.

- 1 Discussion** The Panel accepted the Summary of CAA Action. It would seem, from the BAe146 Captain's report, that at the critical moment, and whilst the pilot flying was identifying beacons, the pilot not flying was writing up the technical log. The Panel believes that this was not an appropriate stage of the flight to be performing this task as it took one of the pilots out of the monitoring loop and the failure of the autopilot to capture the cleared flight level went unnoticed.
- 2 Causal Factors** The BAe146 crew allowed their aircraft to descend below their cleared level and thus to conflict with the ATP.
- 3 Risk Classification C**
- 4 Recommendations** The Panel had no recommendations to make.

**Following the Panel Safety Recommendation J98-1 about this problem, which was made following their review of AIRPROX 1/97, the CAA has decided to investigate this problem further and review potential measures that would reduce the likelihood of further incidents of this type.**

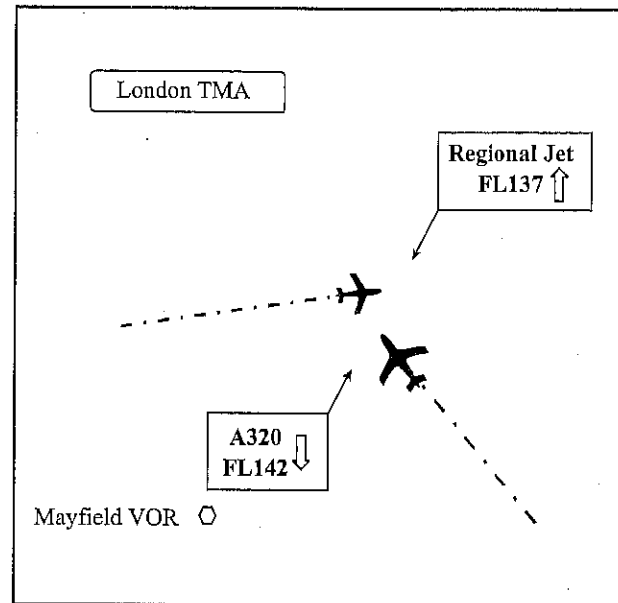
Occ No. 98/00246

Both aircraft involved in this AIRPROX were under the control of LATCC, the A320 with the Terminal Control (TC) South East (SE) Sector and the Canadair Regional Jet (CRJ) with the Area Control (AC) Dover/Lydd Sector controller. The A320 was inbound to Heathrow from Paris Charles de Gaulle Airport. The CRJ had departed from Gatwick enroute to Salzburg on a WIZAD Standard Instrument Departure (SID) and was climbing to FL210.

Members went on to consider the part played by the Dover/Lydd mentor in the AIRPROX. He had reported candidly that, in light traffic conditions, he was not paying particularly close attention to his radar (perhaps the comment above concerning the mentoring role also applies to him). It was recognised by the Panel that the Dover/Lydd Sector controllers were entitled to receive the CRJ "clean" on transfer from the South East Sector but, after some discussion, it was agreed, on balance, that they had contributed to the cause of the AIRPROX. Although the South East Sector trainee had initiated the incident, the Panel believed that the Dover/Lydd mentor had the responsibility for identifying the CRJ on transfer and that this could only be accomplished by looking at his radar. This, the Panel thought, would have reminded him about the presence of the A320 which had been under the control of the Dover/Lydd Sector until shortly before the event.

4 Recommendations The Panel had no recommendations to make.

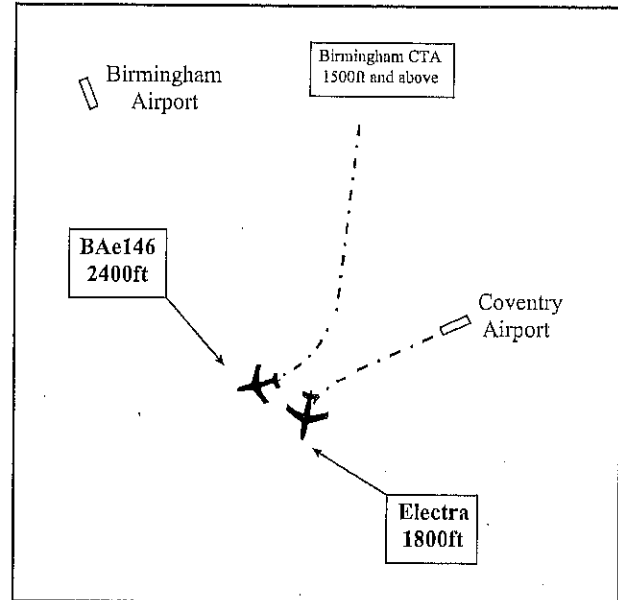
Occ No. 98/00407

The BAe146 was inbound to Birmingham Airport from Belfast City Airport and was being vectored by the Birmingham Approach Radar controller for an ILS approach to runway 33. The Electra had departed from East Midlands Airport on a training flight and was carrying out a practice asymmetric go around from a procedural ILS approach to runway 23 at Coventry Airport, under the control of a Coventry controller who was carrying out the duties of both Aerodrome and Approach controller.

The Birmingham Approach controller recalled that she observed a contact at Coventry having gone around with an unverified mode 'C' readout of 2000 feet. She did consider passing traffic information to the inbound BAe146 but calculated that as the conflicting aircraft was behind it the pilot would not have seen it.

The AIRPROX was caused by the Coventry Aerodrome/Approach controller who did not co-ordinate the Electra's 1500 feet circuit with Birmingham Approach. It was noted that even if the 'Coventry Corner' had been activated, the Electra would have routed outside the confines of this airspace. Furthermore, the loss of separation was greater than that which would otherwise have occurred because the Electra had climbed 150 feet above the circuit height.

The opposing views as to cause were not resolved despite a lively debate. However, the majority opinion was that the pilot's non-compliance with procedures was the crucial factor.

**4 Recommendations** The Panel had no recommendations to make.

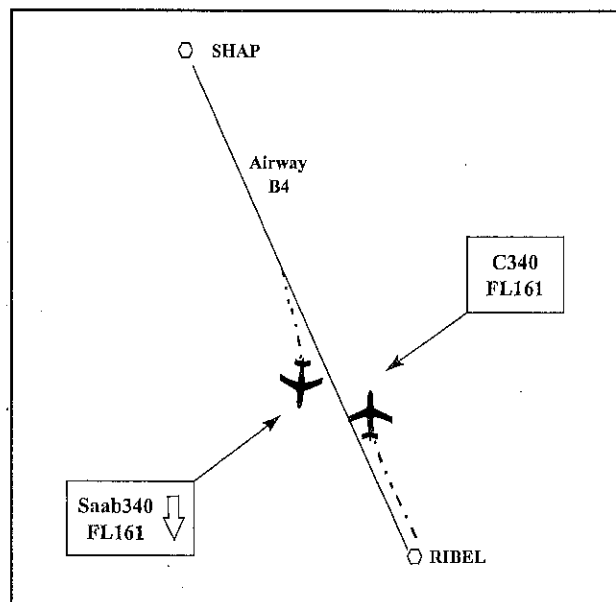
### Occ No. 98/00479

The aircraft involved in this AIRPROX were a Saab 340 en route from Edinburgh to Manchester and a Cessna 340 en route from Staverton to Glasgow. The Saab was southbound, in descent from FL170 to FL150 and under the control of the Manchester Area Control Centre (MACC) North Sector Radar controller. The Cessna was on airway B4, northbound and level at FL160 under the control of the Scottish Area Control Centre (ScACC) TMA 'Inbound' Sector controller.

The ScACC controller, who had not long obtained contact with the Cessna pilot, observed the Saab's Mode C indicating FL167 descending and instructed the Cessna pilot, "*(callsign) avoiding action turn right immediately heading zero four zero, traffic twelve o'clock three miles opposite direction indicating flight*

Meanwhile, the Manchester controller observed the Saab descending through FL163 in close proximity to the Cessna so he instructed the Saab pilot, "*(callsign) turn right heading two zero zero*", and, following the pilot's acknowledgement, transmitted, "*...mmediate right please*" (clipped transmission). He did not pass traffic information as the two aircraft had already passed and it seemed unlikely that the Saab pilot would have seen the other aircraft. He then telephoned the ScACC TMA Inbound controller to acknowledge that he had caused the error.

The AIRPROX was caused by the Manchester North Sector Radar controller who did not take

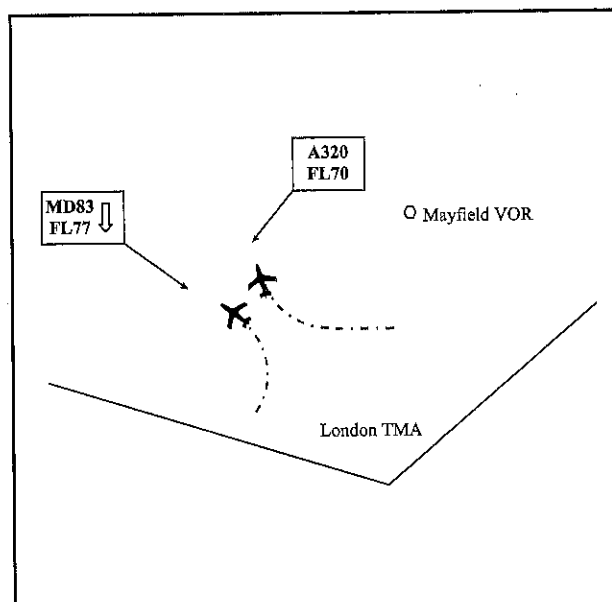
Both aircraft involved in this AIRPROX were under the control of the LATCC TC Gatwick Intermediate Director and were inbound to Gatwick Airport. The A320 had departed from Turin and was level at FL70 on a radar heading of 270°. The MD83 had departed from Madrid and was entering the WILLO hold in descent to FL80.

At 1153.51, the A320 pilot established initial contact with the Gatwick Intermediate Director and was instructed to reduce speed, to descend to FL80 and to take up the hold. One minute later the pilot was instructed to leave the hold heading 270° and then at 1156.21 was instructed to descend to FL70. Immediately afterwards, at 1156.30, the MD83 pilot made his initial contact with the Intermediate Director and was instructed to maintain FL90 and to hold at WILLO. The pilot acknowledged this with, "Okay maintain nine zero er (callsign)", followed about twenty seconds later by the query, "Gatwick (callsign) confirm er to hold at er HOLLY". The controller replied with, "(callsign) make it a left turn to WILLO hold at WILLO descend flight level eight zero". The MD83 pilot responded, "...kay down eight zero and to hold at WILLO (callsign)".

At 1158.10, the controller instructed the A320 pilot to turn right heading 350° and this was acknowledged. Radar pictures, timed at 1158.18, show the A320 at FL70 still heading 270° with the MD83 in its 10 o'clock position range 2.4nm and in a left turn descending through FL80. Subsequent radar pictures show the A320 commencing its right turn at FL70 as the MD83 closes from the left and continues in its descending left turn until, at 1158.48, it is passing FL77 and horizontal separation is about 0.8nm.

Meanwhile, the Gatwick Intermediate Director was on the telephone co-ordinating other traffic with the TC Co-ordinator South East and when he saw the radar return from the MD83 indicating passing FL76 he responded by instructing the pilot at 1158.50, "(callsign) con....turn left now left heading two zero zero". Vertical separation between the aircraft continued to reduce but as they were now in diverging turns away from one another horizontal separation began to increase.

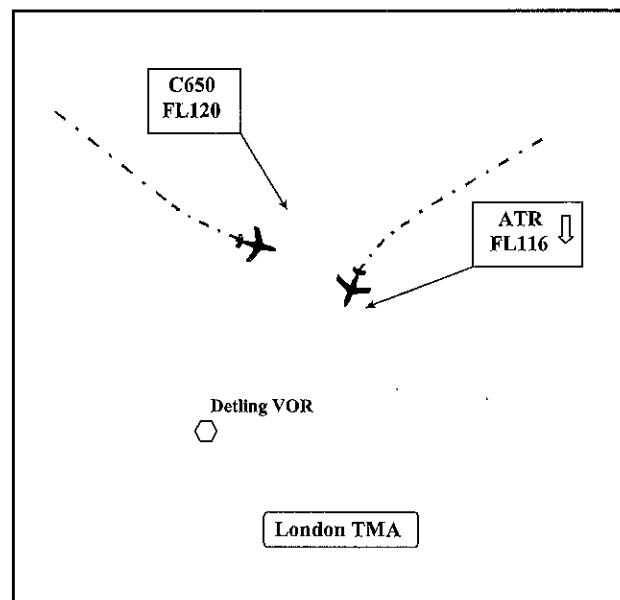
#### Occ No. 98/01139

Both aircraft involved in this AIRPROX were under the control of LATCC Terminal Control (TC). The ATR42 was inbound to Gatwick from Rotterdam and was in descent to FL100. The Cessna C650 was enroute from Luton to Istanbul and was level at FL120. The ATR42 was receiving a service from the TIMBA Sector controller (SC) who was designated as the inbound controller and the C650 was receiving a service from the BIGGIN Sector controller

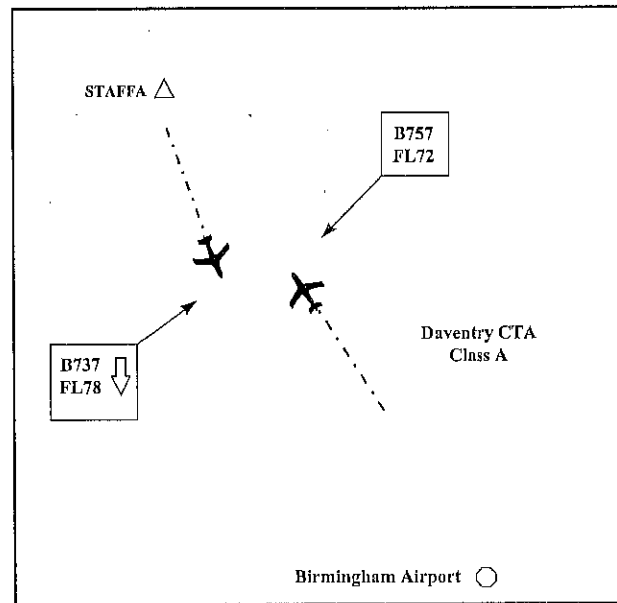
**Occ No. 98/01166**

Both aircraft involved in this AIRPROX were under the control of the Birmingham Approach Radar controller. The B757 had departed from Runway 33 at Birmingham on a Whitegate 2D Standard Instrument Departure (SID) enroute to New York and was climbing to FL100 via airway B3. The B737 was inbound to Birmingham from Dublin, also on Airway B3 but on a near reciprocal heading, and had been cleared to descend to FL70.

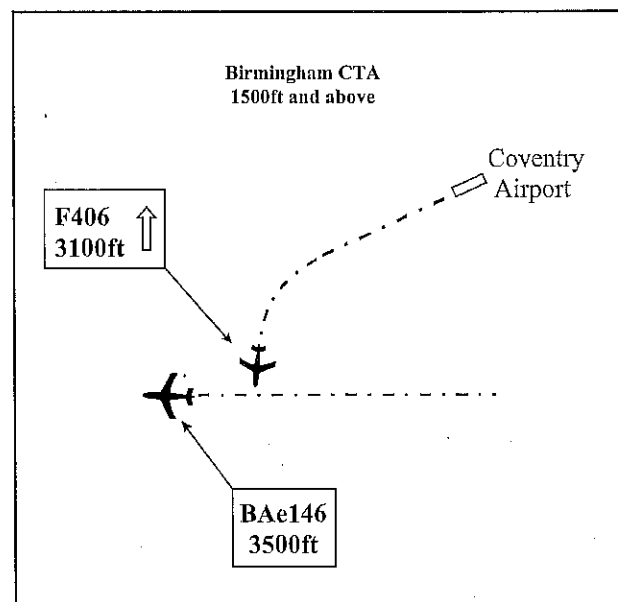
### Occ No. 98/01192

*Date:* 16 March 1998  
*Time:* 2013 UTC  
*Aircraft:* Rheims F406/BAe146  
*Operators:* Foreign Exec/Foreign Airline  
*Position:* 2nm South West of Coventry Airport  
*ALT/HT/FL:* Altitude - 3100 feet  
*Airspace Type:* Birmingham CTA – Class D  
*Reporter:* Birmingham ATC - Approach Radar Controller  
*Reported Separation:* 1.5nm horizontal/300 feet vertical  
*Recorded Separation:* 1.8nm horizontal/400 feet vertical

The Coventry controller believed that in the period leading up to the occurrence traffic loading and overall workload were both light. He also, mistakenly, believed that the zone clearance he issued to the F406 pilot was, "released to two thousand five hundred feet altitude only", and that this was read back. However, he notes that the aircraft had not followed the noise abatement procedure, but instead had flown straight ahead heading 230° to altitude 2500 feet before turning left. He later stated that in his opinion the incident was caused by the pilot's poor understanding of English. He also felt that action should be taken to simplify the departure clearances but that he had to stress the noise abatement procedures to pilots as, in his experience, unless he did so the procedures were regularly ignored. He accepted that he failed to use the phraseology detailed in the MATS Pt2 which is specifically designed to prevent incidents such as this.

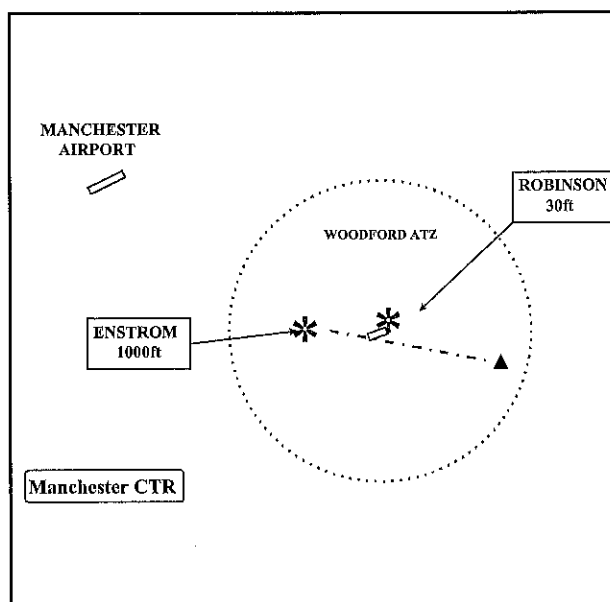
At the time of this AIRPROX the Enstrom helicopter was enroute from a private landing site situated 2.2nm East South East of Woodford Aerodrome to Barton at an altitude not above 1000 feet. It was receiving an approach service from the Sector controller Manchester Approach (SCMA) 1 who was a trainee being monitored by a mentor. The Robinson helicopter was operating in the circuit at Woodford on a training flight and had just lifted off, having been given take off clearance by the Woodford Aerodrome controller.

- 1 Discussion The Panel accepted the Summary of CAA Action.
- 2 Causal Factors The Manchester Approach controller mentor did not ensure that the u/t controller co-ordinated the Elstrom departure with Woodford ATC.
- 3 Risk Classification C
- 4 Recommendations The Panel had no recommendations to make.

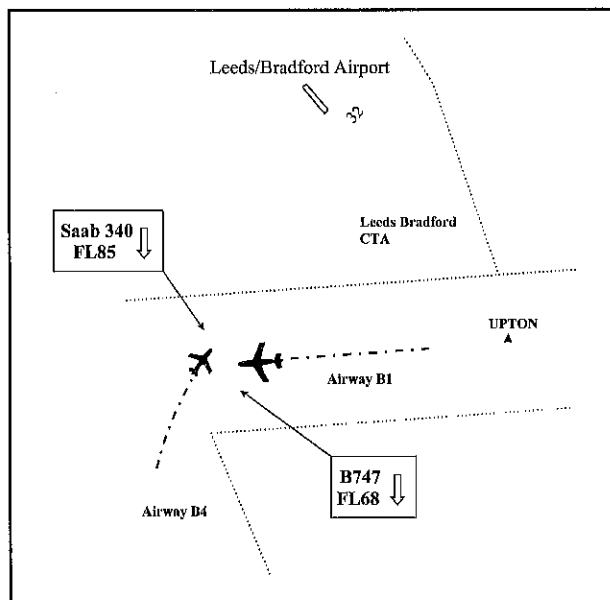
### **Occ No. 98/01930**

*Date:* 16 April 1998  
*Time:* 1030 UTC  
*Aircraft:* Saab 340/B747  
*Operators:* British Airline/Foreign Airline  
*Position:* 20nm South of Leeds/Bradford Airport  
*ALT/HT/FL:* FL80  
*Airspace Type:* Airway B1 - Class A  
*Reporter:* Leeds/Bradford ATC  
*Reported Separation:* Nil horizontal/1000 feet vertical  
*Recorded Separation:* Nil horizontal/1700 feet vertical

The AIRPROX was caused by the MACC TMA NE Sector controller who issued the Saab 340 pilot with a descent clearance to FL60, through the level occupied by the B747 without the required lateral separation being provided.

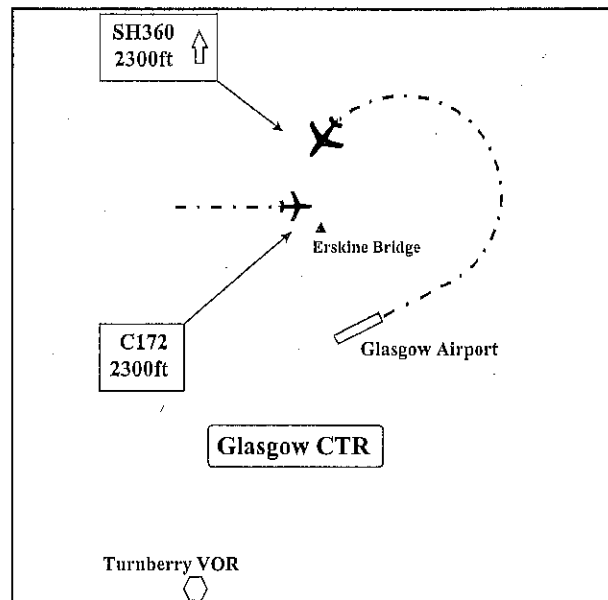
Occ No. 98/01902

Date: 19 April 1998  
Time: 1011 UTC  
Aircraft: SD360/C172  
Operators: British Airline/Private  
Position: 3nm North of Glasgow  
Airport  
ALT/HT/FL: 2000 feet  
Airspace Type: Glasgow CTR – Class D  
Reporter: Glasgow ATC - Aerodrome  
Controller  
Reported Separation: 1.5nm horizontal/500 feet  
vertical

The AIRPROX was caused by the C172 pilot who inadvertently infringed the Glasgow Control Zone when he became unsure of his position having diverged from track after to encountering poor weather.

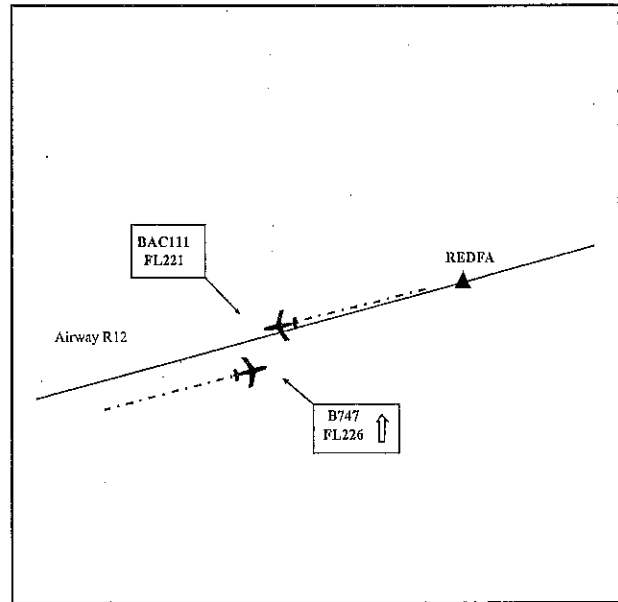
##### Occ No. 98/02074

*Date:* 26 April 1998  
*Time:* 1135 UTC  
*Aircraft:* BAC1-11/B747  
*Operators:* British Airline/Foreign  
*Airline*  
*Position:* 10nm South West of REDFA  
*ALT/HT/FL:* FL220  
*Airspace Type:* Airway R12 - Class A  
*Reporter:* LATCC AC Clacton East  
Sector Controller  
*Reported Separation:* 3nm horizontal/500 feet  
vertical  
*Recorded Separation:* 3nm horizontal/500 feet  
vertical

The AIRPROX was caused by the LATCC Clacton East Sector mentor controller who did not ensure his trainee provided appropriate lateral separation when clearing the B747 pilot to climb to FL330 through the level of the BAC1-11 at FL220.

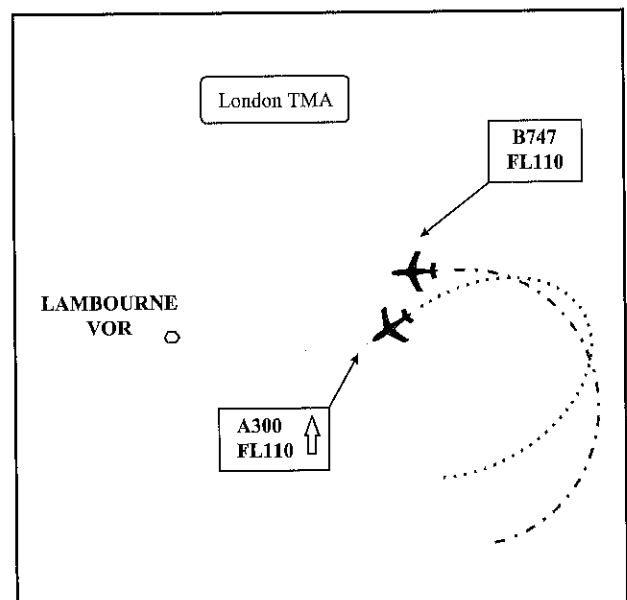
#### **Occ No. 98/02099**

*Date:* 28 April 1998  
*Time:* 1108 UTC  
*Aircraft:* A300/B747  
*Operators:* Foreign Airlines  
*Position:* 10nm East of Lambourne VOR  
*ALT/HT/FL:* FL110  
*Airspace Type:* London TMA - Class A  
*Reporter:* LATCC Terminal Control - Lambourne Sector Controller  
*Reported Separation:* 1.29nm horizontal/nil feet vertical  
*Recorded Separation:* 1.29nm horizontal/nil feet vertical

The AIRPROX was caused by the A300 pilot who did not prevent the aircraft from climbing above his cleared level of FL100 and into conflict with the B747 which was holding at FL110. The cause of the level deviation was the severe up-draught turbulence from the adjacent thunderstorm activity and apparently aggravated by a known technical problem with the A300's autopilot altitude hold.

The Panel was somewhat surprised by the statement that the fault with the altitude hold function of the autopilot was found by the Captain after the event, on searching through the aircraft's technical log. It thought that a problem of this nature would have featured as an "open" entry on the first page of the log and that a warning sticker would have been justified on the instrument panel.

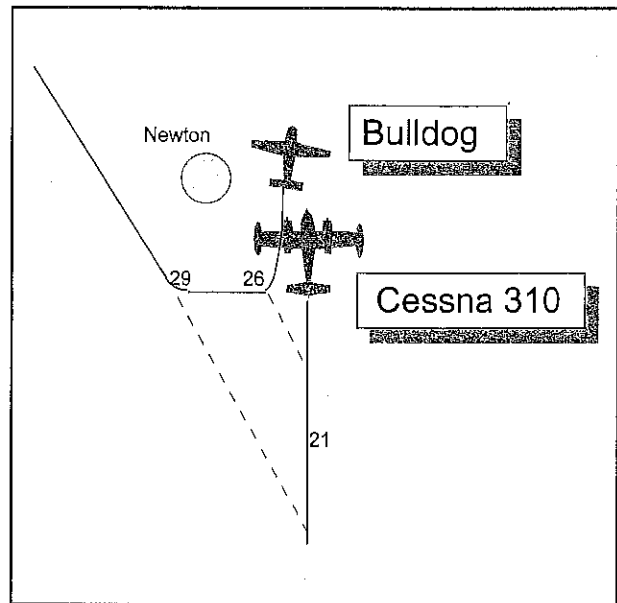
feet". The Bulldog pilot reported that the estimated horizontal separation was 100 ft and that the unknown ac was 10-20 ft below the Bulldog which was at about 1900 ft Newton QFE (1013 mb). The reported ac was subsequently identified as a Cessna 310 which was en-route from Elstree to Leeds Bradford and in receipt of a FIS from East Midlands.

Cause: Effectively a non-sighting by both pilots.

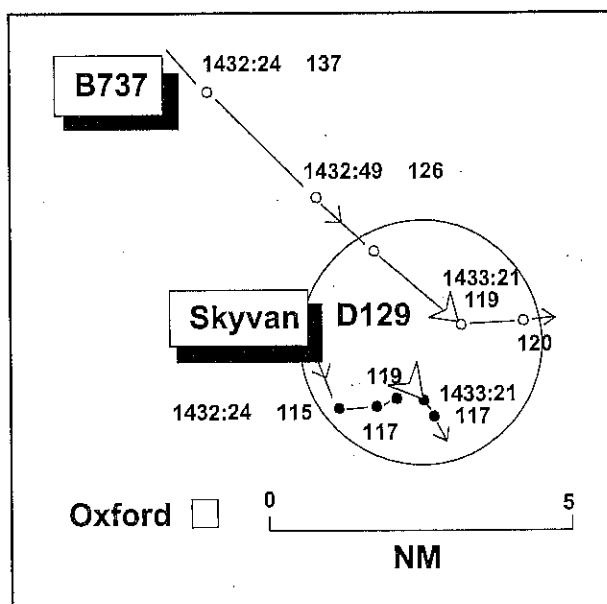
### **AIRPROX (P) REPORT No 43/98**

Date/Time: 03 May 1433 (Sunday)  
Position: N5152 W0113 (10 NM W Westcott)  
Airspace: EG D129 (Class: A)  
Reporting Aircraft Reported Aircraft  
Type: Shorts Skyvan B737  
Operator: Civ Comm CAT  
Alt/FL: FL 120 ↓ FL 100  
Weather VMC CAVOK VMC CAVOK  
Visibility: 40 km 10 km

The Board quickly concluded that the trainee LATCC controller, having not taken into account that EG D 129 was active, caused the Airprox by issuing a descent clearance to the B737

Cause: The LATCC trainee SC did not take into account that EG D 129 was active when issuing descent clearance to the B737.

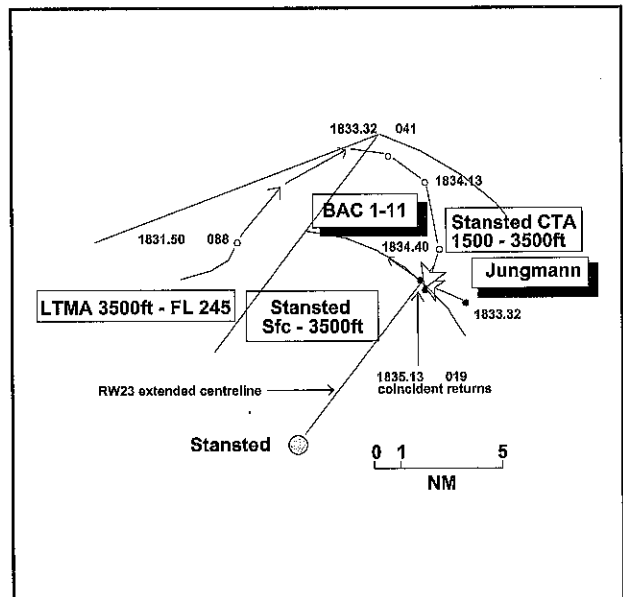
**THE BAC 1-11 PILOT** reports that he was establishing on the ILS to RW 23 at Stansted, heading 230° at 140 kt and level at 2000 ft (QNH 1016) while under radar control from the Stansted Director on 126-95. He was squawking 6077 with Mode C. The visibility was in excess of 10 km in VMC. When about 7 NM from touchdown and about to intercept the glidepath, he saw a high wing single engined monoplane with a tail wheel at his 10 o'clock position about 0.5 NM away as it tracked from L to R about 300 ft below him. He maintained altitude and turned 20° to port to pass behind the other ac which then crossed 0.25 NM ahead of him; he was over the village of Thaxted at the time. He felt there had been a medium to low risk of collision and reported an Airprox to the Stansted Director. ATC confirmed that there

Cause: Confliction on the boundary of controlled airspace.

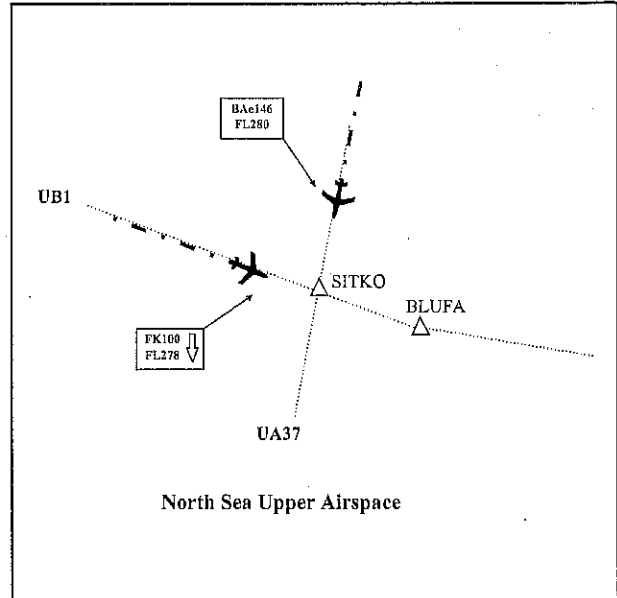
### Occ No. 98/02201

*Date:* 5 May 1998  
*Time:* 0730 UTC  
*Aircraft:* FK100/BAe146  
*Operators:* British Airline/Foreign Airline  
*Position:* SITKO  
*ALT/HT/FL:* FL280  
*Airspace Type:* Upper ATS Route UAR  
UA37 – Class B  
*Reporter:* LATCC Area Control - North  
Sea BEENO Sector  
Controller  
*Reported Separation:* 2.5nm horizontal/400 feet  
vertical  
*Recorded Separation:* 1.59nm horizontal/400 feet  
vertical

The AIRPROX was caused by the LATCC BEENO Sector controller who did not ensure that prescribed lateral separation was maintained when clearing the pilot of the FK100 to descend through the level of the BAe146.

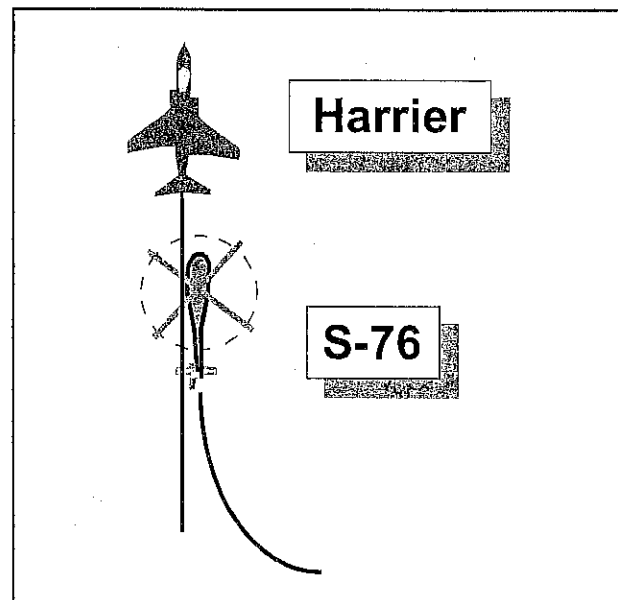
**THE S76 PILOT** reports heading 350° at 80 kt during initial climb-out from N Denes. Anglia Radar had just cleared him to FL 50 when N Denes advised him of a fast jet approaching his overhead. He was passing 800 ft at the time, climbing at 2000 ft/min and levelled at 1000 ft. About 10 seconds later a Harrier passed 500-1000 ft directly overhead. Although the risk of collision was low, the jet had not been seen by Anglia and if N Denes had not warned him so that he could stop his climb, it would have been very close indeed.

Cause: Sighting report.

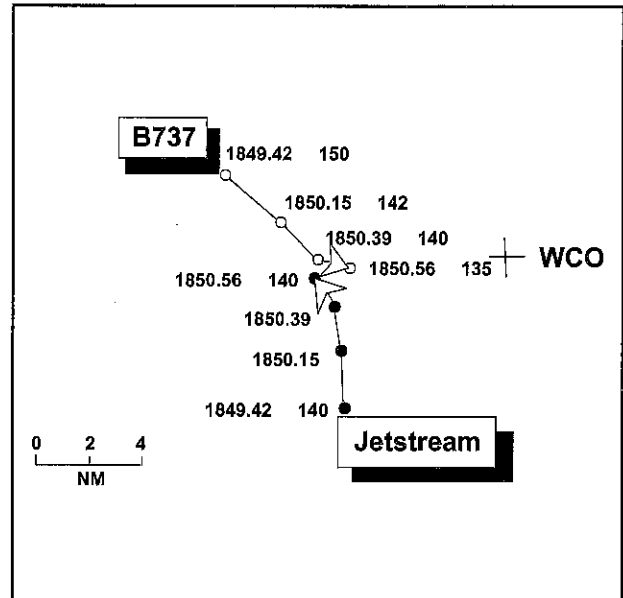
**THE B737 PILOT** reports that he was on a radar heading of 130° at 280 kt and descending to FL 140 under the control of LATCC on 119-775. He was squawking 5152. The visibility was 25 km in VMC. When 22 NM N of BNN at FL 140, ATC instructed him to *“turn left 080° descend to FL 130 avoiding action”*. He complied and the other ac was seen heading in the opposite direction at the same level 1 to 2 NM away on his starboard side. He felt that the safety of his ac had been compromised albeit he believed there was a low risk of collision. The pilot advocates the fitting of TCAS to all ac as soon as possible; in his opinion had his ac been so equipped, the incident would have been avoided.

**THE JETSTREAM PILOT** reports that he was heading 355° at 230 kt and cruising at FL 140 under the control of LATCC on 133-07. The visibility was over 10 km in VMC. He was squawking 6252. ATC instructed him to turn L immediately onto 290°, indicating that this was avoiding action. He complied and the other ac was then seen as it turned L through a southeasterly heading about 1 NM ahead of him at the same level. The avoiding turn kept him clear of the traffic; he believed the other pilot had seen him and was already taking avoiding action. He considered there had been a medium to high risk of collision.

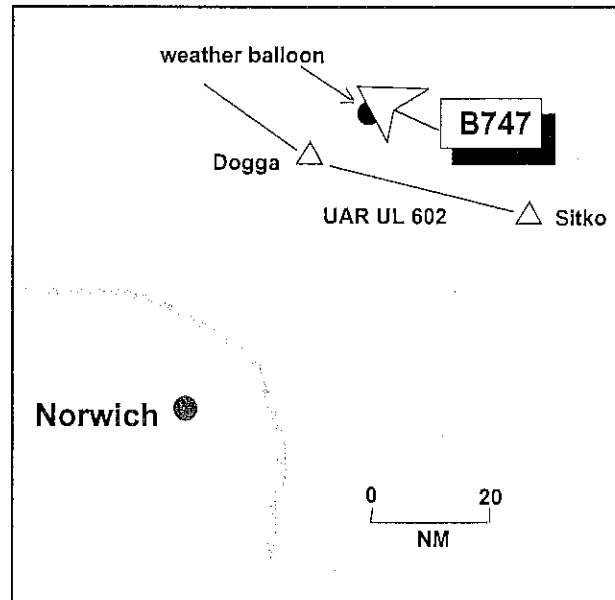
JAS Note (2): Enquiries by AIS (Mil) revealed that weather balloons are launched at regular intervals from Hemsby on the Norfolk coast up to the 20 mb level (in the region of 80,000 to 100,000 ft) where they automatically deflate and return to earth by parachute. On 10th May a launch took place at 0545 and, while such balloons no longer carry radar reflectors for tracking purposes, it has been calculated that, with the upper winds reported at the time (south-westerly at about 25 kt), the balloon in question would have completed its task and been descending into the Airprox area at about the reported time. Given the pilot's description of the object he saw having a deflated appearance, it seems probable that it was the descending weather balloon from Hemsby.

JAS Note (3): Pictures of the LATCC radar at 0643 show the B747 climbing through FL 282 and tracking west about 10 NM NE of DOGGA, slightly N of the centreline of UAR UL 602.

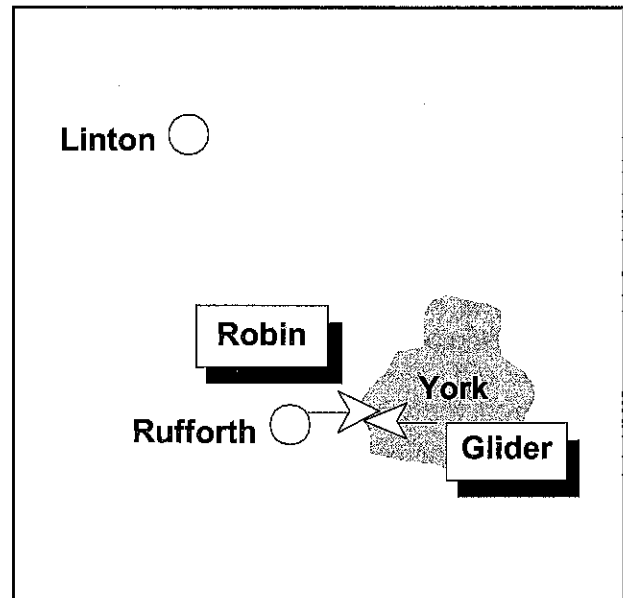
**THE GLIDER PILOT** reports that he was heading W at 45 kt at 2000 ft (Rufforth QFE) 1 NM E of Rufforth airfield. There was no cloud and the visibility was 8 km. He was in contact with Rufforth ground on 129-975. He first saw the other ac, a single engined low wing type with a fixed tricycle undercarriage, as it passed him on a reciprocal heading to his R 50 ft away and 25 ft above. He was unable to take avoiding action due to the late sighting and believed the risk of collision had been very high. As the ac had approached from the opposite direction at a similar level, he believes his view of it would have been obscured by his front seat air experience passenger's head. Subsequently, he discovered that his passenger had seen the other ac before he had

**THE ROBIN 2160 PILOT** reports that he was on a local flight from Sherburn-in-Elmet and descending through 2000 ft (QNH 1023) on a heading of 090° at 105 kt on the W side of York. The visibility was over 15 km in VMC. He was receiving a FIS from Linton on 129-15 and squawking with Mode C selected. Linton ATC had advised him of general gliding activity at Rufforth and he and his passenger were looking out for this. He had previously seen the Rufforth tug ac descending back into its circuit and was counting gliders on the ground as well as scanning for those airborne. However, despite this lookout the other ac, a red/white 2 seat mid-wing glider, appeared at his one o'clock on a reciprocal track about 100 ft below.

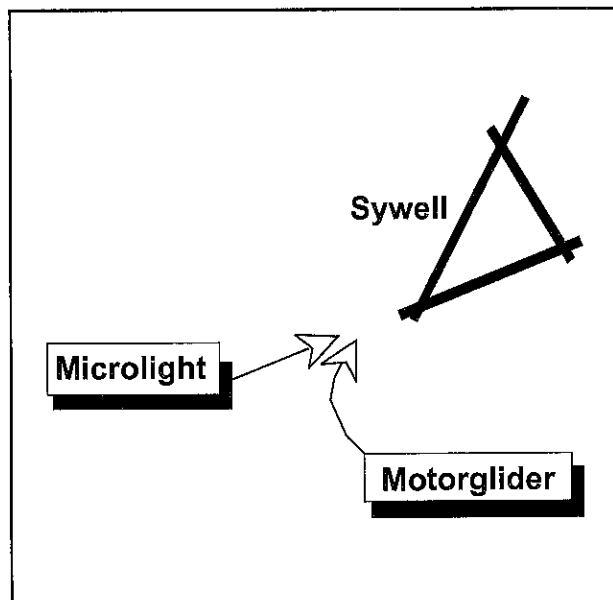
**THE MICROLIGHT PILOT** reports heading 070° at 52 kt and descending through 300 ft while on finals for RW 07 at Sywell with whom he was in contact on 122.7. The visibility was 35 km in VMC. The airfield was busy with several ac carrying out RH circuits and he was the first of 3 on final approach, No 2 being a C172 and No 3 a Yak 52. He had called "finals to land" at 0.75 NM and received a "land at your discretion" response which he acknowledged. During the final stages of the approach he heard another pilot report seeing "a glider in the circuit". The motorglider then appeared out of the blind spot at his 3 o'clock position about 400 m away and slightly above tracking directly towards him. At this point he was in the very late stages of the descent at a height of about 300 ft and the ac was being flown by a student pilot on a training exercise. On seeing the motorglider he took control of the ac from the student, applied full power and raised the nose to the climbing attitude. The motorglider then passed some 50 ft below him from R to L and 20 m away. He assessed the risk of collision as very high and believed that without his avoiding action, there would have been an almost definite collision. Once the immediate danger had passed, he made a go-around call to Sywell and this was followed by similar calls from the 2 following ac. The only radio call made by the motorglider pilot was on initial contact when 13 NM out tracking in from Hinton-in-the-Hedges. Following its

unannounced arrival on a very tight R base, it then landed on RW 07 and taxied clear. He reported an Airprox to Sywell on 122.7 and confirmed it later by telephone.

Cause: The motorglider pilot did not integrate himself into the established circuit traffic pattern.

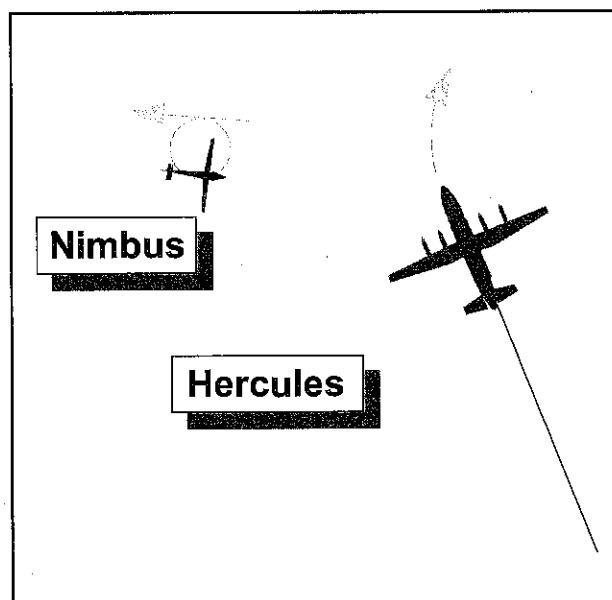
**THE NIMBUS PILOT** reports that while searching for wave lift he was occasionally orbiting but heading predominantly W, and drifting slowly eastwards at about 13 kt. (He provided a list of positions, headings and heights with time from his logger.) During one orbit he saw a Hercules approaching along the line of the A1; it passed about 1 NM ahead of him from right to left and 200 ft above with no risk of collision. He pointed out that his glider has a 25 m span, much larger than most gliders, so he may have seemed to the Hercules pilot to have been closer than he was.

His logger recorded a height of 3151 ft amsl at the reported time of the Airprox.

Note: The Hercules can be seen on LATCC radar recordings tracking 345° towards the Airprox position where it makes an extremely sharp right turn and loses 200 ft. As it starts the turn at 2700 ft Mode C there is a single, very adjacent primary-only return in a position 4 NM due S of Leeming. The point at which the Hercules turns is 1 NM E of the glider's GPS logged position at that time (1413:28). In the minute before the Airprox an intermittent primary-only return can be seen further to the W, where the glider pilot said he was. 2700 ft Mode C equates to 2970 ft on the Leeming QFE.

Cause: Mistaken impression by the Hercules pilot of lack of separation from the glider.

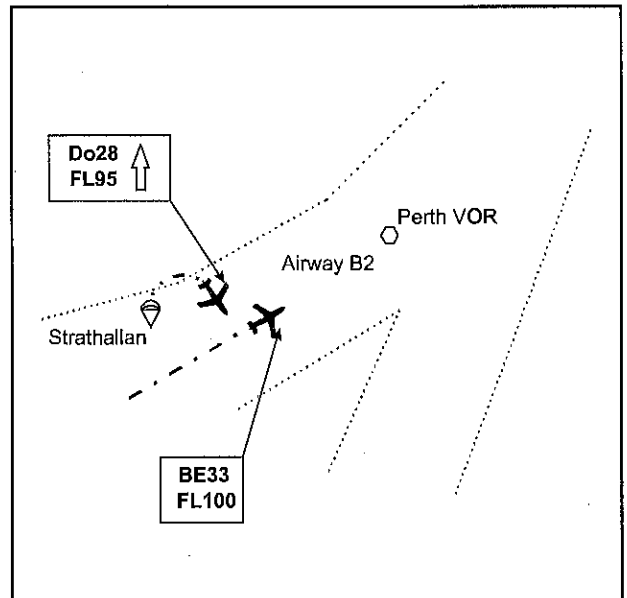
**Occ No. 98/02744**

*Date:* 24 May 1998  
*Time:* 1113 UTC  
*Aircraft:* Do28/BE33  
*Operators:* British Private/Foreign  
Commercial  
*Position:* 5nm South West of Perth  
*ALT/HT/FL:* FL100  
*Airspace Type:* Airway B2 – Class A  
*Reporter:* ScACC Forth Low  
Controller  
*Reported Separation:* 1nm to 2nm horizontal/500  
feet vertical  
*Recorded Separation:* 2.6nm horizontal/600 feet  
vertical

The AIRPROX was caused by the pilot of the Do28 who climbed his aircraft above his cleared level of FL90 and into conflict with the BE33 at FL100.

Both altimeters in the Do28 were subsequently removed and checked for calibration. The reputedly sticking altimeter has been sent to the manufacturer for overhaul and any necessary repair. Finally, it was noted that the Do28 pilot doing the parachute drop did not have an Instrument Rating which he is required to hold to enable him to fly in Airway B2 Class A airspace. The pilot, the operator and the parachute club have been reminded that pilots operating aircraft in Class A airspace require a valid Instrument Rating.

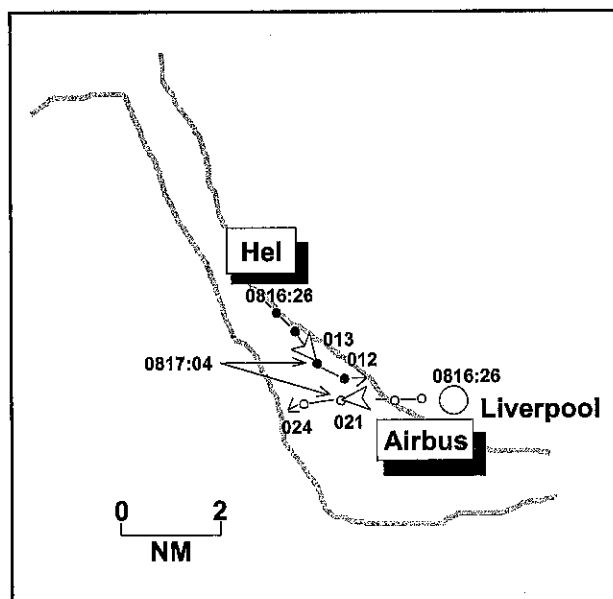
**THE AIRBUS PILOT** reports that he was climbing through 1500 - 2000 ft (QNH 1004) and heading 277° at 155 kt on departure from RW 27 at Liverpool. Cockpit workload was high as he followed the NAN 2T departure SID in IMC with heavy rain showers all around. He was in contact with Liverpool Tower on 118.1 and squawking 5227 with Mode C. Passing 1500 ft, thrust reduction and configuration changes were in progress when a TCAS TA signalled traffic at 12 o'clock at close range; this also coincided with a frequency change call from ATC. The TCAS warning was difficult to interpret because the turning point designator and weather clutter obscured the screen. No RA was triggered and the other ac was not seen; only after they had passed the traffic was it apparent that they had passed above it by an

estimated 700 ft. No information had been passed to him regarding the traffic prior to departure and he felt there had been a high risk of collision. The pilot comments that the position of the other ac could have had serious implications had his rate of climb been less. Furthermore, in an emergency situation it could also have jeopardised his company procedures which required him to turn R onto 285° after passing 700 ft.

Cause: Mistaken impression by the Airbus pilot of lack of separation from the helicopter.

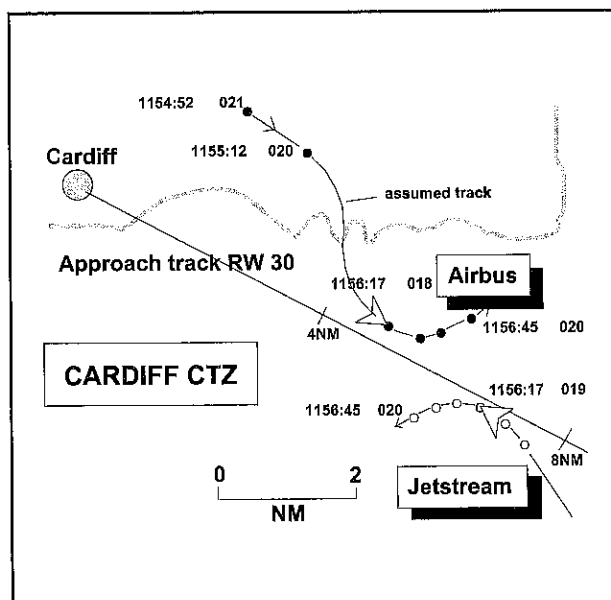
**AIRPROX (P) REPORT No 54/98**

Date/Time: 26 May 1156  
Position: N5121 W0312 (6 NM SE Cardiff airport)  
Airspace: CTZ (Class: D)  
Reporting Aircraft Reported Aircraft  
Type: Jetstream A320 Airbus  
Operator: CAT Civ Trg  
Alt/FL: 1700 ft 2000 ft  
(QNH 1005 mb) (QNH 1004 mb)  
Weather VMC VMC  
Visibility: 28 km 15 km

**THE JETSTREAM PILOT** reports that he was in contact with Cardiff APC on 125-85 who had cleared him to 1700 ft (QNH 1005) and to join the ILS for RW 30 at Cardiff. The visibility was 28 km in VMC. When at a range of about 4 NM from touchdown, established on the glidepath and heading 300° at 140 kt, he saw an Airbus in his 1 o'clock (in a R base leg position for RW 30) turning L towards him and beginning to climb; at the same time the controller, having realised that the Airbus was turning L, instructed him (the Jetstream pilot) also to turn L 90° onto heading 210° in avoidance. Continuous visual contact was maintained with the Airbus which passed down his starboard side at a similar level about 0.5 NM away on a reciprocal heading. There had been a medium risk of collision, in his opinion.

Cause: The aerodrome controller did not safely integrate circuit and instrument traffic.

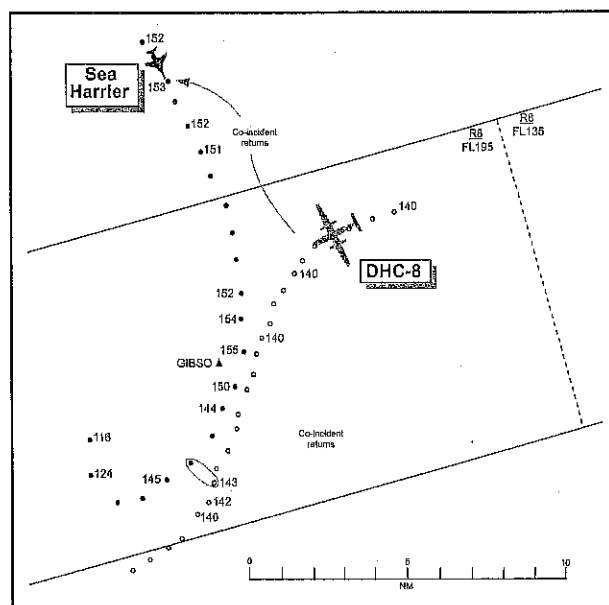
**THE DHC-8 PILOT** reports heading 240° at 220 kt on a radar heading from London Mil from whom he was receiving a RAS. London had advised of traffic 5 NM to the N but he then received a TCAS TA followed by a RA to 'climb >2500 ft/min' as the traffic descended astern of

him indicating 200 ft above, descending. The RA quickly changed to 'descend >3000 ft/min' and then cleared. He informed London Mil who

Cause: The Sea Harrier pilot flew close enough to the DHC-8 to cause its pilot concern for the safety of his aircraft.

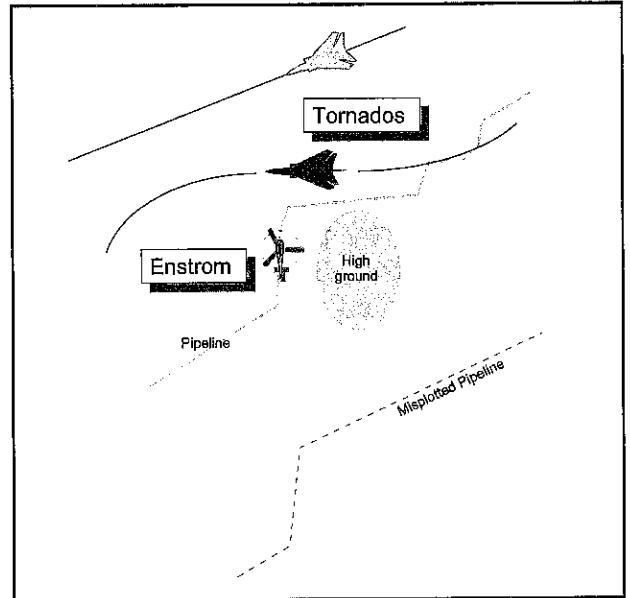
**THE TORNADO PILOT** reports participating in a 2 v 1 sortie which passed through mid Wales at the time of the incident; they were operating in the 250-500 ft agl band. Pre-flight, all NOTAM activity for the sortie had been briefed, including PINS which was active. Aware of this, the formation was briefed to be particularly vigilant. Over mid Wales, all 3 crews saw a helicopter, thought to be heading about 340°, passed well clear of it (over 1 NM) and thought no more of it, not noting the position of the sighting. The crew submitting the report was almost immediately detached overseas and did not have access to any sortie documentation during the subsequent investigation; therefore the position of the helicopter they encountered could not be confirmed and the possibility remained that it was not the reporting helicopter. In retrospect the formation leader

acknowledged that once the helicopter had been spotted, it might have been wise to have increased the separation afforded to it.

Note (1): LATCC radar recordings do not show the Airprox clearly. While the helicopter and one of the Tornados are shown, the Tornado turns from SW to NW passing some 2.3 NM in front of the helicopter. It is probable that the Tornado involved in the Airprox does not appear on the recording.

Cause: The Tornado pilot flew close enough to the helicopter to cause its pilot concern for the safety of his ac.
