**UK AIRPROX BOARD**

# **Analysis of Airprox in UK Airspace**

**Report Number 1**

**January 1998 to December 1998**

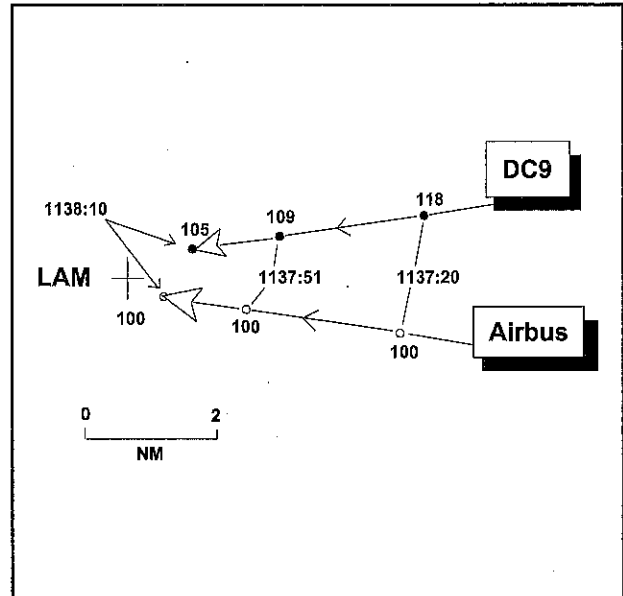
**THE A320 PILOT** reports that he was heading 270° at 220 kt in VMC from Lambourne while maintaining his cleared level of FL 100. He was under the control of the Heathrow Director on 119-72 and squawking 3147 with Mode C. The other ac, believed to be an MD 80 which had been in sight since abeam TRIPO, had been instructed to hold at Lambourne. ATC instructed an immediate descent to FL 90 and advised him that the other ac had descended below its cleared level.

**THE DC9 PILOT** reports that ATC cleared him to hold over LAM, advising him that there would be a short delay. He noticed that the holding data in the GPS computer was not identical to that in the approach chart. While reducing his rate of descent to level the ac at FL 110 he noticed that the FO was having some difficulty reprogramming the equipment and he assisted him with this. During this time the ac had descended through FL 110 and at FL 107 he heard the altitude warning sound. He immediately responded by increasing thrust and climbing to regain FL 110. The controller had also observed that the ac had descended below its cleared level and instructed an immediate climb back to FL 110 which was acknowledged by the FO. He remained in VMC throughout the incident and the only other ac seen was the reporting Airbus. After landing he reported the incident to ATC, and when back at his base completed an incident report for his own Company.

Cause: The DC9 descended below its cleared level while both pilots were distracted in the cockpit

Note (1): The pilot's company reports that following this incident a safety notice concerning level busts was issued to all pilots. A Company investigation concluded that human factors issues contributed to the cause.

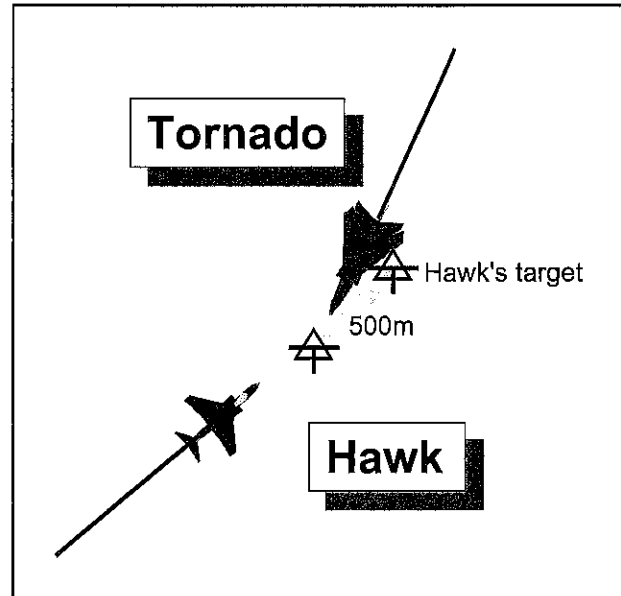
Note: LATCC radar recordings show the Tornado tracking SSW through the Airprox position. The Hawk is not seen and is not squawking until after the incident when it pulls up and adopts a London Radar squawk for its return to Valley.

**HQ PTC** comments that there were more distractions from lookout than normal with both ac on "IP to tgt" runs. With the advantage of an earlier sighting and without the burden of flying instruction, it might have been prudent for the

Tornado to have pulled off and gone for a re-attack. Had the outcome been more serious, then the question might be asked why such a reduced air force could not deconflict its use of simulated targets? The difference in perceived miss-distances might reflect relative experience levels.

Cause: Confliction of flightpaths resolved by the Hawk pilot.

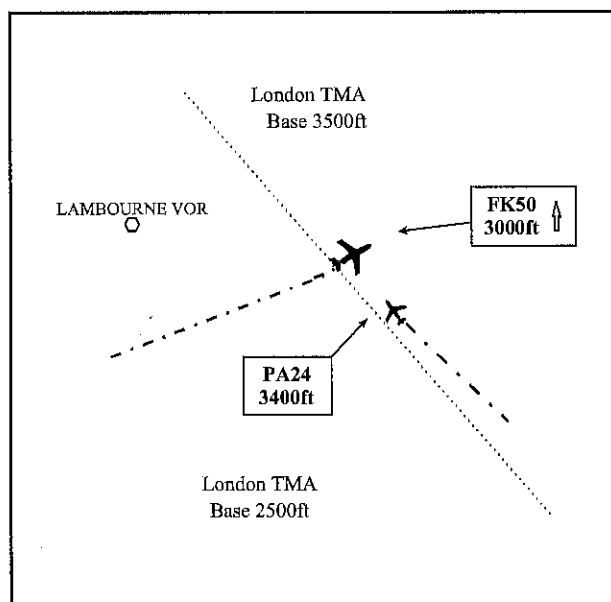
**Occ No. 98/03045**

*Date:* 5 June 1998  
*Time:* 1349 UTC  
*Aircraft:* FK50/PA24  
*Operators:* Foreign Airline/Private  
*Position:* 8nm South East of Lambourne  
*ALT/HT/FL:* Altitude 3000 feet  
*Airspace Type:* FIR - Class G  
*Reporter:* LATCC Terminal Control (TC) North East Sector Controller  
*Reported Separation:* 1nm horizontal/400 feet vertical  
*Recorded Separation:* 1nm horizontal/400 feet vertical

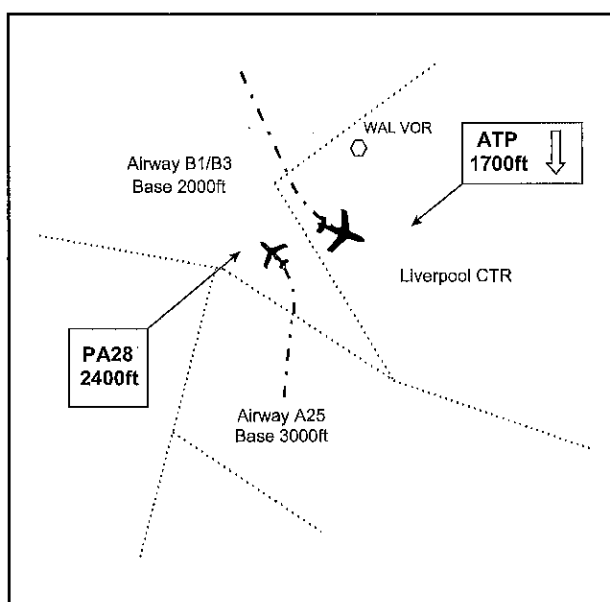
### Occ No. 98/03025

*Date:* 5 June 1998  
*Time:* 1146 UTC  
*Aircraft:* ATP/PA28R  
*Operators:* British Airline/Private  
*Position:* 3nm South of Wallasey  
*ALT/HT/FL:* Altitude 2400 feet  
*Airspace Type:* Airway B1/B3 - Class A  
*Reporter:* Liverpool ATC - Approach Controller  
*Reported Separation:* 2nm horizontal/Nil feet vertical  
*Recorded Separation:* 2nm horizontal/700 feet vertical

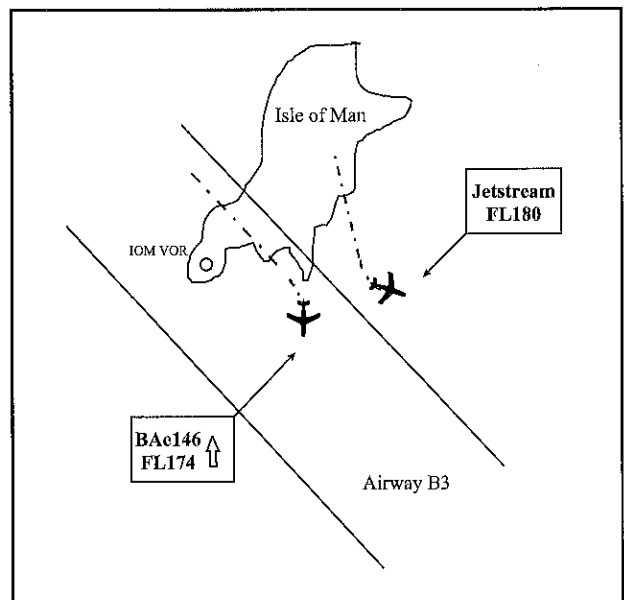
### Occ No. 98/03034

*Date:* 5 June 1998  
*Time:* 1255 UTC  
*Aircraft:* BAe146/Jetstream  
*Operators:* British Airline/British Military  
*Position:* 10nm South East of the Isle of Man of Man VOR  
*ALT/HT/FL:* FL180  
*Airspace Type:* Airway B3 - Class A  
*Reporter:* ScACC Antrim Sector Controller  
*Reported Separation:* 4.4nm horizontal/400 feet vertical  
*Recorded Separation:* 5.1nm horizontal/500 feet vertical

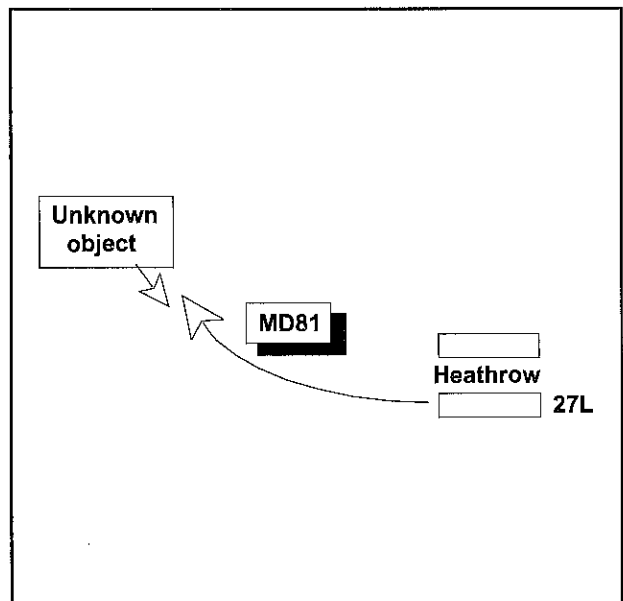
**AIRPROX (P) REPORT No 63/98**

Date/Time: 09 Jun 1245  
Position: N5129 W0032 (2.5 NM WNW Heathrow)  
Airspace: CTZ (Class: A)  
Reporting Aircraft Reported Aircraft  
Type: MD81 Unknown  
Operator: CAT  
Alt/FL: 3000 ft ↑ (QNH 1005 mb)  
Weather IMC INT CLOUD  
Visibility:

**THE MD 81 PILOT** reports that he was passing 3000 - 3500 ft (QNH 1005) at 170 kt having just departed from RW 27L at Heathrow on a BPK SID. He was in IMC flying in and out of cloud. When about 2 NM W of Heathrow, both pilots saw an object pass in the opposite direction down their port side slightly above their ac. The incident was very quick, the object passing in about a tenth of a second. The PIC describes it

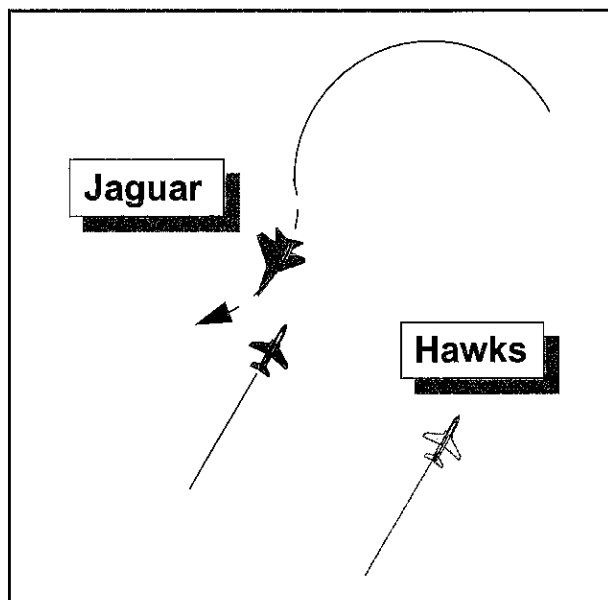
**HQ PTC** comments that the similarity of perceived miss-distances indicates that this

was really quite a close encounter. However, despite the distractions of other ac and the propensity of ac to hide behind cockpit structures, the pilots saw and avoided each other - but not by a comfortable margin. The lesson of leaning to see around the obstruction is clear but not always easy to maintain.

**HQ STC** comments that this Airprox highlights the need for all users of the low flying system to maintain a high level of situational awareness and lookout. Even in excellent weather and with good visibility it can be difficult to get an early 'tally' on other ac at low level. In this instance the Jaguar pilot, having established a turn, would not have been able to see both Hawks. On seeing the first Hawk the Jaguar pilot's instinctive reaction was to reverse his turn to clear his 'blind-side'. In doing so he was able, albeit very late, to acquire the second Hawk and manoeuvre to increase the separation.

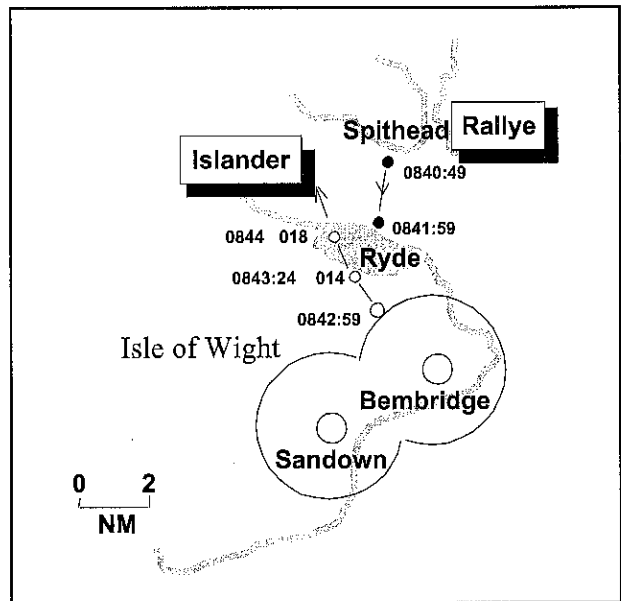
**THE ISLANDER PILOT** reports that he was in a R turn onto 335° at 90 kt and climbing through 1500 ft (QNH 1021) having just departed from Bembridge in VMC; the visibility was about 30 km. Cockpit workload was high due to post take-off checks and a frequency change to Solent Radar. He was squawking 7000 with Mode C. The other ac, believed to be a Rallye, was seen by his passenger, who was occupying the RHS, as it approached from their 12 o'clock position descending through their level in a L turn about 300 m away; it passed down their starboard side about 150 m away and 50 ft below. He was not able to take avoiding action as he did not see the ac himself at any time; however, he believed there had been a high risk of collision. Although the Rallye was about to enter the Bembridge ATZ its pilot was apparently not on the Bembridge radio frequency (123.25). He obtained the registration of the ac which subsequently landed at Sandown. In a subsequent conversation the Sandown air/ground operator said that the Rallye pilot had made no mention to him of any unusual encounter.

**THE RALLYE PILOT** reports heading 185° at 100 kt and descending through 1100 ft (QNH 1022) while inbound to land at Sandown in VMC; the visibility was over 30 km. He was in contact with Sandown air/ground on 123.50 who had passed him airfield information. When about 3 - 4 NM S of Ryde, he saw an Islander ac about 350 yd away to his L as it climbed through his level from L to R. He turned L and increased his rate of descent in avoidance and the Islander passed about 200 m in front of him and 100 - 200 ft above. He did not consider there had been a risk of collision. The pilot comments that he flies into Sandown several times a month, always routeing over Gosport and then lining up with Ryde pier which leads into Sandown, thus keeping him clear of the Bembridge ATZ. Although he had previously been cleared to contact Sandown by Southampton on 120.225, he remained with Southampton until over Ryde, when he received Sandown's information.

Members noted that this incident occurred in excellent weather conditions and they felt that both pilots should have been able to spot each other in good time. In the event, the Islander pilot's only awareness of the other ac was through his passenger's late observation of it as it turned and passed them. Notwithstanding his reported high workload, members said that the pilot was not absolved from exercising his responsibility to maintain an adequate lookout; his non-sighting of the Rallye was assessed to be a part cause of the Airprox. The Rallye pilot, who had right of way, spotted the Islander, albeit late, in time to take avoiding action and members agreed that this removed any risk of collision. His late sighting, however, was assessed to be a part cause of the Airprox.

Cause: Non sighting by the Islander pilot and a late sighting by the Rallye pilot.

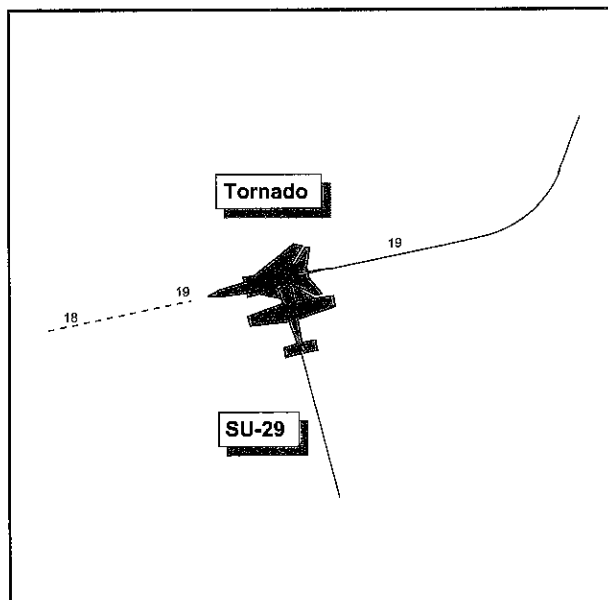
JAS Note: LATCC radar recordings show the Tornado turning from 200° to 260° to close with the SU29 which is tracking 346° with no Mode C. The Tornado's Mode C is steady at 1900 ft for the 25 sec up to a position just after the Airprox; it then drops to 1800 ft. 1900 ft Mode C equates to 2035 ft on the local QNH.

**HQ STC** comments that the descent to low level is a high workload event which also involves a transit through levels used extensively by the GA community. In 'see and avoid' airspace aircrew must rely on an effective lookout scan

and in this instance the Tornado crew spotted the light ac in time to take avoiding action.

Members agreed that both pilots were in a see-and-avoid situation and that the cause of the Airprox was that both pilots saw the other ac very late indeed, notwithstanding the reported fairly good visibility. Being virtually on a collision course, neither pilot would have perceived any relative angular motion in the other ac and each may have been hidden from

The Group noted the very close nature of the encounter; most of the Tornado pilot's instinctive avoiding action appeared to have taken effect after the ac had passed, and even with the SU29 pilot pitching up as the ac passed, the pilots collectively only achieved 50 ft of separation between their ac. The Group assessed that there had been a very real risk of collision.

Cause: A very late sighting by both pilots.

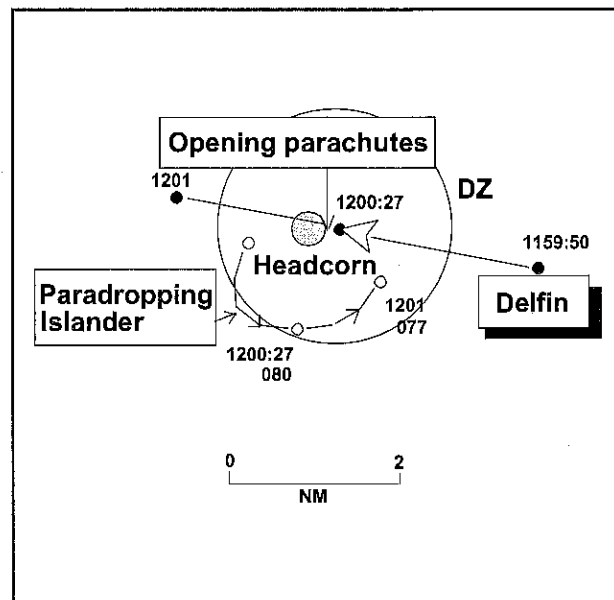
**AIRPROX (P) REPORT No 65/98**

**THE PARACHUTIST**, who was also the club's Chief Instructor, reports that paradropping from an Islander was taking place at Headcorn from 9500 ft. The visibility was in excess of 20 km in VMC. Having obtained clearance for the drop from London ATC and the airfield ground operator, 8 parachutists were despatched. As his canopy was opening at about 3000 ft, to the S of the RW at Headcorn, he immediately

**THE DELFIN PILOT** reports that he was level at 3500 ft and heading about 270° at 200 kt 2 NM N of Headcorn in VMC; the sky was clear and the visibility 30 km. He was maintaining a listening watch with Headcorn on 122.0. He comments that he is a pilot of some 30 years and 1500 flying hours experience and knows Headcorn extremely well as he regularly flies his Stampe ac from there. He states that he is fully aware of the necessary precautions to be observed when flying in the vicinity of a parachute dropping centre, and is familiar with both the club and airfield operator at Headcorn. In view of the 30 km visibility and his extensive knowledge of the area, he felt it was sufficient to maintain only a listening watch on the airfield frequency. He had a very clear view of everything ahead of him from 5 to 7 NM away, including the para-drop, as he approached the airfield. He passed to the N of the ATZ with the parachutists clearly in sight and in his opinion

The Board concluded that the Delfin pilot had caused the Airprox by transiting a notified and active parachute dropping zone. Members found the risk factor more difficult to assess as it was not known how close the Delfin may have come to some of the other canopies. However, it was felt that a parachutist's limited options for manoeuvre, particularly during canopy opening, would render him extremely vulnerable to any ac passing nearby, and in this case members felt that the Delfin's high speed heightened the danger. The Board concluded therefore that the safety of the parachutists had been compromised.

Cause: Conflicts at the base of the LTMA while the Delfin transited through a notified, active, parachute drop zone.

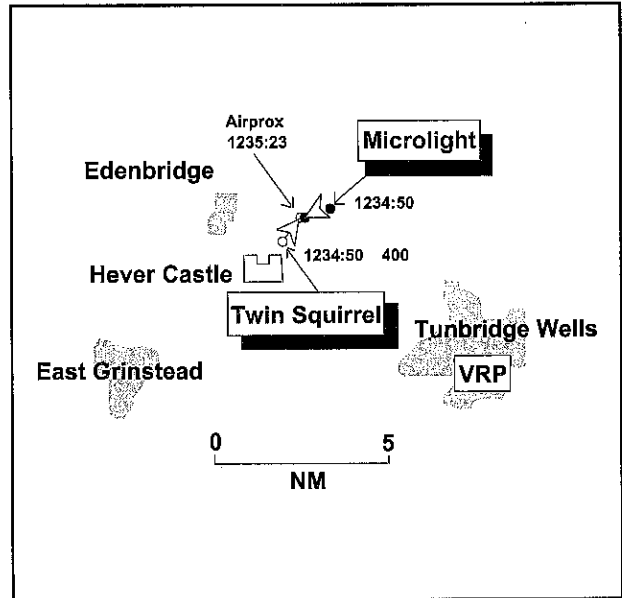
**AIRPROX (P) REPORT No 66/98**

**THE TWIN SQUIRREL PILOT** reports that he was heading 050° at 90 - 100 kt and in a gentle climb through 1200 ft for 1400 ft having just departed from Hever castle. He was receiving a FIS from Biggin Hill APC and squawking 7000 with Mode C. The visibility was in excess of 10 km in VMC. He first saw the other ac, a microlight with red wings, as it flew towards him at a similar altitude in straight and level flight from his R about 70 m away. He had previously been looking down and R towards the castle landing site and believes his lookout in the direction of the microlight may have been obscured by the helicopter's RH cockpit pillar. He banked steeply to the L and dived as the other ac passed no more than 50 m away on his starboard side at a similar level. He thought there had been an extremely high risk of collision.

Board members expressed surprise that the microlight pilot could apparently have flown so close to a helicopter without being aware of its presence; his non sighting of the other ac was assessed by the Board to be a part of the cause of the Airprox. The helicopter pilot's attention was directed downwards as he climbed out from Hever Castle and the direction from which the microlight approached him was possibly obscured by the cockpit's structure; these factors contributed to the pilot seeing the microlight, which had right of way, only just in time to avoid it. It was concluded that the

helicopter pilot's late sighting was a part cause of the Airprox. With regard to risk, members noted that despite his vigorous avoiding action, the helicopter pilot estimated a miss distance of only 50 m from the microlight. This, together with the latter pilot's non-sighting of the helicopter, led the Board to conclude that there had been an actual risk of collision.

Cause: Non-sighting by the microlight pilot and a late sighting by the Twin Squirrel pilot.

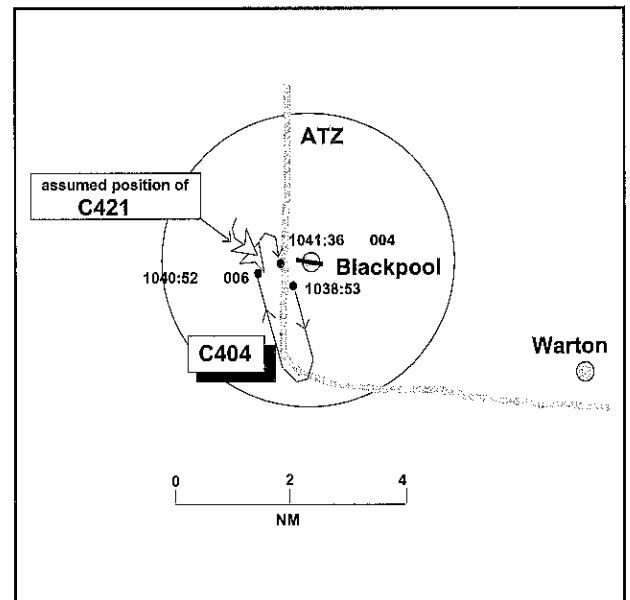
**THE C421 PILOT** reports that he was conducting a simulated asymmetric approach for RW 10 at Blackpool which was to be followed by a go-around. The visibility was 10 km. He was under the control of Blackpool Tower (ADC) on 118.4. During the turn onto finals, passing heading 120° at about 120 kt and descending through 600 ft (QFE), a low wing twin engined ac appeared about 50 ft under his L wing about 100 m away going away from him. It then turned R onto about 180° descending, causing him to carry out a premature go-

around. He felt there had been a high risk of collision. No warning had been passed to him by ATC on the presence of the other ac.

Members agreed that the two APCs did not establish properly the C404's intended area of operation and subsequently did not monitor its movements adequately on radar. Both APCs had known that the circuit was active and the relief controller in particular had sufficient time (3 to 4 mins) to alert the C404. It was the Board's conclusion that the Airprox was caused because the APCs did not provide timely traffic information to the C404 pilot who, as a consequence, flew into conflict with the C421 in the circuit.

In assessing risk, the Board noted that the C421 pilot saw the C404 only after it had passed very close beneath him, and the latter's pilot did not see the C421 until just after the encounter when he was turning R to head S. In view of this, and the C421 pilot's close estimate of separation which is supported by the radar evidence, the Board concluded that there had been an actual risk of collision.

Cause: The Blackpool Approach Controllers did not provide timely traffic information to the C404 pilot who, as a consequence, flew into conflict with the C421 which he did not see.

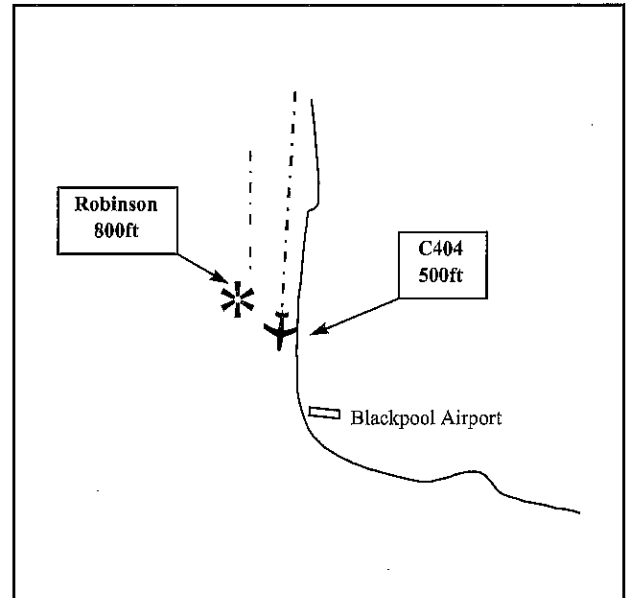
### Occ No. 98/03571

Both aircraft involved in this AIRPROX were VFR flights receiving a Flight Information Service (FIS) from Blackpool ATC, the C404 from the Approach controller and the R22 from the Aerodrome controller. The C404 was at an altitude of 500 feet conducting a low level visual search for oil coming ashore on the beaches to the North and West of Blackpool. The company involved holds the necessary exemptions from the CAA to carry out this aerial work. On this occasion the pilot in the left-hand seat was new to the company and receiving training in the role. The R22 was on a training sortie from Blackpool and was returning to the airport along the beach at an altitude of 800 feet.

It was noted that both aircraft remained on Blackpool ATC frequencies throughout and both received and acknowledged constant traffic information. There was no apparent concern by either pilot on the RTF tape nor is there any apparent alarm or comment from the controllers. Both aircraft were VFR flights in VMC and the situation was under positive

- 1 Discussion The Panel accepted the Summary of CAA Action. Nevertheless, in the circumstances, it thought that the two aircraft could usefully have been on the same frequency.
- 2 Causal Factors Not applicable.
- 3 Risk Classification C
- 4 Recommendations The Panel had no recommendations to make.

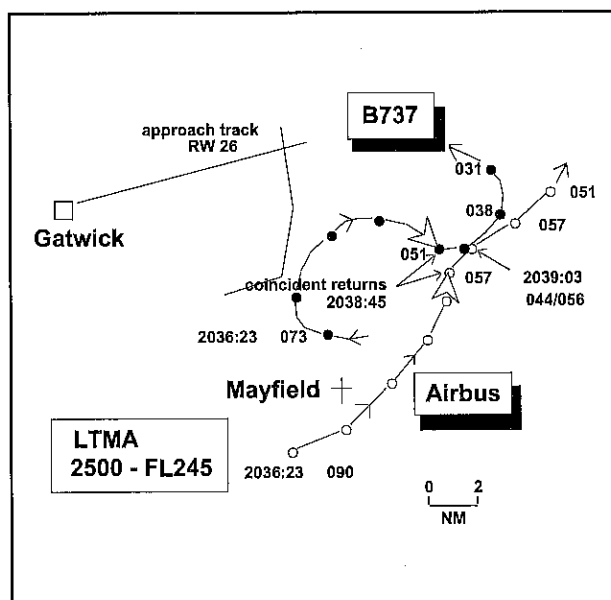
### **AIRPROX (P) REPORT No 69/98**

**THE AIRBUS PILOT** reports that he was heading 350° at 210 kt and descending through 5500 ft (QNH 1010) while positioning for a L base to RW 26L at Gatwick under the control of the Gatwick Director on 126.82. TCAS signalled a TA followed immediately by an RA demanding climb; at the same time ATC instructed him to stop descent and to turn R immediately onto 090°. He complied with both the ATC instructions and the TCAS demand and deduced from the TCAS indications that an ac had passed 100 m away to his L and about 300 ft below him; he thought there had been a very high risk of collision and reported an Airprox to LATCC on 126.82 and subsequently by telephone to the ATC watch supervisor.

Following ATC's detection that the B737 was turning R instead of L, members noted that it took the B737 crew almost a minute to respond to corrective instructions, by which time the ac was turning onto a southerly heading and into conflict with the Airbus. An airline pilot member speculated that the pilot might have inadvertently operated the FMS Heading Select on being instructed to turn onto 340°, thereby disengaging it if it was already engaged. The B737 would then have continued its existing right turn instead of following the selector. This was considered an easy mistake to make, but even so in this incident, whatever the cause, the pilots seemed very slow to recognise and correct the error. The Board concluded that the cause of the Airprox was that the B737 crew did not follow the direction of turn instructed by ATC, and were subsequently slow to correct the error. The Board commended the timely actions of the Gatwick Director whose avoiding instructions enabled sufficient vertical separation to be achieved, thereby removing any risk of collision. Members also acknowledged the part played by the TCAS equipment in the Airbus which assisted in assuring its separation from the B737.

Cause: Contrary to ATC instructions the B737 pilot turned R and was slow to correct this error, which brought his ac into conflict with the Airbus.

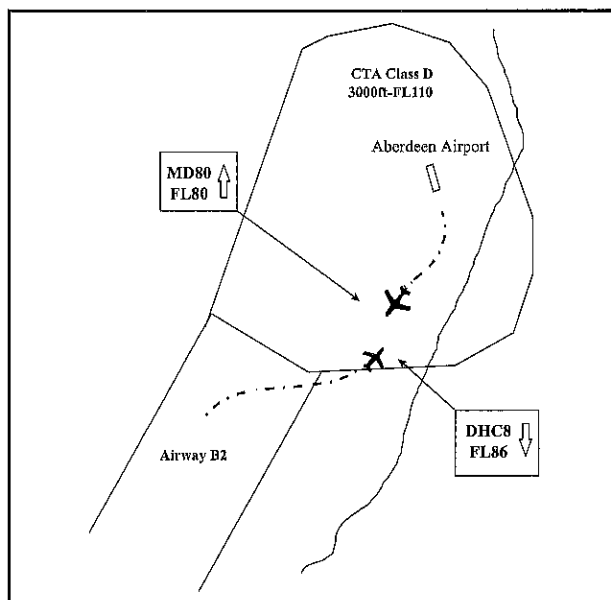
### Occ No. 98/03548

Both aircraft involved in this AIRPROX were under the control of the Aberdeen Approach Radar controller who, because of a light workload and the constraints of weekend manning, was performing the combined duties of Approach Procedural and Approach Radar Controller. The MD80 had departed from runway 16 at Aberdeen en route for Ibiza and was in the climb to FL230. The DHC8 had departed from Newcastle and was being vectored in descent to altitude 4000 feet for an ILS approach to runway 16 at Aberdeen. There were significant thunderstorm weather cells in the vicinity of Aberdeen at the time and these were affecting ATC operations.

The AIRPROX was caused by the Aberdeen Approach Radar controller who descended the DHC8 and climbed the MD80 through each others' level without providing adequate lateral separation.

It was noted that it would have been preferable to have opted for a solution using vertical separation rather than attempting to provide lateral separation by assigning radar headings.

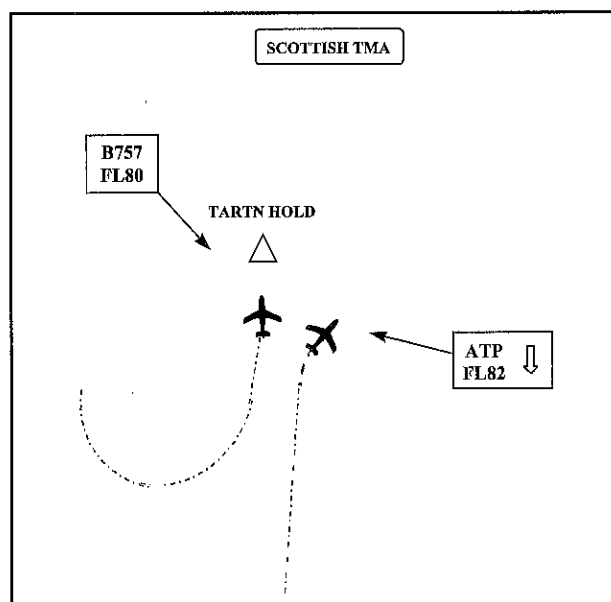
**Occ No. 98/03593**

Both aircraft involved in this AIRPROX were under the control of the Edinburgh Approach Radar controller with the ATP inbound from Manchester and the B757 was inbound from Heathrow Airport. Due to thunderstorm activity in the vicinity of Edinburgh Airport and on the approach to runway 25, the B757 was holding at TARTN awaiting weather improvement before deciding when to make an approach.

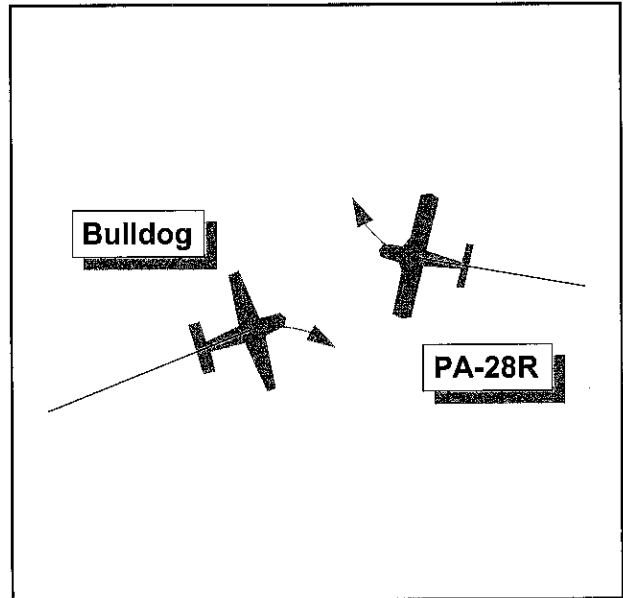
**THE PA28R PILOT** reports heading 275° at 140 kt and had just called Lyneham for a RIS. As he moved his head to set the allotted squawk, he saw a Bulldog approaching from 100 ft away in his 11 o'clock and slightly above. He turned hard right and a Bulldog passed 10-20 ft away; he described the risk of collision as 'A'. He was on an IMC training exercise with a safety pilot and he thought the Bulldog's approach may have been masked by a window frame. It filled the whole windscreen as it passed and he could not believe he had missed it. He was in the LHS and he commented that his safety pilot was scanning all round but was not looking in the direction of the Bulldog at the moment he caught sight of it.

**THE BULLDOG PILOT** reports heading 030° at 100 kt on a recovery to Benson from whom he was receiving a FIS; he was squawking 7366 and had HISL, landing light and taxi lights on. His ac was black with a white fuselage top and red dividing line. While talking to his passenger and with both looking out, a white single engined ac appeared from nowhere about 40 ft away in front and to his left, and 30 ft above. He instinctively broke right and down, and the other ac broke right and up. The risk of collision had been very high. He commented that his ac markings may have saved the day; certainly the other ac, white and heading into sun, was seen late. He believed the incident emphasises the

need for even better lookout, even in the best visibility conditions and especially near a VOR or similar.

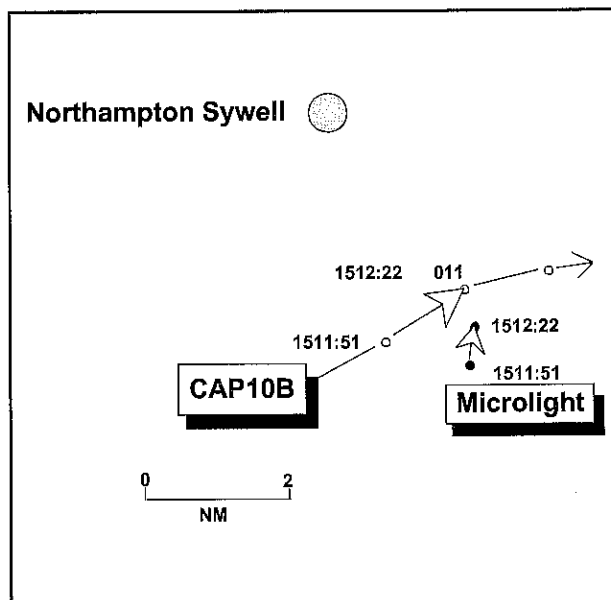
**THE MICROLIGHT PILOT** reports that he had departed from Cranfield (elev 364 ft) and was heading N at 65 kt and level at 800 ft (QFE) inbound to Sywell; he was in contact with Sywell air/ground on 122.7. The visibility was 5 - 6 km in VMC. When about 3 NM S of Sywell, he saw a low wing single engined light ac with a large canopy about 100 yd away to his L as it tracked from L to R across his path. He turned R in avoidance and observed that the other ac also turned away, passing about 500 yd ahead of him at a slightly higher level; he considered there had been a low risk of collision.

**THE CAP 10B PILOT** reports that he was flying between Wycombe Air Park and Swanton Morley in VMC. The visibility, about 800 ft below overcast cloud, was over 10 km. He was squawking 7000 with Mode C and receiving a FIS variously from Luton APC, Marham Radar and Swanton Radio. When about 5 NM S of Wellingborough, heading 045° at 140 kt and level at 2000 ft (Chatham RPS), he saw a high wing single-engined microlight ac about 1 - 2 NM away to his R. It was about 300 ft below his

level and appeared to be climbing at about 70 kt in a NW direction; his greater altitude and considerably higher speed kept him well clear as he passed about 0.5 NM ahead of it. He did not consider there had been any risk of collision.

Note: A replay of the LATCC radars at 1511:51 shows a return, believed to be the CAB10B, as it tracks NE about 3 NM S of Sywell. At the same time a slow moving intermittent northbound return, believed to be the microlight, can be seen at the CAP 10B's 2 o'clock position just over a mile away. No Mode C data is shown on the latter at this time but at 1512:22, as it passes 0.5 NM N of the primary return, it indicates 1100 ft. (Archive material gives the Chatham RPS for the period as 1018 mb; based on this setting, 1100 ft Mode C equates to 1235 ft. Assuming that the microlight pilot had retained the QFE he set at Cranfield, his altitude equivalent would have been 1164 ft. At the levels reported, therefore, vertical separation would have been in the order of 61 ft).

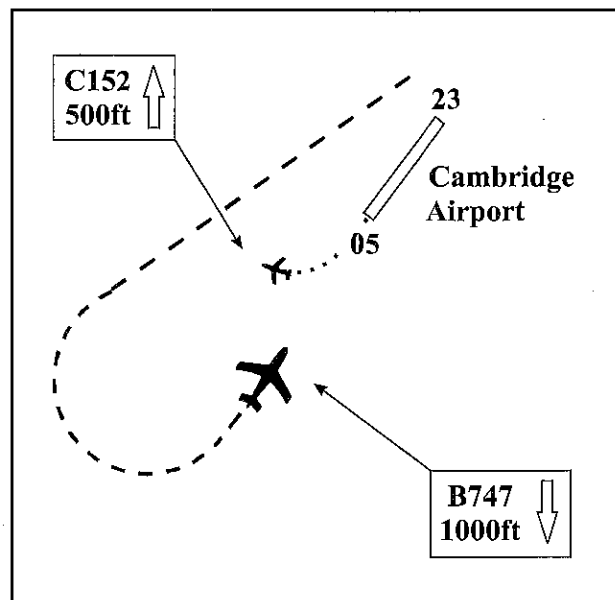
Both aircraft involved in this AIRPROX were operating in the Cambridge circuit under the control of the Cambridge Aerodrome controller. The B747 was a positioning flight from Gatwick to Cambridge and was turning final for a landing on runway 05 following a go around from a radar approach to runway 23 due to tail wind considerations. The C152 was a Cambridge

based aircraft and had just taken off from runway 23 for a local training flight.

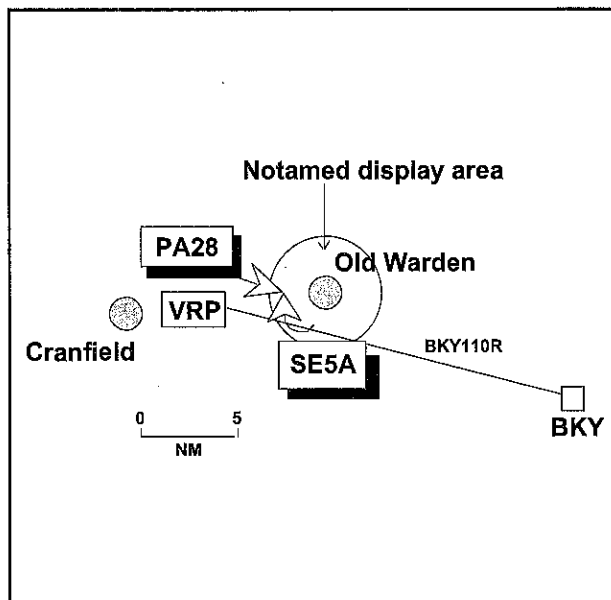
**AIRPROX (P) REPORT No 72/98**

**THE SE5A PILOT** reports that he was carrying out tight RH orbits in display airspace which was the subject of a NOTAM while awaiting the departure of another ac which was to join him in a display at Old Warden aerodrome. The visibility below cloud was over 10 km in VMC. His ac was not radio-equipped. His attention was focused on the display activity. When on a northerly heading at 70 kt at 2000 ft (QFE 1014) about 1.5 NM W of Old Warden, he saw a dark coloured, possibly black, low wing single engined ac he thought was a Beagle Pup as it crossed his track from L to R less than 100 m away and 200 ft below his level. He had no time to take avoiding action and the ac passed less than 50 m behind him and 200 ft below with a high risk of collision. He reported an Airprox to UKAB by telephone.

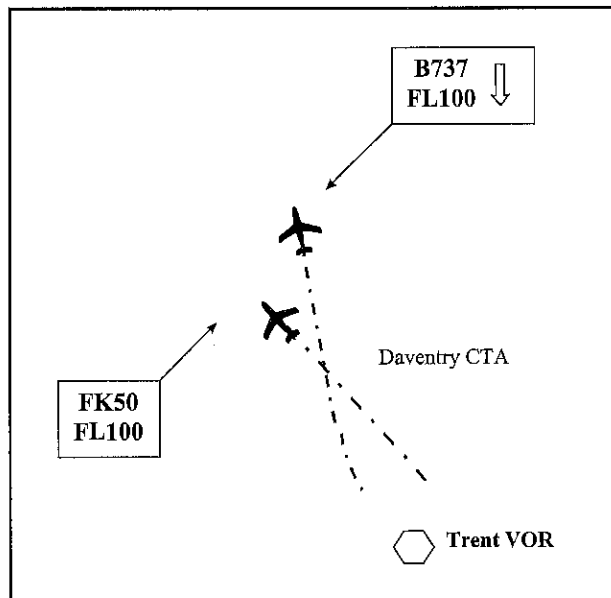
### Occ No. 98/03815

Both the aircraft involved in this AIRPROX were under the control of the Manchester Area Control Centre (MACC) TMA South East (SE) Radar Controller and were inbound to Manchester via the Trent VOR (TNT). The FK50, which had departed from London City, was level at FL100 and was initially ahead of the B737, which had departed from Paris and was in descent to FL100. The controller's workload was assessed as moderate with a radar controller and a co-ordinator operating the MACC TMA SE Sector in a banded configuration.

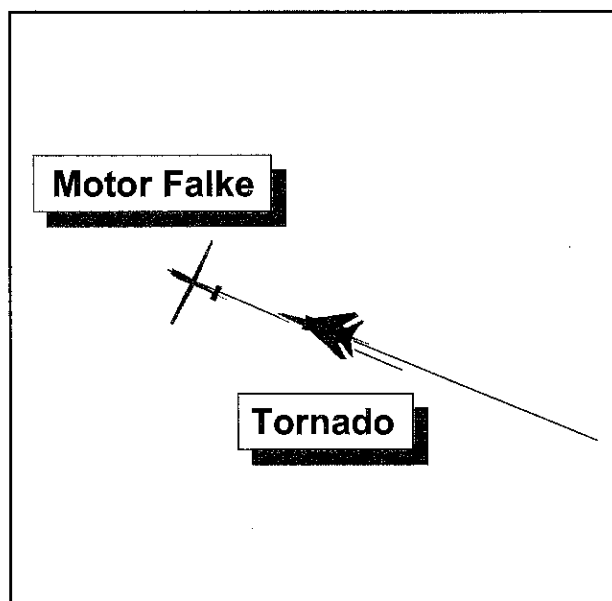
**THE TORNADO PILOT** reports heading 290° at 420 kt, auto terrain following at 8-900 ft agl. The ac pulled up suddenly for no apparent reason so he took control and overbanked, seeing a light ac 5-700 ft beneath and to the left. It had a red nose cone and longer than usual wings.

**THE MOTOR FALKE PILOT** reports heading 265° at 60 kt. He heard the thunder of engine noise above and then briefly saw a Tornado on a similar track descend ahead out of the cloud before disappearing again. He had no idea how

close it had come or that an Airprox had been filed until he was contacted by telephone.

Note: LATCC radar recordings show a slow moving primary only return that was subsequently traced back to its departure airfield and identified there as the Falke T61. At the Airprox position it is overhauled on a similar track by a 7001 return, level at 1000 ft Mode C. As the returns cross, the Mode C changes to 1300 ft and then continues up to 2300 ft before recommencing a descent.

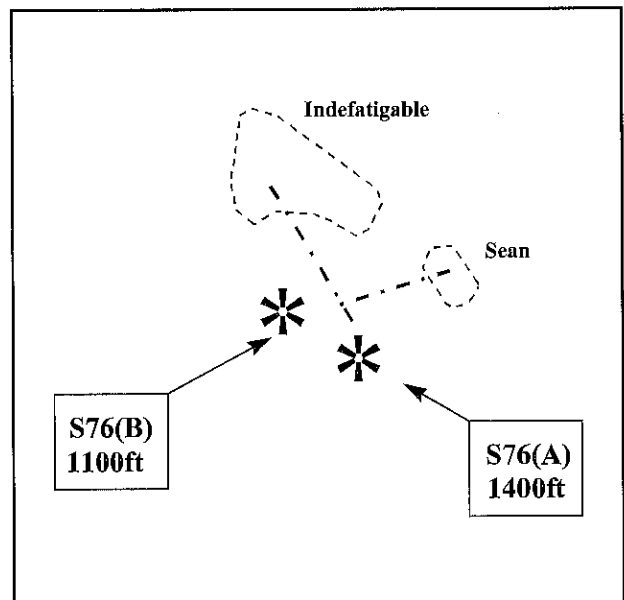
**Occ No. 98/03871**

*Date:* 9 July 1998  
*Time:* 1825 UTC  
*Aircraft:* 2 x S76 Helicopters  
*Operators:* British Commercial  
*Position:* Southern North Sea, West of the Sean Field  
*ALT/HT/FL:* 1100 - 1400 feet altitude  
*Airspace Type:* FIR – Class G  
*Reporter:* Aberdeen ATC – Anglia Radar  
*Reported Separation:* 2nm horizontal/200 feet vertical  
*Recorded Separation:* 4nm horizontal/300 feet vertical

At 1825, the S76(B) pilot called the Anglia controller, who assumed erroneously that the aircraft was now climbing out from the Indefatigable Field into which it had previously descended, and which the controller had noted on the flight strip. Seeing no traffic in the vicinity of the Indefatigable Field, the controller told the S76(B) pilot "no known traffic to affect climb". However, as soon as the S76(B) climbed into radar coverage, the controller recognised the conflict near the Sean Field and instructed the pilot to stop his climb at 1000 feet. Note:- North Sea helicopter procedures allow for 500 feet vertical separation. Radar pictures show that

From the RTF and radar recordings, it would appear that there was only a marginal loss of standard separation between the two S76s. Fortunately, the Anglia radar controller managed to stop the S76(B) pilot from climbing through the level of the S76(A) and radar separation was only eroded to 4nm. The Anglia radar controller, when passing traffic information to the S76(A) pilot about the S76(B), actually reported the range as 5 miles when he observed the S76(B) to be level at altitude 1000 feet. However, the incident clearly

### **4 Recommendations** The Panel had no recommendations to make.

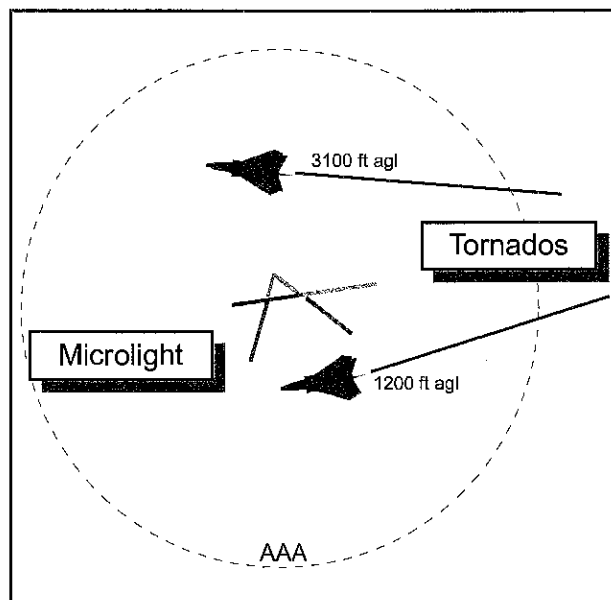
Note: A replay of LATCC radar recordings show the Tornados heading S to the NE of Eshott and turning across the airfield. The northern one appears to tighten its turn sharply to avoid the AAA to the N but passes 0.75 NM N of the airfield centre at 3400 ft Mode C while the southern one passes less than 0.5 NM S of the main runway at 1500 ft Mode C. The local QNH

was 1008 mb; taking this and the airfield elevation into account, the southern Tornado was at about 1200 ft agl.

The radar recording showed the northerly Tornado sharply tightening its turn and pulling up above the avoidance area but the southerly (left hand) ac passed through the Eshott AAA. The Board concluded that this was the cause of the Airprox. Members were advised that Eshott was very difficult to distinguish from the air and was in the middle of an extensively used

Cause: The Tornado pilot penetrated the Eshott airfield avoidance area.

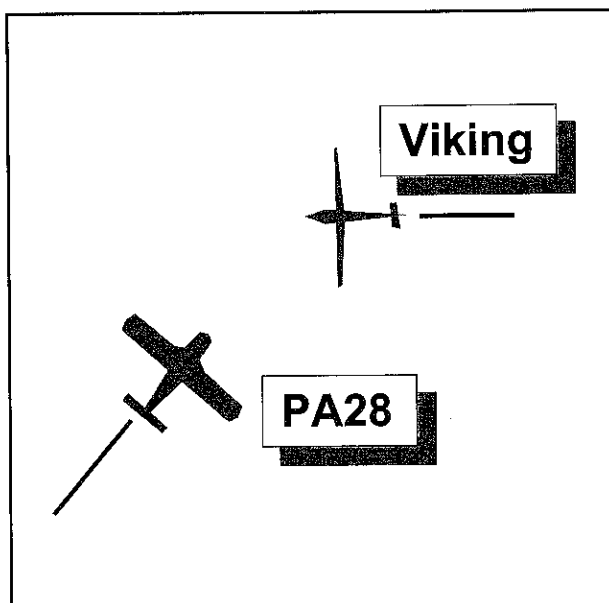
**THE VIKING PILOT** reports heading 280° at 50 kt on an instructional sortie, having just released the cable after launching to 1000 ft. He saw a light single engined ac closing from the left to within 100 ft and 20-50 ft below; it turned right to pass close astern. As he also turned right, he noted its registration. The risk of collision had been high and he had been unable to see the light ac approach due to the extremely high nose attitude while launching.

**THE PA28 PILOT** reports heading 030° at 90 kt having departed from Andrewsfield and was waiting for a service from Essex Radar, whom she had called on take-off and who had asked her to stand by. She climbed to 1000 ft and was trying to avoid Stansted's controlled airspace with the very limited navigational features in the area. Approaching Wethersfield she saw a glider 500 m ahead and thought she had turned

Cause: The PA28 pilot flew into confliction with the glider over a NOTAMed glider site.

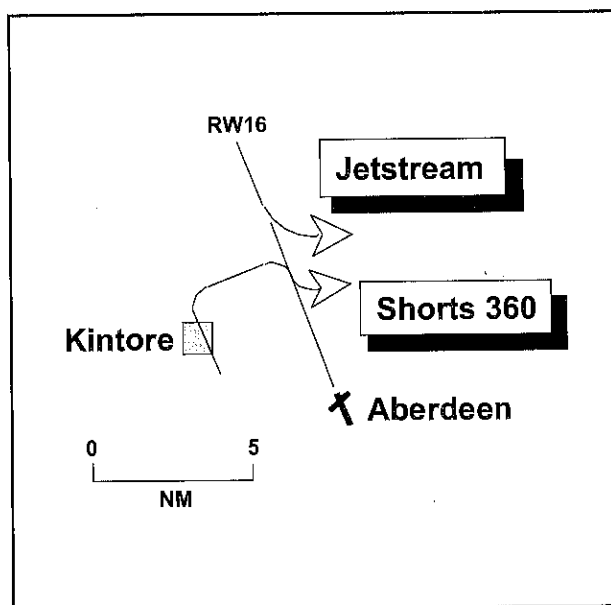
### AIRPROX (P) REPORT No 78/98

Date/Time: 15 Jul 1255  
Position: N5717 W0212 (5 NM NNW Aberdeen airport - elev 215 ft)  
Airspace: CTA (Class: D)  
Reporting Aircraft Reported Aircraft  
Type: Jetstream Shorts 360  
Operator: CAT Civ Trg  
Alt/FL: 2000 ft ↓ 1000 ft  
 (QNH 1007 mb) (QFE)  
Weather VMC VMC  
Visibility: 40 km 40 km

**THE JETSTREAM PILOT** reports that he was established on the ILS to RW 16 at Aberdeen under the control of Aberdeen Approach Radar on 120.4. The visibility was 40 km in VMC. At a range of about 5.5 NM from the threshold, while passing about 2000 ft (QNH 1007) and with speed reducing through 180 kt, a Shorts 360 turned onto finals about 1 NM in front of him and 400 ft below. ATC instructed him to break off and turn 90° to port, climbing to 3000 ft for a further ILS. The other ac was not on his frequency. He felt there had been a medium risk of collision.

Cause: The uncoordinated instructions of the APR and ADC controllers led both the ac into positions where their flightpaths conflicted.

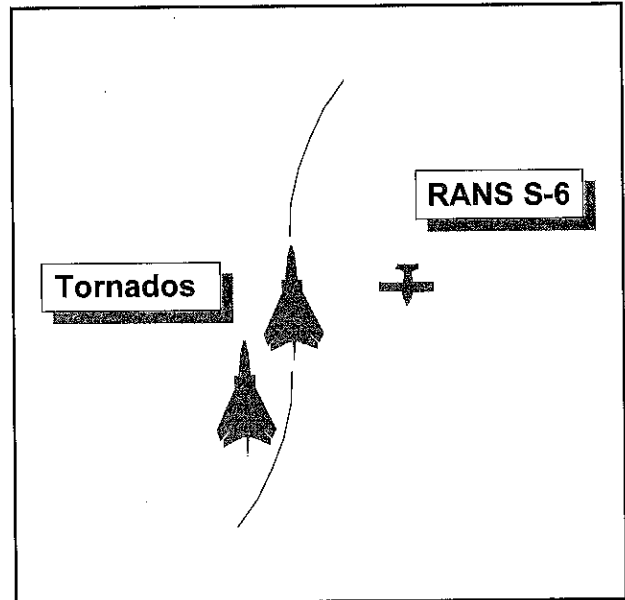
Note: LATCC radar recordings show the Tornados, identified from their Spadeadam squawks, in a shallow left turn from NE onto about 350° as they approach Eshott. The turn tightens somewhat in the Eshott overhead and is then reversed onto NE as the ac depart the scene. There is no sign of the RANS on the recording. The Tornados, in a fairly close

formation and both squawking with Mode C, show 2500 ft just before passing Eshott and 2400 ft just after. Taking local QNH and the airfield elevation into account, this equates to 21-2200 ft agl.

Degree of Risk: C  
Cause: Sighting report.

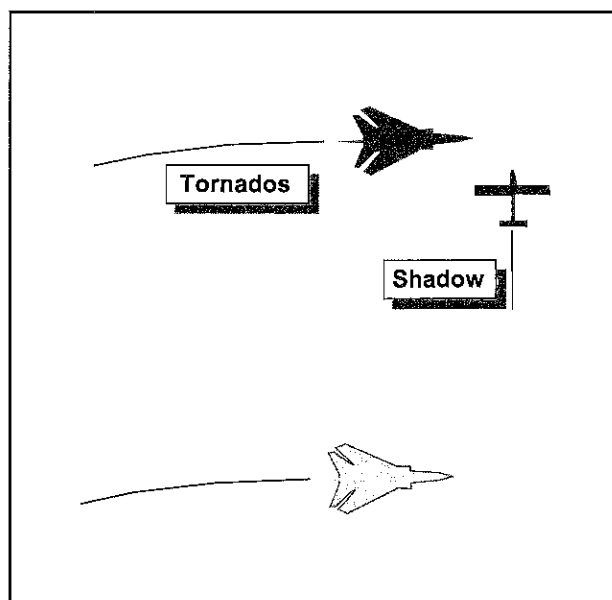
Note: The Clee Hill radar recording shows the Tornado, and intermittently its wingman to the S, gently turning from 078° to 120°. There is no sign of the Shadow but the left hand Tornado passes the reported Airprox position at 1454 in a gentle descent off the Clwydian Hills and passing 2000 ft Mode C at the Airprox position. Local QNH was 1011 mb; Mode C readings are therefore 54 ft above QNH.

**HQ STC** comments that despite the emphasis that is placed on the need for maintaining an effective lookout scan in the 'see and avoid' environment, there are still occasions when lookout breaks down. The crews involved in this Airprox acquired a very late sighting; too late for any avoiding action to be appropriate. It is fortunate that the miss distance, albeit very small, was sufficient to make this an Airprox investigation rather than an accident investigation. As long as 'see and avoid'

Cause: Late sighting by the crews of both ac.

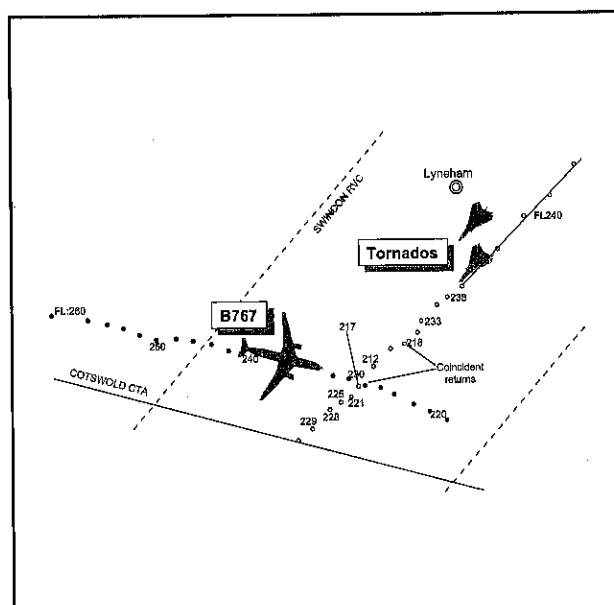
**THE TORNADO PILOT** reports heading 220° at 480 kt, leading a pair transiting the Swindon Radar Corridor (SRC) through the Cotswold CTA under the radar control of London Mil at FL 240. The controller told him to expedite a descent to FL 150 so he began a descent immediately and shortly afterwards saw an airliner in their 12:30-1 o'clock at about 3 NM which crossed right to left at right angles at the same level. With the range closing to about 1.5-2 NM ahead, he turned hard right to avoid it. The controller then told him to turn hard right and then to expedite a climb to FL 250, which he did. Minimum horizontal separation from the airliner was about 0.5 NM and some 2-3000 ft below it; however, in IMC, without the visual avoiding action taken, a collision would have been likely.

The Board concluded that the cause of the incident was that the BRS SC did not maintain standard separation between the B767 and the Swindon RC. Members discussed whether part of the cause was the Tornados' descent initiated by TAC1. This probably extended the resolution of the problem more than a level right turn would have done, but the Board agreed that it was not a causal factor. Indeed, members observed that TAC1 had been alert to a

Cause: The BRS SC did not maintain standard separation between the B767 and the Swindon RC.

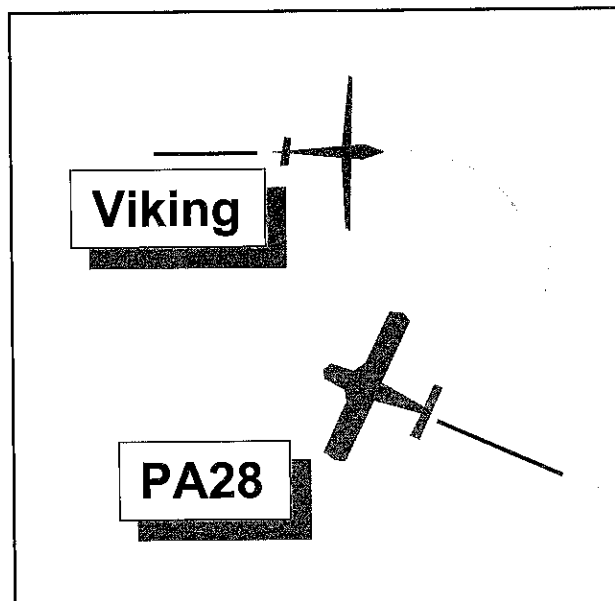
**THE VIKING PILOT** (instructor) reports heading 100° at 50 kt, downwind in a right hand circuit at Wethersfield. He saw a light ac approaching from the SE at a steady height and heading as his student began a turn onto 190° for base leg; the light ac passed 500 ft away and 500 ft above in their 2 o'clock. The risk of collision would have been medium to high if the light ac had appeared earlier or his circuit had been higher. Furthermore, very inexperienced solo students operate from Wethersfield and would be put into great difficulty by this sort of intrusion.

event had overflowed the northern side of the airfield. Wethersfield is huge and unmistakable which led members to consider the pilot had been careless to have flown so close to it. However, in this instance, it did not appear from either pilot's report that the PA28 had flown particularly close in plan or elevation to the glider, which had been able to continue its circuit without taking avoiding action. While the Board fully understood the concern of the gliding authority about the potential danger caused by frequent overflights of Wethersfield, it did not appear there was any danger in this case. Members concluded this incident was a sighting report.

Degree of Risk: C  
Cause: Sighting report.

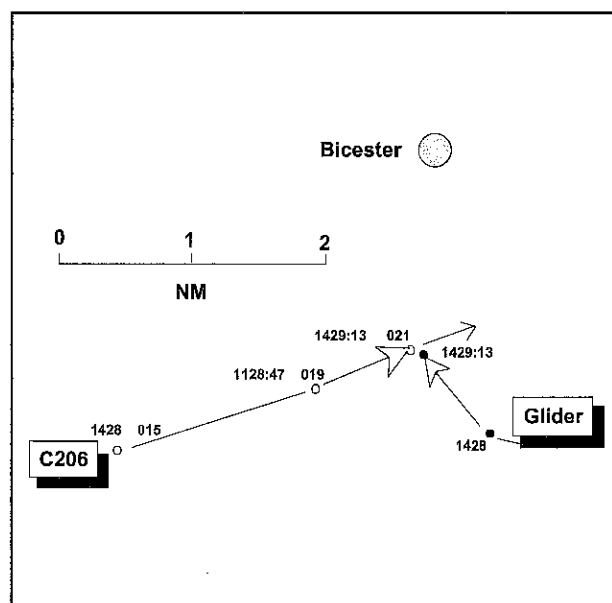
THE GLIDER PILOT reports that he was circling R in a thermal at 1500 ft (QFE 1001) 0.5 NM SE of Bicester airfield (see Note 1), from where he had launched for a general handling sortie. The visibility was 30 km in VMC. He first saw the other ac, a C206, about 600 m away as

it approached from an almost head-on position at a similar level, climbing. He immediately dived in avoidance and the C206 passed no more than 30 - 40 ft above him. He believed that without his action there would have been a

Note (2): A replay of the Cleve Hill radar at 1428 shows the C206, identified by its 0033 squawk, heading ENE from Weston-on-the-Green indicating 1500 ft Mode C; at the same time a slow moving primary return, believed to be the glider, is observed manoeuvring at his 12 o'clock at a range of about 2.5 NM. The latter tracks slowly NW and at 1429:13 merges with the C206's return which is now indicating 2100 ft Mode C. Following the encounter the primary return fades from radar and the C206 continues heading ENE for a short distance before turning N and passing about 1 NM E of Bicester airfield towards its drop area at Fringford. From archive material, the QNH at Weston-on-the-Green was 1014. On this setting the C206's Mode C indication of 2100 ft equates to 2127 ft altitude; at its reported height of 1500 ft the glider's altitude, based on the elevation of Bicester, would have been 1767 ft. Theoretically, therefore, vertical separation would have been in the region of 360 ft at the time the acs' tracks crossed.

Cause: Late sighting by both pilots.
