**UK AIRPROX BOARD**

# **Analysis of Airprox in UK Airspace**

**Report Number 1**

**January 1998 to December 1998**

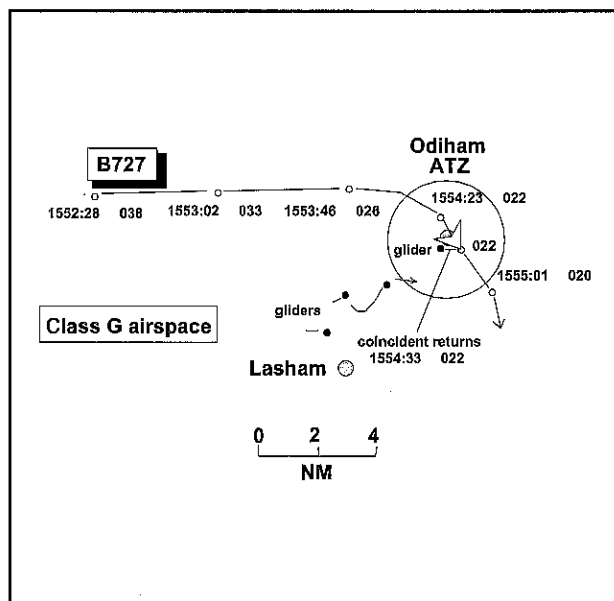
**AIRPROX (P) REPORT No 83/98**

Date/Time: 19 Jul 1555 (Sunday)  
Position: N5114 W0056 (Odiham - elev 404 ft)  
Airspace: ATZ (Class: G)  
Reporting Aircraft Reported Aircraft  
Type: ASK 21 Glider B727  
Operator: Civ Club CAT (Air Test)  
Alt/FL: 1100 ft ↑  
 (QFE 1000 mb) (QNH)  
Weather VMC CLBC VMC  
Visibility: 20 km

**THE GLIDER PILOT** reports that he was being winch-launched from RW 23 at Odiham with whom he was in RT contact on 129-975. The visibility was over 20 km in VMC. He was occupying the rear seat while his pupil flew the ac from the front. He comments that forward vision from the glider is severely restricted during the launch phase, with scanning restricted to the sides only. At around 900 ft (QFE), while heading about 190°, he saw a B727 to his R 800 - 1000 m away; his view was of the lower fuselage, wings and flaps and he concluded that he was directly in line with its flight path. He opted to continue the launch in order to clear the B727's path as soon as possible, thereby passing the ac to its R. He

Cause: Having elected to continue VFR, the B727 pilot entered the Odiham ATZ and flew into conflict with the glider which he did not see.

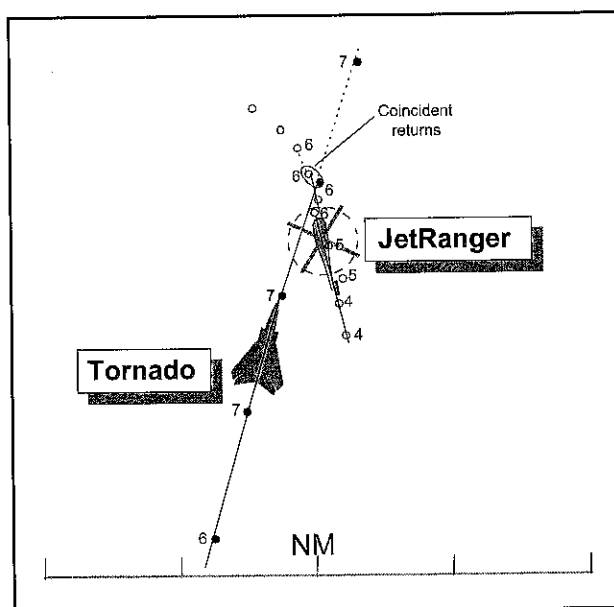
### AIRPROX (P) REPORT No 84/98

<u>Date/Time:</u>	20 Jul 0917	
<u>Position:</u>	N5332 W0045 (2 NM SW of Scunthorpe)	
<u>Airspace:</u>	FIR/LFS	(Class: G)
	<u>Reporting Aircraft</u>	<u>Reported Aircraft</u>
<u>Type:</u>	JetRanger	Tornado GR
<u>Operator:</u>	Civ Comm	HQ STC
<u>Alt/FL:</u>	400 ft ↑	900 ft
	(QNH 1002 mb)	(Rad Alt)
<u>Weather</u>	VMC CAVK	VMC CLNC
<u>Visibility:</u>	30 km+	30 km

**THE JETRANGER PILOT** reports flying a pipeline patrol and was heading 350° at 90 kt in an en route climb when the crew heard a jet, and a Tornado then overflew from behind, about 100 ft directly above, with a very high risk of collision. There was no opportunity for avoiding action and no wing rock from the Tornado so he suspected he had not been seen.

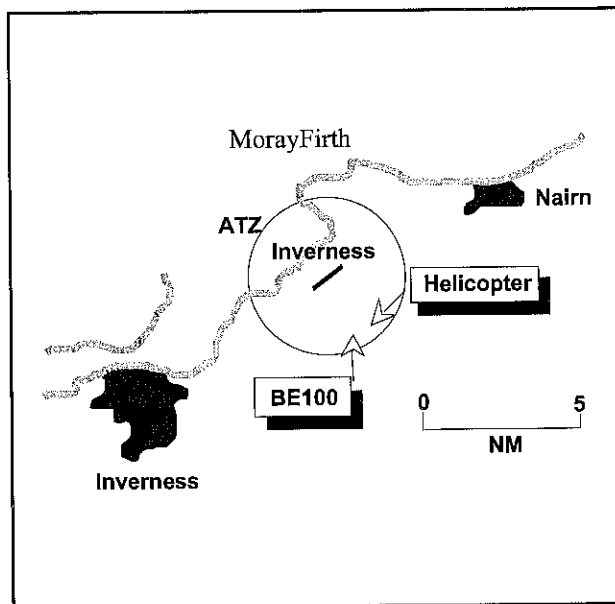
**THE HELICOPTER PILOT** reports that he was receiving a FIS from Inverness ATC on 122.6 and squawking 7000 with Mode C while transiting on a heading of 245° at 120 kt from a field site about 5 NM ENE of Nairn to Raigmore Hospital, in Inverness town. He had a critical patient on board and ATC had approved a direct

and then saw it about 2 NM away at his 11 o'clock position. He had not expected it to descend below 3500 ft as he had heard its pilot being instructed to let down on the N side of the airfield due to the proximity of the helicopter. However, it descended out of cloud and crossed his track on a NNE heading from L to R about 1000 m ahead and not more than 500 ft above him; he stopped his climb and turned L 10° in order to pass behind the ac. He felt there had been a high risk of collision and reported an Airprox to Inverness ATC by telephone on landing. The pilot comments that he believes the other pilot could not have been clear of cloud or visual with the helicopter as he descended, because if he had been he would have expected the ac to pass behind him.

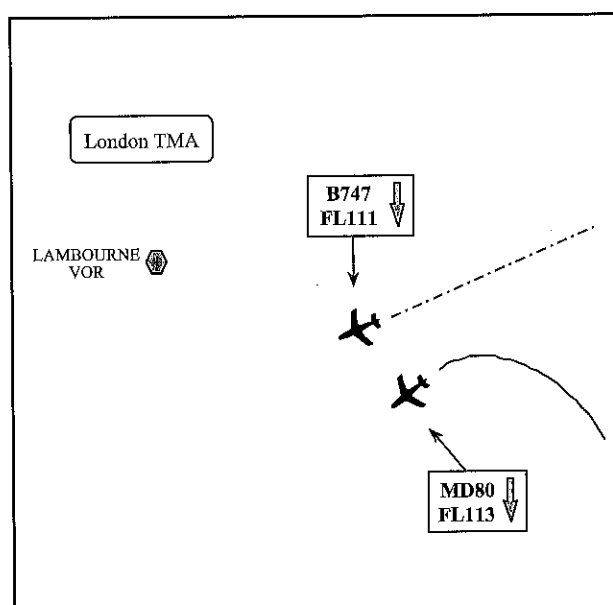
#### **Occ No. 98/04071**

*Date:* 20 July 1998  
*Time:* 1801 UTC  
*Aircraft:* MD80/B747  
*Operators:* Foreign Airlines  
*Position:* 5nm South East of  
Lambourne VOR  
*ALT/HT/FL:* FL110  
*Airspace Type:* London TMA – Class A  
*Reporter:* LATCC Terminal Control  
(TC) – Timba and Lambourne  
Sector Controllers  
*Reported Separation:* 1.62nm horizontal/200 feet  
vertical  
*Recorded Separation:* 1.62nm horizontal/200 feet  
vertical

This AIRPROX occurred during a very busy period of operations in the London Area and Terminal Control Centre (LATCC). Traffic levels reached such a peak that a number of controllers, from both the Area Control (AC) and Terminal Control (TC) sectors, submitted overload reports. Moreover, the general situation was made much worse by very significant thunderstorm activity affecting airspace over Southern England up to FL370 and the limitations of the flow control process. In day-to-day operations, the relationship between AC and TC is such that any breakdown in AC traffic management can impinge upon TC – and did so on this occasion. The Dover/Lydd Sector suffered a very high workload due to the application of the Target Sector Flow (TSF) during adverse weather conditions and things deteriorated further when the imposed inbound flow rate was significantly exceeded for reasons outside the Supervisor's control. Because of the various interactions involved, the circumstances surrounding this AIRPROX were also the subject of a parallel investigation into the overload situations that took place on the same afternoon.

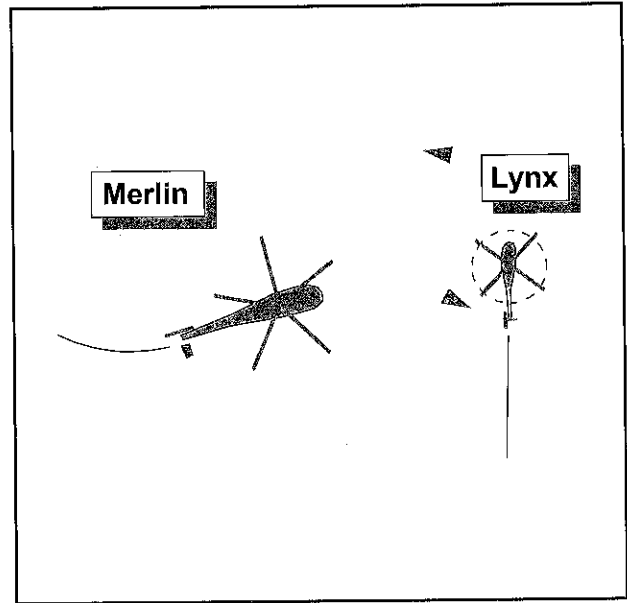
**THE LYNX PILOT** reports heading N at 120 kt while his student was joining for a PAR to RW 27 at Yeovilton from 3500 ft; they were receiving a RAS from Yeovilton on 369.875. There was much cloud around and after emerging into a clear area with cloud above, below and to the left he saw a Merlin in his 9:30-10 o'clock about 450-500 yd away at the same level and closing in a left turn. He took control and made a wing-over to the left to clear its flightpath and keep it in sight. The Merlin reversed its turn and passed 200 yd behind and 350-400 ft below. He had not heard any traffic information from Yeovilton and considered the risk of collision would have been high if he had not fortuitously emerged from cloud and been able to see it and take his own avoiding action.

**THE MERLIN PILOT** reports heading E at 130 kt on a test flight at FL 35 during which he was attempting to remain VMC in broken cloud. He turned left onto 040° and saw a Lynx appear in his 12:30-1 o'clock from the top of cloud about 0.25 NM away, apparently in a climbing left turn. He turned gently right at about 20° AOB and the Lynx passed about 1000 ft away and 3-400 ft

**RNAS YEOVILTON** reports, with RT transcripts, that the approach control team, providing the Lynx with a RAS, consisted of a revalidating controller and an instructor who were extremely busy. The Lynx came on frequency at 0853:20 after a handover which was very protracted due to workload. The Lynx was tracking N and there was a Yeovil squawk 8-10 NM to its NW which the controller did not consider to be a problem at the time. His student was busy with 2 fixed wing ac (one of which was pressing him for a quiet frequency), 3 helicopters and a pending handover of a Sea Harrier. The Lynx was instructed to set the QFE (1011 mb) which took 2 attempts because the student initially called '462' whereas the Lynx c/s was 642. At that point both the controller and the student noticed the conflicting Merlin 3 NM NW heading SE at FL 35 and at 0855:10

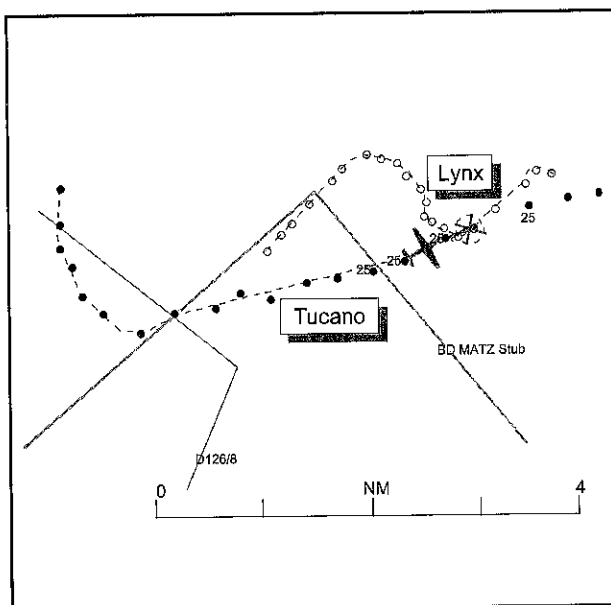
**THE LYNX PILOT** reports passing through 040° in a gentle left turn at 100 kt at 2000 ft, while listening out with Middle Wallop on 253.4. He saw a Tucano going away in his 1 o'clock, tracking about 060°. It had passed 2-300 ft directly overhead; there had been no opportunity for avoiding action and the risk of collision had been high.

**THE TUCANO PILOT** reports heading 100° at 180 kt in the Boscombe Down GCA pattern at 2000 ft. The controller warned him of traffic and having acknowledged it, he saw a Lynx 3 NM ahead, heading about 160° and about 200 ft below. He altered heading by 30° at 1 NM to pass 4000 ft behind and 200 ft above the helicopter which then turned towards him and

**HQ SAAvn** comments that this Airprox occurred in a portion of airspace regularly used by training ac from the School of AAvn for GH as well as by transit traffic to and from Salisbury Plain. The area is directly to the NE of the Boscombe stub. The ac involved were operating in good VMC. The lack of deviation in the Tucano's track suggested that its pilots had not seen the Lynx, or were content with the separation.

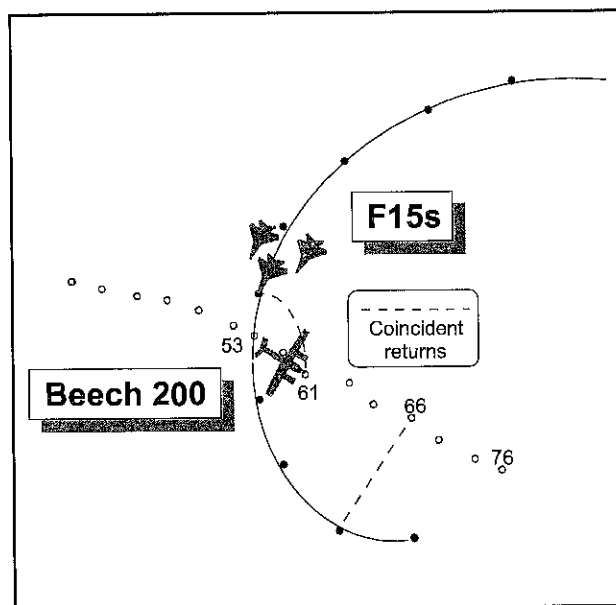
**THE BEECH 200 PILOT** reports heading 125° at 170 kt in a climb through broken, layered cloud. He had been cleared on departure from Plymouth for a climb to FL 280 at SKERY remaining clear of CAS and to squawk 3762 for

clearance to climb through A25, which eventually came from London who cleared him to join controlled airspace NW of SKERY. Passing FL 64 he saw movement at the left edge of his vision and identified 3 fighters below and passing astern in a left bank in close formation. His FO saw them over the right trailing edge emerging from astern and reported the sighting to Plymouth who said they did not know who was controlling the fighters. The fighters, thought by his F/O to be F15s, passed 0.25 NM away and 500 ft below and he thought there was a medium risk of collision, potentially high; if he had been IMC he did not think the F15s would have seen him. In a later telephone conversation he queried why the procedure at Plymouth was to pass ac to Plymouth Radar when ac were not proposing to route through the danger areas, and asked if they could call London Radar instead.

they argued that the F15 formation was in control of the situation throughout, that both parties had seen and avoided each other in good time and that the Plymouth Radar controller had fulfilled his remit under a RIS. However, the view eventually prevailed that because the F15s had seen and taken action to avoid the Beech 200 and that the latter was climbing out of the conflict, the cause of the incident was a conflict of flightpaths which was resolved by both pilots and that there had been no risk of collision.

Cause: Conflict of flightpaths resolved by both pilots.

Members observed that none of the F15s had been squawking Mode C, although there was no exercise reason for not doing so. Accordingly, the Board asked the F15s' operating authority to remind their crews of the benefits of squawking Mode C at all times; the practice allowed controlling agencies to gain better situation awareness, promoted better customer service and could help to reduce the

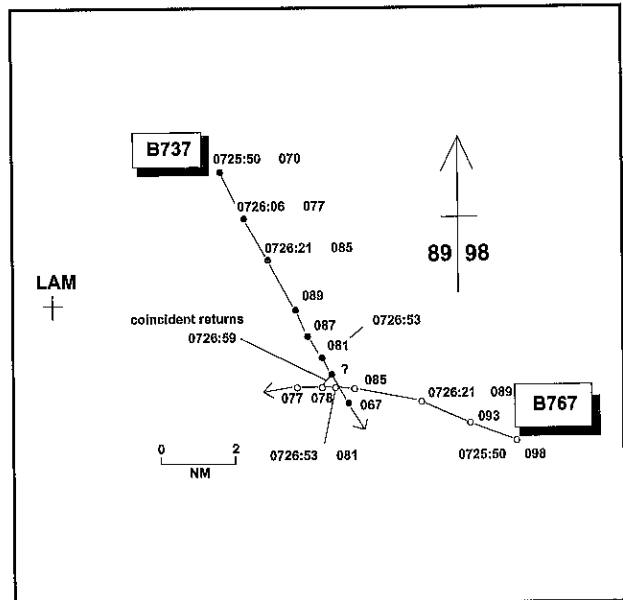
**THE B767 PILOT** reports that he was 10 NM E of LAM heading 300° at 250 kt under the control of LATCC. The visibility was 50 km in VMC. On descending through FL 88 for his cleared level, FL 80, ATC instructed him to maintain FL 90 and to turn L 180°. During the climb back to FL 90 he received a TCAS RA demanding descent, with which he complied and another ac passed about 500 m behind him at the same level. He felt that there had been a high risk of collision.

**THE B737 PILOT** reports that after departure from Stansted for Milan, he was cleared by LATCC on 118.82 to climb to FL 170. The visibility was 30 km in VMC. His ac was not TCAS equipped. On passing FL 83 ATC asked him if he was levelling at FL 70. He advised them that he had been cleared to, and had read back, FL 170, whereupon the controller instructed him to descend immediately to FL 70

and to make an avoidance turn L. The other ac, a B767, passed from L to R about 0.5 NM ahead of him and about 200 ft above. He believed there had been a high risk of collision.

Turning to risk, members noted that the B737 pilot had seen the B767 in sufficient time to deduce that a hard turn to port, as instructed by ATC, was unnecessary as he would pass behind the other ac with only a minor course correction. However, despite this visual sighting and the combined TCAS and ATC actions the two ac passed each other with only marginal vertical and horizontal separation. The Board therefore concluded that the safety of both ac had been compromised to the extent that a collision had been possible.

Cause: The LATCC TC NE DEPS SC mistakenly cleared the B737 to FL 170 believing that he had cleared it to FL 70.

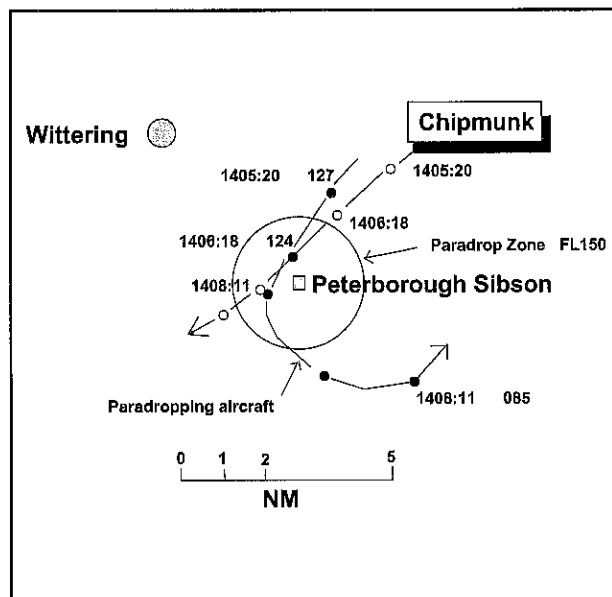
**THE CHIPMUNK PILOT** reports heading 235° at 80 kt and cruising at 2200 ft (QNH 1013) in VMC about 3000 ft below cloud. Her ac was not fitted with a transponder. She had departed

from Fenland at 1355 for Shotteswell and therefore could have been in the vicinity of Sibson 10-15 min later. The visibility was 10 - 20 km and the wind direction southwesterly at 15-20 kt. Having unsuccessfully tried to contact Wittering for a MATZ crossing clearance (see Note 4), she listened out on their MATZ frequency of 130.2. She did not attempt to call Sibson as she was flying above their airfield's ATZ. She was unaware of any parachuting taking place and subsequently assumed that the parachutists must have dropped through the cloud, whose base in the area she estimated at 5000 - 7000 ft. The pilot comments that vision from the Chipmunk cockpit is good forwards and sideways but poor directly above and below when in level flight. No NOTAM relating to the parachute event was found prior to flight.

Chipmunk crew to stray inadvertently into the area. Members noted that although the pilot claimed to be clear of Sibson's ATZ, the margin was only 100 ft above the upper limit during her transit of the airfield; this led the Board to surmise that in her effort to remain clear of Wittering's ATZ, having failed to establish contact, she had come closer than intended to Sibson. Moreover, she was evidently not alert to the possibility of parachuting activity above the ATZ, despite it being marked on the 1:500 000 topo. Members also noted that the pilot was unaware that, being a Sunday, the Wittering MATZ (which is operated by Cottesmore on weekdays) was closed and therefore a MATZ crossing service was not available; in the circumstances a call on Sibson's frequency would have been a sensible precaution. The Board concluded, therefore, that the Airprox was caused by the Chipmunk's entry into a permanently notified area of intense parachuting which then took it into conflict with the parachutists.

Cause: The Chipmunk flew into conflict with the parachutists while transiting a permanently notified area of intense parachuting activity.

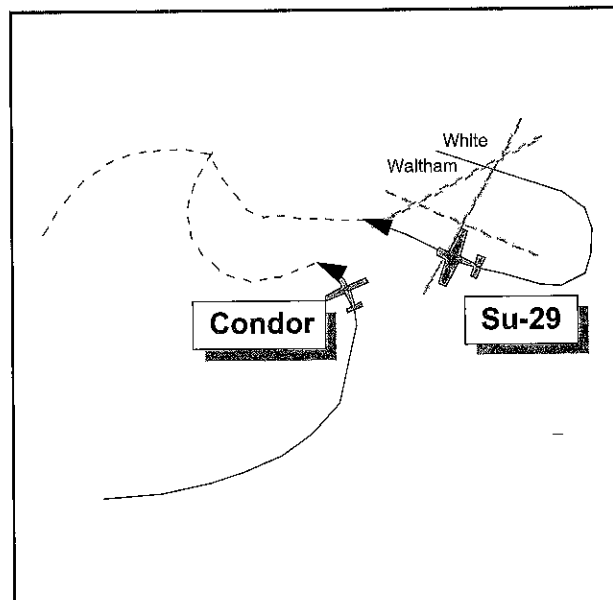
**THE Su29 PILOT** reports flying an air test after some control modifications. He had climbed in the circuit to 1500 ft downwind and up to 2000 ft on the dead side where he made clearing turns before performing security and systems checks which involved pulling and pushing, erect and inverted, to at least ±4G. He did this on a heading of 290° at 135 kt but did not see the other ac. He did not come below 1500 ft so calculated he would have been at least 700 ft above the Condor. He commented that there was an area over the airfield which was specified for aerobatics, but it was mostly used during the week so he thought those who flew at the weekend may not be used to what he

described as normal activity for the area. He emphasised that he was above the circuit while performing his airstest.

Notes: (1) The incident is intermittently visible on LATCC radar recordings. Neither ac is squawking Mode C so no height information is available. The ac appear to pass roughly 300 m apart in plan, due to the effective avoiding action clearly taken by the Condor.

The Board concluded that the cause of the Airprox was that the Su29 pilot had flown in a manner which alarmed the Condor pilot, whose ac he did not see. The degree of risk generated a lengthy discussion because of the entirely different perceptions of the incident reported by the 2 pilots. Some members suggested that it would be impossible while pulling and pushing to 4g at 135 kt to remain both below the 1500 ft ceiling and 700 ft above the Condor's 800 ft circuit height but it was pointed out that W of the RW29/03 intersection the ceiling was 2400 ft. While undoubtedly startled, the Condor pilot might well have mis-assessed the miss distance, but the difference between 40-60 ft at the same level and 700 ft was hard to explain. The radar recording was not as clear as usual but indicated a lateral separation much in excess of the Condor pilot's estimate. The Su29 certainly passed close enough to the Condor for its pilot to have seen it but without corroboration from a third party or separate additional information to judge which pilot had mistaken the miss distance, the Board could not assess the risk level.

Cause: The Su29 pilot flew in a manner which alarmed the Condor pilot, whose ac he did not see.

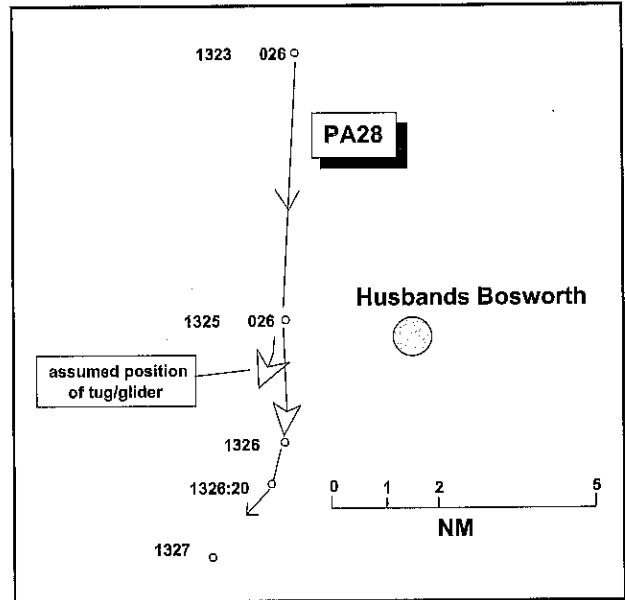
**THE PA28 PILOT** reports that he was heading 190° at 130 kt and cruising at 2500 ft (QNH 1010) while on a flight from Leicester to Cherbourg. The visibility below high broken cloud was over 10 km. He was squawking 7000 with Mode C. When passing about 3 NM SW of Husbands Bosworth, he saw a low wing single engined ac, mainly red in colour, about 1000 m away to his R as he approached from its rear L quarter. He maintained good visual contact with the ac which then passed down his starboard side 200 - 300 m away and about 200 ft below him; he did not consider there had been any risk of collision. The pilot comments that he is very familiar with the area and regularly flies out of Leicester. Husbands Bosworth is clearly shown on the chart; however, in his experience, there is little point in trying to navigate around the site as gliders from there radiate out in all directions. He says

that because the encounter was so unexceptional he did not take notes at the time and therefore could not be certain of the accuracy of his figures. However, he believes his report represents a true description of the encounter.

The Board endorsed this analysis and concluded that the PA 28 caused the Airprox by flying sufficiently close to the combination to cause the tug pilot concern for the safety of his ac. However, since the PA 28 pilot had maintained visual contact with the tug and glider throughout, members were satisfied that he was always in a position to ensure that there was never a risk of collision.

*Cause:* The PA 28 pilot flew close enough to the tug and glider combination to cause the tug pilot concern for the safety of his aircraft.

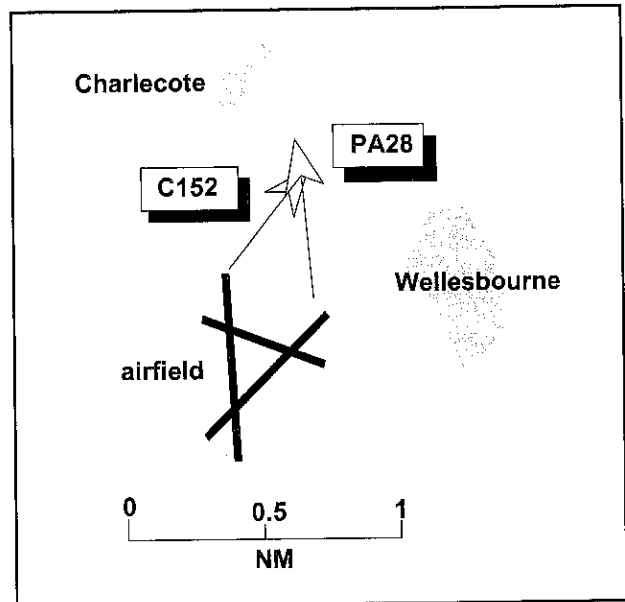
The pilot comments that vision from the cockpit of the C152 is poor above and behind due to the high wing configuration. Later that day he contacted the instructor of the PA28 who was visiting Wellesbourne with a student to practise circuits. The instructor told him that his student had initially spotted the C152 as he was in the process of going-around but had then lost contact with it; he said that at the time he had been paralleling the RW 36 centre line and climbing at 79 kt. He (the C152 pilot) drew a diagram representing the flight paths of the respective ac and the PA28 instructor agreed that it was correct. When the C152's student confirmed his instructor's account of the incident, the PA28 pilot replied that since the

C152 was abeam him on the RW it must have come up behind him. He told the PA28 instructor that as the pilot of the ac making a missed approach, it had been his responsibility to maintain visual contact with traffic departing off the RW ahead of him; the instructor did not appear to share his opinion in this instance.

All members agreed that the PA 28 pilot had a clear responsibility in these circumstances to maintain visual contact with the C152 and to ensure that he remained a safe distance from it during his go around manoeuvre; the Board quickly concluded that by not doing so the PA 28 caused the Airprox. Furthermore, despite his conviction that the C152 could not have caught up with him given his perceived geometry of the situation and the latter's inferior performance capabilities, members felt that once he had lost sight of the Cessna the PA 28 pilot was no longer in a position to comment objectively on the relative positions of the 2 ac. While the C152 pilot may have underestimated the separation distances owing to the 'shock' factor, he and his student were clearly alarmed by the PA 28's sudden appearance and concerned by their inability to take action to avoid it. Members concluded that the ac had been sufficiently close together for a collision to have been possible.

Cause: The PA 28 pilot did not keep sight of or keep clear of the C152.

Recommendation: The UKAB recommend that the Wellesbourne airport Director examines the 'go - around' and noise abatement procedures for RW 36 at Wellesbourne with a view to harmonising them to remove the existing potential for flight path conflicts on the deadside of the circuit.

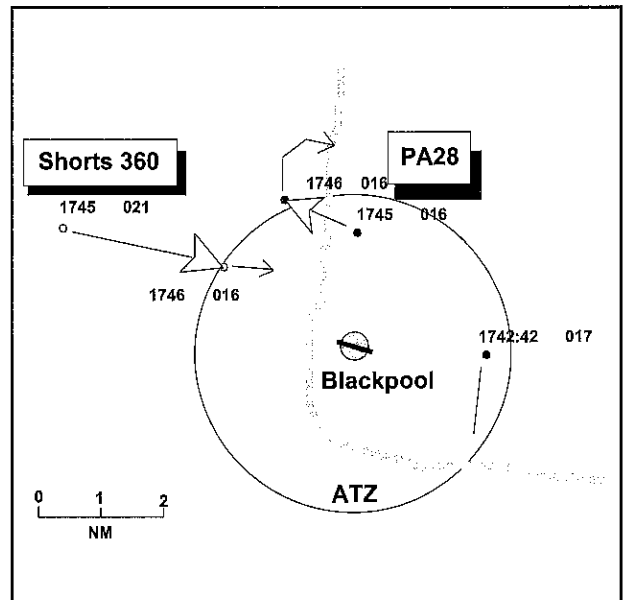
**THE SHORTS 360 PILOT** reports that he was inbound to Blackpool from the Isle of Man in VMC. Landing and navigation lights were on; the visibility was over 10 km. He was in contact with Blackpool Tower on 118.4 who instructed him to descend not below 1500 ft due to circuit traffic and cleared him for a visual approach to RW 28 RH. The FO, who was the handling pilot, positioned the ac at 1500 ft (QNH 1009) at the start of the downwind leg at 190 kt. ATC advised them of two contacts in the circuit, one on short finals and one on base leg. The crew were very familiar with the Blackpool environment and both pilots scanned the area immediately for traffic as it is not uncommon, in their experience, to find inexperienced pilots in the circuit giving inaccurate position reports. The FO confirmed both ac in sight, whereupon the Captain advised that there was also traffic at their 12 o'clock at the same level and closing. On seeing this traffic, the FO prepared to disengage the autopilot; however, the other ac began a steep turn to the N away from them so he left it engaged and subsequently carried out a normal circuit and landing. The pilot estimated minimum separation at 400 m horizontally and 200 ft vertically; he felt there had been a medium to high risk of collision. While taxiing in he asked the controller if he had had control of the conflicting traffic, to which the reply was "maybe". The ambiguity of this response caused him some concern and on querying it with ATC later on the telephone, he was advised that another ac, the subject PA28,

was believed to be the other traffic concerned and that its pilot had either misunderstood or failed to carry out joining instructions. The pilot comments that the crew had experienced a number of similar incidents at Blackpool in recent months where conflicts had arisen with traffic that had not been advised to them by ATC. He said that this problem, which affects both VFR and IFR arrivals and departures, appeared to be particularly prevalent when controllers were handling large numbers of ac in the circuit.

Cause: The Blackpool controller did not appreciate the position of the PA 28 and did not pass relevant traffic information to either the Shorts 360 or the PA 28 pilots.

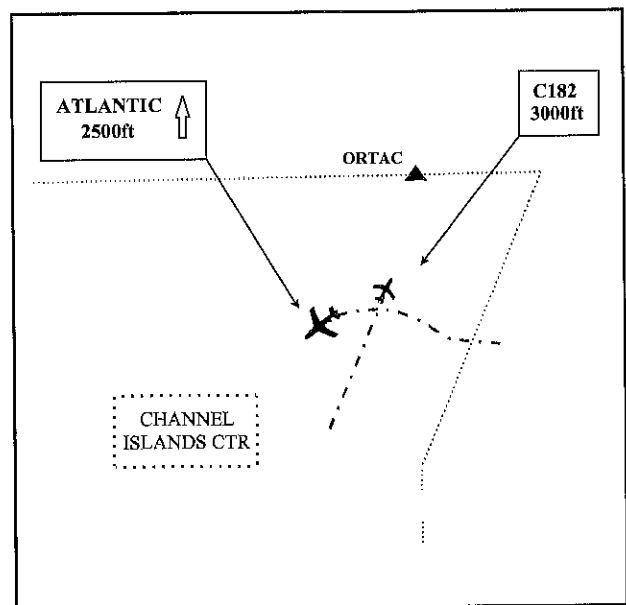
*Date:* 28 July 1998  
*Time:* 1408 UTC  
*Aircraft:* Atlantic/C182  
*Operators:* Foreign Military/Private  
*Position:* 10nm North North East of Alderney  
*ALT/HT/FL:* 3000 feet  
*Airspace Type:* Channel Islands CTR – Class A  
*Reporter:* Jersey ATC - Zone Controller  
*Reported Separation:* 1nm horizontal/500 feet vertical  
*Recorded Separation:* 1nm horizontal/500 feet vertical

The C182 was enroute from Guernsey to Bournemouth at 3000 feet in the Channel Islands Control Zone under the control of the Jersey Zone controller. The Atlantic was operating at varying altitudes on a maritime exercise from Lorient and the pilot had Jersey Radar selected on one of his radios although he did not contact the Jersey controller until after the AIRPROX had occurred.

The AIRPROX was caused by the Atlantic pilot who did not comply with the Letter of Agreement governing his operations in the Channel Islands Control Zone and climbed without clearance from Jersey ATC and into conflict with the C182.

- 1 Discussion: The Panel had nothing to add to the Summary of CAA Action.
- 2 Causal Factors: The Atlantic pilot infringed the Channel Islands CTR and conflicted with the C182.
- 3 Risk Classification: C
- 4 Recommendations: The Panel had no recommendations to make.

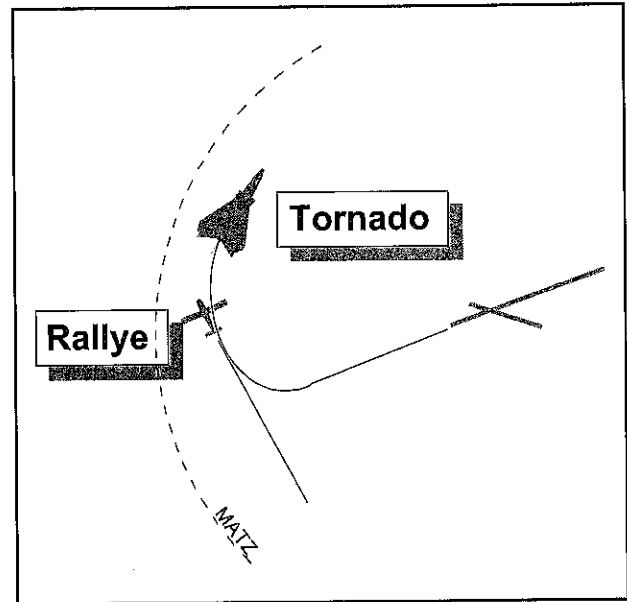
**THE RALLYE PILOT** reports heading 360° at 75 kt en route to the Waddington Air Safety Day at 1500 ft. He had talked to Lakenheath and Coningsby who told him to report at East Kirkby (CGY 070/7) which he had some difficulty identifying and set course for Bardney (CGY 325/9). He was released to the Waddington Director on 132.9 and also had difficulty identifying Bardney. He made some orbits to check his position and to avoid weather and advised Waddington that he was unsure of his position, requesting assistance. He was asked to head N and climb to 3000 ft, which he could not do because of the cloud although he did start a climb. He was told he was SE of Waddington and to maintain heading and it was at about this time that he saw a military ac climbing away to the NE. There was no turbulence but some jet noise. He was unable to assess any risk of collision as he only saw the ac going away.

Note: The Claxby radar recording shows the Tornado departing Coningsby at 1003 on a track of 252° and entering a right turn. A very intermittent primary only return is tracking 338° some 4 NM W of Coningsby and the Tornado passes it very close in plan at 1003:55, passing a similar track in its turn, while its Mode C showed between 2200 ft and 3100 ft. Its rate of climb at the time is 7800 ft/min. (The Tornado's Mode C had showed 100 ft while stationary on the ground.)

Cause: Late sighting by the Tornado pilot, of the Rallye of which he had been given traffic information.

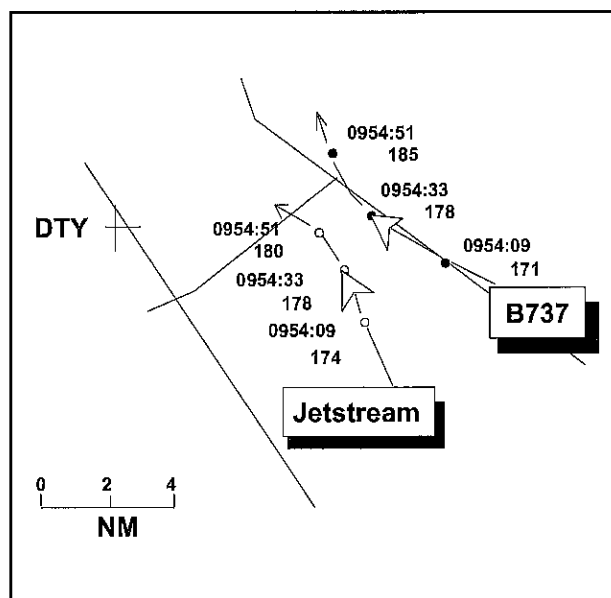
**THE B737 PILOT** reports that he was heading 320° at about 320 kt 40 NM S of the TNT VOR. He was under radar control from LATCC who had cleared him to climb to FL 190. The

visibility was over 10 km in VMC. When passing FL 170, the controller instructed him to turn R immediately heading 030° due to a traffic conflict. After landing he spoke to the ATC supervisor who advised him that the pilot of the other ac, a Jetstream, was filing an Airprox report and that the 2 ac had come within 1.6 NM of each other. He was told that this was due to an ATC error. He did not see the other ac and makes no assessment of risk.

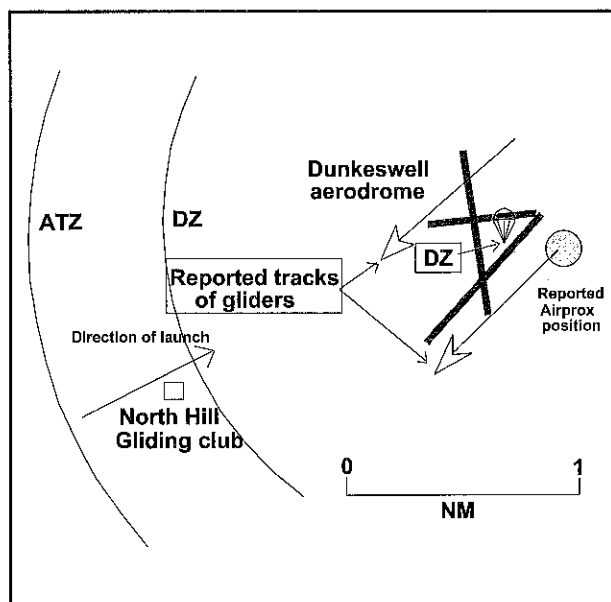
**THE PARACHUTIST** (who is also the parachute school's Chief Instructor) reports that

the dropping ac, a C206, had climbed to 10000 ft over Dunkeswell with two pairs of parachutists (in tandem) plus a cameraman on board. Owing to the wind direction and strength, the exit point was some 300 m to the E side of the airfield. The C206 pilot called DZ control on 129.9 for clearance to drop. Approval was given after a thorough search by the ground crew of the area above the exit point, and the pilot reported despatching on the airfield frequency, 123.475. The parachutist left the ac in the first tandem; after about 30 sec of freefall he deployed his parachute which opened at 4500 ft. Looking down between his legs, he saw a white high performance glider about 300 ft below him tracking W. He watched it fly under the second tandem pair and then cut across the S side of the airfield towards North Hill. A second glider was seen to pass across the N side of the airfield on a similar track. After landing, the DZ controller told him that he had also seen the glider.

The parachutist later telephoned the gliding club at North Hill to inform them of the incident and met one of their members that evening to discuss it. The member was of the opinion that the gliders were probably from outside the area. However, in a later conversation with the gliding club CFI, he was advised it was possible that a club glider might have been involved. The CFI reminded him that although Dunkeswell was NOTAMED for parachuting activities, it was legal for gliders to cross the airfield ATZ at 2000 ft agl; he also said that the gliding club had dispensation from the CAA to fly up to the edge of the airfield (see UKAB Note (2)), which the parachutist found very disturbing. (A full time parachute club has been in existence at Dunkeswell since 1965). The parachutist points out that sky divers can be in free-fall for 50 seconds and a glider transiting the area can cover a large distance in that time. Furthermore, not all gliders are radio equipped so DZ controllers are not always able to give warnings in these circumstances. Notwithstanding the legalities of flying within a NOTAMED parachuting area, parachutists believe that to do so displays poor airmanship which could easily lead to a fatality.

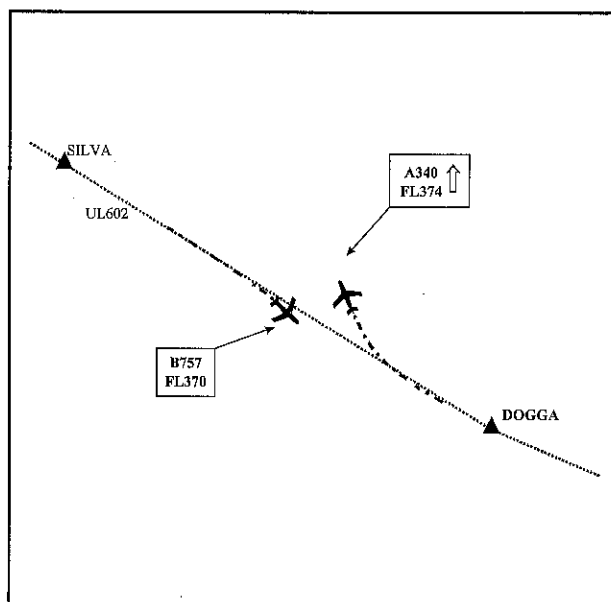
#### **Occ No. 98/04393**

The AIRPROX was caused by the Goles controller who, although he had co-ordinated the climb of the A340 to FL390, did not write the revised cleared level on the DOGGA fps and consequently allowed it to climb into conflict with the B757 at FL370. In addition, the Goles controller should have been aware of the situation when the A340 pilot made his initial call on the Goles frequency, reporting climbing to FL390.

In mitigation, there appears to be some ambiguity in the responsibilities for fps marking, following intra sector co-ordination and that the correct procedure needs to be clarified. Therefore, it has been recommended that LATCC management review and report the progress on the recommendation made by the Air Traffic Services Standards Department following the 1997 audit, with reference to indicating responsibilities for fps marking for Intra Sector co-ordinations in the MATS Pt 2 local operating instructions.

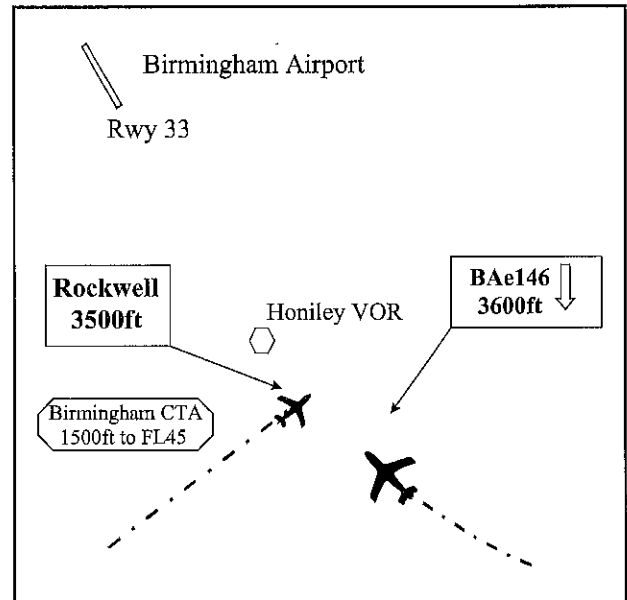
#### **Occ No. 98/04482**

The AIRPROX was caused by the Rockwell pilot who entered the Birmingham CTA without clearance and came into close proximity with the BAe146.

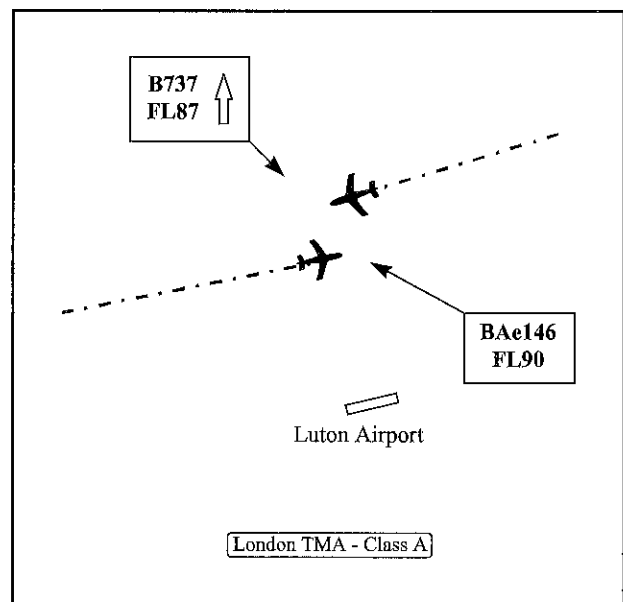
**Occ No. 98/04698**

The AIRPROX was caused by the LATCC TC North West Departures controller who, in a period of high workload, overlooked the presence of the BAe146 at FL90 when clearing the B737 to climb through its level from FL80 to FL120.

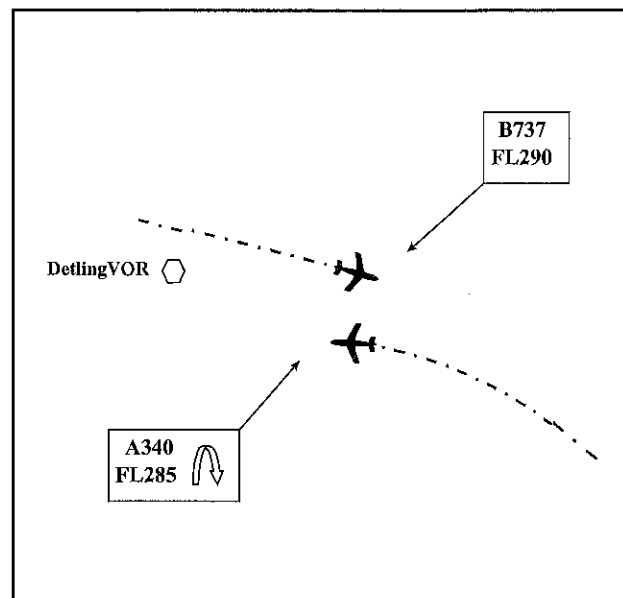
#### **Occ No. 98/04695**

Both aircraft involved in this AIRPROX were under the control of the LATCC Area Control (AC) London Upper Sector (LUS) East Sector. The B737 was en route from Manchester to Brussels and was level at FL290. The A340 was en route from Paris to Montreal and was in the climb to FL310.

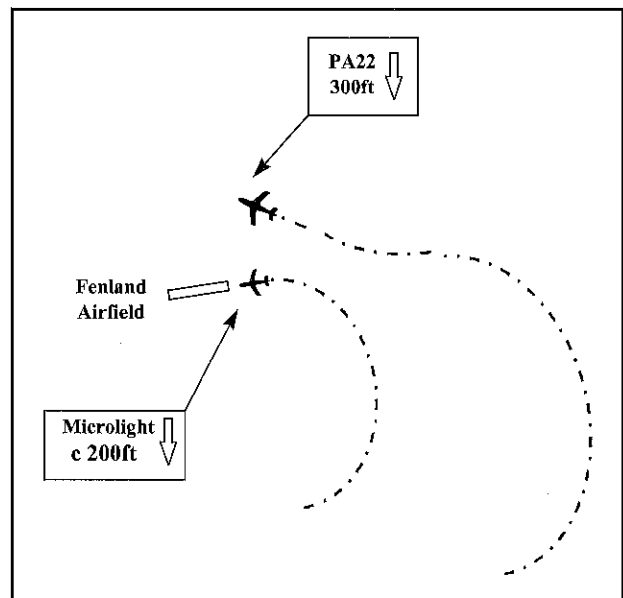
**Occ No. 98/04750**

Both aircraft involved in this AIRPROX were operating in the circuit at Fenland airfield receiving a Flight Information Service from the Fenland Aerodrome Flight Information Service Officer (AFISO). The PA22 was inbound from an airstrip at Burnham and the Microlight was on a local flight from Fenland.

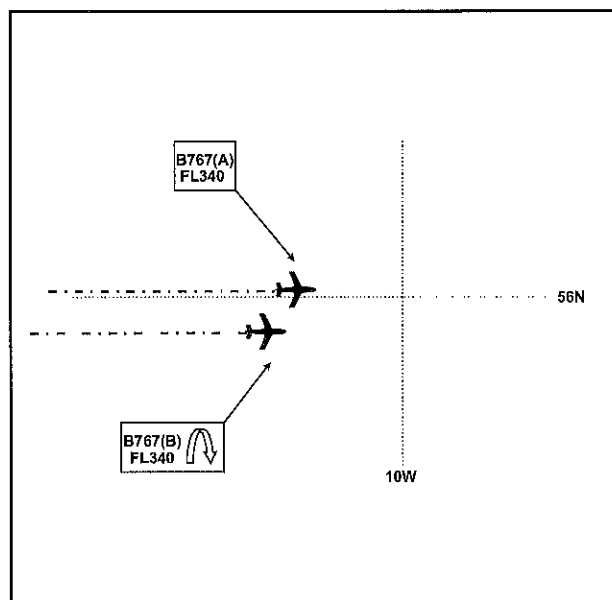
### Occ No. 98/04810

The AIRPROX was caused by the pilot of the B767(B) who reacted to a climb instruction message not directed to him and climbed his aircraft from FL330 into conflict with the B767(A) at FL340. He also used the wrong numerical element of his call sign but with his

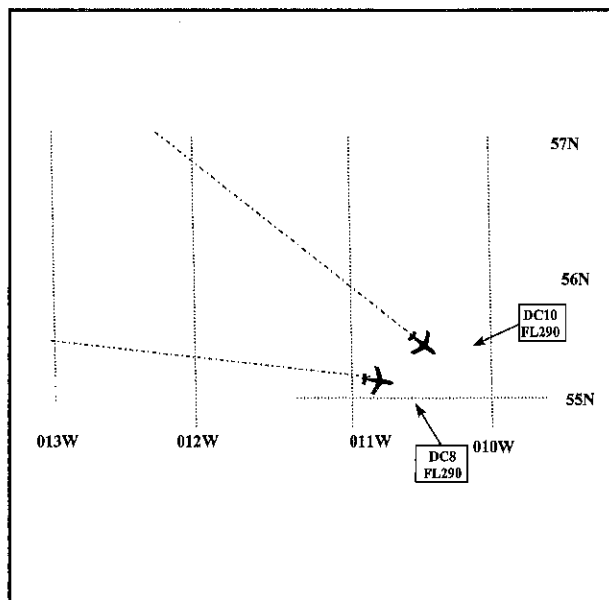
### Occ No. 98/04814

The AIRPROX was caused by the DC10 pilot deviating from his assigned Oceanic track but

In the absence of any follow up report from the DC10 pilot, or his company, the Panel could only surmise as to the cause of the navigation error. The crew were clearly surprised to be told that they had arrived at an incorrect Oceanic exit point. It seemed probable to the JAAP that the new co-ordinates had either not been entered into the aircraft computer or had been entered incorrectly. Whatever the case, the crew did not detect their error and it had to be assumed that inadequate cross-checking had occurred on the flight deck.

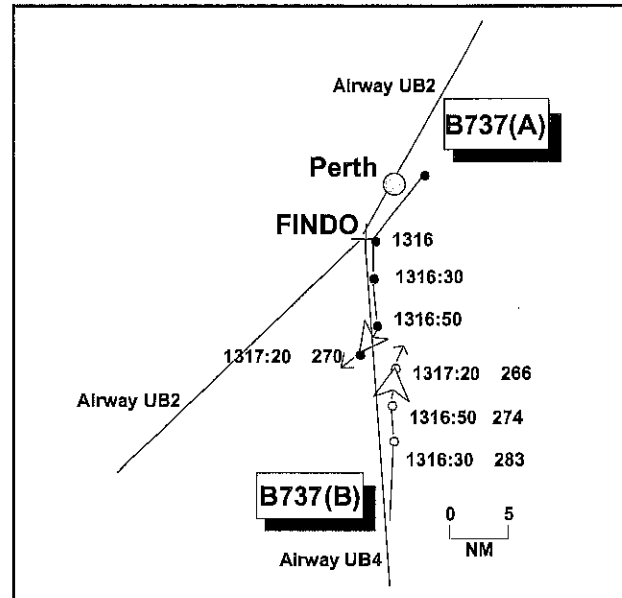
Members quickly agreed that B737(A)'s turn onto the southerly heading put the ac into conflict with B737(B) and caused the Airprox. Much of the lengthy discussion which followed centred on the possible reasons for B737(A) pilot's departure from the heading which ATC had instructed him to maintain.

Cause: The pilot of B737(A) turned off his radar heading and into conflict with B737(B).

Recommendation: The UKAB recommends that the RTF Working Group draws attention to standard phraseology listed in CAP 413

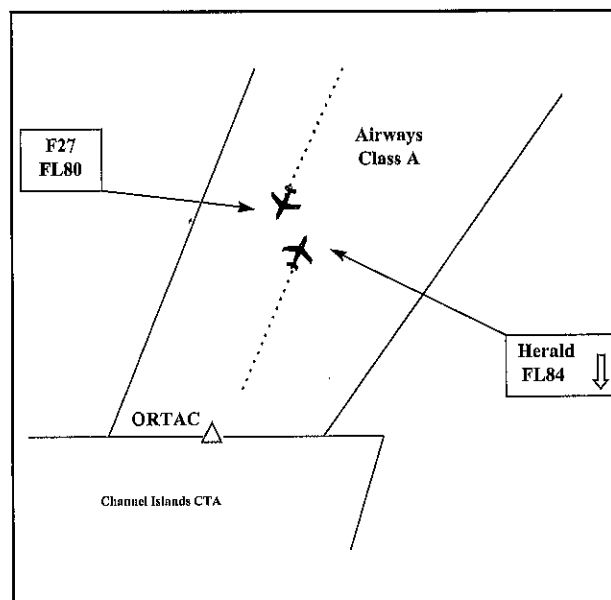
### Occ No. 98/04870

The AIRPROX was caused by the LATCC Hurn Sector Controller who did not take account of the presence of the FK27 when instructing the Herald pilot to descend to FL50.

It was noted that whilst the confliction may not have been apparent from the radar display due to label overlap, the fps display did show the traffic conflict situation. Furthermore, the STCA performed as required but it was not acted upon by either controller involved.

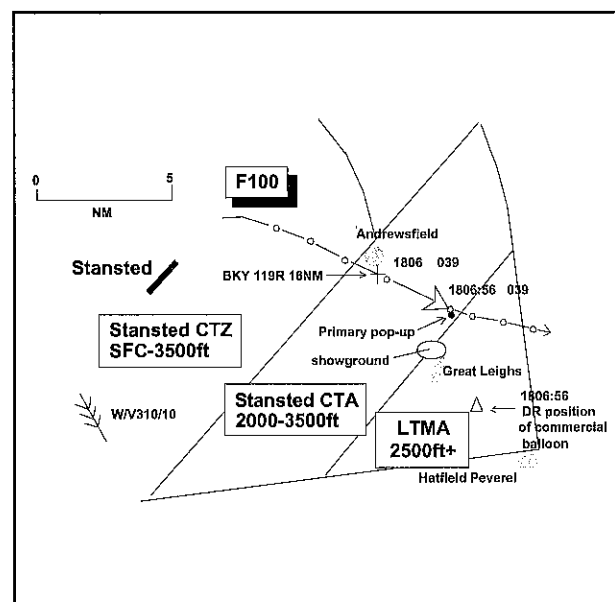
The confliction occurred close to the vertical boundaries of the Stansted CTA and the London TMA which restrict FIR operations in that region to 2000 or 2500 ft respectively. While a very large balloon at these altitudes might appear to be higher than this, members accepted the F100 pilot's perception that the one he saw was no more than about 500 ft below him as he passed it, thus placing it well within the base of both the CTA and the TMA in that area. On balance, therefore, the Board concluded that the Airprox was caused by the penetration of an untraced balloon into CAS. With regard to risk, members noted the F100 pilot's estimate of 500 ft vertical separation and his 'medium' risk assessment and concluded there had not been a risk of collision.

Cause: A conflict within CAS with an untraced hot air balloon

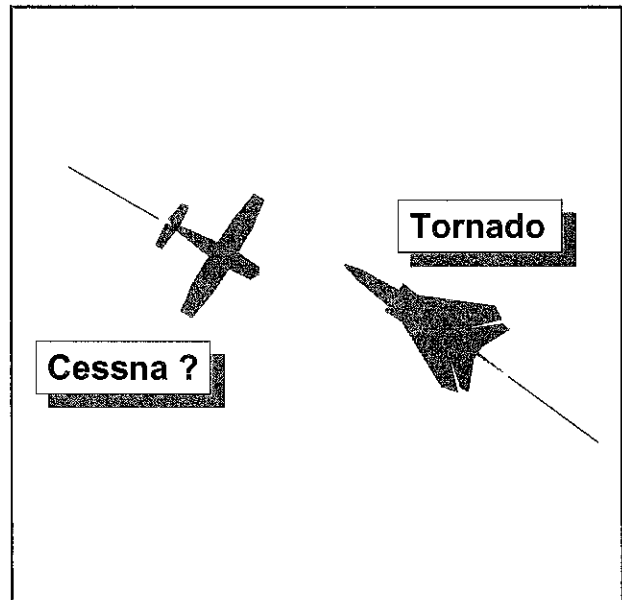
While there was no way to tell if the light ac pilot had seen the Tornado, it was clear that the Tornado pilot had seen the light ac late and the Board agreed that this was the cause of the Airprox. Without the other pilot's report and no

Cause: Late sighting by the Tornado pilot.

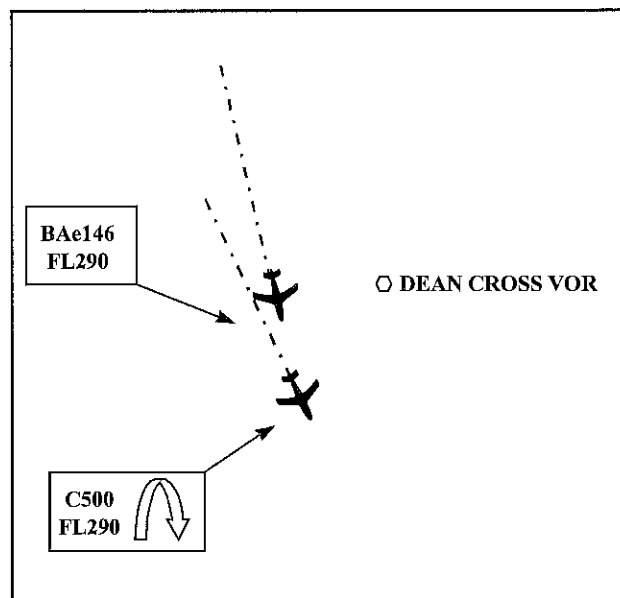
**Occ No. 98/05002**

The AIRPROX was caused by the ScACC Dean Cross Sector Controller who, while clearing the C500 to climb through the level of the BAe146, misjudged the C500's performance, whereby its speed decreased allowing the BAe146 to catch up and the lateral separation to be reduced below that required.

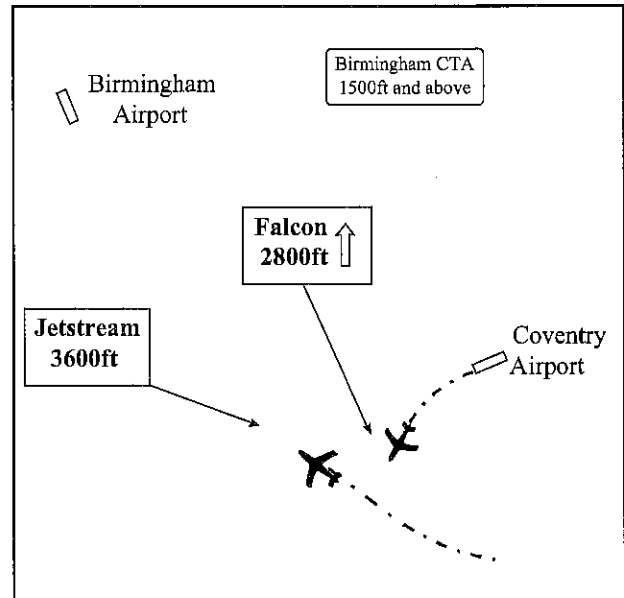
### Occ No. 98/05001

The Jetstream was inbound to Birmingham from Rotterdam and was being vectored by the Birmingham Approach Radar controller for an ILS approach to runway 33. The Falcon had departed from runway 23 at Coventry on a COMPTON Standard Instrument Departure (SID), enroute to Vitoria in Spain. At the time of the incident, the Falcon pilot had been instructed by the Coventry Aerodrome controller to contact Birmingham Approach but had not yet contacted the controller.

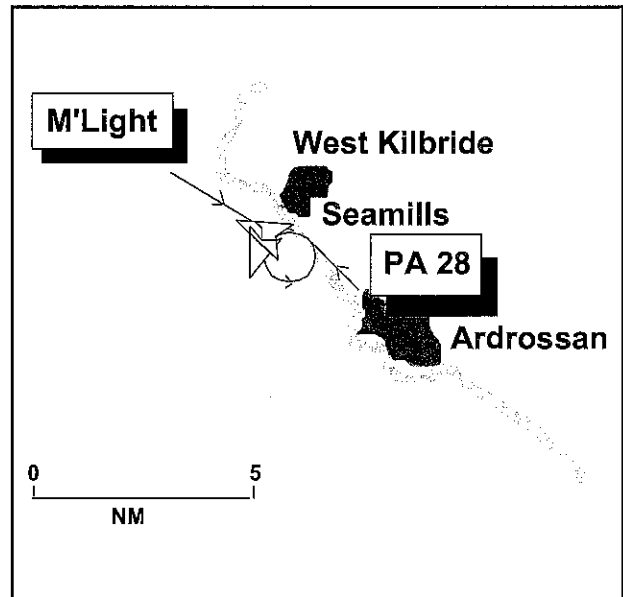
Cause: A late sighting by the PA 28 pilot.

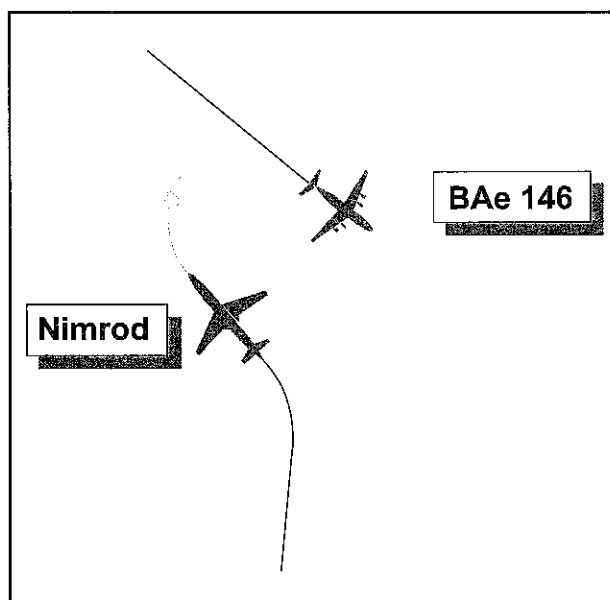
take off checks and turned onto his departure track from Inverness. Passing 3200 ft he saw a Nimrod in his 3 o'clock on a reciprocal track; it looked as if its pilot had seen him and was turning away to the left. It was 200 ft below and about 500-1000 m away as it passed and he considered the risk of collision was medium to high. He had not received any traffic information on it.

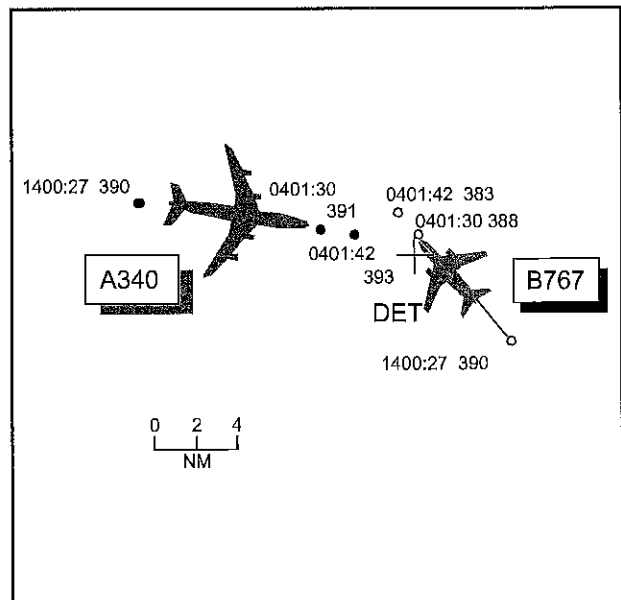
**AIRPROX (P) REPORT No 114/98**

**THE B767 PILOT** reports that he was heading about 330° at M0.8 while cruising at FL 390 under the control of LATCC on 127.42. The visibility was 100 NM in VMC. When about 70 NM NW of Boulogne, he received a TCAS TA, immediately followed by an avoiding action instruction from ATC. A TCAS RA then
