**UK AIRPROX BOARD**

# **Analysis of Airprox in UK Airspace**

**Report Number 1**

**January 1998 to December 1998**

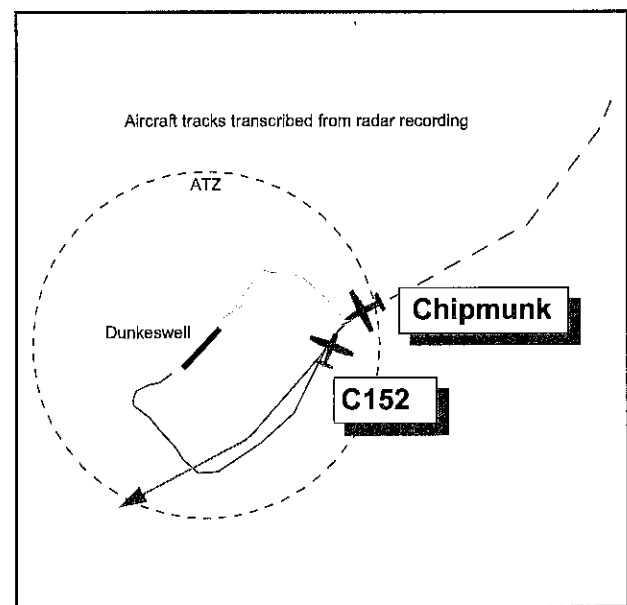
**THE CESSNA PILOT** (instructor) reports heading 045° at 90 kt approaching the end of the downwind leg at 800 ft in a LH circuit at Dunkeswell, with a student pilot. The student shouted out an ac 5-600 yd away, closing from their 12:30 so he took control and made a sharp 70-80° AOB descending right turn, losing 300 ft. The other ac, possibly a Chipmunk, passed 50 ft above and 5-600 yd to his left and continued without deviation. Its pilot did not respond to a call on Dunkeswell A/G frequency, and had not warned of his transit through the ATZ, and there had been a very real risk of collision.

**THE CHIPMUNK PILOT** reports heading 239° at 90 kt on a cross country at 1850 ft (QNH), about 100 ft below cloud. He saw a Cessna 6-700 m ahead which passed 4-500 ft to his left and 2-300 ft below, weaving. There was no risk of collision and no need for avoiding action, and he did not consider it was necessary for the Cessna pilot to have filed an Airprox, which he thought the flying school may have done to deter other pilots from flying near. The Cessna was out of its ATZ as confirmed by his map and the GPS fitted in his ac. He was operating VFR

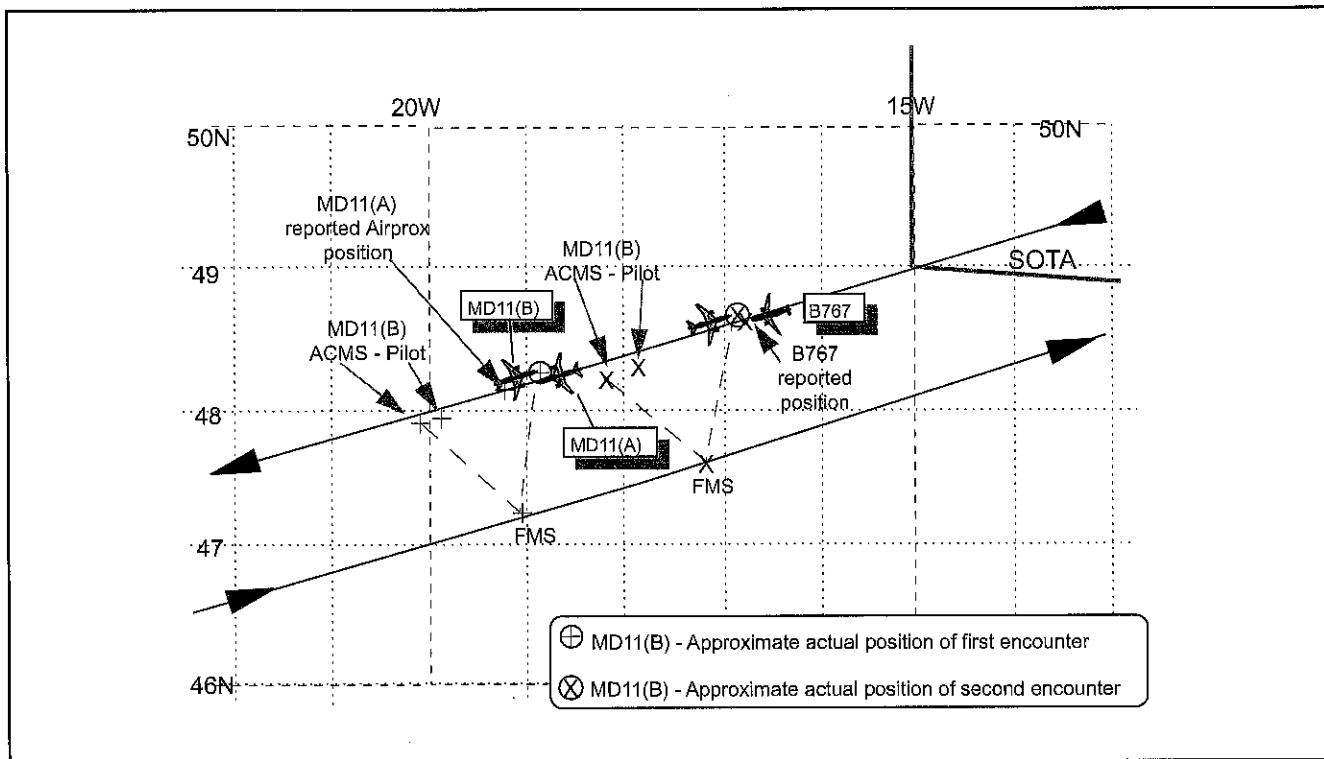
**INVESTIGATION.** It was clear from the start that the reason the ac had come into confliction was that MD11 (B) had suffered a gross navigation error (GNE). The reason for this was thoroughly investigated by the airline's flight safety and quality assurance department under remit from its national air safety authority.

The crew of MD11 (B) had been operating in the Caribbean and northern part of S America for the 10 days before the incident, spending much of the time at one of their destinations some 66 NM W of their final departure airfield. The ICAO designators for these airfields differ only by their final letters. On preparing for departure, while the F/O was loading the route into the FMS he mistakenly entered the designator for the other airfield as the departure location. At the time, the Captain had been distracted from monitoring this task by a conversation with the ground engineer about a 'hot spot' on the floor of the main cabin which had been reported by the incoming crew. The importance of this discussion was heightened by the recent loss of the Swissair MD11 off Nova Scotia after an on-board fire. The small difference in the northings of the 2 airfields appears to have been insufficient to stop the IRS alignment or trigger the master caution, both of which will happen if the system finds itself aligning at a different latitude to that indicated by the departure airfield designator. No abnormalities were apparent during alignment. Furthermore, the 2

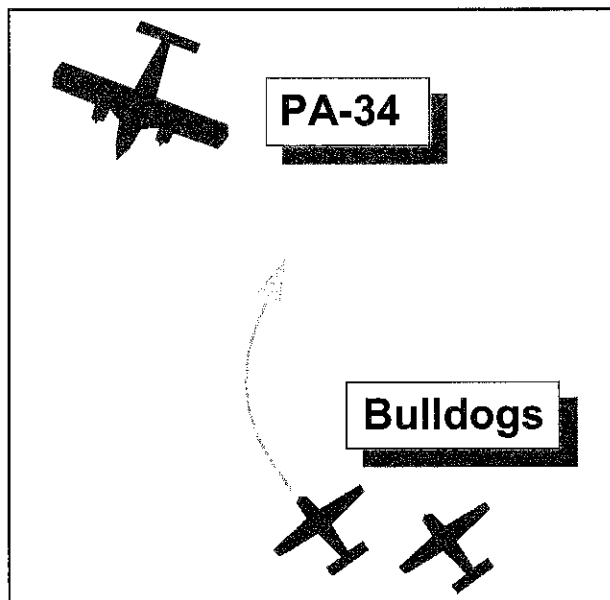
**THE PA34 PILOT** reports heading 220° into sun at 130 kt at 2400 ft on the QFE, receiving a FIS from Benson on 120.9. ATC advised him of a pair of Bulldogs which he saw at the same time about 1 NM away approaching from his 10:30. They were turning away to pass down his left hand side by about 0.5 NM with no risk of collision.

**HQ MATO** reports that the Benson Watchman SRE was unserviceable so only secondary radar data from the Brize Norton MSSR source was available. The Bulldog section departed VFR from RW 19 to the west, receiving a FIS from Benson Approach on 268.825, and squawking 7365 with Mode C. The section then switched to another frequency but the leader recalled Approach at 1433:04 to report an Airprox which he advised occurred at 2500 ft Cotswold

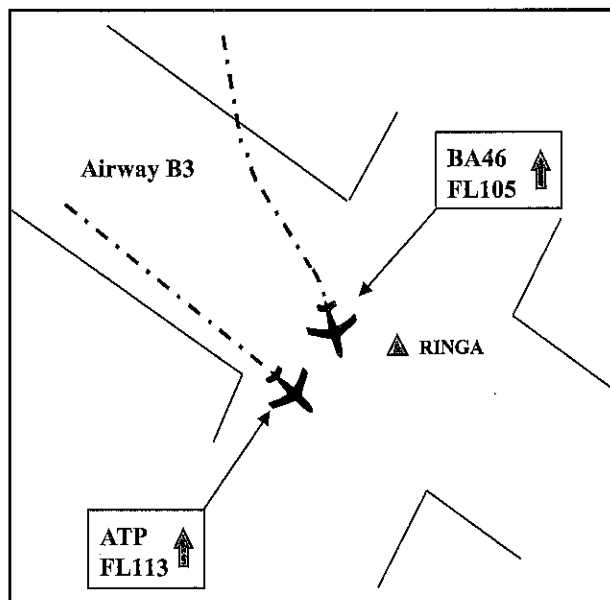
### Occ No. 98/05394

*Date:* 15 September 1998  
*Time:* 1052 UTC  
*Aircraft:* BAe146/ATP  
*Operators:* British Airlines  
*Position:* Ringa  
*ALT/HT/FL:* FL110  
*Airspace Type:* Airway B3 - Class A  
*Reporter:* ScACC - Antrim Sector P & E Controller  
*Reported Separation:* 4nm horizontal/Nil feet vertical  
*Recorded Separation:* 3.2nm horizontal/800 feet vertical

The AIRPROX was caused by the Aldergrove Approach controller who did not ensure that separation was provided between the BAe146

- 2 *Causal Factors:* The Aldergrove controller did not provide standard separation between the ATP and the BAe146.
- 3 *Risk Classification:* C
- 4 *Recommendations:* The Panel had no recommendations to make.

In order to reduce the possibility of any misunderstanding, in similar circumstances in the future, it is recommended that the Aldergrove Approach Controller should identify appropriate aircraft to the Antrim controller prior to co-ordination taking place, and the latter controller should confirm that the identification has been established.

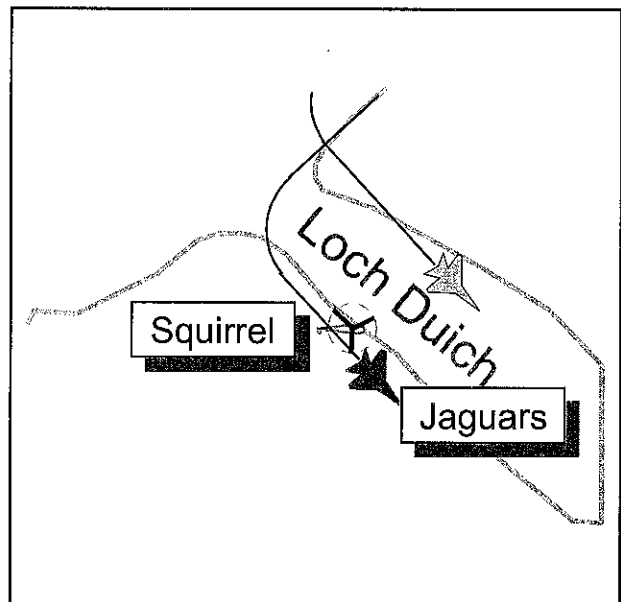
**THE JAGUAR PILOT** reports heading 140° at 450 kt on an operational low level exercise, and authorised not below 100 ft msd. He was climbing through 500 ft in a left turn, following the contours of the loch side, when he saw a helicopter apparently hovering with a USL as it passed below his port wing; it was 2-300 ft

below and about 100 m left of his track. It was too late for avoiding action when he saw it but he transmitted its position to the following pair who were able to avoid the position. Furthermore, he appreciated that had he been

at his authorised minimum height there could have been a collision risk or a danger to the helicopter from his wake. A CANP (No 5846) had been issued for USL work at the Airprox position mandating a 2 NM avoidance up to 1500 ft, but along with another in the area, had expired at 1100. A third CANP to the N at Loch Carron expired at 1200 and was avoided laterally.

*Cause:* Late sighting by the Jaguar pilot.

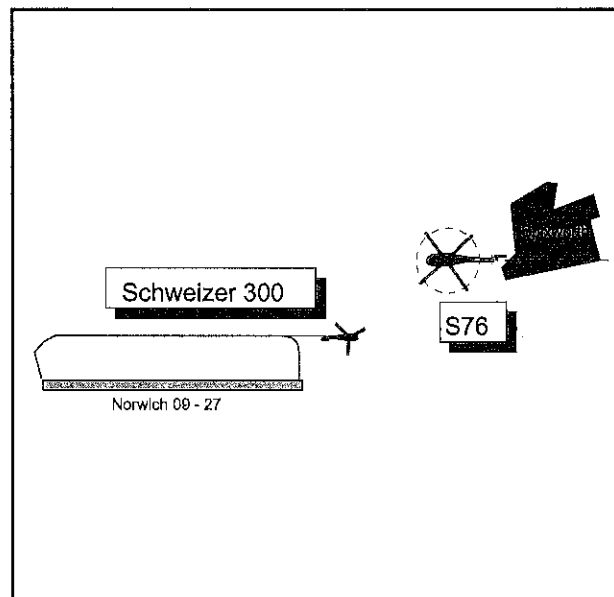
**THE S76 PILOT** reports that Coltishall ATC had vectored him to the E of Coltishall while inbound under IFR from the N to Norwich which was on RW 09. He asked why he was being vectored to the E which he thought was inappropriate with RW 09 in use, and was told that there would be less delay this way. Norwich APP subsequently gave him vectors which brought him over Spixworth at 1000 ft which was within the visual circuit. Had he not widened his downwind leg he would have flown extremely close to a 'Hughes' 300 which was on climb-out. As it was he saw it 4-500 ft away while he was heading 270° passing 800 ft at 110 kt at the same time as tower advised there would be circuit traffic. He made 2 further points: (1) that it was inappropriate to vector him into an active

circuit, especially into the climb-out path of other ac and (2) he should have been told by APP that the circuit was active; he had assumed it was clear because other departing traffic had been notified. Although he could see they were going to miss, he considered the risk of collision was high.

**THE SCHWEIZER 300 PILOT** reports heading 090° at 60 kt having just taken off from the N taxiway at Norwich; he was climbing to 500 ft for a 500 ft circuit because he had been warned of a helicopter joining LH downwind for RW 09. He looked ahead and saw the S76 a couple of miles away at about 500 ft or above heading for the downwind position. He did not consider

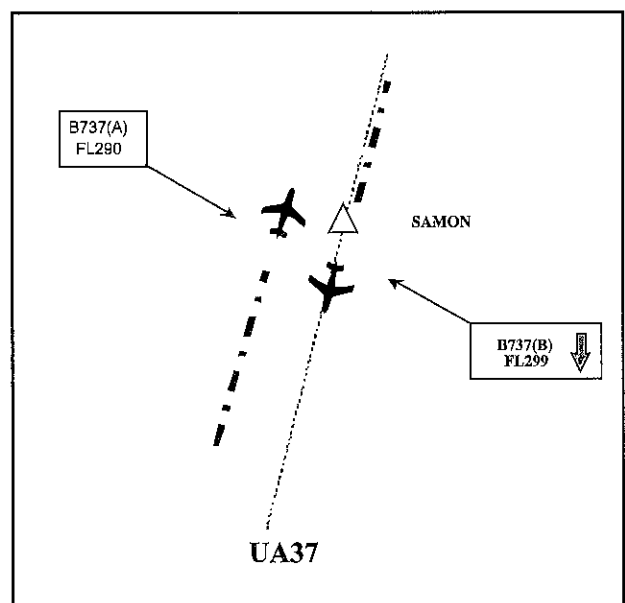
**Occ No. 98/05523**

*Date:* 22 September 1998  
*Time:* 0714 UTC  
*Aircraft:* B737/B737  
*Operators:* Foreign Airlines  
*Position:* SAMON  
*ALT/HT/FL:* FL290  
*Airspace Type:* Upper ATS Route (UAR)  
 UA37 - Class B  
*Reporter:* LATCC - Area Control North  
 Sea Beeno Sector Controller  
*Reported Separation:* 2.1nm horizontal/1000 feet  
 vertical  
*Recorded Separation:* 2nm horizontal/880 feet  
 vertical

The AIRPROX was caused by the LATCC AC Beeno Sector Controller who did not ensure that prescribed lateral separation was maintained when clearing the pilot of the

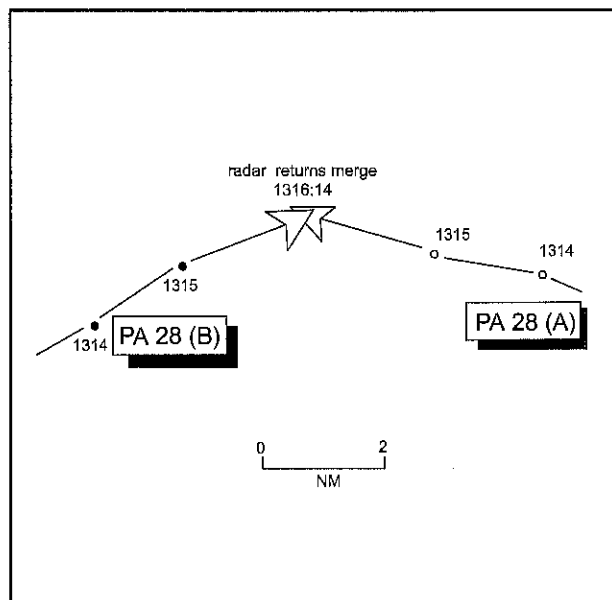
**THE PA28 (B) PILOT** reports that he had departed from Biggin Hill for Southend on an IMC instructional flight. The visibility, 700 ft below cloud, was 8 km in VMC. He was heading 060° at 105 kt and cruising at 2300 - 2400 ft (QNH 1009), squawking 7000 with Mode C off. He was observing the actions of his student, who was in the process of changing frequencies from Biggin to Southend, and was preparing to write down any information passed by ATC, when he became aware of an ac flying about 300 ft under him on a 90° crossing track from the R. He was unable to take avoiding

action owing to the late sighting but thought that, in any case, the existing vertical separation was sufficient to preclude the necessity for such action. He felt there had been a medium risk of collision.

*Cause:* Late avoiding action by PA28 (A) and a non-sighting by PA28 (B).

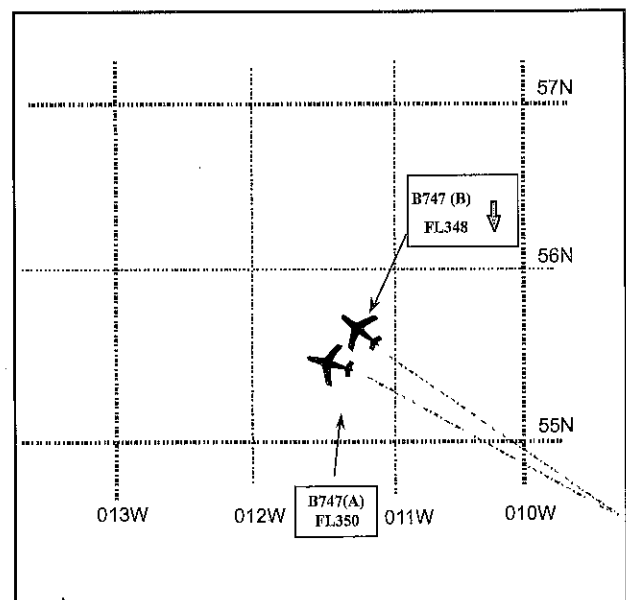
**Occ No. 98/05624**

*Date:* 27 September 1998  
*Time:* 1331 UTC  
*Aircraft:* B747 x 2  
*Operators:* Foreign Airline x 2  
*Position:* Near 55°N 10°W  
*ALT/HT/FL:* FL350  
*Airspace Type:* Shanwick OCA - Class A  
*Reporter:* ScACC/Shanwick OCC South West Sector Controllers and FL360 En Route Controllers  
*Reported Separation:* 2nm horizontal/Nil feet vertical  
*Recorded Separation:* 2nm horizontal/Nil feet vertical

At approximately 1340, the Separation Monitoring Function (SMF) at the ScACC Watch Manager's desk alerted and, on inspection, it revealed that B747(B) had slowly descended and had conflicted with B747(A) causing an AIRPROX. At the time the incident was reported it was understood that the B747(B) may have entered a stall condition at FL360, causing a loss of altitude. Consequently, the occurrence was treated as a serious incident under the provisions of Annex 13 ICAO Air Accident Reporting Procedures. It was later decided that as the event had taken place in North Atlantic airspace between two aircraft en route to Canada that the Canadian Transportation Safety Board (TSB) would carry out the serious incident investigation.

The AIRPROX was caused by the B747(B) crew who, after passing 10°W at FL360, were unable to sustain the aircraft at that level. The subsequent descent to FL350, required to regain sufficient airspeed for level flight, put the aircraft into close horizontal and vertical proximity with the B747(A) which was flying in the same direction. The loss of airspeed was not detected by the flight deck crew none of whom had monitored the aircraft performance to determine if the thrust settings selected were adequate for the aircraft altitude versus weight.

- 2 *Causal Factors:* The crew of B747(B), who had allowed their aircraft to lose speed such that it was unable to sustain level flight at FL360, were forced to descend to regain speed and in doing so flew through the level of B747(A).
- 3 *Risk Classification:* C
- 4 *Recommendations:* The Panel had no recommendations to make.

That the Training Department ensure all crews are trained in the idiosyncrasies of operating under maximum performance altitude, weight/speed conditions such as those faced by the crew of B747(B). The emphasis should be placed on the small margin of performance available and the techniques described in the AMO to handle this type of situation.

As a result of the DFDR recommendation, the operator has published an Aircraft Technical Bulletin #405, dealing with Flight Data Recorder Correlation Checks.

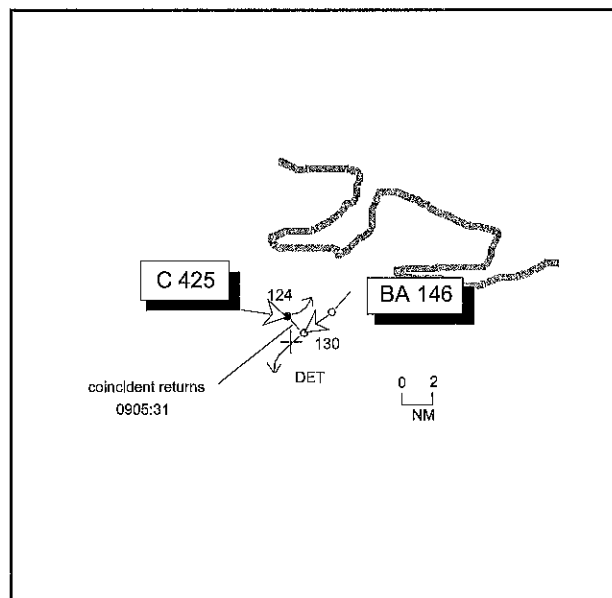
**THE BAe 146 PILOT** reports that he was heading 197° at 295 kt and cruising at FL 130 under radar control from LATCC during a TIMBA 1E arrival to Gatwick. He was squawking 2110 with Mode C. The weather

was CAVOK. ATC advised him of conflicting traffic and instructed him to turn onto 170° for avoiding action. He did not see the other ac but

*Cause:* The C425 pilot exceeded his cleared flight level owing to an incorrectly set altimeter.

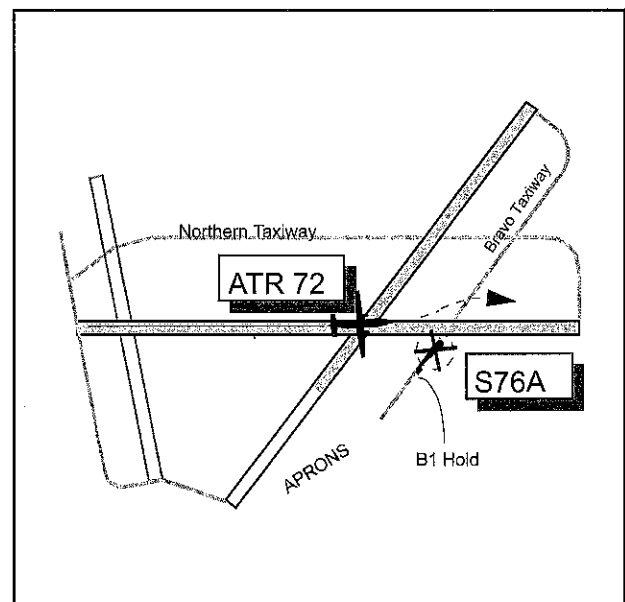
**THE ATR 72 PILOT** reports heading 093° at 90 kt on take-off from RW 09 at Norwich having heard the S76 being told to hold at B1. He

became aware that the helicopter was hover taxiing beyond B1 at the same time as ATC told it to stop immediately. He saw it adopt a high nose-up attitude and stop 5-10 m short of the RW edge. Once airborne he banked left to increase separation, passing the B1 hold at about 100-150 ft in the climb. He thought there had been a medium risk in the incident.

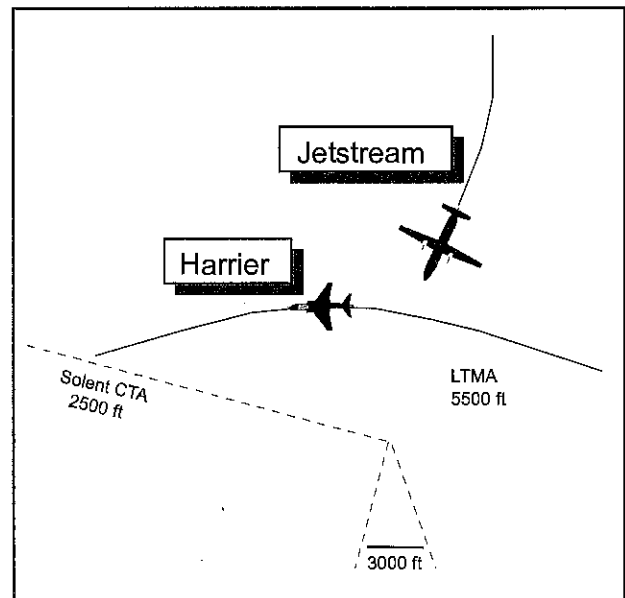
**THE HARRIER PILOT** reports heading 300° at 350 kt on a departure from Dunsfold and

receiving a RIS from Farnborough on UHF. He was cleared to climb to 5000 ft (the base of controlled airspace above him was 5500 ft) and the Jetstream was called to him as unknown traffic; he saw it when it appeared from behind/above a cloud layer. It was never on a collision course; he passed well ahead (2 NM) at a similar level and a much higher speed. There was no risk of collision and no conflict of flightpaths; he was surprised that an Airprox had been filed and queried why the Jetstream had descended out of controlled airspace.

Note: LATCC radar recordings show the Jetstream tracking 178° in a steady descent, and the Harrier converging on it on a track of 295° at Mode C readings varying between FLs 52 to 54. When the ac are about 2 NM apart the Jetstream, passing FL 51 Mode C, turns onto 210° and is passing FL 48 as the Harrier crosses about 2/3 NM ahead at FL 53 in a very gentle left turn from 298° to 252° (the turn was

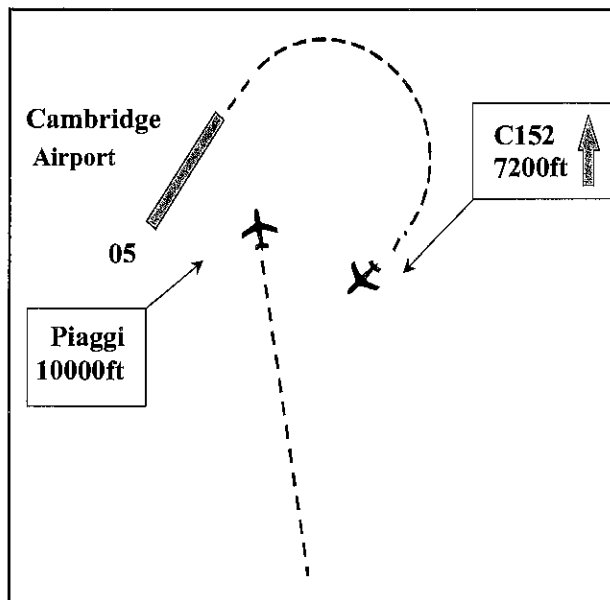
The Aerodrome Controller reported that from an initial good forecast, the weather in the circuit at Cambridge deteriorated within the space of two

hours to give a cloudbase below 500 feet. He reported that during this period, he believed separation was almost certainly lost when the Piaggio pilot flew through the downwind leg and was directly over the runway before realising his position. The Piaggio pilot was at this time still on the Approach frequency and neither he nor the pilots acquired visual contact with any other aircraft. However, the controller took AIRPROX reporting action.

In a subsequent verbal report the controller stated that his objective in submitting the AIRPROX was to highlight the inaccurate weather forecast provided for Cambridge. A later report from the Met Office stated that, with hindsight, the issued low level weather forecast for the area was clearly too optimistic and that no amendment had been issued. In addition, Terminal Aerodrome Forecasts (TAFs) for Cambridge, which took into account the deteriorating conditions which were spreading from the North East, were not issued until after the incident.

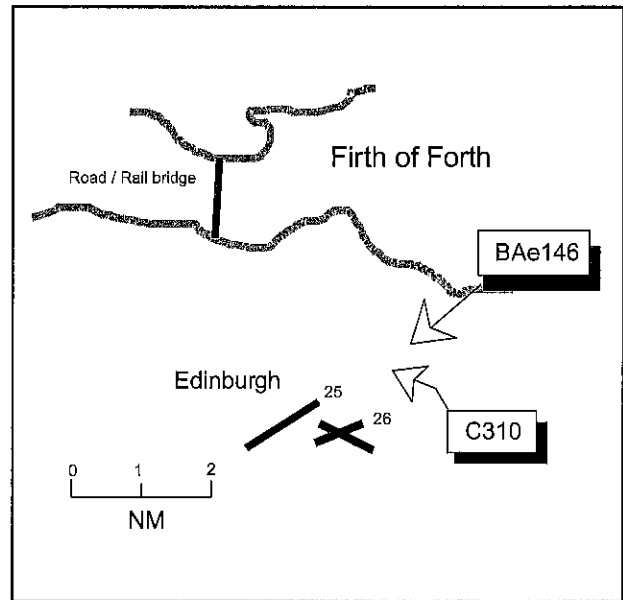
Note (1): Examination of the Edinburgh Approach Control RT transcript (121.2) shows that the C310 pilot first called at 1623. It is evident from the transcript that the pilot's transmissions were almost unreadable at times but eventually, having been given and read

back a clearance limit of the Forth Bridge, the pilot was transferred to the tower frequency (118.7) at 1627. On contact with this frequency at 1629, the pilot reported *'passing the bridges'* and was instructed to report at the South Tower. This he did about a minute later and was instructed to join and report R base for RW 26. (Again, it is clear that there is difficulty understanding some transmissions). The pilot acknowledged this instruction correctly and at 1631 reported R base. He was instructed to call final, which he acknowledged. At 1633 ATC asked the C310 pilot for a *'position report'* to which he replied that he had *'lost the airfield'* and requested radar vectors. When the controller asked if he was *'lost'*, the pilot replied *...."er no I'm not lost I've got the river can I continue with er radar vectors for two six and two five"*... The controller replied that he was unable to give radar vectors for 26 and requested the ac's altitude, which was then given as 1500 ft. At 1634 the pilot was asked to squawk 0431 and instructed to fly a heading of 360° (relayed from the radar controller). At 1635 the pilot reported at *'the bridges'* and was instructed to remain there. About a minute later he reported that he had the airfield in sight and was in a downwind position for RW 25. Having asked for a repeat of this message ATC replied *...."negative c/s remain at the Bridges please....report visual with a Fokker 100 at three miles for RW 25"*. The pilot confirmed he

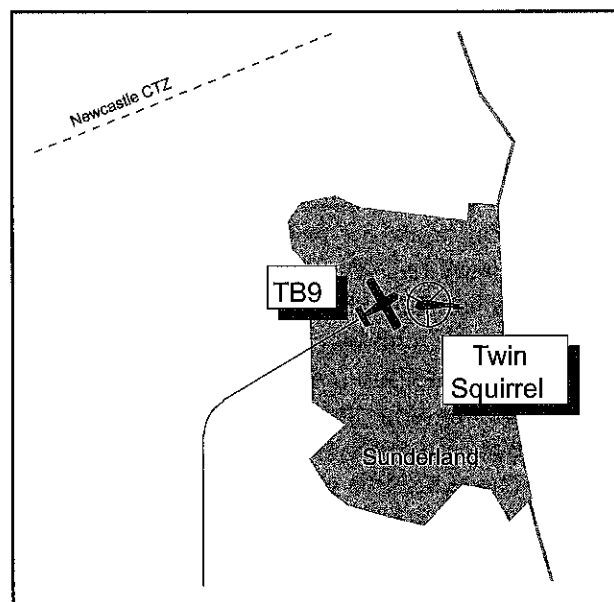
**THE TWIN SQUIRREL PILOT** reports holding during a 'night sun' operation over a stolen vehicle; he was receiving a FIS from Newcastle. He descended to 450-500 ft to make more effective use of the light and as he came out of an orbit in a slow climb, heading 270° at 10 kt, he saw a fixed wing ac 1-200 ft to the W and about 50-100 ft above, heading directly towards

him. He took avoiding action by descending and considered there had been a high risk of collision. He questioned why the other ac was only at 600 ft over a built-up area. He had seen another ac earlier about 6 NM to the W heading N which he thought was the same ac.

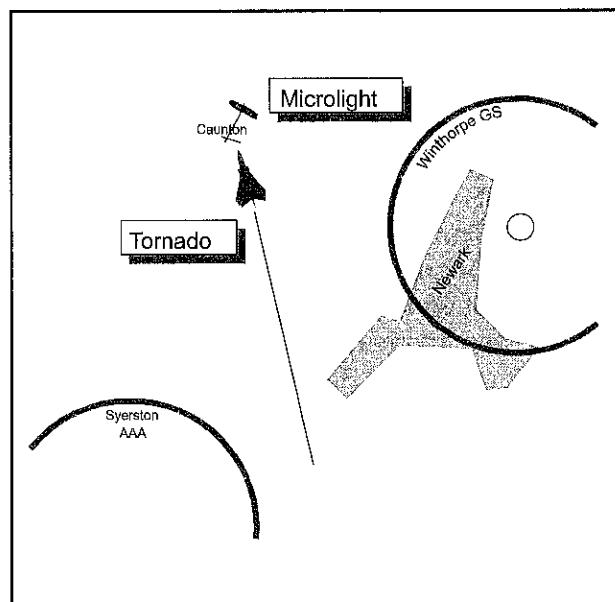
Note: The Microlight pilot filed his report later in the day and could not remember the exact time of the incident; he later advised that it would have been between 10 minutes before the hour to 10 past. LATCC radar recordings showed 3 Tornados passing at low level through the Newark/Syerston gap in the time period but since none of the pilots could remember seeing a microlight, it was not possible to identify positively which one was involved. The middle one believed he may have seen something below and to his right as he passed the area, but this was inconclusive. The LATCC radar

recordings do not show any of the ac involved in the area just W of Newark.

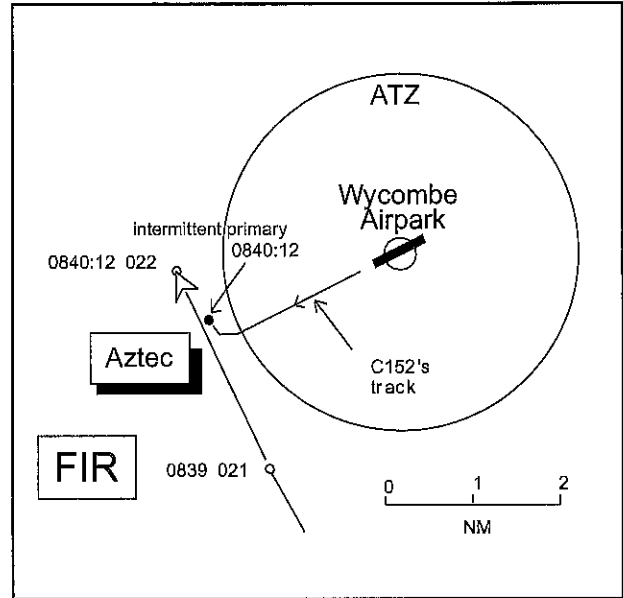
**THE C152 PILOT** reports that following departure from RW 25 at Wycombe he turned crosswind onto a heading of 330° at 65 kt. The visibility was over 20 km in VMC. On passing about 1200 ft (QFE) a low wing twin ac, white in colour with some yellow/brown/orange markings, overtook on his port side about 5 ft away at the same height having approached from behind him. He watched the ac as it tracked towards Stokenchurch. He considered there had been a high risk of collision and reported an Airprox to Wycombe Tower on 126.55. He asked the controller if the other ac had been on the Wycombe frequency and was advised that it was unknown.

**THE PA23 PILOT** reports that he had departed from White Waltham in VMC and was tracking in a northerly direction towards Leicester at 2200 ft QNH (995) and 150 kt. The visibility was over 10 km. He was squawking 7000 with Mode C and listening out with Benson on 120.9. Although unaware of any ac being alongside him, in the High Wycombe area his passenger momentarily saw a high wing light ac behind and slightly R of them about 0.25 NM away. He thought this ac must have either turned or climbed up behind them.

The Board was amazed that the Aztec pilot could have come so close to another ac without being aware of its presence and members agreed it was purely fortuitous that the two ac did not collide. Despite the reportedly good flying conditions and visibility, neither pilot saw the other and this was assessed to be the cause of the Airprox.

*Cause:* Non - sighting by both pilots.

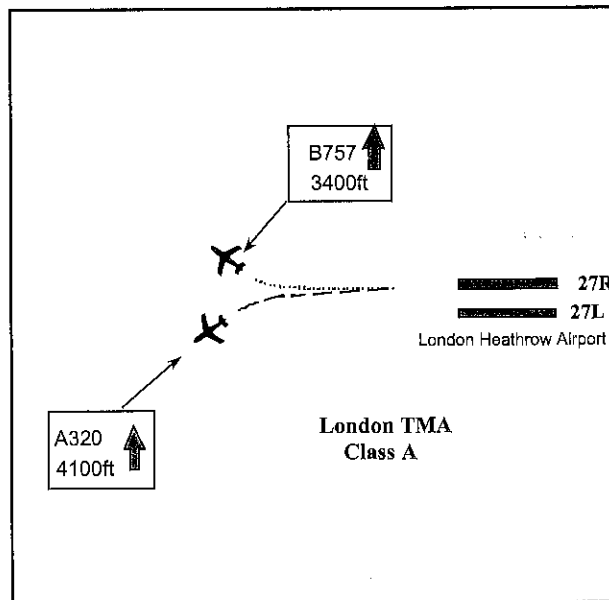
The A320 departed at 1512 and was followed about 45 seconds later by the B757. At 1513.17, the A320 pilot made his initial call to the WILLO controller who lifted the speed restriction. When the B757 departed, it appeared on radar at 1513.34, 1.4nm behind the A320 and 1400 feet below. This loss of separation resulted in the Short Term Conflict Alert (STCA) flashing a white low level alert on the North West Departures controller's radar display and, at 1513.49, when the B757 pilot made his initial call he was given an avoiding action turn on to a heading of 360° and traffic information on the A320 in his 12 o'clock range

1nm, 1000 feet above. By the end of this transmission the STCA was flashing a red high level alert. The radar pictures timed at 1513.48 show the A320 just beginning a left turn on the SID and passing an altitude of 3800 feet in the climb. The B757 is 1.4nm behind the A320 and is passing an altitude of 2700 feet. Subsequent radar pictures show the B757 catching up on the A320 both in distance and height with minimum separation of 1.2nm and 700 feet being recorded at 1514.04 when the A320 was passing altitude 4100 feet in the climb. At about this time the B757 pilot was asked by the North West controller if he was visual with the A320 ahead and replied, "negative India Mike Charlie". He was then instructed to stop his climb at altitude 4000 feet. However, by this time the A320's left turn on the SID and the avoiding action turn right by the B757 had begun to take effect. Although vertical separation reduced to 600 feet, horizontal separation had increased and continued to do so as the tracks quickly diverged.

The AIRPROX was caused by a combination of circumstances. The Heathrow Air Departures controller did not allow a full 1 minute departure separation between the A320 and the B757 and the B757, which was a little faster than the A320, drifted slightly left of initial departure track. Nevertheless, the North West Departures controller, alerted to the hazard by the STCA, acted promptly to resolve what he believed to be a developing serious loss of separation.

The panel's attention was drawn to the Midhurst SID, changed as a consequence of revised go around procedures at Heathrow, which now requires aircraft to proceed further to the West before turning. This has increased the chance of a subsequent departure closing the gap, particularly when the wind is strong, and triggering the STCA.
- 2 *Causal Factors:* The Heathrow Air Departures controller released the B757 too close behind the A320 to allow for the required separation to be achieved.
- 3 *Risk Classification:* C
- 4 *Recommendations:* The panel recommends that, in the light of the revision to the Heathrow runway 27R Midhurst SID (subsequent to AIRPROX 59/97) it may be timely for the CAA to reconsider the current one minute departure separation in order to establish that this is adequate in all relevant circumstances.

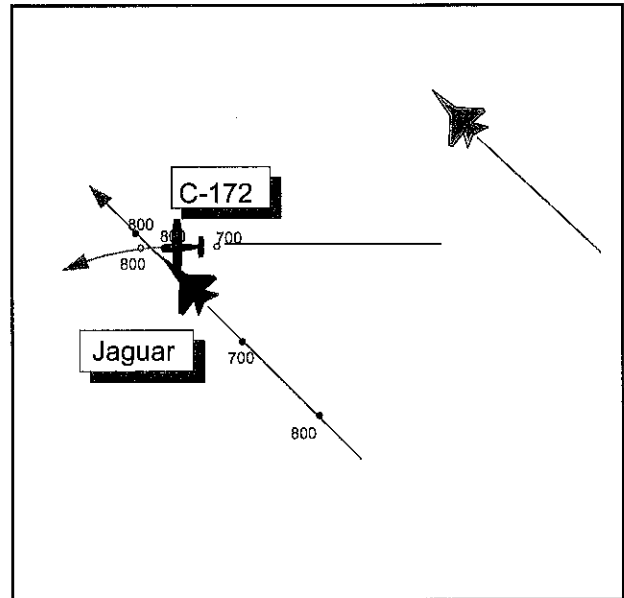
**THE CESSNA PILOT** reports heading 270° at 50 kt climbing away from a PFL when Linton, from whom he was receiving a FIS, warned him of fast moving traffic 1 NM SE of him heading NW at a similar level. Both pilots looked and saw the jet at very close range pointing right at him at the same height. He responded that he was visual and pushed the control column forward. The jet passed directly overhead by about 50 ft although due to the high wing, the separation was difficult to assess. He lifted the right wing as he heard it pass and found themselves looking directly along its smoke trail which obscured the ac itself. Linton then called other traffic which he saw pass behind. He had no doubt there would have been a collision if he had not seen and avoided the jet which did not deviate and gave no impression of having seen him. He later found out that the jets were not in RT contact with Linton.

**THE JAGUAR PILOT** reports heading 350° at 450 kt in a descent to low level. He was leading a box formation with his No 2 to his right and the 3-4 pair about 4 NM astern. Approaching 800 ft he saw a high wing light ac about 1 NM away in his 2 o'clock. He called it to the rest of the formation and reduced his rate of descent so that the light ac passed about 300 m astern and 3-400 ft below. The risk of collision was low.

*Cause:* Apparent non-sighting of the Cessna by the Jaguar pilot and a late sighting by the Cessna pilot.

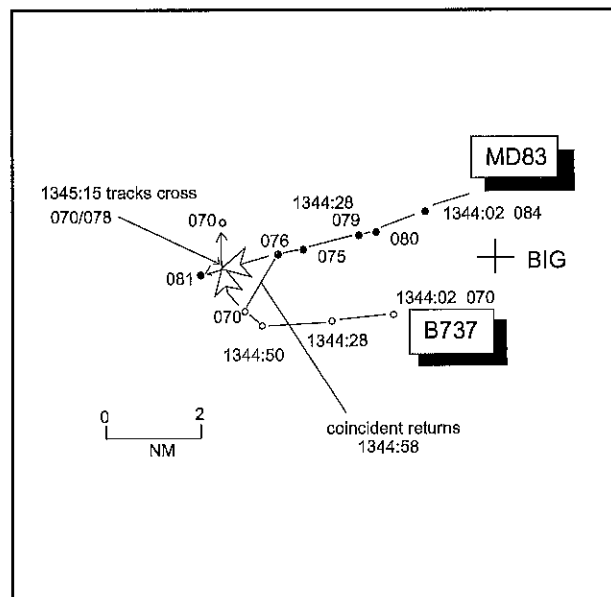
**THE B737 PILOT** reports that he was inbound to Heathrow at FL 70 and 220 kt under the control of LATCC on 120.4. The visibility was 20 km in VMC. While in a level R turn an MD80 was seen about 400 m away to his R crossing from R to L, about 800 ft above him. He heard ATC instruct another pilot to climb to FL 80. This did not elicit a response, and a second more urgent call was heard at which juncture he realised that his was the other ac involved in a confliction. No avoiding action was required because of the ATC instructions issued to the MD80 and he felt there had been a low risk of collision.

**THE MD83 PILOT** reports that he had been cleared to descend to FL 80, which was set on the autopilot. On reaching FL 80 the autopilot altitude capture did not light up; when passing FL 78 the altitude alarm triggered. The crew immediately disengaged the autopilot and climbed back to FL 80. This action coincided with an ATC instruction also to climb back to FL 80. As he could see the other traffic concerned, the manoeuvre was conducted in an expeditious but gentle manner in order to minimise discomfort to the passengers. Maximum deviation from cleared level was estimated to be about 450 ft.

The same defect occurred again on entering the Paris TMA and after landing the ac was declared unserviceable. An engineering investigation indicated an elevator clutch failure and an altitude selection malfunction which have since been remedied. The incident was brought to the attention of the airline's flight safety office and an 'alt-select' check was carried out on their MD83 fleet.

*Cause:* The MD83 pilot descended below his cleared level.

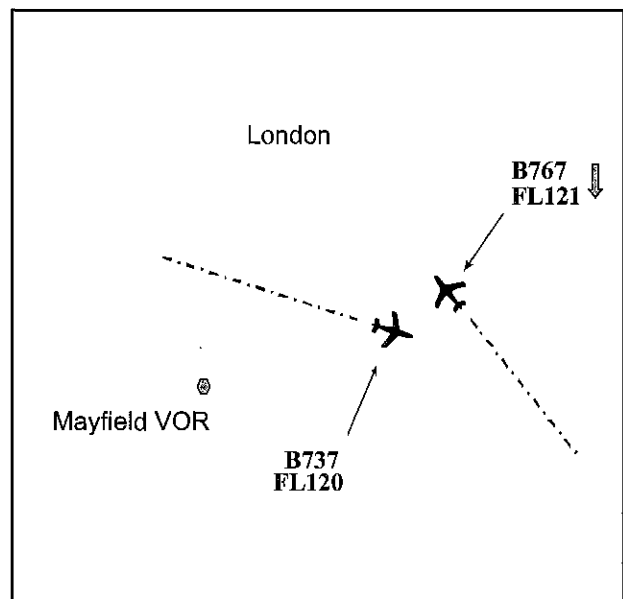
#### **Occ No. 98/06032**

*Date:* 15 October 1998  
*Time:* 1838 UTC  
*Aircraft:* B767/B737  
*Operator:* British Airline  
*Position:* 7nm East of Mayfield  
*ALT/HT/FL:* FL120  
*Airspace Type:* London TMA - Class A  
*Reporter:* LATCC - Terminal Control (TC) South East controller  
*Reported Separation:* 1.66nm horizontal/500 feet vertical  
*Recorded Separation:* 2.53nm horizontal/100 feet vertical

The AIRPROX was caused by the LATCC TC South East Sector controller who descended the B767 pilot to FL120 and into conflict with the B737 without the required horizontal separation.

- 1 *Discussion:* The PANEL accepted the Summary of CAA Action.
- 2 *Causal Factors:* The LATCC TC South East Sector controller descended the B767 to FL 120 and into conflict with the B737.
- 3 *Risk Classification:* C
- 4 *Recommendations:* The Panel had no recommendations to make.

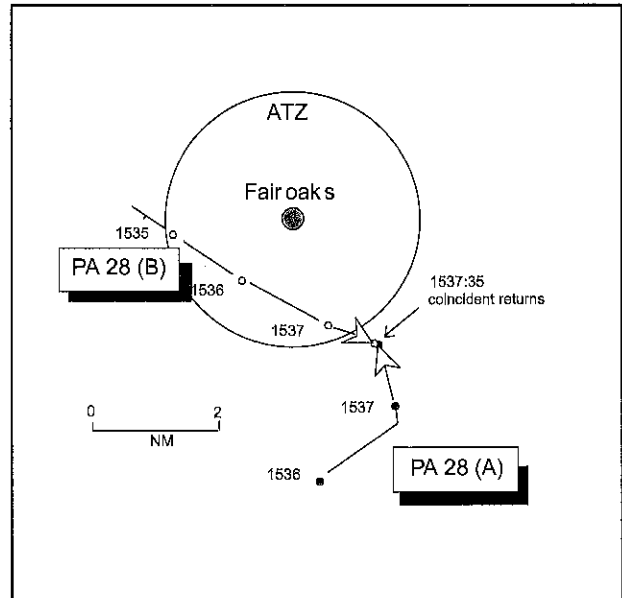
**THE PA28 (A) PILOT** reports that he was returning to Fairoaks from Shoreham with two students on an instructional cross-country exercise. The visibility was around 50 NM. He had been emphasising to his students the importance of maintaining a particularly good lookout in such excellent flying conditions. Approaching Fairoaks from the S descending from 2200 ft (QNH 1019), he called the FISO for traffic and airfield information; the FISO advised that the circuit was clear and no calls were heard from any other ac. While descending through 1500 ft and looking forward and right for any traffic that may have been overlooked, his student suddenly shouted a warning and, on looking L, he saw a Cherokee at his 10:30 - 11:00 position 50 - 70 yd away heading directly towards him. He immediately rolled R and descended steeply in avoidance, believing that the other ac would strike his tail; the other ac was not seen to take avoiding action and he felt that had he not done so himself, in the 2 - 3 sec available to him, there would have been a collision. Not having been warned of any traffic, he was not expecting another ac to be coming from the ATZ in the opposite direction. Despite everyone in his ac looking out, they had not been able to spot the PA28 earlier.

**THE PA28 (B) PILOT** reports that he was on a local PPL training flight from White Waltham in VMC, with one passenger on board; the

visibility was 25 km. A SVFR clearance had been obtained from Heathrow on 119.9 to transit the London zone not above 1500 ft on QNH 1018. When crossing the M3 motorway he was handed over to Fairoaks for transit of their ATZ. Approval was received for this and he heard another ac being advised of "opposite direction traffic". He does not recall being given any such information himself. When about 1 NM W of Wisley, heading 115° at 95 kt and just clear of the Fairoaks ATZ, he first saw a low-wing single engined ac about 300 m to his L as it approached from the opposite direction slightly above his level. He rolled R in avoidance and the other ac passed about 60 ft away and 20 ft above him with a high risk of collision. The pilot comments that although remaining vigilant for other ac, his lookout was degraded by navigational tasks.

Cause: Late sighting by both pilots.

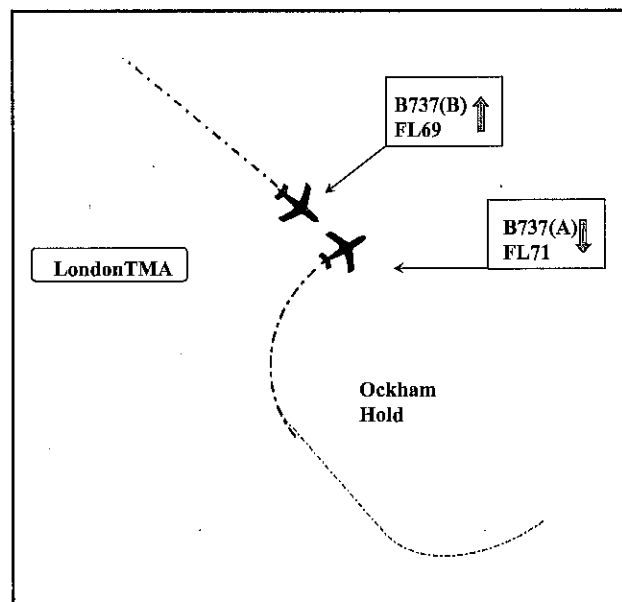
#### Occ No. 98/06068

Date: 19 October 1998  
Time: 0906 UTC  
Aircraft: B737/B737  
Operators: Foreign Airlines  
Position: Ockham Hold  
ALT/HT/FL: FL70  
Airspace Type: London TMA - Class A  
Reporter: LATCC - TC Biggin Sector  
Intermediate Director South  
Controller  
Reported Separation: 0.42nm horizontal/200 feet  
vertical  
Recorded Separation: 0.42nm horizontal/200 feet  
vertical

The AIRPROX was caused by the pilot of the B737(B) who exceeded the SID altitude restriction of 6000ft and climbed into conflict with the B737(A) holding at FL70.

- 1 *Discussion:* It seemed clear to the Panel that some mistake was made on the flight deck of B737(B) but that, in the absence of more information from the company, the nature of the mistake remains uncertain. What could be said is that there is no indication that anything said by ATC on the RTF could be construed as a clearance for the pilot to climb his aircraft above the SID altitude.
- 2 *Causal Factors:* The pilot of B737(B) exceeded the SID altitude restriction and conflicted with B737(A).
- 3 *Risk Classification:* B
- 4 *Recommendations:* The Panel had no recommendations to make.

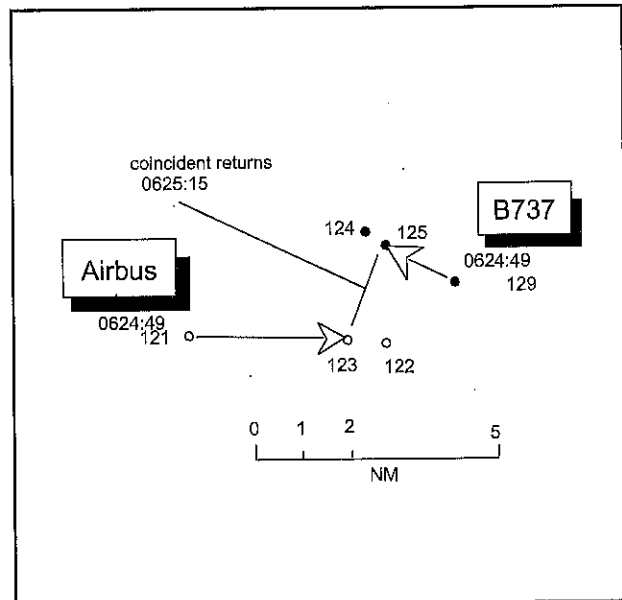
**ATSI** reports that the LATCC TC SE sector was being operated in the "bandboxed" mode by a sector controller under training, and his mentor. The traffic loading and workload was typically high for the time of day but not considered excessive for a trainee of some experience.

The controller under training was an experienced TC controller regaining a certificate of competence following an accident. His radar training was not part of a formal training programme, rather a regaining of his TC South qualification on an opportunity basis as and when conditions allowed on his old

At interview the trainee controller stated that the A321 pilot's transmission caused him some concern and interrupted his concentration because, at the time, he did not register the B737 as a confliction. He had previously assessed from the radar that the rate of climb of the A321 would be sufficient to enable it to climb through the B737's level well before lateral separation was compromised and, furthermore, he had selected a heading which he believed would ensure that it passed behind the B737. Had the A321 maintained its initial high rate of climb, he believed this plan would have succeeded.

*Cause:* The TC SE Mentor controller did not ensure standard separation between the A321 and the B737.

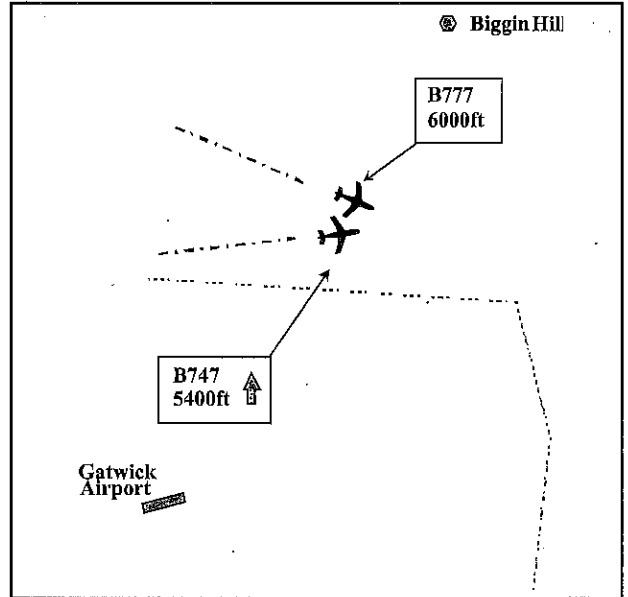
### Occ No. 98/06198

*Date:* 24 October 1998  
*Time:* 1048 UTC  
*Aircraft:* B747/B777  
*Operators:* British Airline  
*Position:* 7nm North East of Gatwick  
*ALT/HT/FL:* 5400 feet  
*Airspace Type:* London TMA - Class A  
*Reporter:* LATCC Terminal Control  
BIGGIN Sector Controller  
*Reported Separation:* 1nm horizontal/600 feet  
vertical  
*Recorded Separation:* 1nm horizontal/600 feet  
vertical

The AIRPROX was caused by the pilot of the B747 who allowed his aircraft to climb above his cleared altitude of 5000 feet and into conflict with the B777.

- 1 *Discussion:* The panel accepted the Summary of CAA Action. With autopilot engaged, it is reported that a significant speed change can require an autopilot input which is greater than its command threshold at the time. During the acquired manoeuvre the autopilot will attempt to limit the 'g' input to 0.10 for passenger comfort reasons.
- 2 *Causal Factors:* The pilot of the B747 allowed his aircraft to climb above his cleared altitude and into conflict with the B777.
- 3 *Risk Classification:* C
- 4 *Recommendations:* The Panel had no recommendations to make.

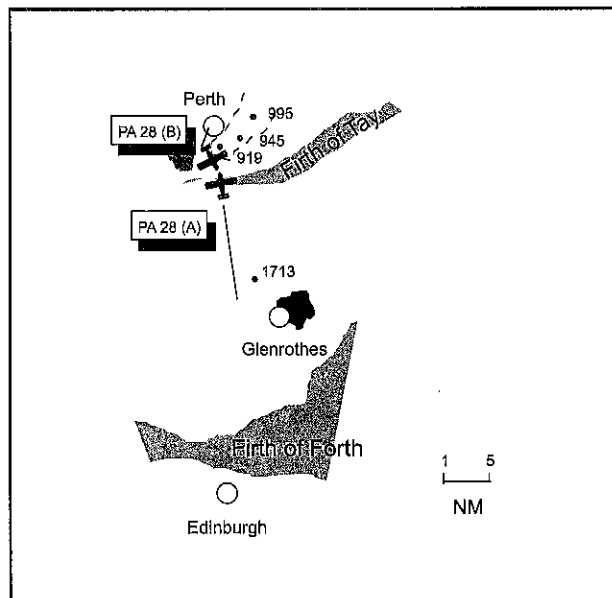
**THE PA28 (A) PILOT** reports that he was flying to the Perth VOR from Edinburgh on an IMC training flight; his student was occupying the LHS 'under the hood'. The visibility was 60 km in VMC. While listening out on the Perth air/ground frequency, 119.80, he heard a pilot reporting airborne from RW 28 at Perth on a direct track for Glenrothes "climbing out not above 2000 ft" on the Tyne RPS. When about 4 NM S of the Perth VOR at 3000 ft (QNH 1002), heading 355° at 120 kt, he suddenly saw this ac, a PA28, as it climbed from L to R across his track about 100 ft away and 50 ft below. Owing to the late sighting he was not able to take avoiding action and the ac passed 50 ft in front of him with a very high risk of collision; it was clearly above the 2000 ft limit of climb stated earlier by its pilot. He reported an Airprox to Perth air/ground. The pilot comments that the view in the direction of the threat was obstructed by his student.

**THE PA28 (B) PILOT** reports that he had departed from Perth for Glenrothes with one passenger on board. The visibility was generally about 15 km in VMC but there was a dark background of cloud above 3000 ft ahead of him to the S. He was listening out and making blind calls on Perth's air/ground frequency, 119.80. When about 6 NM SSE of Perth airfield, heading 165° at 100 kt and

climbing through about 2600 ft (QNH 1005), a low-wing single-engined ac appeared over the hills ahead of him flying in the opposite direction about 1000 ft away. An immediate L turn was made in avoidance and the other ac passed about 500 m away and 600 ft above down his starboard side. He felt that they might have collided had he not turned when he did.

*Degree of Risk:* B  
*Cause:* Late sighting by both pilots.

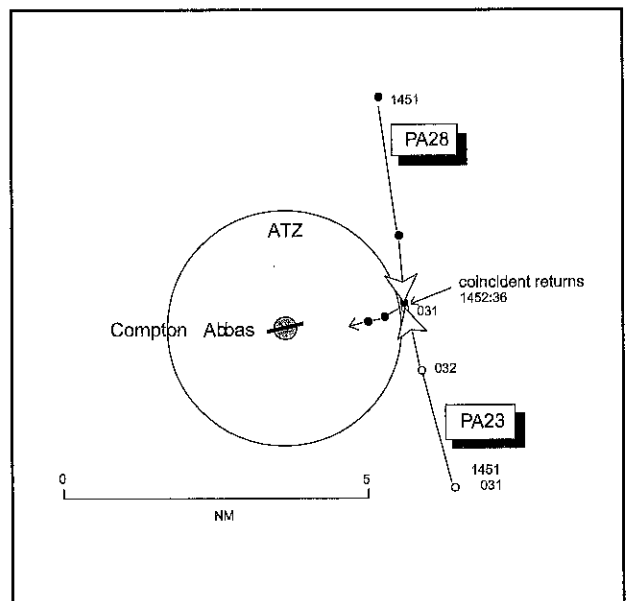
**AIRPROX (P) REPORT No 133/98**

Date/Time: 01 Oct 1452  
Position: N5058 W0206 (2 NM E Compton Abbas - elev 810 ft)  
Airspace: FIR (Class: G)  
Reporting Aircraft Reported Aircraft  
Type: PA23 PA28  
Operator: Civ Pte Civ Trg  
Alt/FL: 3000 ft  
(QNH 1008 mb)  
Weather VMC CLBC  
Visibility: 60 km

**THE PA23 PILOT** reports that he was flying from Guernsey to Gloucester in VMC; workload was low in 60 km visibility. He was squawking 4530 with Mode C and receiving a FIS from Bournemouth Radar on 119.62. When 3 NM NE of Compton Abbas, flying at 3000 ft (QNH 1008) at 120 kt on a northerly heading, he saw a low-wing single-engined ac, whose registration he could part read, at his 2 o'clock. It was about 300 m away and 100 ft above descending towards him in a R turn. He immediately turned 30° R and descended in avoidance. The other ac passed about 100 m ahead and 100 ft above from R to L; he felt there had been a very high risk of collision and reported an Airprox to the Airprox Section by telephone.

This incident took place in Class G airspace where the 'see and avoid' principle applies. Despite the excellent visibility reported, however, the PA23 pilot saw the PA28 only just in time to take avoiding action and the PA28 pilot did not see the PA23 at all. The Board assessed that these late/non sightings were the cause of the Airprox. As to risk assessment, members agreed that although the PA23 pilot's avoiding action removed any likelihood of an actual collision, he had described it as a high risk encounter and this was confirmed by the radar recording. Moreover, the PA28 pilot was not in a position to take avoiding action as he did not see the other ac. For these reasons the Board concluded that there had been a possible risk of collision.

Cause: A late sighting by the PA23 pilot and a non-sighting by the PA28 pilot.

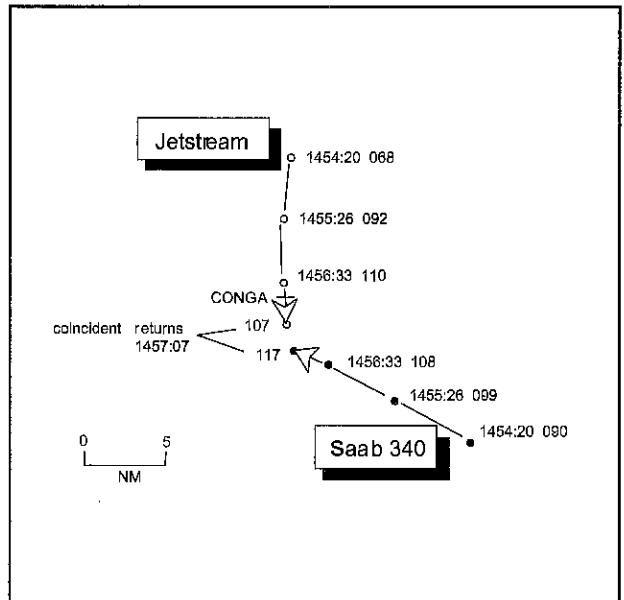
**AIRPROX (P) REPORT No 137/98**

Date/Time: 03 Nov 1457  
Position: N5306 W0212 (3 NM S CONGA)  
Airspace: MTMA (Class: A)  
Reporting Aircraft Reported Aircraft  
Type: Jetstream Saab 340  
Operator: CAT CAT  
Alt/FL: ↑ FL 130 ↑ FL 120  
Weather IMC IICL  
Visibility:  
Reported separation: 2.5NM/300 ft  
Recorded separation: 2.8 NM/500 ft (radar)

**THE JETSTREAM PILOT** reports that he was climbing out from Manchester at 200 kt in intermittent IMC with the RHS pilot flying the ac. He was instructed to climb by ATC to FL 150 on a radar heading of 175°, but was then told to stop the climb at FL 110 and to turn R, first onto heading 180°, then L onto 145°. These instructions were followed immediately by ... "descend now FL 100, avoiding action aircraft crossing left to right same level." The Capt took control, disengaged the autopilot and complied immediately. As the ac descended back through FL 107, a Saab 340 was seen passing about 300 ft above from L to R 2.5 - 3.0 NM away. He thought there had been a low risk of collision.

All ATCO members reiterated yet again that any plan made on the basis of assumed ac performance only was inherently unsound because, unless very carefully monitored, this technique was not fail-safe. The normal method of achieving a climbthrough in these circumstances is to establish lateral separation by the use of appropriate headings until vertical separation is assured. Unfortunately in this case the controller not only misjudged the rates of climb of the 2 ac concerned, but his inexplicable misinterpretation of the Jetstream's level on its FPS compounded the problem,

*Cause:* The Manchester ACC SE Radar Controller did not ensure standard separation.

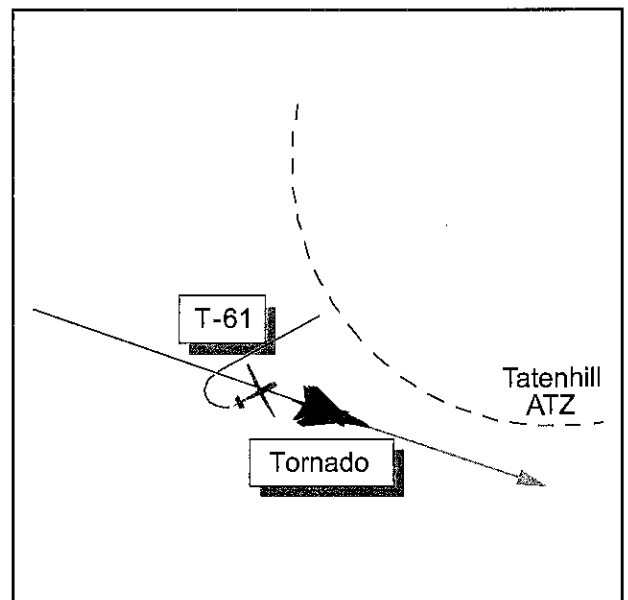
**THE TORNADO PILOT** reports heading 113° at 420 kt on a low level exercise. Both crew members glanced at Tatenhill to check their distance from the airfield as they were about to pass it and on looking ahead, they saw a motor glider about 300 m in their 2 o'clock and 100 ft

above. It was too late to take any avoiding action and the risk of collision was high.

Both pilots showed unusual agreement in the circumstances and miss distances involved which, along with the fact that neither party saw the other in time to take avoiding action, led members to assess that there had been a risk of collision. It was a 'see and avoid' situation and the Board concluded that the cause of the ac getting so close was a late sighting by the Tornado pilot and effectively a non-sighting by the T61 pilot. The light coloured T61 would have been very hard to see against the sky and similarly the camouflaged Tornado approaching from the T61's 7:30 would have been very hard to spot, with virtually no relative angular motion in either case.

*Cause:* Late sighting by the Tornado pilot and effectively a non-sighting by the T61 pilot.
