**UK AIRPROX BOARD**

# **Analysis of Airprox in UK Airspace**

**Report Number 1**

**January 1998 to December 1998**

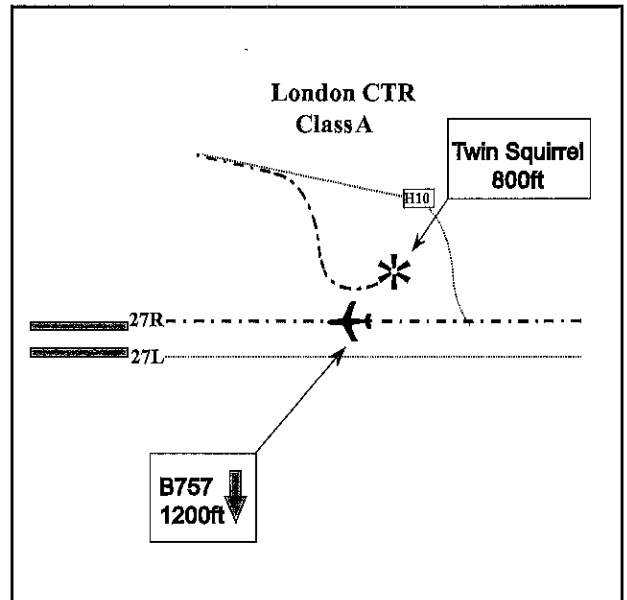
### Occ No. 98/06501

**Date:** 6 November 1998  
**Time:** 1651 UTC  
**Aircraft:** B757/Twin Squirrel  
**Operators:** British Airline/British Private  
**Position:** 4nm East of London  
Heathrow Airport  
**ALT/HT/FL:** Altitude 800 feet  
**Airspace Type:** London CTR, Heli Route  
H10 - Class A  
**Reporter:** Heathrow ATC - Special  
VFR Controller  
**Reported Separation:** 1.23 nm horizontal/500 feet  
vertical  
**Recorded Separation:** 1.29 nm horizontal/400 feet  
vertical

The AIRPROX was caused by the pilot of the Twin Squirrel who deviated from London Heli Route H10 and came into conflict with the B757 on approach to runway 27R at Heathrow.

It was noted that at night the Twin Squirrel pilot probably mistook the A4127 road for the A406 road. However, he was reminded that correct timekeeping would have identified the desired turning point and that precise track keeping was essential to avoid the congested areas and Heathrow landing traffic.

- 1 *Discussion:* The panel accepted the Summary of CAA Action.
- 2 *Causal Factors:* The Twin Squirrel pilot deviated from Heli Route 10 and conflicted with the B757.
- 3 *Risk Classification:* C
- 4 *Recommendations:* The Panel had no recommendations to make.

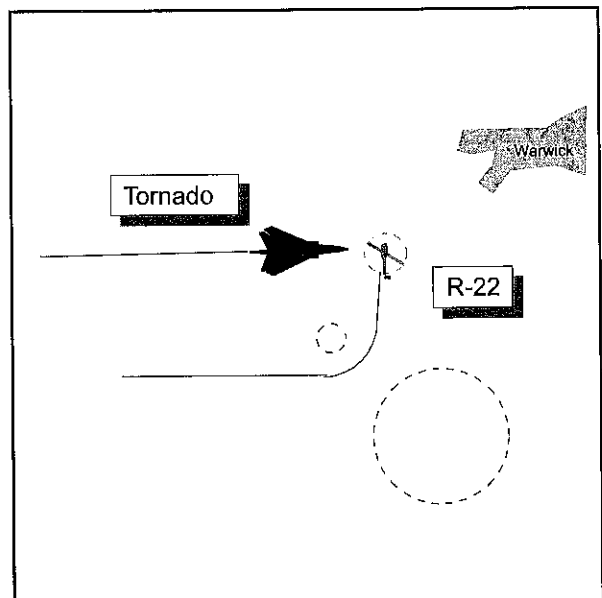
**AIRPROX (P) REPORT No 139/98**

Date/Time: 9 Nov 1501  
Position: N5216 W0140 (3 NM WSW of Warwick)  
Airspace: LFS/FIR (Class: G)  
Reporting Aircraft Reported Aircraft  
Type: Tornado GR R22 B  
Operator: HQ STC Civ Pte  
Alt/FL: 1000 ft 15-1600 ft  
(Rad Alt) (QNH)  
Weather VMC CLOC VMC CLBC  
Visibility: 10 km+ 10-15 NM

**THE TORNADO PILOT** reports heading 085° at 400 kt maintaining 1000 ft through the West Midlands Weather Corridor on a singleton low level exercise. He was looking out carefully and suddenly saw a large shadowy shape 300 m away in his 2 o'clock high, heading N. It passed 200 ft above and slightly astern before he could react. He considered there had been a high risk of collision.

The sightings reported by the R22 pilot could not be resolved from the radar recording, but he did not report an ac passing left to right at right angles beneath him, so members concluded that his non sighting of the Tornado was part of the cause, as was the Tornado's very late sighting. Neither ac would have been easy to see; the R22 is tiny and hard to spot at the best of times and a camouflaged Tornado approaching at a lower level is designed not to be seen. The lack of relative angular motion in either case would also have made a sighting less likely.

*Cause:* Late sighting by the Tornado pilot and a non-sighting by the R22 pilot.

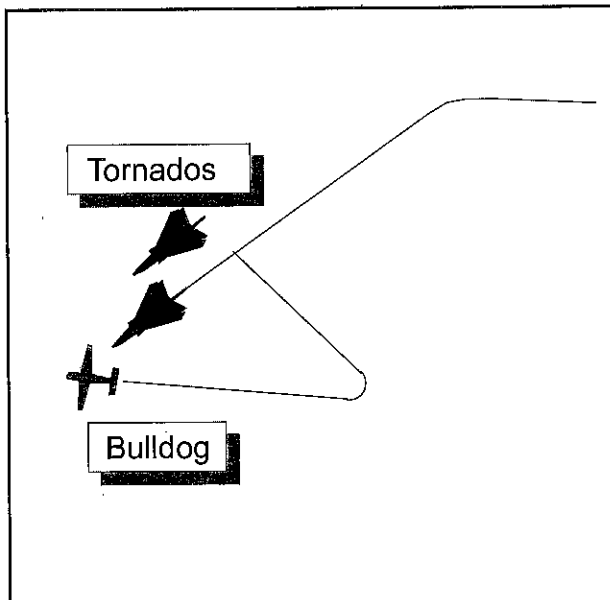
## AIRPROX (P) REPORT No 138/98

Date/Time: 11 Nov 1503  
Position: N5254 W0023 (14 NM NE of Cottesmore - elev 461 ft)  
Airspace: FIR (Class: G)  
Reporting Ac Reported Ac  
Type: Tornado GR Bulldog  
Operator: HQ STC HQ PTC  
Alt/FL: 2000 ft 2500 ↓  
(QFE 1006 mb) (RPS 1014 mb)  
Weather VMC CLNC VMC CLNC  
Visibility: 5-8 km 10 km+  
Reported Separation: 200 ft  
Recorded Separation: 200 ft

**THE TORNADO PILOT** reports heading 230° at 200 kt leading a pair of ac in the landing configuration in a left hand radar pattern for RW 23 at Cottesmore, at 2000 ft and into sun. He was receiving a RIS from Cottesmore Director and TD, squawking with Mode C. ATC reported an ac at 5000 ft and 5 NM which was acknowledged. He then saw a Bulldog in his 12 o'clock, level, heading SW, and entered a shallow descent to pass about 200 ft beneath it. The risk of collision was high until avoiding action was taken.

Members were surprised that the Bulldog pilot had performed a PFL on Cottesmore's extended centreline without manoeuvring sufficiently to see any approaching instrument traffic. The selected PFL location was a hazardous place for such an exercise, as demonstrated by the Airprox, and the Board was reassured to hear that the practice had since been discouraged. Bearing in mind the extreme density of radar returns in the area at the time and the Bulldog's 'late' descent it was not surprising that traffic information on this particular return did not appear to have been passed. While some members thought it possible that the 'traffic 600 ft above' might have been the Bulldog, it seemed unlikely that the formation would then have undertaken a frequency change with an impending conflict

*Cause:* Conflict of flightpaths in Class G airspace, resolved by the Tornado pilots.

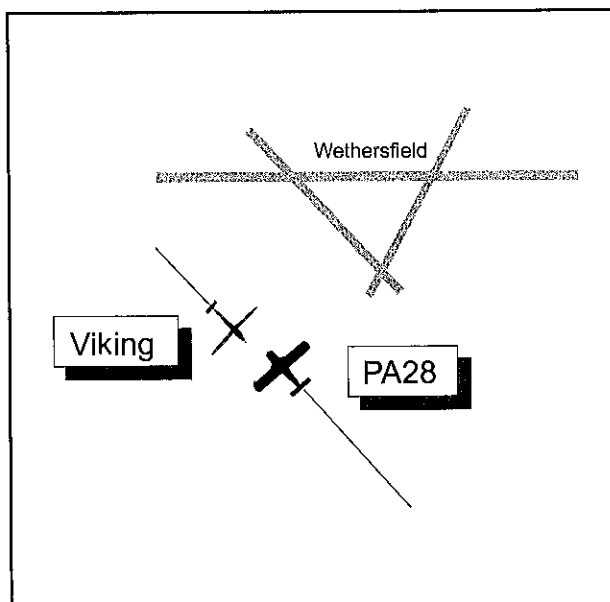
### **AIRPROX (P) REPORT No 141/98**

*Date/Time:* 15 Nov 1430 (Sunday)  
*Position:* N5158 E0030 (0.5 NM SW of Wethersfield - elev 321 ft)  
*Airspace:* FIR (Class: G)  
 Reporting Aircraft Reported Aircraft  
*Type:* Viking glider PA28  
*Operator:* HQ PTC Civ Club  
*Alt/FL:* 700 ft ↓ 1400  
 (QFE 1009 mb) (QNH 1016 mb)  
*Weather* VMC CLBC VMC CLBC  
*Visibility:* 20 km 6 km

**THE VIKING PILOT** reports heading 150° at 50 kt while downwind in a LH circuit for RW 33 at Wethersfield. Passing 700 ft (300 ft below cloud) he was warned on the radio by another

The Board congratulated the personnel on the ground at Wethersfield who were keeping a lookout and were able to warn the Viking pilot of the passing PA28; it seemed a very necessary activity in view of the number of light ac pilots who, like this one, apparently were content to ignore the warning on the chart about intense gliding activity at Wethersfield at weekends and public holidays. All members felt that this flight through the glider circuit showed a lapse of airmanship by the PA28 pilot and they considered the cause of the Airprox was that the PA28 pilot flew over an active glider site and into conflict with the glider which he did not see.

Cause: The PA28 pilot flew over an active glider site and into conflict with the glider which he did not see.

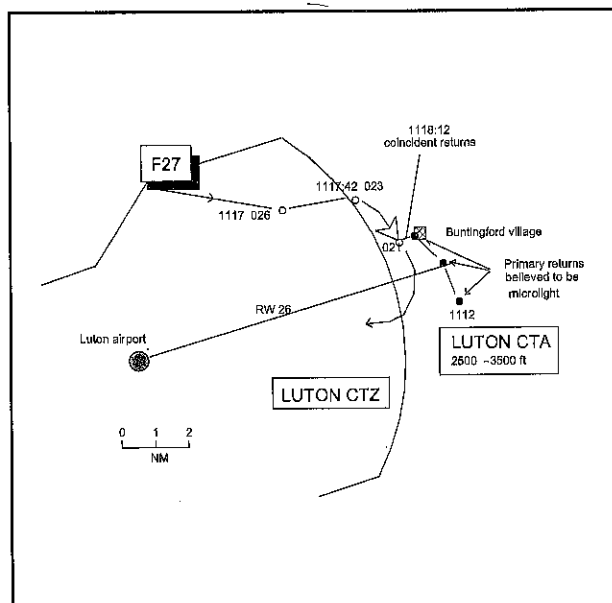
**THE MICROLIGHT PILOT** reports that he was 3 - 4 NM NE of Stevenage at 2400 ft (QNH), heading about 360° at 55 kt. The visibility was over 10 km in VMC. He saw a twin turbo-prop ac about 2 miles away as it approached him from the N in a R turn; the ac eventually passed about a mile from him and 600 ft above. The

pilot, a microlight instructor, comments that he had a continuous clear view of the other ac and did not feel there was any risk of collision with it, or danger from its wake. Furthermore, he was satisfied that at his reported altitude and position he was not within controlled airspace. He did not consider the encounter constituted an Airprox.

Members noted that there was considerable disparity between the estimates of reported lateral separation. It was felt that if the F27 had passed as close to the microlight as the F27 pilot estimated, the microlight pilot would almost certainly have expressed much more concern. In the event, while the microlight pilot clearly thought there was no risk in the encounter, the radar recording indicates that actual separation was about half the 1 NM he estimated, and considerably more than the F27 pilot's assessment of 150-200 m. Based on the evidence of the radar, members were satisfied that there had not been a risk of collision.

*Cause:* The Luton Radar controller descended the F27 to the base of the CTA and into conflict with the microlight.

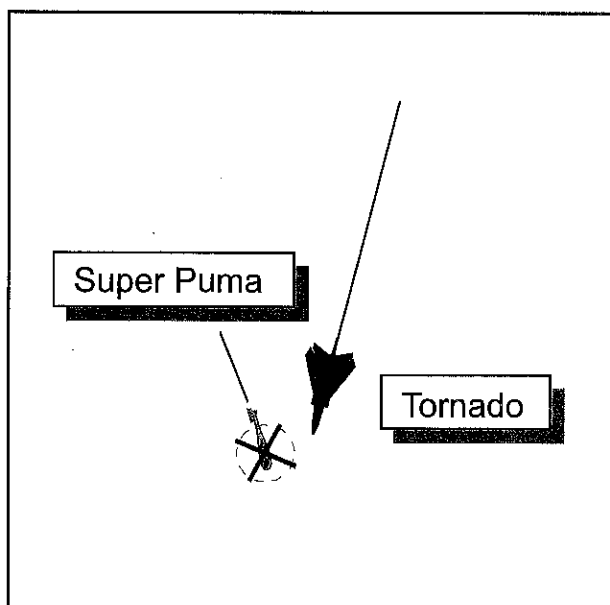
**THE SUPER PUMA PILOT** reports heading 166° at 123 kt, maintaining 2000 ft and receiving a RIS from Lossiemouth on 119.35. He saw an ac on his left just before it passed about 500 ft beneath him; he asked the Lossiemouth controller what height it was flying at. The controller replied that it was 'fast jet traffic just popped up indicating 2000 ft southbound'. It did not appear to be climbing to his level as it went away but he thought the risk of collision was high.

**THE TORNADO PILOT** reports heading 190° at 420 kt at low level, recovering to Lossiemouth. He started a climb from 500 ft to 2000 ft to clear D807 which he assumed was active. He levelled at 1500 ft when Lossiemouth told him it was inactive and that there was a helicopter at 2000 ft. He did not see the helicopter but was later informed by ATC that he had passed 500 ft beneath it. He did not think there had been a risk of collision; he had been unable to call Lossiemouth earlier as the frequency was busy.

**HQ MATO** reports that the Super Puma pilot was flying from Wick to Aberdeen along HMR X-RAY at 2000 ft Orkney RPS (1023 mb) and approaching MORAY. The pilot was in receipt of a RIS from Lossiemouth Approach (APP) on 119.35 and squawking 3721 with Mode C. The limited Lossiemouth night flying programme resulted in the controller simultaneously providing a LARS on VHF and a Radar Approach service on UHF. The weather at Lossiemouth was reported as colour code WHITE, but deteriorating with shallow fog approaching the aerodrome from the west. At 1846:31, about 20 seconds before the Airprox occurred, the crew of the reported Tornado GR1 free-called APP on 376.65 advising, "...presently 30 miles to the North with information Foxtrot for self-position, internal aids to land". To assist radar detection at the extremities of the Lossiemouth Watchman radar coverage and for identification, the controller instructed the Tornado crew to squawk 3711,

*Cause:* Sighting report.

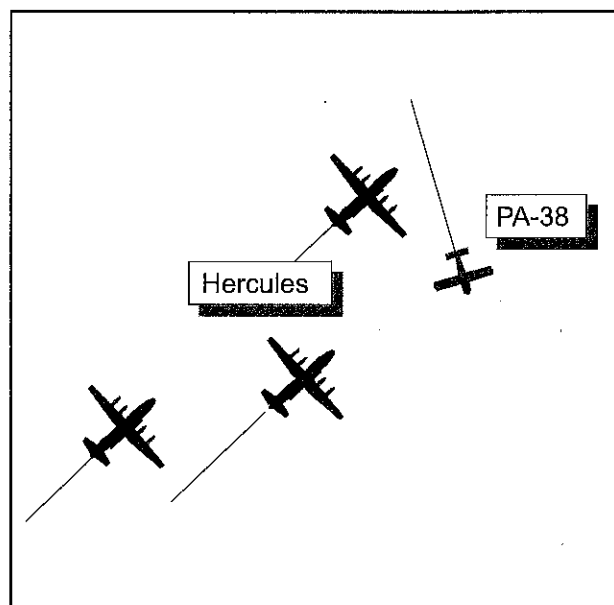
**THE HERCULES PILOT** reports heading 045° at 220 kt on a low level exercise having climbed to 2000 ft to remain VMC above a layer of broken cloud and haze. He first spotted the light ac in cloud tops in his 10 o'clock less than 1 km away; it appeared to be 500 ft below and

passed about 300 ft below his No 2, the middle ac in the stream. No avoiding action had been possible due to the brief nature of the incident and he assessed the risk of collision as slight.

**HQ STC** comments that the hazy conditions, undercast and relative size of the PA38 contributed to a late sighting by the Hercules crew. The PA38 pilot cites high workload in mitigation for a late spot of the Hercules formation. Nevertheless, despite a pick-up range of 2 km, the PA38 pilot did not deem avoiding action necessary. When VFR, pilots must maintain an effective lookout even under

It seemed to members that in the prevailing weather conditions the crews of both ac had seen the other ac about as early as could be expected and in time to take avoiding action had they considered it necessary. Therefore there was no risk of them actually colliding. The PA38 pilot had added by telephone some comment on how busy the airspace was which was agreed by a Board member who operated from Kidlington. The PA38 pilot appeared to have been looking out accordingly and members agreed that the incident was a conflict of flightpaths in Class G airspace. It was observed that there would have been some 700 ft of separation if the PA38 pilot's reported height had been correct, but he had been unsure about it; both parties estimated the vertical separation had been about 300 ft.

*Cause:* Conflict of flightpaths in Class G airspace.

high workload conditions, and attempt to manoeuvre to negate even a slight collision risk.

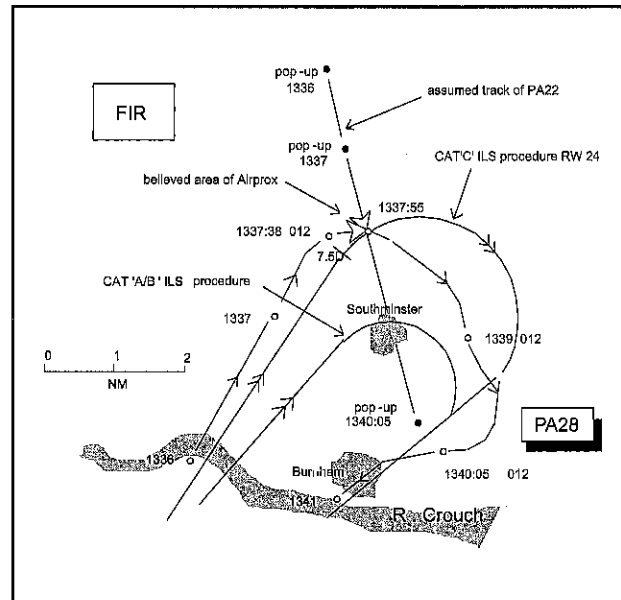
**THE PA22 PILOT** reports that he had been on a local flight in his white/maroon coloured ac to the W and N of the airfield, completing his detail just S of Osea Island at 1500 ft (QNH 1025) heading about 150°. About 3 NM NW of Burnham, he called Southend APC for rejoin and was asked to descend to below 1000 ft owing to traffic in the ILS procedure. This he did immediately, levelling at 900 ft when

approximately abeam Southminster. After ATC had accepted his readback of the rejoin instructions, he heard the controller ask the pilot of the ILS ac whether he had the PA 22 in sight. He heard the pilot reply, in a fairly excited tone,..."He's just gone right underneath us". He immediately looked around, maintaining heading and altitude, but initially made no contact before eventually spotting it heading towards the airfield about a mile away and considerably higher than himself. Flying well past the extended centre line of RW 24 he was then cleared by Southend to join the ILS.

Notwithstanding all these considerations, it was ultimately the responsibility of both pilots to maintain an effective lookout to avoid collisions in this class of airspace, whatever the nature of their flights or cockpit duties. The PA28 saw the PA22 as it passed below, but too late to take any action to avoid it which effectively amounted to a non-sighting, and the PA22 pilot did not see the PA28 until some time after the encounter. The Board concluded that the non-sightings by both pilots caused the Airprox. Moreover, as the radar and RT evidence and the PA28 pilot's description all suggest that both ac were at the same or very similar levels, with neither pilot being in a position to avoid, the Board concluded that there had been an actual risk of collision.

*Degree of Risk:* A  
*Cause:* Non-sighting by both pilots.

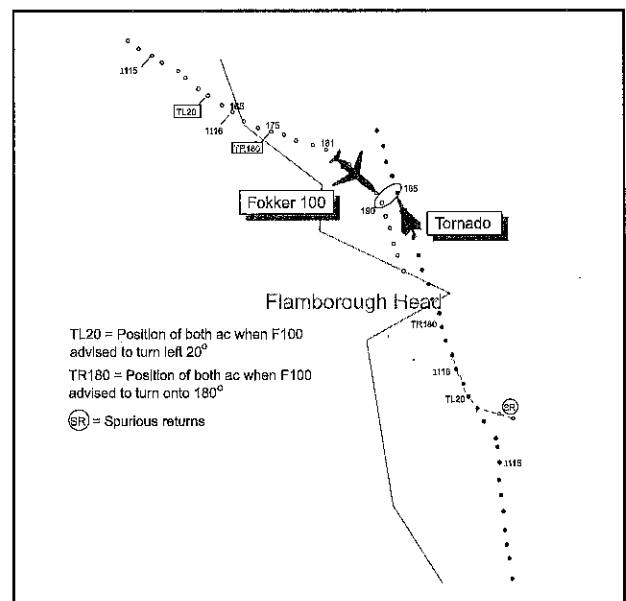
**THE F100 PILOT** reports climbing on a heading of 100° at 250 kt and receiving a RAS from Pennine Radar. Pennine advised him to turn left 20° to avoid military traffic, and then 30

seconds later to turn right 80°. Passing FL 185, a Tornado flew down his port side on a

reciprocal heading at the same level about 2 NM away.

The Board discussed at length what the Pennine controller's requirement was in terms of separation between the F100 and the Tornado. The discussion revealed that despite several years' work to harmonise the definition and interpretation of a RAS between civil and military agencies, clear differences in interpretation remained, at least among the controller members of the Board, some of whom did not believe the controller had a remit to achieve as much separation as possible if he could not achieve standard separation. Eventually the Board recommended that action should be taken to resolve these differences in interpretation.

*Cause:* The Pennine Radar controller achieved a level of separation which caused concern to the F100 pilot.

controller should have on this occasion used the phrase "avoiding action" to elicit a more appropriate response from the pilot. The Board also recommended that the need to react promptly to controllers instructions while under RAS should be emphasised to airline pilots.

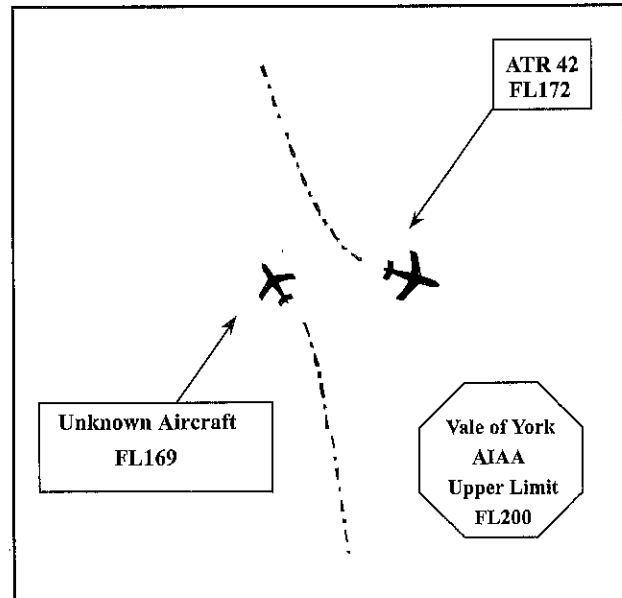
### Occ No. 98/06945

**Date:** 30 November 1998  
**Time:** 1405 UTC  
**Aircraft:** ATR42/Unknown  
**Operators:** British Airline/Unknown  
**Position:** 12nm East of Linton on Ouse  
**ALT/HT/FL:** FL170  
**Airspace Type:** FIR - Class G  
**Reporter:** Manchester ACC - Pennine Radar  
**Reported Separation:** 1.5nm horizontal/Nil feet vertical  
**Recorded Separation:** 1.5nm horizontal/300 feet vertical

The aircraft involved in this AIRPROX were operating in the Vale of York Area of Intensive Aerial Activity (AIAA). The ATR42 was receiving a radar information service (RIS) from Pennine Radar whilst en route from Newcastle to Stansted at FL170. The unknown aircraft, probably military, was manoeuvring at FL170 and displaying a Vale of York SSR conspicuity code.

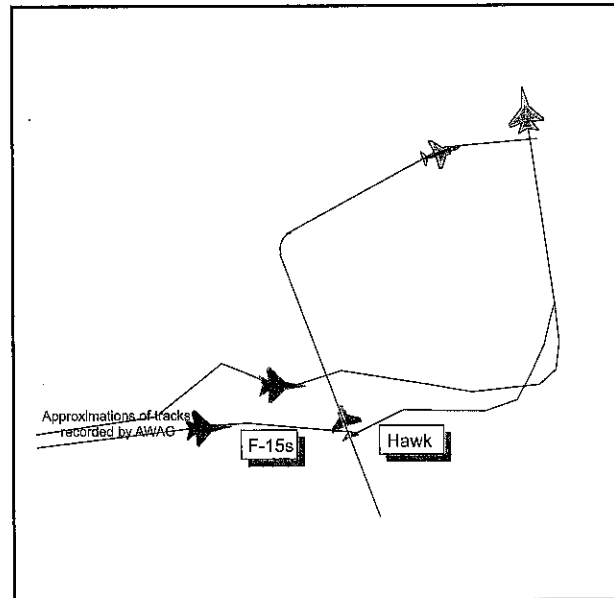
**THE F15 PILOT** reports heading 095° at 450 kt and 2000 ft agl in 4-5 NM trail on his leader. He saw a Hawk 3 NM to the SE, tracking NW. He turned right to obtain a boresight radar lock and then turned further right to obtain separation for a stern engagement. At about 1-2 NM he manoeuvred behind the Hawk, carried out a mock attack and then broke-off to the E, never descending below 1500 ft. At his closest he was 0.5 NM from the Hawk and 1000 ft above it. 2 minutes later they were heading 350° at 2000 ft, conducting a SAP, but did not see the Hawk re-crossing their track.

Note: LATCC radar recordings show the F15s tracking 077° into the Airprox area in trail with the leader at 1600 ft Mode C. Neither the Airprox nor the Hawk are shown. An AWAC

mission recording showed the 2 F15s throughout the area but not the Hawk. The No 2 is consistently to the S of the leader until the ac turn N after the incident. The leader's Mode C shows 1500 ft 5 NM W of the incident position and not below 1600 ft in the incident area but the No 2 shows no Mode C.

**HQ PTC** comments that the more sources of information that become available, the more equivocal becomes the picture in this case. However, the Hawk appeared on neither radar source but the F15s did on both, with consistent Mode C readings (from the leader) well above that declared by the Hawk. This tends toward a view that the ac were further apart than the student perceived. It is to his credit that he maintained such an effective lookout against a manoeuvring pair even during an IP to tgt run but it looks as though he misappreciated the size of the F15.

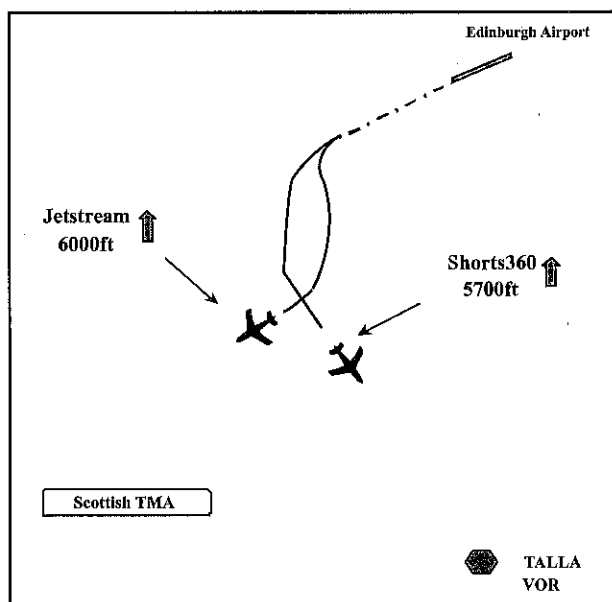
**Occ No. 98/07076**

*Date:* 8 December 1998  
*Time:* 1046 UTC  
*Aircraft:* Jetstream 41/SD360  
*Operators:* British Airlines  
*Position:* 12nm SW of Edinburgh Airport  
*ALT/HT/FL:* Altitude 6000 feet  
*Airspace Type:* Scottish TMA - Class E  
*Reporter:* ScACC - TMA In Radar controller  
*Reported Separation:* 2nm horizontal/300 feet vertical  
*Recorded Separation:* 1.8nm horizontal/300 feet vertical

The aircraft involved in this AIRPROX had both been transferred from the Edinburgh Aerodrome controller to the ScACC TMA In Sector controller immediately prior to the incident. The SD360 was en route to Leeds and the Jetstream was en route to Belfast Aldergrove. Both had departed from runway 25 at Edinburgh on a Talla 4C Standard Instrument Departure (SID). The SID routeing is initially straight ahead to 7nm DME then a left turn onto the Talla (TLA) VOR radial 349° to TLA VOR, climbing to an altitude of 6000 feet. The TMA In controller was acting as a mentor to a trainee and was operating as both Planning (P) and Radar (E) controller at the time of the incident.

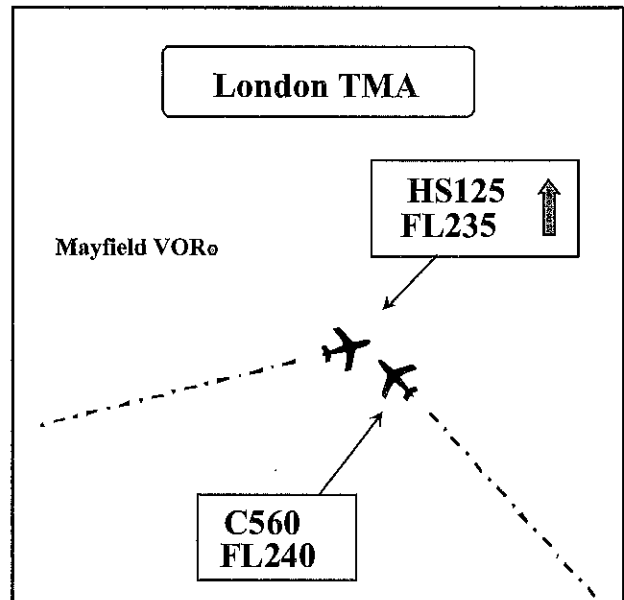
**Occ No. 98/07116**

**Date:** 9 December 1998  
**Time:** 1057 UTC  
**Aircraft:** HS125/C560  
**Operators:** British Executive/Foreign Executive  
**Position:** 5nm South East of Mayfield  
**ALT/HT/FL:** FL240  
**Airspace Type:** London TMA - Class A  
**Reporter:** LATCC - Area Control Lydd sector controller  
**Reported Separation:** 0.5nm horizontal/600 feet vertical  
**Recorded Separation:** 1nm horizontal/500 feet vertical

The aircraft involved in this AIRPROX were both under the control of the LATCC Area Control (AC) Lydd Sector Controller. The C560 which had departed from Le Bourget en route to Luton was level at FL240 and awaiting descent into Stansted as a weather diversion. The HS125 was en route from Farnborough to Dusseldorf and in the climb to FL270.

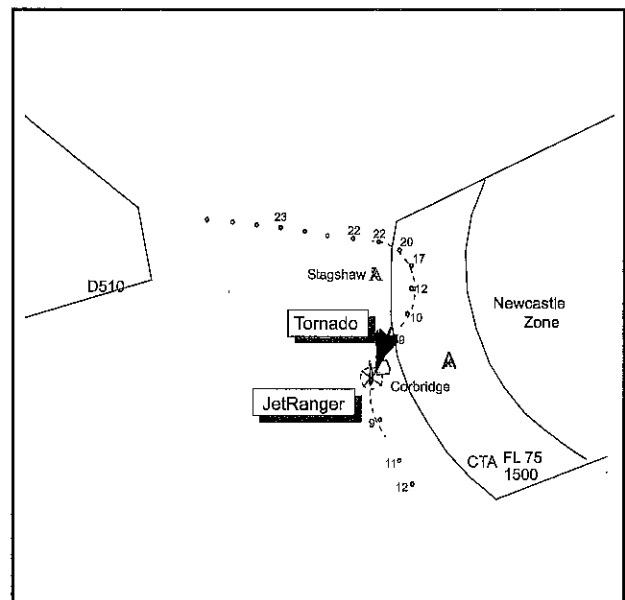
**THE JETRANGER PILOT** reports heading 180° at 10 kt on a photographic task 1000 ft above the Roman fort at Corbridge. Newcastle Approach warned him of a military ac at Stagshaw, the masts 3+ NM N of him. He then heard a roar and saw a black shadow at the top of his windscreen and what he thought was a Harrier descended in front of him, rocking his ac from side to side in its wake; he could smell burnt kerosene. He was amazed how loud the ac's noise was above the sound of his noisy helicopter and through his headset. He estimated the jet passed about 50 ft (certainly less than 100 ft) above him and realised how close he had come to being killed. The jet continued on a southerly track and he reported the incident to Newcastle.

Note: No Harrier could be found that had been in the area at the time. The Gt Dun Fell radar recording showed a return departing Spadeadam Range to the E and changing to a 7001 squawk before turning right onto 198° around the Stagshaw masts, descending from 2000 ft to 900 ft Mode C before disappearing below radar cover just over 1 NM from the Airprox position. It reappears at 900 ft just under 1 NM beyond the Airprox position at 1314:05; Corbridge fort lies on a line between these positions. The local QNH was 1012 mb so the Mode C equates to altitudes. The Spadeadam squawk used by this return was allocated to a Tornado.

This was a very serious Airprox; all members agreed that there had been a very high risk of collision and that the cause of it was that the Tornado pilot did not see the JetRanger he was

*Cause:* The Tornado pilot did not see the JetRanger he was overtaking.

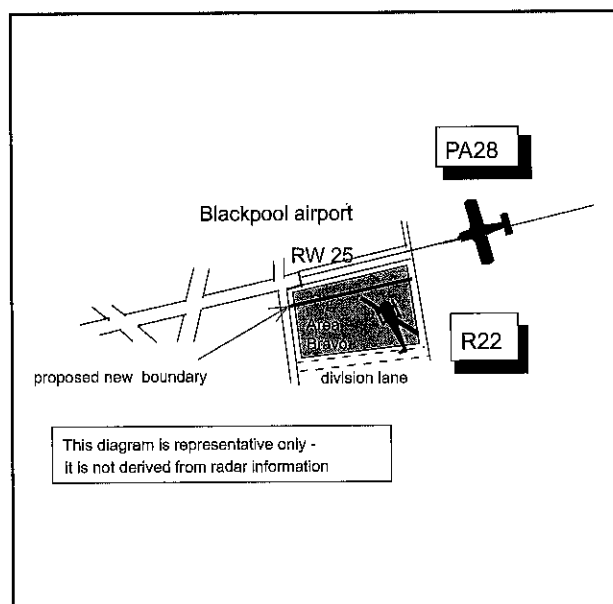
**THE PA28 PILOT** reports that he was 0.5 NM from touchdown and descending through 150 ft while on finals for RW 25 at Blackpool; workload was high as he concentrated on his imminent landing. The visibility was 25 km in VMC. He saw an R22 helicopter at his 10 o'clock tracking from L to R. It encroached the centreline ahead of him, less than 0.5 NM away, before turning L and clearing to the S. Although he did not consider it necessary to take avoiding action he felt that the helicopter's presence was a serious risk to his safety.

himself from any ac on the final approach. The Board therefore concluded that the cause of the Airprox was that the R22 pilot had flown sufficiently close to the centreline of RW 25 to cause concern to the pilot of the PA28.

*Cause:* The R22 pilot flew close enough to RW 25 to cause concern to the PA28 pilot.

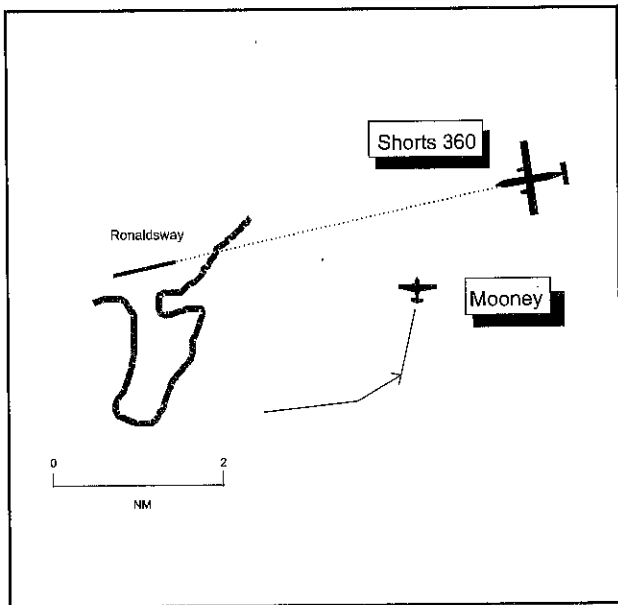
### **AIRPROX (P) REPORT No 154/98**

**THE SHORTS 360 PILOT** reports that he was inbound to the Isle of Man under the control of Ronaldsway APR on 120.85. The weather was VMC. When 6.5 NM from touchdown for RW 26, approaching the glidepath, he saw a Mooney ac at his 10 o'clock about 3 NM away tracking from L to R 700 ft above; he kept the ac in sight and watched it pass about 200 m in front of him. Although he had not felt it necessary to take avoiding action and thought the risk of collision was low, he considered his

The Board quickly concluded that the Mooney pilot caused the Airprox by not complying with ATC heading instructions; however, his honest admittance and apology for the error were appreciated. Aside from the possibility that he had unwittingly slipped into 'VFR' mode, members could find no explanation for his uncommanded turn onto base leg. Analysis of the RT recording shows that, having been passed the weather information, the pilot requested radar vectors for the ILS and was given an IFR clearance. Although he was not given specific information on the Shorts 360, or advised of his position in the traffic sequence, the RT transcript shows that the Shorts 360 was receiving ATC positioning instructions for the ILS at the same time as the Mooney and therefore the latter should have been aware of the situation.

*Cause:* The Mooney pilot did not obey ATC heading instructions and flew into conflict with the Shorts 360.

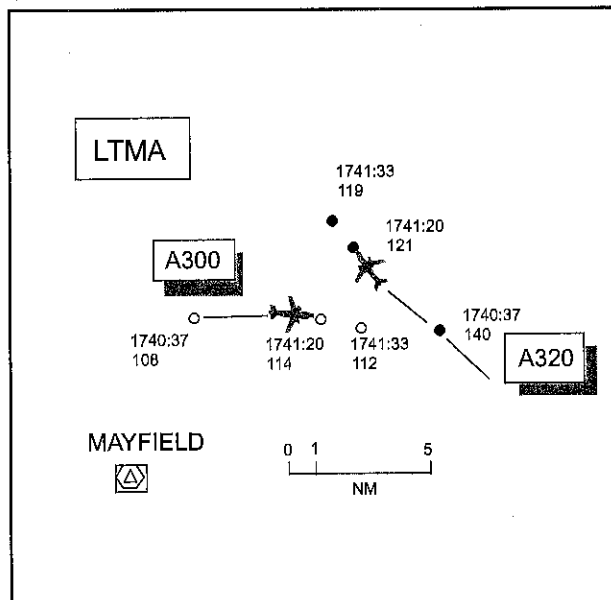
**THE A300 PILOT** reports that having departed from Gatwick on a WIZAD 4M SID, he was instructed to head E and climb to FL 110 (note: the RT transcript shows that the pilot was cleared to and acknowledged FL 120). On changing to the next frequency he was further cleared to FL 170, which was almost immediately amended to FL 130. When passing through about FL 120, a TCAS TA signalled traffic at his 12 o'clock descending at a range of about 8 NM. Assuming that the cause of the TA might be his own high rate of climb, he reduced it [by using the autopilot vertical speed function]. On informing ATC of the situation, he was advised that the other ac had 'bust its level'. No instructions were passed either to him or the pilot of the other ac. ATCAS RA then cautioned "monitor vertical speed", by which time the other ac was 3 NM ahead of him and still apparently on a reciprocal heading; being unsure of what it might do, he disconnected the autopilot and made an immediate R turn in avoidance. At no time did he see the other ac, but TCAS indicated that it passed down his port side 2 - 3 NM away and 300 ft above. He felt there had been a very high risk of collision.

**THE A320 PILOT** reports that he was unaware until some weeks later that he had been involved in an incident. He recalls that he had been given and read back a clearance to descend to FL 80 by LATCC. Passing about FL 115 he was asked to confirm his passing level;

Cause: The LATCC TC SE SC descended the A320 into conflict with the A300.

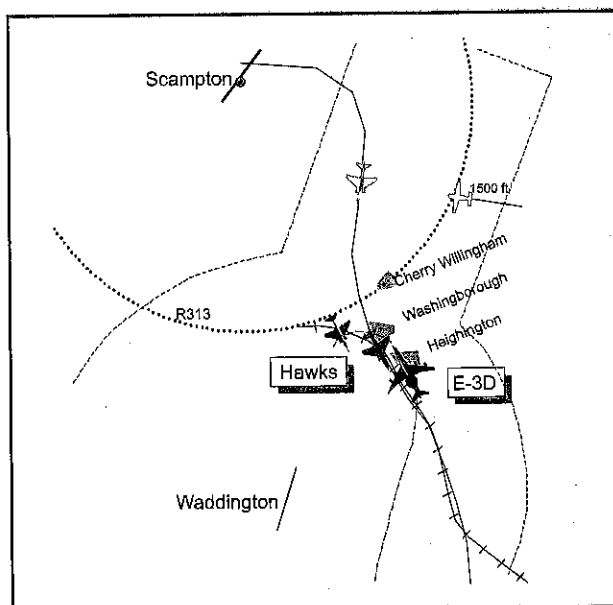
### AIRPROX (P) REPORT No 156/98

**THE SENTRY PILOT** reports heading 300° at 155 kt descending through 700 ft in a LH final turn for RW 21 at Waddington. He saw 2 Hawks less than 0.25 NM head-on and slightly below which he first thought were 2 lights in Lincoln. One Hawk gave a short burst of smoke. Both passed directly beneath by 200 ft as he turned and climbed to maintain separation; his ability in this respect was limited by his speed and configuration. He had not been warned about the traffic and there had been a moderate risk of collision. R313 had been briefed pre-flight as inactive for a 3 week period but before flight ATC had advised him that R313 had become active.

The Board agreed that the actions taken to modify the LoA should make a recurrence of this type of incident less likely. Members agreed that the Sentry pilot had every right to expect traffic information on the Hawks about to penetrate the MATZ and that part of the cause of the incident was that ADC inexplicably did not pass on APP's warning to the E3D pilot. The Hawks flew an inconsiderate path through the airspace the Sentry pilot would have used during his final turn, causing him to delay his descent on finals in avoidance; the Bulldog at 1500 ft could not have been a sufficient reason for the Hawks to have flown where they did and the Board agreed that part of the cause of the incident was that the Hawk pilots flew sufficiently close to the E3D to cause its pilot concern for the safety of his ac.

*Cause:* ADC did not pass traffic information on the Hawks to the Sentry pilot and the Hawk pilots flew sufficiently close to the Sentry to cause its pilot concern for the safety of his ac.

**HQ PTC** comments that this report might not have been filed had either ADC warned the E3D that the Hawks were about to underfly him in visual contact or had the Hawks stuck more closely to the promulgated route. Despite these 2 factors the procedure failed safe by virtue of its VFR limitation and the transit height allocated to the pair. Moreover, the radar recording tends to support a greater vertical separation than the E3D pilot's assessment; he appears to have maintained his downwind height rather than to have climbed in avoidance. Since this incident RAFC Cranwell and RAF Waddington have agreed a new transit procedure to ensure that there is no conflict with the wider

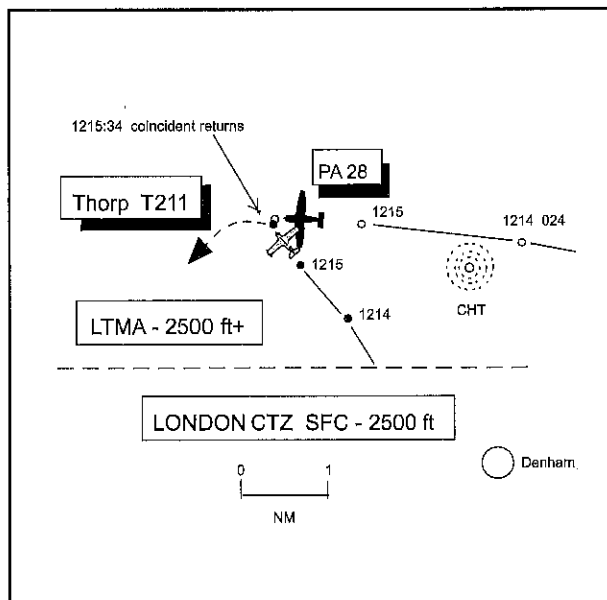
**AIRPROX (P) REPORT No 158/98**

**THE THORP T211 PILOT** reports that he was receiving a FIS (this point is discussed in Part B) from Denham radio on 130.72 while conducting a local flight to the NW of Denham in VMC. The visibility, between cloud layers, was about 30 km. When heading 330° at 80 kt and climbing through 2300 ft (QNH 1013) about 4 NM NW of the airfield, he saw the other ac, a Piper Arrow, 100 - 150 ft away to the R heading W at the same level having approached from his 4.30 position; he was able to read its registration. He immediately banked hard L, climbing about 300 ft to avoid the other ac's wake. He thought there had been a very high risk of collision. The pilot comments that vision to the rear from the cockpit of this ac is limited. Being familiar with the airspace around Denham and knowing how congested it is, he always tries to maintain a careful lookout. However, on this occasion the other ac had approached unseen from behind him and he could not understand why its pilot had not seen him.

Although the Thorp did not strictly have right of way under the Rules of the Air, members observed that there was an overtaking element in the geometry of the encounter which shifted some of the onus for avoiding action onto the PA28 pilot. In the circumstances, and allowing for the restricted vision from the Thorp's cockpit, it was felt the PA28 pilot was in a better position from a visual aspect to have seen the Thorp in good time to avoid it. But he did not and his non-sighting was assessed also to be part of the cause.

*Cause:* Non-sighting by the PA28 pilot and a late sighting by the Thorp pilot.

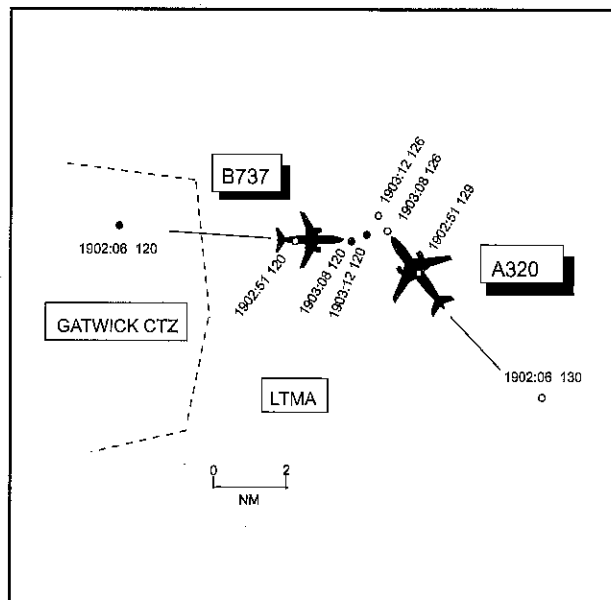
**ATSI** reports that the Airprox occurred in Class A airspace of the LTMA about 5 NM S of the BIGGIN VOR. The LATCC TC SE sector was operating in the split mode with one controller managing all LTMA inbound ac on TC TIMBA position (TC SE INs), and another controller

The Board noted that radar separation at the time the acs' paths crossed was in the order of 1 NM and 600 ft and concluded that there had not been a risk of collision.
