### **AIRPROX REPORT No 2020156**

Date: 25 Oct 2020 Time: 1426Z Position: 5119N 00048W Location: Blackbushe circuit

# PART A: SUMMARY OF INFORMATION REPORTED TO UKAB

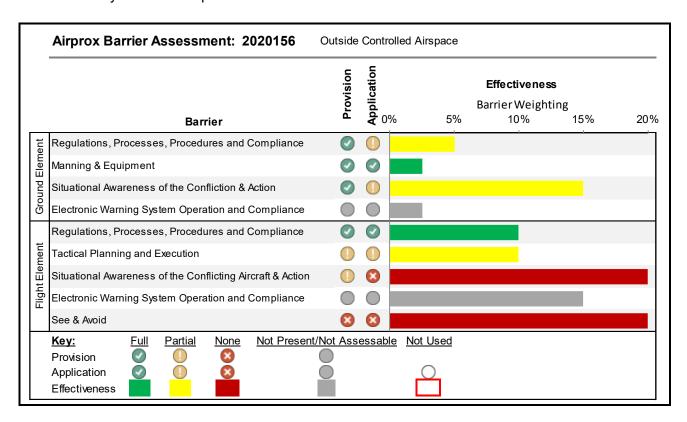
<sup>&</sup>lt;sup>4</sup> The UK Airprox Board scheme for assessing the Availability, Functionality and Effectiveness of safety barriers can be found on the UKAB Website.

**See and Avoid** were assessed as **ineffective** because neither pilot saw the other aircraft in time to materially affect the separation.
