AIRPROX REPORT No 2021003

Date: 13 Jan 2021 Time: 1117Z Position: 5240N 00030W Location: IVO Stamford

PART A: SUMMARY OF INFORMATION REPORTED TO UKAB

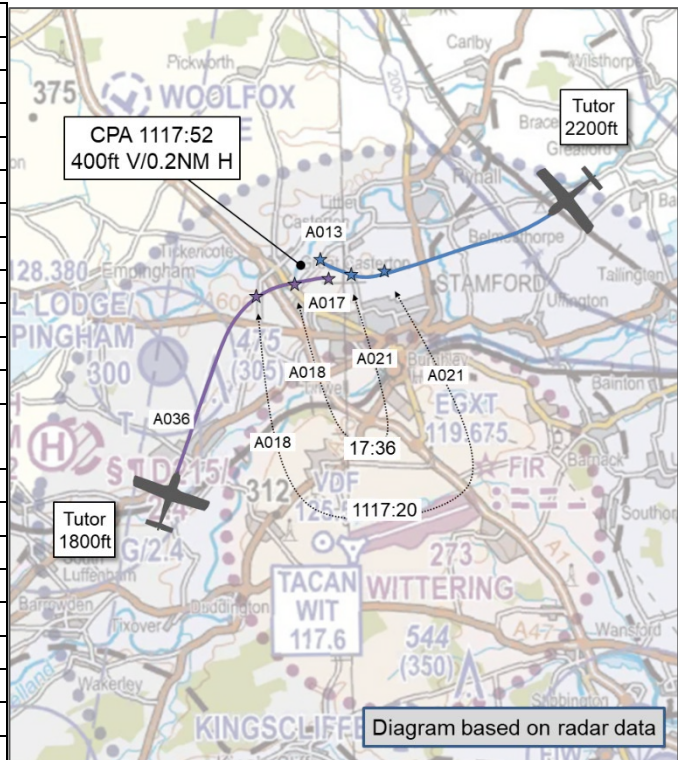
Recorded	Aircraft 1	Aircraft 2
Aircraft	Tutor(A)	Tutor(B)
Operator	HQ Air (Trg)	HQ Air (Trg)
Airspace	Wittering MATZ	Wittering MATZ
Class	G	G
Rules	IFR	IFR
Service	Deconfliction	Deconfliction
Provider	Wittering	Wittering
Altitude/FL	1300ft	1700ft
Transponder	A, C, S	A, C, S
Reported		
Colours	White	White
Lighting	Nav, HISL, Landing	Nav, HISL
Conditions	IMC	IMC
Visibility	0km	1km
Altitude/FL	2000ft	1500ft
Altimeter	QFE (1007hPa)	QFE (1007hPa)
Heading	255°	070°
Speed	100kt	100kt
ACAS/TAS	TAS	TAS
Alert	TA	TA
Separation		
Reported	100-150ftV/3-400m H	0ft V/0.3NM H
Recorded	400ft V/0.2NM H
