AIRPROX REPORT No 2021093

Date: 24 Jun 2021 Time: 1442Z Position: 5142N 00146W Location: Brize Norton

PART A: SUMMARY OF INFORMATION REPORTED TO UKAB

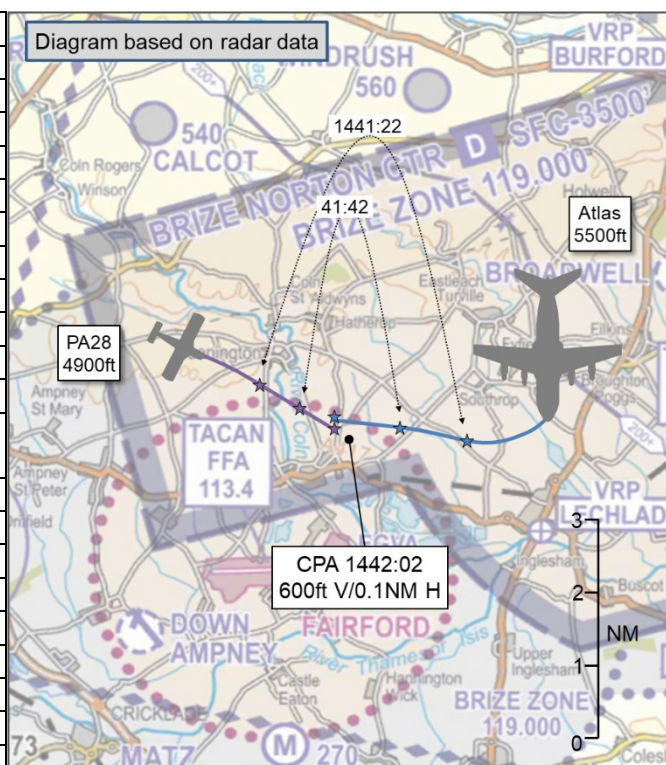
Recorded	Aircraft 1	Aircraft 2
Aircraft	Atlas	PA28
Operator	HQ Air (Ops)	Civ FW
Airspace	London FIR	London FIR
Class	G	G
Rules	IFR	IFR
Service	Traffic	Traffic
Provider	Brize	Brize
Altitude/FL	5500ft	4900ft
Transponder	A, C, S	A, C, S
Reported		
Colours	NR	White
Lighting	Strobes, HISLs, Nav	Strobes
Conditions	VMC	VMC
Visibility	NR	5-10km
Altitude/FL	5700ft	5000ft
Altimeter	QNH (1021hPa)	QNH (1021hPa)
Heading	278°	120°
Speed	180kt	100kt
ACAS/TAS	TCAS II	Not fitted
Alert	RA	N/A
Separation		
Reported	700ft V/0m H	500ft V/0m H
Recorded	600ft V/0.1NM H

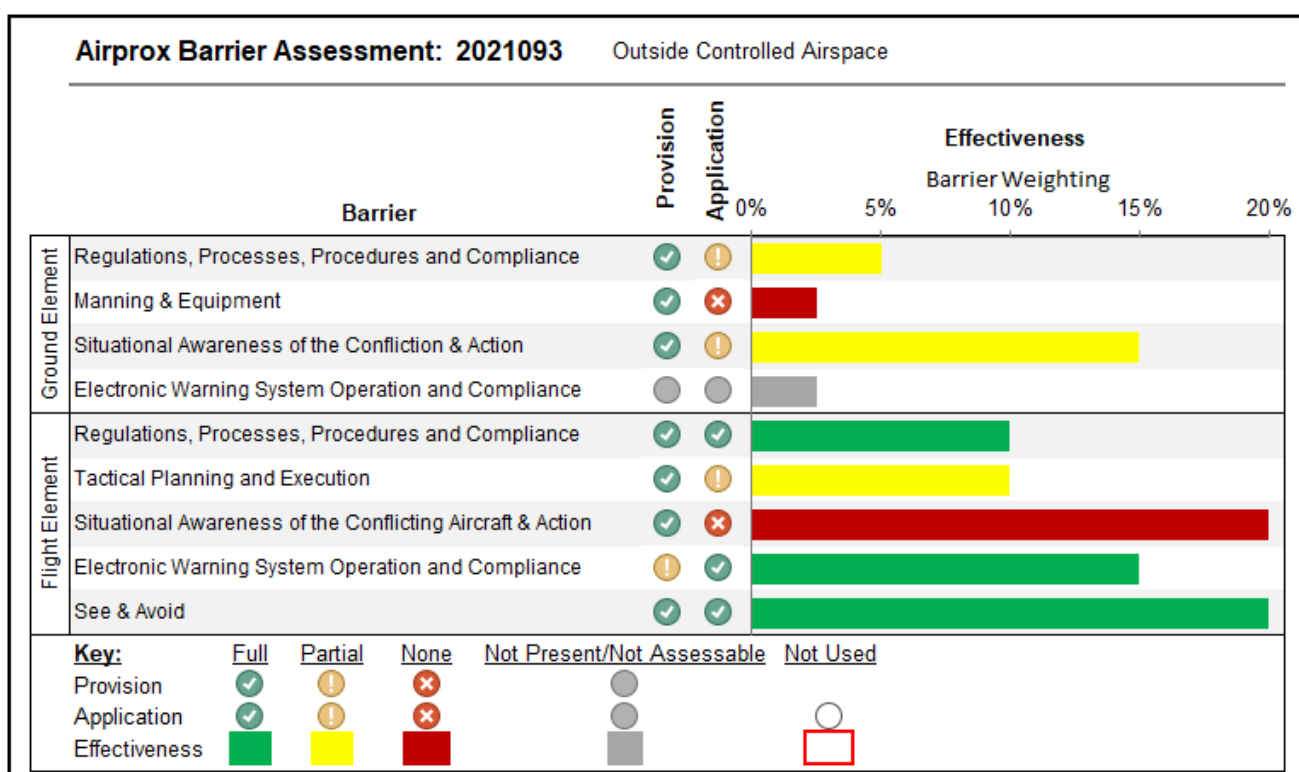
Tactical Planning and Execution was assessed as **partially effective** because the Atlas pilot did not update their plan after receiving Traffic Information from ATC.

Situational Awareness of the Conflicting Aircraft and Action were assessed as **ineffective** because the PA28 pilot did not have any situational awareness about the Atlas and the Atlas pilot continued towards the PA28 despite situational awareness.
