AIRPROX REPORT No 2021206

Date: 04 Oct 2021 Time: 1237Z Position: 5211N 00030W Location: 2.5NM NW of Bedford

PART A: SUMMARY OF INFORMATION REPORTED TO UKAB

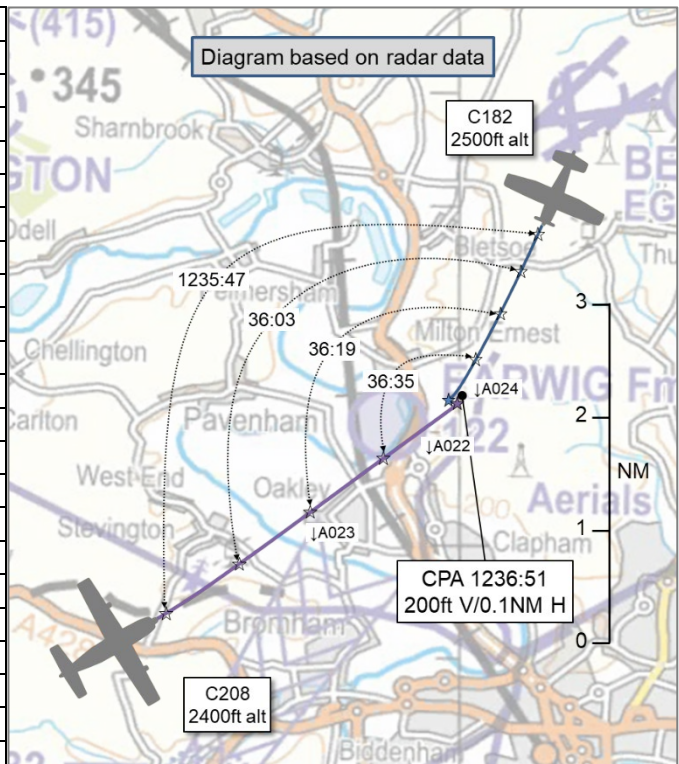
Recorded	Aircraft 1	Aircraft 2
Aircraft	C182	C208
Operator	Civ FW	Civ FW
Airspace	London FIR	London FIR
Class	G	G
Rules	IFR	VFR
Service	ACS	Basic
Provider	Cranfield Tower	London Info
Altitude/FL	2400ft	2200ft
Transponder	A, C, S	A, C, S
Reported		
Colours	White, red	White, red, blue
Lighting	Nav, strobes	Nav
Conditions	VMC	VMC
Visibility	>10km	>10km
Altitude/FL	2500ft	2000ft
Altimeter	QNH (NK hPa)	QNH (NK hPa)
Heading	212°	'North-east'
Speed	115kt	135kt
ACAS/TAS	Not fitted	Not fitted
Separation at CPA		
Reported	100ft V/100ft H	400ft V/400m H
Recorded	200ft V/0.1NM H
