AIRPROX REPORT No 2021213

Date: 13 Oct 2021 Time: 1243Z Position: 5102N 00221W Location: 2.5NM N Henstridge

PART A: SUMMARY OF INFORMATION REPORTED TO UKAB

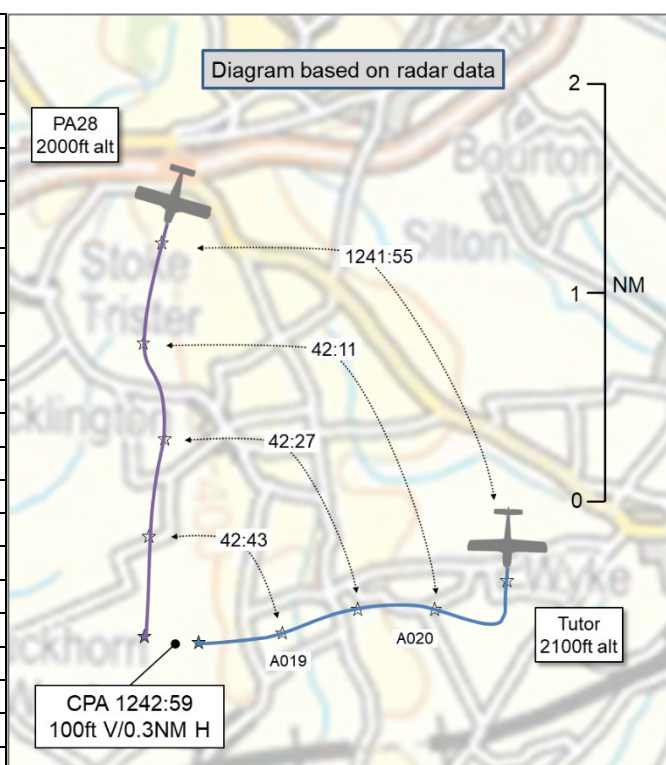
Recorded	Aircraft 1	Aircraft 2
Aircraft	Tutor	PA28
Operator	RN	Civ FW
Airspace	London FIR	London FIR
Class	G	G
Rules	IFR	VFR
Service	Traffic	None
Provider	Yeovilton Approach	N/A
Altitude/FL	1900ft	2000ft
Transponder	A, C, S	A, C
Reported		
Colours	White and blue	White and blue
Lighting	Nav, Strobe, HISL	Nav Anti-col
Conditions	VMC	VMC
Visibility	>10km	>10km
Altitude/FL	2000ft	2500ft
Altimeter	QFE (1025hPa)	QNH (NK hPa)
Heading	220°	180°
Speed	NR	100kt
ACAS/TAS	TAS	Not fitted
Alert	Information	N/A
Separation at CPA		
Reported	0ft V/0.5NM H	500ft V/2NM H
Recorded	100ft V/0.3NM H
