AIRPROX REPORT No 2022211

Date: 15 Sep 2022 Time: ~0933Z Position: 5100N 00219W Location: 1.5NM ENE Henstridge

PART A: SUMMARY OF INFORMATION REPORTED TO UKAB

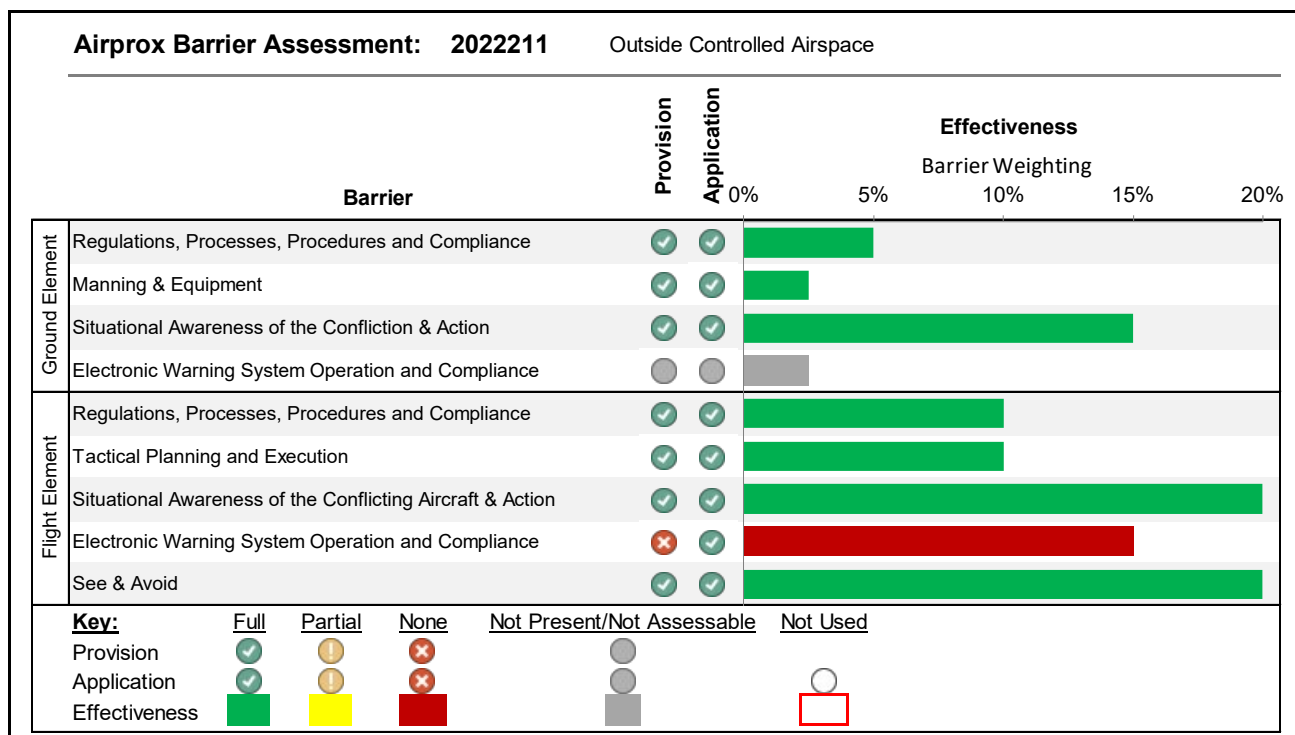
Flight Elements:

Electronic Warning System Operation and Compliance were assessed as **ineffective** because the EC equipment fitted to the Avenger had been unable to detect the unknown light-aircraft and had therefore been incompatible with any equipment its pilot had carried.
