**AIRPROX REPORT No 2022234**

Date: 23 Sep 2022 Time: 1417Z Position: 5322N 00010W Location: 6NM W Louth

**PART A: SUMMARY OF INFORMATION REPORTED TO UKAB**

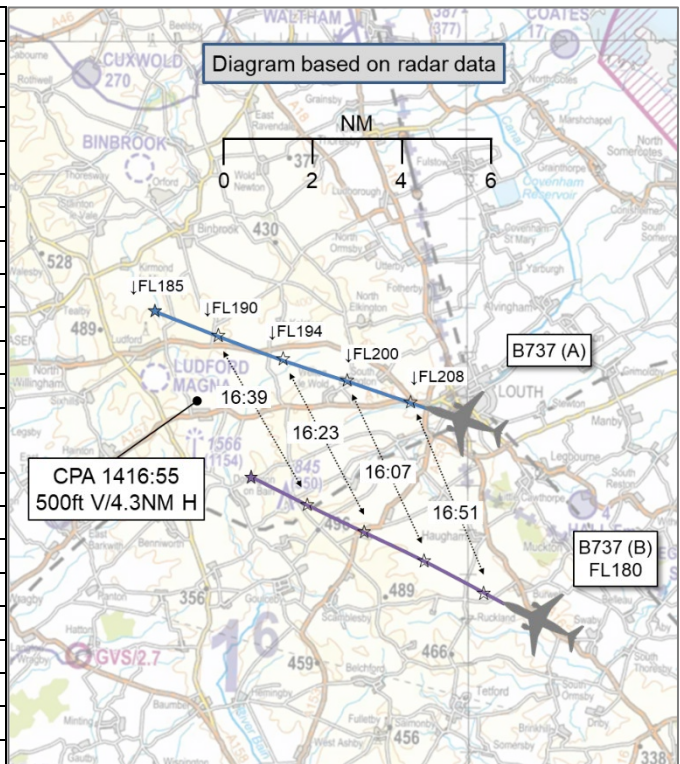
Recorded	Aircraft 1	Aircraft 2
Aircraft	B737(A)	B737(B)
Operator	CAT	CAT
Airspace	Lincolnshire CTA1	Lincolnshire CTA1
Class	A	A
Rules	IFR	IFR
Service	Radar Control	Radar Control
Provider	Scottish Control	Doncaster App
Altitude/FL	FL185	FL180
Transponder	A, C, S+	A, C, S+
<b>Reported</b>		
Colours	White, Blue	Blue, White, Red
Lighting	Anti-col, Strobe, Nav	Anti-col, Strobe, Nav
Conditions	VMC	VMC
Visibility	>10km	NR
Altitude/FL	FL185	NR
Altimeter	Std (1013hPa)	Std (1013hPa)
Heading	NR	NR
Speed	290kt	NR
ACAS/TAS	TCAS II	TCAS II
Alert	None	None
<b>Separation at CPA</b>		
Reported	600ft V/3NM H	Not seen
Recorded	500ft V/4.3NM H
