AIRPROX REPORT No 2022266

Date: 18 Nov 2022 Time: 1248Z Position: 5047N 00112W Location: Lee-on-Solent ATZ

PART A: SUMMARY OF INFORMATION REPORTED TO UKAB

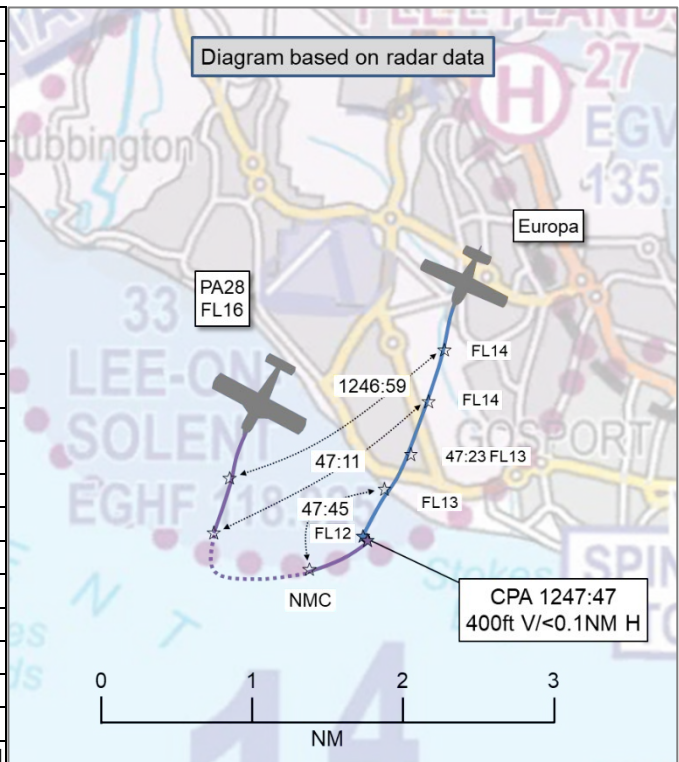
Recorded	Aircraft 1	Aircraft 2
Aircraft	PA28	Europa
Operator	Civ FW	Civ FW
Airspace	Lee on Solent ATZ	Lee on Solent ATZ
Class	G	G
Rules	VFR	VFR
Service	AFIS	AFIS
Provider	Lee Information	Lee Information
Altitude/FL	FL016	FL012
Transponder	A, C, S	A, C, S
Reported		
Colours	White	White
Lighting	Beacon, landing	Strobes, nose
Conditions	VMC	VMC
Visibility	>10km	>10km
Altitude/FL	1000ft	1000ft
Altimeter	QFE (NK hPa)	QFE (1002hPa)
Heading	180°	190°
Speed	100kt	100kt
ACAS/TAS	Not fitted	PowerFLARM
Alert	N/A	None
Separation at CPA		
Reported	200ft V/0m H	~250ft V/~0.1NM H
Recorded	400ft V/<0.1NM H
