AIRPROX REPORT No 2022268

Date: 28 Nov 2022 Time: 1355Z Position: 5616N 00312W Location: 4NM N Glenrothes

PART A: SUMMARY OF INFORMATION REPORTED TO UKAB

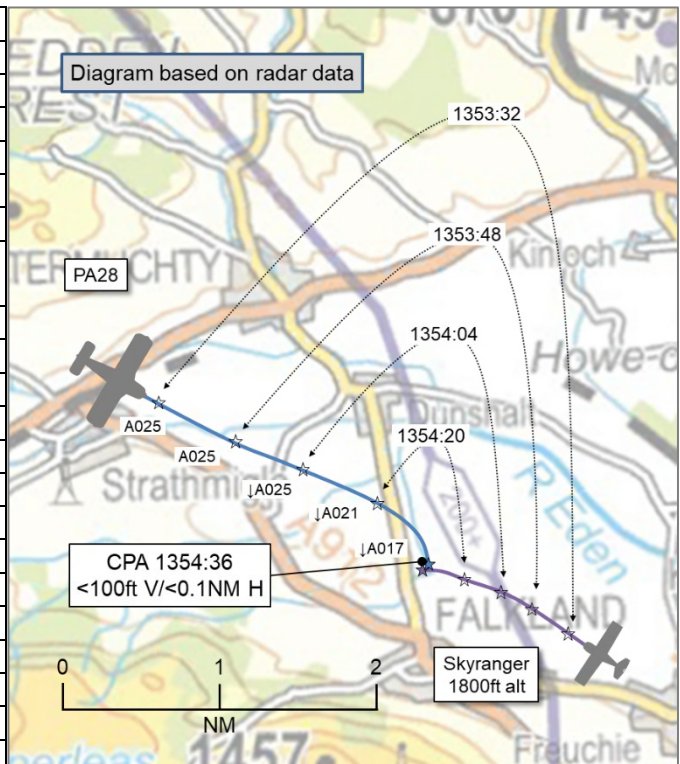
| Recorded | Aircraft 1 | Aircraft 2 |
|---|---|---|
| Separation at CPA | | |
| Reported | 30-40ft V/0m H | Not seen |
| Recorded | <100ft V/<0.1NM H | |
