## **AIRPROX REPORT No 2022273**

Date: 08 Dec 2022 Time: ~1208Z Position: 5059N 00207W Location: Compton Abbas

### **PART A: SUMMARY OF INFORMATION REPORTED TO UKAB**

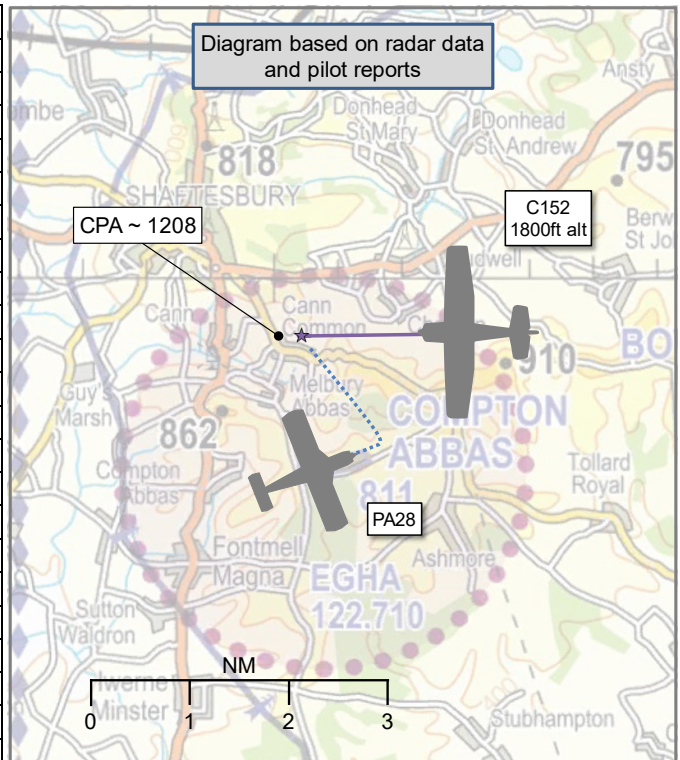
**THE PA28 PILOT** reports that they were in the Compton Abbas visual circuit when, during the climb-out after take-off, traffic was heard advising that they were joining the circuit downwind and would give way to crosswind traffic. The joining aircraft did not give way and was flying the extended downwind leg as they [the PA28] turned from crosswind to downwind. When sighted, the C152 was in their two o'clock approximately 200ft above and 200m laterally displaced. The instructor took control from the student and took avoiding action by descending and turning behind the other aircraft. Having assured adequate displacement, they then continued their climb to depart the circuit to the west. They believed that a conversation took place with Compton Ops staff when the visitor had landed. They understood that the other pilot said that they saw the PA28, but expected it to turn inside.

**THE C152 PILOT** reports that they were about 2 miles from downwind for RW08 when they heard the other pilot call downwind touch-and-go. They then saw the other aircraft turning crosswind. They therefore made the following call to Compton Radio, (this is word for word). '[C/S] has the aircraft in sight that is turning crosswind, I will join wide downwind, and will slot in No2 behind the other aircraft'. No reply was heard, and nothing from the other aircraft. As the other aircraft approached from the left it did not appear to be turning downwind, so they maintained height and the other aircraft passed underneath them. The other pilot subsequently called to say they were vacating the circuit to the north. They had the other aircraft in sight from them turning crosswind and would have taken evading action if there had been danger of collision. They did not believe there was a danger of collision at any time. They noted that they were fully aware that joining traffic should give way to established circuit traffic, which is what they intended to do by turning right and going wide.

**THE COMPTON AGO** reports the [C152 C/S pilot] inbound had called for airfield information, which was relayed. They did not request that the C152 perform a standard overhead join. [PA28 C/S] was crosswind traffic, when the next transmission from [C152 C/S pilot] was that they were joining the circuit at the downwind leg, and would 'give way to the crosswind traffic'. The C152 did not appear to change its course. The two aircraft seemed to converge to within such a distance that they [the AGO] thought concerning, at the turn between crosswind and downwind. When both aircraft were on the downwind leg, [C152 C/S pilot] appeared unsure as they declared they were 'second on downwind', but then followed this with 'becoming first' once realising that the PA28 was behind them. The PA28 then departed the circuit, and the C152 completed the circuit, landed, and parked-up. They discussed the event with the pilot at the desk, and the pilot informed them that they were visual with [PA28 C/S] the entire time, and were expecting the PA28 to turn on the inside of the C152.
