**AIRPROX REPORT No 2023008**

Date: 24 Jan 2023 Time: 0952Z Position: 5139N 00028W Location: 5NM SSE Elstree

**PART A: SUMMARY OF INFORMATION REPORTED TO UKAB**

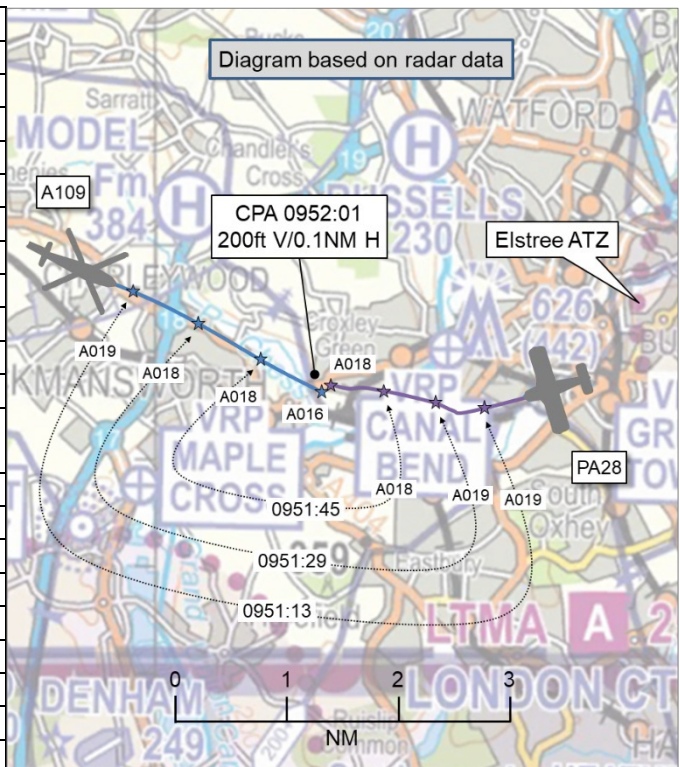
Recorded	Aircraft 1	Aircraft 2
Aircraft	A109	PA28
Operator	Civ Comm	Civ FW
Airspace	London FIR	London FIR
Class	G	G
Rules	VFR	VFR
Service	Basic	AFIS
Provider	Heathrow Radar	Elstree Information
Altitude/FL	1600ft	1800ft
Transponder	A, C, S	A, C, S
Reported		
Colours	Gold	White
Lighting	Anti-col, strobes, landing	Anti-col, HISL, beacon
Conditions	VMC	VMC
Visibility	5-10km	<5km
Altitude/FL	1800ft	1100ft
Altimeter	QNH (NK hPa)	QFE (NR hPa)
Heading	120°	260°
Speed	140kt	90kt
ACAS/TAS	TAS	Not fitted
Alert	None	N/A
Separation at CPA		
Reported	100ft V/100m H	NK V/NK H
Recorded	200ft V/0.1NM H

At 0951:24, when approximately 0.5NM south of Canal Bend VRP, the pilot of the PA28 was observed to turn right by approximately 25° and the CPA occurred less than a minute later. Just after CPA, the pilot of the PA28 turned left to track back to Elstree, initially on the new runway heading (080°).
