AIRPROX REPORT No 2023087

Date: 22 May 2023 Time: 1009Z Position: 5214N 00126W Location: 7NM ENE of Wellesbourne

PART A: SUMMARY OF INFORMATION REPORTED TO UKAB

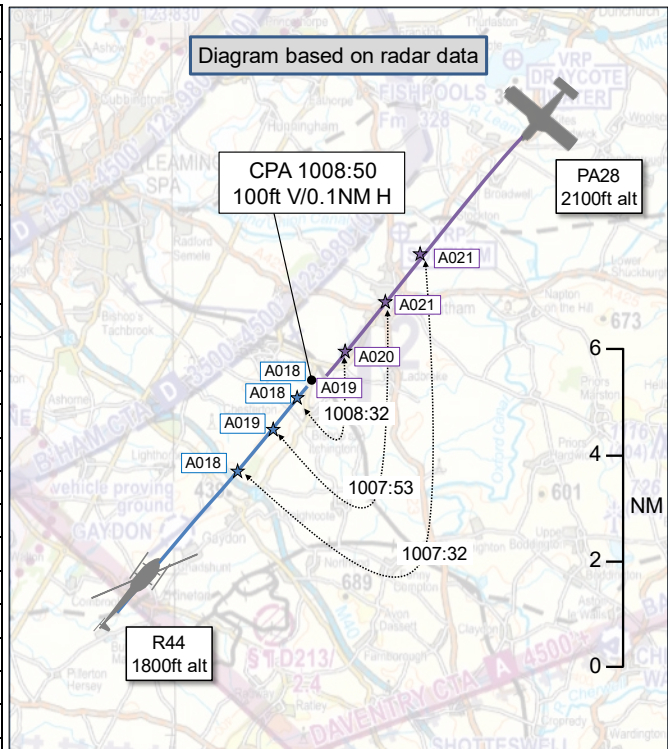
[The Airprox occurred] between the waypoints of Gaydon and junction 19 of the M1 at an altitude of 2000ft. After flying over Gaydon they encountered some turbulence, to which they [reacted by] slowing the helicopter down to 80kts to lessen the effects, which was maintained up to the point of a visual of, what was later identified as, [a PA28]. While flying north of Gaydon, at Bishop’s Itchington, they noticed ‘wings and a fuselage’ at roughly the same altitude, they could not see the tail or the underside of the aircraft, which was positioned to their right but located in the front right quarter of the windscreen. They immediately established that [the PA28] was flying towards them and had assumed that the [other pilot] would turn [the PA28] further towards their port side to run parallel to them. They reported that it had quickly become apparent that the [PA28] had not [been flown as expected] and was flying at roughly a 15° angle towards them.

They reduced [the R44’s] power to lower its altitude and gain time with [the PA28] passing in their right hand door window, top 1/4 at circa 50ft to their right and circa 40ft higher while [the PA28] had maintained the same angle of approach. As [the PA28] passed, their main focus had been to ensure that they had cleared each other, having taken no time to think about taking the registration number down, but it was clearly identifiable with a red top tail, red underside and the remaining aircraft white. It was a fixed-wing aircraft, with the wings on the underside of the fuselage and a single engine. After passing [the PA28], they levelled [the R44] and were around 1800ft at time 1012. Immediately afterwards there was a radio call from a [pilot] to Wellesbourne Information [stating] that they were on the east of the airfield for an approach to them. They [the reporter] assumed that this was [the PA28 pilot making the call] but their focus at the time had been on gaining a steady flight path. They continued their navigation exercise but cut it short and turned southeast once they were at the HS2 construction
